**Flood Control Project Maintenance
Levee Inspections**

Maintenance Issue Types Only, Levee Inspection Report By Mile - Fall 2023

San Joaquin County Flood Control and Water Conservation District

Waterway	Bank	Unit Miles	Inspection Start/End	Inspector
Unit No. 01 Littlejohn Creek	Left	2.59	10/20/2023 10/20/2023	Alberto De Leon

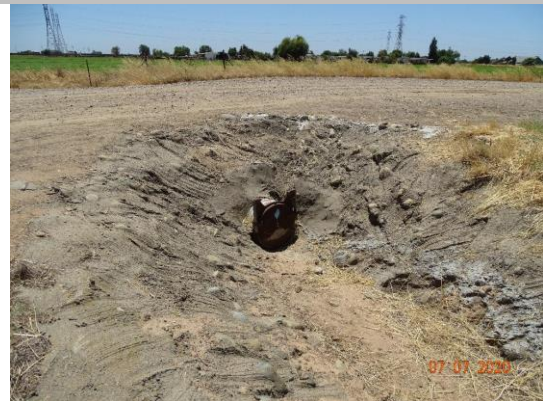
Photo 2 of 3 : UCIP_FA_2023_79114_87170.jpg

View of pipe outlet at the WS toe.

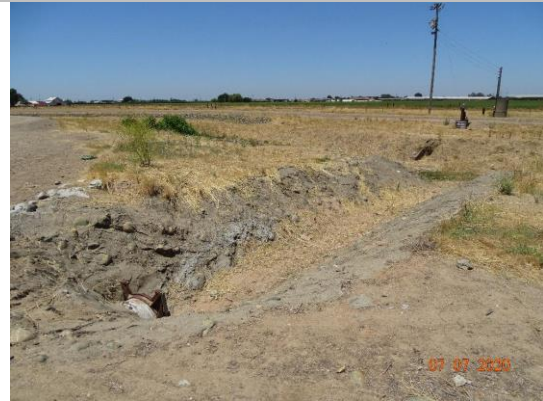
Photo 3 of 3 : UCIP_FA_2023_79114_87171.jpg

View of pipe outlet and cobble grouted outlet channel at the WS toe.

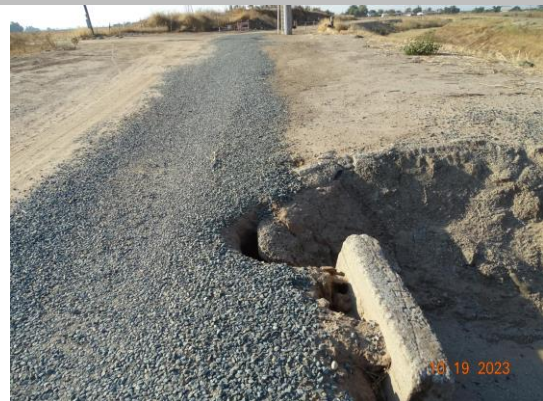
Photo 1 of 1 : FA_2023_NA0017_156_26_20231030_00069.jpg

LM Start	2.71	Rating **	M	Issue No.	26
LM End	2.71	Issue Type +	Ma	Location *	WS
Category	Earthen Levee			GPS Latitude/Longitude	
				Start	End
Item	Erosion / Bank Caving			38.122719°	38.122719°
				-121.144326°	-121.144326°
DWR ID	DWR_NA0017_12_f_2023_26

Erosion near culvert headwall is encroaching onto the patrol road.

Erosion next to concrete headwall on the waterside side. Fall 2023

E2 : Schedule repair of erosion site prior to the next inspection.

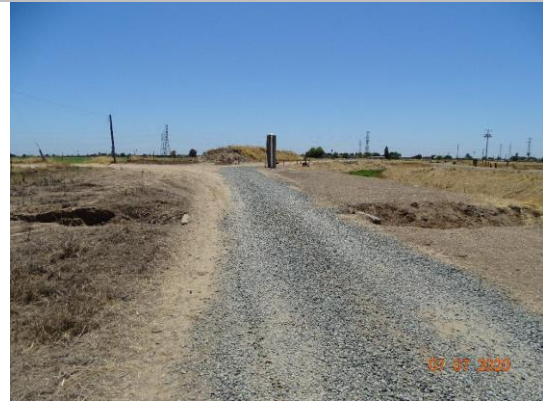
Photo 1 of 3 : UCIP_FA_2023_79109_87211.jpg

Comment Code						
Inspector Comment						
DS_ID:23915						
FS_ID:79109						
EP_NO: N/A						
Repair Type: Non-Urgent						
EVAL Issue:						
Crossing Status: Found						
UCIP Comments: 07/07/2020 Crossing evaluated as "Non-Urgent" because there was no permit found authorizing this pipe. Inlet partially blocked with sediment. (A. McDonald - DWR UCIP)						
FIELD_STRUCT_DESC: 12-inch corrugated metal drainage pipe through the levee, 2 feet below the crown. Flap gate on the waterside (WS) end. Cobble grouted outlet. Cobble grouted intake on the landside (LS). [Additional Reference(s): DWR Levee Log, 1978, (HLM 2.72). USACE San Joaquin O&M Manual 612.2, 1967, (HLM 2.72), 12-inch pipe listed].						
FS Date: 7/7/2020

Overview of levee crown looking d/s.

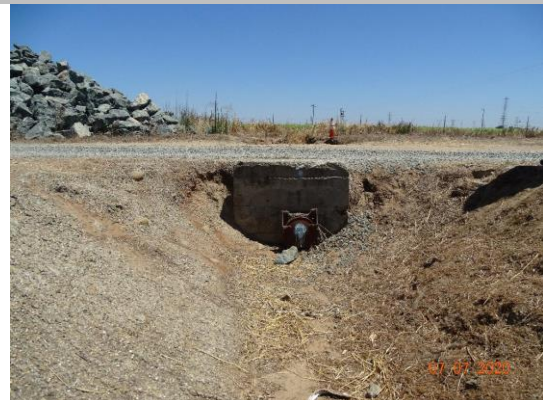
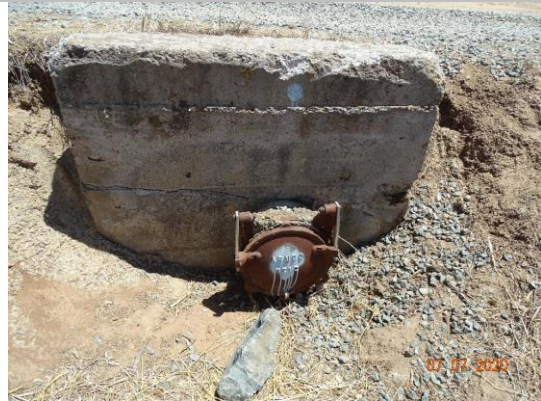
Photo 2 of 3 : UCIP_FA_2023_79109_87212.jpg

View of pipe outlet, flap gate, and headwall located at the WS levee toe.

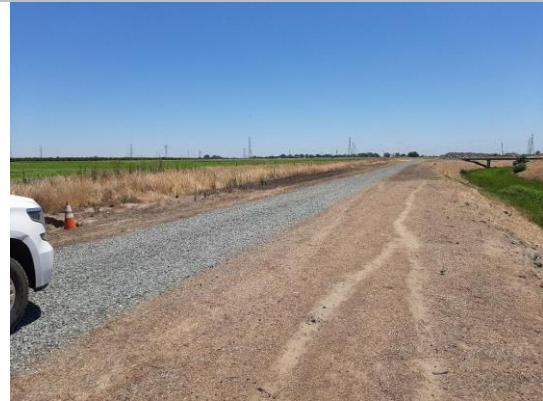
Photo 1 of 3 : UCIP_FA_2023_79110_87220.jpg

Comment Code						
Inspector Comment						
DS_ID:23916 FS_ID:79110 EP_NO: N/A Repair Type: No Action Needed EVAL Issue: Crossing Status: Found UCIP Comments: 07/03/2020 Crossing evaluated as "No Action Needed." Permit and inspection requirements have been met. (A. McDonald - DWR UCIP) FIELD_STRUCT_DESC: 12-inch corrugated metal drainage pipe through the levee, 3 feet below the crown. Flap gate on the waterside (WS) end. Cobble grouted outlet. (Positive closure device installed on intake end under Permit No. 17426, 2003 - Western Dairy Design Associates, Inc.). [Additional Reference(s): DWR Levee Log, 1978, (HLM 2.95). USACE San Joaquin O&M Manual 612.2, 1967, (HLM 2.95), 12-inch pipe listed]. FS Date: 7/3/2020

Overview of levee crown looking d/s.

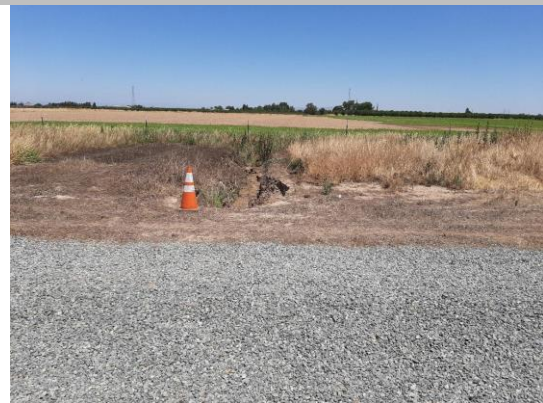
Photo 2 of 3 : UCIP_FA_2023_79110_87222.jpg

Overview of the LS and pipe inlet location.

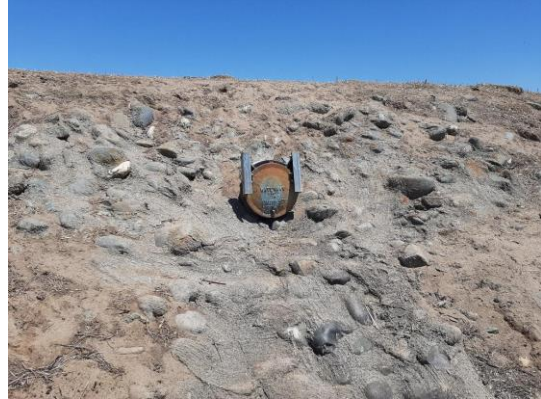
Photo 3 of 3 : UCIP_FA_2023_79110_87221.jpg

View of pipe outlet, flap gate, and splash apron located at the WS levee toe.

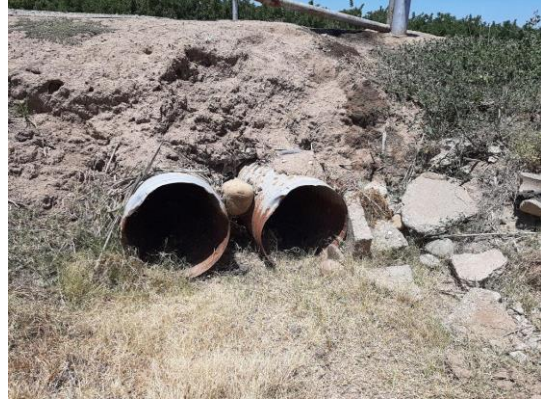
Photo 1 of 3 : UCIP_FA_2023_79115_87233.jpg

Comment Code					
Inspector Comment					
DS_ID:23928 FS_ID:79115 EP_NO: N/A Repair Type: Urgent EVAL Issue: 1, Pipe Integrity Crossing Status: Found UCIP Comments: 07/03/2020 Crossing evaluated as "Urgent" because of a badly deteriorated drainage pipe that is also open on both ends. There was no permit found authorizing this pipe, either. (A. McDonald - DWR UCIP)11/12/2018 NA0017 found corrosion and holes along the bottom of this CMP drainage culvert. Culvert is also open on both ends. Crossing escalated to "Urgent" due to the extensive corrosion that was found. Internal inspection and/or rehabilitation recommended. (A. McDonald - DWR UCIP)Pipe open on both ends. FIELD_STRUCT_DESC: 1 of 2: 24-inch corrugated metal drainage pipe through the levee, 3.0 feet below the crown. No closure device or flap gate. [Additional Reference(s): USACE San Joaquin O&M Manual 612.2, 1967, (HLM 3.15), 24-inch pipe listed]. FS Date: 7/3/2020

View of two drainage pipe inlets located at the LS levee toe.

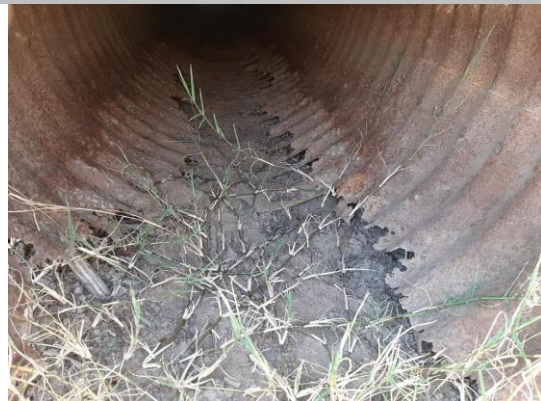
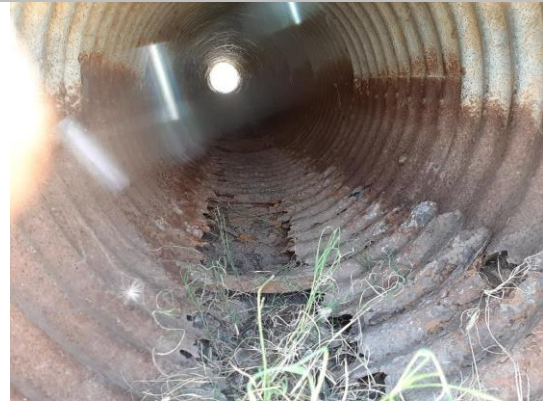
Photo 2 of 3 : UCIP_FA_2023_79115_87225.jpg

View of corrosion inside drainage pipe.

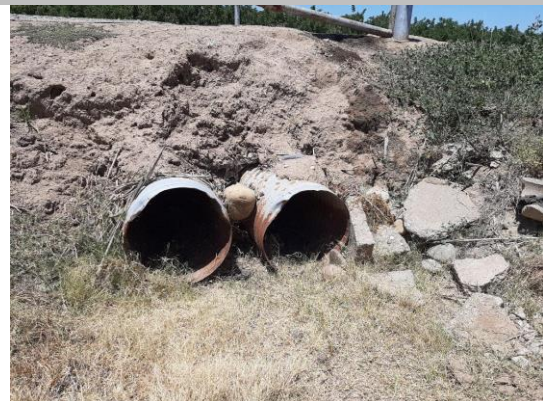
Photo 1 of 3 : UCIP_FA_2023_79116_87244.jpg

DS_ID:23926
FS_ID:79116
EP_NO: N/A
Repair Type: Urgent
EVAL Issue: 1, Pipe Integrity
Crossing Status: Found
UCIP Comments: 07/03/2020 Crossing evaluated as "Urgent" because of a badly deteriorated drainage pipe that is also open on both ends. There was no permit found authorizing this pipe, either. (A. McDonald - DWR UCIP)11/12/2018 NA0017 found corrosion and holes along the bottom of this CMP drainage culvert. Culvert is also open on both ends. Crossing escalated to "Urgent" due to the extensive corrosion that was found. Internal inspection and/or rehabilitation recommended. (A. McDonald - DWR UCIP)Pipe open with no flap gate.
FIELD_STRUCT_DESC: 2 of 2: 24-inch corrugated metal drainage pipe through the levee, 3 feet below the crown. No closure device or flap gate. [Additional Reference(s): USACE San Joaquin O&M Manual 612.2, 1967, (HLM 3.15), 24-inch pipe listed].
FS Date: 7/3/2020

View of two drainage pipe inlets located at the LS levee toe.

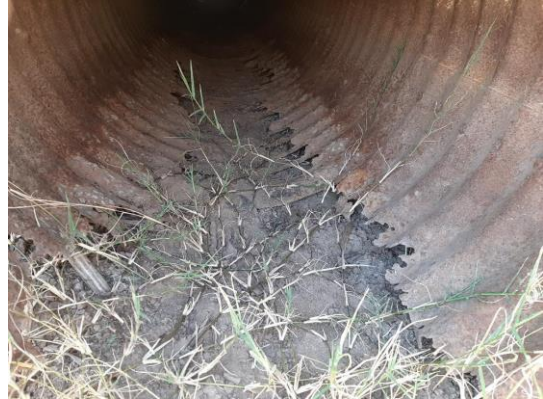
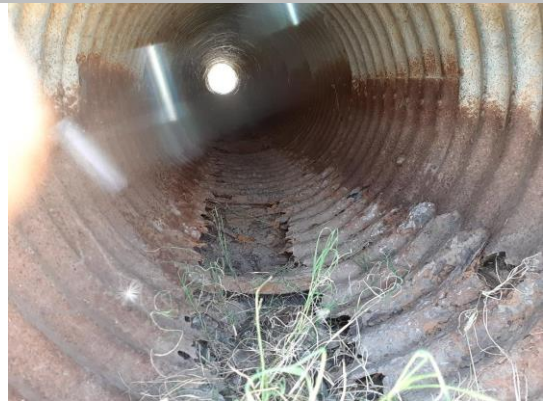
Photo 2 of 3 : UCIP_FA_2023_79116_87236.jpg

View of corrosion inside drainage pipe.

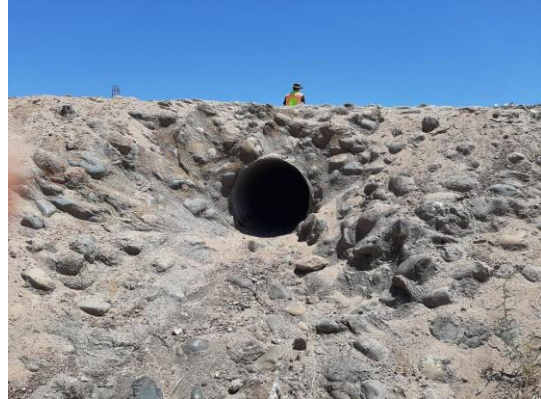
Photo 1 of 2 : UCIP_FA_2023_79117_87248.jpg

Comment Code					
Inspector Comment					
DS_ID:23917 FS_ID:79117 EP_NO: N/A Repair Type: Urgent EVAL Issue: 1, Pipe Integrity Crossing Status: Found UCIP Comments: 09/19/2023 DMP internal video inspection has found severe pipe defects. Crossing will be monitored until funding becomes available to address the issues. (O. Yakimov - DWR UCIP) 07/03/2020 Crossing evaluated as "Urgent" because it is a straight-through drainage pipe with no flap gate on the WS end. There was also no permit found authorizing this pipe. (A. McDonald - DWR UCIP) 06/19/2014 No flap gate. (DWR UCIP) FIELD_STRUCT_DESC: 24-inch corrugated metal drainage pipe through the levee, 4.5 feet below the crown. Cobble grouted outlet. Cobble grouted intake on the landside (LS). [Additional Reference(s): DWR Levee Log, 1978, (HLM 3.25). USACE San Joaquin O&M Manual 612.2, 1967, (HLM 3.25), 24-inch pipe listed]. FS Date: 7/3/2020

View of pipe outlet and splash apron located at the WS levee toe.

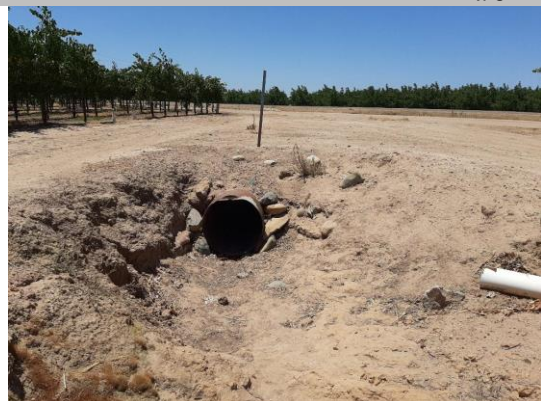
Photo 2 of 2 : UCIP_FA_2023_79117_87249.jpg

View of pipe inlet located 50 to 100 feet off the LS levee toe.

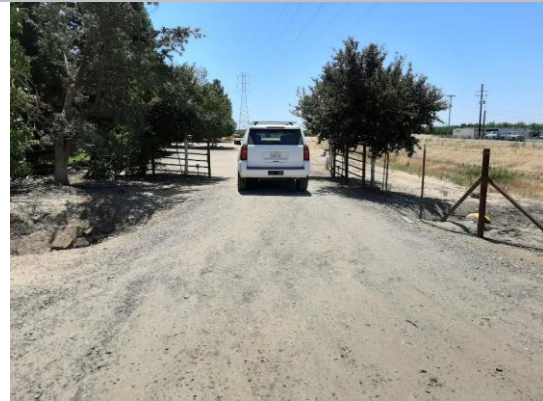
Photo 1 of 3 : UCIP_FA_2023_79119_87257.jpg

LM Start	3.51	Rating **	U	Issue No.	72	
LM End	3.51	Issue Type +	Ma	Location *		
Category	Supplemental			GPS Latitude/Longitude		
				Start	End	
Item	DWR UCIP LMA Responsibility			38.131725°	38.131725°	
				-121.138422°	-121.138422°	
DWR ID	23920					
Comment Code						
Inspector Comment						
DS_ID:23920 FS_ID:79119 EP_NO: N/A Repair Type: Urgent EVAL Issue: 1, Pipe Integrity Crossing Status: Found UCIP Comments: 07/03/2020 Crossing evaluated as "Non-Urgent" because there was no permit found authorizing this pipe. Video inspection performed on 04-22-2020. (A. McDonald - DWR UCIP) FIELD_STRUCT_DESC: 12-inch corrugated metal drainage pipe through the levee, 4.5 feet below the crown. Cobble grouted outlet. [Additional Reference(s): DWR Levee Log, 1978, (HLM 3.52). USACE San Joaquin O&M Manual 612.2, 1967, (HLM 3.52), 12-inch pipe listed]. FS Date: 7/3/2020

Overview of levee crown looking d/s.

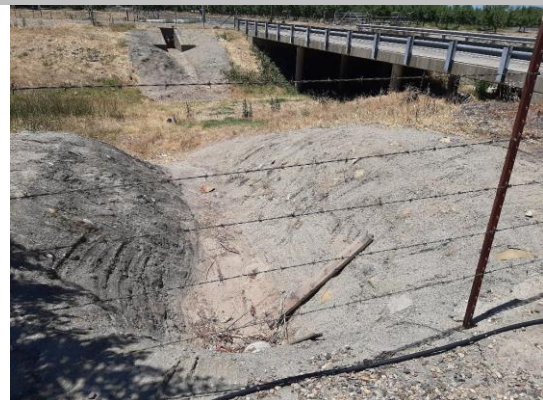
Photo 2 of 3 : UCIP_FA_2023_79119_87258.jpg

View of WS channel and splash apron.

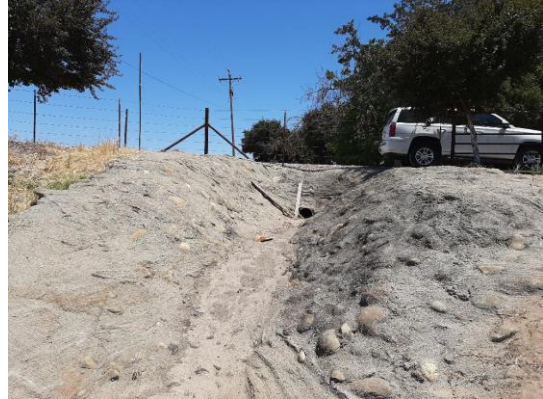
Photo 3 of 3 : UCIP_FA_2023_79119_87259.jpg

View of pipe outlet and splash apron located at the WS levee toe.

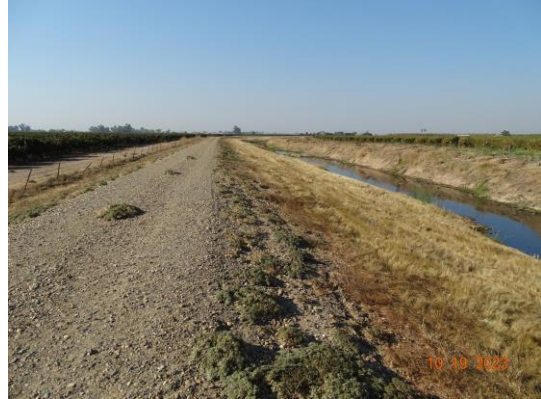
Photo 1 of 1 : FA_2023_NA0017_157_11_20231030_00011.jpg

LM Start	0.00	Rating **	A	Issue No.	11
LM End	1.38	Issue Type +	Ma	Location *	WS
Category	Earthen Levee			GPS Latitude/Longitude	
				Start	End
Item	Vegetation			38.109390°	38.110860°
				-121.160422°	-121.138841°
DWR ID	DWR_NA0017_13_f_2023_11				
Comment Code					
V1 : Control annual grass and weeds on the levee slopes and easements.					
Inspector Comment

View of well maintained vegetation along the waterside slope. Fall 2023

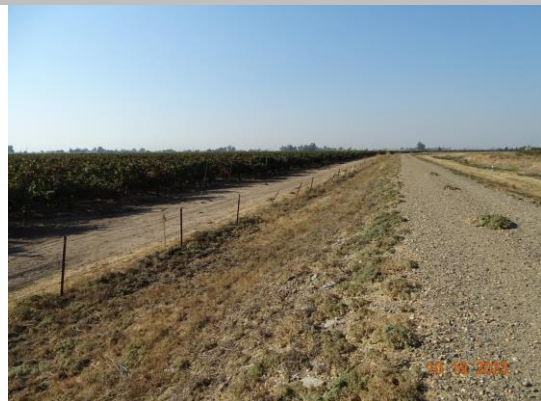
Photo 1 of 1 : FA_2023_NA0017_157_10_20231030_00010.jpg

LM Start	0.00	Rating **	A	Issue No.	10	
LM End	1.38	Issue Type +	Ma	Location *	LS	
Category	Earthen Levee			GPS Latitude/Longitude		
				Start		End
Item	Vegetation			38.109390°		38.110860°
				-121.160421°		-121.138840°
DWR ID	DWR_NA0017_13_f_2023_10					
Comment Code						
V1 : Control annual grass and weeds on the levee slopes and easements.						
Inspector Comment

View of well maintained vegetation along the landside slope and easement. Fall 2023

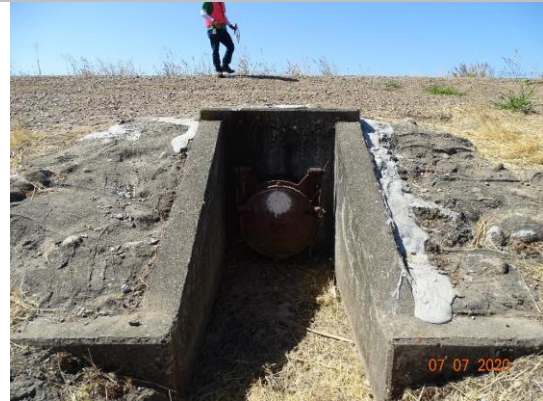
Photo 1 of 1 : UCIP_FA_2023_79121_86686.jpg

Comment Code					
Inspector Comment					
DS_ID:23931 FS_ID:79121 EP_NO: N/A Repair Type: No Action Needed EVAL Issue: Crossing Status: Found UCIP Comments: 07/07/2020 Record remains No Action Needed. This is s system feature without any modification to system. Same observation as last inspection. Pipe is in good condition. Video Inspection was performed in 4/24/2020 and the result will be appended to this report when it becomes available. (S.Donovan - DWR UCIP) FIELD_STRUCT_DESC: 24-inch corrugated metal drainage pipe through the levee, 5.5 feet below the crown. Concrete U-shaped headwall on both ends. Flap gate on the waterside (WS) end. [Additional Reference(s): DWR Levee Log, 1978, (HLM 0.03). USACE San Joaquin O&M Manual 612.2, 1967, (HLM 0.03), 24-inch pipe listed]. FS Date: 7/7/2020

Water-Side: View of pipe, headwall, and flapgate.

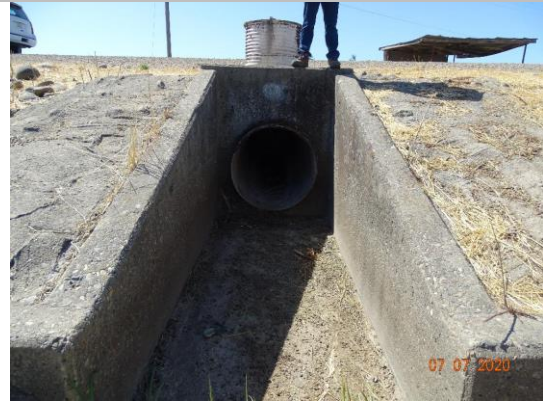
Photo 1 of 1 : UCIP_FA_2023_79122_86732.jpg

LM Start	0.41	Rating **	A/W	Issue No.	13
LM End	0.41	Issue Type +	Ma	Location *	
Category	Supplemental			GPS Latitude/Longitude	
				Start	End
Item	DWR UCIP LMA Responsibility			38.109602°	38.109602°
				-121.152997°	-121.152997°
DWR ID	23932				
Comment Code					
Inspector Comment					
DS_ID:23932 FS_ID:79122 EP_NO: N/A Repair Type: No Action Needed EVAL Issue: Crossing Status: Found UCIP Comments: 07/07/2020 Record remains No Action Needed. Pipe is in good condition, same as last inspection. (S.Donovan - DWR UCIP) FIELD_STRUCT_DESC: 36-inch corrugated metal drainage pipe through the levee, 7 feet below the crown. Concrete U-shaped headwall on both ends. Slide gate in 48-inch corrugated metal riser unit on the waterside (WS). Cobble grouted outlet. Cobble grouted intake on the landside (LS). [Additional Reference(s): DWR Levee Log, 1978, (HLM 0.41)]. FS Date: 7/7/2020 12:54:19 PM

Water-Side: view of pipe, headwall and standpipe.

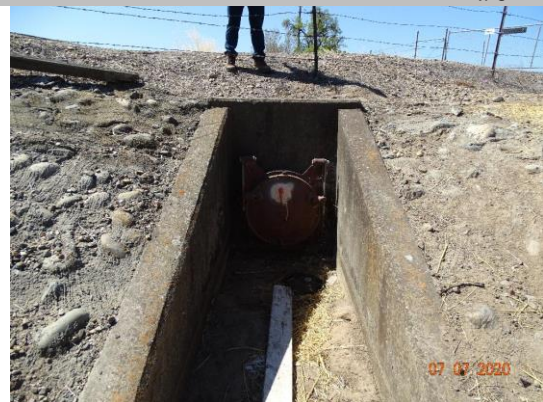
Photo 1 of 1 : UCIP_FA_2023_79123_86735.jpg

Comment Code					
Inspector Comment					
DS_ID:23933 FS_ID:79123 EP_NO: N/A Repair Type: No Action Needed EVAL Issue: Crossing Status: Found UCIP Comments: 07/07/2020 Record remains No Action Needed. Pipe was in good condition, same as last inspection. Internal video Inspection was performed on 2/21/2020 (S.Donovan - DWR UCIP) FIELD_STRUCT_DESC: 24-inch corrugated metal drainage pipe through the levee, 5 feet below the crown. Concrete U-shaped headwall on both ends. Flap gate on the waterside (WS) end. Cobble grouted outlet. Cobble grouted intake on the landside (LS). [Additional Reference(s): DWR Levee Log, 1978. USACE San Joaquin O&M Manual 612.2, 1967, (HLM 0.58), 24-inch pipe listed]. FS Date: 7/7/2020 1:09:28 PM

Water-Side: View of pipe, headwall and flapgate.

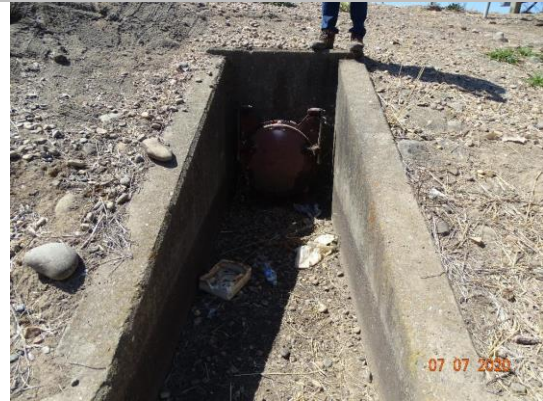
Photo 1 of 1 : UCIP_FA_2023_79124_86744.jpg

Comment Code						
Inspector Comment						
DS_ID:23934						
FS_ID:79124						
EP_NO: N/A						
Repair Type: No Action Needed						
EVAL Issue:						
Crossing Status: Found						
UCIP Comments: 07/07/2020 Record remains No Action Needed. This is a system feature with no modification to the system. Pipe is in good condition. Same observation as last inspection. Internal video inspection was performed in 4/24/2020. (S.Donovan - DWR UCIP)						
FIELD_STRUCT_DESC: 24-inch corrugated metal drainage pipe through the levee, 5 feet below the crown. Concrete U-shaped headwall on both ends. Flap gate on the waterside (WS) end. Cobble grouted outlet. Cobble grouted intake on the landside (LS). [Additional Reference(s): DWR Levee Log, 1978. USACE San Joaquin O&M Manual 612.2, 1967, (HLM 0.60), 24-inch pipe listed].						
FS Date: 7/7/2020 1:13:53 PM

Water-Side: view of pipe, headwall, and flapgate.

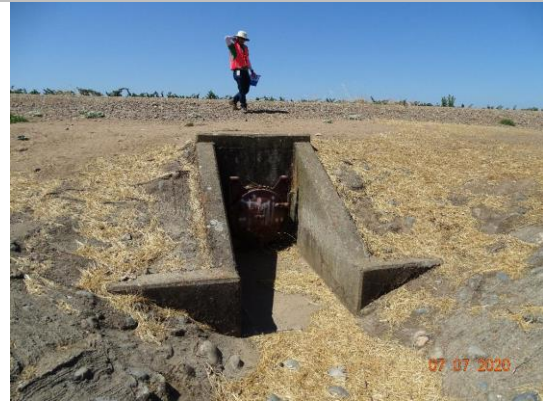
Photo 1 of 1 : UCIP_FA_2023_79126_86747.jpg

Comment Code						
Inspector Comment						
DS_ID:23935 FS_ID:79126 EP_NO: N/A Repair Type: No Action Needed EVAL Issue: Crossing Status: Found UCIP Comments: 07/07/2020 Record remains No Action Needed. This is a system feature without any modification to the system. Pipe is in good condition. Same observation as last inspection. Internal video inspection was performed in 4/24/2020. (S.Donovan - DWR UCIP) FIELD_STRUCT_DESC: 24-inch corrugated metal drainage pipe through the levee, 5 feet below the crown. Concrete U-shaped headwall on both ends. Flap gate on the waterside (WS) end. Cobble grouted outlet. Cobble grouted intake on the landside (LS). [Additional Reference(s): DWR Levee Log, 1978. USACE San Joaquin O&M Manual 612.2, 1967, (HLM 0.91), 24-inch pipe listed]. FS Date: 7/7/2020 1:14:37 PM

Water-Side: view of pipe, headwall, and flapgate.

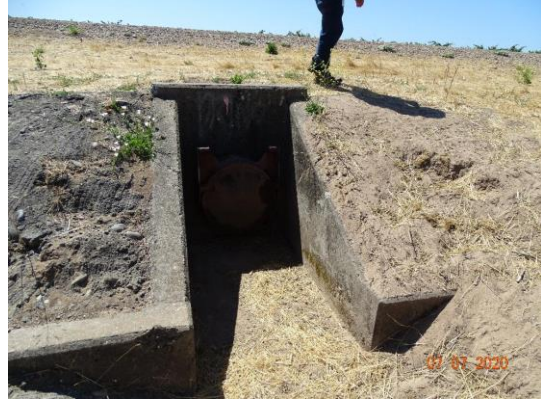
Photo 1 of 1 : UCIP_FA_2023_79127_86752.jpg

Comment Code						
Inspector Comment						
DS_ID:23936 FS_ID:79127 EP_NO: N/A Repair Type: No Action Needed EVAL Issue: Crossing Status: Found UCIP Comments: 07/07/2020 Record remains No Action Needed. This is a system feature without any modification to the pipe. Pipe is in good condition. Same observation as last inspection. (S.Donovan - DWR UCIP) FIELD_STRUCT_DESC: 24-inch corrugated metal drainage pipe through the levee, 6.5 feet below the crown. Concrete U-shaped headwall on both ends. Flap gate on the waterside (WS) end. Cobble grouted outlet. Cobble grouted intake on the landside (LS). [Additional Reference(s): DWR Levee Log, 1978. USACE San Joaquin O&M Manual 612.2, 1967, (HLM 1.11), 24-inch pipe listed]. FS Date: 7/7/2020 1:15:26 PM

Water-Side: view of pipe with headwall and flapgate.

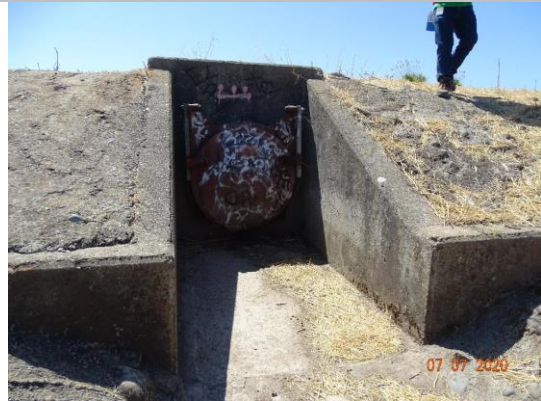
Photo 1 of 1 : UCIP_FA_2023_79128_86755.jpg

Comment Code						
Inspector Comment						
DS_ID:23937						
FS_ID:79128						
EP_NO: N/A						
Repair Type: No Action Needed						
EVAL Issue:						
Crossing Status: Found						
UCIP Comments: 07/07/2020 Record remains No Action Needed. This is a system feature without any modification to the system. Pipe is in good condition. Same observation as last inspection. (S.Donovan - DWR UCIP)						
FIELD_STRUCT_DESC: 36-inch corrugated metal drainage pipe through the levee, 4 feet below the crown. Concrete U-shaped headwall on both ends. Flap gate on the waterside (WS) end. Cobble grouted outlet. Cobble grouted intake on the landside (LS). [Additional Reference(s): DWR Levee Log, 1978. USACE San Joaquin O&M Manual 612.2, 1967, (HLM 1.18), 36-inch pipe listed].						
FS Date: 7/7/2020 1:16:27 PM

Water-Side: view of pipe with headwall and flapgate.

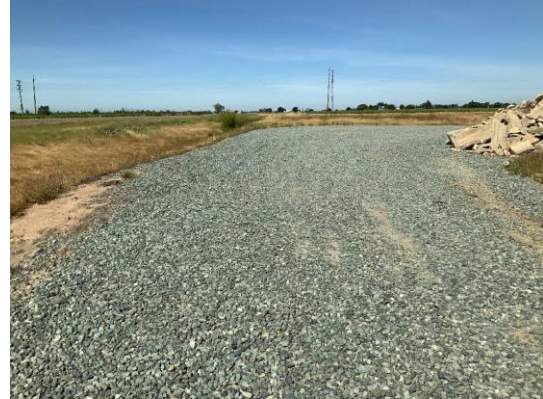
Photo 1 of 3 : UCIP_FA_2023_79138_98394.jpg

Comment Code					
Inspector Comment					
DS_ID:23939 FS_ID:79138 EP_NO: N/A Repair Type: Non-Urgent EVAL Issue: Crossing Status: Found UCIP Comments: 04/29/2021 Record has been upgraded from No Action Needed to Non-Urgent. Unit 14 – Middle Paddle Creek (CLM 0 to 1.38) is considered a patrol road/high ground area with no defined levee prism, any issue found between CLM 0 to 1.38 of Unit 14 will be considered a maintenance issue, or an unauthorized encroachment, or an abandoned encroachment. DWR DMP internal inspection has not found pipe integrity issues. LOF of crossing is less or equal to 4.0. Recommend next inspection in 5 years. Current condition of pipe crossing does not impede access to patrol road/high ground area. No permit was found authorizing this encroachment. CVFPB will need to review crossing to determine owner. The UCIP inspection was completed with LMA representative, J. Nelson. (H. Dunn – GEI) FIELD_STRUCT_DESC: 12-inch corrugated metal storm drainage pipe (CMP) through the levee, 3.0 feet below the crown. Flap gate on the waterside (WS) end. Cobble grouted outlet on the WS end. Cobble grouted intake on the landside (LS). [Additional Reference(s): DWR Levee Log, 1978, (HLM 0.02). USACE San Joaquin O&M Manual 612.2, 1967, (HLM 0.02), 12-inch pipe listed]. FS Date: 4/29/2021

Levee crown looking downstream.

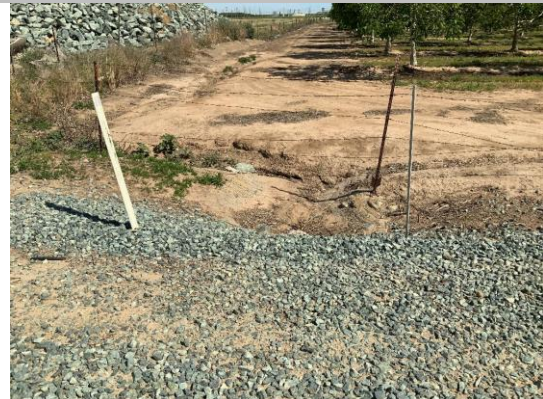
Photo 2 of 3 : UCIP_FA_2023_79138_98395.jpg

LS view: Toe from crown.

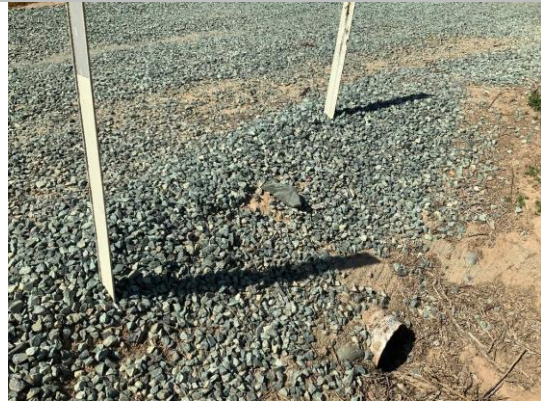
Photo 3 of 3 : UCIP_FA_2023_79138_98396.jpg

LS view: Slope and pipe inlet at toe.

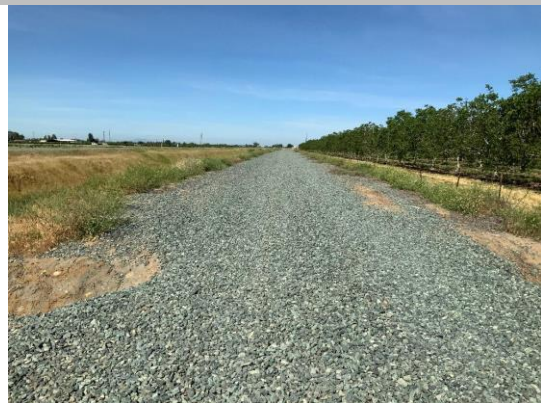
Photo 1 of 3 : UCIP_FA_2023_79139_98400.jpg

DS_ID:23940
 FS_ID:79139
 EP_NO: N/A
 Repair Type: Non-Urgent
 EVAL Issue:
 Crossing Status: Found
 UCIP Comments: 04/29/2021 Pipe status is still Non-Urgent. Unit 14 ? Middle Paddle Creek (CLM 0 to 1.38) is considered a patrol road/high ground area with no defined levee prism, any issue found between CLM 0 to 1.38 of Unit 14 will be considered a maintenance issue, or an unauthorized encroachment, or an abandoned encroachment. DWR DMP internal inspection has not found pipe integrity issues. LOF of crossing is less or equal to 4.0. Recommend inspection in 5 years. Current condition of pipe crossing does not impede access to patrol road/high ground area. No permit was found authorizing this encroachment. CVFPB will need to review crossing to determine owner. The UCIP inspection was completed with LMA representative, J. Nelson. (H. Dunn ? GEI) 06/12/2014 Debris partially blocking closure of flapgate. (W. Wylie - DWR UCIP)

FIELD_STRUCT_DESC: 12-inch corrugated metal storm drainage pipe (CMP) through the levee, 3.0 feet below the crown. Flap gate on the waterside (WS) end. Cobble grouted outlet on the WS end. [Additional Reference(s): DWR Levee Log, 1978, (HLM 0.25). USACE San Joaquin O&M Manual 612.2, 1967, (HLM 0.25), 12-inch pipe listed].
 FS Date: 4/29/2021

Levee crown looking downstream.

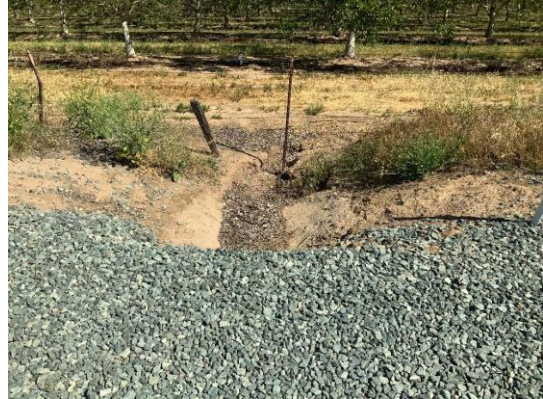
Photo 2 of 3 : UCIP_FA_2023_79139_98401.jpg

LS view: Toe from crown.

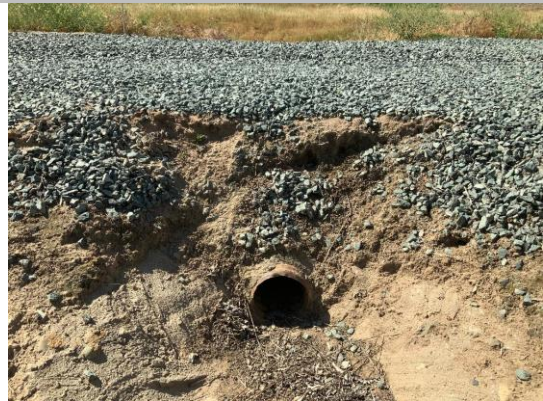
Photo 3 of 3 : UCIP_FA_2023_79139_98402.jpg

LS view: Slope and pipe inlet at toe.

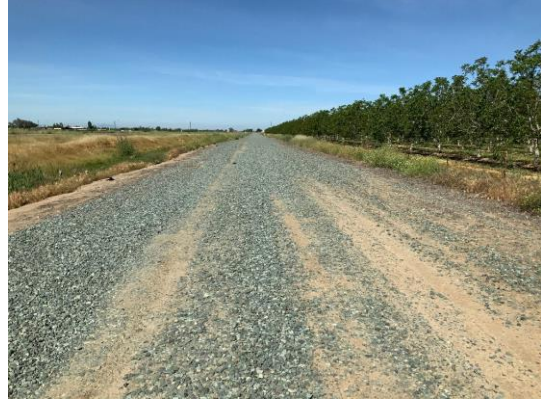
Photo 1 of 3 : UCIP_FA_2023_79140_98406.jpg

Comment Code					
Inspector Comment					
DS_ID:23941 FS_ID:79140 EP_NO: N/A Repair Type: Non-Urgent EVAL Issue: 11, Maintenance Compliance Issue Crossing Status: Found UCIP Comments: 04/29/2021 Pipe status is still Non-Urgent. Unit 14 – Middle Paddle Creek (CLM 0 to 1.38) is considered a patrol road/high ground area with no defined levee prism, any issue found between CLM 0 to 1.38 of Unit 14 will be considered a maintenance issue, or an unauthorized encroachment, or an abandoned encroachment. DWR DMP internal inspection has not found pipe integrity issues. LOF of crossing is less or equal to 4.0. Recommend inspection in 5 years. Current condition of pipe crossing does not impede access to patrol road/high ground area. Pipe is open on both ends without a flapgate and LS pipe edges are warped, recommend maintenance. No permit was found authorizing this encroachment. CVFPB will need to review crossing to determine owner. The UCIP inspection was completed with LMA representative, J. Nelson. (H. Dunn – GEI) 06/12/2014 Pipe buried on WS slope. (W. Wylie - DWR UCIP) FIELD_STRUCT_DESC: 12-inch corrugated metal storm drainage pipe (CMP) through the levee, 1.0 foot below the crown. Flap gate on the waterside (WS) end. Cobble grouted outlet on the WS end. [Additional Reference(s): DWR Levee Log, 1978, (HLM 0.38). USACE San Joaquin O&M Manual 612.2, 1967, (HLM 0.38), 12-inch pipe listed]. FS Date: 4/29/2021

Levee crown looking downstream.

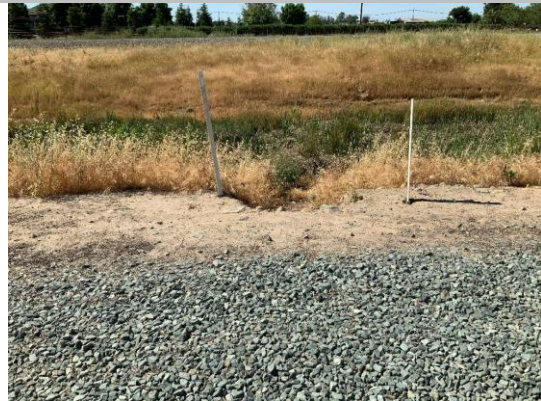
Photo 2 of 3 : UCIP_FA_2023_79140_98407.jpg

WS view: Toe from crown with markers on either side.

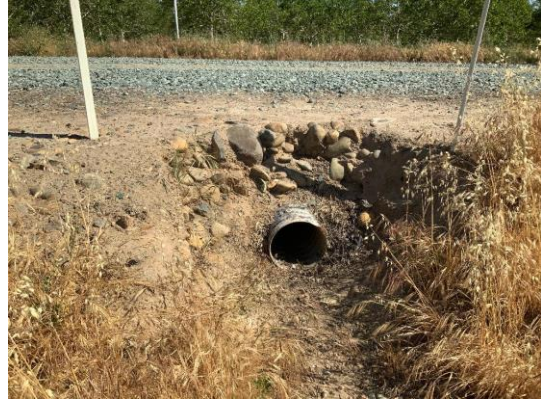
Photo 3 of 3 : UCIP_FA_2023_79140_98408.jpg

WS view: Slope and pipe outlet at toe, no flapgate.

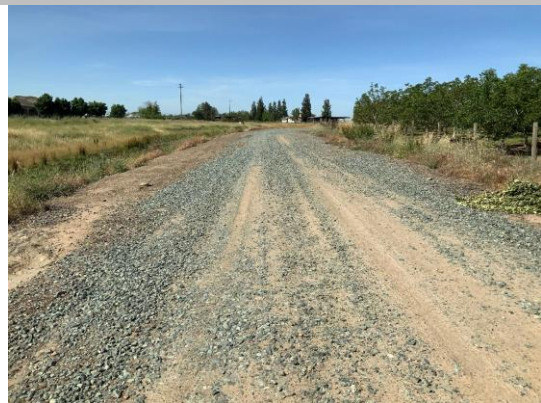
Photo 1 of 3 : UCIP_FA_2023_79141_98412.jpg

DS_ID:23942
 FS_ID:79141
 EP_NO: N/A
 Repair Type: Non-Urgent
 EVAL Issue:
 Crossing Status: Found
 UCIP Comments: 04/29/2021 Record has been upgraded from No Action Needed to Non-Urgent. Unit 14 – Middle Paddle Creek (CLM 0 to 1.38) is considered a patrol road/high ground area with no defined levee prism, any issue found between CLM 0 to 1.38 of Unit 14 will be considered a maintenance issue, or an unauthorized encroachment, or an abandoned encroachment. DWR DMP internal inspection has not found pipe integrity issues. LOF of crossing is less or equal to 4.0. Recommend inspection in 5 years. Current condition of pipe crossing does not impede access to patrol road/high ground area. No permit was found authorizing this encroachment. CVFPB will need to review crossing to determine owner. The UCIP inspection was completed with LMA representative, J. Nelson. (H. Dunn – GEI)
 FIELD_STRUCT_DESC: 12-inch corrugated metal storm drainage pipe (CMP) through the levee, 2.0 feet below the crown. Flap gate on the waterside (WS) end. Cobble grouted outlet on the WS end. Cobble grouted intake on the landside (LS). [Additional Reference(s): DWR Levee Log, 1978, (HLM 0.46). USACE San Joaquin O&M Manual 612.2, 1967, (HLM 0.46), 12-inch pipe listed].

Levee crown looking downstream.

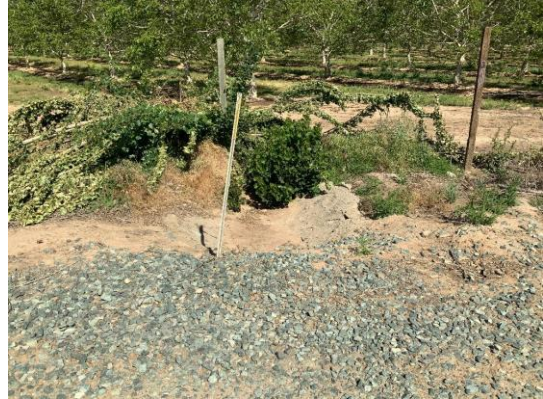
Photo 2 of 3 : UCIP_FA_2023_79141_98413.jpg

LS view: Toe from crown, marker visible.

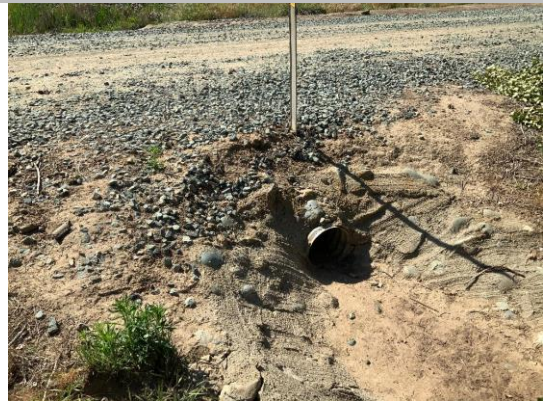
Photo 3 of 3 : UCIP_FA_2023_79141_98414.jpg

LS view: Slope and pipe inlet at toe.

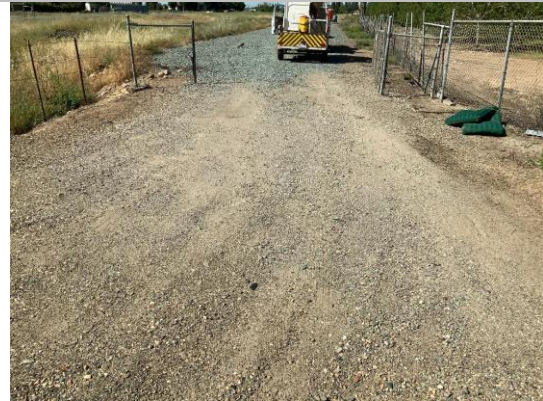
Photo 1 of 3 : UCIP_FA_2023_79142_98421.jpg

Comment Code					
Inspector Comment					
DS_ID:23943 FS_ID:79142 EP_NO: N/A Repair Type: Non-Urgent EVAL Issue: 11, Maintenance Compliance Issue Crossing Status: Found UCIP Comments: 04/29/2021 Pipe status is still Non-Urgent. Unit 14 – Middle Paddle Creek (CLM 0 to 1.38) is considered a patrol road/high ground area with no defined levee prism, any issue found between CLM 0 to 1.38 of Unit 14 will be considered a maintenance issue, or an unauthorized encroachment, or an abandoned encroachment. DWR DMP internal inspection has not found pipe integrity issues. LOF of crossing is less or equal to 4.0. Recommend inspection in 5 years. Current condition of pipe crossing does not impede access to patrol road/high ground area. Pipe is open on both ends and there is some erosion around pipe on both WS and LS ends, recommend maintenance for erosion. No permit was found authorizing this encroachment. CVFPB will need to review crossing to determine owner. The UCIP inspection was completed with LMA representative, J. Nelson. (H. Dunn – GEI) 09/18/2018 Pipe is close to the crown. It may not create a serious situation. Maintenance required by owner at pipe inlet. Crossing downgraded to "Non-Urgent." (A. McDonald - DWR UCIP)11/04/2016 Same as previous inspection. Crossing remains Urgent crossing, open on both ends. (O. Magana - DWR UCIP)06/12/2014 Pipe inlet and outlet partially blocked by sediment. No flapgate. (W. Wylie - DWR UCIP) FIELD_STRUCT_DESC: 18-inch corrugated metal storm drainage pipe (CMP) through the levee, 2.5 feet below the crown. Pipe open on both ends. Inlet at end of drainage ditch along the road. Cobble grouted outlet on the waterside (WS) end. [Additional Reference(s): DWR Levee Log, 1977, 1978, 1987, 1990, (HLM 0.55). USACE San Joaquin O&M Manual 612.2, 1967, (HLM 0.55), Unit 7 (HLM 7.19–16.77), Unit 8 (HLM 7.55–16.48), Unit 9 (HLM 0.10–1.52), Unit 10 (HLM 0.03–1.35), Unit 11 (HLM 0.16–3.55), Unit 12 (HLM 0.14–3.91), Unit 13 (HLM 0.03–1.18), Unit 14 (HLM 0.02–1.17), 18-inch pipe listed]. FS Date: 4/29/2021

Levee crown looking downstream.

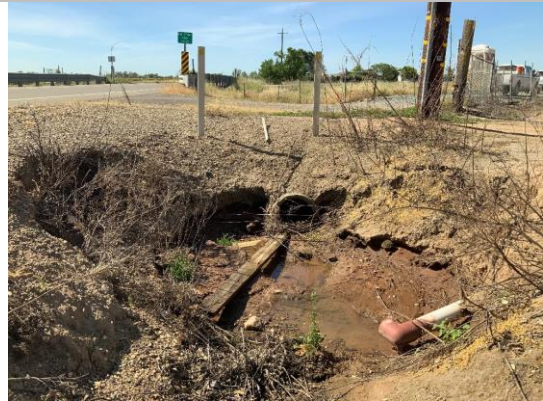
Photo 2 of 3 : UCIP_FA_2023_79142_98419.jpg

LS view: Slope and pipe inlet at toe.

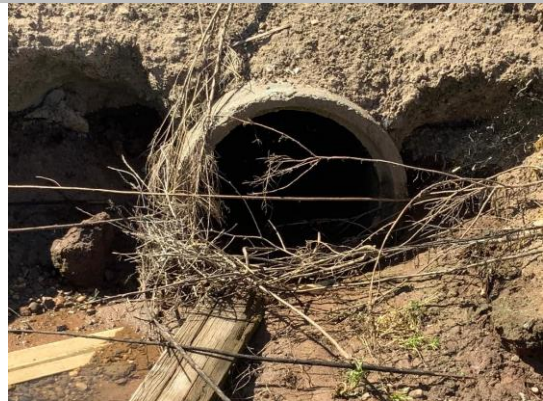
Photo 3 of 3 : UCIP_FA_2023_79142_98420.jpg

LS view: Close up of pipe inlet at toe, some erosion around pipe.

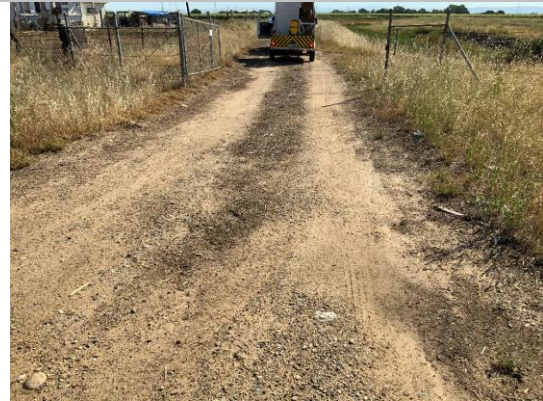
Photo 1 of 3 : UCIP_FA_2023_79143_98437.jpg

Comment Code					
Inspector Comment					
DS_ID:23944 FS_ID:79143 EP_NO: N/A Repair Type: Non-Urgent EVAL Issue: 11, Maintenance Compliance Issue Crossing Status: Found UCIP Comments: 04/29/2021 Record has been upgraded from No Action Needed to Non-Urgent. Unit 14 – Middle Paddle Creek (CLM 0 to 1.38) is considered a patrol road/high ground area with no defined levee prism, any issue found between CLM 0 to 1.38 of Unit 14 will be considered a maintenance issue, or an unauthorized encroachment, or an abandoned encroachment. DWR DMP internal inspection has found pipe integrity issues. LOF of crossing is between 5 and 6. Crossing will be monitored until funding becomes available to address the issues. Current condition of pipe crossing does not impede access to patrol road/high ground area. Pipe is open on both ends, no flapgate. Erosion and gapping to the side and above LS pipe inlet, recommend maintenance. No permit was found authorizing this encroachment. CVFPB will need to review crossing to determine owner. The UCIP inspection was completed with LMA representative, J. Nelson. (H. Dunn – GEI) FIELD_STRUCT_DESC: *HIGH GROUND* 18-inch corrugated metal storm drainage pipe (CMP) through the levee, 2.5 feet below the crown. Pipe open on both ends. Cobble grouted outlet on the waterside (WS) end. Cobble grouted intake on the landside (LS). [Additional Reference(s): DWR Levee Log, 1978, (HLM 0.57). USACE San Joaquin O&M Manual 612.2, 1967, (HLM 0.57), 18-inch pipe listed]. FS Date: 4/29/2021

Levee crown looking upstream.

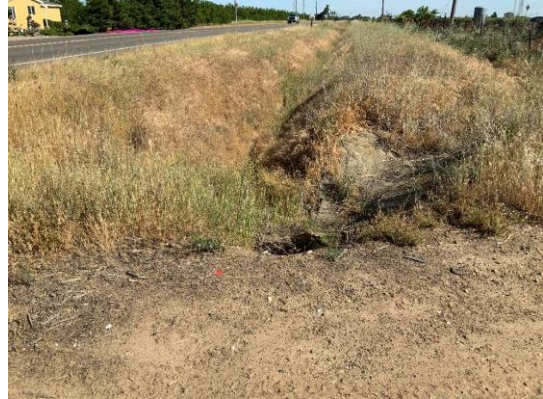
Photo 2 of 3 : UCIP_FA_2023_79143_98439.jpg

LS view: Toe from crown.

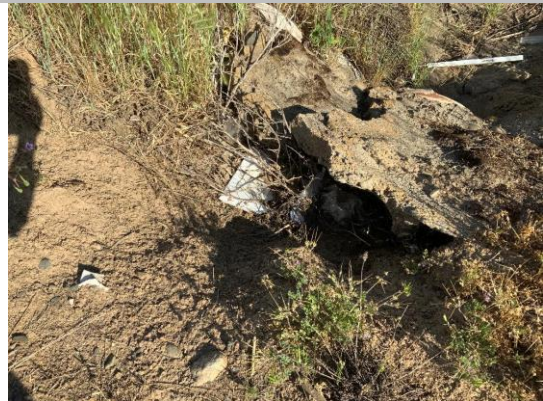
Photo 3 of 3 : UCIP_FA_2023_79143_98440.jpg

LS view: Erosion and gapping above pipe inlet on slope.

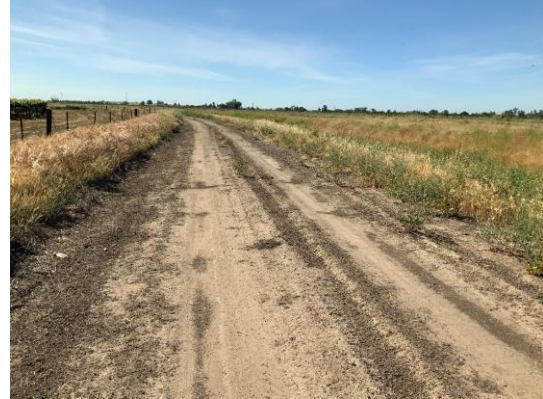
Photo 1 of 3 : UCIP_FA_2023_79144_98442.jpg

Comment Code					
Inspector Comment					
DS_ID:23945 FS_ID:79144 EP_NO: N/A Repair Type: Non-Urgent EVAL Issue: 11, Maintenance Compliance Issue Crossing Status: Found UCIP Comments: 04/29/2021 Pipe status is still Non-Urgent. Unit 14 – Middle Paddle Creek (CLM 0 to 1.38) is considered a patrol road/high ground area with no defined levee prism, any issue found between CLM 0 to 1.38 of Unit 14 will be considered a maintenance issue, or an unauthorized encroachment, or an abandoned encroachment. DWR DMP internal inspection has found pipe integrity issues. LOF of crossing is between 4.1 and 5. Crossing will be monitored until funding becomes available for rehabilitation. Current condition of pipe crossing does not impede access to patrol road/high ground area. Pipe is open on both ends and LS pipe end is covered in vegetation and behind barbed wire, could not inspect. No permit was found authorizing this encroachment. CVFPB will need to review crossing to determine owner. The UCIP inspection was completed with LMA representative, J. Nelson. (H. Dunn – GEI) 06/12/2014 Pipe open on both ends. Levee appears abandoned. (W. Wylie - DWR UCIP) FIELD_STRUCT_DESC: 24-inch corrugated metal storm drainage pipe (CMP) through the levee, 1.0 foot below the crown. Pipe open on both ends. Cobble grouted outlet on the waterside (WS) end. Cobble grouted intake on the landside (LS). [Additional Reference(s): DWR Levee Log, 1978, (HLM 0.76). USACE San Joaquin O&M Manual 612.2, 1967, (HLM 0.76), 24-inch pipe listed]. FS Date: 4/29/2021

Levee crown looking upstream.

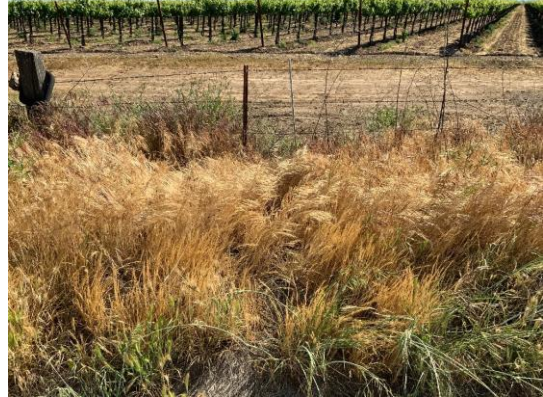
Photo 2 of 3 : UCIP_FA_2023_79144_98443.jpg

LS view: Toe from crown.

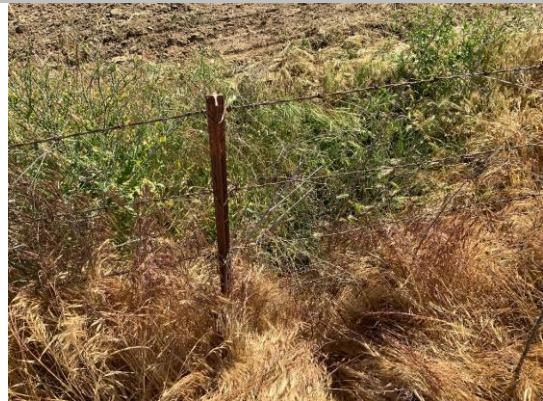
Photo 3 of 3 : UCIP_FA_2023_79144_98444.jpg

LS view: Pipe inlet covered by vegetation and barbed wire at toe.

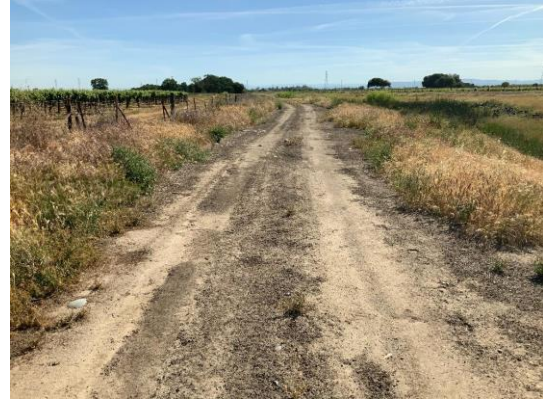
Photo 1 of 3 : UCIP_FA_2023_79145_98447.jpg

Comment Code					
Inspector Comment					
DS_ID:23946 FS_ID:79145 EP_NO: N/A Repair Type: Non-Urgent EVAL Issue: 11, Maintenance Compliance Issue Crossing Status: Found UCIP Comments: 04/29/2021 Pipe status is still Non-Urgent. Unit 14 – Middle Paddle Creek (CLM 0 to 1.38) is considered a patrol road/high ground area with no defined levee prism, any issue found between CLM 0 to 1.38 of Unit 14 will be considered a maintenance issue, or an unauthorized encroachment, or an abandoned encroachment. DWR DMP internal inspection has not found pipe integrity issues. LOF of crossing is less or equal to 4.0. Recommend inspection in 5 years. Current condition of pipe crossing does not impede access to patrol road/high ground area. Pipe is open on both ends, no flapgates and LS pipe end filled with dirt, recommend maintenance for sediment removal. No permit was found authorizing this encroachment. CVFPB will need to review crossing to determine owner. The UCIP inspection was completed with LMA representative, J. Nelson. (H. Dunn – GEI) 06/12/2014 Pipe burried on LS. Levee appears abandoned. (W. Wylie - DWR UCIP) FIELD_STRUCT_DESC: 12-inch corrugated metal storm drainage pipe (CMP) through the levee, 2.0 feet below the crown. Pipe open on both ends. Cobble grouted outlet on the waterside (WS) end. [Additional Reference(s): DWR Levee Log, 1978, (HLM 0.95). USACE San Joaquin O&M Manual 612.2, 1967, (HLM 0.95), 12-inch pipe listed]. FS Date: 4/29/2021

Levee crown looking upstream.

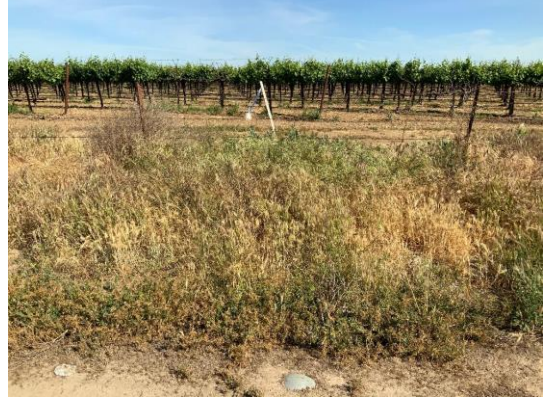
Photo 2 of 3 : UCIP_FA_2023_79145_98448.jpg

LS view: Toe from crown, marker visible.

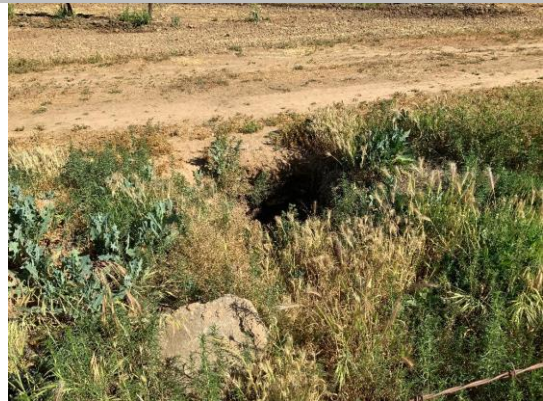
Photo 3 of 3 : UCIP_FA_2023_79145_98449.jpg

LS view: Inlet barely visible at toe.

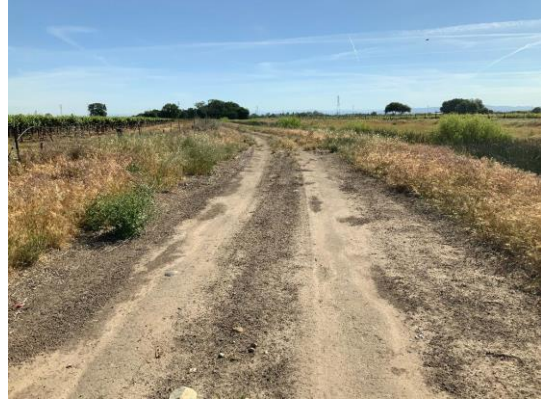
Photo 1 of 3 : UCIP_FA_2023_79146_98454.jpg

Comment Code						
Inspector Comment						
DS_ID:23947 FS_ID:79146 EP_NO: N/A Repair Type: Non-Urgent EVAL Issue: 5, Pipe Damage Crossing Status: Found UCIP Comments: 04/29/2021 Pipe status is still Non-Urgent. Unit 14 – Middle Paddle Creek (CLM 0 to 1.38) is considered a patrol road/high ground area with no defined levee prism, any issue found between CLM 0 to 1.38 of Unit 14 will be considered a maintenance issue, or an unauthorized encroachment, or an abandoned encroachment. DWR DMP internal inspection has found pipe integrity issues. LOF of crossing is between 4.1 and 5. Crossing will be monitored until funding becomes available for rehabilitation. Current condition of pipe crossing does not impede access to patrol road/high ground area. Pipe is open on both ends, no flapgate. No permit was found authorizing this encroachment. CVFPB will need to review crossing to determine owner. The UCIP inspection was completed with LMA representative, J. Nelson. (H. Dunn – GEI) 06/12/2014 Pipe buried on LS shoulder and open on WS. Levee appears abandoned. (W. Wylie - DWR UCIP) FIELD_STRUCT_DESC: 18-inch corrugated metal storm drainage pipe (CMP) through the levee, 3.0 feet below the crown. Pipe open on both ends. Cobble grouted outlet on the waterside (WS) end. Cobble grouted intake on the landside (LS). [Additional Reference(s): DWR Levee Log, 1978, (HLM 0.97). USACE San Joaquin O&M Manual 612.2, 1967, (HLM 0.97), 18-inch pipe listed]. FS Date: 4/29/2021

Levee crown looking upstream.

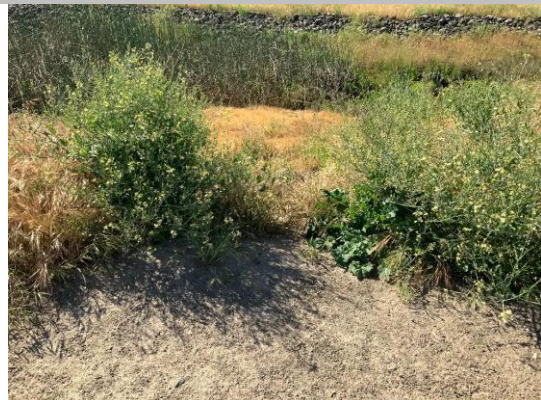
Photo 2 of 3 : UCIP_FA_2023_79146_98455.jpg

WS view: Toe from crown.

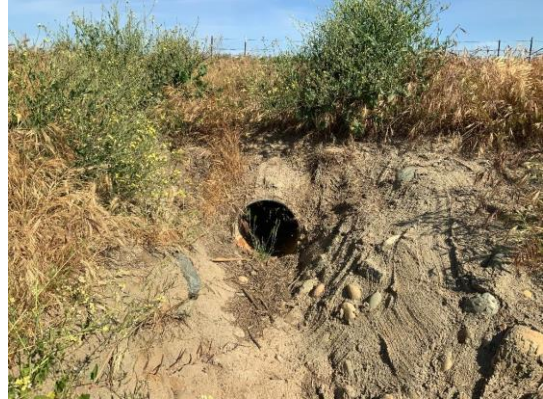
Photo 3 of 3 : UCIP_FA_2023_79146_98456.jpg

WS view: Slope and pipe outlet at toe.

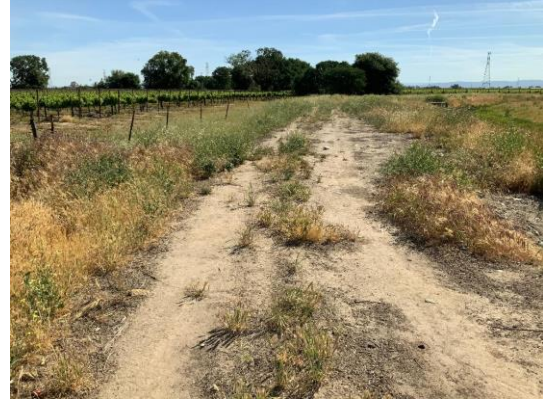
Photo 1 of 3 : UCIP_FA_2023_79148_98468.jpg

Comment Code						
Inspector Comment						
DS_ID:23949 FS_ID:79148 EP_NO: N/A Repair Type: Non-Urgent EVAL Issue: 11, Maintenance Compliance Issue Crossing Status: Found UCIP Comments: 04/29/2021 Pipe status is still Non-Urgent. Unit 14 – Middle Paddle Creek (CLM 0 to 1.38) is considered a patrol road/high ground area with no defined levee prism, any issue found between CLM 0 to 1.38 of Unit 14 will be considered a maintenance issue, or an unauthorized encroachment, or an abandoned encroachment. DWR DMP internal inspection has not found pipe integrity issues. LOF of crossing is less or equal to 4.0. Recommend inspection in 5 years. Current condition of pipe crossing does not impede access to patrol road/high ground area. LS and WS pipe inlet and flapgate covered with vegetation, recommend removal. No permit was found authorizing this encroachment. CVFPB will need to review crossing to determine owner. The UCIP inspection was completed with LMA representative, J. Nelson. (H. Dunn – GEI) 06/12/2014 Pipe appears abandoned. Levee appears Abandoned. (W. Wylie - DWR UCIP) FIELD_STRUCT_DESC: 12-inch corrugated metal storm drainage pipe (CMP) through the levee, 2.5 feet below the crown. Flap gate on the waterside (WS) end. Cobble grouted outlet on the WS end. Cobble grouted intake on the landside (LS). [Additional Reference(s): DWR Levee Log, 1978, (HLM 1.12). USACE San Joaquin O&M Manual 612.2, 1967, (HLM 1.12), 12-inch pipe listed]. FS Date: 4/29/2021

Levee crown looking upstream.

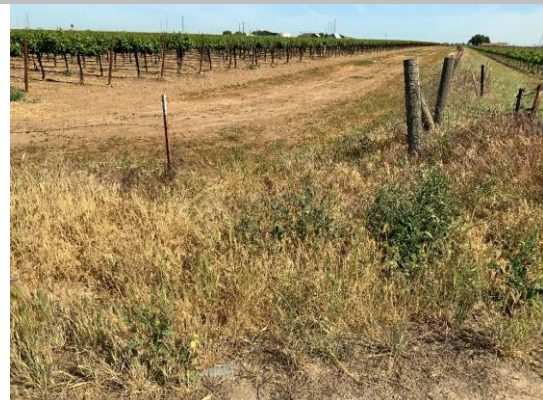
Photo 2 of 3 : UCIP_FA_2023_79148_98469.jpg

LS view: Toe from crown.

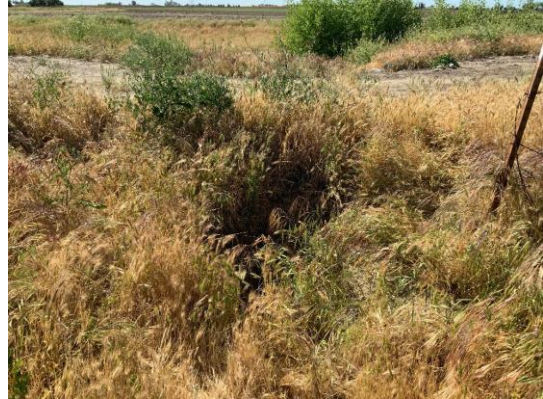
Photo 3 of 3 : UCIP_FA_2023_79148_98470.jpg

LS view: Pipe inlet covered by vegetation at toe.

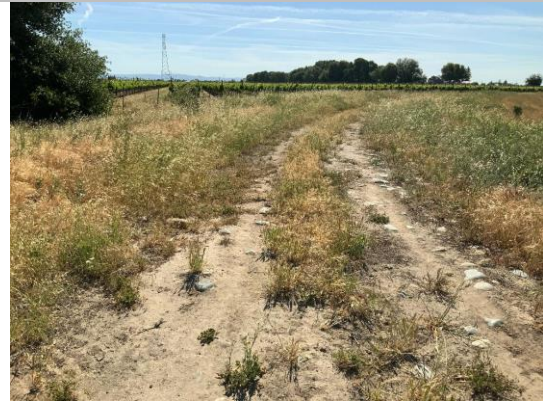
Photo 1 of 3 : UCIP_FA_2023_79150_98476.jpg

Comment Code						
Inspector Comment						
DS_ID:23950 FS_ID:79150 EP_NO: N/A Repair Type: Non-Urgent EVAL Issue: 11, Maintenance Compliance Issue Crossing Status: Found UCIP Comments: 04/29/2021 Pipe status is still Non-Urgent. Unit 14 – Middle Paddle Creek (CLM 0 to 1.38) is considered a patrol road/high ground area with no defined levee prism, any issue found between CLM 0 to 1.38 of Unit 14 will be considered a maintenance issue, or an unauthorized encroachment, or an abandoned encroachment. DWR DMP internal inspection has not found pipe integrity issues. LOF of crossing is less or equal to 4.0. Recommend inspection in 5 years. Current condition of pipe crossing does not impede access to patrol road/high ground area. Pipe is open on both ends, no flapgate. No permit was found authorizing this encroachment. CVFPB will need to review crossing to determine owner. The UCIP inspection was completed with LMA representative, J. Nelson. (H. Dunn – GEI) 06/12/2014 Pipe open on both ends. Levee appears abandoned. (W. Wylie - DWR UCIP) FIELD_STRUCT_DESC: 48-inch reinforced concrete storm drainage pipe (RCP) through the levee, 5.5 feet below the crown. Pipe open on both ends. Cobble grouted outlet on the waterside (WS) end. Cobble grouted intake on the landside (LS). [Additional Reference(s): DWR Levee Log, 1978, (HLM 1.17). USACE San Joaquin O&M Manual 612.2, 1967, (HLM 1.17), 48-inch pipe listed]. FS Date: 4/29/2021

Levee crown looking upstream.
