**Flood Control Project Maintenance
Levee Inspections**

Maintenance Issue Types Only, Levee Inspection Report By Mile - Fall 2023

San Joaquin County Flood Control and Water Conservation District

Waterway	Bank	Unit Miles	Inspection Start/End	Inspector
Unit No. 01 Littlejohn Creek	Left	2.59	10/20/2023 10/20/2023	Alberto De Leon

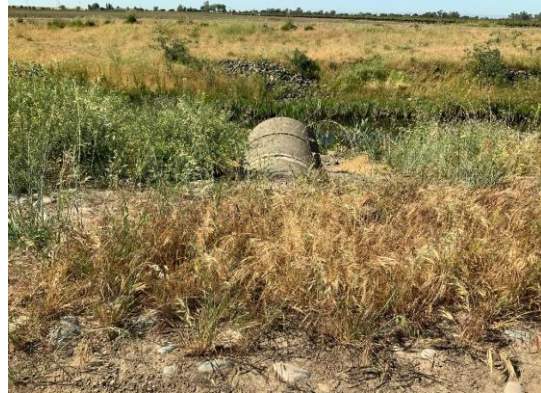
Photo 2 of 3 : UCIP_FA_2023_79150_98477.jpg

WS view: Pipe visible at toe from crown.

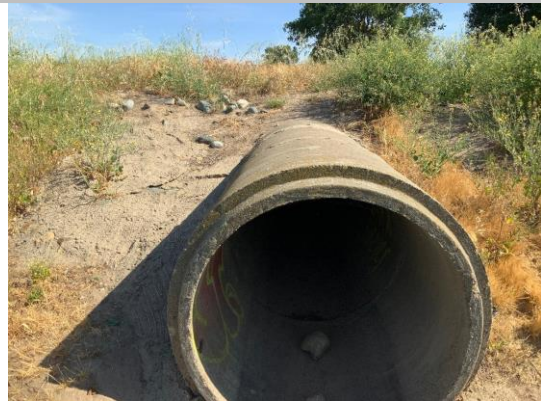
Photo 3 of 3 : UCIP_FA_2023_79150_98478.jpg

WS view: Slope and pipe outlet at toe.

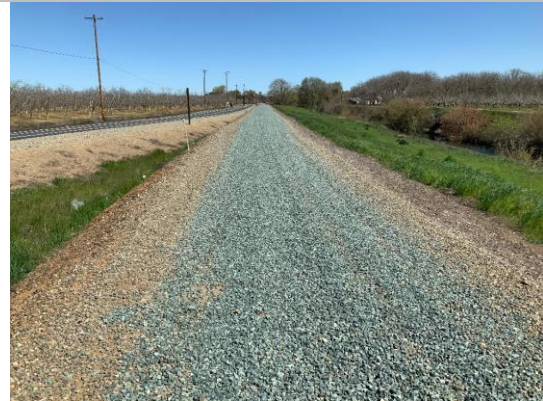
Photo 1 of 3 : UCIP_FA_2023_79155_93981.jpg

Comment Code						
Inspector Comment						
DS_ID:23199 FS_ID:79155 EP_NO: N/A Repair Type: Non-Urgent EVAL Issue: 11, Maintenance Compliance Issue Crossing Status: Found UCIP Comments: 03/26/2021 Record has been upgraded from No Action Needed to Non-Urgent. Unit 15 – Mormon Slough (CLM 0 to 1.50 and 5.0 - 11.0) are considered a patrol road/high ground area with no defined levee prism, any issue found between CLM 0 - 1.50 and 5.0 – 11.0 of Unit 15 will be considered a maintenance issue, or an unauthorized encroachment, or an abandoned encroachment. DWR DMP internal video inspection has found pipe integrity issues. LOF of crossing is between 5 and 6. Crossing will be monitored until funding becomes available to address the issues. Current condition of pipe crossing does not impede access to patrol road/high ground area. No permit was found authorizing this encroachment. CVFPB will need to review crossing to determine owner. The UCIP inspection was completed with LMA representative, H. Latu. (H. Dunn – GEI)

04/09/2014 Deformed inlet opening. Needs cleaning and clearing on inlet opening on landside. (P. Tariq - DWR UCIP) FIELD_STRUCT_DESC: *HIGH GROUND* 18-inch corrugated metal drainage pipe (CMP) through the levee, 4.5 feet below the crown. Grouted outlet on the waterside (WS) end. Open on both ends. [Additional Reference(s): DWR Levee Log, 1992, (HLM 1.18). USACE San Joaquin O&M Manual 611.1, Volume F, (HLM 1.18), 18-inch pipe listed]. FS Date: 3/26/2021

Levee crown looking upstream.

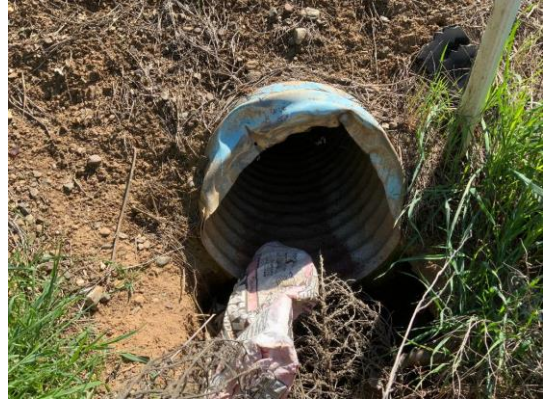
Photo 2 of 3 : UCIP_FA_2023_79155_93985.jpg

LS view: Inside pipe inlet.

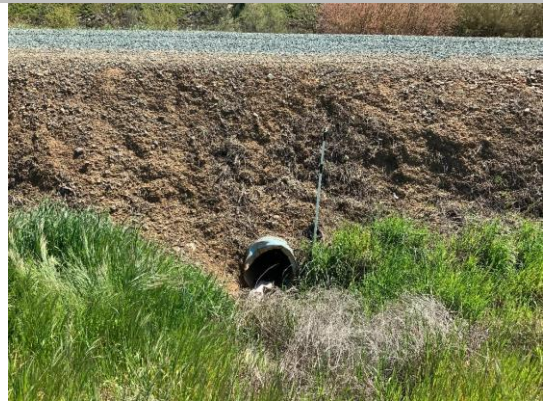
Photo 3 of 3 : UCIP_FA_2023_79155_93984.jpg

LS view: Pipe end at toe.

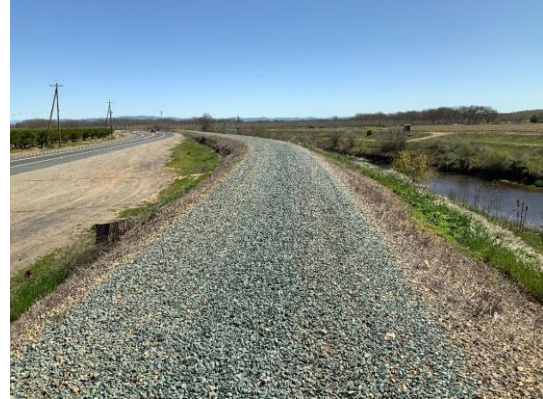
Photo 1 of 3 : UCIP_FA_2023_81172_93996.jpg

Comment Code						
Inspector Comment						
DS_ID:23200 FS_ID:81172 EP_NO: N/A Repair Type: Non-Urgent EVAL Issue: 11, Maintenance Compliance Issue Crossing Status: Found UCIP Comments: 09/25/2023 DMP internal video inspection has found none or minor pipe defects. Recommend next video inspection in 5 years. (J. Taylor - DWR UCIP)03/26/2021 Record has been upgraded from No Action Needed to Non-Urgent. Unit 15 – Mormon Slough (CLM 0 to 1.50 and 5.0 - 11.0) are considered a patrol road/high ground area with no defined levee prism, any issue found between CLM 0 - 1.50 and 5.0 – 11.0 of Unit 15 will be considered a maintenance issue, or an unauthorized encroachment, or an abandoned encroachment. DWR DMP internal video inspection has found pipe integrity issues. LOF of crossing is between 5 and 6. Crossing will be monitored until funding becomes available to address the issues. Recommend cleaning dirt/vegetation debris off/out of LS pipe end. Current condition of pipe crossing does not impede access to patrol road/high ground area. No permit was found authorizing this encroachment. CVFPB will need to review crossing to determine owner. The UCIP inspection was completed with LMA representative, H. Latu. (H. Dunn – GEI)

04/09/2021 Pipe needs cleaning and clearing on both pipe ends. (P. Tariq - DWR UCIP) FIELD_STRUCT_DESC: *HIGH GROUND* 18-inch CIPP lined drainage pipe of an unknown material through the levee, 6.0 feet below the crown. Grouted outlet on the waterside (WS) end. Electrical conduit through the levee. [Additional Reference(s): DWR Levee Log, 1992, (HLM 1.49). USACE San Joaquin O&M Manual 611.1, Volume F, (HLM 1.49), 18-inch pipe listed]. FS Date: 3/26/2021

Levee crown looking upstream.

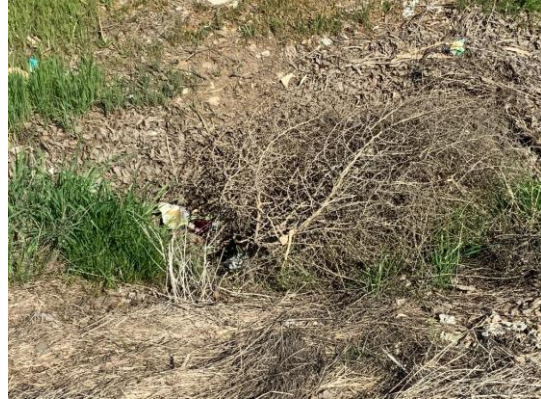
Photo 2 of 3 : UCIP_FA_2023_81172_94001.jpg

LS view: Pipe end covered in vegetation and dirt.

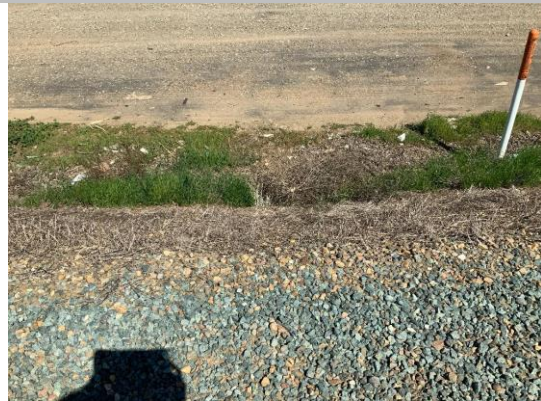
Photo 3 of 3 : UCIP_FA_2023_81172_94000.jpg

LS view: Toe from crown.

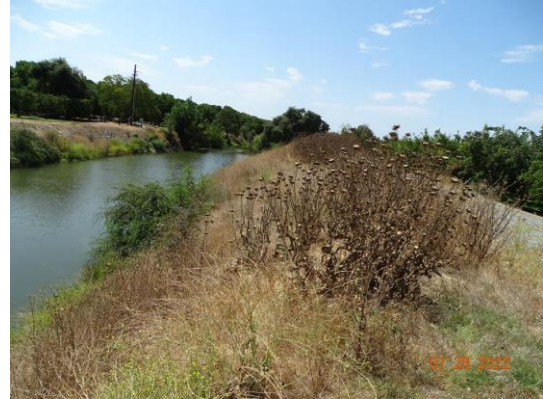
Photo 2 of 2 : SJR2023_NA0017U15RM18.45_2.JPG

7/28/2022: View of the erosion looking downstream. Dense vegetation is limiting visibility.

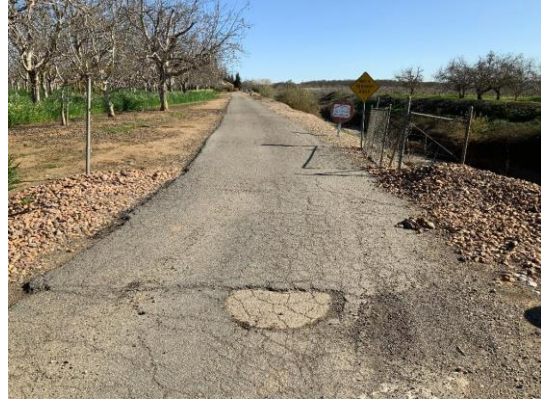
Photo 1 of 3 : UCIP_FA_2023_78687_94206.jpg

Comment Code					
Inspector Comment					
DS_ID:23308 FS_ID:78687 EP_NO: N/A Repair Type: Non-Urgent EVAL Issue: 11, Maintenance Compliance Issue Crossing Status: Found UCIP Comments: 03/26/2021 Record has been upgraded from No Action Needed to Non-Urgent. Unit 15 – Mormon Slough (CLM 0 to 1.50 and 5.0 - 11.0) are considered a patrol road/high ground area with no defined levee prism, any issue found between CLM 0 - 1.50 and 5.0 – 11.0 of Unit 15 will be considered a maintenance issue, or an unauthorized encroachment, or an abandoned encroachment. DWR DMP internal video inspection has found pipe integrity issues. LOF of crossing is between 5 and 6. Crossing will be monitored until funding becomes available to address the issues. Current condition of pipe crossing does not impede access to patrol road/high ground area. No permit was found authorizing this encroachment. CVFPB will need to review crossing to determine owner. The UCIP inspection was completed with LMA representative, H. Latu. (H. Dunn – GEI)

04/09/2014 Inlet CM pipe riser on landside shoulder. Pipe not found on waterside. Dense vegetation on channel bank. May need inlet cleaning. (P. Tariq - DWR UCIP) FIELD_STRUCT_DESC: *HIGH GROUND* 18-inch corrugated metal storm drainage pipe (CMP) through the levee, 2.0 feet below the crown. Concrete rubble splash apron on the waterside (WS) end. [Additional Reference(s): DWR Levee Log, 1977, (HLM 5.58). USACE San Joaquin O&M Manual 611.1, Volume F, (HLM 5.58), 18-inch pipe listed]. FS Date: 3/26/2021

Levee crown looking upstream.

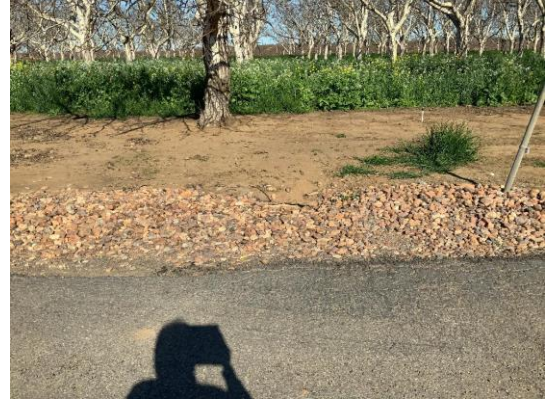
Photo 2 of 3 : UCIP_FA_2023_78687_94207.jpg

LS view: Toe from crown.

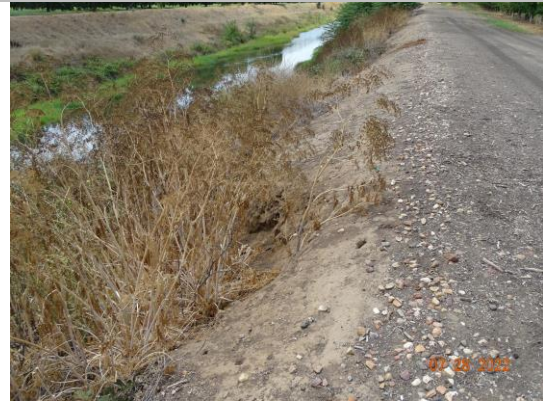
Photo 1 of 1 : FA_2023_NA0017_159_124_20231101_00244.jpg

Comment Code					
E1 : Note and monitor erosion site.					
Inspector Comment					
Issue has been transferred to Levee Mile Report and will continued to monitored. Site ID: NA0017U15RM17.67					
*This area is patrol road only and therefore the site is not rated					
07/28/2022: No significant changes were observed since the previous inspection.					
06/29/2021: There is more vegetation on the slope. Otherwise, no significant changes were observed since the previous inspection.					
07/24/2020: Some burrowing activity observed. Site is likely to extend toward downstream during the next rain event.					
08/28/2019: The erosion is located at the upper slope of the channel bank and was likely caused by rainfall runoff.

View of erosion on waterside slope. July 2022

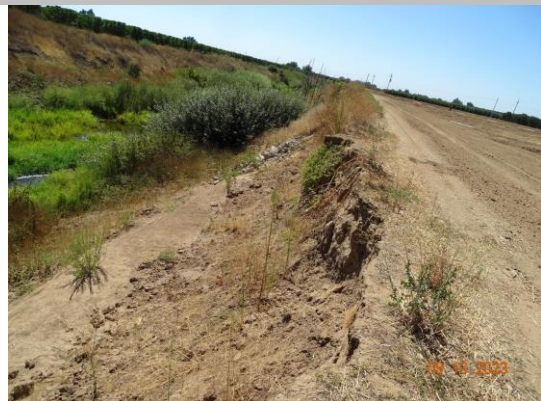
Photo 1 of 1 : FA_2023_NA0017_159_11_20231101_00245.jpg

LM Start	7.67	Rating **	A/W	Issue No.	11
LM End	7.67	Issue Type +	Ma	Location *	WS
Category	Earthen Levee			GPS Latitude/Longitude	
				Start	End
Item	Erosion / Bank Caving			37.976275°	37.976275°
				-121.106364°	-121.106364°
DWR ID	DWR_NA0017_15_f_2023_11				
Comment Code					
E1 : Note and monitor erosion site.					
Inspector Comment					
Issue has been transferred to Levee Mile Report and will continued to monitored. Site ID: NA0017U15RM15.25					
*This area is patrol road only and therefore the site is not rated					
07/28/2022: No changes were observed since the previous inspection.					
The erosion is visible in two locations.					
07/24/2020: This site was discovered during the DWR Fall 2017 Levee Inspections. The erosion is caused by surface runoff and likely to cut into the patrol road during the next storm events.

View of erosion on waterside slope. Summer 2023

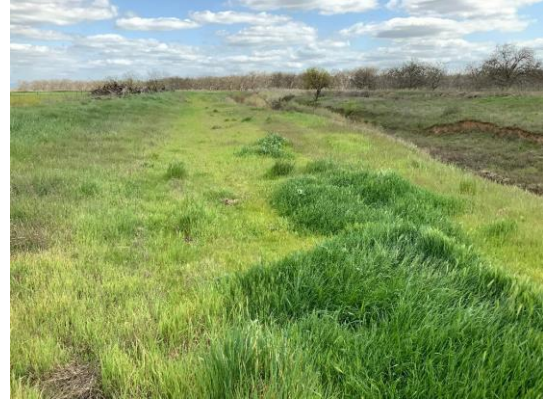
Photo 1 of 3 : UCIP_FA_2023_78694_94355.jpg

DS_ID:23227
FS_ID:78694
EP_NO: N/A
Repair Type: Non-Urgent
EVAL Issue: 11, Maintenance Compliance Issue
Crossing Status: Found
UCIP Comments: 03/25/2021 Pipe status is still Non-Urgent. Unit 15 – Mormon Slough (CLM 0 to 1.50 and 5.0 - 11.0) are considered a patrol road/high ground area with no defined levee prism, any issue found between CLM 0 - 1.50 and 5.0 – 11.0 of Unit 15 will be considered a maintenance issue, or an unauthorized encroachment, or an abandoned encroachment. LS pipe end covered in dirt and vegetation, recommend cleaning out. Cannot see WS pipe end. Current condition of pipe crossing does not impede access to patrol road/high ground area. No permit was found authorizing this encroachment. CVFPB will need to review crossing to determine owner. The UCIP inspection was completed with LMA representative, H. Latu. (H. Dunn – GEI)

04/10/2014 Distorted inlet pipe opening on landside. No pipe found on waterside. Dense vegetation and steep slope on waterside. (P. Tariq - DWR UCIP)
FIELD_STRUCT_DESC: 18-inch corrugated metal storm drainage pipe (CMP) through the levee, 1.0 foot below the crown. [Additional Reference(s): DWR Levee Log, 1992, (HLM 8.65). USACE San Joaquin O&M Manual 611.1, Volume F, (HLM 8.65), 18-inch pipe listed].
FS Date: 3/25/2021

Levee crown looking upstream.

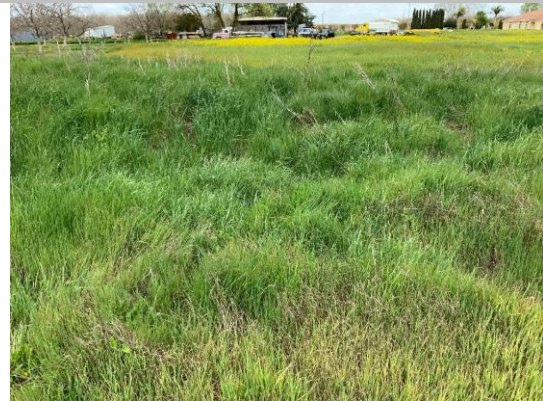
Photo 2 of 3 : UCIP_FA_2023_78694_94356.jpg

LS view: Toe from crown, pipe not visible.

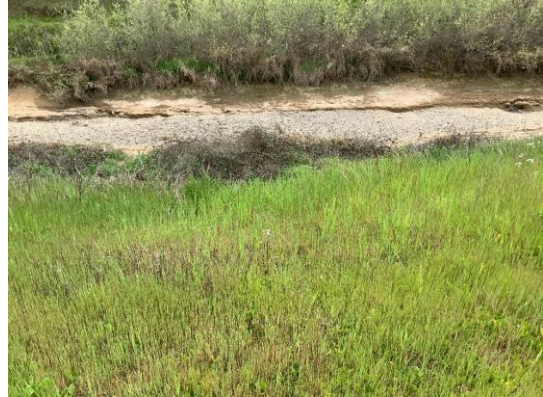
Photo 3 of 3 : UCIP_FA_2023_78694_94358.jpg

WS view: Toe from crown, no pipe visible.

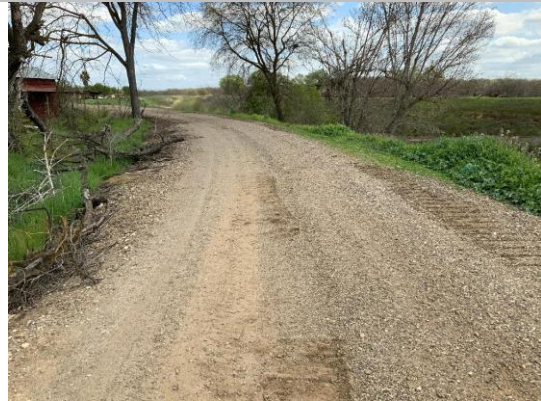
Photo 1 of 3 : UCIP_FA_2023_78695_94363.jpg

Comment Code						
Inspector Comment						
DS_ID:23229 FS_ID:78695 EP_NO: N/A Repair Type: Non-Urgent EVAL Issue: 11, Maintenance Compliance Issue Crossing Status: Found UCIP Comments: 03/25/2021 Pipe status is still Non-Urgent. Unit 15 – Mormon Slough (CLM 0 to 1.50 and 5.0 - 11.0) are considered a patrol road/high ground area with no defined levee prism, any issue found between CLM 0 - 1.50 and 5.0 – 11.0 of Unit 15 will be considered a maintenance issue, or an unauthorized encroachment, or an abandoned encroachment. LS pipe end bent and warped and covered with debris, recommend clearing away. Cannot see WS pipe end. Current condition of pipe crossing does not impede access to patrol road/high ground area. No permit was found authorizing this encroachment. CVFPB will need to review crossing to determine owner. The UCIP inspection was completed with LMA representative, H. Latu. (H. Dunn – GEI)

04/10/2014 Distorted pipe opening on landside. Inlet pipe needs clearing and cleaning. (P. Tariq - DWR UCIP)No pipe visible on waterside. FIELD_STRUCT_DESC: 18-inch corrugated metal storm drainage pipe (CMP) and an electrical conduit of an unknown material through the levee, 1.0 foot below the crown. Power pole on the landside (LS). Pipe outlet rock revetted. [Additional Reference(s): DWR Levee Log, 1992, (HLM 8.88). USACE San Joaquin O&M Manual 611.1, Volume F, (HLM 8.88), 18-inch pipe listed]. FS Date: 3/25/2021

Levee crown looking upstream.

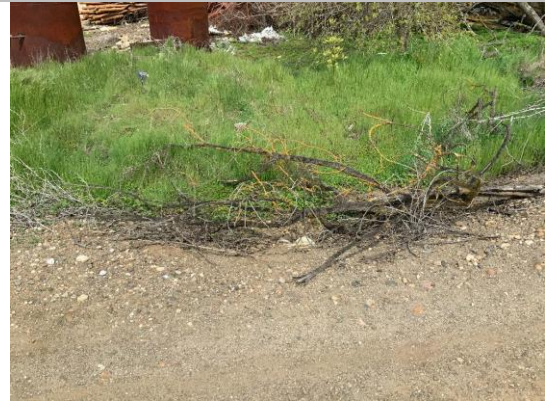
Photo 2 of 3 : UCIP_FA_2023_78695_94364.jpg

LS view: Toe from crown.

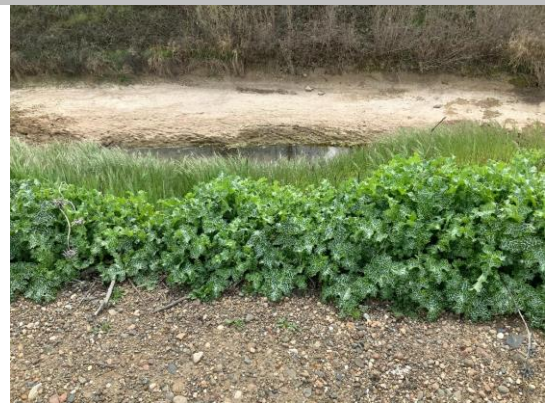
Photo 3 of 3 : UCIP_FA_2023_78695_94367.jpg

WS view: Toe from crown, no pipe visible.

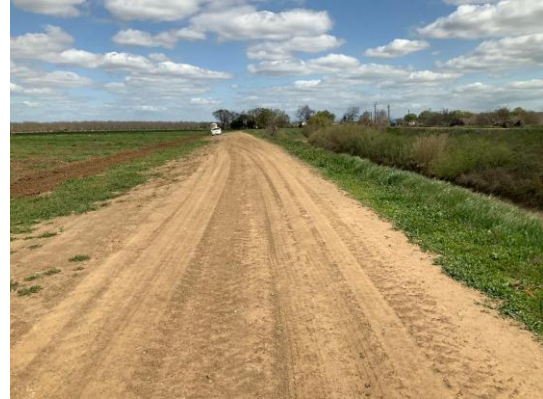
Photo 1 of 3 : UCIP_FA_2023_78696_94378.jpg

Comment Code						
Inspector Comment						
DS_ID:23230 FS_ID:78696 EP_NO: N/A Repair Type: Non-Urgent EVAL Issue: Crossing Status: Indicator Found UCIP Comments: 03/25/2021 Record has been upgraded from No Action Needed to Non-Urgent. Unit 15 – Mormon Slough (CLM 0 to 1.50 and 5.0 - 11.0) are considered a patrol road/high ground area with no defined levee prism, any issue found between CLM 0 - 1.50 and 5.0 – 11.0 of Unit 15 will be considered a maintenance issue, or an unauthorized encroachment, or an abandoned encroachment. Pipe not found by visual inspection. Geophysical study indicates possible presence of pipe through levee. Owner needs to coordinate with the CVFPB to remove or abandon crossing according to Title 23 requirements. Current condition of pipe crossing does not impede access to patrol road/high ground area. No permit was found authorizing this encroachment. CVFPB will need to review crossing to determine owner. The UCIP inspection was completed with LMA representative, H. Latu. (H. Dunn – GEI) FIELD_STRUCT_DESC: 18-inch corrugated metal storm drainage pipe (CMP) through the levee, 3.0 feet below the crown. Grouted inlet and outlet. [Additional Reference(s): DWR Levee Log, 1992, (HLM 9.12). USACE San Joaquin O&M Manual 611.1, Volume F, (HLM 9.12), 18-inch pipe listed]. FS Date: 3/25/2021

Levee crown looking upstream.

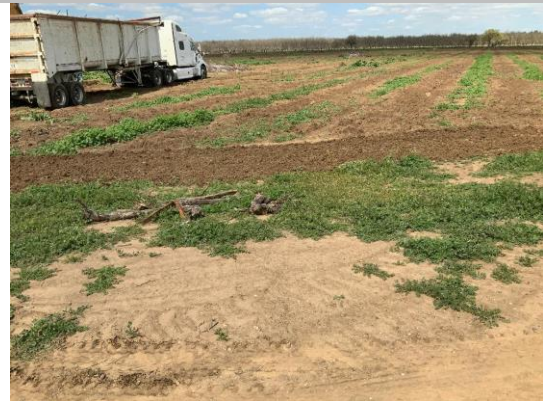
Photo 2 of 3 : UCIP_FA_2023_78696_94379.jpg

LS view: Toe from crown, no pipe visible.

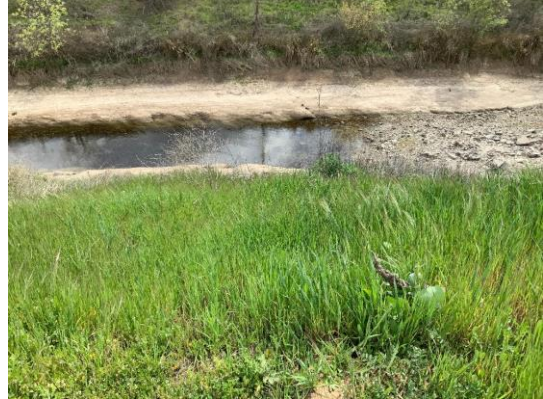
Photo 3 of 3 : UCIP_FA_2023_78696_94380.jpg

WS view: Toe from crown, no pipe visible.

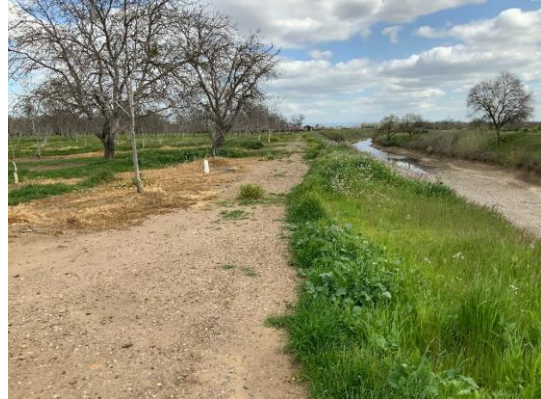
Photo 1 of 3 : UCIP_FA_2023_78700_94407.jpg

Comment Code						
Inspector Comment						
DS_ID:23233 FS_ID:78700 EP_NO: N/A Repair Type: Non-Urgent EVAL Issue: 11, Maintenance Compliance Issue Crossing Status: Found UCIP Comments: 03/25/2021 Pipe status is still Non-Urgent. Unit 15 - Mormon Slough (CLM 0 to 1.50 and 5.0 - 11.0) are considered a patrol road/high ground area with no defined levee prism, any issue found between CLM 0 - 1.50 and 5.0 - 11.0 of Unit 15 will be considered a maintenance issue, or an unauthorized encroachment, or an abandoned encroachment. DWR DMP internal video inspection has found pipe integrity issues. LOF of crossing is between 4.1 and 5. Crossing will be monitored until funding becomes available for rehabilitation. LS pipe buried under dirt and vegetation with some dirt seen inside WS pipe, recommend cleaning out both sides. Current condition of pipe crossing does not impede access to patrol road/high ground area. No permit was found authorizing this encroachment. CVFPB will need to review crossing to determine owner. The UCIP inspection was completed with LMA representative, H. Latu. (H. Dunn - GEI) 04/10/2014 Needs clearing and cleaning of the pipe. (P. Tariq - DWR UCIP) FIELD_STRUCT_DESC: 18-inch corrugated metal storm drainage pipe (CMP) through the levee, 3.5 feet below the crown. Pipe discharges onto the waterside (WS) slope, which is eroding. [Additional Reference(s): DWR Levee Log, 1992, (HLM 9.75). USACE San Joaquin O&M Manual 611.1, Volume F, (HLM 9.75), 18-inch pipe listed]. FS Date: 3/25/2021

Levee crown looking upstream.

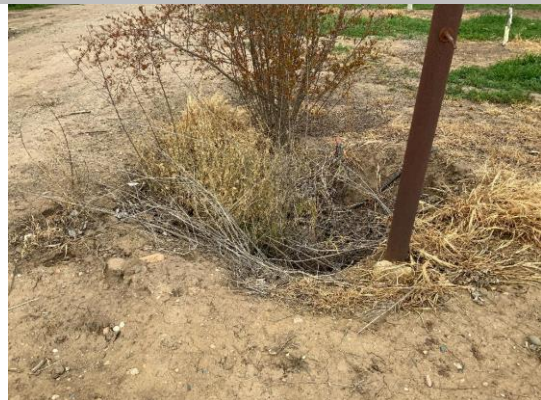
Photo 2 of 3 : UCIP_FA_2023_78700_94408.jpg

LS view: Toe from crown.

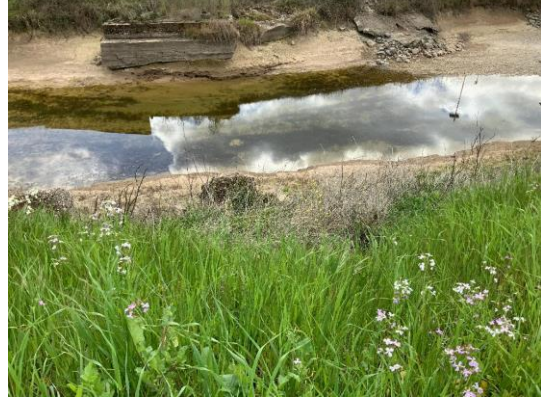
Photo 3 of 3 : UCIP_FA_2023_78700_94410.jpg

WS view: Toe from crown.

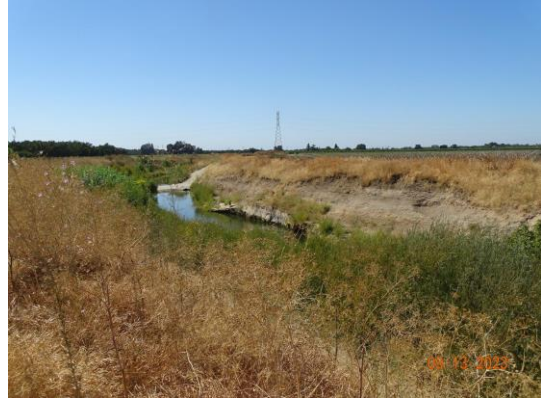
Photo 1 of 1 : FA_2023_NA0017_159_7_20231101_00248.jpg

*This area is patrol road only and therefore the site is not rated
08/02/2022: No significant changes were observed since the previous inspection. The length was extended to 350 ft based on more accurate field measurements.

07/24/2020: The site was discovered during the field survey. The erosion is immediately downstream of a newly repaired erosion site (NA0017U15RM13.25). The erosion begins at the shoulder and extends down the entire slope. Some sloughing is visible on the upper slope and the stream has cut into the bank.

View of channel bank erosion from opposite bank. Summer 2023

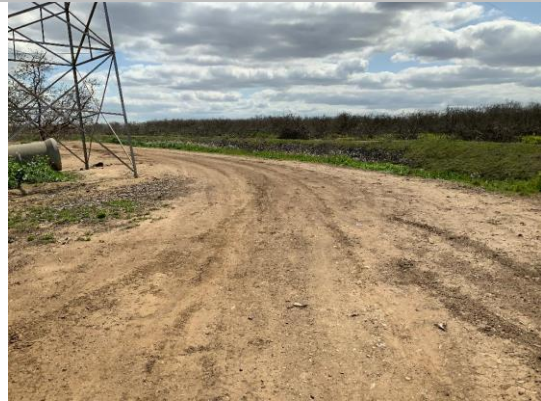
Photo 1 of 3 : UCIP_FA_2023_78702_94427.jpg

Comment Code					
Inspector Comment					
DS_ID:23235 FS_ID:78702 EP_NO: N/A Repair Type: Non-Urgent EVAL Issue: 11, Maintenance Compliance Issue Crossing Status: Found UCIP Comments: 03/25/2021 Pipe status is still Non-Urgent. Unit 15 - Mormon Slough (CLM 0 to 1.50 and 5.0 - 11.0) are considered a patrol road/high ground area with no defined levee prism, any issue found between CLM 0 - 1.50 and 5.0 - 11.0 of Unit 15 will be considered a maintenance issue, or an unauthorized encroachment, or an abandoned encroachment. LS pipe has some debris piled up, recommend cleaning out. DWR DMP internal video inspection has found pipe integrity issues. LOF of crossing is between 4.1 and 5. Crossing will be monitored until funding becomes available for rehabilitation. Current condition of pipe crossing does not impede access to patrol road/high ground area. No permit was found authorizing this encroachment. CVFPB will need to review crossing to determine owner. The UCIP inspection was completed with LMA representative, H. Latu. (H. Dunn - GEI) 04/10/2014 Mud/soil in inlet pipe. Needs cleaning. (P. Tariq - DWR UCIP)No pipe or appurtenances visible on waterside. Dense vegetation (may be visible from other channel bank). FIELD_STRUCT_DESC: 18-inch corrugated metal storm drainage pipe (CMP) through the levee, 4.0 feet below the crown. Grouted inlet and outlet. [Additional Reference(s): DWR Levee Log, 1992, (HLM 10.01). USACE San Joaquin O&M Manual 611.1, Volume F, (HLM 10.01), 18-inch pipe listed]. FS Date: 3/25/2021

Levee crown looking upstream.

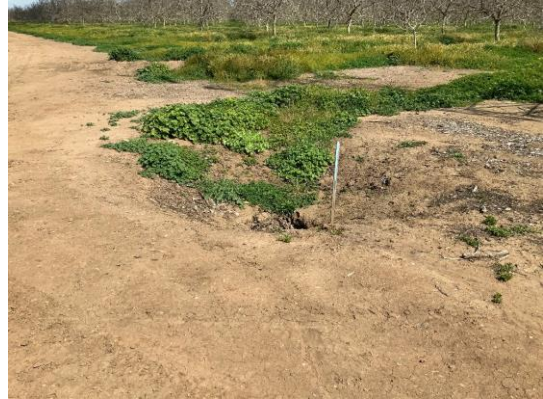
Photo 2 of 3 : UCIP_FA_2023_78702_94428.jpg

LS view: Toe from crown.

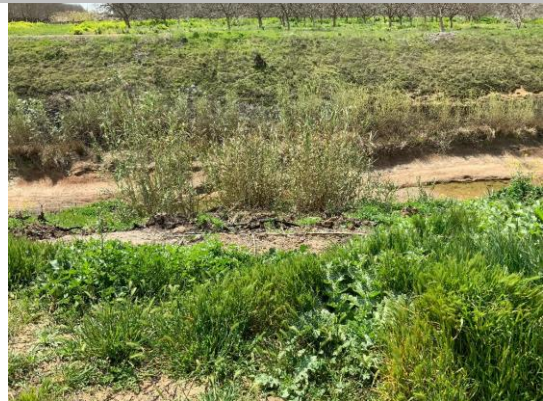
Photo 3 of 3 : UCIP_FA_2023_78702_94431.jpg

WS view: Toe from crown.

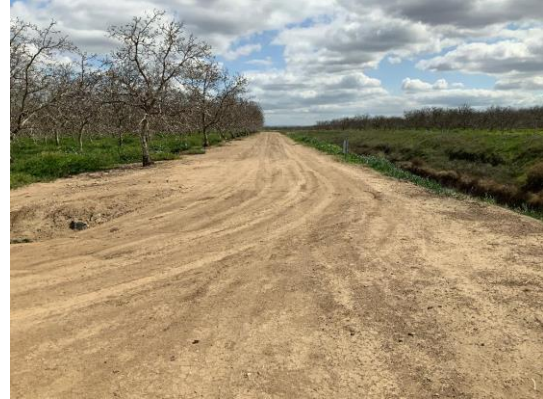
Photo 1 of 3 : UCIP_FA_2023_78703_94436.jpg

Comment Code						
Inspector Comment						
DS_ID:23236 FS_ID:78703 EP_NO: N/A Repair Type: Non-Urgent EVAL Issue: 11, Maintenance Compliance Issue Crossing Status: Found UCIP Comments: 03/25/2021 Pipe status is still Non-Urgent. Unit 15 - Mormon Slough (CLM 0 to 1.50 and 5.0 - 11.0) are considered a patrol road/high ground area with no defined levee prism, any issue found between CLM 0 - 1.50 and 5.0 - 11.0 of Unit 15 will be considered a maintenance issue, or an unauthorized encroachment, or an abandoned encroachment. LS pipe end filled with debris and dirt, recommend cleaning out. WS pipe end not seen. DWR DMP internal video inspection has not found pipe integrity issues. LOF of crossing is less or equal to 4.0. Recommend next video inspection in 5 years. Current condition of pipe crossing does not impede access to patrol road/high ground area. No permit was found authorizing this encroachment. CVFPB will need to review crossing to determine owner. The UCIP inspection was completed with LMA representative, H. Latu. (H. Dunn - GEI) 04/10/2014 May need cleaning of the pipe. (P. Tariq - DWR UCIP)Pipe not visible on waterside. FIELD_STRUCT_DESC: 18-inch corrugated metal storm drainage pipe (CMP) through the levee, 4.5 feet below the crown. Grouted inlet and outlet. [Additional Reference(s): DWR Levee Log, 1992, (HLM 10.22). USACE San Joaquin O&M Manual 611.1, Volume F, (HLM 10.22), 18-inch pipe listed]. FS Date: 3/25/2021

Levee crown looking upstream.

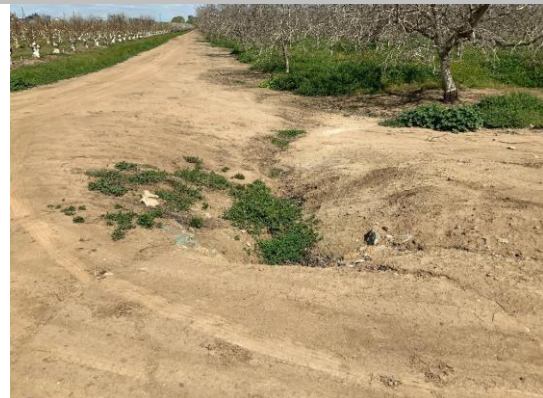
Photo 2 of 3 : UCIP_FA_2023_78703_94437.jpg

LS view: Toe from crown.

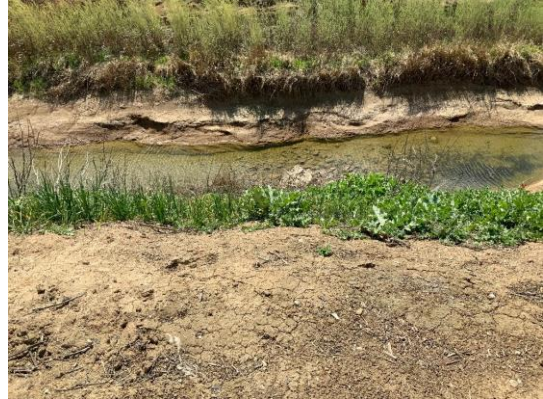
Photo 3 of 3 : UCIP_FA_2023_78703_94440.jpg

WS view: Toe from crown, no pipe visible.

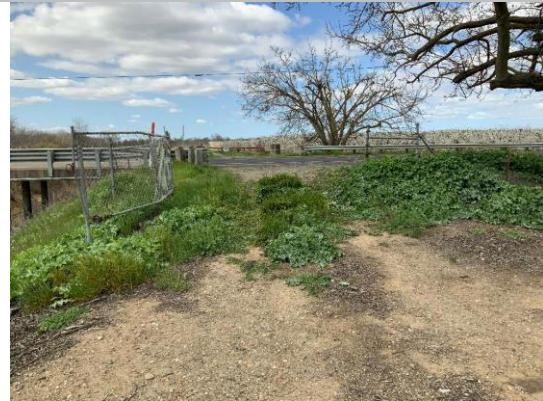
Photo 1 of 3 : UCIP_FA_2023_78704_94453.jpg

Comment Code						
Inspector Comment						
DS_ID:23237 FS_ID:78704 EP_NO: N/A Repair Type: Non-Urgent EVAL Issue: 11, Maintenance Compliance Issue Crossing Status: Found UCIP Comments: 03/25/2021 Record has been upgraded from No Action Needed to Non-Urgent. Unit 15 – Mormon Slough (CLM 0 to 1.50 and 5.0 - 11.0) are considered a patrol road/high ground area with no defined levee prism, any issue found between CLM 0 - 1.50 and 5.0 – 11.0 of Unit 15 will be considered a maintenance issue, or an unauthorized encroachment, or an abandoned encroachment. DWR DMP internal video inspection has found pipe integrity issues. LOF of crossing is between 4.1 and 5. Crossing will be monitored until funding becomes available for rehabilitation. Current condition of pipe crossing does not impede access to patrol road/high ground area. No permit was found authorizing this encroachment. CVFPB will need to review crossing to determine owner. The UCIP inspection was completed with LMA representative, H. Latu. (H. Dunn – GEI) 04/10/2014 May need cleaning of the inlet pipe. Vegetation debris on inlet box. (P. Tariq - DWR UCIP) FIELD_STRUCT_DESC: 18-inch corrugated metal storm drainage pipe (CMP) through the levee, 7.5 feet below the crown. Concrete U-shaped headwall on the landside (LS). Flap gate on the waterside (WS). [Additional Reference(s): DWR Levee Log, 1992, (HLM 10.47). USACE San Joaquin O&M Manual 611.1, Volume F, (HLM 10.47), 18-inch pipe listed]. FS Date: 3/25/2021

Levee crown looking downstream.

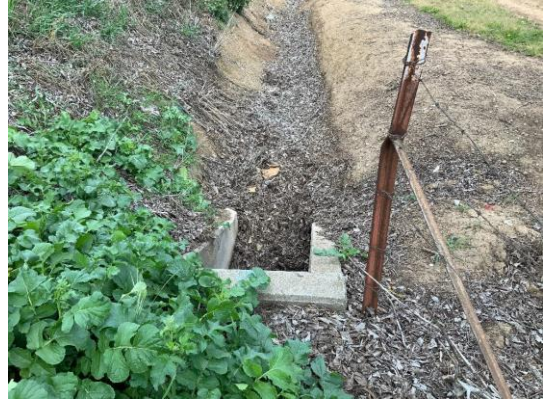
Photo 2 of 3 : UCIP_FA_2023_78704_94456.jpg

LS view: Toe from crown, headwall visible.

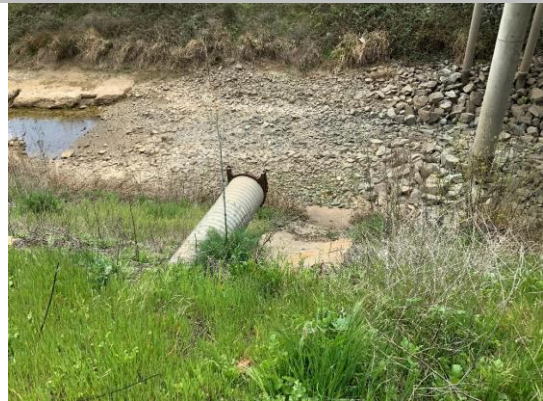
Photo 3 of 3 : UCIP_FA_2023_78704_94454.jpg

WS view: Toe from crown, pipe and flapgate visible.

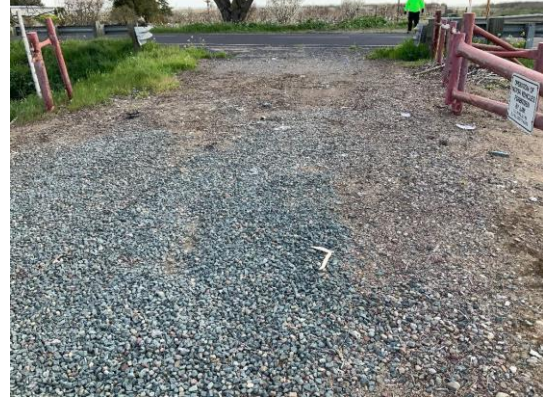
Photo 1 of 3 : UCIP_FA_2023_78705_94465.jpg

Comment Code						
Inspector Comment						
DS_ID:23238 FS_ID:78705 EP_NO: N/A Repair Type: Non-Urgent EVAL Issue: 11, Maintenance Compliance Issue Crossing Status: Found UCIP Comments: 03/25/2021 Pipe status is still Non-Urgent. Unit 15 – Mormon Slough (CLM 0 to 1.50 and 5.0 - 11.0) are considered a patrol road/high ground area with no defined levee prism, any issue found between CLM 0 - 1.50 and 5.0 – 11.0 of Unit 15 will be considered a maintenance issue, or an unauthorized encroachment, or an abandoned encroachment. Cannot see inlet or pipe on LS, likely covered in trash or vegetation, recommend clearing out. DWR DMP internal video inspection has not found pipe integrity issues. LOF of crossing is less or equal to 4.0. Recommend next video inspection in 5 years. Current condition of pipe crossing does not impede access to patrol road/high ground area. No permit was found authorizing this encroachment. CVFPB will need to review crossing to determine owner. The UCIP inspection was completed with LMA representative, H. Latu. (H. Dunn – GEI) 04/10/2014 Pipe buried on landside. May need cleaning of vegetation debris in inlet opening. (P. Tariq - DWR UCIP) FIELD_STRUCT_DESC: 18-inch corrugated metal storm drainage pipe (CMP) through the levee, 7.5 feet below the crown. Flap gate on the waterside (WS). [Additional Reference(s): DWR Levee Log, 1992, (HLM 10.49). USACE San Joaquin O&M Manual 611.1, Volume F, (HLM 10.49), 18-inch pipe listed]. FS Date: 3/25/2021

Levee crown looking upstream.

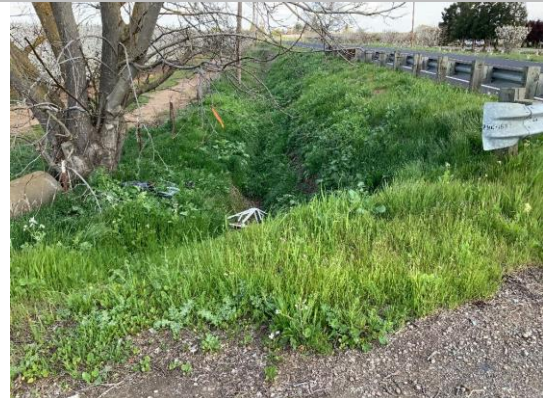
Photo 2 of 3 : UCIP_FA_2023_78705_94466.jpg

LS view: Toe from levee crown.

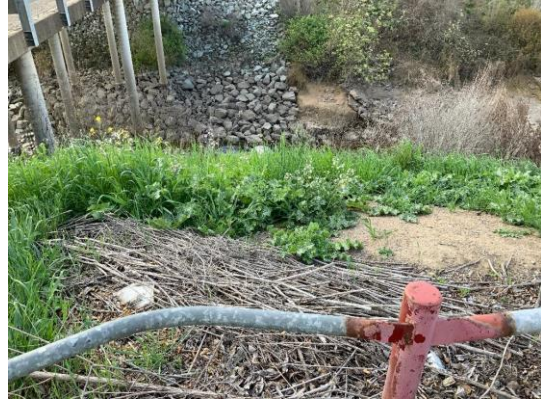
Photo 3 of 3 : UCIP_FA_2023_78705_94468.jpg

WS view: Toe from crown.

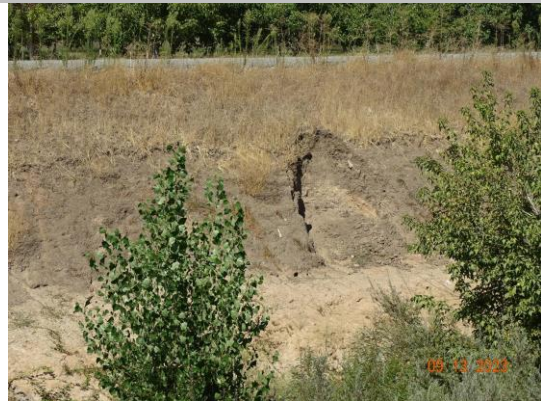
Photo 1 of 1 : FA_2023_NA0017_159_22_20231101_00249.jpg

*This area is patrol road only and therefore the site is not rated
08/02/2022: From 2020 to present, no significant changes were observed during the annual survey.

08/28/2019: The erosion is located at the lower slope of the channel bank and covered by dense vegetation.

View of bank erosion from the opposite bank. Summer 2023

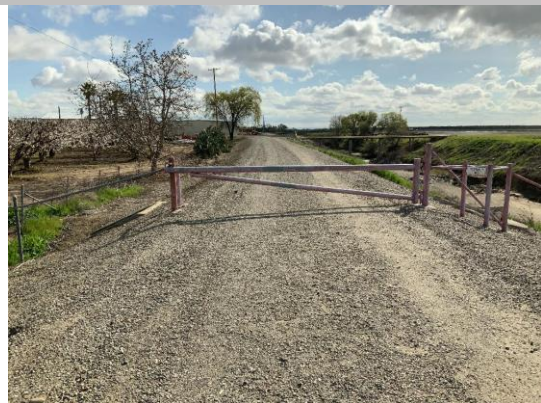
Photo 1 of 3 : UCIP_FA_2023_78710_94524.jpg

Comment Code						
Inspector Comment						
DS_ID:23243						
FS_ID:78710						
EP_NO: N/A						
Repair Type: Urgent						
EVAL Issue: 3a, Flood Risk						
Crossing Status: Found						
UCIP Comments: 03/25/2021 The record has been upgraded from Non-Urgent to Urgent. Pipe is heavily grouted around on WS, fairly hidden. No flapgate, open on both ends. Latest DMP internal video inspection has found moderate pipe defects. Crossing will be monitored until funding becomes available for rehabilitation. No permit was found authorizing this encroachment. CVFPB will need to review crossing to determine owner. The UCIP inspection was completed with LMA representative, H. Latu. (H. Dunn ? GEI) 04/14/2014 Distorted outlet pipe on waterside. (P. Andy - DWR UCIP)						
FIELD_STRUCT_DESC: 18-inch corrugated metal storm drainage pipe (CMP) through the levee, 4.0 feet below the crown. Grouted outlet on the waterside (WS). [Additional Reference(s): DWR Levee Log, 1992, (HLM 11.64). USACE San Joaquin O&M Manual 611.1, Volume F, (HLM 11.64), 18-inch pipe listed].

Levee crown looking upstream.

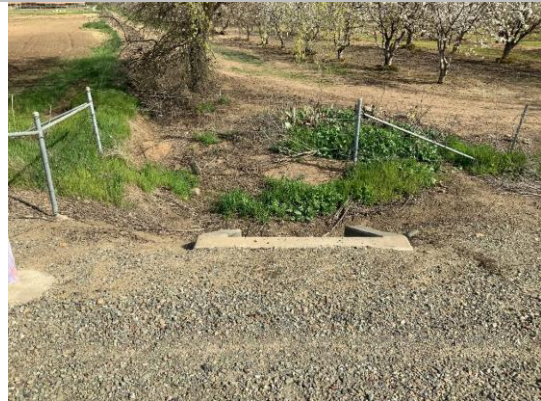
Photo 2 of 3 : UCIP_FA_2023_78710_94525.jpg

LS view: Toe from crown, headwall visible.

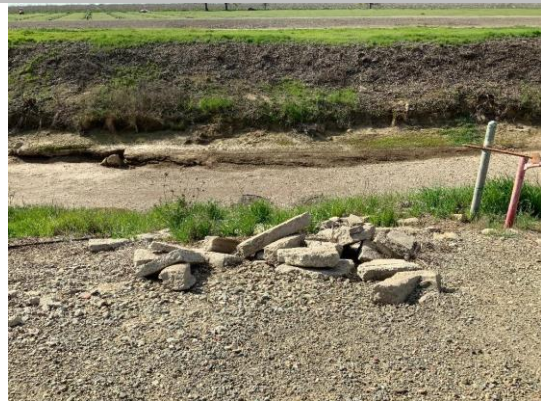
Photo 3 of 3 : UCIP_FA_2023_78710_94528.jpg

WS view: Toe from crown.

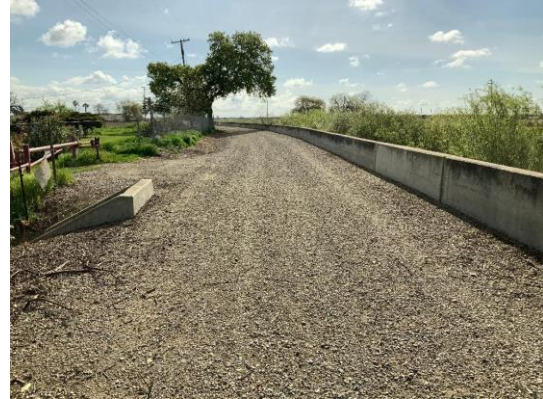
Photo 1 of 3 : UCIP_FA_2023_77709_94534.jpg

Comment Code					
Inspector Comment					
DS_ID:23244 FS_ID:77709 EP_NO: N/A Repair Type: Non-Urgent EVAL Issue: Crossing Status: Found UCIP Comments: 03/25/2021 The record has been upgraded from No Action Needed to Non-Urgent. DWR DMP internal video inspection has not found pipe integrity issues. LOF of crossing is less or equal to 4.0. Recommend next video inspection in 5 years. No permit was found authorizing this encroachment. CVFPB will need to review crossing to determine owner. The UCIP inspection was completed with LMA representative, H. Latu. (H. Dunn – GEI) 04/14/2014 New pipe and flapgate. (P. Andy - DWR UCIP) FIELD_STRUCT_DESC: 30-inch corrugated metal storm drainage pipe (CMP) through the levee, 4.5 feet below the crown. Flap gate on the waterside (WS). Headwall with open inlet pipe on the landside (LS). Grouted outlet. [Additional Reference(s): DWR Levee Log, 1992, (HLM 11.79), 18-inch pipe listed. USACE San Joaquin O&M Manual 611.1, Volume F, (HLM 11.79), 18-inch pipe listed]. FS Date: 3/25/2021

Levee crown looking upstream.

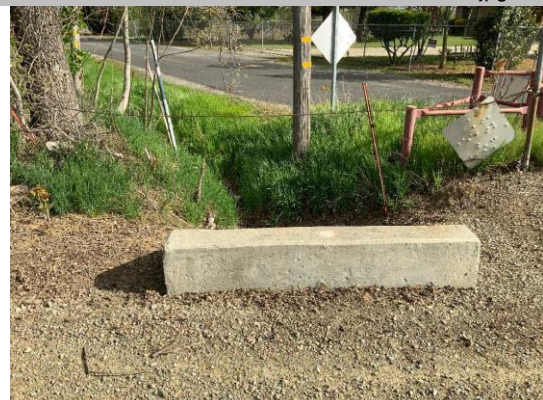
Photo 2 of 3 : UCIP_FA_2023_77709_94535.jpg

LS view: Toe from crown, headwall visible.

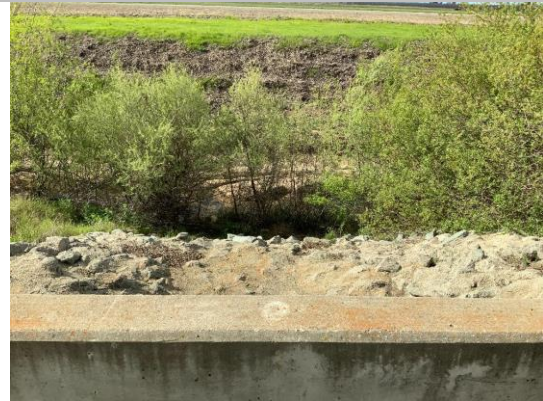
Photo 3 of 3 : UCIP_FA_2023_77709_94538.jpg

WS view: Toe from crown, headwall visible.

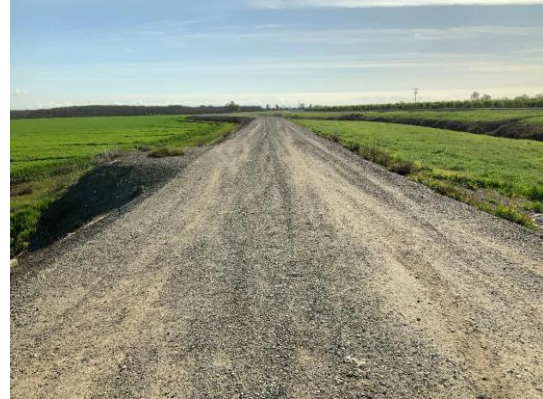
Photo 1 of 3 : UCIP_FA_2023_79157_94583.jpg

Comment Code					
Inspector Comment					
DS_ID:23247 FS_ID:79157 EP_NO: N/A Repair Type: Non-Urgent EVAL Issue: Crossing Status: Found UCIP Comments: 03/25/2021 The record has been upgraded from No Action Needed to Non- Urgent. DWR DMP internal video inspection has not found pipe integrity issues. LOF of crossing is less or equal to 4.0, Recommend next video inspection in 5 years. No permit was found authorizing this encroachment. CVFPB will need to review crossing to determine owner. The UCIP inspection was completed with LMA representative, H. Latu. (H. Dunn – GEI) 04/14/2014 May need mud and debris cleaning. (P. Andy - DWR UCIP) FIELD_STRUCT_DESC: 1 of 2: 48-inch drainage pipe of an unknown material through the levee, 11.5 feet below the crown. Slide gate in a corrugated metal pipe (CMP) riser unit on the waterside (WS) slope. Concrete U-shaped headwalls on each end. Flap gate on the WS end. Grouted rock outlet on the WS. [Additional Reference(s): DWR Levee Log, 1992, (HLM 12.65). USACE San Joaquin O&M Manual 611.1, Volume F, (HLM 12.65), 48-inch CMP listed]. FS Date: 3/25/2021

Levee crown looking upstream.

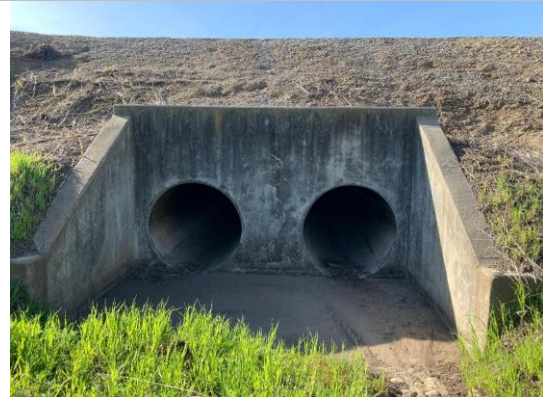
Photo 2 of 3 : UCIP_FA_2023_79157_94578.jpg

LS view: Headwall at toe.

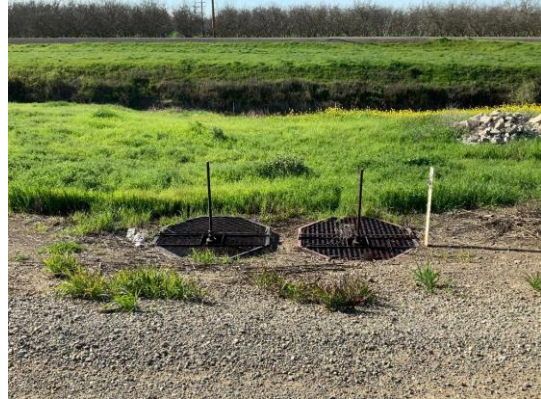
Photo 3 of 3 : UCIP_FA_2023_79157_94576.jpg

WS view: Toe from crown.

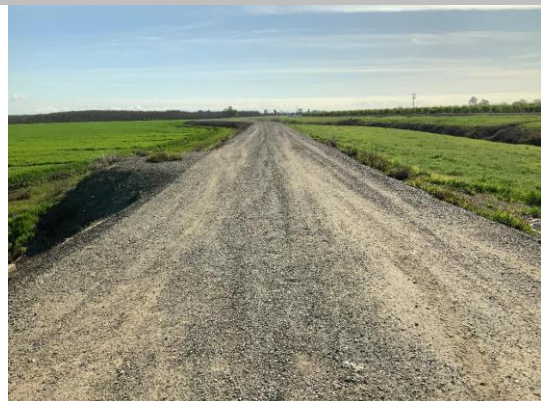
Photo 1 of 3 : UCIP_FA_2023_79158_94588.jpg

DS_ID:23454
 FS_ID:79158
 EP_NO: N/A
 Repair Type: Urgent
 EVAL Issue: 1, Pipe Integrity
 Crossing Status: Found
 UCIP Comments: 03/25/2021 The record has been upgraded from No Action Needed to Urgent. Significant peeling of metal inside LS pipe. DWR DMP internal video inspection has found pipe integrity issues. LOF of crossing is between 5 and 6. Crossing will be monitored until funding becomes available to address the issues. No permit was found authorizing this encroachment. CVFPB will need to review crossing to determine owner. The UCIP inspection was completed with LMA representative, H. Latu. (H. Dunn – GEI) 04/14/2014 May need mud and debris cleaning. (P. Andy - DWR UCIP)
 FIELD_STRUCT_DESC: 2 of 2: 48-inch drainage pipe of an unknown material through the levee, 11.5 feet below the crown. Slide gate in a corrugated metal pipe (CMP) riser unit on the waterside (WS) slope. Concrete U-shaped headwalls on each end. Flap gate on the WS end. Grouted rock outlet on the WS. [Additional Reference(s): DWR Levee Log, 1992, (HLM 12.65). USACE San Joaquin O&M Manual 611.1, Volume F, (HLM 12.65), 48-inch CMP listed].

Levee crown looking upstream.

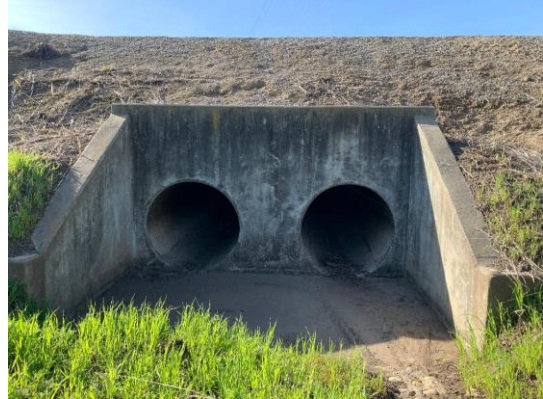
Photo 2 of 3 : UCIP_FA_2023_79158_94591.jpg

LS view: Headwall at toe.

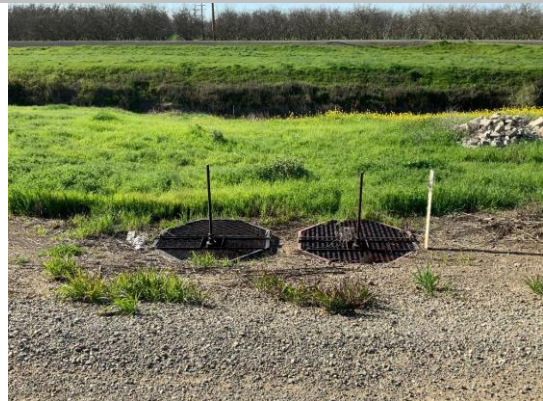
Photo 3 of 3 : UCIP_FA_2023_79158_94589.jpg

WS view: Toe from crown.

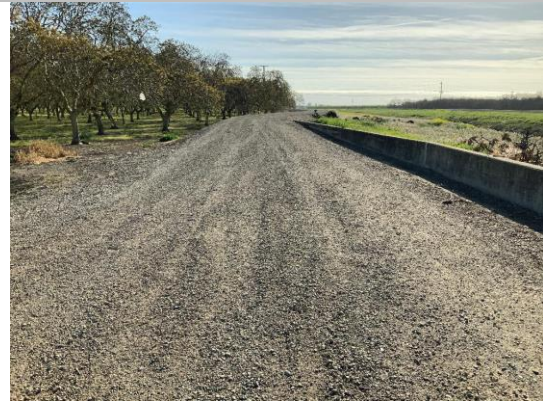
Photo 1 of 3 : UCIP_FA_2023_79160_94611.jpg

Comment Code					
Inspector Comment					
DS_ID:23249 FS_ID:79160 EP_NO: N/A Repair Type: Urgent EVAL Issue: 1, Pipe Integrity Crossing Status: Found UCIP Comments: 03/25/2021 The record has been upgraded from No Action Needed to Urgent. DWR DMP internal video inspection has found pipe integrity issues. LOF of crossing is between 5 and 6. Minor erosion along LS headwall edges. Unknown plastic pipe underground adjacent to LS headwall, does not go through the levee. Crossing will be monitored until funding becomes available to address the issues. No permit was found authorizing this encroachment. CVFPB will need to review crossing to determine owner. The UCIP inspection was completed with LMA representative, H. Latu. (H. Dunn – GEI) 04/14/2014 May need cleaning of pipes. Flood wall on waterside shoulder. (P. Andy - DWR UCIP) FIELD_STRUCT_DESC: 30-inch corrugated metal storm drainage pipe (CMP) through the levee, 8.5 feet below the crown. Concrete U-shaped headwalls on each end. Flap gate on the waterside (WS) end. Grouted intake and outlet. [Additional Reference(s): DWR Levee Log, 1992, (HLM 12.83). USACE San Joaquin O&M Manual 611.1, Volume F, (HLM 12.83), 30-inch pipe listed]. FS Date: 3/25/2021

Levee crown looking upstream.

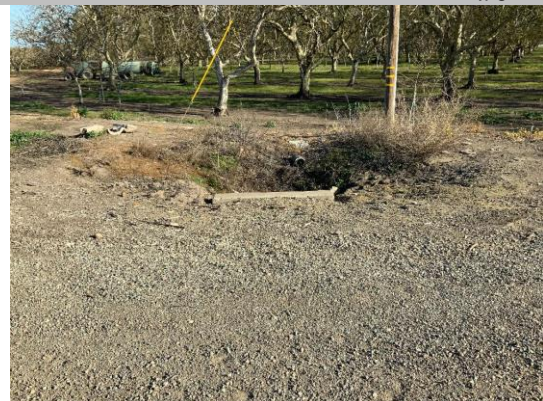
Photo 2 of 3 : UCIP_FA_2023_79160_94613.jpg

LS view: Headwall at toe from crown.

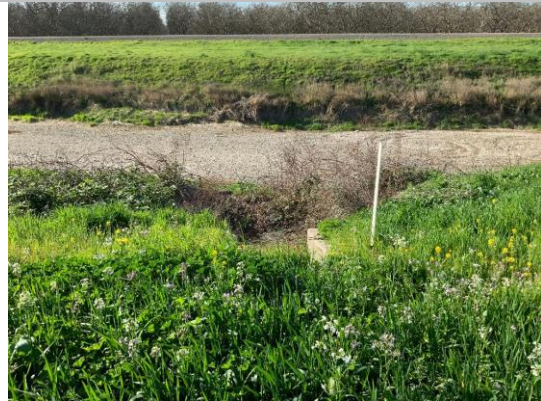
Photo 3 of 3 : UCIP_FA_2023_79160_94617.jpg

WS view: Headwall at toe from crown.

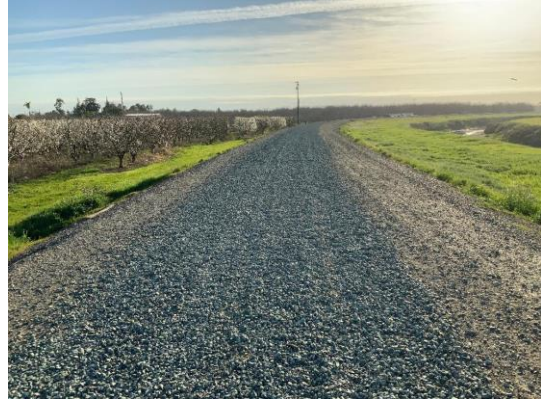
Photo 1 of 3 : UCIP_FA_2023_79161_94652.jpg

Comment Code						
Inspector Comment						
DS_ID:23252 FS_ID:79161 EP_NO: N/A Repair Type: Non-Urgent EVAL Issue: Crossing Status: Found UCIP Comments: 03/25/2021 Pipe status is still Non-Urgent. DWR DMP internal video inspection has not found pipe integrity issues. LOF of crossing is less or equal to 4.0. Recommend next video inspection in 5 years. No permit was found authorizing this encroachment. CVFPB will need to review crossing to determine owner. The UCIP inspection was completed with LMA representative, H. Latu. (H. Dunn – GEI) 04/14/2014 Needs pipe cleaning. (P. Andy - DWr UCIP) FIELD_STRUCT_DESC: 30-inch corrugated metal storm drainage pipe (CMP) through the levee, 8.5 feet below the crown. Concrete U-shaped headwalls on each end. Flap gate on the waterside (WS) end. Grouted outlet on the WS. [Additional Reference(s): DWR Levee Log, 1992, (HLM 13.43). USACE San Joaquin O&M Manual 611.1, Volume F, (HLM 13.43), 30-inch pipe listed]. FS Date: 3/25/2021

Levee crown looking upstream.

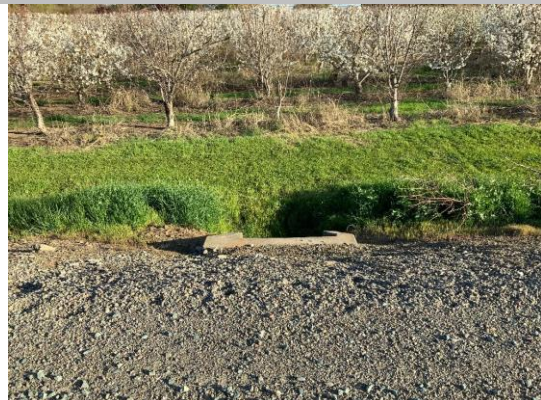
Photo 2 of 3 : UCIP_FA_2023_79161_94654.jpg

LS view: Headwall at toe from crown.

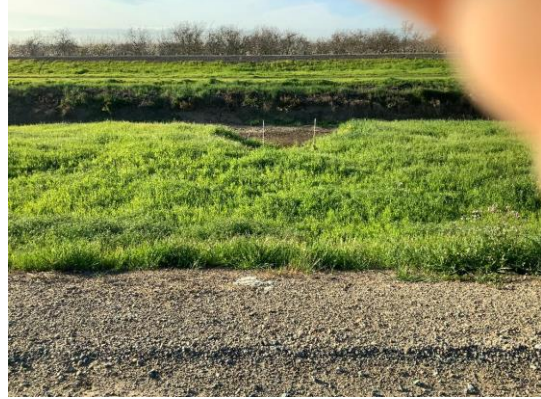
Photo 3 of 3 : UCIP_FA_2023_79161_94648.jpg

WS view: Toe and slope from crown.

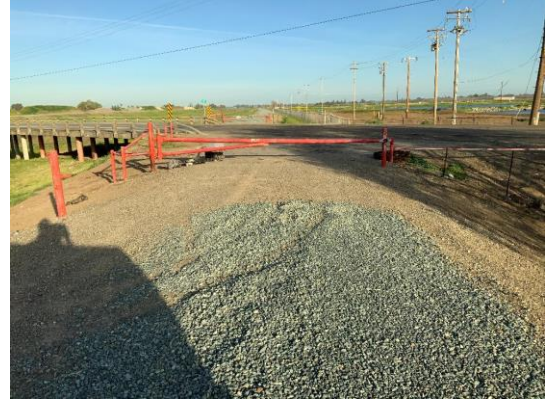
Photo 1 of 3 : UCIP_FA_2023_79162_95094.jpg

Comment Code					
Inspector Comment					
DS_ID:23254 FS_ID:79162 EP_NO: N/A Repair Type: Non-Urgent EVAL Issue: Crossing Status: Found UCIP Comments: 03/25/2021 Pipe status is still Non-Urgent. No permit was found authorizing this encroachment. CVFPB will need to review crossing to determine owner. The UCIP inspection was completed with LMA representative, H. Latu. (H. Dunn – GEI) 04/14/2014 Needs cleaning. (P. Andy - DWR UCIP) FIELD_STRUCT_DESC: 36-inch corrugated metal storm drainage pipe (CMP) through the levee, 8.5 feet below the crown. Concrete U-shaped headwalls on each end. Flap gate on the waterside (WS) end. Grouted outlet on the WS. [Additional Reference(s): DWR Levee Log, 1992, (HLM 13.75). USACE San Joaquin O&M Manual 611.1, Volume F, (Station 0+79), 36-inch pipe listed]. FS Date: 3/25/2021

Levee crown looking upstream.

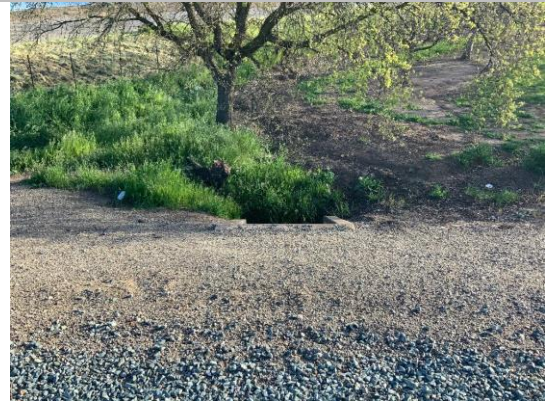
Photo 2 of 3 : UCIP_FA_2023_79162_95095.jpg

LS view: Headwall visible at toe from crown.

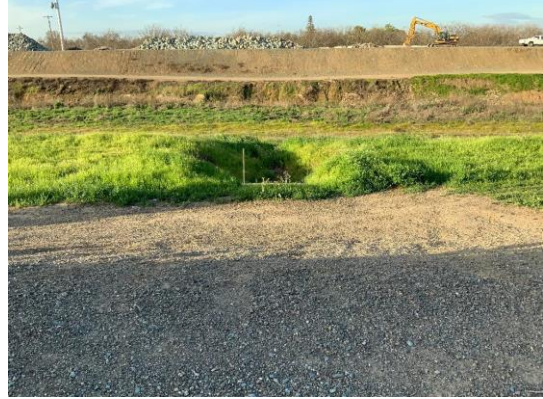
Photo 3 of 3 : UCIP_FA_2023_79162_95098.jpg

WS view: Headwall at toe from crown.

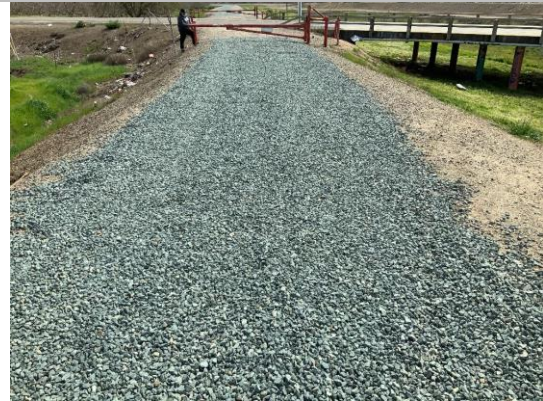
Photo 1 of 3 : UCIP_FA_2023_79420_95108.jpg

Comment Code						
Inspector Comment						
DS_ID:23257 FS_ID:79420 EP_NO: N/A Repair Type: Non-Urgent EVAL Issue: 5, Pipe Damage Crossing Status: Found UCIP Comments: 03/31/2023 Record updated from Urgent to Non-Urgent. LoF is equal to 5 due to pipe surface damage corrosion, integrity issues are not found. Crossing will be monitored until funding becomes available for rehabilitation. (O.Yakimov - DWR UCIP). 03/22/2021 The record has been upgraded from No Action Needed to Urgent. DWR DMP internal video inspection has found pipe integrity issues. LOF of crossing is between 5 and 6. Crossing will be monitored until funding becomes available to address the issues. No permit was found authorizing this encroachment. CVFPB will need to review crossing to determine owner. The UCIP inspection was completed with LMA representative, J. Jauregui. (H. Dunn ? GEI) 04/14/2014 May need cleaning. (P. Andy - DWR UCIP) FIELD_STRUCT_DESC: 30-inch corrugated metal storm drainage pipe (CMP) through the levee, 9.5 feet below the crown. Concrete U-shaped headwalls on each end. Flap gate on the waterside (WS) end. Grouted intake and outlet. [Additional Reference(s): DWR Levee Log, 1992, (HLM 13.79). USACE San Joaquin O&M Manual 611.1, Volume F, (HLM 13.79), 30-inch pipe listed]. FS Date: 3/22/2021

Levee crown looking upstream.
