**Flood Control Project Maintenance
Levee Inspections**

Maintenance Issue Types Only, Levee Inspection Report By Mile - Fall 2023

San Joaquin County Flood Control and Water Conservation District

Waterway	Bank	Unit Miles	Inspection Start/End	Inspector
Unit No. 01 Littlejohn Creek	Left	2.59	10/20/2023 10/20/2023	Alberto De Leon

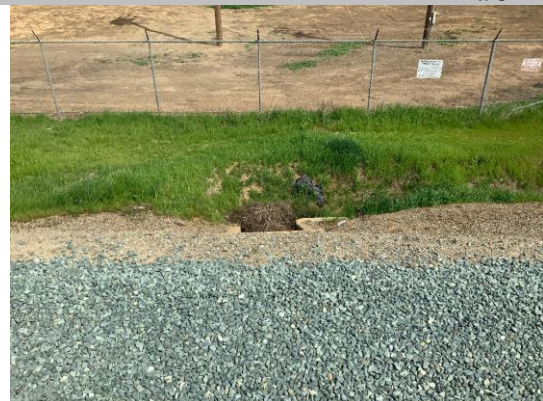
Photo 2 of 3 : UCIP_FA_2023_79420_95109.jpg

Comment Code						
Inspector Comment						
DS_ID:23257 FS_ID:79420 EP_NO: N/A Repair Type: Non-Urgent EVAL Issue: 5, Pipe Damage Crossing Status: Found UCIP Comments: 03/31/2023 Record updated from Urgent to Non-Urgent. LoF is equal to 5 due to pipe surface damage corrosion, integrity issues are not found. Crossing will be monitored until funding becomes available for rehabilitation. (O.Yakimov - DWR UCIP). 03/22/2021 The record has been upgraded from No Action Needed to Urgent. DWR DMP internal video inspection has found pipe integrity issues. LOF of crossing is between 5 and 6. Crossing will be monitored until funding becomes available to address the issues. No permit was found authorizing this encroachment. CVFPB will need to review crossing to determine owner. The UCIP inspection was completed with LMA representative, J. Jauregui. (H. Dunn ? GEI) 04/14/2014 May need cleaning. (P. Andy - DWR UCIP) FIELD_STRUCT_DESC: 30-inch corrugated metal storm drainage pipe (CMP) through the levee, 9.5 feet below the crown. Concrete U-shaped headwalls on each end. Flap gate on the waterside (WS) end. Grouted intake and outlet. [Additional Reference(s): DWR Levee Log, 1992, (HLM 13.79). USACE San Joaquin O&M Manual 611.1, Volume F, (HLM 13.79), 30-inch pipe listed]. FS Date: 3/22/2021

LS view: Headwall visible at toe from crown.

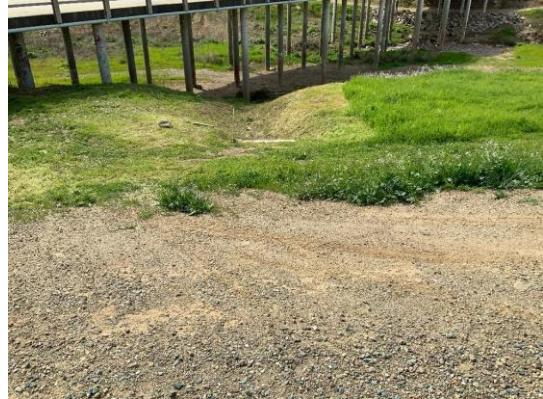
Photo 3 of 3 : UCIP_FA_2023_79420_95112.jpg

WS view: Headwall at toe from crown.

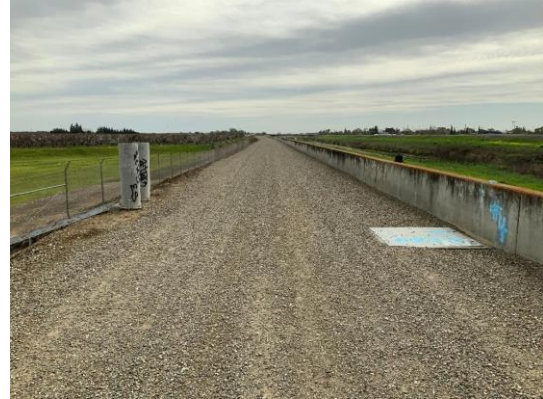
Photo 1 of 3 : UCIP_FA_2023_79582_95139.jpg

Comment Code						
Inspector Comment						
DS_ID:23456						
FS_ID:79582						
EP_NO: N/A						
Repair Type: No Action Needed						
EVAL Issue:						
Crossing Status: Found						
UCIP Comments: 04/20/2023 Record updated from Urgent to No Action Needed. Latest PACP inspection found minor pipe defects. Recommend next video inspection in 5 years. (O.Yakimov - DWR UCIP)						
03/22/2021 The record has been upgraded from No Action Needed to Urgent. DWR DMP internal video inspection has found pipe integrity issues. LOF of crossing is between 5 and 6. Crossing will be monitored until funding becomes available to address the issues. No permit was found authorizing this encroachment. CVFPB will need to review crossing to determine owner. The UCIP inspection was completed with LMA representative, J. Jauregui. (H. Dunn – GEI) 10/27/2017 This structure is inspected annually under the Structure and Channel Summer Inspection (part of the Levee Inspection Program) conducted by the DWR Flood Project Integrity and Inspection Branch (FPIIB). (DWR UCIP - O. Magana)

Culvert inlet under the pump house.						
FIELD_STRUCT_DESC: [Mormon Slough Pumping Plant No. 3] 1 of 3: 30-inch by 30-inch reinforced concrete box drainage culvert (RCBC) through the levee, 18.0 feet below the crown. Slide gate in a riser unit on the waterside (WS) slope. Flap gate on the WS end. Concrete U-shaped headwall around all three pipes on the WS. Steel steps on the LS slope. [Additional Reference(s): DWR Levee Log, 1992, (HLM 15.42). USACE San Joaquin O&M Manual 611.1, Volume F, (HLM 15.42), 30-inch by 30-inch RCBC listed].						
FS Date: 3/22/2021

Levee crown looking upstream.

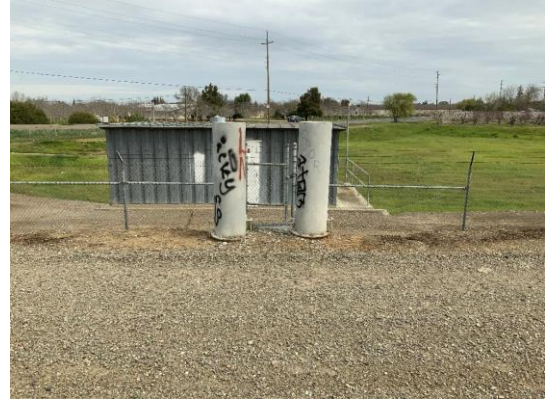
Photo 2 of 3 : UCIP_FA_2023_79582_95141.jpg

LS view: Toe from crown, pump house and risers.

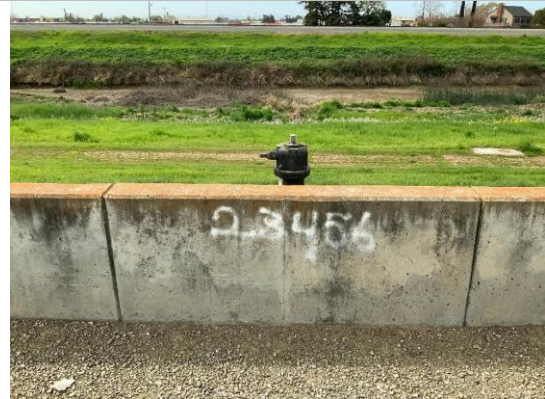
Photo 3 of 3 : UCIP_FA_2023_79582_95143.jpg

WS view: Toe from crown.

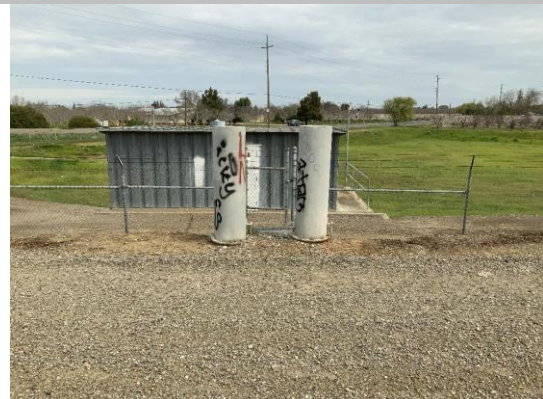
Photo 2 of 3 : UCIP_FA_2023_80885_95149.jpg

Comment Code						
Inspector Comment						
DS_ID:23261 FS_ID:80885 EP_NO: N/A Repair Type: No Action Needed EVAL Issue: Crossing Status: Found UCIP Comments: 03/22/2021 The record has been upgraded from No Action Needed to Non-Urgent. No permit was found authorizing this encroachment. CVFPB will need to review crossing to determine owner. The UCIP inspection was completed with LMA representative, J. Jauregui. (H. Dunn – GEI) 10/27/2017 This structure is inspected annually under the Structure and Channel Summer Inspection (part of the Levee Inspection Program) conducted by the DWR Flood Project Integrity and Inspection Branch (FPIIB). (DWR UCIP - O. Magana) Trash rack in inlet opening box. FIELD_STRUCT_DESC: [Mormon Slough Pumping Plant No. 3] 2 of 3: 20-inch steel drainage pipe through the levee, 1.9 feet below the crown. Siphon breakers in 4-foot-high riser units on the landside (LS) shoulder. Flap gates on the waterside (WS) end. Concrete U-shaped headwall around all three pipes on the WS. Pump house on the LS. Steel steps on the LS slope. [Additional Reference(s): DWR Levee Log, 1992, (HLM 15.42). USACE San Joaquin O&M Manual 611.1, Volume F, (HLM 15.42), 20-inch pipe listed]. FS Date: 3/22/2021

LS view: Toe from crown, risers and pump house.

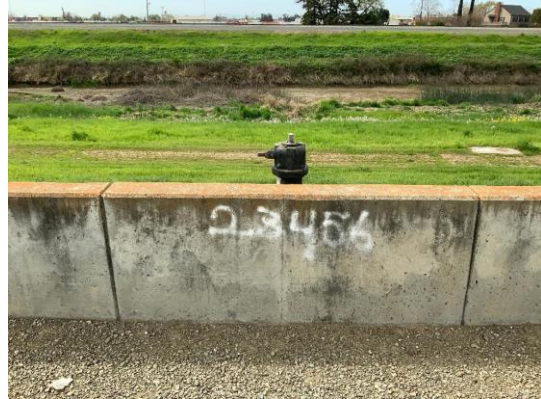
Photo 3 of 3 : UCIP_FA_2023_80885_95151.jpg

WS view: Toe from crown.

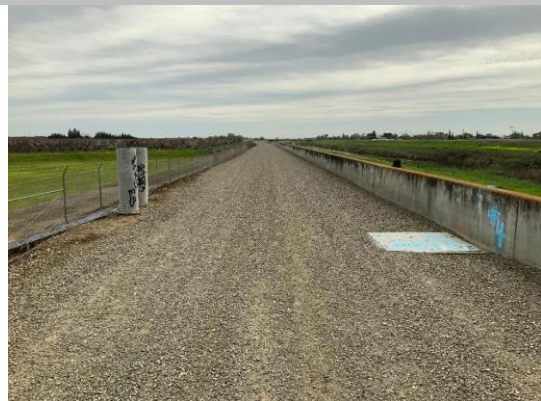
Photo 1 of 3 : UCIP_FA_2023_80886_95156.jpg

DS_ID:23455
 FS_ID:80886
 EP_NO: N/A
 Repair Type: No Action Needed
 EVAL Issue:
 Crossing Status: Found
 UCIP Comments: 03/22/2021 The record has been upgraded from No Action Needed to Non-Urgent. No permit was found authorizing this encroachment. CVFPB will need to review crossing to determine owner. The UCIP inspection was completed with LMA representative, J. Jauregui. (H. Dunn – GEI) 10/27/2017 This structure is inspected annually under the Structure and Channel Summer Inspection (part of the Levee Inspection Program) conducted by the DWR Flood Project Integrity and Inspection Branch (FPIIB). (DWR UCIP - O. Magana)
 Steel trash rack in inlet opening.
 FIELD_STRUCT_DESC: [Mormon Slough Pumping Plant No. 3] 3 of 3: 20-inch steel drainage pipe through the levee, 1.9 feet below the crown. Siphon breakers in 4-foot-high riser units on the landside (LS) shoulder. Flap gates on the waterside (WS) end. Concrete U-shaped headwall around all three pipes on the WS. Pump house on the LS. Steel steps on the LS slope. [Additional Reference(s): DWR Levee Log, 1992, (HLM 15.42). USACE San Joaquin O&M Manual 611.1, Volume F, (HLM 15.42), 20-inch pipe listed].

Levee crown looking upstream.

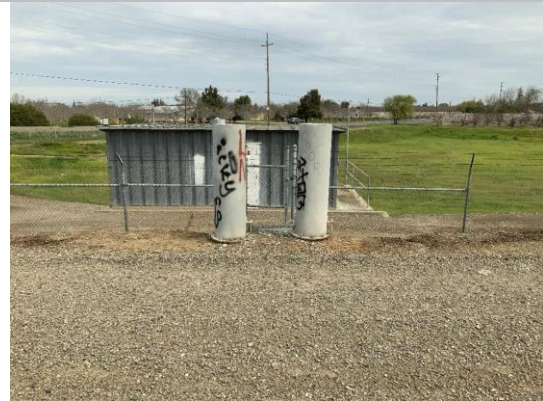
Photo 2 of 3 : UCIP_FA_2023_80886_95157.jpg

LS view: Toe from crown, risers and pump house.

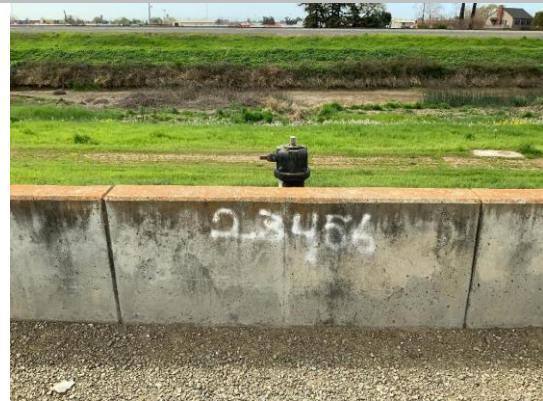
Photo 3 of 3 : UCIP_FA_2023_80886_95159.jpg

WS view: Toe from crown.

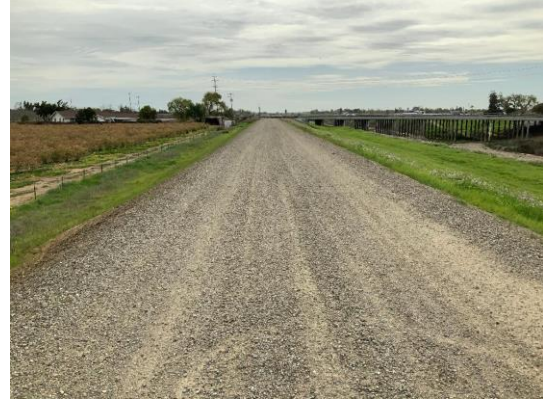
Photo 1 of 3 : UCIP_FA_2023_79421_95201.jpg

Comment Code						
Inspector Comment						
DS_ID:23188 FS_ID:79421 EP_NO: N/A Repair Type: Non-Urgent EVAL Issue: 5, Pipe Damage Crossing Status: Found UCIP Comments: 03/31/2023 Record updated from Urgent to Non-Urgent. LoF is equal to 5 due to pipe surface damage corrosion, integrity issues are not found. Crossing will be monitored until funding becomes available for rehabilitation. (O.Yakimov - DWR UCIP). 03/22/2021 The record has been upgraded from No Action Needed to Urgent. DWR DMP internal video inspection has found pipe integrity issues. LOF of crossing is between 5 and 6. Crossing will be monitored until funding becomes available to address the issues. No permit was found authorizing this encroachment. CVFPB will need to review crossing to determine owner. The UCIP inspection was completed with LMA representative, J. Jauregui. (H. Dunn ? GEI) 04/15/2014 May need cleaning. (P. Andy - DWR UCIP) FIELD_STRUCT_DESC: 30-inch corrugated metal storm drainage pipe (CMP) through the levee, 9.5 feet below the crown. Flap gate on the waterside (WS) end. Concrete U-shaped headwalls on each end. Grouted intake and outlet. [Additional Reference(s): DWR Levee Log, 1992, (HLM 15.58). USACE San Joaquin O&M Manual 611.1, Volume F, (HLM 15.58), 30-inch pipe listed]. FS Date: 3/22/2021

Levee crown looking upstream.

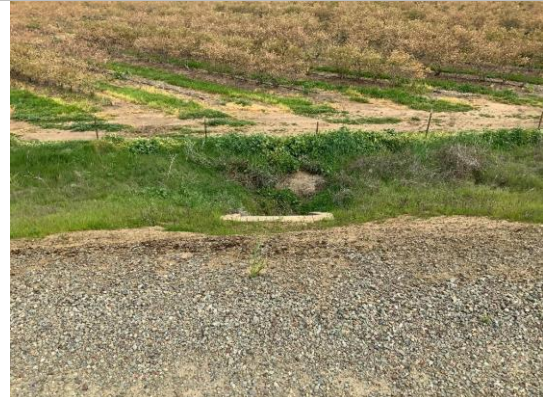
Photo 2 of 3 : UCIP_FA_2023_79421_95202.jpg

LS view: Headwall visible at toe from crown.

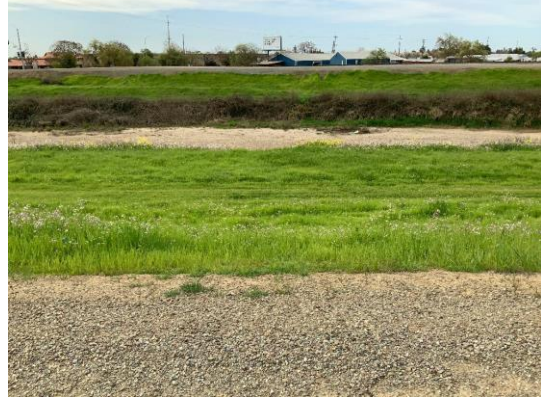
Photo 3 of 3 : UCIP_FA_2023_79421_95205.jpg

WS view: Toe from crown.

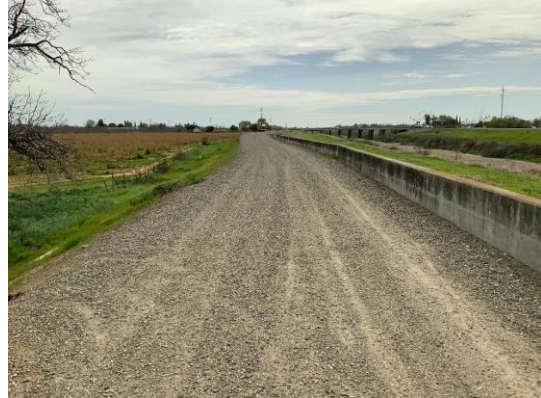
Photo 1 of 3 : UCIP_FA_2023_79422_95208.jpg

DS_ID:23189
 FS_ID:79422
 EP_NO: N/A
 Repair Type: Non-Urgent
 EVAL Issue: 5, Pipe Damage
 Crossing Status: Found
 UCIP Comments: 03/31/2023 Record updated from Urgent to Non-Urgent. LoF is equal to 5 due to pipe surface damage corrosion, integrity issues are not found. Crossing will be monitored until funding becomes available for rehabilitation. (O.Yakimov - DWR UCIP).
 03/22/2021 Record updated from No Action Needed to Urgent. DMP internal video inspection has found pipe integrity issues. LOF of crossing is between 5 and 6. Crossing will be monitored until funding becomes available to address the issues. No permit was found authorizing this encroachment. CVFPB will need to review crossing to determine owner. The UCIP inspection was completed with LMA representative, J. Jauregui. (H. Dunn ? GEI) 04/15/2014 May need cleaning. (P. Andy - DWR UCIP)
 FIELD_STRUCT_DESC: 30-inch corrugated metal storm drainage pipe (CMP) through the levee, 9.5 feet below the crown. Flap gate on the waterside (WS) end. Concrete U-shaped headwalls on each end. Grouted intake and outlet. [Additional Reference(s): DWR Levee Log, 1992, (HLM 15.70). USACE San Joaquin O&M Manual 611.1, Volume F, (HLM 15.70), 30-inch pipe listed].

Levee crown looking upstream.

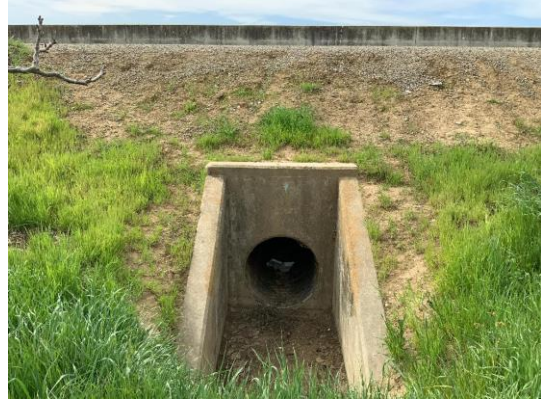
Photo 2 of 3 : UCIP_FA_2023_79422_95210.jpg

LS view: Headwall at toe.

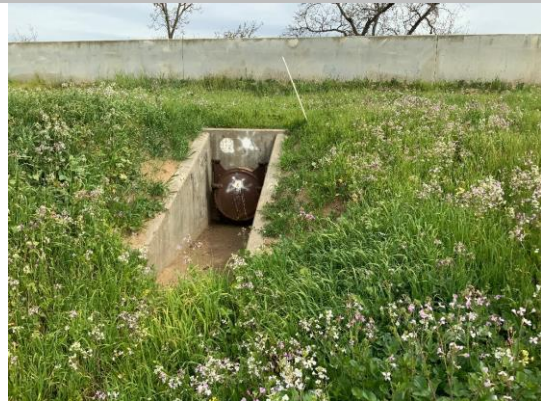
Photo 3 of 3 : UCIP_FA_2023_79422_95213.jpg

WS view: Headwall and flapgate at toe.

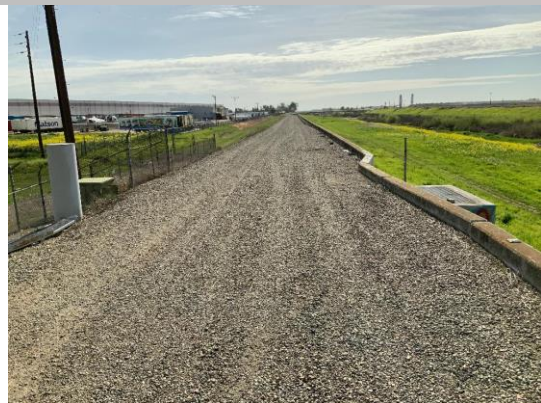
Photo 1 of 3 : UCIP_FA_2023_80887_95260.jpg

Comment Code						
Inspector Comment						
DS_ID:23457 FS_ID:80887 EP_NO: N/A Repair Type: No Action Needed EVAL Issue: Crossing Status: Found UCIP Comments: 03/22/2021 The record has been upgraded from No Action Needed to Non-Urgent. No permit was found authorizing this encroachment. CVFPB will need to review crossing to determine owner. The UCIP inspection was completed with LMA representative, J. Jauregui. (H. Dunn – GEI) 10/27/2017 This structure is inspected annually under the Structure and Channel Summer Inspection (part of the Levee Inspection Program) conducted by the DWR Flood Project Integrity and Inspection Branch (FPIIB). (DWR UCIP - O. Magana) Adjacent pipe is 48-inch by 48-inch RC box culvert through the levee 17.3 feet below the crown. Due to dense vegetation and unsafe condition, headwall and flapgates not accessible. FIELD_STRUCT_DESC: [Mormon Slough Pumping Plant No. 2] 2 of 3: 30-inch steel drainage pipe through the levee, 4.5 feet below the crown. Siphon breaker in a 4-foot-high riser unit on the landside (LS) shoulder. Flap gate on a concrete U-shaped headwall on the waterside (WS). Pump house on the LS. Steel steps on the LS slope. [Additional Reference(s): DWR Levee Log, 1992, (HLM 16.64). USACE San Joaquin O&M Manual 611.1, Volume F, (HLM 16.64), 30-inch pipe listed]. FS Date: 3/22/2021

Levee crown looking upstream.

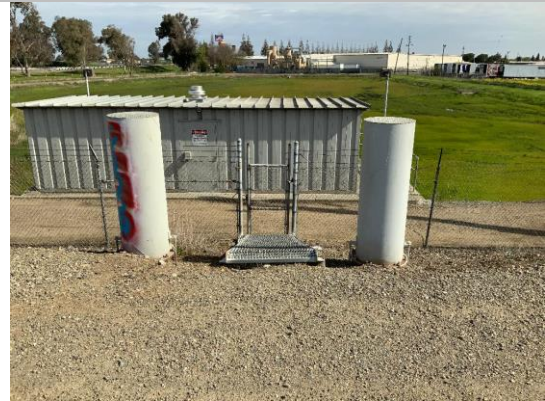
Photo 2 of 3 : UCIP_FA_2023_80887_95262.jpg

LS view: Toe from crown, pump station and risers.

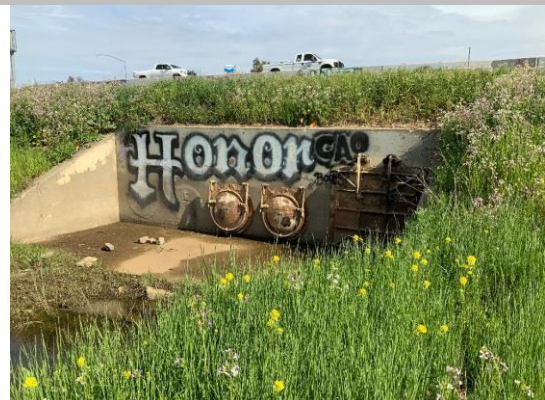
Photo 3 of 3 : UCIP_FA_2023_80887_95267.jpg

WS view: Headwall and flapgate at toe.

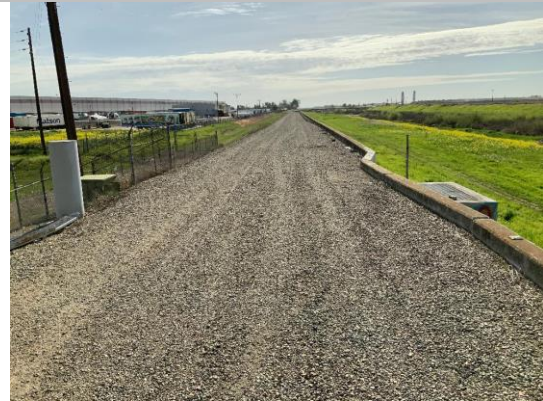
Photo 1 of 3 : UCIP_FA_2023_80888_95269.jpg

DS_ID:23458
FS_ID:80888
EP_NO: N/A
Repair Type: No Action Needed
EVAL Issue:
Crossing Status: Found
UCIP Comments: 03/22/2021 The record has been upgraded from No Action Needed to Non-Urgent. No permit was found authorizing this encroachment. CVFPB will need to review crossing to determine owner. The UCIP inspection was completed with LMA representative, J. Jauregui. (H. Dunn – GEI) 10/27/2017 This structure is inspected annually under the Structure and Channel Summer Inspection (part of the Levee Inspection Program) conducted by the DWR Flood Project Integrity and Inspection Branch (FPIIB). (DWR UCIP - O. Magana) Adjacent pipe is: 48-inch by 48-inch RC box culvert through the levee 17.3 feet below the crown. Due to dense vegetation and unsafe condition, headwall and flapgates not accessible.
FIELD_STRUCT_DESC: [Mormon Slough Pumping Plant No. 2] 3 of 3: 30-inch steel drainage pipe through the levee, 4.5 feet below the crown. Siphon breaker in a 4-foot-high riser unit on the landside (LS) shoulder. Flap gate on a concrete U-shaped headwall on the waterside (WS). Pump house on the LS. Steel steps on the LS slope. [Additional Reference(s): DWR Levee Log, 1992, (HLM 16.64). USACE San Joaquin O&M Manual 611.1, Volume F, (HLM 16.64), 30-inch pipe listed].

Levee crown looking upstream.

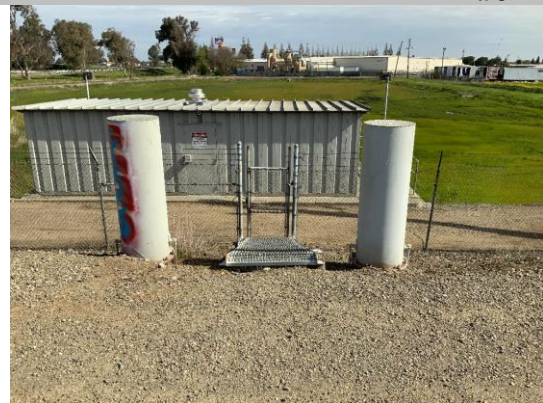
Photo 2 of 3 : UCIP_FA_2023_80888_95270.jpg

LS view: Toe from crown, pump station and risers.

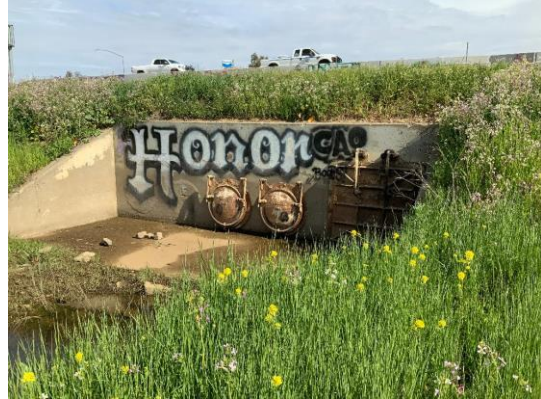
Photo 3 of 3 : UCIP_FA_2023_80888_95275.jpg

WS view: Headwall and flapgates at toe.

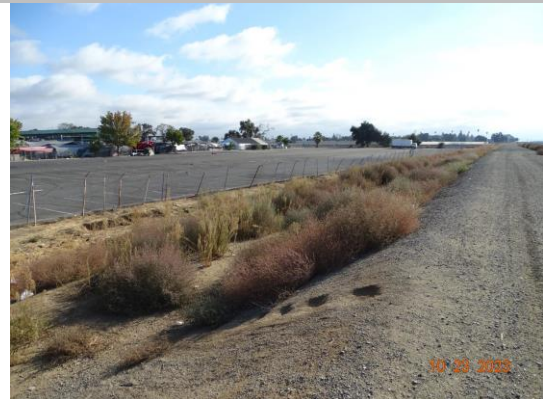
Photo 1 of 1 : FA_2023_NA0017_159_96_20231101_00241.jpg

LM Start	17.27	Rating **	U	Issue No.	96
LM End	17.37	Issue Type +	Ma	Location *	LS
Category	Earthen Levee			GPS Latitude/Longitude	
				Start	End
Item	Vegetation			37.988639°	37.989282°
				-121.264754°	-121.266307°
DWR ID	DWR_NA0017_15_f_2023_96				
Comment Code					
V1 : Control annual grass and weeds on the levee slopes and easements.					
Inspector Comment

Typical view of vegetation along the landside slope and easement. Fall 2023

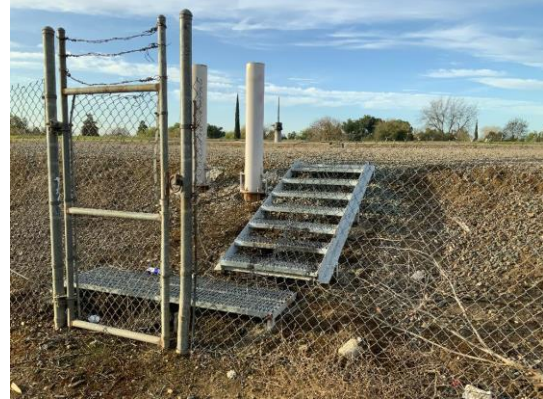
Photo 1 of 3 : UCIP_FA_2023_79171_95334.jpg

Comment Code					
Inspector Comment					
DS_ID:23265 FS_ID:79171 EP_NO: N/A Repair Type: Non-Urgent EVAL Issue: Crossing Status: Found UCIP Comments: 03/22/2021 The record has been upgraded from No Action Needed to Non-Urgent. DWR DMP internal video inspection has not found pipe integrity issues. LOF of crossing is less or equal to 4.0. Recommend next video inspection in 5 years. No permit was found authorizing this encroachment. CVFPB will need to review crossing to determine owner. The UCIP inspection was completed with LMA representative, J. Jauregui. (H. Dunn – GEI) 10/27/2017 This structure is inspected annually under the Structure and Channel Summer Inspection (part of the Levee Inspection Program) conducted by the DWR Flood Project Integrity and Inspection Branch (FPIIB). (DWR UCIP - O. Magana) Adjacent pipes are: two 14-inch pipes through the levee 3.0 feet below the crown. Steel trash rack on landside intake. FIELD_STRUCT_DESC: [Mormon Slough Pumping Plant No. 1] 1 of 3: 30-inch by 30-inch reinforced concrete box drainage culvert (RCBC) through the levee, 17.6 feet below the crown. Slide gate in a riser unit on the waterside (WS) slope. Flap gate on the WS end. Concrete U-shaped headwall around all three pipes on the WS. Intake under the pump house on the landside (LS). Steel steps on the LS slope. [Additional Reference(s): DWR Levee Log, 1992, (HLM 17.74). USACE San Joaquin O&M Manual 611.1, Volume F, (HLM 17.74), 30-inch by 30-inch RCBC listed]. FS Date: 3/22/2021

LS view: Slope from toe, stairs and standpipe.

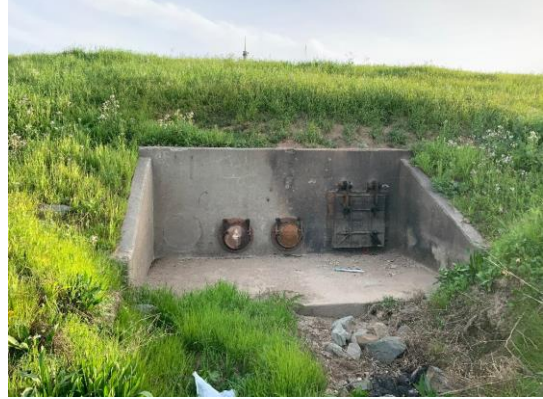
Photo 2 of 3 : UCIP_FA_2023_79171_95331.jpg

WS view: Headwall and flapgates at toe.

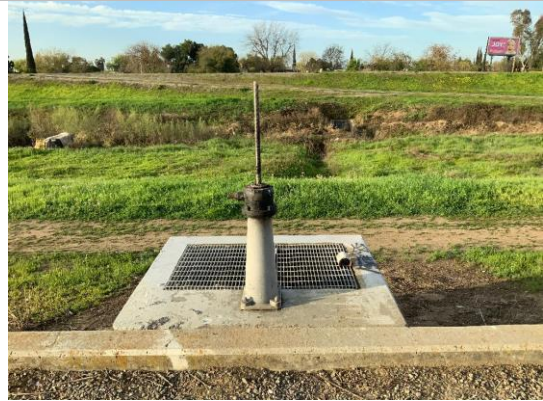
Photo 3 of 3 : UCIP_FA_2023_79171_95335.jpg

WS view: Toe from crown, slidegate in concrete box.

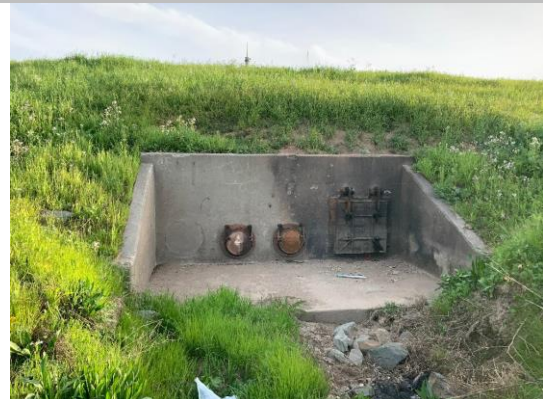
Photo 2 of 3 : UCIP_FA_2023_79172_95343.jpg

Comment Code						
Inspector Comment						
DS_ID:23460 FS_ID:79172 EP_NO: N/A Repair Type: Non-Urgent EVAL Issue: Crossing Status: Found UCIP Comments: 03/22/2021 The record has been upgraded from No Action Needed to Non-Urgent. No permit was found authorizing this encroachment. CVFPB will need to review crossing to determine owner. The UCIP inspection was completed with LMA representative, J. Jauregui. (H. Dunn – GEI) 10/27/2017 This structure is inspected annually under the Structure and Channel Summer Inspection (part of the Levee Inspection Program) conducted by the DWR Flood Project Integrity and Inspection Branch (FPIIB). (DWR UCIP - O. Magana) Adjacent pipe is: 30-inch by 30-inch RC box culvert through the levee 17.6 feet below the crown. Steel trash rack on landside intake. FIELD_STRUCT_DESC: [Mormon Slough Pumping Plant No. 1] 2 of 3: 14-inch steel drainage pipe through the levee, 3.0 feet below the crown. Siphon breakers in 4-foot-high riser units on the landside (LS) shoulder. Flap gates on the waterside (WS) end. Concrete U-shaped headwall around all three pipes on the WS. Pump house on the LS. Steel steps on the LS slope. [Additional Reference(s): DWR Levee Log, 1992, (HLM 17.74). USACE San Joaquin O&M Manual 611.1, Volume F, (HLM 17.74), 14-inch pipe listed]. FS Date: 3/22/2021

WS view: Headwall and flapgate.

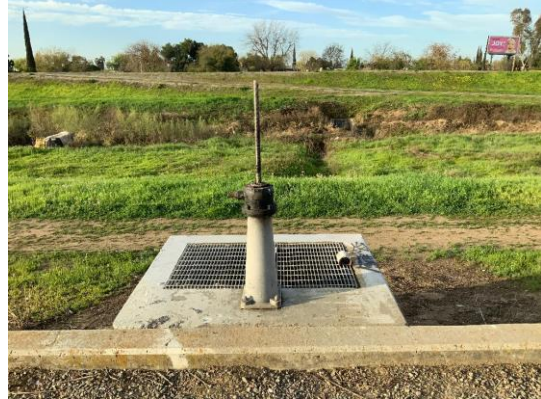
Photo 3 of 3 : UCIP_FA_2023_79172_95348.jpg

WS view: Toe from crown, slidegate in concrete box.

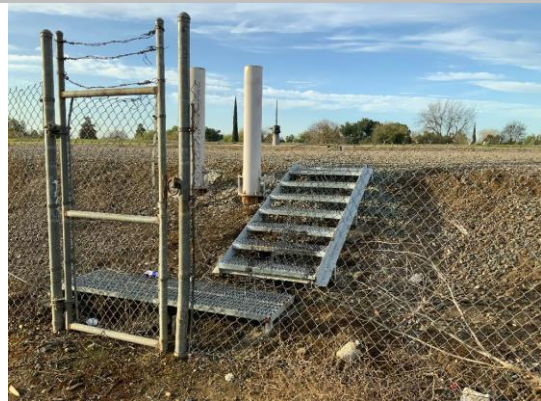
Photo 1 of 3 : UCIP_FA_2023_79173_95358.jpg

DS_ID:23461
 FS_ID:79173
 EP_NO: N/A
 Repair Type: Non-Urgent
 EVAL Issue:
 Crossing Status: Found
 UCIP Comments: 03/22/2021 The record has been upgraded from No Action Needed to Non-Urgent. No permit was found authorizing this encroachment. CVFPB will need to review crossing to determine owner. The UCIP inspection was completed with LMA representative, J. Jauregui. (H. Dunn – GEI) 10/27/2017 This structure is inspected annually under the Structure and Channel Summer Inspection (part of the Levee Inspection Program) conducted by the DWR Flood Project Integrity and Inspection Branch (FPIIB). (DWR UCIP - O. Magana) Adjacent pipe is: 30-inch by 30-inch RC box culvert through the levee 17.6 feet below the crown. Steel trash rack on landside.
 FIELD_STRUCT_DESC: [Mormon Slough Pumping Plant No. 1] 3 of 3: 14-inch steel drainage pipe through the levee, 3.0 feet below the crown. Siphon breakers in 4-foot-high riser units on the landside (LS) shoulder. Flap gates on the waterside (WS) end. Concrete U-shaped headwall around all three pipes on the WS. Pump house on the LS. Wooden steps on the LS slope. [Additional Reference(s): DWR Levee Log, 1992, (HLM 17.74). USACE San Joaquin O&M Manual 611.1, Volume F, (HLM 17.74), 14-inch pipe listed].

LS view: Slope from toe.

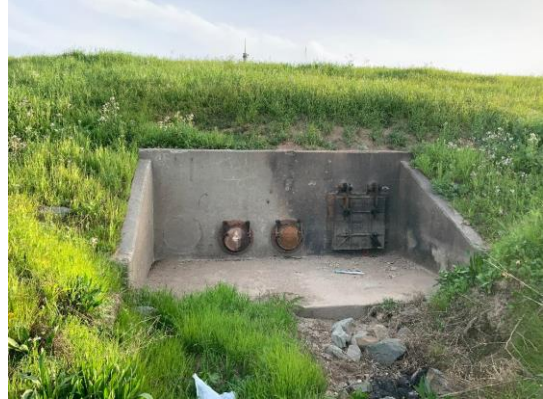
Photo 2 of 3 : UCIP_FA_2023_79173_95354.jpg

WS view: Headwall and flapgate at toe.

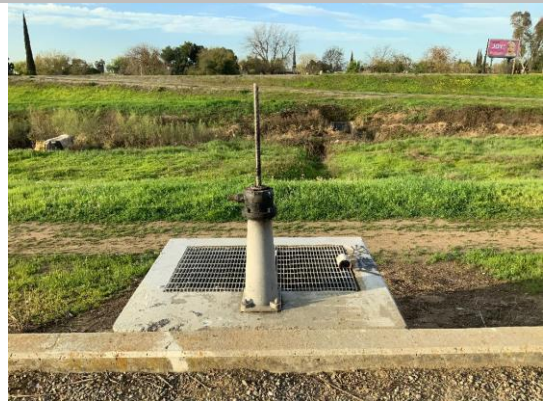
Photo 3 of 3 : UCIP_FA_2023_79173_95359.jpg

WS view: Toe from crown, slidegate in concrete box.

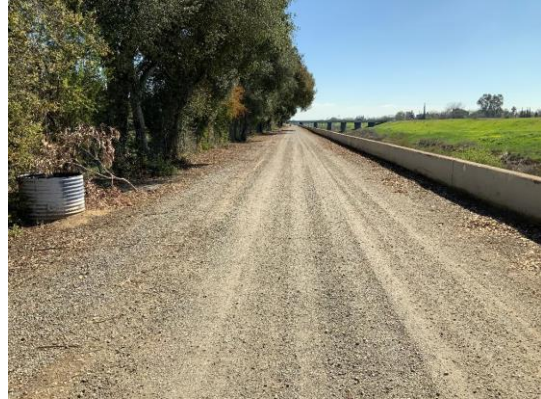
Photo 1 of 3 : UCIP_FA_2023_79174_96286.jpg

Comment Code					
Inspector Comment					
DS_ID:23267 FS_ID:79174 EP_NO: N/A Repair Type: Non-Urgent EVAL Issue: 4b, Safety Issue Crossing Status: Found UCIP Comments: 03/12/2021 Pipe status is still Non-Urgent. No cover on LS riser. Could not inspect LS pipe end due to fence for golf course. DMP internal video inspection has found moderate pipe defects. Crossing will be monitored until funding becomes available for rehabilitation. No permit was not found authorizing this encroachment. CVFPB will need to review crossing to determine owner. The UCIP inspection was completed with LMA representative, J. Jauregui. (H. Dunn – GEI) 04/15/2014 CMP riser needs cleaning. (P. Taroq - DWR UCIP) FIELD_STRUCT_DESC: 30-inch corrugated metal storm drainage pipe (CMP) through the levee, 13.0 feet below the crown. Concrete U-shaped headwall on the waterside (WS) end. CMP riser unit at the landside (LS) toe. [Additional Reference(s): DWR Levee Log, 1992, (HLM 18.01). USACE San Joaquin O&M Manual 611.1, Volume F, (HLM 18.01), 30-inch pipe listed]. FS Date: 3/12/2021

Levee crown looking upstream.

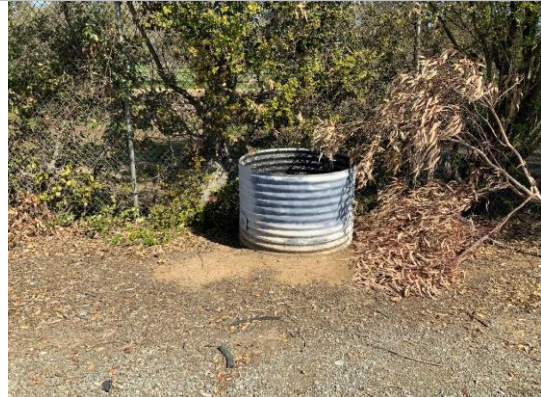
Photo 2 of 3 : UCIP_FA_2023_79174_96287.jpg

LS view: Toe from crown, fence behind CMP riser, cannot access.

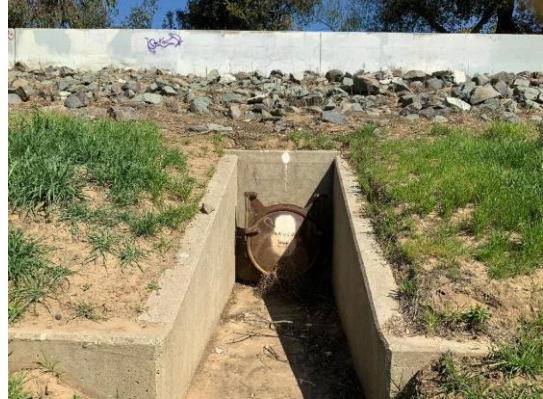
Photo 3 of 3 : UCIP_FA_2023_79174_96290.jpg

WS view: Headwall and flapgate at toe.

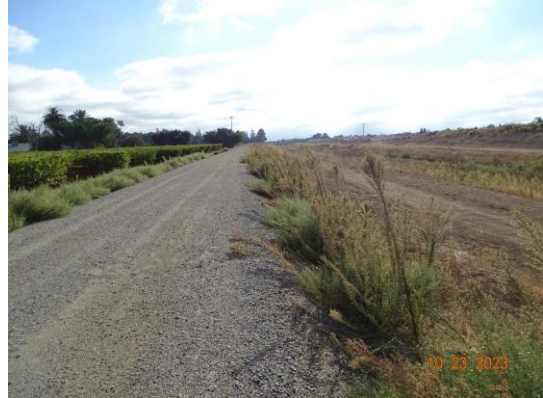
Photo 1 of 1 : FA_2023_NA0017_159_95_20231101_00240.jpg

LM Start	17.76	Rating **	U	Issue No.	95
LM End	18.13	Issue Type +	Ma	Location *	WS
Category	Earthen Levee			GPS Latitude/Longitude	
				Start	End
Item	Vegetation			37.991913°	37.994252°
				-121.272524°	-121.278499°
DWR ID	DWR_NA0017_15_f_2023_95				
Comment Code					
V1 : Control annual grass and weeds on the levee slopes and easements.					
Inspector Comment

Typical view of vegetation along the waterside slope. Fall 2023

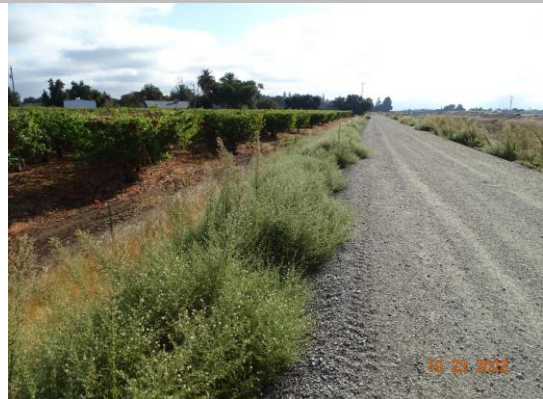
Photo 1 of 1 : FA_2023_NA0017_159_93_20231101_00239.jpg

LM Start	17.76	Rating **	U	Issue No.	93
LM End	18.12	Issue Type +	Ma	Location *	LS
Category	Earthen Levee			GPS Latitude/Longitude	
				Start	End
Item	Vegetation			37.991916°	37.994258°
				-121.272522°	-121.278486°
DWR ID	DWR_NA0017_15_f_2023_93				
Comment Code					
V1 : Control annual grass and weeds on the levee slopes and easements.					
Inspector Comment

Typical view of vegetation along the landside slope and easement. Fall 2023

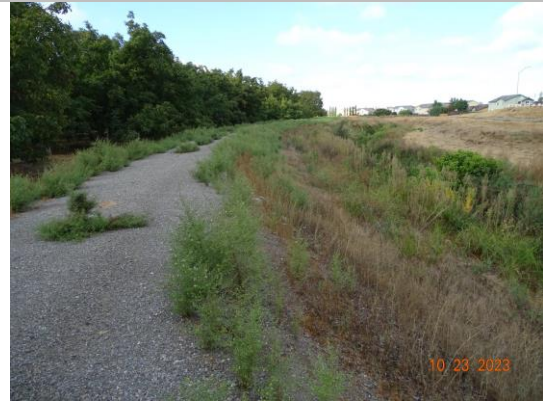
Photo 1 of 1 : FA_2023_NA0017_159_91_20231101_00238.jpg

LM Start	18.14	Rating **	U	Issue No.	91
LM End	18.85	Issue Type +	Ma	Location *	WS
Category	Earthen Levee			GPS Latitude/Longitude	
				Start	End
Item	Vegetation			37.994488°	37.999842°
				-121.278543°	-121.268963°
DWR ID	DWR_NA0017_15_f_2023_91				
Comment Code					
V1 : Control annual grass and weeds on the levee slopes and easements.					
Inspector Comment

Typical view of vegetation along the waterside slope. Fall 2023

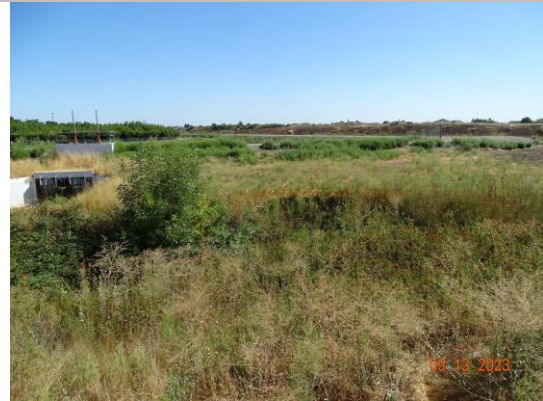
Photo 1 of 2 : SJR2023_NA0017U15RM4.62_1.JPG

09/13/2023: From 2022 to present, no significant changes were observed during the annual survey.

9/13/2023: View of the erosion from the opposite bank.

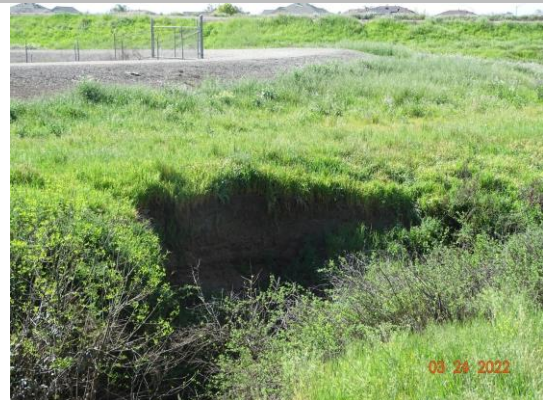
Photo 2 of 2 : SJR2023_NA0017U15RM4.62_2.JPG

3/24/2022: Close-up view of the erosion pocket.

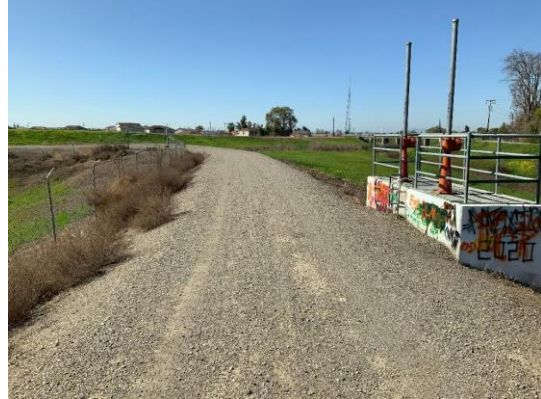
Photo 1 of 3 : UCIP_FA_2023_79175_96302.jpg

Comment Code					
Inspector Comment					
DS_ID:23462 FS_ID:79175 EP_NO: N/A Repair Type: Non-Urgent EVAL Issue: Crossing Status: Found UCIP Comments: 03/12/2021 The record has been upgraded from No Action Needed to Non-Urgent. No permit was found authorizing this encroachment. CVFPB will need to review crossing to determine owner. The UCIP inspection was completed with LMA representative, J. Jauregui. (H. Dunn – GEI) 04/15/2014 Slide gate in a concrete box on landside shoulder. (P. Tariq - DWR UCIP)Concrete headwall and flapgates on waterside. FIELD_STRUCT_DESC: Double 72-inch by 72-inch reinforced concrete box return structure (RCBC) through the levee, at an unknown depth. Slide gate in a concrete box on the landside (LS) shoulder. Concrete headwall and flap gates on the waterside (WS) end. [Additional Reference(s): USACE San Joaquin O&M Manual 611.1, Volume F, (Station 310+46), 72-inch by 72-inch RCBC listed]. FS Date: 3/12/2021

Levee crown looking upstream.

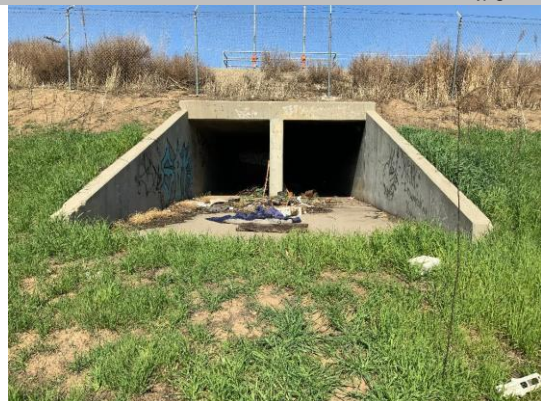
Photo 2 of 3 : UCIP_FA_2023_79175_96298.jpg

LS view: Headwall at toe.

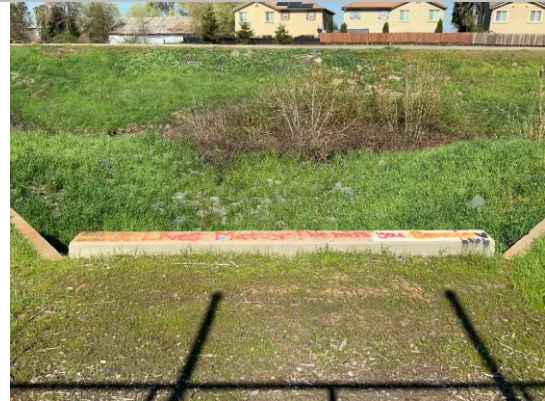
Photo 3 of 3 : UCIP_FA_2023_79175_96304.jpg

WS view: Headwall visible at toe from crown.

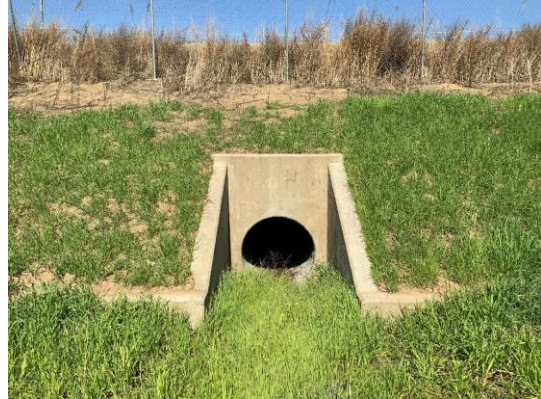
Photo 1 of 3 : UCIP_FA_2023_79176_96316.jpg

Comment Code					
Inspector Comment					
DS_ID:23269 FS_ID:79176 EP_NO: N/A Repair Type: Non-Urgent EVAL Issue: 4b, Safety Issue Crossing Status: Found UCIP Comments: 12/20/2022 Record updated from Urgent to Non-Urgent. Pipe has been CIPP lined. LOF of crossing is less or equal to 4. Recommend next video inspection in 5 years. Minor erosion above the WS headwall and a foot-wide hole under the riprap on one outer edge of the headwall still needs repair. (O.Yakimov - DWR UCIP) 03/12/2021 Record updated from Non-Urgent to Urgent. DMP internal video inspection has found pipe integrity issues. LOF of crossing is between 5 and 6. Crossing will be monitored until funding becomes available to address the issues. WS riser is missing the cover. Some minor erosion above the WS headwall and a foot wide hole under the riprap on one outer edge of the headwall, see pics. No permit was found authorizing this encroachment. CVFPB will need to review crossing to determine owner. The UCIP inspection was completed with LMA representative, J. Jauregui. (H. Dunn – GEI) 04/15/2014 Slide gate handle missing. Vegetation on both inlet and outlet box. (P. Tariq - DWR UCIP) FIELD_STRUCT_DESC: 36-inch CIPP-lined corrugated metal storm drainage pipe (CMP) through the levee, 15.0 feet below the crown. Concrete U-shaped headwalls on each side. Slide gate in a CMP riser unit on the waterside (WS) slope. Flap gate on the WS end. [Additional Reference(s): DWR Levee Log, 1992, (HLM 18.54). USACE San Joaquin O&M Manual 611.1, Volume F, (HLM 18.54), 36-inch pipe listed]. FS Date: 3/12/2021 11:46:30 AM

LS view: Headwall at toe.

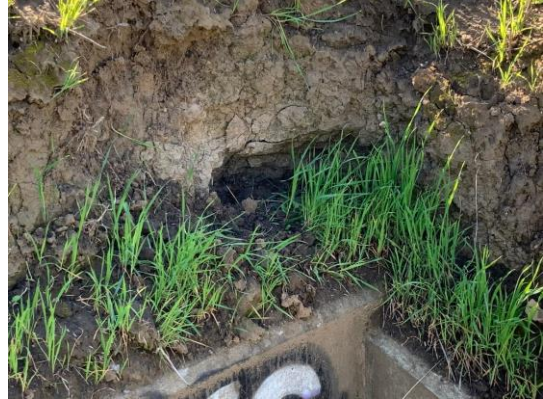
Photo 2 of 3 : UCIP_FA_2023_79176_96314.jpg

WS view: Minor erosion above headwall, 3 of 3 photos.

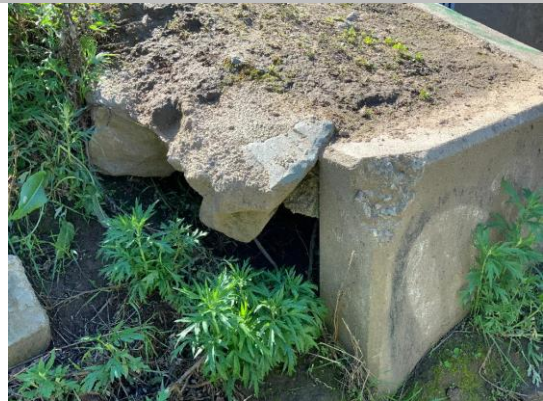
Photo 3 of 3 : UCIP_FA_2023_79176_96307.jpg

WS view: Hole underneath riprap and headwall edge.

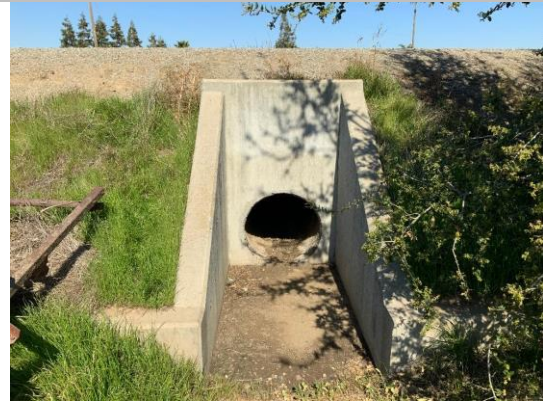
Photo 1 of 3 : UCIP_FA_2023_79177_96323.jpg

Comment Code						
Inspector Comment						
DS_ID:23270 FS_ID:79177 EP_NO: N/A Repair Type: Urgent EVAL Issue: 1, Pipe Integrity Crossing Status: Found UCIP Comments: 03/12/2021 The record has been upgraded from No Action Needed to Urgent. Inside of LS pipe is protruded down and there is metal peeling away around the pipe a few feet in. Recommend internal video inspection to verify pipe integrity. No permit was found authorizing this encroachment. CVFPB will need to review crossing to determine owner. The UCIP inspection was completed with LMA representative, J. Jauregui. (H. Dunn – GEI) FIELD_STRUCT_DESC: 30-inch steel storm drainage pipe through the levee, 7.0 feet below the crown. Concrete U-shaped headwalls on each end. Flap gate on the waterside (WS) end. Grouted outlet on the WS. [Additional Reference(s): DWR Levee Log, 1992, (HLM 18.68). USACE San Joaquin O&M Manual 611.1, Volume F, (HLM 18.68), 30-inch corrugated metal pipe (CMP) listed]. FS Date: 3/12/2021

LS view: Headwall at toe.

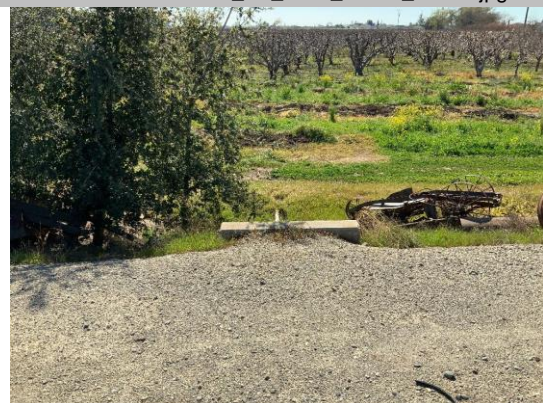
Photo 2 of 3 : UCIP_FA_2023_79177_96322.jpg

LS view: Headwall visible at toe from crown.

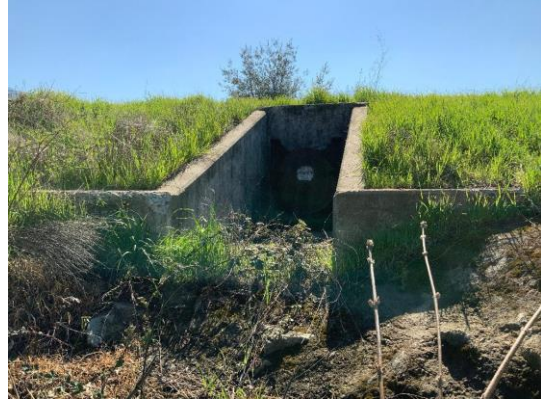
Photo 3 of 3 : UCIP_FA_2023_79177_96327.jpg

WS view: Headwall and flapgate at toe.

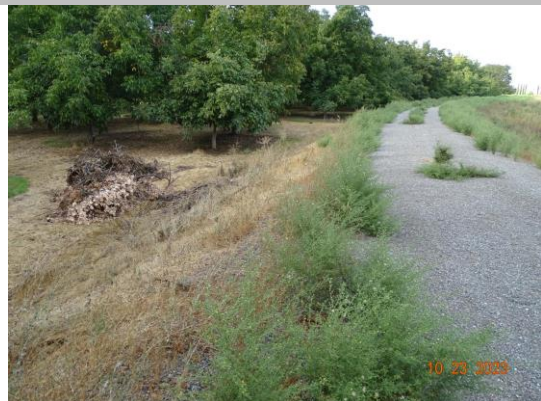
Photo 1 of 1 : FA_2023_NA0017_159_90_20231101_00237.jpg

LM Start	18.44	Rating **	U	Issue No.	90
LM End	18.85	Issue Type +	Ma	Location *	LS
Category	Earthen Levee			GPS Latitude/Longitude	
				Start	End
Item	Vegetation			37.996613°	37.999848°
				-121.274535°	-121.268968°
DWR ID	DWR_NA0017_15_f_2023_90				
Comment Code					
V1 : Control annual grass and weeds on the levee slopes and easements.					
Inspector Comment

Typical view of vegetation along the landside slope and easement. Fall 2023

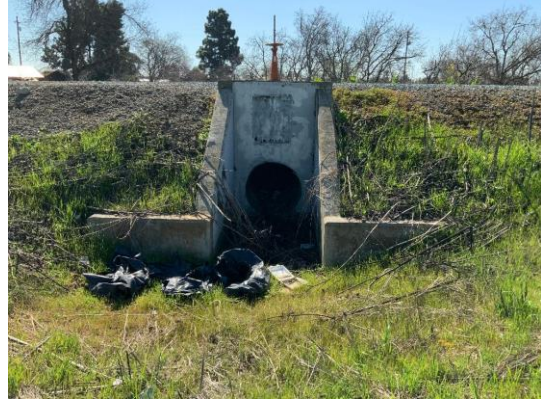
Photo 1 of 3 : UCIP_FA_2023_79178_96341.jpg

Comment Code					
Inspector Comment					
DS_ID:23464 FS_ID:79178 EP_NO: N/A Repair Type: Non-Urgent EVAL Issue: 11, Maintenance Compliance Issue Crossing Status: Found UCIP Comments: 03/12/2021 The record has been upgraded from No Action Needed to Non-Urgent. Vegetation debris and trash seen in LS pipe, recommend cleaning out. No permit was found authorizing this encroachment. CVFPB will need to review crossing to determine owner. The UCIP inspection was completed with LMA representative, J. Jauregui. (H. Dunn – GEI) 04/15/2014 Slide gate in a concrete box on waterside shoulder. (P. tariq - DWR UCIP) FIELD_STRUCT_DESC: 30-inch reinforced concrete (RC) storm drainage pipe through the levee, 6.0 feet below the crown. Slide gate in a concrete box on the waterside (WS) shoulder. [Additional Reference(s): USACE San Joaquin O&M Manual 611.1, Volume F, (Station 345+65), 30-inch pipe listed]. FS Date: 3/12/2021

LS view: Headwall at toe.

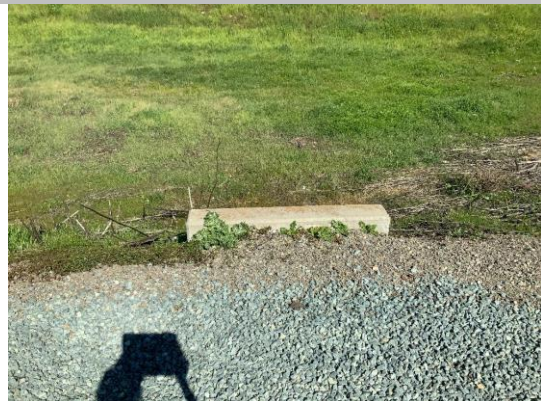
Photo 2 of 3 : UCIP_FA_2023_79178_96340.jpg

LS view: Headwall visible at toe from crown.

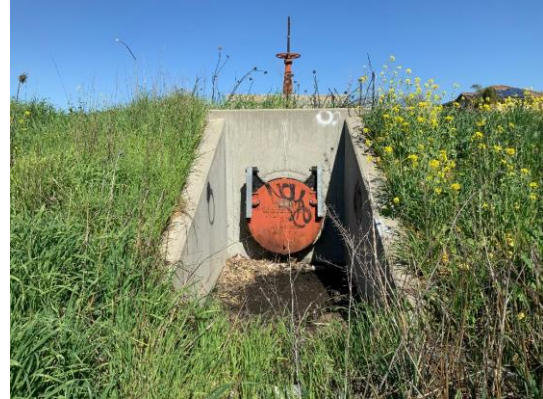
Photo 3 of 3 : UCIP_FA_2023_79178_96337.jpg

WS view: Headwall, flapgates, and slidegate at toe.

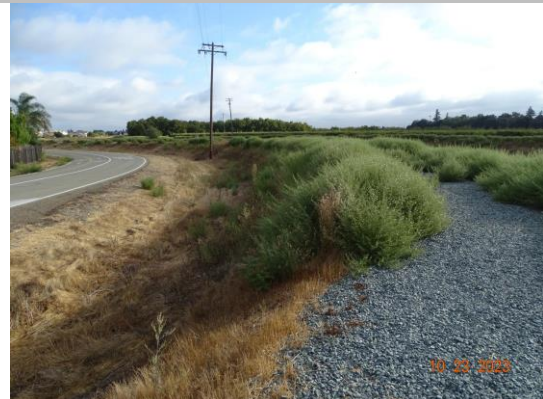
Photo 1 of 1 : FA_2023_NA0017_159_86_20231101_00235.jpg

LM Start	18.99	Rating **	U	Issue No.	86
LM End	19.42	Issue Type +	Ma	Location *	LS
Category	Earthen Levee			GPS Latitude/Longitude	
				Start	End
Item	Vegetation			37.999976°	37.995322°
				-121.271426°	-121.276157°
DWR ID	DWR_NA0017_15_f_2023_86				
Comment Code					
V1 : Control annual grass and weeds on the levee slopes and easements.					
Inspector Comment

Typical view of vegetation along the landside slope and easement. Fall 2023

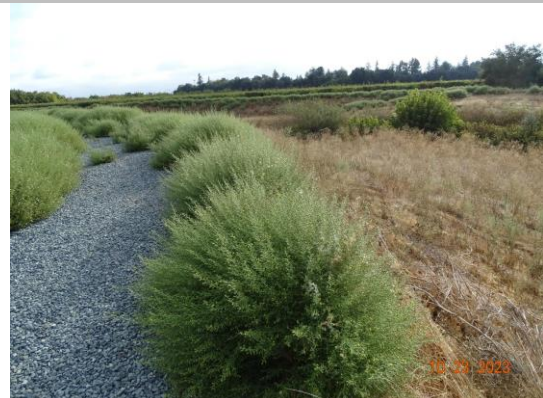
Photo 1 of 1 : FA_2023_NA0017_159_87_20231101_00236.jpg

LM Start	18.99	Rating **	U	Issue No.	87
LM End	19.42	Issue Type +	Ma	Location *	WS
Category	Earthen Levee			GPS Latitude/Longitude	
				Start	End
Item	Vegetation			37.999976°	37.995316°
				-121.271437°	-121.276156°
DWR ID	DWR_NA0017_15_f_2023_87				
Comment Code					
V1 : Control annual grass and weeds on the levee slopes and easements.					
Inspector Comment

Typical view of vegetation along the waterside slope. Fall 2023

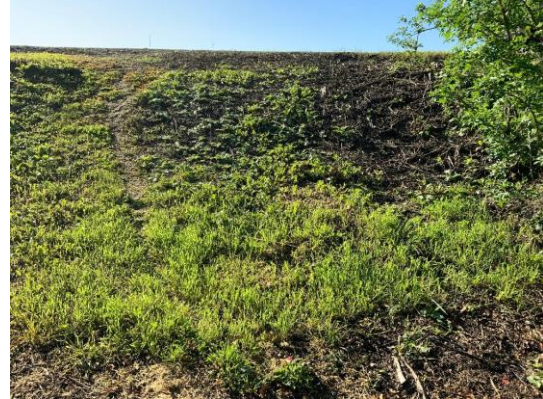
Photo 1 of 3 : UCIP_FA_2023_79183_96406.jpg

Comment Code					
Inspector Comment					
DS_ID:23274 FS_ID:79183 EP_NO: N/A Repair Type: Urgent EVAL Issue: 1, Pipe Integrity Crossing Status: Found UCIP Comments: 03/12/2021 Record has been upgraded from Non-Urgent to Urgent. DWR DMP internal video inspection has found pipe integrity issues. LOF of crossing is between 5 and 6. Crossing will be monitored until funding becomes available to address the issues. Cannot see LS manhole due to vegetation debris. WS flapgate overgrown with vegetation, recommend clearing. Based on previous inspection, a concrete block was found within the pipe so it is presumed abandoned, need confirmation from the owner. No permit was found authorizing this encroachment. CVFPB will need to review crossing to determine owner. The UCIP inspection was completed with LMA representative, J. Jauregui. (H. Dunn – GEI)11/16/2018 Internal video inspection revealed a concrete plug in the pipe, 49.2 feet from the outlet on the WS. Pipe improperly abandoned. Abandon properly or remove from levee. Crossing escalated to "Non-Urgent" due to the improper abandonment. Material type changed from steel to reinforced concrete. (A. McDonald - DWR UCIP)Concrete headwall not found on the LS. Manhole found on the LS. FIELD_STRUCT_DESC: 24-inch reinforced concrete (RC) gravity stormwater drainage pipe through the levee, 12.0 feet below the crown. Flap gate and concrete headwall on the waterside (WS). Manhole on the landside (LS). Pipe partially plugged with concrete on the LS. [Additional Reference(s): DWR Levee Log, 1992, (HLM 20.14). USACE San Joaquin O&M Manual 611.1, Volume F, (HLM 20.14), 24-inch pipe listed]. FS Date: 3/12/2021

LS view: Slope from toe.

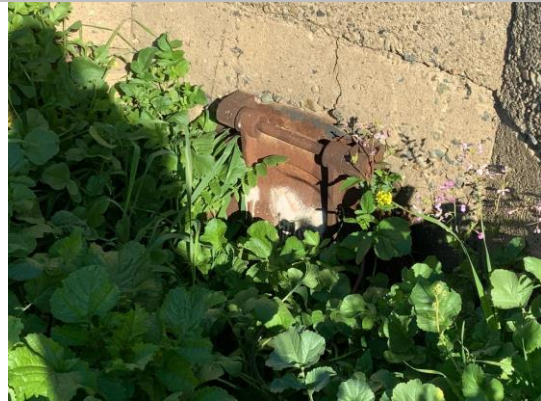
Photo 2 of 3 : UCIP_FA_2023_79183_96409.jpg

WS view: Close up of headwall and flapgate, overgrown with vegetation.

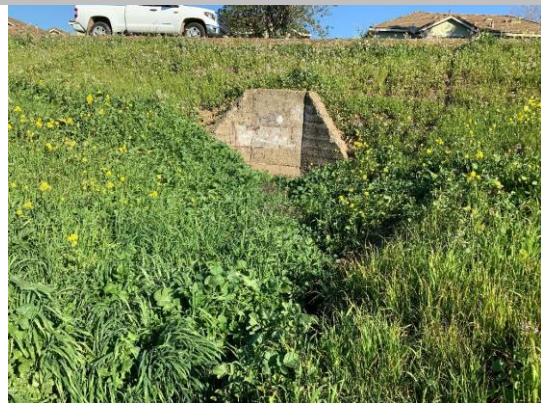
Photo 3 of 3 : UCIP_FA_2023_79183_96408.jpg

WS view: Headwall at toe, overgrown with vegetation.

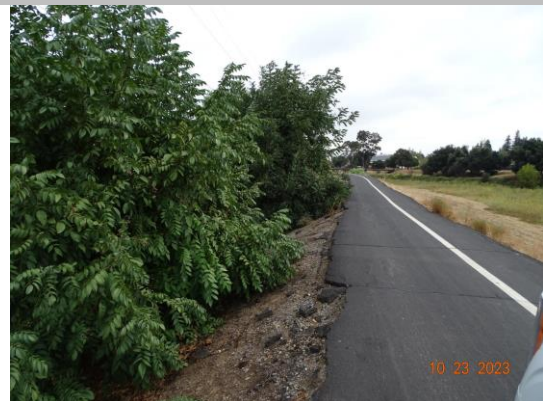
Photo 1 of 1 : FA_2023_NA0017_159_208_20231101_00233.jpg

LM Start	22.04	Rating **	U	Issue No.	208
LM End	22.07	Issue Type +	Ma	Location *	LS
Category	Earthen Levee			GPS Latitude/Longitude	
				Start	End
Item	Trim / Thin Trees			37.980550°	37.980414°
				-121.316184°	-121.316686°
DWR ID	DWR_NA0017_15_f_2022_208				
Comment Code					
T1 : Trim and thin trees to at least five feet above ground level to allow visibility of the ground and room to flood fight.					
Inspector Comment

View of untrimmed trees along the landside slope and easement. Fall 2023

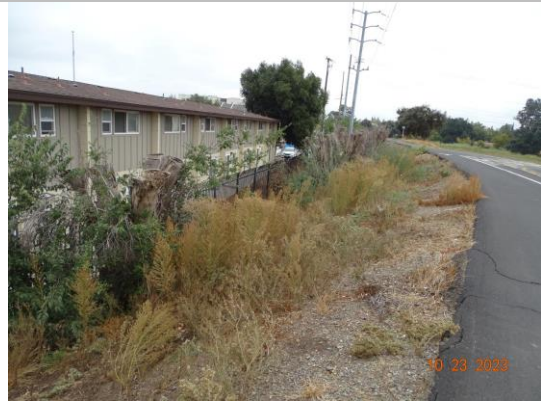
Photo 1 of 1 : FA_2023_NA0017_159_206_20231101_00232.jpg

LM Start	22.14	Rating **	U	Issue No.	206
LM End	22.14	Issue Type +	Ma	Location *	LS
Category	Earthen Levee			GPS Latitude/Longitude	
				Start	End
Item	Vegetation			37.980066°	37.980066°
				-121.317953°	-121.317953°
DWR ID	DWR_NA0017_15_f_2022_206				
Comment Code					
V2 : Remove the wild growth and woody vegetation other than native grasses from the levee slopes.					
Inspector Comment

View of wild vegetation growth along the landside slope. Fall 2023

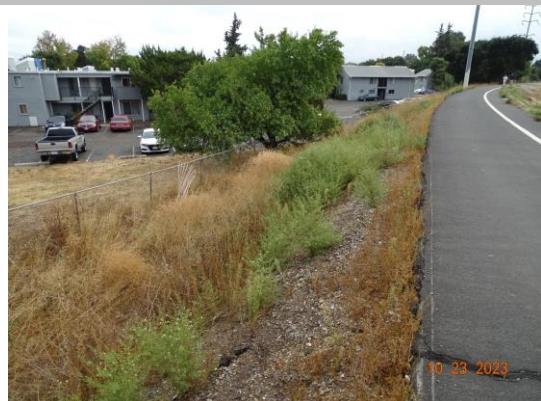
Photo 1 of 1 : FA_2023_NA0017_159_82_20231101_00231.jpg

LM Start	22.23	Rating **	U	Issue No.	82
LM End	22.31	Issue Type +	Ma	Location *	LS
Category	Earthen Levee			GPS Latitude/Longitude	
				Start	End
Item	Vegetation			37.980582°	37.981198°
				-121.319332°	-121.320507°
DWR ID	DWR_NA0017_15_f_2023_82				
Comment Code					
V1 : Control annual grass and weeds on the levee slopes and easements.					
Inspector Comment

Typical view of vegetation along the landside slope and easement. Fall 2023

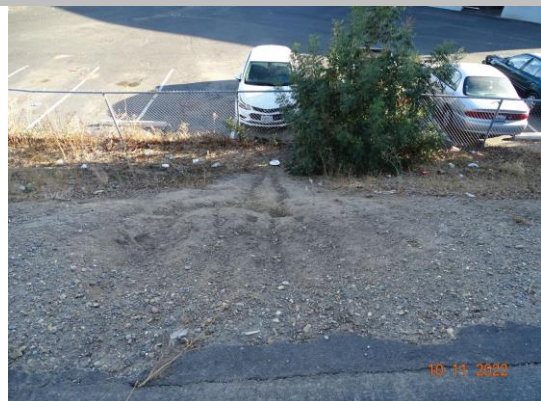
Photo 1 of 1 : FA_2023_NA0017_159_134_20230905_00029.jpg

LM Start	22.26	Rating **	M	Issue No.	134
LM End	22.26	Issue Type +	Ma	Location *	LS
Category	Earthen Levee			GPS Latitude/Longitude	
				Start	End
Item	Erosion / Rills			37.980937°	37.980937°
				-121.319809°	-121.319809°
DWR ID	DWR_NA0017_15_s_2020_134				
Comment Code					
E5 : Schedule repair of rills prior to the next inspection.					
Inspector Comment

View of rills on the landside slope. Fall 2022
