**Flood Control Project Maintenance
Levee Inspections**

Maintenance Issue Types Only, Levee Inspection Report By Mile - Fall 2023

San Joaquin County Flood Control and Water Conservation District

Waterway	Bank	Unit Miles	Inspection Start/End	Inspector
Unit No. 01 Littlejohn Creek	Left	2.59	10/20/2023 10/20/2023	Alberto De Leon

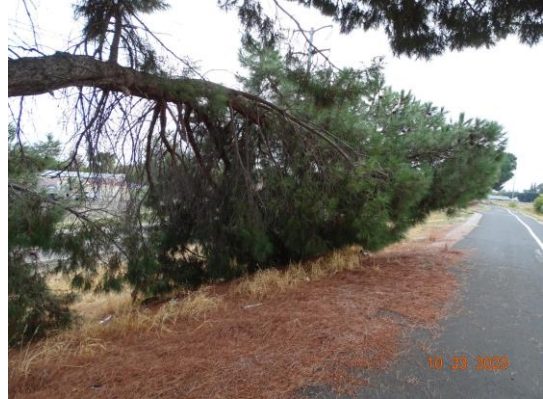
Photo 1 of 1 : FA_2023_NA0017_159_126_20231101_00230.jpg

LM Start	22.47	Rating **	U	Issue No.	126
LM End	22.47	Issue Type +	Ma	Location *	LS
Category	Earthen Levee			GPS Latitude/Longitude	
				Start	End
Item	Trim / Thin Trees			37.981644°	37.981644°
				-121.323532°	-121.323532°
DWR ID	DWR_NA0017_15_s_2020_126				
Comment Code					
T1 : Trim and thin trees to at least five feet above ground level to allow visibility of the ground and room to flood fight.					
Inspector Comment

View of untrimmed tree along the landside slope. Fall 2023

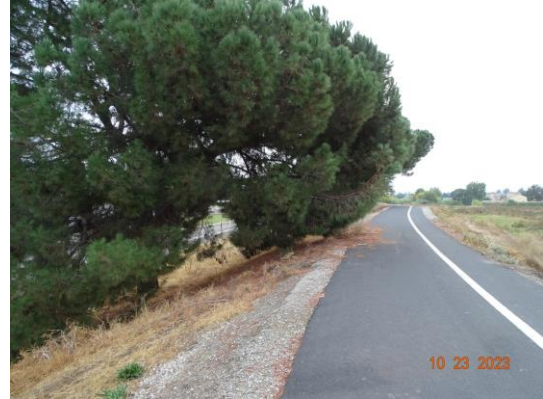
Photo 1 of 1 : FA_2023_NA0017_159_190_20231101_00229.jpg

LM Start	22.56	Rating **	U	Issue No.	190
LM End	22.56	Issue Type +	Ma	Location *	LS
Category	Earthen Levee			GPS Latitude/Longitude	
				Start	End
Item	Trim / Thin Trees			37.981900°	37.981900°
				-121.324967°	-121.324967°
DWR ID	DWR_NA0017_15_f_2019_190				
Comment Code					
T1 : Trim and thin trees to at least five feet above ground level to allow visibility of the ground and room to flood fight.					
Inspector Comment

View of untrimmed tree along the landside slope. Fall 2023

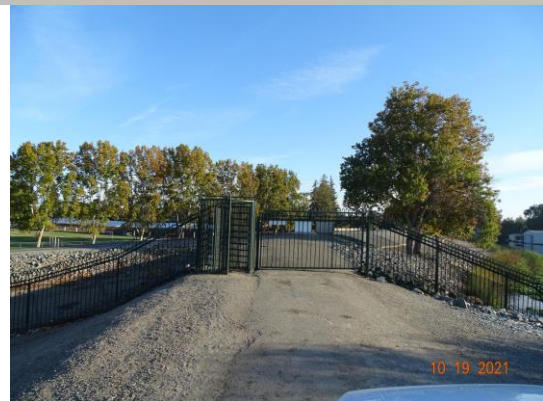
Photo 1 of 1 : FA_2023_NA0017_159_113_20230905_00028.jpg

LM Start	23.99	Rating **	A/W	Issue No.	113
LM End	23.99	Issue Type +	Ma	Location *	CR
Category	Earthen Levee			GPS Latitude/Longitude	
				Start	End
Item	Access Gates			37.974932°	37.974932°
				-121.347699°	-121.347699°
DWR ID	DWR_NA0017_15_s_2020_113				
Comment Code					
AG : Access Gates					
Inspector Comment					
The gate across the levee is for RD 2074.

View of metal gate and fence over levee road. Fall 2021

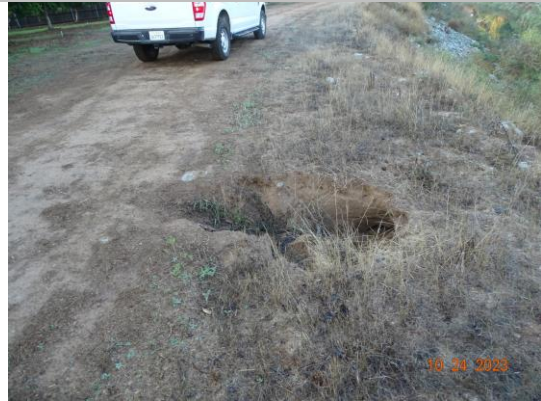
Photo 1 of 1 : FA_2023_NA0017_160_114_20231101_00271.jpg

LM Start	0.18	Rating **	U	Issue No.	114
LM End	0.18	Issue Type +	Ma	Location *	CR
Category	Earthen Levee			GPS Latitude/Longitude	
				Start	End
Item	Erosion / Bank Caving			38.048838°	38.048838°
				-121.014634°	-121.014634°
DWR ID	DWR_NA0017_16_f_2023_114				
Comment Code					
E2 : Schedule repair of erosion site prior to the next inspection.					
Inspector Comment					
Erosion site on patrol road (waterside) 4ft x 2ft x 18in

View of erosion on the waterside shoulder. Fall 2023

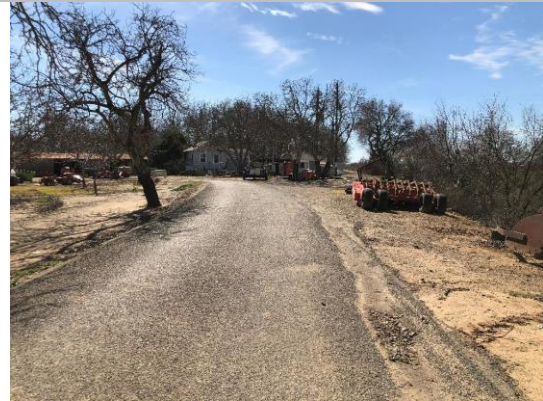
Photo 1 of 3 : UCIP_FA_2023_81202_93500.jpg

Comment Code					
Inspector Comment					
DS_ID:23315 FS_ID:81202 EP_NO: N/A Repair Type: Non-Urgent EVAL Issue: Crossing Status: Not Found UCIP Comments: 02/25/2021 Record updated from No Action Needed to Non-Urgent. Unit 16 – Mormon Slough (CLM 0 to 11) is considered a patrol road/high ground area with no defined levee prism, any issue found between CLM 0 to 11 of Unit 16 will be considered a maintenance issue, or an unauthorized encroachment, or an abandoned encroachment. Current condition of pipe crossing does not impede access to patrol road/high ground area. Utility not found during inspection. Geophysical survey not suggestive of a pipe. The UCIP inspection was completed with LMA representative, J. Caruso. (N. Cholewinski - GEI) FIELD_STRUCT_DESC: 18-inch corrugated metal storm drainage pipe (CMP), 4.5 feet below the roadway. [Additional Reference(s): DWR Levee Log, 1992, (HLM 0.82). USACE San Joaquin O&M Manual 611.1, Volume F, (HLM 0.82), 18-inch pipe listed]. FS Date: 2/25/2021

Crossing Overview

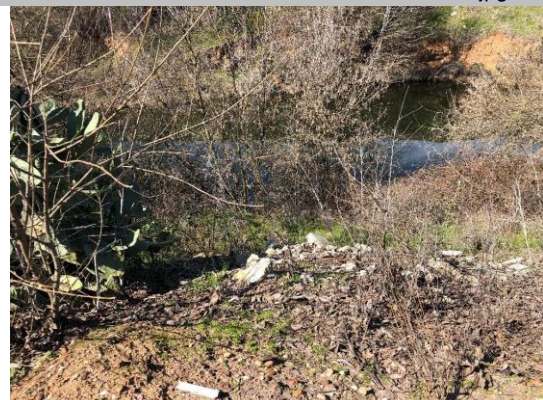
Photo 2 of 3 : UCIP_FA_2023_81202_93501.jpg

WS View: No utility visible.

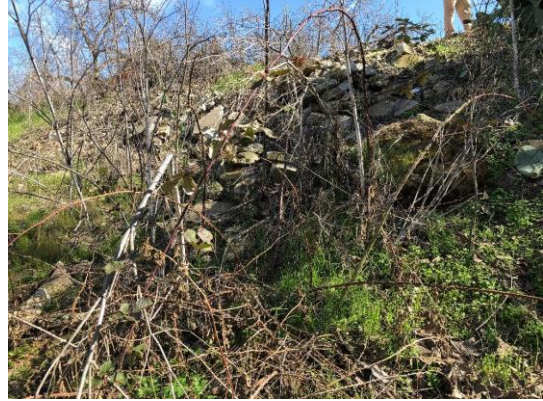
Photo 3 of 3 : UCIP_FA_2023_81202_93502.jpg

WS View: No utility visible.

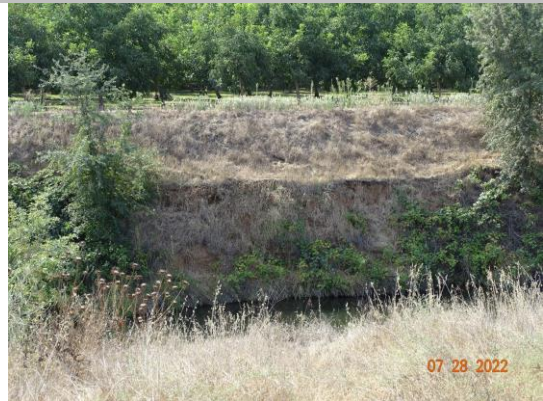
Photo 1 of 1 : FA_2023_NA0017_160_119_20231101_00281.jpg

LM Start	0.93	Rating **	A/W	Issue No.	119
LM End	0.96	Issue Type +	Ma	Location *	WS
Category	Earthen Levee			GPS Latitude/Longitude	
				Start	End
Item	Erosion / Bank Caving			38.042836°	38.042512°
				-121.025613°	-121.025905°
DWR ID	DWR_NA0017_16_f_2023_119

*This area is patrol road only and therefore the site is not rated
07/28/2022: From 2013 to present, no significant changes were observed during the annual survey. The erosion length was updated to 180 ft based on more accurate field measurements.

08/22/2012: The erosion was surveyed and documented for monitoring purpose. There is no levee structure on the site, only high ground protecting the land behind. There is a drainage pipe at the site, which might have caused the problem at one pocket erosion.

View of bank erosion from opposite bank. Summer 2022

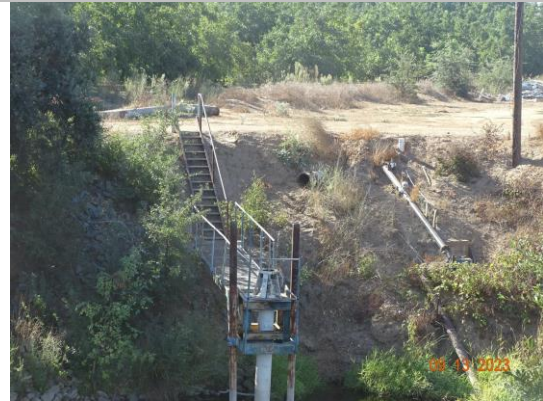
Photo 1 of 1 : FA_2023_NA0017_160_120_20231101_00282.jpg

Comment Code					
E1 : Note and monitor erosion site.					
Inspector Comment					
Issue has been transferred to Levee Mile Report and will continued to monitored. Site ID: NA0017U16RM22.58					
*This area is patrol road only and therefore the site is not rated					
07/28/2022: From 2021 to present, no significant changes were observed during the annual survey.					
07/23/2020: The site has less vegetation and more bare soil on the upper slope since the previous inspection. Some sloughing was also observed.					
08/28/2019: From 2013 to 2019, no significant changes were observed during the annual survey.					
08/22/2012: The erosion is at the outside corner of a river bend, and next to a tree at the levee toe. Irrigation structure presents at the site. There is no levee structure on site.

View of bank erosion from opposite bank. Summer 2023

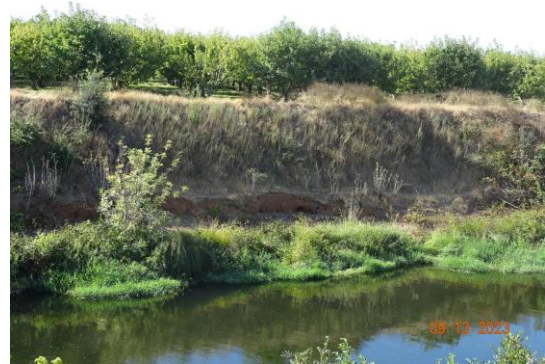
Photo 1 of 1 : FA_2023_NA0017_160_126_20231101_00283.jpg

Comment Code					
E1 : Note and monitor erosion site.					
Inspector Comment					
Issue has been transferred to Levee Mile Report and will continued to monitored. Site ID: NA0017U16RM22.58					
*This area is patrol road only and therefore the site is not rated					
07/28/2022: From 2021 to present, no significant changes were observed during the annual survey.					
07/23/2020: The site has less vegetation and more bare soil on the upper slope since the previous inspection. Some sloughing was also observed.					
08/28/2019: From 2013 to 2019, no significant changes were observed during the annual survey.					
08/22/2012: The erosion is at the outside corner of a river bend, and next to a tree at the levee toe. Irrigation structure presents at the site. There is no levee structure on site. Site ID: NA0017U16RM22.16					
*This area is patrol road only and therefore the site is not rated					
07/28/2022: The length was increased to 100 ft. Otherwise, no significant changes were observed since the previous inspection.

06/23/2021: The site was discovered during the field survey. The erosion is just downstream of a weir. There is some caving and sloughing visible on the slope and a large, 1.5-ft long and 0.8-ft wide rodent hole at the toe.

View of bank erosion from opposite bank. Summer 2023

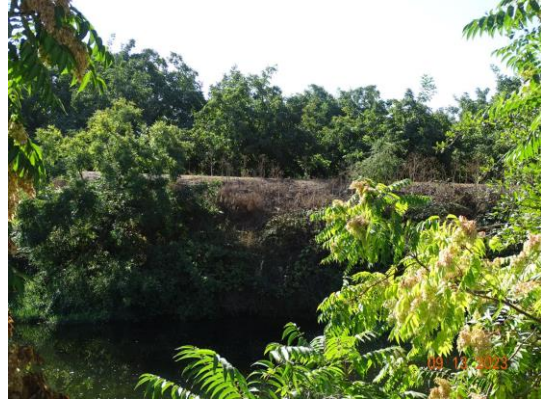
Photo 1 of 1 : FA_2023_NA0017_160_127_20231101_00284.jpg

LM Start	1.67	Rating **	A/W	Issue No.	127
LM End	1.68	Issue Type +	Ma	Location *	WS
Category	Earthen Levee			GPS Latitude/Longitude	
				Start	End
Item	Erosion / Bank Caving			38.038691°	38.038587°
				-121.037411°	-121.037514°
DWR ID	DWR_NA0017_16_f_2023_127				
Comment Code					
E1 : Note and monitor erosion site.					
Inspector Comment					
Issue has been transferred to Levee Mile Report and will continued to monitored. Site ID: NA0017U16RM22.15					
*This area is patrol road only and therefore the site is not rated					
07/28/2022: From 2013 to present, no significant changes were					
observed during the annual survey. This site was combined with a site					
immediately downstream (NA0017U016RM22.01) and the erosion					
length increased to 50 ft.					
08/22/2012: The berm is estimated at 10 ft. Dense vegetation on site.					
There is no levee structure on site.

View of bank erosion from the opposite bank. Summer 2023

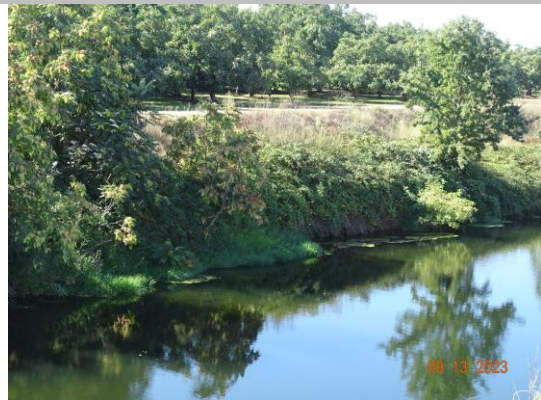
Photo 1 of 1 : FA_2023_NA0017_160_129_20231101_00285.jpg

LM Start	1.72	Rating **	A/W	Issue No.	129
LM End	1.78	Issue Type +	Ma	Location *	WS
Category	Earthen Levee			GPS Latitude/Longitude	
				Start	End
Item	Erosion / Bank Caving			38.038360°	38.037812°
				-121.038088°	-121.039016°
DWR ID	DWR_NA0017_16_f_2023_129

Comment Code					
E1 : Note and monitor erosion site.					
Inspector Comment					
Issue has been transferred to Levee Mile Report and will continued to monitored. Site ID: NA0017U16RM21.95					
*This area is patrol road only and therefore the site is not rated					
07/28/2022: From 2013 to present, no significant changes were					
observed during the annual survey. The scarp is nearly vertical at the					
toe. This site was combined with a site immediately downstream					
(NA0017U16RM21.94) and the erosion length increased to 320 ft.					
08/22/2012: The erosion is covered by dense vegetation. There is no					
levee structure on site.

View of bank erosion from the opposite bank. Summer 2023

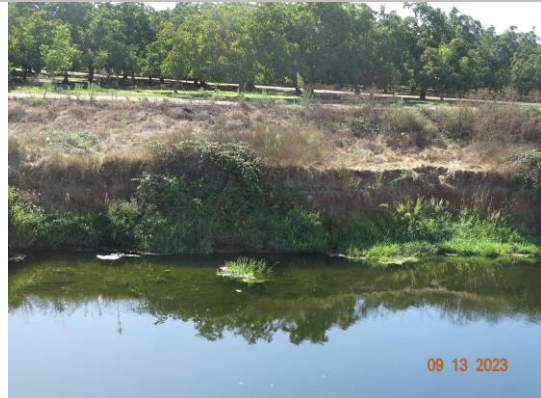
Photo 1 of 1 : FA_2023_NA0017_160_130_20231101_00286.jpg

Comment Code					
E1 : Note and monitor erosion site.					
Inspector Comment					
Issue has been transferred to Levee Mile Report and will continued to monitored. Site ID: NA0017U16RM21.05					
*This area is patrol road only and therefore the site is not rated					
07/28/2022: From 2013 to present, no significant changes were observed during the annual survey. The erosion length was updated to 290 ft in 2021 based on more accurate field measurements and the site was combined with a site immediately downstream (NA0017U16RM21.03). The erosion is just up and downstream of an irrigation pipe crossing (see DSIDs 23321/24938).					
08/22/2012: Berm width is estimated as 5 ft. There is no levee structure on site.

View of bank erosion from the opposite bank. Summer 2023

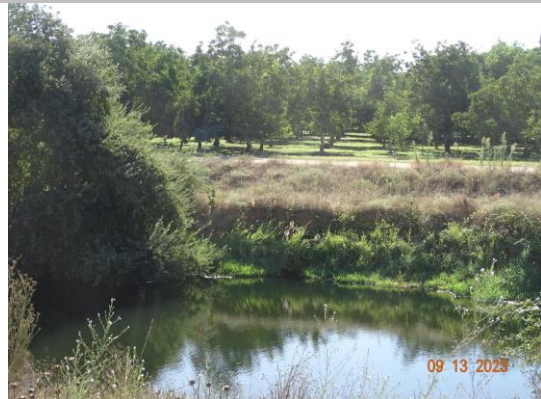
Photo 1 of 1 : FA_2023_NA0017_160_131_20231101_00287.jpg

LM Start	2.26	Rating **	A/W	Issue No.	131
LM End	2.27	Issue Type +	Ma	Location *	WS
Category	Earthen Levee			GPS Latitude/Longitude	
				Start	End
Item	Erosion / Bank Caving			38.032553°	38.032481°
				-121.044654°	-121.044755°
DWR ID	DWR_NA0017_16_f_2023_131				
Comment Code					
E1 : Note and monitor erosion site.					
Inspector Comment					
Issue has been transferred to Levee Mile Report and will continued to monitored. Site ID: NA0017U16RM20.71					
*This area is patrol road only and therefore the site is not rated 07/28/2022: From 2013 to present, no significant changes were observed during the annual survey. The erosion length was updated to 75 ft based on more accurate field measurements.					
08/22/2012: Site is covered with dense vegetation. There is no levee structure on site.

View of bank erosion from the opposite bank. Summer 2023

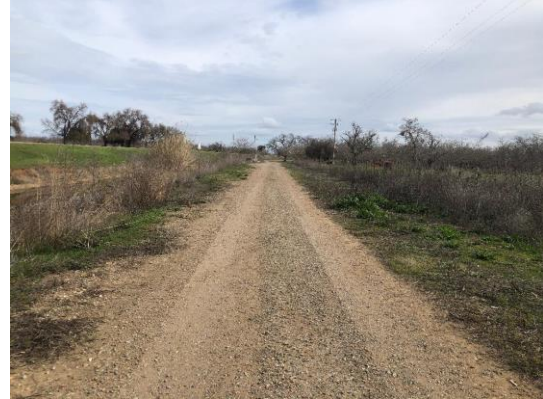
Photo 1 of 3 : UCIP_FA_2023_79191_95459.jpg

Comment Code						
Inspector Comment						
DS_ID:23323 FS_ID:79191 EP_NO: N/A Repair Type: Non-Urgent EVAL Issue: Crossing Status: Found UCIP Comments: 03/09/2021 Record remains Non-Urgent. Unit 16 – Mormon Slough (CLM 0 to 11) is considered a patrol road/high ground area with no defined levee prism, any issue found between CLM 0 to 11 of Unit 16 will be considered a maintenance issue, or an unauthorized encroachment, or an abandoned encroachment. Current condition of pipe crossing does not impede access to patrol road/high ground area. Access limited to pipe inlet due to fencing. Pipe inlet appears bent and partly filled with sediment. Briar bush and vegetation overgrowth limiting visibility of WS slope. No permit has been identified authorizing utility. CVFPB will need to review crossing to determine owner. The UCIP inspection was completed with LMA representative, H. Latu. (N. Cholewinski - GEI)04/24/2014 Heavy vegetation obscuring outlet. remove vegetation and verify flapgate installed. (W. Wylie - DWR UCIP) FIELD_STRUCT_DESC: 18-inch corrugated metal storm drainage pipe (CMP) through the levee, 3.0 feet below the roadway. Grouted outlet on the waterside (WS). [Additional Reference(s): DWR Levee Log, 1992, (HLM 2.52). USACE San Joaquin O&M Manual 611.1, Volume F, (HLM 2.52), 18-inch pipe listed]. FS Date: 3/9/2021

Crossing Overview

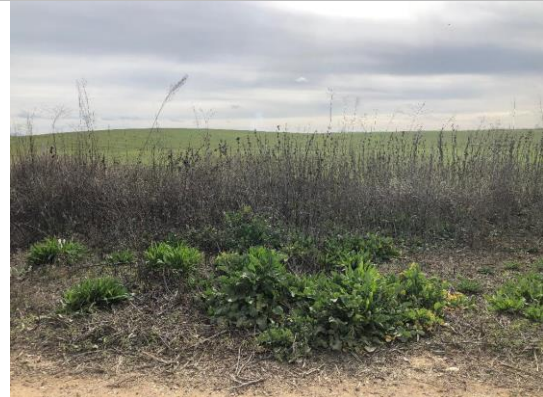
Photo 2 of 3 : UCIP_FA_2023_79191_95460.jpg

LS View

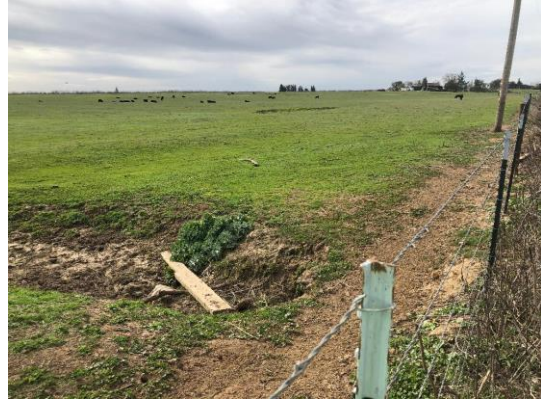
Photo 3 of 3 : UCIP_FA_2023_79191_95461.jpg

LS View: Pipe inlet visible at LS.

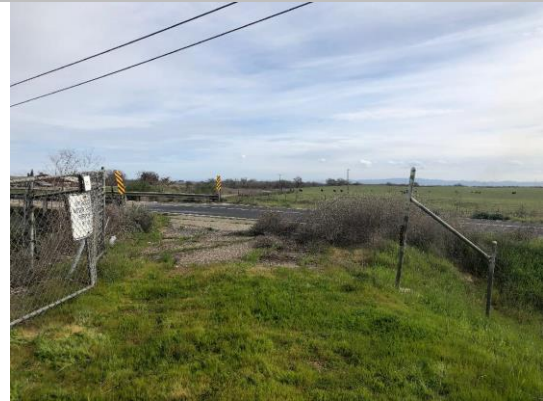
Photo 1 of 3 : UCIP_FA_2023_81203_95452.jpg

Comment Code					
Inspector Comment					
DS_ID:23446 FS_ID:81203 EP_NO: N/A Repair Type: Non-Urgent EVAL Issue: Crossing Status: Found UCIP Comments: 03/09/2021 Record remains Non-Urgent. Unit 16 – Mormon Slough (CLM 0 to 11) is considered a patrol road/high ground area with no defined levee prism, any issue found between CLM 0 to 11 of Unit 16 will be considered a maintenance issue, or an unauthorized encroachment, or an abandoned encroachment. DWR DMP internal video inspection has not found pipe integrity issues. LOF of crossing is less or equal to 4.0. Recommend next video inspection in 5 years. Current condition of pipe crossing does not impede access to patrol road/high ground area. Briar bush overgrowth limiting access and visibility at WS slope. No flapgate at WS. No permit has been identified authorizing utility. CVFPB will need to review crossing to determine owner. The UCIP inspection was completed with LMA representative, H. Latu. (N. Cholewinski - GEI)09/18/2018 Lots of sediment in the inlet: needs to be cleared out. No integrity issues, yet there's dense vegetation and potential flooding risk during high water. Crossing downgraded to "Non-Urgent." (A. McDonald - DWR UCIP)10/31/2016 Same as last inspection. Pipe is open on both ends, no flap gate. (O. Magana - DWR UCIP)04/24/2014 Pipe in non-project levee area. Pipe open on both ends, no flapgate. (W. Wylie - DWR UCIP) FIELD_STRUCT_DESC: 36-inch corrugated metal storm drainage pipe (CMP) through the levee, 10.0 feet below the crown. Pipe open on both ends. [Additional Reference(s): USACE San Joaquin O&M Manual Unit 611, Part No. 1 – Mormon Slough Project, Unit 16 Mormon Slough, (HLM 2.82), 36-inch pipe listed]. FS Date: 3/9/2021

Crossing Overview

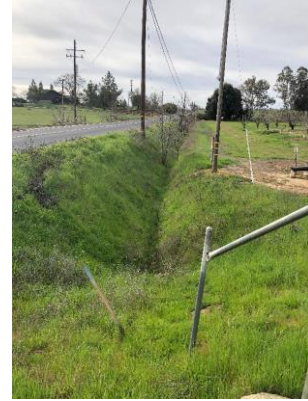
Photo 2 of 3 : UCIP_FA_2023_81203_95453.jpg

LS View: Pipe in drainage ditch at LS.

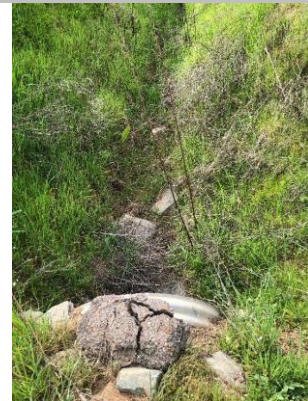
Photo 3 of 3 : UCIP_FA_2023_81203_95454.jpg

LS View: Pipe in drainage ditch at LS.

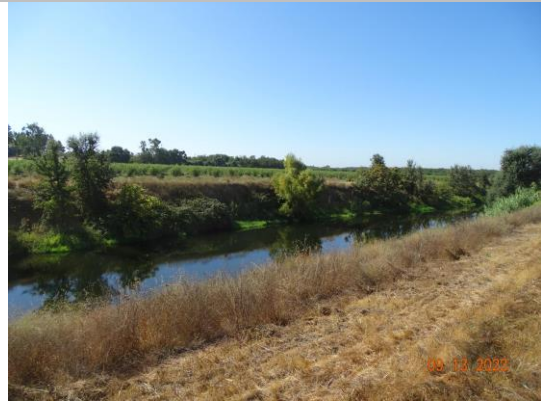
Photo 1 of 1 : FA_2023_NA0017_160_133_20231101_00289.jpg

Comment Code					
E1 : Note and monitor erosion site.					
Inspector Comment					
Issue has been transferred to Levee Mile Report and will continued to monitored. Site ID: NA0017U16RM19.95					
*This area is patrol road only and therefore the site is not rated					
07/28/2022: From 2013 to present, no significant changes were observed during the annual survey. The erosion length was updated to 110 ft based on more accurate field measurements. Additionally, the coordinates, LM, and RM were updated and the Site ID changed from NA0017U16RM20 to NA0017U16RM19.95.					
08/22/2012: Site comprised of series of pocket and scarp erosions.					
Some of erosions are covered by grass or shrubs. There is no levee structure on site.

View of bank erosion from the opposite bank. Summer 2023

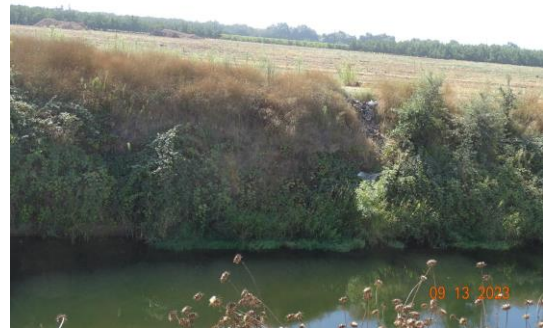
Photo 1 of 1 : FA_2023_NA0017_160_134_20231101_00290.jpg

LM Start	3.61	Rating **	A/W	Issue No.	134
LM End	3.62	Issue Type +	Ma	Location *	WS
Category	Earthen Levee			GPS Latitude/Longitude	
				Start	End
Item	Erosion / Bank Caving			38.019626 °	38.019523 °
				-121.062832 °	-121.062950 °
DWR ID	DWR_NA0017_16_f_2023_134				
Comment Code					
E1 : Note and monitor erosion site.					
Inspector Comment					
Issue has been transferred to Levee Mile Report and will continued to monitored. Site ID: NA0017U16RM19.29					
*This area is patrol road only and therefore the site is not rated					
07/28/2022: From 2015 to present, no significant changes were observed during the annual survey. The erosion length was updated to 60 ft based on more accurate field measurements.The vegetation growth has increased.					
08/20/2014: A pocket erosion was found near the water's edge.

View of bank erosion from the opposite bank. Summer 2023

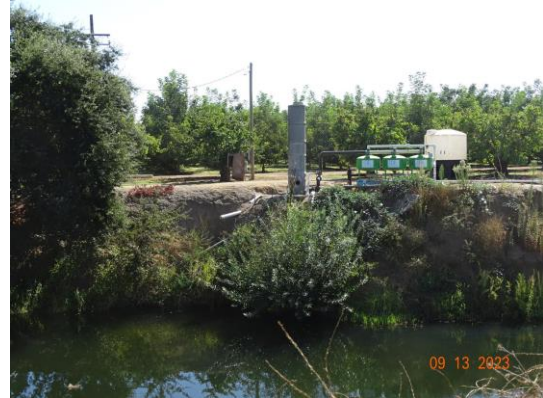
Photo 1 of 1 : FA_2023_NA0017_160_135_20231101_00291.jpg

Comment Code					
E1 : Note and monitor erosion site.					
Inspector Comment					
Issue has been transferred to Levee Mile Report and will continued to monitored. Site ID: NA0017U16RM18.69					
*This area is patrol road only and therefore the site is not rated					
07/28/2022: From 2018 to present, no significant changes were observed during the annual survey. The erosion length was updated to 50 ft based on more accurate field measurements. The site is located just upstream of an irrigation pipe crossing (DSIDs 23328/24945).					
08/30/2017: New erosion observed at the site, under the irrigation pipe.					
08/16/2016: From 2013 to present, no significant changes were observed during the annual survey.					
08/22/2012: An irrigation pipe is present at the site, but probably did not cause the erosion. There is no levee structure on site.

View of bank erosion from the opposite bank. Summer 2023

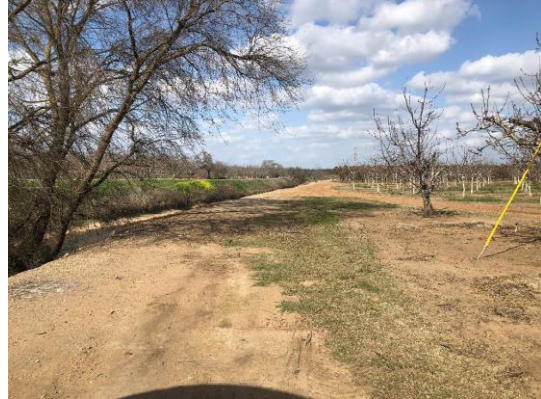
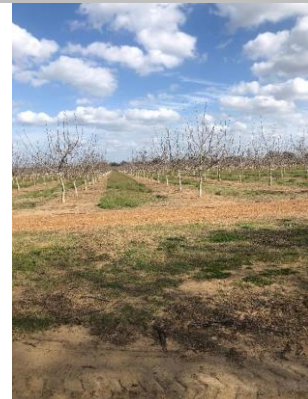
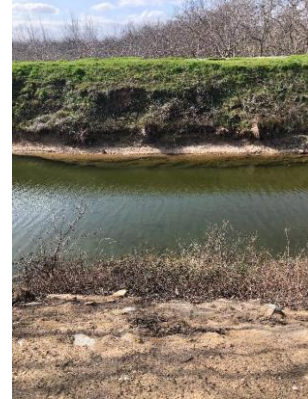
LM Start	4.17	Rating **	M	Issue No.	348 (cont)
LM End	4.17	Issue Type +	Ma	Location *

Comment Code					
Inspector Comment					
DS_ID:23447 FS_ID:81206 EP_NO: N/A Repair Type: Non-Urgent EVAL Issue: Crossing Status: Indicator Found UCIP Comments: 03/08/2021 Record updated from No Action Needed to Non-Urgent. Unit 16 – Mormon Slough (CLM 0 to 11) is considered a patrol road/high ground area with no defined levee prism, any issue found between CLM 0 to 11 of Unit 16 will be considered a maintenance issue, or an unauthorized encroachment, or an abandoned encroachment. Geophysical study indicates possible presence of pipe through levee. Owner needs to coordinate with the CVFPB to remove or abandon crossing according to Title 23 requirements. Current condition of pipe crossing does not impede access to patrol road/high ground area. Utility not found during inspection. Grout apron observed on WS slope, approximately 50 feet upstream of geophysics location. No permit was found authorizing this encroachment. CVFPB will need to review crossing to determine owner. The UCIP inspection was completed with LMA representative, H. Latu. (N. Cholewinski - GEI) FIELD_STRUCT_DESC: 18-inch corrugated metal storm drainage pipe (CMP) through the levee, 3.0 feet below the roadway. Drain inlet ungated. [Additional Reference(s): USACE San Joaquin O&M Manual 611.1, Volume F, (HLM 4.33), 18-inch pipe listed]. FS Date: 3/8/2021

Crossing Overview

LS View

WS View: Grout apron at WS slope.

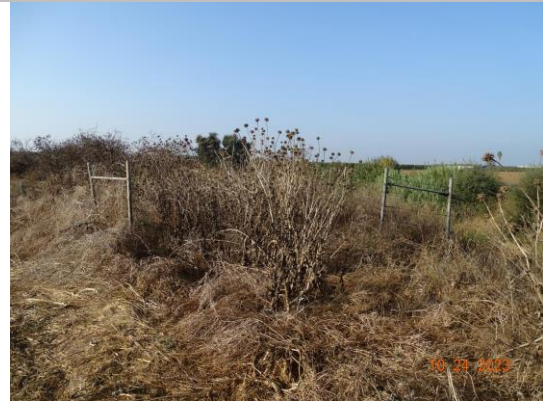
Photo 1 of 1 : FA_2023_NA0017_160_112_20231101_00272.jpg

LM Start	5.26	Rating **	U	Issue No.	112
LM End	5.27	Issue Type +	Ma	Location *	CR
Category	Earthen Levee			GPS Latitude/Longitude	
				Start	End
Item	Vegetation			37.998779°	37.998733°
				-121.076832°	-121.076951°
DWR ID	DWR_NA0017_16_s_2023_112				
Comment Code					
V3 : Keep the crown roadway free of vegetation.					
Inspector Comment

View of vegetation blocking gate access. Fall 2023

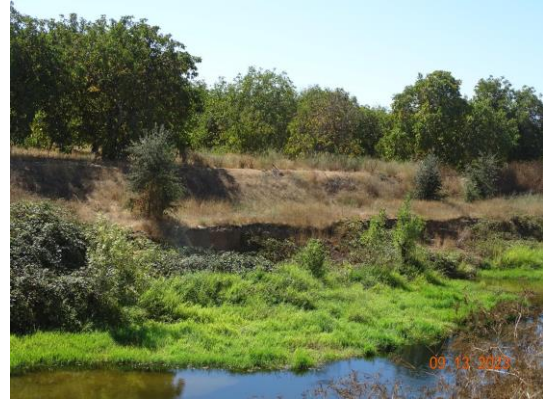
Photo 1 of 1 : FA_2023_NA0017_160_136_20231101_00292.jpg

LM Start	5.33	Rating **	A/W	Issue No.	136
LM End	5.37	Issue Type +	Ma	Location *	WS
Category	Earthen Levee			GPS Latitude/Longitude	
				Start	End
Item	Erosion / Bank Caving			37.997992°	37.997423°
				-121.077478°	-121.077952°
DWR ID	DWR_NA0017_16_f_2023_136				
Comment Code					
E1 : Note and monitor erosion site.					
Inspector Comment					
Issue has been transferred to Levee Mile Report and will continued to monitored. Site ID: NA0017U16RM17.81					
*This area is patrol road only and therefore the site is not rated					
07/28/2022: From 2013 to present, no significant changes were observed during the annual survey. The erosion length was updated to 210 ft based on more accurate field measurements.					
08/22/2012: The site is located at the opposite river bank of E. Tobacco Road. There is no levee structure on site.

View of bank erosion from the opposite bank. Summer 2023

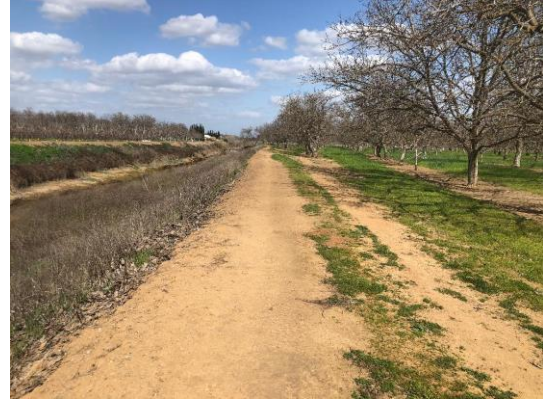
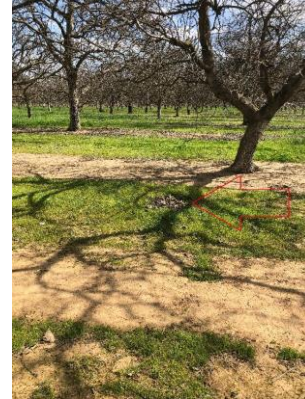
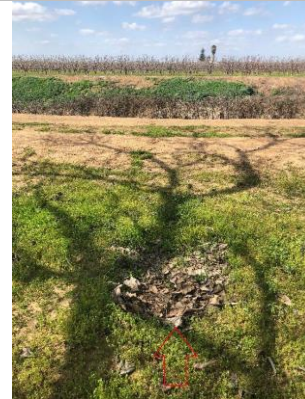
Photo 1 of 3 : UCIP_FA_2023_78013_95182.jpg

Comment Code					
Inspector Comment					
DS_ID:23332 FS_ID:78013 EP_NO: N/A Repair Type: Non-Urgent EVAL Issue: 11, Maintenance Compliance Issue Crossing Status: Found UCIP Comments: 03/08/2021 Record remains Non-Urgent. Unit 16 – Mormon Slough (CLM 0 to 11) is considered a patrol road/high ground area with no defined levee prism, any issue found between CLM 0 to 11 of Unit 16 will be considered a maintenance issue, or an unauthorized encroachment, or an abandoned encroachment. DWR DMP internal video inspection has found pipe integrity issues. LOF of crossing is between 5 and 6. Crossing will be monitored until funding becomes available to address the issues. Current condition of pipe crossing does not impede access to patrol road/high ground area. riar bush overgrowth limiting access and visibility on WS. Pipe appears to be deteriorating and severely corroded at the WS toe. Pipe inlet not visible on LS. Small depression visible at LS along alignment, possible location of buried pipe inlet. No permit was found authorizing this encroachment. CVFPB will need to review crossing to determine owner. The UCIP inspection was completed with LMA representative, H. Latu. (N. Cholewinski - GEI)04/30/2014 Pipe appears abandoned and if so should be done so properly. LS of pipe is burried and WS is badly rusted. Pipe should be inspected internally. (W. Wylie - DWR UCIP) FIELD_STRUCT_DESC: *HIGH GROUND* 18-inch corrugated metal storm drainage pipe (CMP) through the levee, 3.0 feet below the roadway. Grout over the pipe in the channel with pipe open and visible in the water at the waterside (WS) toe. [Additional Reference(s): DWR Levee Log, 1992, (HLM 5.69). USACE San Joaquin O&M Manual 611.1, Volume F, (HLM 5.69), 18-inch pipe listed]. FS Date: 3/8/2021

Crossing Overview

LS View: Small depression visible at LS.

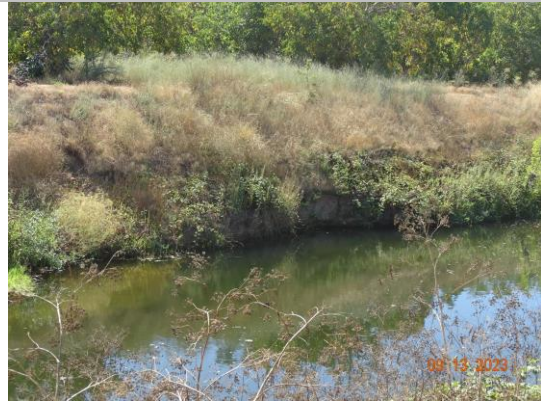
Photo 1 of 1 : FA_2023_NA0017_160_137_20231101_00293.jpg

LM Start	5.54	Rating **	A/W	Issue No.	137
LM End	5.58	Issue Type +	Ma	Location *	WS
Category	Earthen Levee			GPS Latitude/Longitude	
				Start	End
Item	Erosion / Bank Caving			37.995498°	37.995042°
				-121.079745°	-121.080220°
DWR ID	DWR_NA0017_16_f_2023_137				
Comment Code					
E1 : Note and monitor erosion site.					
Inspector Comment					
Issue has been transferred to Levee Mile Report and will continued to monitored. Site ID: NA0017U16RM17.27					
*This area is patrol road only and therefore the site is not rated 07/28/2022: From 2014 to present, no significant changes were observed during the annual survey. The erosion is visible in three locations.					
09/12/2013: The erosion seems to be caused by high river flow. Dense vegetation is present at the site. Signs of animal activities are visible. There is no levee structure on site.

View of bank erosion from the opposite bank. Summer 2023

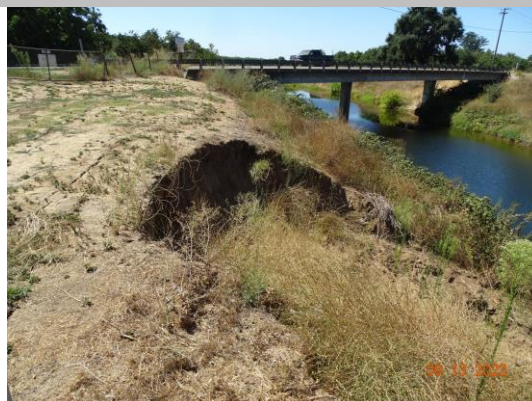
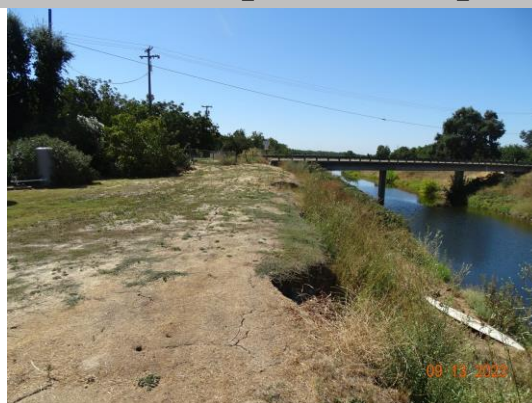
Photo 1 of 2 : SJR2023_NA0017U16RM16.60_4.JPG

LM Start	6.24	Rating **	M	Issue No.	4
LM End	6.26	Issue Type +	Ma	Location *	WS
Category	Supplemental			GPS Latitude/Longitude	
				Start	End
Item	DWR Erosion Survey			37.987153°	37.987153°
				-121.087327°	-121.087327°
DWR ID	NA0017U16RM16.6				
Comment Code					
Inspector Comment					
Site ID: NA0017U16RM16.6					
9/13/2023: The site was discovered by the LMA and visited during the annual field survey. There is a 6-ft vertical scarp for approximately 100 ft along the patrol road hinge.

9/13/2023: View of erosion looking downstream.

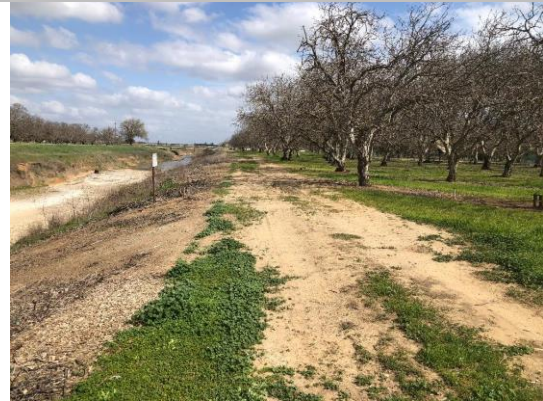
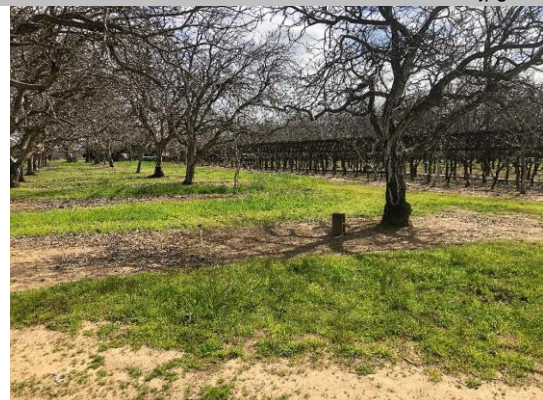
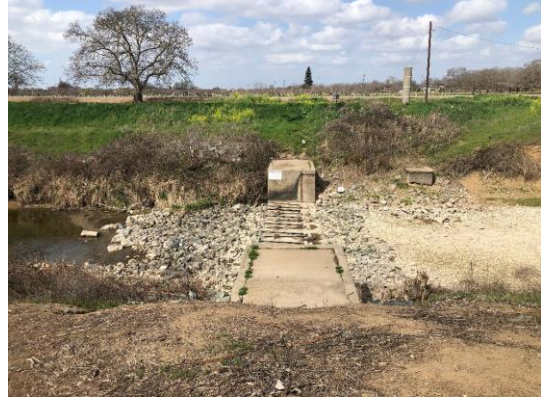
LM Start	6.49	Rating **	M	Issue No.	356 (cont)
LM End	6.49	Issue Type +	Ma	Location *

Comment Code						
Inspector Comment						
DS_ID:23448 FS_ID:81210 EP_NO: N/A Repair Type: Non-Urgent EVAL Issue: Crossing Status: Indicator Found UCIP Comments: 03/08/2021 Record updated from No Action Needed to Non-Urgent. Unit 16 – Mormon Slough (CLM 0 to 11) is considered a patrol road/high ground area with no defined levee prism, any issue found between CLM 0 to 11 of Unit 16 will be considered a maintenance issue, or an unauthorized encroachment, or an abandoned encroachment. Current condition of pipe crossing does not impede access to patrol road/high ground area. Utility not found during inspection. No permit has been identified authorizing utility. CVFPB will need to review crossing to determine owner. The UCIP inspection was completed with LMA representative, H. Latu. (N. Cholewinski - GEI) FIELD_STRUCT_DESC: 18-inch corrugated metal storm drainage pipe (CMP) through the levee, 3.0 feet below the roadway. Drain inlet ungated. [Additional Reference(s): USACE San Joaquin O&M Manual 611.1, Volume F, (HLM 6.70), 18-inch pipe listed]. FS Date: 3/8/2021

Crossing Overview

LS View

WS View

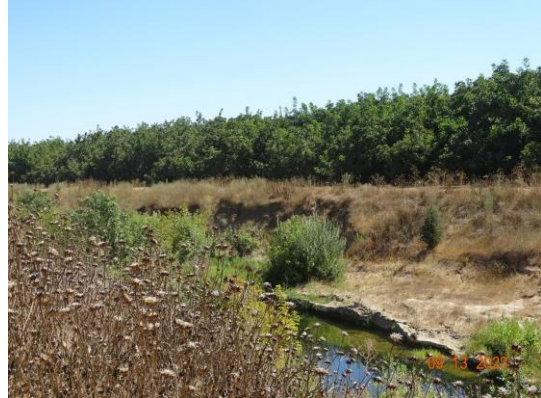
Photo 1 of 1 : FA_2023_NA0017_160_138_20231101_00294.jpg

*This area is patrol road only and therefore the site is not rated
07/28/2022: From 2014 to present, no significant changes were observed during the annual survey. Noticed several locations with signs of burrowing activity near the downstream end of the erosion site. The erosion length was updated to 600 ft based on more accurate field measurements.

08/22/2012: Discontinuous scarp or pocket erosions occurred along a long stretch of the river, with an erosion height greater than 25 ft. at certain points. There is no levee structure on site.

View of bank erosion from the opposite bank. Summer 2023

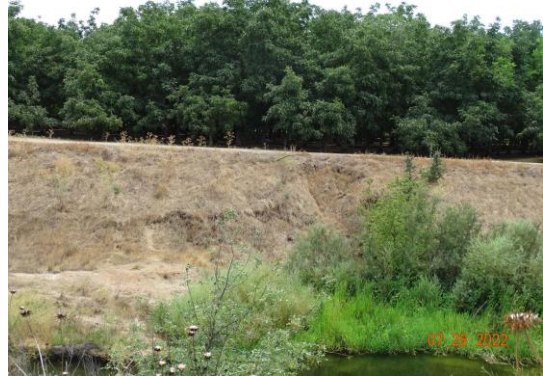
Photo 1 of 1 : FA_2023_NA0017_160_140_20231101_00295.jpg

LM Start	6.70	Rating **	A/W	Issue No.	140
LM End	6.71	Issue Type +	Ma	Location *	WS
Category	Earthen Levee			GPS Latitude/Longitude	
				Start	End
Item	Erosion / Bank Caving			37.982343°	37.982251°
				-121.092543°	-121.092750°
DWR ID	DWR_NA0017_16_f_2023_140				
Comment Code					
E1 : Note and monitor erosion site.					
Inspector Comment					
Issue has been transferred to Levee Mile Report and will continued to monitored. Site ID: NA0017U16RM16.15					
*This area is patrol road only and therefore the site is not rated					
07/28/2022: From 2020 to present, no changes were observed during the annual survey.					
08/29/2019: There is no levee at the site. The erosion is likely caused by surface runoff.

View of bank erosion from the opposite bank. Summer 2022

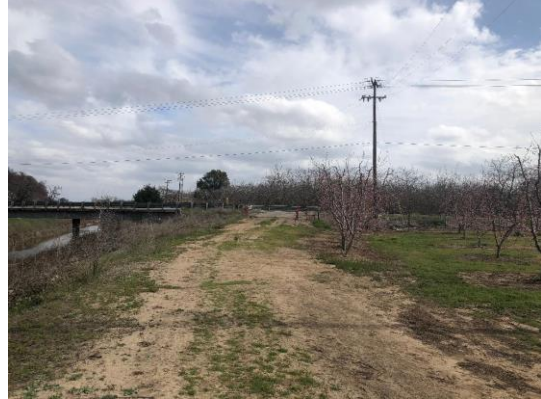
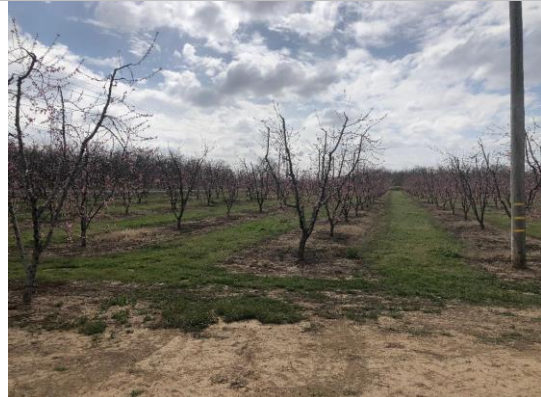
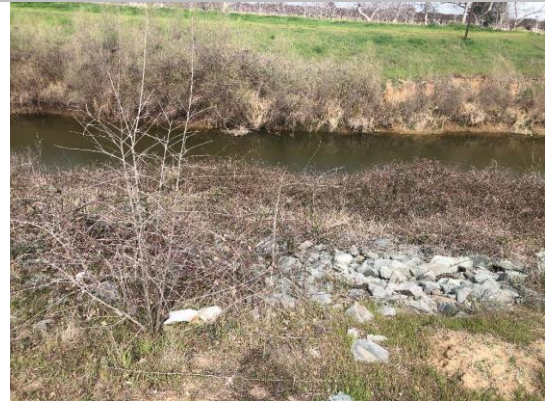
LM Start	6.84	Rating **	M	Issue No.	357 (cont)
LM End	6.84	Issue Type +	Ma	Location *

Comment Code						
Inspector Comment						
DS_ID:23450 FS_ID:78026 EP_NO: N/A Repair Type: Non-Urgent EVAL Issue: Crossing Status: Indicator Found UCIP Comments: 03/08/2021 Record updated from No Action Needed to Non-Urgent. Unit 16 – Mormon Slough (CLM 0 to 11) is considered a patrol road/high ground area with no defined levee prism, any issue found between CLM 0 to 11 of Unit 16 will be considered a maintenance issue, or an unauthorized encroachment, or an abandoned encroachment. Geophysical study indicates possible presence of pipe through levee. Owner needs to coordinate with the CVFPB to remove or abandon crossing according to Title 23 requirements. Utility not found during visual inspection. Current condition of pipe crossing does not impede access to patrol road/high ground area. No permit was found authorizing this encroachment. CVFPB will need to review crossing to determine owner. Angular cobbles and briar bush overgrowth on WS slope. The UCIP inspection was completed with LMA representative, H. Latu. (N. Cholewinski - GEI) FIELD_STRUCT_DESC: 18-inch corrugated metal storm drainage pipe (CMP) through the levee, 3.0 feet below the roadway. Drain inlet ungated. [Additional Reference(s): USACE San Joaquin O&M Manual 611.1, Volume F, (HLM 7.10), 18-inch pipe listed]. FS Date: 3/8/2021

Crossing Overview

LS View

WS View: Angular cobbles on WS slope.

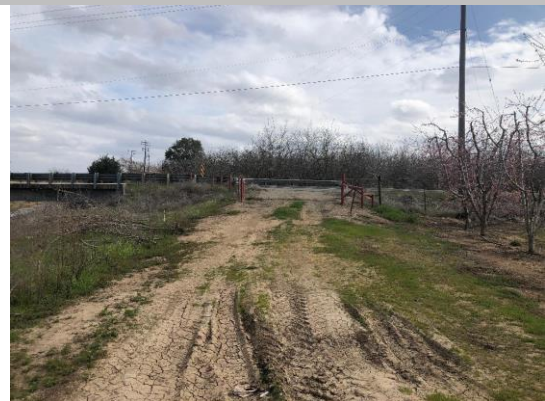
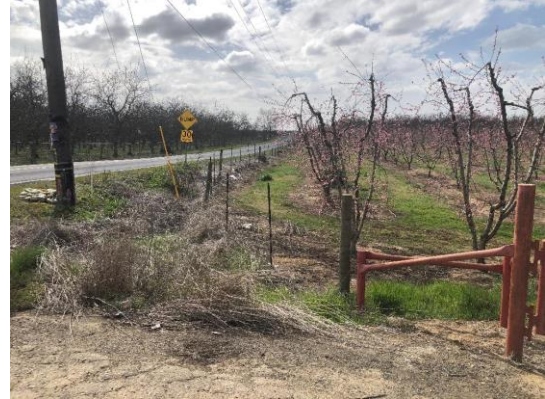
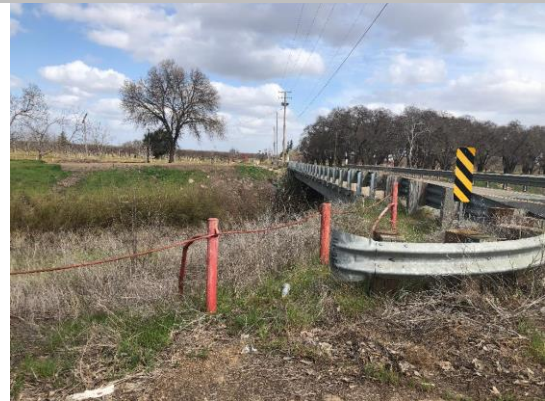
LM Start	6.89	Rating **	M	Issue No.	358
LM End	6.89	Issue Type +	Ma	Location *	
Category	Supplemental		GPS Latitude/Longitude		
			Start	End	
Item	DWR UCIP LMA Responsibility		37.980978°	37.980978°	
			-121.095021°	-121.095021°	
DWR ID	23449

Crossing Overview

DS_ID:23449
 FS_ID:78027
 EP_NO: N/A
 Repair Type: Non-Urgent
 EVAL Issue:
 Crossing Status: Indicator Found
 UCIP Comments: 03/08/2021 Record updated from No Action Needed to Non-Urgent. Unit 16 – Mormon Slough (CLM 0 to 11) is considered a patrol road/high ground area with no defined levee prism, any issue found between CLM 0 to 11 of Unit 16 will be considered a maintenance issue, or an unauthorized encroachment, or an abandoned encroachment. Utility not found during visual inspection. Geophysical study indicates possible presence of pipe through levee. Owner needs to coordinate with the CVFPB to remove or abandon crossing according to Title 23 requirements. Current condition of pipe crossing does not impede access to patrol road/high ground area. No permit was found authorizing this encroachment. CVFPB will need to review crossing to determine owner. Angular cobbles and briar bush overgrowth on WS slope. The UCIP inspection was completed with LMA representative, H. Latu. (N. Cholewinski - GEI)

LS View

WS View: Angular cobbles and briar bush overgrowth on WS slope.

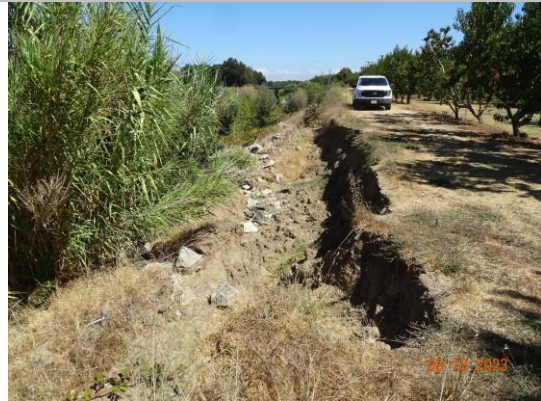
Photo 2 of 2 : SJR2023_NA0017U16RM15.87_4.JPG

LM Start	6.97	Rating **	U	Issue No.	2
LM End	6.99	Issue Type +	Ma	Location *	WS
Category	Supplemental			GPS Latitude/Longitude	
				Start	End
Item	DWR Erosion Survey			37.980367°	37.980367°
				-121.096588°	-121.096588°
DWR ID	NA0017U16RM15.87				
Comment Code					
Inspector Comment					
Site ID: NA0017U16RM15.87 9/13/2023: The site was discovered by the LMA and visited during the annual field survey. There is a 8-ft vertical scarp for approximately 100 ft along the patrol road hinge.

9/13/2023: View of erosion looking upstream.

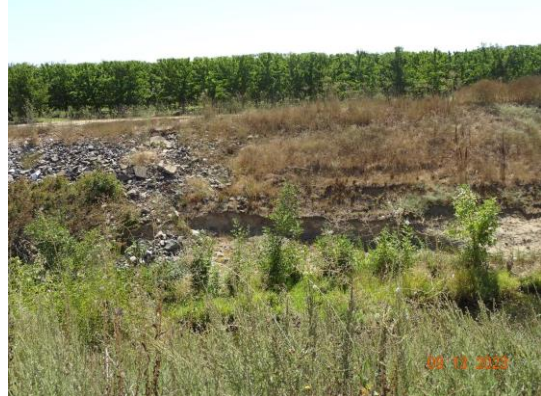
Photo 1 of 1 : FA_2023_NA0017_160_144_20231101_00296.jpg

Issue has been transferred to Levee Mile Report and will continued to monitored. Site ID: NA0017U16RM15.57
 *This area is patrol road only and therefore the site is not rated
 07/28/2022: From 2014 to present, no significant changes were observed during the annual survey. The erosion length was updated to 80 ft based on more accurate field measurements. The site ID changed from NA0017U16RM10.82 to NA0017U16RM15.57 in 2014 to reflect the correct river mile.
 09/12/2013: The site is located at immediately downstream of a levee segment protected by broken concrete. There is no levee structure on site.

View of bank erosion from the opposite bank. Summer 2023

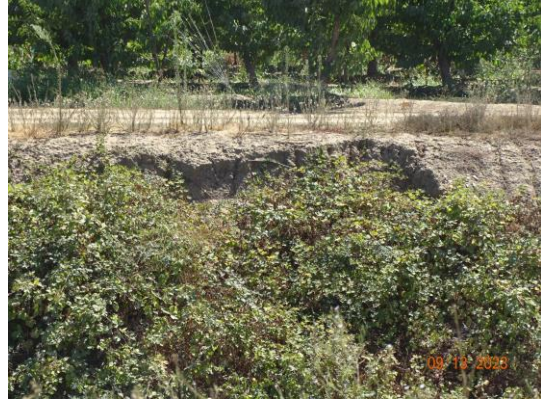
Photo 1 of 1 : FA_2023_NA0017_160_145_20231101_00297.jpg

LM Start	7.41	Rating **	A/W	Issue No.	145
LM End	7.43	Issue Type +	Ma	Location *	WS
Category	Earthen Levee			GPS Latitude/Longitude	
				Start	End
Item	Erosion / Bank Caving			37.977475°	37.977315°
				-121.103379°	-121.103690°
DWR ID	DWR_NA0017_16_f_2023_145				
Comment Code					
E1 : Note and monitor erosion site.					
Inspector Comment					
Issue has been transferred to Levee Mile Report and will continued to monitored. Site ID: NA0017U16RM15.45					
*This area is patrol road only and therefore the site is not rated					
07/28/2022: From 2021 to present, no significant changes were observed during the annual survey.					
07/24/2020: This site was discovered during the DWR Fall 2015 Levee Inspections and first included in the erosion survey in 2019. Some fill, which is eroding, was placed on top of the erosion in one location.

View of bank erosion from the opposite bank. Summer 2023

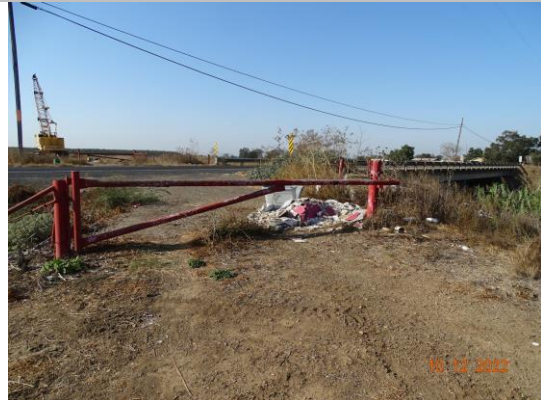
Photo 1 of 1 : FA_2023_NA0017_160_285_20230905_00079.jpg

LM Start	8.05	Rating **	M	Issue No.	285
LM End	8.05	Issue Type +	Ma	Location *	WS
Category	Earthen Levee			GPS Latitude/Longitude	
				Start	End
Item	Encroachments			37.971953°	37.971953°
				-121.112837°	-121.112837°
DWR ID	DWR_NA0017_16_f_2022_285				
Comment Code					
DE : Debris					
Inspector Comment

View of debris along the waterside shoulder. Fall 2022

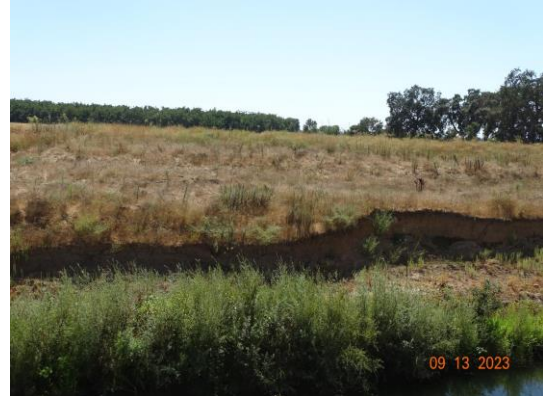
Photo 1 of 1 : FA_2023_NA0017_160_146_20231101_00298.jpg

LM Start	8.34	Rating **	A/W	Issue No.	146
LM End	8.38	Issue Type +	Ma	Location *	WS
Category	Earthen Levee			GPS Latitude/Longitude	
				Start	End
Item	Erosion / Bank Caving			37.969288°	37.969174°
				-121.116172°	-121.116901°
DWR ID	DWR_NA0017_16_f_2023_146				
Comment Code					
E1 : Note and monitor erosion site.					
Inspector Comment					
Issue has been transferred to Levee Mile Report and will continued to monitored. Site ID: NA0017U16RM14.48					
*This area is patrol road only and therefore the site is not rated					
07/28/2022: From 2013 to present, no significant changes were observed during the annual survey. The erosion length was updated to 200 ft based on more accurate field measurements.					
08/22/2012: The erosion occurred on a berm of approximately 25 ft. wide. Site is covered with dense vegetation. There is no levee structure on site.

view of bank erosion from the opposite bank. Summer 2023

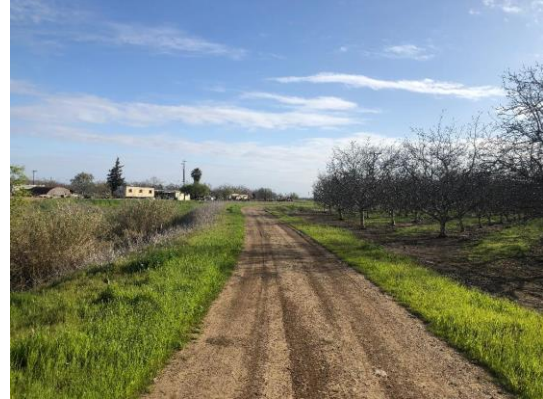
Photo 1 of 3 : UCIP_FA_2023_79194_94940.jpg

Comment Code						
Inspector Comment						
DS_ID:23341 FS_ID:79194 EP_NO: N/A Repair Type: Non-Urgent EVAL Issue: Crossing Status: Indicator Found UCIP Comments: 03/08/2021 Record remains Non-Urgent. Unit 16 – Mormon Slough (CLM 0 to 11) is considered a patrol road/high ground area with no defined levee prism, any issue found between CLM 0 to 11 of Unit 16 will be considered a maintenance issue, or an unauthorized encroachment, or an abandoned encroachment. Geophysical study indicates possible presence of pipe through levee. Owner needs to coordinate with the CVFPB to remove or abandon crossing according to Title 23 requirements. Utility not found during inspection. Current condition of pipe crossing does not impede access to patrol road/high ground area. No permit was found authorizing this encroachment. CVFPB will need to review crossing to determine owner. No inlet observed on LS, but low point visible at LS toe. Briar bush overgrowth at WS toe. The UCIP inspection was completed with LMA representative, H. Latu. (N. Cholewinski - GEI)04/30/2014 Pipe inlet filled with soil and should be cleared. (W. Wylie - DWR UCIP) FIELD_STRUCT_DESC: 18-inch corrugated metal storm drainage pipe (CMP) through the levee, 6.0 feet below the crown. Grouted inlet and outlet. [Additional Reference(s): DWR Levee Log, 1992, (HLM 8.83). USACE San Joaquin O&M Manual 611.1, Volume F, (HLM 8.83), 18-inch pipe listed]. FS Date: 3/8/2021

Crossing Overview

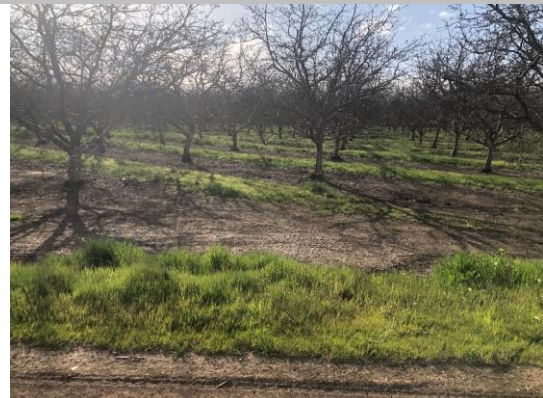
Photo 2 of 3 : UCIP_FA_2023_79194_94941.jpg

LS View: Depression at LS toe.

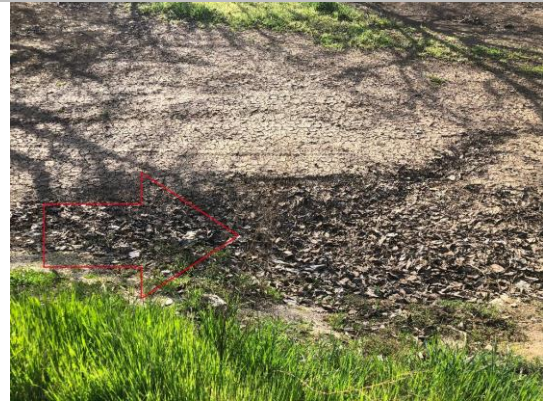
Photo 3 of 3 : UCIP_FA_2023_79194_94942.jpg

LS View: Depression at LS toe.

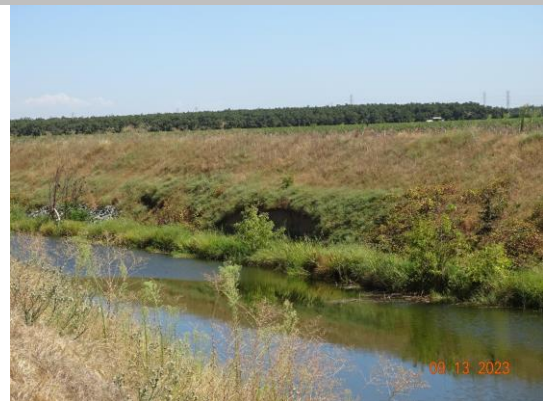
Photo 1 of 1 : FA_2023_NA0017_160_147_20231101_00299.jpg

*This area is patrol road only and therefore the site is not rated
08/02/2022: From 2014 to present, no significant changes were observed during the annual survey. The site was combined with NA0017U16RM13.83 and NA0017U16RM13.86 and the length increased to 160 ft.

09/12/2013: The erosion might have been caused by river flow combined with runoff. Dense vegetation is presents at the site. There is no levee structure on site.

View of bank erosion from the opposite bank. Summer 2023

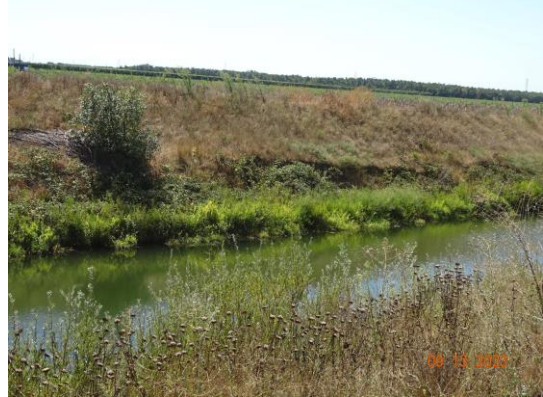
Photo 1 of 1 : FA_2023_NA0017_160_148_20231101_00300.jpg

LM Start	9.11	Rating **	A/W	Issue No.	148
LM End	9.13	Issue Type +	Ma	Location *	WS
Category	Earthen Levee			GPS Latitude/Longitude	
				Start	End
Item	Erosion / Bank Caving			37.966857°	37.966926°
				-121.129388°	-121.129763°
DWR ID	DWR_NA0017_16_f_2023_148				
Comment Code					
E1 : Note and monitor erosion site.					
Inspector Comment					
Issue has been transferred to Levee Mile Report and will continued to monitored. Site ID: NA0017U16RM13.72					
*This area is patrol road only and therefore the site is not rated					
08/02/2022: From 2013 to present, no significant changes were observed during the annual survey. The erosion length was updated to 110 ft based on more accurate field measurements.					
08/22/2012: The erosion is covered with dense vegetation. There is no levee structure on site.

View of bank erosion from the opposite bank. Summer 2023

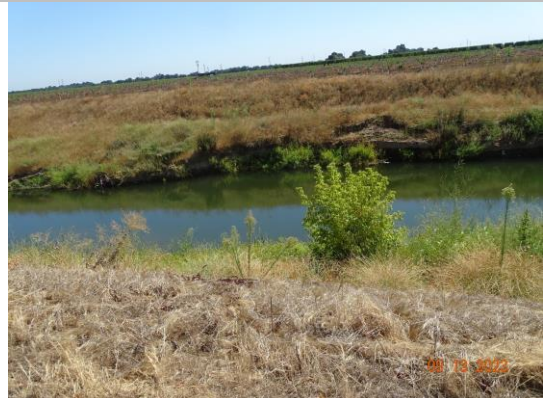
Photo 1 of 1 : FA_2023_NA0017_160_149_20231101_00301.jpg

LM Start	9.31	Rating **	A/W	Issue No.	149
LM End	9.33	Issue Type +	Ma	Location *	WS
Category	Earthen Levee			GPS Latitude/Longitude	
				Start	End
Item	Erosion / Bank Caving			37.966735°	37.966657°
				-121.133001°	-121.133340°
DWR ID	DWR_NA0017_16_f_2023_149				
Comment Code					
E1 : Note and monitor erosion site.					
Inspector Comment					
Issue has been transferred to Levee Mile Report and will continued to monitored. Site ID: NA0017U16RM13.53					
*This area is patrol road only and therefore the site is not rated					
08/02/2022: From 2013 to present, no significant changes were observed during the annual survey. The erosion length was updated to 130 ft based on more accurate field measurements.					
08/22/2012: The erosion is on berm. The berm width is estimated.					
There is no levee structure on site.

View of bank erosion from the opposite bank. Summer 2023
