**Flood Control Project Maintenance
Levee Inspections**

Maintenance Issue Types Only, Levee Inspection Report By Mile - Fall 2023

San Joaquin County Flood Control and Water Conservation District

Waterway	Bank	Unit Miles	Inspection Start/End	Inspector
Unit No. 01 Littlejohn Creek	Left	2.59	10/20/2023 10/20/2023	Alberto De Leon

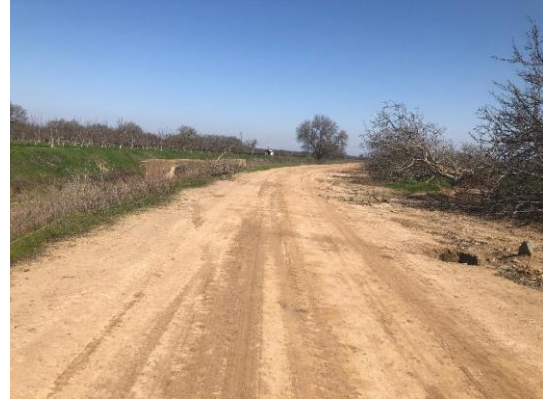
Photo 1 of 3 : UCIP_FA_2023_79196_94889.jpg

Comment Code					
Inspector Comment					
DS_ID:23344 FS_ID:79196 EP_NO: N/A Repair Type: Non-Urgent EVAL Issue: 11, Maintenance Compliance Issue Crossing Status: Found UCIP Comments: 03/04/2021 Record status is still Non-Urgent. Unit 16 – Mormon Slough (CLM 0 to 11) is considered a patrol road/high ground area with no defined levee prism, any issue found between CLM 0 to 11 of Unit 16 will be considered a maintenance issue, or an unauthorized encroachment, or an abandoned encroachment. DMP internal video inspection has found pipe integrity issues. LOF of crossing is between 5 and 6. Crossing will be monitored until funding becomes available for rehabilitation. CM pipe is rusty and bent at LS opening. Observed a 2.5-inch PVC pipe discharging at LS pipe opening. Pipe is severely corroded at the WS toe. The metal is thinned, brittle, and peeling off from the pipe walls. Current condition of pipe crossing does not impede access to patrol road/high ground area. No permit was found authorizing this encroachment. CVFPB will need to review crossing to determine owner. The UCIP inspection was completed with LMA representative, H. Latu. (N. Cholewinski - GEI)04/30/2014 Inlet appears to be buried with soil on LS. Pipe heavily corroded at outlet on WS toe. Good candidate for video inspection. (W. Wylie - DWR UCIP) FIELD_STRUCT_DESC: *HIGH GROUND* 18-inch corrugated metal storm drainage pipe (CMP) through the levee, 3.5 feet below the crown. Grouted inlet and outlet. [Additional Reference(s): DWR Levee Log, 1992, (HLM 9.77). USACE San Joaquin O&M Manual 611.1, Volume F, (HLM 9.77), 18-inch pipe listed]. FS Date: 3/4/2021

Crossing Overview

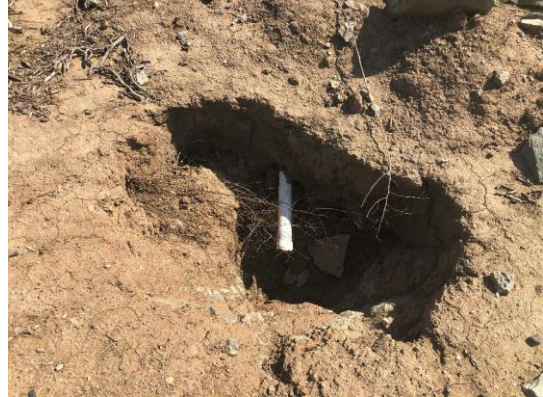
Photo 2 of 3 : UCIP_FA_2023_79196_94890.jpg

LS View: PVC pipe discharging at LS pipe opening.

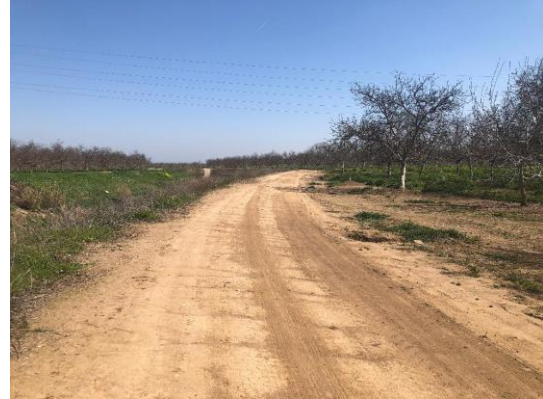
Photo 1 of 3 : UCIP_FA_2023_79949_94882.jpg

Comment Code					
Inspector Comment					
DS_ID:23345 FS_ID:79949 EP_NO: N/A Repair Type: No Action Needed EVAL Issue: Crossing Status: Found UCIP Comments: 05/09/2023 Record updated from Non-Urgent to No Action Needed. CIPP liner was installed on June 15, 2022. DMP internal video inspection has found none or minor pipe defects. Recommend next video inspection in 5 years. (O.Yakimov - DWR UCIP) 03/04/2021 Record remains Non-Urgent. Unit 16 ? Mormon Slough (CLM 0 to 11) is considered a patrol road/high ground area with no defined levee prism, any issue found between CLM 0 to 11 of Unit 16 will be considered a maintenance issue, or an unauthorized encroachment, or an abandoned encroachment. DMP internal video inspection has found pipe integrity issues. LOF of crossing is between 5 and 6. Crossing will be monitored until funding becomes available to address the issues. CM pipe is bent and deformed with visible gaps at the LS pipe opening. Pipe appears rusty and weathered on WS. Current condition of pipe crossing does not impede access to patrol road/high ground area. No permit was found authorizing this encroachment. CVFPB will need to review crossing to determine owner. The UCIP inspection was completed with LMA representative, H. Latu. (N. Cholewinski - GEI)04/30/2014 Inlet on LS burried in soil. (W. Wylie - DWR UCIP) FIELD_STRUCT_DESC: *HIGH GROUND* 18-inch CIPP-lined corrugated metal storm drainage pipe (CMP) through the levee, 3.5 feet below the crown. Grouted inlet and outlet. [Additional Reference(s): DWR Levee Log, 1992, (HLM 10.07). USACE San Joaquin O&M Manual 611.1, Volume F, (HLM 10.07), 18-inch pipe listed]. FS Date: 3/4/2021

Crossing Overview

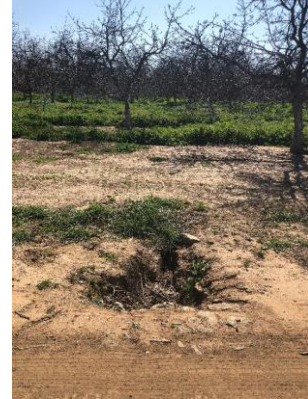
Photo 2 of 3 : UCIP_FA_2023_79949_94883.jpg

LS View: Pipe damaged at LS.

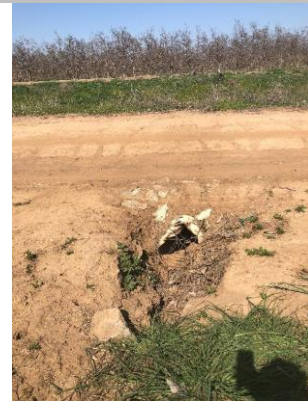
Photo 3 of 3 : UCIP_FA_2023_79949_94884.jpg

LS View: Pipe damaged at LS.

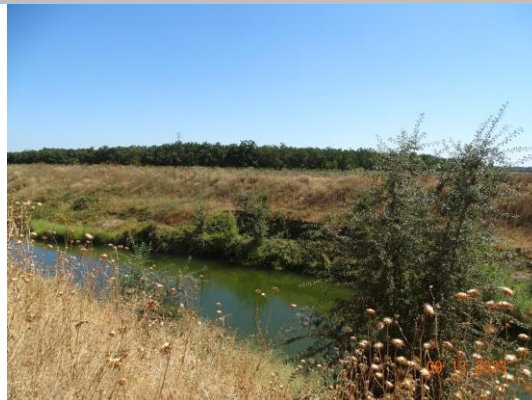
Photo 1 of 1 : FA_2023_NA0017_160_150_20231101_00302.jpg

LM Start	9.86	Rating **	A/W	Issue No.	150
LM End	9.88	Issue Type +	Ma	Location *	WS
Category	Earthen Levee			GPS Latitude/Longitude	
				Start	End
Item	Erosion / Bank Caving			37.964699°	37.964709°
				-121.142398°	-121.142726°
DWR ID	DWR_NA0017_16_f_2023_150				
Comment Code					
E1 : Note and monitor erosion site.					
Inspector Comment					
Issue has been transferred to Levee Mile Report and will continued to monitored. Site ID: NA0017U16RM12.95					
*This area is patrol road only and therefore the site is not rated					
08/02/2022: From 2013 to present, no significant changes were observed during the annual survey. The erosion length was updated to 80 ft based on more accurate field measurements.					
08/22/2012: Dense vegetation on site. There is no levee structure on site.

View of bank erosion from the opposite bank. Summer 2023

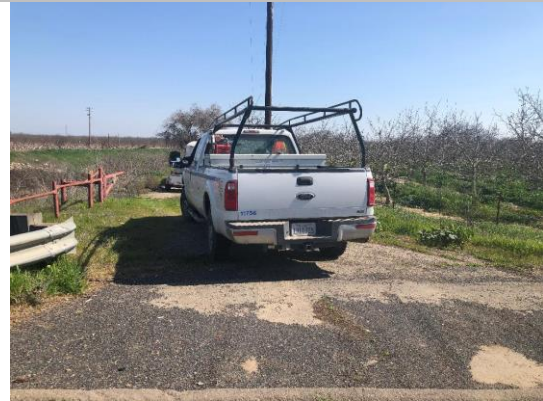
Photo 1 of 3 : UCIP_FA_2023_79950_94863.jpg

DS_ID:23347
FS_ID:79950
EP_NO: N/A
Repair Type: No Action Needed
EVAL Issue:
Crossing Status: Found
UCIP Comments: 05/09/2023 Record updated from Non-Urgent to No Action Needed. CIPP liner was installed on June 15, 2022. DMP internal video inspection has found none or minor pipe defects. Recommend next video inspection in 5 years. (O.Yakimov - DWR UCIP)
03/04/2021 Record remains Non-Urgent. Unit 16 Mormon Slough (CLM 0 to 11) is considered a patrol road/high ground area with no defined levee prism, any issue found between CLM 0 to 11 of Unit 16 will be considered a maintenance issue, or an unauthorized encroachment, or an abandoned encroachment. DMP internal video inspection has found pipe integrity issues. LOF of crossing is between 5 and 6. Crossing will be monitored until funding becomes available to address the issues. Limited access to and briar bush overgrowth on WS. Pipe is corroding and rusty at LS. Current condition of pipe crossing does not impede access to patrol road/high ground area. No permit was found authorizing this encroachment. CVFPB will need to review crossing to determine owner. The UCIP inspection was completed with LMA representative, H. Latu. (N. Cholewinski - GEI)04/30/2014 Heavy sediment buildup at inlet on LS toe. (W. Wylie - DWR UCIP)

FIELD_STRUCT_DESC: *HIGH GROUND* 18-inch CIPP-lined corrugated metal storm drainage pipe (CMP) through the levee, 5.5 feet below the crown. Concrete U-shaped headwall on the landside (LS) end. Flap gate on the waterside (WS) end. [Additional Reference(s): DWR Levee Log, 1992, (HLM 10.50). USACE San Joaquin O&M Manual 611.1, Volume F, (HLM 10.50), 18-inch pipe listed].
FS Date: 3/4/2021

Crossing Overview

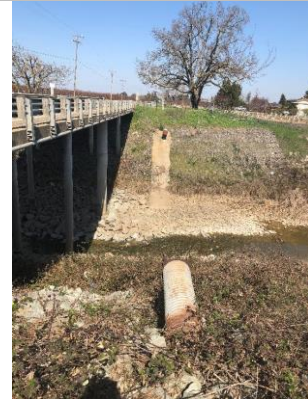
Photo 3 of 3 : UCIP_FA_2023_79950_94865.jpg

WS View: Pipe and flapgate at WS slope. Briar bush overgrowth present.

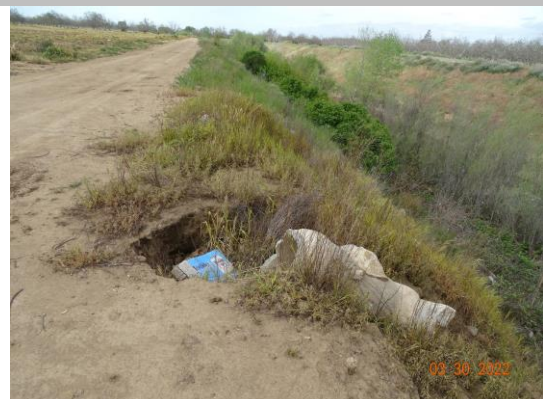
Photo 1 of 1 : FA_2023_NA0017_160_288_20230905_00080.jpg

LM Start	10.57	Rating **	M	Issue No.	288
LM End	10.57	Issue Type +	Ma	Location *	WS
Category	Earthen Levee			GPS Latitude/Longitude	
				Start	End
Item	Erosion / Bank Caving			37.963542°	37.963542°
				-121.155111°	-121.155111°
DWR ID	DWR_NA0017_16_f_2019_288				
Comment Code					
E2 : Schedule repair of erosion site prior to the next inspection.					
Inspector Comment					
Erosion may cut into patrol access road.

View of erosion on the waterside shoulder. Spring 2022

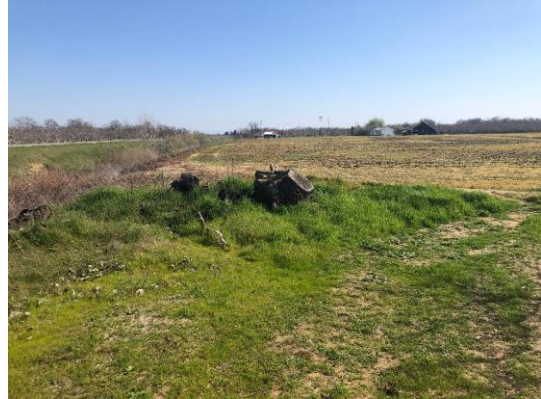
Photo 1 of 3 : UCIP_FA_2023_81216_94830.jpg

Crossing Overview

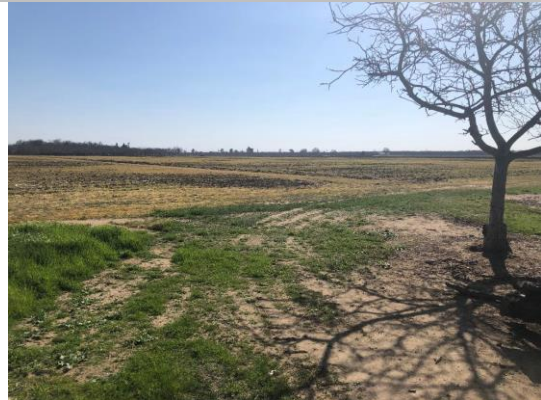
Photo 2 of 3 : UCIP_FA_2023_81216_94831.jpg

LS View

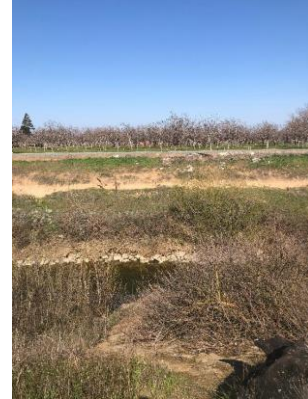
Photo 3 of 3 : UCIP_FA_2023_81216_94832.jpg

WS View: Grout apron at WS slope.

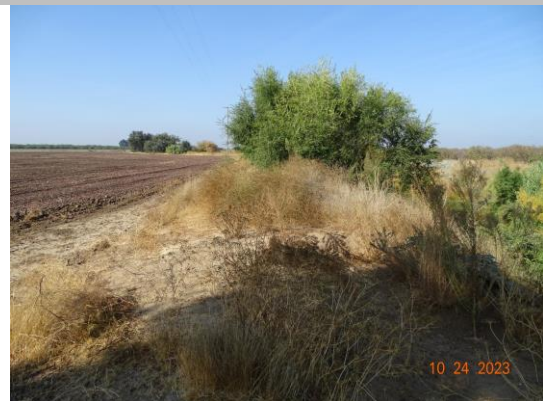
Photo 1 of 1 : FA_2023_NA0017_160_151_20231101_00274.jpg

LM Start	10.88	Rating **	U	Issue No.	151
LM End	11.01	Issue Type +	Ma	Location *	CR
Category	Earthen Levee			GPS Latitude/Longitude	
				Start	End
Item	Vegetation			37.961509°	37.960817°
				-121.160083°	-121.162036°
DWR ID	DWR_NA0017_16_f_2023_151				
Comment Code					
V1 : Control annual grass and weeds on the levee slopes and easements.					
Inspector Comment

Typical view of vegetation along the crown. Fall 2023

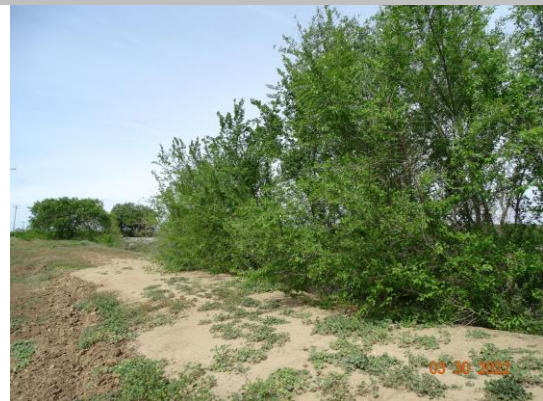
Photo 1 of 1 : FA_2023_NA0017_160_3_20230905_00002.jpg

LM Start	10.90	Rating **	U	Issue No.	3
LM End	10.90	Issue Type +	Ma	Location *	CR
Category	Earthen Levee			GPS Latitude/Longitude	
				Start	End
Item	Trim / Thin Trees			37.961464°	37.961464°
				-121.160376°	-121.160376°
DWR ID	DWR_NA0017_16_s_2022_3				
Comment Code					
T4 : Trim trees over roadway to at least 12 feet above ground level.					
Inspector Comment

View of untrimmed trees along the waterside of the crown. Spring 2022

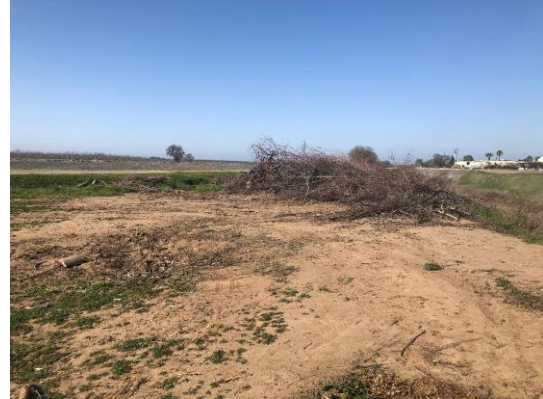
Photo 1 of 3 : UCIP_FA_2023_79199_94805.jpg

Comment Code					
Inspector Comment					
DS_ID:23354 FS_ID:79199 EP_NO: N/A Repair Type: Non-Urgent EVAL Issue: 5, Pipe Damage Crossing Status: Found UCIP Comments: 03/04/2021 Record was updated from No Action Needed to Non-Urgent. DWR DMP has found integrity issues, LOF between 4 and 5. Crossing will be monitored until funding becomes available for rehabilitation. No permit was found authorizing this encroachment. CVFPB will need to review crossing to determine owner. Soil accumulation and concrete debris near LS pipe opening. No visual of pipe at WS grout apron. The UCIP inspection was completed with LMA representative, H. Latu. (N. Cholewinski - GEI) FIELD_STRUCT_DESC: 18-inch corrugated metal storm drainage pipe (CMP) through the levee, 3.5 feet below the crown. Grouted outlet on the waterside (WS). [Additional Reference(s): DWR Levee Log, 1992, (HLM 11.41). USACE San Joaquin O&M Manual 611.1, Volume F, (HLM 11.41), 18-inch pipe listed]. FS Date: 3/4/2021

Crown Overview

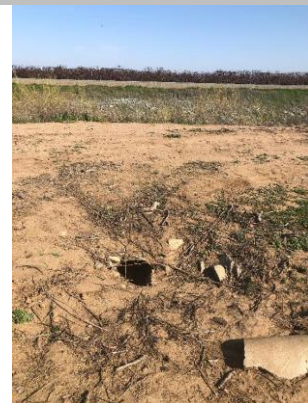
Photo 2 of 3 : UCIP_FA_2023_79199_94806.jpg

LS View: Soil accumulation and concrete debris at pipe opening.

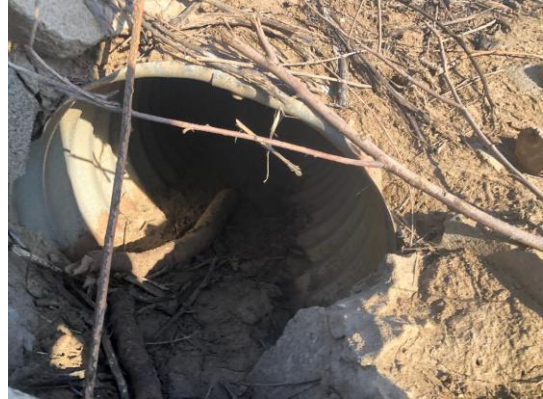
Photo 3 of 3 : UCIP_FA_2023_79199_94807.jpg

LS View: Pipe opening at LS.

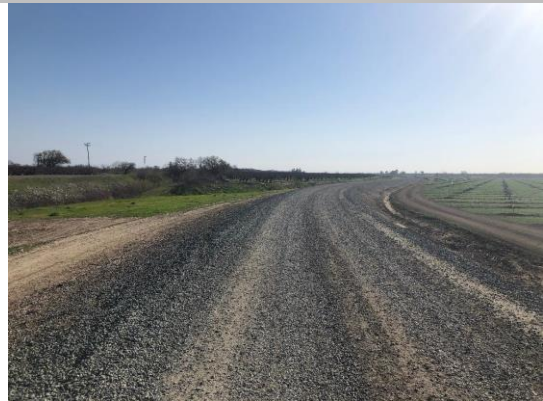
Photo 1 of 3 : UCIP_FA_2023_79200_94795.jpg

DS_ID:23355
FS_ID:79200
EP_NO: N/A
Repair Type: Non-Urgent
EVAL Issue:
Crossing Status: Found
UCIP Comments: 12/20/2022 Record updated from Urgent to Non-Urgent. Pipe has been CIPP lined. LOF of crossing is less or equal to 4. Recommend next video inspection in 5 years. (O.Yakimov - DWR UCIP)
03/04/2021 Record was updated from No Action Needed to Urgent. DWR DMP has found integrity issues, LOF between 5 and 6. Crossing will be monitored until funding becomes available to be addressed. No permit was found authorizing this encroachment. CVFPB will need to review crossing to determine owner. Flapgate on WS appears misaligned at collar by approximately 1-inch. The UCIP inspection was completed with LMA representative, H. Latu. (N. Cholewinski - GEI)
FIELD_STRUCT_DESC: 30-inch CIPP-lined steel storm drainage pipe (CMP) through the levee, 6.0 feet below the crown. Concrete U-shaped headwalls on each end. Flap gate on the waterside (WS) end. Grouted inlet and outlet. [Additional Reference(s): DWR Levee Log, 1992, (HLM 11.45). USACE San Joaquin O&M Manual 611.1, Volume F, (HLM 11.45), 30-inch CMP listed].

Crown Overview

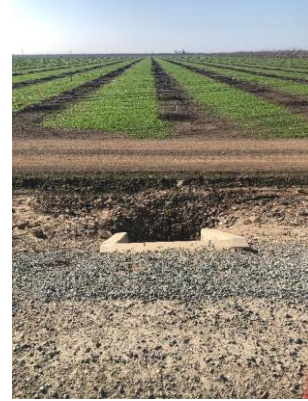
Photo 2 of 3 : UCIP_FA_2023_79200_94796.jpg

LS View: Headwall at LS toe.

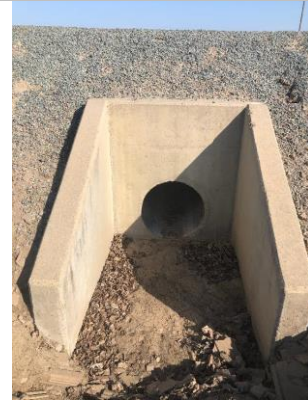
Photo 3 of 3 : UCIP_FA_2023_79200_94797.jpg

LS View: Headwall at LS toe.

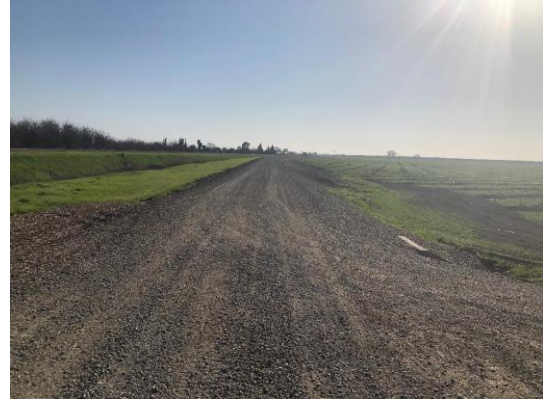
Photo 1 of 3 : UCIP_FA_2023_79201_94767.jpg

Comment Code					
Inspector Comment					
DS_ID:23385 FS_ID:79201 EP_NO: N/A Repair Type: Non-Urgent EVAL Issue: Crossing Status: Found UCIP Comments: 03/04/2021 Record was updated from No Action Needed to Non-Urgent. No permit was found authorizing this encroachment. CVFPB will need to review crossing to determine owner. Observed a 4.5-inch PVC pipe discharging at headwall on LS. Flapgate on WS has single bullet hole. The UCIP inspection was completed with LMA representative, H. Latu. (N. Cholewinski - GEI) FIELD_STRUCT_DESC: 30-inch corrugated metal storm drainage pipe (CMP) through the levee, 5.5 feet below the crown. Concrete U-shaped headwalls on each end. Flap gate on the waterside (WS) end. Grouted inlet and outlet. [Additional Reference(s): DWR Levee Log, 1992, (HLM 12.24). USACE San Joaquin O&M Manual 611.1, Volume F, (HLM 12.24), 30-inch pipe listed]. FS Date: 3/4/2021

Crown Overview

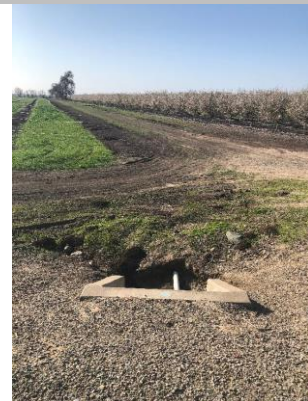
Photo 2 of 3 : UCIP_FA_2023_79201_94768.jpg

LS View: Headwall at LS toe.

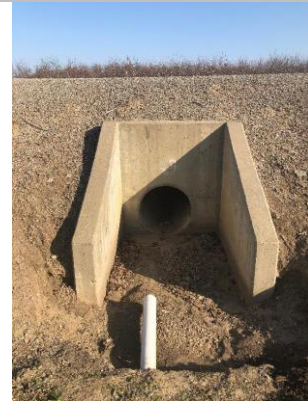
Photo 3 of 3 : UCIP_FA_2023_79201_94769.jpg

LS View: Headwall at LS toe. PVC pipe discharging at headwall.

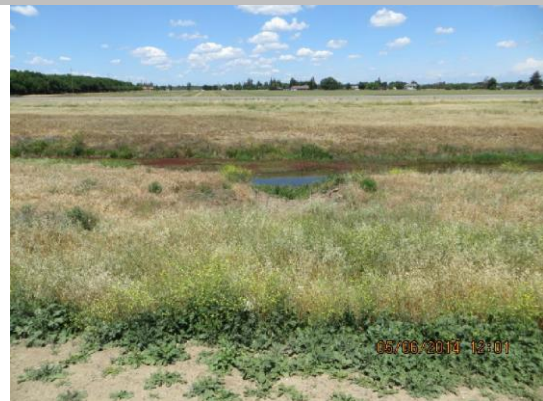
Photo 1 of 3 : UCIP_FA_2023_79202_65589.jpg

DS_ID:23388
 FS_ID:79202
 EP_NO: N/A
 Repair Type: Non-Urgent
 EVAL Issue:
 Crossing Status: Found
 UCIP Comments: 03/03/2021 Record was updated from No Action Needed to Non-Urgent. DMP internal video inspection has not found pipe integrity issues. LOF of crossing is less or equal to 4.0. Recommend next video inspection in 5 years. No permit was found authorizing this encroachment. CVFPB will need to review crossing to determine owner. Burrow holes observed above headwall on LS slope. Pipe is rusty and CM of pipe seems to be slightly separating at LS toe. The UCIP inspection was completed with LMA representative, H. Latu. (N. Cholewinski - GEI)
 FIELD_STRUCT_DESC: 30-inch corrugated metal storm drainage pipe (CMP) through the levee, 9.0 feet below the crown. Concrete U-shaped headwalls on each end. Flap gate on the waterside (WS) end. Grouted inlet and outlet. [Additional Reference(s): DWR Levee Log, 1992, (HLM 12.58). USACE San Joaquin O&M Manual 611.1, Volume F, (HLM 12.58), 30-inch pipe listed].

Grouted spillway on WS berm.

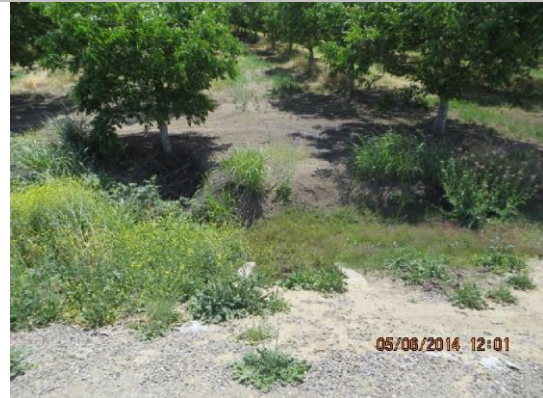
Photo 2 of 3 : UCIP_FA_2023_79202_65588.jpg

Concrete headwall on LS toe.

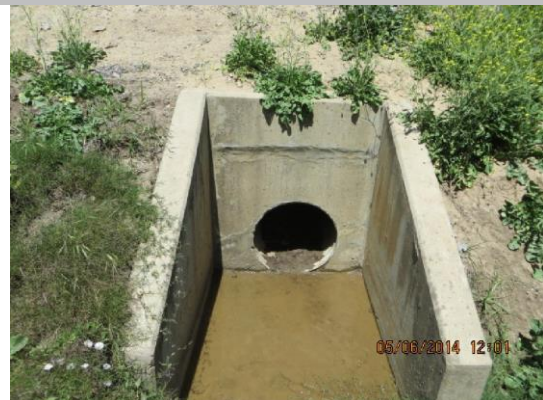
Photo 3 of 3 : UCIP_FA_2023_79202_65587.jpg

Concrete headwall on LS toe.

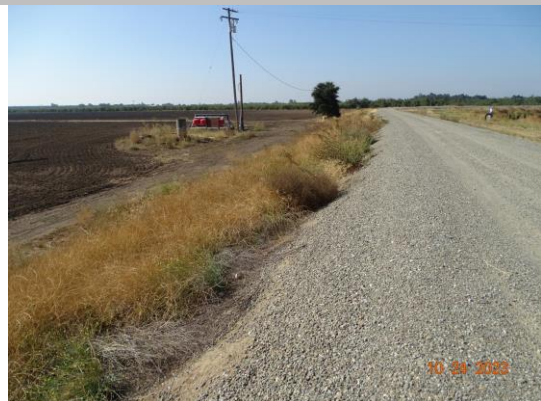
Photo 1 of 1 : FA_2023_NA0017_160_153_20231101_00275.jpg

LM Start	12.43	Rating **	U	Issue No.	153
LM End	12.83	Issue Type +	Ma	Location *	LS
Category	Earthen Levee			GPS Latitude/Longitude	
				Start	End
Item	Vegetation			37.960289°	37.959404°
				-121.187513°	-121.194641°
DWR ID	DWR_NA0017_16_f_2023_153				
Comment Code					
V1 : Control annual grass and weeds on the levee slopes and easements.					
Inspector Comment

Typical view of vegetation along the landside slope and easement. Fall 2023

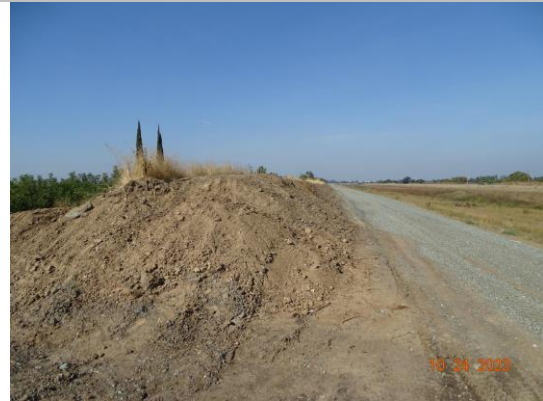
Photo 1 of 1 : FA_2023_NA0017_160_277_20231101_00277.jpg

LM Start	13.96	Rating **	U	Issue No.	277
LM End	14.01	Issue Type +	Ma	Location *	CR
Category	Earthen Levee			GPS Latitude/Longitude	
				Start	End
Item	Encroachments			37.964838°	37.965214°
				-121.212834°	-121.213627°
DWR ID	DWR_NA0017_16_s_2019_277				
Comment Code					
MA : Material					
Inspector Comment					
Fill material is stored on the landside crown.

View of fill material stored landside shoulder. Fall 2023

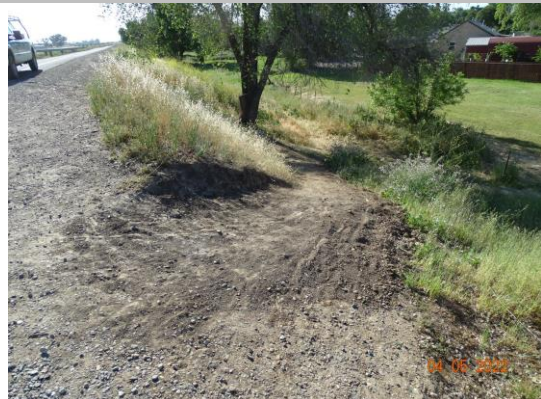
Photo 1 of 1 : FA_2023_NA0017_160_289_20230905_00081.jpg

LM Start	17.07	Rating **	M	Issue No.	289
LM End	17.07	Issue Type +	Ma	Location *	LS
Category	Earthen Levee			GPS Latitude/Longitude	
				Start	End
Item	Erosion / Foot Traffic			37.986713°	37.986713°
				-121.262346°	-121.262346°
DWR ID	DWR_NA0017_16_s_2022_289				
Comment Code					
E3 : Repair the levee slope damaged by foot traffic and prevent access where possible.					
Inspector Comment

View of foot path along the landside slope. Spring 2022

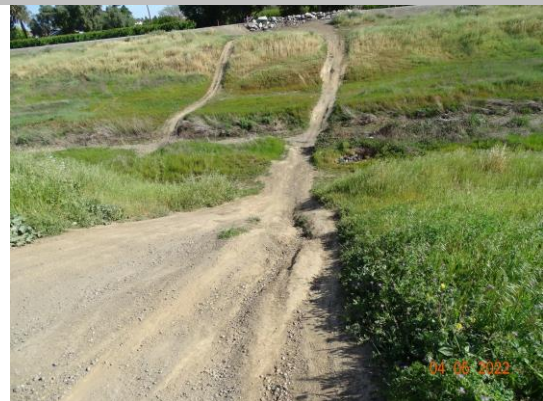
Photo 1 of 1 : FA_2023_NA0017_160_306_20230905_00086.jpg

LM Start	17.89	Rating **	M	Issue No.	306
LM End	17.89	Issue Type +	Ma	Location *	LS
Category	Earthen Levee			GPS Latitude/Longitude	
				Start	End
Item	Erosion / Vehicle Traffic			37.992320°	37.992320°
				-121.275567°	-121.275567°
DWR ID	DWR_NA0017_16_s_2022_306				
Comment Code					
E6 : Repair the levee slope damaged by vehicle traffic and prevent access where possible.					
Inspector Comment					
The erosion is caused by off-road motorcycle activity.

View of erosion within the waterside slope caused by motorcycle traffic.
Spring 2022

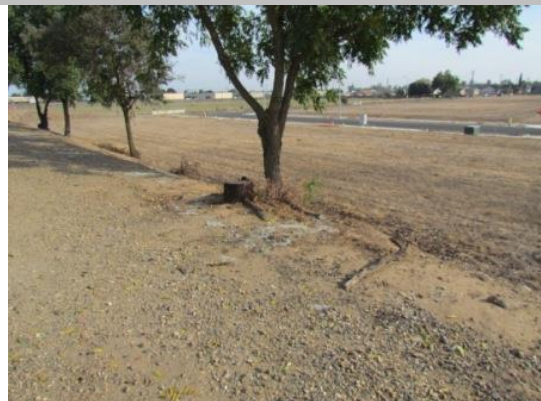
Photo 1 of 1 : FA_2023_NA0017_160_65_20230905_00052.jpg

LM Start	18.94	Rating **	N	Issue No.	65
LM End	18.94	Issue Type +	Ma	Location *	LS
Category	Earthen Levee			GPS Latitude/Longitude	
				Start	End
Item	Trim / Thin Trees			37.991937°	37.991937°
				-121.293932°	-121.293932°
DWR ID	DWR_NA0017_16_s_2012_65				
Comment Code					
T5 : Tree stumps.					
Inspector Comment

A tree stump was found on the landside of the levee looking upstream.

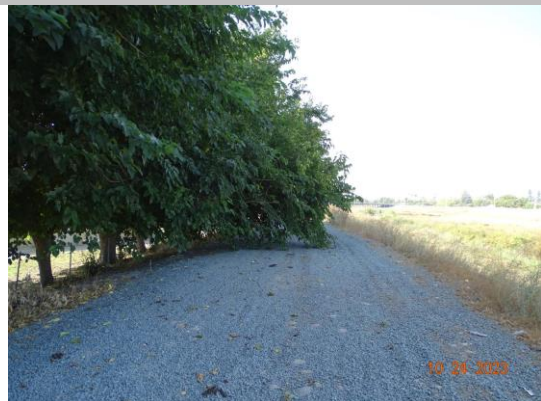
Photo 1 of 1 : FA_2023_NA0017_160_161_20231101_00278.jpg

LM Start	19.19	Rating **	U	Issue No.	161
LM End	19.19	Issue Type +	Ma	Location *	LS
Category	Earthen Levee			GPS Latitude/Longitude	
				Start	End
Item	Trim / Thin Trees			37.991138°	37.991138°
				-121.298360°	-121.298360°
DWR ID	DWR_NA0017_16_f_2023_161				
Comment Code					
T4 : Trim trees over roadway to at least 12 feet above ground level.					
Inspector Comment

View of untrimmed tree over crown. Fall 2023

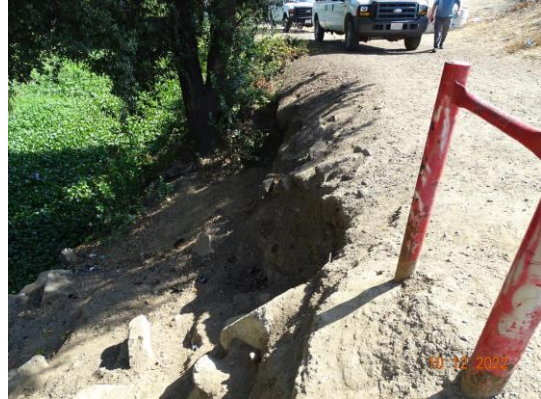
Photo 1 of 1 : FA_2023_NA0017_160_316_20230905_00087.jpg

LM Start	20.73	Rating **	U	Issue No.	316
LM End	20.73	Issue Type +	Ma	Location *	WS
Category	Earthen Levee			GPS Latitude/Longitude	
				Start	End
Item	Erosion / Bank Caving			37.979119°	37.979119°
				-121.319013°	-121.319013°
DWR ID	DWR_NA0017_16_s_2022_316				
Comment Code					
E2 : Schedule repair of erosion site prior to the next inspection.					
Inspector Comment

View of erosion/digging within the waterside slope caused by campers.
Fall 2022

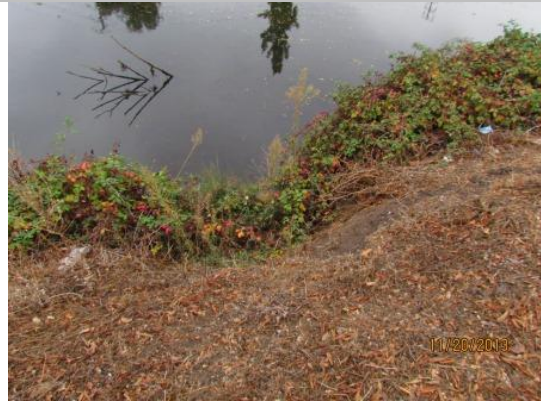
Photo 1 of 1 : FA_2023_NA0017_160_62_20230905_00051.jpg

LM Start	21.94	Rating **	A/W	Issue No.	62
LM End	21.94	Issue Type +	Ma	Location *	WS
Category	Earthen Levee			GPS Latitude/Longitude	
				Start	End
Item	Erosion / Bank Caving			37.979251°	37.979251°
				-121.340012°	-121.340012°
DWR ID	DWR_NA0017_16_f_2020_62				
Comment Code					
E1 : Note and monitor erosion site.					
Inspector Comment

Erosion was found on the waterside slope of the levee looking upstream.

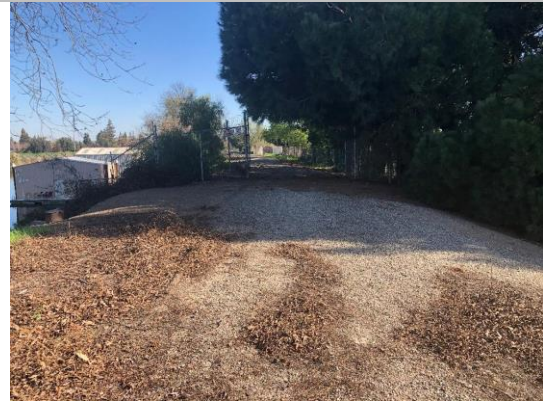
Photo 1 of 3 : UCIP_FA_2023_81580_93598.jpg

Comment Code					
Inspector Comment					
DS_ID:23407 FS_ID:81580 EP_NO: N/A Repair Type: Non-Urgent EVAL Issue: Crossing Status: Not Found UCIP Comments: 03/01/2021 Record was updated from No Action Needed to Non-Urgent. No permit was found authorizing this encroachment. CVFPB will need to review crossing to determine owner. Utility not found/ observed in the field. Geophysical survey not suggestive of a pipe. The UCIP inspection was completed with LMA representative, H. Latu. (N. Cholewinski - GEI) FIELD_STRUCT_DESC: 18-inch steel storm drainage pipe through the levee, 5.1 feet below the crown. Siphon breaker on the waterside (WS) slope. Pump house on the landside (LS). [Additional Reference(s): DWR Levee Log, 1992, (HLM 22.88). USACE San Joaquin O&M Manual 611.1, Volume F, (HLM 22.88), 18-inch pipe listed]. FS Date: 3/1/2021

Crown Overview

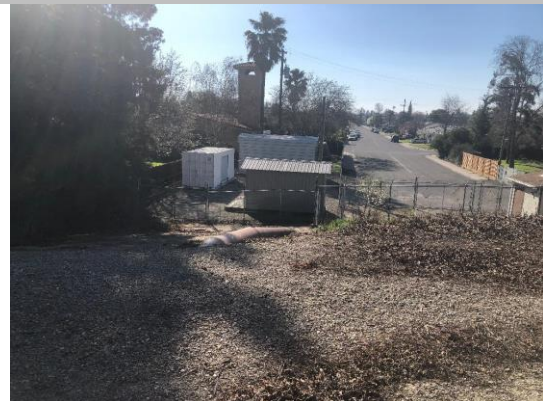
Photo 2 of 3 : UCIP_FA_2023_81580_93599.jpg

LS View

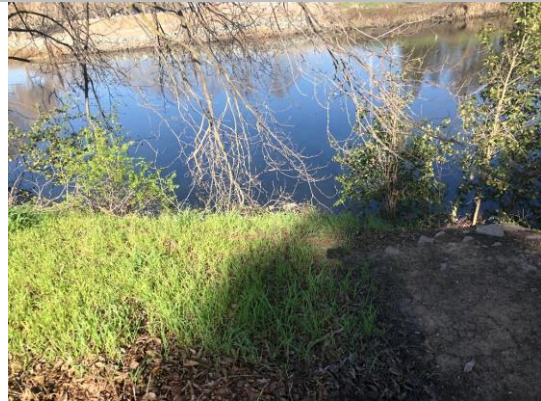
Photo 3 of 3 : UCIP_FA_2023_81580_93600.jpg

WS View

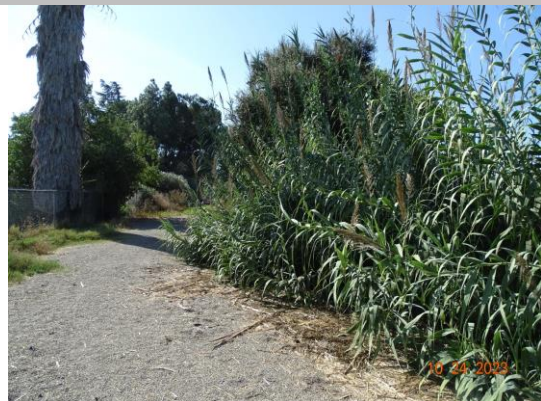
Photo 1 of 1 : FA_2023_NA0017_160_321_20231101_00279.jpg

LM Start	22.52	Rating **	U	Issue No.	321
LM End	22.56	Issue Type +	Ma	Location *	WS
Category	Earthen Levee			GPS Latitude/Longitude	
				Start	End
Item	Vegetation			37.973616°	37.973324°
				-121.347749°	-121.348326°
DWR ID	DWR_NA0017_16_s_2022_321				
Comment Code					
V2 : Remove the wild growth and woody vegetation other than native grasses from the levee slopes.					
Inspector Comment

View of Arundo within the waterside slope. Fall 2023

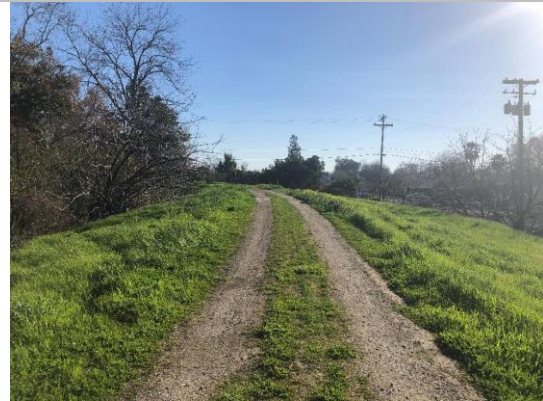
Photo 1 of 3 : UCIP_FA_2023_78197_93577.jpg

Comment Code						
Inspector Comment						
DS_ID:23409						
FS_ID:78197						
EP_NO: N/A						
Repair Type: Non-Urgent						
EVAL Issue:						
Crossing Status: Found						
UCIP Comments: 03/01/2021 Record was updated from No Action						
Needed to Non-Urgent. No permit was found authorizing this						
encroachment. CVFPB will need to review crossing to determine owner.						
No issues observed during inspection. The UCIP inspection was						
completed with LMA representative, H. Latu. (N. Cholewinski - GEI)						
FIELD_STRUCT_DESC: 1 of 2: 18-inch steel storm drainage pipe						
through the levee, 3.2 feet below the crown. Siphon breaker on the						
waterside (WS) slope. Pump house near the landside (LS) toe.						
(Reclamation District No. 1618 [RD1618]). [Additional Reference(s):						
DWR Levee Log, 1992, (HLM 23.36). USACE San Joaquin O&M						
Manual 611.1, Volume F, (HLM 23.36), 18-inch pipe listed].

Crown Overview

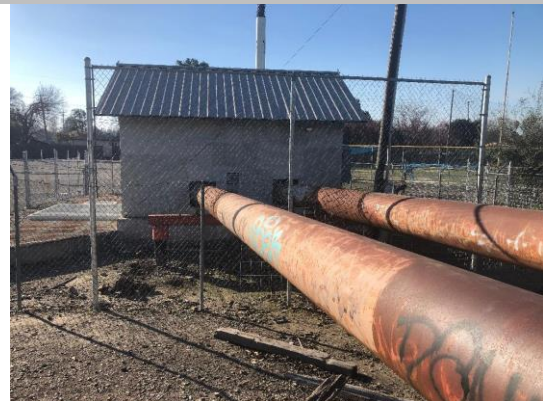
Photo 2 of 3 : UCIP_FA_2023_78197_93578.jpg

LS View: Pipe and pumphouse at LS toe.

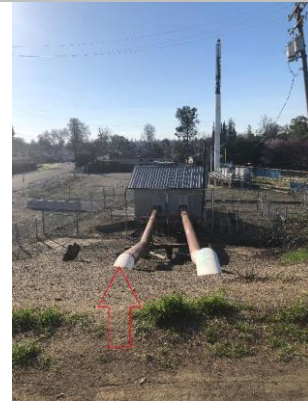
Photo 3 of 3 : UCIP_FA_2023_78197_93579.jpg

LS View: Pipe and pumphouse at LS slope and toe.

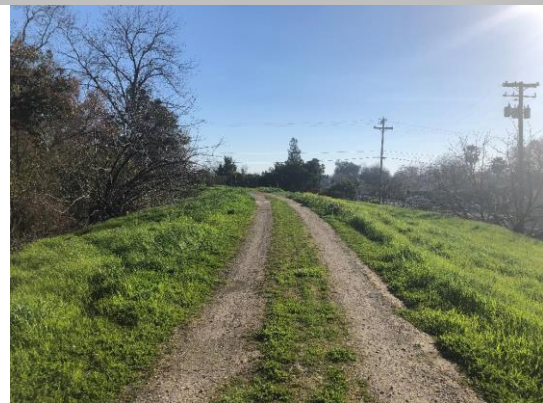
Photo 1 of 3 : UCIP_FA_2023_78198_93572.jpg

DS_ID:23503
 FS_ID:78198
 EP_NO: N/A
 Repair Type: Non-Urgent
 EVAL Issue:
 Crossing Status: Found
 UCIP Comments: 03/01/2021 Record was updated from No Action Needed to Non-Urgent. No permit was found authorizing this encroachment. CVFPB will need to review crossing to determine owner. No issues observed during inspection. The UCIP inspection was completed with LMA representative, H. Latu. (N. Cholewinski - GEI)
 FIELD_STRUCT_DESC: 2 of 2: 20-inch steel storm drainage pipe through the levee, 4.3 feet below the crown. Siphon breaker on the waterside (WS) slope. Pump house near the landside (LS) toe. (Reclamation District No. 1618 [RD1618]). [Additional Reference(s): DWR Levee Log, 1992, (HLM 23.36). USACE San Joaquin O&M Manual 611.1, Volume F, (HLM 23.36), 20-inch pipe listed].
 FS Date: 3/1/2021

Crown Overview

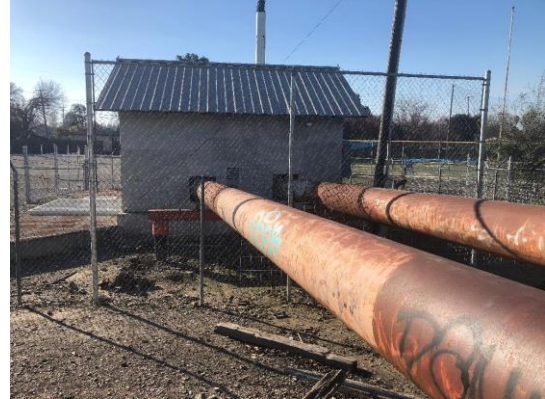
Photo 2 of 3 : UCIP_FA_2023_78198_93574.jpg

LS View: Pipe and pumphouse at LS toe.

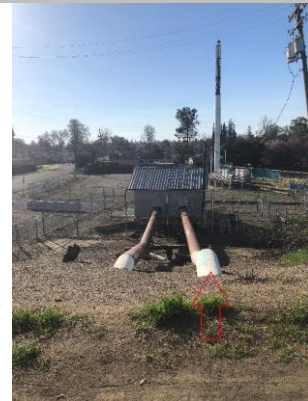
Photo 3 of 3 : UCIP_FA_2023_78198_93575.jpg

LS View: Pipe and pumphouse at LS slope and toe.

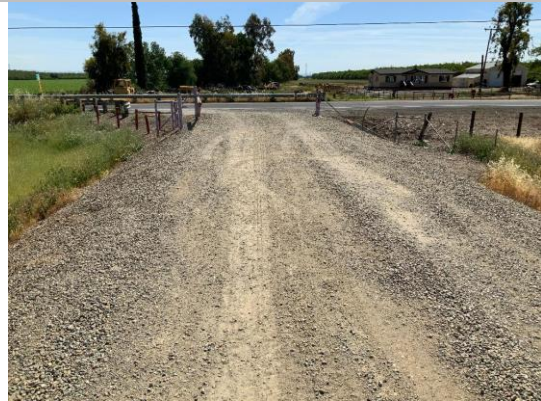
Photo 1 of 2 : UCIP_FA_2023_78217_98503.jpg

Comment Code						
Inspector Comment						
DS_ID:18542						
FS_ID:78217						
EP_NO: N/A						
Repair Type: Non-Urgent						
EVAL Issue:						
Crossing Status: Not Found						
UCIP Comments: 04/29/2021 The record has been upgraded from No						
Action Needed to Non-Urgent. Pipe not found by visual inspection.						
Geophysical results did not confirm presence of pipe through levee.						
Record will remain in UCIP's inspection records until future Levee						
Improvement Project can confirm no crossing was found through the						
levee. No permit was found authorizing this encroachment. CVFPB will						
need to review crossing to determine owner. The UCIP inspection was						
completed with LMA representative, J. Nelson. (H. Dunn – GEI)						
FIELD_STRUCT_DESC: 30-inch corrugated metal storm drainage pipe						
(CMP) through the levee, 6.0 feet below the crown. Concrete U-shaped						
headwalls on each end. Flap gate on the waterside (WS) end. Grouted

Levee crown looking upstream.

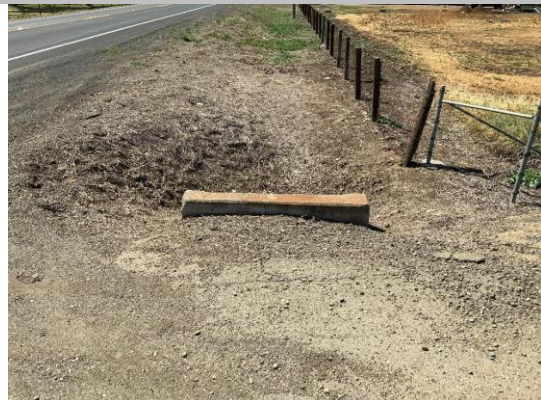
Photo 2 of 2 : UCIP_FA_2023_78217_98504.jpg

LS view: Toe from crown, pipe not visible.

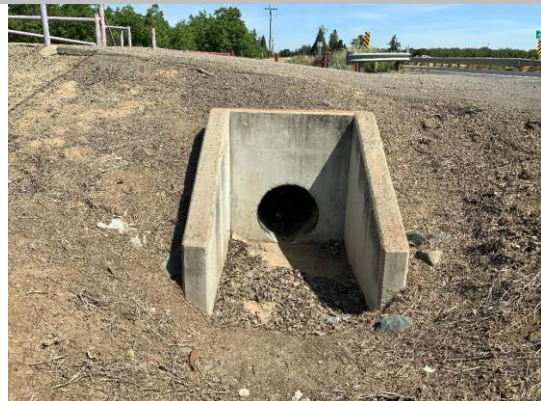
Photo 2 of 3 : UCIP_FA_2023_79205_98740.jpg

Comment Code						
Inspector Comment						
DS_ID:23952 FS_ID:79205 EP_NO: N/A Repair Type: Non-Urgent EVAL Issue: Crossing Status: Found UCIP Comments: 04/29/2021 The record has been upgraded from No Action Needed to Non-Urgent. No permit was found authorizing this encroachment. CVFPB will need to review crossing to determine owner. The UCIP inspection was completed with LMA representative, J. Nelson. (H. Dunn – GEI) 04/04/2014 Looks well maintained crossing. (P. Mahesh - DWR UCIP) FIELD_STRUCT_DESC: 30-inch corrugated metal storm drainage pipe (CMP) through the levee, 6.0 feet below the crown. Concrete U-shaped headwalls on each end. Flap gate on the waterside (WS) end. Grouted inlet and outlet. [Additional Reference(s): USACE San Joaquin O&M Manual 611.1, Volume F, (Station 173+30), 30-inch pipe listed]. FS Date: 4/29/2021

LS view: Slope and headwall at toe.

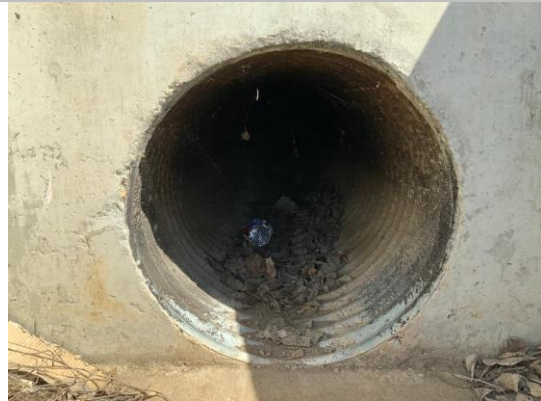
Photo 3 of 3 : UCIP_FA_2023_79205_98741.jpg

LS view: Close up of pipe inlet.

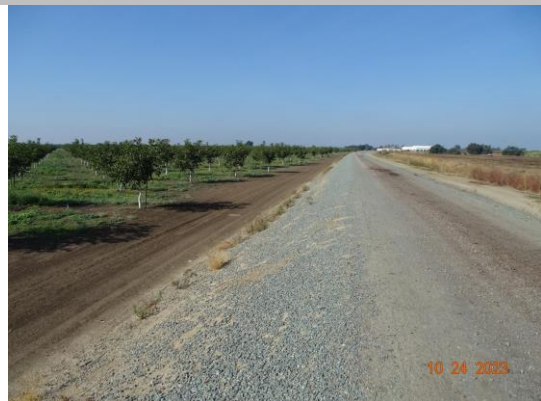
Photo 1 of 1 : FA_2023_NA0017_162_6_20231026_00016.jpg

LM Start	0.01	Rating **	A	Issue No.	6
LM End	0.90	Issue Type +	Ma	Location *	LS
Category	Earthen Levee			GPS Latitude/Longitude	
				Start	End
Item	Vegetation			37.957518°	37.960308°
				-121.148640°	-121.164109°
DWR ID	DWR_NA0017_18_f_2023_6				
Comment Code					
V1 : Control annual grass and weeds on the levee slopes and easements.					
Inspector Comment

Typical view of well maintained vegetation along the landside slope and easement. Fall 2023

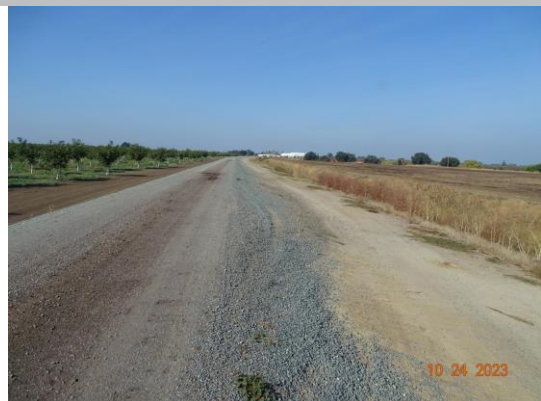
Photo 1 of 1 : FA_2023_NA0017_162_7_20231026_00017.jpg

LM Start	0.01	Rating **	A	Issue No.	7
LM End	0.90	Issue Type +	Ma	Location *	WS
Category	Earthen Levee			GPS Latitude/Longitude	
				Start	End
Item	Vegetation			37.957519°	37.960308°
				-121.148643°	-121.164106°
DWR ID	DWR_NA0017_18_f_2023_7				
Comment Code					
V1 : Control annual grass and weeds on the levee slopes and easements.					
Inspector Comment

Typical view of well maintained vegetation along the waterside slope. Fall 2023

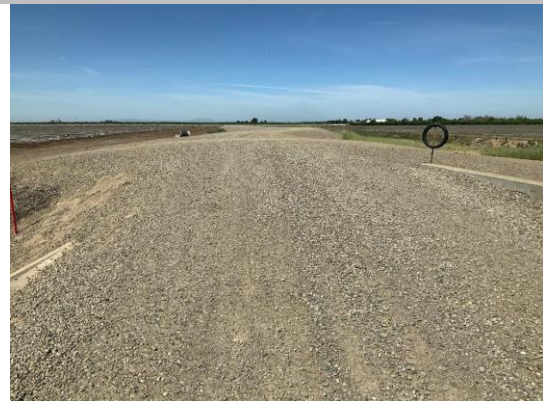
Photo 1 of 3 : UCIP_FA_2023_78219_98748.jpg

Comment Code					
Inspector Comment					
DS_ID:18541 FS_ID:78219 EP_NO: N/A Repair Type: Urgent EVAL Issue: 3a, Flood Risk Crossing Status: Found UCIP Comments: 04/29/2021 The record has been upgraded from No Action Needed to Urgent. There is a new plastic irrigation pipe going through this metal pipe that prevents the flapgate from closing. Pipe needs to be removed before flood season so flapgate can close. No permit was found authorizing this encroachment. CVFPB will need to review crossing to determine owner. The UCIP inspection was completed with LMA representative, J. Nelson. (H. Dunn – GEI) 04/04/2014 Long flood wall along the levee. (P. Mahesh - DWR UCIP) FIELD_STRUCT_DESC: 30-inch corrugated metal storm drainage pipe (CMP) through the levee, 6.0 feet below the crown. Concrete U-shaped headwalls on each end. Flap gate on the waterside (WS) end. Grouted inlet and outlet. [Additional Reference(s): DWR Levee Log, 1992, (HLM 0.28), 36-inch pipe listed. USACE San Joaquin O&M Manual 611.1, Volume F, (HLM 0.28), 30-inch pipe listed]. FS Date: 4/29/2021

Levee crown looking downstream.

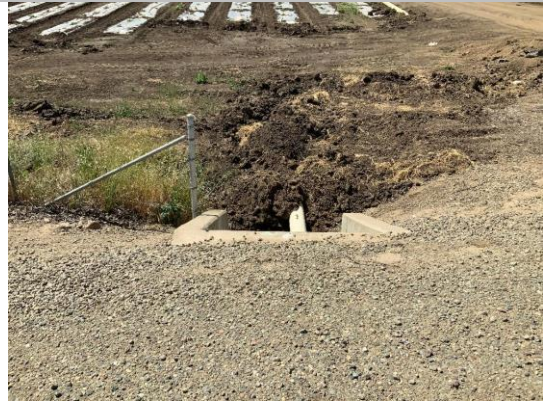
Photo 2 of 3 : UCIP_FA_2023_78219_98750.jpg

LS view: Headwall visible at toe from crown.

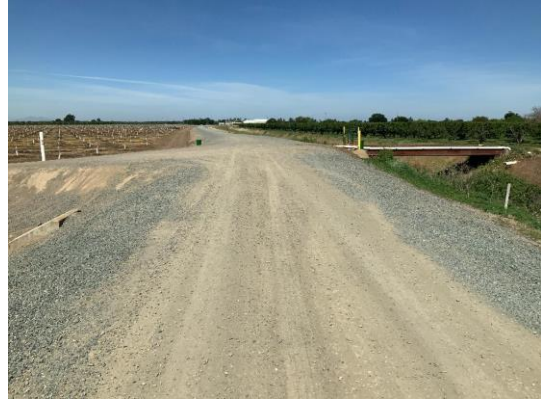
Photo 1 of 3 : UCIP_FA_2023_78222_98760.jpg

Comment Code						
Inspector Comment						
DS_ID:23954 FS_ID:78222 EP_NO: N/A Repair Type: Non-Urgent EVAL Issue: Crossing Status: Not Found UCIP Comments: 04/29/2021 The record has been upgraded from No Action Needed to Non-Urgent. Pipe not found by visual inspection. Geophysical results did not confirm presence of pipe through levee. Record will remain in UCIP's inspection records until future Levee Improvement Project can confirm no crossing was found through the levee. No permit was found authorizing this encroachment. CVFPB will need to review crossing to determine owner. The UCIP inspection was completed with LMA representative, J. Nelson. (H. Dunn ? GEI) FIELD_STRUCT_DESC: 30-inch corrugated metal storm drainage pipe (CMP) through the levee, 6.0 feet below the crown. Concrete U-shaped headwalls on each end. Flap gate on the waterside (WS) end. Grouted inlet and outlet. [Additional Reference(s): USACE San Joaquin O&M Manual 611.1, Volume F, (Station 145+26), 30-inch pipe listed]. FS Date: 4/29/2021

Levee crown looking downstream.

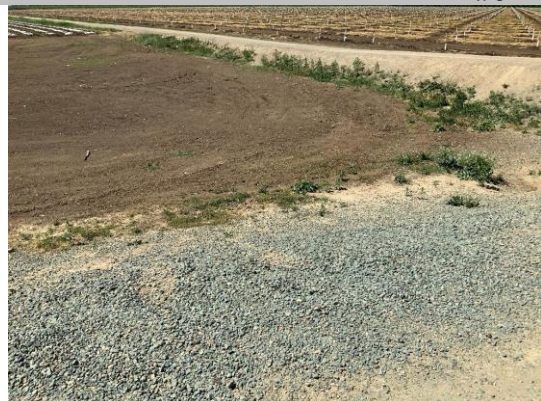
Photo 2 of 3 : UCIP_FA_2023_78222_98761.jpg

LS view: Toe from crown, no pipe visible.

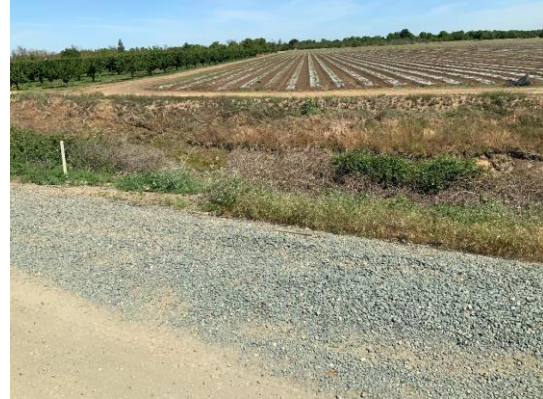
Photo 3 of 3 : UCIP_FA_2023_78222_98762.jpg

WS view: Toe from crown, no pipe visible.

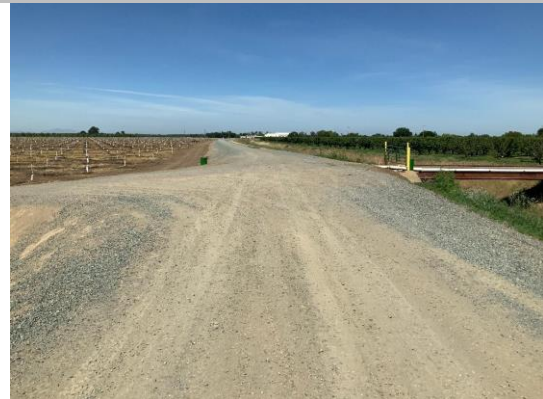
Photo 1 of 3 : UCIP_FA_2023_78223_98763.jpg

DS_ID:18539
 FS_ID:78223
 EP_NO: N/A
 Repair Type: Urgent
 EVAL Issue: 1, Pipe Integrity
 Crossing Status: Found
 UCIP Comments: 04/29/2021 Record has been upgraded from No Action Needed to Urgent. DWR DMP internal video inspection has found pipe integrity issues. LOF of crossing is between 5 and 6. Crossing will be monitored until funding becomes available to address the issues. No permit was found authorizing this encroachment. CVFPB will need to review crossing to determine owner. The UCIP inspection was completed with LMA representative, J. Nelson. (H. Dunn – GEI)04/04/2014 May need cleaning the pipe. (P. Mahesh - DWR UCIP)
 FIELD_STRUCT_DESC: 30-inch corrugated metal storm drainage pipe (CMP) through the levee, 6.0 feet below the crown. Concrete U-shaped headwalls on each end. Flap gate on the waterside (WS) end. Grouted inlet and outlet. [Additional Reference(s): DWR Levee Log, 1992, (HLM 0.54), 36-inch pipe listed. USACE San Joaquin O&M Manual 611.1, Volume F, (HLM 0.54), 30-inch pipe listed].

Levee crown looking downstream.

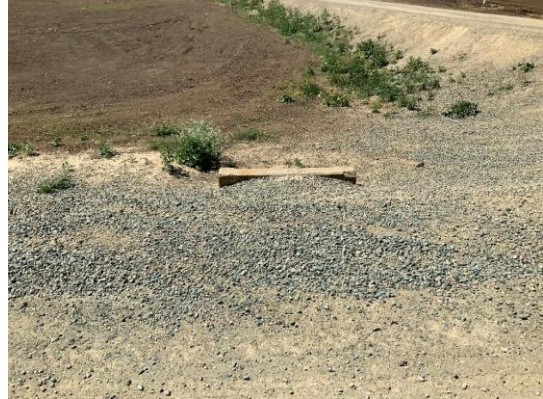
Photo 2 of 3 : UCIP_FA_2023_78223_98764.jpg

LS view: Headwall visible at toe from crown.

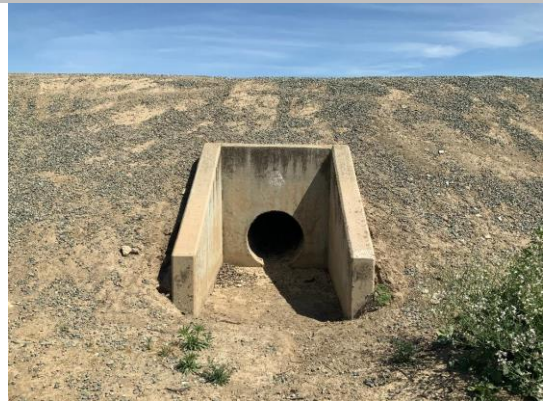
Photo 3 of 3 : UCIP_FA_2023_78223_98765.jpg

LS view: Slope and headwall at toe.
