**Flood Control Project Maintenance
Levee Inspections****Maintenance Issue Types Only, Levee Inspection Report By Mile - Fall 2024****San Joaquin County Flood Control and Water Conservation District**

Waterway	Bank	Unit Miles	Inspection Start/End	Inspector
Unit No. 01 Littlejohn Creek	Left	2.59	10/21/2024 10/21/2024	Alberto De Leon

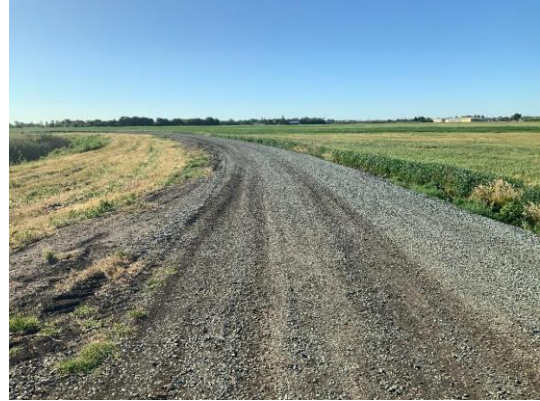
Photo 1 of 3 : UCIP_FA_2024_80420_96772.jpg

Comment Code					
Inspector Comment					
DS_ID:17965 FS_ID:80420 EP_NO: N/A Repair Type: Non-Urgent EVAL Issue: 5, Pipe Damage Crossing Status: Found UCIP Comments: 06/21/2023 Pipe diameter was DMP field confirmed to be 15 inches. (O.Yakimov - DWR UCIP) 03/31/2023 Record updated from Urgent to Non-Urgent. LoF is equal to 5 due to pipe deformation, integrity issues are not found. Crossing will be monitored until funding becomes available for rehabilitation. (O.Yakimov - DWR UCIP) 04/27/2021 Record has been upgraded from Non-Urgent to Urgent. DWR DMP internal video inspection has found pipe integrity issues. LOF of crossing is between 5 and 6. Crossing will be monitored until funding becomes available to address the issues. LS pipe edges are still slightly warped, but have been reshaped greatly since last report. Levee prism in this section appears to be less than 3 feet. No permit was found authorizing this encroachment. CVFPB will need to review crossing to determine owner. The UCIP inspection was completed with LMA representative, J. Nelson. (H. Dunn ? GEI)03/25/2014 May need cleaning of the pipe. Reshaping the pipe end on landside. (P. Tariq - DWR UCIP) FIELD_STRUCT_DESC: 15-inch corrugated metal drainage pipe (CMP) through the levee, 6.0 feet below the crown. Flap gate on the waterside (WS) end. Inlet open on the landside (LS). [Additional Reference(s): DWR Levee Log, 1977, (HLM 0.43), 24-inch pipe listed. USACE San Joaquin O&M Manual, Unit No. 613, Part C, May 1963, Revised 15 April 2010, (Station 131+25 "S"), 24-inch pipe listed. USACE As-Built File No. CA-2-6-147, Sheet No. 147/2, 25 March 1954, (Station 131+25 "S"), 24-inch pipe listed]. FS Date: 4/27/2021

Levee crown looking downstream.

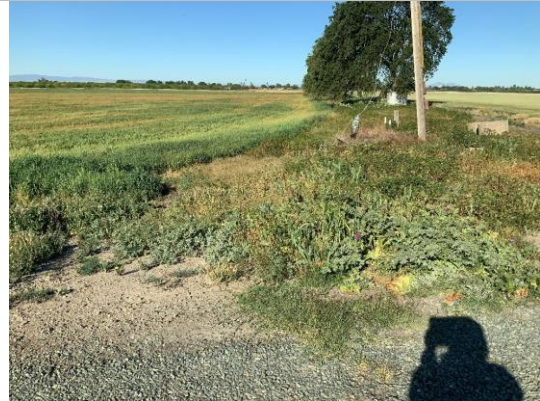
Photo 2 of 3 : UCIP_FA_2024_80420_96767.jpg

LS view: Slope from crown.

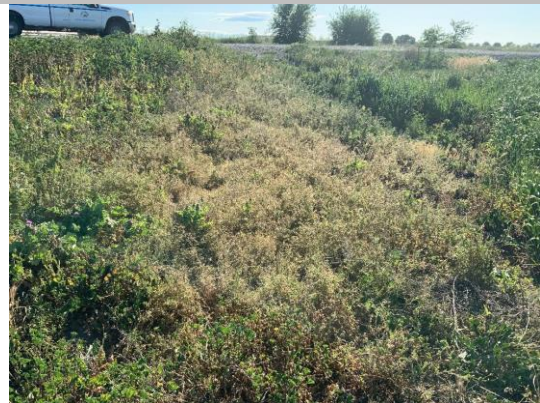
Photo 3 of 3 : UCIP_FA_2024_80420_96770.jpg

LS view: Slope from toe.

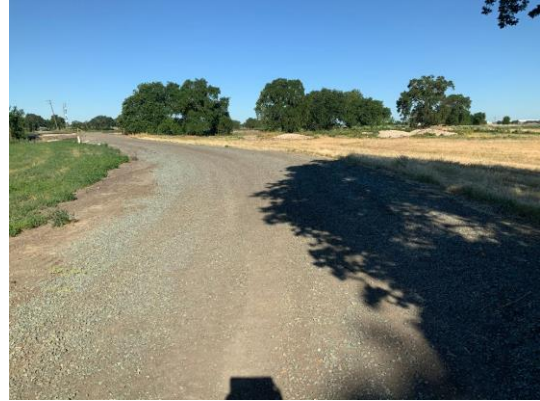
Photo 1 of 3 : UCIP_FA_2024_78235_96798.jpg

DS_ID:17973
FS_ID:78235
EP_NO: N/A
Repair Type: Urgent
EVAL Issue: 3a, Flood Risk
Crossing Status: Found
UCIP Comments: 04/27/2021 Pipe status is still Urgent. Slide gate no longer on WS, pipe is open on both ends. LS pipe edges are bent and warped. DWR DMP internal video inspection has found pipe integrity issues. LOF of crossing is between 4.1 and 5. Crossing will be monitored until funding becomes available for rehabilitation. Levee prism in this section appears to be less than 3 feet. No permit was found authorizing this encroachment. CVFPB will need to review crossing to determine owner. The UCIP inspection was completed with LMA representative, J. Nelson. (H. Dunn ? GEI)11/02/2018 Inlet deformed. Outlet missing a slide gate. The LMA states that a new slide gate will be installed in about two weeks. Inlet and outlet have dirt and vegetation issues. Crossing remains "Urgent" until a new slide gate is installed. Contact the LMA to see if they have photographic evidence that a new slide gate was put in. (A. McDonald - DWR UCIP)10/18/2018 Inlet deformed. Outlet missing a slide gate. This means that the pipe cannot be closed during high water. I have escalated this crossing from "No Action Needed" to "Urgent" due to the straight through pipe which could cause flooding during high water. There is a hole in the inlet, due to the deformity. It was most likely ran over by heavy equipment. I do not see enough evidence for an internal pipe inspection. (A. McDonald - DWR UCIP)3/25/2014 May need cleaning of mud in inlet pipe. (W. Wylie - DWR UCIP)

FIELD_STRUCT_DESC: 24-inch corrugated metal drainage culvert (CMP) through the levee, 4.2 feet below the crown. Slide gate on the waterside (WS) end. [Additional Reference(s): DWR Levee Log, 1977, (HLM 1.00). USACE San Joaquin O&M Manual, Unit No. 613, Part C, May 1963, Revised 15 April 2010, (Station 98+65), 24-inch pipe listed. USACE As-Built File No. CA-2-6-147, Sheet No. 147/22, 25 March 1954, (Station 98+65)].
FS Date: 4/27/2021

Levee crown looking downstream.

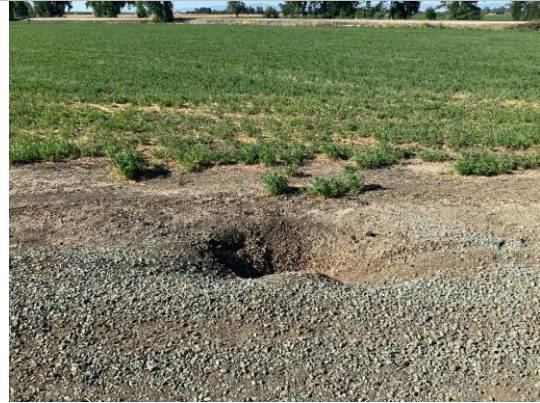
Photo 2 of 3 : UCIP_FA_2024_78235_96792.jpg

LS view: Slope from crown, inlet visible at toe.

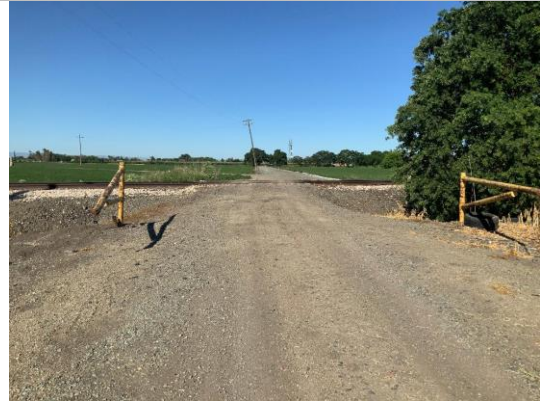
Photo 1 of 3 : UCIP_FA_2024_84806_96806.jpg

Comment Code						
Inspector Comment						
DS_ID:17972 FS_ID:84806 EP_NO: N/A Repair Type: Urgent EVAL Issue: 1, Pipe Integrity Crossing Status: Found UCIP Comments: 09/23/2024 Record updated from Non-Urgent to Urgent. DMP internal video inspection has found severe pipe defects. Crossing will be monitored until funding becomes available to address the issues. (O. Yakimov - DWR UCIP) 04/27/2021 The record has been upgraded from No Action Needed to Non-Urgent. Some vegetation in front of WS flapgate, recommend removal. DWR DMP internal video inspection has not found pipe integrity issues. LOF of crossing is less or equal to 4.0. Recommend next video inspection in 5 years. Levee prism in this section appears to be less than 3 feet. No permit was found authorizing this encroachment. CVFPB will need to review crossing to determine owner. The UCIP inspection was completed with LMA representative, J. Nelson. (H. Dunn ? GEI)11/02/2018 Inlet and outlet cleared of dirt by the LMA. Crossing has been downgraded to "No Action Needed." (A. McDonald - DWR UCIP)03/25/2014 LS vegetation debris and mud on the inlet ditch and inside the pipe. (P. Amatya - DWR UCIP) FIELD_STRUCT_DESC: 1 of 2: 36-inch corrugated metal drainage pipe (CMP) through the levee, 6.6 feet below the crown. Flap gate on the waterside (WS) end. [Additional Reference(s): DWR Levee Log, 1977, (HLM 1.05). USACE San Joaquin O&M Manual, Unit No. 613, Part C, May 1963, Revised 15 April 2010, (Station 94+40), 36-inch pipe listed. USACE As-Built File No. CA-2-6-147, Sheet No. 147/22, 25 March 1954, (Station 94+40)]. FS Date: 4/27/2021

Levee crown looking downstream.

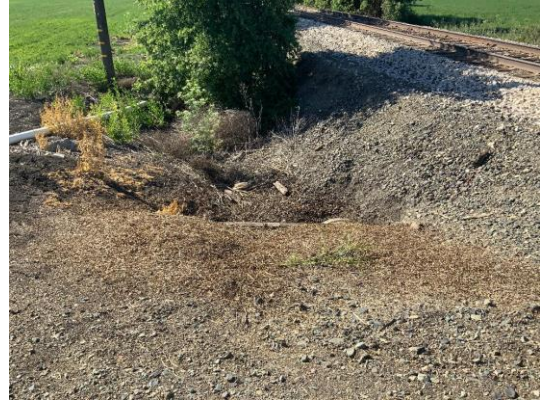
Photo 2 of 3 : UCIP_FA_2024_84806_96808.jpg

LS view: Headwall visible at toe from crown.

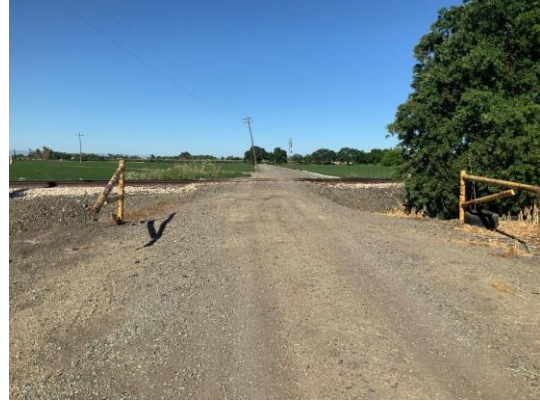
Photo 1 of 3 : UCIP_FA_2024_78237_96814.jpg

Comment Code					
Inspector Comment					
DS_ID:23995 FS_ID:78237 EP_NO: N/A Repair Type: Non-Urgent EVAL Issue: 5, Pipe Damage Crossing Status: Found UCIP Comments: 04/27/2021 The record has been upgraded from No Action Needed to Non-Urgent. DWR DMP internal video inspection has found pipe integrity issues. LOF of crossing is between 4.1 and 5. Crossing will be monitored until funding becomes available for rehabilitation. Vegetation covering WS flapgate, recommend removal. The levee prism in this section appears to be less than 3 feet. No permit was found authorizing this encroachment. CVFPB will need to review crossing to determine owner. The UCIP inspection was completed with LMA representative, J. Nelson. (H. Dunn ? GH/02/2018 Inlet and outlet covered in dirt. Inlet and outlet cleared of dirt by the LMA. (A. McDonald - DWR UCIP) 03/25/2014 Needs cleaning and clearing of the culvert. (P. Amatya - DWR UCIP) FIELD_STRUCT_DESC: 2 of 2: 36-inch corrugated metal drainage pipe (CMP) through the levee, 6.6 feet below the crown. Flap gate on the waterside (WS) end. [Additional Reference(s): DWR Levee Log, 1977, (HLM 1.05). USACE San Joaquin O&M Manual, Unit No. 613, Part C, May 1963, Revised 15 April 2010, (Station 94+40), 36-inch pipe listed. USACE As-Built File No. CA-2-6-147, Sheet No. 147/22, 25 March 1954, (Station 94+40)]. FS Date: 4/27/2021

Levee crown looking downstream.

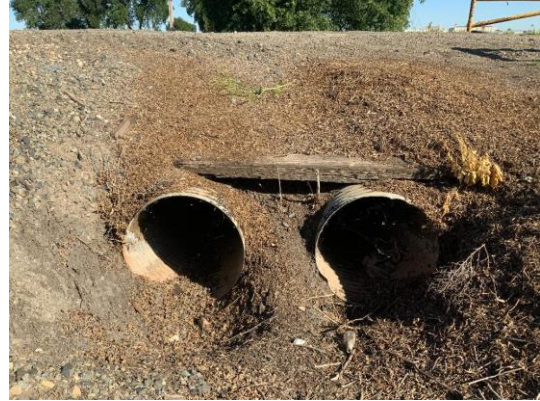
Photo 3 of 3 : UCIP_FA_2024_78237_96816.jpg

LS view: Inlets at toe.

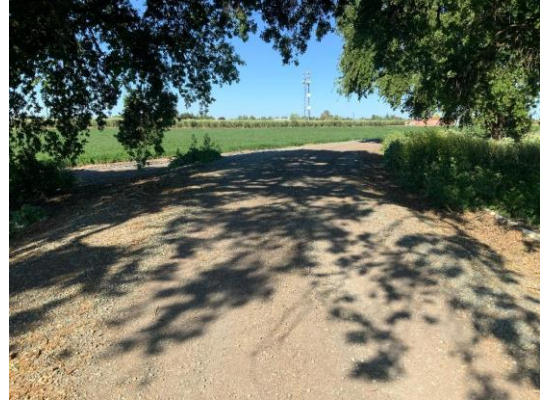
Photo 1 of 3 : UCIP_FA_2024_79413_96822.jpg

Comment Code						
Inspector Comment						
DS_ID:23985 FS_ID:79413 EP_NO: N/A Repair Type: Non-Urgent EVAL Issue: 5, Pipe Damage Crossing Status: Found UCIP Comments: 03/31/2023 Record updated from Urgent to Non-Urgent. LoF is equal to 5 due to pipe surface damage corrosion, integrity issues are not found. Crossing will be monitored until funding becomes available for rehabilitation. (O.Yakimov - DWR UCIP) 04/27/2021 Record updated from No Action Needed to Urgent. DMP internal video inspection has found pipe integrity issues. LOF of crossing is between 5 and 6. Crossing will be monitored until funding becomes available to address the issues. LS and WS pipe end and flapgate both partially covered by vegetation debris, recommend removal. The levee prism in this section appears to be less than 3 feet. No permit was found authorizing this encroachment. CVFPB will need to review crossing to determine owner. The UCIP inspection was completed with LMA representative, J. Nelson. (H. Dunn ? GEI) 11/02/2018 Inlet and outlet cleared of dirt and vegetation by the LMA. Crossing has been downgraded to "No Action Needed." (A. McDonald - DWR UCIP) 03/25/2014 Debris and mud on inlet ditch and inside pipe. Needs cleaning and clearing the culvert. (P. Amatya - DWR UCIP) FIELD_STRUCT_DESC: 30-inch corrugated metal drainage pipe (CMP) through the levee, 11.0 feet below the crown. Flap gate on the waterside (WS) end. [Additional Reference(s): USACE San Joaquin O&M Manual, Unit No. 613, Part C, May 1963, Revised 15 April 2010, (Station 83+00), 30-inch pipe listed. USACE As-Built File No. CA-2-6-147, Sheet No. 147/1, 25 March 1954, (Station 83+00)]. FS Date: 4/27/2021

Levee crown looking downstream.

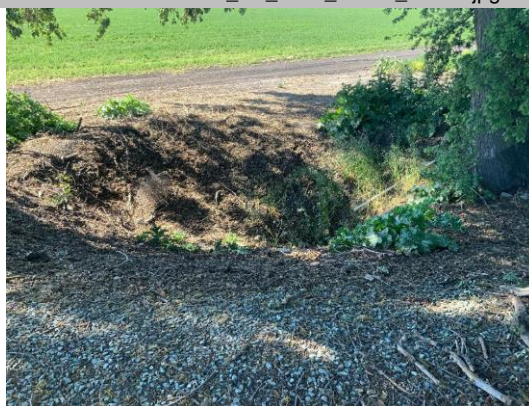
Photo 2 of 3 : UCIP_FA_2024_79413_96823.jpg

LS view: Toe from crown.

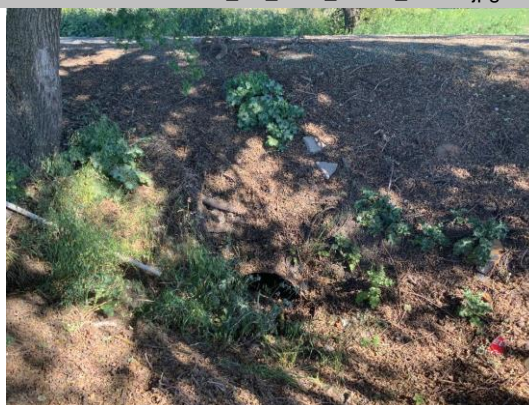
Photo 3 of 3 : UCIP_FA_2024_79413_96824.jpg

LS view: Pipe inlet at toe.

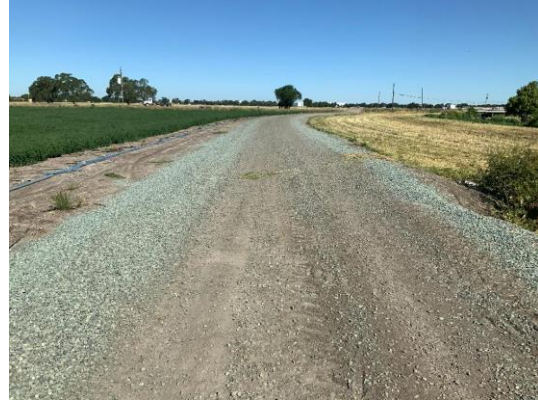
Photo 1 of 3 : UCIP_FA_2024_79414_96829.jpg

Comment Code						
Inspector Comment						
DS_ID:17970 FS_ID:79414 EP_NO: N/A Repair Type: Non-Urgent EVAL Issue: 5, Pipe Damage Crossing Status: Found UCIP Comments: 03/31/2023 Record updated from Urgent to Non-Urgent. LoF is equal to 5.1 due to pipe surface damage corrosion and deformed pipe end, integrity issues are not found. Crossing will be monitored until funding becomes available for rehabilitation. (O.Yakimov - DWR UCIP). 04/27/2021 The record has been upgraded from Non-Urgent to Urgent. DWR DMP internal video inspection has found pipe integrity issues. LOF of crossing is between 5 and 6. Crossing will be monitored until funding becomes available to address the issues. The levee prism in this section appears to be less than 3 feet. No permit was found authorizing this encroachment. CVFPB will need to review crossing to determine owner. The UCIP inspection was completed with LMA representative, J. Nelson. (H. Dunn ? GB) 02/2018 Inlet still deformed. Inlet and outlet cleared of dirt and vegetation by the LMA. Crossing continues to be rated "Non-Urgent." (A. McDonald - DWR UCIP) 03/25/2014 Needs cleaning and clearing the culvert. (P. Amatya - DWR UCIP) FIELD_STRUCT_DESC: 24-inch corrugated metal drainage pipe (CMP) through the levee, 4.1 feet below the crown. Flap gate on the waterside (WS) end. [Additional Reference(s): DWR Levee Log, 1977, (HLM 1.44). USACE San Joaquin O&M Manual, Unit No. 613, Part C, May 1963, Revised 15 April 2010, (Station 76+60), 24-inch pipe listed. USACE As-Built File No. CA-2-6-147, Sheet No. 147/1, 25 March 1954, (Station 76+60)]. FS Date: 4/27/2021

Levee crown looking downstream.

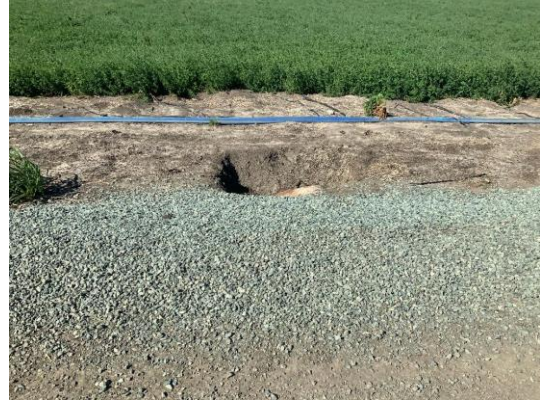
Photo 2 of 3 : UCIP_FA_2024_79414_96830.jpg

LS view: Toe from crown.

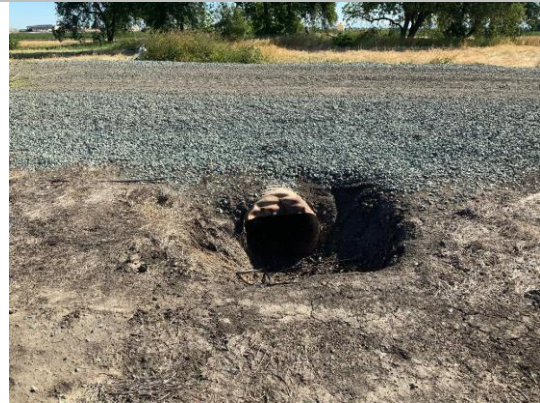
Photo 3 of 3 : UCIP_FA_2024_79414_96831.jpg

LS view: Pipe inlet at toe.

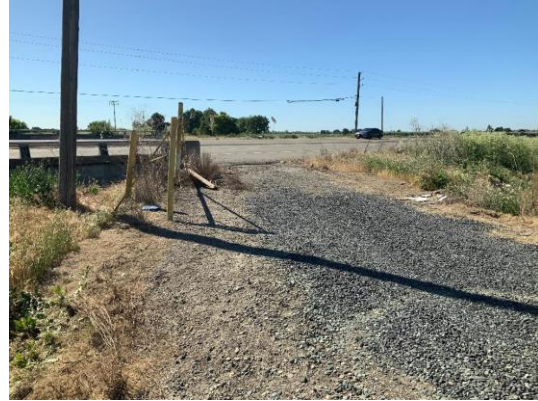
Photo 1 of 3 : UCIP_FA_2024_78240_96838.jpg

DS_ID:17969
FS_ID:78240
EP_NO: N/A
Repair Type: Non-Urgent
EVAL Issue: 10, Unauthorized Modification or Non-Compliant Permit
Crossing Status: Indicator Found
UCIP Comments: 04/27/2021 Pipe status is still Non-Urgent. This pipe appears abandoned, no standpipe on WS and no inlet structure on LS. Only pipe with appertence left on WS. Geophysical results did not confirm presence of pipe through levee. Record will remain in UCIP's inspection records until future Levee Improvement Project can confirm no crossing was found through the levee. The levee prism in this section appears to be less than 3 feet. This crossing was identified as a System Feature. The UCIP inspection was completed with LMA representative, J. Nelson. (H. Dunn ? GEI)03/25/2014 Appears abandoned and should be verified as having been done so properly. (P. Tariq - DWR UCIP) Concrete standpipe on waterside. Abandoned gate valve on waterside. Steel pipe disconnected with the standpipe inlet structure with steel gates and 18-inch alfalfa valve on landside.

Levee crown looking upstream.

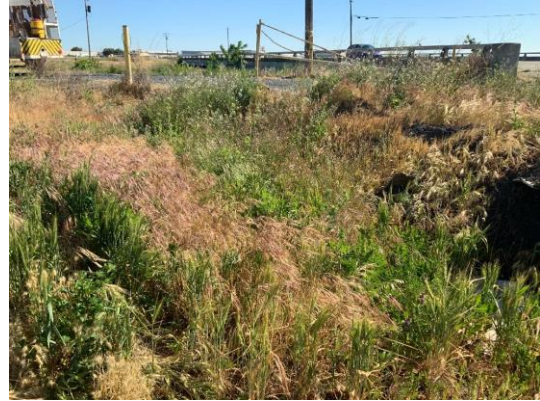
Photo 3 of 3 : UCIP_FA_2024_78240_96843.jpg

LS view: Slope from toe, no inlet structure seen.

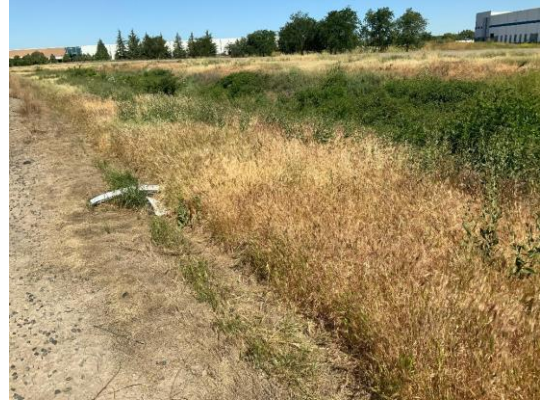
Photo 3 of 3 : UCIP_FA_2024_78241_96856.jpg

WS view: Slope from crown, no pipe visible.

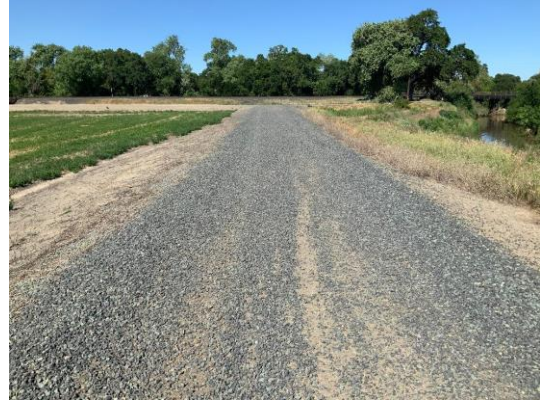
Photo 1 of 3 : UCIP_FA_2024_78852_96871.jpg

Comment Code					
Inspector Comment					
DS_ID:17966 FS_ID:78852 EP_NO: N/A Repair Type: Non-Urgent EVAL Issue: 11, Maintenance Compliance Issue Crossing Status: Found UCIP Comments: 04/27/2021 The record has been upgraded from No Action Needed to Non-Urgent. WS flapgate completely covered in vegetation and LS inlet has some sediment buildup inside, recommend cleaning on both ends. DWR DMP internal video inspection has not found pipe integrity issues. LOF of crossing is less or equal to 4.0. Recommend next video inspection in 5 years No permit was found authorizing this encroachment. CVFPB will need to review crossing to determine owner. The levee prism in this section appears to be less than 3 feet. The UCIP inspection was completed with LMA representative, J. Nelson. (H. Dunn ? GEI)11/02/2018 Inlet uncovered from the dirt by the LMA. Some vegetation at the flap gate. Crossing continues to be rated "No Action Needed." (A. McDonald - DWR UCIP)03/25/2014 Grouted riprap outlet box and concrete outfall pipe on waterside. Pipe not visible on landside. (P. Amatya - DWR UCIP) FIELD_STRUCT_DESC: 24-inch corrugated metal drainage pipe (CMP) through the levee, 5.0 feet below the crown. Flap gate on the waterside (WS) end. Grouted riprap outlet box and concrete outfall pipe on the WS. [Additional Reference(s): DWR Levee Log, 1977, (HLM 2.82). USACE San Joaquin O&M Manual, Unit No. 613, Part C, May 1963, Revised 15 April 2010, (Station 4+00), 24-inch pipe listed. USACE As-Built File No. CA-2-6-147, Sheet No. 147/1, 25 March 1954, (Station 4+00)]. FS Date: 4/27/2021

Levee crown looking downstream.

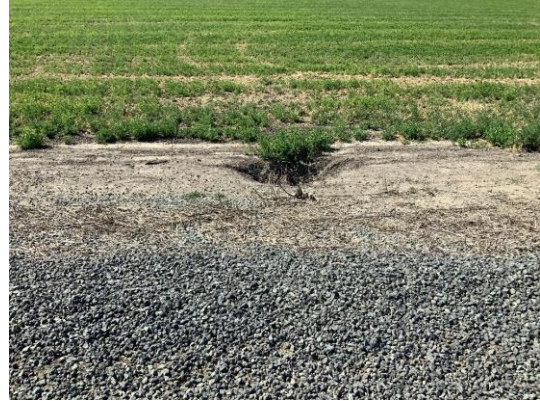
Photo 2 of 3 : UCIP_FA_2024_78852_96872.jpg

LS view: Slope from crown.

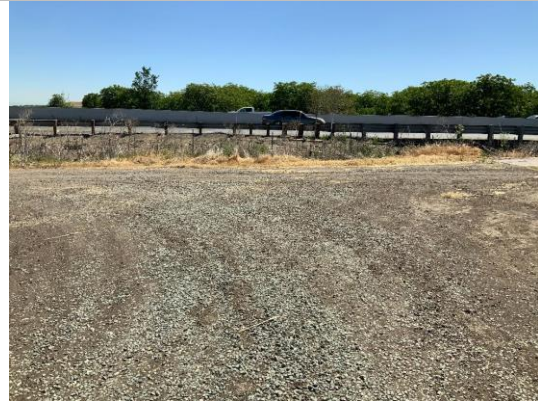
Photo 1 of 3 : UCIP_FA_2024_78244_96979.jpg

Comment Code					
Inspector Comment					
DS_ID:23987 FS_ID:78244 EP_NO: N/A Repair Type: Non-Urgent EVAL Issue: Crossing Status: Not Found UCIP Comments: 04/28/2021 Pipe status is still Non-Urgent. Pipe not found in the field. No permit was found authorizing this encroachment. CVFPB will need to review crossing to determine owner. The UCIP inspection was completed with LMA representative, J. Nelson. (H. Dunn ? GEI)04/02/2014 Not found: 24-inch CM pipe with flap gate on waterside of the levee. O&M Manual May 1963 (SJR 613C Vol 15). Probably, the pipe mentioned in desk study is one across the channel on other bank of the creek. Needs confirmation from DWR inspector or LMA. (P. Amatya - DWR) FIELD_STRUCT_DESC: 24-inch corrugated metal gravity drainage pipe (CMP) through the levee, invert elevation 25.0 feet. Flap gate on the waterside (WS) end. [Additional Reference(s): USACE San Joaquin O&M Manual, Unit No. 613, Part C, May 1963, Revised 15 April 2010, (Station 176+80 "N"), 24-inch pipe listed. USACE As-Built File No. CA-2-6-147, Sheet No. 147/2, 25 March 1954, (Station 176+80 "N")]. FS Date: 4/28/2021

Levee crown looking upstream.

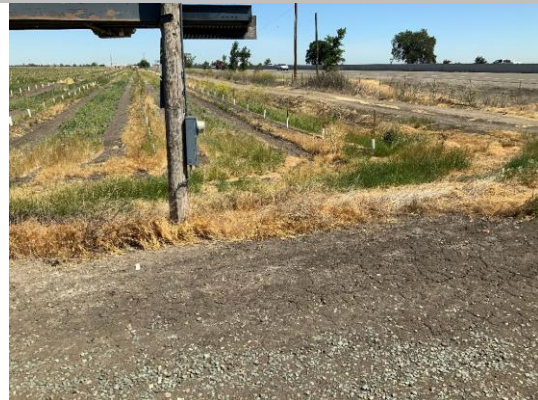
Photo 2 of 3 : UCIP_FA_2024_78244_96980.jpg

LS view: Slope from crown, no pipe visible.

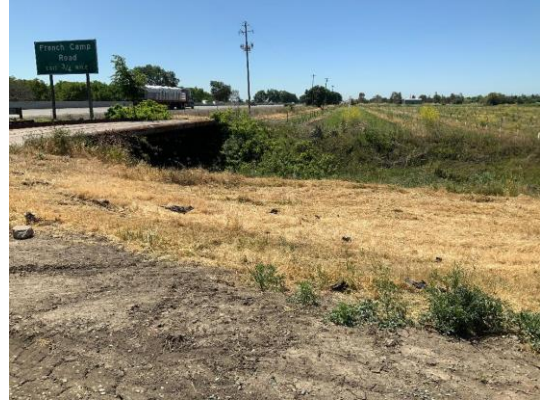
Photo 3 of 3 : UCIP_FA_2024_78244_96981.jpg

WS view: Slope from crown, no pipe visible.

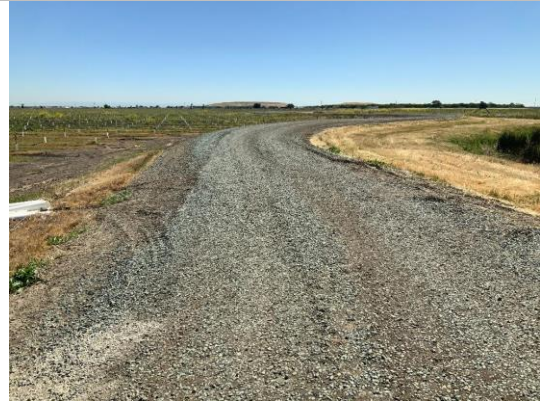
Photo 1 of 3 : UCIP_FA_2024_78245_96992.jpg

DS_ID:17986
FS_ID:78245
EP_NO: N/A
Repair Type: Urgent
EVAL Issue: 3a, Flood Risk
Crossing Status: Found
UCIP Comments: 04/28/2021 The record has been upgraded from No Action Needed to Urgent. No flapgate on the WS, pipe is open on both ends. There is an 8inch plastic pipe now going through this metal pipe that looks to go underground possibly under the channel on WS. Need more information from owner. No permit was found authorizing this encroachment. CVFPB will need to review crossing to determine owner. The UCIP inspection was completed with LMA representative, J. Nelson. (H. Dunn ? GEI)11/02/2018 Inlet cleared of dirt and vegetation by the LMA. Crossing continues to be rated "No Action Needed." (A. McDonald - DWR UCIP)4/02/2014 May need cleaning. (P. Amatya - DWR UCIP)
FIELD_STRUCT_DESC: 24-inch corrugated metal gravity drainage pipe (CMP) through the levee, 5.0 feet below the crown. Flap gate on the waterside (WS) end. [Additional Reference(s): DWR Levee Log, 1977, (HLM 0.50). USACE San Joaquin O&M Manual, Unit No. 613, Part C, May 1963, Revised 15 April 2010, (Station 148+18 "N"), 24-inch pipe listed. USACE As-Built File No. CA-2-6-147, Sheet No. 147/2, 25 March 1954, (Station 148+18 "N")].

Levee crown looking upstream.

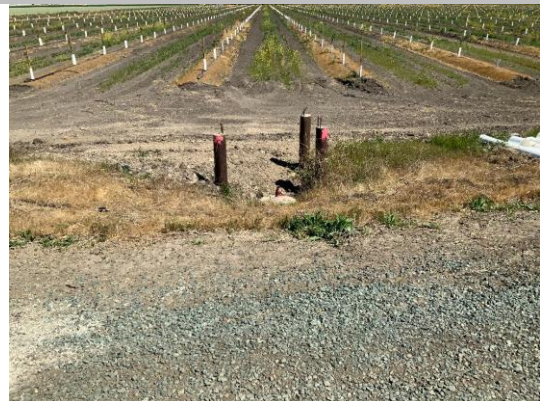
Photo 2 of 3 : UCIP_FA_2024_78245_96994.jpg

LS view: Pipe end visible at toe from crown.

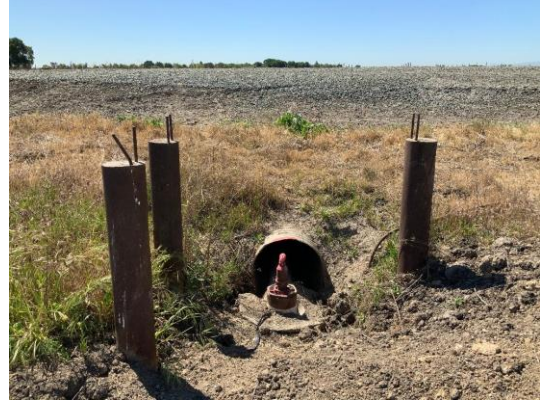
Photo 3 of 3 : UCIP_FA_2024_78245_96995.jpg

LS view: Pipe inlet at toe.

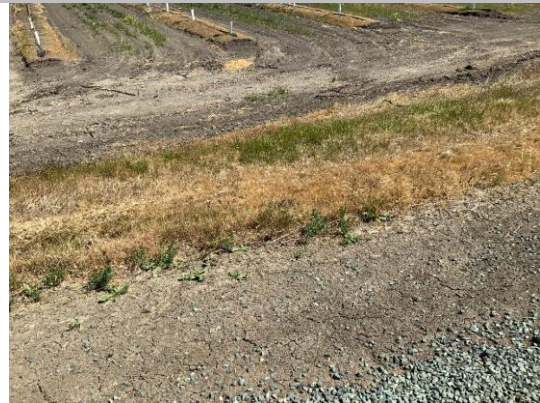
Photo 1 of 3 : UCIP_FA_2024_78246_96997.jpg

DS_ID:23986
 FS_ID:78246
 EP_NO: N/A
 Repair Type: Non-Urgent
 EVAL Issue:
 Crossing Status: Not Found
 UCIP Comments: 04/28/2021 The record has been upgraded from No Action Needed to Non-Urgent. Pipe not found by visual inspection. No permit was found authorizing this encroachment. CVFPB will need to review crossing to determine owner. The UCIP inspection was completed with LMA representative, J. Nelson. (H. Dunn ? GEI)
 FIELD_STRUCT_DESC: 10-inch steel drainage discharge pipe through the levee, 2.0 feet below the crown. Gate valve on the waterside (WS). Pump structure on the landside (LS). [Additional Reference(s): USACE San Joaquin O&M Manual, Unit No. 613, Part C, May 1963, Revised 15 April 2010, (Station 148+18 "N"), 10-inch pipe listed. USACE As-Built File No. CA-2-6-147, Sheet No. 147/2, 25 March 1954, (Station 148+18 "N")].
 FS Date: 4/28/2021

LS view: Slope and toe from crown, no pipe visible.

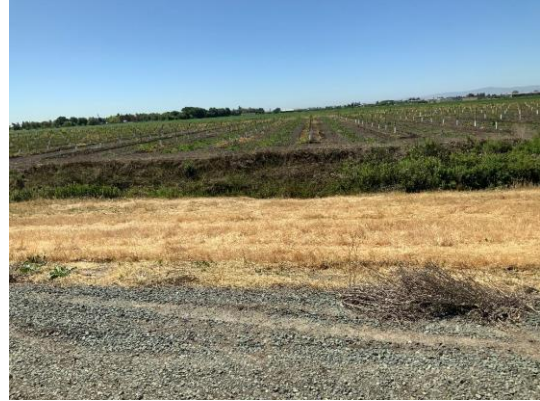
Photo 2 of 3 : UCIP_FA_2024_78246_96998.jpg

WS view: Slope from crown, no pipe visible.

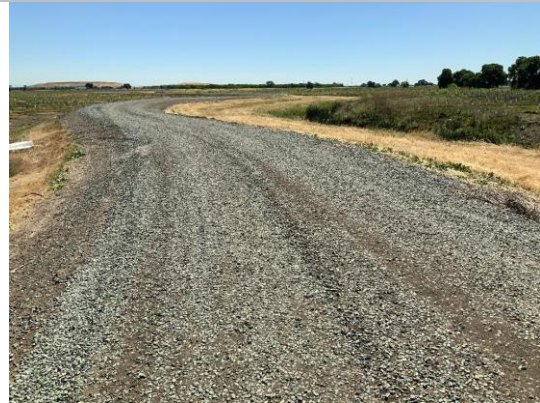
Photo 3 of 3 : UCIP_FA_2024_78246_96999.jpg

Levee crown looking upstream.

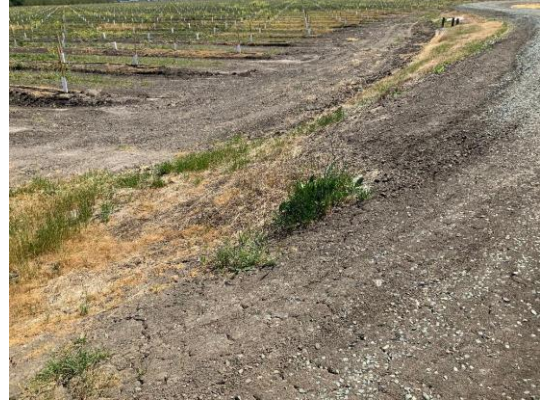
Photo 1 of 3 : UCIP_FA_2024_78247_97000.jpg

Comment Code					
Inspector Comment					
DS_ID:23982 FS_ID:78247 EP_NO: N/A Repair Type: Non-Urgent EVAL Issue: Crossing Status: Not Found UCIP Comments: 04/28/2021 The record has been upgraded from No Action Needed to Non-Urgent. Pipe not found by visual inspection. No permit was found authorizing this encroachment. CVFPB will need to review crossing to determine owner. The UCIP inspection was completed with LMA representative, J. Nelson. (H. Dunn ? GEI) FIELD_STRUCT_DESC: 24-inch corrugated metal gravity drainage pipe (CMP) through the levee, invert elevation 24.0 feet. Flap gate on the waterside (WS) end. [Additional Reference(s): USACE San Joaquin O&M Manual, Unit No. 613, Part C, May 1963, Revised 15 April 2010, (Station 146+40 "N"), 24-inch pipe listed. USACE As-Built File No. CA-2-6-147, Sheet No. 147/2, 25 March 1954, (Station 146+40 "N")]. FS Date: 4/28/2021

LS view: Slope from crown, no pipe visible.

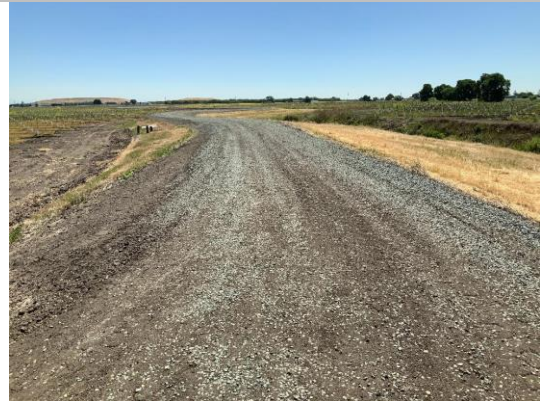
Photo 2 of 3 : UCIP_FA_2024_78247_97001.jpg

Levee crown looking upstream.

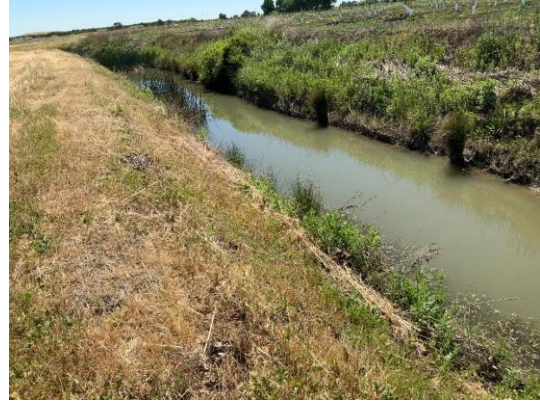
Photo 3 of 3 : UCIP_FA_2024_78247_97002.jpg

WS view: Slope from berm, no pipe visible.

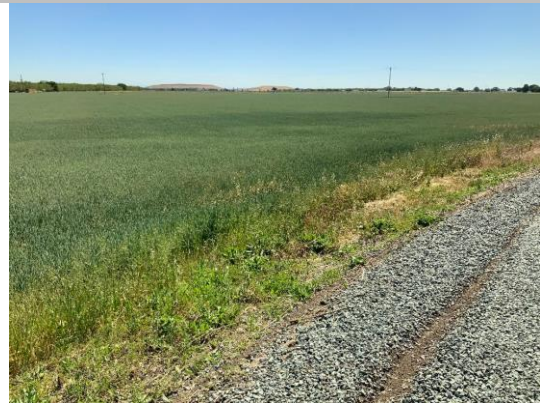
Photo 1 of 3 : UCIP_FA_2024_78248_97006.jpg

DS_ID:17984
 FS_ID:78248
 EP_NO: N/A
 Repair Type: Non-Urgent
 EVAL Issue:
 Crossing Status: Indicator Found
 UCIP Comments: 08/31/2022 Erosion at both ends of the pipe. (A. McDonald - DWR UCIP) 4/28/2021 The record has been upgraded from No Action Needed to Non-Urgent. Pipe not found by visual inspection. No permit was found authorizing this encroachment. CVFPB will need to review crossing to determine owner. The UCIP inspection was completed with LMA representative, J. Nelson. (H. Dunn ? GEI)
 FIELD_STRUCT_DESC: 24-inch corrugated metal gravity drainage pipe (CMP) through the levee, 8.0 feet below the crown. Flap gate on the waterside (WS) end. [Additional Reference(s): DWR Levee Log, 1977, (HLM 0.84). USACE San Joaquin O&M Manual, Unit No. 613, Part C, May 1963, Revised 15 April 2010, (Station 129+55 "N"), 24-inch pipe listed. USACE As-Built File No. CA-2-6-147, Sheet No. 147/2, 25 March 1954, (Station 129+55 "N")].

LS view: Slope from crown, no pipe visible.

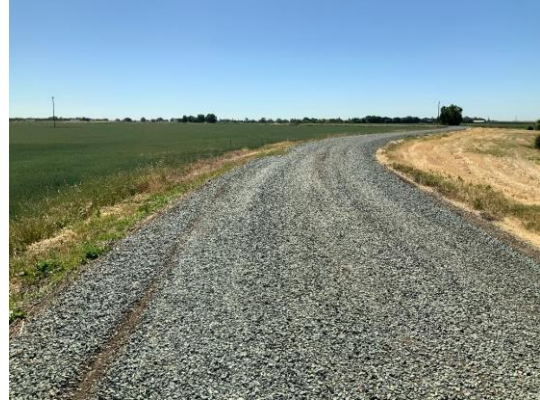
Photo 2 of 3 : UCIP_FA_2024_78248_97007.jpg

Levee crown looking upstream.

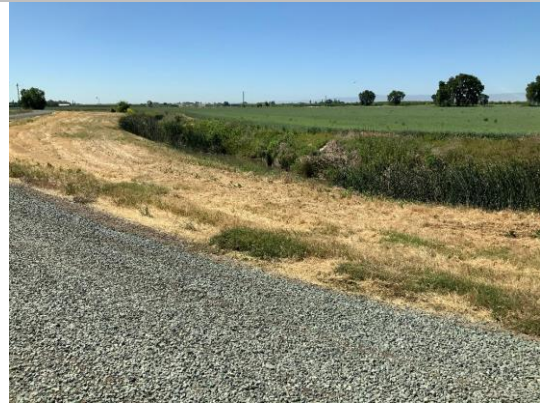
Photo 3 of 3 : UCIP_FA_2024_78248_97008.jpg

WS view: Slope from crown, no pipe visible.

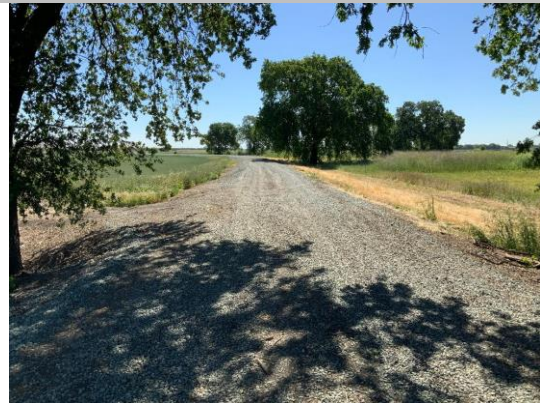
Photo 1 of 3 : UCIP_FA_2024_78249_97012.jpg

Comment Code					
Inspector Comment					
DS_ID:17983 FS_ID:78249 EP_NO: N/A Repair Type: Non-Urgent EVAL Issue: Crossing Status: Found UCIP Comments: 04/28/2021 The record has been upgraded from No Action Needed to Non-Urgent. No permit was found authorizing this encroachment. CVFPB will need to review crossing to determine owner. The UCIP inspection was completed with LMA representative, J. Nelson. (H. Dunn ? GEI)11/02/2018 Inlet and outlet cleared of dirt and vegetation by the LMA. Crossing has been downgraded to "No Action Needed." (A. McDonald - DWR UCIP)4/02/2014 Needs cleaning and clearing the culvert. (P. Amatya - DWR UCIP) FIELD_STRUCT_DESC: 24-inch corrugated metal gravity drainage pipe (CMP) through the levee, 6.4 feet below the crown. Flap gate on the waterside (WS) end. [Additional Reference(s): DWR Levee Log, 1977, (HLM 1.08). USACE San Joaquin O&M Manual, Unit No. 613, Part C, May 1963, Revised 15 April 2010, (Station 114+50), 24-inch pipe listed. USACE As-Built File No. CA-2-6-147, Sheet No. 147/2, 25 March 1954, (Station 114+50)]. FS Date: 4/28/2021

Levee crown looking upstream.

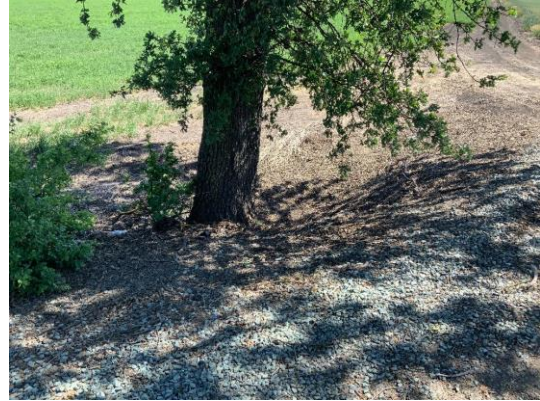
Photo 2 of 3 : UCIP_FA_2024_78249_97013.jpg

LS view: Slope and toe from crown.

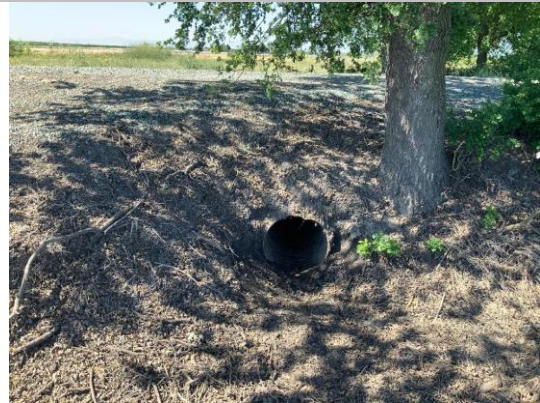
Photo 3 of 3 : UCIP_FA_2024_78249_97014.jpg

LS view: Slope and pipe inlet at toe.

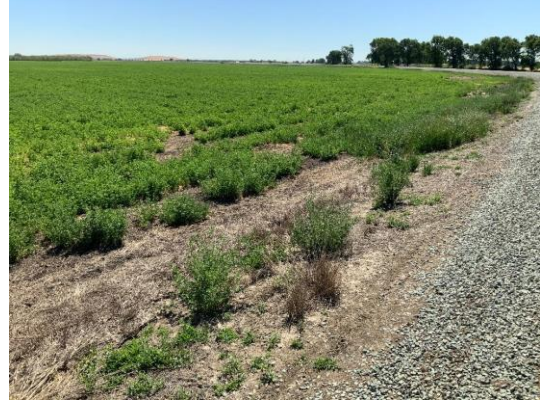
Photo 1 of 3 : UCIP_FA_2024_78250_97016.jpg

Comment Code						
Inspector Comment						
DS_ID:23983 FS_ID:78250 EP_NO: N/A Repair Type: Non-Urgent EVAL Issue: Crossing Status: Indicator Found UCIP Comments: 04/28/2021 Record has been upgraded from No Action Needed to Non-Urgent. Unit 2 ? Littlejohn Creek (CLM 1.20 to 1.70) is considered a patrol road/high ground area with no defined levee prism, any issue found between CLM 1.20-1.70 of Unit 2 will be considered a maintenance issue, or an unauthorized encroachment, or an abandoned encroachment. Current condition of pipe crossing does not impede access to patrol road/high ground area. Pipe not found by visual inspection. No permit was found authorizing this encroachment. CVFPB will need to review crossing to determine owner. The UCIP inspection was completed with LMA representative, J. Nelson. (H. Dunn ? GEI) FIELD_STRUCT_DESC: 24-inch corrugated metal gravity drainage pipe (CMP) through the levee, 5.0 feet below the crown. Flap gate on the waterside (WS) end. [Additional Reference(s): USACE San Joaquin O&M Manual, Unit No. 613, Part C, May 1963, Revised 15 April 2010, (Station 104+00), 24-inch pipe listed. USACE As-Built File No. CA-2-6-147, Sheet No. 147/22, 25 March 1954, (Station 104+00)]. FS Date: 4/28/2021

LS view: Slope from crown, no pipe visible.

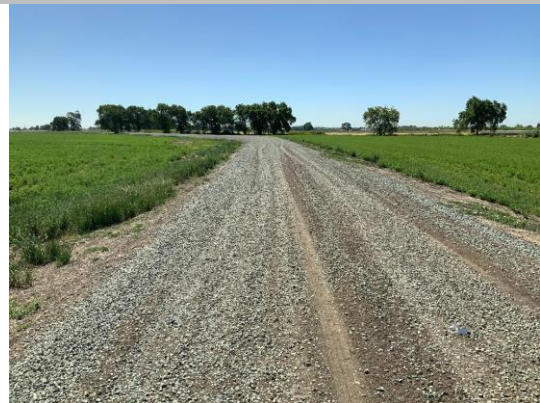
Photo 2 of 3 : UCIP_FA_2024_78250_97017.jpg

Levee crown looking upstream.

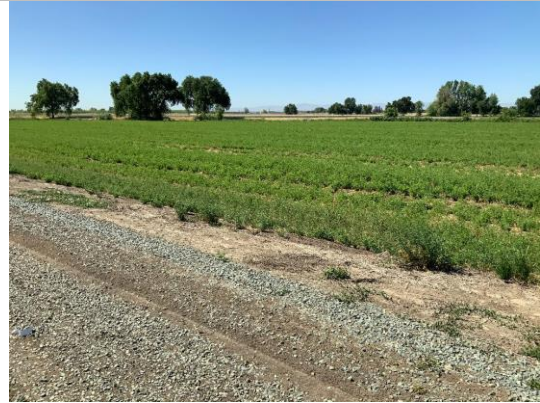
Photo 3 of 3 : UCIP_FA_2024_78250_97018.jpg

WS view: Slope from toe, no pipe visible.

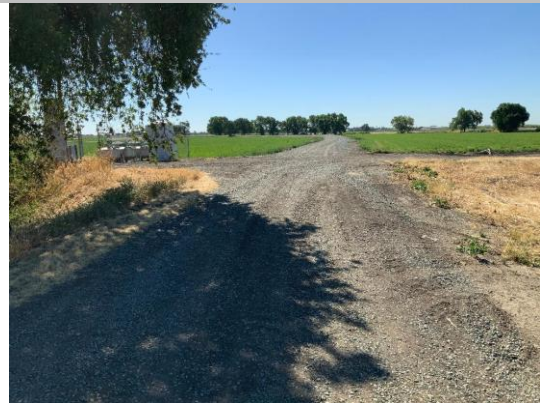
Photo 1 of 3 : UCIP_FA_2024_78253_97027.jpg

DS_ID:17982
FS_ID:78253
EP_NO: N/A
Repair Type: Non-Urgent
EVAL Issue:
Crossing Status: Indicator Found
UCIP Comments: 04/28/2021 Record has been upgraded from No Action Needed to Non-Urgent. Unit 2 ? Littlejohn Creek (CLM 1.20 to 1.70) is considered a patrol road/high ground area with no defined levee prism, any issue found between CLM 1.20-1.70 of Unit 2 will be considered a maintenance issue, or an unauthorized encroachment, or an abandoned encroachment. Current condition of pipe crossing does not impede access to patrol road/high ground area. No permit was found authorizing this encroachment. CVFPB will need to review crossing to determine owner. The UCIP inspection was completed with LMA representative, J. Nelson. (H. Dunn ? GEI)04/02/2014 Pipe submerged into the water. (P. David - DWR UCIP)
FIELD_STRUCT_DESC: 30-inch corrugated metal gravity drainage pipe (CMP) through the levee, 11.5 feet below the crown. Slide gate in a 42-inch CMP riser unit/pipe well on the waterside (WS) slope. [Additional Reference(s): DWR Levee Log, 1977, (HLM 1.29). USACE San Joaquin O&M Manual, Unit No. 613, Part C, May 1963, Revised 15 April 2010, (Station 100+60), 30-inch pipe listed. USACE As-Built File No. CA-2-6-147, Sheet No. 147/22, 25 March 1954, (Station 100+60)].

Levee crown looking upstream.

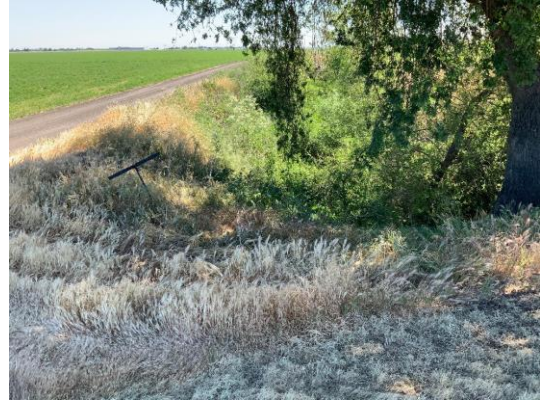
Photo 2 of 3 : UCIP_FA_2024_78253_97031.jpg

LS view: Slope from crown.

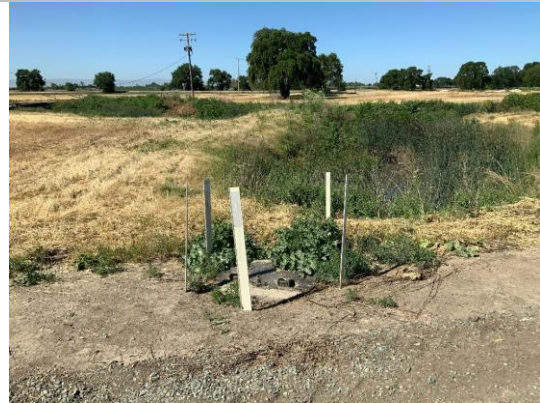
Photo 3 of 3 : UCIP_FA_2024_78253_97028.jpg

WS view: Manhole visible on crown.

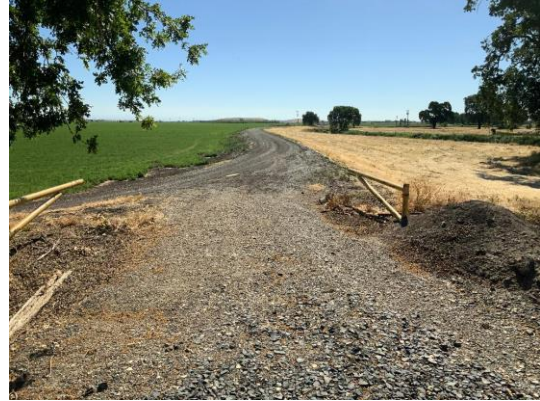
Photo 1 of 3 : UCIP_FA_2024_78254_97051.jpg

DS_ID:23984
FS_ID:78254
EP_NO: N/A
Repair Type: Non-Urgent
EVAL Issue: 5, Pipe Damage
Crossing Status: Found
UCIP Comments: 09/25/2024 DMP internal video inspection has found moderate pipe defects. Crossing will be monitored until funding becomes available for rehabilitation. (O. Yakimov - DWR UCIP) 05/06/2022 According to USACE As-Built File No. CA-2-6-147, Sheet No. 147/22, 25 March 1954, at Station 93+00 there was an existing 12-inch steel pipe (DSID 24008) that was removed and replaced with a 24-inch CMP (DSID 23984). (A. McDonald - DWR UCIP) 4/28/2021 Record has been upgraded from No Action Needed to Non-Urgent. Unit 2 ? Littlejohn Creek (CLM 1.20 to 1.70) is considered a patrol road/high ground area with no defined levee prism, any issue found between CLM 1.20-1.70 of Unit 2 will be considered a maintenance issue, or an unauthorized encroachment, or an abandoned encroachment. DWR DMP internal video inspection has not found pipe integrity issues. LOF of crossing is less or equal to 4.0. Recommend next video inspection in 5 years. Minor warping of LS pipe edges. Current condition of pipe crossing does not impede access to patrol road/high ground area. No permit was found authorizing this encroachment. CVFPB will need to review crossing to determine owner. The UCIP inspection was completed with LMA representative, J. Nelson. (H. Dunn ? GEI)

11/02/2018 Inlet and outlet cleared of dirt and vegetation by the LMA. Crossing continues to be rated "No Action Needed." (A. McDonald - DWR UCIP) 4/02/2014 May need cleaning. (P. Amatya - DWR UCIP) FIELD_STRUCT_DESC: 24-inch corrugated metal gravity drainage pipe (CMP) through the levee, 7.8 feet below the crown. Flap gate on the waterside (WS) end. [Additional Reference(s): USACE San Joaquin O&M Manual, Unit No. 613, Part C, May 1963, Revised 15 April 2010, (Station 93+00), 24-inch pipe listed. USACE As-Built File No. CA-2-6-147, Sheet No. 147/22, 25 March 1954, (Station 93+00)].
FS Date: 4/28/2021

Levee crown looking upstream.

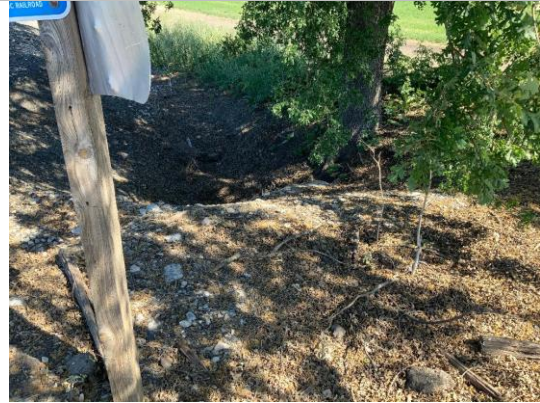
Photo 2 of 3 : UCIP_FA_2024_78254_97052.jpg

LS view: Toe from crown.

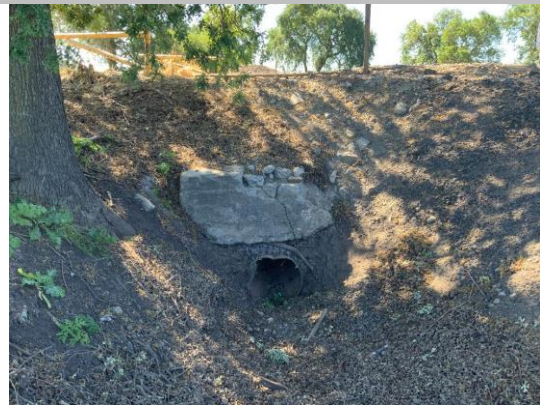
Photo 3 of 3 : UCIP_FA_2024_78254_97053.jpg

LS view: Slope and pipe inlet at toe.

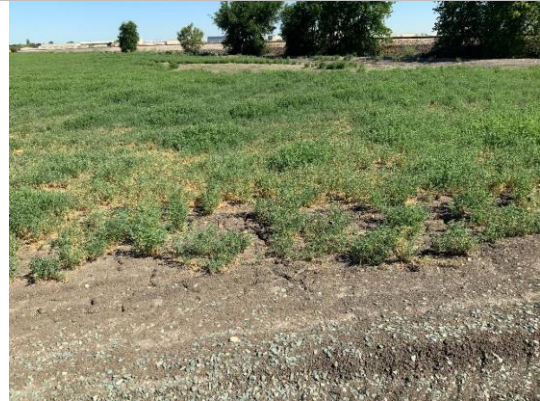
Photo 1 of 3 : UCIP_FA_2024_78255_97076.jpg

Comment Code						
Inspector Comment						
DS_ID:17980						
FS_ID:78255						
EP_NO: N/A						
Repair Type: Non-Urgent						
EVAL Issue:						
Crossing Status: Not Found						
UCIP Comments: 04/28/2021 Record has been upgraded from No						
Action Needed to Non-Urgent. Unit 2 ? Littlejohn Creek (CLM 1.20 to

1.70) is considered a patrol road/high ground area with no defined levee						
prism, any issue found between CLM 1.20-1.70 of Unit 2 will be						
considered a maintenance issue, or an unauthorized encroachment, or						
an abandoned encroachment. Pipe not found by visual inspection. No						
permit was found authorizing this encroachment. CVFPB will need to						
review crossing to determine owner. The UCIP inspection was						
completed with LMA representative, J. Nelson. (H. Dunn ? GEI)						
FIELD_STRUCT_DESC: 12-inch corrugated metal gravity drainage pipe						
(CMP) through the levee, 7.0 feet below the crown. Flap gate on the						
waterside (WS) end. [Additional Reference(s): DWR Levee Log, 1977,						
(HLM 1.52). USACE San Joaquin O&M Manual, Unit No. 613, Part C,						
May 1963, Revised 15 April 2010, (Station 91+80), 12-inch pipe listed.						
USACE As-Built Drawing No. CA-2-6-147, Sheets 22 and 24, STA

LS view: Toe from crown, no pipe visible.

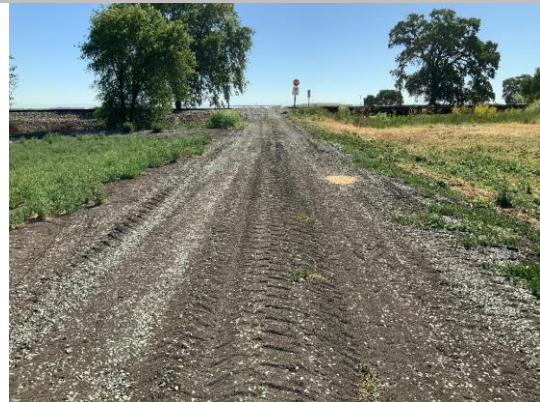
Photo 2 of 3 : UCIP_FA_2024_78255_97077.jpg

Levee crown looking upstream.

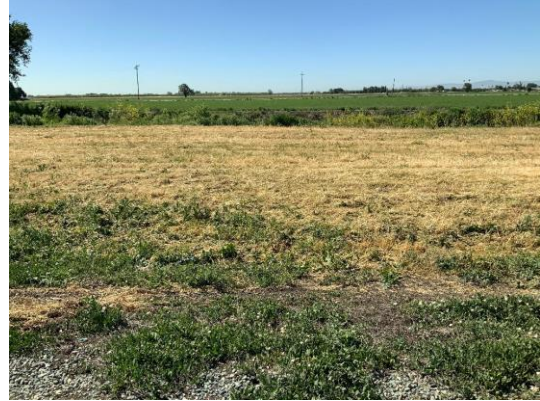
Photo 3 of 3 : UCIP_FA_2024_78255_97078.jpg

WS view: Toe from crown, no pipe visible.

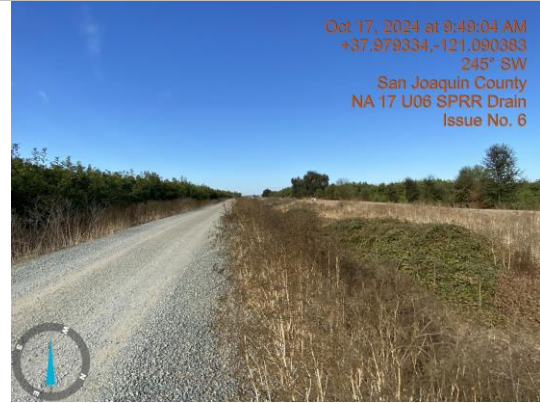
Photo 1 of 1 : FA_2024_NA0017_150_6_20241019_00005.jpg

LM Start	0.30	Rating **	M	Issue No.	6
LM End	0.46	Issue Type +	Ma	Location *	WS
Category	Earthen Levee			GPS Latitude/Longitude	
				Start	End
Item	Vegetation			37.979274°	37.979311°
				-121.093326°	-121.090471°
DWR ID	DWR_NA0017_06_f_2024_6				
Comment Code					
V1 : Control annual grass and weeds on the levee slopes and easements.					
Inspector Comment

View of vegetation along the waterside slope. Fall 2024

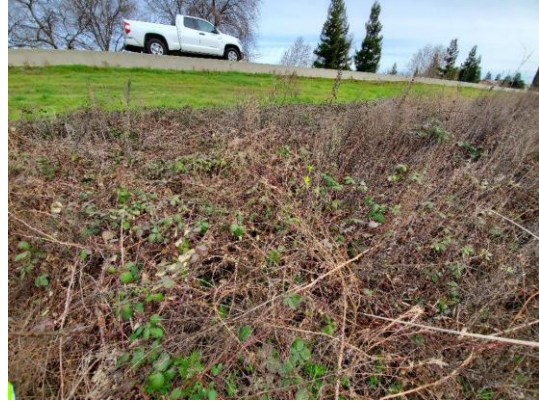
Photo 1 of 3 : UCIP_FA_2024_78858_95618.jpg

Comment Code						
Inspector Comment						
DS_ID:23620 FS_ID:78858 EP_NO: N/A Repair Type: Non-Urgent EVAL Issue: Crossing Status: Not Found UCIP Comments: 02/16/2021 The record has been upgraded from No Action Needed to Non-Urgent. Pipe was not found at the indicated location or surrounding. Dense vegetation at WS toe limited inspection, but no indication of an existing pipe at LS toe with high visibility. DWR DMP geophysical results did not confirm presence of pipe through levee. Record will remain in UCIP's inspection records until future Levee Improvement Project can confirm no crossing was found through the levee. The UCIP inspection was completed with GEI staff, H. Dunn and LMA representative, M. Mccoy. (B. Singh ? GEI) FIELD_STRUCT_DESC: 24-inch corrugated metal drainage pipe (CMP) through the levee, 8.8 feet below the crown. Flap gate on the waterside (WS) end. Concrete U-shaped headwall on the WS end. Cobble grouted outlet across the berm. [Additional Reference(s): DWR Levee Log, 1976, (HLM 0.67). USACE San Joaquin O&M Manual 612.1, June 1965, (HLM 0.67), 24-inch pipe listed]. FS Date: 2/16/2021

WS view: WS slope from WS toe. Dense vegetation limiting view.

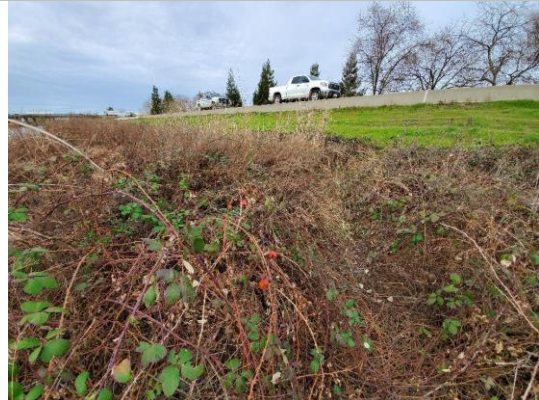
Photo 2 of 3 : UCIP_FA_2024_78858_95619.jpg

WS view: WS slope from toe approximately 30 yards US of indicated location.

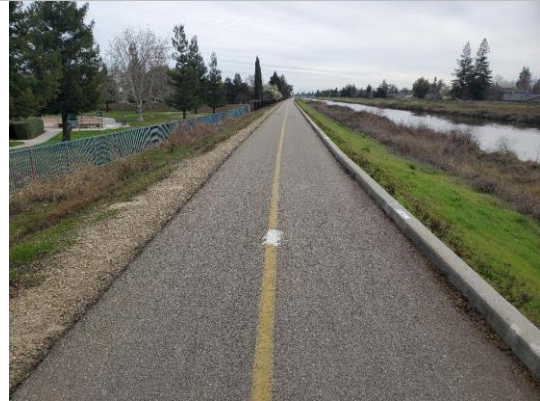
Photo 3 of 3 : UCIP_FA_2024_78858_95620.jpg

Overview of levee crown at indicated location, looking US

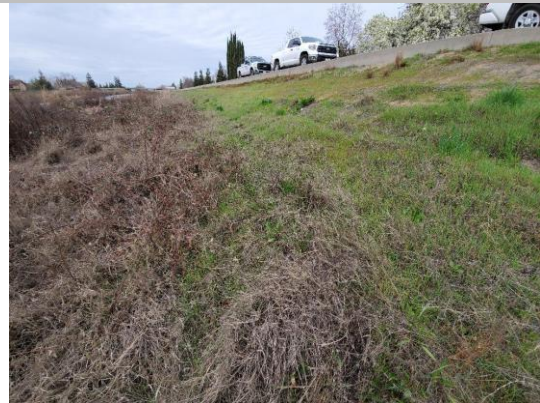
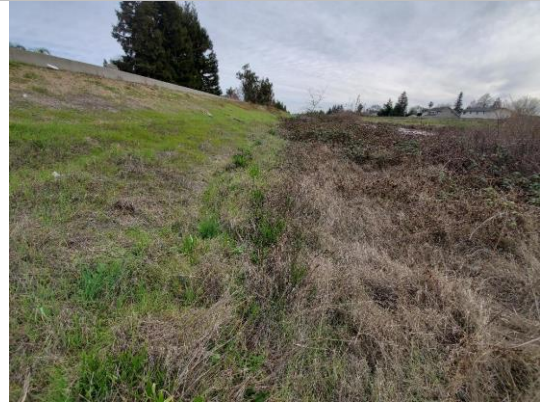
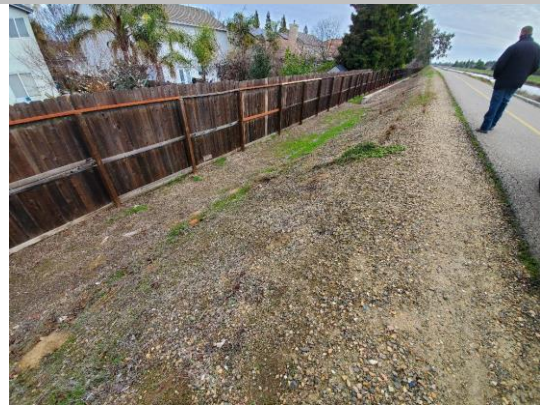
Photo 1 of 3 : UCIP_FA_2024_78859_95644.jpg

DS_ID:23514
 FS_ID:78859
 EP_NO: N/A
 Repair Type: Non-Urgent
 EVAL Issue:
 Crossing Status: Not Found
 UCIP Comments: 02/16/2021 The record has been upgraded from No Action Needed to Non-Urgent. Pipe listed in USACE O&M Manual but was not found in the field. DWR DMP geophysical results did not confirm presence of pipe through levee. Record will remain in UCIP's inspection records until future Levee Improvement Project can confirm no crossing was found through the levee. The UCIP inspection was completed with GEI staff, H. Dunn and LMA representative, M. Mccoy. (B. Singh ? GEI)
 FIELD_STRUCT_DESC: 24-inch corrugated metal drainage pipe (CMP) through the levee, 8.4 feet below the crown. Flap gate on the waterside (WS) end. Concrete U-shaped headwall on the WS end. Cobble grouted outlet across the berm. [Additional Reference(s): DWR Levee Log, 1987, (HLM 0.81). USACE San Joaquin O&M Manual 612.1, June 1965, (HLM 0.81), 24-inch pipe listed].

WS view: View DS from WS toe

WS view: View US from WS toe

LS view: View toward LS toe, looking US

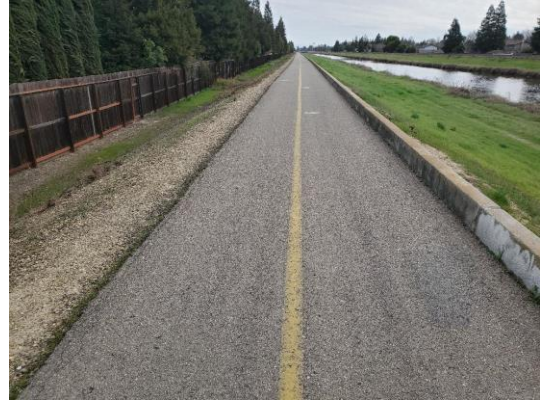
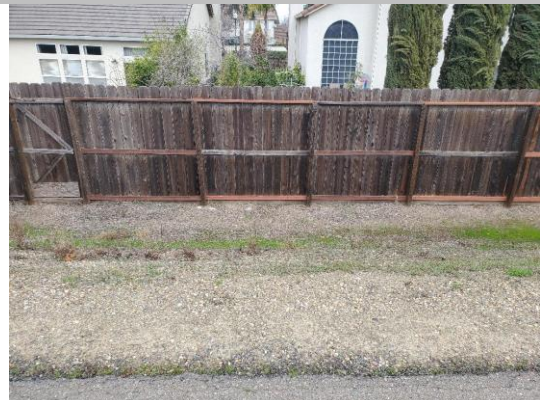
Photo 1 of 3 : UCIP_FA_2024_78860_95685.jpg

Comment Code					
Inspector Comment					
DS_ID:23515 FS_ID:78860 EP_NO: N/A Repair Type: Non-Urgent EVAL Issue: Crossing Status: Not Found UCIP Comments: 02/16/2021 The record has been upgraded from No Action Needed to Non-Urgent. Pipe was not found at indicated or surrounding locations in the field. DWR DMP geophysical results did not confirm presence of pipe through levee. Record will remain in UCIP's inspection records until future Levee Improvement Project can confirm no crossing was found through the levee. The UCIP inspection was completed with GEI staff, H. Dunn and LMA representative, M. Mccoy. (B. Singh ? GEI) FIELD_STRUCT_DESC: 24-inch corrugated metal drainage pipe (CMP) through the levee, 8.1 feet below the crown. Flap gate on the waterside (WS) end. Concrete U-shaped headwall on the WS end. Cobble grouted outlet across the berm. [Additional Reference(s): DWR Levee Log, 1987, (HLM 0.94). USACE San Joaquin O&M Manual 612.1, June 1965, (HLM 0.94), 24-inch pipe listed]. FS Date: 2/16/2021

Overview of levee crown, looking US

LS view: View toward LS toe from levee crown
