**Flood Control Project Maintenance
Levee Inspections****Maintenance Issue Types Only, Levee Inspection Report By Mile - Fall 2024****San Joaquin County Flood Control and Water Conservation District**

Waterway	Bank	Unit Miles	Inspection Start/End	Inspector
Unit No. 01 Littlejohn Creek	Left	2.59	10/21/2024 10/21/2024	Alberto De Leon

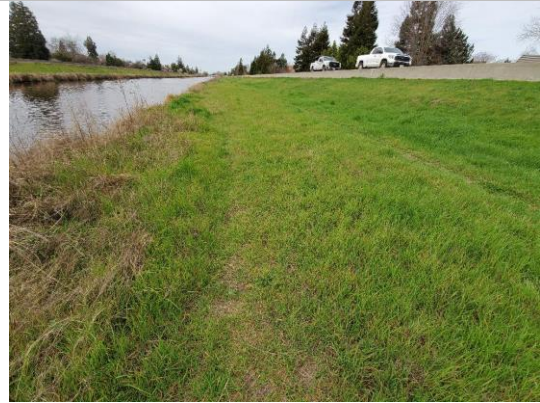
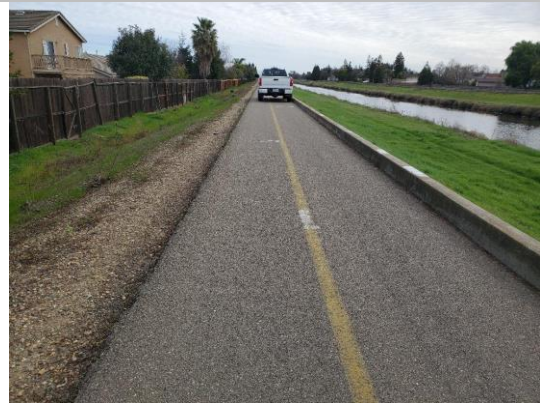
Photo 2 of 3 : UCIP_FA_2024_78861_95694.jpg

WS view: View DS along WS toe

Overview of levee crown, looking US

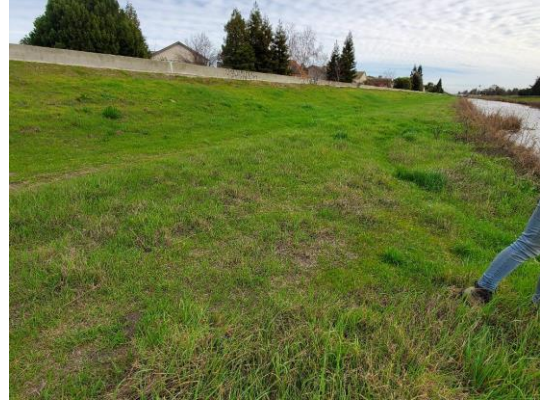
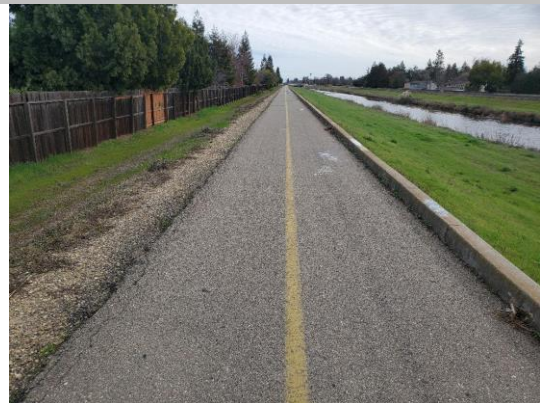
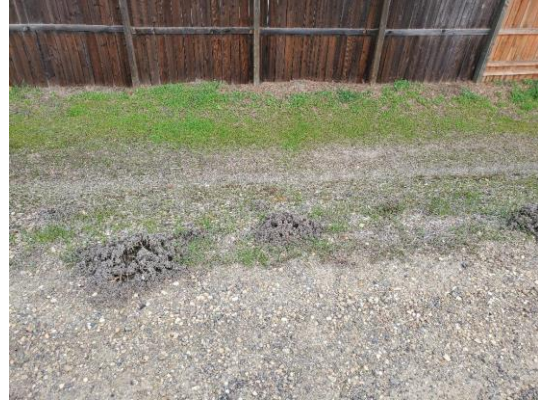
Photo 1 of 3 : UCIP_FA_2024_78862_95702.jpg

Comment Code					
Inspector Comment					
DS_ID:23517 FS_ID:78862 EP_NO: N/A Repair Type: Non-Urgent EVAL Issue: Crossing Status: Indicator Found UCIP Comments: 02/16/2021 The record has been upgraded from No Action Needed to Non-Urgent. Pipe was not found at indicated or surrounding locations in the field. DWR DMP Geophysical study indicates possible presence of pipe through levee. Owner needs to coordinate with the CVFPB to remove or abandon crossing according to Title 23 requirements. Record will remain in UCIP's database and site should be monitored for integrity issues that might arise with buried pipe. No permit was found authorizing this encroachment. CVFPB will need to review crossing to determine owner. The UCIP inspection was completed with GEI staff, H. Dunn and LMA representative, M. Mccoy. (B. Singh ? GEI) FIELD_STRUCT_DESC: 24-inch corrugated metal drainage pipe (CMP) through the levee, 7.2 feet below the crown. Flap gate on the waterside (WS) end. Concrete U-shaped headwall on the WS end. Cobble grouted outlet across the berm. [Additional Reference(s): DWR Levee Log, 1987, (HLM 1.22). USACE San Joaquin O&M Manual 612.1, June 1965, (HLM 1.22), 24-inch pipe listed]. FS Date: 2/16/2021

WS view: View US along WS toe

Overview of levee crown, looking US

LS view: View toward LS toe from levee crown

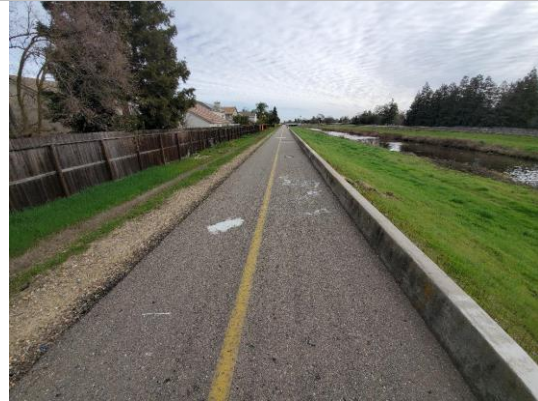
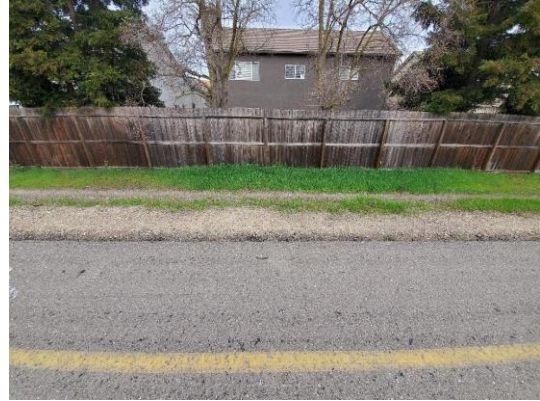
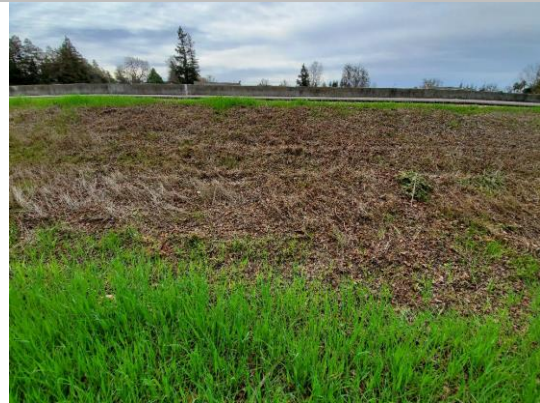
Photo 1 of 3 : UCIP_FA_2024_78863_95711.jpg

DS_ID:23518
FS_ID:78863
EP_NO: N/A
Repair Type: Non-Urgent
EVAL Issue:
Crossing Status: Indicator Found
UCIP Comments: 02/16/2021 The record has been upgraded from No Action Needed to Non-Urgent. Pipe was not found at indicated or surrounding locations in the field. DWR DMP Geophysical study indicates possible presence of pipe through levee. Owner needs to coordinate with the CVFPB to remove or abandon crossing according to Title 23 requirements. Updated coordinates are 38.0432064, -121.3530273. CVFPB will need to review crossing to determine owner. The UCIP inspection was completed with GEI staff, H. Dunn and LMA representative, M. McCoy. (B. Singh ? GEI)
FIELD_STRUCT_DESC: 24-inch corrugated metal drainage pipe (CMP) through the levee, 7.1 feet below the crown. Flap gate on the waterside (WS) end. Concrete U-shaped headwall on the WS end. Cobble grouted outlet across the berm. [Additional Reference(s): DWR Levee Log, 1987, (HLM 1.36). USACE San Joaquin O&M Manual 612.1, June 1965, (HLM 1.36), 24-inch pipe listed].

Overview of levee crown, looking US

LS view: View toward LS toe from levee crown

LS view: LS slope from LS toe

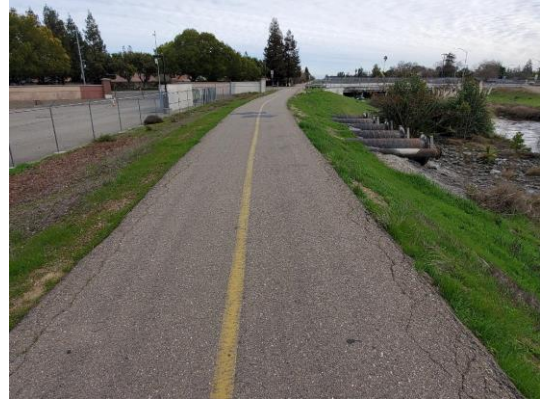
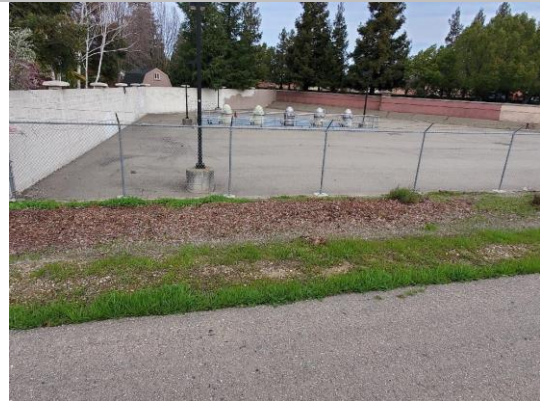
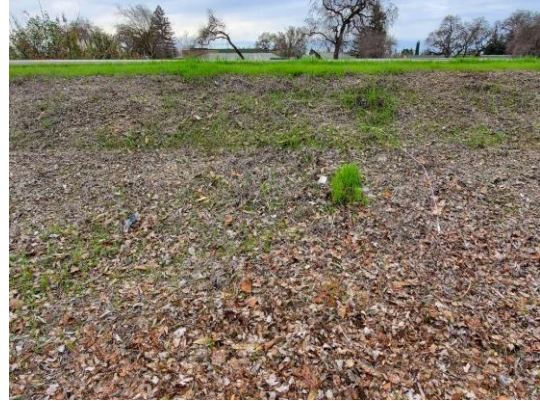
Photo 1 of 3 : UCIP_FA_2024_78263_95727.jpg

Comment Code					
Inspector Comment					
DS_ID:23695 FS_ID:78263 EP_NO: N/A Repair Type: Non-Urgent EVAL Issue: Crossing Status: Found UCIP Comments: 02/16/2021 The record has been upgraded from No Action Needed to Non-Urgent. No permit was found authorizing this encroachment. CVFPB will need to review crossing to determine owner. The UCIP inspection was completed with GEI staff, H. Dunn and LMA representative, M. McCoy. (B. Singh ? GEI) FIELD_STRUCT_DESC: [Thornton Road Pump Station] 1 of 6: 12-inch wrapped steel storm drainage pipe through the levee, approximately 3.0 feet below the crown. Pump station on the landside (LS). Flap gate on the waterside (WS) end. [Additional Reference(s): USACE San Joaquin O&M Manual 612 (addendum), February 1999, (HLM 2.16), (Station 114+25), 12-inch pipe listed]. FS Date: 2/16/2021

Overview of levee crown, looking US

LS view: View toward LS toe and pumping plant from levee crown

LS view: LS slope from LS toe

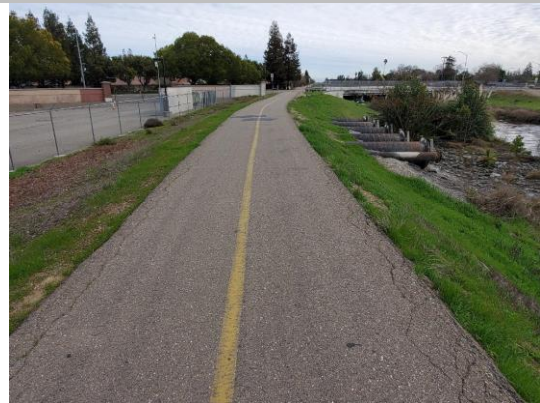
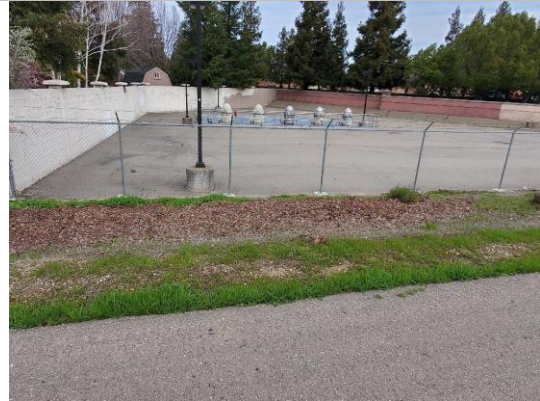
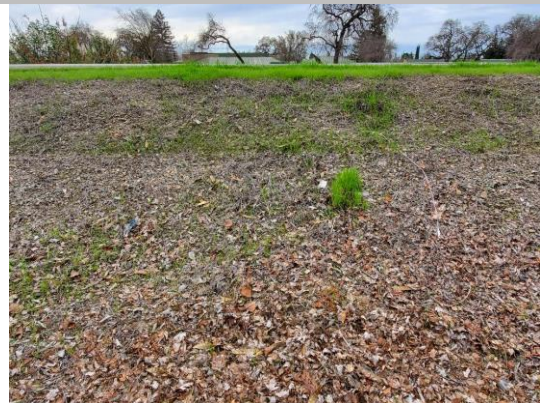
Photo 1 of 3 : UCIP_FA_2024_78264_95733.jpg

DS_ID:23650
 FS_ID:78264
 EP_NO: N/A
 Repair Type: Non-Urgent
 EVAL Issue:
 Crossing Status: Found
 UCIP Comments: 02/16/2021 The record has been upgraded from No Action Needed to Non-Urgent. No permit was found authorizing this encroachment. CVFPB will need to review crossing to determine owner. The UCIP inspection was completed with GEI staff, H. Dunn and LMA representative, M. McCoy. (B. Singh ? GEI)
 FIELD_STRUCT_DESC: [Thornton Road Pump Station] 2 of 6: 36-inch wrapped steel storm drainage pipe through the levee, approximately 3.0 feet below the crown. Pump station on the landside (LS). Flap gate on the waterside (WS) end. [Additional Reference(s): USACE San Joaquin O&M Manual 612 (addendum), February 1999, (HLM 2.16), (Station 114+25), 36-inch pipe listed].
 FS Date: 2/16/2021

Overview of levee crown, looking US

LS view: View toward LS toe and pump station from levee crown

LS view: LS slope from LS toe

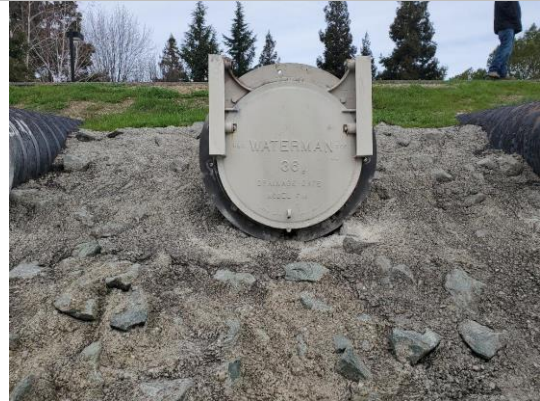
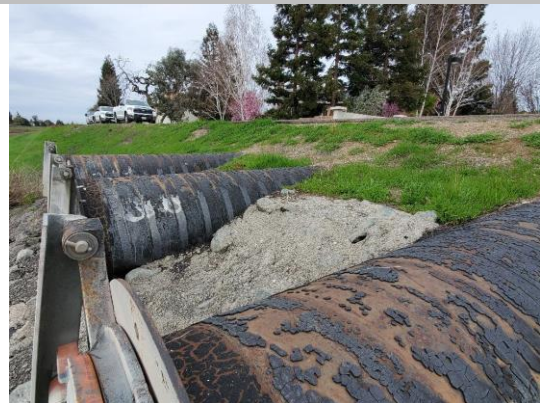
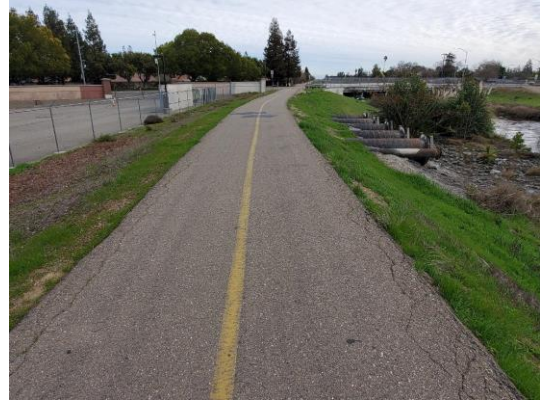
Photo 1 of 3 : UCIP_FA_2024_78265_95739.jpg

Comment Code					
Inspector Comment					
DS_ID:23691 FS_ID:78265 EP_NO: N/A Repair Type: Non-Urgent EVAL Issue: Crossing Status: Found UCIP Comments: 02/16/2021 The record has been upgraded from No Action Needed to Non-Urgent. No permit was found authorizing this encroachment. CVFPB will need to review crossing to determine owner. The UCIP inspection was completed with GEI staff, H. Dunn and LMA representative, M. Mccoy. (B. Singh ? GEI) FIELD_STRUCT_DESC: [Thornton Road Pump Station] 3 of 6: 36-inch wrapped steel storm drainage pipe through the levee, approximately 3.0 feet below the crown. Pump station on the landside (LS). Flap gate on the waterside (WS) end. [Additional Reference(s): USACE San Joaquin O&M Manual 612 (addendum), February 1999, (HLM 2.16), (Station 114+25), 36-inch pipe listed]. FS Date: 2/16/2021

WS view: Pipe at WS toe

WS view: Pipe and WS slope from WS toe

Overview of levee crown

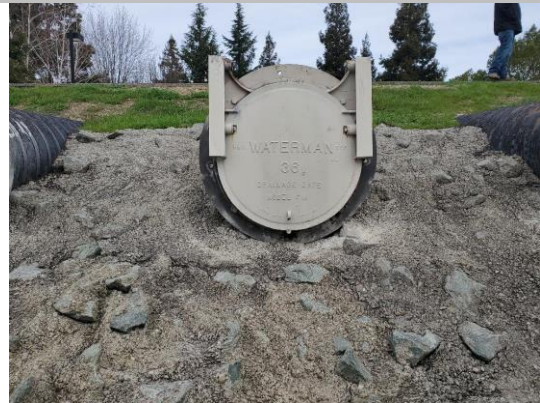
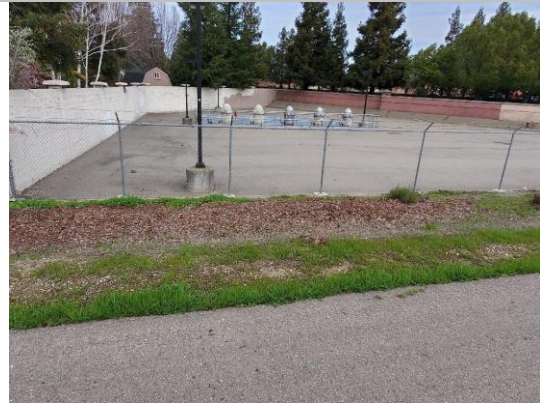
Photo 1 of 3 : UCIP_FA_2024_78266_95745.jpg

DS_ID:23692
FS_ID:78266
EP_NO: N/A
Repair Type: Non-Urgent
EVAL Issue:
Crossing Status: Found
UCIP Comments: 02/16/2021 The record has been upgraded from No Action Needed to Non-Urgent. No permit was found authorizing this encroachment. CVFPB will need to review crossing to determine owner. The UCIP inspection was completed with GEI staff, H. Dunn and LMA representative, M. McCoy. (B. Singh ? GEI)
FIELD_STRUCT_DESC: [Thornton Road Pump Station] 4 of 6: 36-inch wrapped steel storm drainage pipe through the levee, approximately 3.0 feet below the crown. Pump station on the landside (LS). Flap gate on the waterside (WS) end. [Additional Reference(s): USACE San Joaquin O&M Manual 612 (addendum), February 1999, (HLM 2.16), (Station 114+25), 36-inch pipe listed].
FS Date: 2/16/2021

WS view: Pipe at WS toe

LS view: View toward LS toe and pump station from levee crown

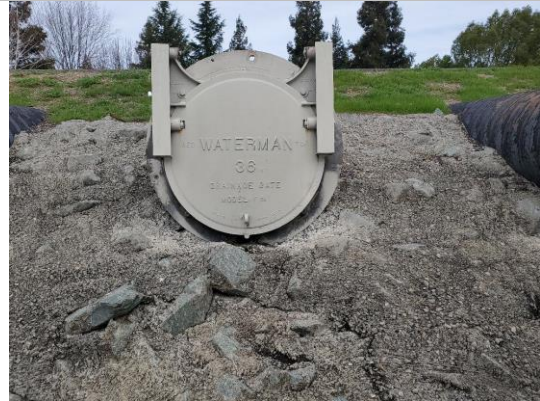
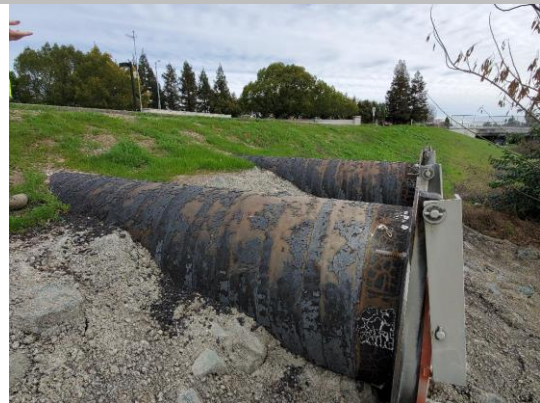
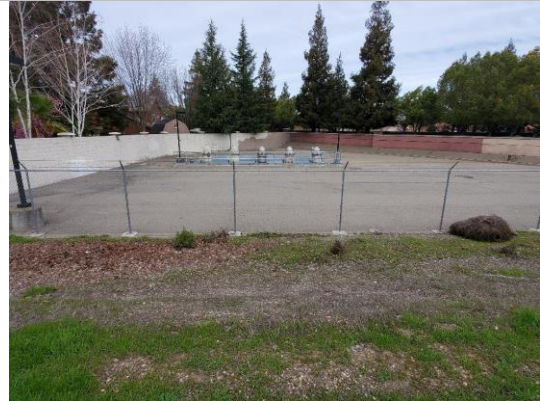
Photo 1 of 3 : UCIP_FA_2024_78267_95749.jpg

Comment Code					
Inspector Comment					
DS_ID:23693 FS_ID:78267 EP_NO: N/A Repair Type: Non-Urgent EVAL Issue: Crossing Status: Found UCIP Comments: 02/16/2021 The record has been upgraded from No Action Needed to Non-Urgent. No permit was found authorizing this encroachment. CVFPB will need to review crossing to determine owner. The UCIP inspection was completed with GEI staff, H. Dunn and LMA representative, M. Mccoy. (B. Singh ? GEI) FIELD_STRUCT_DESC: [Thornton Road Pump Station] 5 of 6: 36-inch wrapped steel storm drainage pipe through the levee, approximately 3.0 feet below the crown. Pump station on the landside (LS). Flap gate on the waterside (WS) end. [Additional Reference(s): USACE San Joaquin O&M Manual 612 (addendum), February 1999, (HLM 2.16), (Station 114+25), 36-inch pipe listed]. FS Date: 2/16/2021

WS view: Pipe at WS toe

WS view: Pipe and slope from WS toe

LS view: View toward pump station and LS toe from levee crown

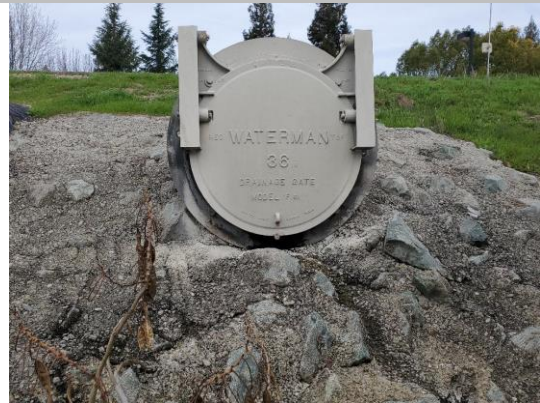
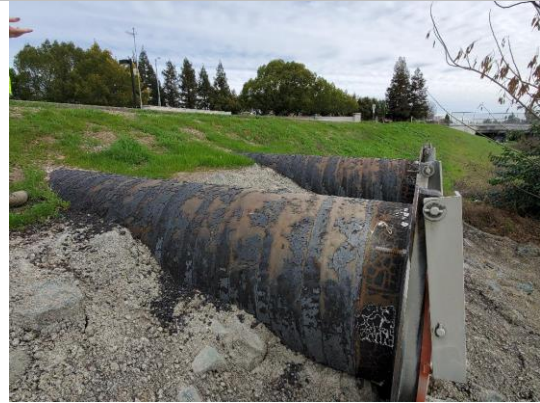
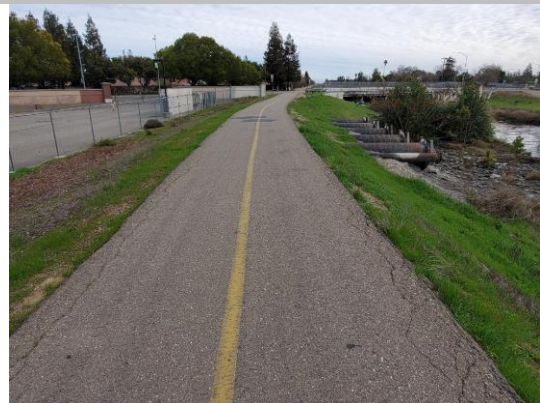
Photo 1 of 3 : UCIP_FA_2024_78268_95755.jpg

DS_ID:23694
FS_ID:78268
EP_NO: N/A
Repair Type: Non-Urgent
EVAL Issue:
Crossing Status: Found
UCIP Comments: 02/16/2021 The record has been upgraded from No Action Needed to Non-Urgent. No permit was found authorizing this encroachment. CVFPB will need to review crossing to determine owner. The UCIP inspection was completed with GEI staff, H. Dunn and LMA representative, M. McCoy. (B. Singh ? GEI)
FIELD_STRUCT_DESC: [Thornton Road Pump Station] 6 of 6: 36-inch wrapped steel storm drainage pipe through the levee, approximately 3.0 feet below the crown. Pump station on the landside (LS). Flap gate on the waterside (WS) end. [Additional Reference(s): USACE San Joaquin O&M Manual 612 (addendum), February 1999, (HLM 2.16), (Station 114+25), 36-inch pipe listed].
FS Date: 2/16/2021

WS view: Pipe at WS toe

WS view: Pipe (right) and WS slope from WS toe

Overview of levee crown, looking US

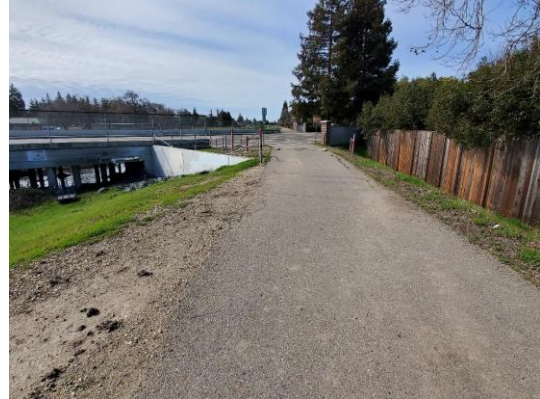
Photo 1 of 2 : UCIP_FA_2024_78865_95778.jpg

Comment Code						
Inspector Comment						
DS_ID:23520 FS_ID:78865 EP_NO: N/A Repair Type: Non-Urgent EVAL Issue: 4b, Safety Issue Crossing Status: Not Found UCIP Comments: 02/16/2021 The record has been upgraded from No Action Needed to Non-Urgent. Inspection was not completed due to housing encampment at site location. Unable to verify presence of crossing. No permit was found authorizing this encroachment. CVFPB will need to review crossing to determine owner. The UCIP inspection was completed with GEI staff, H. Dunn and LMA representative, M. Mccoy. (B. Singh ? GEI) FIELD_STRUCT_DESC: 24-inch corrugated metal drainage pipe (CMP) through the levee, 7.6 feet below the crown. Concrete U-shaped headwall on both ends. Flap gate on the waterside (WS) end. Cobble grouted outlet across the berm. [Additional Reference(s): DWR Levee Log, 1987, (HLM 1.63). USACE San Joaquin O&M Manual 612.1, June 1965, (HLM 1.63), 24-inch pipe listed]. FS Date: 2/16/2021

Overview of levee crown, looking DS

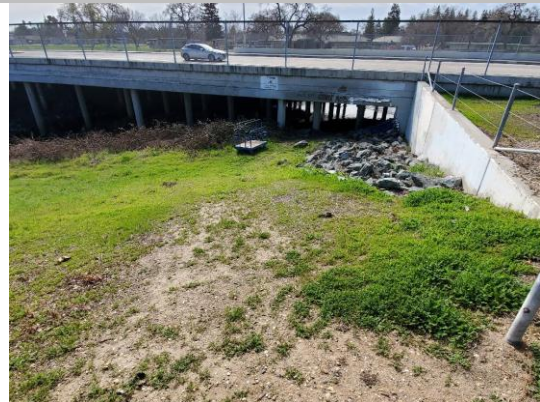
Photo 2 of 2 : UCIP_FA_2024_78865_95779.jpg

WS slope. No indicator found.

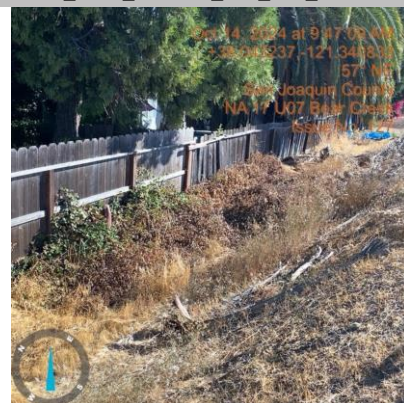
Photo 1 of 1 : FA_2024_NA0017_151_127_20241019_00360.jpg

View of wild growth and berry bushes along the landside easement. Fall 2024

LM Start	1.79	Rating **	U	Issue No.	127
LM End	1.79	Issue Type +	Ma	Location *	LS
Category	Earthen Levee			GPS Latitude/Longitude	
				Start	End
Item	Vegetation			38.043237°	38.043237°
				-121.340834°	-121.340834°
DWR ID	DWR_NA0017_07_f_2024_127				
Comment Code					
V2 : Remove the wild growth and woody vegetation other than native grasses from the levee slopes.					
Inspector Comment

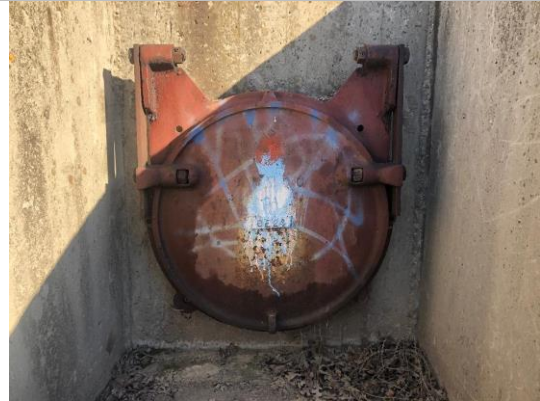
Photo 1 of 3 : UCIP_FA_2024_78866_91080.jpg

Comment Code					
Inspector Comment					
DS_ID:23522					
FS_ID:78866					
EP_NO: N/A					
Repair Type: Non-Urgent					
EVAL Issue:					
Crossing Status: Found					
UCIP Comments: 02/17/2021 Record was updated from No Action					
Needed to Non-Urgent. Upon inspection, LS pipe edges were warped					
and the coated tar lining deteriorating. DWR DMP internal inspection					
has not found pipe integrity issues. LOF of crossing is less or equal to

WS view: Flapgate on WS toe.

4.0. Recommend next video inspection in 5 years. No permit was found					
authorizing this encroachment. CVFPB will need to review crossing to					
determine owner. The UCIP inspection was completed with GEI staff, B.					
Singh, N. Cholewinski, and LMA representative, J. Caruso. (H. Dunn ?					
GEI)					
FIELD_STRUCT_DESC: 24-inch corrugated metal drainage pipe (CMP)					
through the levee, 5.5 feet below the crown. Concrete U-shaped					
headwalls on both ends. Flap gate on the waterside (WS) end. Cobble					
grouted outlet across the berm. [Additional Reference(s): DWR Levee					
Log, 1987, (HLM 2.59). USACE San Joaquin O&M Manual 612.1, June					
1965, (HLM 2.59), 24-inch pipe listed].					
FS Date: 2/17/2021

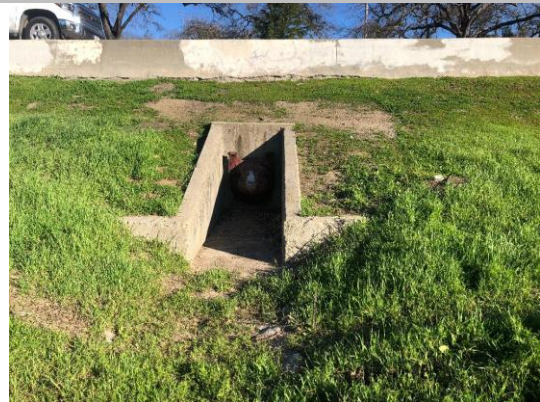
Photo 2 of 3 : UCIP_FA_2024_78866_91081.jpg

WS view: Headwall and flapgate on WS toe.

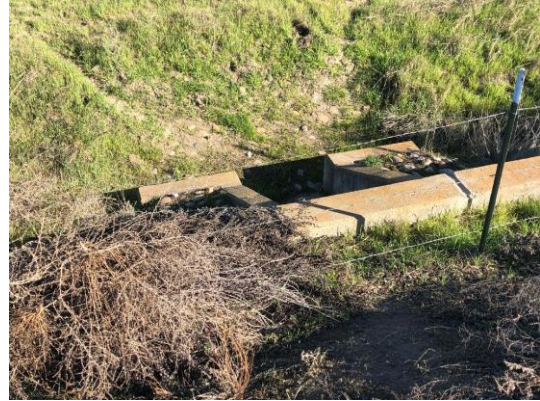
Photo 2 of 3 : UCIP_FA_2024_78937_91086.jpg

Comment Code						
Inspector Comment						
DS_ID:23523 FS_ID:78937 EP_NO: N/A Repair Type: Non-Urgent EVAL Issue: 5, Pipe Damage Crossing Status: Found UCIP Comments: 09/23/2024 DMP internal video inspection has found moderate pipe defects. Crossing will be monitored until funding becomes available for rehabilitation. (O. Yakimov - DWR UCIP) 02/17/2021 Record was updated from No Action Needed to Non-Urgent. DWR DMP has not found internal issues, LOF between 1 and 2. Recommend inspection in 5 years. Barbed wire over the LS toe headwall, could not inspect further. No permit was found authorizing this encroachment. CVFPB will need to review crossing to determine owner. The UCIP inspection was completed with GEI staff, B. Singh, N. Cholewinski, and LMA representative, J. Caruso. (H. Dunn ? GEI) FIELD_STRUCT_DESC: 24-inch corrugated metal drainage pipe (CMP) through the levee, 10.0 feet below the crown. Concrete U-shaped headwalls on both ends. Flap gate on the waterside (WS) end. Cobble grouted outlet across the berm. [Additional Reference(s): USACE San Joaquin O&M Manual 612.1, June 1965, (HLM 2.82), 24-inch pipe listed]. FS Date: 2/17/2021

LS view: LS headwall from crown. Note barbed wire prevented access to pipe.

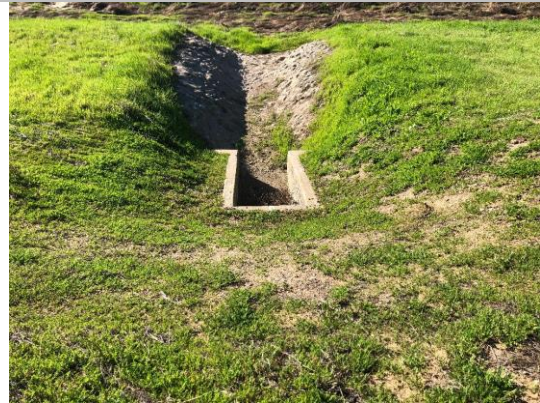
Photo 3 of 3 : UCIP_FA_2024_78937_91087.jpg

LS view: WS headwall at toe from crown.

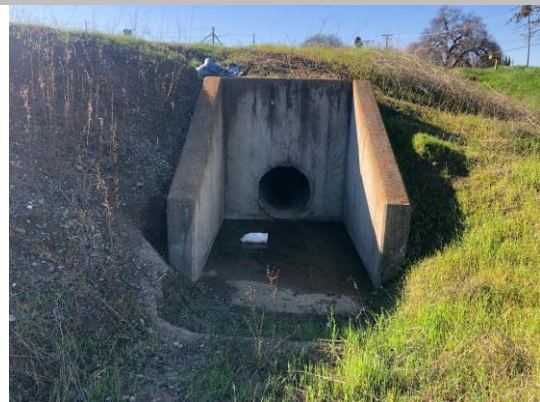
Photo 2 of 3 : UCIP_FA_2024_78868_91141.jpg

Comment Code						
Inspector Comment						
DS_ID:23525 FS_ID:78868 EP_NO: N/A Repair Type: Non-Urgent EVAL Issue: Crossing Status: Found UCIP Comments: 02/17/2021 Record was updated from No Action Needed to Non-Urgent. DWR DMP has not found internal issues, LOF between 1 and 2. Recommend inspection in 5 years. Minor erosion on one edge of the LS headwall. CVFPB will need to review crossing to determine owner. The UCIP inspection was completed with GEI staff, B. Singh, N. Cholewinski, and LMA representative, J. Caruso. (H. Dunn ? GEI) FIELD_STRUCT_DESC: 24-inch corrugated metal drainage pipe (CMP) through the levee, 8.0 feet below the crown. Concrete U-shaped headwalls on both ends. Flap gate on the waterside (WS) end. Cobble grouted outlet across the berm. [Additional Reference(s): DWR Levee Log, 1987, (HLM 3.09). USACE San Joaquin O&M Manual 612.1, June 1965, (HLM 3.09), 24-inch pipe listed]. FS Date: 2/17/2021

LS view: LS headwall at toe. Minor scouring on left side of headwall.

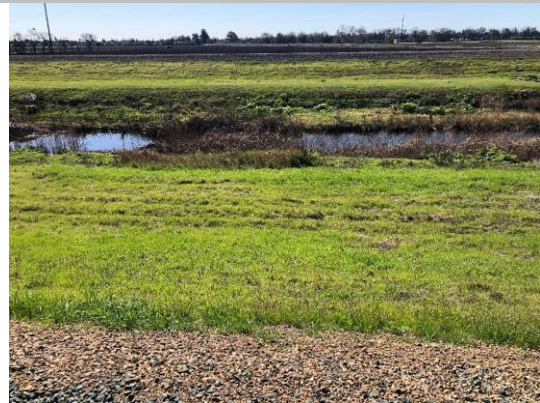
Photo 1 of 3 : UCIP_FA_2024_78278_93643.jpg

DS_ID:23651
 FS_ID:78278
 EP_NO: N/A
 Repair Type: Non-Urgent
 EVAL Issue:
 Crossing Status: Not Found
 UCIP Comments: 02/17/2021 The record has been upgraded from No Action Needed to Non-Urgent. Pipe not found by visual inspection. DWR DMP geophysical study did not confirm presence of pipe through levee. Record will remain in UCIP's inspection records until future Levee Improvement Project can confirm no crossing was found through the levee. No permit was found authorizing this encroachment. CVFPB will need to review crossing to determine owner. The UCIP inspection was completed with GEI staff, B. Singh, N. Cholewinski, and LMA representative, J. Caruso. (H. Dunn ? GEI)
 FIELD_STRUCT_DESC: 24-inch storm drainage pipe of an unknown material through the levee, at an unknown depth. [Additional Reference(s): USACE San Joaquin O&M Manual 612 (addendum), February 1999, (HLM 3.48), (Station 183+50), 24-inch pipe listed].

WS toe from crown, no pipe visible.

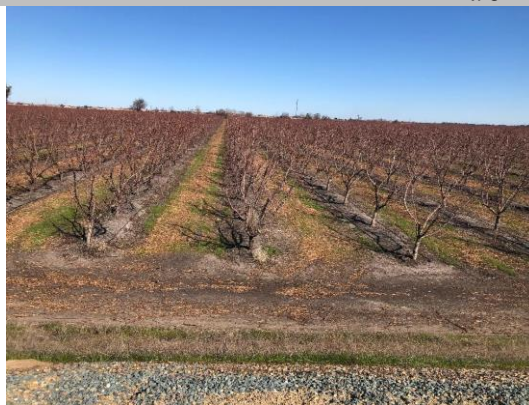
Photo 3 of 3 : UCIP_FA_2024_78278_93645.jpg

LS toe from crown, no pipe visible.

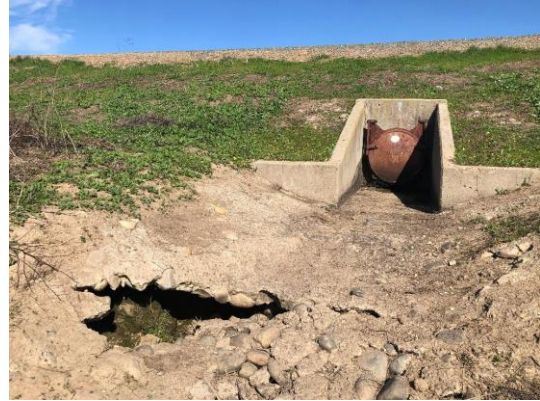
Photo 1 of 3 : UCIP_FA_2024_78940_93666.jpg

Comment Code					
Inspector Comment					
DS_ID:23532 FS_ID:78940 EP_NO: N/A Repair Type: Non-Urgent EVAL Issue: 6, Levee Damage or Threat for Levee Damage Crossing Status: Found UCIP Comments: 09/18/2023 Pipe was CIPP lined. DMP internal video inspection has found none or minor pipe defects. Recommend next video inspection in 5 years. (O. Yakimov - DWR UCIP) 02/17/2021 The record has been upgraded from No Action Needed to Non-Urgent. DWR DMP has found integrity issues, LOF between 4 and 5. Crossing will be monitored until funding becomes available for rehabilitation. Minor erosion underneath the grouted WS outlet. 2 feet in length, half foot in height. No permit was found authorizing this encroachment. CVFPB will need to review crossing to determine owner. The UCIP inspection was completed with GEI staff, B. Singh, N. Cholewinski, and LMA representative, J. Caruso. (H. Dunn ? GEI) FIELD_STRUCT_DESC: 36-inch CIPP-lined corrugated metal drainage pipe (CMP) through the levee, 8.5 feet below the crown. Concrete U-shaped headwalls on both ends. Flap gate on the waterside (WS) end. Cobble grouted outlet across the berm. [Additional Reference(s): DWR Levee Log, 1987, (HLM 3.58). USACE San Joaquin O&M Manual 612.1, June 1965, (HLM 3.58), 36-inch pipe listed]. FS Date: 2/17/2021

WS headwall and flap gate at toe. Minor erosion underneath cobble grouted outlet.

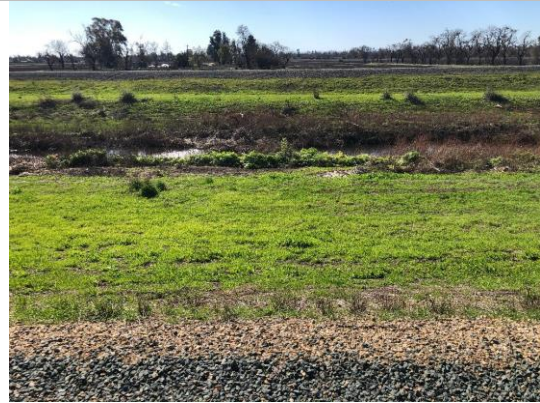
Photo 1 of 3 : UCIP_FA_2024_78281_93668.jpg

DS_ID:23652
 FS_ID:78281
 EP_NO: N/A
 Repair Type: Non-Urgent
 EVAL Issue:
 Crossing Status: Not Found
 UCIP Comments: 02/17/2021 The record has been upgraded from No Action Needed to Non-Urgent. Pipe not found by visual inspection. DWR DMP geophysical study did not confirm presence of pipe through levee. Record will remain in UCIP's inspection records until future Levee Improvement Project can confirm no crossing was found through the levee. No permit was found authorizing this encroachment. CVFPB will need to review crossing to determine owner. The UCIP inspection was completed with GEI staff, B. Singh, N. Cholewinski, and LMA representative, J. Caruso. (H. Dunn ? GEI)
 FIELD_STRUCT_DESC: 24-inch storm drainage pipe of an unknown material through the levee, at an unknown depth. [Additional Reference(s): USACE San Joaquin O&M Manual 612 (addendum), February 1999, (HLM 3.63), (Station 192+15), 24-inch pipe listed].

WS toe from crown, pipe not visible.

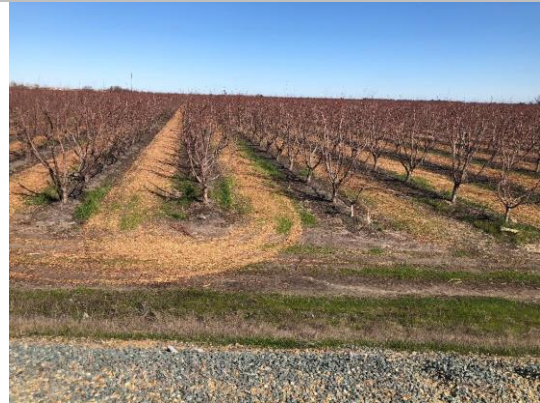
Photo 3 of 3 : UCIP_FA_2024_78281_93670.jpg

LS toe from crown, no pipe visible.

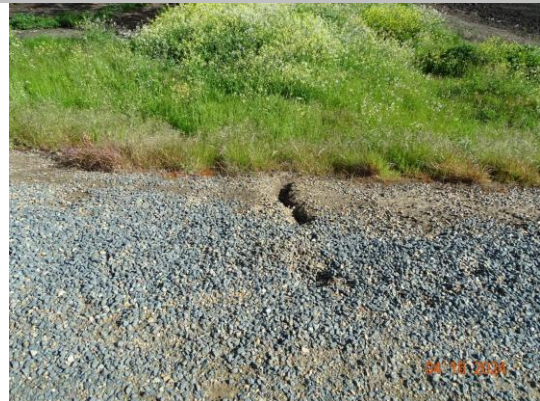
Photo 1 of 1 : FA_2024_NA0017_151_163_20240910_00014.jpg

View of erosion rill along the landside slope. Spring 2024

LM Start	3.48	Rating **	M	Issue No.	163
LM End	3.48	Issue Type +	Ma	Location *	LS
Category	Earthen Levee			GPS Latitude/Longitude	
				Start	End
Item	Erosion / Rills			38.042986°	38.042986°
				-121.309816°	-121.309816°
DWR ID	DWR_NA0017_07_s_2024_163				
Comment Code					
E5 : Schedule repair of rills prior to the next inspection.					
Inspector Comment

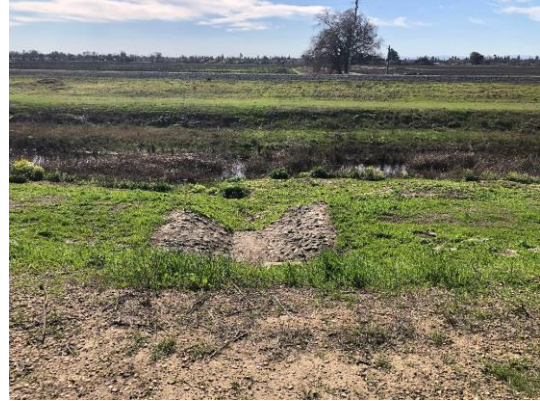
Photo 1 of 3 : UCIP_FA_2024_78941_93682.jpg

Comment Code						
Inspector Comment						
DS_ID:23533 FS_ID:78941 EP_NO: N/A Repair Type: Non-Urgent EVAL Issue: 5, Pipe Damage Crossing Status: Found UCIP Comments: 09/23/2024 DMP internal video inspection has found moderate pipe defects. Crossing will be monitored until funding becomes available for rehabilitation. (O. Yakimov - DWR UCIP) 02/17/2021 The record has been upgraded from No Action Needed to Non-Urgent. DWR DMP has not found internal issues, LOF between 1 and 2. Recommend inspection in 5 years. No permit was found authorizing this encroachment. CVFPB will need to review crossing to determine owner. The UCIP inspection was completed with GEI staff, B. Singh, N. Cholewinski, and LMA representative, J. Caruso. (H. Dunn ? GEI) FIELD_STRUCT_DESC: 24-inch corrugated metal drainage pipe (CMP) through the levee, 7.0 feet below the crown. Concrete U-shaped headwalls on both ends. Flap gate on the waterside (WS) end. Slide gate on the landside (LS) end. Grouted intake on the LS. Cobble grouted outlet across the berm. [Additional Reference(s): DWR Levee Log, 1987, (HLM 3.81). USACE San Joaquin O&M Manual 612.1, June 1965, (HLM 3.81), 24-inch pipe listed]. FS Date: 2/17/2021

WS view: WS headwall at toe from crown.

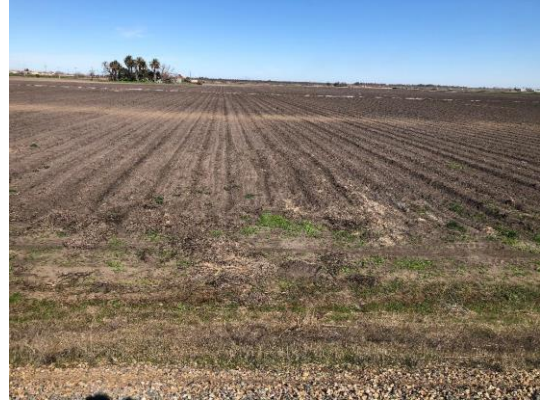
Photo 2 of 3 : UCIP_FA_2024_78284_93690.jpg

LS view: LS toe from crown, no pipe visible.

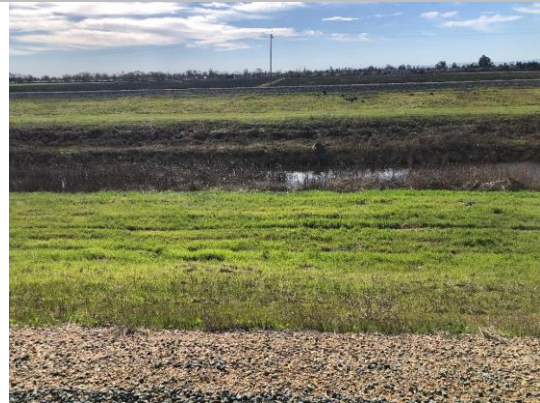
Photo 3 of 3 : UCIP_FA_2024_78284_93691.jpg

WS view: WS toe from crown, no pipe visible.

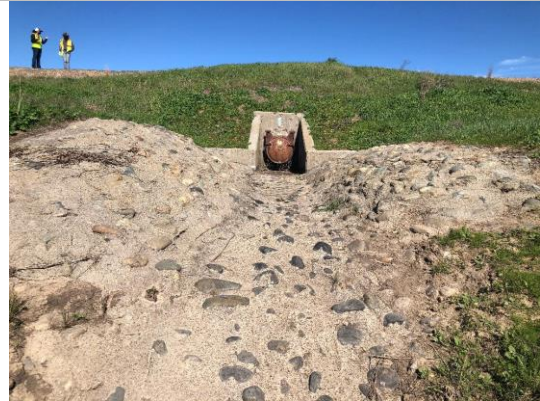
Photo 1 of 3 : UCIP_FA_2024_78874_93717.jpg

Comment Code						
Inspector Comment						
DS_ID:23534 FS_ID:78874 EP_NO: N/A Repair Type: Non-Urgent EVAL Issue: Crossing Status: Found UCIP Comments: 12/20/2022 Record updated from Urgent to Non-Urgent. Pipe has been CIPP lined. LOF of crossing is less or equal to 4. Recommend next video inspection in 5 years. (O.Yakimov - DWR UCIP) 02/17/2021 The record has been upgraded from No Action Needed to Urgent. DWR DMP has found integrity issues, LOF between 5 and 6. Crossing will be monitored until funding becomes available to be addressed. Holes and peeling of metal on the inside bottom of the LS pipe. Recommend LMA create contingency plan for increased inspections during high-water. No permit was found authorizing this encroachment. CVFPB will need to review crossing to determine owner. The UCIP inspection was completed with GEI staff, B. Singh, N. Cholewinski, and LMA representative, J. Caruso. (H. Dunn ? GEI) FIELD_STRUCT_DESC: 24-inch CIPP-lined corrugated metal storm drainage pipe (CMP) through the levee, 7.0 feet below the crown. Concrete U-shaped headwalls on both ends. Flap gate on the waterside (WS) end. Slide gate on the landside (LS) end. Grouted intake on the LS. Cobble grouted outlet across the berm. [Additional Reference(s): DWR Levee Log, 1987, (HLM 4.10). USACE San Joaquin O&M Manual 612.1, June 1965, (HLM 4.10), and 612 (addendum), February 1999, (HLM 4.10), (Station 216+43), 24-inch pipe listed]. FS Date: 2/17/2021 11:33:47 AM

WS view: WS headwall and flapgate at toe.

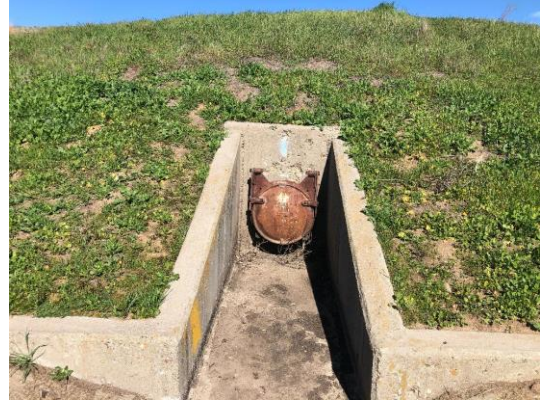
Photo 2 of 3 : UCIP_FA_2024_78874_93718.jpg

WS view: WS headwall and flapgate at toe.

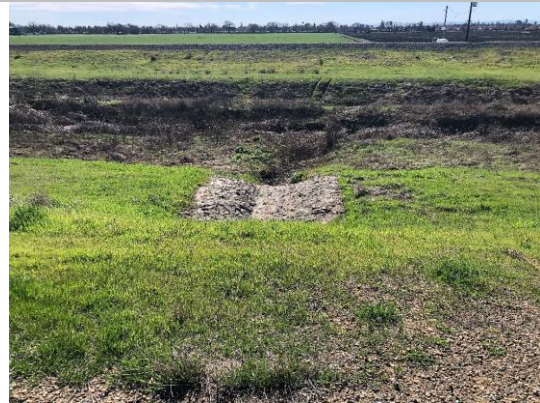
Photo 3 of 3 : UCIP_FA_2024_78874_93719.jpg

WS view: WS headwall at toe from crown.

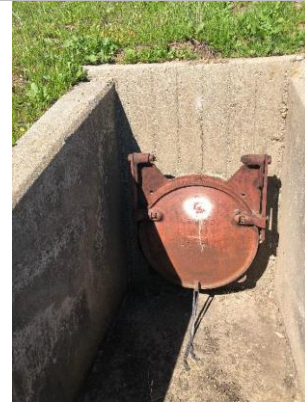
Photo 1 of 3 : UCIP_FA_2024_78875_95535.jpg

Comment Code						
Inspector Comment						
DS_ID:23535 FS_ID:78875 EP_NO: N/A Repair Type: Non-Urgent EVAL Issue: Crossing Status: Found UCIP Comments: 12/20/2022 Record updated from Urgent to Non-Urgent. Pipe has been CIPP lined. LOF of crossing is less or equal to 4. Recommend next video inspection in 5 years. (O.Yakimov - DWR UCIP) 02/17/2021 The record has been upgraded from No Action Needed to Urgent. DWR DMP has found integrity issues, LOF between 5 and 6. Crossing will be monitored until funding becomes available to be addressed. Recommend LMA to prepare contingency plan for increased inspections during high-water. No permit was found authorizing this encroachment. CVFPB will need to review crossing to determine owner. The UCIP inspection was completed with GEI staff, B. Singh, N. Cholewinski, and LMA representative, J. Caruso. (H. Dunn ? GEI) FIELD_STRUCT_DESC: 24-inch CIPP-lined corrugated metal storm drainage pipe (CMP) through the levee, 8.0 feet below the crown. Concrete U-shaped headwalls on both ends. Flap gate on the waterside (WS) end. Grouted intake on the landside (LS). Cobble grouted outlet across the berm. [Additional Reference(s): DWR Levee Log, 1987, (HLM 4.37). USACE San Joaquin O&M Manual 612.1, June 1965, (HLM 4.37), and 612 (addendum), February 1999, (HLM 4.33), (Station 228+58), 24-inch pipe listed]. FS Date: 2/17/2021 11:34:22 AM

WS view: Headwall and close up of flapgate.

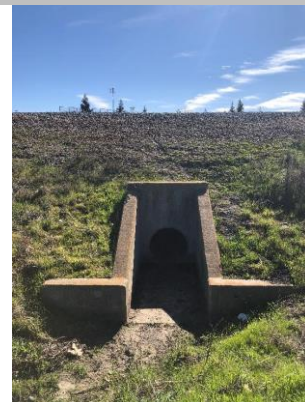
Photo 2 of 3 : UCIP_FA_2024_78875_95536.jpg

LS view: Headwall at toe.

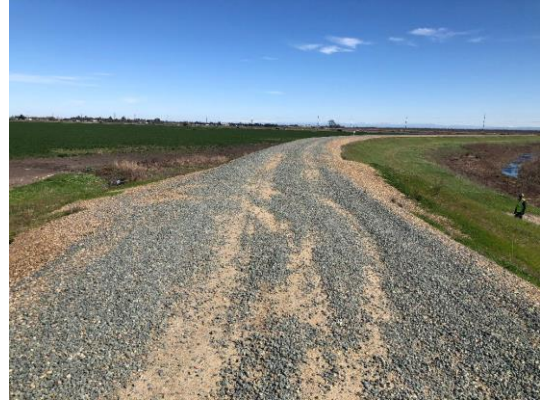
Photo 3 of 3 : UCIP_FA_2024_78875_93735.jpg

Levee crown looking upstream.

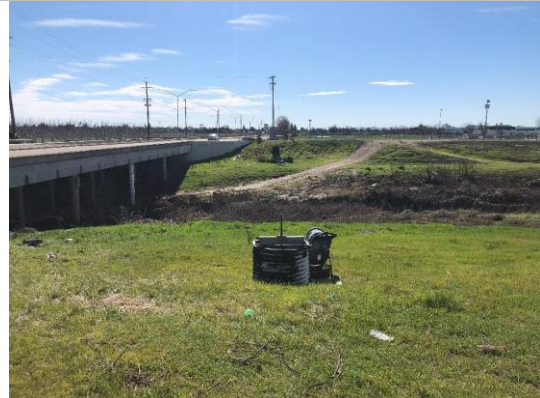
Photo 1 of 3 : UCIP_FA_2024_78288_93742.jpg

DS_ID:23536
FS_ID:78288
EP_NO: N/A
Repair Type: Non-Urgent
EVAL Issue: 4b, Safety Issue
Crossing Status: Found
UCIP Comments: 02/17/2021 The record has been upgraded from No Action Needed to Non-Urgent. LS concrete liner around riser is cracked and misaligned, as well as no cover. DWR DMP Geophysical study indicates possible presence of pipe through levee at 38.0444641, -121.2956106, coordinates have been updated. Owner needs to coordinate with the CVFPB to remove or abandon crossing according to Title 23 requirements. No permit was found authorizing this encroachment. CVFPB will need to review crossing to determine owner. The UCIP inspection was completed with GEI staff, B. Singh, N. Cholewinski, and LMA representative, J. Caruso. (H. Dunn ? GEI)
FIELD_STRUCT_DESC: 24-inch corrugated metal pipe (CMP) siphon through the levee, 10.4 feet below the crown. Slide gate in a 36-inch CMP riser unit on the waterside (WS) slope. Siphon cleanout in center of channel. Slide gate in concrete standpipe at the landside (LS) toe.

WS view: WS toe from crown, metal riser with slidegate.

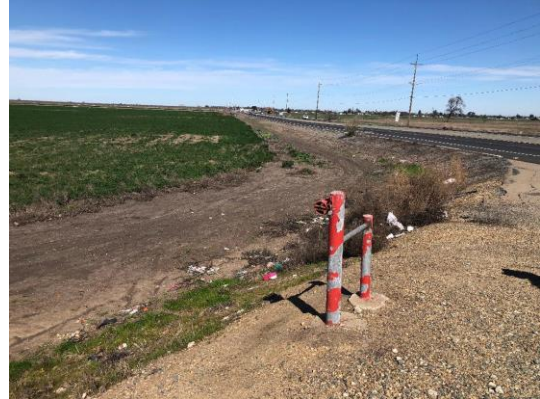
Photo 2 of 3 : UCIP_FA_2024_78288_93743.jpg

LS view: LS toe from crown, metal riser with slidegate.

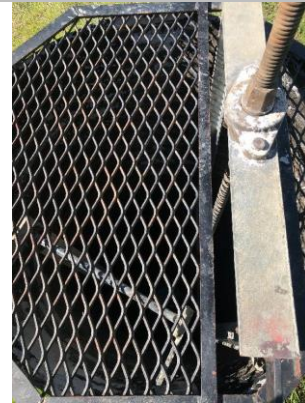
Photo 3 of 3 : UCIP_FA_2024_78288_95547.jpg

WS view: Inside metal riser with slidegate.

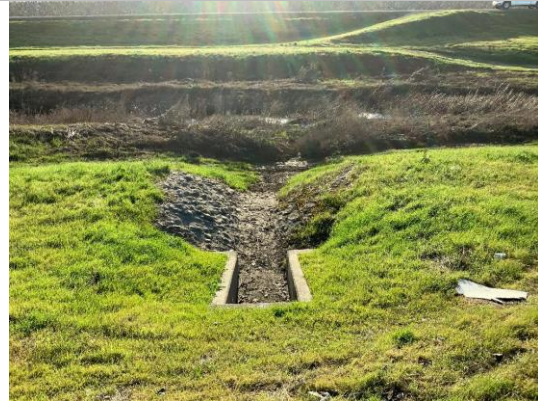
Photo 1 of 3 : UCIP_FA_2024_78942_91205.jpg

Comment Code						
Inspector Comment						
DS_ID:23538 FS_ID:78942 EP_NO: N/A Repair Type: Non-Urgent EVAL Issue: 5, Pipe Damage Crossing Status: Found UCIP Comments: 09/23/2024 DMP internal video inspection has found moderate pipe defects. Crossing will be monitored until funding becomes available for rehabilitation. (O. Yakimov - DWR UCIP) 02/18/2021 The record has been upgraded from No Action Needed to Non-Urgent. DWR DMP has not found internal issues, LOF between 1 and 2. Recommend inspection in 5 years. True location was around 20 feet south, coordinates have been updated to 38.0450489. - 121.2950334. No permit was found authorizing this encroachment. CVFPB will need to review crossing to determine owner. The UCIP inspection was completed with GEI staff, B. Singh and LMA representative, M. Mccoy. (H. Dunn ? GEI) FIELD_STRUCT_DESC: 24-inch corrugated metal drainage pipe (CMP) through the levee, 8.3 feet below the crown. Concrete U-shaped headwalls on both ends. Flap gate on the waterside (WS) end. Grouted intake on the landside (LS). Cobble grouted outlet across the berm. [Additional Reference(s): DWR Levee Log, 1987, (HLM 4.65). USACE San Joaquin O&M Manual 612.1, June 1965, (HLM 4.66), 24-inch pipe listed]. FS Date: 2/18/2021

WS view: WS headwall at toe from crown.

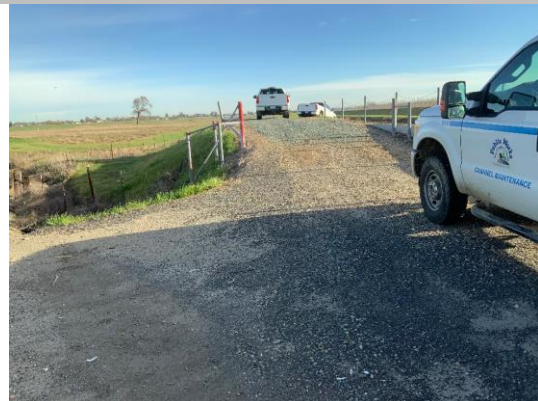
Photo 2 of 3 : UCIP_FA_2024_78942_91206.jpg

Levee crown looking upstream.

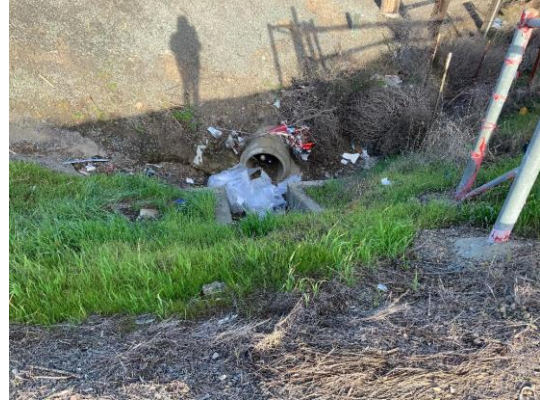
Photo 3 of 3 : UCIP_FA_2024_78942_91207.jpg

LS view: LS headwall at toe from crown.

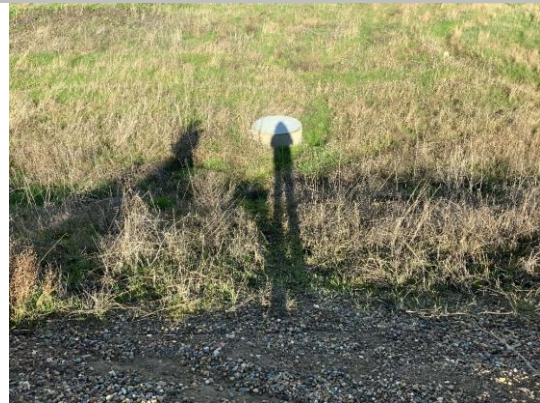
Photo 1 of 3 : UCIP_FA_2024_78877_91229.jpg

DS_ID:23540
FS_ID:78877
EP_NO: N/A
Repair Type: Non-Urgent
EVAL Issue:
Crossing Status: Found
UCIP Comments: 12/20/2022 Record updated from Urgent to Non-Urgent. Pipe has been CIPP lined. LOF of crossing is less or equal to 4. Recommend next video inspection in 5 years. (O.Yakimov - DWR UCIP)
02/18/2021 The record has been upgraded from No Action Needed to Urgent. DWR DMP has found integrity issues, LOF between 5 and 6. Crossing will be monitored until funding becomes available to be addressed. No permit was found authorizing this encroachment. CVFPB will need to review crossing to determine owner. The UCIP inspection was completed with GEI staff, B. Singh and LMA representative, M. McCoy. (H. Dunn ? GEI)
FIELD_STRUCT_DESC: 24-inch CIPP-lined corrugated metal storm drainage pipe (CMP) through the levee, 8.8 feet below the crown. 44-inch concrete standpipe on the landside (LS) toe. Concrete U-shaped headwall on the waterside (WS) end. Flap gate on the WS end. Cobble grouted outlet across the berm. [Additional Reference(s): DWR Levee Log, 1987, (HLM 4.88). USACE San Joaquin O&M Manual 612.1, June 1965, (HLM 4.88), and 612 (addendum), February 1999, (HLM 4.88), (Station 257+60), 24-inch pipe listed].

LS view: Concrete standpipe on LS toe from crown.

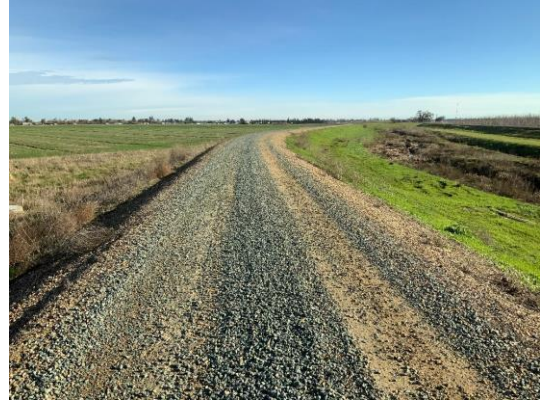
Photo 2 of 3 : UCIP_FA_2024_78877_91230.jpg

Levee crown looking upstream.

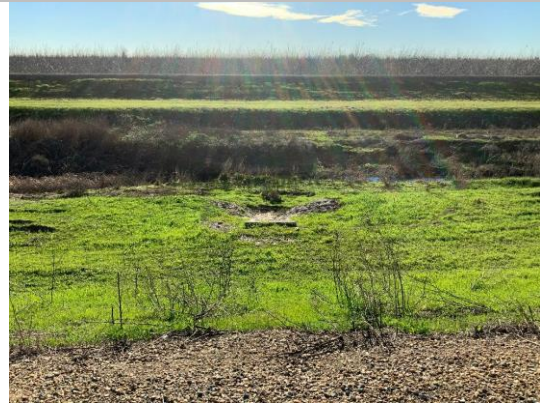
Photo 3 of 3 : UCIP_FA_2024_78877_91231.jpg

WS view: Headwall at WS toe from crown.

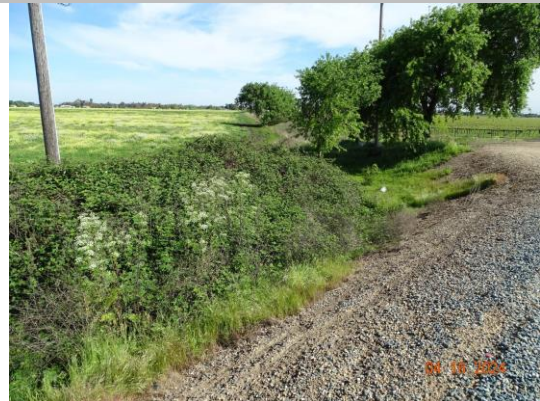
Photo 1 of 1 : FA_2024_NA0017_151_241_20240910_00022.jpg

LM Start	4.94	Rating **	U	Issue No.	241
LM End	4.94	Issue Type +	Ma	Location *	LS
Category	Earthen Levee			GPS Latitude/Longitude	
				Start	End
Item	Vegetation			38.050361°	38.050361°
				-121.286959°	-121.286959°
DWR ID	DWR_NA0017_07_s_2022_241				
Comment Code					
V2 : Remove the wild growth and woody vegetation other than native grasses from the levee slopes.					
Inspector Comment

View of wild growth vegetation along the landside slope and easement.
Spring 2024

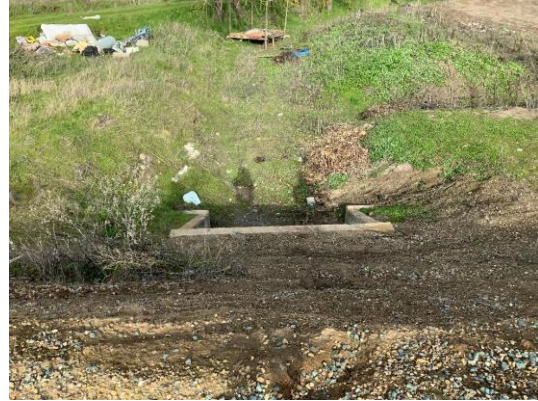
Photo 1 of 3 : UCIP_FA_2024_78878_91293.jpg

Comment Code						
Inspector Comment						
DS_ID:23543 FS_ID:78878 EP_NO: N/A Repair Type: No Action Needed EVAL Issue: Crossing Status: Found UCIP Comments: 09/18/2023 Record updated from Non-Urgent to No Action Needed. Pipe was CIPP lined. DMP internal video inspection has found none or minor pipe defects. Recommend next video inspection in 5 years. (O. Yakimov - DWR UCIP) 02/18/2021 The record has been upgraded from No Action Needed to Non-Urgent. DWR DMP has found integrity issues, LOF between 4 and 5. Crossing will be monitored until funding becomes available for rehabilitation. No permit was found authorizing this encroachment. CVFPB will need to review crossing to determine owner. The UCIP inspection was completed with GEI staff, B. Singh and LMA representative, M. McCoy. (H. Dunn ? GEI) FIELD_STRUCT_DESC: 1 of 2: 36-inch CIPP-lined corrugated metal storm drainage pipe (CMP) through the levee, 8.9 feet below the crown. Concrete U-shaped headwall on both ends. Flap gate on the waterside (WS) end. Grouted intake on the landside (LS). Cobble grouted outlet across the berm. [Additional Reference(s): DWR Levee Log, 1987, (HLM 5.33). USACE San Joaquin O&M Manual 612.1, June 1965, (HLM 5.33), and 612 (addendum), February 1999, (HLM 5.37), (Station 283+76), 36-inch pipe listed]. FS Date: 2/18/2021

LS view: LS headwall at toe from crown.

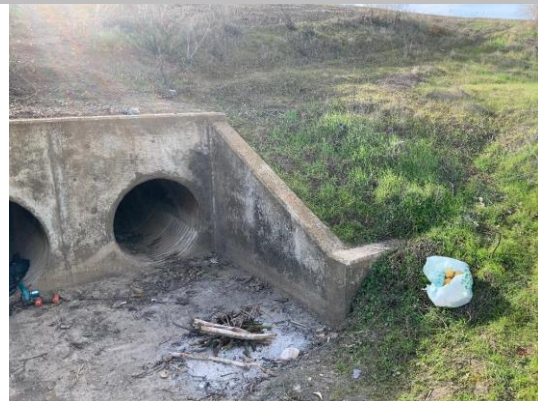
Photo 2 of 3 : UCIP_FA_2024_78878_91294.jpg

LS view: Left side headwall and pipe on LS toe.

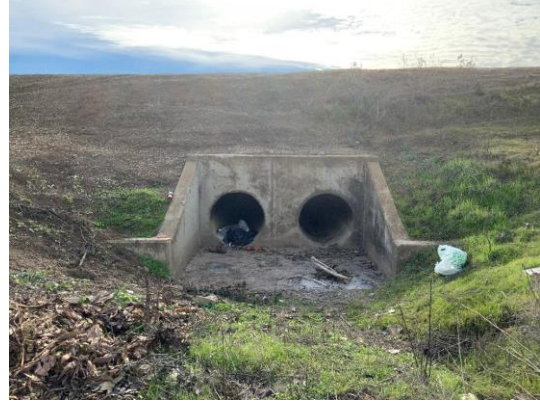
Photo 3 of 3 : UCIP_FA_2024_78878_91295.jpg

LS view: Headwall and pipes on LS toe.

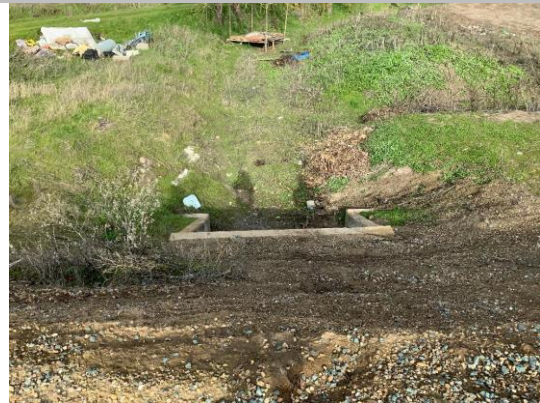
Photo 1 of 3 : UCIP_FA_2024_78879_91399.jpg

DS_ID:23678
FS_ID:78879
EP_NO: N/A
Repair Type: Non-Urgent
EVAL Issue: 5, Pipe Damage
Crossing Status: Found
UCIP Comments: 09/25/2024 DMP internal video inspection has found moderate pipe defects. Crossing will be monitored until funding becomes available for rehabilitation. (O. Yakimov - DWR UCIP)
02/18/2021 Pipe status is still Non-Urgent. DWR DMP has not found internal issues, LOF between 1 and 2. Recommend inspection in 5 years. Minor debris inside LS pipe. No permit was found authorizing this encroachment. CVFPB will need to review crossing to determine owner. The UCIP inspection was completed with GEI staff, B. Singh and LMA representative, M. McCoy. (H. Dunn ? GEI)
FIELD_STRUCT_DESC: 2 of 2: 36-inch corrugated metal storm drainage pipe (CMP) through the levee, 8.9 feet below the crown. Concrete U-shaped headwall on both ends. Flap gate on the waterside (WS) end. Grouted intake on the landside (LS). Cobble grouted outlet across the berm. [Additional Reference(s): DWR Levee Log, 1987, (HLM 5.33). USACE San Joaquin O&M Manual 612.1, June 1965, (HLM 5.33), 36-inch pipe listed].

LS view: LS headwall at toe from crown.

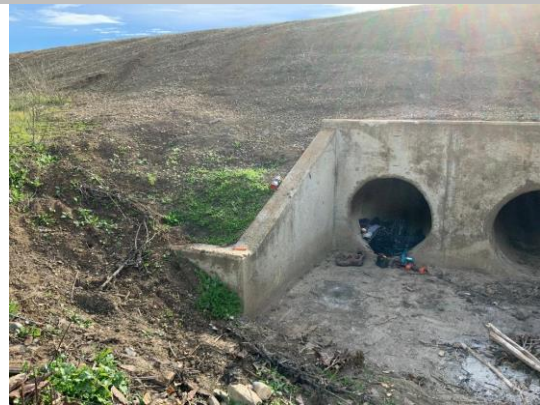
Photo 3 of 3 : UCIP_FA_2024_78879_91402.jpg

LS view: LS headwall and pipe at toe.
