**Flood Control Project Maintenance
Levee Inspections****Maintenance Issue Types Only, Levee Inspection Report By Mile - Fall 2024****San Joaquin County Flood Control and Water Conservation District**

Waterway	Bank	Unit Miles	Inspection Start/End	Inspector
Unit No. 01 Littlejohn Creek	Left	2.59	10/21/2024 10/21/2024	Alberto De Leon

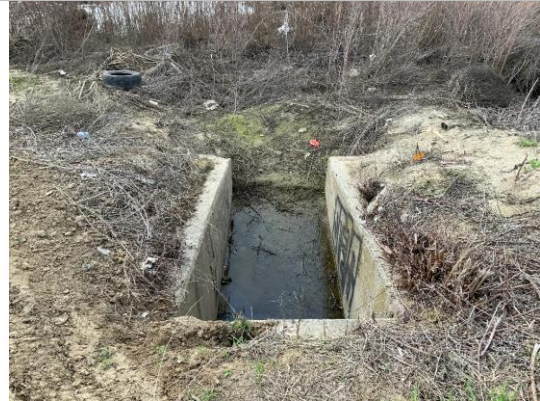
Photo 1 of 3 : UCIP_FA_2024_78880_91418.jpg

DS_ID:23544
FS_ID:78880
EP_NO: N/A
Repair Type: Non-Urgent
EVAL Issue: 6, Levee Damage or Threat for Levee Damage
Crossing Status: Found
UCIP Comments: 12/20/2022 Record updated from Urgent to Non-Urgent. Pipe has been CIPP lined. DMP internal video inspection has found none or minor pipe defects. Recommend next video inspection in 5 years. (O.Yakimov - DWR UCIP)
02/18/2021 The record has been upgraded from No Action Needed to Urgent. Outside edges of WS pipe are warped with minor erosion on WS slope along pipe alignment. DWR DMP has found integrity issues, LOF between 5 and 6. Crossing will be monitored until funding becomes available to address. No permit was found authorizing this encroachment. CVFPB will need to review crossing to determine owner. The UCIP inspection was completed with GEI staff, B. Singh and LMA representative, M. McCoy. (H. Dunn ? GEI)
FIELD_STRUCT_DESC: 36-inch CIPP-lined corrugated metal storm drainage pipe (CMP) through the levee, 10.6 feet below the crown. Concrete U-shaped headwall on the waterside (WS) end. Flap gate on the WS end. Cobble grouted outlet across the berm. [Additional Reference(s): DWR Levee Log, 1987, (HLM 5.87). USACE San Joaquin O&M Manual 612.1, June 1965, (HLM 5.87), and 612 (addendum), February 1999, (HLM 5.81), (Station 306+88), 36-inch pipe listed].

WS view: WS headwall at toe from crown.

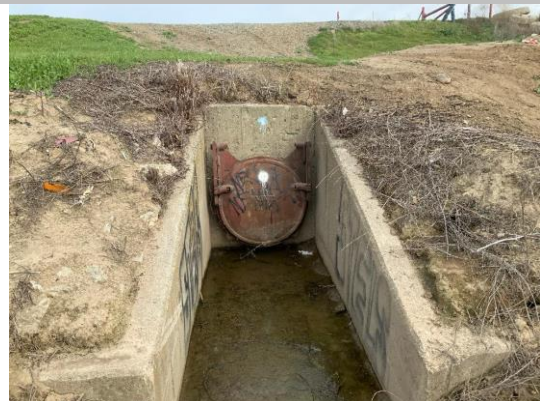
Photo 2 of 3 : UCIP_FA_2024_78880_91419.jpg

WS view: WS headwall and flagate at toe.

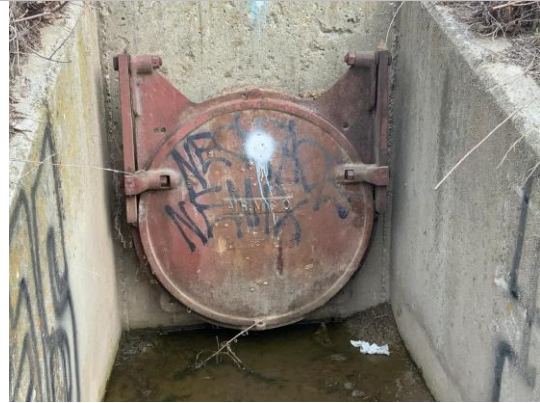
Photo 3 of 3 : UCIP_FA_2024_78880_91415.jpg

WS view: WS flapgate.

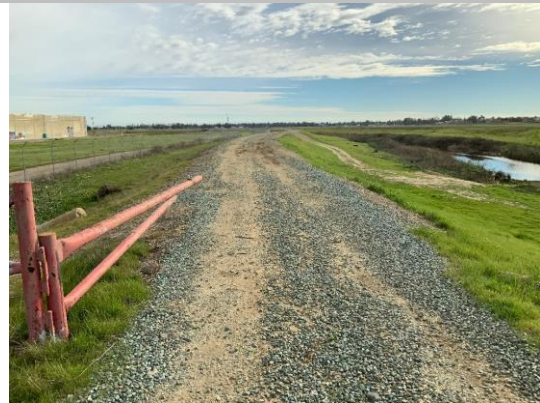
Photo 1 of 3 : UCIP_FA_2024_78881_91732.jpg

DS_ID:23545
FS_ID:78881
EP_NO: N/A
Repair Type: Non-Urgent
EVAL Issue: 11, Maintenance Compliance Issue
Crossing Status: Found
UCIP Comments: 09/18/2023 Pipe was CIPP lined. DMP internal video inspection has found none or minor pipe defects. Recommend next video inspection in 5 years. (O. Yakimov - DWR UCIP)
02/18/2021 Pipe status is still Non-Urgent. Bullet holes seen through LS flapgate compromising effectiveness. LMA stated they would have the holes welded shut within 2 years. DWR DMP has found integrity issues, LOF between 4 and 5. Crossing will be monitored until funding becomes available for rehabilitation. No permit was found authorizing this encroachment. CVFPB will need to review crossing to determine owner. The UCIP inspection was completed with GEI staff, B. Singh and LMA representative, M. McCoy. (H. Dunn ? GEI) 05/15/2014 Some sediment buildup inside pipe. (W. Wylie - DWR UCIP)
FIELD_STRUCT_DESC: 24-inch CIPP-lined corrugated metal drainage pipe (CMP) through the levee, 6.9 feet below the crown. Concrete U-shaped headwalls on both ends. Flap gate on the waterside (WS) end. Grouted intake on the landside (LS). Cobble grouted outlet across the berm. [Additional Reference(s): DWR Levee Log, 1987, (HLM 5.90). USACE San Joaquin O&M Manual 612.1, June 1965, (HLM 5.90), 24-inch pipe listed].

Levee crown looking upstream.

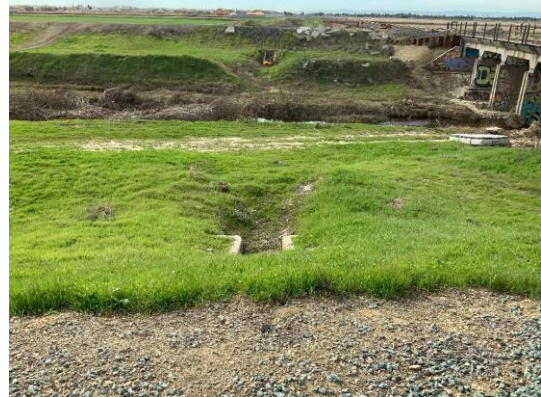
Photo 2 of 3 : UCIP_FA_2024_78881_91733.jpg

WS view: WS headwall at toe from crown.

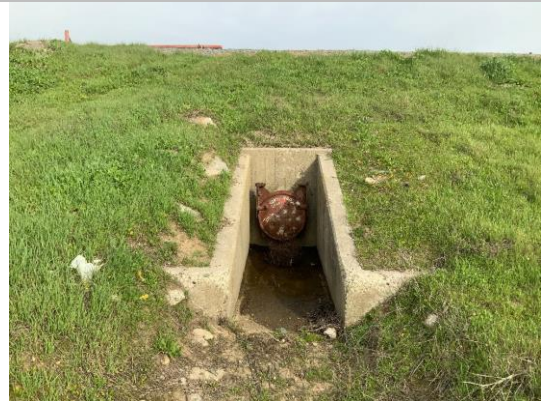
Photo 3 of 3 : UCIP_FA_2024_78881_91734.jpg

WS view: WS headwall and flapgate at toe.

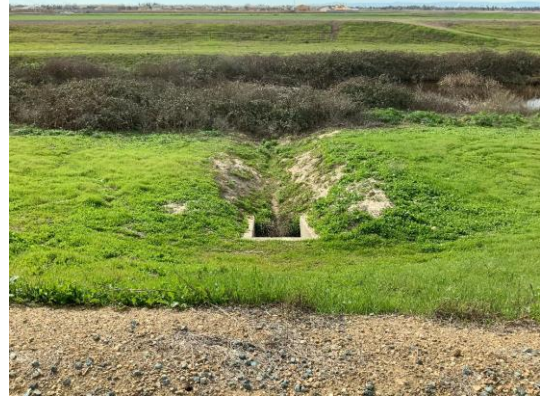
Photo 1 of 3 : UCIP_FA_2024_78882_91739.jpg

Comment Code						
Inspector Comment						
DS_ID:23546 FS_ID:78882 EP_NO: N/A Repair Type: Urgent EVAL Issue: 1, Pipe Integrity Crossing Status: Found UCIP Comments: 02/18/2021 The record has been upgraded from Non-Urgent to Urgent. No LS pipe visible, and LMA has confirmed that the pipe is abandoned, has been grouted, and will be removed within 5 years. DWR DMP has found integrity issues, LOF between 5 and 6. Crossing will be monitored until funding becomes available for it to be addressed. No permit was found authorizing this encroachment. CVFPB will need to review crossing to determine owner. The UCIP inspection was completed with GEI staff, B. Singh and LMA representative, M. McCoy. (H. Dunn ? GEI)05/15/2014 Inlet buried at LS toe. Pipe may be abandoned and if so should be done so properly. (W. Wylie - DWR UCIP) FIELD_STRUCT_DESC: 36-inch corrugated metal drainage pipe (CMP) through the levee, 7.9 feet below the crown. Concrete U-shaped headwall on the waterside (WS) end. Concrete headwall on the landside (LS). Flap gate on the WS end. Cobble grouted outlet across the berm. [Additional Reference(s): DWR Levee Log, 1987, (HLM 5.97). USACE San Joaquin O&M Manual 612.1, June 1965, (HLM 5.97), 36-inch pipe listed]. FS Date: 2/18/2021

WS view: WS headwall at toe from crown.

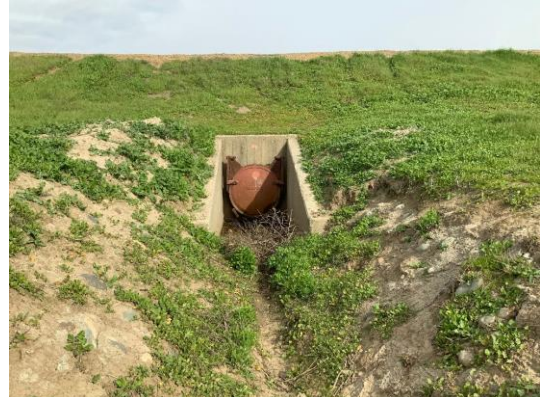
Photo 2 of 3 : UCIP_FA_2024_78882_91740.jpg

WS view: WS headwall and flapgate at toe.

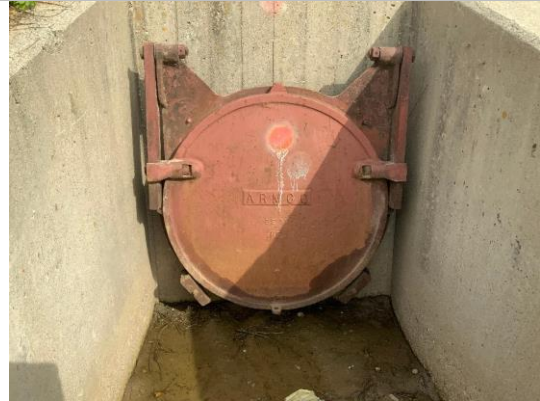
Photo 3 of 3 : UCIP_FA_2024_78882_91737.jpg

WS view: WS flapgate at toe.

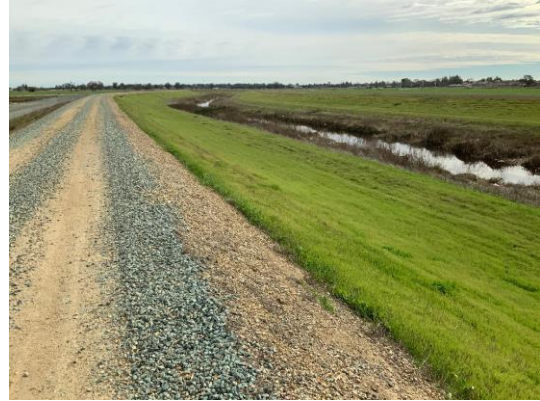
Photo 1 of 3 : UCIP_FA_2024_78306_91767.jpg

Comment Code						
Inspector Comment						
DS_ID:23549 FS_ID:78306 EP_NO: N/A Repair Type: Non-Urgent EVAL Issue: Crossing Status: Not Found UCIP Comments: 02/18/2021 The record has been upgraded from No Action Needed to Non-Urgent. Pipe not found by visual inspection. DWR DMP geophysical study did not confirm presence of pipe through levee. Record will remain in UCIP's inspection records until future Levee Improvement Project can confirm no crossing was found through the levee. LMA has confirmed that a stretch of multiple pipes have been removed in this levee mile, including this one. The UCIP inspection was completed with GEI staff, B. Singh and LMA representative, M. Mccoy. (H. Dunn ? GEI) FIELD_STRUCT_DESC: 24-inch corrugated metal drainage pipe (CMP) through the levee, 6.9 feet below the crown. Concrete U-shaped headwall on both ends. Flap gate on the waterside (WS) end. Grouted intake on the landside (LS). [Additional Reference(s): DWR Levee Log, 1987, (HLM 6.05). USACE San Joaquin O&M Manual 612.1, June 1965, (HLM 6.06), 24-inch pipe listed]. FS Date: 2/18/2021

Levee crown looking upstream.

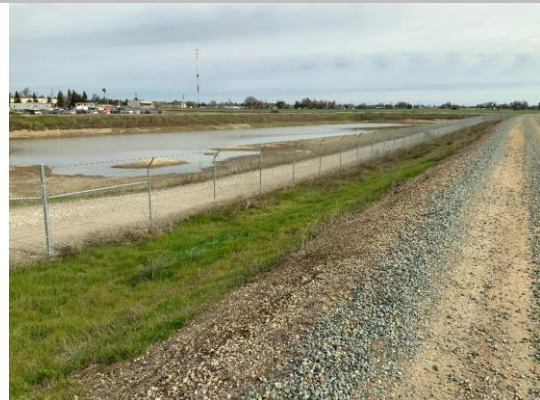
Photo 2 of 3 : UCIP_FA_2024_78306_91768.jpg

LS view: LS toe from crown, pipe removed.

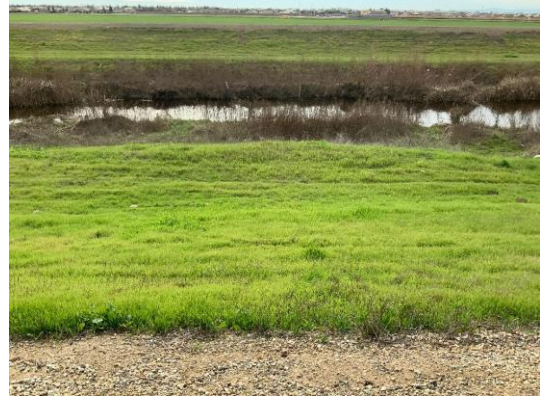
Photo 3 of 3 : UCIP_FA_2024_78306_91769.jpg

WS view: WS toe from crown, pipe removed.

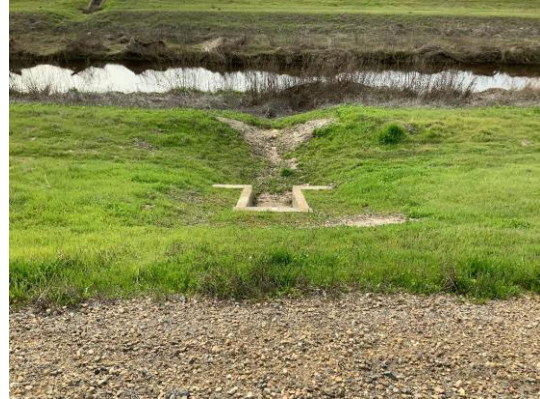
Photo 1 of 3 : UCIP_FA_2024_78943_91770.jpg

DS_ID:23550
FS_ID:78943
EP_NO: N/A
Repair Type: Non-Urgent
EVAL Issue:
Crossing Status: Found
UCIP Comments: 12/20/2022 Record updated from Urgent to Non-Urgent. Pipe has been CIPP lined. LOF of crossing is less or equal to 4. Recommend next video inspection in 5 years. (O.Yakimov - DWR UCIP)
02/18/2021 The record has been upgraded from No Action Needed to Urgent. DWR DMP has found integrity issues, LOF between 5 and 6. Crossing will be monitored until funding becomes available for it to be addressed. No permit was found authorizing this encroachment. CVFPB will need to review crossing to determine owner. The UCIP inspection was completed with GEI staff, B. Singh and LMA representative, M. McCoy. (H. Dunn ? GEI)
FIELD_STRUCT_DESC: 24-inch CIPP-lined corrugated metal drainage pipe (CMP) through the levee, 5.9 feet below the crown. Concrete U-shaped headwalls on both ends. Flap gate on the waterside (WS) end. Grouted intake on the landside (LS). Cobble grouted outlet across the berm. [Additional Reference(s): DWR Levee Log, 1987, (HLM 6.20). USACE San Joaquin O&M Manual 612.1, June 1965, (HLM 6.20), 24-inch pipe listed].

WS view: WS headwall at toe from crown.

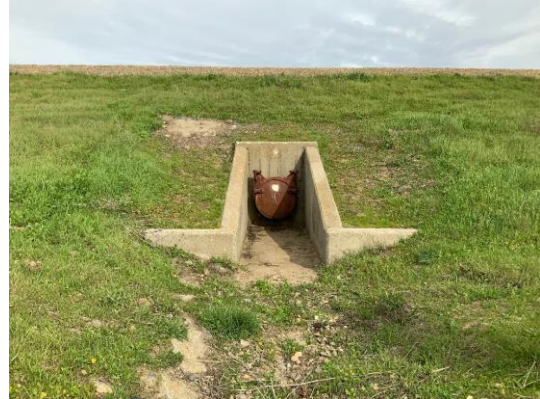
Photo 2 of 3 : UCIP_FA_2024_78943_91771.jpg

WS view: WS headwall and flapgate at toe.

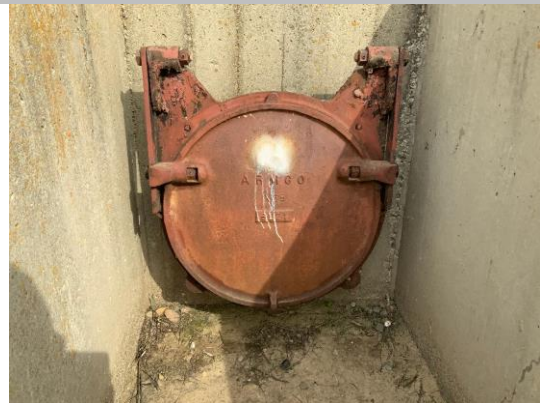
Photo 3 of 3 : UCIP_FA_2024_78943_91772.jpg

WS view: WS flapgate at toe.

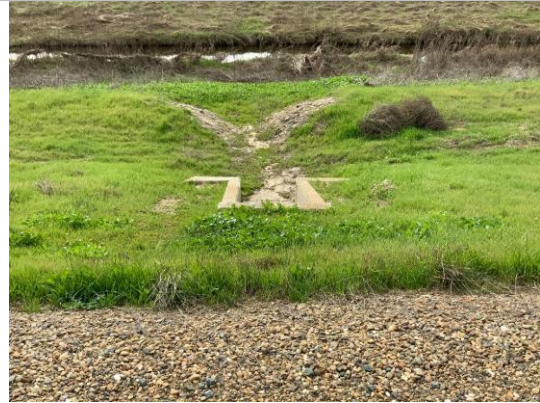
Photo 1 of 3 : UCIP_FA_2024_78884_91777.jpg

Comment Code						
Inspector Comment						
DS_ID:23551 FS_ID:78884 EP_NO: N/A Repair Type: No Action Needed EVAL Issue: Crossing Status: Found UCIP Comments: 09/18/2023 Record updated from Non-Urgent to No Action Needed. Pipe was CIPP lined. DMP internal video inspection has found none or minor pipe defects. Recommend next video inspection in 5 years. (O. Yakimov - DWR UCIP) 02/18/2021 Pipe status is still Non-Urgent. DWR DMP has found integrity issues, LOF between 4 and 5. Crossing will be monitored until funding becomes available for rehabilitation. No permit was found authorizing this encroachment. CVFPB will need to review crossing to determine owner. The UCIP inspection was completed with GEI staff, B. Singh and LMA representative, M. Mccoy. (H. Dunn ? GEI) 05/15/2014 Sediment buildup in pipe at LS toe. (W. Wylie - DWR UCIP) FIELD_STRUCT_DESC: 24-inch CIPP-lined corrugated metal storm drainage pipe (CMP) through the levee, 5.5 feet below the crown. Concrete U-shaped headwalls on both ends. Flap gate on the waterside (WS) end. Grouted intake on the landside (LS). Cobble grouted outlet across the berm. [Additional Reference(s): DWR Levee Log, 1987, (HLM 6.32). USACE San Joaquin O&M Manual 612.1, June 1965, (HLM 6.32), and 612 (addendum), February 1999, (HLM 6.34), (Station 334+54), 36-inch pipe listed]. FS Date: 2/18/2021

WS view: WS headwall at toe from crown.

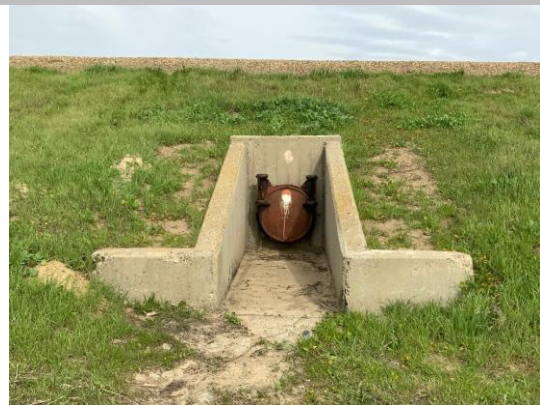
Photo 2 of 3 : UCIP_FA_2024_78884_91778.jpg

WS view: WS headwall and flapgate at toe.

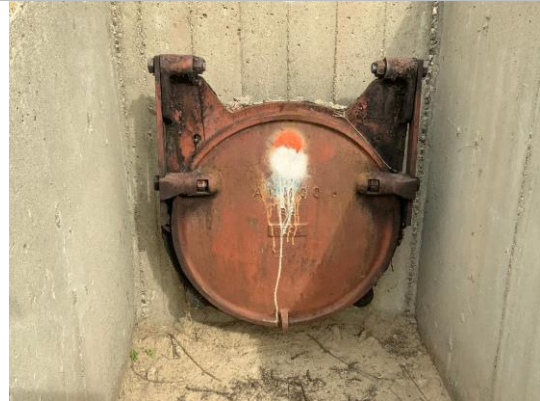
Photo 3 of 3 : UCIP_FA_2024_78884_91779.jpg

WS view: WS flapgate at toe.

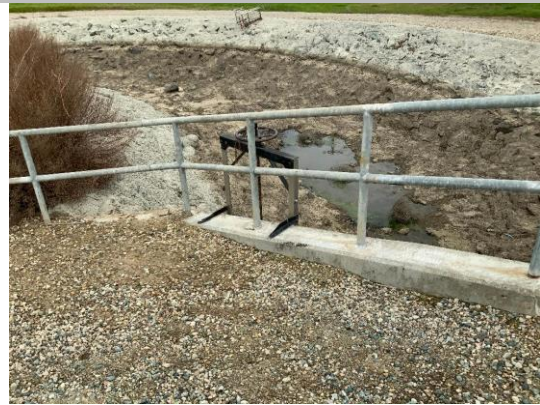
Photo 1 of 3 : UCIP_FA_2024_78944_91804.jpg

LS view: LS headwall at toe from crown.

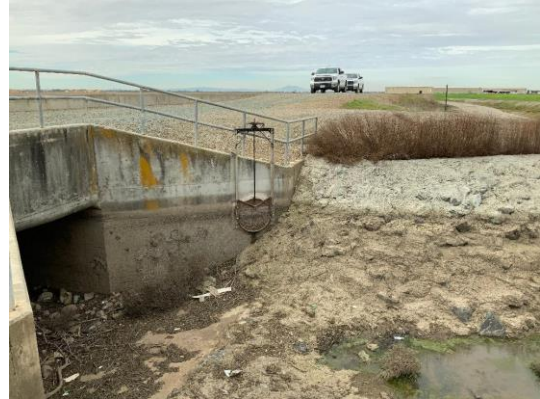
Photo 2 of 3 : UCIP_FA_2024_78944_91805.jpg

LS view: LS headwall and slide gate at toe.

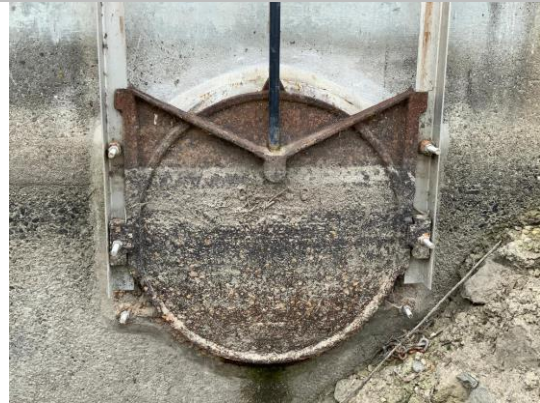
Photo 3 of 3 : UCIP_FA_2024_78944_91806.jpg

LS view: LS slide gate at toe.

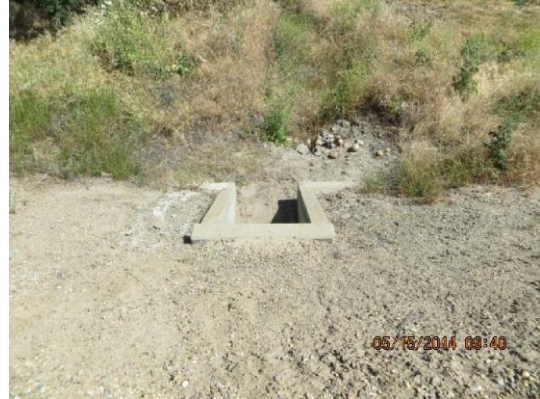
Photo 1 of 3 : UCIP_FA_2024_78945_68873.jpg

Comment Code						
Inspector Comment						
DS_ID:23554 FS_ID:78945 EP_NO: N/A Repair Type: No Action Needed EVAL Issue: Crossing Status: Found UCIP Comments: 09/18/2023 Record updated from Non-Urgent to No Action Needed. Pipe was CIPP lined. DMP internal video inspection has found none or minor pipe defects. Recommend next video inspection in 5 years. (O. Yakimov - DWR UCIP) 02/18/2021 The record has been upgraded from No Action Needed to Non-Urgent. DWR DMP has found integrity issues, LOF between 4 and 5. Crossing will be monitored until funding becomes available for rehabilitation. No permit was found authorizing this encroachment. CVFPB will need to review crossing to determine owner. The UCIP inspection was completed with GEI staff, B. Singh and LMA representative, M. Mccoy. (H. Dunn ? GEI) FIELD_STRUCT_DESC: 24-inch CIPP-lined corrugated metal storm drainage pipe (CMP) through the levee, 5.3 feet below the crown. Concrete U-shaped headwalls on both ends. Flap gate on the waterside (WS) end. Grouted intake on the landside (LS). Cobble grouted outlet across the berm. [Additional Reference(s): DWR Levee Log, 1987, (HLM 6.53). USACE San Joaquin O&M Manual 612.1, June 1965, (HLM 6.53), 24-inch pipe listed]. FS Date: 2/18/2021

Headwall on LS toe.

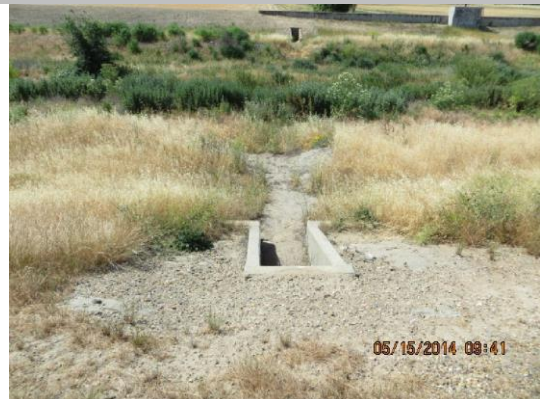
Photo 2 of 3 : UCIP_FA_2024_78945_68872.jpg

Headwall, flap gate, and cobble grouted outlet on WS toe.

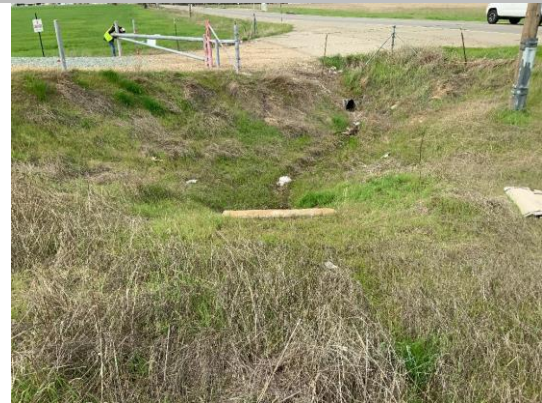
Photo 1 of 3 : UCIP_FA_2024_78947_91834.jpg

DS_ID:23555
 FS_ID:78947
 EP_NO: N/A
 Repair Type: No Action Needed
 EVAL Issue:
 Crossing Status: Found
 UCIP Comments: 09/18/2023 Record updated from Non-Urgent to No Action Needed. Pipe was CIPP lined. DMP internal video inspection has found none or minor pipe defects. Recommend next video inspection in 5 years. (O. Yakimov - DWR UCIP)
 02/18/2021 The record has been upgraded from No Action Needed to Non-Urgent. DWR DMP has found integrity issues, LOF between 4 and 5. Crossing will be monitored until funding becomes available for rehabilitation. No permit was found authorizing this encroachment. CVFPB will need to review crossing to determine owner. The UCIP inspection was completed with GEI staff, B. Singh and LMA representative, M. McCoy. (H. Dunn ? GEI)
 FIELD_STRUCT_DESC: 24-inch CIPP-lined corrugated metal storm drainage pipe (CMP) through the levee, 6.7 feet below the crown. Concrete U-shaped headwalls on both ends. Flap gate on the waterside (WS) end. Grouted intake on the landside (LS). Cobble grouted outlet across the berm. [Additional Reference(s): DWR Levee Log, 1987, (HLM 6.85). USACE San Joaquin O&M Manual 612.1, June 1965, (HLM 6.85), 24-inch pipe listed].

LS view: LS headwall at toe from crown.

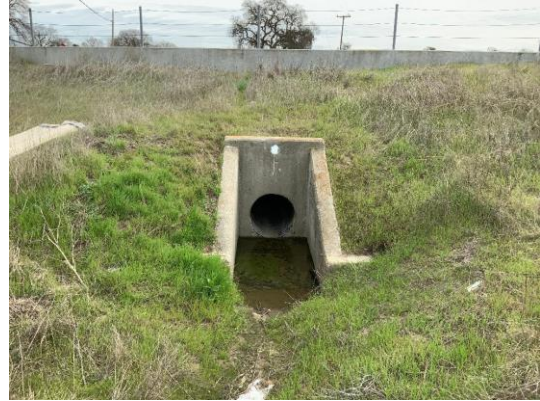
Photo 2 of 3 : UCIP_FA_2024_78947_91835.jpg

LS view: LS headwall at toe.

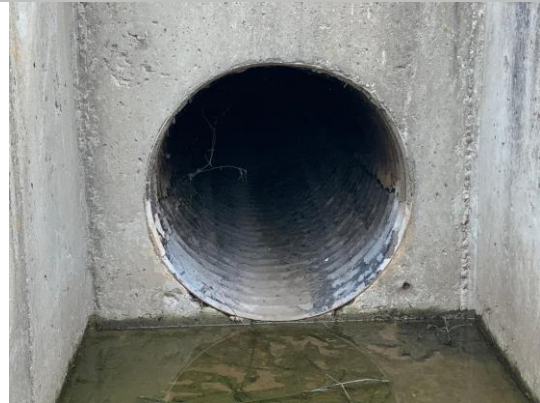
Photo 3 of 3 : UCIP_FA_2024_78947_91836.jpg

LS view: LS pipe.

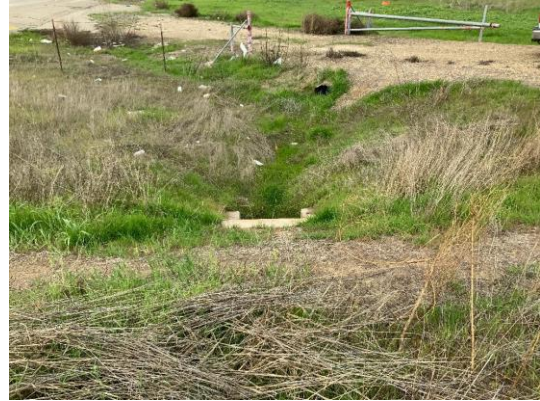
Photo 1 of 3 : UCIP_FA_2024_78948_91844.jpg

Comment Code					
Inspector Comment					
DS_ID:23556 FS_ID:78948 EP_NO: N/A Repair Type: No Action Needed EVAL Issue: Crossing Status: Found UCIP Comments: 09/18/2023 Record updated from Non-Urgent to No Action Needed. Pipe was CIPP lined. DMP internal video inspection has found none or minor pipe defects. Recommend next video inspection in 5 years. (O. Yakimov - DWR UCIP) 02/18/2021 Pipe status is still Non-Urgent. DWR DMP has found integrity issues, LOF between 4 and 5. Crossing will be monitored until funding becomes available for rehabilitation. The UCIP inspection was completed with GEI staff, B. Singh and LMA representative, M. Mccoy. (H. Dunn ? GEI)05/15/2014 Some silt buildup inside pipe at LS toe. (W. Wylie - DWR UCIP) FIELD_STRUCT_DESC: 24-inch CIPP-lined corrugated metal storm drainage pipe (CMP) through the levee, 6.0 feet below the crown. Concrete U-shaped headwalls on both ends. Flap gate on the waterside (WS) end. Grouted intake on the landside (LS) end. Cobble grouted outlet across the berm. [Additional Reference(s): DWR Levee Log, 1987, (HLM 6.88). USACE San Joaquin O&M Manual 612.1, June 1965, (HLM 6.88), and 612 (addendum), February 1999, (HLM 6.95), (Station 367+11), 24-inch pipe listed]. FS Date: 2/18/2021

LS view: LS headwall at toe from crown.

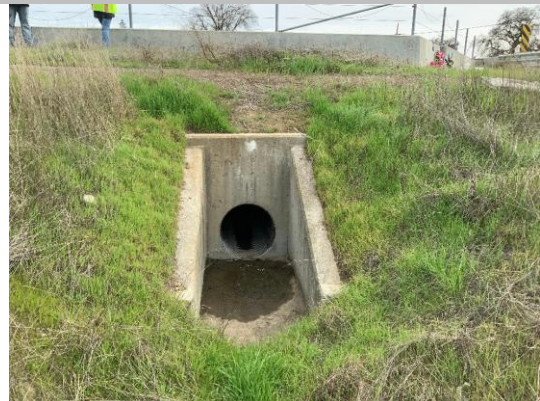
Photo 2 of 3 : UCIP_FA_2024_78948_91845.jpg

LS view: LS headwall at toe.

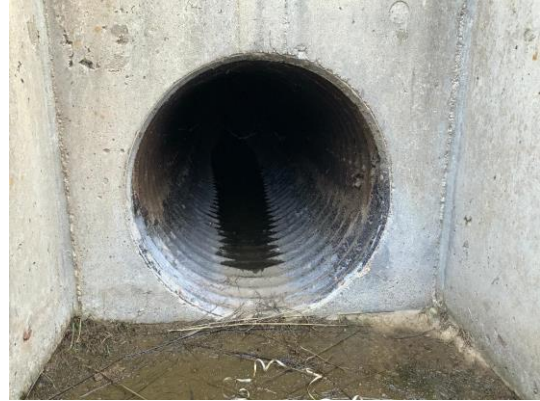
Photo 3 of 3 : UCIP_FA_2024_78948_91846.jpg

LS view: LS pipe.

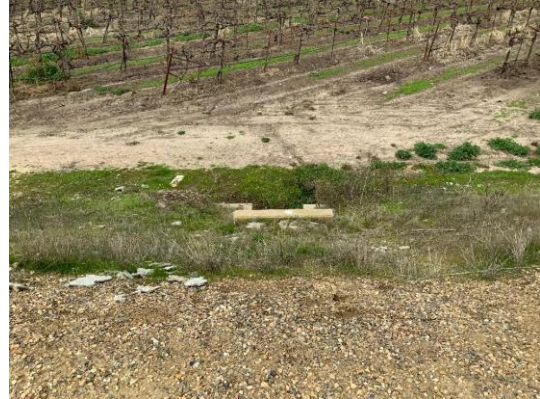
Photo 1 of 3 : UCIP_FA_2024_78889_91851.jpg

DS_ID:23557
FS_ID:78889
EP_NO: N/A
Repair Type: No Action Needed
EVAL Issue:
Crossing Status: Found
UCIP Comments: 09/18/2023 Record updated from Non-Urgent to No Action Needed. Pipe was CIPP lined. DMP internal video inspection has found none or minor pipe defects. Recommend next video inspection in 5 years. (O. Yakimov - DWR UCIP)
02/18/2021 The record has been upgraded from No Action Needed to Non-Urgent. DWR DMP has found integrity issues, LOF between 4 and 5. Crossing will be monitored until funding becomes available for rehabilitation. No permit was found authorizing this encroachment. CVFPB will need to review crossing to determine owner. The UCIP inspection was completed with GEI staff, B. Singh and LMA representative, M. McCoy. (H. Dunn ? GEI)
FIELD_STRUCT_DESC: 24-inch CIPP-lined corrugated metal storm drainage pipe (CMP) through the levee, 6.5 feet below the crown. Concrete U-shaped headwalls on both ends. Flap gate on the waterside (WS) end. Cobble grouted outlet across the berm. Culvert with slide gate in headwall on the WS. [Additional Reference(s): DWR Levee Log, 1987, (HLM 7.04). USACE San Joaquin O&M Manual 612.1, June 1965, (HLM 7.02), and 612 (addendum), February 1999, (HLM 6.97), (Station 368+08), 24-inch pipe listed].

LS view: LS headwall at toe from crown.

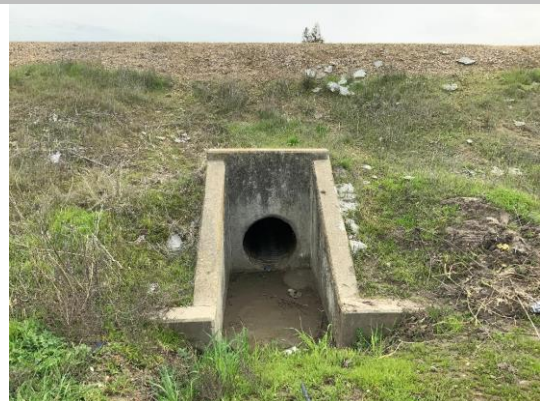
Photo 2 of 3 : UCIP_FA_2024_78889_91852.jpg

LS view: LS headwall at toe.

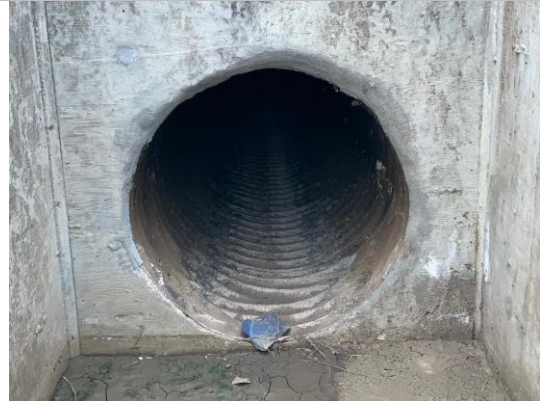
Photo 3 of 3 : UCIP_FA_2024_78889_91853.jpg

LS view: LS pipe.

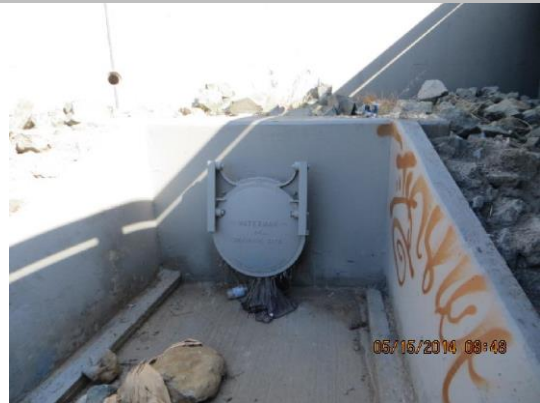
Photo 1 of 3 : UCIP_FA_2024_78890_68857.jpg

DS_ID:23559
FS_ID:78890
EP_NO: N/A
Repair Type: Urgent
EVAL Issue: 1, Pipe Integrity
Crossing Status: Found
UCIP Comments: 02/24/2021 The record has been upgraded from No Action Needed to Urgent. Did not inspect LS due to safety issues (large homeless encampment under freeway). DWR DMP has found integrity issues, LOF between 5 and 6. Crossing will be monitored until funding becomes available to address the issues. No permit was found authorizing this encroachment. CVFPB will need to review crossing to determine owner. The UCIP inspection was completed with GEI staff, B. Singh. (H. Dunn ? GEI)
FIELD_STRUCT_DESC: 24-inch corrugated metal storm drainage pipe (CMP) through the levee, 9.0 feet below the crown. Concrete U-shaped headwalls on both ends. Flap gate on the waterside (WS) end. Cobble grouted outlet across the berm. Cobble grouted apron on the landside (LS) end. [Additional Reference(s): DWR Levee Log, 1987, (HLM 7.17). USACE As-Built Drawing No. CA3-04-008, Sheet No. 28, 1 February 1963, existing structure just downstream of southbound Highway 99].

Pipe, headwall, and flapgate on WS toe.

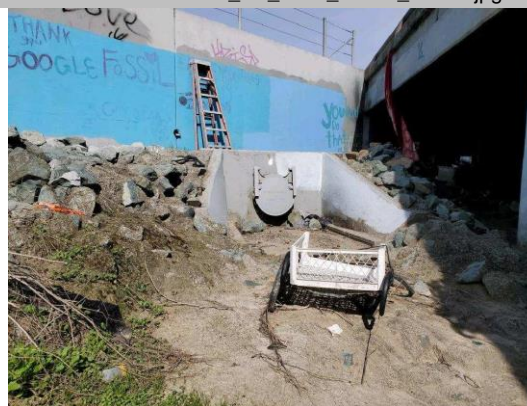
Photo 2 of 3 : UCIP_FA_2024_78890_91860.jpg

WS headwall and flapgate at toe.

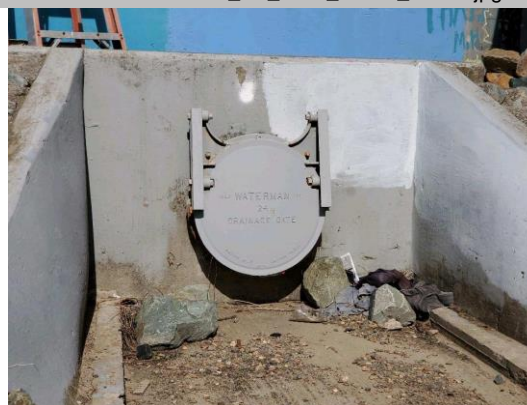
Photo 3 of 3 : UCIP_FA_2024_78890_91861.jpg

WS flapgate at toe.

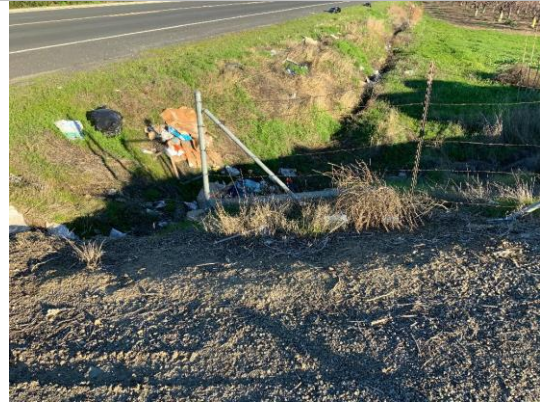
Photo 1 of 3 : UCIP_FA_2024_78892_91867.jpg

Comment Code					
Inspector Comment					
DS_ID:23561 FS_ID:78892 EP_NO: N/A Repair Type: Non-Urgent EVAL Issue: 6, Levee Damage or Threat for Levee Damage Crossing Status: Found UCIP Comments: 02/24/2021 The record has been upgraded from No Action Needed to Non-Urgent. Minor erosion along the right edge of the LS headwall and slope. DWR DMP has not found internal issues, LOF between 1 and 2. Recommend inspection in 5 years. No permit was found authorizing this encroachment. CVFPB will need to review crossing to determine owner. The UCIP inspection was completed with GEI staff, B. Singh. (H. Dunn ? GEI) FIELD_STRUCT_DESC: 36-inch concrete storm drainage pipe through the levee, 8.0 feet below the crown. Concrete U-shaped headwalls on both ends. Flap gate on the waterside (WS) end. Cobble grouted outlet across the berm. Cobble grouted apron on the landside (LS) end. [Additional Reference(s): DWR Levee Log, 1987, (HLM 7.21). USACE San Joaquin O&M Manual 612.2, 1967, (HLM 7.21), 36-inch pipe listed]. FS Date: 2/24/2021

LS headwall at toe from crown.

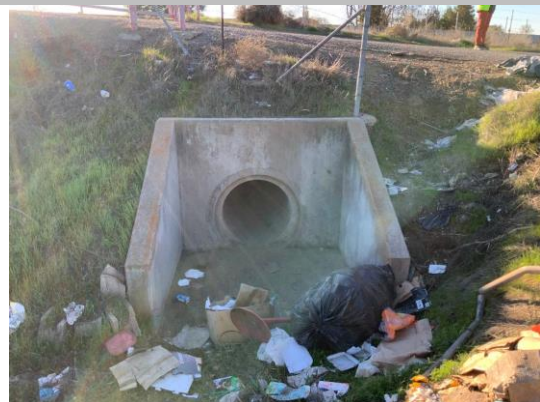
Photo 2 of 3 : UCIP_FA_2024_78892_91868.jpg

LS headwall at toe.

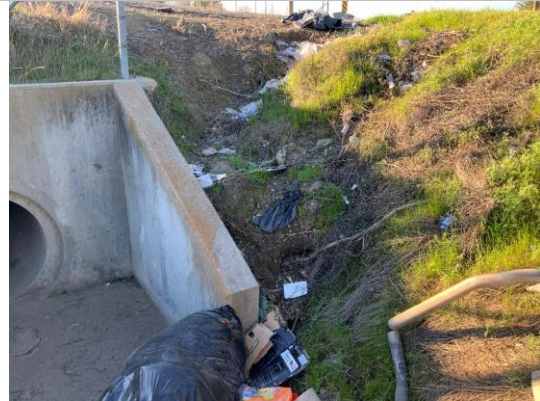
Photo 3 of 3 : UCIP_FA_2024_78892_91862.jpg

LS headwall with minor erosion on slope on side of headwall.

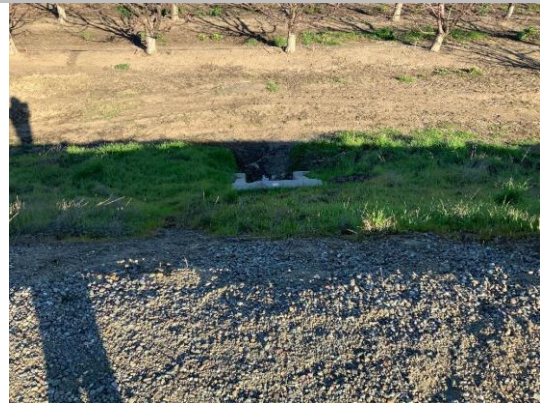
Photo 1 of 3 : UCIP_FA_2024_78949_91882.jpg

DS_ID:23562
FS_ID:78949
EP_NO: N/A
Repair Type: Non-Urgent
EVAL Issue:
Crossing Status: Found
UCIP Comments: 12/20/2022 Record updated from Urgent to Non-Urgent. Pipe has been CIPP lined. LOF of crossing is less or equal to 4. Recommend next video inspection in 5 years. (O.Yakimov - DWR UCIP)
02/24/2021 Record updated from No Action Needed to Urgent. DMP internal video inspection has found pipe integrity issues. LOF of crossing is between 5 and 6. Crossing will be monitored until funding becomes available to address the issues. No permit was found authorizing this encroachment. CVFPB will need to review crossing to determine owner. The UCIP inspection was completed with GEI staff, B. Singh. (H. Dunn ? GEI)
FIELD_STRUCT_DESC: 24-inch CIPP-lined corrugated metal storm drainage pipe (CMP) through the levee, 8.0 feet below the crown. Concrete U-shaped headwalls on both ends. Flap gate on the waterside (WS) end. Cobble grouted outlet across the berm. Cobble grouted apron on the landside (LS) end. [Additional Reference(s): DWR Levee Log, 1987, (HLM 7.34). USACE San Joaquin O&M Manual 612.2, 1967, (HLM 7.34), and 612 (addendum), February 1999, (HLM 7.30), (Station 385+65), 24-inch pipe listed].

LS view: LS headwall at toe from crown.

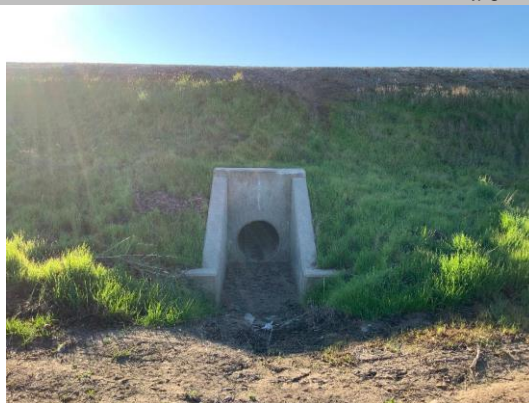
Photo 2 of 3 : UCIP_FA_2024_78949_91883.jpg

LS view: LS headwall at toe.

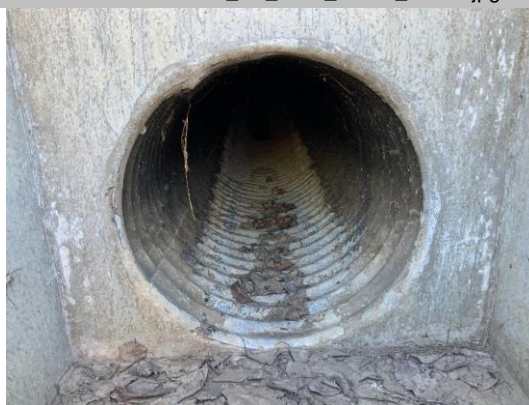
Photo 3 of 3 : UCIP_FA_2024_78949_91884.jpg

LS view: LS pipe.

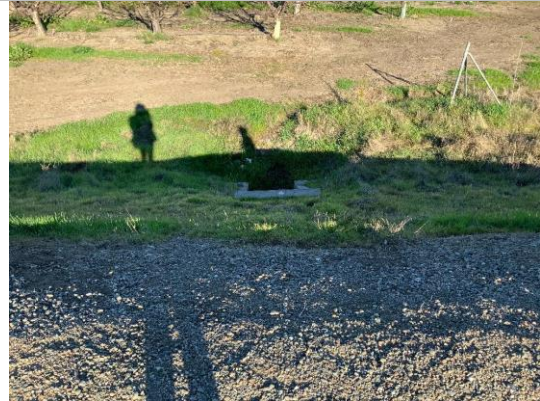
Photo 1 of 3 : UCIP_FA_2024_78950_91889.jpg

Comment Code						
Inspector Comment						
DS_ID:23563 FS_ID:78950 EP_NO: N/A Repair Type: Non-Urgent EVAL Issue: Crossing Status: Found UCIP Comments: 02/24/2021 The record has been upgraded from No Action Needed to Non-Urgent. DWR DMP has not found internal issues, LOF between 1 and 2. Recommend inspection in 5 years. No permit was found authorizing this encroachment. CVFPB will need to review crossing to determine owner. The UCIP inspection was completed with GEI staff, B. Singh. (H. Dunn ? GEI) FIELD_STRUCT_DESC: 24-inch corrugated metal storm drainage pipe (CMP) through the levee, 7.0 feet below the crown. Concrete U-shaped headwalls on both ends. Flap gate on the waterside (WS) end. Cobble grouted outlet across the berm. Cobble grouted apron on the landside (LS) end. [Additional Reference(s): DWR Levee Log, 1987, (HLM 7.52). USACE San Joaquin O&M Manual 612.2, 1967, (HLM 7.51), and 612 (addendum), February 1999, (HLM 7.45), (Station 393+26), 24-inch pipe listed]. FS Date: 2/24/2021

LS headwall at toe from crown.

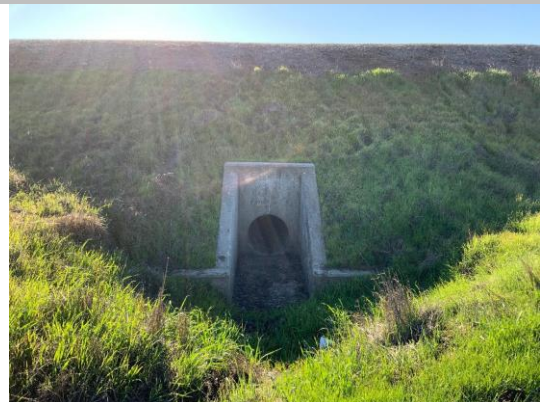
Photo 2 of 3 : UCIP_FA_2024_78950_91890.jpg

LS headwall at toe.

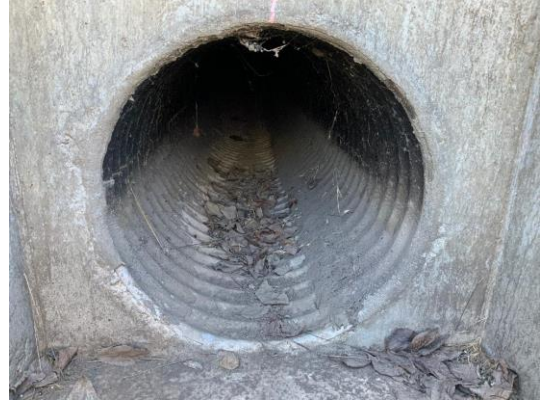
Photo 3 of 3 : UCIP_FA_2024_78950_91891.jpg

LS pipe.

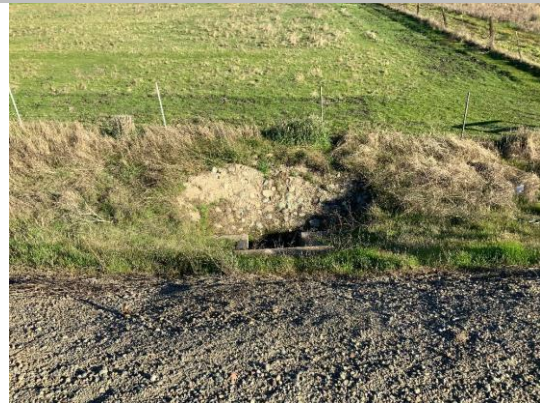
Photo 1 of 3 : UCIP_FA_2024_78952_91896.jpg

DS_ID:23564
 FS_ID:78952
 EP_NO: N/A
 Repair Type: Non-Urgent
 EVAL Issue:
 Crossing Status: Found
 UCIP Comments: 02/24/2021 The record has been upgraded from No Action Needed to Non-Urgent. DWR DMP has not found internal issues, LOF between 1 and 2. Recommend inspection in 5 years. No permit was found authorizing this encroachment. CVFPB will need to review crossing to determine owner. The UCIP inspection was completed with GEI staff, B. Singh. (H. Dunn ? GEI)
 FIELD_STRUCT_DESC: 24-inch corrugated metal storm drainage pipe (CMP) through the levee, 7.5 feet below the crown. Concrete U-shaped headwalls on both ends. Flap gate on the waterside (WS) end. Cobble grouted outlet across the berm. Cobble grouted apron on the landside (LS) end. [Additional Reference(s): DWR Levee Log, 1987, (HLM 7.72). USACE San Joaquin O&M Manual 612.2, 1967, (HLM 7.72), 24-inch pipe listed].
 FS Date: 2/24/2021

LS view: LS headwall at toe from crown.

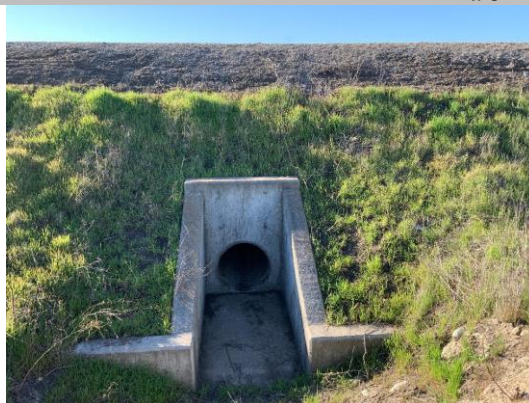
Photo 2 of 3 : UCIP_FA_2024_78952_91897.jpg

LS view: LS headwall at toe.

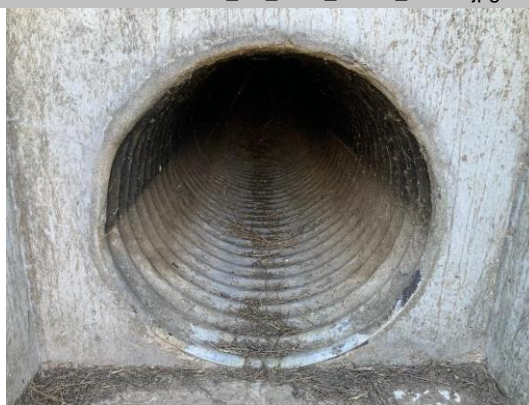
Photo 3 of 3 : UCIP_FA_2024_78952_91898.jpg

LS view: LS pipe.

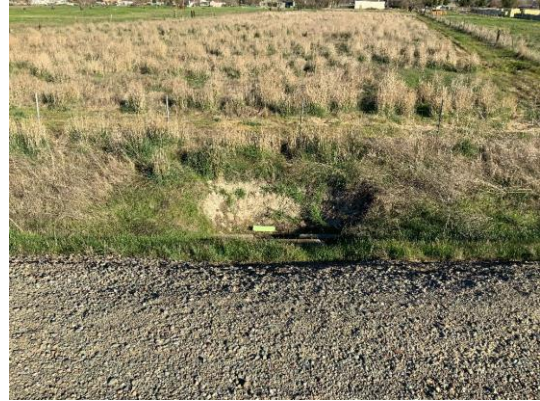
Photo 1 of 3 : UCIP_FA_2024_78953_91904.jpg

Comment Code						
Inspector Comment						
DS_ID:23565 FS_ID:78953 EP_NO: N/A Repair Type: No Action Needed EVAL Issue: Crossing Status: Found UCIP Comments: 09/18/2023 Record updated from Non-Urgent to No Action Needed. Pipe was CIPP lined. DMP internal video inspection has found none or minor pipe defects. Recommend next video inspection in 5 years. (O. Yakimov - DWR UCIP) 02/24/2021 The record has been upgraded from No Action Needed to Non-Urgent. DWR DMP has found integrity issues, LOF between 4 and 5. Crossing will be monitored until funding becomes available for rehabilitation. No permit was found authorizing this encroachment. CVFPB will need to review crossing to determine owner. The UCIP inspection was completed with GEI staff, B. Singh. (H. Dunn ? GEI) FIELD_STRUCT_DESC: 24-inch CIPP-lined corrugated metal storm drainage pipe (CMP) through the levee, 7.0 feet below the crown. Concrete U-shaped headwalls on both ends. Flap gate on the waterside (WS) end. Cobble grouted outlet across the berm. Cobble grouted apron on the landside (LS) end. [Additional Reference(s): DWR Levee Log, 1987, (HLM 7.75). USACE San Joaquin O&M Manual 612.2, 1967, (HLM 7.75), 24-inch pipe listed]. FS Date: 2/24/2021

LS headwall at toe from crown.

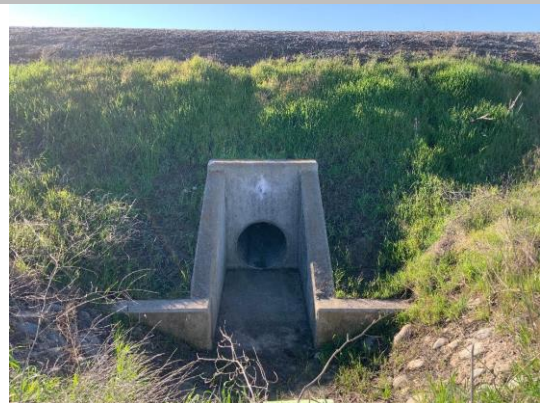
Photo 2 of 3 : UCIP_FA_2024_78953_91905.jpg

LS headwall at toe.

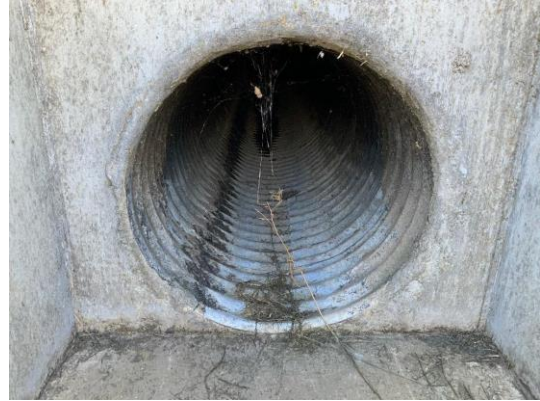
Photo 3 of 3 : UCIP_FA_2024_78953_91906.jpg

LS pipe.

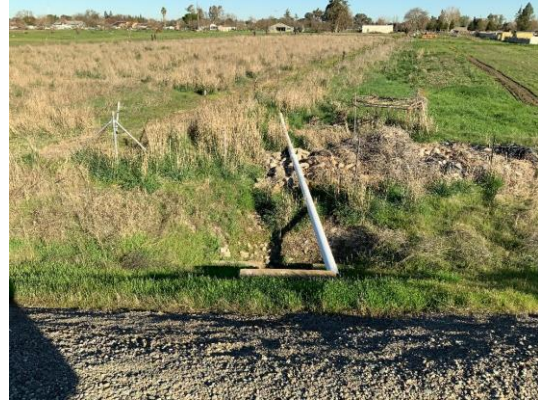
Photo 1 of 3 : UCIP_FA_2024_78954_91912.jpg

Comment Code						
Inspector Comment						
DS_ID:23566 FS_ID:78954 EP_NO: N/A Repair Type: No Action Needed EVAL Issue: Crossing Status: Found UCIP Comments: 09/18/2023 Record updated from Non-Urgent to No Action Needed. Pipe was CIPP lined. DMP internal video inspection has found none or minor pipe defects. Recommend next video inspection in 5 years. (O. Yakimov - DWR UCIP) 02/24/2021 The record has been upgraded from No Action Needed to Non-Urgent. DWR DMP has found integrity issues, LOF between 4 and 5. Crossing will be monitored until funding becomes available for rehabilitation. No permit was found authorizing this encroachment. CVFPB will need to review crossing to determine owner. Small plastic pipe that was previously laying inside drainage pipe is now laying outside adjacent to headwall. The UCIP inspection was completed with GEI staff, B. Singh. (H. Dunn ? GEI) FIELD_STRUCT_DESC: 24-inch CIPP-lined corrugated metal storm drainage pipe (CMP) through the levee, 7.0 feet below the crown. Concrete U-shaped headwalls on both ends. Flap gate on the waterside (WS) end. Cobble grouted outlet across the berm. Cobble grouted apron on the landside (LS) end. [Additional Reference(s): DWR Levee Log, 1987, (HLM 7.76). USACE San Joaquin O&M Manual 612.2, 1967, (HLM 7.76), and 612 (addendum), February 1999, (HLM 7.78), (Station 410+54), 24-inch pipe listed]. FS Date: 2/24/2021

LS headwall at toe from crown.

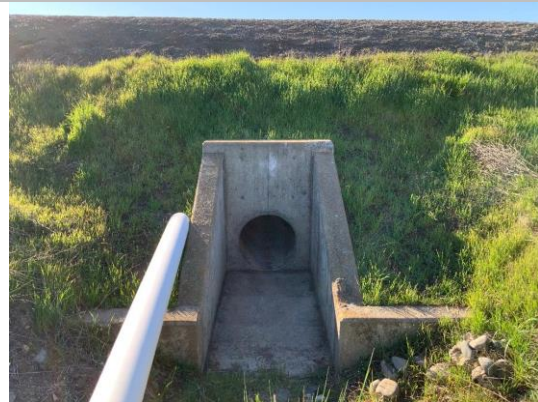
Photo 2 of 3 : UCIP_FA_2024_78954_91913.jpg

LS headwall at toe.

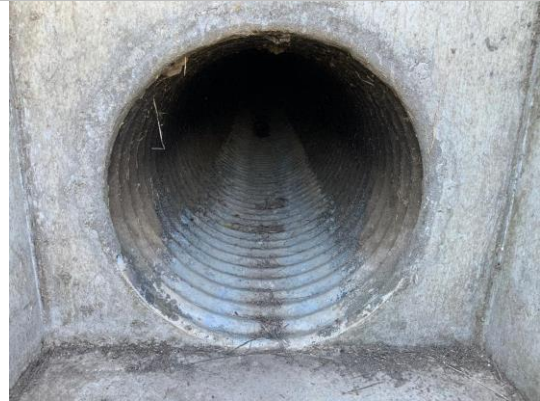
Photo 3 of 3 : UCIP_FA_2024_78954_91914.jpg

LS pipe.

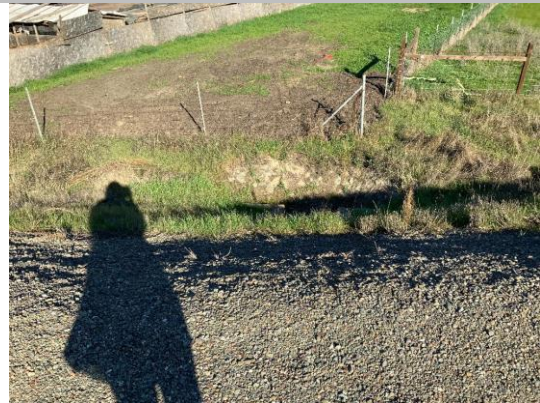
Photo 1 of 3 : UCIP_FA_2024_78955_91921.jpg

DS_ID:23567
FS_ID:78955
EP_NO: N/A
Repair Type: Non-Urgent
EVAL Issue:
Crossing Status: Found
UCIP Comments: 12/20/2022 Record updated from Urgent to Non-Urgent. Pipe has been CIPP lined. LOF of crossing is less or equal to 4. Recommend next video inspection in 5 years. (O.Yakimov - DWR UCIP)
02/24/2021 The record has been upgraded from No Action Needed to Urgent. Significant peeling of metal inside LS pipe. DWR DMP has found integrity issues, LOF between 5 and 6. Crossing will be monitored until funding becomes available to address the issues. No permit was found authorizing this encroachment. CVFPB will need to review crossing to determine owner. The UCIP inspection was completed with GEI staff, B. Singh. (H. Dunn ? GEI)
FIELD_STRUCT_DESC: 24-inch CIPP-lined corrugated metal storm drainage pipe (CMP) through the levee, 7.0 feet below the crown. Concrete U-shaped headwalls on both ends. Flap gate on the waterside (WS) end. Cobble grouted outlet across the berm. Cobble grouted apron on the landside (LS) end. [Additional Reference(s): DWR Levee Log, 1987, (HLM 7.99). USACE San Joaquin O&M Manual 612.2, 1967, (HLM 7.99), and 612 (addendum), February 1999, (HLM 7.94), (Station 419+06), 24-inch pipe listed].

LS view: LS headwall at toe from crown.

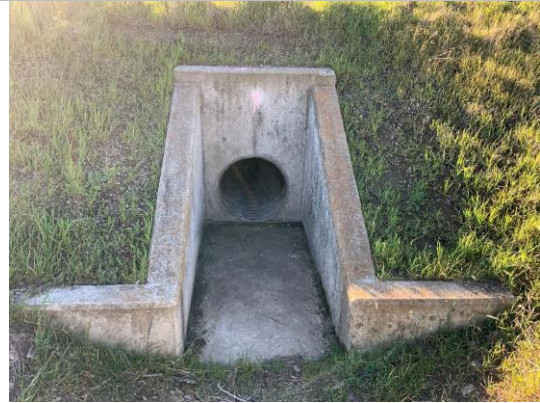
Photo 2 of 3 : UCIP_FA_2024_78955_91922.jpg

LS view: LS headwall at toe.

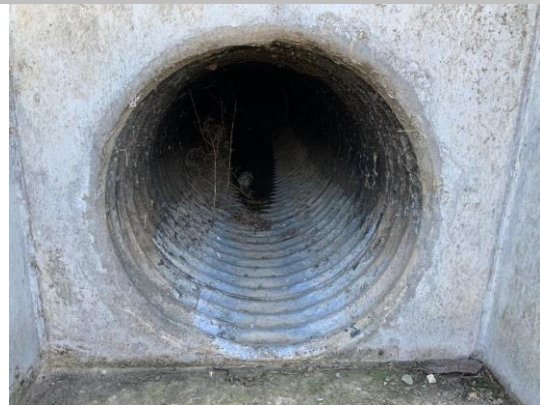
Photo 3 of 3 : UCIP_FA_2024_78955_91915.jpg

LS view: LS pipe.

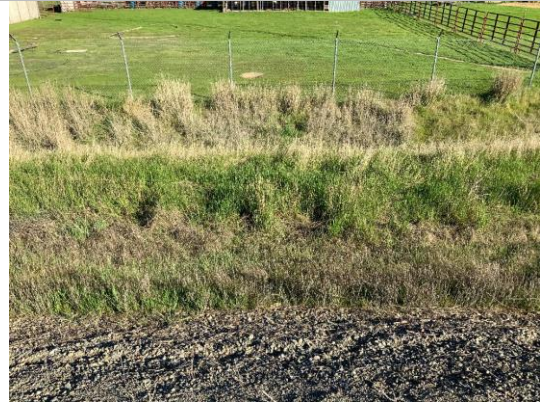
Photo 1 of 3 : UCIP_FA_2024_78330_91925.jpg

Comment Code					
Inspector Comment					
DS_ID:23663 FS_ID:78330 EP_NO: N/A Repair Type: Non-Urgent EVAL Issue: Crossing Status: Not Found UCIP Comments: 02/24/2021 The record has been upgraded from No Action Needed to Non-Urgent. Pipe not found by visual inspection. DWR DMP geophysical study did not confirm presence of pipe through levee. Record will remain in UCIP's inspection records until future Levee Improvement Project can confirm no crossing was found through the levee. No permit was found authorizing this encroachment. CVFPB will need to review crossing to determine owner. The UCIP inspection was completed with GEI staff, B. Singh. (H. Dunn ? GEI) FIELD_STRUCT_DESC: 24-inch storm drainage pipe of an unknown material through the levee, at an unknown depth. [Additional Reference(s): USACE San Joaquin O&M Manual 612 (addendum), February 1999, (HLM 8.14), (Station 429+90), 24-inch pipe listed]. FS Date: 2/24/2021

LS view: LS toe from crown, no pipe visible.

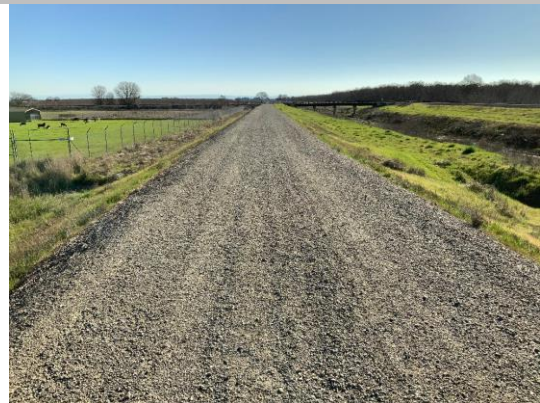
Photo 2 of 3 : UCIP_FA_2024_78330_91923.jpg

Levee crown looking upstream.

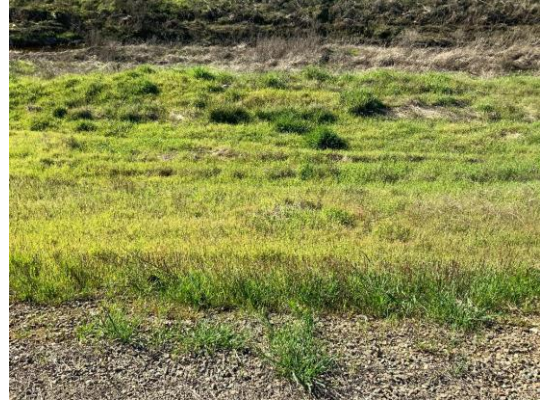
Photo 3 of 3 : UCIP_FA_2024_78330_91924.jpg

WS view: WS toe from crown, no pipe visible.

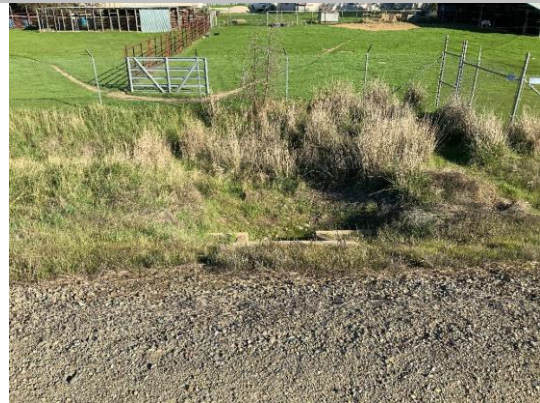
Photo 1 of 3 : UCIP_FA_2024_78899_91930.jpg

DS_ID:23568
FS_ID:78899
EP_NO: N/A
Repair Type: No Action Needed
EVAL Issue:
Crossing Status: Found
UCIP Comments: 09/18/2023 Record updated from Non-Urgent to No Action Needed. Pipe was CIPP lined. DMP internal video inspection has found none or minor pipe defects. Recommend next video inspection in 5 years. (O. Yakimov - DWR UCIP)
02/24/2021 The record has been upgraded from No Action Needed to Non-Urgent. Significant peeling of metal inside LS pipe. DWR DMP has found integrity issues, LOF between 4 and 5. Crossing will be monitored until funding becomes available for rehabilitation. No permit was found authorizing this encroachment. CVFPB will need to review crossing to determine owner. The UCIP inspection was completed with GEI staff, B. Singh. (H. Dunn ? GEI)
FIELD_STRUCT_DESC: 36-inch CIPP-lined corrugated metal storm drainage pipe (CMP) through the levee, 8.0 feet below the crown. Concrete U-shaped headwalls on both ends. Flap gate on the waterside (WS) end. Cobble grouted outlet across the berm. Cobble grouted apron on the landside (LS) end. [Additional Reference(s): DWR Levee Log, 1987, (HLM 8.15). USACE San Joaquin O&M Manual 612.2, 1967, (HLM 8.15), 36-inch pipe listed].

LS view: LS headwall at toe from crown.

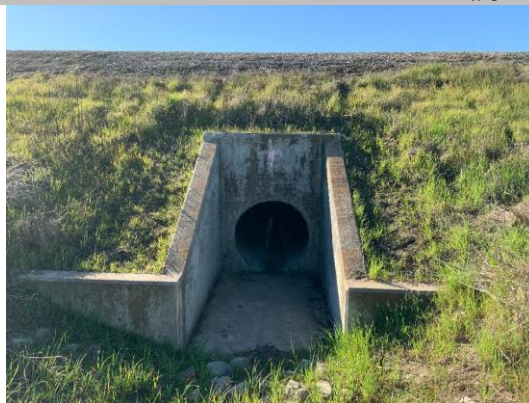
Photo 2 of 3 : UCIP_FA_2024_78899_91931.jpg

LS view: LS headwall at toe.

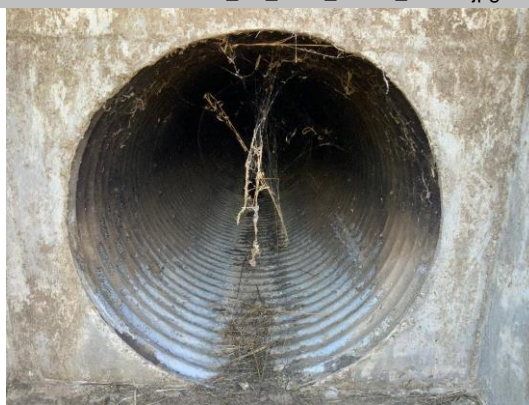
Photo 3 of 3 : UCIP_FA_2024_78899_91932.jpg

LS view: LS pipe.

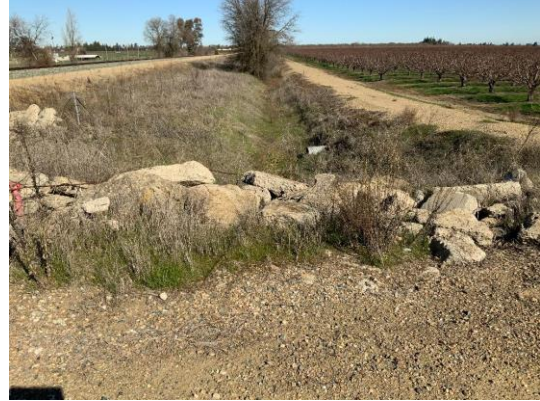
Photo 1 of 3 : UCIP_FA_2024_78900_91942.jpg

Comment Code						
Inspector Comment						
DS_ID:23569 FS_ID:78900 EP_NO: N/A Repair Type: Non-Urgent EVAL Issue: Crossing Status: Found UCIP Comments: 02/24/2021 The record has been upgraded from No Action Needed to Non-Urgent. DWR DMP has not found internal issues, LOF between 1 and 2. Recommend inspection in 5 years. No permit was found authorizing this encroachment. CVFPB will need to review crossing to determine owner. The UCIP inspection was completed with GEI staff, B. Singh. (H. Dunn ? GEI) FIELD_STRUCT_DESC: 1 of 2: 36-inch corrugated metal storm drainage pipe (CMP) through the levee, 10.5 feet below the crown. Flap gate on the waterside (WS) end. Slide gate in a 48-inch CMP riser unit on the WS slope. Concrete U-shaped headwalls on both ends. Cobble grouted outlet on the bank. Cobble grouted apron on the landside (LS) end. [Additional Reference(s): DWR Levee Log, 1987, (HLM 8.28). USACE San Joaquin O&M Manual 612.2, 1967, (HLM 8.28), 36-inch pipe listed]. FS Date: 2/24/2021

LS view: LS headwall at toe from crown.

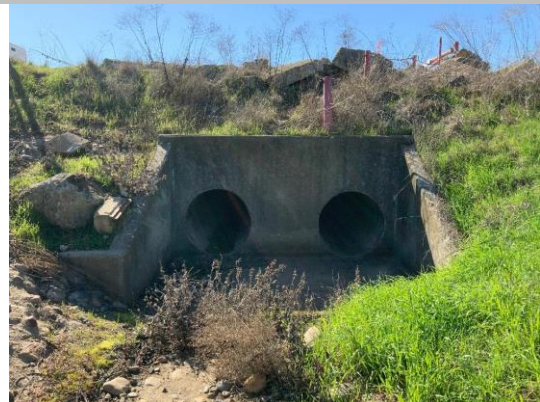
Photo 2 of 3 : UCIP_FA_2024_78900_91943.jpg

LS view: LS headwall at toe.

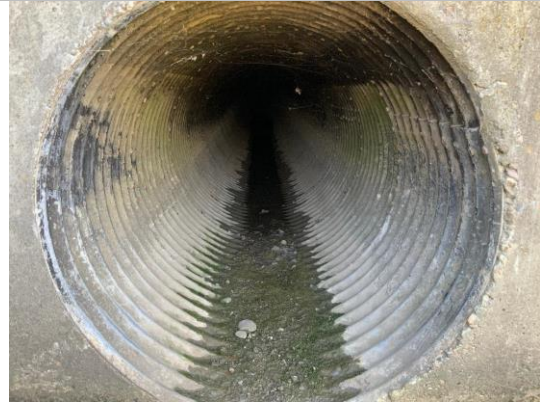
Photo 3 of 3 : UCIP_FA_2024_78900_91945.jpg

LS view: LS pipe.
