**Flood Control Project Maintenance
Levee Inspections****Maintenance Issue Types Only, Levee Inspection Report By Mile - Fall 2024****San Joaquin County Flood Control and Water Conservation District**

Waterway	Bank	Unit Miles	Inspection Start/End	Inspector
Unit No. 01 Littlejohn Creek	Left	2.59	10/21/2024 10/21/2024	Alberto De Leon

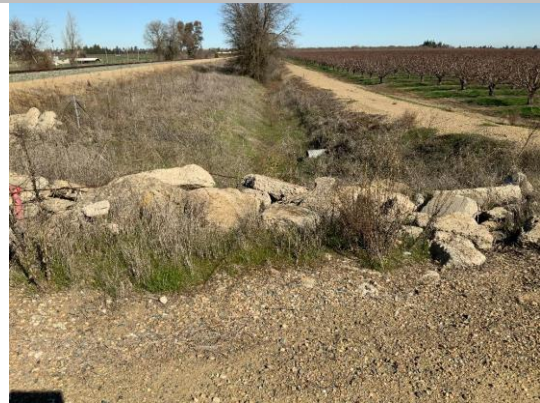
Photo 1 of 3 : UCIP_FA_2024_78901_91952.jpg

DS_ID:23682
 FS_ID:78901
 EP_NO: N/A
 Repair Type: Non-Urgent
 EVAL Issue:
 Crossing Status: Found
 UCIP Comments: 02/24/2021 The record has been upgraded from No Action Needed to Non-Urgent. DWR DMP has not found internal issues, LOF between 1 and 2. Recommend inspection in 5 years. No permit was found authorizing this encroachment. CVFPB will need to review crossing to determine owner. The UCIP inspection was completed with GEI staff, B. Singh. (H. Dunn ? GEI)
 FIELD_STRUCT_DESC: 2 of 2: 36-inch corrugated metal storm drainage pipe (CMP) through the levee, 10.5 feet below the crown. Flap gate on the waterside (WS) end. Slide gate in a 48-inch CMP riser unit on the WS slope. Concrete U-shaped headwalls on both ends. Cobble grouted outlet on the bank. Cobble grouted apron on the landside (LS) end. [Additional Reference(s): DWR Levee Log, 1987, (HLM 8.28). USACE San Joaquin O&M Manual 612.2, 1967, (HLM 8.28), 36-inch pipe listed].

LS headwall at toe from crown.

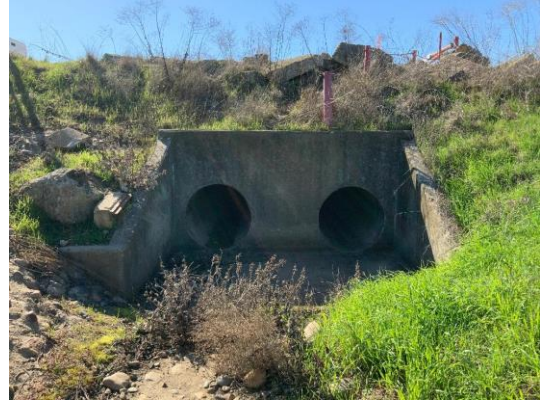
Photo 2 of 3 : UCIP_FA_2024_78901_91953.jpg

LS headwall at toe.

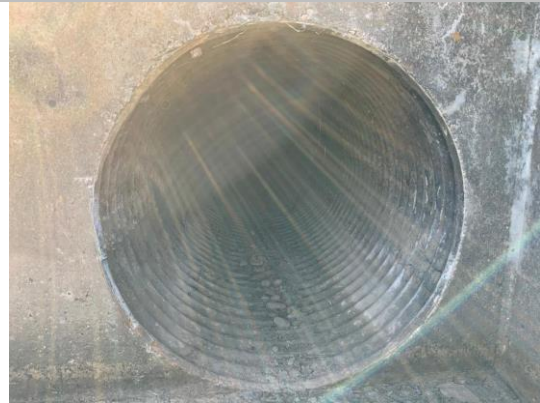
Photo 3 of 3 : UCIP_FA_2024_78901_91955.jpg

LS pipe.

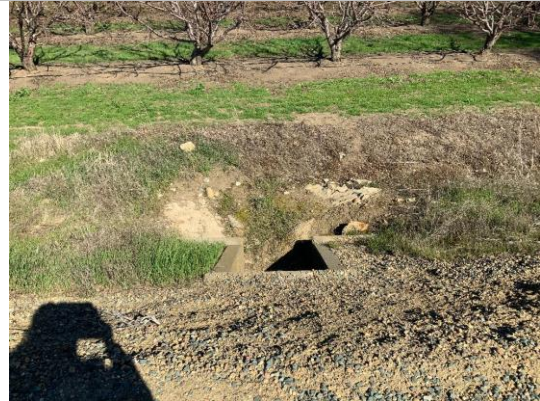
Photo 1 of 3 : UCIP_FA_2024_78902_91962.jpg

Comment Code						
Inspector Comment						
DS_ID:23570 FS_ID:78902 EP_NO:N/A Repair Type: Non-Urgent EVAL Issue: 5, Pipe Damage Crossing Status: Found UCIP Comments: 02/24/2021 The record has been upgraded from No Action Needed to Non-Urgent. DWR DMP has found integrity issues, LOF between 4 and 5. Crossing will be monitored until funding becomes available for rehabilitation. No permit was found authorizing this encroachment. CVFPB will need to review crossing to determine owner. The UCIP inspection was completed with GEI staff, B. Singh. (H. Dunn ? GEI) FIELD_STRUCT_DESC: 24-inch corrugated metal storm drainage pipe (CMP) through the levee, 6.5 feet below the crown. Flap gate on the waterside (WS) end. Concrete U-shaped headwalls on both ends. Cobble grouted outlet across the berm. Cobble grouted apron on the landside (LS) end. [Additional Reference(s): DWR Levee Log, 1987, (HLM 8.49). USACE San Joaquin O&M Manual 612.2, 1967, (HLM 8.49), and 612 (addendum), February 1999, (HLM 8.41), (Station 444+00), 24-inch pipe listed]. FS Date: 2/24/2021

LS headwall at toe from crown.

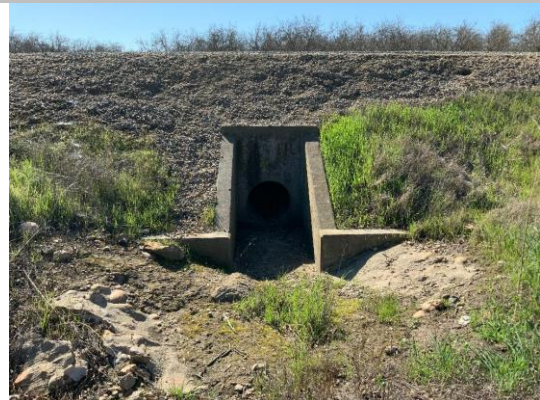
Photo 2 of 3 : UCIP_FA_2024_78902_91963.jpg

LS headwall at toe.

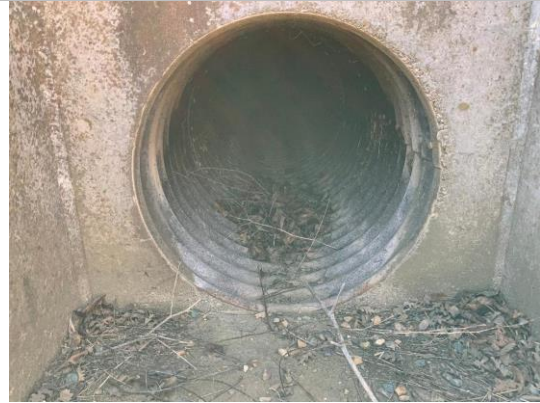
Photo 3 of 3 : UCIP_FA_2024_78902_91964.jpg

LS pipe.

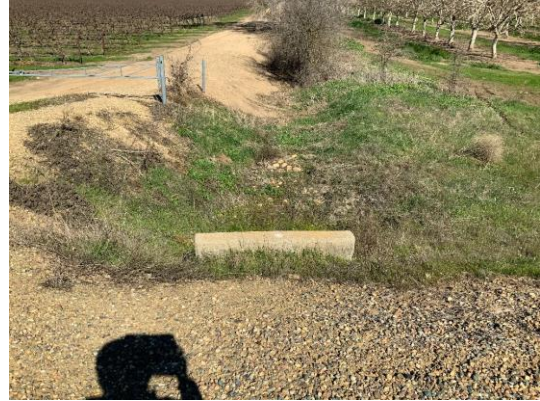
Photo 1 of 3 : UCIP_FA_2024_79415_91987.jpg

Comment Code					
Inspector Comment					
DS_ID:23572 FS_ID:79415 EP_NO: N/A Repair Type: Non-Urgent EVAL Issue: 5, Pipe Damage Crossing Status: Found UCIP Comments: 03/31/2023 Record updated from Urgent to Non-Urgent. LoF is equal to 5.1 due to a small offset joint likely without soil migration, other integrity issues were not found. Crossing will be monitored until funding becomes available for rehabilitation. (O.Yakimov - DWR UCIP). 02/24/2021 The record has been upgraded from Non-Urgent to Urgent. Significant peeling of metal and gap inside of LS pipe. DWR DMP has found integrity issues, LOF between 5 and 6. Crossing will be monitored until funding becomes available to address the issues. No permit was found authorizing this encroachment. CVFPB will need to review crossing to determine owner. The UCIP inspection was completed with GEI staff, B. Singh. (H. Dunn ? GEI)05/14/2014 A gap at the joint between pipe sections was noted inside pipe at LS toe. This may indicate a need for further maintenance. (W. Wylie -DWR UCIP) FIELD_STRUCT_DESC: 36-inch corrugated metal storm drainage pipe (CMP) through the levee, 7.0 feet below the crown. Flap gate on the waterside (WS) end. Concrete U-shaped headwalls on both ends. Cobble grouted outlet across the berm. Cobble grouted apron on the landside (LS) end. [Additional Reference(s): DWR Levee Log, 1987, (HLM 8.77). USACE San Joaquin O&M Manual 612.2, 1967, (HLM 8.77), 36-inch pipe listed]. FS Date: 2/24/2021

LS view: LS headwall at toe from crown.

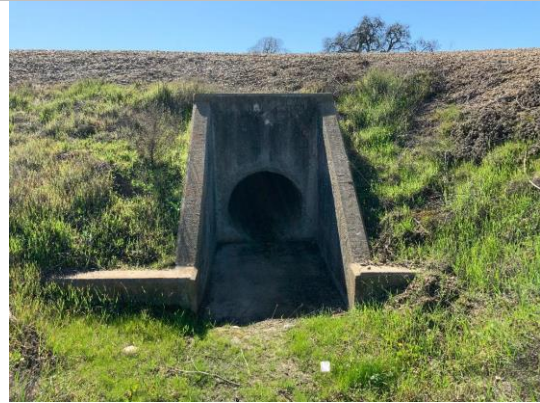
Photo 2 of 3 : UCIP_FA_2024_79415_91988.jpg

LS view: LS headwall at toe.

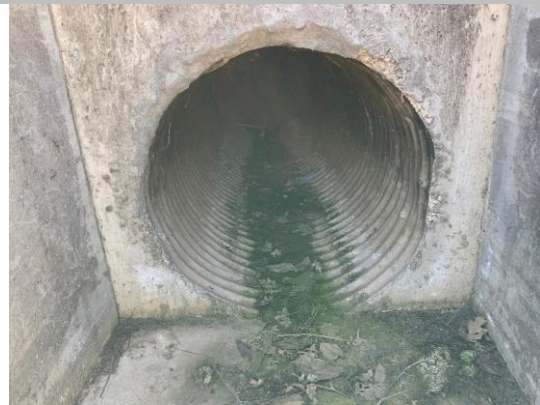
Photo 3 of 3 : UCIP_FA_2024_79415_91989.jpg

LS view: LS pipe.

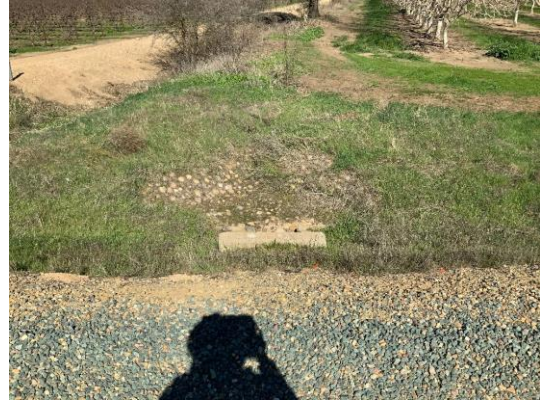
Photo 1 of 3 : UCIP_FA_2024_78957_91996.jpg

Comment Code						
Inspector Comment						
DS_ID:23573 FS_ID:78957 EP_NO: N/A Repair Type: Non-Urgent EVAL Issue: 5, Pipe Damage Crossing Status: Found UCIP Comments: 02/24/2021 Pipe status is still Non-Urgent. Significant peeling of metal inside LS pipe in multiple spots. DWR DMP has found integrity issues, LOF between 4 and 5. Crossing will be monitored until funding becomes available for rehabilitation. No permit was found authorizing this encroachment. No permit was found authorizing this encroachment. CVFPB will need to review crossing to determine owner. The UCIP inspection was completed with GEI staff, B. Singh. (H. Dunn ? GEI) FIELD_STRUCT_DESC: 24-inch corrugated metal storm drainage pipe (CMP) through the levee, 6.5 feet below the crown. Flap gate on the waterside (WS) end. Concrete U-shaped headwalls on both ends. Cobble grouted outlet across the berm. Cobble grouted apron on the landside (LS) end. [Additional Reference(s): DWR Levee Log, 1987, (HLM 8.77). USACE San Joaquin O&M Manual 612.2, 1967, (HLM 8.78), 24-inch pipe listed]. FS Date: 2/24/2021

LS view: LS headwall at toe from crown.

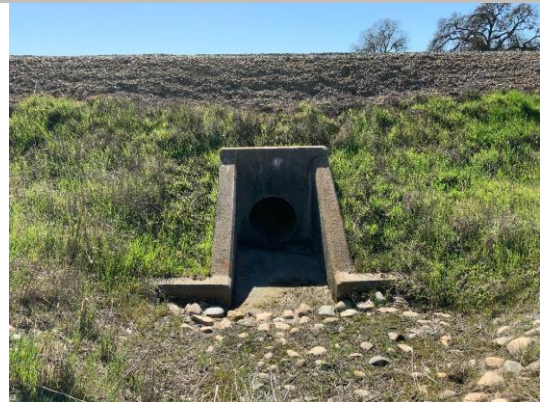
Photo 2 of 3 : UCIP_FA_2024_78957_91997.jpg

LS view: LS headwall at toe.

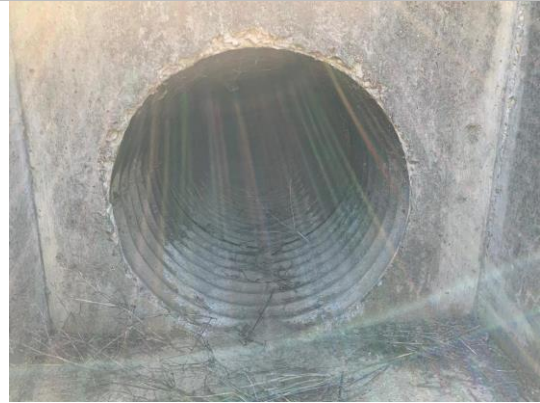
Photo 3 of 3 : UCIP_FA_2024_78957_91998.jpg

LS view: LS pipe.

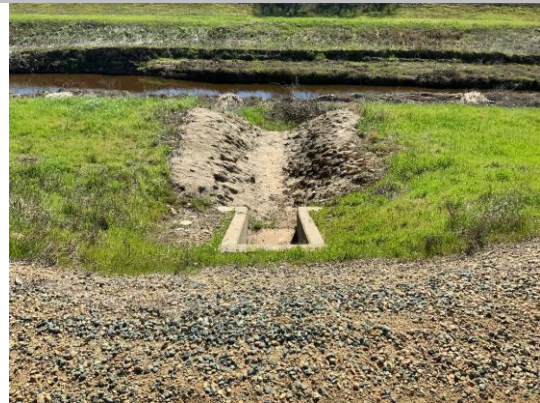
Photo 1 of 3 : UCIP_FA_2024_78958_92004.jpg

DS_ID:23574
 FS_ID:78958
 EP_NO: N/A
 Repair Type: Non-Urgent
 EVAL Issue: 5, Pipe Damage
 Crossing Status: Found
 UCIP Comments: 02/24/2021 The record has been upgraded from No Action Needed to Non-Urgent. DWR DMP has found integrity issues, LOF between 4 and 5. Crossing will be monitored until funding becomes available for rehabilitation. No permit was found authorizing this encroachment. CVFPB will need to review crossing to determine owner. The UCIP inspection was completed with GEI staff, B. Singh. (H. Dunn ? GEI)
 FIELD_STRUCT_DESC: 24-inch corrugated metal storm drainage pipe (CMP) through the levee, 7.0 feet below the crown. Flap gate on the waterside (WS) end. Concrete U-shaped headwalls on both ends. Cobble grouted outlet across the berm. [Additional Reference(s): DWR Levee Log, 1987, (HLM 8.97). USACE San Joaquin O&M Manual 612.2, 1967, (HLM 8.97), and 612 (addendum), February 1999, (HLM 8.90), (Station 469+82), 24-inch pipe listed].

WS view: WS headwall at toe.

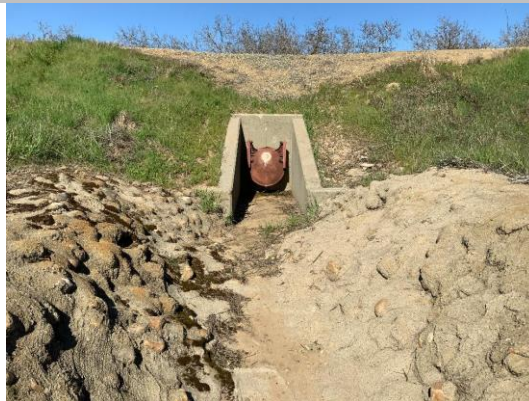
Photo 2 of 3 : UCIP_FA_2024_78958_92005.jpg

WS view: WS headwall and flapgate at toe.

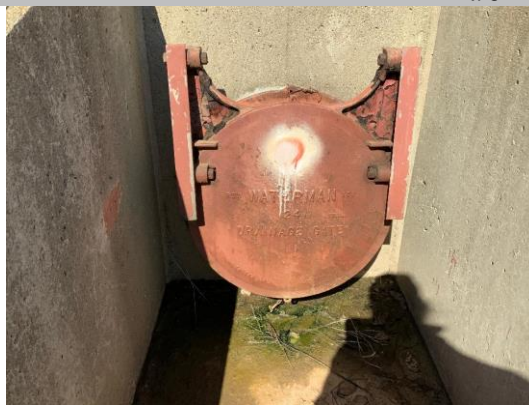
Photo 3 of 3 : UCIP_FA_2024_78958_92006.jpg

WS view: WS flapgate.

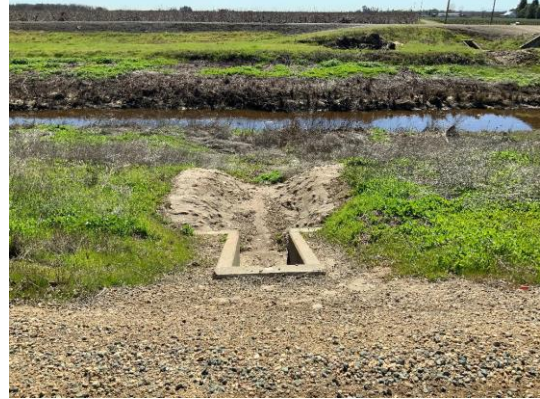
Photo 1 of 3 : UCIP_FA_2024_78906_92009.jpg

Comment Code						
Inspector Comment						
DS_ID:23576 FS_ID:78906 EP_NO: N/A Repair Type: Non-Urgent EVAL Issue: 5, Pipe Damage Crossing Status: Found UCIP Comments: 02/24/2021 The record has been upgraded from No Action Needed to Non-Urgent. DWR DMP has found integrity issues, LOF between 4 and 5. Crossing will be monitored until funding becomes available for rehabilitation. Minor flaking off of concrete on the inside edge of LS headwall. No permit was found authorizing this encroachment. CVFPB will need to review crossing to determine owner. The UCIP inspection was completed with GEI staff, B. Singh. (H. Dunn ? GEI) FIELD_STRUCT_DESC: 24-inch corrugated metal storm drainage pipe (CMP) through the levee, 6.5 feet below the crown. Flap gate on the waterside (WS) end. Concrete U-shaped headwalls on both ends. Cobble grouted outlet across the berm. Cobble grouted apron on the landside (LS) end. [Additional Reference(s): DWR Levee Log, 1987, (HLM 9.18). USACE San Joaquin O&M Manual 612.2, 1967, (HLM 9.17), and 612 (addendum), February 1999, (HLM 9.17), (Station 484+30), 24-inch pipe listed]. FS Date: 2/24/2021

WS view: WS headwall at toe from crown.

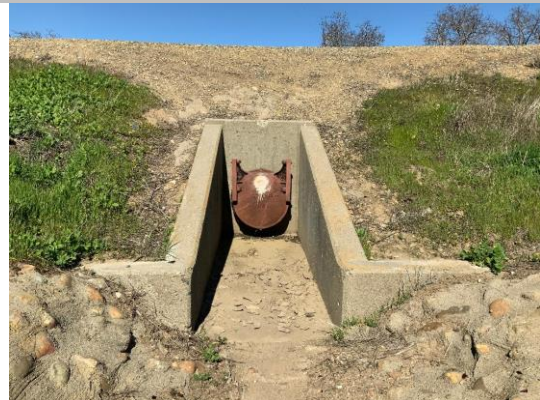
Photo 2 of 3 : UCIP_FA_2024_78906_92010.jpg

WS view: WS headwall and flapgate at toe.

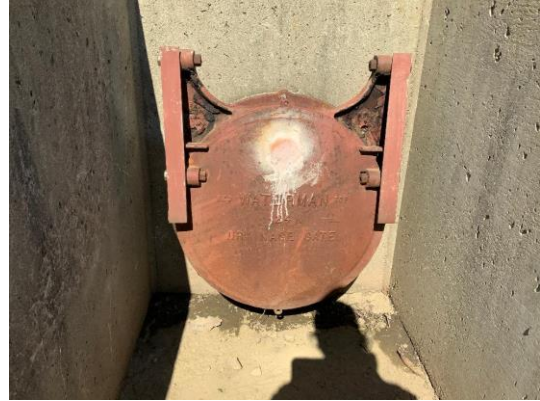
Photo 3 of 3 : UCIP_FA_2024_78906_92012.jpg

WS view: WS flapgate.

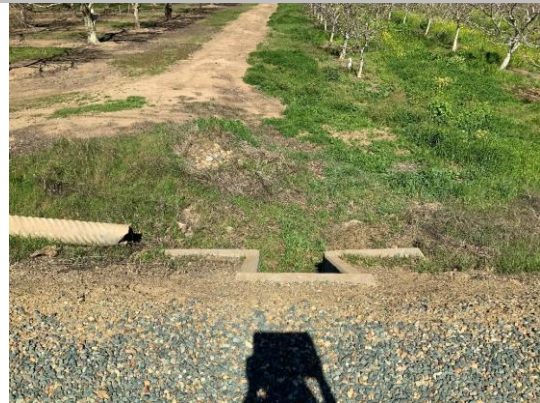
Photo 1 of 3 : UCIP_FA_2024_78959_92030.jpg

DS_ID:23578
 FS_ID:78959
 EP_NO: N/A
 Repair Type: Non-Urgent
 EVAL Issue:
 Crossing Status: Found
 UCIP Comments: 02/24/2021 The record has been upgraded from No Action Needed to Non-Urgent. DWR DMP has not found internal issues, LOF between 1 and 2. Recommend inspection in 5 years. No permit was found authorizing this encroachment. CVFPB will need to review crossing to determine owner. The UCIP inspection was completed with GEI staff, B. Singh. (H. Dunn ? GEI)
 FIELD_STRUCT_DESC: 24-inch corrugated metal storm drainage pipe (CMP) through the levee, 8.0 feet below the crown. Flap gate on the waterside (WS) end. Concrete U-shaped headwalls on both ends. Cobble grouted outlet across the berm. Cobble grouted apron on the landside (LS) end. [Additional Reference(s): DWR Levee Log, 1987, (HLM 9.41). USACE San Joaquin O&M Manual 612.2, 1967, (HLM 9.41), and 612 (addendum), February 1999, (HLM 9.37), (Station 494+50), 24-inch pipe listed].

LS view: LS headwall at toe from crown.

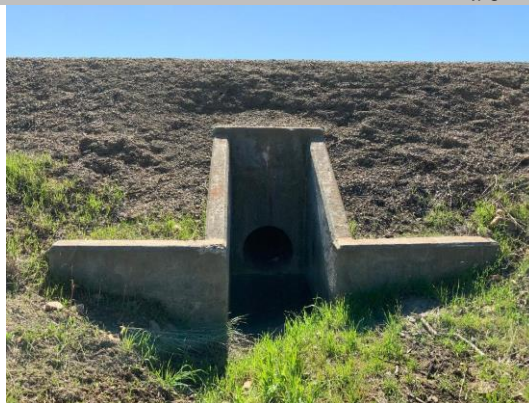
Photo 2 of 3 : UCIP_FA_2024_78959_92029.jpg

LS view: LS headwall at toe.

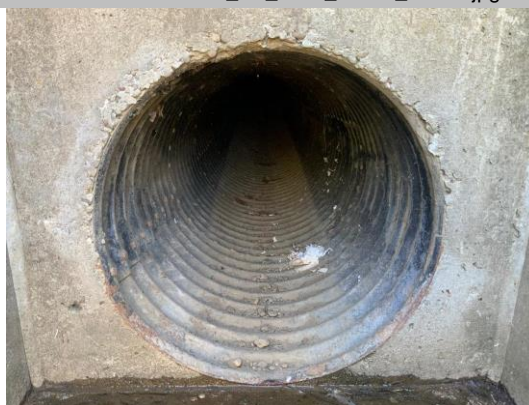
Photo 3 of 3 : UCIP_FA_2024_78959_92028.jpg

LS view: LS pipe.

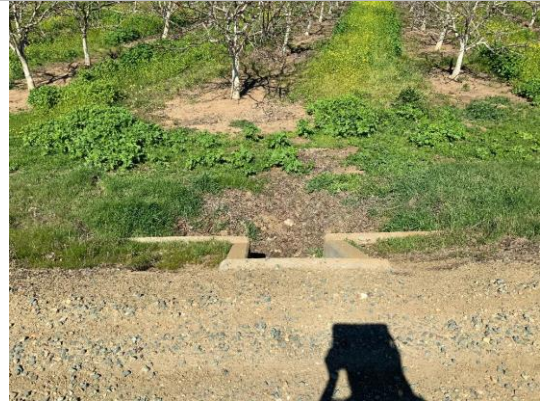
Photo 1 of 3 : UCIP_FA_2024_78960_92040.jpg

Comment Code						
Inspector Comment						
DS_ID:23580 FS_ID:78960 EP_NO: N/A Repair Type: Non-Urgent EVAL Issue: 5, Pipe Damage Crossing Status: Found UCIP Comments: 02/24/2021 The record has been upgraded from No Action Needed to Non-Urgent. DWR DMP has found integrity issues, LOF between 4 and 5. Crossing will be monitored until funding becomes available for rehabilitation. No permit was found authorizing this encroachment. CVFPB will need to review crossing to determine owner. The UCIP inspection was completed with GEI staff, B. Singh. (H. Dunn ? GEI) FIELD_STRUCT_DESC: 24-inch corrugated metal storm drainage pipe (CMP) through the levee, 6.5 feet below the crown. Flap gate on the waterside (WS) end. Concrete U-shaped headwalls on both ends. Cobble grouted outlet and apron. [Additional Reference(s): DWR Levee Log, 1987, (HLM 9.56). USACE San Joaquin O&M Manual 612.2, 1967, (HLM 9.56), and 612 (addendum), February 1999, (HLM 9.56), (Station 504+71), 24-inch pipe listed]. FS Date: 2/24/2021

LS headwall at toe from crown.

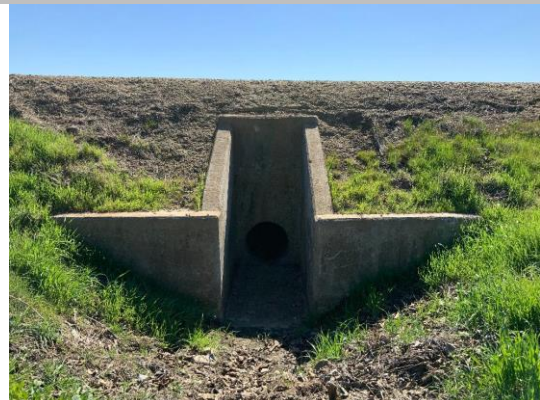
Photo 2 of 3 : UCIP_FA_2024_78960_92041.jpg

LS headwall at toe.

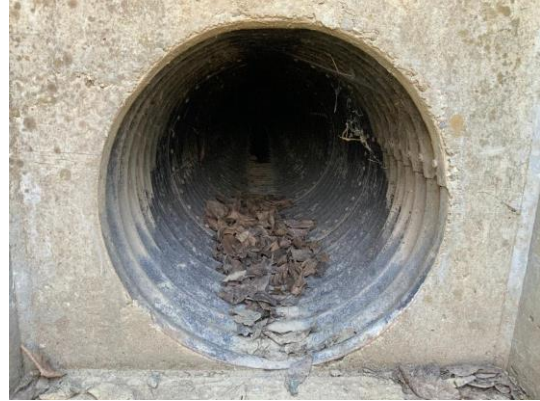
Photo 3 of 3 : UCIP_FA_2024_78960_92042.jpg

LS pipe.

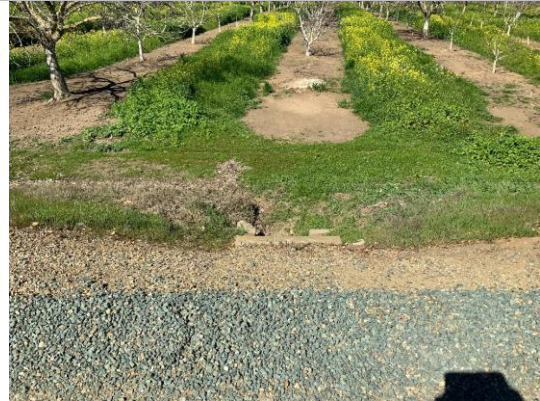
Photo 1 of 3 : UCIP_FA_2024_78909_92058.jpg

Comment Code						
Inspector Comment						
DS_ID:23582						
FS_ID:78909						
EP_NO: N/A						
Repair Type: Non-Urgent						
EVAL Issue: 5, Pipe Damage						
Crossing Status: Found						
UCIP Comments: 02/24/2021 The record has been upgraded from No Action Needed to Non-Urgent. DWR DMP has found integrity issues, LOF between 4 and 5. Crossing will be monitored until funding becomes available for rehabilitation. No permit was found authorizing this encroachment. CVFPB will need to review crossing to determine owner. The UCIP inspection was completed with GEI staff, B. Singh. (H. Dunn ? GEI)						
FIELD_STRUCT_DESC: 24-inch corrugated metal storm drainage pipe (CMP) through the levee, 7.5 feet below the crown. Flap gate on the waterside (WS) end. Concrete U-shaped headwalls on both ends. Cobble grouted outlet across the berm. Cobble grouted apron on the WS end. [Additional Reference(s): DWR Levee Log, 1987, (HLM 9.91). USACE San Joaquin O&M Manual 612.2, 1967, (HLM 9.91), 24-inch pipe listed].

LS view: LS headwall at toe from crown.

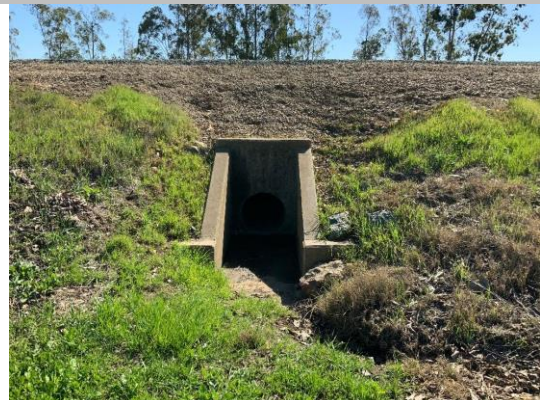
Photo 2 of 3 : UCIP_FA_2024_78909_92059.jpg

LS view: LS headwall at toe.

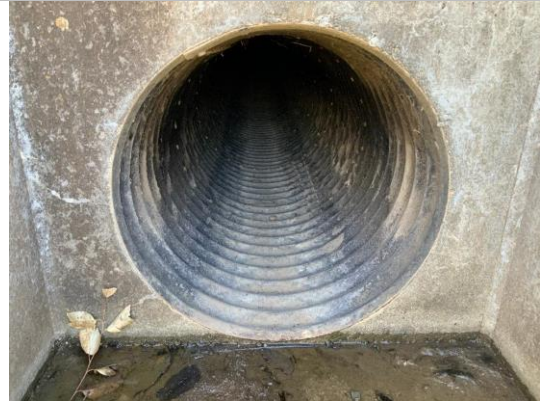
Photo 3 of 3 : UCIP_FA_2024_78909_92060.jpg

LS view: LS pipe.

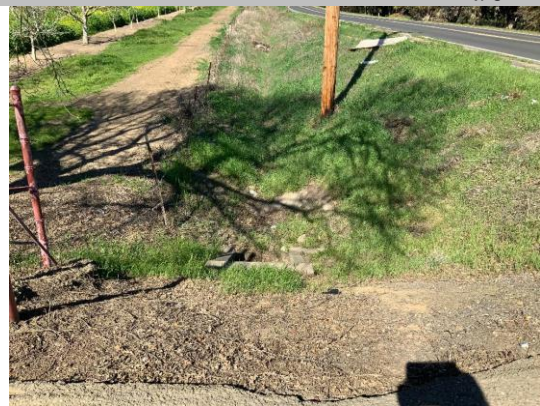
Photo 1 of 3 : UCIP_FA_2024_78910_92065.jpg

DS_ID:23583
 FS_ID:78910
 EP_NO: N/A
 Repair Type: Non-Urgent
 EVAL Issue: 5, Pipe Damage
 Crossing Status: Found
 UCIP Comments: 02/24/2021 The record has been upgraded from No Action Needed to Non-Urgent. DWR DMP has found integrity issues, LOF between 4 and 5. Crossing will be monitored until funding becomes available for rehabilitation. No permit was found authorizing this encroachment. CVFPB will need to review crossing to determine owner. The UCIP inspection was completed with GEI staff, B. Singh. (H. Dunn ? GEI)
 FIELD_STRUCT_DESC: 24-inch corrugated metal storm drainage pipe (CMP) through the levee, 10.0 feet below the crown. Flap gate on the waterside (WS) end. Concrete U-shaped headwalls on both ends. Cobble grouted outlet across the berm. Cobble grouted apron on the landside (LS) end. [Additional Reference(s): DWR Levee Log, 1987, (HLM 10.09). USACE San Joaquin O&M Manual 612.2, 1967, (HLM 10.09), and 612 (addendum), February 1999, (HLM 9.94), (Station 524+90), 24-inch pipe listed].

LS view: LS headwall at toe from crown.

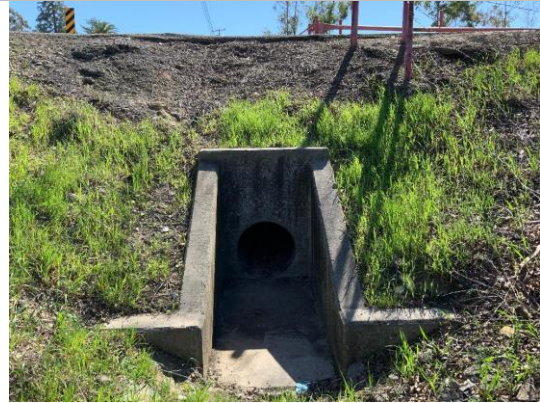
Photo 2 of 3 : UCIP_FA_2024_78910_92066.jpg

LS view: LS headwall at toe.

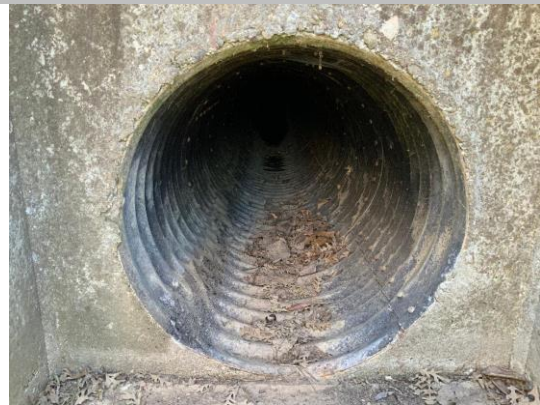
Photo 3 of 3 : UCIP_FA_2024_78910_92067.jpg

LS view: LS pipe.

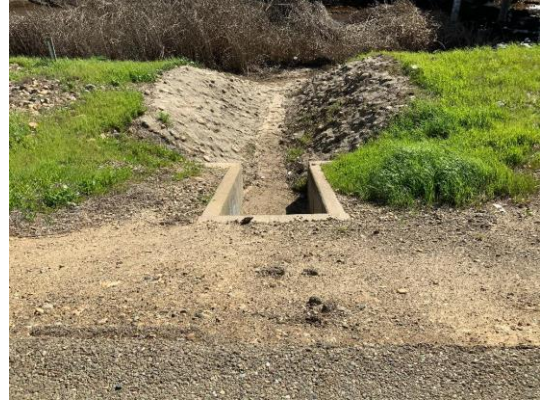
Photo 1 of 3 : UCIP_FA_2024_78961_92077.jpg

Comment Code					
Inspector Comment					
DS_ID:23584 FS_ID:78961 EP_NO: N/A Repair Type: Non-Urgent EVAL Issue: 5, Pipe Damage Crossing Status: Found UCIP Comments: 02/24/2021 The record has been upgraded from No Action Needed to Non-Urgent. DWR DMP has found integrity issues, LOF between 4 and 5. Crossing will be monitored until funding becomes available for rehabilitation. No permit was found authorizing this encroachment. CVFPB will need to review crossing to determine owner. The UCIP inspection was completed with GEI staff, B. Singh. (H. Dunn ? GEI) FIELD_STRUCT_DESC: 36-inch corrugated metal storm drainage pipe (CMP) through the levee, 6.0 feet below the crown. Flap gate on the waterside (WS) end. Concrete U-shaped headwalls on both ends. Cobble grouted outlet across the berm. Cobble grouted apron on the landside (LS) end. [Additional Reference(s): DWR Levee Log, 1987, (HLM 10.11). USACE San Joaquin O&M Manual 612.2, 1967, (HLM 10.11), 36-inch pipe listed]. FS Date: 2/24/2021

WS view: WS headwall at toe from crown.

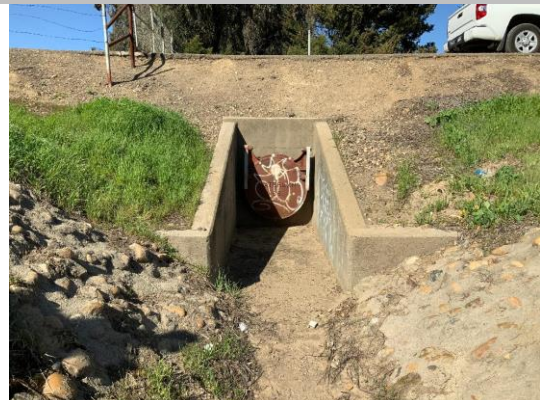
Photo 2 of 3 : UCIP_FA_2024_78961_92078.jpg

WS view: WS headwall and flapgate at toe.

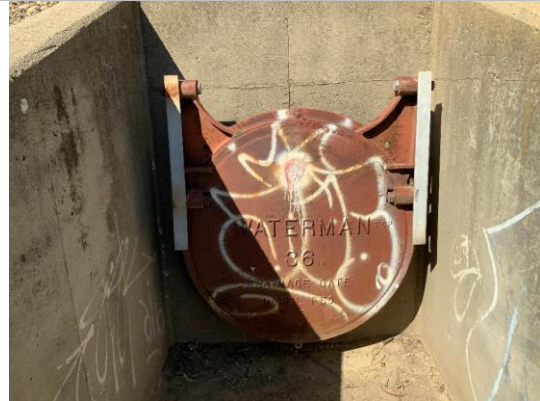
Photo 3 of 3 : UCIP_FA_2024_78961_92079.jpg

WS view: WS flapgate.

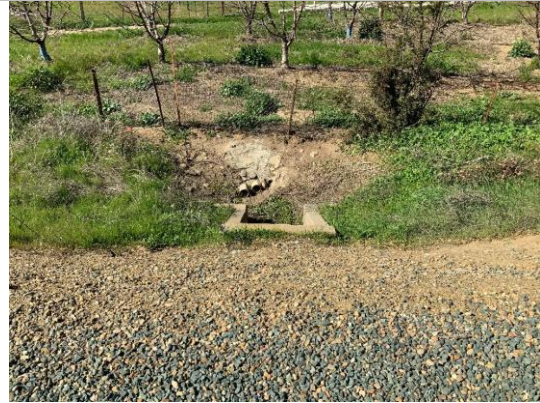
Photo 1 of 3 : UCIP_FA_2024_78962_92096.jpg

Comment Code					
Inspector Comment					
DS_ID:23585 FS_ID:78962 EP_NO: N/A Repair Type: Non-Urgent EVAL Issue: 5, Pipe Damage Crossing Status: Found UCIP Comments: 09/23/2024 DMP internal video inspection has found moderate pipe defects. Crossing will be monitored until funding becomes available for rehabilitation. (O. Yakimov - DWR UCIP) 02/24/2021 Pipe status is still Non-Urgent. DWR DMP has not found internal issues, LOF between 1 and 2. Recommend inspection in 5 years. No permit was found authorizing this encroachment. CVFPB will need to review crossing to determine owner. The UCIP inspection was completed with GEI staff, B. Singh. (H. Dunn ? GEI) FIELD_STRUCT_DESC: 24-inch corrugated metal storm drainage pipe (CMP) through the levee, 7.5 feet below the crown. Flap gate on the waterside (WS) end. Concrete U-shaped headwalls on both ends. Cobble grouted outlet across the berm. [Additional Reference(s): DWR Levee Log, 1987, (HLM 10.45). USACE San Joaquin O&M Manual 612.2, 1967, (HLM 10.45), and 612 (addendum), February 1999, (HLM 10.46), (Station 552+25), 24-inch pipe listed]. FS Date: 2/24/2021

LS view: LS headwall at toe from crown.

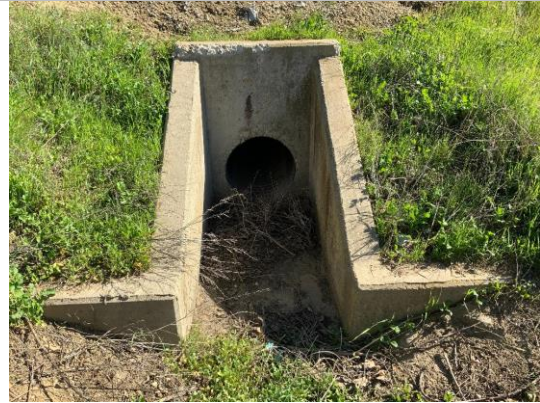
Photo 2 of 3 : UCIP_FA_2024_78962_92097.jpg

LS view: LS headwall at toe.

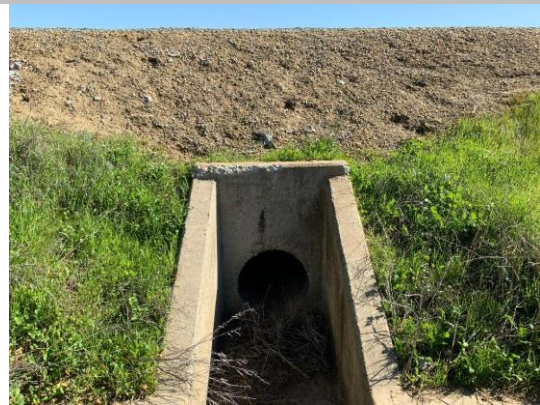
Photo 3 of 3 : UCIP_FA_2024_78962_92098.jpg

LS view: LS headwall at toe.

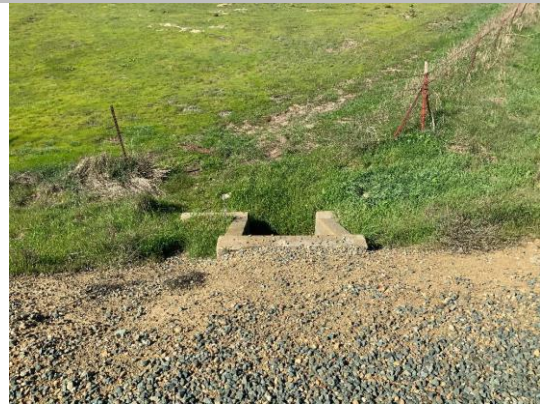
Photo 1 of 3 : UCIP_FA_2024_78963_92108.jpg

Comment Code						
Inspector Comment						
DS_ID:23586 FS_ID:78963 EP_NO: N/A Repair Type: Non-Urgent EVAL Issue: Crossing Status: Found UCIP Comments: 02/24/2021 The record has been upgraded from No Action Needed to Non-Urgent. DWR DMP has not found internal issues, LOF between 1 and 2. Recommend inspection in 5 years. No permit was found authorizing this encroachment. CVFPB will need to review crossing to determine owner. The UCIP inspection was completed with GEI staff, B. Singh. (H. Dunn ? GEI) FIELD_STRUCT_DESC: 24-inch corrugated metal storm drainage pipe (CMP) through the levee, 6.0 feet below the crown. Flap gate on the waterside (WS) end. Concrete U-shaped headwalls on both ends. Cobble grouted outlet across the berm. Cobble grouted apron on the landside (LS) end. [Additional Reference(s): DWR Levee Log, 1987, (HLM 10.62). USACE San Joaquin O&M Manual 612.2, 1967, (HLM 10.62), 24-inch pipe listed]. FS Date: 2/24/2021

LS view: LS headwall at toe from crown.

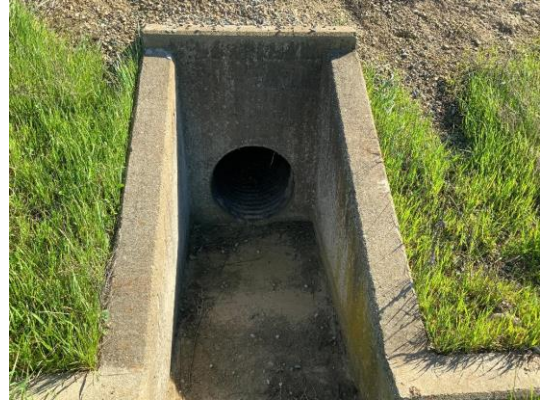
Photo 2 of 3 : UCIP_FA_2024_78963_92109.jpg

LS view: LS headwall at toe.

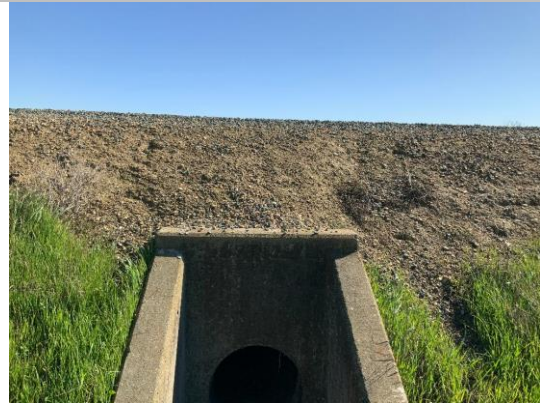
Photo 3 of 3 : UCIP_FA_2024_78963_92110.jpg

LS view: LS headwall at toe.

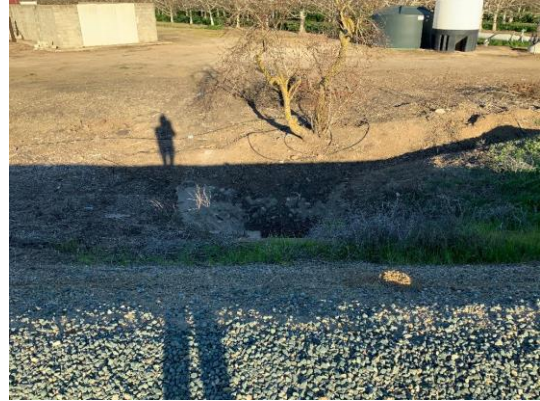
Photo 1 of 3 : UCIP_FA_2024_78964_92115.jpg

Comment Code						
Inspector Comment						
DS_ID:23646 FS_ID:78964 EP_NO: N/A Repair Type: Non-Urgent EVAL Issue: Crossing Status: Found UCIP Comments: 02/25/2021 The record has been upgraded from No Action Needed to Non-Urgent. DWR DMP has not found internal issues, LOF between 1 and 2. Recommend inspection in 5 years. WS flapgate partially covered by vegetation. No permit was found authorizing this encroachment. CVFPB will need to review crossing to determine owner. The UCIP inspection was completed with LMA representative, M. Mccoy. (H. Dunn ? GEI) FIELD_STRUCT_DESC: 24-inch corrugated metal storm drainage pipe (CMP) through the levee, 7.5 feet below the crown. Flap gate on the waterside (WS) end. Concrete U-shaped headwalls on both ends. [Additional Reference(s): DWR Levee Log, 1987, (HLM 10.62). USACE San Joaquin O&M Manual 612.2, 1967, (HLM 10.91), and 612 (addendum), February 1999, (HLM 10.80), (Station 570+48), 24-inch pipe listed]. FS Date: 2/25/2021

LS view: LS headwall at toe from crown.

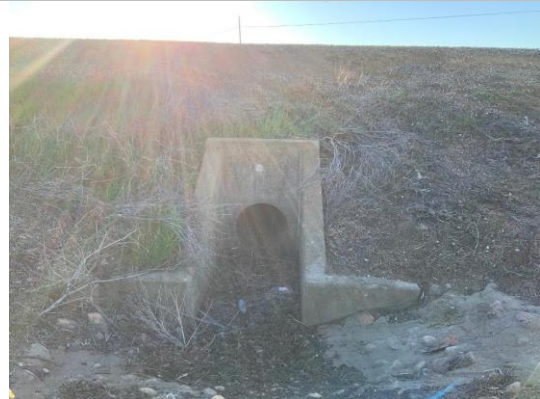
Photo 2 of 3 : UCIP_FA_2024_78964_92116.jpg

LS view: LS headwall at toe.

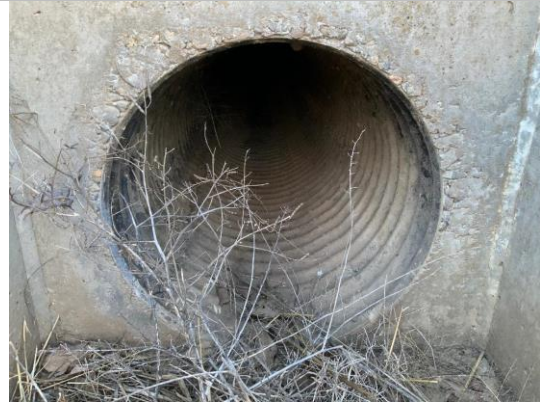
Photo 3 of 3 : UCIP_FA_2024_78964_92117.jpg

LS view: LS pipe.

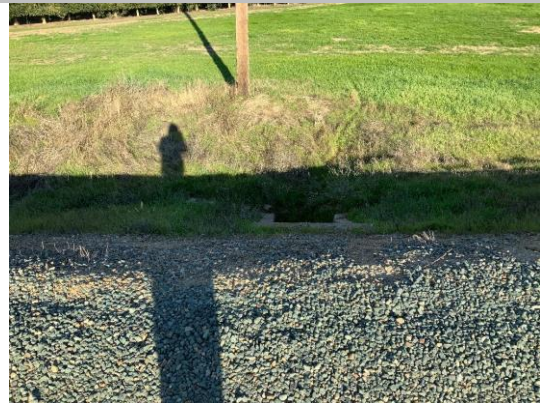
Photo 1 of 3 : UCIP_FA_2024_78965_92127.jpg

DS_ID:23587
 FS_ID:78965
 EP_NO: N/A
 Repair Type: Non-Urgent
 EVAL Issue: 5, Pipe Damage
 Crossing Status: Found
 UCIP Comments: 09/23/2024 DMP internal video inspection has found moderate pipe defects. Crossing will be monitored until funding becomes available for rehabilitation. (O. Yakimov - DWR UCIP)
 02/25/2021 Pipe status is still Non-Urgent. DWR DMP has not found internal issues, LOF between 1 and 2. Recommend inspection in 5 years. No permit was found authorizing this encroachment. CVFPB will need to review crossing to determine owner. The UCIP inspection was completed with LMA representative, M. McCoy. (H. Dunn ? GEI)
 05/14/2014 Silt buildup in pipe at LS toe. (W. Wylie - DWR UCIP)
 FIELD_STRUCT_DESC: 24-inch corrugated metal storm drainage pipe (CMP) through the levee, 6.5 feet below the crown. Flap gate on the waterside (WS) end. Concrete U-shaped headwalls on both ends. Cobble grouted outlet across the berm. Cobble grouted apron on the WS end. [Additional Reference(s): DWR Levee Log, 1987, (HLM 11.14). USACE San Joaquin O&M Manual 612.2, 1967, (HLM 11.13), 24-inch pipe listed].

LS view: LS headwall at toe from crown.

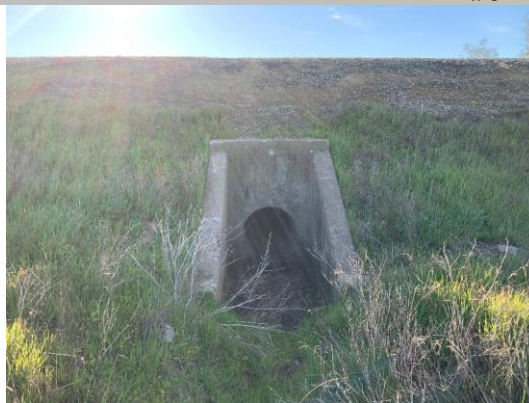
Photo 2 of 3 : UCIP_FA_2024_78965_92128.jpg

LS view: LS headwall at toe.

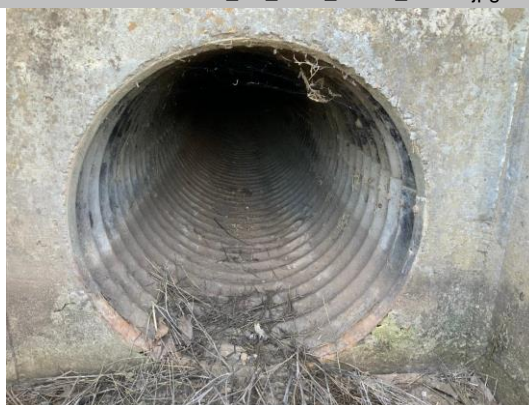
Photo 3 of 3 : UCIP_FA_2024_78965_92129.jpg

LS view: LS pipe.

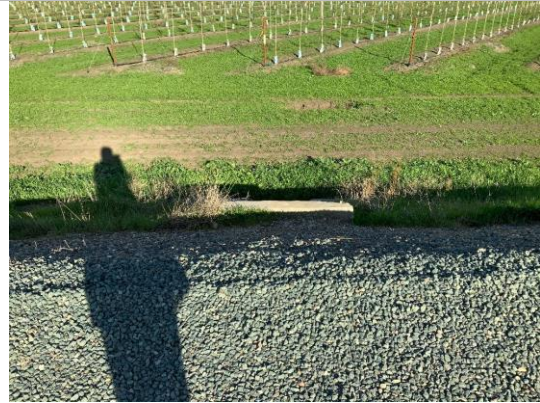
Photo 1 of 3 : UCIP_FA_2024_78966_92134.jpg

Comment Code						
Inspector Comment						
DS_ID:23588 FS_ID:78966 EP_NO: N/A Repair Type: Non-Urgent EVAL Issue: 5, Pipe Damage Crossing Status: Found UCIP Comments: 09/23/2024 DMP internal video inspection has found moderate pipe defects. Crossing will be monitored until funding becomes available for rehabilitation. (O. Yakimov - DWR UCIP) 02/25/2021 The record has been upgraded from No Action Needed to Non-Urgent. DWR DMP has not found internal issues, LOF between 1 and 2. Recommend inspection in 5 years. No permit was found authorizing this encroachment. CVFPB will need to review crossing to determine owner. The UCIP inspection was completed with LMA representative, M. McCoy. (H. Dunn ? GEI) FIELD_STRUCT_DESC: 24-inch corrugated metal storm drainage pipe (CMP) through the levee, 6.5 feet below the crown. Flap gate on the waterside (WS) end. Concrete U-shaped headwalls on both ends. Cobble grouted outlet across the berm. Cobble grouted apron on the landside (LS) end. [Additional Reference(s): DWR Levee Log, 1987, (HLM 11.30). USACE San Joaquin O&M Manual 612.2, 1967, (HLM 11.30), and 612 (addendum), February 1999, (HLM 11.26), (Station 594+46), 24-inch pipe listed]. FS Date: 2/25/2021

LS headwall at toe from crown.

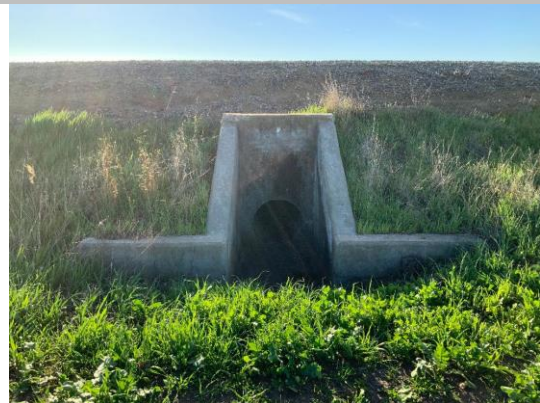
Photo 2 of 3 : UCIP_FA_2024_78966_92135.jpg

LS headwall at toe.

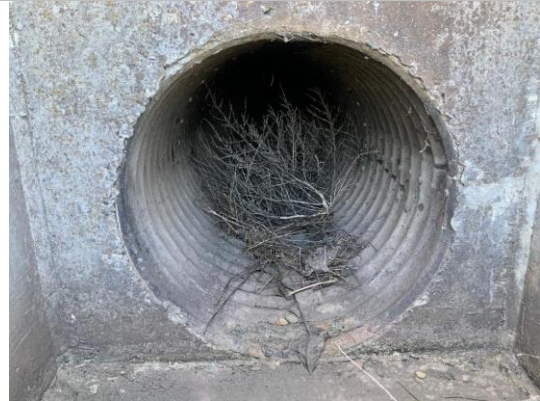
Photo 3 of 3 : UCIP_FA_2024_78966_92136.jpg

LS pipe, minor vegetation inside pipe.

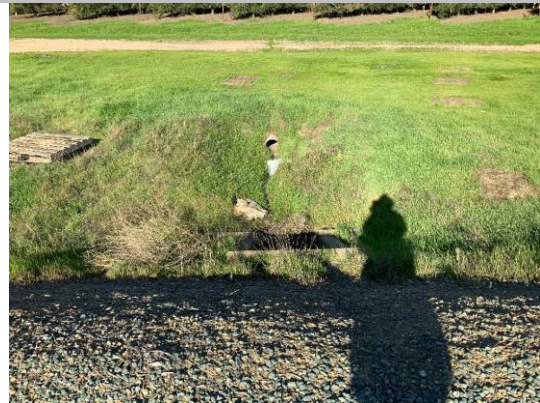
Photo 1 of 3 : UCIP_FA_2024_78981_92218.jpg

DS_ID:23590
 FS_ID:78981
 EP_NO: N/A
 Repair Type: Non-Urgent
 EVAL Issue:
 Crossing Status: Found
 UCIP Comments: 02/25/2021 The record has been upgraded from No Action Needed to Non-Urgent. DWR DMP has not found internal issues, LOF between 1 and 2. Recommend inspection in 5 years. No permit was found authorizing this encroachment. CVFPB will need to review crossing to determine owner. The UCIP inspection was completed with LMA representative, M. McCoy. (H. Dunn ? GEI)
 FIELD_STRUCT_DESC: 24-inch corrugated metal storm drainage pipe (CMP) through the levee, 7.5 feet below the crown. Flap gate on the waterside (WS) end. Concrete U-shaped headwalls on both ends. Cobble grouted outlet across the berm. Cobble grouted apron on the landside (LS) end. [Additional Reference(s): DWR Levee Log, 1987, (HLM 11.78). USACE San Joaquin O&M Manual 612.2, 1967, (HLM 11.78), 24-inch pipe listed].
 FS Date: 2/25/2021

LS view: LS headwall at toe from crown.

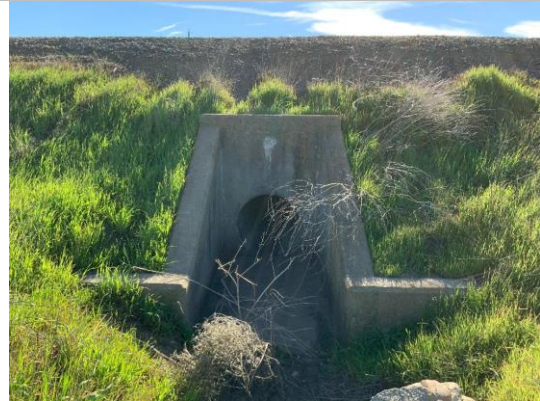
Photo 2 of 3 : UCIP_FA_2024_78981_92219.jpg

LS view: LS headwall at toe.

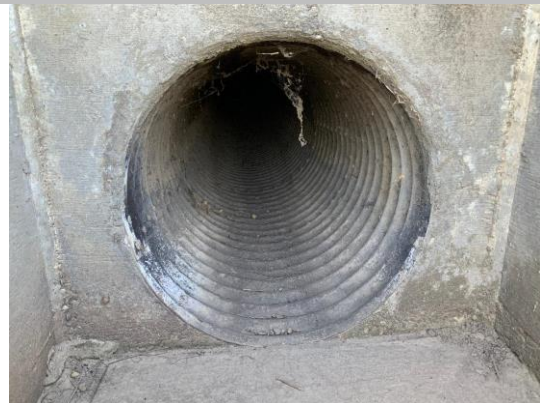
Photo 3 of 3 : UCIP_FA_2024_78981_92220.jpg

LS view: LS pipe.

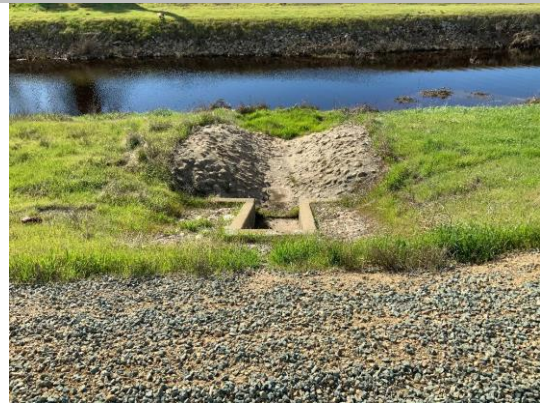
Photo 1 of 3 : UCIP_FA_2024_78968_92239.jpg

Comment Code					
Inspector Comment					
DS_ID:23593 FS_ID:78968 EP_NO: N/A Repair Type: Non-Urgent EVAL Issue: Crossing Status: Found UCIP Comments: 02/25/2021 Pipe status is still Non-Urgent. DWR DMP has not found internal issues, LOF between 1 and 2. Recommend inspection in 5 years. No permit was found authorizing this encroachment. CVFPB will need to review crossing to determine owner. The UCIP inspection was completed with LMA representative, M. Mccoy. (H. Dunn ? GEI)05/14/2014 Some rocky debris buildup inside pipe on LS toe. (W. Wylie - DWR UCIP) FIELD_STRUCT_DESC: 24-inch corrugated metal storm drainage pipe (CMP) through the levee, 8.5 feet below the crown. Flap gate on the waterside (WS) end. Concrete U-shaped headwalls on both ends. Cobble grouted outlet across the berm. Cobble grouted apron on the landside (LS) end. [Additional Reference(s): DWR Levee Log, 1987, (HLM 12.30). USACE San Joaquin O&M Manual 612.2, 1967, (HLM 12.30), 24-inch pipe listed]. FS Date: 2/25/2021

WS headwall at toe from crown.

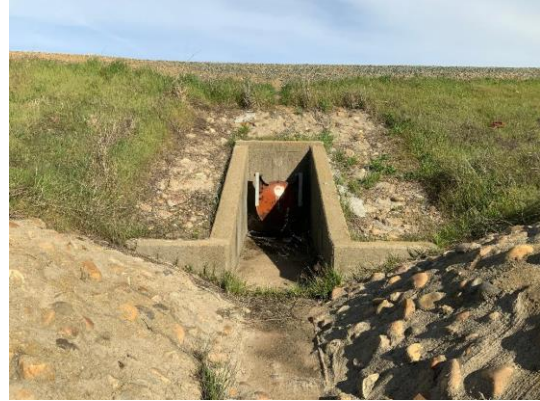
Photo 2 of 3 : UCIP_FA_2024_78968_92240.jpg

WS headwall and flapgate at toe.

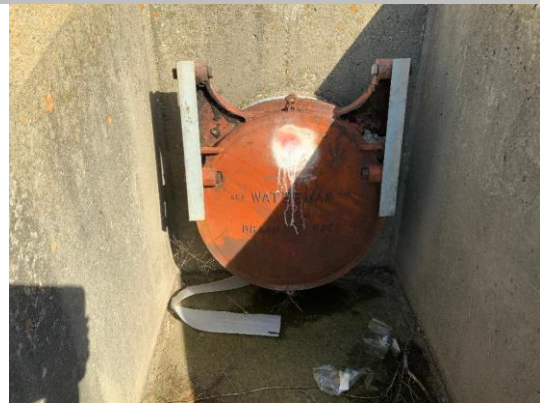
Photo 3 of 3 : UCIP_FA_2024_78968_92241.jpg

WS flapgate.

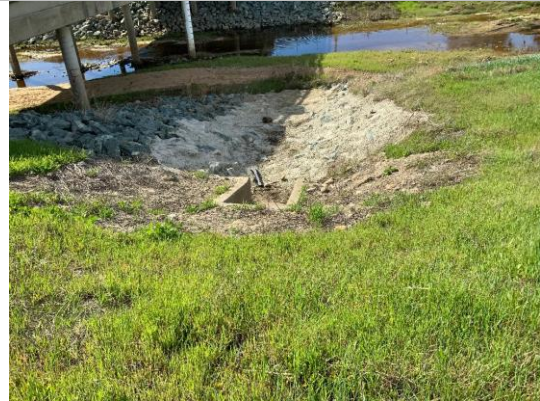
Photo 1 of 3 : UCIP_FA_2024_85079_92247.jpg

DS_ID:23594
FS_ID:85079
EP_NO: N/A
Repair Type: Non-Urgent
EVAL Issue: 10, Unauthorized Modification or Non-Compliant Permit
Crossing Status: Found
UCIP Comments: 10/21/2024 Record updated from Urgent to No Action Needed. DMP internal video inspection conducted after the pipe slip lining has found none or minor pipe defects. A permit for sleeving PVC pipe was not found. (O. Yakimov - DWR UCIP)
12/14/2022 Record updated from Non-Urgent to Urgent. DMP internal video inspection has found pipe integrity issues. LOF of crossing is between 5 and 6. Crossing will be monitored until funding becomes available to address the issues. (O.Yakimov - DWR UCIP)
02/25/2021 The record has been upgraded from No Action Needed to Non-Urgent. In August 2018, under the DWR DMP efforts the internal inspection found integrity issues, LOF between 5 and 6. According to Mr. Eric Ambriz, with San Joaquin County, Caltrans completed the slip Snap-Tite lining effort in October 2018. There is currently no post install inspection of the Snap-Tite lining. Unable to locate permit for sleeving PVC pipe. No permit was found authorizing original 24-inch CMP. CVFPB will need to review crossing to determine owner. The UCIP inspection was completed with LMA representative, M. Mccoy. (H. Dunn ? GEI)10/10/2018 20-inch Snap-Tite lining pipes were sleeved through the damaged 24-inch CMP culvert. Annular space was pressure grouted. (A. McDonald - DWR UCIP)

FIELD_STRUCT_DESC: 20-inch Snap-Tite culvert lining pipe sleeved through 24-inch corrugated metal storm drainage pipe through the levee, 7.5 feet below the crown. Annular space pressure grouted. Flap gate on the waterside (WS) end. Concrete U-shaped headwalls on each end. Cobble grouted outlet across the berm. Cobble grouted apron on the landside (LS) end. [Additional Reference(s): DWR Levee Log, 1987, (HLM 12.40). USACE San Joaquin O&M Manual 612.2, 1967, (HLM 12.40), 24-inch pipe listed].
FS Date: 2/25/2021 3:15:52 PM

WS view: WS headwall at toe from crown.

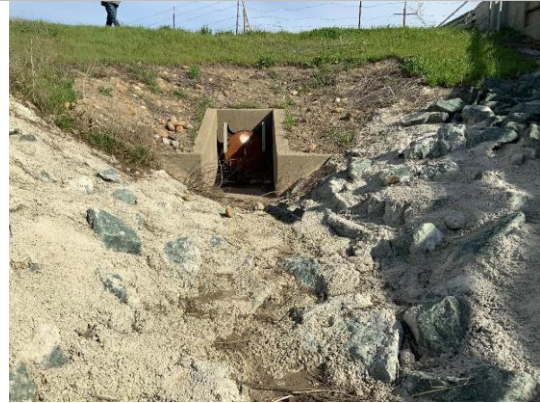
Photo 2 of 3 : UCIP_FA_2024_85079_92248.jpg

WS view: WS headwall and flapgate at toe.

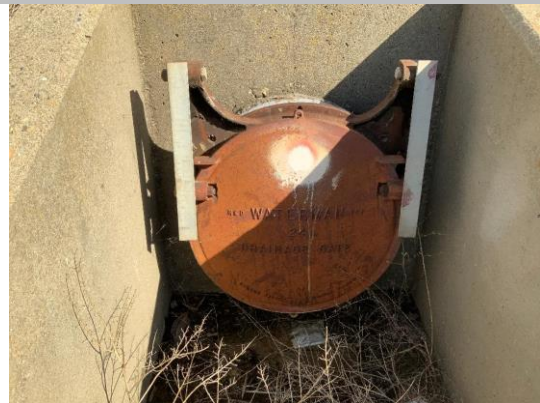
Photo 3 of 3 : UCIP_FA_2024_85079_92249.jpg

WS view: WS flapgate.

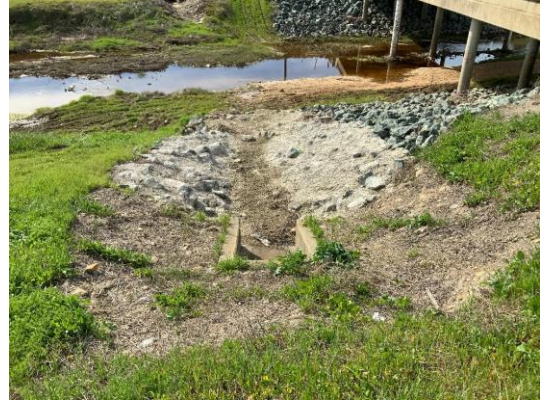
Photo 1 of 3 : UCIP_FA_2024_78919_92256.jpg

Comment Code						
Inspector Comment						
DS_ID:23505 FS_ID:78919 EP_NO: N/A Repair Type: Non-Urgent EVAL Issue: 5, Pipe Damage Crossing Status: Found UCIP Comments: 09/23/2024 DMP internal video inspection has found moderate pipe defects. Crossing will be monitored until funding becomes available for rehabilitation. (O. Yakimov - DWR UCIP) 02/25/2021 The record has been upgraded from No Action Needed to Non-Urgent. Edges of LS pipe are warped. DWR DMP has not found internal issues, LOF between 1 and 2. Recommend inspection in 5 years. No permit was found authorizing this encroachment. CVFPB will need to review crossing to determine owner. The UCIP inspection was completed with LMA representative, M. McCoy. (H. Dunn ? GEI) FIELD_STRUCT_DESC: 24-inch corrugated metal storm drainage pipe (CMP) through the levee, 7.5 feet below the crown. Flap gate on the waterside (WS) end. Concrete U-shaped headwalls on both ends. Cobble grouted outlet across the berm. Cobble grouted apron on the landside (LS) end. [Additional Reference(s): DWR Levee Log, 1987, (HLM 12.42). USACE San Joaquin O&M Manual 612.2, 1967, (HLM 12.42), 24-inch pipe listed]. FS Date: 2/25/2021

WS view: WS headwall at toe from crown.

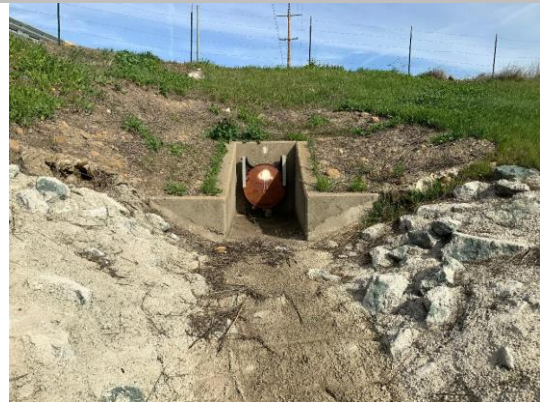
Photo 2 of 3 : UCIP_FA_2024_78919_92257.jpg

WS view: WS headwall and flapgate at toe.

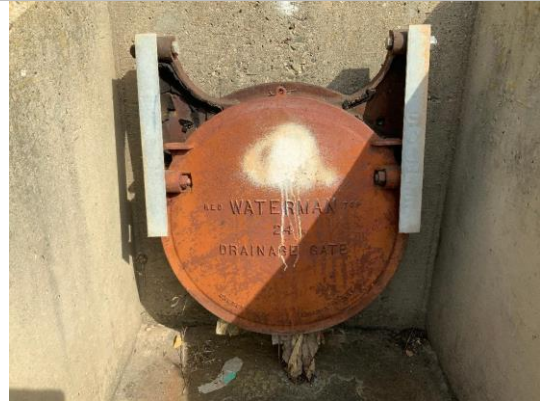
Photo 3 of 3 : UCIP_FA_2024_78919_92258.jpg

WS view: WS flapgate.

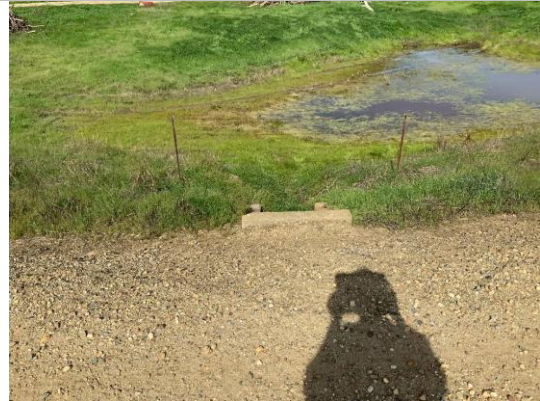
Photo 1 of 3 : UCIP_FA_2024_78970_92274.jpg

Comment Code						
Inspector Comment						
DS_ID:23507 FS_ID:78970 EP_NO: N/A Repair Type: Non-Urgent EVAL Issue: 5, Pipe Damage Crossing Status: Found UCIP Comments: 09/23/2024 DMP internal video inspection has found moderate pipe defects. Crossing will be monitored until funding becomes available for rehabilitation. (O. Yakimov - DWR UCIP) 02/25/2018 The record has been upgraded from No Action Needed to Non-Urgent. DWR DMP has not found internal issues, LOF between 1 and 2. Recommend inspection in 5 years. No permit was found authorizing this encroachment. CVFPB will need to review crossing to determine owner. The UCIP inspection was completed with LMA representative, M. McCoy. (H. Dunn ? GEI) FIELD_STRUCT_DESC: 24-inch corrugated metal storm drainage pipe (CMP) through the levee, 7.5 feet below the crown. Flap gate on the waterside (WS) end. Concrete U-shaped headwalls on both ends. Cobble grouted outlet across the berm. Cobble grouted apron on the landside (LS) end. [Additional Reference(s): DWR Levee Log, 1987, (HLM 12.64). USACE San Joaquin O&M Manual 612.2, 1967, (HLM 12.64), and 612 (addendum), February 1999, (HLM 12.61), (Station 666+02), 24-inch pipe listed]. FS Date: 2/25/2021

LS view: LS headwall at toe from crown.

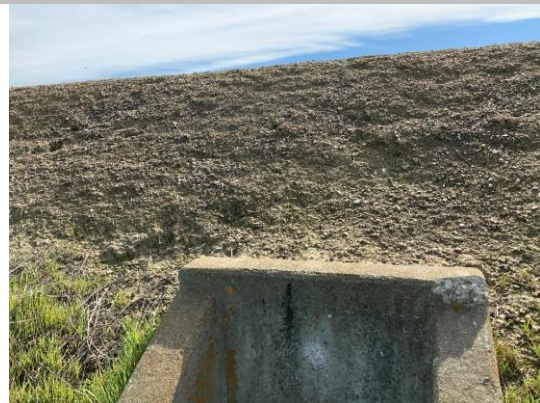
Photo 2 of 3 : UCIP_FA_2024_78970_92276.jpg

LS view: LS headwall at toe.

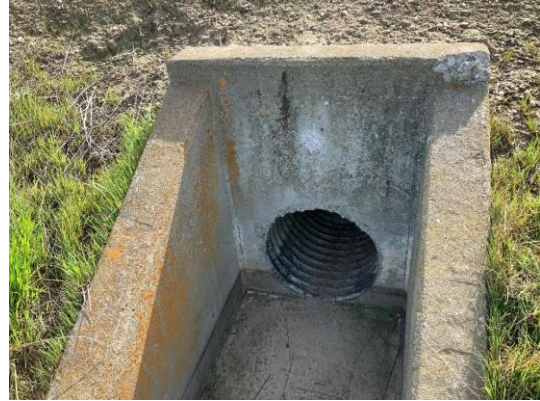
Photo 3 of 3 : UCIP_FA_2024_78970_92275.jpg

LS view: LS headwall at toe.

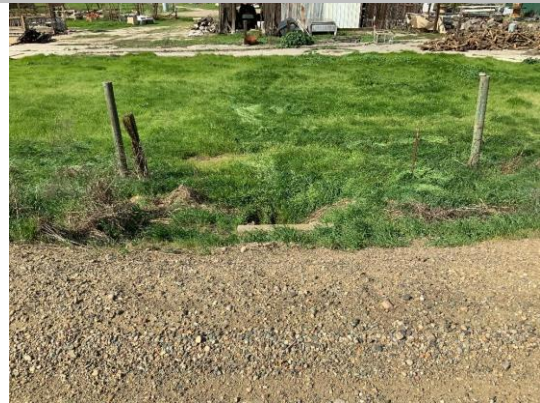
Photo 1 of 3 : UCIP_FA_2024_78971_92282.jpg

DS_ID:23508
FS_ID:78971
EP_NO: N/A
Repair Type: Non-Urgent
EVAL Issue: 5, Pipe Damage
Crossing Status: Found
UCIP Comments: 02/25/2021 The record has been upgraded from No Action Needed to Non-Urgent. DWR DMP has found integrity issues, LOF between 4 and 5. Crossing will be monitored until funding becomes available for rehabilitation. Recommend maintenance to clear up sediment buildup through LS pipe. No permit was found authorizing this encroachment. CVFPB will need to review crossing to determine owner. The UCIP inspection was completed with LMA representative, M. McCoy. (H. Dunn ? GEI)
FIELD_STRUCT_DESC: 24-inch corrugated metal storm drainage pipe (CMP) through the levee, 7.5 feet below the crown. Flap gate on the waterside (WS) end. Concrete U-shaped headwalls on both ends. Cobble grouted outlet across the berm. Cobble grouted apron on the landside (LS) end. [Additional Reference(s): DWR Levee Log, 1987, (HLM 12.72). USACE San Joaquin O&M Manual 612.2, 1967, (HLM 12.72), and 612 (addendum), February 1999, (HLM 12.71), (Station 671+24), 24-inch pipe listed].

LS view: LS headwall at toe from crown.

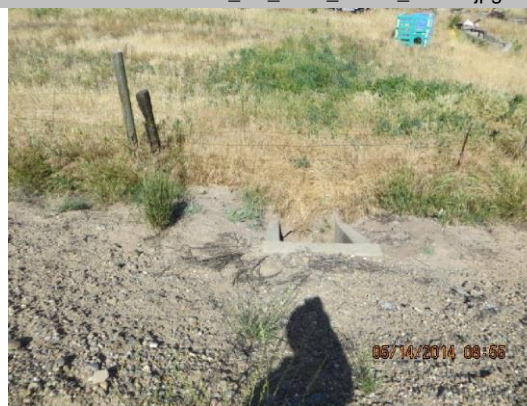
Photo 2 of 3 : UCIP_FA_2024_78971_68555.jpg

Pipe and headwall at LS toe.
