**Flood Control Project Maintenance
Levee Inspections****Maintenance Issue Types Only, Levee Inspection Report By Mile - Fall 2024****San Joaquin County Flood Control and Water Conservation District**

Waterway	Bank	Unit Miles	Inspection Start/End	Inspector
Unit No. 01 Littlejohn Creek	Left	2.59	10/21/2024 10/21/2024	Alberto De Leon

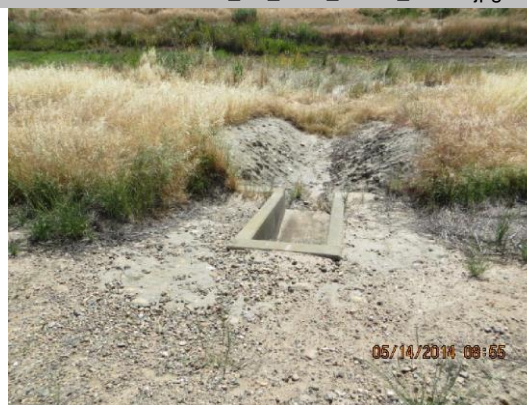
Photo 3 of 3 : UCIP_FA_2024_78971_68554.jpg

Pipe, flap gate, headwall, and cobble grouted outlet on the WS toe.

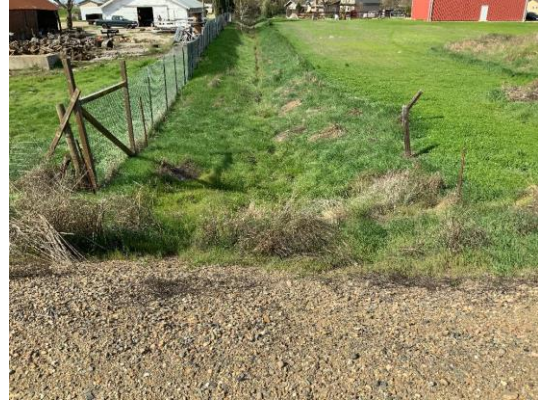
Photo 1 of 3 : UCIP_FA_2024_78922_92291.jpg

Comment Code					
Inspector Comment					
DS_ID:23509 FS_ID:78922 EP_NO: N/A Repair Type: Non-Urgent EVAL Issue: 5, Pipe Damage Crossing Status: Found UCIP Comments: 09/23/2024 DMP internal video inspection has found moderate pipe defects. Crossing will be monitored until funding becomes available for rehabilitation. (O. Yakimov - DWR UCIP) 02/25/2021 The record has been upgraded from No Action Needed to Non-Urgent. DWR DMP internal inspection has not found pipe integrity issues. LOF of crossing is less or equal to 4.0. Recommend next video inspection in 5 years. No permit was found authorizing this encroachment. CVFPB will need to review crossing to determine owner. The UCIP inspection was completed with LMA representative, M. Mccoy. (H. Dunn ? GEI) FIELD_STRUCT_DESC: 24-inch corrugated metal storm drainage pipe (CMP) through the levee, 7.5 feet below the crown. Flap gate on the waterside (WS) end. Concrete U-shaped headwalls on both ends. Cobble grouted outlet across the berm. Cobble grouted apron on the landside (LS) end. [Additional Reference(s): DWR Levee Log, 1987, (HLM 12.74). USACE San Joaquin O&M Manual 612.2, 1967, (HLM 12.74), and 612 (addendum), February 1999, (HLM 12.73), (Station 672+05), 24-inch pipe listed]. FS Date: 2/25/2021

LS view: LS headwall at toe from crown.

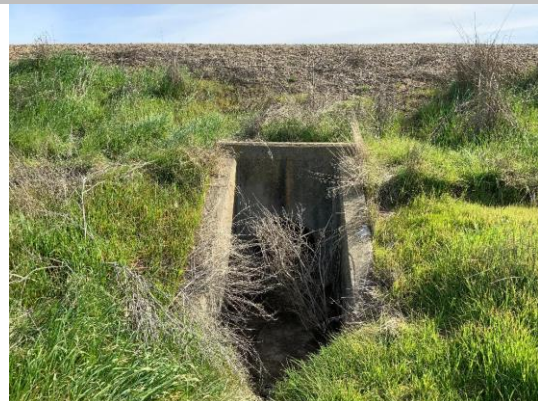
Photo 2 of 3 : UCIP_FA_2024_78922_95682.jpg

LS view: Headwall at toe.

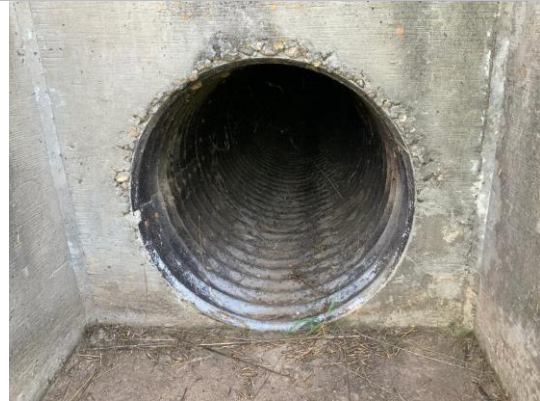
Photo 3 of 3 : UCIP_FA_2024_78922_95683.jpg

LS view: Pipe inlet, 1 of 2 photos.

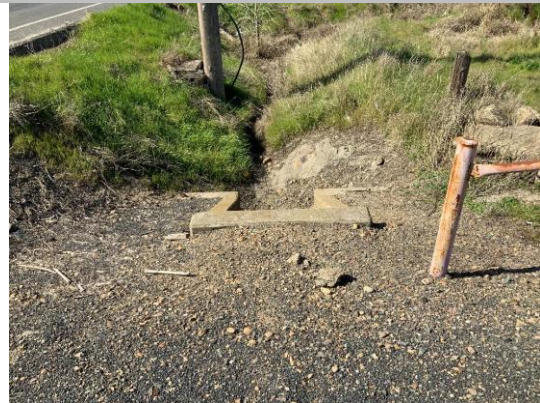
Photo 1 of 3 : UCIP_FA_2024_78923_92340.jpg

Comment Code						
Inspector Comment						
DS_ID:23512 FS_ID:78923 EP_NO: N/A Repair Type: Non-Urgent EVAL Issue: 5, Pipe Damage Crossing Status: Found UCIP Comments: 09/23/2024 DMP internal video inspection has found moderate pipe defects. Crossing will be monitored until funding becomes available for rehabilitation. (O. Yakimov - DWR UCIP) 02/25/2021 The record has been upgraded from No Action Needed to Non-Urgent. DWR DMP has not found internal issues, LOF between 1 and 2. Recommend inspection in 5 years. No permit was found authorizing this encroachment. CVFPB will need to review crossing to determine owner. The UCIP inspection was completed with LMA representative, M. Mccoy. (H. Dunn ? GEI) FIELD_STRUCT_DESC: 24-inch corrugated metal storm drainage pipe (CMP) through the levee, 7.0 feet below the crown. Flap gate on the waterside (WS) end. Concrete U-shaped headwalls on both ends. Cobble grouted outlet on the WS. Cobble grouted intake on the landside (LS). [Additional Reference(s): DWR Levee Log, 1987, (HLM 13.29). USACE San Joaquin O&M Manual 612.2, 1967, (HLM 13.29), 24-inch pipe listed]. FS Date: 2/25/2021

LS view: LS headwall at toe from crown.

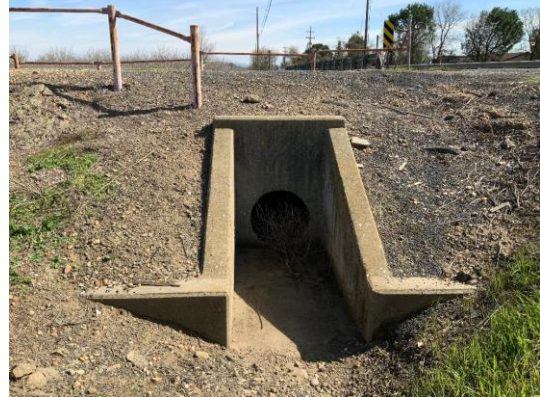
Photo 2 of 3 : UCIP_FA_2024_78923_92341.jpg

LS view: LS headwall at toe.

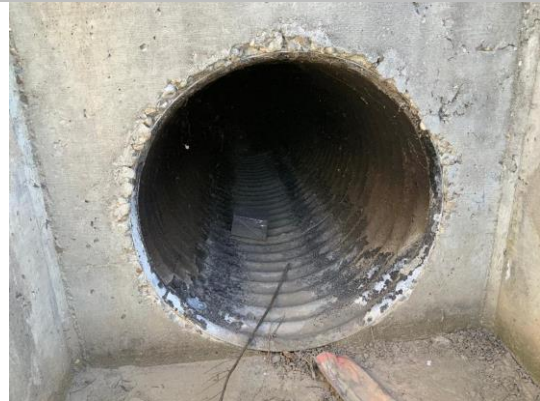
Photo 3 of 3 : UCIP_FA_2024_78923_92342.jpg

LS view: LS pipe.

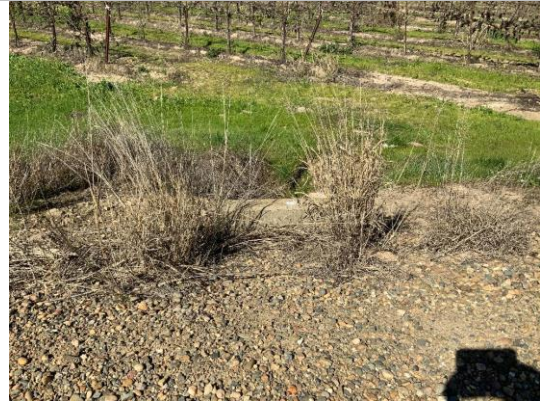
Photo 1 of 3 : UCIP_FA_2024_78972_92446.jpg

Comment Code						
Inspector Comment						
DS_ID:23597 FS_ID:78972 EP_NO: N/A Repair Type: Non-Urgent EVAL Issue: Crossing Status: Found UCIP Comments: 02/25/2021 The record has been upgraded from No Action Needed to Non-Urgent. DWR DMP has not found internal issues, LOF between 1 and 2. Recommend inspection in 5 years. No permit was found authorizing this encroachment. CVFPB will need to review crossing to determine owner. The UCIP inspection was completed with LMA representative, M. Mccoy. (H. Dunn ? GEI) FIELD_STRUCT_DESC: 24-inch corrugated metal storm drainage pipe (CMP) through the levee, 5.5 feet below the crown. Flap gate on the waterside (WS) end. Concrete U-shaped headwalls on both ends. Cobble grouted outlet on the WS. Cobble grouted intake on the landside (LS). [Additional Reference(s): DWR Levee Log, 1987, (HLM 13.64). USACE San Joaquin O&M Manual 612.2, 1967, (HLM 13.64), 24-inch pipe listed]. FS Date: 2/25/2021

LS view: LS headwall at toe from crown.

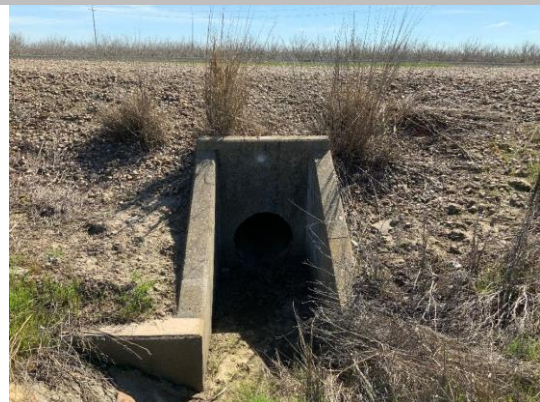
Photo 2 of 3 : UCIP_FA_2024_78972_92447.jpg

LS view: LS headwall at toe.

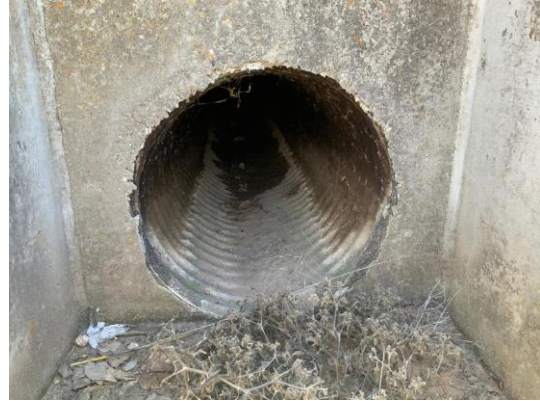
Photo 3 of 3 : UCIP_FA_2024_78972_92448.jpg

LS view: LS pipe.

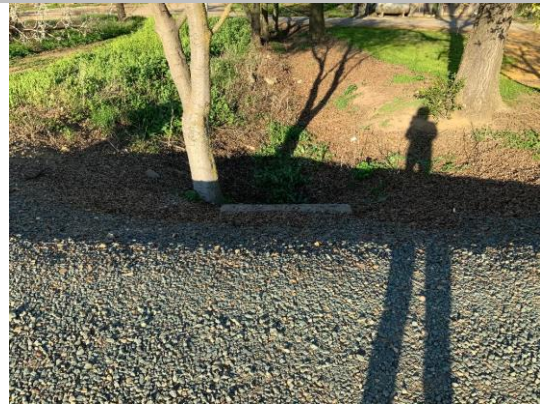
Photo 1 of 3 : UCIP_FA_2024_78973_92704.jpg

Comment Code						
Inspector Comment						
DS_ID:23598 FS_ID:78973 EP_NO: N/A Repair Type: Non-Urgent EVAL Issue: Crossing Status: Found UCIP Comments: 02/26/2021 The record has been upgraded from No Action Needed to Non-Urgent. DWR DMP has not found internal issues, LOF between 1 and 2. Recommend inspection in 5 years. No permit was found authorizing this encroachment. CVFPB will need to review crossing to determine owner. The UCIP inspection was completed with LMA representative, J. Caruso. (H. Dunn ? GEI) FIELD_STRUCT_DESC: 24-inch corrugated metal storm drainage pipe (CMP) through the levee, 7.5 feet below the crown. Flap gate on the waterside (WS) end. Concrete U-shaped headwalls on both ends. Cobble grouted outlet on the WS. Cobble grouted intake on the landside (LS) slope. [Additional Reference(s): DWR Levee Log, 1987, (HLM 14.04). USACE San Joaquin O&M Manual 612.2, 1967, (HLM 14.04), 24-inch pipe listed]. FS Date: 2/26/2021

LS headwall at toe from crown.

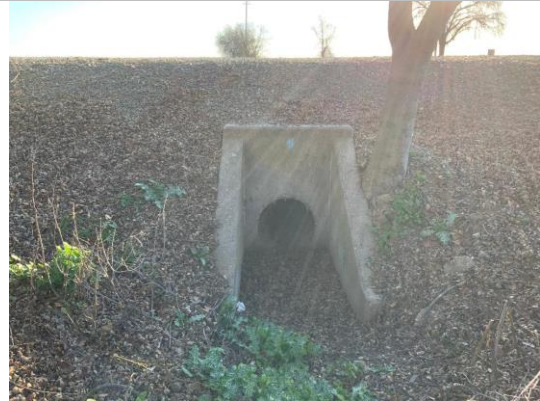
Photo 2 of 3 : UCIP_FA_2024_78973_92705.jpg

LS headwall at toe.

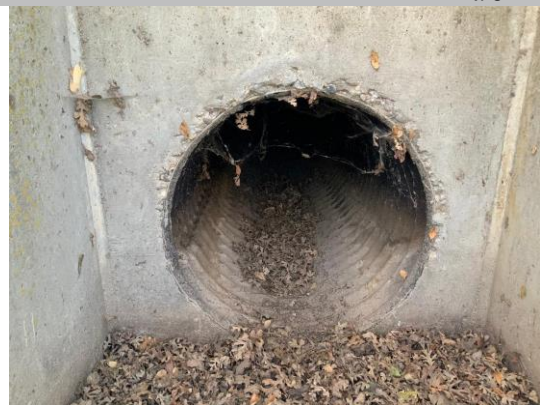
Photo 3 of 3 : UCIP_FA_2024_78973_92706.jpg

LS pipe.

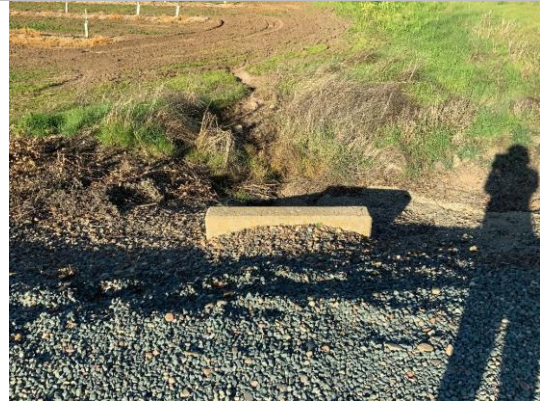
Photo 1 of 3 : UCIP_FA_2024_78974_92726.jpg

Comment Code					
Inspector Comment					
DS_ID:23600 FS_ID:78974 EP_NO: N/A Repair Type: Non-Urgent EVAL Issue: Crossing Status: Found UCIP Comments: 02/26/2021 The record has been upgraded from No Action Needed to Non-Urgent. DWR DMP has not found internal issues, LOF between 1 and 2. Recommend inspection in 5 years. No permit was found authorizing this encroachment. CVFPB will need to review crossing to determine owner. The UCIP inspection was completed with LMA representative, J. Caruso. (H. Dunn ? GEI) FIELD_STRUCT_DESC: 24-inch corrugated metal storm drainage pipe (CMP) through the levee, 6.0 feet below the crown. Flap gate on the waterside (WS) end. Concrete U-shaped headwalls on both ends. Cobble grouted outlet on the WS. [Additional Reference(s): DWR Levee Log, 1987, (HLM 14.37). USACE San Joaquin O&M Manual 612.2, 1967, (HLM 14.37), 24-inch pipe listed]. FS Date: 2/26/2021

LS view: LS headwall at toe from crown.

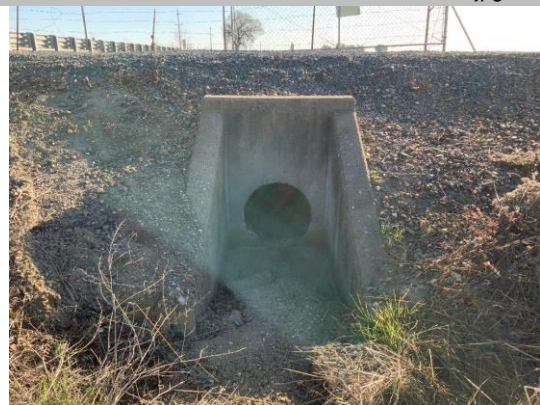
Photo 2 of 3 : UCIP_FA_2024_78974_92727.jpg

LS view: LS headwall at toe.

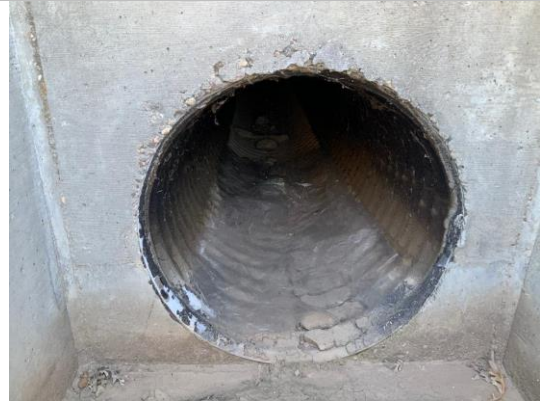
Photo 3 of 3 : UCIP_FA_2024_78974_92728.jpg

LS view: LS pipe.

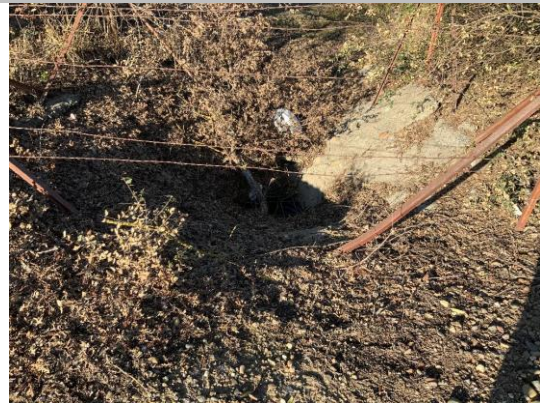
Photo 1 of 3 : UCIP_FA_2024_78927_92737.jpg

DS_ID:23601
 FS_ID:78927
 EP_NO: N/A
 Repair Type: Non-Urgent
 EVAL Issue: 5, Pipe Damage
 Crossing Status: Found
 UCIP Comments: 02/26/2021 Record record has been updated from No Action Needed to Non-Urgent. DWR DMP has found integrity issues, LOF between 4 and 5. Crossing will be monitored until funding becomes available for rehabilitation. No permit was found authorizing this encroachment. CVFPB will need to review crossing to determine owner. The UCIP inspection was completed with LMA representative, J. Caruso. (H. Dunn GEI)
 FIELD_STRUCT_DESC: 24-inch corrugated metal storm drainage pipe (CMP) through the levee, 8.0 feet below the crown. Flap gate on the waterside (WS) end. Concrete U-shaped headwall on the WS end. Cobble grouted outlet on the WS. 24-inch CMP drop inlet and cobble grouted intake on the landside (LS), no headwall. (Drainage ditch and 12-inch culverts adjacent to levee authorized under Permit No. 12659, 1979 - Richard Stasand). [Additional Reference(s): DWR Levee Log, 1987, (HLM 14.39). USACE San Joaquin O&M Manual 612.2, 1967, (HLM 14.39), 24-inch pipe listed].

LS view: LS toe inlet, surrounded by barbed wire.

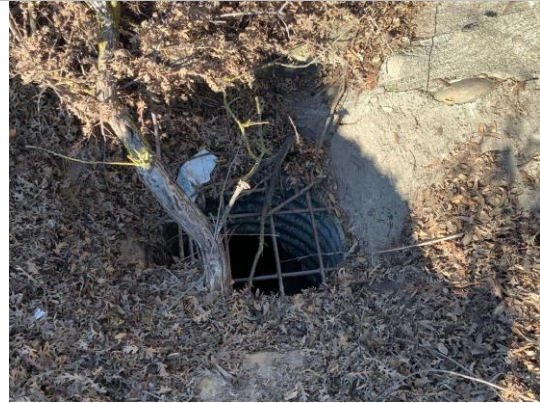
Photo 2 of 3 : UCIP_FA_2024_78927_92738.jpg

LS view: LS toe pipe and inlet.

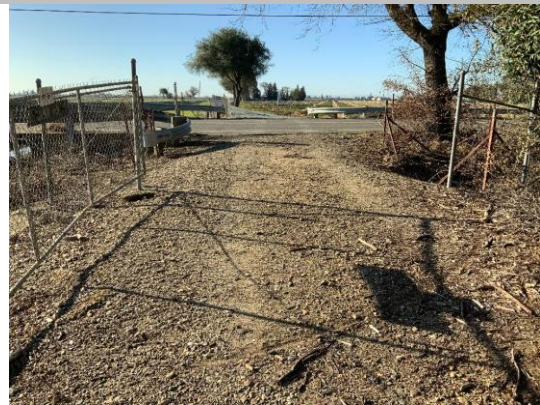
Photo 3 of 3 : UCIP_FA_2024_78927_92733.jpg

Levee crown looking downstream.

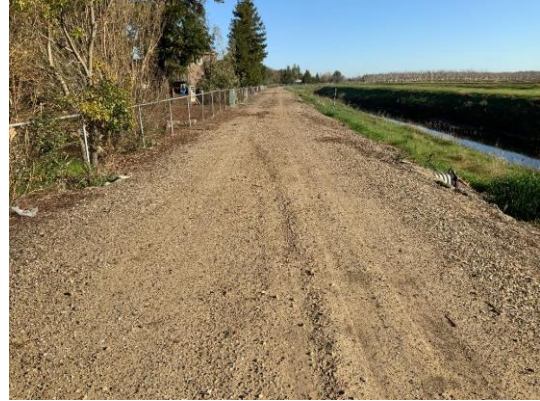
Photo 1 of 3 : UCIP_FA_2024_79423_92758.jpg

Comment Code						
Inspector Comment						
DS_ID:23602 FS_ID:79423 EP_NO: N/A Repair Type: Non-Urgent EVAL Issue: 5, Pipe Damage Crossing Status: Found UCIP Comments: 03/31/2023 Record updated from Urgent to Non-Urgent. LoF is equal to 5.1 due to pipe deformation, integrity issues are not found. Crossing will be monitored until funding becomes available for rehabilitation. (O.Yakimov - DWR UCIP). 02/26/2021 Record has been updated from No Action Needed to Urgent. DWR DMP has found integrity issues, LOF between 5 and 6. Recommend monitoring crossing until funding becomes available to address. WS outlet is slightly overgrown with vegetation. No permit was found authorizing this encroachment. CVFPB will need to review crossing to determine owner. LS flap gate is broken and needs repair. The UCIP inspection was completed with LMA representative, J. Caruso. (H. Dunn ? GEI) FIELD_STRUCT_DESC: 12-inch corrugated metal drainage pipe (CMP) through the levee, 1.0 foot below the crown. Cobble grouted inlet at fish pond on the landside (LS) toe. [Additional Reference(s): DWR Levee Log, 1987, (HLM 14.42), 7-inch pipe listed. USACE San Joaquin O&M Manual 612.2, 1967, (HLM 14.42), 7-inch pipe listed]. FS Date: 2/26/2021

Levee crown looking upstream.

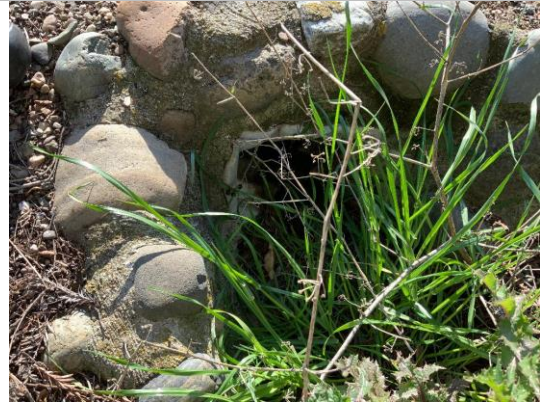
Photo 3 of 3 : UCIP_FA_2024_79423_92760.jpg

LS view: LS pipe at toe.

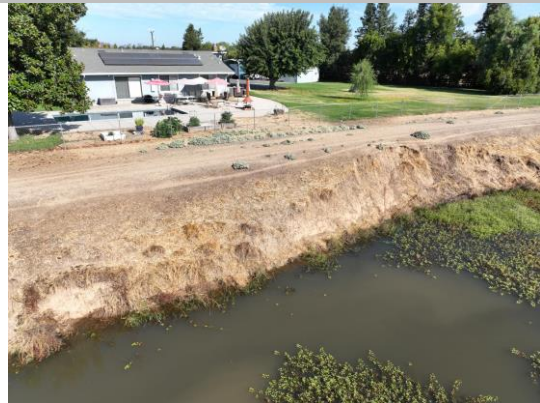
Photo 1 of 3 : SJR2024_NA0017U07RM21.29_1.JPG

8/29/2023: The site was discovered by the LMA and visited during the annual field survey. There is a 6 foot vertical scarp approximately 100 feet long along the patrol road hinge.

8/8/2024: View of erosion.

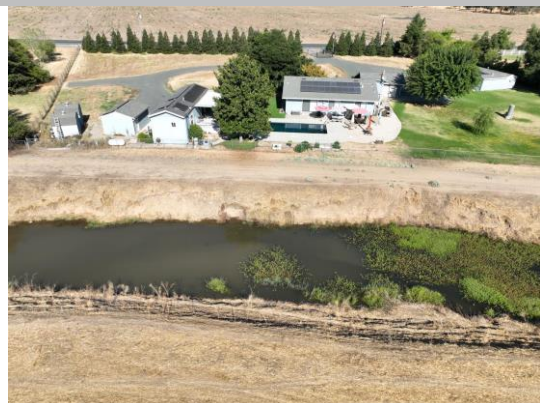
Photo 2 of 3 : SJR2024_NA0017U07RM21.29_5.JPG

8/8/2024: View of erosion from opposite bank.

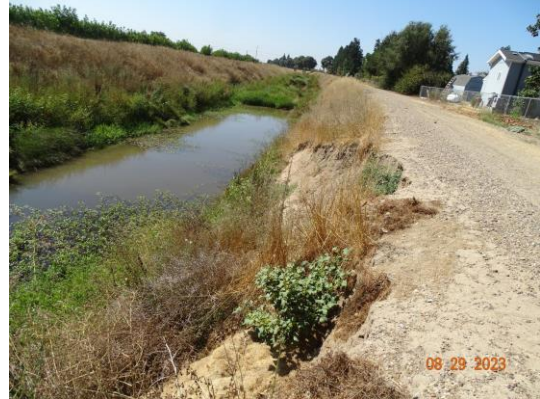
Photo 3 of 3 : SJR2024_NA0017U07RM21.29_11.JPG

8/29/2023: View of erosion.

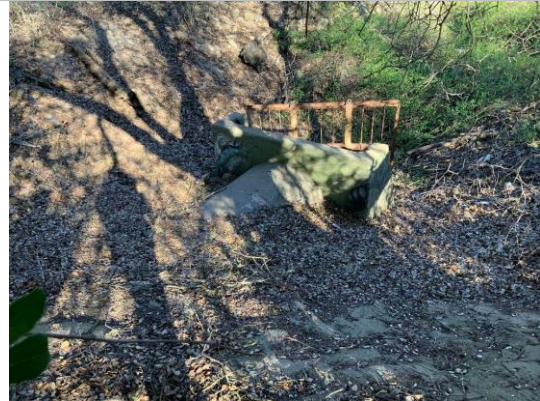
Photo 1 of 3 : UCIP_FA_2024_78928_92790.jpg

DS_ID:23604
 FS_ID:78928
 EP_NO: N/A
 Repair Type: No Action Needed
 EVAL Issue:
 Crossing Status: Found
 UCIP Comments: 02/26/2021 Record updated from Non-Urgent to No Action Needed. Unit 7 ? Bear Creek (CLM 13.95 to 14.90) is considered a patrol road/high ground area with no defined levee prism, any issue found between CLM 13.95 to 14.90 of Unit 7 will be considered a maintenance issue, or an unauthorized encroachment, or an abandoned encroachment. DMP internal video inspection has found none or minor pipe defects. Current condition of pipe crossing does not impede access to patrol road/high ground area. No permit was found authorizing this encroachment. CVFPB will need to review crossing to determine owner.. The UCIP inspection was completed with LMA representative, J. Caruso. (H. Dunn ? GEI)05/12/2014 No flapgate. (W. Wylie - DWR UCIP)
 FIELD_STRUCT_DESC: *High Ground* 48-inch reinforced concrete drainage pipe (RCP) through the levee, 9.0 feet below the crown. Concrete headwall with trash rack on the landside (LS). Cobble grouted intake on the LS. Cobble grouted outlet on the waterside (WS). Open on both ends. [Additional Reference(s): DWR Levee Log, 1987, (HLM 15.00). USACE San Joaquin O&M Manual 612.2, 1967, (HLM 15.00), 48-inch pipe listed].

LS view: LS headwall off of the toe.

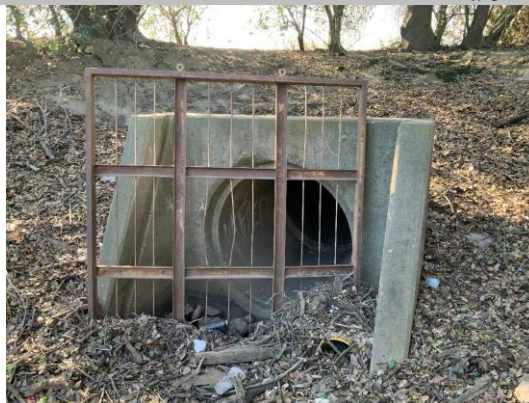
Photo 2 of 3 : UCIP_FA_2024_78928_92791.jpg

LS view: LS headwall, gate ajar, no flapgate.

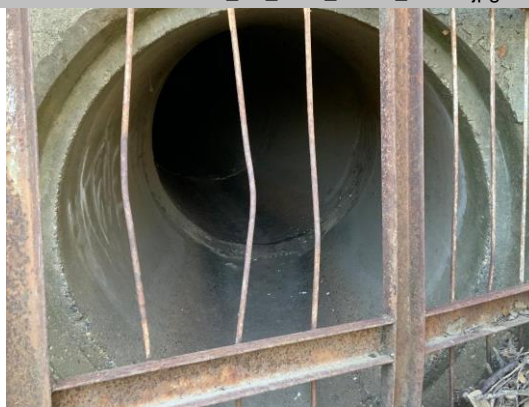
Photo 3 of 3 : UCIP_FA_2024_78928_92792.jpg

LS view: LS pipe.

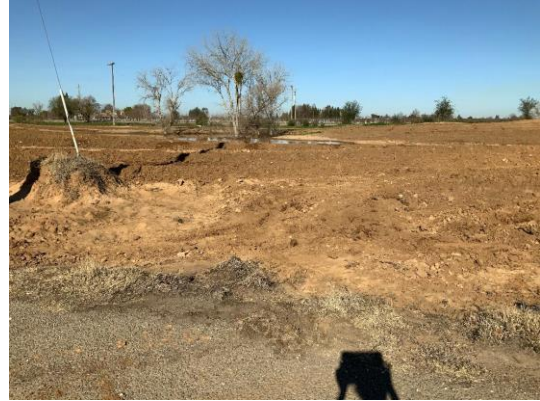
Photo 1 of 3 : UCIP_FA_2024_78976_92809.jpg

DS_ID:23605
FS_ID:78976
EP_NO: N/A
Repair Type: Non-Urgent
EVAL Issue: 11, Maintenance Compliance Issue
Crossing Status: Found
UCIP Comments: 02/26/2021 Record remains Non-Urgent. Unit 7 ? Bear Creek (CLM 13.95 to 14.90) is considered a patrol road/high ground area with no defined levee prism, any issue found between CLM 13.95 to 14.90 of Unit 7 will be considered a maintenance issue, or an unauthorized encroachment, or an abandoned encroachment. DWR DMP has found integrity issues, LOF between 5 and 6. Crossing will be monitored until funding becomes available to address. Current condition of pipe crossing does not impede access to patrol road/high ground area. No permit was found authorizing this encroachment. CVFPB will need to review crossing to determine owner. The UCIP inspection was completed with LMA representative, J. Caruso. (H. Dunn ? GEI)

LS toe from crown, pipe not visible.

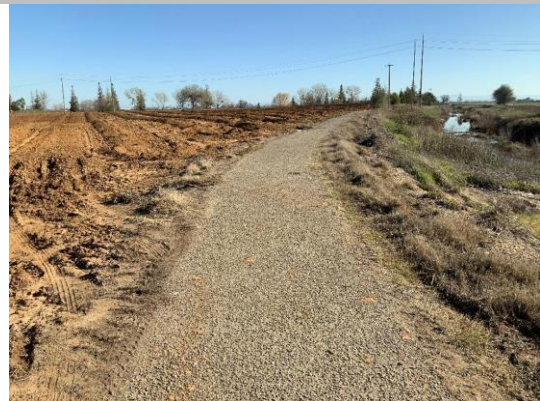
Photo 2 of 3 : UCIP_FA_2024_78976_92805.jpg

Levee crown looking upstream.

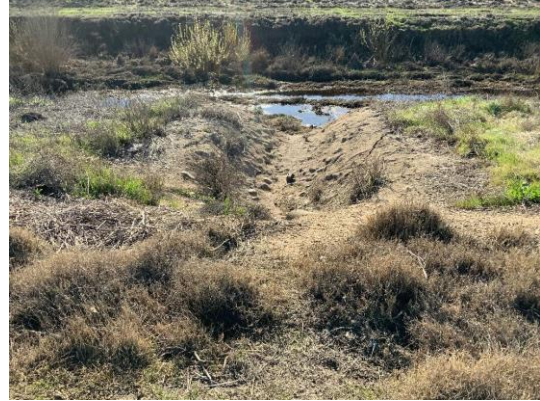
Photo 3 of 3 : UCIP_FA_2024_78976_92806.jpg

WS view: WS pipe at toe from crown.

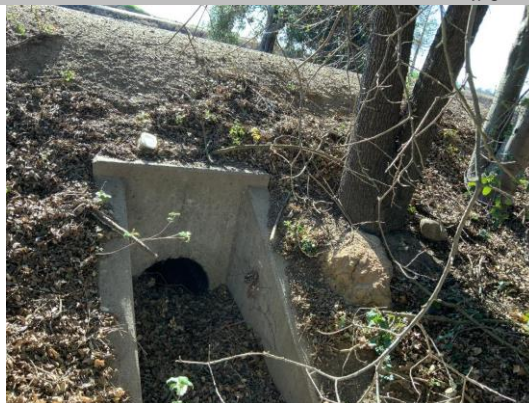
Photo 2 of 3 : UCIP_FA_2024_78977_92825.jpg

LS view: LS headwall at toe.

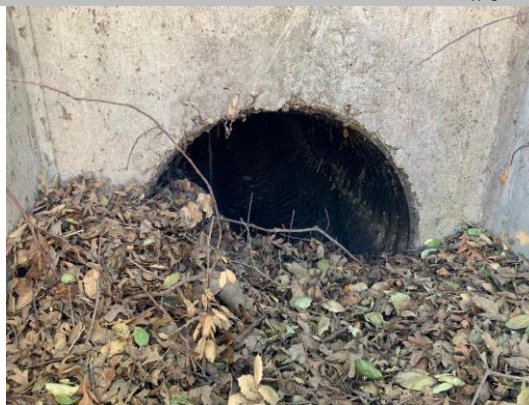
Photo 3 of 3 : UCIP_FA_2024_78977_92826.jpg

LS view: LS pipe, vegetation debris covering pipe.

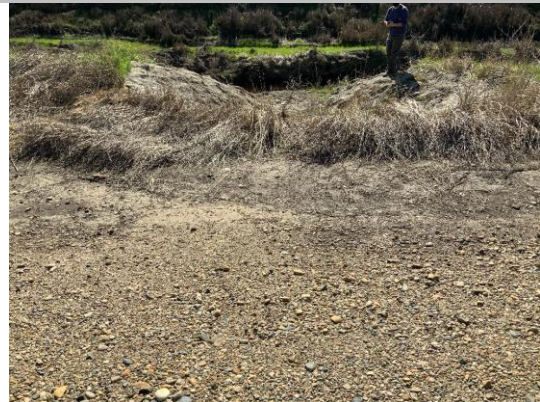
Photo 1 of 3 : UCIP_FA_2024_78978_92893.jpg

Comment Code					
Inspector Comment					
DS_ID:23609 FS_ID:78978 EP_NO: N/A Repair Type: Non-Urgent EVAL Issue: Crossing Status: Found UCIP Comments: 02/26/2021 The record has been upgraded from No Action Needed to Non-Urgent. DWR DMP has not found internal issues, LOF between 1 and 2. Recommend inspection in 5 years. No permit was found authorizing this encroachment. CVFPB will need to review crossing to determine owner. The UCIP inspection was completed with LMA representative, J. Caruso. (H. Dunn ? GEI)05/12/2014 Rodent hole on crown side of headwall on WS slope. (W. Wylie - DWR UCIP) FIELD_STRUCT_DESC: 24-inch corrugated metal storm drainage pipe (CMP) through the levee, 7.5 feet below the crown. Flap gate on the waterside (WS) end. Concrete U-shaped headwalls on both ends. Cobble grouted outlet on the WS. Cobble grouted intake on the landside (LS). [Additional Reference(s): DWR Levee Log, 1987, (HLM 15.68). USACE San Joaquin O&M Manual 612.2, 1967, (HLM 15.68), 24-inch pipe listed]. FS Date: 2/26/2021

WS view: WS headwall at toe from crown.

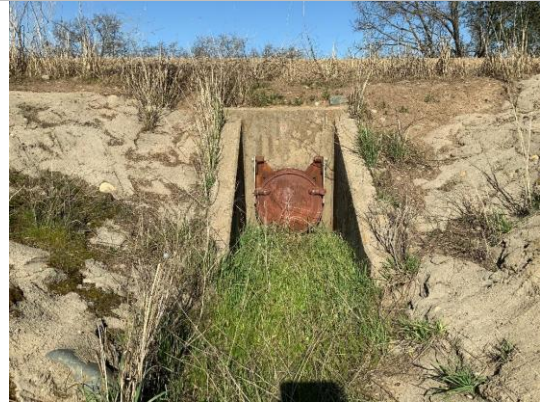
Photo 2 of 3 : UCIP_FA_2024_78978_92894.jpg

WS view: WS headwall and flapgate at toe.

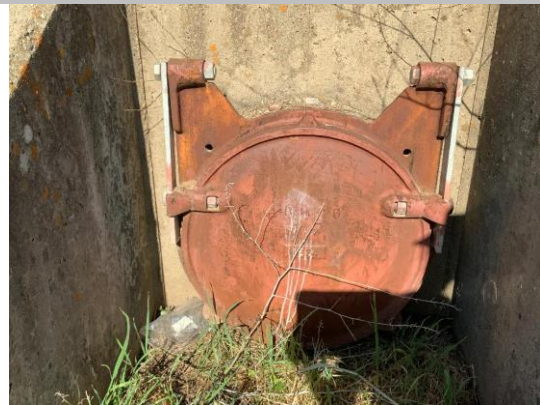
Photo 3 of 3 : UCIP_FA_2024_78978_92895.jpg

WS view: WS flapgate.

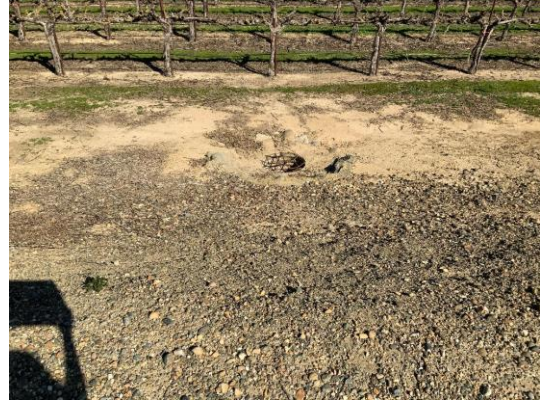
Photo 1 of 3 : UCIP_FA_2024_78389_92905.jpg

Comment Code						
Inspector Comment						
DS_ID:23610 FS_ID:78389 EP_NO: N/A Repair Type: Non-Urgent EVAL Issue: 4b, Safety Issue Crossing Status: Found UCIP Comments: 02/26/2021 Pipe status is still Non-Urgent. LS inlet only has wiring covering it, no cover or riser, safety concern. DWR DMP has not found internal issues, LOF between 1 and 2. Recommend inspection in 5 years. No permit was found authorizing this encroachment. CVFPB will need to review crossing to determine owner. The UCIP inspection was completed with LMA representative, J. Caruso. (H. Dunn ? GEI)05/12/2014 No inlet cover or grate at LS toe. (W. Wylie - DWR UCIP) FIELD_STRUCT_DESC: 24-inch corrugated metal storm drainage pipe (CMP) through the levee, 11.0 feet below the crown. Flap gate on the waterside (WS) end. Concrete U-shaped headwall on the WS end. 24-inch CMP riser unit/drop inlet on the landside (LS). [Additional Reference(s): DWR Levee Log, 1987, (HLM 15.80). USACE San Joaquin O&M Manual 612.2, 1967, (HLM 15.80), 24-inch pipe listed]. FS Date: 2/26/2021

LS view: LS toe from crown, pipe inlet with no riser.

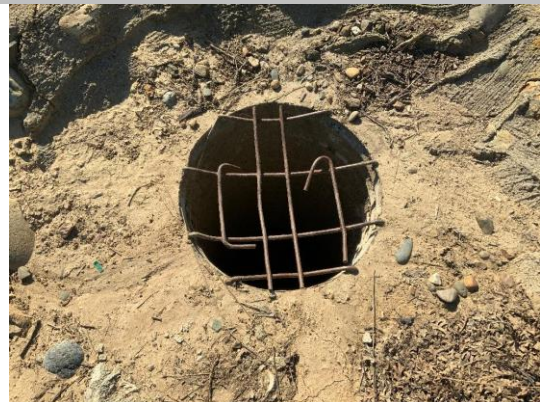
Photo 2 of 3 : UCIP_FA_2024_78389_92906.jpg

LS view: LS pipe inlet, no cover, safety concern.

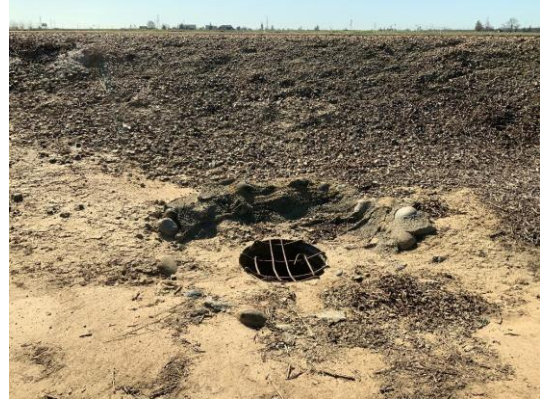
Photo 3 of 3 : UCIP_FA_2024_78389_92907.jpg

LS view: LS pipe inlet at toe, safety concern.

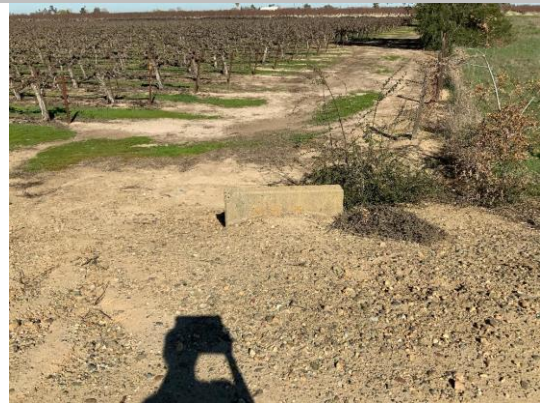
Photo 1 of 3 : UCIP_FA_2024_78979_92920.jpg

DS_ID:23611
 FS_ID:78979
 EP_NO: N/A
 Repair Type: Non-Urgent
 EVAL Issue:
 Crossing Status: Found
 UCIP Comments: 02/26/2021 The record has been upgraded from No Action Needed to Non-Urgent. Some peeling away of metal on inside edge of WS pipe. DWR DMP has not found internal issues, LOF between 1 and 2. Recommend inspection in 5 years. No permit was found authorizing this encroachment. CVFPB will need to review crossing to determine owner. The UCIP inspection was completed with LMA representative, J. Caruso. (H. Dunn ? GEI)
 FIELD_STRUCT_DESC: 24-inch corrugated metal storm drainage pipe (CMP) through the levee, 4.0 feet below the crown. Flap gate on the waterside (WS) end. Concrete U-shaped headwalls on both ends. Cobble grouted outlet on the WS. Cobble grouted intake on the landside (LS). [Additional Reference(s): DWR Levee Log, 1987, (HLM 15.90). USACE San Joaquin O&M Manual 612.2, 1967, (HLM 15.90), 24-inch pipe listed].

LS view: LS headwall at toe from crown.

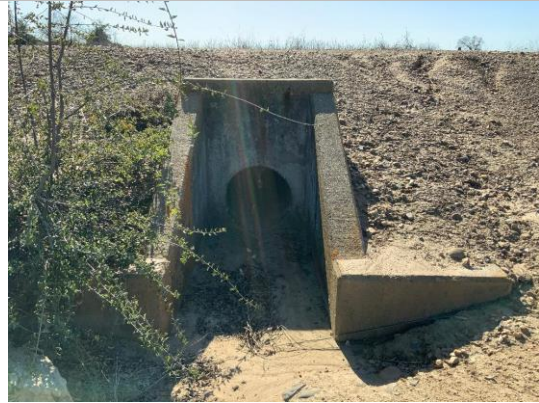
Photo 2 of 3 : UCIP_FA_2024_78979_92921.jpg

LS view: LS headwall at toe.

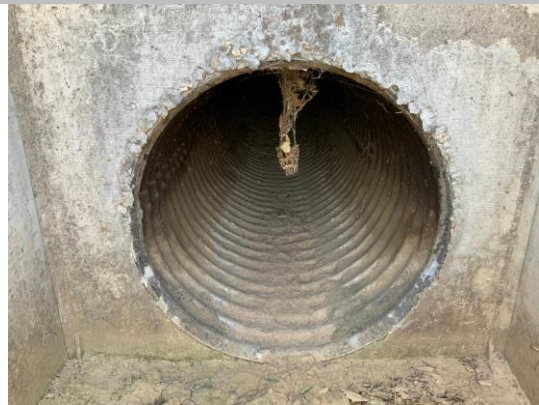
Photo 3 of 3 : UCIP_FA_2024_78979_92922.jpg

LS view: LS pipe.

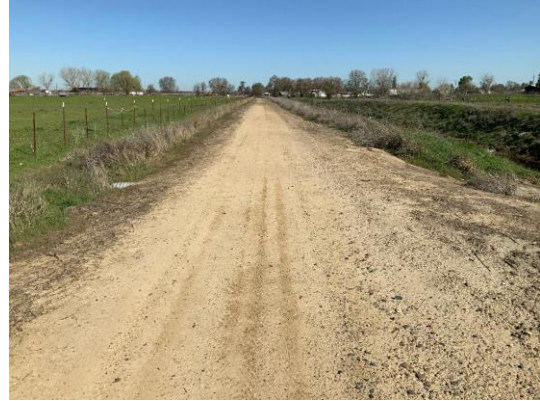
Photo 1 of 3 : UCIP_FA_2024_78980_92930.jpg

Comment Code					
Inspector Comment					
DS_ID:23612 FS_ID:78980 EP_NO: Repair Type: Non-Urgent EVAL Issue: 11, Maintenance Compliance Issue Crossing Status: Found UCIP Comments: 02/26/2021 Record remains Non-Urgent. Unit 7 - Bear Creek (CLM 15.50 to 16.13) is considered a patrol road/high ground area with no defined levee prism, any issue found between CLM 15.50 to 16.13 of Unit 7 will be considered a maintenance issue, or an unauthorized encroachment, or an abandoned encroachment. Current condition of pipe crossing does not impede access to patrol road/high ground area. Pipe is open on both ends and LS pipe edges are severely bent, recommend maintenance. No permit was found authorizing this encroachment. CVFPB will need to review crossing to determine owner. The UCIP inspection was completed with LMA representative, J. Caruso. (H. Dunn - GE09/18/2018 Levee is so short that it's almost nonexistent. Pipe goes just under levee and acts as an open storm drain. Inlet is bent down. There is a flooding potential because this pipe is open and goes straight through the levee; therefore, this crossing remains "Urgent." (A. McDonald - DWR UCIP04/20/2017 Pipe is open on both ends. Requires a positive closure device. Crossing has been upgraded from No Action Needed to Urgent. (K. Fazel - UCIP) FIELD_STRUCT_DESC: *HIGH GROUND* 12-inch corrugated metal drainage culvert pipe (CMP) through the levee, 1.5 feet below the crown. Cobble grouted outlet on the waterside (WS). Open on both ends. [Additional Reference(s): DWR Levee Log, 1987, (HLM 16.09). USACE San Joaquin O&M Manual 612.2, 1967, (HLM 16.10), 12-inch pipe listed] FS Date: 2/26/2021

Levee crown looking upstream.

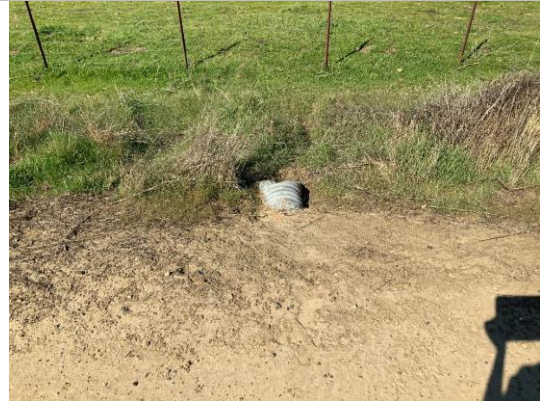
Photo 2 of 3 : UCIP_FA_2024_78980_92931.jpg

LS view: LS pipe at toe from crown.

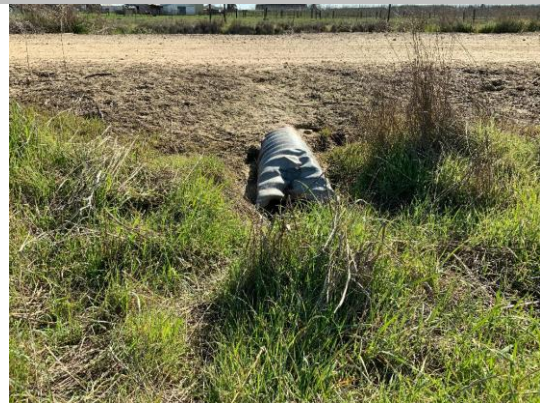
Photo 3 of 3 : UCIP_FA_2024_78980_92924.jpg

LS view: LS pipe at toe.

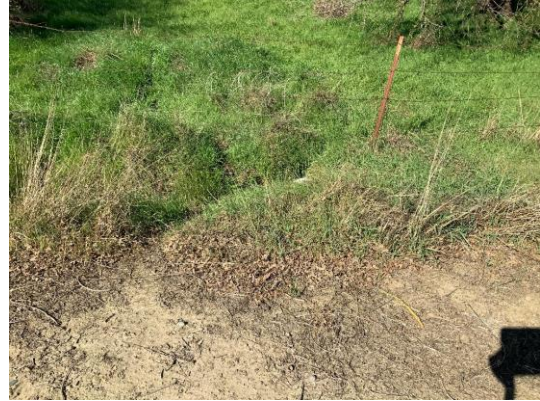
Photo 1 of 3 : UCIP_FA_2024_78934_92948.jpg

Comment Code						
Inspector Comment						
DS_ID:23614 FS_ID:78934 EP_NO: Repair Type: Non-Urgent EVAL Issue: 11, Maintenance Compliance Issue Crossing Status: Found UCIP Comments: 02/26/2021 Record remains Non-Urgent. Unit 7 ? Bear Creek (CLM 15.50 to 16.13) is considered a patrol road/high ground area with no defined levee prism, any issue found between CLM 15.50 to 16.13 of Unit 7 will be considered a maintenance issue, or an unauthorized encroachment, or an abandoned encroachment. Pipe is barely a foot below crown and open on both WS and LS toes. WS has bad erosion and large burrow holes under and around it, recommend maintenance for open pipe and erosion. Pipe is surrounded by large pieces of broken concrete. No permit was found authorizing this encroachment. CVFPB will need to review crossing to determine owner. The UCIP inspection was completed with LMA representative, J. Caruso. (H. Dunn ? GEI)09/18/2018 Levee is so short that it's almost nonexistent. Pipe goes just under levee and acts as an open storm drain. There is a flooding potential because this pipe is open and goes straight through the levee; therefore, this crossing remains "Urgent." (A. McDonald - DWR UCIP)4/20/2017 Pipe is open on both ends. Requires a positive closure device. Crossing has been upgraded from No Action Needed to Urgent. (K. Fazel - UCIP) FIELD_STRUCT_DESC: *HIGH GROUND* 12-inch corrugated metal drainage culvert pipe (CMP) through the levee, 2.0 feet below the crown. Cobble grouted outlet on the waterside (WS). Open on both ends. [Additional Reference(s): DWR Levee Log, 1987, (HLM 16.32). USACE San Joaquin O&M Manual 612.2, 1967, (HLM 16.32), 12-inch pipe listed]. FS Date: 2/26/2021

LS view: LS pipe at toe from crown.

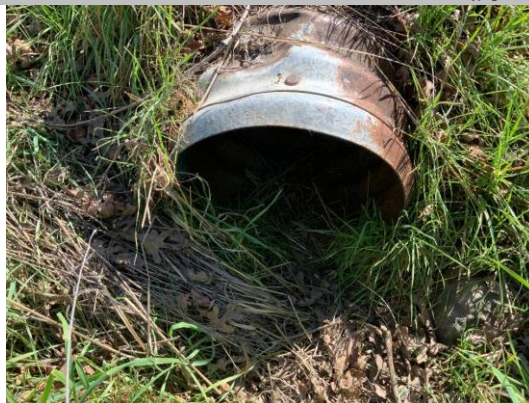
Photo 2 of 3 : UCIP_FA_2024_78934_92940.jpg

LS view: LS pipe, some bending on top.

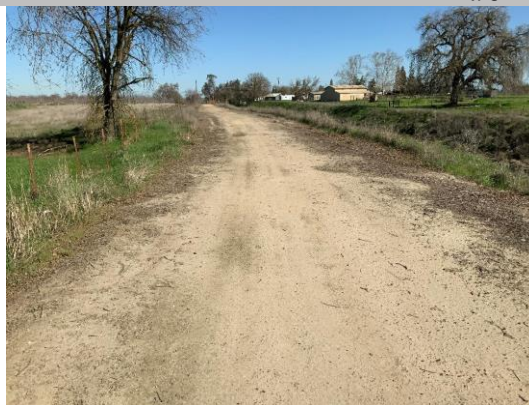
Photo 3 of 3 : UCIP_FA_2024_78934_92946.jpg

Levee crown looking upstream.

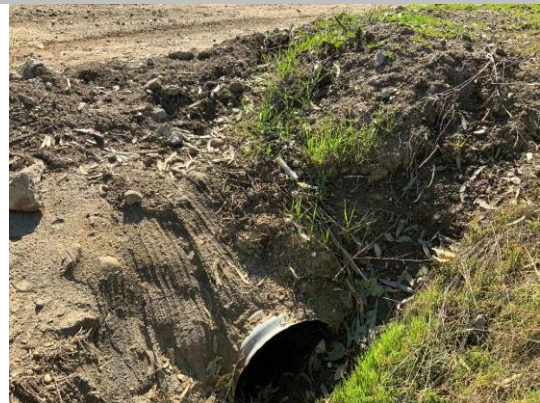
Photo 2 of 3 : UCIP_FA_2024_78935_92987.jpg

LS pipe slope.

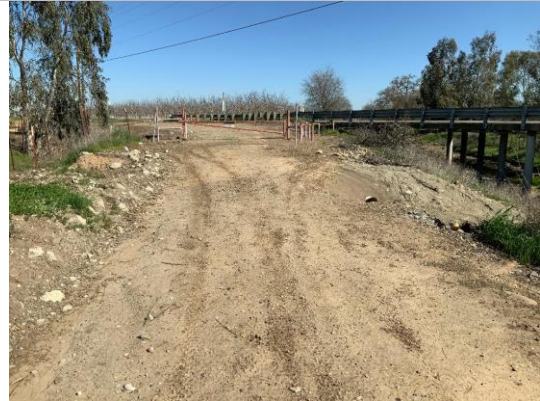
Photo 3 of 3 : UCIP_FA_2024_78935_92985.jpg

Levee crown looking upstream.

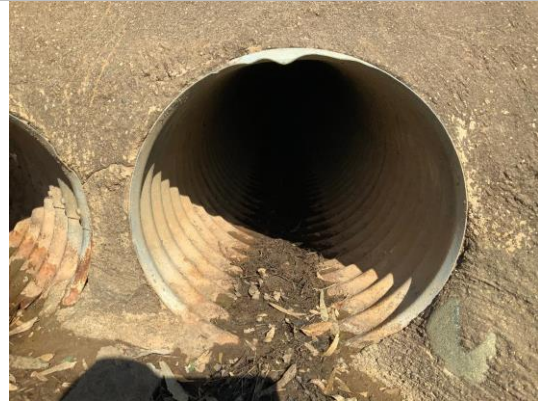
Photo 2 of 3 : UCIP_FA_2024_84811_92997.jpg

DS_ID:23617
FS_ID:84811
EP_NO: N/A
Repair Type: Urgent
EVAL Issue: 1, Pipe Integrity
Crossing Status: Found
UCIP Comments: 09/23/2024 Record updated from No Action Needed to Urgent. DMP internal video inspection has found severe pipe defects. Crossing will be monitored until funding becomes available to address the issues. (O. Yakimov - DWR UCIP)
02/26/2021 Record updated from Non-Urgent to No Action Needed. DWR DMP internal inspection has not found pipe integrity issues. LOF of crossing is less or equal to 4.0. Recommend next video inspection in 5 years. Minor warping on edges of both LS and WS pipes. Both ends open, no flap gate. Current condition of pipe crossing does not impede access to patrol road/high ground area. No permit was found authorizing this encroachment. CVFPB will need to review crossing to determine owner. The UCIP inspection was completed with LMA representative, J. Caruso. (H. Dunn ? GEI)05/12/2014 No Flapgate. (W. Wylie - DWR UCIP)

WS view: WS pipe, minor warping of edges and no flapgate.

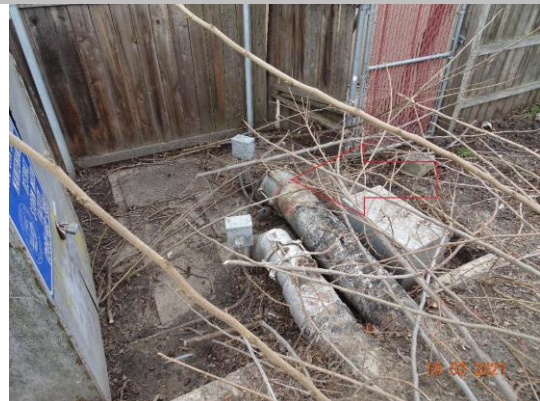
Photo 2 of 3 : UCIP_FA_2024_78438_93422.jpg

LS View: Pipe visible at LS toe. Electrical control panel and post adjacent to utility.

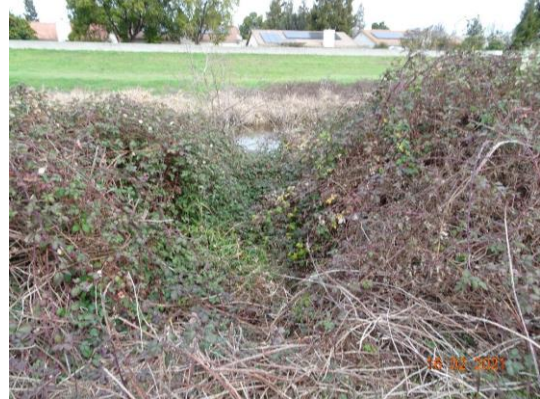
Photo 3 of 3 : UCIP_FA_2024_78438_93426.jpg

WS View: Briar bush overgrowth limiting visual of WS toe.

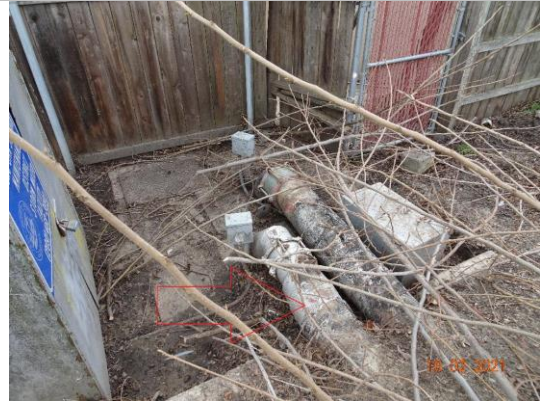
Photo 2 of 3 : UCIP_FA_2024_78439_93415.jpg

LS View: Pipe visible at LS toe. Electrical panel and post adjacent to pipe.

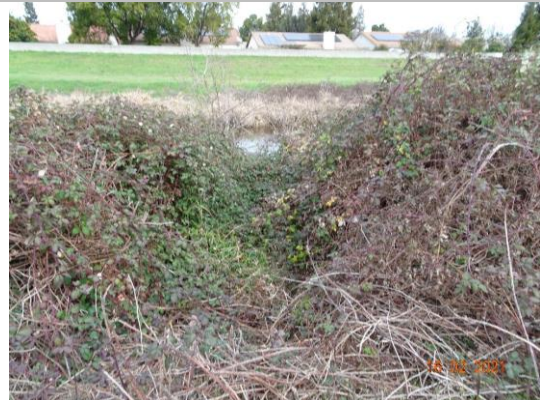
Photo 3 of 3 : UCIP_FA_2024_78439_93419.jpg

WS View: Briar bush overgrowth limiting visual of WS toe.

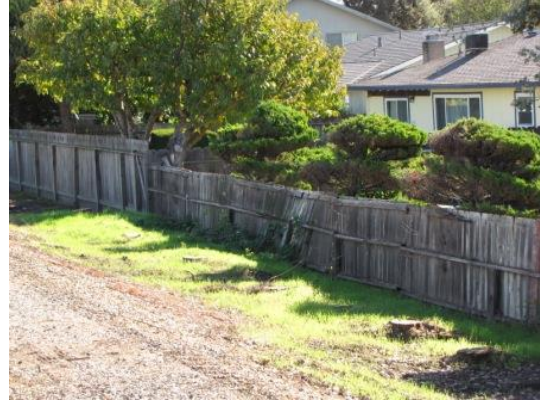
Photo 1 of 1 : FA_2024_NA0017_152_12_20240910_00001.jpg

LM Start	2.50	Rating **	N	Issue No.	12
LM End	2.50	Issue Type +	Ma	Location *	LS
Category	Earthen Levee			GPS Latitude/Longitude	
				Start	End
Item	Trim / Thin Trees			38.042749°	38.042749°
				-121.338402°	-121.338402°
DWR ID	DWR_NA0017_08_s_2012_12				
Comment Code					
T5 : Tree stumps.					
Inspector Comment

View of stumps along the landward toe looking upstream.

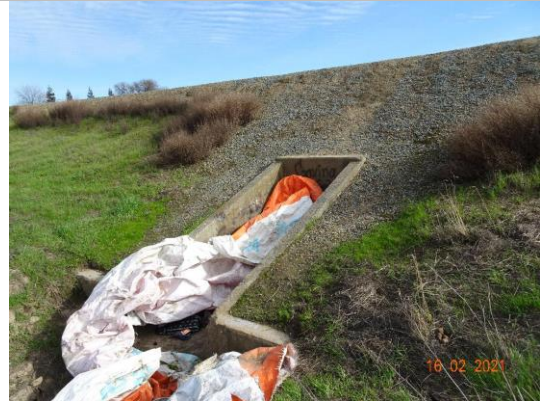
Photo 3 of 3 : UCIP_FA_2024_78985_93313.jpg

WS View: Headwall and flapgate at WS slope. Debris present.

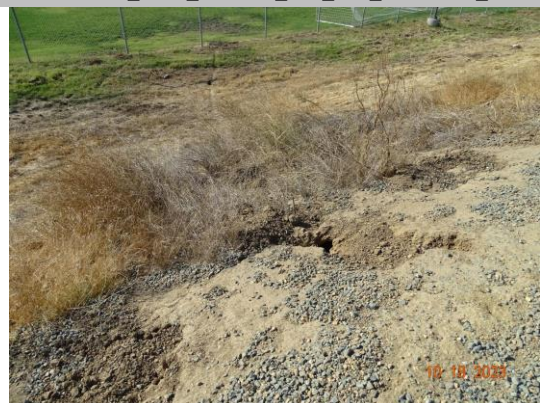
Photo 1 of 1 : FA_2024_NA0017_152_145_20240910_00019.jpg

LM Start	4.74	Rating **	U	Issue No.	145
LM End	4.80	Issue Type +	Ma	Location *	LS
Category	Earthen Levee			GPS Latitude/Longitude	
				Start	End
Item	Animal Control			38.043883°	38.043907°
				-121.297882°	-121.296700°
DWR ID	DWR_NA0017_08_f_2020_145				
Comment Code					
A3 : No rodents visible, but rodent burrows visible; need to backfill and compact or grout burrows.					
Inspector Comment

View of large animal burrow along the landside slope. Fall 2023

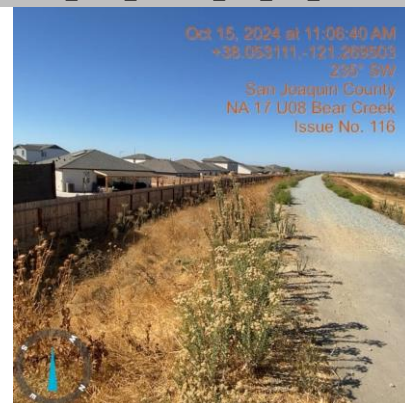
Photo 1 of 1 : FA_2024_NA0017_152_116_20241019_00258.jpg

LM Start	6.10	Rating **	U	Issue No.	116
LM End	6.53	Issue Type +	Ma	Location *	LS
Category	Earthen Levee			GPS Latitude/Longitude	
				Start	End
Item	Vegetation			38.052218°	38.053153°
				-121.277240°	-121.269410°
DWR ID	DWR_NA0017_08_f_2024_116				
Comment Code					
V1 : Control annual grass and weeds on the levee slopes and easements.					
Inspector Comment

View of wild growth along the landside slope and easement. Fall 2024

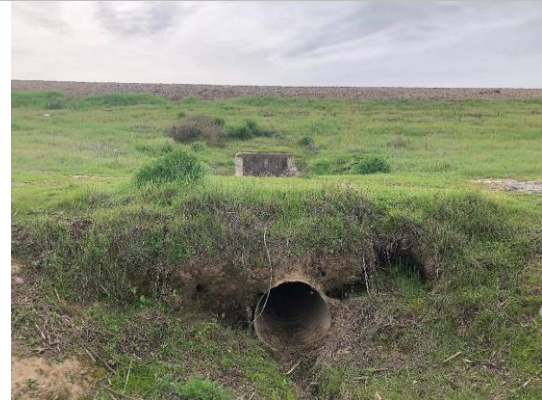
Photo 2 of 3 : UCIP_FA_2024_78989_93181.jpg

Comment Code						
Inspector Comment						
DS_ID:23713 FS_ID:78989 EP_NO: N/A Repair Type: Non-Urgent EVAL Issue: 5, Pipe Damage Crossing Status: Found UCIP Comments: 02/18/2021 Pipe status is still Non-Urgent. DWR DMP has found integrity issues, LOF between 4 and 5. No permit was found authorizing this encroachment. CVFPB will need to review crossing to determine owner. The UCIP inspection was completed with DWR Inspector, S. Donovan, and LMA representative, J. Caruso. (N. Cholewinski - GE05/22/2014 Gate rusted shut on LS toe. (W. Wylie - DWR UCIP) FIELD_STRUCT_DESC: 24-inch corrugated metal storm drainage pipe (CMP) through the levee, 7.9 feet below the crown. Concrete U-shaped headwalls on both ends. Flap gate on the waterside (WS) end. Slide gate on the landside (LS) end. Cobble grouted outlet across the berm. [Additional Reference(s): DWR Levee Log, 1990, (HLM 6.35). USACE San Joaquin O&M Manual 612.1, June 1965, (HLM 6.35), and 612 (addendum), February 1999, (HLM 6.36), (Station 335+70), 24-inch pipe listed]. FS Date: 2/18/2021

WS View: Headwall and flapgate at WS slope with pipe through WS berm.

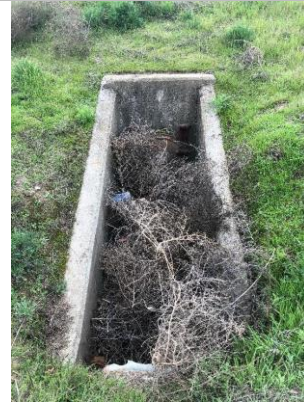
Photo 3 of 3 : UCIP_FA_2024_78989_93182.jpg

WS View: Headwall and flapgate at WS slope. Filled with tumble weeds.

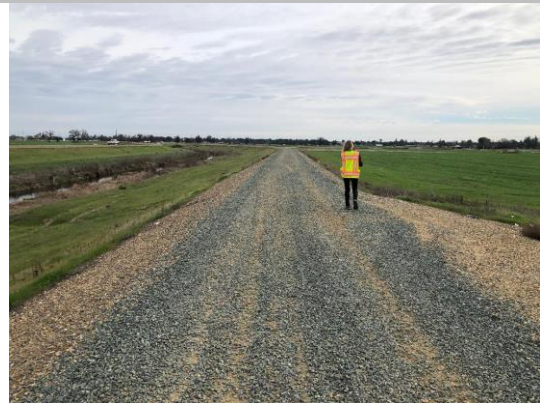
Photo 1 of 3 : UCIP_FA_2024_78990_93167.jpg

DS_ID:23714
 FS_ID:78990
 EP_NO: N/A
 Repair Type: Non-Urgent
 EVAL Issue:
 Crossing Status: Found
 UCIP Comments: 02/18/2021 Record was updated from No Action Needed to Non-Urgent. No permit was found authorizing this encroachment. CVFPB will need to review crossing to determine owner. DWR DMP has not found internal issues, LOF between 1 and 2. Recommend inspection in 5 years. Slight weathering of pipe interior coating at LS toe. The UCIP inspection was completed with DWR Inspector, S. Donovan, and LMA representative, J. Caruso. (N. Cholewinski - GEI)
 FIELD_STRUCT_DESC: 24-inch corrugated metal drainage pipe (CMP) through the levee, 8.5 feet below the crown. Concrete U-shaped headwalls on both ends. Flap gate on the waterside (WS) end. Grouted intake on the landside (LS). Cobble grouted outlet across the berm.
 [Additional Reference(s): DWR Levee Log, 1990, (HLM 6.56). USACE San Joaquin O&M Manual 612.1, June 1965, (HLM 6.56), 24-inch pipe listed].

Crown Overview

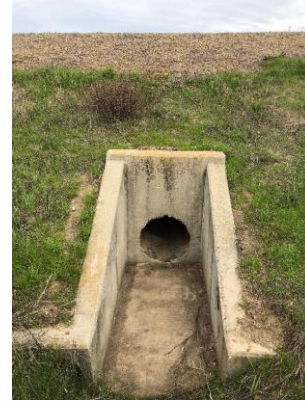
Photo 2 of 3 : UCIP_FA_2024_78990_93169.jpg

LS View: Headwall at LS toe.

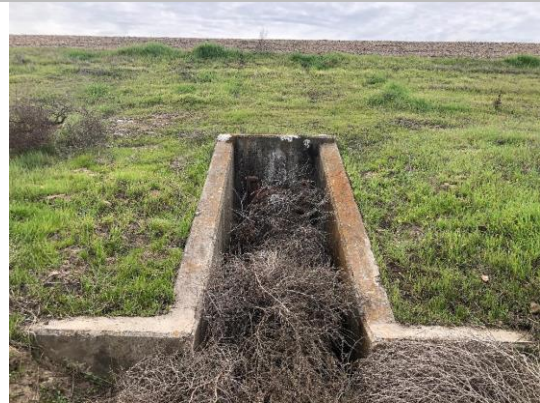
Photo 3 of 3 : UCIP_FA_2024_78990_93172.jpg

WS View: Headwall and flapgate at WS slope.

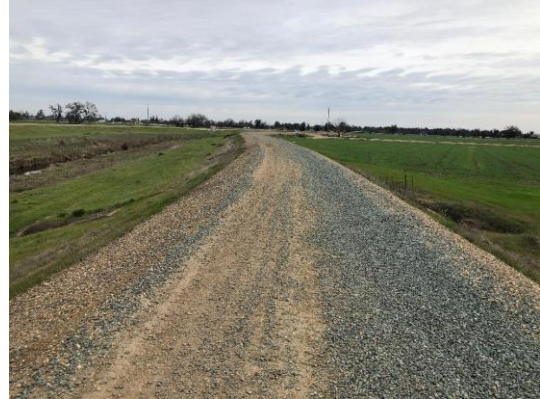
Photo 1 of 3 : UCIP_FA_2024_83584_93159.jpg

Comment Code						
Inspector Comment						
DS_ID:23715 FS_ID:83584 EP_NO: N/A Repair Type: No Action Needed EVAL Issue: Crossing Status: Not Found UCIP Comments: 05/08/2024 Pipe was abandoned in place according to Permit No. 19510. (A. McDonald - DWR UCIP) 02/18/2021 Record was updated from No Action Needed to Non-Urgent. No permit was found authorizing this encroachment. CVFPB will need to review crossing to determine owner. DWR DMP has not found internal issues, LOF between 1 and 2. Recommend inspection in 5 years. Stiff WS flapgate, but still opens. Pipe bent and small gap observed at base of pipe at LS toe. The UCIP inspection was completed with DWR Inspector, S. Donovan, and LMA representative, J. Caruso. (N. Cholewinski - GEI) FIELD_STRUCT_DESC: 24-inch corrugated metal storm drainage pipe (CMP) through the levee, 8.0 feet below the crown. Concrete U-shaped headwalls on both ends. Flap gate on the waterside (WS) end. Grouted intake on the landside (LS). Cobble grouted outlet across the berm. (Pipe was abandoned in place according to sheet 5 of Bridge Plans drawing, Permit No. 19510, 2021 - Holman Investors, LLC). [Additional Reference(s): DWR Levee Log, 1990, (HLM 6.72). USACE San Joaquin O&M Manual 612.1, June 1965, (HLM 6.72), and 612 (addendum), February 1999, (HLM 6.67), (Station 352+14), 24-inch pipe listed]. FS Date: 2/18/2021

Crown Overview

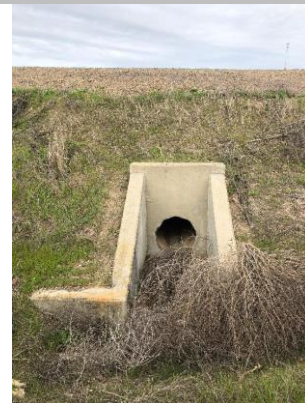
Photo 2 of 3 : UCIP_FA_2024_83584_93161.jpg

LS View: Headwall at LS toe.

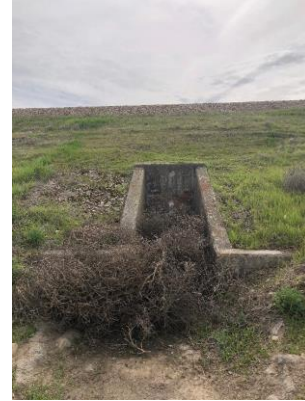
Photo 3 of 3 : UCIP_FA_2024_83584_93165.jpg

WS View: Headwall and flapgate at WS slope.

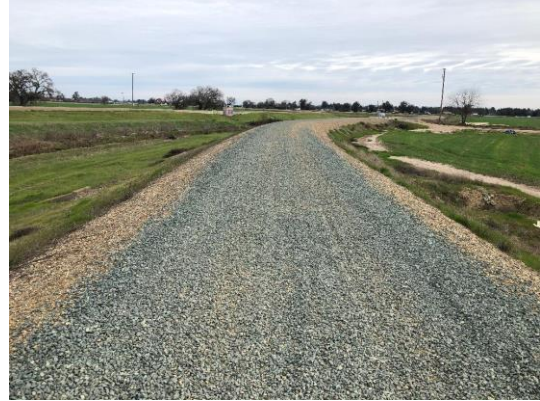
Photo 1 of 3 : UCIP_FA_2024_78992_93152.jpg

Comment Code						
Inspector Comment						
DS_ID:23716 FS_ID:78992 EP_NO: N/A Repair Type: Non-Urgent EVAL Issue: Crossing Status: Found UCIP Comments: 02/18/2021 Record was updated from No Action Needed to Non-Urgent. No permit was found authorizing this encroachment. CVFPB will need to review crossing to determine owner. DWR DMP has not found internal issues, LOF between 1 and 2. Recommend inspection in 5 years. The UCIP inspection was completed with DWR Inspector, S. Donovan, and LMA representative, J. Caruso. (N. Cholewinski - GEI) FIELD_STRUCT_DESC: 24-inch corrugated metal storm drainage pipe through the levee, 7.7 feet below the crown. Concrete U-shaped headwalls on both ends. Flap gate on the waterside (WS) end. Grouted intake on the landside (LS). Cobble grouted outlet across the berm. [Additional Reference(s): DWR Levee Log, 1990, (HLM 6.79). USACE San Joaquin O&M Manual 612.1, June 1965, (HLM 6.79), and 612 (addendum), February 1999, (HLM 6.82), (Station 360+08), 24-inch pipe listed]. FS Date: 2/18/2021

Crown Overview

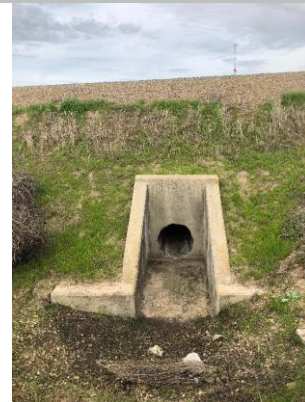
Photo 2 of 3 : UCIP_FA_2024_78992_93154.jpg

LS View: Headwall at LS toe.

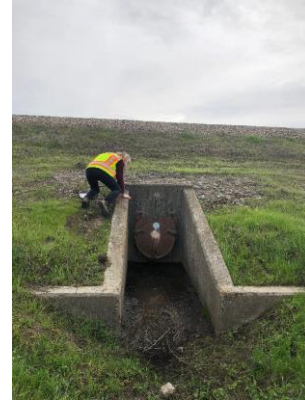
Photo 3 of 3 : UCIP_FA_2024_78992_93157.jpg

WS View: Headwall and flapgate at WS slope.
