**Flood Control Project Maintenance
Levee Inspections****Maintenance Issue Types Only, Levee Inspection Report By Mile - Fall 2024****San Joaquin County Flood Control and Water Conservation District**

Waterway	Bank	Unit Miles	Inspection Start/End	Inspector
Unit No. 01 Littlejohn Creek	Left	2.59	10/21/2024 10/21/2024	Alberto De Leon

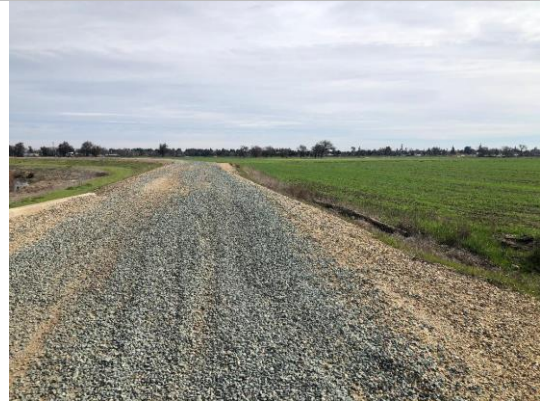
Photo 1 of 3 : UCIP_FA_2024_84812_93140.jpg

DS_ID:23718
FS_ID:84812
EP_NO: N/A
Repair Type: Urgent
EVAL Issue: 1, Pipe Integrity
Crossing Status: Found
UCIP Comments: 09/23/2024 Record updated from Non-Urgent to Urgent. DMP internal video inspection has found severe pipe defects. Crossing will be monitored until funding becomes available to address the issues. (O. Yakimov - DWR UCIP)
02/18/2021 Record was updated from No Action Needed to Non-Urgent. No permit was found authorizing this encroachment. CVFPB will need to review crossing to determine owner. DWR DMP has not found internal issues, LOF between 1 and 2. Recommend inspection in 5 years. Slight crumbling of concrete around pipe opening on LS. The UCIP inspection was completed with DWR Inspector, S. Donovan, and LMA representative, J. Caruso. (N. Cholewinski - GEI)
FIELD_STRUCT_DESC: 24-inch corrugated metal storm drainage pipe (CMP) through the levee, 6.5 feet below the crown. Concrete U-shaped headwalls on both ends. Flap gate on the waterside (WS) end. Grouted intake on the landside (LS). Cobble grouted outlet across the berm.

Crown Overview

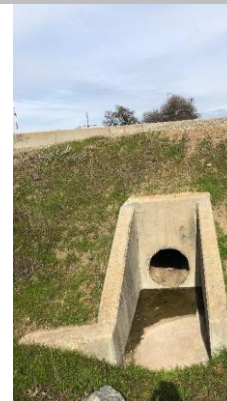
Photo 2 of 3 : UCIP_FA_2024_84812_93142.jpg

LS View: Headwall at LS toe.

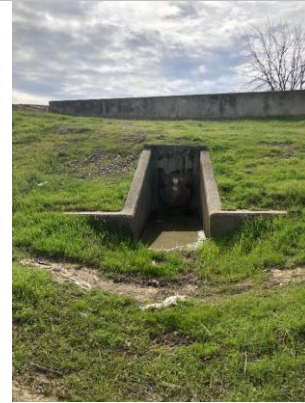
Photo 3 of 3 : UCIP_FA_2024_84812_93145.jpg

WS View: Headwall and flapgate at WS slope.

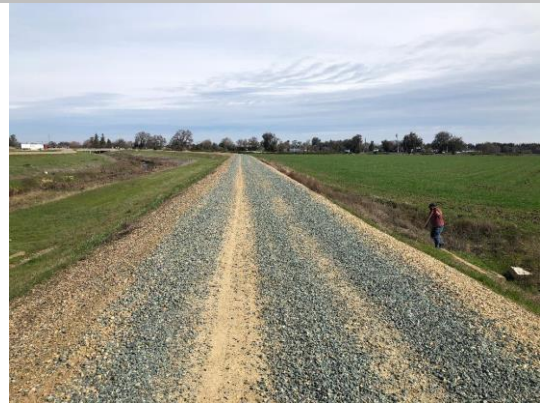
Photo 1 of 3 : UCIP_FA_2024_78994_93130.jpg

DS_ID:23719
 FS_ID:78994
 EP_NO: N/A
 Repair Type: Non-Urgent
 EVAL Issue:
 Crossing Status: Found
 UCIP Comments: 02/18/2021 Record was updated from No Action Needed to Non-Urgent. No permit was found authorizing this encroachment. CVFPB will need to review crossing to determine owner. DWR DMP has not found internal issues, LOF between 1 and 2. Recommend inspection in 5 years. The UCIP inspection was completed with DWR Inspector, S. Donovan, and LMA representative, J. Caruso. (N. Cholewinski - GEI)
 FIELD_STRUCT_DESC: 1 of 2: 30-inch corrugated metal storm drainage pipe (CMP) through the levee, 8.3 feet below the crown. Concrete U-shaped headwalls on both ends. Flap gate on the waterside (WS) end. Grouted intake on the landside (LS). Cobble grouted outlet across the berm. [Additional Reference(s): DWR Levee Log, 1990, (HLM 7.00). USACE San Joaquin O&M Manual 612.1, June 1965, (HLM 7.00), and 612 (addendum), February 1999, (HLM 7.10), (Station 374+70), 30-inch pipe listed].

Crown Overview

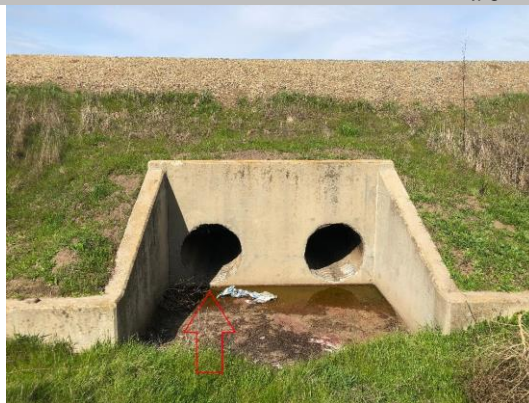
Photo 2 of 3 : UCIP_FA_2024_78994_93132.jpg

LS View: Headwall at LS toe.

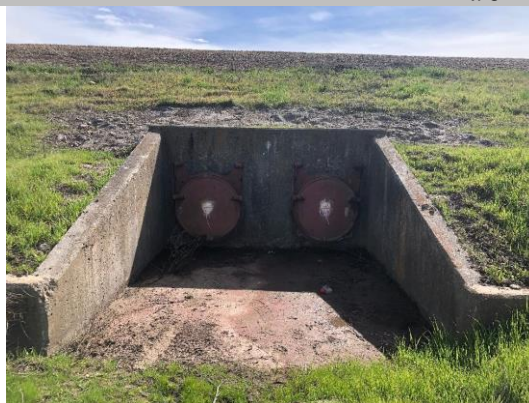
Photo 3 of 3 : UCIP_FA_2024_78994_93135.jpg

WS View: Headwall and flapgate at WS slope.

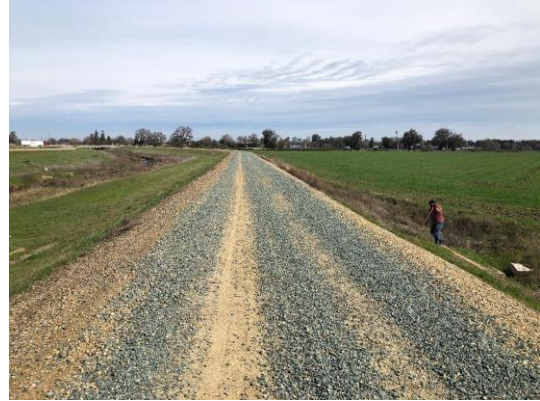
Photo 1 of 3 : UCIP_FA_2024_78995_93123.jpg

Comment Code						
Inspector Comment						
DS_ID:23812 FS_ID:78995 EP_NO: N/A Repair Type: Non-Urgent EVAL Issue: Crossing Status: Found UCIP Comments: 02/18/2021 Record was updated from No Action Needed to Non-Urgent. No permit was found authorizing this encroachment. CVFPB will need to review crossing to determine owner. DWR DMP has not found internal issues, LOF between 1 and 2. Recommend inspection in 5 years. The UCIP inspection was completed with DWR Inspector, S. Donovan, and LMA representative, J. Caruso. (N. Cholewinski - GEI) FIELD_STRUCT_DESC: 2 of 2: 30-inch corrugated metal storm drainage pipe (CMP) through the levee, 8.3 feet below the crown. Concrete U-shaped headwalls on both ends. Flap gate on the waterside (WS) end. Grouted intake on the landside (LS). Cobble grouted outlet across the berm. [Additional Reference(s): DWR Levee Log, 1990, (HLM 7.00). USACE San Joaquin O&M Manual 612.1, June 1965, (HLM 7.00), and 612 (addendum), February 1999, (HLM 7.10), (Station 374+70), 30-inch pipe listed]. FS Date: 2/18/2021

Crown Overview

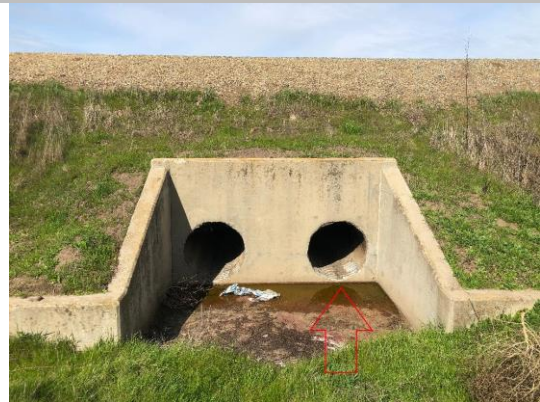
Photo 2 of 3 : UCIP_FA_2024_78995_93125.jpg

LS View: Headwall at LS toe.

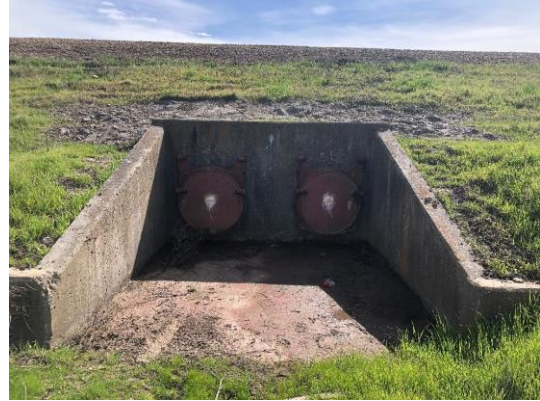
Photo 3 of 3 : UCIP_FA_2024_78995_93128.jpg

WS View: Headwall and flapgate at WS slope.

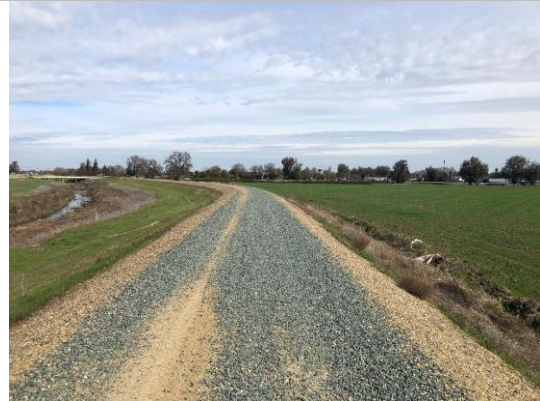
Photo 1 of 3 : UCIP_FA_2024_78996_93117.jpg

DS_ID:23720
 FS_ID:78996
 EP_NO: N/A
 Repair Type: Non-Urgent
 EVAL Issue:
 Crossing Status: Found
 UCIP Comments: 02/18/2021 Record was updated from No Action Needed to Non-Urgent. No permit was found authorizing this encroachment. CVFPB will need to review crossing to determine owner. DWR DMP has not found internal issues, LOF between 1 and 2. Recommend inspection in 5 years. The UCIP inspection was completed with DWR Inspector, S. Donovan, and LMA representative, J. Caruso. (N. Cholewinski - GEI)
 FIELD_STRUCT_DESC: 36-inch corrugated metal storm drainage pipe (CMP) through the levee, 6.5 feet below the crown. Concrete U-shaped headwalls on both ends. Flap gate on the waterside (WS) end. Grouted intake on the landside (LS). Cobble grouted outlet across the berm. [Additional Reference(s): DWR Levee Log, 1990, (HLM 7.07). USACE San Joaquin O&M Manual 612.1, June 1965, (HLM 7.07), and 612 (addendum), February 1999, (HLM 7.18), (Station 379+00), 36-inch pipe listed].

Crown Overview

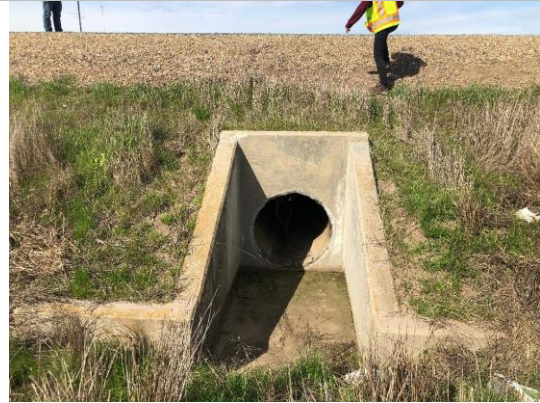
Photo 2 of 3 : UCIP_FA_2024_78996_93119.jpg

LS View: Headwall at LS toe.

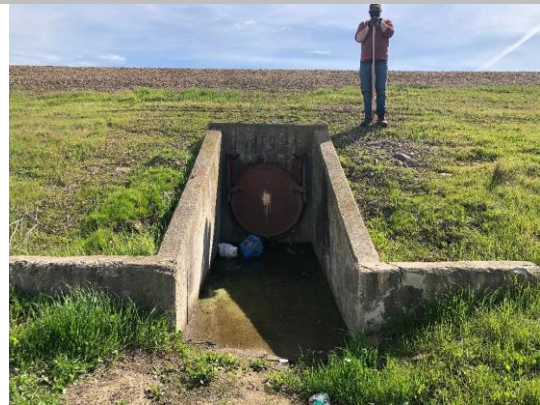
Photo 3 of 3 : UCIP_FA_2024_78996_93122.jpg

WS View: Headwall and flapgate at WS slope.

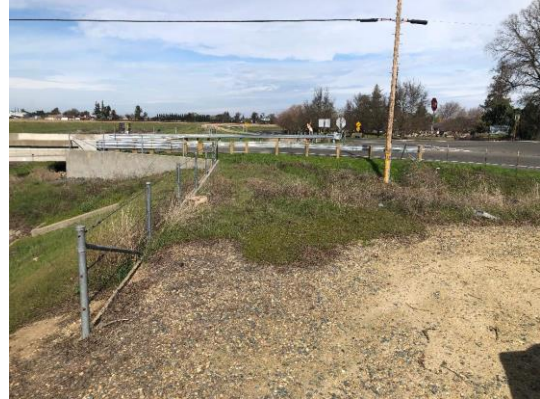
Photo 1 of 3 : UCIP_FA_2024_78997_93109.jpg

Comment Code						
Inspector Comment						
DS_ID:23721 FS_ID:78997 EP_NO: N/A Repair Type: Non-Urgent EVAL Issue: Crossing Status: Found UCIP Comments: 02/18/2021 Record was updated from No Action Needed to Non-Urgent. No permit was found authorizing this encroachment. CVFPB will need to review crossing to determine owner. DWR DMP has not found internal issues, LOF between 1 and 2. Recommend inspection in 5 years. The UCIP inspection was completed with DWR Inspector, S. Donovan, and LMA representative, J. Caruso. (N. Cholewinski - GEI) FIELD_STRUCT_DESC: 36-inch corrugated metal storm drainage pipe (CMP) through the levee, 6.8 feet below the crown. Concrete U-shaped headwalls on both ends. Flap gate on the waterside (WS) end. Grouted intake on the landside (LS). Cobble grouted outlet across the berm. [Additional Reference(s): DWR Levee Log, 1990, (HLM 7.26). USACE San Joaquin O&M Manual 612.1, June 1965, (HLM 7.26), and 612 (addendum), February 1999, (HLM 7.34), (Station 387+80), 36-inch pipe listed]. FS Date: 2/18/2021

Crown Overview

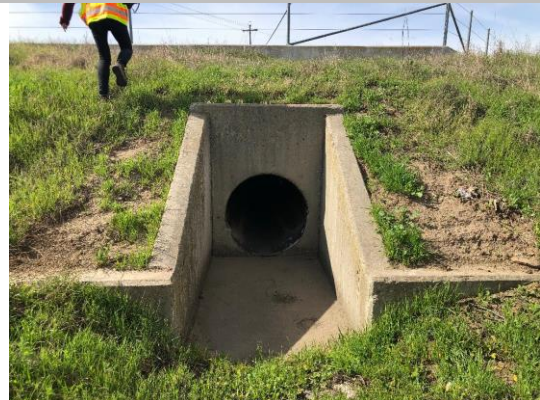
Photo 2 of 3 : UCIP_FA_2024_78997_93111.jpg

LS View: Headwall at LS toe.

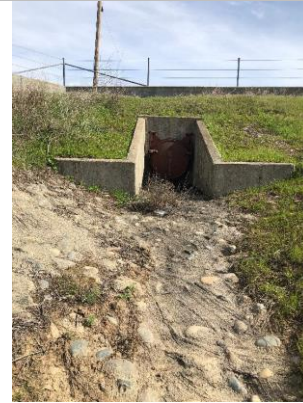
Photo 3 of 3 : UCIP_FA_2024_78997_93115.jpg

WS View: Headwall and flapgate at WS slope.

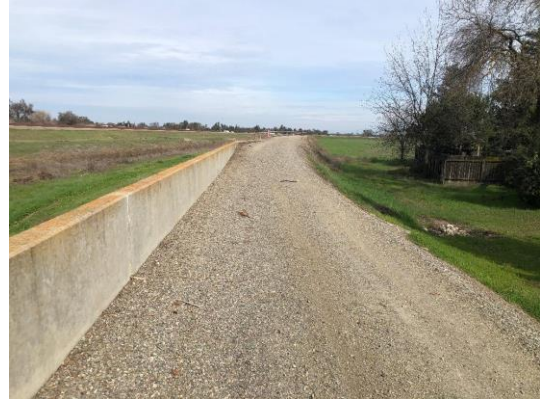
Photo 1 of 3 : UCIP_FA_2024_78999_93087.jpg

Comment Code					
Inspector Comment					
DS_ID:23743 FS_ID:78999 EP_NO: N/A Repair Type: Non-Urgent EVAL Issue: Crossing Status: Found UCIP Comments: 02/18/2021 Record remains Non-Urgent. No permit was found authorizing this encroachment. CVFPB will need to review crossing to determine owner. DWR DMP has not found internal issues, LOF between 1 and 2. Recommend inspection in 5 years. No cobbles observed in pipe at LS toe. The UCIP inspection was completed with DWR Inspector, S. Donovan, and LMA representative, J. Caruso. (N. Cholewinski - GE05/21/2014 Cobbles building up at inlet and inside pipe along with sediment. (W. Wylie - DWR UCIP) FIELD_STRUCT_DESC: 24-inch corrugated metal storm drainage pipe (CMP) through the levee, 7.0 feet below the crown. Flap gate on the waterside (WS) end. Concrete U-shaped headwalls on both ends. Cobble grouted outlet across the berm. Cobble grouted apron on the landside (LS) end. [Additional Reference(s): DWR Levee Log, 1990, (HLM 7.65). USACE San Joaquin O&M Manual 612.2, 1967, (HLM 7.65), and 612 (addendum), February 1999, (HLM 7.70), (Station 406+58), 24-inch pipe listed]. FS Date: 2/18/2021

Crown Overview

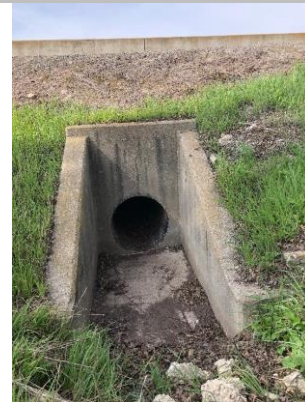
Photo 2 of 3 : UCIP_FA_2024_78999_93089.jpg

LS View: Headwall at LS toe.

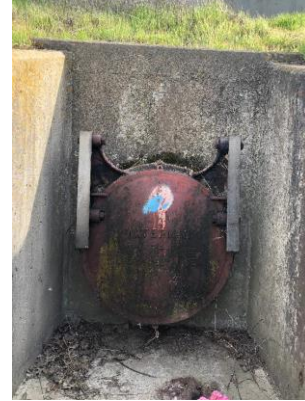
Photo 3 of 3 : UCIP_FA_2024_78999_93092.jpg

WS View: Headwall and 24-inch flapgate at WS slope.

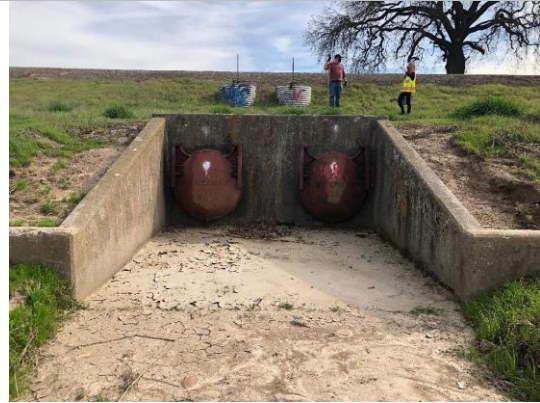
Photo 3 of 3 : UCIP_FA_2024_79000_93085.jpg

WS View: Headwall and flapgate at WS toe.

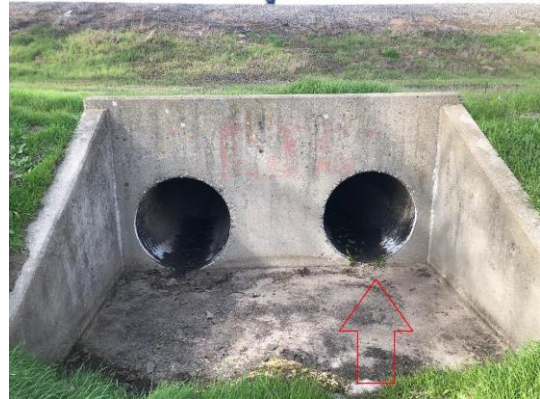
Photo 1 of 3 : UCIP_FA_2024_79001_93071.jpg

Comment Code						
Inspector Comment						
DS_ID:23820 FS_ID:79001 EP_NO: N/A Repair Type: Non-Urgent EVAL Issue: 4b, Safety Issue Crossing Status: Found UCIP Comments: 09/25/2024 DMP internal video inspection has found moderate pipe defects. Crossing will be monitored until funding becomes available for rehabilitation. (O. Yakimov - DWR UCIP) 02/18/2021 Record remains Non-Urgent. No permit was found authorizing this encroachment. CVFPB will need to review crossing to determine owner. DWR DMP has not found internal issues, LOF between 1 and 2. Recommend inspection in 5 years. No lid on riser. Recommend adding lid to riser as a safety measure. The UCIP inspection was completed with DWR Inspector, S. Donovan, and LMA representative, J. Caruso. (N. Cholewinski - GE05/21/2014 Lid damaged/missing on 48-inch CMP riser on WS slope. (W. Wylie - DWR UCIP) FIELD_STRUCT_DESC: 2 of 2: 36-inch corrugated metal storm drainage pipe (CMP) through the levee, 9.0 feet below the crown. Flap gate on the waterside (WS) end. Slide gate inside a 48-inch CMP riser unit on the WS slope. Concrete U-shaped headwalls on both ends. Cobble grouted outlet on the channel bank. Cobble grouted apron in ditch on the landside (LS). [Additional Reference(s): DWR Levee Log, 1990, (HLM 8.18). USACE San Joaquin O&M Manual 612.2, 1967, (HLM 8.18), and 612 (addendum), February 1999, (HLM 8.21), (Station 433+70), 36-inch pipe listed]. FS Date: 2/18/2021

LS View: Headwall at LS toe.

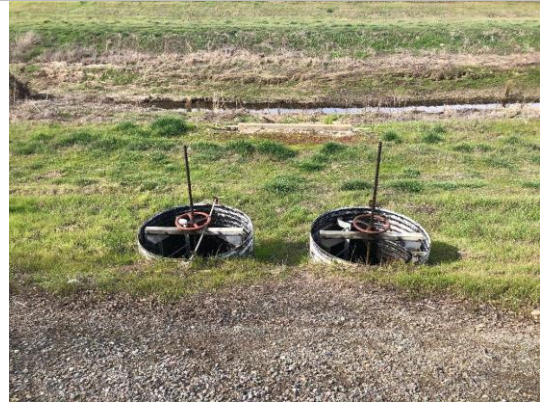
Photo 2 of 3 : UCIP_FA_2024_79001_93073.jpg

WS View

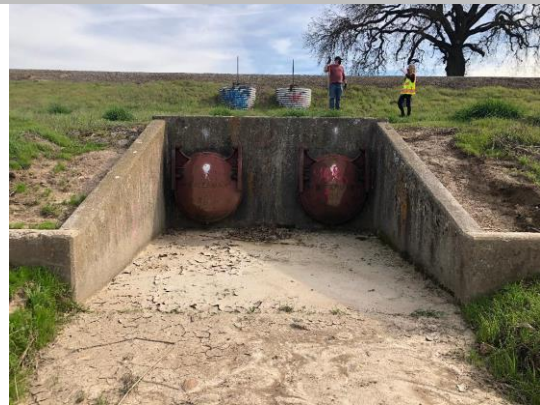
Photo 3 of 3 : UCIP_FA_2024_79001_93076.jpg

WS View: Headwall and 36-inch flapgate at WS toe.

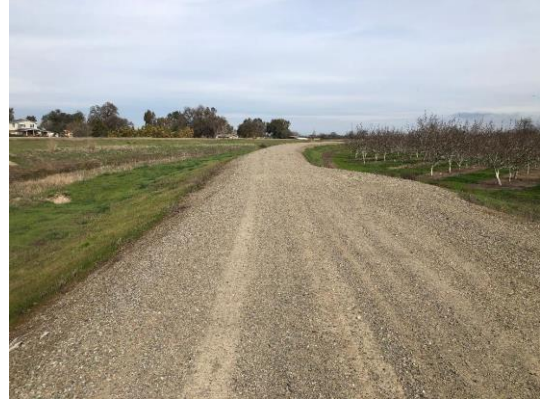
Photo 1 of 3 : UCIP_FA_2024_79002_93054.jpg

Comment Code						
Inspector Comment						
DS_ID:23745 FS_ID:79002 EP_NO: N/A Repair Type: Non-Urgent EVAL Issue: Crossing Status: Found UCIP Comments: 02/18/2021 Record was updated from No Action Needed to Non-Urgent. No permit was found authorizing this encroachment. CVFPB will need to review crossing to determine owner. DWR DMP has not found internal issues, LOF between 1 and 2. Recommend inspection in 5 years. The UCIP inspection was completed with DWR Inspector, S. Donovan, and LMA representative, J. Caruso. (N. Cholewinski - GEI) FIELD_STRUCT_DESC: 24-inch corrugated metal storm drainage pipe (CMP) through the levee, 7.0 feet below the crown. Flap gate on the waterside (WS) end. Concrete U-shaped headwalls on both ends. Cobble grouted outlet across the berm. Cobble grouted apron on the landside (LS) end. [Additional Reference(s): DWR Levee Log, 1990, (HLM 8.34). USACE San Joaquin O&M Manual 612.2, 1967, (HLM 8.34), and 612 (addendum), February 1999, (HLM 8.37), (Station 442+14), 24-inch pipe listed]. FS Date: 2/18/2021

Crown Overview

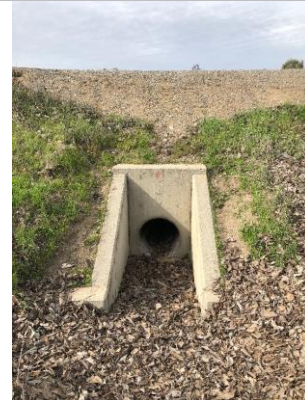
Photo 2 of 3 : UCIP_FA_2024_79002_93056.jpg

LS View: Headwall at LS toe.

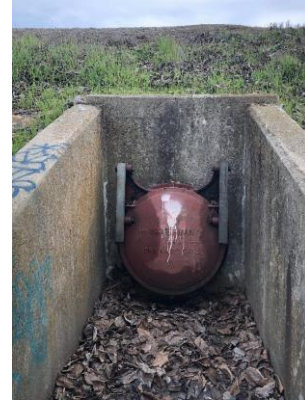
Photo 3 of 3 : UCIP_FA_2024_79002_93062.jpg

WS View: Headwall and 24-inch flapgate at WS slope.

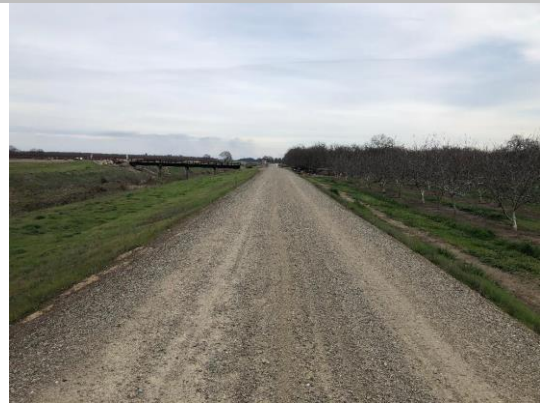
Photo 1 of 3 : UCIP_FA_2024_79003_93044.jpg

DS_ID:23746
 FS_ID:79003
 EP_NO: N/A
 Repair Type: Non-Urgent
 EVAL Issue:
 Crossing Status: Not Found
 UCIP Comments: 02/22/2021 Record was updated from No Action Needed to Non-Urgent. DWR DMP study found no evidence of pipe at lat/long 38.066918/-121.243749. Pipe not found by visual inspection. No permit was found authorizing this encroachment. CVFPB will need to review crossing to determine owner. The UCIP inspection was completed with DWR Inspector, S. Donovan, and LMA representative, J. Caruso. (N. Cholewinski - GEI)
 FIELD_STRUCT_DESC: 24-inch corrugated metal storm drainage pipe (CMP) through the levee, 7.0 feet below the crown. Flap gate on the waterside (WS) end. Concrete U-shaped headwalls on both ends. Cobble grouted outlet across the berm. Cobble grouted apron on the landside (LS) end. [Additional Reference(s): DWR Levee Log, 1990, (HLM 8.54). USACE San Joaquin O&M Manual 612.2, 1967, (HLM 8.54), and 612 (addendum), February 1999, (HLM 8.57), (Station 452+52), 24-inch pipe listed].

Crown Overview

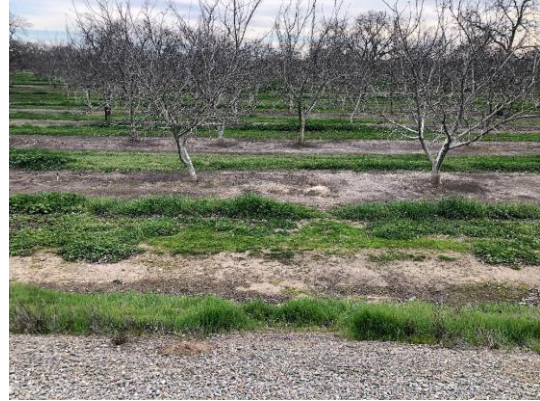
Photo 2 of 3 : UCIP_FA_2024_79003_93045.jpg

LS View

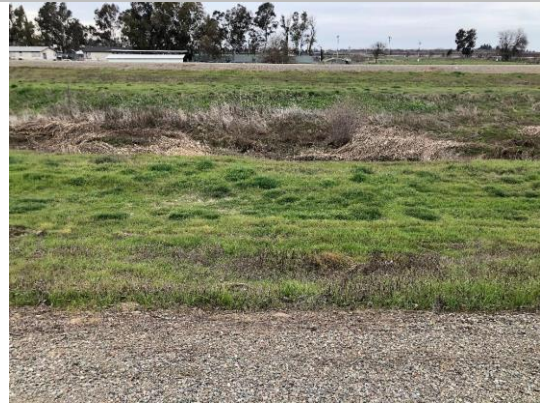
Photo 3 of 3 : UCIP_FA_2024_79003_93046.jpg

WS View

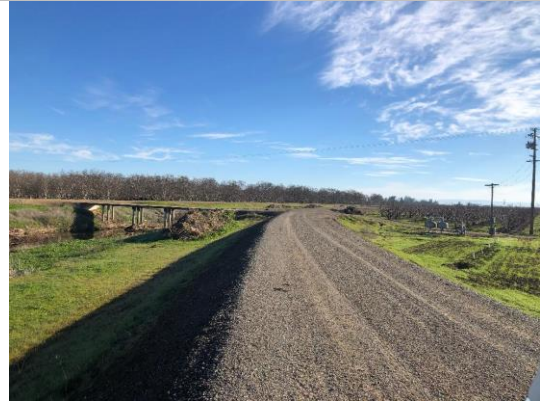
Photo 1 of 3 : UCIP_FA_2024_79004_93021.jpg

Comment Code						
Inspector Comment						
DS_ID:23722 FS_ID:79004 EP_NO: N/A Repair Type: Non-Urgent EVAL Issue: Crossing Status: Found UCIP Comments: 02/22/2021 Record was updated from No Action Needed to Non-Urgent. No permit was found authorizing this encroachment. CVFPB will need to review crossing to determine owner. DWR DMP has not found internal issues, LOF between 1 and 2. Recommend inspection in 5 years. The UCIP inspection was completed with DWR Inspector, S. Donovan, and LMA representative, J. Caruso. (N. Cholewinski - GEI) FIELD_STRUCT_DESC: 24-inch corrugated metal storm drainage pipe (CMP) through the levee, 5.5 feet below the crown. Flap gate on the waterside (WS) end. Concrete U-shaped headwalls on both ends. Cobble grouted outlet across the berm. Cobble grouted apron on the landside (LS) end. [Additional Reference(s): DWR Levee Log, 1990, (HLM 9.52). USACE San Joaquin O&M Manual 612.2, 1967, (HLM 9.52), and 612 (addendum), February 1999, (HLM 9.52), (Station 502+83), 24-inch pipe listed]. FS Date: 2/22/2021

Crown Overview

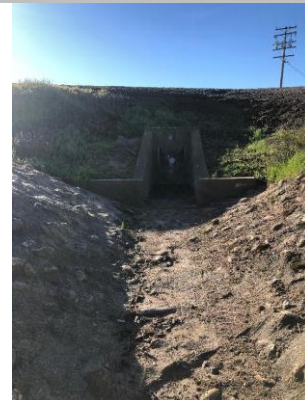
Photo 2 of 3 : UCIP_FA_2024_79004_93023.jpg

WS View: Headwall and flapgate at WS slope.

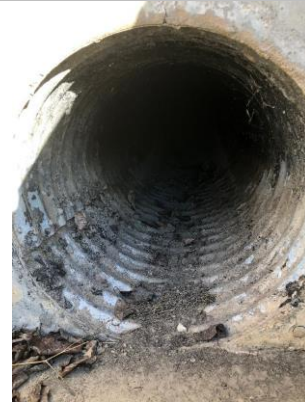
Photo 3 of 3 : UCIP_FA_2024_79004_93026.jpg

LS View: Pipe at LS toe.

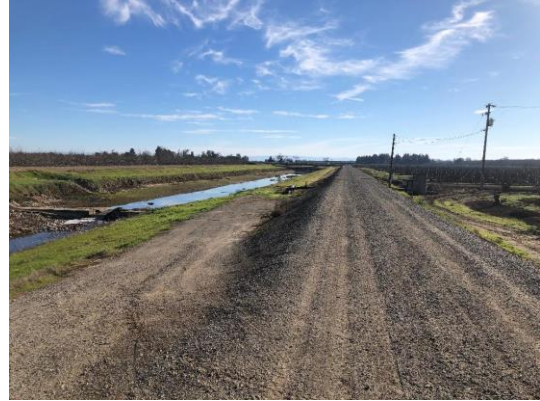
Photo 1 of 3 : UCIP_FA_2024_79039_92901.jpg

Comment Code						
Inspector Comment						
DS_ID:23726 FS_ID:79039 EP_NO: N/A Repair Type: No Action Needed EVAL Issue: Crossing Status: Found UCIP Comments: 09/18/2023 Record updated from Non-Urgent to No Action Needed. Pipe was CIPP lined. DMP internal video inspection has found none or minor pipe defects. Recommend next video inspection in 5 years. (O. Yakimov - DWR UCIP) 02/22/2021 Record was updated from No Action Needed to Non-Urgent. DWR DMP has found integrity issues, LOF between 4 and 5. Crossing will be monitored until funding becomes available for rehabilitation. No permit was found authorizing this encroachment. CVFPB will need to review crossing to determine owner. Approximately 7 bullet holes observed in WS flapgate. The UCIP inspection was completed with DWR Inspector, S. Donovan, and LMA representative, J. Caruso. (N. Cholewinski - GEI) FIELD_STRUCT_DESC: 24-inch CIPP-lined corrugated metal storm drainage pipe (CMP) through the levee, 8.5 feet below the crown. Flap gate on the waterside (WS) end. Concrete U-shaped headwalls on both ends. Cobble grouted outlet across the berm. Cobble grouted apron on the landside (LS) end. [Additional Reference(s): DWR Levee Log, 1990, (HLM 9.76). USACE San Joaquin O&M Manual 612.2, 1967, (HLM 9.85), and 612 (addendum), February 1999, (HLM 9.76), (Station 515+23), 24-inch pipe listed]. FS Date: 2/22/2021

Crown Overview

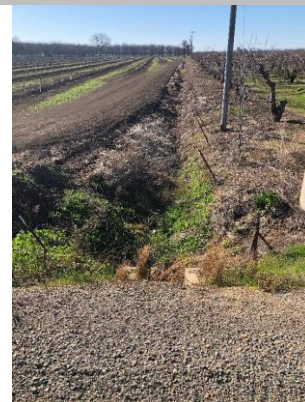
Photo 2 of 3 : UCIP_FA_2024_79039_92902.jpg

LS View: Headwall at LS toe.

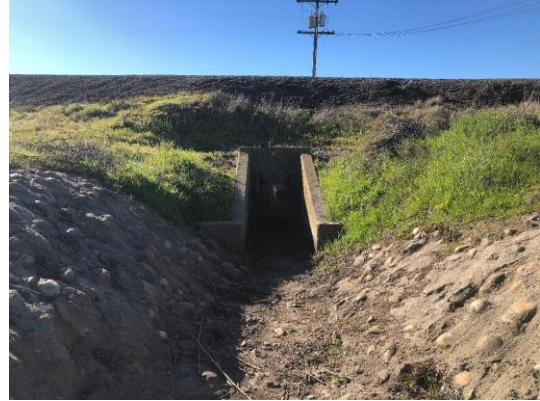
Photo 3 of 3 : UCIP_FA_2024_79039_92913.jpg

WS View: Headwall and flapgate at WS slope.

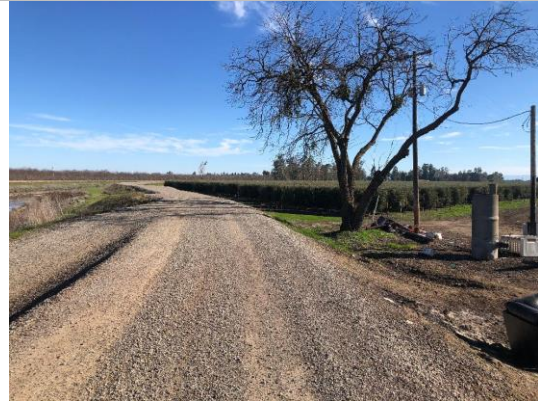
Photo 1 of 3 : UCIP_FA_2024_79006_92888.jpg

Comment Code						
Inspector Comment						
DS_ID:23727 FS_ID:79006 EP_NO: N/A Repair Type: Non-Urgent EVAL Issue: Crossing Status: Found UCIP Comments: 02/22/2021 Pipe status is still Non-Urgent. No permit was found authorizing this encroachment. CVFPB will need to review crossing to determine owner. DWR DMP has not found internal issues, LOF between 1 and 2. Recommend inspection in 5 years. Slope above WS headwall is very steep and eroding. Sediment from erosion observed on top of WS pipe outlet. Sediment build-up has decreased in pipe at LS toe. The UCIP inspection was completed with DWR Inspector, S. Donovan, and LMA representative, J. Caruso. (N. Cholewinski - GE05/21/2014 Sediment and debris buildup inside pipe on LS toe. (W. Wylie - DWR UCIP) FIELD_STRUCT_DESC: 24-inch corrugated metal storm drainage pipe (CMP) through the levee, 7.0 feet below the crown. Flap gate on the waterside (WS) end. Concrete U-shaped headwalls on both ends. Cobble grouted outlet across the berm. Cobble grouted apron on the landside (LS) end. [Additional Reference(s): DWR Levee Log, 1990, (HLM 10.01). USACE San Joaquin O&M Manual 612.2, 1967, (HLM 10.09), and 612 (addendum), February 1999, (HLM 10.00), (Station 528+18), 24-inch pipe listed]. FS Date: 2/22/2021

Crown Overview

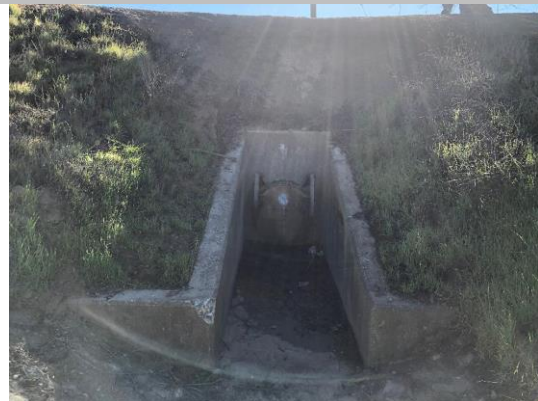
Photo 2 of 3 : UCIP_FA_2024_79006_92890.jpg

WS View: Headwall and flapgate on WS slope. Erosion observed above headwall.

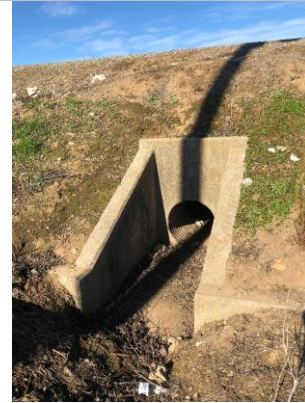
Photo 3 of 3 : UCIP_FA_2024_79006_92892.jpg

LS View: Headwall at LS toe.

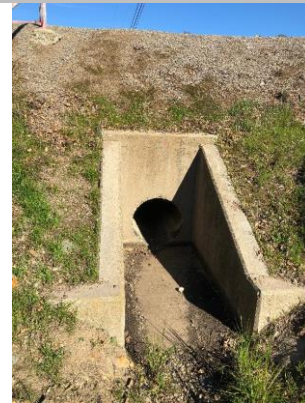
Photo 1 of 3 : UCIP_FA_2024_79007_92864.jpg

DS_ID:23728
 FS_ID:79007
 EP_NO: N/A
 Repair Type: Non-Urgent
 EVAL Issue:
 Crossing Status: Found
 UCIP Comments: 02/22/2021 Record was updated from No Action Needed to Non-Urgent. No permit was found authorizing this encroachment. CVFPB will need to review crossing to determine owner. DWR DMP has not found internal issues, LOF between 1 and 2. Recommend inspection in 5 years. Some concrete rubble observed above headwall on WS. The UCIP inspection was completed with DWR Inspector, S. Donovan, and LMA representative, J. Caruso. (N. Cholewinski - GEI)
 FIELD_STRUCT_DESC: 24-inch corrugated metal storm drainage pipe (CMP) through the levee, 9.0 feet below the crown. Flap gate on the waterside (WS) end. Concrete U-shaped headwalls on both ends. Cobble grouted outlet across the berm. Cobble grouted apron on the landside (LS) end. [Additional Reference(s): DWR Levee Log, 1990, (HLM 10.46). USACE San Joaquin O&M Manual 612.2, 1967, (HLM 10.46), and 612 (addendum), February 1999, (HLM 10.44), (Station 551+22), 24-inch pipe listed].

LS View: Facing headwall at LS toe.

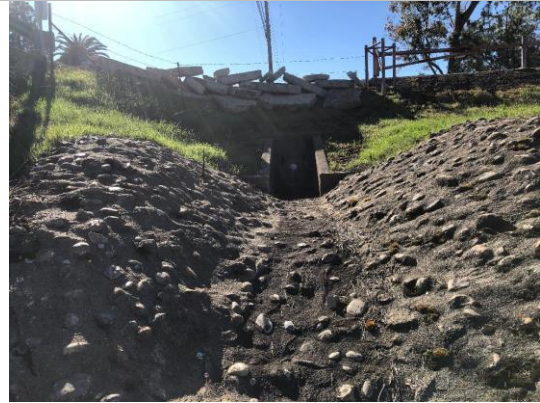
Photo 2 of 3 : UCIP_FA_2024_79007_92871.jpg

WS View: Headwall and flapgate at WS slope.

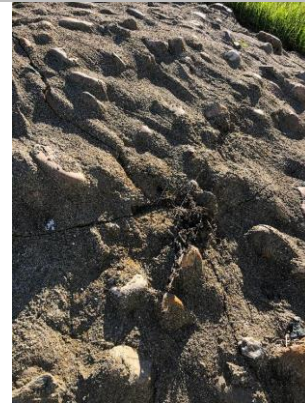
Photo 3 of 3 : UCIP_FA_2024_79007_92873.jpg

WS View: Small crack observed in apron on WS slope.

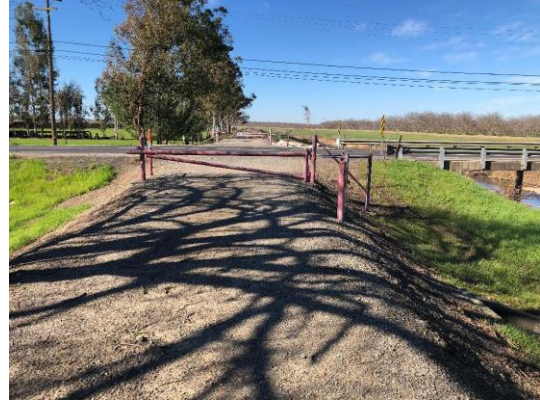
Photo 1 of 3 : UCIP_FA_2024_79008_92828.jpg

Comment Code					
Inspector Comment					
DS_ID:23729 FS_ID:79008 EP_NO: N/A Repair Type: Non-Urgent EVAL Issue: Crossing Status: Found UCIP Comments: 02/22/2021 Pipe status is still Non-Urgent. No permit was found authorizing this encroachment. CVFPB will need to review crossing to determine owner. DWR DMP has not found internal issues, LOF between 1 and 2. Recommend inspection in 5 years. Water observed at pipe opening at LS toe. The UCIP inspection was completed with DWR Inspector, S. Donovan, and LMA representative, J. Caruso. (N. Cholewinski - GE05/21/2014 Some sediment buildup in pipe at LS toe. (W. Wylie - DWR UCIP) FIELD_STRUCT_DESC: 24-inch corrugated metal storm drainage pipe (CMP) through the levee, 7.0 feet below the crown. Flap gate on the waterside (WS) end. Concrete U-shaped headwalls on both ends. Cobble grouted outlet across the berm. Cobble grouted apron on the landside (LS) end. [Additional Reference(s): DWR Levee Log, 1990, (HLM 10.48). USACE San Joaquin O&M Manual 612.2, 1967, (HLM 10.48), and 612 (addendum), February 1999, (HLM 10.46), (Station 552+17), 24-inch pipe listed]. FS Date: 2/22/2021

Crown Overview

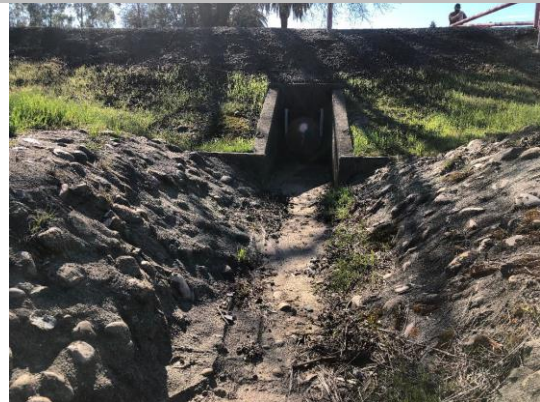
Photo 2 of 3 : UCIP_FA_2024_79008_92829.jpg

WS View: Headwall and flapgate at WS slope.

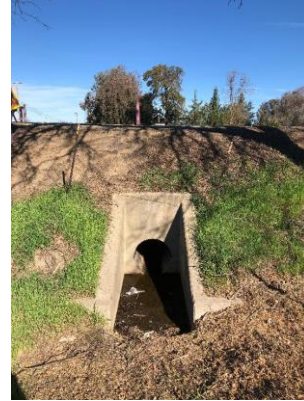
Photo 3 of 3 : UCIP_FA_2024_79008_92831.jpg

LS View: Headwall at LS toe.

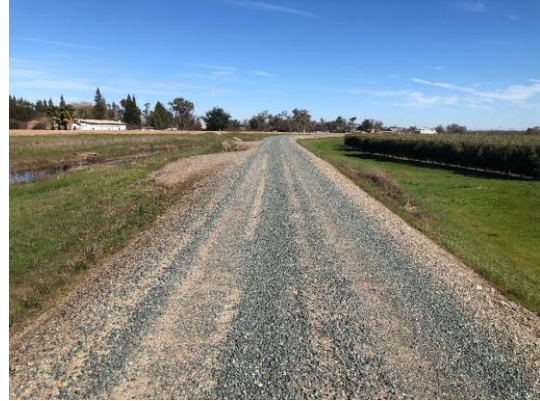
Photo 1 of 3 : UCIP_FA_2024_79009_92810.jpg

Comment Code						
Inspector Comment						
DS_ID:23748 FS_ID:79009 EP_NO: N/A Repair Type: Non-Urgent EVAL Issue: 5, Pipe Damage Crossing Status: Found UCIP Comments: 09/25/2024 DMP internal video inspection has found moderate pipe defects. Crossing will be monitored until funding becomes available for rehabilitation. (O. Yakimov - DWR UCIP) 02/22/2021 Record was updated from No Action Needed to Non-Urgent. No permit was found authorizing this encroachment. CVFPB will need to review crossing to determine owner. DWR DMP has not found internal issues, LOF between 1 and 2. Recommend inspection in 5 years. 4.5-inch PVC pipe discharging at LS toe headwall. 2-inch PVC pipe on LS slope adjacent to headwall, seems disconnected. The UCIP inspection was completed with DWR Inspector, S. Donovan, and LMA representative, J. Caruso. (N. Cholewinski - GE05/21/2014 2-small PVC pipes discharge into inlet on LS toe. (W. Wylie - DWR UCIP) FIELD_STRUCT_DESC: 24-inch corrugated metal storm drainage pipe (CMP) through the levee, 7.0 feet below the crown. Flap gate on the waterside (WS) end. Concrete U-shaped headwalls on both ends. Cobble grouted outlet across the berm. Cobble grouted apron on the landside (LS) end. [Additional Reference(s): DWR Levee Log, 1990, (HLM 10.75). USACE San Joaquin O&M Manual 612.2, 1967, (HLM 10.75), and 612 (addendum), February 1999, (HLM 10.72), (Station 566+09), 24-inch pipe listed]. FS Date: 2/22/2021

Crown Overview

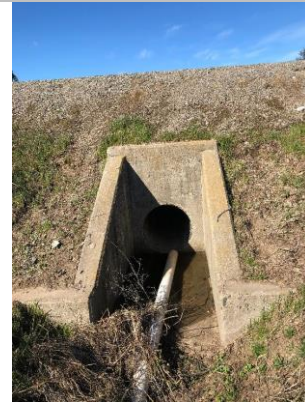
Photo 2 of 3 : UCIP_FA_2024_79009_92812.jpg

LS View: Headwall at LS toe. 4.5-inch PVC pipe discharges at headwall.

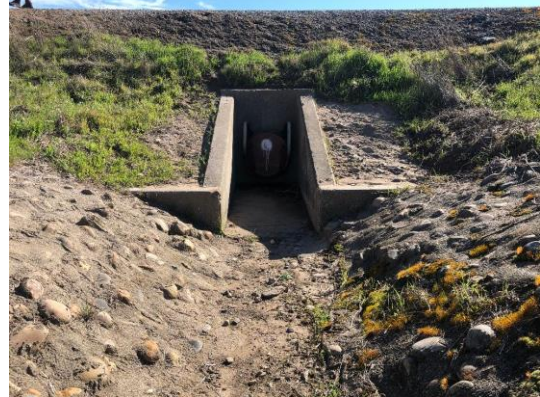
Photo 3 of 3 : UCIP_FA_2024_79009_92819.jpg

WS View: Headwall and flapgate at WS slope.

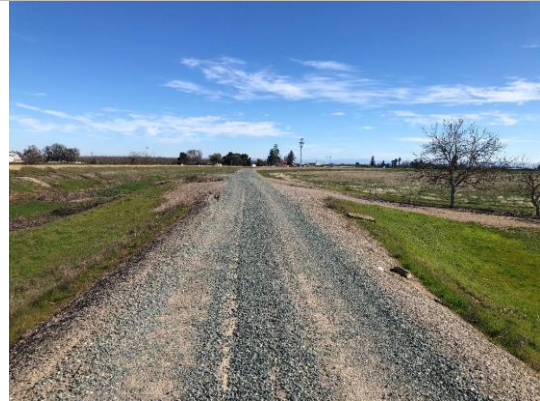
Photo 1 of 3 : UCIP_FA_2024_79010_92787.jpg

DS_ID:23749
FS_ID:79010
EP_NO: N/A
Repair Type: Non-Urgent
EVAL Issue: 5, Pipe Damage
Crossing Status: Found
UCIP Comments: 09/25/2024 DMP internal video inspection has found moderate pipe defects. Crossing will be monitored until funding becomes available for rehabilitation. (O. Yakimov - DWR UCIP)
02/22/2021 Pipe status is still Non-Urgent. No permit was found authorizing this encroachment. CVFPB will need to review crossing to determine owner. DWR DMP has not found internal issues, LOF between 1 and 2. Recommend inspection in 5 years. The UCIP inspection was completed with DWR Inspector, S. Donovan, and LMA representative, J. Caruso. (N. Cholewinski - GE05/21/2014 Some silt buildup in pipe at LS toe. (W. Wylie - DWR UCIP)
FIELD_STRUCT_DESC: 24-inch corrugated metal storm drainage pipe (CMP) through the levee, 8.0 feet below the crown. Flap gate on the waterside (WS) end. Concrete U-shaped headwalls on both ends. Cobble grouted outlet across the berm. Cobble grouted apron on the landside (LS) end. [Additional Reference(s): DWR Levee Log, 1990, (HLM 10.97). USACE San Joaquin O&M Manual 612.2, 1967, (HLM 10.97), and 612 (addendum), February 1999, (HLM 10.94), (Station 577+59), 24-inch pipe listed].

Crown Overview

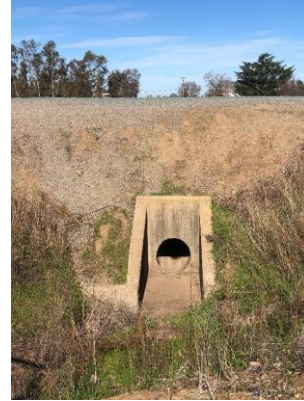
Photo 2 of 3 : UCIP_FA_2024_79010_92789.jpg

LS View: Headwall at LS toe.

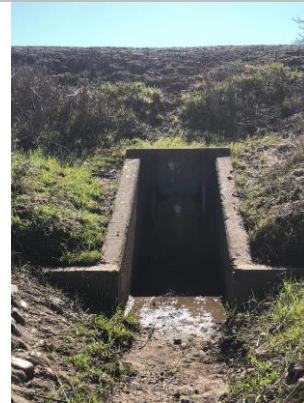
Photo 3 of 3 : UCIP_FA_2024_79010_92799.jpg

WS View: Headwall and flapgate at WS slope.

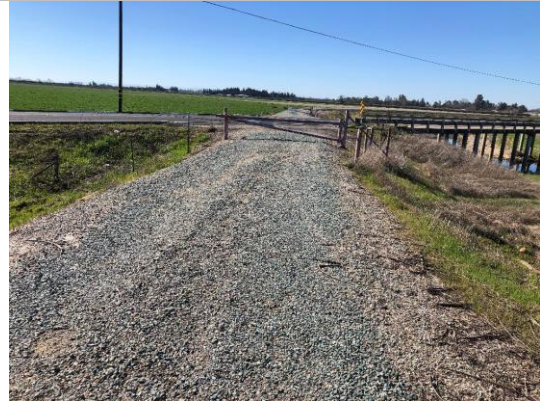
Photo 1 of 3 : UCIP_FA_2024_79011_92755.jpg

Comment Code						
Inspector Comment						
DS_ID:23750 FS_ID:79011 EP_NO: N/A Repair Type: Non-Urgent EVAL Issue: 5, Pipe Damage Crossing Status: Found UCIP Comments: 09/25/2024 DMP internal video inspection has found moderate pipe defects. Crossing will be monitored until funding becomes available for rehabilitation. (O. Yakimov - DWR UCIP) 02/22/2021 Record was updated from No Action Needed to Non-Urgent. No permit was found authorizing this encroachment. CVFPB will need to review crossing to determine owner. DWR DMP has not completed an internal inspection of the pipe. The UCIP inspection was completed with DWR Inspector, S. Donovan, and LMA representative, J. Caruso. (N. Cholewinski - GEI) FIELD_STRUCT_DESC: 24-inch corrugated metal storm drainage pipe (CMP) through the levee, 7.0 feet below the crown. Flap gate on the waterside (WS) end. Concrete U-shaped headwalls on both ends. Cobble grouted outlet across the berm. Cobble grouted apron on the landside (LS) end. [Additional Reference(s): DWR Levee Log, 1990, (HLM 11.32). USACE San Joaquin O&M Manual 612.2, 1967, (HLM 11.32), and 612 (addendum), February 1999, (HLM 11.28), (Station 595+39), 24-inch pipe listed]. FS Date: 2/22/2021

Crown Overview

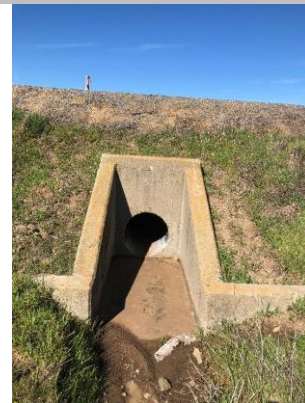
Photo 2 of 3 : UCIP_FA_2024_79011_92764.jpg

LS View: Headwall at LS toe.

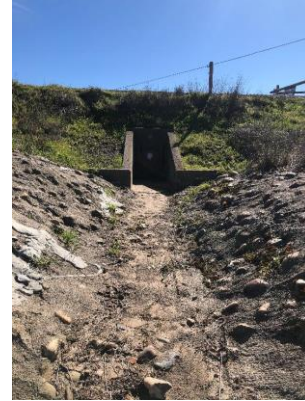
Photo 3 of 3 : UCIP_FA_2024_79011_92768.jpg

WS View: Headwall and flapgate at WS slope.

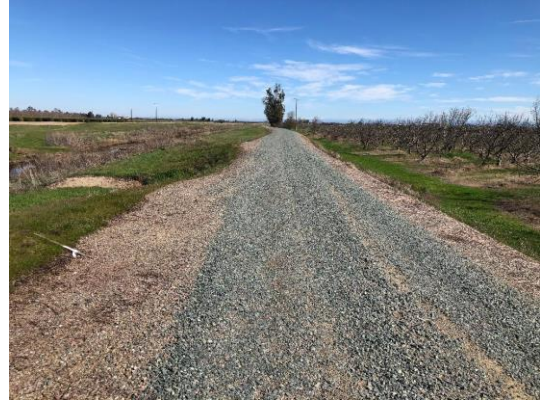
Photo 1 of 3 : UCIP_FA_2024_79012_92742.jpg

Comment Code						
Inspector Comment						
DS_ID:23751 FS_ID:79012 EP_NO: N/A Repair Type: Non-Urgent EVAL Issue: 5, Pipe Damage Crossing Status: Found UCIP Comments: 09/25/2024 DMP internal video inspection has found moderate pipe defects. Crossing will be monitored until funding becomes available for rehabilitation. (O. Yakimov - DWR UCIP) 02/22/2021 Record was updated from No Action Needed to Non-Urgent. No permit was found authorizing this encroachment. CVFPB will need to review crossing to determine owner. DWR DMP has not found internal issues, LOF between 1 and 2. Recommend inspection in 5 years. The UCIP inspection was completed with DWR Inspector, S. Donovan, and LMA representative, J. Caruso. (N. Cholewinski - GEI) FIELD_STRUCT_DESC: 36-inch corrugated metal storm drainage pipe (CMP) through the levee, 7.5 feet below the crown. Flap gate on the waterside (WS) end. Concrete U-shaped headwalls on both ends. Cobble grouted outlet across the berm. Cobble grouted apron on the landside (LS) end. [Additional Reference(s): DWR Levee Log, 1990, (HLM 11.37). USACE San Joaquin O&M Manual 612.2, 1967, (HLM 11.37), and 612 (addendum), February 1999, (HLM 11.32), (Station 597+78), 36-inch pipe listed]. FS Date: 2/22/2021

Crown Overview

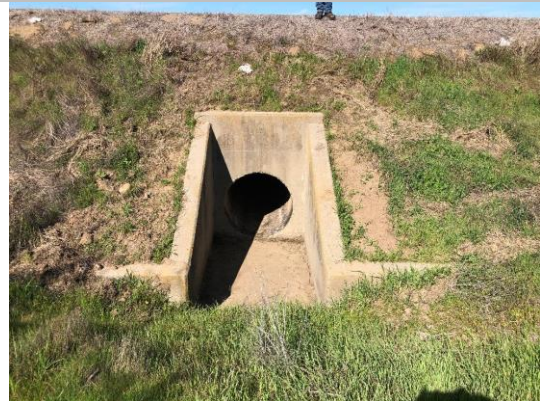
Photo 2 of 3 : UCIP_FA_2024_79012_92744.jpg

LS View: Headwall at LS toe.

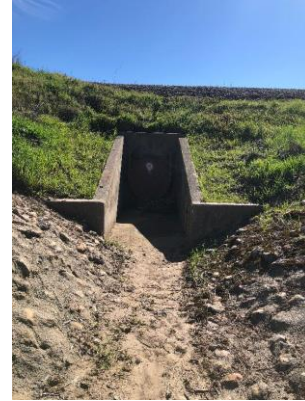
Photo 3 of 3 : UCIP_FA_2024_79012_92748.jpg

WS View: Headwall and flapgate at WS slope.

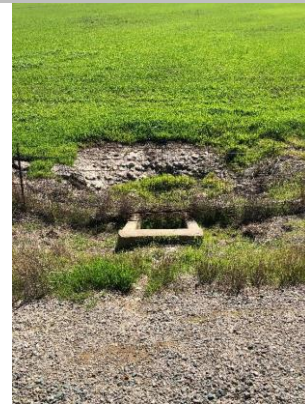
Photo 1 of 3 : UCIP_FA_2024_79013_92695.jpg

Comment Code					
Inspector Comment					
DS_ID:23752 FS_ID:79013 EP_NO: N/A Repair Type: Non-Urgent EVAL Issue: 5, Pipe Damage Crossing Status: Found UCIP Comments: 09/25/2024 DMP internal video inspection has found moderate pipe defects. Crossing will be monitored until funding becomes available for rehabilitation. (O. Yakimov - DWR UCIP) 02/22/2021 Record was updated from No Action Needed to Non-Urgent. No permit was found authorizing this encroachment. CVFPB will need to review crossing to determine owner. DWR DMP has not found internal issues, LOF between 1 and 2. Recommend inspection in 5 years. The UCIP inspection was completed with DWR Inspector, S. Donovan, and LMA representative, J. Caruso. (N. Cholewinski - GEI) FIELD_STRUCT_DESC: 24-inch corrugated metal storm drainage pipe (CMP) through the levee, 9.5 feet below the crown. Flap gate on the waterside (WS) end. Concrete U-shaped headwalls on both ends. Cobble grouted outlet across the berm. Cobble grouted apron on the landside (LS) end. [Additional Reference(s): DWR Levee Log, 1990, (HLM 11.59). USACE San Joaquin O&M Manual 612.2, 1967, (HLM 11.59), and 612 (addendum), February 1999, (HLM 11.60), (Station 612+48), 24-inch pipe listed]. FS Date: 2/22/2021

LS View: Headwall at LS toe.

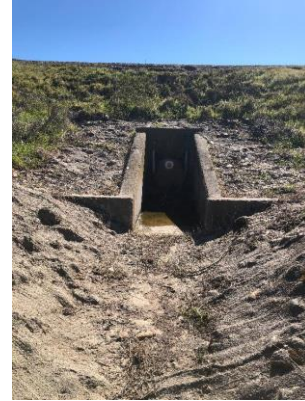
Photo 2 of 3 : UCIP_FA_2024_79013_92699.jpg

WS View: Headwall and flapgate at WS slope.

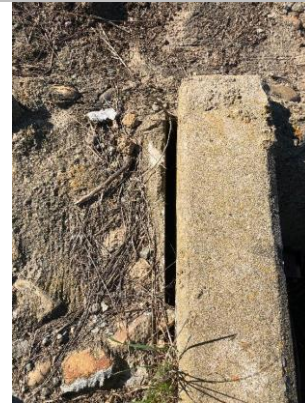
Photo 3 of 3 : UCIP_FA_2024_79013_92700.jpg

WS View: 1.5-inch gap observed between headwall and apron at WS slope.

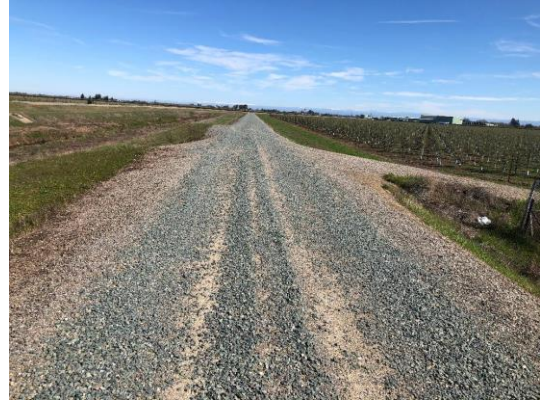
Photo 1 of 3 : UCIP_FA_2024_79014_92687.jpg

Comment Code						
Inspector Comment						
DS_ID:23753 FS_ID:79014 EP_NO: N/A Repair Type: Non-Urgent EVAL Issue: 5, Pipe Damage Crossing Status: Found UCIP Comments: 09/25/2024 DMP internal video inspection has found moderate pipe defects. Crossing will be monitored until funding becomes available for rehabilitation. (O. Yakimov - DWR UCIP) 02/22/2021 Record was updated from No Action Needed to Non-Urgent. No permit was found authorizing this encroachment. CVFPB will need to review crossing to determine owner. DWR DMP has not found internal issues, LOF between 1 and 2. Recommend inspection in 5 years. The UCIP inspection was completed with DWR Inspector, S. Donovan, and LMA representative, J. Caruso. (N. Cholewinski - GE04/26/2017 Rodent activity is already accounted for via DWR FPIIB inspections. As per inspection chief G. Wylie, crossing has been downgraded from Non-Urgent to No Action Needed, as pipe integrity itself is not in question. (K. Fazel - UCIP05/21/2014 Rodent activity at LS shoulder. (G. Wylie - FPIIB) FIELD_STRUCT_DESC: 24-inch corrugated metal storm drainage pipe (CMP) through the levee, 7.5 feet below the crown. Flap gate on the waterside (WS) end. Concrete U-shaped headwalls on both slopes. Cobble grouted outlet on the WS slope. [Additional Reference(s): DWR Levee Log, 1990, (HLM 11.65). USACE San Joaquin O&M Manual 612.2, 1967, (HLM 11.65), and 612 (addendum), February 1999, (HLM 11.99), (Station 633+20), 24-inch pipe listed]. FS Date: 2/22/2021

Crown Overview

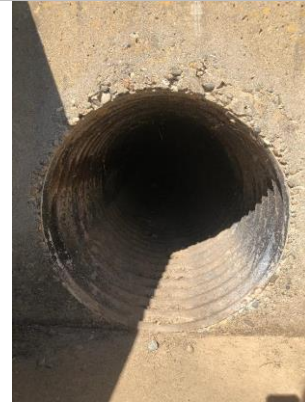
Photo 2 of 3 : UCIP_FA_2024_79014_92690.jpg

LS View: Pipe at LS toe.

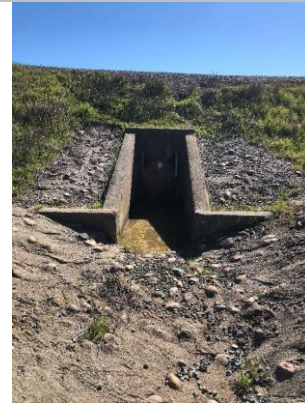
Photo 3 of 3 : UCIP_FA_2024_79014_92692.jpg

WS View: Headwall and flapgate at WS slope.

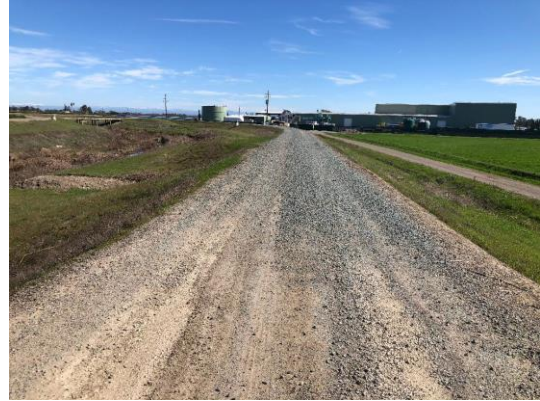
Photo 1 of 3 : UCIP_FA_2024_84813_92681.jpg

Comment Code						
Inspector Comment						
DS_ID:23754 FS_ID:84813 EP_NO: N/A Repair Type: Urgent EVAL Issue: 1, Pipe Integrity Crossing Status: Found UCIP Comments: 09/23/2024 Record updated from Non-Urgent to Urgent. DMP internal video inspection has found severe pipe defects. Crossing will be monitored until funding becomes available to address the issues. (O. Yakimov - DWR UCIP) 02/22/2021 Record was updated from No Action Needed to Non-Urgent. No permit was found authorizing this encroachment. CVFPB will need to review crossing to determine owner. DWR DMP has not found internal issues, LOF between 1 and 2. Recommend inspection in 5 years. A 4.5-inch PVC pipe is positioned to discharge at the LS inlet. The 4.5-inch PVC pipe is an unauthorized encroachment that has been installed along the LS toe. Recommend having the CVFPB review this record to have landowner remove the illegal encroachment along the LS toe. The UCIP inspection was completed with DWR Inspector, S. Donovan, and LMA representative, J. Caruso. (N. Cholewinski - GE04/26/2017 Rodent activity is already accounted for via DWR FPIIB inspections. As per inspection chief G. Wylie, crossing has been downgraded from Non-Urgent to No Action Needed, as pipe integrity itself is not in question. (K. Fazel - UCIP05/21/2014 Rodent activity at LS shoulder. (G. Wylie - FPIIB) FIELD_STRUCT_DESC: 24-inch corrugated metal storm drainage pipe (CMP) through the levee, 7.5 feet below the crown. Flap gate on the waterside (WS) end. Concrete U-shaped headwalls on both ends. Cobble grouted outlet across the berm. Cobble grouted apron on the landside (LS) end. [Additional Reference(s): DWR Levee Log, 1990, (HLM 12.06). USACE San Joaquin O&M Manual 612.2, 1967, (HLM 12.06), 24-inch pipe listed]. FS Date: 2/22/2021

Crown Overview

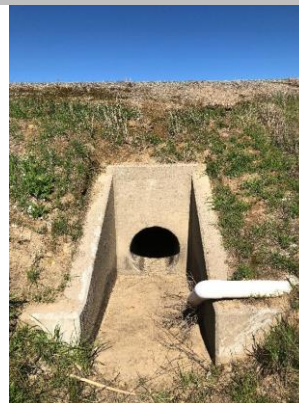
Photo 2 of 3 : UCIP_FA_2024_84813_92683.jpg

LS View: Headwall at LS toe. PVC pipe discharging at inlet.

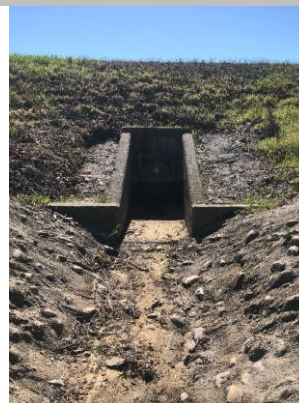
Photo 3 of 3 : UCIP_FA_2024_84813_92685.jpg

WS View: Headwall and flapgate at WS slope.

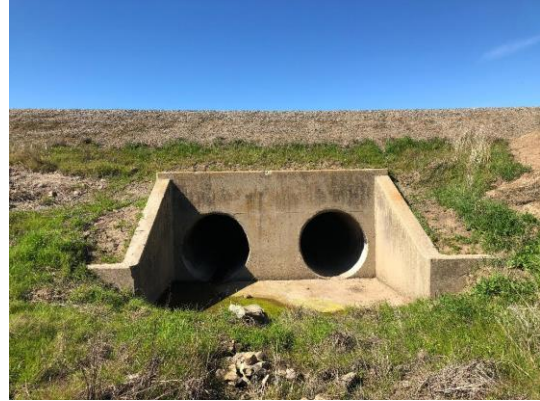
Photo 1 of 3 : UCIP_FA_2024_79016_92663.jpg

DS_ID:23756
FS_ID:79016
EP_NO: N/A
Repair Type: Non-Urgent
EVAL Issue: 4b, Safety Issue
Crossing Status: Found
UCIP Comments: 09/25/2024 DMP internal video inspection has found moderate pipe defects. Crossing will be monitored until funding becomes available for rehabilitation. (O. Yakimov - DWR UCIP) 02/22/2021 Pipe status is still Non-Urgent. No permit was found authorizing this encroachment. CVFPB will need to review crossing to determine owner. DWR DMP has not found internal issues, LOF between 1 and 2. Recommend inspection in 5 years. Riser lid damage. Recommend adding lid to riser as a safety measure. The UCIP inspection was completed with DWR Inspector, S. Donovan, and LMA representative, J. Caruso. (N. Cholewinski - GE05/21/2014 CMP riser missing cover on WS slope. (W. Wylie - DWR UCIP) FIELD_STRUCT_DESC: 1 of 2: 48-inch corrugated metal storm drainage pipe (CMP) through the levee, 8.5 feet below the crown. Slide gate inside a 60-inch CMP riser unit on the waterside (WS) slope. Concrete U-shaped headwalls on both ends. Cobble grouted outlet on the WS end. Cobble grouted apron on the landside (LS) end. [Additional Reference(s): DWR Levee Log, 1990, (HLM 12.20). USACE San Joaquin O&M Manual 612.2, 1967, (HLM 12.20), and 612 (addendum), February 1999, (HLM 12.13), (Station 640+50), 48-inch pipe listed]. FS Date: 2/22/2021

LS View: Headwall at LS toe.

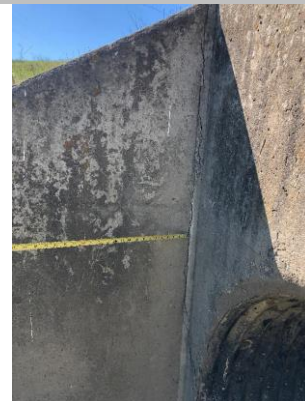
Photo 2 of 3 : UCIP_FA_2024_79016_92664.jpg

LS View: Surficial crack observed at headwall bend leading to pipe.

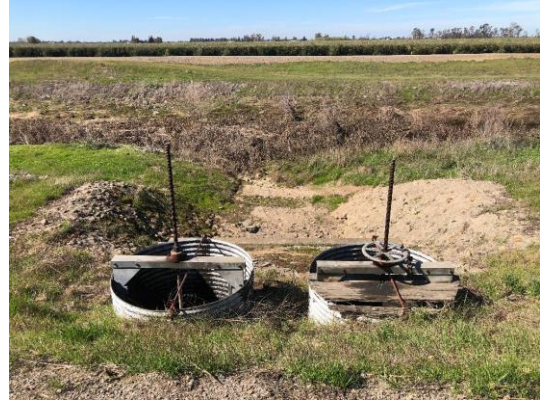
Photo 3 of 3 : UCIP_FA_2024_79016_92667.jpg

WS View: Riser at WS shoulder.

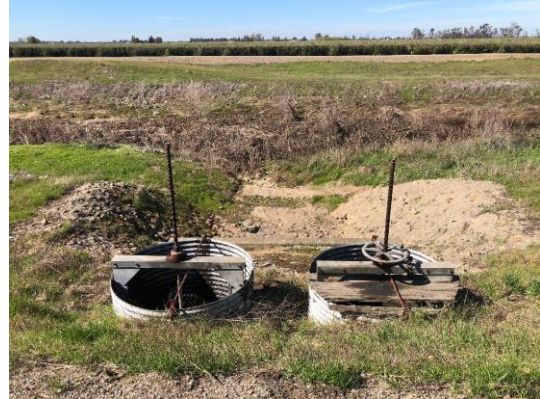
Photo 1 of 3 : UCIP_FA_2024_79017_92656.jpg

Comment Code						
Inspector Comment						
DS_ID:23818 FS_ID:79017 EP_NO: N/A Repair Type: Non-Urgent EVAL Issue: 4b, Safety Issue Crossing Status: Found UCIP Comments: 09/25/2024 DMP internal video inspection has found moderate pipe defects. Crossing will be monitored until funding becomes available for rehabilitation. (O. Yakimov - DWR UCIP) 02/22/2021 Pipe status is still Non-Urgent. No permit was found authorizing this encroachment. CVFPB will need to review crossing to determine owner. DWR DMP has not found internal issues, LOF between 1 and 2. Recommend inspection in 5 years. Riser lid missing. Recommend adding riser lid for safety reasons. The UCIP inspection was completed with DWR Inspector, S. Donovan, and LMA representative, J. Caruso. (N. Cholewinski - GE05/21/2014 CMP riser missing cover on WS slope may be hazard. (W. Wylie - DWR UCIP) FIELD_STRUCT_DESC: 2 of 2: 48-inch corrugated metal storm drainage pipe (CMP) through the levee, 8.5 feet below the crown. Slide gate inside a 60-inch CMP riser unit on the waterside (WS) slope. Concrete U-shaped headwalls on both ends. Cobble grouted outlet on the WS end. Cobble grouted apron on the landside (LS) end. [Additional Reference(s): DWR Levee Log, 1990, (HLM 12.20). USACE San Joaquin O&M Manual 612.2, 1967, (HLM 12.20), and 612 (addendum), February 1999, (HLM 12.13), (Station 640+50), 48-inch pipe listed]. FS Date: 2/22/2021

WS View: Riser at WS Shoulder. Partly covered with wood boards.
Headwall and flapgate at WS toe.

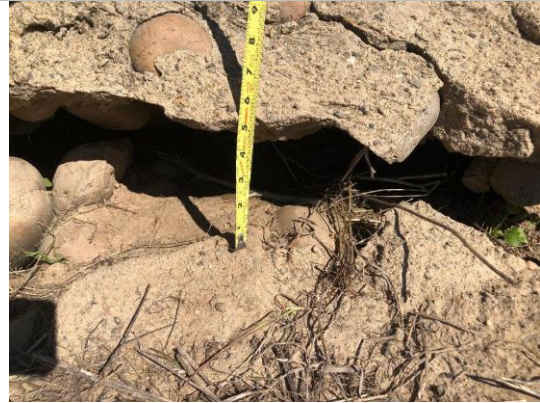
Photo 3 of 3 : UCIP_FA_2024_79017_92659.jpg

WS View: Crack observed in apron at WS toe.

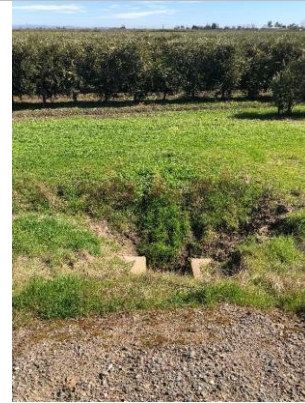
Photo 1 of 3 : UCIP_FA_2024_79018_92645.jpg

DS_ID:23757
FS_ID:79018
EP_NO: N/A
Repair Type: Non-Urgent
EVAL Issue: 5, Pipe Damage
Crossing Status: Found
UCIP Comments: 09/25/2024 DMP internal video inspection has found moderate pipe defects. Crossing will be monitored until funding becomes available for rehabilitation. (O. Yakimov - DWR UCIP)
02/22/2021 Pipe status is still Non-Urgent. No permit was found authorizing this encroachment. CVFPB will need to review crossing to determine owner. DWR DMP has not found internal issues, LOF between 1 and 2. Recommend inspection in 5 years. The UCIP inspection was completed with DWR Inspector, S. Donovan, and LMA representative, J. Caruso. (N. Cholewinski ? GE05/21/2014 Some sediment buildup in pipe at inlet. (W. Wylie - DWR DMP)
FIELD_STRUCT_DESC: 24-inch corrugated metal storm drainage pipe (CMP) through the levee, 9.0 feet below the crown. Flap gate on the waterside (WS) end. Concrete U-shaped headwalls on both ends. Cobble grouted outlet across the berm. Cobble grouted apron on the landside (LS) end. [Additional Reference(s): DWR Levee Log, 1990, (HLM 12.43). USACE San Joaquin O&M Manual 612.2, 1967, (HLM 12.43), and 612 (addendum), February 1999, (HLM 12.36), (Station 652+74), 24-inch pipe listed].

LS View: Headwall at LS toe.

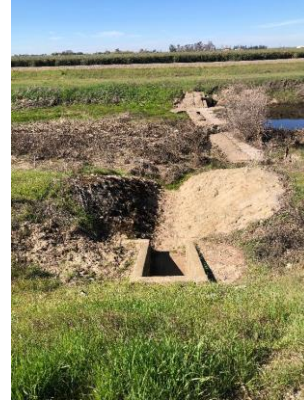
Photo 2 of 3 : UCIP_FA_2024_79018_92647.jpg

WS View: Headwall and flapgate at WS slope.
