**Flood Control Project Maintenance
Levee Inspections****Maintenance Issue Types Only, Levee Inspection Report By Mile - Fall 2024****San Joaquin County Flood Control and Water Conservation District**

Waterway	Bank	Unit Miles	Inspection Start/End	Inspector
Unit No. 01 Littlejohn Creek	Left	2.59	10/21/2024 10/21/2024	Alberto De Leon

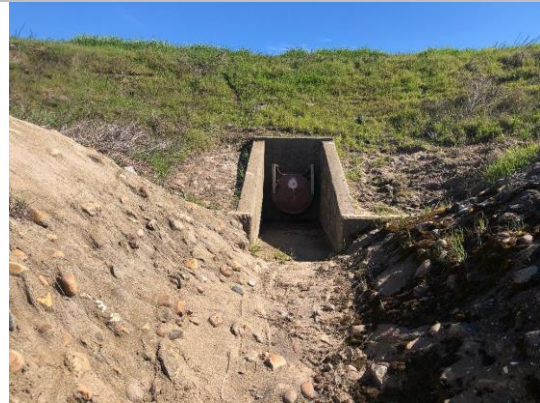
Photo 3 of 3 : UCIP_FA_2024_79018_92648.jpg

WS View: Headwall and flapgate at WS slope.

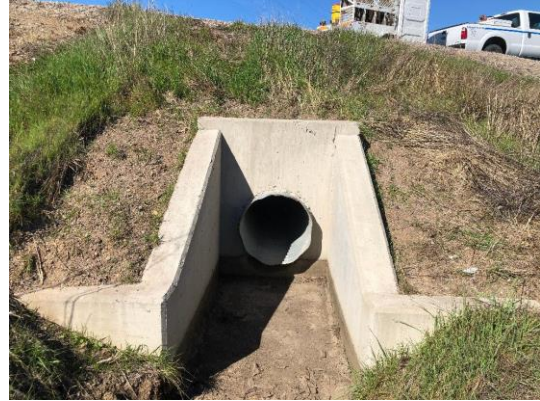
Photo 1 of 3 : UCIP_FA_2024_79019_92629.jpg

Comment Code					
Inspector Comment					
DS_ID:23761 FS_ID:79019 EP_NO: N/A Repair Type: Urgent EVAL Issue: 1, Pipe Integrity Crossing Status: Found UCIP Comments: 02/22/2021 Record was updated from No Action Needed to Urgent. DWR DMP has found integrity issues, LOF between 5 and 6. Crossing will be monitored until funding becomes available for removal. No permit was found authorizing this encroachment. There appears to be a gap between the headwall and concrete apron. Recommend monitoring the gap to determine if it is associated with undermining occurring. CVFPB will need to review crossing to determine owner. The UCIP inspection was completed with LMA representative, J. Caruso. (N. Cholewinski - GEI) FIELD_STRUCT_DESC: 24-inch corrugated metal storm drainage pipe (CMP) through the levee, 7.5 feet below the crown. Flap gate on the waterside (WS) end. Concrete U-shaped headwalls on both ends. Cobble grouted outlet across the berm. Cobble grouted apron on the landside (LS) end. [Additional Reference(s): DWR Levee Log, 1990, (HLM 12.78). USACE San Joaquin O&M Manual 612.2, 1967, (HLM 12.78), and 612 (addendum), February 1999, (HLM 12.70), (Station 670+43), 24-inch pipe listed]. FS Date: 2/22/2021

LS View: Headwall at LS toe.

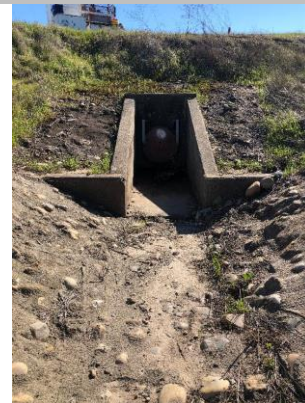
Photo 2 of 3 : UCIP_FA_2024_79019_92633.jpg

WS View: Headwall and flapgate at WS slope.

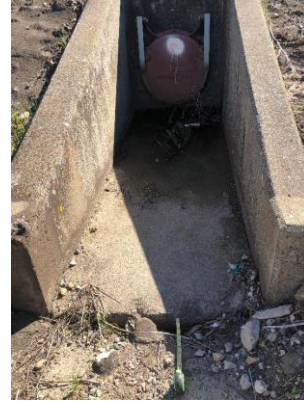
Photo 3 of 3 : UCIP_FA_2024_79019_92634.jpg

WS View: Headwall and flapgate at WS slope. Gap visible between headwall and apron.

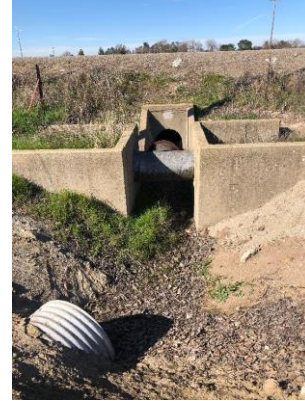
Photo 1 of 3 : UCIP_FA_2024_79020_92608.jpg

Comment Code					
Inspector Comment					
DS_ID:23764 FS_ID:79020 EP_NO: N/A Repair Type: Non-Urgent EVAL Issue: 5, Pipe Damage Crossing Status: Found UCIP Comments: 09/25/2024 DMP internal video inspection has found moderate pipe defects. Crossing will be monitored until funding becomes available for rehabilitation. (O. Yakimov - DWR UCIP) 02/22/2021 Record was updated from No Action Needed to Non-Urgent. No permit was found authorizing this encroachment. CVFPB will need to review crossing to determine owner. DWR DMP has not found internal issues, LOF between 1 and 2. Recommend inspection in 5 years. The UCIP inspection was completed with LMA representative, J. Caruso. (N. Cholewinski ? GEI) FIELD_STRUCT_DESC: 36-inch corrugated metal storm drainage pipe (CMP) through the levee, 9.0 feet below the crown. Flap gate on the waterside (WS) end. Concrete U-shaped headwalls on both ends. Cobble grouted outlet on the WS end. Cobble grouted apron on the landside (LS) end. [Additional Reference(s): DWR Levee Log, 1990, (HLM 12.94). USACE San Joaquin O&M Manual 612.2, 1967, (HLM 12.94), and 612 (addendum), February 1999, (HLM 12.86), (Station 678+88), 36-inch pipe listed]. FS Date: 2/22/2021

LS View: Abandoned irrigation structure at LS toe.

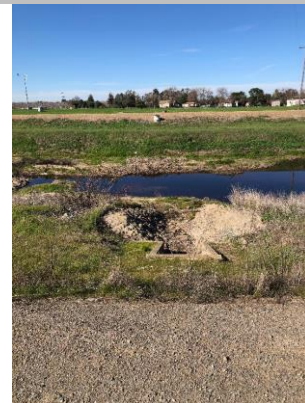
Photo 2 of 3 : UCIP_FA_2024_79020_92611.jpg

WS View: Headwall and flapgate at WS slope.

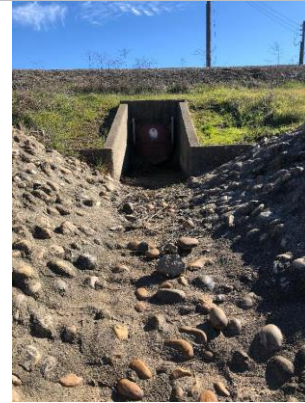
Photo 3 of 3 : UCIP_FA_2024_79020_92612.jpg

WS View: Headwall and flapgate at WS slope.

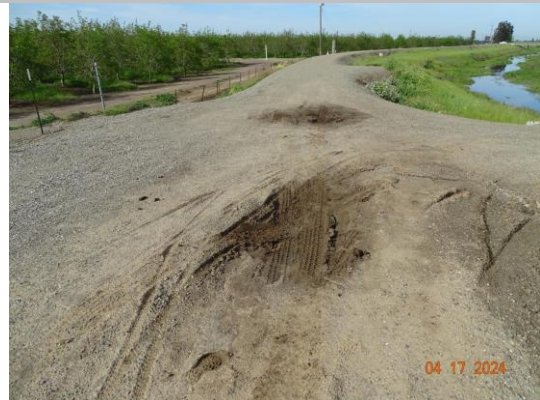
Photo 1 of 1 : FA_2024_NA0017_152_133_20240910_00015.jpg

LM Start	12.62	Rating **	M	Issue No.	133
LM End	12.62	Issue Type +	Ma	Location *	CR
Category	Earthen Levee			GPS Latitude/Longitude	
				Start	End
Item	Crown Surface / Depressions / Rutting			38.092502°	38.092502°
				-121.177378°	-121.177378°
DWR ID	DWR_NA0017_08_s_2024_133				
Comment Code					
C2 : Repair depressions or ruts in the crown or slope.					
Inspector Comment

View of depressions on the crown surface. Spring 2024

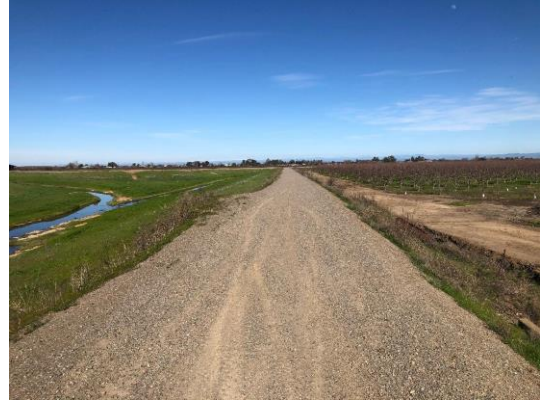
Photo 1 of 3 : UCIP_FA_2024_79021_92597.jpg

Comment Code					
Inspector Comment					
DS_ID:23765 FS_ID:79021 EP_NO: N/A Repair Type: No Action Needed EVAL Issue: Crossing Status: Found UCIP Comments: 09/18/2023 Record updated from Non-Urgent to No Action Needed. Pipe was CIPP lined. DMP internal video inspection has found none or minor pipe defects. Recommend next video inspection in 5 years. (O. Yakimov - DWR UCIP) 02/22/2021 Record was updated from No Action Needed to Non-Urgent. DWR DMP has found integrity issues, LOF between 4 and 5. Crossing will be monitored until funding becomes available for rehabilitation. No permit was found authorizing this encroachment. CVFPB will need to review crossing to determine owner. The UCIP inspection was completed with LMA representative, J. Caruso. (N. Cholewinski - GEI) FIELD_STRUCT_DESC: 24-inch CIPP-lined corrugated metal storm drainage pipe (CMP) through the levee, 9.0 feet below the crown. Flap gate on the waterside (WS) end. Slide gate on the landside (LS) end. Concrete U-shaped headwalls on both ends. Cobble grouted outlet across the berm. Cobble grouted apron on the LS end. [Additional Reference(s): DWR Levee Log, 1990, (HLM 13.00). USACE San Joaquin O&M Manual 612.2, 1967, (HLM 13.00), 24-inch pipe listed]. FS Date: 2/22/2021

Crown Overview

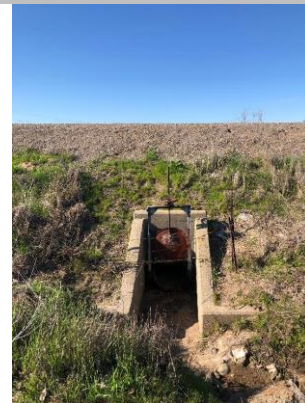
Photo 2 of 3 : UCIP_FA_2024_79021_92600.jpg

LS View: Headwall and slide gate at LS toe.

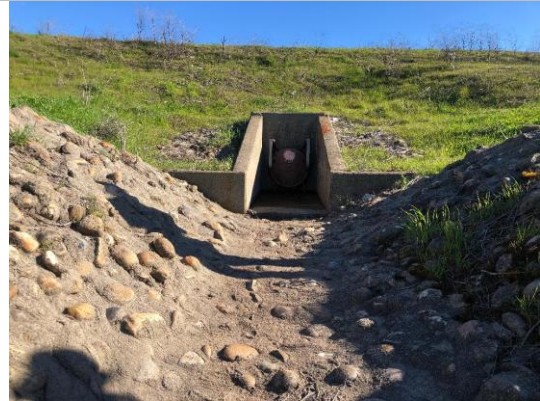
Photo 3 of 3 : UCIP_FA_2024_79021_92602.jpg

WS View: Headwall and flapgate at WS toe.

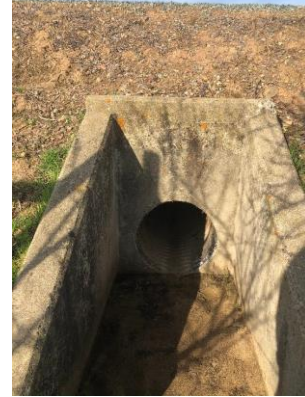
Photo 1 of 2 : UCIP_FA_2024_79022_92583.jpg

Comment Code					
Inspector Comment					
DS_ID:23767 FS_ID:79022 EP_NO: N/A Repair Type: Non-Urgent EVAL Issue: 5, Pipe Damage Crossing Status: Found UCIP Comments: 09/25/2024 DMP internal video inspection has found moderate pipe defects. Crossing will be monitored until funding becomes available for rehabilitation. (O. Yakimov - DWR UCIP) 02/23/2021 Record was updated from No Action Needed to Non-Urgent. No permit was found authorizing this encroachment. CVFPB will need to review crossing to determine owner. DWR DMP has not found internal issues, LOF between 1 and 2. Recommend inspection in 5 years. The UCIP inspection was completed with LMA representative, J. Caruso. (N. Cholewinski ? GEI) FIELD_STRUCT_DESC: 24-inch corrugated metal storm drainage pipe (CMP) through the levee, 7.0 feet below the crown. Flap gate on the waterside (WS) end. Concrete U-shaped headwalls on both ends. Cobble grouted outlet on the WS end. Cobble grouted intake on the landside (LS). [Additional Reference(s): DWR Levee Log, 1990, (HLM 13.26). USACE San Joaquin O&M Manual 612.2, 1967, (HLM 13.26), 24-inch pipe listed]. FS Date: 2/23/2021

LS View: Headwall at LS toe.

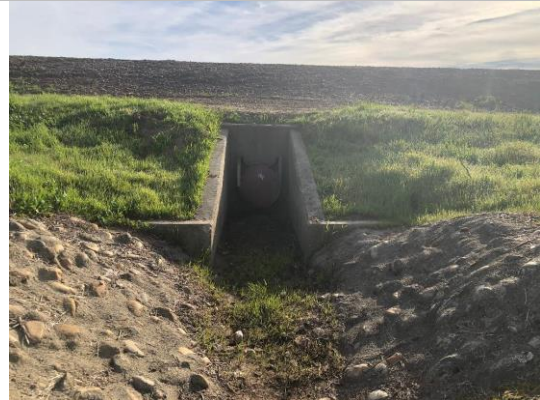
Photo 2 of 2 : UCIP_FA_2024_79022_92586.jpg

WS View: Headwall and flapgate at WS slope.

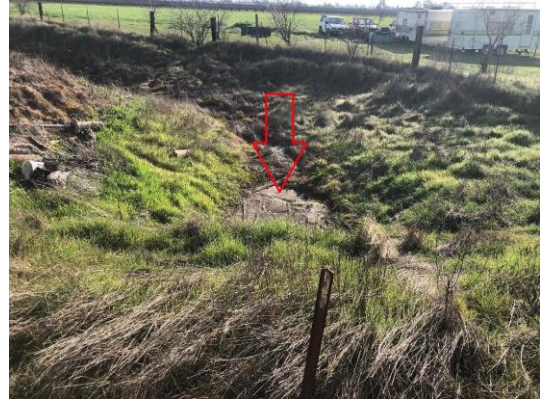
Photo 1 of 3 : UCIP_FA_2024_78501_92575.jpg

DS_ID:23768
FS_ID:78501
EP_NO: N/A
Repair Type: Non-Urgent
EVAL Issue: 4b, Safety Issue
Crossing Status: Found
UCIP Comments: 09/25/2024 DMP internal video inspection has found moderate pipe defects. Crossing will be monitored until funding becomes available for rehabilitation. (O. Yakimov - DWR UCIP) 02/23/2021 Pipe status is still Non-Urgent. No permit was found authorizing this encroachment. CVFPB will need to review crossing to determine owner. DWR DMP has not found internal issues, LOF between 1 and 2. Recommend inspection in 5 years. LS not accessible due to barbed cattle fencing. Riser lid missing. Recommend adding lid to riser as a safety measure. The UCIP inspection was completed with LMA representative, J. Caruso. (N. Cholewinski ? GE05/21/2014 Some debris buildup at inlet. No lid on CMP riser on WS slope. (W. Wylie - DWR DMP)
FIELD_STRUCT_DESC: 1 of 2: 36-inch corrugated metal storm drainage pipe (CMP) through the levee, 10.0 feet below the crown. Concrete U-shaped headwalls on both ends. Slide gate inside a CMP riser unit on the waterside (WS) slope. Flap gate on the WS end. [Additional Reference(s): DWR Levee Log, 1990, (HLM 13.35). USACE San Joaquin O&M Manual 612.2, 1967, (HLM 13.35), 36-inch pipe listed].

LS View: Pipe at LS toe with cattle fencing around opening.

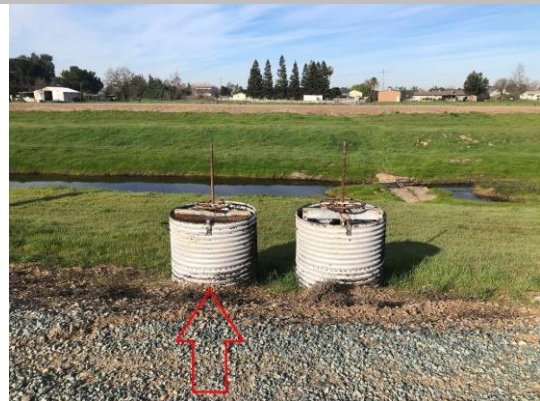
Photo 2 of 3 : UCIP_FA_2024_78501_92580.jpg

WS View: Riser on WS shoulder.

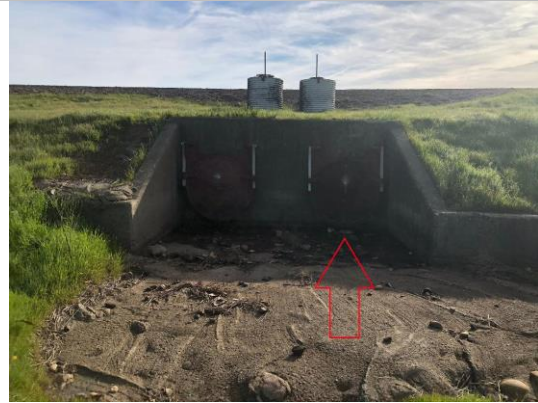
Photo 3 of 3 : UCIP_FA_2024_78501_92579.jpg

WS View: Headwall and flapgate at WS toe.

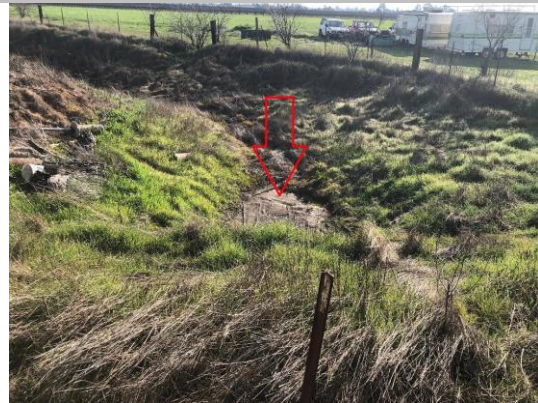
Photo 1 of 3 : UCIP_FA_2024_78502_92569.jpg

DS_ID:23816
FS_ID:78502
EP_NO: N/A
Repair Type: Non-Urgent
EVAL Issue: 4b, Safety Issue
Crossing Status: Found
UCIP Comments: 09/25/2024 DMP internal video inspection has found moderate pipe defects. Crossing will be monitored until funding becomes available for rehabilitation. (O. Yakimov - DWR UCIP)
02/23/2021 Pipe status is still Non-Urgent. No permit was found authorizing this encroachment. CVFPB will need to review crossing to determine owner. DWR DMP has not found internal issues, LOF between 1 and 2. Recommend inspection in 5 years. LS not accessible due to barbed cattle fencing. Riser lid missing. Recommend adding lid to riser as a safety measure. The UCIP inspection was completed with LMA representative, J. Caruso. (N. Cholewinski - GEI)
05/21/2014 Some debris buildup at inlet and no lid on standpipe at WS shoulder. (W. Wylie - DWR DMP)
FIELD_STRUCT_DESC: 2 of 2: 36-inch corrugated metal storm drainage pipe (CMP) through the levee, 10.0 feet below the crown. Concrete U-shaped headwalls on both ends. Slide gate inside a CMP riser unit on the waterside (WS) slope. Flap gate on the WS end.

LS View: Cattle fencing around inlet at LS toe.

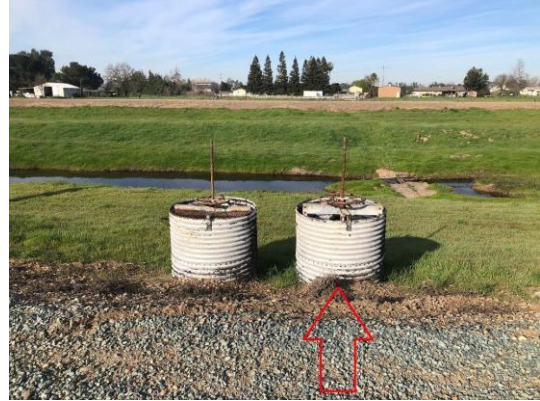
Photo 2 of 3 : UCIP_FA_2024_78502_92570.jpg

WS View: Riser on WS shoulder.

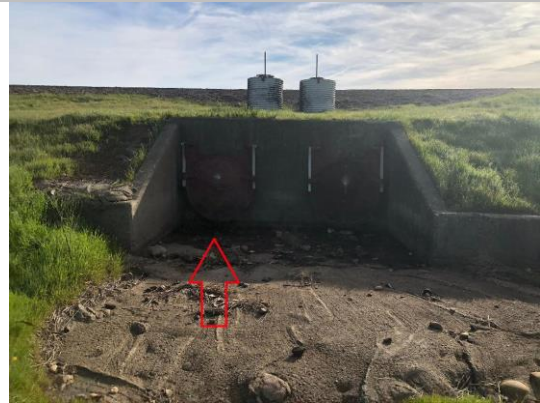
Photo 3 of 3 : UCIP_FA_2024_78502_92572.jpg

WS View: Headwall and flapgate at WS toe.

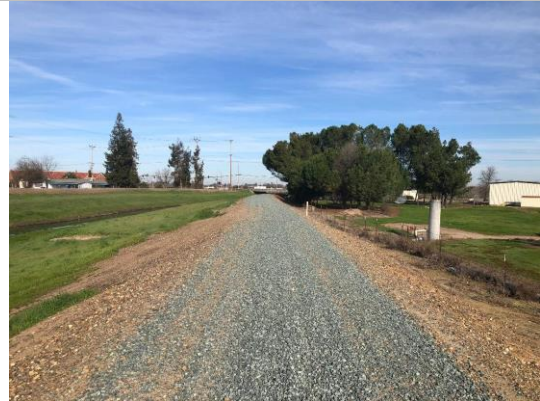
Photo 1 of 3 : UCIP_FA_2024_79023_92560.jpg

Comment Code						
Inspector Comment						
DS_ID:23769 FS_ID:79023 EP_NO: N/A Repair Type: Non-Urgent EVAL Issue: Crossing Status: Found UCIP Comments: 02/23/2021 Record was updated from No Action Needed to Non-Urgent. No permit was found authorizing this encroachment. CVFPB will need to review crossing to determine owner. DWR DMP has not found internal issues, LOF between 1 and 2. Recommend inspection in 5 years. Standpipe, 24-inch OD, located landward of LS toe is discharging at storm drain inlet at LS toe. The UCIP inspection was completed with LMA representative, J. Caruso. (N. Cholewinski ? GEI) FIELD_STRUCT_DESC: 24-inch corrugated metal storm drainage pipe (CMP) through the levee, 8.0 feet below the crown. Flap gate on the waterside (WS) end. Concrete U-shaped headwalls on both ends. Cobble grouted outlet on the WS end. Cobble grouted intake on the landside (LS). [Additional Reference(s): DWR Levee Log, 1990, (HLM 13.50). USACE San Joaquin O&M Manual 612.2, 1967, (HLM 13.50), 24-inch pipe listed]. FS Date: 2/23/2021

Crown Overview

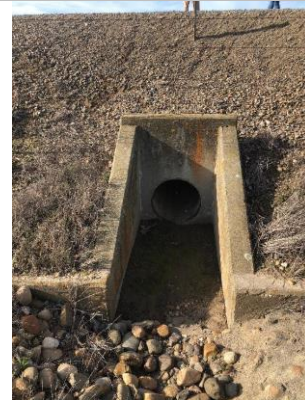
Photo 2 of 3 : UCIP_FA_2024_79023_92562.jpg

LS View: Headwall at LS toe.

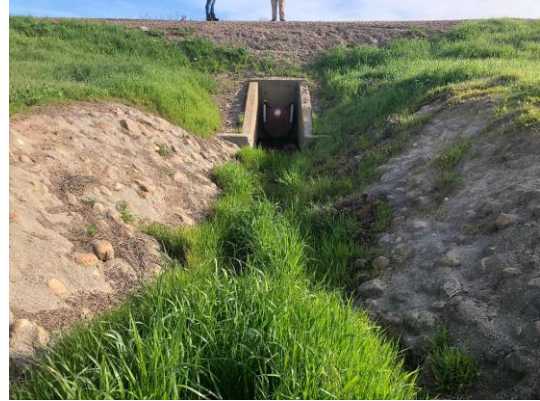
Photo 3 of 3 : UCIP_FA_2024_79023_92565.jpg

WS View: Headwall and flapgate at WS slope.

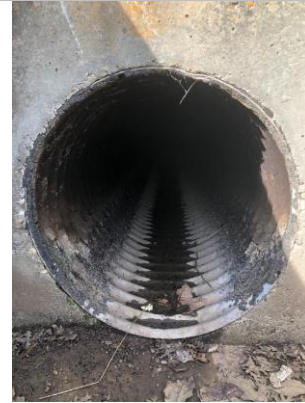
Photo 1 of 2 : UCIP_FA_2024_79024_92552.jpg

Comment Code					
Inspector Comment					
DS_ID:23770 FS_ID:79024 EP_NO: N/A Repair Type: Non-Urgent EVAL Issue: 5, Pipe Damage Crossing Status: Found UCIP Comments: 02/23/2021 Record was updated from No Action Needed to Non-Urgent. DWR DMP has found integrity issues, LOF between 4 and 5. Crossing will be monitored until funding becomes available for rehabilitation. No permit was found authorizing this encroachment. CVFPB will need to review crossing to determine owner. Slight weathering of interior pipe coating observed. The UCIP inspection was completed with LMA representative, J. Caruso. (N. Cholewinski - GEI) FIELD_STRUCT_DESC: 24-inch corrugated metal storm drainage pipe (CMP) through the levee, 6.0 feet below the crown. Flap gate on the waterside (WS) end. Concrete U-shaped headwalls on both ends. Cobble grouted outlet on the WS end. Cobble grouted intake on the landside (LS). [Additional Reference(s): DWR Levee Log, 1990, (HLM 13.60). USACE San Joaquin O&M Manual 612.2, 1967, (HLM 13.60), 24-inch pipe listed]. FS Date: 2/23/2021

LS View: Pipe at LS toe.

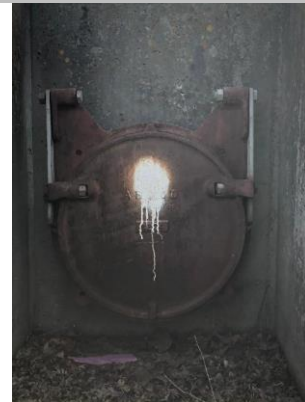
Photo 2 of 2 : UCIP_FA_2024_79024_92555.jpg

WS View: Flapgate at WS slope.

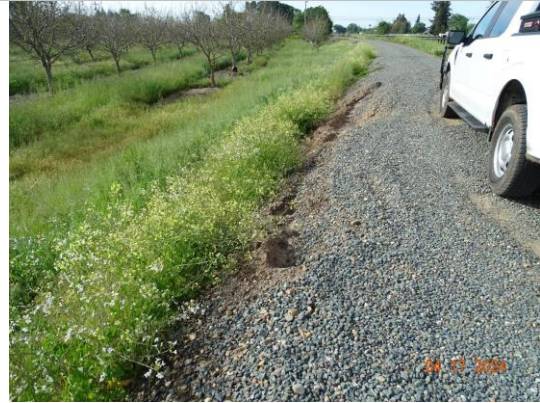
Photo 1 of 1 : FA_2024_NA0017_152_118_20240910_00011.jpg

LM Start	13.30	Rating **	M	Issue No.	118
LM End	13.30	Issue Type +	Ma	Location *	LS
Category	Earthen Levee			GPS Latitude/Longitude	
				Start	End
Item	Erosion / Rills			38.102891°	38.102891°
				-121.177067°	-121.177067°
DWR ID	DWR_NA0017_08_s_2024_118				
Comment Code					
E5 : Schedule repair of rills prior to the next inspection.					
Inspector Comment

View of rills along the landside shoulder. Spring 2024

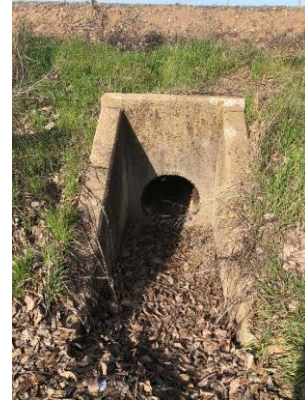
Photo 1 of 2 : UCIP_FA_2024_79025_92534.jpg

Comment Code					
Inspector Comment					
DS_ID:23771 FS_ID:79025 EP_NO: N/A Repair Type: Non-Urgent EVAL Issue: Crossing Status: Found UCIP Comments: 02/23/2021 Record was updated from No Action Needed to Non-Urgent. No permit was found authorizing this encroachment. CVFPB will need to review crossing to determine owner. DWR DMP has not found internal issues, LOF between 1 and 2. Recommend inspection in 5 years. Leaf vegetation build-up present at LS toe. The UCIP inspection was completed with LMA representative, J. Caruso. (N. Cholewinski ? GEI) FIELD_STRUCT_DESC: 24-inch corrugated metal storm drainage pipe (CMP) through the levee, 6.0 feet below the crown. Flap gate on the waterside (WS) end. Concrete U-shaped headwalls on both ends. Cobble grouted outlet on the WS end. Cobble grouted intake on the landside (LS). [Additional Reference(s): DWR Levee Log, 1990, (HLM 13.81). USACE San Joaquin O&M Manual 612.2, 1967, (HLM 13.81), 24-inch pipe listed]. FS Date: 2/23/2021

LS View: Headwall at LS toe.

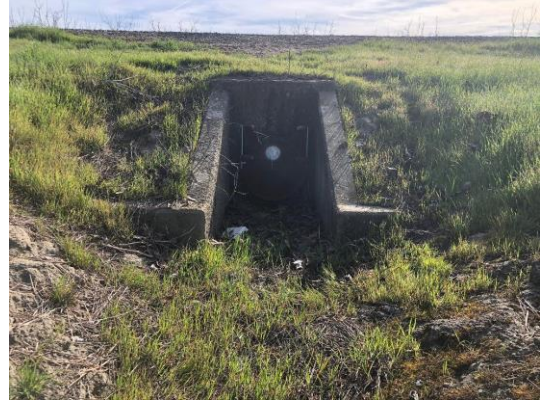
Photo 2 of 2 : UCIP_FA_2024_79025_92537.jpg

WS View: Headwall and flapgate at WS slope.

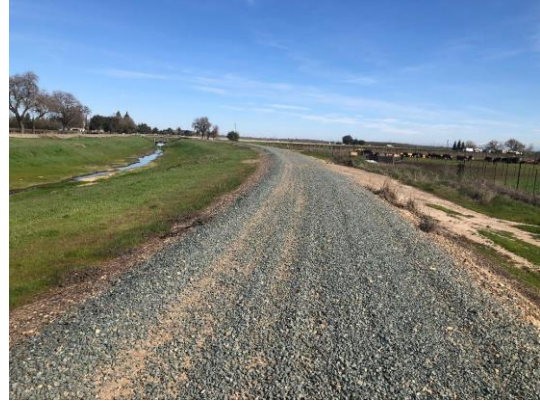
Photo 1 of 3 : UCIP_FA_2024_85081_92517.jpg

Comment Code					
Inspector Comment					
DS_ID:23773 FS_ID:85081 EP_NO: N/A Repair Type: No Action Needed EVAL Issue: Crossing Status: Found UCIP Comments: 10/21/2024 Record updated from Non-Urgent to No Action Needed. Likely that 2024 PACP operator did not find the pin size hole during inspection due to panning. (O. Yakimov - DWR UCIP) 03/31/2023 Record updated from Urgent to Non-Urgent. LoF is equal to 5.1 due to a pin hole at pipe entrance, other integrity issues are not found. Crossing will be monitored until funding becomes available for rehabilitation. (O.Yakimov - DWR UCIP). 02/23/2021 Record was updated from No Action Needed to Urgent. DWR DMP has found integrity issues, LOF between 5 and 6. Crossing will be monitored until funding becomes available for removal. No permit was found authorizing this encroachment. CVFPB will need to review crossing to determine owner. Slight offset, <1-inch, observed within interior of pipe at approximately 10 feet inside pipe from LS pipe opening. Small gap, approximately 1/4-inch, present at base of pipe along exterior of pipe opening at LS toe. The UCIP inspection was completed with LMA representative, J. Caruso. (N. Cholewinski - GEI) FIELD_STRUCT_DESC: 1 of 2: 36-inch corrugated metal storm drainage pipe (CMP) through the levee, 4.0 feet below the crown. Flap gate on the waterside (WS) end. Concrete U-shaped headwalls on both ends. Cobble grouted outlet on the WS end. Cobble grouted intake on the landside (LS). [Additional Reference(s): DWR Levee Log, 1990, (HLM 14.16). USACE San Joaquin O&M Manual 612.2, 1967, (HLM 14.16), 36-inch pipe listed]. FS Date: 2/23/2021

Crown Overview

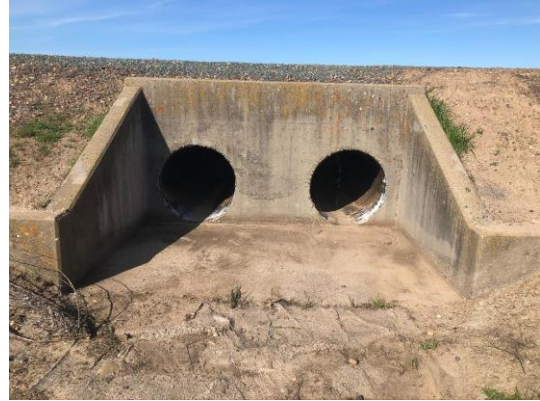
Photo 2 of 3 : UCIP_FA_2024_85081_92519.jpg

LS View: Headwall at LS toe.

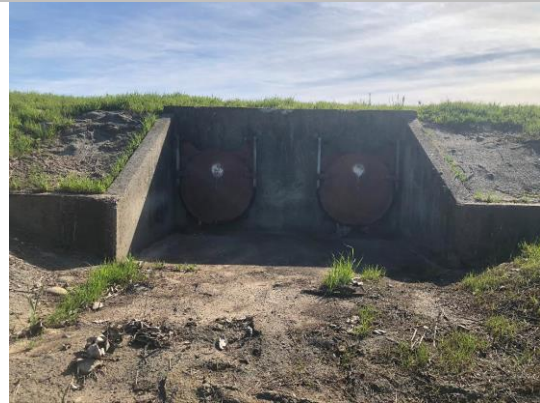
Photo 3 of 3 : UCIP_FA_2024_85081_92524.jpg

WS View: Headwall and flapgate at WS slope.

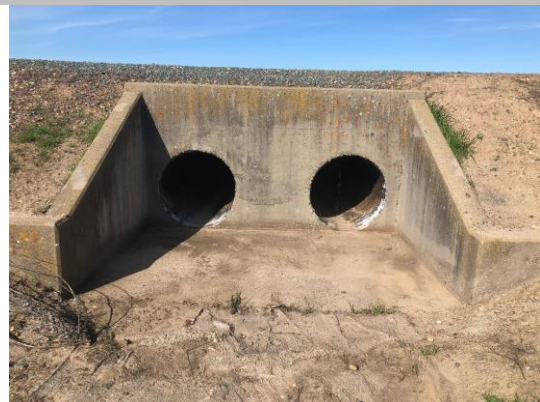
Photo 2 of 3 : UCIP_FA_2024_79027_92510.jpg

Comment Code					
Inspector Comment					
DS_ID:23815 FS_ID:79027 EP_NO: N/A Repair Type: Non-Urgent EVAL Issue: Crossing Status: Found UCIP Comments: 02/23/2021 Record was updated from No Action Needed to Non-Urgent. No permit was found authorizing this encroachment. CVFPB will need to review crossing to determine owner. DWR DMP has not found internal issues, LOF between 1 and 2. Recommend inspection in 5 years. The UCIP inspection was completed with LMA representative, J. Caruso. (N. Cholewinski ? GEI) FIELD_STRUCT_DESC: 2 of 2: 36-inch corrugated metal storm drainage pipe (CMP) through the levee, 4.0 feet below the crown. Flap gate on the waterside (WS) end. Concrete U-shaped headwalls on both ends. Cobble grouted outlet on the WS end. Cobble grouted intake on the landside (LS). [Additional Reference(s): DWR Levee Log, 1990, (HLM 14.16). USACE San Joaquin O&M Manual 612.2, 1967, (HLM 14.16), 36-inch pipe listed]. FS Date: 2/23/2021

LS View: Headwall at LS toe.

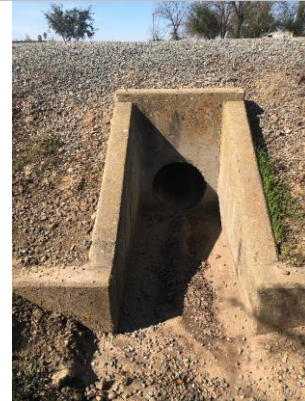
Photo 2 of 3 : UCIP_FA_2024_79028_92495.jpg

LS View: Headwall at LS toe.

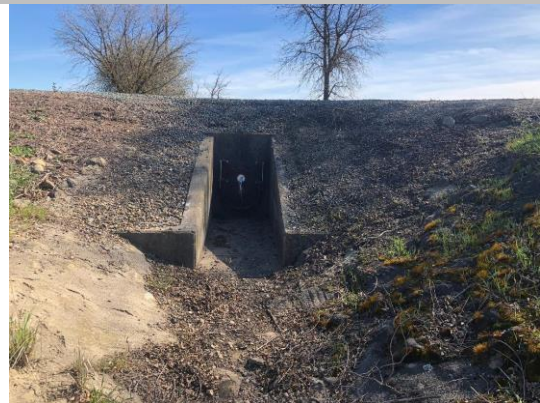
Photo 3 of 3 : UCIP_FA_2024_79028_92498.jpg

WS View: Headwall and 24-inch flapgate at WS slope.

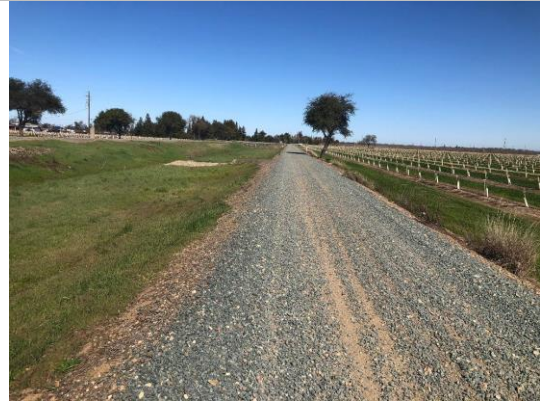
Photo 1 of 3 : UCIP_FA_2024_79029_92485.jpg

Comment Code						
Inspector Comment						
DS_ID:23776 FS_ID:79029 EP_NO: N/A Repair Type: Non-Urgent EVAL Issue: Crossing Status: Found UCIP Comments: 02/23/2021 Pipe status is still Non-Urgent. No permit was found authorizing this encroachment. CVFPB will need to review crossing to determine owner. DWR DMP has not found internal issues, LOF between 1 and 2. Recommend inspection in 5 years. Observed small gap, approximately 1/4-inch wide, at base of pipe on LS toe. The UCIP inspection was completed with LMA representative, J. Caruso. (N. Cholewinski ? GE06/21/2014 Some silt buildup inside pipe. (W. Wylie - DWR DMP) FIELD_STRUCT_DESC: 24-inch corrugated metal storm drainage pipe (CMP) through the levee, 4.0 feet below the crown. Flap gate on the waterside (WS) end. Concrete U-shaped headwalls on both ends. Cobble grouted outlet on the WS end. Cobble grouted intake on the landside (LS). [Additional Reference(s): DWR Levee Log, 1990, (HLM 14.46). USACE San Joaquin O&M Manual 612.2, 1967, (HLM 14.46), 24-inch pipe listed]. FS Date: 2/23/2021

Crown Overview

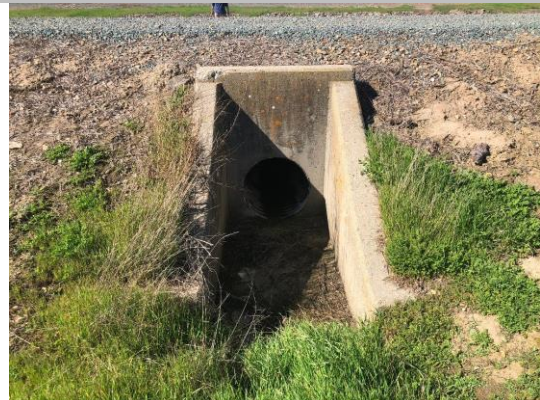
Photo 2 of 3 : UCIP_FA_2024_79029_92487.jpg

LS View: Headwall at LS toe.

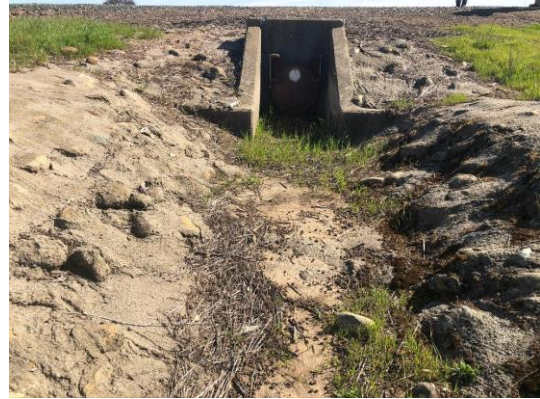
Photo 3 of 3 : UCIP_FA_2024_79029_92491.jpg

WS View: Headwall and flapgate at WS slope.

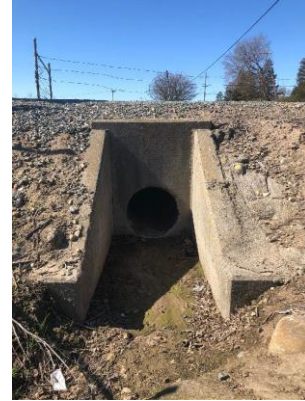
Photo 1 of 2 : UCIP_FA_2024_79030_92472.jpg

Comment Code						
Inspector Comment						
DS_ID:23778 FS_ID:79030 EP_NO: N/A Repair Type: Non-Urgent EVAL Issue: Crossing Status: Found UCIP Comments: 02/23/2021 Pipe status is still Non-Urgent. No permit was found authorizing this encroachment. CVFPB will need to review crossing to determine owner. DWR DMP has not found internal issues, LOF between 1 and 2. Recommend inspection in 5 years. The UCIP inspection was completed with LMA representative, J. Caruso. (N. Cholewinski ? GE05/21/2014 Some silt buildup inside pipe. (W. Wylie - DWR DMP) FIELD_STRUCT_DESC: 24-inch corrugated metal storm drainage pipe (CMP) through the levee, 4.0 feet below the crown. Flap gate on the waterside (WS) end. Concrete U-shaped headwalls on both ends. Cobble grouted outlet on the WS end. Cobble grouted intake on the landside (LS). [Additional Reference(s): DWR Levee Log, 1990, (HLM 14.69). USACE San Joaquin O&M Manual 612.2, 1967, (HLM 14.69), 24-inch pipe listed]. FS Date: 2/23/2021

LS View: Headwall at LS toe.

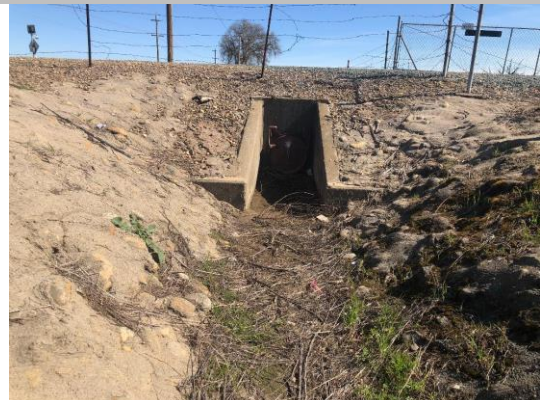
Photo 2 of 2 : UCIP_FA_2024_79030_92475.jpg

WS View: Headwall and flapgate on WS slope.

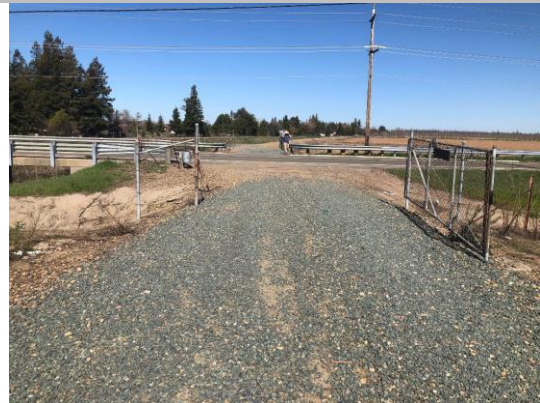
Photo 1 of 3 : UCIP_FA_2024_79031_92457.jpg

Comment Code						
Inspector Comment						
DS_ID:23779 FS_ID:79031 EP_NO: N/A Repair Type: Non-Urgent EVAL Issue: Crossing Status: Found UCIP Comments: 02/23/2021 Record was updated from No Action Needed to Non-Urgent . No permit was found authorizing this encroachment. CVFPB will need to review crossing to determine owner. DWR DMP has not found internal issues, LOF between 1 and 2. Recommend inspection in 5 years. The UCIP inspection was completed with LMA representative, J. Caruso. (N. Cholewinski - GEI) FIELD_STRUCT_DESC: 24-inch corrugated metal storm drainage pipe (CMP) through the levee, 6.5 feet below the crown. Flap gate on the waterside (WS) end. Concrete U-shaped headwalls on both ends. Cobble grouted outlet on the WS end. Cobble grouted intake on the landside (LS). [Additional Reference(s): DWR Levee Log, 1990, (HLM 14.70). USACE San Joaquin O&M Manual 612.2, 1967, (HLM 14.70), 24-inch pipe listed]. FS Date: 2/23/2021

Crown Overview - Utility across road.

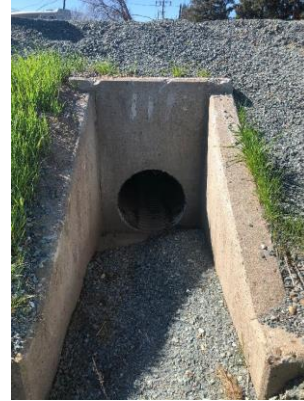
Photo 2 of 3 : UCIP_FA_2024_79031_92459.jpg

LS View: Headwall at LS toe.

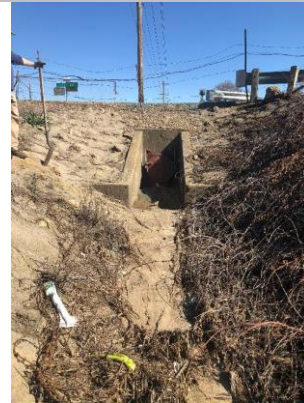
Photo 3 of 3 : UCIP_FA_2024_79031_92463.jpg

WS View: Headwall and flapgate on WS slope.

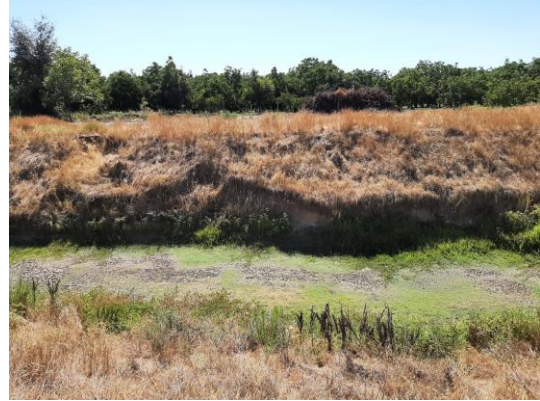
Photo 1 of 1 : FA_2024_NA0017_152_78_20240910_00005.jpg

Comment Code					
E1 : Note and monitor erosion site.					
Inspector Comment					
Issue has been transferred to Levee Mile Report and will continued to monitored. Site ID: NA0017U08RM21.46					
*This area is patrol road only and therefore the site is not rated					
07/13/2022: No significant changes were observed during the annual survey.					
06/22/2021: A large rodent hole was discovered at the bank toe a few feet upstream of the erosion. Otherwise, no significant changes were observed during the annual survey.					
07/31/2020: Observed two scour locations at the toe, beneath the existing erosion, approximately 5 ft long and 3 to 4 high. Also noticed some signs of burrow activity.					
08/01/2019: Erosion likely has been caused by rainfall runoff.

View of erosion from opposite bank. July 2022

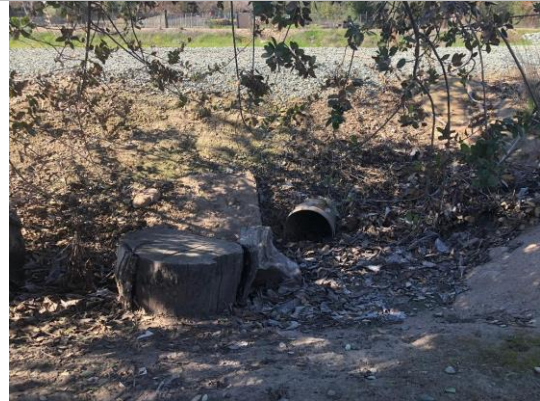
Photo 1 of 3 : UCIP_FA_2024_79032_92451.jpg

Comment Code						
Inspector Comment						
DS_ID:23780 FS_ID:79032 EP_NO: N/A Repair Type: Non-Urgent EVAL Issue: 5, Pipe Damage Crossing Status: Found UCIP Comments: 02/23/2021 Record was updated from No Action Needed to Non-Urgent. DWR DMP has found integrity issues, LOF between 4 and 5. Crossing will be monitored until funding becomes available for rehabilitation. No permit was found authorizing this encroachment. CVFPB will need to review crossing to determine owner. The UCIP inspection was completed with LMA representative, J. Caruso. (N. Cholewinski - GEI) FIELD_STRUCT_DESC: 12-inch corrugated metal storm drainage pipe (CMP) through the levee, 3.0 feet below the crown. Flap gate on the waterside (WS) end. Cobble grouted outlet on the WS end. Cobble grouted intake on the landside (LS). [Additional Reference(s): DWR Levee Log, 1990, (HLM 15.08). USACE San Joaquin O&M Manual 612.2, 1967, (HLM 15.08), 12-inch pipe listed]. FS Date: 2/23/2021

LS View: CM pipe at LS toe.

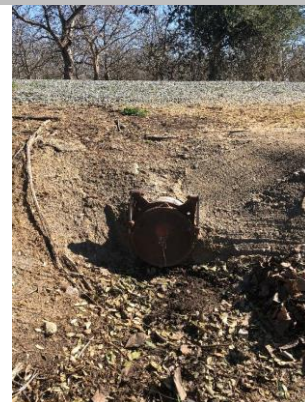
Photo 2 of 3 : UCIP_FA_2024_79032_92454.jpg

WS View: CM pipe and flapgate on WS slope.

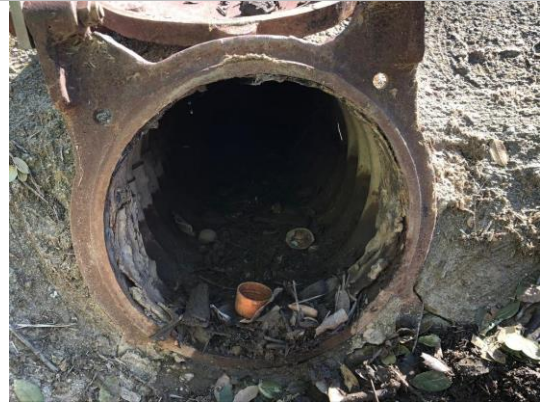
Photo 3 of 3 : UCIP_FA_2024_79032_92455.jpg

WS View: Pipe slightly corroded at outlet. Moisture observed in pipe, possible leakage occurring.

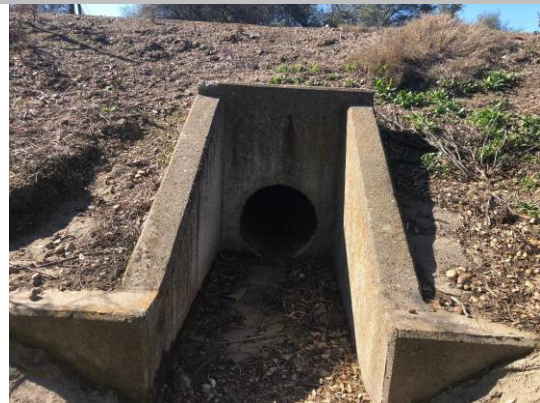
Photo 1 of 3 : UCIP_FA_2024_79033_92398.jpg

DS_ID:23781
 FS_ID:79033
 EP_NO: N/A
 Repair Type: Non-Urgent
 EVAL Issue:
 Crossing Status: Found
 UCIP Comments: 02/23/2021 Record was updated from No Action Needed to Non-Urgent. No permit was found authorizing this encroachment. CVFPB will need to review crossing to determine owner. DWR DMP has not found internal issues, LOF between 1 and 2. Recommend inspection in 5 years. Tree on downstream side of WS headwall is causing slight separation between headwall and apron, 1- to 2-inch gap. The UCIP inspection was completed with LMA representative, J. Caruso. (N. Cholewinski - GEI)
 FIELD_STRUCT_DESC: 24-inch corrugated metal storm drainage pipe (CMP) through the levee, 6.0 feet below the crown. Flap gate on the waterside (WS) end. Concrete U-shaped headwalls on both ends. Cobble grouted outlet on the WS end. Cobble grouted intake on the landside (LS). [Additional Reference(s): DWR Levee Log, 1990, (HLM 15.24). USACE San Joaquin O&M Manual 612.2, 1967, (HLM 15.24), 24-inch pipe listed].

LS View: Headwall at LS toe.

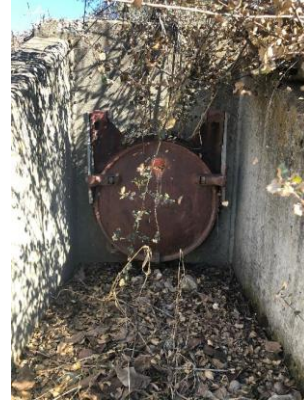
Photo 2 of 3 : UCIP_FA_2024_79033_92408.jpg

WS View: 24-inch flapgate at WS slope.

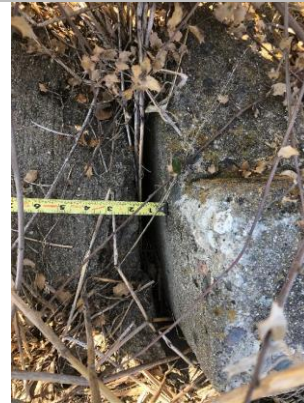
Photo 3 of 3 : UCIP_FA_2024_79033_92415.jpg

WS View: Gap observed between headwall and apron on downstream side.

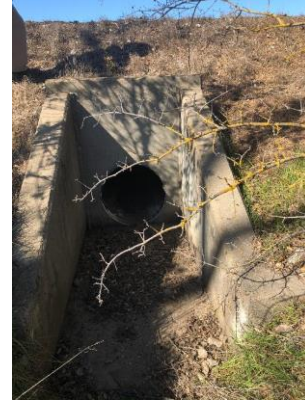
Photo 1 of 3 : UCIP_FA_2024_79034_92360.jpg

Comment Code					
Inspector Comment					
DS_ID:23782 FS_ID:79034 EP_NO: N/A Repair Type: Non-Urgent EVAL Issue: Crossing Status: Found UCIP Comments: 02/23/2021 Record was updated from No Action Needed to Non-Urgent No permit was found authorizing this encroachment. CVFPB will need to review crossing to determine owner. DWR DMP has not found internal issues, LOF between 1 and 2. Recommend inspection in 5 years. The UCIP inspection was completed with LMA representative, J. Caruso. (N. Cholewinski - GEI) FIELD_STRUCT_DESC: 24-inch corrugated metal storm drainage pipe (CMP) through the levee, 6.0 feet below the crown. Flap gate on the waterside (WS) end. Concrete U-shaped headwalls on both ends. Cobble grouted outlet on the WS end. Cobble grouted intake on the landside (LS). [Additional Reference(s): DWR Levee Log, 1990, (HLM 15.44). USACE San Joaquin O&M Manual 612.2, 1967, (HLM 15.44), 24-inch pipe listed]. FS Date: 2/23/2021

LS View: Headwall at LS toe.

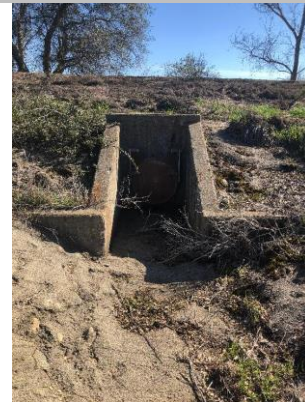
Photo 2 of 3 : UCIP_FA_2024_79034_92366.jpg

WS View: Headwall and flapgate on WS slope.

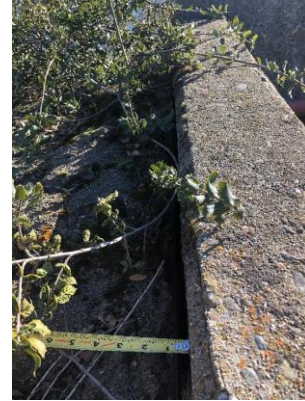
Photo 3 of 3 : UCIP_FA_2024_79034_92367.jpg

WS View: Small gap present on upstream side of headwall.

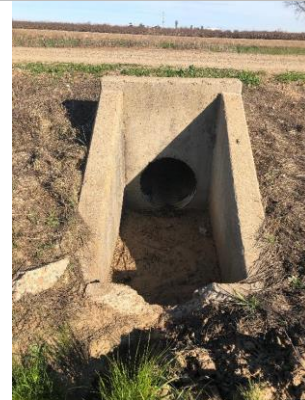
Photo 2 of 3 : UCIP_FA_2024_79035_92188.jpg

Comment Code					
Inspector Comment					
DS_ID:23784 FS_ID:79035 EP_NO: N/A Repair Type: Non-Urgent EVAL Issue: Crossing Status: Found UCIP Comments: 02/25/2021 Record changed from No Action Needed to Non-Urgent. No permit was found authorizing this encroachment. CVFPB will need to review crossing to determine owner. DWR DMP has not found internal issues, LOF between 1 and 2. Recommend inspection in 5 years. Observed slight damage to concrete on LS headwall toe, but no noticeable integrity issues. The UCIP inspection was completed with LMA representative, J. Caruso. (N. Cholewinski - GEI) FIELD_STRUCT_DESC: 24-inch corrugated metal storm drainage pipe (CMP) through the levee, 3.0 feet below the crown. Flap gate on the waterside (WS) end. Concrete U-shaped headwalls on both ends. Cobble grouted outlet on the WS end. Cobble grouted intake on the landside (LS). [Additional Reference(s): DWR Levee Log, 1990, (HLM 16.02). USACE San Joaquin O&M Manual 612.2, 1967, (HLM 16.02), 24-inch pipe listed]. FS Date: 2/25/2021

LS View: Headwall at LS toe.

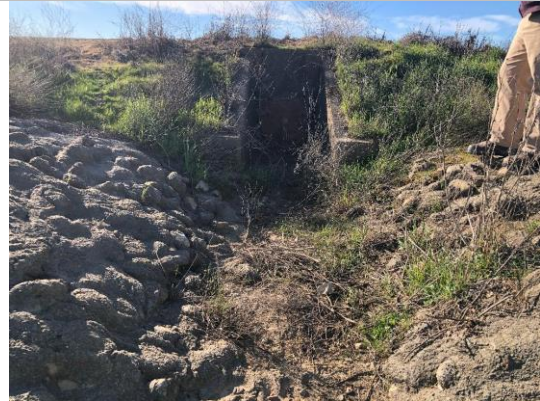
Photo 3 of 3 : UCIP_FA_2024_79035_92192.jpg

WS View: Headwall and 24-inch flapgate at WS slope.

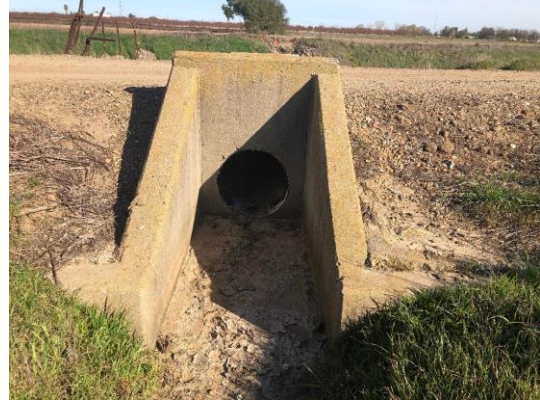
Photo 2 of 3 : UCIP_FA_2024_79036_92181.jpg

DS_ID:23785
 FS_ID:79036
 EP_NO: N/A
 Repair Type: Non-Urgent
 EVAL Issue:
 Crossing Status: Found
 UCIP Comments: 02/25/2021 Record changed from No Action Needed to Non-Urgent. No permit was found authorizing this encroachment. CVFPB will need to review crossing to determine owner. DWR DMP has not found internal issues, LOF between 1 and 2. Recommend inspection in 5 years. The UCIP inspection was completed with LMA representative, J. Caruso. (N. Cholewinski - GEI)
 FIELD_STRUCT_DESC: 24-inch corrugated metal storm drainage pipe (CMP) through the levee, 1.5 feet below the crown. Flap gate on the waterside (WS) end. Concrete U-shaped headwalls on both ends. Cobble grouted outlet on the WS end. Cobble grouted intake on the landside (LS). [Additional Reference(s): DWR Levee Log, 1990, (HLM 16.15). USACE San Joaquin O&M Manual 612.2, 1967, (HLM 16.15), 24-inch pipe listed].
 FS Date: 2/25/2021

LS View: Headwall at LS toe.

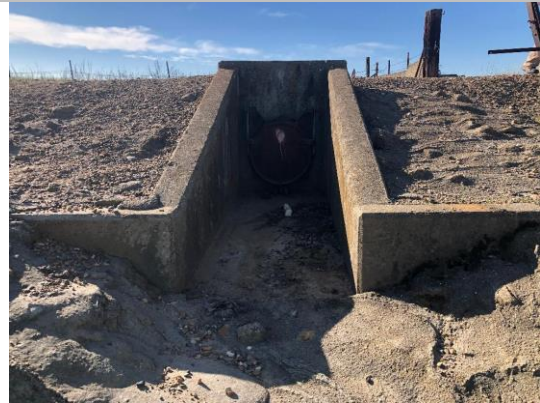
Photo 3 of 3 : UCIP_FA_2024_79036_92184.jpg

WS View: Headwall and 24-inch flapgate at WS slope.

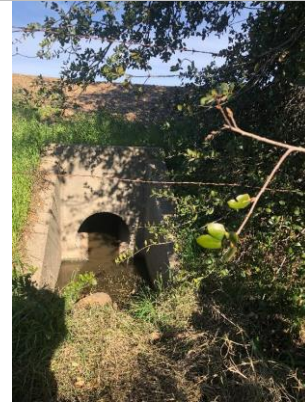
Photo 2 of 3 : UCIP_FA_2024_79417_92171.jpg

Comment Code					
Inspector Comment					
DS_ID:23786 FS_ID:79417 EP_NO: N/A Repair Type: Non-Urgent EVAL Issue: 5, Pipe Damage Crossing Status: Found UCIP Comments: 03/31/2023 Record updated from Urgent to Non-Urgent. LoF is equal to 5.1 due to a small hole near waterside pipe end, other integrity issues were not found. Crossing will be monitored until funding becomes available for rehabilitation. (O.Yakimov - DWR UCIP). 02/25/2021 Record was updated from No Action Needed to Urgent due to a corroded through pipe wall at the WS pipe outlet and leakage observed at the LS pipe inlet. DWR DMP has found integrity issues, LOF between 5 and 6. Crossing will be monitored until funding becomes available for removal. No permit was found authorizing this encroachment. CVFPB will need to review crossing to determine owner. An additional 1-inch steel pipe oriented parallel to levee was observed approximately 1 foot adjacent to LS headwall at LS toe. The UCIP inspection was completed with LMA representative, J. Caruso. (N. Cholewinski - GEI) FIELD_STRUCT_DESC: 24-inch corrugated metal storm drainage pipe (CMP) through the levee, 8.0 feet below the crown. Flap gate on the waterside (WS) end. Concrete U-shaped headwalls on both ends. Cobble grouted outlet on the WS end. Cobble grouted intake on the landside (LS). [Additional Reference(s): DWR Levee Log, 1990, (HLM 16.22). USACE San Joaquin O&M Manual 612.2, 1967, (HLM 16.22), 24-inch pipe listed]. FS Date: 2/25/2021

Headwall at LS toe.

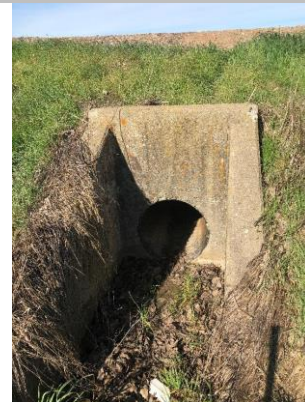
Photo 2 of 3 : UCIP_FA_2024_79038_92162.jpg

Comment Code					
Inspector Comment					
DS_ID:23787 FS_ID:79038 EP_NO: N/A Repair Type: Non-Urgent EVAL Issue: Crossing Status: Found UCIP Comments: 02/25/2021 Record changed from No Action Needed to Non-Urgent. No permit was found authorizing this encroachment. CVFPB will need to review crossing to determine owner. DWR DMP has not found internal issues, LOF between 1 and 2. Recommend inspection in 5 years. The UCIP inspection was completed with LMA representative, J. Caruso. (N. Cholewinski - GEI) FIELD_STRUCT_DESC: 24-inch corrugated metal storm drainage pipe (CMP) through the levee, 6.0 feet below the crown. Flap gate on the waterside (WS) end. Concrete U-shaped headwalls on both ends. Cobble grouted outlet on the WS end. Cobble grouted intake on the landside (LS). [Additional Reference(s): DWR Levee Log, 1990, (HLM 16.27). USACE San Joaquin O&M Manual 612.2, 1967, (HLM 16.27), 24-inch pipe listed]. FS Date: 2/25/2021

Concrete headwall on LS toe.

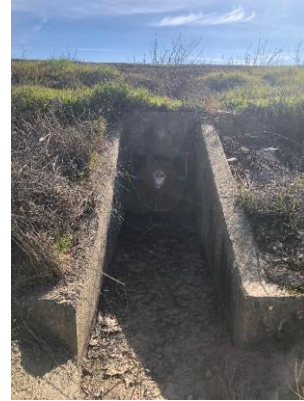
Photo 3 of 3 : UCIP_FA_2024_79038_92167.jpg

Headwall with 24-inch flapgate at WS toe.

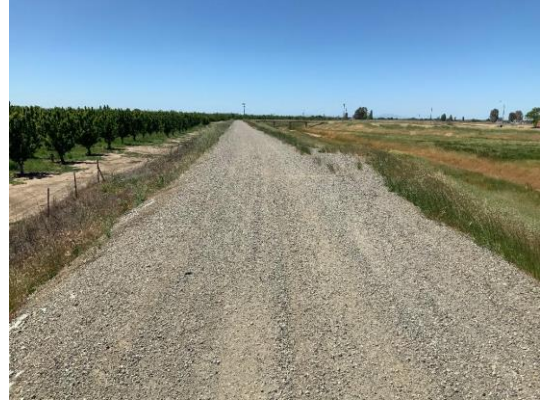
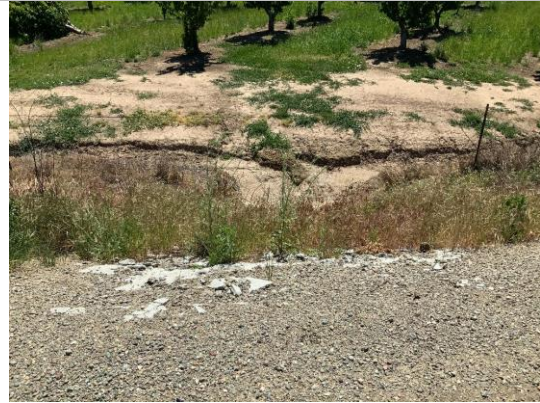
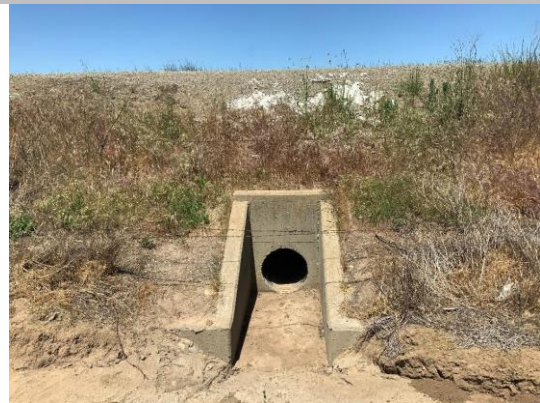
Photo 1 of 3 : UCIP_FA_2024_79040_96876.jpg

Comment Code					
Inspector Comment					
DS_ID:23850 FS_ID:79040 EP_NO: N/A Repair Type: Non-Urgent EVAL Issue: 5, Pipe Damage Crossing Status: Found UCIP Comments: 09/25/2024 DMP internal video inspection has found moderate pipe defects. Crossing will be monitored until funding becomes available for rehabilitation. (O. Yakimov - DWR UCIP) 04/27/2021 The record has been upgraded from No Action Needed to Non-Urgent. DWR DMP internal inspection has not found pipe integrity issues. LOF of crossing is less or equal to 4.0. Recommend next inspection in 5 years. No permit was found authorizing this encroachment. CVFPB will need to review crossing to determine owner. The UCIP inspection was completed with LMA representative, J. Nelson. (H. Dunn ? GEI) FIELD_STRUCT_DESC: 24-inch corrugated metal storm drainage pipe (CMP) through the levee, 9.5 feet below the crown. Flap gate on the waterside (WS) end. Concrete U-shaped headwalls on both ends. Cobble grouted outlet on the WS end. Cobble grouted intake on the landside (LS). [Additional Reference(s): DWR Levee Log, 1977, 1978, 1987, 1990, (HLM 0.10). USACE San Joaquin O&M Manual 612.2, 1967, (HLM 0.10), Unit 7 (HLM 7.19?16.77), Unit 8 (HLM 7.55?16.48), Unit 9 (HLM 0.10?1.52), Unit 10 (HLM 0.03?1.35), Unit 11 (HLM 0.16?3.55), Unit 12 (HLM 0.14?3.91), Unit 13 (HLM 0.03?1.18), Unit 14 (HLM 0.02?1.17), and 612 (addendum), February 1999, 24-inch pipe listed]. FS Date: 4/27/2021

Levee crown looking downstream.

LS view: Toe from crown.

LS view: Slope and headwall from toe.

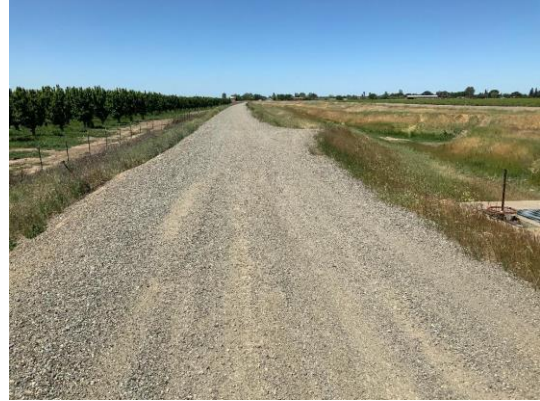
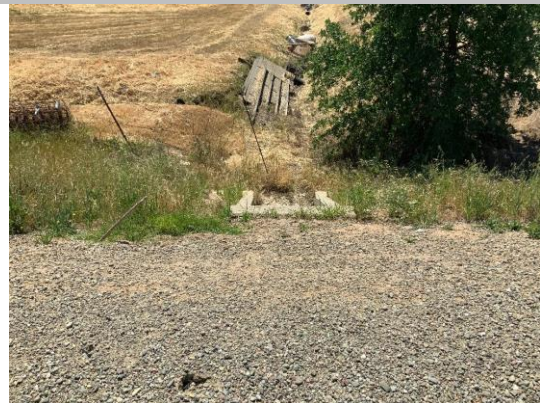
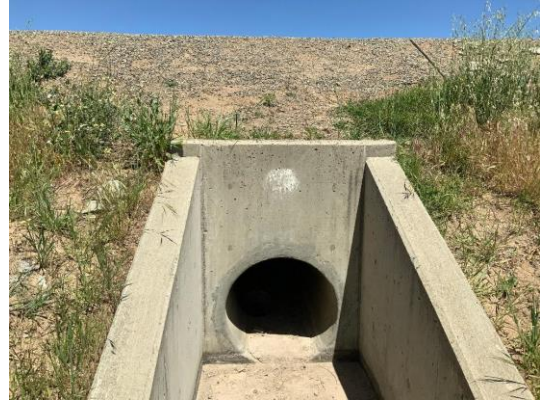
Photo 1 of 3 : UCIP_FA_2024_79041_96884.jpg

Comment Code					
Inspector Comment					
DS_ID:23852 FS_ID:79041 EP_NO: N/A Repair Type: Non-Urgent EVAL Issue: Crossing Status: Found UCIP Comments: 04/27/2021 The record has been upgraded from No Action Needed to Non-Urgent. DWR DMP internal inspection has not found pipe integrity issues. LOF of crossing is less or equal to 4.0. Recommend next inspection in 5 years. The UCIP inspection was completed with LMA representative, J. Nelson. (H. Dunn ? GEI) FIELD_STRUCT_DESC: 30-inch reinforced concrete (RC) storm drainage pipe through the levee, 8.0 feet below the crown. Concrete U-shaped headwalls on both ends. Slide gate inside a 7-foot by 7-foot concrete box on the waterside (WS) shoulder. [Additional Reference(s): DWR Levee Log, 1987, (HLM 0.45). USACE San Joaquin O&M Manual 612 (addendum), February 1999, (HLM 0.44), (Station 23+20), 24-inch pipe listed]. FS Date: 4/27/2021

Levee crown looking downstream.

LS view: Headwall visible at toe from crown.

LS view: Slope and headwall from toe.

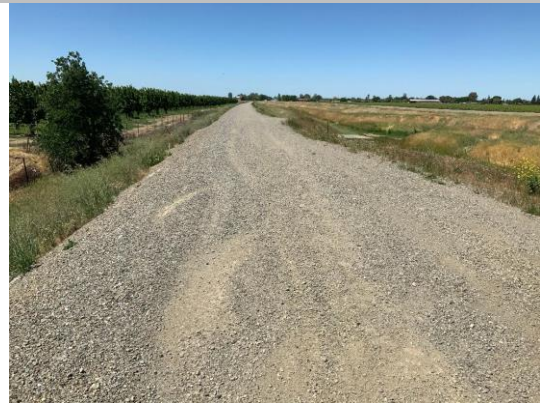
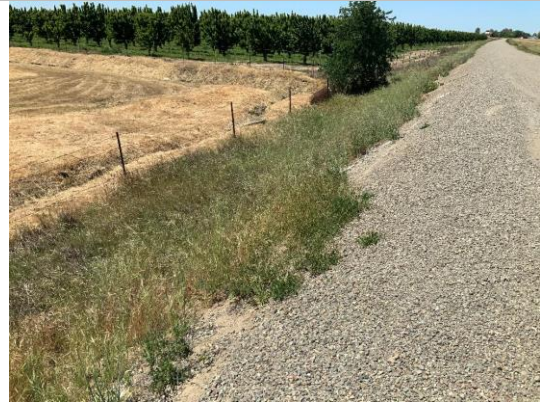
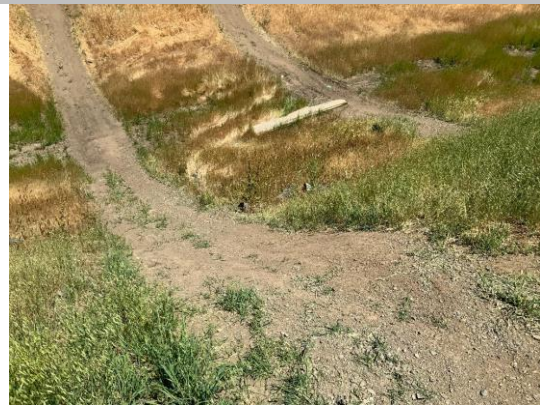
Photo 1 of 3 : UCIP_FA_2024_78577_96889.jpg

DS_ID:23856
 FS_ID:78577
 EP_NO: N/A
 Repair Type: Non-Urgent
 EVAL Issue:
 Crossing Status: Not Found
 UCIP Comments: 04/27/2021 The record has been upgraded from No Action Needed to Non-Urgent. Pipe not found by visual inspection. No permit was found authorizing this encroachment. CVFPB will need to review crossing to determine owner. The UCIP inspection was completed with LMA representative, J. Nelson. (H. Dunn ? GEI)
 FIELD_STRUCT_DESC: 24-inch storm drainage pipe of an unknown material through the levee, at an unknown depth. Drainage structure at this location. [Additional Reference(s): USACE San Joaquin O&M Manual 612 (addendum), February 1999, (HLM 0.44), (Station 23+20), 24-inch pipe listed].
 FS Date: 4/27/2021

Levee crown looking downstream.

LS view: Slope from crown, no pipe visible.

WS view: Slope from crown, no pipe visible.

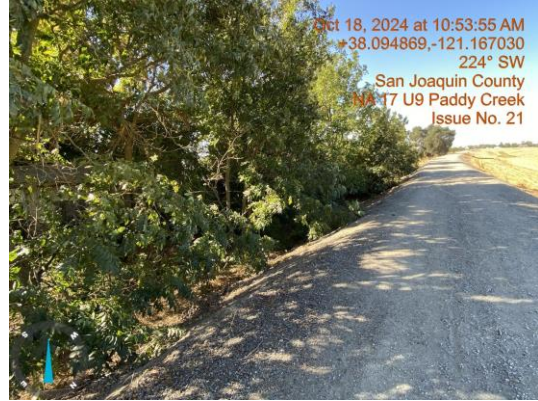
Photo 1 of 1 : FA_2024_NA0017_153_21_20241019_00050.jpg

LM Start	0.51	Rating **	U	Issue No.	21
LM End	0.54	Issue Type +	Ma	Location *	LS
Category	Earthen Levee			GPS Latitude/Longitude	
				Start	End
Item	Trim / Thin Trees			38.094780°	38.094851°
				-121.167512°	-121.167005°
DWR ID	DWR_NA0017_09_f_2024_21				
Comment Code					
T1 : Trim and thin trees to at least five feet above ground level to allow visibility of the ground and room to flood fight.					
Inspector Comment

View of untrimmed trees along the landside slope. Fall 2024
