**Flood Control Project Maintenance
Levee Inspections****Maintenance Issue Types Only, Levee Inspection Report By Mile - Fall 2024****San Joaquin County Flood Control and Water Conservation District**

Waterway	Bank	Unit Miles	Inspection Start/End	Inspector
Unit No. 01 Littlejohn Creek	Left	2.59	10/21/2024 10/21/2024	Alberto De Leon

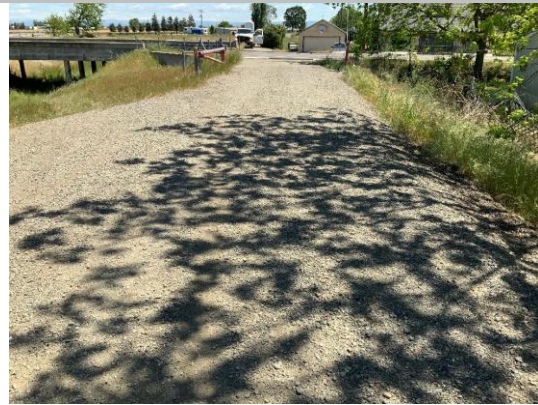
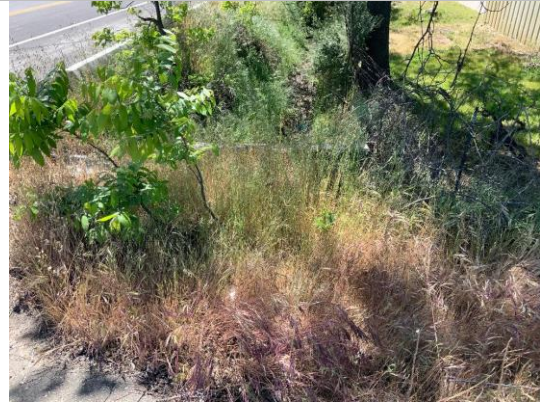
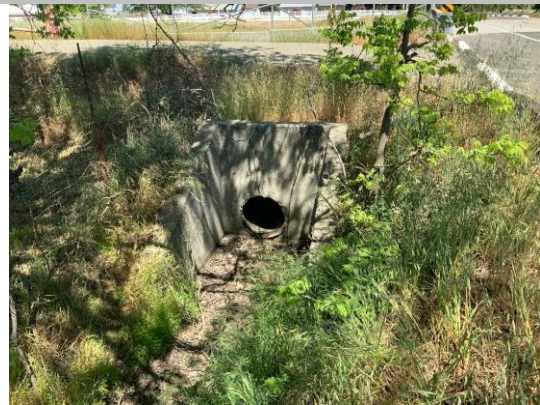
Photo 1 of 3 : UCIP_FA_2024_79042_96893.jpg

Comment Code						
Inspector Comment						
DS_ID:23853 FS_ID:79042 EP_NO: N/A Repair Type: Non-Urgent EVAL Issue: 5, Pipe Damage Crossing Status: Found UCIP Comments: 09/25/2024 DMP internal video inspection has found moderate pipe defects. Crossing will be monitored until funding becomes available for rehabilitation. (O. Yakimov - DWR UCIP) 04/27/2021 The record has been upgraded from No Action Needed to Non-Urgent. DWR DMP internal inspection has not found pipe integrity issues. LOF of crossing is less or equal to 4.0. Recommend next inspection in 5 years. No permit was found authorizing this encroachment. CVFPB will need to review crossing to determine owner. The UCIP inspection was completed with LMA representative, J. Nelson. (H. Dunn ? GEI) FIELD_STRUCT_DESC: 24-inch corrugated metal storm drainage pipe (CMP) through the levee, 4.5 feet below the crown. Flap gate on the waterside (WS) end. Concrete U-shaped headwalls on both ends. Cobble grouted outlet on the WS end. Cobble grouted intake on the landside (LS). [Additional Reference(s): DWR Levee Log, 1987, (HLM 0.56). USACE San Joaquin O&M Manual 612.2, 1967, (HLM 0.56), 24-inch pipe listed]. FS Date: 4/27/2021

Levee crown looking upstream.

LS view: Toe from crown.

LS view: Slope and headwall at toe.

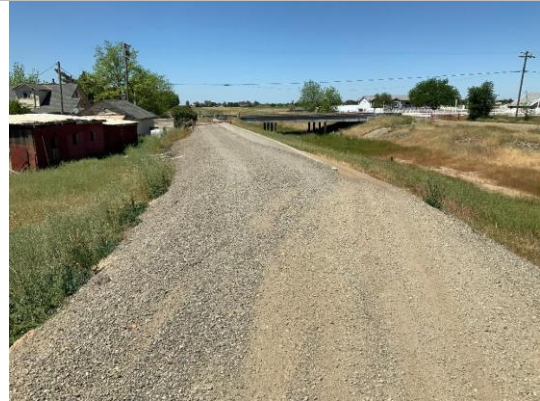
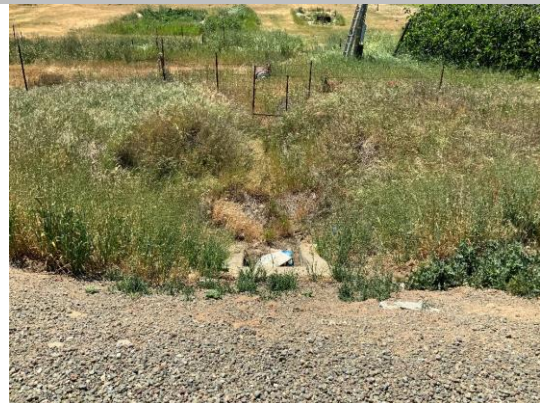
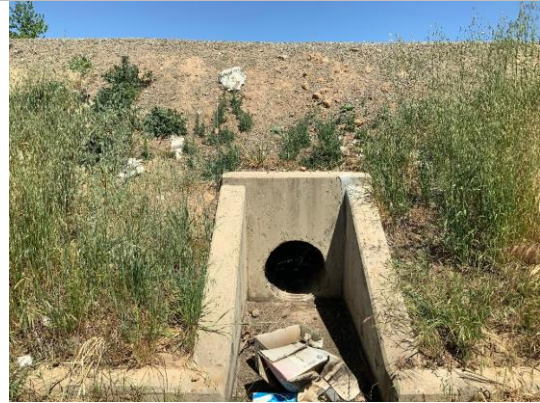
Photo 1 of 3 : UCIP_FA_2024_79043_96901.jpg

DS_ID:23839
FS_ID:79043
EP_NO: N/A
Repair Type: No Action Needed
EVAL Issue:
Crossing Status: Found
UCIP Comments: 04/27/2021 Pipe status is still No Action Needed.
DWR DMP internal inspection has not found pipe integrity issues. LOF of crossing is less or equal to 4.0. Recommend next inspection in 5 years. The UCIP inspection was completed with LMA representative, J. Nelson. (H. Dunn ? GEI)6/19/2014 Suction hose and appurtenances appear to be abandoned. (W. Wylie - DWR UCIP)
FIELD_STRUCT_DESC: 24-inch corrugated metal storm drainage pipe (CMP) through the levee, 8.0 feet below the crown. Flap gate on the waterside (WS) end. Concrete U-shaped headwalls on both ends. Cobble grouted outlet on the WS end. Cobble grouted intake on the landside (LS). Pump with suction hose sleeved through the storm drainage pipe located on the LS?removed during winter months. (Suction hose authorized under Permit No. 11530, 1976 - Constantine M. Copulos). [Additional Reference(s): DWR Levee Log, 1987, (HLM 0.62). USACE San Joaquin O&M Manual 612.2, 1967, (HLM 0.62), and 612 (addendum), February 1999, (HLM 0.61), (Station 32+46), 24-inch pipe listed].

Levee crown looking downstream.

LS view: Headwall visible at toe from crown.

LS view: Slope and headwall at toe.

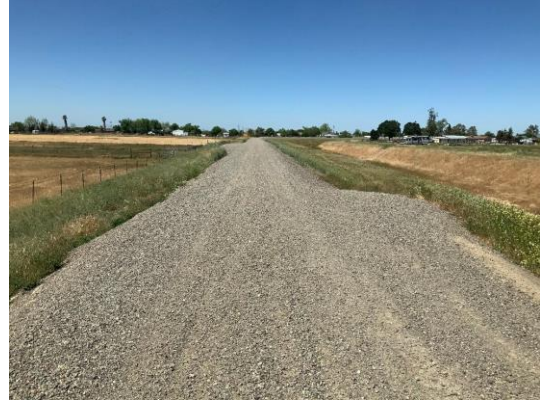
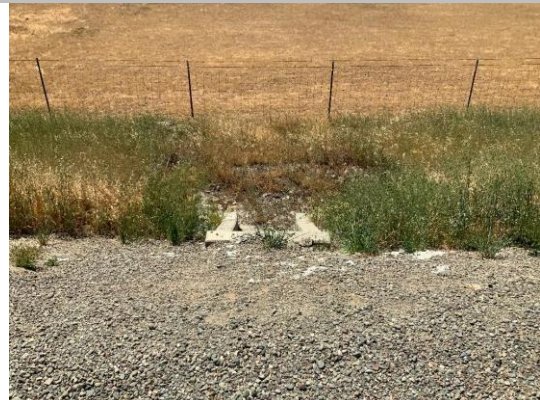
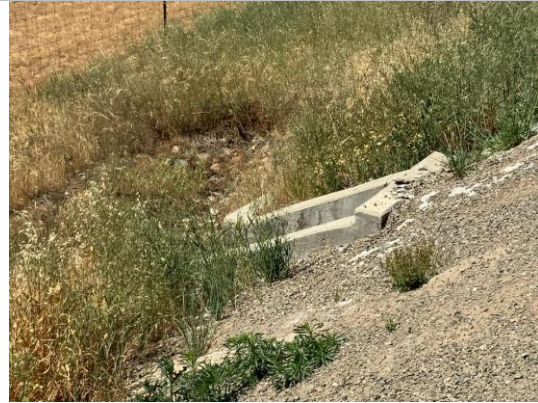
Photo 1 of 3 : UCIP_FA_2024_79044_96906.jpg

Comment Code						
Inspector Comment						
DS_ID:23840 FS_ID:79044 EP_NO: N/A Repair Type: Non-Urgent EVAL Issue: Crossing Status: Found UCIP Comments: 04/27/2021 The record has been upgraded from No Action Needed to Non-Urgent. Did not inspect LS headwall due to steep slope and slippery rubble. DWR DMP internal inspection has not found pipe integrity issues. LOF of crossing is less or equal to 4.0. Recommend next inspection in 5 years. No permit was found authorizing this encroachment. CVFPB will need to review crossing to determine owner. The UCIP inspection was completed with LMA representative, J. Nelson. (H. Dunn ? GEI) FIELD_STRUCT_DESC: 24-inch corrugated metal storm drainage pipe (CMP) through the levee, 7.0 feet below the crown. Flap gate on the waterside (WS) end. Concrete U-shaped headwalls on both ends. Cobble grouted outlet on the WS end. Cobble grouted intake on the landside (LS). [Additional Reference(s): DWR Levee Log, 1987, (HLM 0.86). USACE San Joaquin O&M Manual 612.2, 1967, (HLM 0.86), 24-inch pipe listed]. FS Date: 4/27/2021

Levee crown looking downstream.

LS view: Headwall visible at toe from crown.

LS view: Slope and headwall from crown.

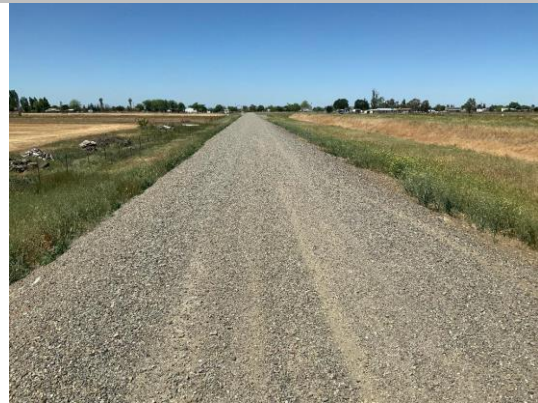
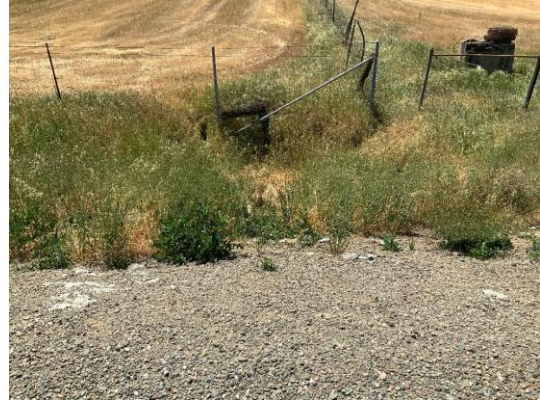
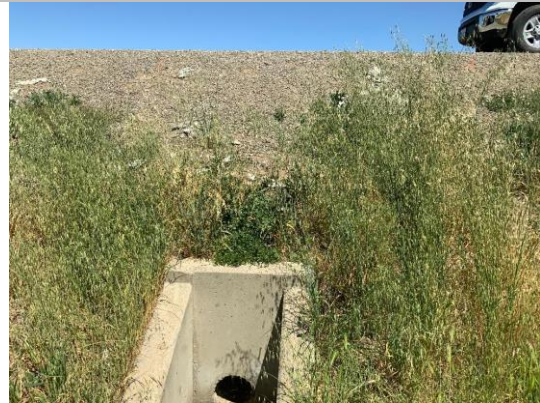
Photo 1 of 3 : UCIP_FA_2024_79045_96917.jpg

DS_ID:23841
FS_ID:79045
EP_NO: N/A
Repair Type: No Action Needed
EVAL Issue:
Crossing Status: Found
UCIP Comments: 09/18/2023 Record updated from Non-Urgent to No Action Needed. Pipe was CIPP lined. DMP internal video inspection has found none or minor pipe defects. Recommend next video inspection in 5 years. (O. Yakimov - DWR UCIP)
04/27/2021 Pipe status is still Non-Urgent. DWR DMP internal inspection has found pipe integrity issues. LOF of crossing is between 4.1 and 5. Crossing will be monitored until funding becomes available for rehabilitation. No permit was found authorizing this encroachment. CVFPB will need to review crossing to determine owner. The UCIP inspection was completed with LMA representative, J. Nelson. (H. Dunn ? GE 10/19/2014 Sediment buildup inside pipe. (W. Wylie -DWR UCIP)
FIELD_STRUCT_DESC: 12-inch CIPP-lined corrugated metal storm drainage pipe (CMP) through the levee, 7.0 feet below the crown. Flap gate on the waterside (WS) end. Headwall at the landside (LS) toe. Cobble grouted outlet on the WS end. [Additional Reference(s): DWR Levee Log, 1987, (HLM 0.94). USACE San Joaquin O&M Manual 612 (addendum), February 1999, (HLM 0.93), (Station 49+30), 12-inch pipe listed].

Levee crown looking downstream.

LS view: Toe from crown.

LS view: Slope from toe.

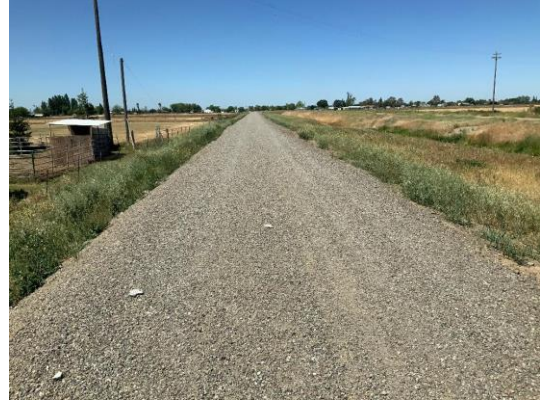
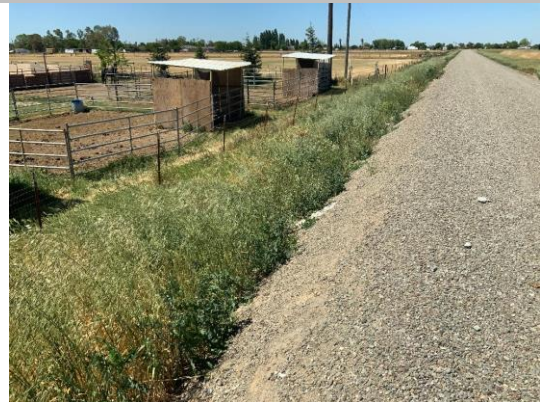
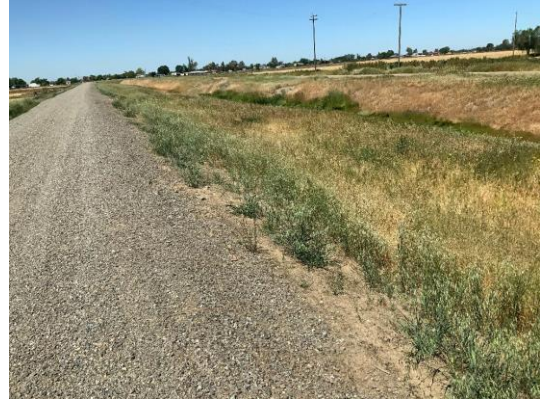
Photo 1 of 3 : UCIP_FA_2024_78583_96922.jpg

Comment Code					
Inspector Comment					
DS_ID:23858 FS_ID:78583 EP_NO: N/A Repair Type: Non-Urgent EVAL Issue: Crossing Status: Not Found UCIP Comments: 04/27/2021 The record has been upgraded from No Action Needed to Non-Urgent. Pipe not found by visual inspection. No permit was found authorizing this encroachment. CVFPB will need to review crossing to determine owner. The UCIP inspection was completed with LMA representative, J. Nelson. (H. Dunn ? GEI) FIELD_STRUCT_DESC: 24-inch corrugated metal storm drainage pipe (CMP) through the levee, at an unknown depth. [Additional Reference(s): USACE San Joaquin O&M Manual 612 (addendum), February 1999, (HLM 1.02), (Station 54+05), 24-inch pipe listed]. FS Date: 4/27/2021

Levee crown looking downstream.

LS view: Slope from crown, no pipe visible.

WS view: Slope from crown, no pipe visible.

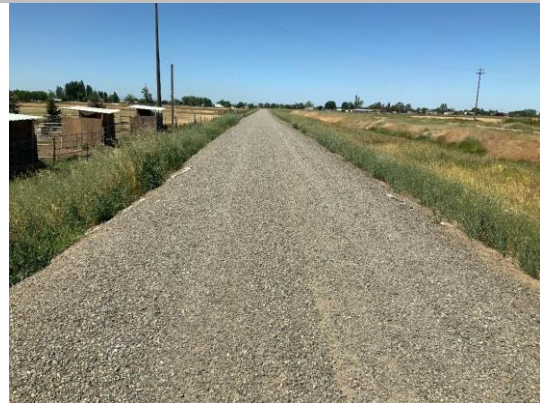
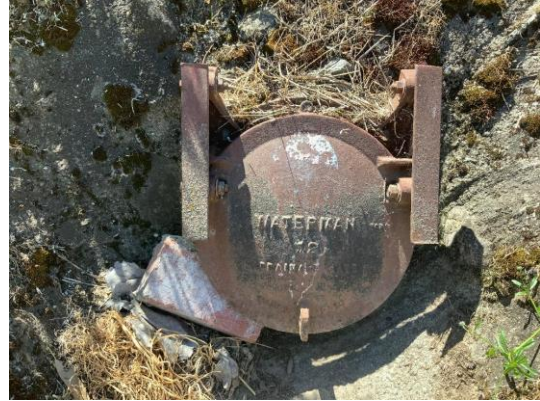
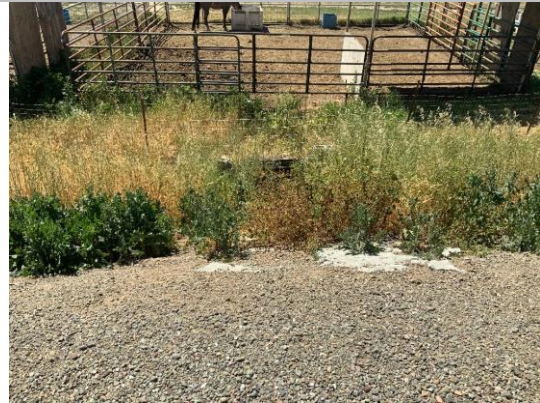
Photo 1 of 3 : UCIP_FA_2024_79046_96928.jpg

DS_ID:23842
FS_ID:79046
EP_NO: N/A
Repair Type: Non-Urgent
EVAL Issue:
Crossing Status: Found
UCIP Comments: 12/20/2022 Record updated from Urgent to Non-Urgent. Pipe has been CIPP lined. LOF of crossing is less or equal to 4. Recommend next video inspection in 5 years. (O.Yakimov - DWR UCIP)
04/27/2021 The record has been upgraded from No Action Needed to Urgent. DWR DMP internal inspection has found pipe integrity issues. LOF of crossing is between 5 and 6. Crossing will be monitored until funding becomes available to address the issues. No permit was found authorizing this encroachment. CVFPB will need to review crossing to determine owner. The UCIP inspection was completed with LMA representative, J. Nelson. (H. Dunn ? GEI)
FIELD_STRUCT_DESC: 12-inch CIPP-lined corrugated metal storm drainage pipe (CMP) through the levee, 6.0 feet below the crown. Flap gate on the waterside (WS) end. Cobble grouted outlet on the WS end. [Additional Reference(s): DWR Levee Log, 1987, (HLM 1.03). USACE San Joaquin O&M Manual 612.2, 1967, (HLM 1.03), 12-inch pipe listed].

Levee crown looking downstream.

WS view: Close up of flapgate at toe.

LS view: Toe from crown.

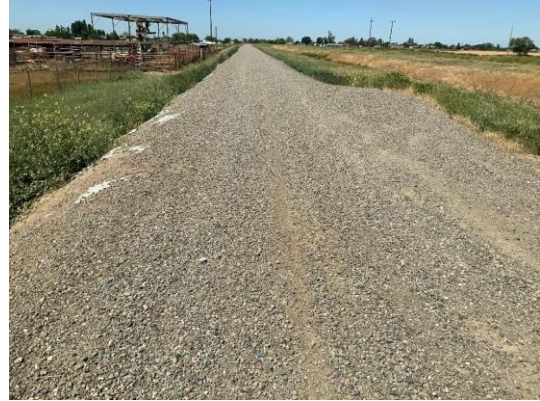
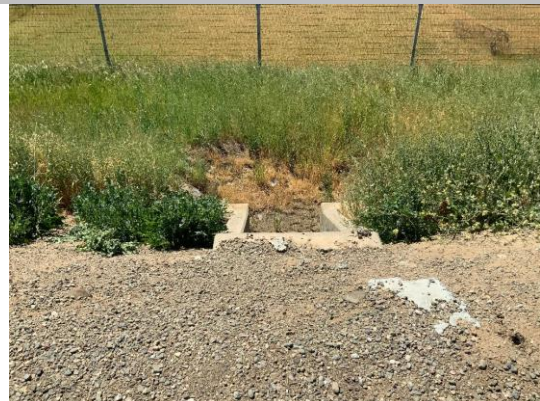
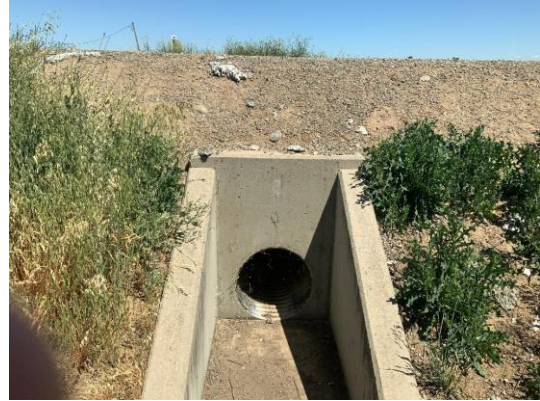
Photo 1 of 3 : UCIP_FA_2024_79047_96936.jpg

Comment Code					
Inspector Comment					
DS_ID:23843 FS_ID:79047 EP_NO: N/A Repair Type: Non-Urgent EVAL Issue: 5, Pipe Damage Crossing Status: Found UCIP Comments: 09/25/2024 DMP internal video inspection has found moderate pipe defects. Crossing will be monitored until funding becomes available for rehabilitation. (O. Yakimov - DWR UCIP) 04/27/2021 The record has been upgraded from No Action Needed to Non-Urgent. DWR DMP internal inspection has not found pipe integrity issues. LOF of crossing is less or equal to 4.0. Recommend next inspection in 5 years. No permit was found authorizing this encroachment. CVFPB will need to review crossing to determine owner. The UCIP inspection was completed with LMA representative, J. Nelson. (H. Dunn ? GEI) FIELD_STRUCT_DESC: 24-inch corrugated metal storm drainage pipe (CMP) through the levee, 4.5 feet below the crown. Flap gate on the waterside (WS) end. Concrete U-shaped headwalls on both ends. One corrugated metal cutoff wall. Cobble grouted outlet on the WS end. Cobble grouted intake on the landside (LS). [Additional Reference(s): DWR Levee Log, 1987, (HLM 1.09). USACE San Joaquin O&M Manual 612.2, 1967, (HLM 1.09), and 612 (addendum), February 1999, (HLM 1.09), (Station 57+30), 24-inch pipe listed]. FS Date: 4/27/2021

Levee crown looking downstream.

LS view: Headwall visible at toe from crown.

LS view: Slope and headwall at toe.

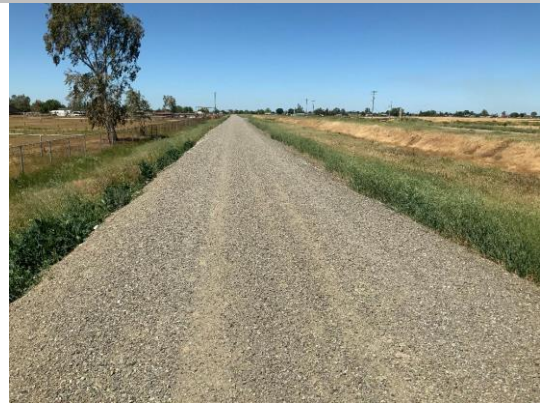
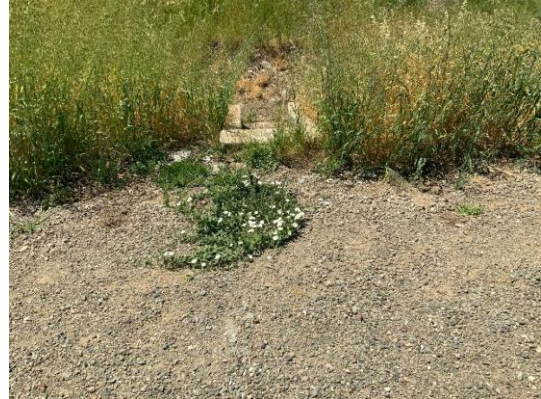
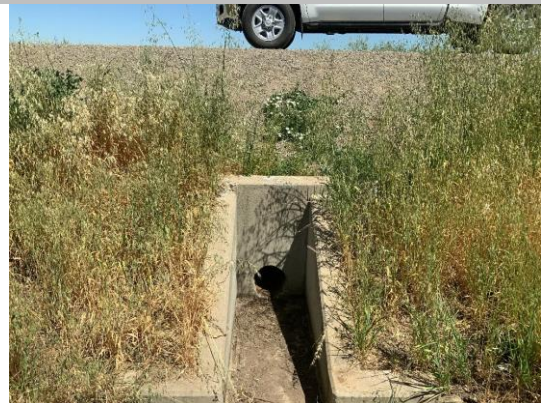
Photo 1 of 3 : UCIP_FA_2024_79048_96942.jpg

DS_ID:23844
 FS_ID:79048
 EP_NO: N/A
 Repair Type: Urgent
 EVAL Issue: 1, Pipe Integrity
 Crossing Status: Found
 UCIP Comments: 04/27/2021 The record has been upgraded from No Action Needed to Urgent. DWR DMP internal inspection has found pipe integrity issues. LOF of crossing is between 5 and 6. Crossing will be monitored until funding becomes available to address the issues. No permit was found authorizing this encroachment. CVFPB will need to review crossing to determine owner. The UCIP inspection was completed with LMA representative, J. Nelson. (H. Dunn ? GEI)
 FIELD_STRUCT_DESC: 12-inch corrugated metal storm drainage pipe (CMP) through the levee, 7.0 feet below the crown. Flap gate on the waterside (WS) end. Headwall on the landside (LS) toe. Cobble grouted outlet on the WS end. [Additional Reference(s): DWR Levee Log, 1987, (HLM 1.18). USACE San Joaquin O&M Manual 612.2, 1967, (HLM 1.18), and 612 (addendum), February 1999, (HLM 1.17), (Station 61+82), 12-inch pipe listed].

Levee crown looking downstream.

LS view: Headwall visible at toe from crown.

LS view: Slope and headwall at toe.

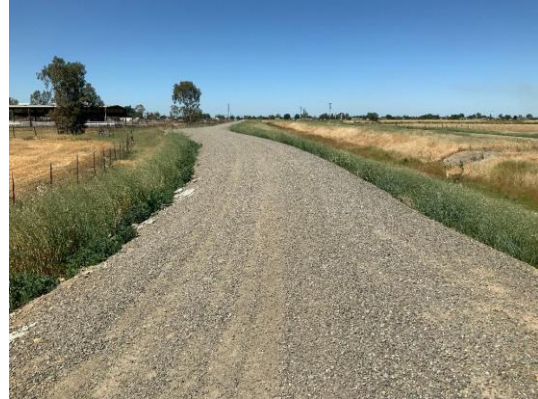
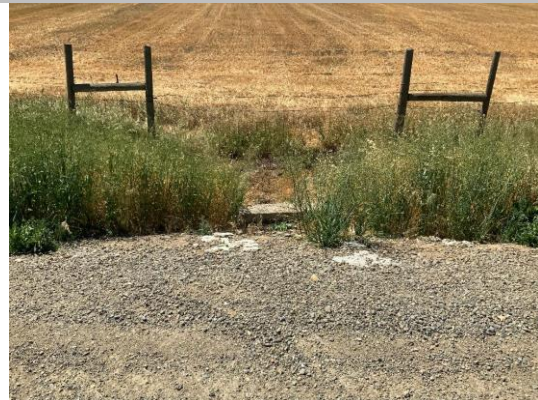
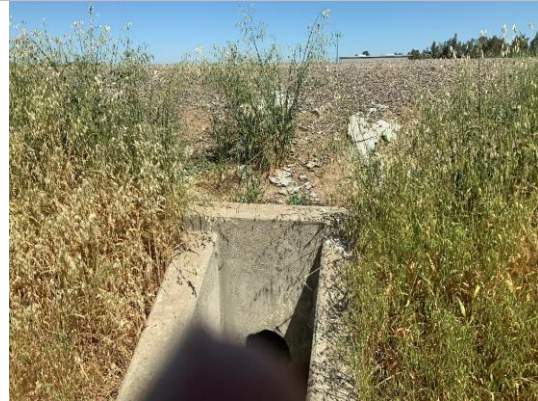
Photo 1 of 3 : UCIP_FA_2024_79049_96949.jpg

Comment Code					
Inspector Comment					
DS_ID:23845 FS_ID:79049 EP_NO: N/A Repair Type: Non-Urgent EVAL Issue: 5, Pipe Damage Crossing Status: Found UCIP Comments: 09/25/2024 DMP internal video inspection has found moderate pipe defects. Crossing will be monitored until funding becomes available for rehabilitation. (O. Yakimov - DWR UCIP) 04/27/2021 The record has been upgraded from No Action Needed to Non-Urgent. DWR DMP internal inspection has not found pipe integrity issues. LOF of crossing is less or equal to 4.0. Recommend next inspection in 5 years. No permit was found authorizing this encroachment. CVFPB will need to review crossing to determine owner. The UCIP inspection was completed with LMA representative, J. Nelson. (H. Dunn ? GEI) FIELD_STRUCT_DESC: 12-inch corrugated metal storm drainage pipe (CMP) through the levee, 6.5 feet below the crown. Flap gate on the waterside (WS) end. Cobble grouted outlet on the WS end. [Additional Reference(s): DWR Levee Log, 1987, (HLM 1.23). USACE San Joaquin O&M Manual 612.2, 1967, (HLM 1.23), and 612 (addendum), February 1999, (HLM 1.23), (Station 64+78), 12-inch pipe listed]. FS Date: 4/27/2021

Levee crown looking downstream.

LS view: Headwall visible at toe from crown.

LS view: Slope and headwall at toe.

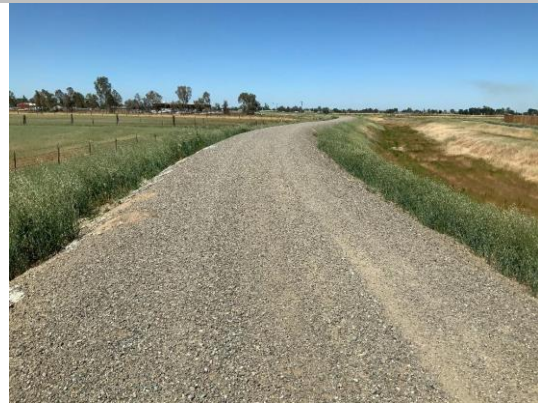
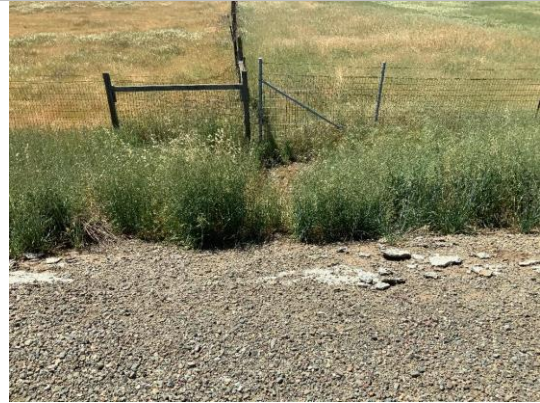
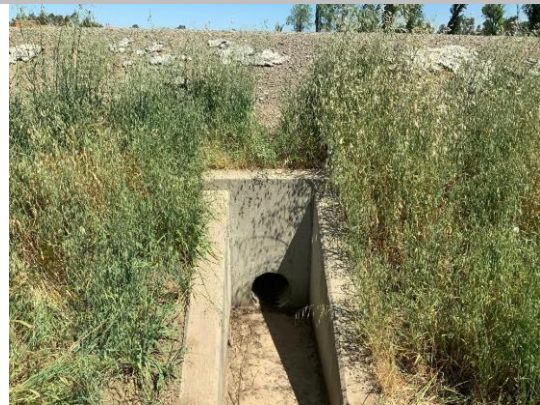
Photo 1 of 3 : UCIP_FA_2024_79050_96956.jpg

DS_ID:23846
FS_ID:79050
EP_NO: N/A
Repair Type: Non-Urgent
EVAL Issue: 5, Pipe Damage
Crossing Status: Found
UCIP Comments: 09/25/2024 DMP internal video inspection has found moderate pipe defects. Crossing will be monitored until funding becomes available for rehabilitation. (O. Yakimov - DWR UCIP)
04/27/2021 Record remains No Action Needed. DWR DMP internal inspection has not found pipe integrity issues. LOF of crossing is less or equal to 4.0. Recommend next inspection in 5 years. The UCIP inspection was completed with LMA representative, J. Nelson. (H. Dunn ? GEI)
FIELD_STRUCT_DESC: 12-inch corrugated metal storm drainage pipe (CMP) through the levee, 7.0 feet below the crown. Flap gate on the waterside (WS) end. Headwall on the landside (LS) toe. Cobble grouted outlet on the WS end. [Additional Reference(s): DWR Levee Log, 1987, (HLM 1.33). USACE San Joaquin O&M Manual 612.2, 1967, (HLM 1.33), and 612 (addendum), February 1999, (HLM 1.33), (Station 69+98), 12-inch pipe listed].

Levee crown looking downstream.

LS view: Toe from crown.

LS view: Slope and headwall at toe.

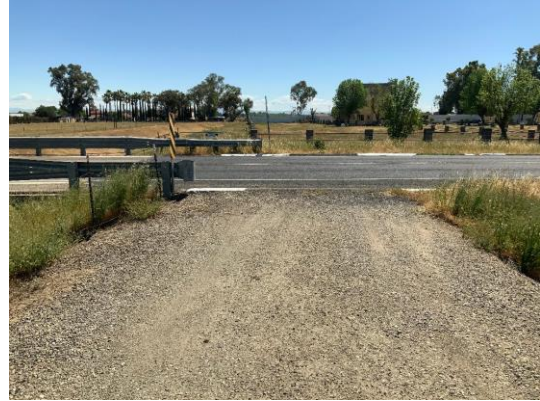
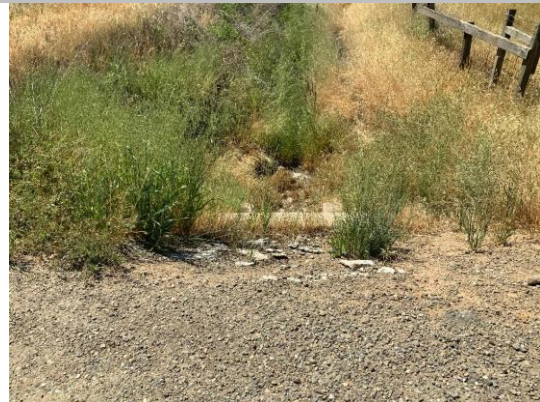
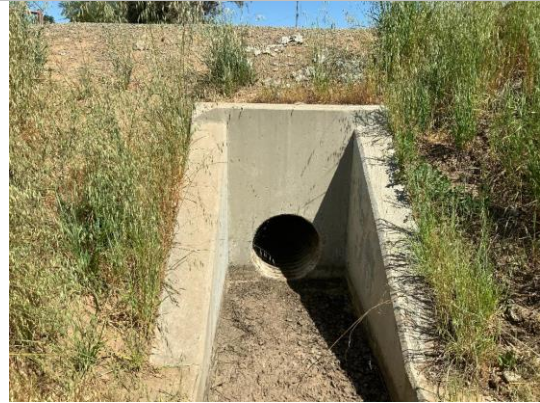
Photo 1 of 3 : UCIP_FA_2024_79051_96963.jpg

Comment Code					
Inspector Comment					
DS_ID:23847 FS_ID:79051 EP_NO: N/A Repair Type: Non-Urgent EVAL Issue: Crossing Status: Found UCIP Comments: 04/27/2021 Pipe status is still Non-Urgent. Barbed wire limiting closeup inspection of WS flapgate, but looked fine from afar. DWR DMP internal inspection has not found pipe integrity issues. LOF of crossing is less or equal to 4.0. Recommend next inspection in 5 years. No permit was found authorizing this encroachment. CVFPB will need to review crossing to determine owner. The UCIP inspection was completed with LMA representative, J. Nelson. (H. Dunn ? GEI) 06/19/2014 Flapgate blocked by soil and possibly concrete on WS slope. (W. Wylie - DWR UCIP) FIELD_STRUCT_DESC: 21-inch corrugated metal storm drainage pipe (CMP) through the levee, 5.5 feet below the crown. Flap gate on the waterside (WS) end. Cobble grouted outlet on the WS end. [Additional Reference(s): DWR Levee Log, 1987, (HLM 1.45). USACE San Joaquin O&M Manual 612.2, 1967, (HLM 1.45), and 612 (addendum), February 1999, (HLM 1.45), (Station 76+42), 21-inch pipe listed]. FS Date: 4/27/2021

Levee crown looking upstream.

LS view: Headwall visible at toe from crown.

LS view: Slope and headwall at toe.

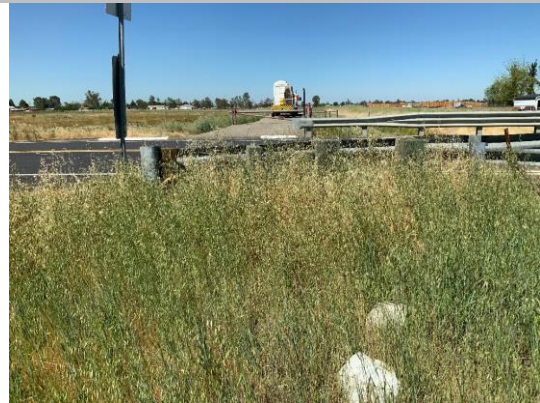
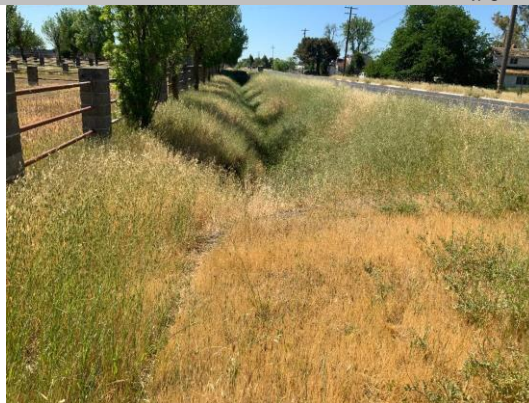
Photo 1 of 3 : UCIP_FA_2024_79052_96969.jpg

DS_ID:23848
FS_ID:79052
EP_NO: N/A
Repair Type: Non-Urgent
EVAL Issue: 5, Pipe Damage
Crossing Status: Found
UCIP Comments: 04/27/2021 The record has been upgraded from No Action Needed to Non-Urgent. DWR DMP internal inspection has found pipe integrity issues. LOF of crossing is between 4.1 and 5. Crossing will be monitored until funding becomes available for rehabilitation. WS pipe edges midly warped. No permit was found authorizing this encroachment. CVFPB will need to review crossing to determine owner. The UCIP inspection was completed with LMA representative, J. Nelson. (H. Dunn ? GEI)
FIELD_STRUCT_DESC: 21-inch corrugated metal storm drainage pipe (CMP) through the levee, 4.0 feet below the crown. Flap gate on the waterside (WS) end. Cobble grouted outlet on the WS end. [Additional Reference(s): DWR Levee Log, 1987, (HLM 1.47). USACE San Joaquin O&M Manual 612.2, 1967, (HLM 1.47), 21-inch pipe listed].

Levee crown looking downstream.

LS view: Toe from crown.

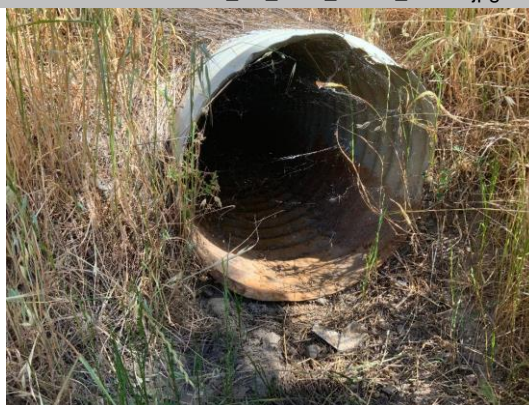
Photo 3 of 3 : UCIP_FA_2024_79052_96971.jpg

LS view: Close up of pipe inlet at toe, minor warping on edges.

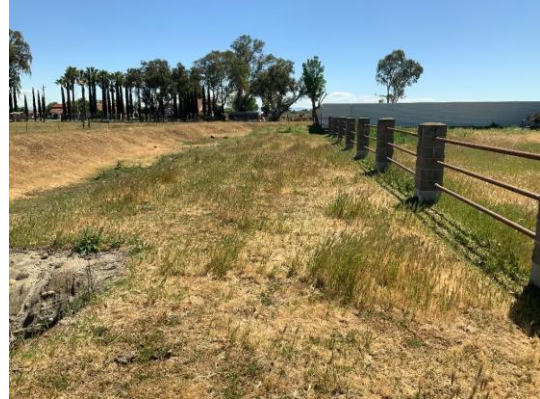
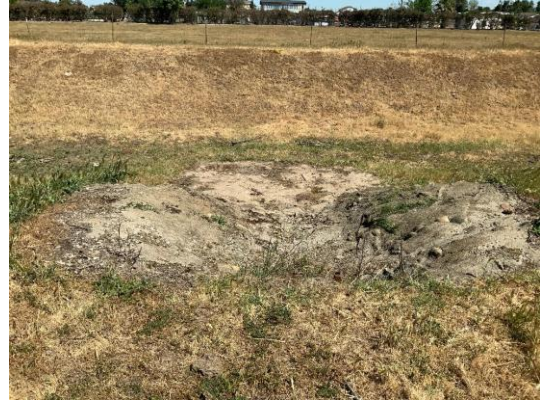
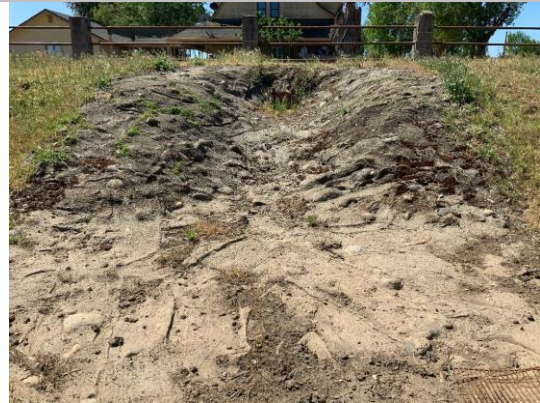
Photo 1 of 3 : UCIP_FA_2024_79053_96974.jpg

Comment Code						
Inspector Comment						
DS_ID:23849 FS_ID:79053 EP_NO: N/A Repair Type: Non-Urgent EVAL Issue: Crossing Status: Found UCIP Comments: 04/27/2021 The record has been upgraded from No Action Needed to Non-Urgent. No pipe on LS visible, appears to be buried and abandoned. Need confirmation from owner on status of pipe. No permit was found authorizing this encroachment. CVFPB will need to review crossing to determine owner. The UCIP inspection was completed with LMA representative, J. Nelson. (H. Dunn ? GEI) 11/04/2016 Crossing has been downgraded to No Action Needed the vegetation and sediment has been cleared from the WS. Based on the current inspection this crossing does not appear to be abandoned. Need to coordinate with owner to determine status of crossing. (O. Magana - DWR UCIP) 06/19/2014 Flapgate blocked by sediment and vegetation on WS toe. Pipe outlet appears abandoned and if so should be done so properly. (W. Wylie - DWR UCIP) FIELD_STRUCT_DESC: 12-inch corrugated metal storm drainage pipe (CMP) through the levee, 2.0 feet below the crown. Flap gate on the waterside (WS) end. Cobble grouted outlet on the WS end. [Additional Reference(s): DWR Levee Log, 1977, 1978, 1987, 1990, (HLM 1.52). USACE San Joaquin O&M Manual 612.2, 1967, (HLM 1.52), Unit 7 (HLM 7.19?16.77), Unit 8 (HLM 7.55?16.48), Unit 9 (HLM 0.10?1.52), Unit 10 (HLM 0.03?1.35), Unit 11 (HLM 0.16?3.55), Unit 12 (HLM 0.14?3.91), Unit 13 (HLM 0.03?1.18), Unit 14 (HLM 0.02?1.17), 12-inch pipe listed]. FS Date: 4/27/2021

Levee crown looking upstream.

WS view: toe from crown.

WS view: Slope and flapgate at toe.

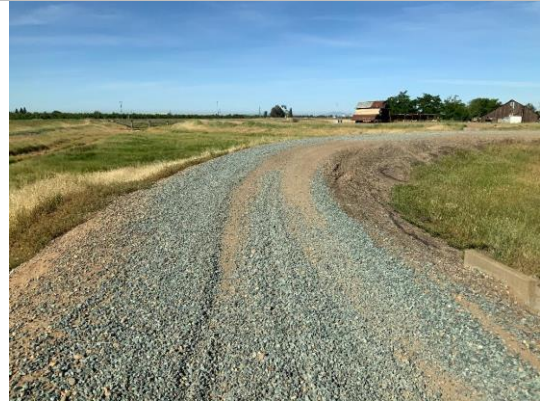
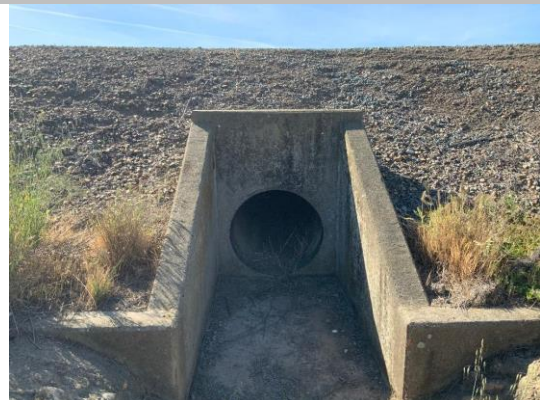
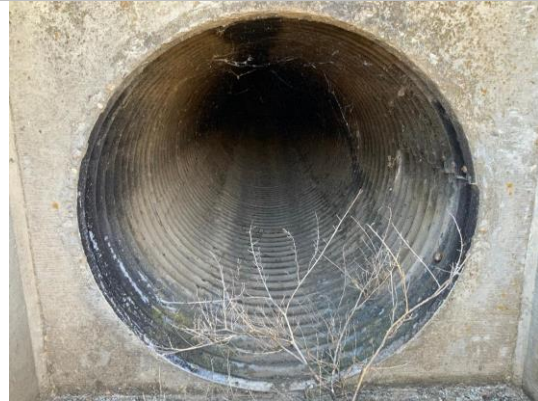
Photo 1 of 3 : UCIP_FA_2024_79054_97221.jpg

Comment Code						
Inspector Comment						
DS_ID:23859 FS_ID:79054 EP_NO: N/A Repair Type: Non-Urgent EVAL Issue: Crossing Status: Found UCIP Comments: 04/29/2021 The record has been upgraded from No Action Needed to Non-Urgent. DWR DMP internal inspection has not found pipe integrity issues. LOF of crossing is less or equal to 4.0. Recommend inspection in 5 years. No permit was found authorizing this encroachment. CVFPB will need to review crossing to determine owner. The UCIP inspection was completed with LMA representative, J. Nelson. (H. Dunn ? GEI) FIELD_STRUCT_DESC: 36-inch corrugated metal storm drainage pipe (CMP) through the levee, 7.0 feet below the crown. Flap gate on the waterside (WS) end. Concrete U-shaped headwalls on both ends. Cobble grouted outlet on the WS end. Cobble grouted intake on the landside (LS). [Additional Reference(s): DWR Levee Log, 1978, (HLM 0.03). USACE San Joaquin O&M Manual 612.2, 1967, (HLM 0.03), 36-inch pipe listed]. FS Date: 4/29/2021

Levee crown looking downstream.

LS view: Slope and headwall at toe.

LS view: Close up of pipe inlet at toe.

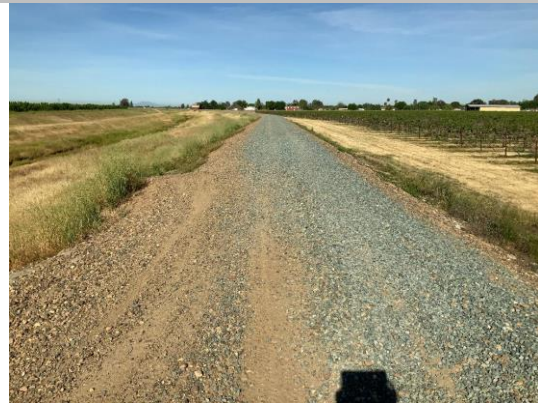
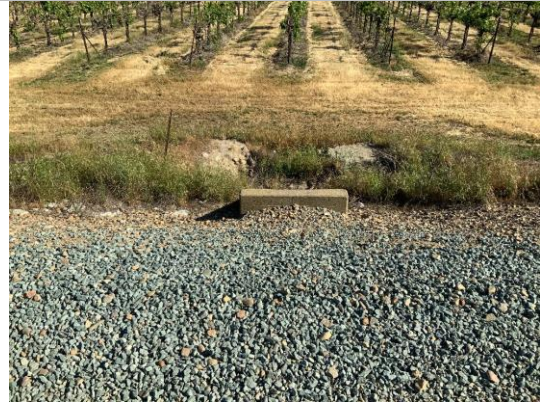
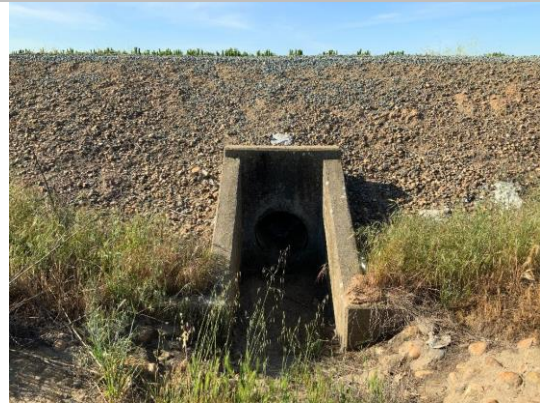
Photo 1 of 3 : UCIP_FA_2024_79055_97226.jpg

UCIP Comments: 04/29/2021 The record has been upgraded from No Action Needed to Non-Urgent. DWR DMP internal inspection has not found pipe integrity issues. LOF of crossing is less or equal to 4.0. Recommend inspection in 5 years. No permit was found authorizing this encroachment. CVFPB will need to review crossing to determine owner. The UCIP inspection was completed with LMA representative, J. Nelson. (H. Dunn ? GEI)

Levee crown looking downstream.

LS view: Headwall visible at toe from crown.

LS view: Slope and headwall at toe.

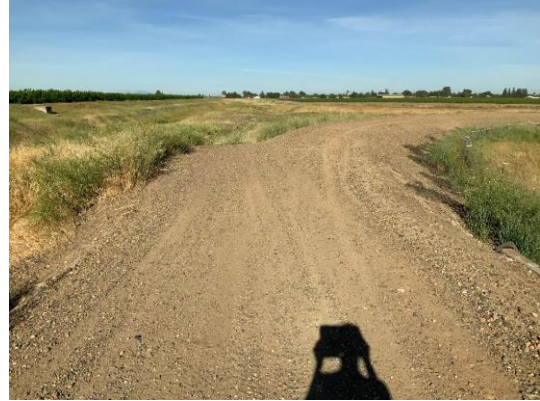
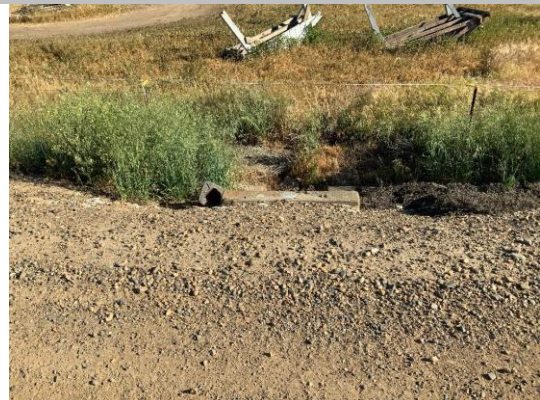
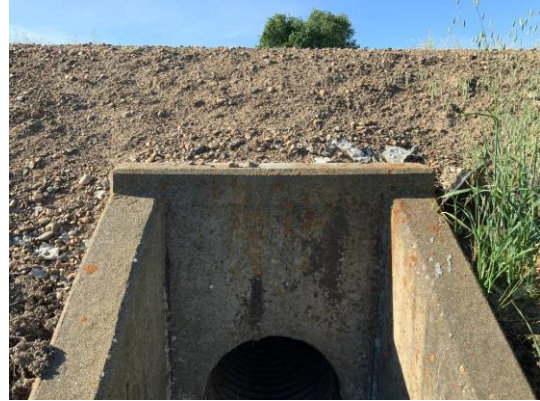
Photo 1 of 3 : UCIP_FA_2024_79056_97235.jpg

Comment Code						
Inspector Comment						
DS_ID:23861 FS_ID:79056 EP_NO: N/A Repair Type: Non-Urgent EVAL Issue: Crossing Status: Found UCIP Comments: 04/29/2021 The record has been upgraded from No Action Needed to Non-Urgent. DWR DMP internal inspection has not found pipe integrity issues. LOF of crossing is less or equal to 4.0. Recommend inspection in 5 years. No permit was found authorizing this encroachment. CVFPB will need to review crossing to determine owner. The UCIP inspection was completed with LMA representative, J. Nelson. (H. Dunn ? GEI) FIELD_STRUCT_DESC: 24-inch corrugated metal storm drainage pipe (CMP) through the levee, 5.0 feet below the crown. Flap gate on the waterside (WS) end. Concrete U-shaped headwalls on both ends. Cobble grouted outlet on the WS end. Cobble grouted intake on the landside (LS). [Additional Reference(s): DWR Levee Log, 1978, (HLM 0.36). USACE San Joaquin O&M Manual 612.2, 1967, (HLM 0.36), 24-inch pipe listed]. FS Date: 4/29/2021

Levee crown looking downstream.

LS view: Headwall visible at toe from crown.

LS view: Slope and headwall at toe.

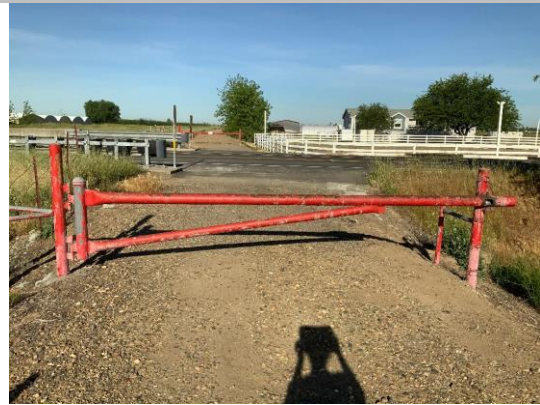
Photo 1 of 3 : UCIP_FA_2024_79057_97247.jpg

Comment Code						
Inspector Comment						
DS_ID:23863 FS_ID:79057 EP_NO: N/A Repair Type: Non-Urgent EVAL Issue: Crossing Status: Found UCIP Comments: 04/29/2021 The record has been upgraded from No Action Needed to Non-Urgent. DWR DMP internal inspection has not found pipe integrity issues. LOF of crossing is less or equal to 4.0. Something is peeling away inside the pipe inlet, possibly just the liner. No permit was found authorizing this encroachment. CVFPB will need to review crossing to determine owner. The UCIP inspection was completed with LMA representative, J. Nelson. (H. Dunn ? GEI) FIELD_STRUCT_DESC: 24-inch corrugated metal storm drainage pipe (CMP) through the levee, 4.0 feet below the crown. Flap gate on the waterside (WS) end. Concrete U-shaped headwalls on both ends. Cobble grouted outlet on the WS end. Cobble grouted intake on the landside (LS). [Additional Reference(s): DWR Levee Log, 1978, (HLM 0.46). USACE San Joaquin O&M Manual 612.2, 1967, (HLM 0.46), 24-inch pipe listed]. FS Date: 4/29/2021

Levee crown looking downstream.

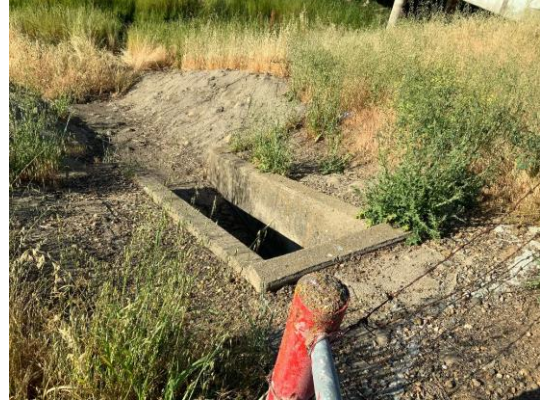
Photo 2 of 3 : UCIP_FA_2024_79057_97248.jpg

WS view: Headwall visible at toe from crown.

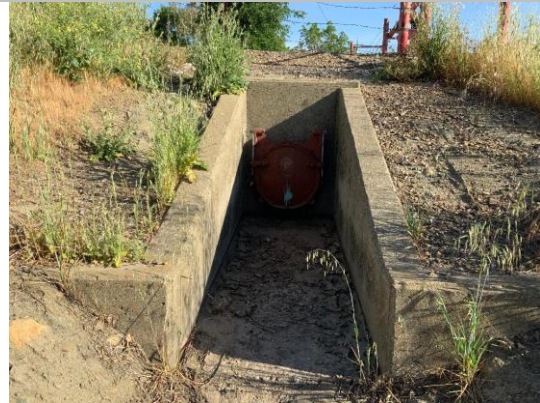
Photo 3 of 3 : UCIP_FA_2024_79057_97249.jpg

WS view: Slope, headwall, and flapgate at toe.

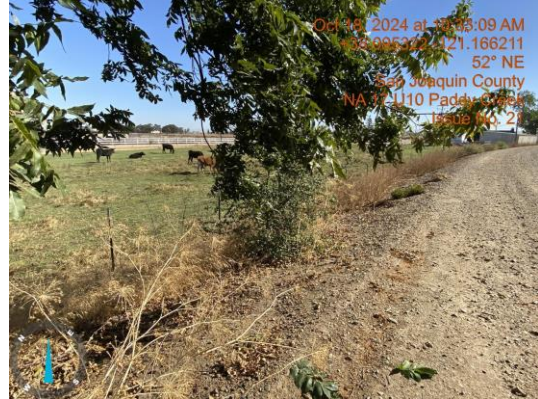
Photo 1 of 1 : FA_2024_NA0017_154_21_20241019_00035.jpg

LM Start	0.49	Rating **	M	Issue No.	21
LM End	0.49	Issue Type +	Ma	Location *	LS
Category	Earthen Levee			GPS Latitude/Longitude	
				Start	End
Item	Vegetation			38.095322°	38.095322°
				-121.165981°	-121.165981°
DWR ID	DWR_NA0017_10_s_2024_21				
Comment Code					
V2 : Remove the wild growth and woody vegetation other than native grasses from the levee slopes.					
Inspector Comment					
There are tree saplings along the landside slope.

View of tree saplings growing along the landside slope. Fall 2024

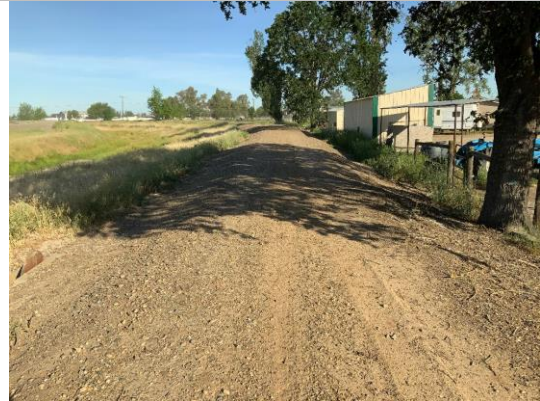
Photo 1 of 3 : UCIP_FA_2024_79058_97258.jpg

Levee crown looking downstream.

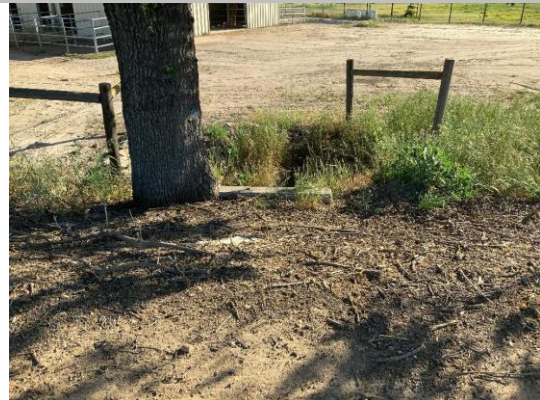
Photo 2 of 3 : UCIP_FA_2024_79058_97259.jpg

LS view: Headwall visible at toe from crown.

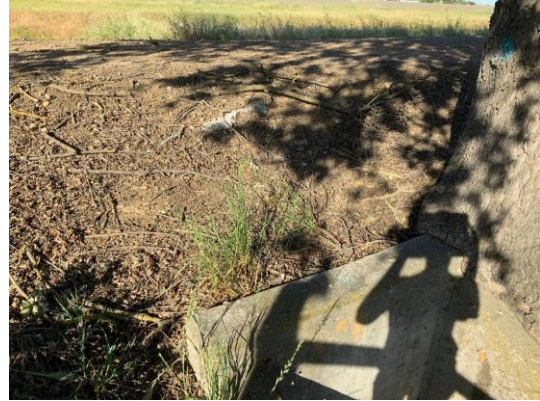
Photo 3 of 3 : UCIP_FA_2024_79058_97260.jpg

LS view: Slope above headwall from toe.

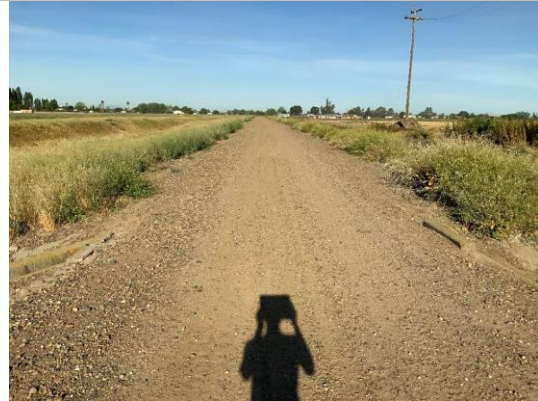
Photo 1 of 3 : UCIP_FA_2024_79059_97264.jpg

Levee crown looking downstream.

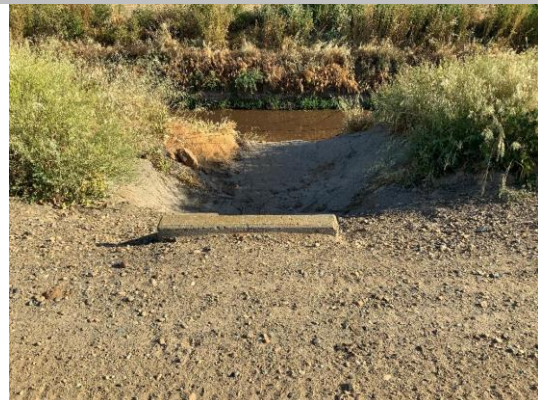
Photo 2 of 3 : UCIP_FA_2024_79059_97265.jpg

LS view: Headwall visible at toe from crown.

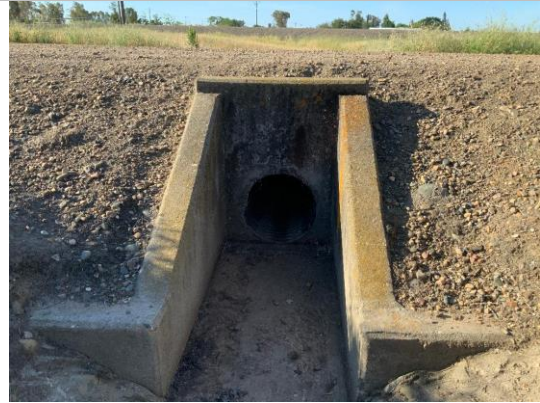
Photo 3 of 3 : UCIP_FA_2024_79059_97266.jpg

LS view: Slope and headwall at toe.

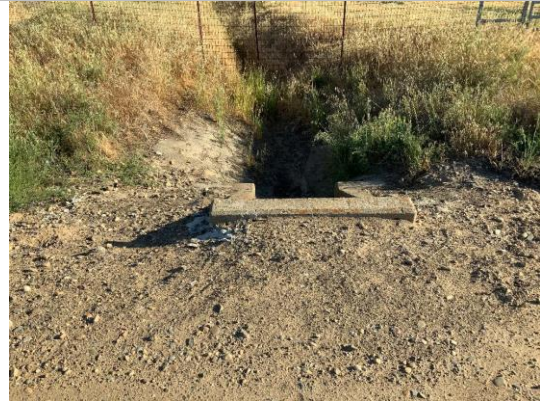
Photo 2 of 3 : UCIP_FA_2024_79060_97271.jpg

LS view: Headwall visible at toe from crown.

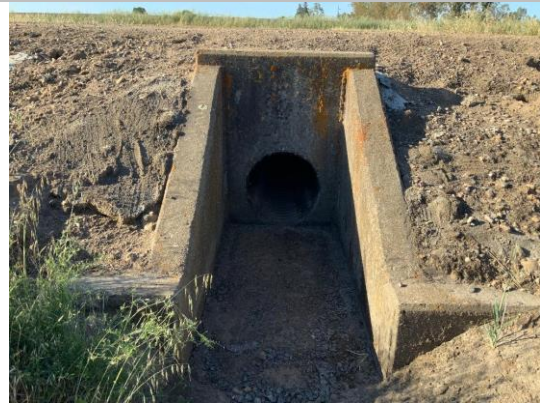
Photo 3 of 3 : UCIP_FA_2024_79060_97271.jpg

LS view: Slope and headwall at toe.

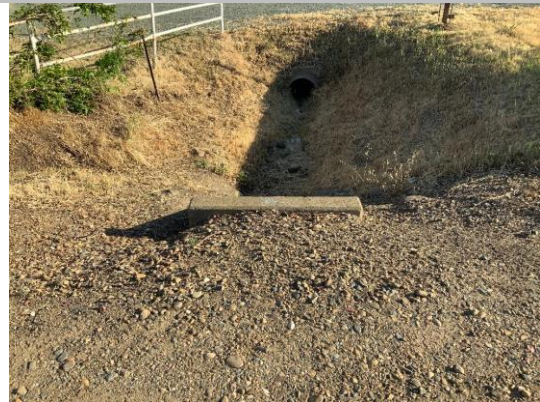
Photo 2 of 3 : UCIP_FA_2024_79061_97279.jpg

LS view: Headwall visible at toe from crown.

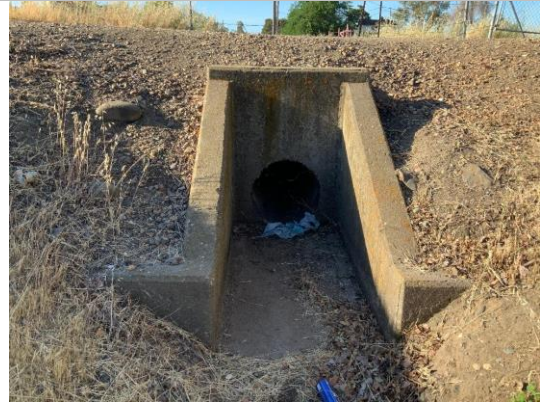
Photo 3 of 3 : UCIP_FA_2024_79061_97280.jpg

LS view: Slope and headwall at toe.

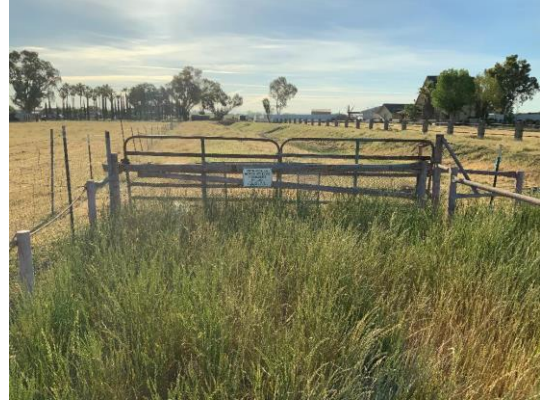
Photo 1 of 3 : UCIP_FA_2024_79418_97285.jpg

DS_ID:23868
FS_ID:79418
EP_NO: N/A
Repair Type: Non-Urgent
EVAL Issue: 5, Pipe Damage
Crossing Status: Found
UCIP Comments: 03/31/2023 Record updated from Urgent to Non-Urgent. LoF is equal to 5.1 due to a small hole near landside pipe end, other integrity issues were not found. Crossing will be monitored until funding becomes available for rehabilitation. (O.Yakimov - DWR UCIP).
04/29/2021 Record has been upgraded from No Action Needed to Urgent. DWR DMP internal inspection has found pipe integrity issues. LOF of crossing is between 5 and 6. Crossing will be monitored until funding becomes available to address the issues. No permit was found authorizing this encroachment. CVFPB will need to review crossing to determine owner. The UCIP inspection was completed with LMA representative, J. Nelson. (H. Dunn ? GE04/28/2017 Crossing has been downgraded from Non-Urgent to No Action Needed, since sediment buildup is only minimal. (K. Fazel - UCIP 06/19/2014 Some sediment buildup in pipe at LS toe. (G. Wylie - FPIIB)

Levee crown looking downstream.

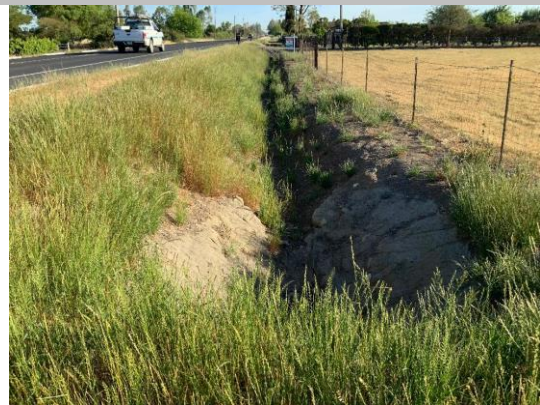
Photo 2 of 3 : UCIP_FA_2024_79418_97286.jpg

LS view: Slope from crown.

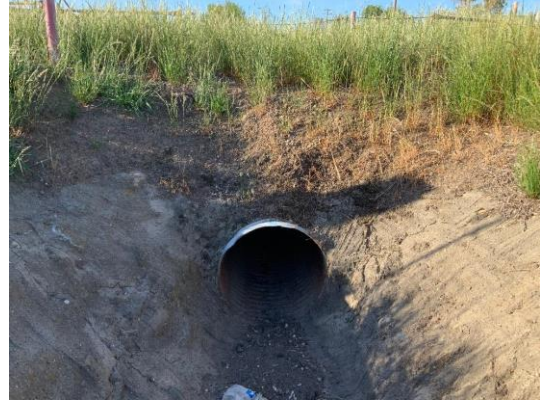
Photo 3 of 3 : UCIP_FA_2024_79418_97287.jpg

LS view: Slope and pipe inlet at toe.

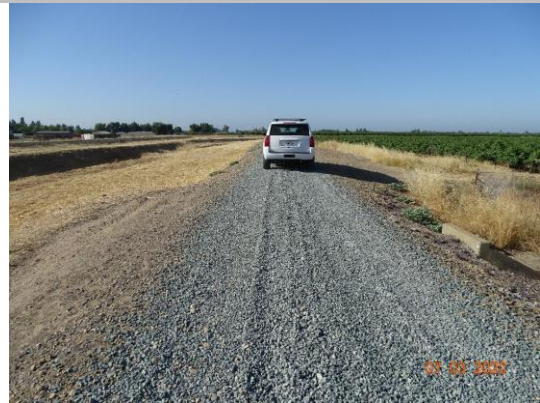
Photo 1 of 3 : UCIP_FA_2024_79064_86887.jpg

Comment Code						
Inspector Comment						
DS_ID:23880 FS_ID:79064 EP_NO: N/A Repair Type: Non-Urgent EVAL Issue: Crossing Status: Found UCIP Comments: 07/03/2020 Crossing evaluated as "Non-Urgent" because there was no permit found authorizing this pipe. (A. McDonald - DWR UCIP) FIELD_STRUCT_DESC: 24-inch corrugated metal drainage pipe through the levee, 5 feet below the crown. Concrete U-shaped headwall on both ends. Flap gate on the waterside (WS) end. Cobble grouted outlet. Cobble grouted intake on the landside (LS). [Additional Reference(s): DWR Levee Log, 1978, (HLM 0.16). USACE San Joaquin O&M Manual 612.2, 1967, (HLM 0.16), 24-inch pipe listed]. FS Date: 7/3/2020

Overview of levee crown looking d/s.

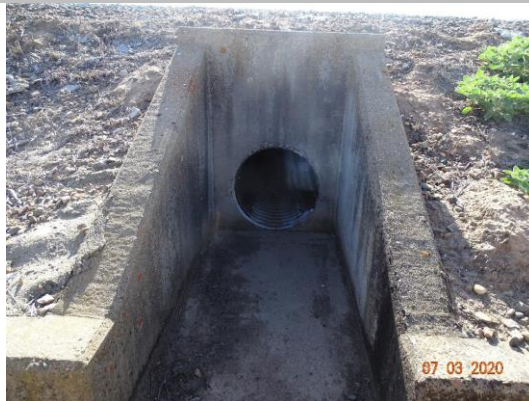
Photo 2 of 3 : UCIP_FA_2024_79064_86888.jpg

Pipe inlet and headwall at LS levee toe.

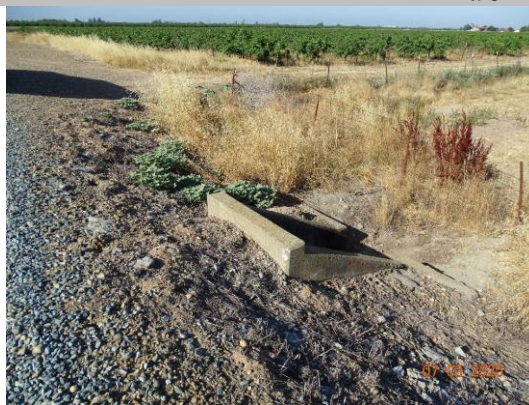
Photo 3 of 3 : UCIP_FA_2024_79064_86889.jpg

Pipe inlet, headwall, and flap gate at LS levee toe.

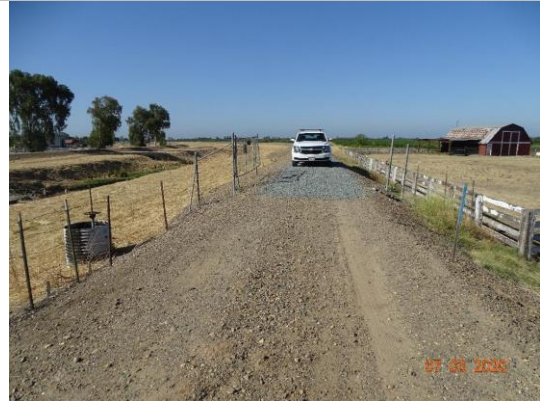
Photo 1 of 3 : UCIP_FA_2024_79065_86893.jpg

Overview of levee crown looking d/s.

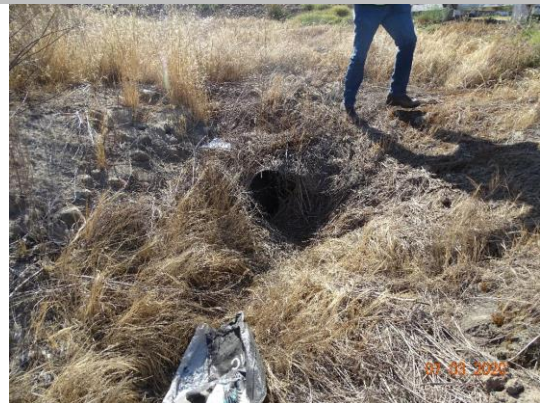
Photo 2 of 3 : UCIP_FA_2024_79065_86894.jpg

Pipe inlet at the LS levee toe. No headwall.

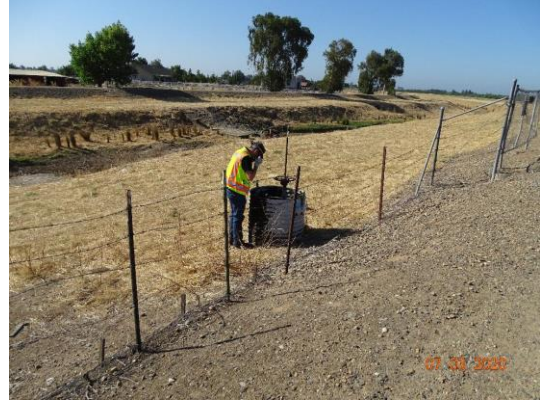
Photo 3 of 3 : UCIP_FA_2024_79065_86895.jpg

Riser and slide gate at the WS levee toe.
