**Flood Control Project Maintenance
Levee Inspections****Maintenance Issue Types Only, Levee Inspection Report By Mile - Fall 2024****San Joaquin County Flood Control and Water Conservation District**

Waterway	Bank	Unit Miles	Inspection Start/End	Inspector
Unit No. 01 Littlejohn Creek	Left	2.59	10/21/2024 10/21/2024	Alberto De Leon

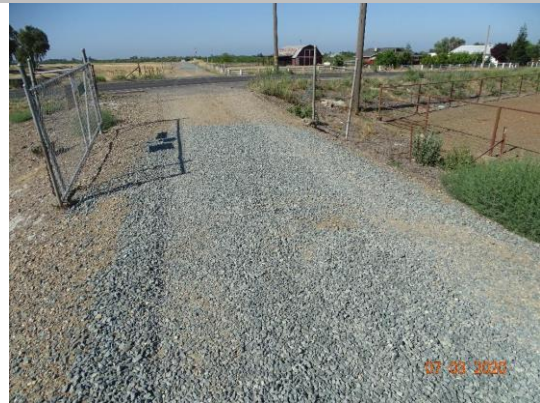
Photo 1 of 3 : UCIP_FA_2024_79066_86906.jpg

DS_ID:23882
 FS_ID:79066
 EP_NO: N/A
 Repair Type: Non-Urgent
 EVAL Issue: 5, Pipe Damage
 Crossing Status: Found
 UCIP Comments: 07/03/2020 Crossing evaluated as "Non-Urgent" because there was no permit found authorizing this pipe. Video inspection performed on 02/21/2020. (A. McDonald - DWR UCIP)
 FIELD_STRUCT_DESC: 24-inch corrugated metal drainage pipe through the levee, 7 feet below the crown. Concrete U-shaped headwall on both ends. Flap gate on the waterside (WS) end. Cobble grouted outlet. Cobble grouted intake on the landside (LS). [Additional Reference(s): DWR Levee Log, 1978, (HLM 0.50). USACE San Joaquin O&M Manual 612.2, 1967, (HLM 0.50), 24-inch pipe listed].
 FS Date: 7/3/2020

Overview of levee crown looking d/s.

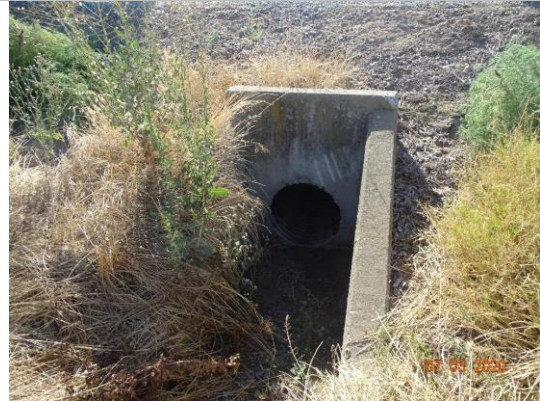
Photo 2 of 3 : UCIP_FA_2024_79066_86907.jpg

Pipe inlet and headwall at the LS levee toe.

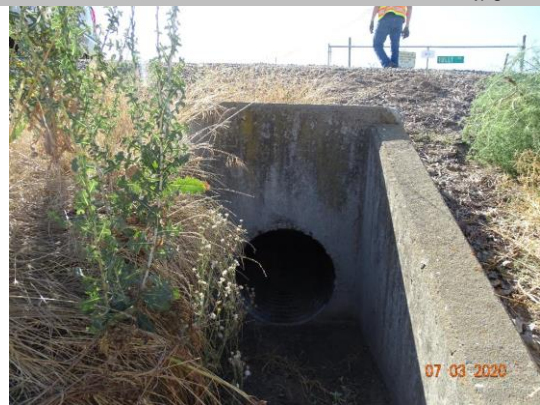
Photo 3 of 3 : UCIP_FA_2024_79066_86908.jpg

Pipe inlet and headwall at the LS levee toe.

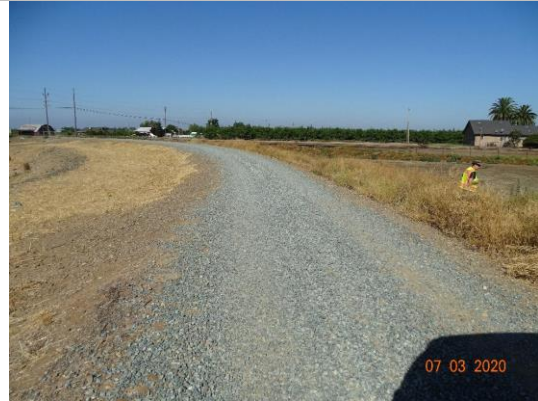
Photo 1 of 3 : UCIP_FA_2024_79067_86911.jpg

DS_ID:23883
FS_ID:79067
EP_NO: N/A
Repair Type: Non-Urgent
EVAL Issue:
Crossing Status: Found
UCIP Comments: 07/03/2020 Crossing evaluated as "Non-Urgent" because there was no permit found authorizing this pipe. Video inspection performed on 02-21-2020. (A. McDonald - DWR UCIP) 06/12/2014 Pipe filled in with soil on the LS toe and appears to be temporarily abandoned. (DWR UCIP)
FIELD_STRUCT_DESC: 24-inch corrugated metal drainage pipe through the levee, 6.5 feet below the crown. Concrete U-shaped headwall on both ends. Flap gate on the waterside (WS) end. Cobble grouted outlet. Cobble grouted intake on the landside (LS). [Additional Reference(s): DWR Levee Log, 1978, (HLM 0.55). USACE San Joaquin O&M Manual 612.2, 1967, (HLM 0.55), 24-inch pipe listed].
FS Date: 7/3/2020

Overview of levee crown looking d/s.

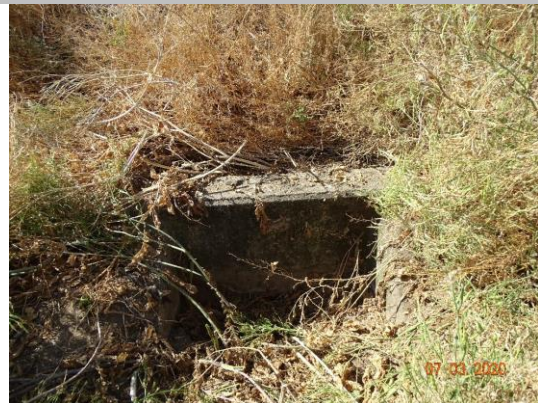
Photo 2 of 3 : UCIP_FA_2024_79067_86912.jpg

Pipe inlet and headwall at the LS levee toe.

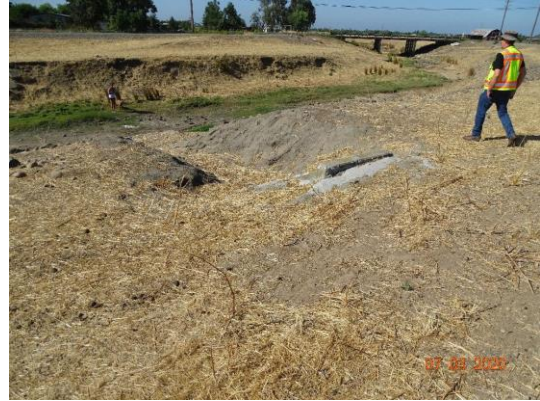
Photo 3 of 3 : UCIP_FA_2024_79067_86913.jpg

Pipe outlet, headwall, and flap gate at the WS levee toe.

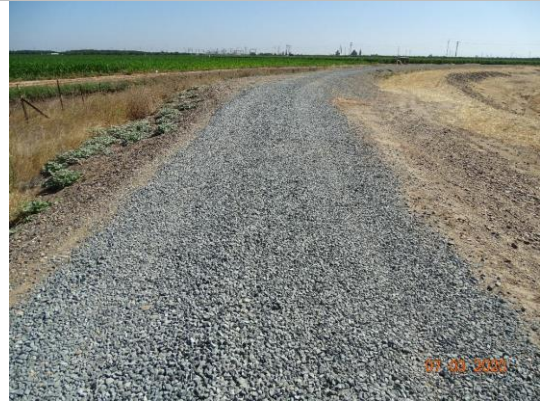
Photo 1 of 3 : UCIP_FA_2024_79068_86934.jpg

Comment Code						
Inspector Comment						
DS_ID:23885 FS_ID:79068 EP_NO: N/A Repair Type: Non-Urgent EVAL Issue: Crossing Status: Found UCIP Comments: 07/03/2020 Crossing evaluated as "Non-Urgent" because there was no permit found authorizing this pipe. Video inspection performed on 04-24-2020. (A. McDonald - DWR UCIP) FIELD_STRUCT_DESC: 24-inch corrugated metal drainage pipe through the levee, 6 feet below the crown. Concrete U-shaped headwall on both ends. Flap gate on the waterside (WS) end. Slide gate on the landside (LS) end. Cobble grouted outlet. Cobble grouted intake on the LS. [Additional Reference(s): DWR Levee Log, 1978, (HLM 1.07). USACE San Joaquin O&M Manual 612.2, 1967, (HLM 1.07), 24-inch pipe listed]. FS Date: 7/3/2020

Overview of levee crown looking d/s.

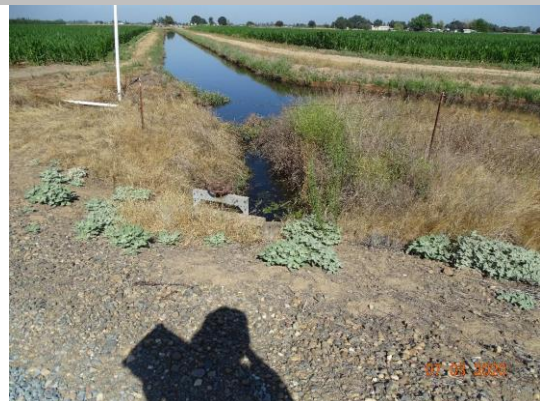
Photo 2 of 3 : UCIP_FA_2024_79068_86930.jpg

View of pipe inlet, headwall, and slide gate at the LS levee toe.

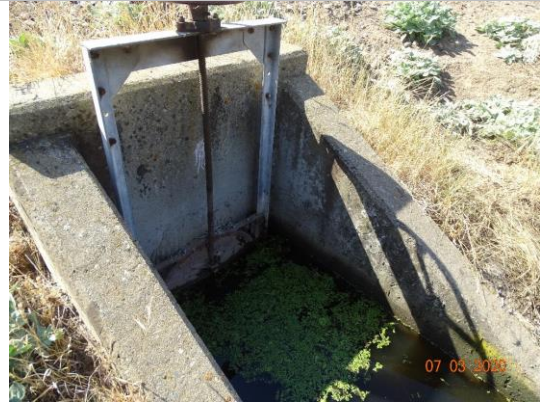
Photo 3 of 3 : UCIP_FA_2024_79068_86931.jpg

Pipe inlet, headwall, and slide gate at the LS levee toe.

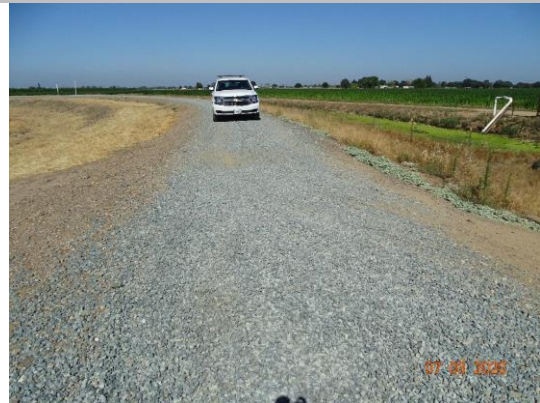
Photo 1 of 3 : UCIP_FA_2024_79069_86936.jpg

DS_ID:23870
 FS_ID:79069
 EP_NO: N/A
 Repair Type: Non-Urgent
 EVAL Issue:
 Crossing Status: Found
 UCIP Comments: 07/03/2020 Crossing evaluated as "Non-Urgent" because there was no permit found authorizing this pipe. (A. McDonald - DWR UCIP)
 FIELD_STRUCT_DESC: 24-inch corrugated metal drainage pipe through the levee, 8 feet below the crown. Concrete U-shaped headwall on both ends. Flap gate on the waterside (WS) end. Slide gate on the landside (LS) end. Two corrugated metal cutoff walls. Cobble grouted outlet. Cobble grouted intake on the LS. [Additional Reference(s): DWR Levee Log, 1978, (HLM 1.15). USACE San Joaquin O&M Manual 612.2, 1967, (HLM 1.15), 24-inch pipe listed].
 FS Date: 7/3/2020

Overview of levee crown looking d/s.

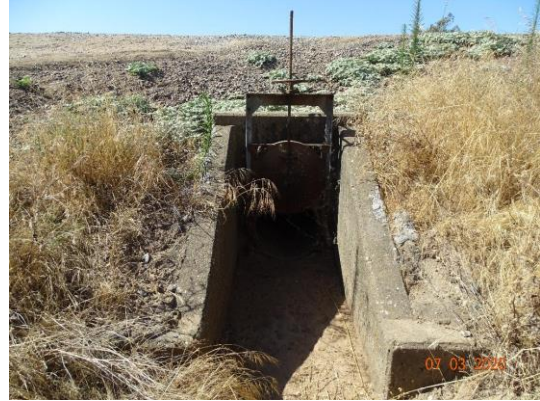
Photo 2 of 3 : UCIP_FA_2024_79069_86937.jpg

Pipe inlet, headwall, and slide gate at the LS levee toe.

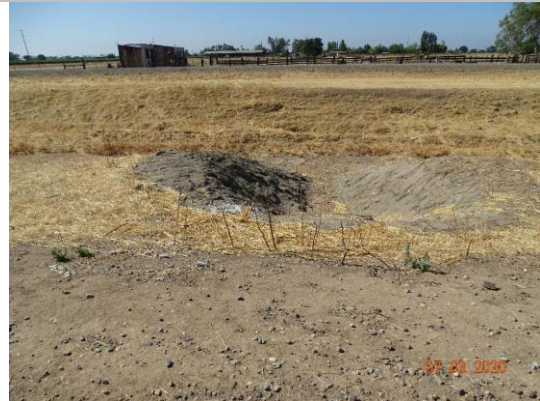
Photo 3 of 3 : UCIP_FA_2024_79069_86938.jpg

View of WS channel looking from the levee crown.

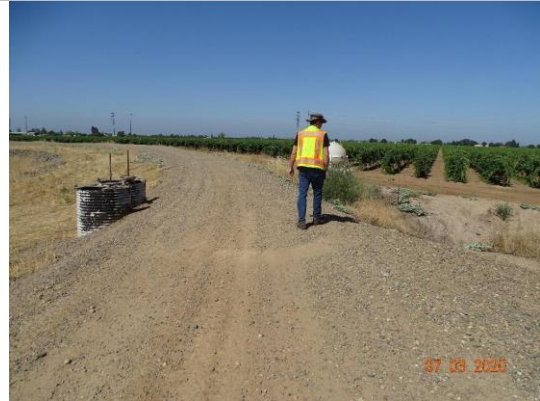
Photo 1 of 3 : UCIP_FA_2024_79070_86960.jpg

DS_ID:23871
FS_ID:79070
EP_NO: N/A
Repair Type: Non-Urgent
EVAL Issue:
Crossing Status: Found
UCIP Comments: 07/03/2020 Crossing evaluated as "Non-Urgent" because there was no permit found authorizing this pipe. (A. McDonald - DWR UCIP)
06/12/2014 Slide gate may be rusted shut or does not function. Heavy sediment buildup in pipe. Lid on CMP riser needs repair. (DWR UCIP)
FIELD_STRUCT_DESC: 1 of 2: 36-inch corrugated metal drainage pipe through the levee, 7 feet below the crown. Slide gate in 48-inch corrugated metal riser unit on the waterside (WS) slope. Concrete U-shaped headwall on both ends. Flap gate on the WS end. Cobble grouted outlet. Cobble grouted intake on the landside (LS). [Additional Reference(s): DWR Levee Log, 1978 (HLM 1.51). USACE San Joaquin O&M Manual 612.2, 1967, (HLM 1.51), 36-inch pipe listed].
FS Date: 7/3/2020

Overview of levee crown looking d/s.

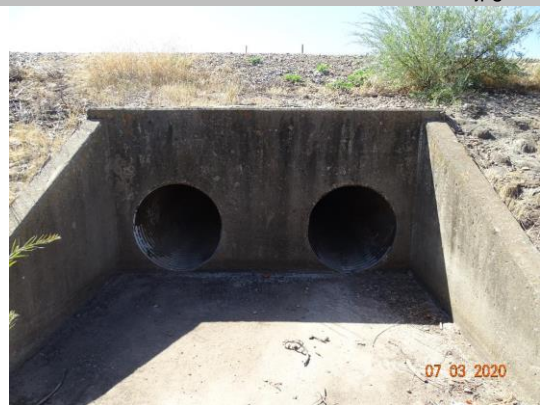
Photo 2 of 3 : UCIP_FA_2024_79070_86961.jpg

Two pipe inlets and headwall at the LS levee toe.

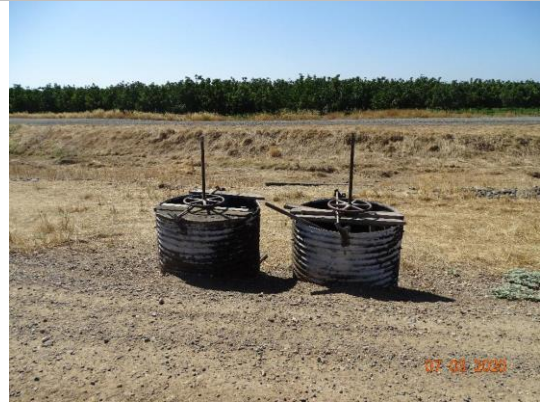
Photo 3 of 3 : UCIP_FA_2024_79070_86962.jpg

Two slide gates and risers on the WS levee slope.

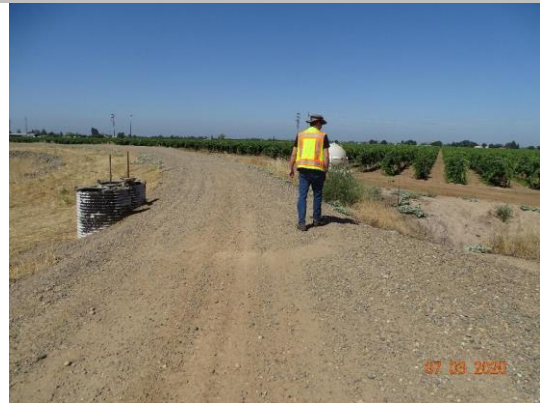
Photo 1 of 3 : UCIP_FA_2024_79071_86965.jpg

DS_ID:23897
FS_ID:79071
EP_NO: N/A
Repair Type: Non-Urgent
EVAL Issue:
Crossing Status: Found
UCIP Comments: 07/03/2020 Crossing evaluated as "Non-Urgent" because there was no permit found authorizing this pipe. (A. McDonald - DWR UCIP)
06/12/2014 Slide gate not functional or rusted in place. No lid on CMP riser at WS slope. (DWR UCIP)
FIELD_STRUCT_DESC: 2 of 2: 36-inch corrugated metal drainage pipe through the levee, 7 feet below the crown. Slide gate in 48-inch corrugated metal riser unit on the waterside (WS) slope. Concrete U-shaped headwall on both ends. Flap gate on the WS end. Cobble grouted outlet. Cobble grouted intake on the landside (LS). [Additional Reference(s): DWR Levee Log, 1978 (HLM 1.51). USACE San Joaquin O&M Manual 612.2, 1967, (HLM 1.51), 36-inch pipe listed].
FS Date: 7/3/2020

Overview of levee crown looking d/s.

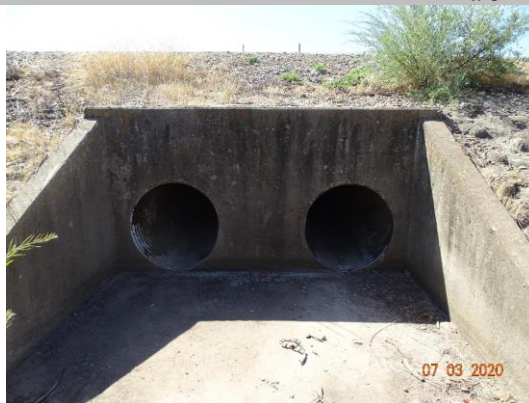
Photo 2 of 3 : UCIP_FA_2024_79071_86966.jpg

Two pipe inlets and headwall at the LS levee toe.

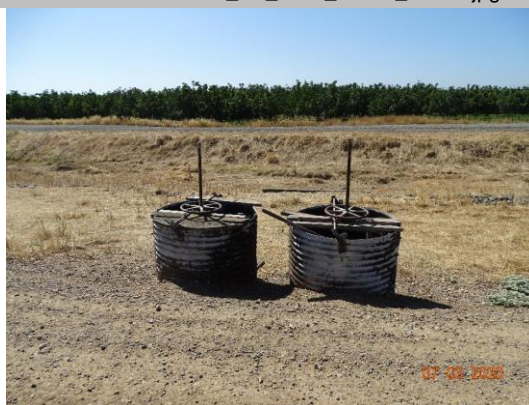
Photo 3 of 3 : UCIP_FA_2024_79071_86967.jpg

Two risers and slide gates on the WS levee slope.

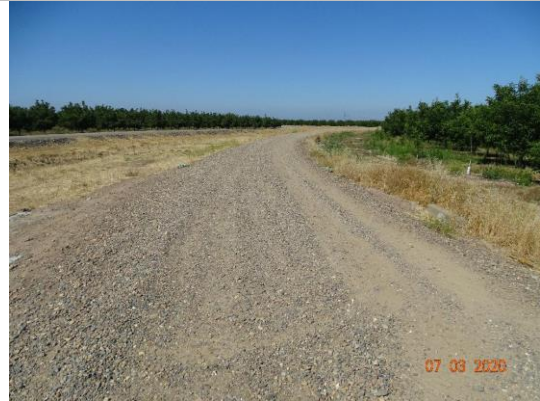
Photo 1 of 3 : UCIP_FA_2024_79072_86978.jpg

Comment Code					
Inspector Comment					
DS_ID:23872 FS_ID:79072 EP_NO: N/A Repair Type: Non-Urgent EVAL Issue: Crossing Status: Found UCIP Comments: 07/03/2020 Crossing evaluated as "Non-Urgent" because there was no permit found authorizing this pipe. (A. McDonald - DWR UCIP) FIELD_STRUCT_DESC: 24-inch corrugated metal drainage pipe through the levee, 5.5 feet below the crown. Concrete U-shaped headwall on both ends. Flap gate on the waterside (WS) end. Cobble grouted outlet. Cobble grouted intake on the landside (LS). [Additional Reference(s): DWR Levee Log, 1978, (HLM 1.82). USACE San Joaquin O&M Manual 612.2, 1967, (HLM 1.82), 24-inch pipe listed]. FS Date: 7/3/2020

Overview of levee crown looking d/s.

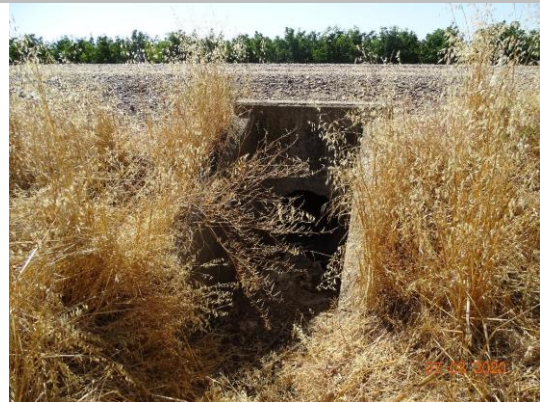
Photo 2 of 3 : UCIP_FA_2024_79072_86979.jpg

Pipe inlet and headwall located at the LS levee toe.

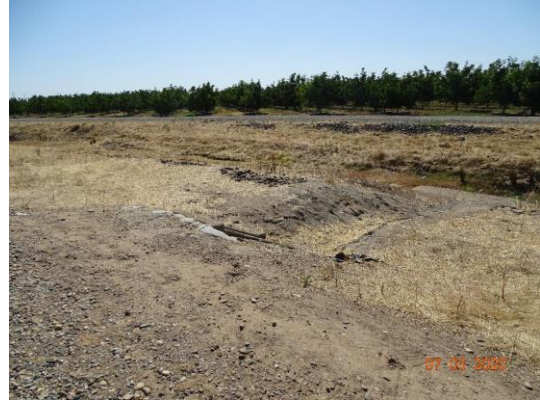
Photo 3 of 3 : UCIP_FA_2024_79072_86980.jpg

Overview of WS channel looking from the levee crown.

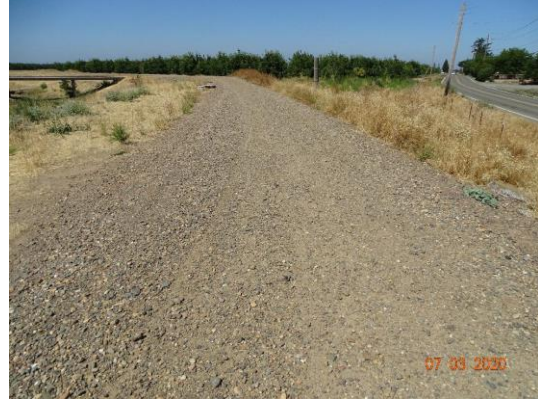
Photo 1 of 3 : UCIP_FA_2024_79074_86988.jpg

Comment Code					
Inspector Comment					
DS_ID:23874 FS_ID:79074 EP_NO: N/A Repair Type: Non-Urgent EVAL Issue: 5, Pipe Damage Crossing Status: Found UCIP Comments: 09/25/2024 DMP internal video inspection has found moderate pipe defects. Crossing will be monitored until funding becomes available for rehabilitation. (O. Yakimov - DWR UCIP) 07/03/2020 Crossing evaluated as "Non-Urgent" because there was no permit found authorizing this pipe. (A. McDonald - DWR UCIP) FIELD_STRUCT_DESC: 24-inch corrugated metal drainage pipe through the levee, 6 feet below the crown. Concrete U-shaped headwall on both ends. Flap gate on the waterside (WS) end. Cobble grouted outlet. Cobble grouted intake on the landside (LS). [Additional Reference(s): DWR Levee Log, 1978, (HLM 2.05). USACE San Joaquin O&M Manual 612.2, 1967, (HLM 2.05), 24-inch pipe listed]. FS Date: 7/3/2020

Overview of levee crown looking d/s.

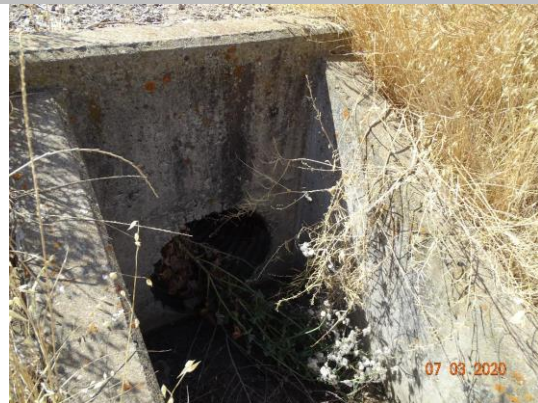
Photo 2 of 3 : UCIP_FA_2024_79074_86989.jpg

Inlet pipe and headwall located at the LS levee toe.

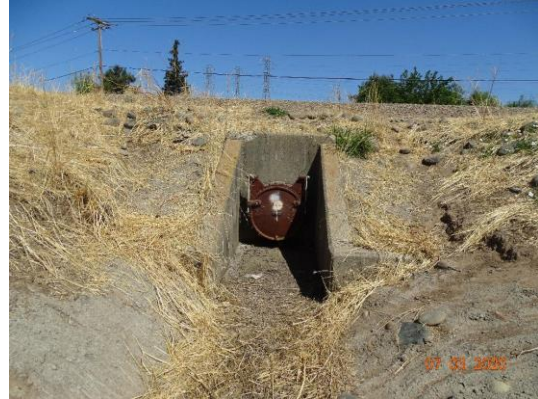
Photo 3 of 3 : UCIP_FA_2024_79074_86990.jpg

Outlet pipe, flap gate, and headwall located at the WS levee toe.

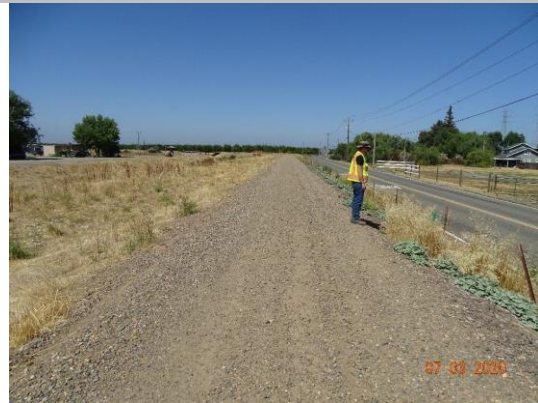
Photo 1 of 3 : UCIP_FA_2024_79419_86991.jpg

DS_ID:23875
FS_ID:79419
EP_NO: N/A
Repair Type: Non-Urgent
EVAL Issue: 5, Pipe Damage
Crossing Status: Found
UCIP Comments: 03/31/2023 Record updated from Urgent to Non-Urgent. LoF is equal to 5 due to pipe surface damage corrosion, integrity issues are not found. Crossing will be monitored until funding becomes available for rehabilitation. (O.Yakimov - DWR UCIP).
07/03/2020 Crossing evaluated as "Non-Urgent" because there was no permit found authorizing this pipe. Video inspection performed on 04-22-2020. (A. McDonald - DWR UCIP)
FIELD_STRUCT_DESC: 12-inch corrugated metal drainage pipe through the levee, 5.5 feet below the crown. Flap gate on the waterside (WS) end. Drop inlet with grate at the landside (LS) toe. Cobble grouted outlet. [Additional Reference(s): DWR Levee Log, 1978, (HLM 2.14). USACE San Joaquin O&M Manual 612.2, 1967, (HLM 2.14), 12-inch pipe listed].
FS Date: 7/3/2020

Overview of levee crown looking d/s.

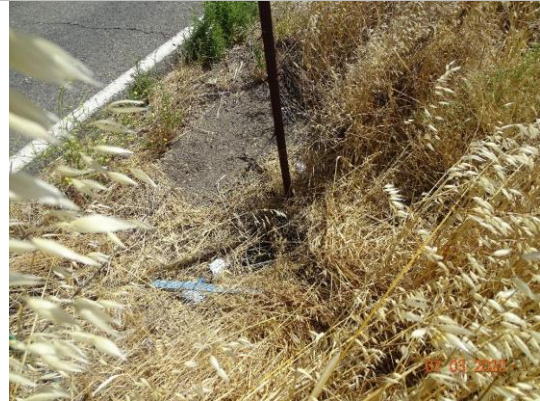
Photo 2 of 3 : UCIP_FA_2024_79419_86992.jpg

View of pipe inlet at the LS levee toe.

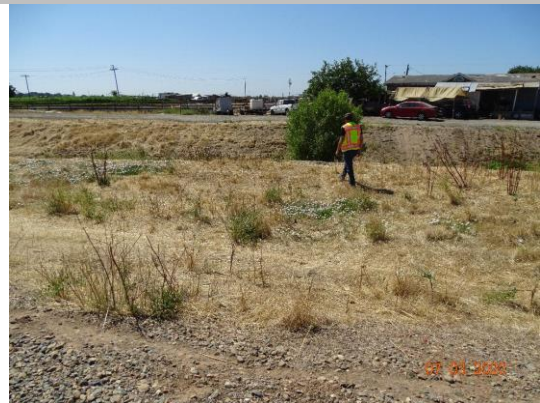
Photo 3 of 3 : UCIP_FA_2024_79419_86993.jpg

View of WS berm and channel looking from the levee crown.

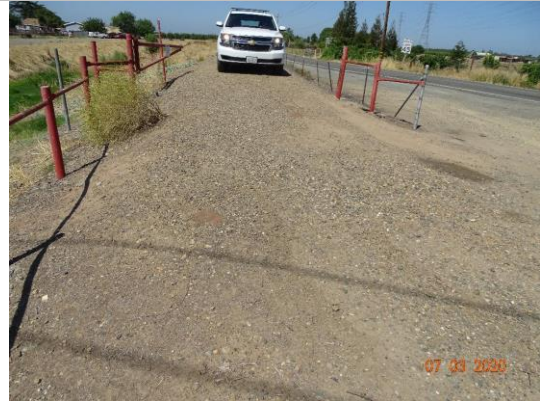
Photo 1 of 3 : UCIP_FA_2024_79076_86996.jpg

DS_ID:23876
FS_ID:79076
EP_NO: N/A
Repair Type: Non-Urgent
EVAL Issue:
Crossing Status: Found
UCIP Comments: 07/03/2020 Crossing evaluated as "Non-Urgent" because there was no permit found authorizing this pipe. (A. McDonald - DWR UCIP)
06/12/2014 Concrete inlet at LS of East Kettleman road is damaged...may or may not be a hazard. (DWR UCIP)
FIELD_STRUCT_DESC: 24-inch corrugated metal drainage pipe through the levee, 5 feet below the crown. Concrete U-shaped headwall on the waterside (WS) end. Flap gate on the WS end. Cobble grouted outlet. 36-inch concrete catch basin on the landside (LS) end.
[Additional Reference(s): DWR Levee Log, 1978, (HLM 2.22). USACE San Joaquin O&M Manual 612.2, 1967, (HLM 2.22), 24-inch pipe listed].
FS Date: 7/3/2020

Overview of levee crown looking d/s.

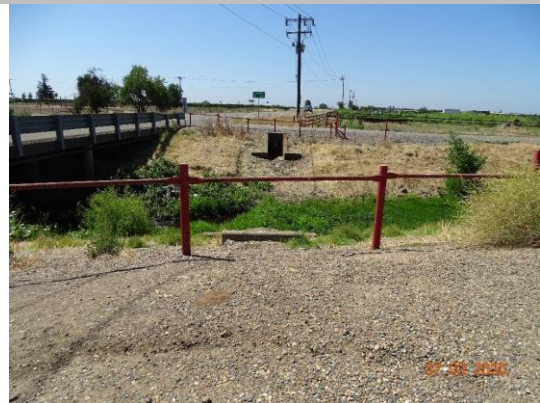
Photo 2 of 3 : UCIP_FA_2024_79076_86997.jpg

View of channel on WS and opposite levee.

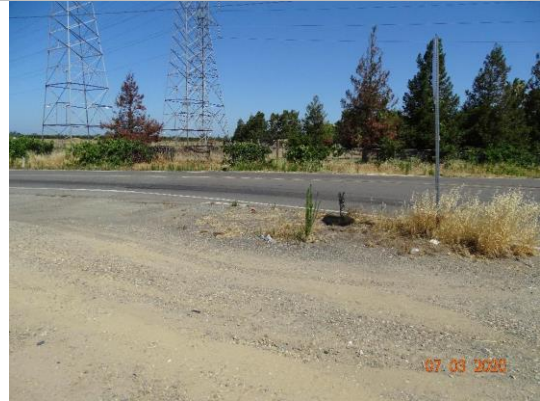
Photo 3 of 3 : UCIP_FA_2024_79076_86998.jpg

View of LS and pipe inlet.

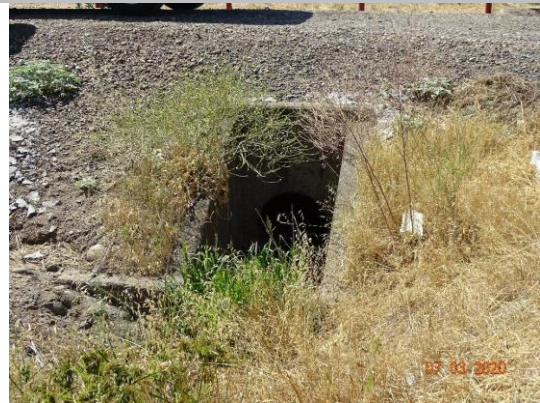
Photo 1 of 3 : UCIP_FA_2024_79077_87021.jpg

DS_ID:23878
 FS_ID:79077
 EP_NO: N/A
 Repair Type: Non-Urgent
 EVAL Issue:
 Crossing Status: Found
 UCIP Comments: 07/03/2020 Crossing evaluated as "Non-Urgent" because there was no permit found authorizing this pipe. (A. McDonald - DWR UCIP)
 FIELD_STRUCT_DESC: 24-inch corrugated metal drainage pipe through the levee, 5 feet below the crown. Concrete U-shaped headwall on both ends. Flap gate on the waterside (WS) end. Cobble grouted outlet. Cobble grouted intake on the landside (LS). [Additional Reference(s): DWR Levee Log, 1978, (HLM 2.24). USACE San Joaquin O&M Manual 612.2, 1967, (HLM 2.24), 24-inch pipe listed].
 FS Date: 7/3/2020

View of pipe inlet and headwall located at the LS levee toe.

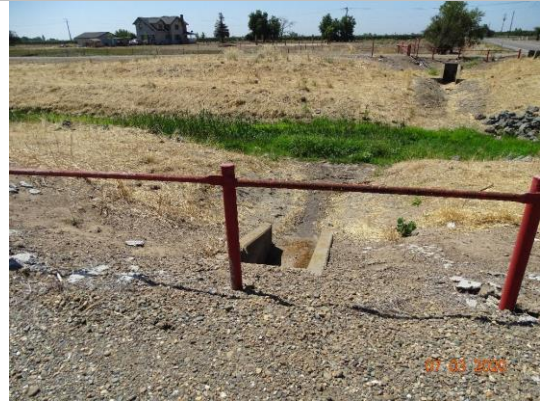
Photo 2 of 3 : UCIP_FA_2024_79077_87022.jpg

View of pipe outlet, WS channel, and opposite levee looking from the levee crown.

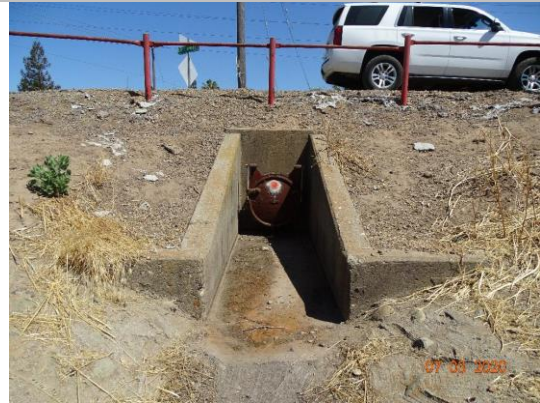
Photo 3 of 3 : UCIP_FA_2024_79077_87023.jpg

View of pipe outlet, flap gate, and headwall located at the WS levee toe.

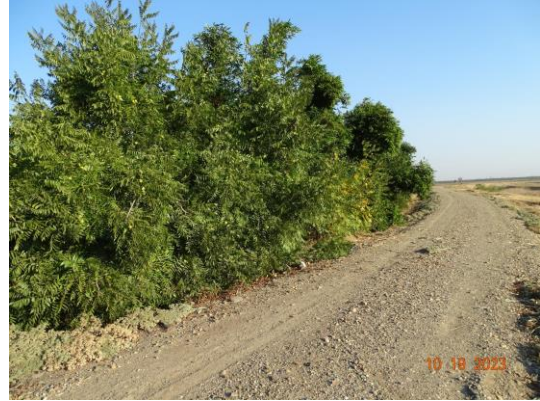
Photo 1 of 1 : FA_2024_NA0017_155_49_20240910_00007.jpg

LM Start	2.33	Rating **	U	Issue No.	49
LM End	2.33	Issue Type +	Ma	Location *	LS
Category	Earthen Levee			GPS Latitude/Longitude	
				Start	End
Item	Vegetation			38.118393°	38.118393°
				-121.148896°	-121.148896°
DWR ID	DWR_NA0017_11_f_2022_49				
Comment Code					
V2 : Remove the wild growth and woody vegetation other than native grasses from the levee slopes.					
Inspector Comment					
There is arundo on the landside slope.

View of Arundo and wild growth blocking the view of landside slope and easement. Fall 2023

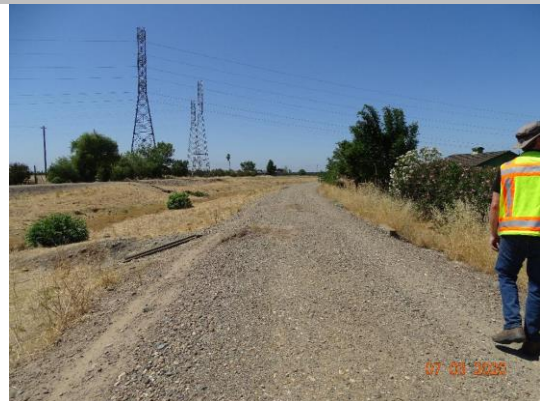
Photo 1 of 3 : UCIP_FA_2024_79078_87027.jpg

Comment Code						
Inspector Comment						
DS_ID:23886						
FS_ID:79078						
EP_NO: N/A						
Repair Type: Non-Urgent						
EVAL Issue:						
Crossing Status: Found						
UCIP Comments: 07/03/2020 Crossing evaluated as "Non-Urgent" because there was no permit found authorizing this pipe. (A. McDonald - DWR UCIP)						
FIELD_STRUCT_DESC: 24-inch corrugated metal drainage pipe through the levee, 4.5 feet below the crown. Concrete U-shaped headwall on both ends. Flap gate on the waterside (WS) end. Cobble grouted outlet. Cobble grouted intake on the landside (LS). [Additional Reference(s): DWR Levee Log, 1978, (HLM 2.44). USACE San Joaquin O&M Manual 612.2, 1967, (HLM 2.44), 24-inch pipe listed].						
FS Date: 7/3/2020

Overview of levee crown looking d/s.

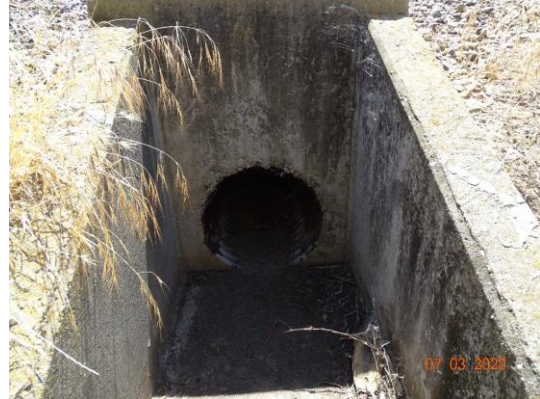
Photo 2 of 3 : UCIP_FA_2024_79078_87028.jpg

View of pipe inlet and headwall located at the LS levee toe.

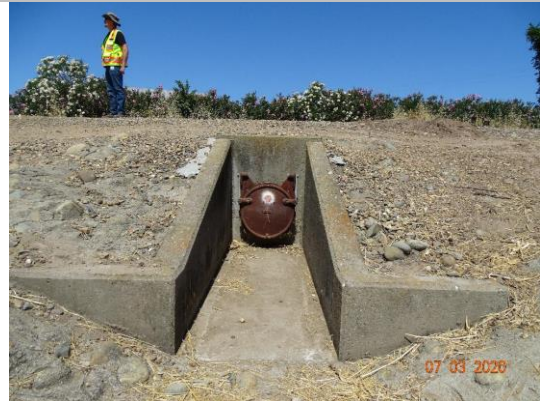
Photo 3 of 3 : UCIP_FA_2024_79078_87029.jpg

View of pipe outlet, flap gate, and headwall located at the WS levee toe.

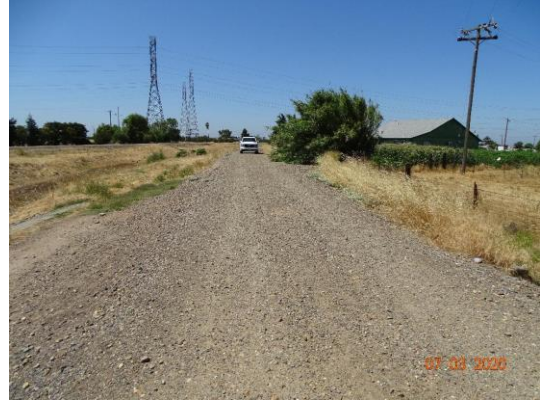
Photo 1 of 3 : UCIP_FA_2024_79079_87030.jpg

Comment Code					
Inspector Comment					
DS_ID:23887 FS_ID:79079 EP_NO: N/A Repair Type: Non-Urgent EVAL Issue: Crossing Status: Found UCIP Comments: 07/03/2020 Crossing evaluated as "Non-Urgent" because there was no permit found authorizing this pipe. (A. McDonald - DWR UCIP) FIELD_STRUCT_DESC: 24-inch corrugated metal drainage pipe through the levee, 5.5 feet below the crown. Concrete U-shaped headwall on both ends. Flap gate on the waterside (WS) end. Cobble grouted outlet. Cobble grouted intake on the landside (LS). [Additional Reference(s): DWR Levee Log, 1978, (HLM 2.48). USACE San Joaquin O&M Manual 612.2, 1967, (HLM 2.48), 24-inch pipe listed]. FS Date: 7/3/2020

Overview of levee crown looking d/s.

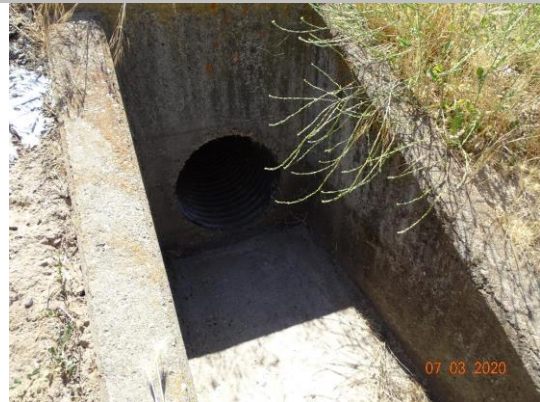
Photo 2 of 3 : UCIP_FA_2024_79079_87031.jpg

View of pipe inlet and headwall located at the LS levee toe.

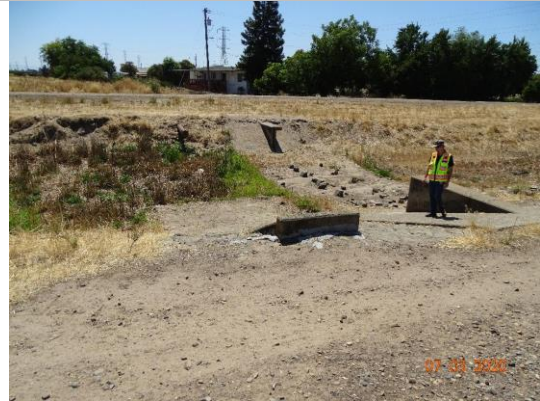
Photo 3 of 3 : UCIP_FA_2024_79079_87032.jpg

View of pipe outlet and channel located on the WS.

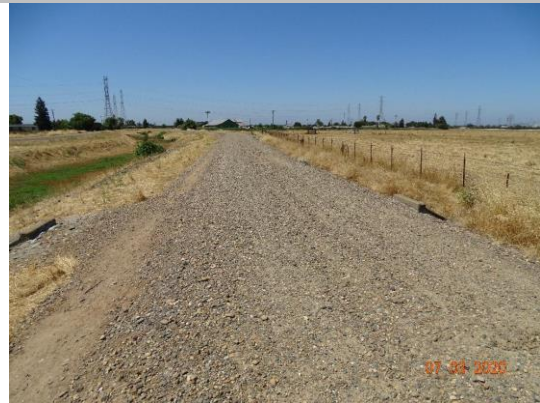
Photo 1 of 3 : UCIP_FA_2024_79080_87034.jpg

DS_ID:23888
FS_ID:79080
EP_NO: N/A
Repair Type: Non-Urgent
EVAL Issue: 5, Pipe Damage
Crossing Status: Found
UCIP Comments: 09/25/2024 DMP internal video inspection has found moderate pipe defects. Crossing will be monitored until funding becomes available for rehabilitation. (O. Yakimov - DWR UCIP)
07/03/2020 Crossing evaluated as "Non-Urgent" because there was no permit found authorizing this pipe. Video inspection performed on 04-22-2020. (A. McDonald - DWR UCIP)
FIELD_STRUCT_DESC: 24-inch corrugated metal drainage pipe through the levee, 6 feet below the crown. Concrete U-shaped headwall on both ends. Flap gate on the waterside (WS) end. Cobble grouted outlet. Cobble grouted intake on the landside (LS). [Additional Reference(s): DWR Levee Log, 1978, (HLM 2.58). USACE San Joaquin O&M Manual 612.2, 1967, (HLM 2.58), 24-inch pipe listed].
FS Date: 7/3/2020

Overview of levee crown looking d/s.

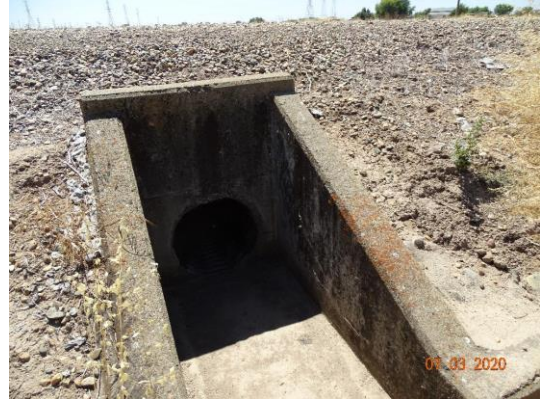
Photo 2 of 3 : UCIP_FA_2024_79080_87035.jpg

View of pipe inlet and headwall located at the LS levee toe.

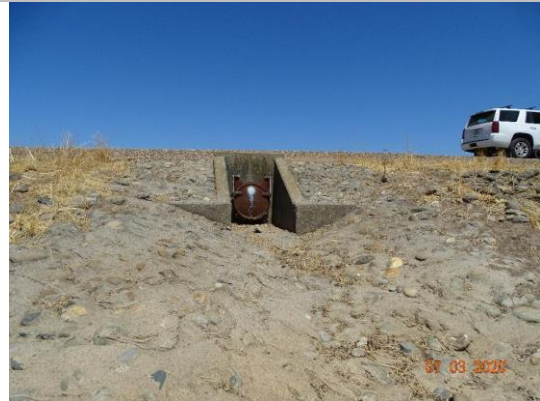
Photo 3 of 3 : UCIP_FA_2024_79080_87036.jpg

View of pipe outlet, flap gate, headwall, and splash apron located on the WS levee slope.

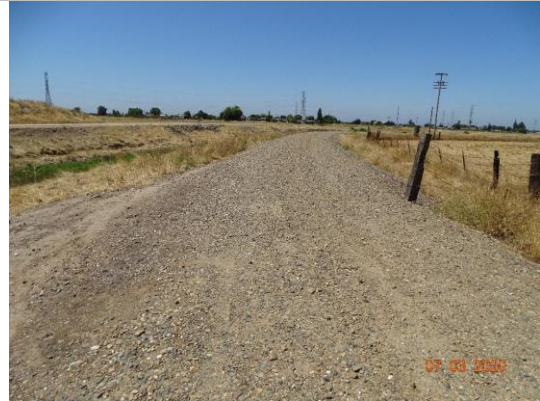
Photo 1 of 3 : UCIP_FA_2024_79081_87045.jpg

Comment Code						
Inspector Comment						
DS_ID:23890 FS_ID:79081 EP_NO: N/A Repair Type: Non-Urgent EVAL Issue: 5, Pipe Damage Crossing Status: Found UCIP Comments: 07/03/2020 Crossing evaluated as "No Action Needed." Permit and inspection requirements have been met. Video inspection performed on 04-22-2020. (A. McDonald - DWR UCIP) FIELD_STRUCT_DESC: 36-inch corrugated metal drainage pipe (CMP) through the levee, 7.0 feet below the crown. Concrete U-shaped headwall on both ends. Flap gate on the waterside (WS) end. Cobble grouted outlet. Cobble grouted intake on the landside (LS). (Installation of a positive closure device on intake end authorized under Permit No. 17426, 2003 - Western Dairy Design Associates, Inc, alterations were cancelled according to a note in the permit for site D.6). [Additional Reference(s): DWR Levee Log, 1978, (HLM 2.73). USACE San Joaquin O&M Manual 612.2, 1967, (HLM 2.73), 36-inch pipe listed]. FS Date: 7/3/2020

Overview of levee crown looking d/s.

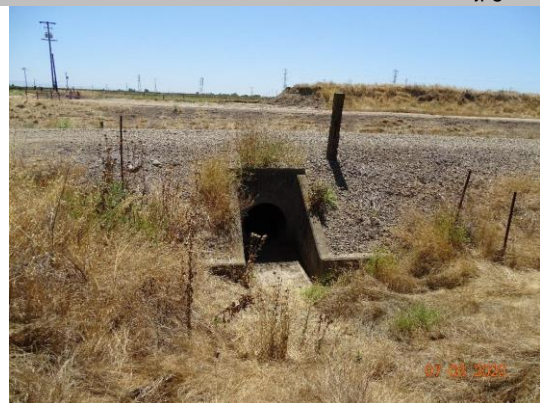
Photo 2 of 3 : UCIP_FA_2024_79081_87046.jpg

View of pipe inlet and headwall located at the LS levee toe.

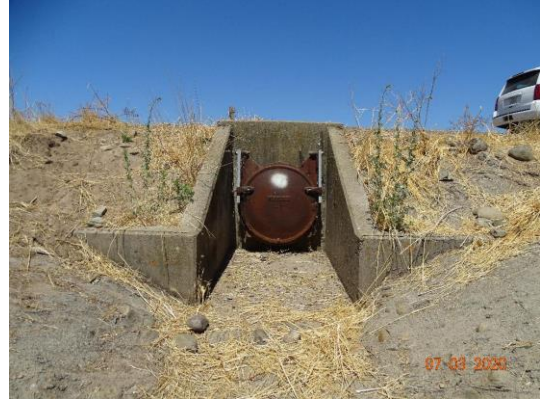
Photo 3 of 3 : UCIP_FA_2024_79081_87047.jpg

View of pipe outlet, flap gate, headwall, and splash apron located at the WS levee toe.

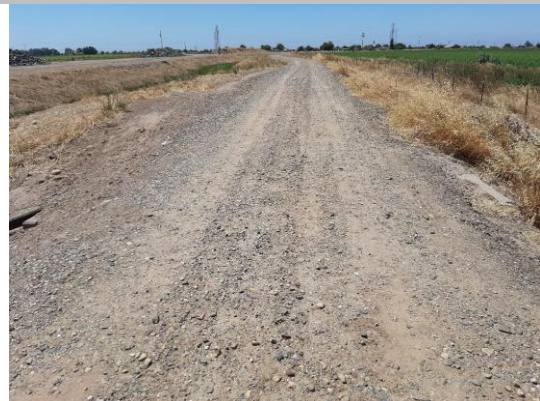
Photo 1 of 3 : UCIP_FA_2024_79082_87048.jpg

DS_ID:23891
FS_ID:79082
EP_NO: N/A
Repair Type: Non-Urgent
EVAL Issue:
Crossing Status: Found
UCIP Comments: 07/03/2020 Crossing evaluated as "Non-Urgent" because there was no permit found authorizing this pipe. Video inspection performed on 04-22-2020. (A. McDonald - DWR UCIP)
FIELD_STRUCT_DESC: 24-inch corrugated metal drainage pipe through the levee, 6 feet below the crown. Concrete U-shaped headwall on both ends. Flap gate on the waterside (WS) end. Cobble grouted outlet. Cobble grouted intake on the landside (LS). (Installation of a positive closure device on intake end authorized under Permit No. 17426, 2003 - Western Dairy Design Associates, Inc). [Additional Reference(s): DWR Levee Log, 1978, (HLM 2.88). USACE San Joaquin O&M Manual 612.2, 1967, (HLM 2.88), 24-inch pipe listed].
FS Date: 7/3/2020

Overview of levee crown looking d/s.

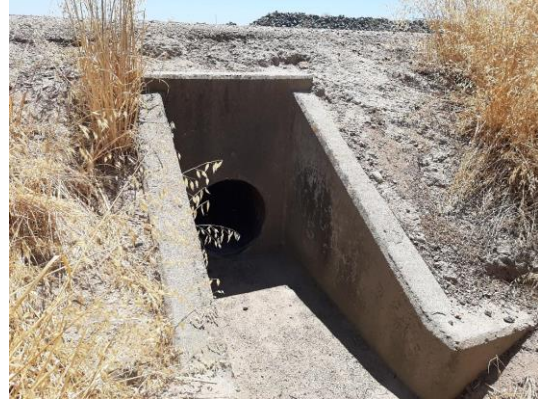
Photo 2 of 3 : UCIP_FA_2024_79082_87049.jpg

View of pipe inlet and headwall located at the LS levee toe.

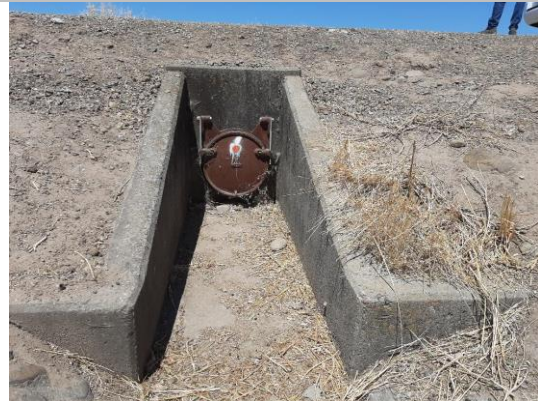
Photo 3 of 3 : UCIP_FA_2024_79082_87050.jpg

View of pipe outlet, flap gate, and headwall located at the WS levee toe.

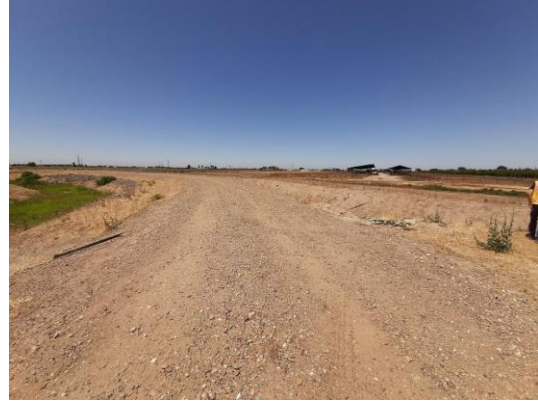
Photo 1 of 3 : UCIP_FA_2024_84748_87054.jpg

Comment Code					
Inspector Comment					
DS_ID:23892 FS_ID:84748 EP_NO: N/A Repair Type: Non-Urgent EVAL Issue: 5, Pipe Damage Crossing Status: Found UCIP Comments: 09/05/2024 Pipe abandonmet was not complted as authorized in permit. DMP internal video inspection has found moderate pipe defects. Crossing will be monitored until funding becomes available for rehabilitation. (O. Yakimov - DWR UCIP) 07/03/2020 Crossing evaluated as "No Action Needed" because this is an abandoned encroachment. Video inspection performed on 02-21-2020. (A. McDonald - DWR UCIP) 06/11/2014 Pipe abandoned and if so should be done so properly. Verify if possible pipe filled with concrete. (DWR UCIP) FIELD_STRUCT_DESC: *ABANDONED* 24-inch corrugated metal drainage pipe through the levee, 6.5 feet below the crown. Concrete U-shaped headwall on both ends. Flap gate on the waterside (WS) end. Cobble grouted outlet. Cobble grouted intake on the landside (LS). (Plugging the Intake end and filling the pipe with concrete authorized under Permit No. 17426, 2003 - Western Dairy Design Associates, Inc). [Additional Reference(s): DWR Levee Log, 1978, (HLM 3.04). USACE San Joaquin O&M Manual 612.2, 1967, (HLM 3.04), 24-inch pipe listed]. FS Date: 7/3/2020

Overview of levee crown looking d/s.

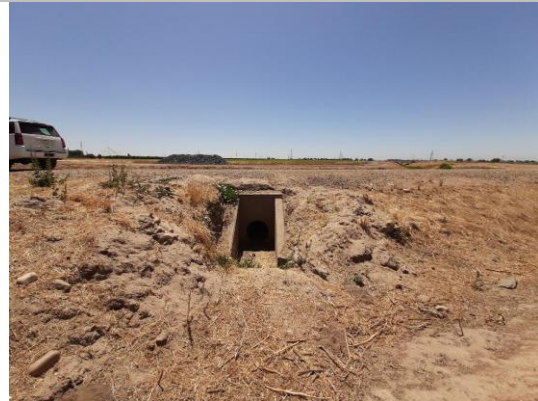
Photo 2 of 3 : UCIP_FA_2024_84748_87055.jpg

View of pipe inlet and headwall located at the LS levee toe.

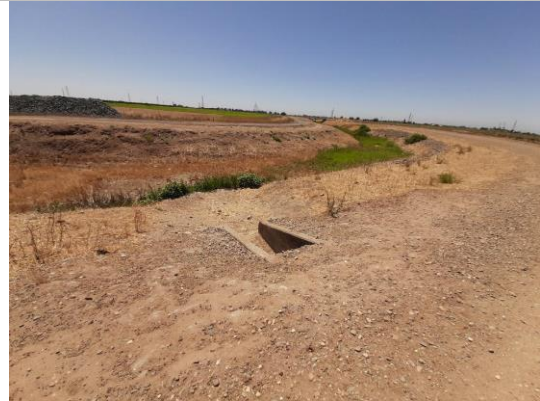
Photo 3 of 3 : UCIP_FA_2024_84748_87056.jpg

View of pipe outlet and WS channel.

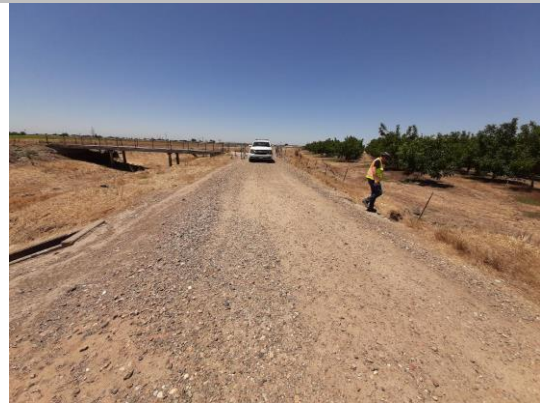
Photo 1 of 3 : UCIP_FA_2024_78626_87058.jpg

DS_ID:23893
FS_ID:78626
EP_NO: N/A
Repair Type: Non-Urgent
EVAL Issue: 5, Pipe Damage
Crossing Status: Found
UCIP Comments: 09/25/2024 DMP internal video inspection has found moderate pipe defects. Crossing will be monitored until funding becomes available for rehabilitation. (O. Yakimov - DWR UCIP)
07/03/2020 Crossing evaluated as "Non-Urgent" because there was no permit found authorizing this pipe. (A. McDonald - DWR UCIP)
FIELD_STRUCT_DESC: 24-inch corrugated metal drainage pipe through the levee, 4.6 feet below the crown. Flap gate on the waterside (WS) end. [Additional Reference(s): DWR Levee Log, 1978, (HLM 3.15). USACE San Joaquin O&M Manual 612.2, 1967, (HLM 3.15), 24-inch pipe listed].
FS Date: 7/3/2020

Overview of levee crown looking d/s.

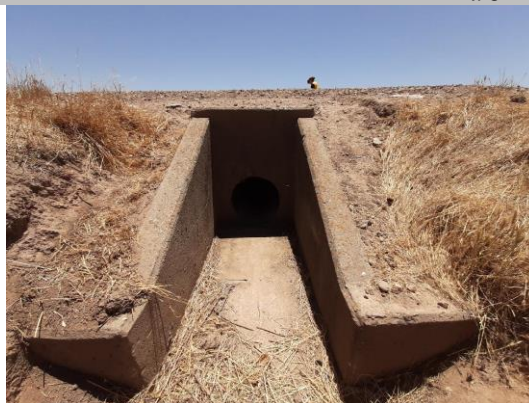
Photo 2 of 3 : UCIP_FA_2024_78626_87059.jpg

View of pipe inlet and headwall located at the LS levee toe.

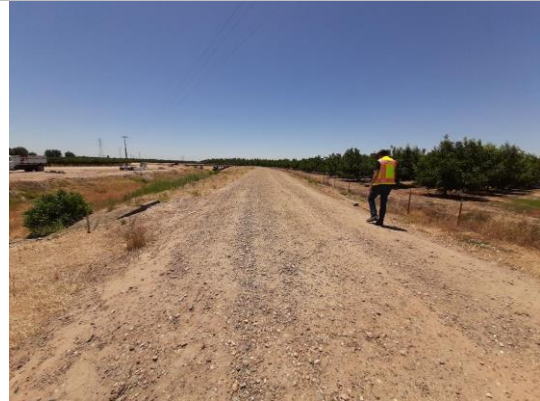
Photo 1 of 3 : UCIP_FA_2024_79084_87065.jpg

Comment Code					
Inspector Comment					
DS_ID:23895 FS_ID:79084 EP_NO: N/A Repair Type: Non-Urgent EVAL Issue: Crossing Status: Found UCIP Comments: 07/03/2020 Crossing evaluated as "Non-Urgent" because there was no permit found authorizing this pipe. (A. McDonald - DWR UCIP) FIELD_STRUCT_DESC: 24-inch corrugated metal drainage pipe through the levee, 5 feet below the crown. Concrete U-shaped headwall on both ends. Flap gate on the waterside (WS) end. Cobble grouted outlet. Cobble grouted intake on the landside (LS). [Additional Reference(s): DWR Levee Log, 1978, (HLM 3.47). USACE San Joaquin O&M Manual 612.2, 1967, (HLM 3.47), 24-inch pipe listed]. FS Date: 7/3/2020

Overview of levee crown looking d/s.

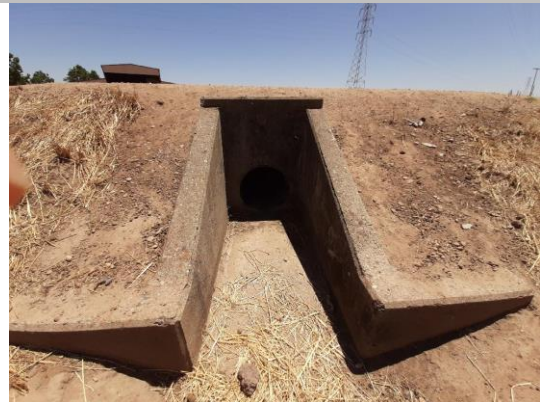
Photo 2 of 3 : UCIP_FA_2024_79084_87066.jpg

View of pipe inlet and headwall located at the LS levee toe.

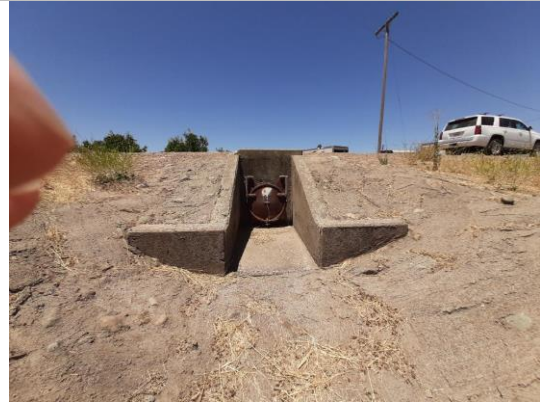
Photo 3 of 3 : UCIP_FA_2024_79084_87067.jpg

View of pipe outlet, flap gate, and headwall located at the WS levee toe.

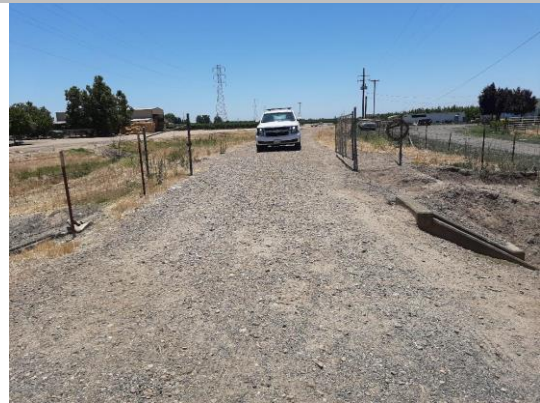
Photo 1 of 3 : UCIP_FA_2024_79085_87068.jpg

DS_ID:23896
 FS_ID:79085
 EP_NO: N/A
 Repair Type: Non-Urgent
 EVAL Issue:
 Crossing Status: Found
 UCIP Comments: 07/03/2020 Crossing evaluated as "Non-Urgent" because there was no permit found authorizing this pipe. Video inspection performed on 04-22-2020. (A. McDonald - DWR UCIP)
 FIELD_STRUCT_DESC: 24-inch corrugated metal drainage pipe through the levee, 4.5 feet below the crown. Concrete U-shaped headwall on both ends. Flap gate on the waterside (WS) end. Cobble grouted outlet. Cobble grouted intake on the landside (LS). [Additional Reference(s): DWR Levee Log, 1978, (HLM 3.55). USACE San Joaquin O&M Manual 612.2, 1967, (HLM 3.55), 24-inch pipe listed].
 FS Date: 7/3/2020

Overview of levee crown looking d/s.

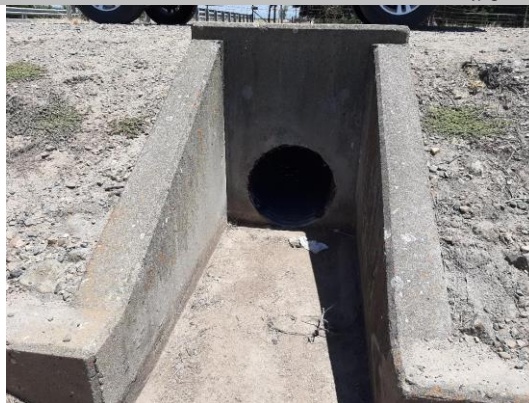
Photo 2 of 3 : UCIP_FA_2024_79085_87069.jpg

View of pipe inlet and headwall located at the LS levee toe.

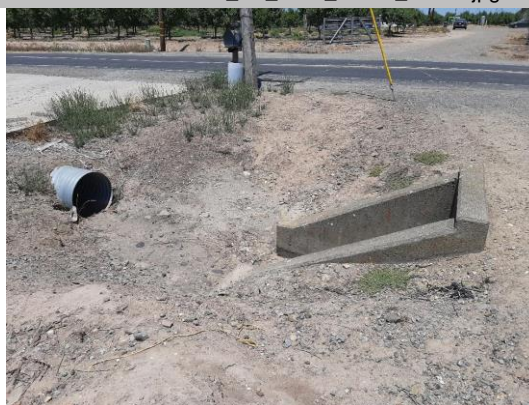
Photo 3 of 3 : UCIP_FA_2024_79085_87070.jpg

Drainage pipe under driveway leading to the inlet at the LS levee toe.

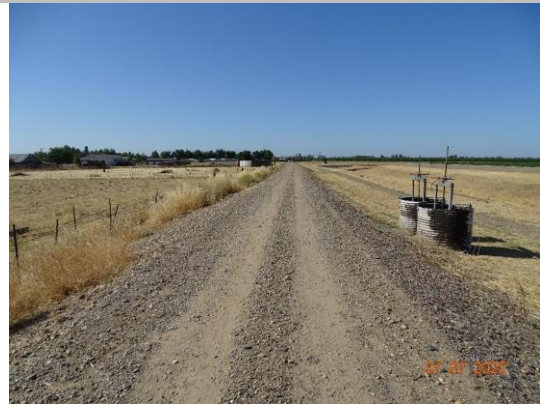
Photo 1 of 3 : UCIP_FA_2024_78630_87072.jpg

Comment Code					
Inspector Comment					
DS_ID:23925 FS_ID:78630 EP_NO: N/A Repair Type: Non-Urgent EVAL Issue: Crossing Status: Found UCIP Comments: 07/07/2020 Crossing evaluated as "Non-Urgent" because there was no permit found authorizing this pipe. Video inspection performed on 05-07-2020. (A. McDonald - DWR UCIP Gate valve rusted in place. No lid or cover on Standpipe on WS slope. FIELD_STRUCT_DESC: 1 of 2: 42-inch corrugated metal drainage pipe through the levee, 7.0 feet below the crown. Slide gate in a 56-inch corrugated metal riser unit on the waterside (WS) slope. Flap gate on the WS end. Concrete headwall on both ends. [Additional Reference(s): DWR Levee Log, 1978, (HLM 0.14). USACE San Joaquin O&M Manual 612.2, 1967, (HLM 0.14) 36-inch pipe listed]. FS Date: 7/7/2020

Overview of levee crown looking d/s.

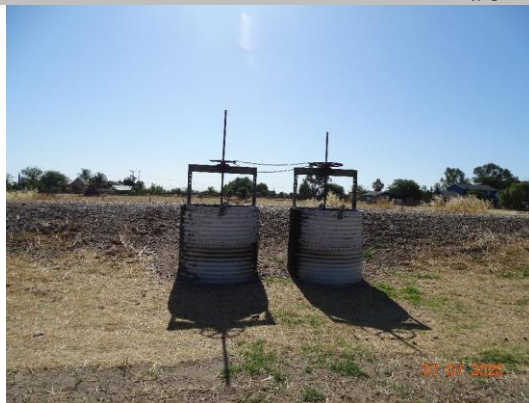
Photo 2 of 3 : UCIP_FA_2024_78630_87073.jpg

Two risers with gate valves located on the WS levee slope.

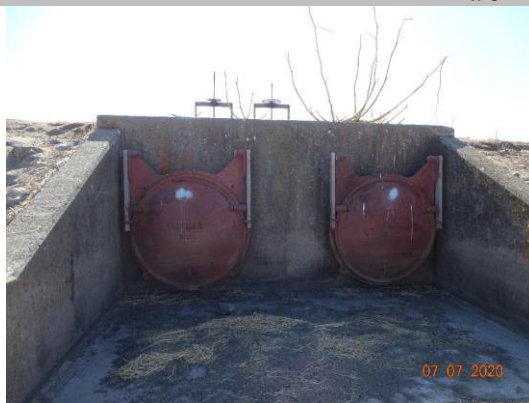
Photo 3 of 3 : UCIP_FA_2024_78630_87074.jpg

Two pipe outlets, flap gates, and headwall located on the WS berm.

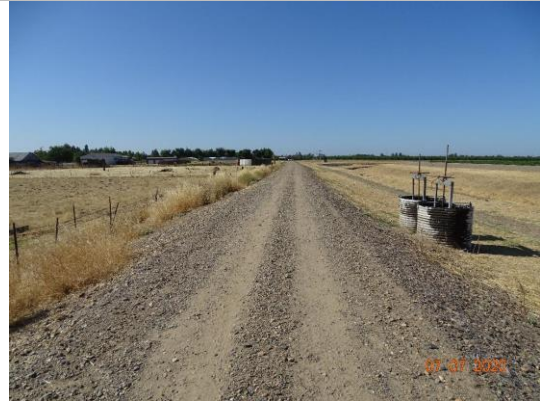
Photo 1 of 3 : UCIP_FA_2024_78631_87076.jpg

Comment Code					
Inspector Comment					
DS_ID:23930 FS_ID:78631 EP_NO: N/A Repair Type: Non-Urgent EVAL Issue: Crossing Status: Found UCIP Comments: 07/07/2020 Crossing evaluated as "Non-Urgent" because there was no permit found authorizing this pipe. (A. McDonald - DWR UCIP) 06/12/2014 No lid on riser and slide gate actuator rusted in place. (DWR UCIP) FIELD_STRUCT_DESC: 2 of 2: 42-inch corrugated metal drainage pipe through the levee, 7.0 feet below the crown. Slide gate in 56-inch corrugated metal riser unit on the waterside (WS) slope. Flap gate on the WS end. [Additional Reference(s): DWR Levee Log, 1978, (HLM 0.14). USACE San Joaquin O&M Manual 612.2, 1967, (HLM 0.14) 36-inch pipe listed]. FS Date: 7/7/2020

Overview of levee crown looking d/s.

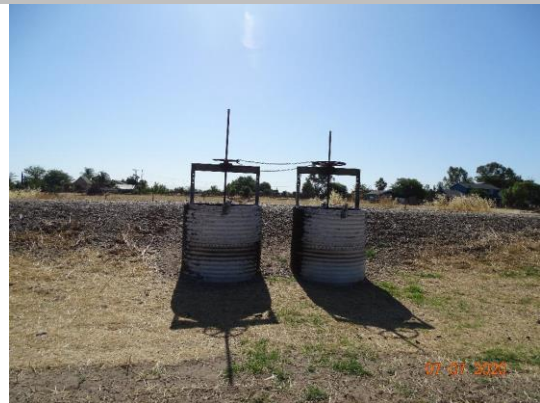
Photo 2 of 3 : UCIP_FA_2024_78631_87077.jpg

Two risers and gate valves located on the WS levee slope.

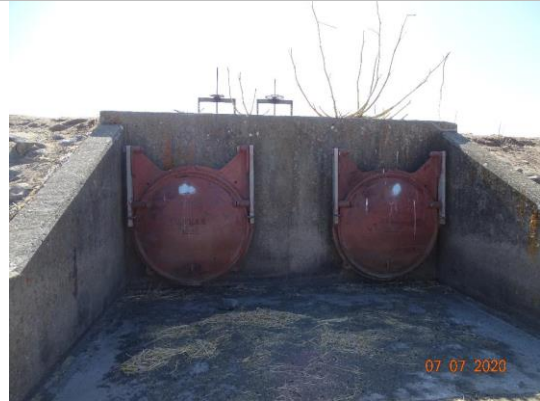
Photo 3 of 3 : UCIP_FA_2024_78631_87078.jpg

Two pipe outlets, flap gates, and headwall located on the WS berm.

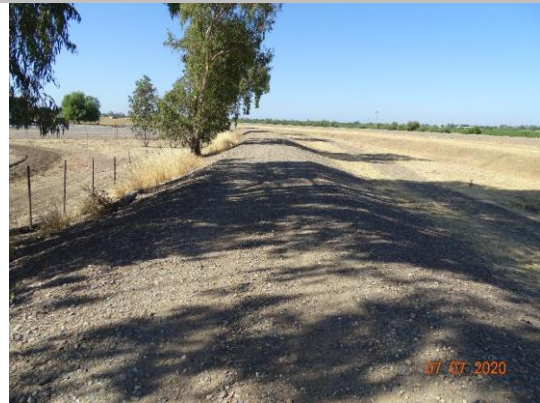
Photo 1 of 3 : UCIP_FA_2024_79096_87080.jpg

DS_ID:23900
 FS_ID:79096
 EP_NO: N/A
 Repair Type: Non-Urgent
 EVAL Issue:
 Crossing Status: Found
 UCIP Comments: 07/07/2020 Crossing evaluated as "Non-Urgent" because there was no permit found authorizing this pipe. (A. McDonald - DWR UCIP)
 FIELD_STRUCT_DESC: 24-inch corrugated metal drainage pipe through the levee, 6.5 feet below the crown. Concrete U-shaped headwall on both ends. Flap gate on the waterside (WS) end. Cobble grouted outlet. Cobble grouted intake on the landside (LS). [Additional Reference(s): DWR Levee Log, 1978, (HLM 0.40). USACE San Joaquin O&M Manual 612.2, 1967, (HLM 0.40), 24-inch pipe listed].
 FS Date: 7/7/2020

Overview of levee crown looking d/s.

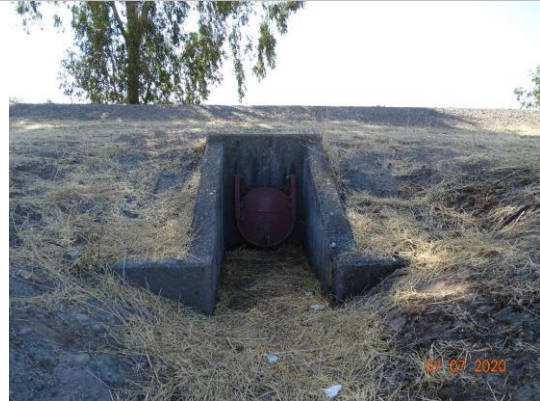
Photo 2 of 3 : UCIP_FA_2024_79096_87081.jpg

View of pipe outlet, flap gate, and headwall located on the WS berm.

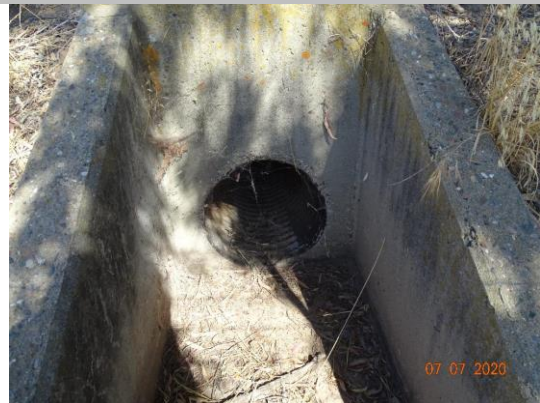
Photo 3 of 3 : UCIP_FA_2024_79096_87082.jpg

View of pipe inlet and headwall located at the LS levee toe.

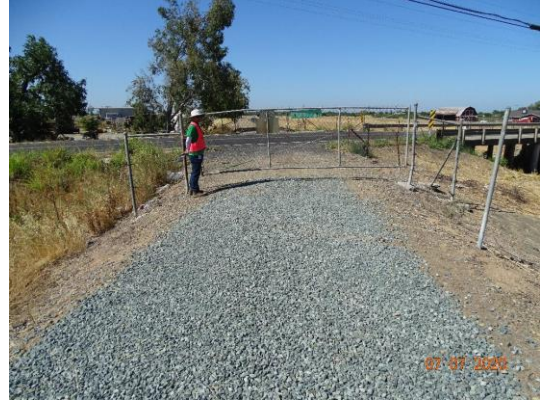
Photo 1 of 3 : UCIP_FA_2024_79097_87089.jpg

Comment Code					
Inspector Comment					
DS_ID:23901 FS_ID:79097 EP_NO: N/A Repair Type: Non-Urgent EVAL Issue: Crossing Status: Found UCIP Comments: 07/07/2020 Crossing evaluated as "Non-Urgent" because there was no permit found authorizing this pipe. (A. McDonald - DWR UCIP) FIELD_STRUCT_DESC: 24-inch corrugated metal drainage pipe through the levee, 7 feet below the crown. Concrete U-shaped headwall on both ends. Flap gate on the waterside (WS) end. Cobble grouted outlet. Cobble grouted intake on the landside (LS) end. [Additional Reference(s): DWR Levee Log, 1978, (HLM 0.48). USACE San Joaquin O&M Manual 612.2, 1967, (HLM 0.48), 24-inch pipe listed]. FS Date: 7/7/2020

Overview of levee crown looking d/s.
