**Flood Control Project Maintenance
Levee Inspections****Maintenance Issue Types Only, Levee Inspection Report By Mile - Fall 2024****San Joaquin County Flood Control and Water Conservation District**

Waterway	Bank	Unit Miles	Inspection Start/End	Inspector
Unit No. 01 Littlejohn Creek	Left	2.59	10/21/2024 10/21/2024	Alberto De Leon

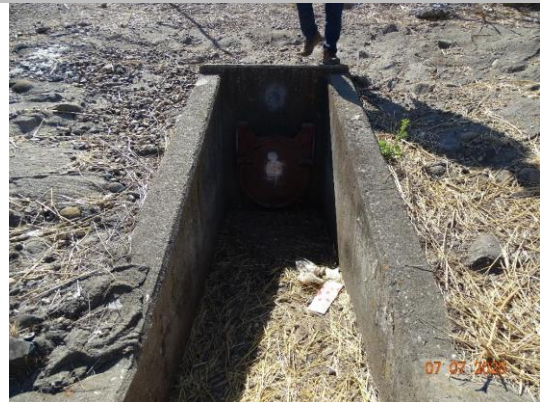
Photo 2 of 3 : UCIP_FA_2024_79097_87090.jpg

View of pipe outlet, flap gate, and headwall located at the WS levee toe.

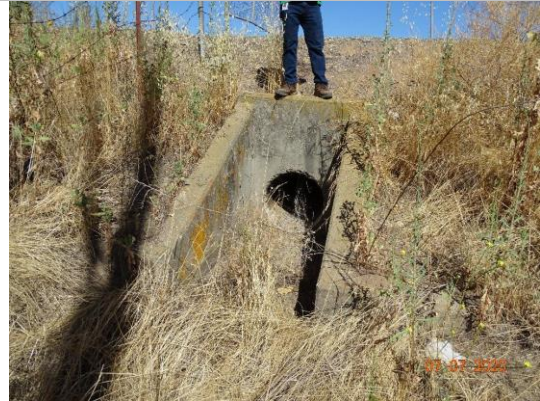
Photo 3 of 3 : UCIP_FA_2024_79097_87091.jpg

View of pipe inlet and headwall located at the LS levee toe.

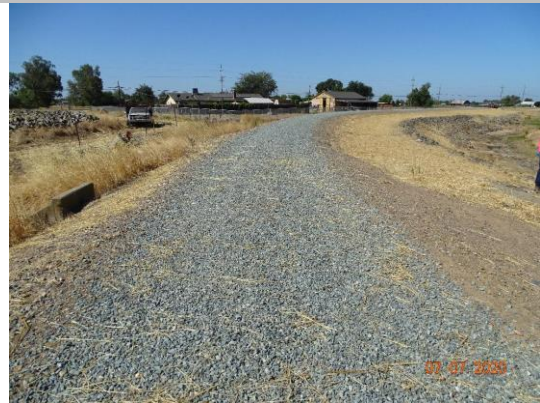
Photo 1 of 3 : UCIP_FA_2024_79098_87092.jpg

DS_ID:23902
FS_ID:79098
EP_NO: N/A
Repair Type: Non-Urgent
EVAL Issue:
Crossing Status: Found
UCIP Comments: 07/07/2020 Crossing evaluated as "Non-Urgent" because there was no permit found authorizing this pipe. (A. McDonald - DWR UCIP)
FIELD_STRUCT_DESC: 24-inch corrugated metal drainage pipe through the levee, 4 feet below the crown. Concrete U-shaped headwall on both ends. Flap gate on the waterside (WS) end. Cobble grouted outlet. Cobble grouted intake on the landside (LS). [Additional Reference(s): DWR Levee Log, 1978, (HLM 0.61). USACE San Joaquin O&M Manual 612.2, 1967, (HLM 0.61), 24-inch pipe listed].
FS Date: 7/7/2020

Overview of levee crown looking d/s.

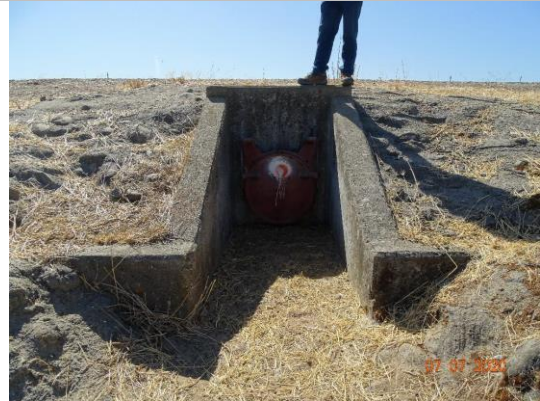
Photo 2 of 3 : UCIP_FA_2024_79098_87093.jpg

View of pipe outlet, flap gate, and headwall located at the WS levee toe.

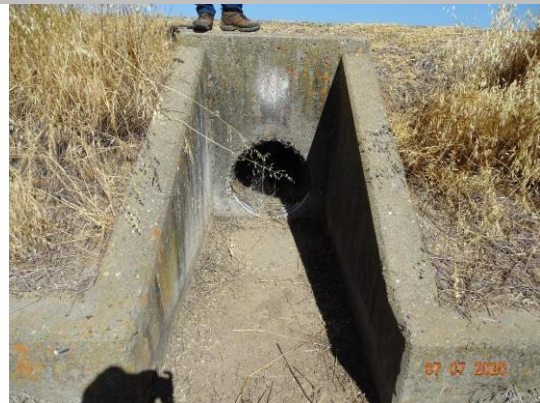
Photo 3 of 3 : UCIP_FA_2024_79098_87094.jpg

View of pipe inlet and headwall located at the LS levee toe.

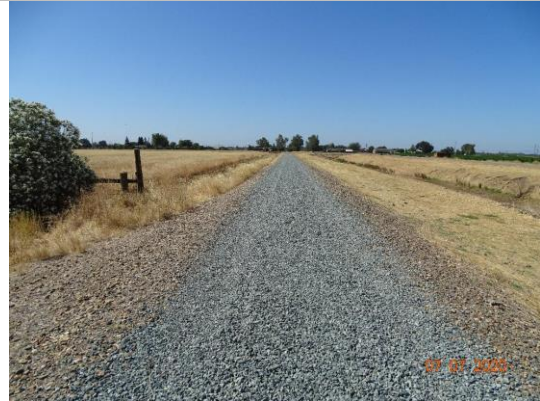
Photo 1 of 3 : UCIP_FA_2024_79099_87095.jpg

Comment Code						
Inspector Comment						
DS_ID:23903 FS_ID:79099 EP_NO: N/A Repair Type: Non-Urgent EVAL Issue: Crossing Status: Found UCIP Comments: 07/07/2020 Crossing evaluated as "Non-Urgent" because there was no permit found authorizing this pipe. Video inspection performed on 04-24-2020. (A. McDonald - DWR UCIP) FIELD_STRUCT_DESC: 24-inch corrugated metal drainage pipe through the levee, 5.5 feet below the crown. Concrete U-shaped headwalls on both ends. Flap gate on the waterside (WS) end. Cobble grouted outlet. Cobble grouted intake on the landside (LS) end. [Additional Reference(s): DWR Levee Log, 1978, (HLM 0.77). USACE San Joaquin O&M Manual 612.2, 1967, (HLM 0.77), 24-inch pipe listed]. FS Date: 7/7/2020

Overview of levee crown looking d/s.

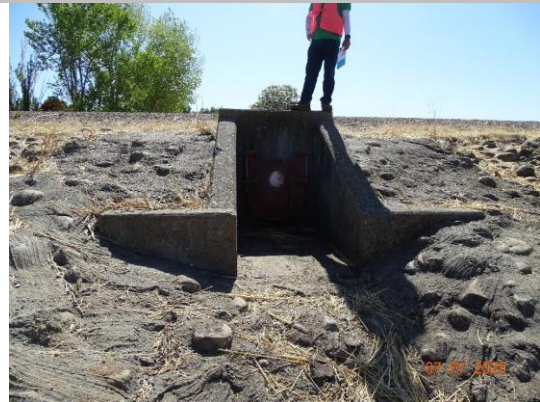
Photo 2 of 3 : UCIP_FA_2024_79099_87096.jpg

View of pipe outlet, flap gate, headwall, and splash apron located on the WS berm.

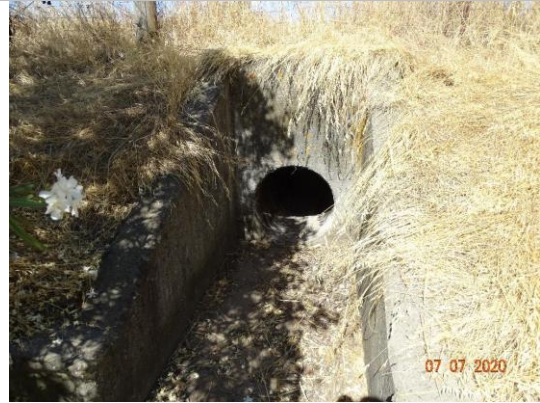
Photo 3 of 3 : UCIP_FA_2024_79099_87097.jpg

View of pipe inlet and headwall located at the LS levee toe.

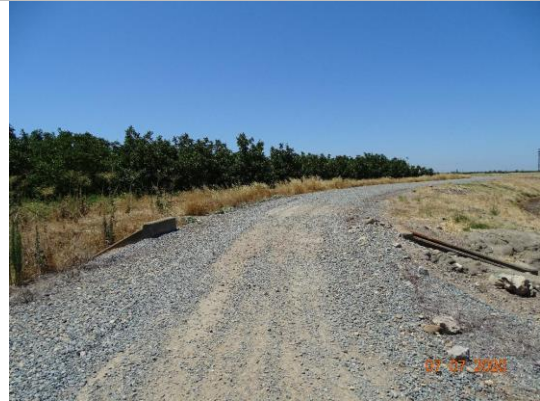
Photo 1 of 3 : UCIP_FA_2024_79100_87098.jpg

Comment Code						
Inspector Comment						
DS_ID:23904 FS_ID:79100 EP_NO: N/A Repair Type: Non-Urgent EVAL Issue: Crossing Status: Found UCIP Comments: 07/07/2020 Crossing evaluated as "Non-Urgent" because there was no permit found authorizing this pipe. (A. McDonald - DWR UCIP) FIELD_STRUCT_DESC: 24-inch corrugated metal drainage pipe through the levee, 2 feet below the crown. Concrete U-shaped headwalls on both ends. Flap gate on the waterside (WS) end. Cobble grouted outlet. Cobble grouted intake on the landside (LS). [Additional Reference(s): DWR Levee Log, 1978, (HLM 1.51). USACE San Joaquin O&M Manual 612.2, 1967, (HLM 1.51), 24-inch pipe listed]. FS Date: 7/7/2020

Overview of levee crown looking d/s.

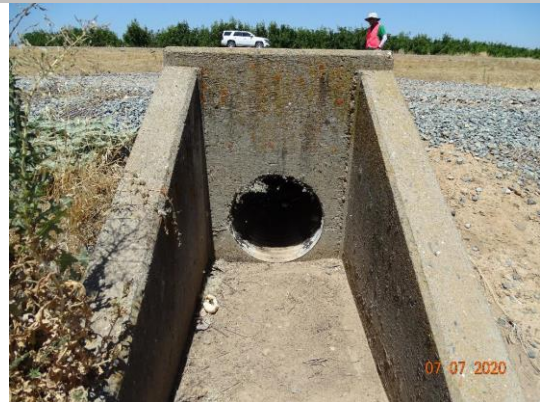
Photo 2 of 3 : UCIP_FA_2024_79100_87099.jpg

View of pipe inlet and headwall located at the LS levee toe.

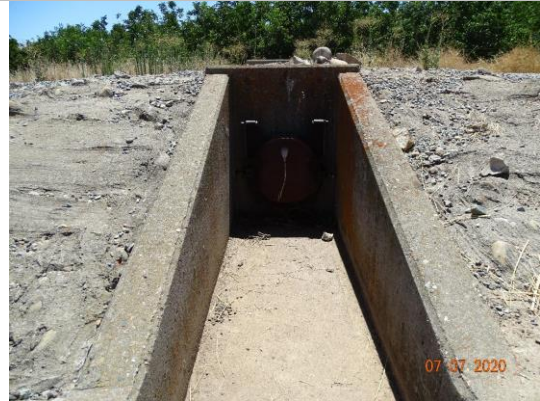
Photo 3 of 3 : UCIP_FA_2024_79100_87100.jpg

View of pipe outlet, flap gate, and headwall located on the WS berm.

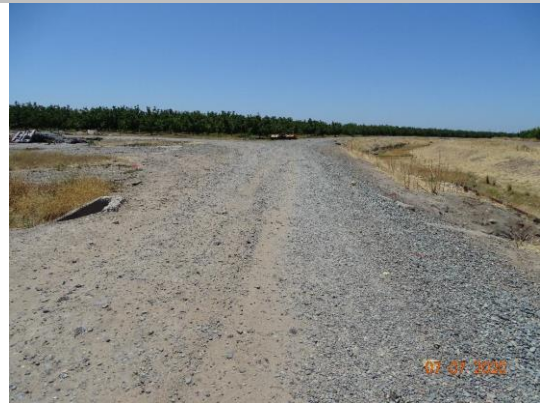
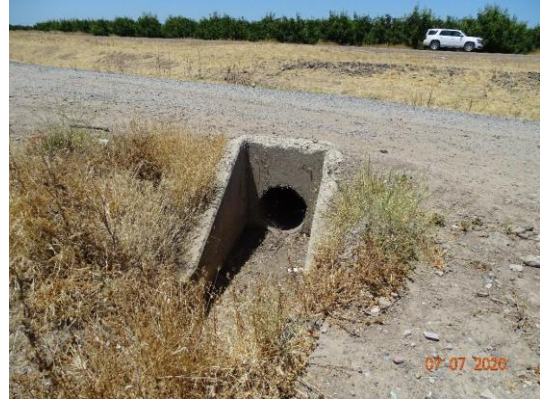
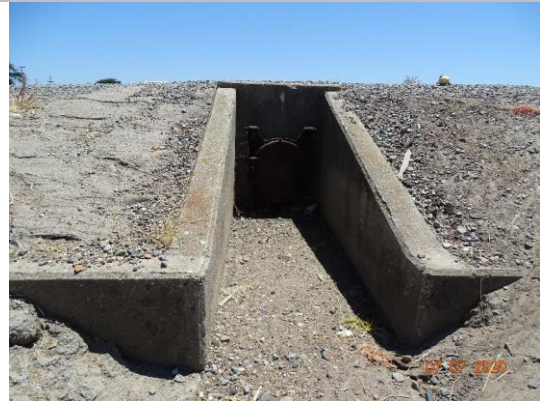
Photo 1 of 3 : UCIP_FA_2024_79101_87101.jpg

DS_ID:23905
 FS_ID:79101
 EP_NO: N/A
 Repair Type: Non-Urgent
 EVAL Issue:
 Crossing Status: Found
 UCIP Comments: 07/07/2020 Crossing evaluated as "Non-Urgent" because there was no permit found authorizing this pipe. Pipe inlet is clear of debris. (A. McDonald - DWR UCIP)
 06/12/2014 Pipe is covered with soil at inlet on LS. (DWR UCIP)
 FIELD_STRUCT_DESC: 24-inch corrugated metal drainage pipe through the levee, 3.5 feet below the crown. Concrete U-shaped headwalls on both ends. Flap gate on the waterside (WS) end. Cobble grouted outlet. Cobble grouted intake on the landside (LS). [Additional Reference(s): DWR Levee Log, 1978, (HLM 1.90). USACE San Joaquin O&M Manual 612.2, 1967, (HLM 1.90), 24-inch pipe listed].
 FS Date: 7/7/2020

LM Start	1.90	Rating **	M	Issue No.	51 (cont)
LM End	1.90	Issue Type +	Ma	Location *	
Category	Supplemental			GPS Latitude/Longitude	
				Start	End
Item	DWR UCIP LMA Responsibility			38.115827°	38.115827°
				-121.154602°	-121.154602°
DWR ID	23905

View of pipe inlet and headwall located at the LS levee toe.

View of pipe outlet, flap gate, and headwall located at the WS levee toe.

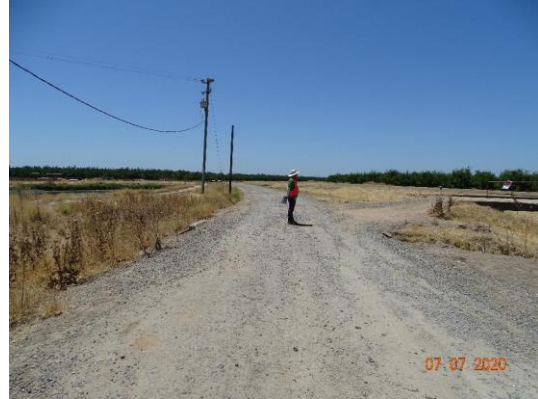
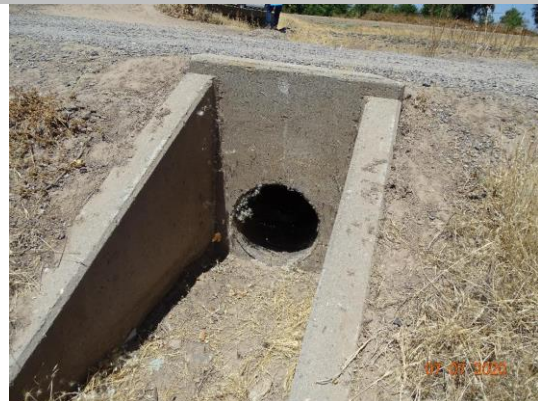
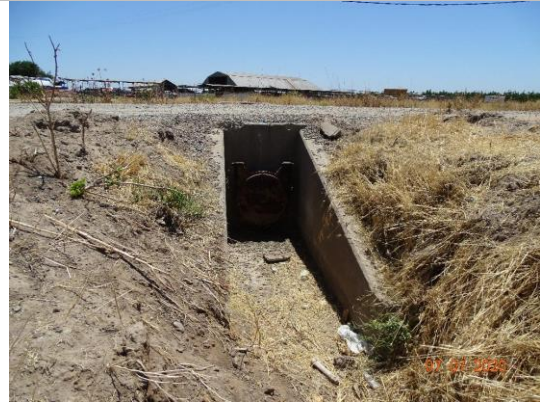
Photo 1 of 3 : UCIP_FA_2024_79102_87104.jpg

Comment Code					
Inspector Comment					
DS_ID:23906 FS_ID:79102 EP_NO: N/A Repair Type: Non-Urgent EVAL Issue: Crossing Status: Found UCIP Comments: 07/07/2020 Crossing evaluated as "Non-Urgent" because there was no permit found authorizing this pipe. Pipe no longer buried and not abandoned. Video inspection performed on 04-22-2020. (A. McDonald - DWR UCIP) 06/12/2014 Pipe burried on both ends and appears to be abandoned. IF so, it should be done so properly. (DWR UCIP) FIELD_STRUCT_DESC: 24-inch corrugated metal drainage pipe through the levee, 4 feet below the crown. Concrete U-shaped headwall on both ends. Flap gate on the waterside (WS) end. Cobble grouted outlet. Cobble grouted intake on the landside (LS). [Additional Reference(s): DWR Levee Log, 1978, (HLM 1.96). USACE San Joaquin O&M Manual 612.2, 1967, (HLM 1.96), 24-inch pipe listed]. FS Date: 7/7/2020

LM Start	1.96	Rating **	M	Issue No.	52 (cont)
LM End	1.96	Issue Type +	Ma	Location *

View of pipe inlet and headwall located at the LS levee toe.

View of pipe outlet, flap gate, and headwall located at the WS levee toe.

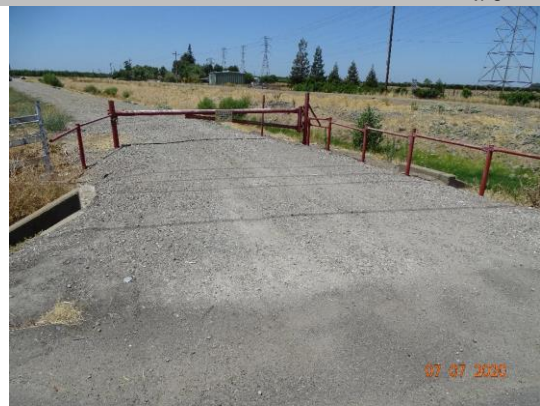
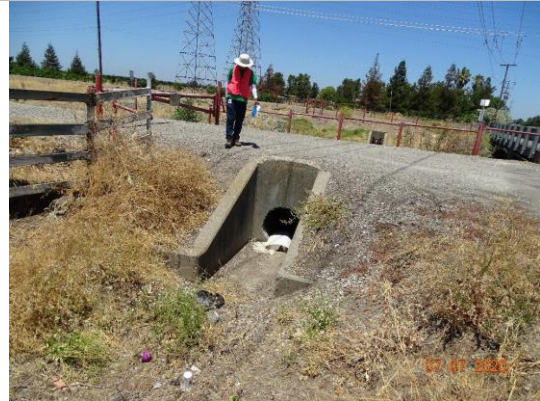
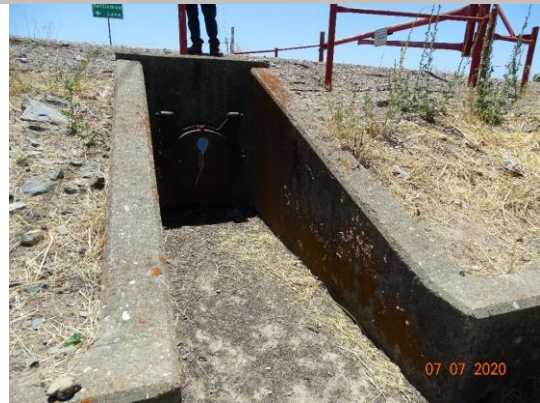
Photo 1 of 3 : UCIP_FA_2024_79103_87120.jpg

LM Start	2.15	Rating **	M	Issue No.	53
LM End	2.15	Issue Type +	Ma	Location *	
Category	Supplemental			GPS Latitude/Longitude	
				Start	End
Item	DWR UCIP LMA Responsibility			38.117702°	38.117702°
				-121.151033°	-121.151033°
DWR ID	23908

DS_ID:23908
FS_ID:79103
EP_NO: N/A
Repair Type: Non-Urgent
EVAL Issue:
Crossing Status: Found
UCIP Comments: 07/07/2020 Crossing evaluated as "Non-Urgent" because there was no permit found authorizing this pipe. Video inspection performed on 04-21-2020. (A. McDonald - DWR UCIP)
FIELD_STRUCT_DESC: 24-inch corrugated metal drainage pipe through the levee, 4 feet below the crown. Concrete U-shaped headwalls on both ends. Flap gate on the waterside (WS) end. Cobble grouted outlet. Cobble grouted intake on the landside (LS). [Additional Reference(s): DWR Levee Log, 1978, (HLM 2.15). USACE San Joaquin O&M Manual 612.2, 1967, (HLM 2.15), 24-inch pipe listed].
FS Date: 7/7/2020

View of pipe inlet and headwall located at the LS levee toe.

View of pipe outlet, flap gate, and headwall located at the WS levee toe.

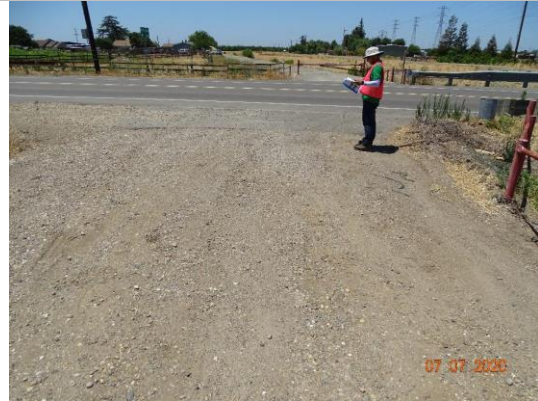
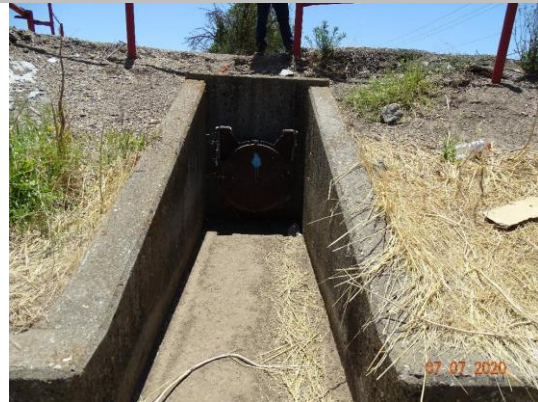
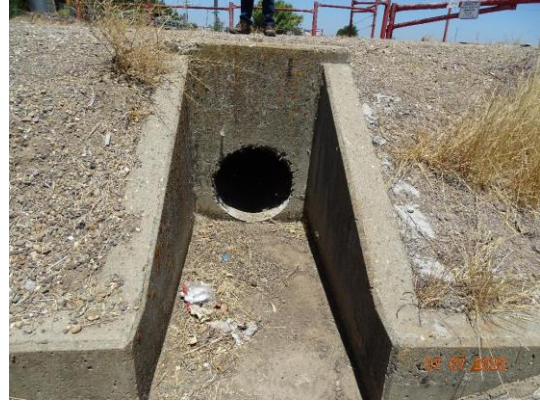
Photo 1 of 3 : UCIP_FA_2024_79104_87134.jpg

Comment Code						
Inspector Comment						
DS_ID:23909						
FS_ID:79104						
EP_NO: N/A						
Repair Type: Non-Urgent						
EVAL Issue:						
Crossing Status: Found						
UCIP Comments: 07/07/2020 Crossing evaluated as "Non-Urgent" because there was no permit found authorizing this pipe. (A. McDonald - DWR UCIP)						
FIELD_STRUCT_DESC: 24-inch corrugated metal drainage pipe through the levee, 5 feet below the crown. Concrete U-shaped headwalls on both ends. Flap gate on the waterside (WS) end. Cobble grouted outlet. Cobble grouted intake on the landside (LS). [Additional Reference(s): DWR Levee Log, 1978 (HLM 2.16). USACE San Joaquin O&M Manual 612.2, 1967, (HLM 2.16), 24-inch pipe listed].						
FS Date: 7/7/2020

LM Start	2.16	Rating **	M	Issue No.	54 (cont)
LM End	2.16	Issue Type +	Ma	Location *

View of pipe outlet, flap gate, and headwall located at the WS levee toe.

View of pipe inlet and headwall located at the LS levee toe.

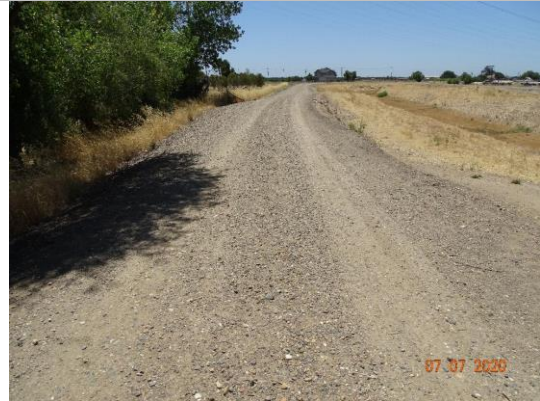
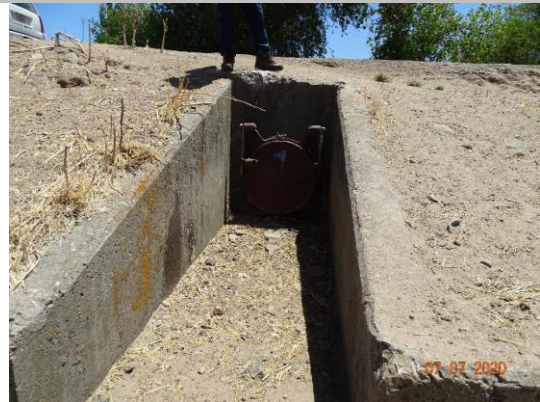
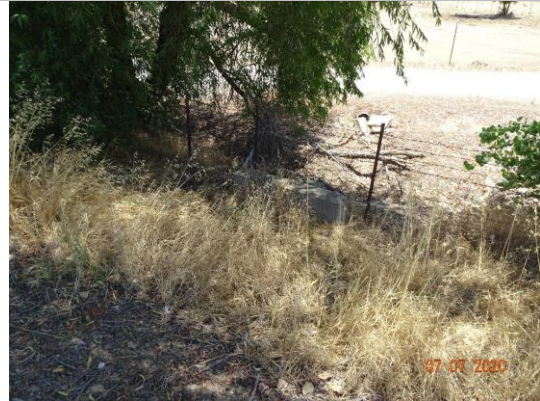
Photo 1 of 3 : UCIP_FA_2024_79105_87162.jpg

Comment Code						
Inspector Comment						
DS_ID:23911 FS_ID:79105 EP_NO: N/A Repair Type: Non-Urgent EVAL Issue: Crossing Status: Found UCIP Comments: 07/07/2020 Crossing evaluated as "Non-Urgent" because there was no permit found authorizing this pipe. (A. McDonald - DWR UCIP) FIELD_STRUCT_DESC: 24-inch corrugated metal drainage pipe through the levee, 6.0 feet below the crown. Concrete U-shaped headwalls on both ends. Flap gate on the waterside (WS) end. Cobble grouted outlet. Cobble grouted intake on the landside (LS). [Additional Reference(s): DWR Levee Log, 1978, (HLM 2.36). USACE San Joaquin O&M Manual 612.2, 1967, (HLM 2.36), 24-inch pipe listed]. FS Date: 7/7/2020

LM Start	2.36	Rating **	M	Issue No.	55 (cont)
LM End	2.36	Issue Type +	Ma	Location *

View of pipe outlet, flap gate, and headwall located at the WS levee toe.

View of pipe inlet and headwall located at the LS levee toe.

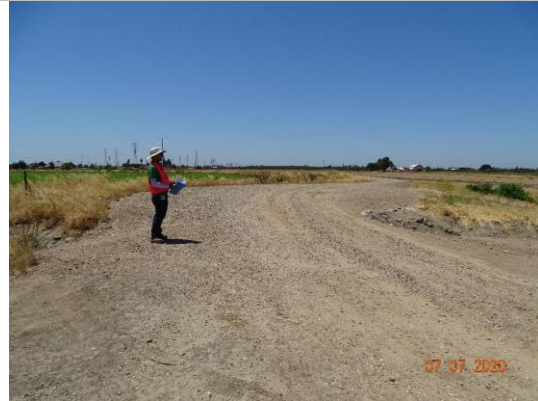
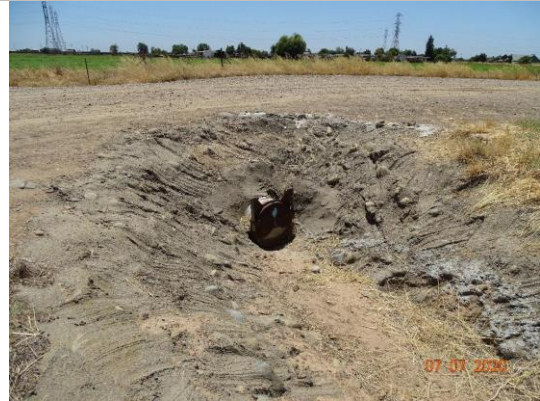
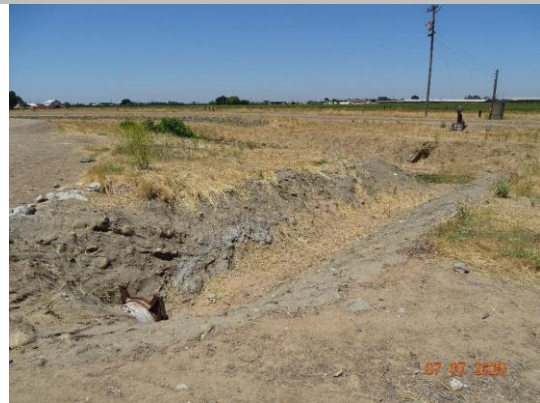
Photo 1 of 3 : UCIP_FA_2024_79114_87169.jpg

Comment Code						
Inspector Comment						
DS_ID:23913 FS_ID:79114 EP_NO: N/A Repair Type: Non-Urgent EVAL Issue: 5, Pipe Damage Crossing Status: Found UCIP Comments: 09/25/2024 DMP internal video inspection has found moderate pipe defects. Crossing will be monitored until funding becomes available for rehabilitation. (O. Yakimov - DWR UCIP) 07/07/2020 Crossing evaluated as "Non-Urgent" because there was no permit found authorizing this pipe. (A. McDonald - DWR UCIP) 11/04/2016 Crossing has been downgraded from Urgent to Non-Urgent the silt buildup in front of the flap gate on the WS has been removed, however the sediment buildup inside the crossing still remains. Recommend clearing the sediment buildup inside the pipe and complete an internal integrity inspection to confirm crossing is in good condition. (O. Magana - DWR UCIP) 06/19/2014 Silt buildup on WS toe blocking flap gate operation. (W. Wylie - DWR UCIP) FIELD_STRUCT_DESC: 24-inch corrugated metal drainage pipe through the levee, 4 feet below the crown. Flap gate is located on the waterside (WS) end with a cobble grouted outlet. Cobble grouted intake on the landside (LS). (Installation of a positive closure device on intake end authorized under Permit No. 17426, 2003 - Western Dairy Design Associates, Inc). [Additional Reference(s): DWR Levee Log, 1978, (HLM 2.61). USACE San Joaquin O&M Manual Unit 612.2, 1967, (HLM 2.61), 24-inch pipe listed]. FS Date: 7/7/2020

LM Start	2.61	Rating **	M	Issue No.	56 (cont)
LM End	2.61	Issue Type +	Ma	Location *	
Category	Supplemental		GPS Latitude/Longitude		
			Start	End	
Item	DWR UCIP LMA Responsibility		38.121463°	38.121463°	
			-121.145437°	-121.145437°	
DWR ID	23913

View of pipe outlet at the WS toe.

View of pipe outlet and cobble grouted outlet channel at the WS toe.

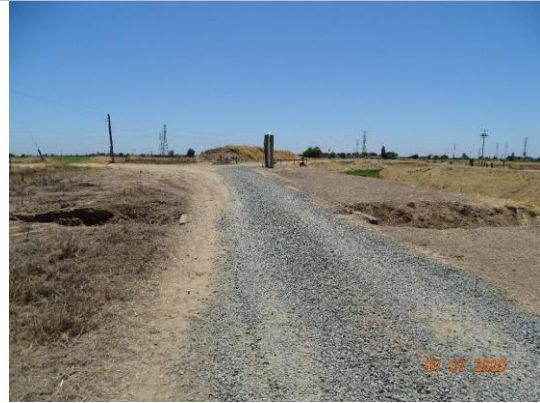
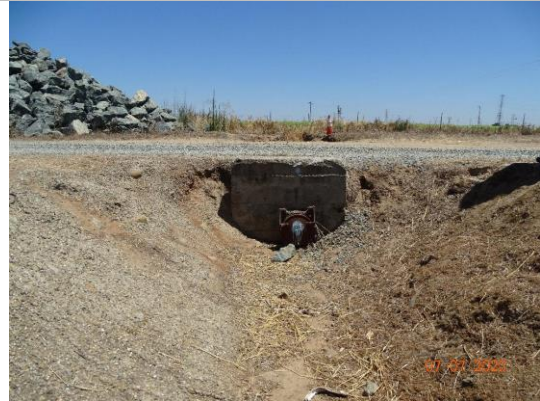
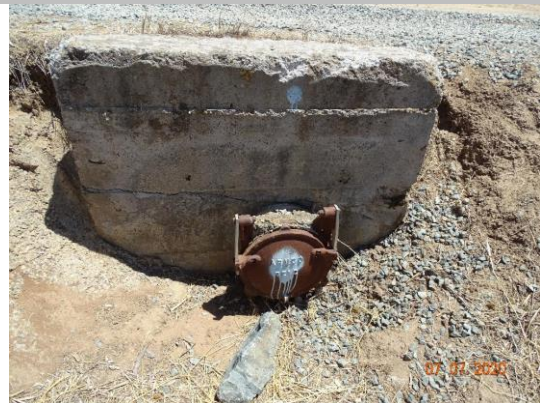
Photo 1 of 3 : UCIP_FA_2024_79109_87211.jpg

Comment Code						
Inspector Comment						
DS_ID:23915 FS_ID:79109 EP_NO: N/A Repair Type: Non-Urgent EVAL Issue: 5, Pipe Damage Crossing Status: Found UCIP Comments: 09/25/2024 DMP internal video inspection has found moderate pipe defects. Crossing will be monitored until funding becomes available for rehabilitation. (O. Yakimov - DWR UCIP) 07/07/2020 Crossing evaluated as "Non-Urgent" because there was no permit found authorizing this pipe. Inlet partially blocked with sediment. (A. McDonald - DWR UCIP) FIELD_STRUCT_DESC: 12-inch corrugated metal drainage pipe through the levee, 2 feet below the crown. Flap gate on the waterside (WS) end. Cobble grouted outlet. Cobble grouted intake on the landside (LS). (Installation of a positive closure device on intake end authorized under Permit No. 17426, 2003 - Western Dairy Design Associates, Inc). [Additional Reference(s): DWR Levee Log, 1978, (HLM 2.72). USACE San Joaquin O&M Manual 612.2, 1967, (HLM 2.72), 12-inch pipe listed]. FS Date: 7/7/2020

LM Start	2.72	Rating **	M	Issue No.	57 (cont)
LM End	2.72	Issue Type +	Ma	Location *	
Category	Supplemental		GPS Latitude/Longitude		
Item	DWR UCIP LMA Responsibility	Start		End	
		38.122733°		38.122733°	
DWR ID	23915	-121.144351°		-121.144351°

View of pipe outlet, flap gate, and headwall located at the WS levee toe.

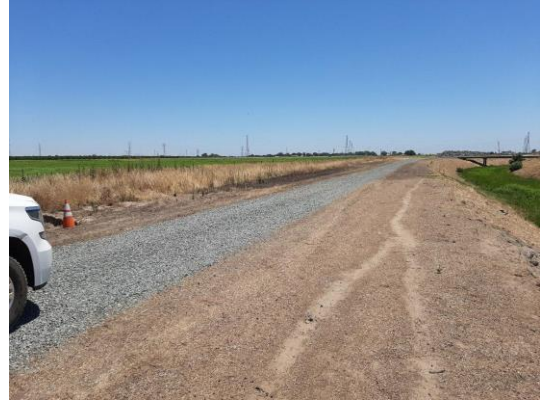
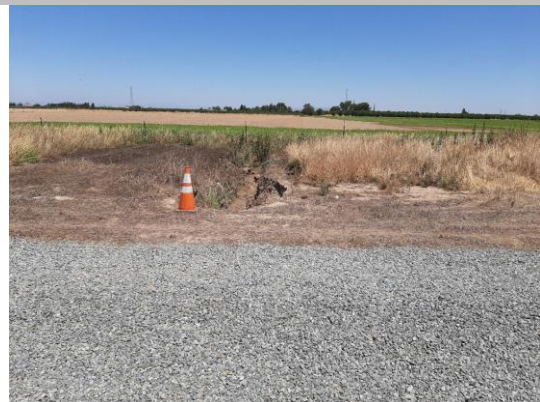
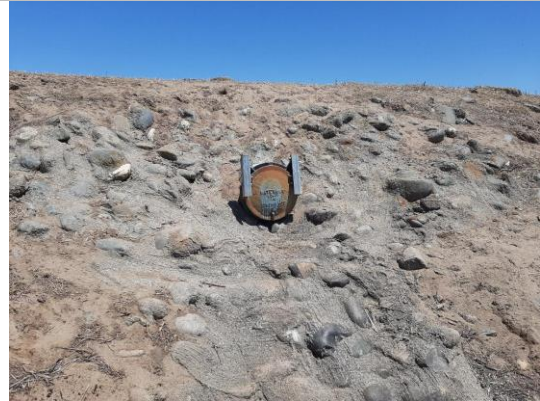
Photo 1 of 3 : UCIP_FA_2024_84814_87220.jpg

Comment Code					
Inspector Comment					
DS_ID:23916 FS_ID:84814 EP_NO: N/A Repair Type: Urgent EVAL Issue: 1, Pipe Integrity Crossing Status: Found UCIP Comments: 09/23/2024 Record updated from No Action Needed to Urgent. DMP internal video inspection has found severe pipe defects. Crossing will be monitored until funding becomes available to address the issues. (O. Yakimov - DWR UCIP) 07/03/2020 Crossing evaluated as "No Action Needed." Permit and inspection requirements have been met. (A. McDonald - DWR UCIP) FIELD_STRUCT_DESC: 12-inch corrugated metal drainage pipe through the levee, 3 feet below the crown. Flap gate on the waterside (WS) end. Cobble grouted outlet. (Installation of a positive closure device on intake end authorized under Permit No. 17426, 2003 - Western Dairy Design Associates, Inc). [Additional Reference(s): DWR Levee Log, 1978, (HLM 2.95). USACE San Joaquin O&M Manual 612.2, 1967, (HLM 2.95), 12-inch pipe listed]. FS Date: 7/3/2020

LM Start	2.94	Rating **	U	Issue No.	58 (cont)
LM End	2.94	Issue Type +	Ma	Location *

Overview of the LS and pipe inlet location.

View of pipe outlet, flap gate, and splash apron located at the WS levee toe.

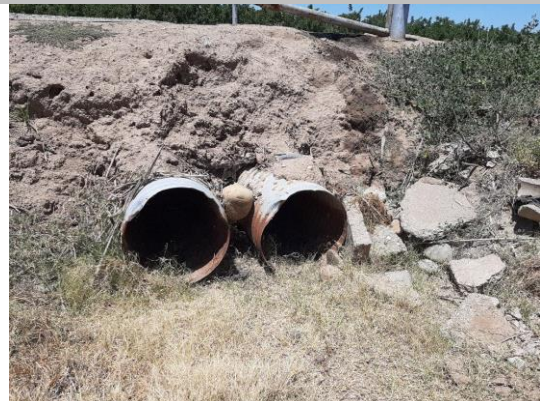
Photo 1 of 3 : UCIP_FA_2024_79115_87233.jpg

LM Start	3.09	Rating **	U	Issue No.	59
LM End	3.09	Issue Type +	Ma	Location *	
Category	Supplemental			GPS Latitude/Longitude	
				Start	End
Item	DWR UCIP LMA Responsibility			38.126939°	38.126939°
				-121.141925°	-121.141925°
DWR ID	23928

DS_ID:23928
FS_ID:79115
EP_NO: N/A
Repair Type: Urgent
EVAL Issue: 1, Pipe Integrity
Crossing Status: Found
UCIP Comments: 07/03/2020 Crossing evaluated as "Urgent" because of a badly deteriorated drainage pipe that is also open on both ends. There was no permit found authorizing this pipe, either. (A. McDonald - DWR UCIP#)1/12/2018 NA0017 found corrosion and holes along the bottom of this CMP drainage culvert. Culvert is also open on both ends. Crossing escalated to "Urgent" due to the extensive corrosion that was found. Internal inspection and/or rehabilitation recommended. (A. McDonald - DWR UCIP#)pipe open on both ends.
FIELD_STRUCT_DESC: 1 of 2: 24-inch corrugated metal drainage pipe through the levee, 3.0 feet below the crown. No closure device or flap gate. [Additional Reference(s): USACE San Joaquin O&M Manual 612.2, 1967, (HLM 3.15), 24-inch pipe listed].
FS Date: 7/3/2020

View of two drainage pipe inlets located at the LS levee toe.

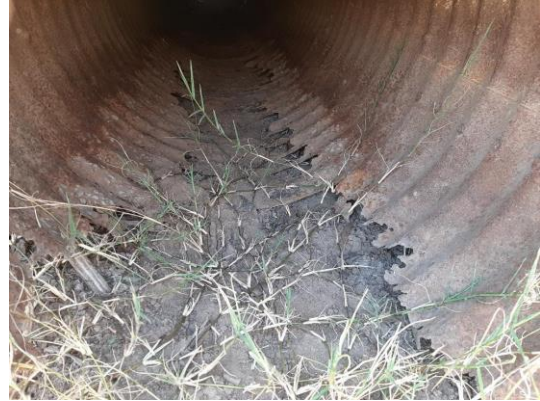
Photo 2 of 3 : UCIP_FA_2024_79115_87225.jpg

View of corrosion inside drainage pipe.

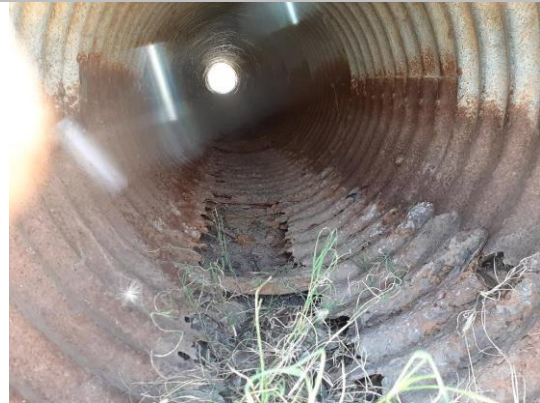
Photo 3 of 3 : UCIP_FA_2024_79115_87229.jpg

View of corrosion inside drainage pipe.

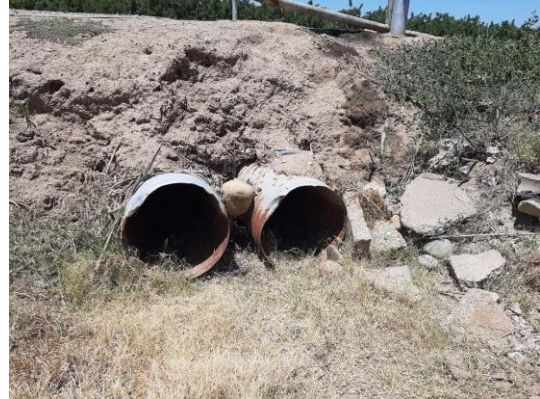
Photo 1 of 3 : UCIP_FA_2024_79116_87244.jpg

Comment Code					
Inspector Comment					
DS_ID:23926 FS_ID:79116 EP_NO: N/A Repair Type: Urgent EVAL Issue: 1, Pipe Integrity Crossing Status: Found UCIP Comments: 07/03/2020 Crossing evaluated as "Urgent" because of a badly deteriorated drainage pipe that is also open on both ends. There was no permit found authorizing this pipe, either. (A. McDonald - DWR UCIP) 1/12/2018 NA0017 found corrosion and holes along the bottom of this CMP drainage culvert. Culvert is also open on both ends. Crossing escalated to "Urgent" due to the extensive corrosion that was found. Internal inspection and/or rehabilitation recommended. (A. McDonald - DWR UCIP) pipe open with no flap gate. FIELD_STRUCT_DESC: 2 of 2: 24-inch corrugated metal drainage pipe through the levee, 3 feet below the crown. No closure device or flap gate. [Additional Reference(s): USACE San Joaquin O&M Manual 612.2, 1967, (HLM 3.15), 24-inch pipe listed]. FS Date: 7/3/2020

View of two drainage pipe inlets located at the LS levee toe.

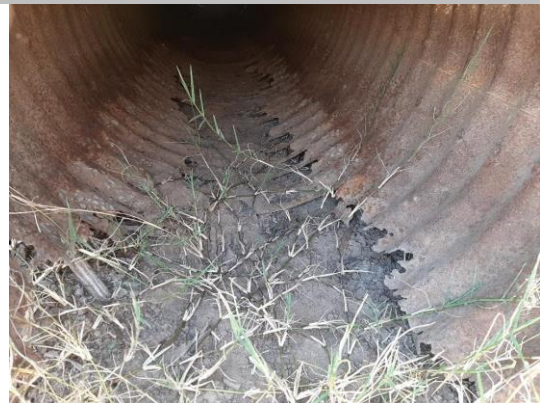
Photo 2 of 3 : UCIP_FA_2024_79116_87236.jpg

View of corrosion inside drainage pipe.

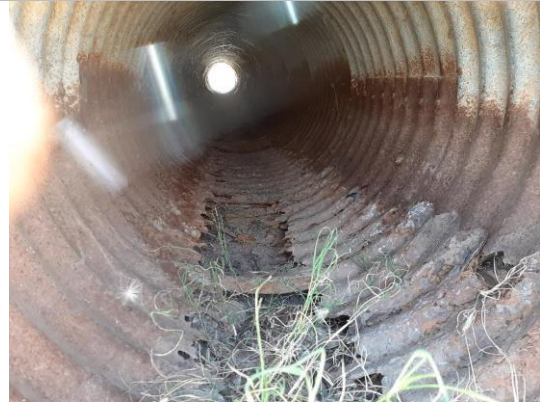
Photo 3 of 3 : UCIP_FA_2024_79116_87240.jpg

View of corrosion inside drainage pipe.

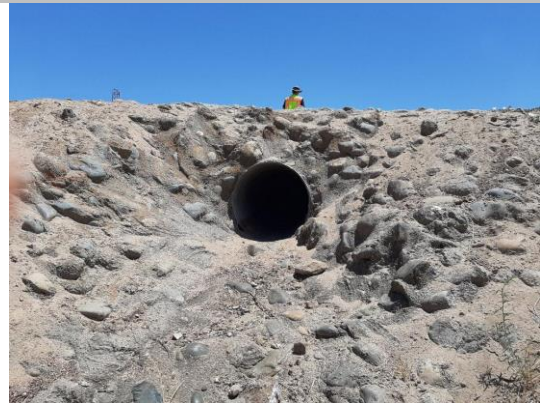
Photo 1 of 2 : UCIP_FA_2024_79117_87248.jpg

DS_ID:23917
 FS_ID:79117
 EP_NO: N/A
 Repair Type: Urgent
 EVAL Issue: 1, Pipe Integrity
 Crossing Status: Found
 UCIP Comments: 09/19/2023 DMP internal video inspection has found severe pipe defects. Crossing will be monitored until funding becomes available to address the issues. (O. Yakimov - DWR UCIP)
 07/03/2020 Crossing evaluated as "Urgent" because it is a straight-through drainage pipe with no flap gate on the WS end. There was also no permit found authorizing this pipe. (A. McDonald - DWR UCIP)
 06/19/2014 No flap gate. (DWR UCIP)
 FIELD_STRUCT_DESC: 24-inch corrugated metal drainage pipe through the levee, 4.5 feet below the crown. Cobble grouted outlet. Cobble grouted intake on the landside (LS). [Additional Reference(s): DWR Levee Log, 1978, (HLM 3.25). USACE San Joaquin O&M Manual 612.2, 1967, (HLM 3.25), 24-inch pipe listed].
 FS Date: 7/3/2020

View of pipe outlet and splash apron located at the WS levee toe.

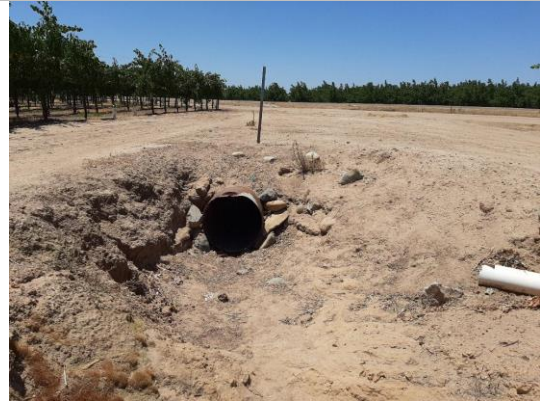
Photo 2 of 2 : UCIP_FA_2024_79117_87249.jpg

View of pipe inlet located 50 to 100 feet off the LS levee toe.

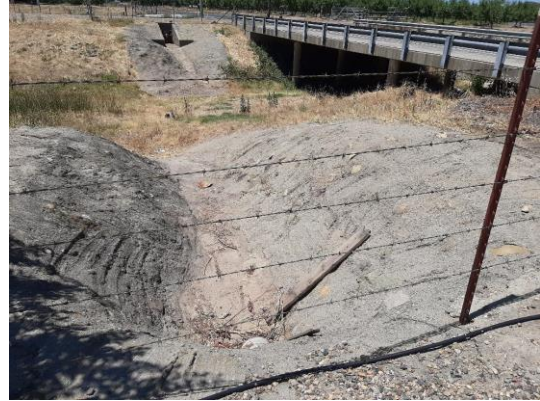
Photo 2 of 3 : UCIP_FA_2024_79119_87258.jpg

View of WS channel and splash apron.

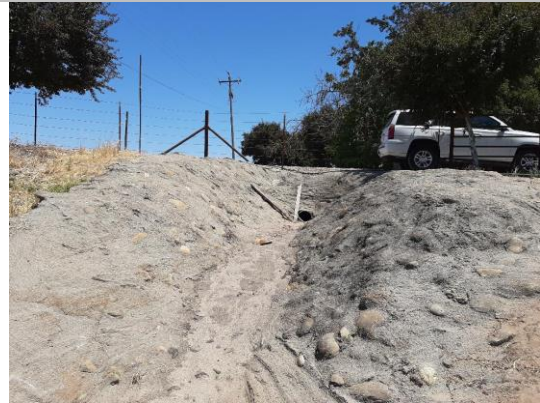
Photo 3 of 3 : UCIP_FA_2024_79119_87259.jpg

View of pipe outlet and splash apron located at the WS levee toe.

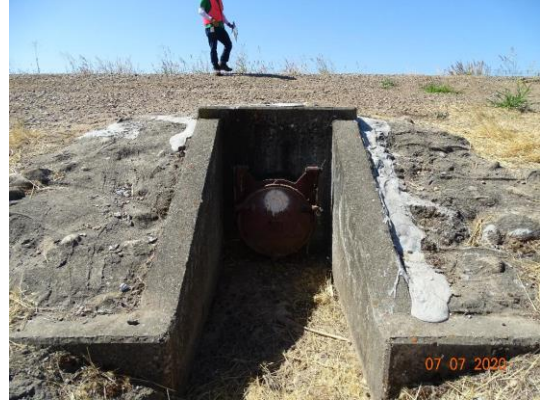
Photo 1 of 1 : UCIP_FA_2024_79121_86686.jpg

Comment Code					
Inspector Comment					
DS_ID:23931 FS_ID:79121 EP_NO: N/A Repair Type: No Action Needed EVAL Issue: Crossing Status: Found UCIP Comments: 07/07/2020 Record remains No Action Needed. This is s system feature without any modification to system. Same observation as last inspection. Pipe is in good condition. Video Inspection was performed in 4/24/2020 and the result will be appended to this report when it becomes available. (S.Donovan - DWR UCIP) FIELD_STRUCT_DESC: 24-inch corrugated metal drainage pipe through the levee, 5.5 feet below the crown. Concrete U-shaped headwall on both ends. Flap gate on the waterside (WS) end. [Additional Reference(s): DWR Levee Log, 1978, (HLM 0.03). USACE San Joaquin O&M Manual 612.2, 1967, (HLM 0.03), 24-inch pipe listed]. FS Date: 7/7/2020

Water-Side: View of pipe, headwall, and flapgate.

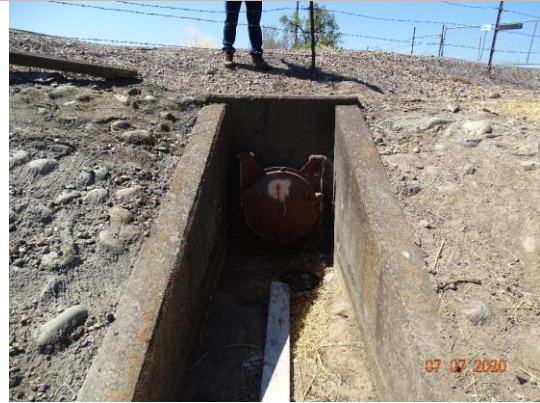
Photo 1 of 1 : UCIP_FA_2024_79123_86735.jpg

Comment Code						
Inspector Comment						
DS_ID:23933 FS_ID:79123 EP_NO: N/A Repair Type: No Action Needed EVAL Issue: Crossing Status: Found UCIP Comments: 07/07/2020 Record remains No Action Needed. Pipe was in good condition, same as last inspection. Internal video Inspection was performed on 2/21/2020 (S.Donovan - DWR UCIP) FIELD_STRUCT_DESC: 24-inch corrugated metal drainage pipe through the levee, 5 feet below the crown. Concrete U-shaped headwall on both ends. Flap gate on the waterside (WS) end. Cobble grouted outlet. Cobble grouted intake on the landside (LS). [Additional Reference(s): DWR Levee Log, 1978. USACE San Joaquin O&M Manual 612.2, 1967, (HLM 0.58), 24-inch pipe listed]. FS Date: 7/7/2020 1:09:28 PM

Water-Side: View of pipe, headwall and flapgate.

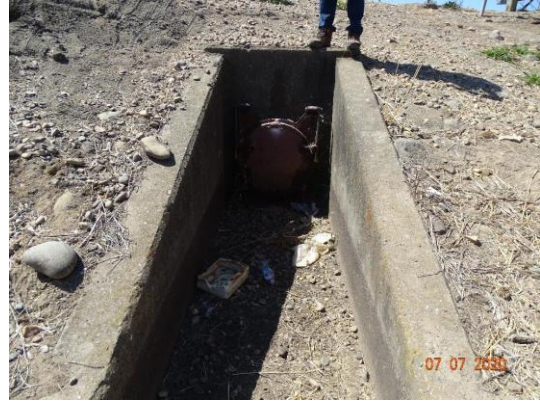
Photo 1 of 1 : UCIP_FA_2024_79124_86744.jpg

Comment Code						
Inspector Comment						
DS_ID:23934 FS_ID:79124 EP_NO: N/A Repair Type: No Action Needed EVAL Issue: Crossing Status: Found UCIP Comments: 07/07/2020 Record remains No Action Needed. This is a system feature with no modification to the system. Pipe is in good condition. Same observation as last inspection. Internal video inspection was performed in 4/24/2020. (S.Donovan - DWR UCIP) FIELD_STRUCT_DESC: 24-inch corrugated metal drainage pipe through the levee, 5 feet below the crown. Concrete U-shaped headwall on both ends. Flap gate on the waterside (WS) end. Cobble grouted outlet. Cobble grouted intake on the landside (LS). [Additional Reference(s): DWR Levee Log, 1978. USACE San Joaquin O&M Manual 612.2, 1967, (HLM 0.60), 24-inch pipe listed]. FS Date: 7/7/2020 1:13:53 PM

Water-Side: view of pipe, headwall, and flapgate.

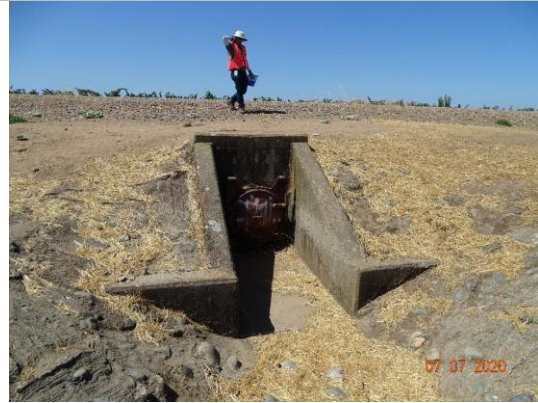
Photo 1 of 1 : UCIP_FA_2024_79126_86747.jpg

Comment Code						
Inspector Comment						
DS_ID:23935 FS_ID:79126 EP_NO: N/A Repair Type: No Action Needed EVAL Issue: Crossing Status: Found UCIP Comments: 07/07/2020 Record remains No Action Needed. This is a system feature without any modification to the system. Pipe is in good condition. Same observation as last inspection. Internal video inspection was performed in 4/24/2020. (S.Donovan - DWR UCIP) FIELD_STRUCT_DESC: 24-inch corrugated metal drainage pipe through the levee, 5 feet below the crown. Concrete U-shaped headwall on both ends. Flap gate on the waterside (WS) end. Cobble grouted outlet. Cobble grouted intake on the landside (LS). [Additional Reference(s): DWR Levee Log, 1978. USACE San Joaquin O&M Manual 612.2, 1967, (HLM 0.91), 24-inch pipe listed]. FS Date: 7/7/2020 1:14:37 PM

Water-Side: view of pipe, headwall, and flapgate.

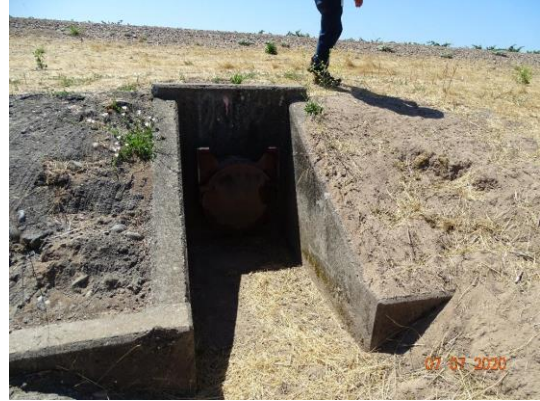
Photo 1 of 1 : UCIP_FA_2024_79127_86752.jpg

Comment Code						
Inspector Comment						
DS_ID:23936 FS_ID:79127 EP_NO: N/A Repair Type: No Action Needed EVAL Issue: Crossing Status: Found UCIP Comments: 07/07/2020 Record remains No Action Needed. This is a system feature without any modification to the pipe. Pipe is in good condition. Same observation as last inspection. (S.Donovan - DWR UCIP) FIELD_STRUCT_DESC: 24-inch corrugated metal drainage pipe through the levee, 6.5 feet below the crown. Concrete U-shaped headwall on both ends. Flap gate on the waterside (WS) end. Cobble grouted outlet. Cobble grouted intake on the landside (LS). [Additional Reference(s): DWR Levee Log, 1978. USACE San Joaquin O&M Manual 612.2, 1967, (HLM 1.11), 24-inch pipe listed]. FS Date: 7/7/2020 1:15:26 PM

Water-Side: view of pipe with headwall and flapgate.

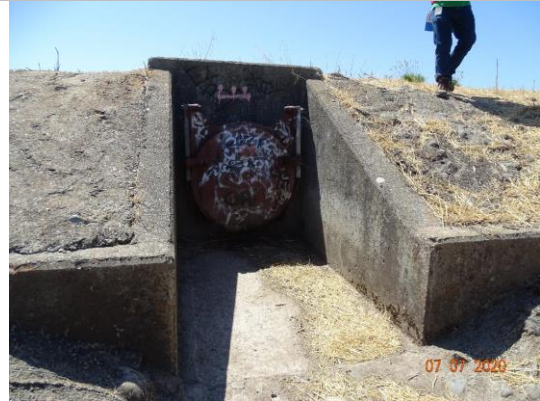
Photo 1 of 1 : UCIP_FA_2024_79128_86755.jpg

Comment Code						
Inspector Comment						
DS_ID:23937						
FS_ID:79128						
EP_NO: N/A						
Repair Type: No Action Needed						
EVAL Issue:						
Crossing Status: Found						
UCIP Comments: 07/07/2020 Record remains No Action Needed. This is a system feature without any modification to the system. Pipe is in good condition. Same observation as last inspection. (S.Donovan - DWR UCIP)						
FIELD_STRUCT_DESC: 36-inch corrugated metal drainage pipe through the levee, 4 feet below the crown. Concrete U-shaped headwall on both ends. Flap gate on the waterside (WS) end. Cobble grouted outlet. Cobble grouted intake on the landside (LS). [Additional Reference(s): DWR Levee Log, 1978. USACE San Joaquin O&M Manual 612.2, 1967, (HLM 1.18), 36-inch pipe listed].						
FS Date: 7/7/2020 1:16:27 PM

Water-Side: view of pipe with headwall and flapgate.

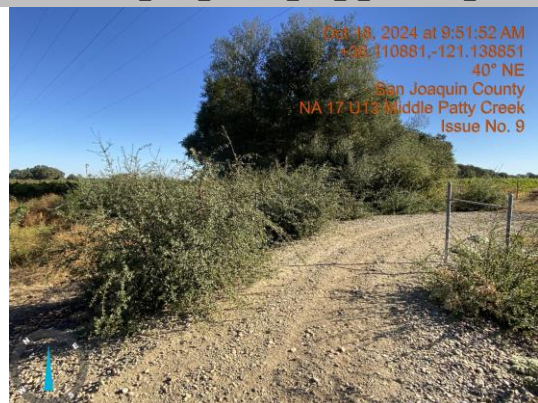
Photo 1 of 1 : FA_2024_NA0017_157_9_20241019_00009.jpg

LM Start	1.39	Rating **	U	Issue No.	9
LM End	1.39	Issue Type +	Ma	Location *	WS
Category	Earthen Levee			GPS Latitude/Longitude	
				Start	End
Item	Vegetation			38.110910°	38.110910°
				-121.138683°	-121.138683°
DWR ID	DWR_NA0017_13_f_2024_9				
Comment Code					
V2 : Remove the wild growth and woody vegetation other than native grasses from the levee slopes.					
Inspector Comment					
Tree saplings growing along the waterside slope.

View of tree saplings growing along the waterside slope. Fall 2024

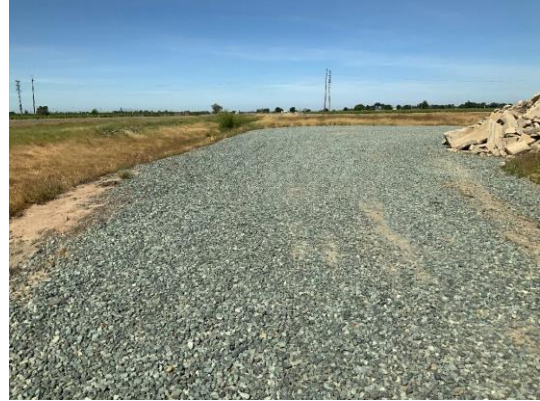
Photo 1 of 3 : UCIP_FA_2024_79138_98394.jpg

Comment Code						
Inspector Comment						
DS_ID:23939 FS_ID:79138 EP_NO: N/A Repair Type: Non-Urgent EVAL Issue: Crossing Status: Found UCIP Comments: 04/29/2021 Record has been upgraded from No Action Needed to Non-Urgent. Unit 14 ? Middle Paddle Creek (CLM 0 to 1.38) is considered a patrol road/high ground area with no defined levee prism, any issue found between CLM 0 to 1.38 of Unit 14 will be considered a maintenance issue, or an unauthorized encroachment, or an abandoned encroachment. DWR DMP internal inspection has not found pipe integrity issues. LOF of crossing is less or equal to 4.0. Recommend next inspection in 5 years. Current condition of pipe crossing does not impede access to patrol road/high ground area. No permit was found authorizing this encroachment. CVFPB will need to review crossing to determine owner. The UCIP inspection was completed with LMA representative, J. Nelson. (H. Dunn ? GEI) FIELD_STRUCT_DESC: 12-inch corrugated metal storm drainage pipe (CMP) through the levee, 3.0 feet below the crown. Flap gate on the waterside (WS) end. Cobble grouted outlet on the WS end. Cobble grouted intake on the landside (LS). [Additional Reference(s): DWR Levee Log, 1978, (HLM 0.02). USACE San Joaquin O&M Manual 612.2, 1967, (HLM 0.02), 12-inch pipe listed]. FS Date: 4/29/2021

Levee crown looking downstream.

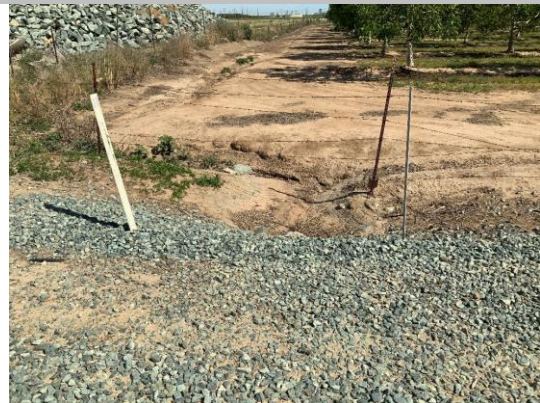
Photo 2 of 3 : UCIP_FA_2024_79138_98395.jpg

LS view: Toe from crown.

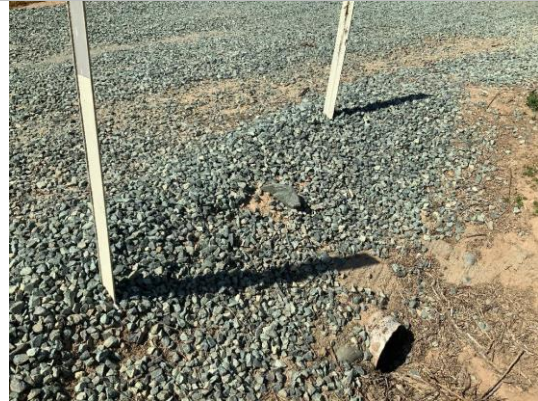
Photo 3 of 3 : UCIP_FA_2024_79138_98396.jpg

LS view: Slope and pipe inlet at toe.

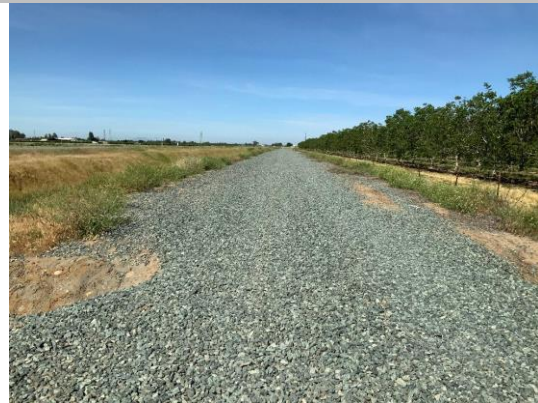
Photo 1 of 3 : UCIP_FA_2024_79139_98400.jpg

DS_ID:23940
 FS_ID:79139
 EP_NO: N/A
 Repair Type: Non-Urgent
 EVAL Issue:
 Crossing Status: Found
 UCIP Comments: 04/29/2021 Pipe status is still Non-Urgent. Unit 14 ? Middle Paddle Creek (CLM 0 to 1.38) is considered a patrol road/high ground area with no defined levee prism, any issue found between CLM 0 to 1.38 of Unit 14 will be considered a maintenance issue, or an unauthorized encroachment, or an abandoned encroachment. DWR DMP internal inspection has not found pipe integrity issues. LOF of crossing is less or equal to 4.0. Recommend inspection in 5 years. Current condition of pipe crossing does not impede access to patrol road/high ground area. No permit was found authorizing this encroachment. CVFPB will need to review crossing to determine owner. The UCIP inspection was completed with LMA representative, J. Nelson. (H. Dunn ? GEI)06/12/2014 Debris partially blocking closure of flapgate. (W. Wylie - DWR UCIP)

FIELD_STRUCT_DESC: 12-inch corrugated metal storm drainage pipe (CMP) through the levee, 3.0 feet below the crown. Flap gate on the waterside (WS) end. Cobble grouted outlet on the WS end. [Additional Reference(s): DWR Levee Log, 1978, (HLM 0.25). USACE San Joaquin O&M Manual 612.2, 1967, (HLM 0.25), 12-inch pipe listed].
 FS Date: 4/29/2021

Levee crown looking downstream.

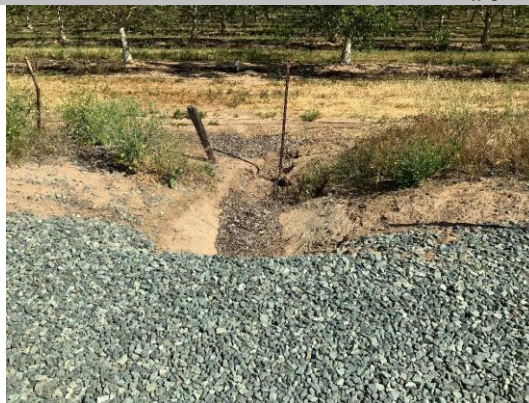
Photo 2 of 3 : UCIP_FA_2024_79139_98401.jpg

LS view: Toe from crown.

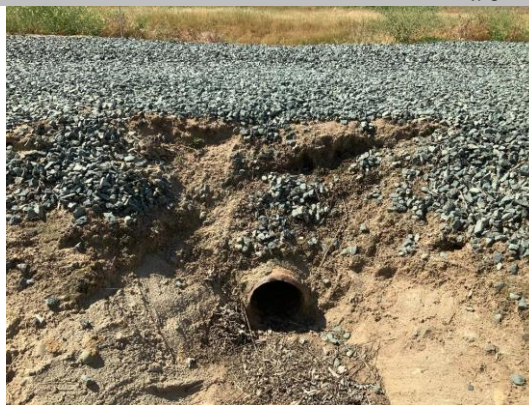
Photo 3 of 3 : UCIP_FA_2024_79139_98402.jpg

LS view: Slope and pipe inlet at toe.

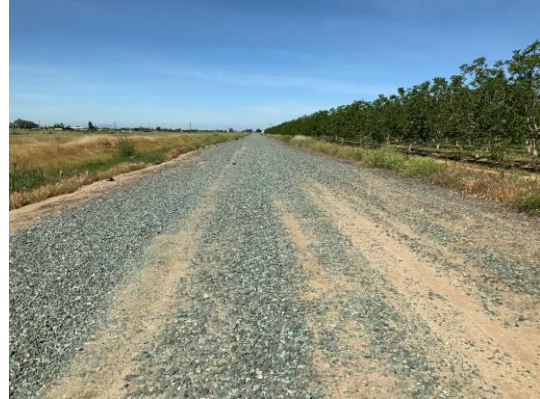
Levee crown looking downstream.

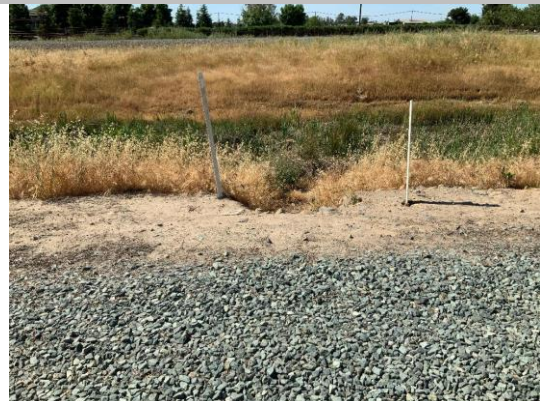
WS view: Toe from crown with markers on either side.

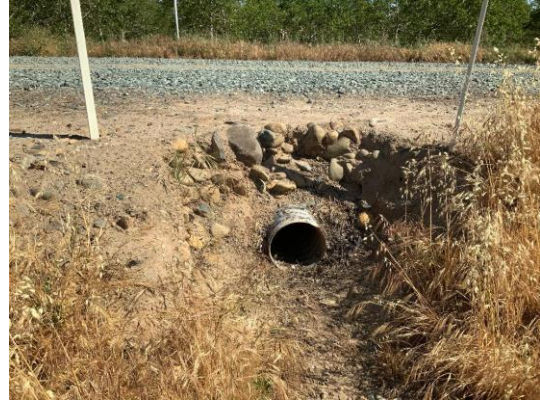
DS_ID:23941
FS_ID:79140
EP_NO: N/A
Repair Type: Non-Urgent
EVAL Issue: 11, Maintenance Compliance Issue
Crossing Status: Found
UCIP Comments: 04/29/2021 Pipe status is still Non-Urgent. Unit 14 ? Middle Paddle Creek (CLM 0 to 1.38) is considered a patrol road/high ground area with no defined levee prism, any issue found between CLM 0 to 1.38 of Unit 14 will be considered a maintenance issue, or an unauthorized encroachment, or an abandoned encroachment. DWR DMP internal inspection has not found pipe integrity issues. LOF of crossing is less or equal to 4.0. Recommend inspection in 5 years. Current condition of pipe crossing does not impede access to patrol road/high ground area. Pipe is open on both ends without a flapgate and LS pipe edges are warped, recommend maintenance. No permit was found authorizing this encroachment. CVFPB will need to review crossing to determine owner. The UCIP inspection was completed with LMA representative, J. Nelson. (H. Dunn ? GEI)06/12/2014 Pipe buried on WS slope. (W. Wylie - DWR UCIP)

WS view: Slope and pipe outlet at toe, no flapgate.

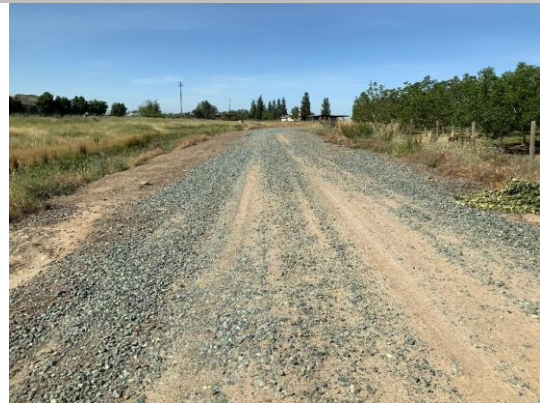
DS_ID:23942
FS_ID:79141
EP_NO: N/A
Repair Type: Non-Urgent
EVAL Issue:
Crossing Status: Found
UCIP Comments: 04/29/2021 Record has been upgraded from No Action Needed to Non-Urgent. Unit 14 ? Middle Paddle Creek (CLM 0 to 1.38) is considered a patrol road/high ground area with no defined levee prism, any issue found between CLM 0 to 1.38 of Unit 14 will be considered a maintenance issue, or an unauthorized encroachment, or an abandoned encroachment. DWR DMP internal inspection has not found pipe integrity issues. LOF of crossing is less or equal to 4.0. Recommend inspection in 5 years. Current condition of pipe crossing does not impede access to patrol road/high ground area. No permit was found authorizing this encroachment. CVFPB will need to review crossing to determine owner. The UCIP inspection was completed with LMA representative, J. Nelson. (H. Dunn ? GEI)
FIELD_STRUCT_DESC: 12-inch corrugated metal storm drainage pipe (CMP) through the levee, 2.0 feet below the crown. Flap gate on the waterside (WS) end. Cobble grouted outlet on the WS end. Cobble grouted intake on the landside (LS). [Additional Reference(s): DWR Levee Log, 1978, (HLM 0.46). USACE San Joaquin O&M Manual 612.2, 1967, (HLM 0.46), 12-inch pipe listed].

Levee crown looking downstream.

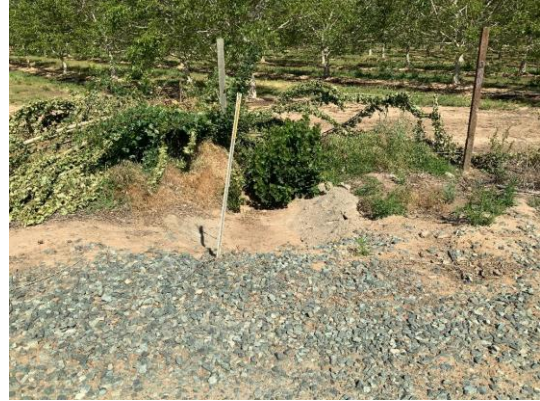
LS view: Toe from crown, marker visible.

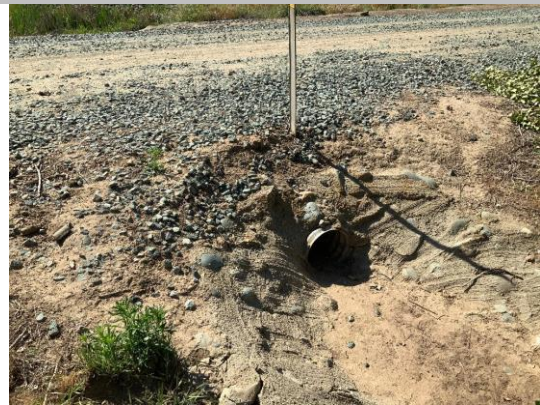
LS view: Slope and pipe inlet at toe.
