**Flood Control Project Maintenance
Levee Inspections****Maintenance Issue Types Only, Levee Inspection Report By Mile - Fall 2024****San Joaquin County Flood Control and Water Conservation District**

Waterway	Bank	Unit Miles	Inspection Start/End	Inspector
Unit No. 01 Littlejohn Creek	Left	2.59	10/21/2024 10/21/2024	Alberto De Leon

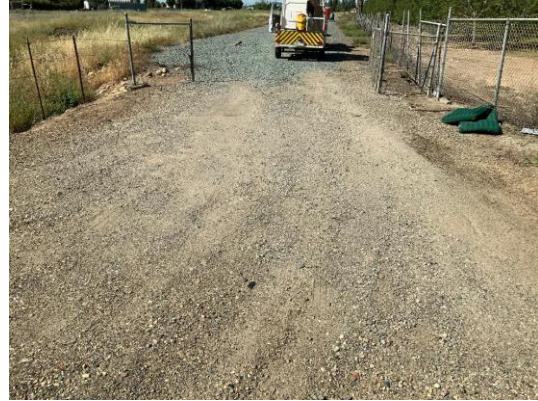
DS_ID:23943
FS_ID:79142
EP_NO: N/A
Repair Type: Non-Urgent
EVAL Issue: 11, Maintenance Compliance Issue
Crossing Status: Found
UCIP Comments: 04/29/2021 Pipe status is still Non-Urgent. Unit 14 ? Middle Paddle Creek (CLM 0 to 1.38) is considered a patrol road/high ground area with no defined levee prism, any issue found between CLM 0 to 1.38 of Unit 14 will be considered a maintenance issue, or an unauthorized encroachment, or an abandoned encroachment. DWR DMP internal inspection has not found pipe integrity issues. LOF of crossing is less or equal to 4.0. Recommend inspection in 5 years. Current condition of pipe crossing does not impede access to patrol road/high ground area. Pipe is open on both ends and there is some erosion around pipe on both WS and LS ends, recommend maintenance for erosion. No permit was found authorizing this encroachment. CVFPB will need to review crossing to determine owner. The UCIP inspection was completed with LMA representative, J. Nelson. (H. Dunn ? GEI)09/18/2018 Pipe is close to the crown. It may not create a serious situation. Maintenance required by owner at pipe inlet. Crossing downgraded to "Non-Urgent." (A. McDonald - DWR UCIP)11/04/2016 Same as previous inspection. Crossing remains Urgent crossing, open on both ends. (O. Magana - DWR UCIP)06/12/2014 Pipe inlet and outlet partially blocked by sediment. No flapgate. (W. Wylie - DWR UCIP)

Levee crown looking downstream.

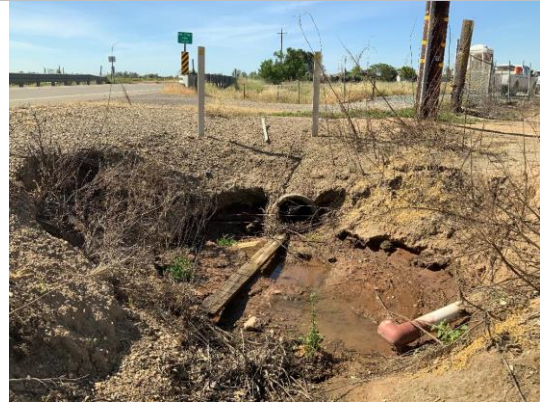
LS view: Slope and pipe inlet at toe.

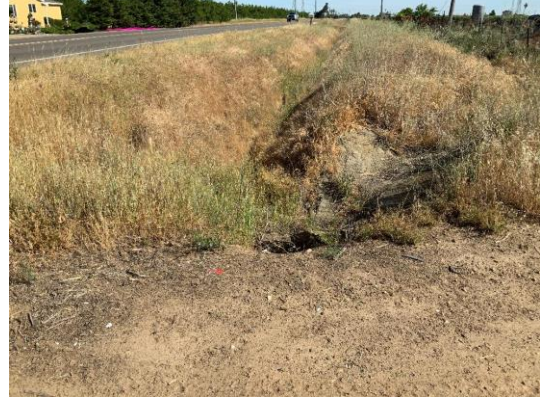
LS view: Toe from crown.

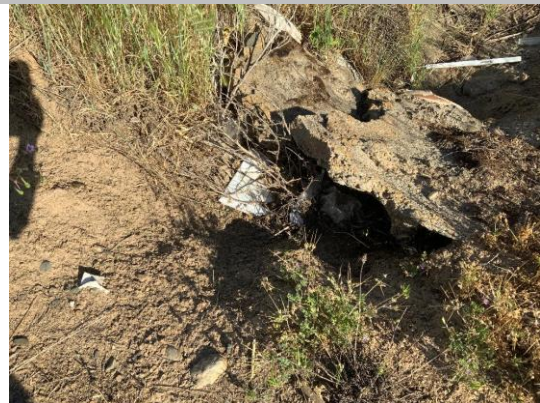
LS view: Erosion and gapping above pipe inlet on slope.

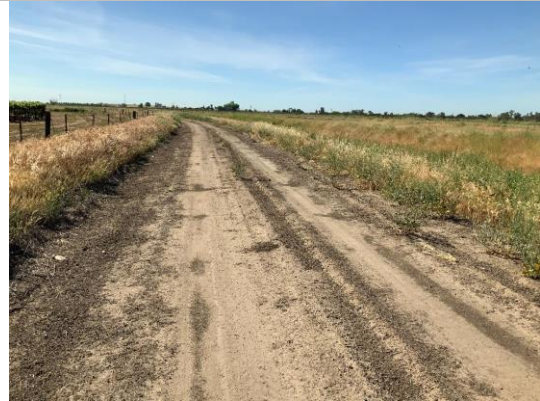
Comment Code						
Inspector Comment						
DS_ID:23945 FS_ID:79144 EP_NO: N/A Repair Type: Non-Urgent EVAL Issue: 11, Maintenance Compliance Issue Crossing Status: Found UCIP Comments: 04/29/2021 Pipe status is still Non-Urgent. Unit 14 ? Middle Paddle Creek (CLM 0 to 1.38) is considered a patrol road/high ground area with no defined levee prism, any issue found between CLM 0 to 1.38 of Unit 14 will be considered a maintenance issue, or an unauthorized encroachment, or an abandoned encroachment. DWR DMP internal inspection has found pipe integrity issues. LOF of crossing is between 4.1 and 5. Crossing will be monitored until funding becomes available for rehabilitation. Current condition of pipe crossing does not impede access to patrol road/high ground area. Pipe is open on both ends and LS pipe end is covered in vegetation and behind barbed wire, could not inspect. No permit was found authorizing this encroachment. CVFPB will need to review crossing to determine owner. The UCIP inspection was completed with LMA representative, J. Nelson. (H. Dunn ? GEI)06/12/2014 Pipe open on both ends. Levee appears abandoned. (W. Wylie - DWR UCIP) FIELD_STRUCT_DESC: 24-inch corrugated metal storm drainage pipe (CMP) through the levee, 1.0 foot below the crown. Pipe open on both ends. Cobble grouted outlet on the waterside (WS) end. Cobble grouted intake on the landside (LS). [Additional Reference(s): DWR Levee Log, 1978, (HLM 0.76). USACE San Joaquin O&M Manual 612.2, 1967, (HLM 0.76), 24-inch pipe listed]. FS Date: 4/29/2021

Levee crown looking upstream.

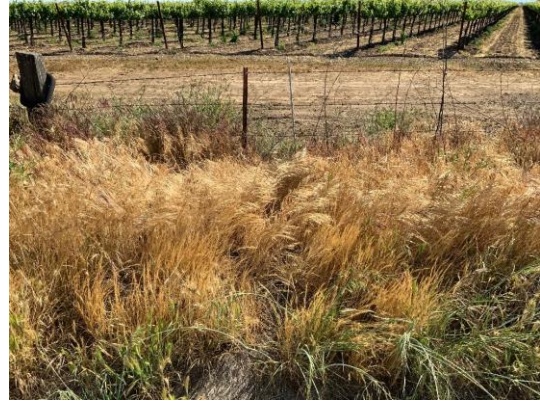
LS view: Toe from crown.

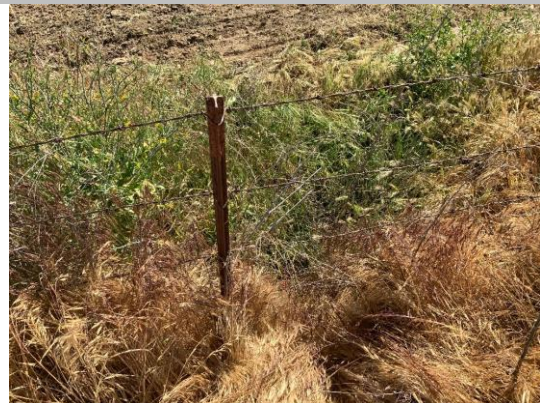
LS view: Pipe inlet covered by vegetation and barbed wire at toe.

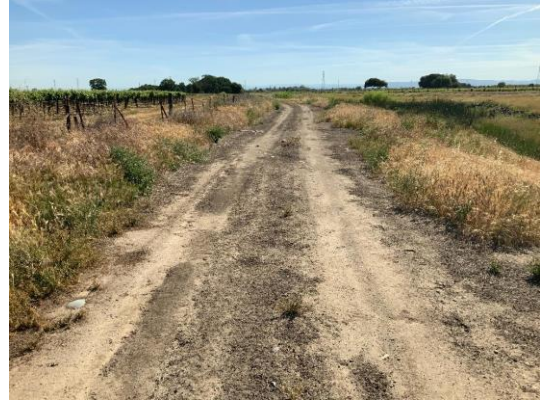
Comment Code					
Inspector Comment					
DS_ID:23946 FS_ID:79145 EP_NO: N/A Repair Type: Non-Urgent EVAL Issue: 11, Maintenance Compliance Issue Crossing Status: Found UCIP Comments: 04/29/2021 Pipe status is still Non-Urgent. Unit 14 ? Middle Paddle Creek (CLM 0 to 1.38) is considered a patrol road/high ground area with no defined levee prism, any issue found between CLM 0 to 1.38 of Unit 14 will be considered a maintenance issue, or an unauthorized encroachment, or an abandoned encroachment. DWR DMP internal inspection has not found pipe integrity issues. LOF of crossing is less or equal to 4.0. Recommend inspection in 5 years. Current condition of pipe crossing does not impede access to patrol road/high ground area. Pipe is open on both ends, no flapgates and LS pipe end filled with dirt, recommend maintenance for sediment removal. No permit was found authorizing this encroachment. CVFPB will need to review crossing to determine owner. The UCIP inspection was completed with LMA representative, J. Nelson. (H. Dunn ? GEI)

06/12/2014 Pipe burried on LS. Levee appears abandoned. (W. Wylie - DWR UCIP) FIELD_STRUCT_DESC: 12-inch corrugated metal storm drainage pipe (CMP) through the levee, 2.0 feet below the crown. Pipe open on both ends. Cobble grouted outlet on the waterside (WS) end. [Additional Reference(s): DWR Levee Log, 1978, (HLM 0.95). USACE San Joaquin O&M Manual 612.2, 1967, (HLM 0.95), 12-inch pipe listed]. FS Date: 4/29/2021

Levee crown looking upstream.

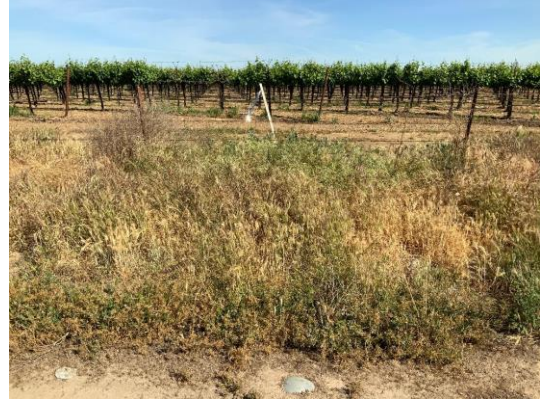
LS view: Toe from crown, marker visible.

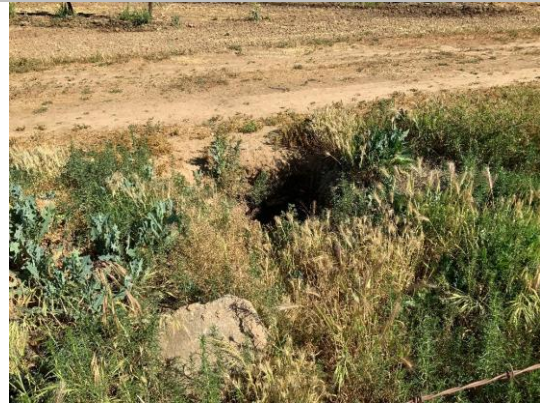
LS view: Inlet barely visible at toe.

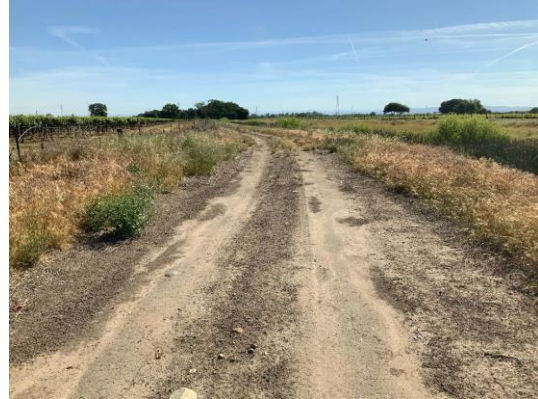
Comment Code						
Inspector Comment						
DS_ID:23947 FS_ID:79146 EP_NO: N/A Repair Type: Non-Urgent EVAL Issue: 5, Pipe Damage Crossing Status: Found UCIP Comments: 04/29/2021 Pipe status is still Non-Urgent. Unit 14 ? Middle Paddle Creek (CLM 0 to 1.38) is considered a patrol road/high ground area with no defined levee prism, any issue found between CLM 0 to 1.38 of Unit 14 will be considered a maintenance issue, or an unauthorized encroachment, or an abandoned encroachment. DWR DMP internal inspection has found pipe integrity issues. LOF of crossing is between 4.1 and 5. Crossing will be monitored until funding becomes available for rehabilitation. Current condition of pipe crossing does not impede access to patrol road/high ground area. Pipe is open on both ends, no flapgate. No permit was found authorizing this encroachment. CVFPB will need to review crossing to determine owner. The UCIP inspection was completed with LMA representative, J. Nelson. (H. Dunn ? GEI)06/12/2014 Pipe burried on LS shoulder and open on WS. Levee appears abandoned. (W. Wylie - DWR UCIP) FIELD_STRUCT_DESC: 18-inch corrugated metal storm drainage pipe (CMP) through the levee, 3.0 feet below the crown. Pipe open on both ends. Cobble grouted outlet on the waterside (WS) end. Cobble grouted intake on the landside (LS). [Additional Reference(s): DWR Levee Log, 1978, (HLM 0.97). USACE San Joaquin O&M Manual 612.2, 1967, (HLM 0.97), 18-inch pipe listed]. FS Date: 4/29/2021

Levee crown looking upstream.

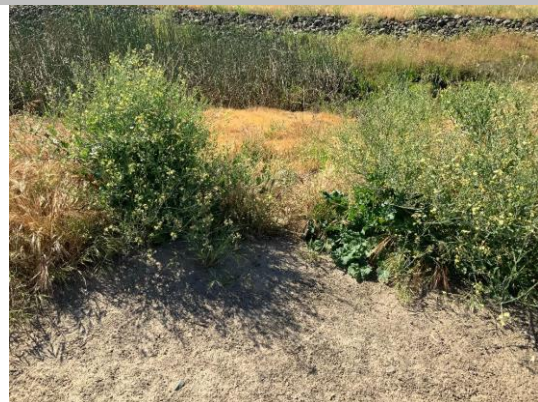
WS view: Toe from crown.

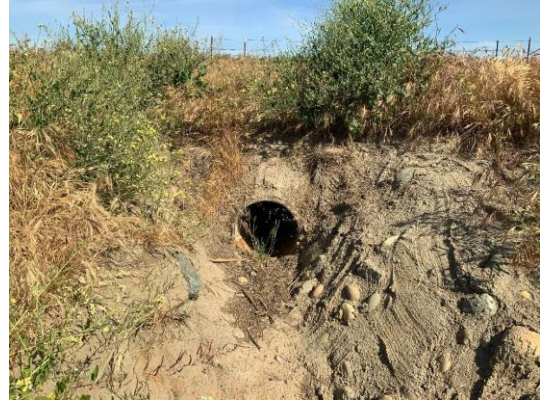
WS view: Slope and pipe outlet at toe.

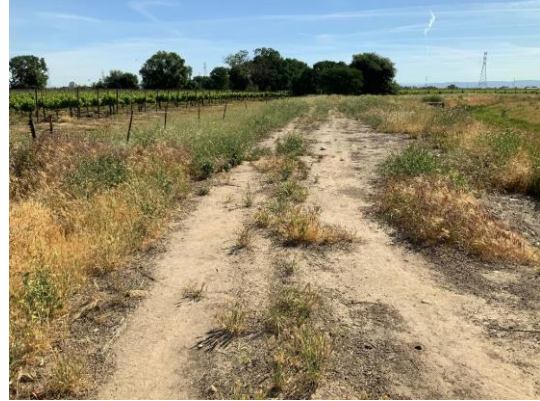
Comment Code						
Inspector Comment						
DS_ID:23949 FS_ID:79148 EP_NO: N/A Repair Type: Non-Urgent EVAL Issue: 11, Maintenance Compliance Issue Crossing Status: Found UCIP Comments: 04/29/2021 Pipe status is still Non-Urgent. Unit 14 ? Middle Paddle Creek (CLM 0 to 1.38) is considered a patrol road/high ground area with no defined levee prism, any issue found between CLM 0 to 1.38 of Unit 14 will be considered a maintenance issue, or an unauthorized encroachment, or an abandoned encroachment. DWR DMP internal inspection has not found pipe integrity issues. LOF of crossing is less or equal to 4.0. Recommend inspection in 5 years. Current condition of pipe crossing does not impede access to patrol road/high ground area. LS and WS pipe inlet and flapgate covered with vegetation, recommend removal. No permit was found authorizing this encroachment. CVFPB will need to review crossing to determine owner. The UCIP inspection was completed with LMA representative, J. Nelson. (H. Dunn ? GEI)06/12/2014 Pipe appears abandoned. Levee appears Abandoned. (W. Wylie - DWR UCIP) FIELD_STRUCT_DESC: 12-inch corrugated metal storm drainage pipe (CMP) through the levee, 2.5 feet below the crown. Flap gate on the waterside (WS) end. Cobble grouted outlet on the WS end. Cobble grouted intake on the landside (LS). [Additional Reference(s): DWR Levee Log, 1978, (HLM 1.12). USACE San Joaquin O&M Manual 612.2, 1967, (HLM 1.12), 12-inch pipe listed]. FS Date: 4/29/2021

Levee crown looking upstream.

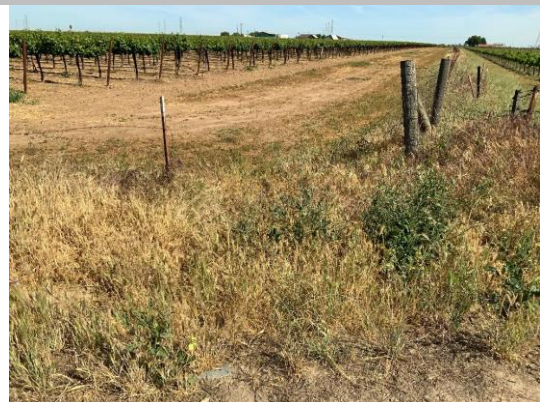
LS view: Toe from crown.

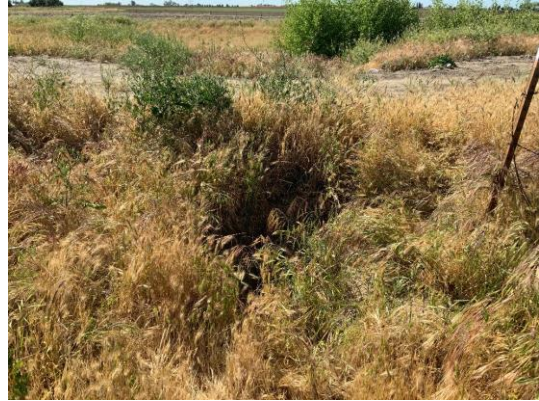
LS view: Pipe inlet covered by vegetation at toe.

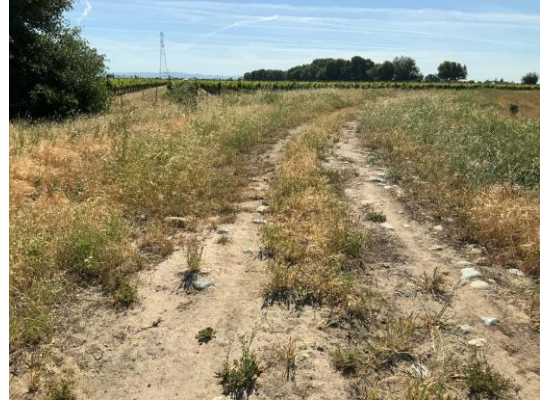
Comment Code						
Inspector Comment						
DS_ID:23950 FS_ID:79150 EP_NO: N/A Repair Type: Non-Urgent EVAL Issue: 11, Maintenance Compliance Issue Crossing Status: Found UCIP Comments: 04/29/2021 Pipe status is still Non-Urgent. Unit 14 ? Middle Paddle Creek (CLM 0 to 1.38) is considered a patrol road/high ground area with no defined levee prism, any issue found between CLM 0 to 1.38 of Unit 14 will be considered a maintenance issue, or an unauthorized encroachment, or an abandoned encroachment. DWR DMP internal inspection has not found pipe integrity issues. LOF of crossing is less or equal to 4.0. Recommend inspection in 5 years. Current condition of pipe crossing does not impede access to patrol road/high ground area. Pipe is open on both ends, no flapgate. No permit was found authorizing this encroachment. CVFPB will need to review crossing to determine owner. The UCIP inspection was completed with LMA representative, J. Nelson. (H. Dunn ? GEI)

06/12/2014 Pipe open on both ends. Levee appears abandoned. (W. Wylie - DWR UCIP) FIELD_STRUCT_DESC: 48-inch reinforced concrete storm drainage pipe (RCP) through the levee, 1.5 feet below the crown. Pipe open on both ends. Cobble grouted outlet on the waterside (WS) end. Cobble grouted intake on the landside (LS). [Additional Reference(s): DWR Levee Log, 1978, (HLM 1.17). USACE San Joaquin O&M Manual 612.2, 1967, (HLM 1.17), 48-inch pipe listed]. FS Date: 4/29/2021

Levee crown looking upstream.

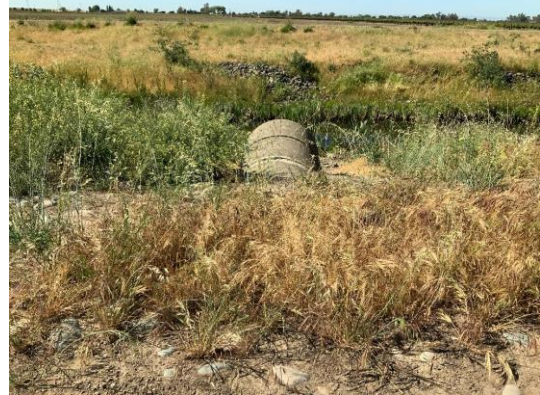
WS view: Pipe visible at toe from crown.

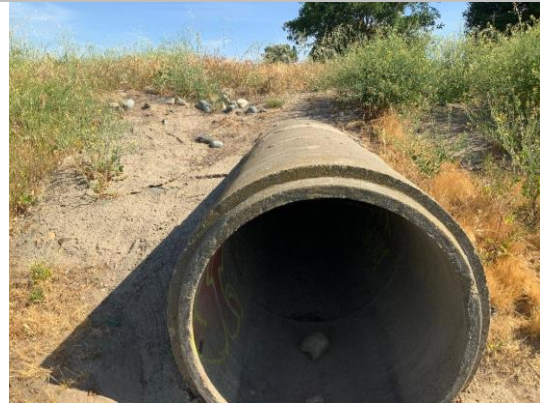
WS view: Slope and pipe outlet at toe.

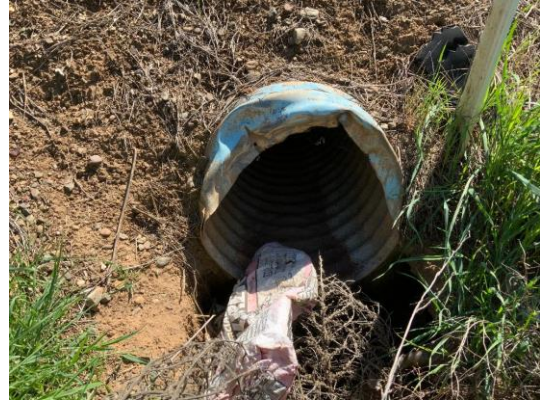
LS view: Inside pipe inlet.

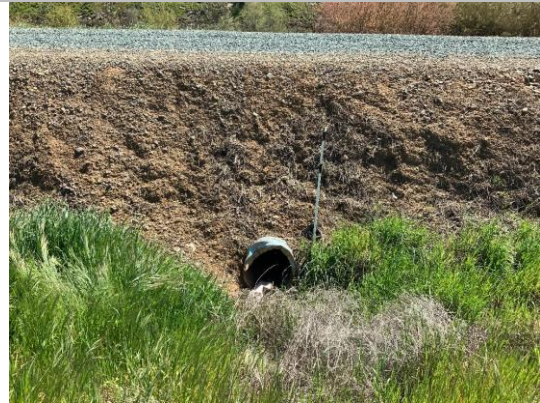
LS view: Pipe end at toe.

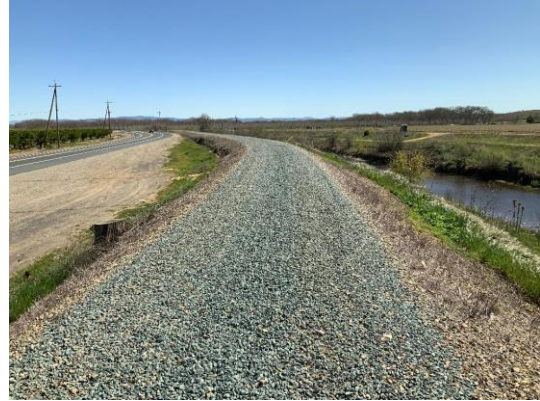
Comment Code					
Inspector Comment					
DS_ID:23200 FS_ID:81172 EP_NO: N/A Repair Type: Non-Urgent EVAL Issue: 11, Maintenance Compliance Issue Crossing Status: Found UCIP Comments: 09/25/2023 DMP internal video inspection has found none or minor pipe defects. Recommend next video inspection in 5 years. (J. Taylor - DWR UCIP) 03/26/2021 Record has been upgraded from No Action Needed to Non-Urgent. Unit 15 ? Mormon Slough (CLM 0 to 1.50 and 5.0 - 11.0) are considered a patrol road/high ground area with no defined levee prism, any issue found between CLM 0 - 1.50 and 5.0 ? 11.0 of Unit 15 will be considered a maintenance issue, or an unauthorized encroachment, or an abandoned encroachment. DWR DMP internal video inspection has found pipe integrity issues. LOF of crossing is between 5 and 6. Crossing will be monitored until funding becomes available to address the issues. Recommend cleaning dirt/vegetation debris off/out of LS pipe end. Current condition of pipe crossing does not impede access to patrol road/high ground area. No permit was found authorizing this encroachment. CVFPB will need to review crossing to determine owner. The UCIP inspection was completed with LMA representative, H. Latu. (H. Dunn ? GEI) 04/09/2021 Pipe needs cleaning and clearing on both pipe ends. (P. Tariq - DWR UCIP) FIELD_STRUCT_DESC: *HIGH GROUND* 18-inch CIPP lined drainage pipe of an unknown material through the levee, 6.0 feet below the crown. Grouted outlet on the waterside (WS) end. Electrical conduit through the levee. [Additional Reference(s): DWR Levee Log, 1992, (HLM 1.49). USACE San Joaquin O&M Manual 611.1, Volume F, (HLM 1.49), 18-inch pipe listed]. FS Date: 3/26/2021

Levee crown looking upstream.

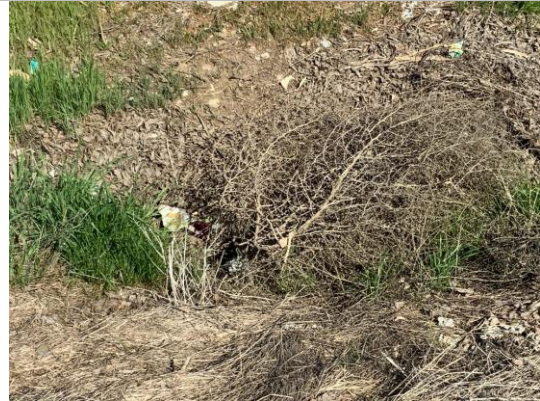
Photo 2 of 3 : UCIP_FA_2024_81172_94001.jpg

LS view: Pipe end covered in vegetation and dirt.

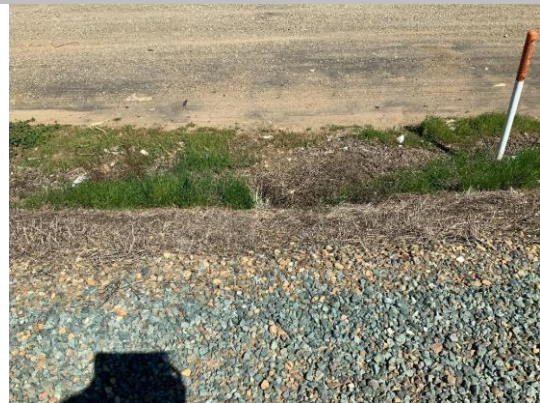
Photo 3 of 3 : UCIP_FA_2024_81172_94000.jpg

LS view: Toe from crown.

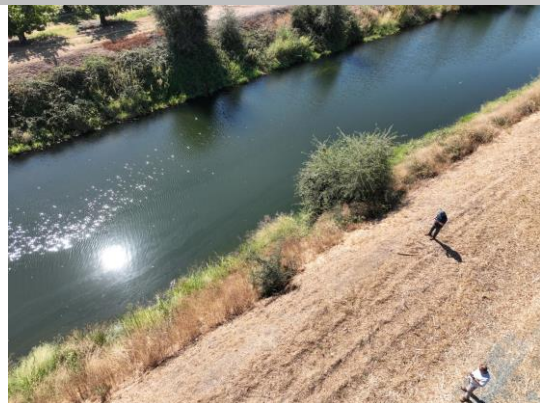
Photo 1 of 1 : SJR2024_NA0017U15RM18.45_8.JPG

8/8/2024: From 2020 to present, no significant changes were observed during the annual survey.

07/23/2020: This site was discovered during the DWR Fall 2015 Levee Inspections. Although dense vegetation is limiting the view, the erosion, which extends to the upper levee slope, could still be seen.

8/8/2024: Aerial view of the erosion.

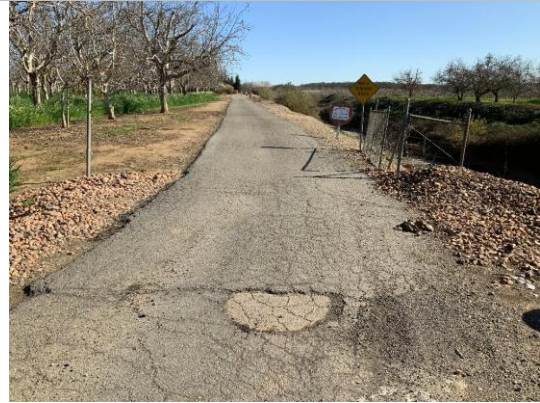
Photo 1 of 3 : UCIP_FA_2024_78687_94206.jpg

04/09/2014 Inlet CM pipe riser on landside shoulder. Pipe not found on waterside. Dense vegetation on channel bank. May need inlet cleaning. (P. Tariq - DWR UCIP)
FIELD_STRUCT_DESC: *HIGH GROUND* 18-inch corrugated metal storm drainage pipe (CMP) through the levee, 2.0 feet below the crown. Concrete rubble splash apron on the waterside (WS) end. [Additional Reference(s): DWR Levee Log, 1977, (HLM 5.58). USACE San Joaquin O&M Manual 611.1, Volume F, (HLM 5.58), 18-inch pipe listed].
FS Date: 3/26/2021

Levee crown looking upstream.

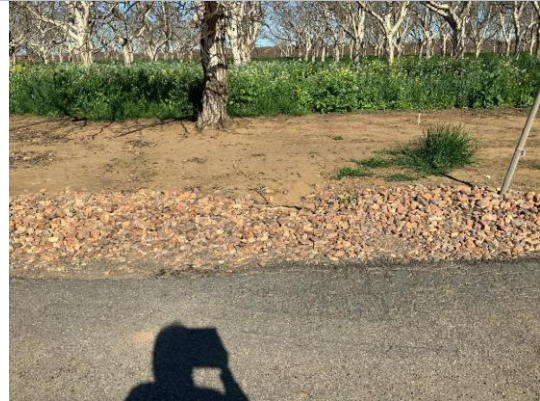
Photo 2 of 3 : UCIP_FA_2024_78687_94207.jpg

LS view: Toe from crown.

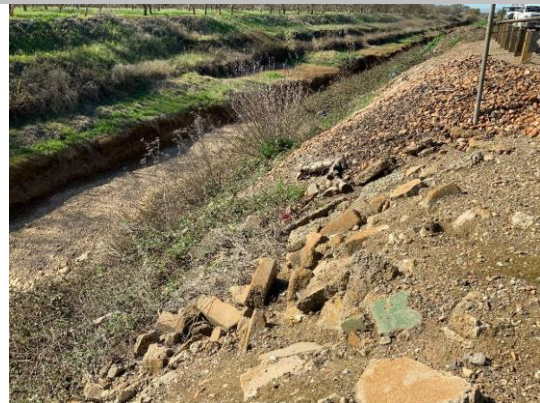
Photo 3 of 3 : UCIP_FA_2024_78687_94211.jpg

WS view: Slope from crown, no pipe visible due to vegetation.

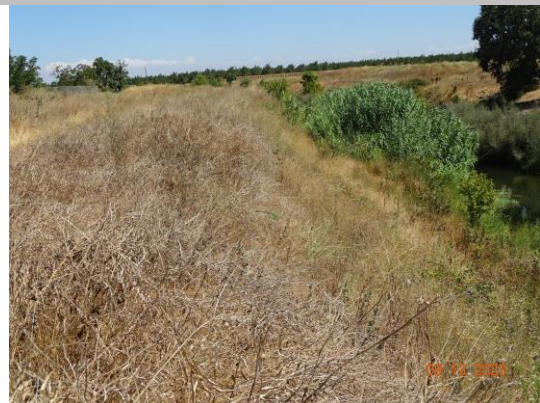
Photo 1 of 1 : FA_2024_NA0017_159_17_20240910_00009.jpg

LM Start	8.43	Rating **	A/W	Issue No.	17
LM End	8.43	Issue Type +	Ma	Location *	WS
Category	Earthen Levee			GPS Latitude/Longitude	
				Start	End
Item	Erosion / Bank Caving			37.969711°	37.969711°
				-121.116739°	-121.116739°
DWR ID	DWR_NA0017_15_f_2023_17				
Comment Code					
E1 : Note and monitor erosion site.					
Inspector Comment					
Issue has been transferred to Levee Mile Report and will continued to monitored. Site ID: NA0017U15RM14.49					
*This area is patrol road only and therefore the site is not rated					
07/28/2022: From 2014 to present, no significant changes were					
observed during the annual survey. There are signs of animal activity.					
09/12/2013: The erosion has been caused by runoff.

View channel bank erosion. Summer 2023

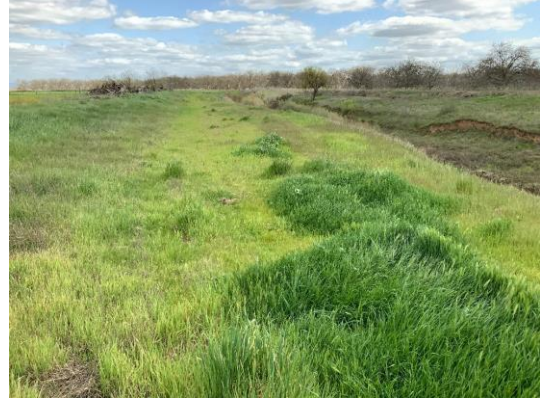
Photo 1 of 3 : UCIP_FA_2024_78694_94355.jpg

Comment Code						
Inspector Comment						
DS_ID:23227 FS_ID:78694 EP_NO: N/A Repair Type: Non-Urgent EVAL Issue: 11, Maintenance Compliance Issue Crossing Status: Found UCIP Comments: 03/25/2021 Pipe status is still Non-Urgent. Unit 15 ? Mormon Slough (CLM 0 to 1.50 and 5.0 - 11.0) are considered a patrol road/high ground area with no defined levee prism, any issue found between CLM 0 - 1.50 and 5.0 ? 11.0 of Unit 15 will be considered a maintenance issue, or an unauthorized encroachment, or an abandoned encroachment. LS pipe end covered in dirt and vegetation, recommend cleaning out. Cannot see WS pipe end. Current condition of pipe crossing does not impede access to patrol road/high ground area. No permit was found authorizing this encroachment. CVFPB will need to review crossing to determine owner. The UCIP inspection was completed with LMA representative, H. Latu. (H. Dunn ? GEI) 04/10/2014 Distorted inlet pipe opening on landside. No pipe found on waterside. Dense vegetation and steep slope on waterside. (P. Tariq - DWR UCIP) FIELD_STRUCT_DESC: 18-inch corrugated metal storm drainage pipe (CMP) through the levee, 1.0 foot below the crown. [Additional Reference(s): DWR Levee Log, 1992, (HLM 8.65). USACE San Joaquin O&M Manual 611.1, Volume F, (HLM 8.65), 18-inch pipe listed]. FS Date: 3/25/2021

Levee crown looking upstream.

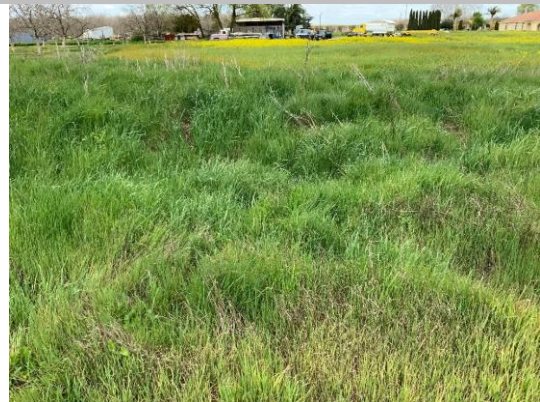
Photo 2 of 3 : UCIP_FA_2024_78694_94356.jpg

LS view: Toe from crown, pipe not visible.

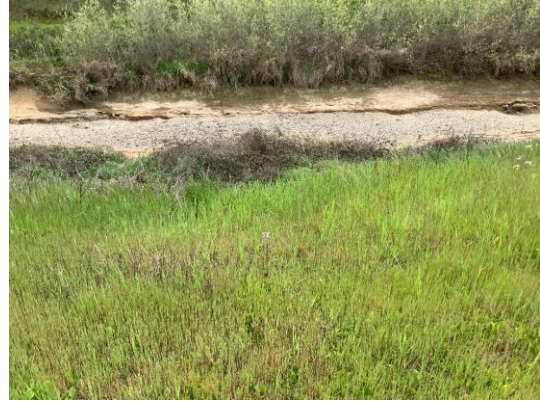
Photo 3 of 3 : UCIP_FA_2024_78694_94358.jpg

WS view: Toe from crown, no pipe visible.

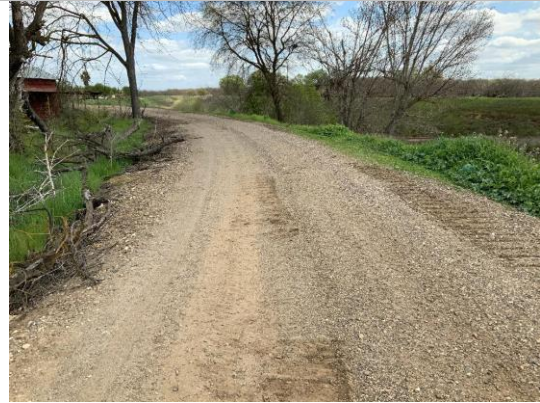
Photo 1 of 3 : UCIP_FA_2024_78695_94363.jpg

04/10/2014 Distorted pipe opening on landside. Inlet pipe needs clearing and cleaning. (P. Tariq - DWR UCIP) No pipe visible on waterside.					
FIELD_STRUCT_DESC: 18-inch corrugated metal storm drainage pipe (CMP) and an electrical conduit of an unknown material through the levee, 1.0 foot below the crown. Power pole on the landside (LS). Pipe outlet rock revetted. [Additional Reference(s): DWR Levee Log, 1992, (HLM 8.88). USACE San Joaquin O&M Manual 611.1, Volume F, (HLM 8.88), 18-inch pipe listed].					
FS Date: 3/25/2021

Levee crown looking upstream.

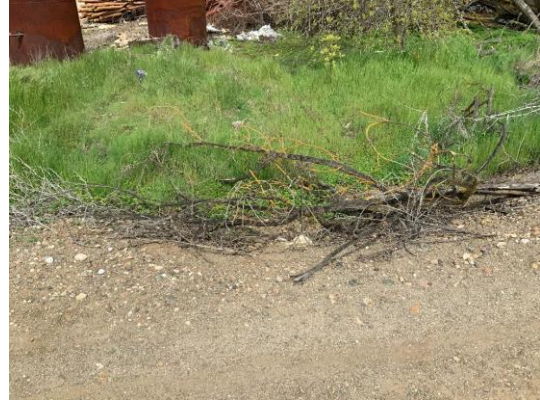
Photo 2 of 3 : UCIP_FA_2024_78695_94364.jpg

LS view: Toe from crown.

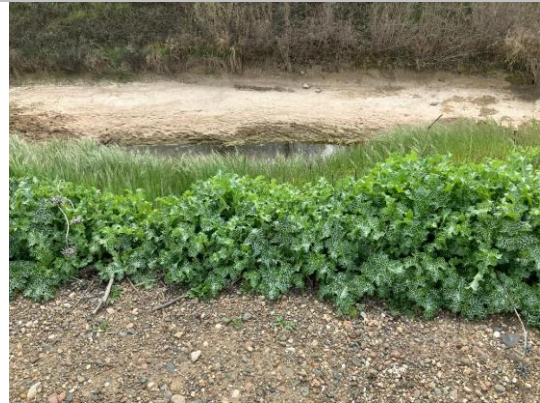
Photo 3 of 3 : UCIP_FA_2024_78695_94367.jpg

WS view: Toe from crown, no pipe visible.

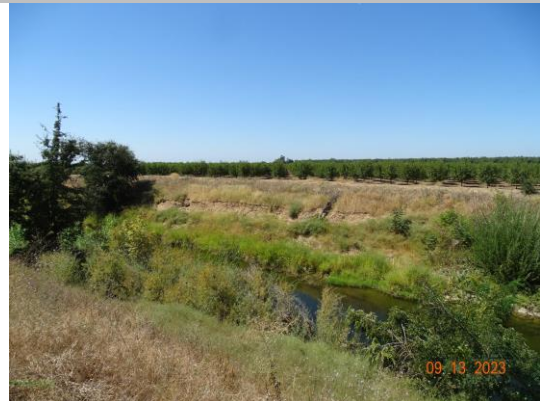
Photo 1 of 1 : FA_2024_NA0017_159_6_20240910_00006.jpg

LM Start	8.82	Rating **	A/W	Issue No.	6
LM End	8.82	Issue Type +	Ma	Location *	WS
Category	Earthen Levee			GPS Latitude/Longitude	
				Start	End
Item	Erosion / Bank Caving			37.968060°	37.968060°
				-121.123299°	-121.123299°
DWR ID	DWR_NA0017_15_f_2023_6				
Comment Code					
E1 : Note and monitor erosion site.					
Inspector Comment					
Issue has been transferred to Levee Mile Report and will continued to monitored. Site ID: NA0017U15RM13.87					
*This area is patrol road only and therefore the site is not rated					
08/02/2022: From 2015 to present, no significant changes were					
observed during the annual survey.					
08/20/2014: Both ends of the erosion site are protected by riprap.

View of channel bank erosion from opposite bank. Summer 2023

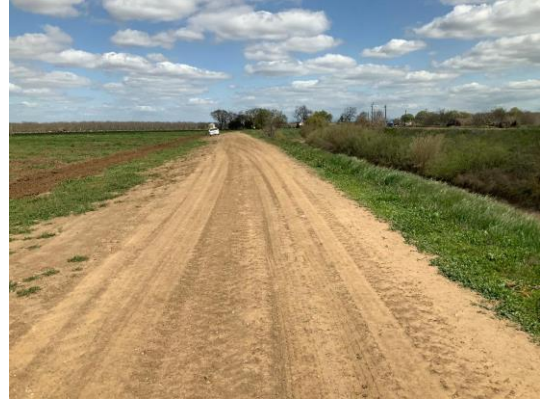
Photo 1 of 3 : UCIP_FA_2024_78696_94378.jpg

DS_ID:23230
FS_ID:78696
EP_NO: N/A
Repair Type: Non-Urgent
EVAL Issue:
Crossing Status: Indicator Found
UCIP Comments: 03/25/2021 Record has been upgraded from No Action Needed to Non-Urgent. Unit 15 ? Mormon Slough (CLM 0 to 1.50 and 5.0 - 11.0) are considered a patrol road/high ground area with no defined levee prism, any issue found between CLM 0 - 1.50 and 5.0 ? 11.0 of Unit 15 will be considered a maintenance issue, or an unauthorized encroachment, or an abandoned encroachment. Pipe not found by visual inspection. Geophysical study indicates possible presence of pipe through levee. Owner needs to coordinate with the CVFPB to remove or abandon crossing according to Title 23 requirements. Current condition of pipe crossing does not impede access to patrol road/high ground area. No permit was found authorizing this encroachment. CVFPB will need to review crossing to determine owner. The UCIP inspection was completed with LMA representative, H. Latu. (H. Dunn ? GEI)

Levee crown looking upstream.

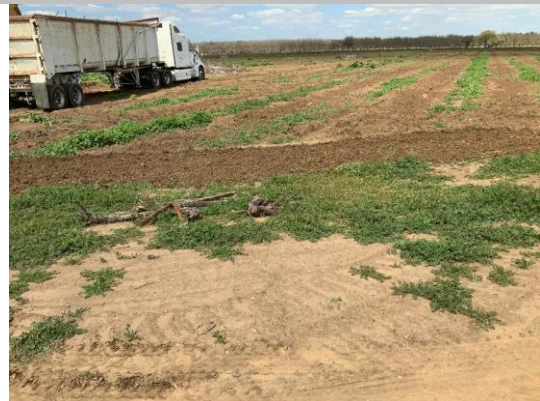
Photo 2 of 3 : UCIP_FA_2024_78696_94379.jpg

LS view: Toe from crown, no pipe visible.

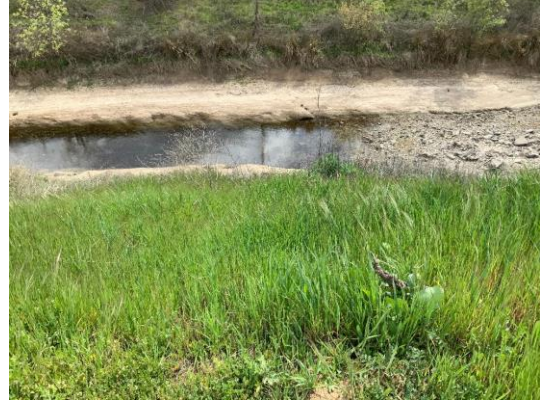
Photo 3 of 3 : UCIP_FA_2024_78696_94380.jpg

WS view: Toe from crown, no pipe visible.

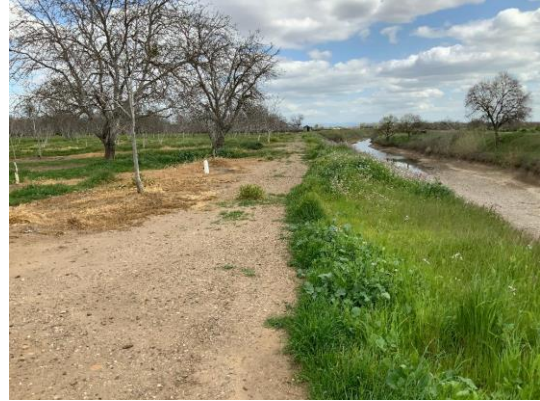
Photo 1 of 3 : UCIP_FA_2024_78700_94407.jpg

Comment Code						
Inspector Comment						
DS_ID:23233 FS_ID:78700 EP_NO: N/A Repair Type: Non-Urgent EVAL Issue: 11, Maintenance Compliance Issue Crossing Status: Found UCIP Comments: 03/25/2021 Pipe status is still Non-Urgent. Unit 15 - Mormon Slough (CLM 0 to 1.50 and 5.0 - 11.0) are considered a patrol road/high ground area with no defined levee prism, any issue found between CLM 0 - 1.50 and 5.0 - 11.0 of Unit 15 will be considered a maintenance issue, or an unauthorized encroachment, or an abandoned encroachment. DWR DMP internal video inspection has found pipe integrity issues. LOF of crossing is between 4.1 and 5. Crossing will be monitored until funding becomes available for rehabilitation. LS pipe buried under dirt and vegetation with some dirt seen inside WS pipe, recommend cleaning out both sides. Current condition of pipe crossing does not impede access to patrol road/high ground area. No permit was found authorizing this encroachment. CVFPB will need to review crossing to determine owner. The UCIP inspection was completed with LMA representative, H. Latu. (H. Dunn - GEI)04/10/2014 Needs clearing and cleaning of the pipe. (P. Tariq - DWR UCIP) FIELD_STRUCT_DESC: 18-inch corrugated metal storm drainage pipe (CMP) through the levee, 3.5 feet below the crown. Pipe discharges onto the waterside (WS) slope, which is eroding. [Additional Reference(s): DWR Levee Log, 1992, (HLM 9.75). USACE San Joaquin O&M Manual 611.1, Volume F, (HLM 9.75), 18-inch pipe listed]. FS Date: 3/25/2021

Levee crown looking upstream.

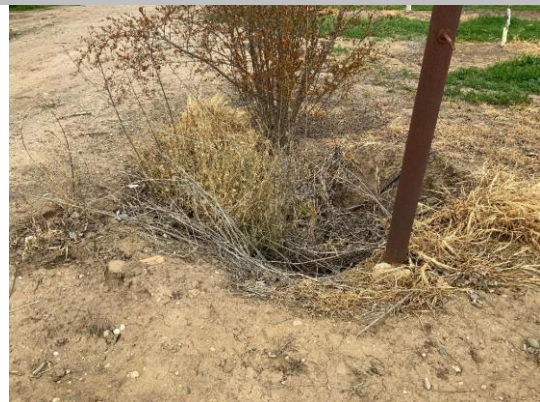
Photo 2 of 3 : UCIP_FA_2024_78700_94408.jpg

LS view: Toe from crown.

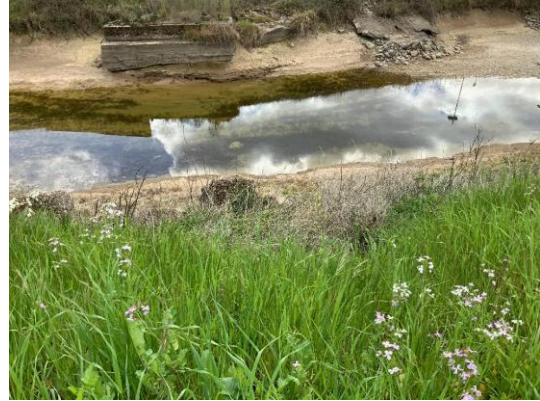
Photo 3 of 3 : UCIP_FA_2024_78700_94410.jpg

WS view: Toe from crown.

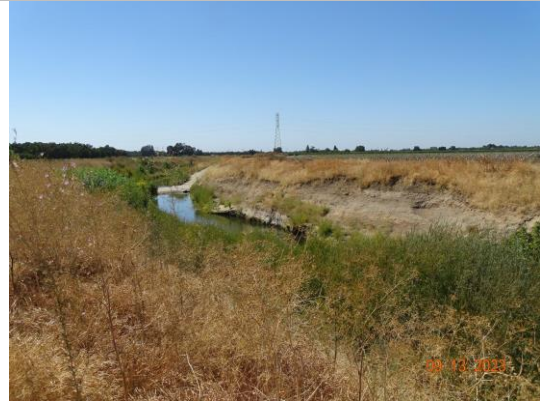
Photo 1 of 1 : FA_2024_NA0017_159_7_20240910_00007.jpg

Issue has been transferred to Levee Mile Report and will continued to monitored. Site ID: NA0017U15RM13.22
 *This area is patrol road only and therefore the site is not rated
 08/02/2022: No significant changes were observed since the previous inspection. The length was extended to 350 ft based on more accurate field measurements.
 06/29/2021: The erosion extends downstream to the ford. The erosion length was updated to 280 ft.
 07/24/2020: The site was discovered during the field survey. The erosion is immediately downstream of a newly repaired erosion site (NA0017U15RM13.25). The erosion begins at the shoulder and extends down the entire slope. Some sloughing is visible on the upper slope and the stream has cut into the bank.

View of channel bank erosion from opposite bank. Summer 2023

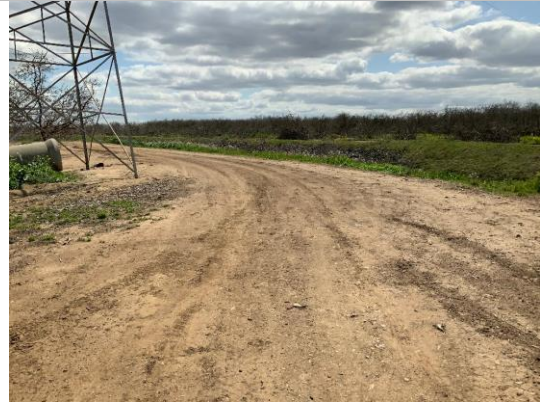
Photo 1 of 3 : UCIP_FA_2024_78702_94427.jpg

04/10/2014 Mud/soil in inlet pipe. Needs cleaning. (P. Tariq - DWR UCIR)
No pipe or appurtenances visible on waterside. Dense vegetation (may be visible from other channel bank).
FIELD_STRUCT_DESC: *HIGH GROUND* 18-inch corrugated metal storm drainage pipe (CMP) through the levee, 4.0 feet below the crown. Grouted inlet and outlet. [Additional Reference(s): DWR Levee Log, 1992, (HLM 10.01). USACE San Joaquin O&M Manual 611.1, Volume F, (HLM 10.01), 18-inch pipe listed].
FS Date: 3/25/2021

Levee crown looking upstream.

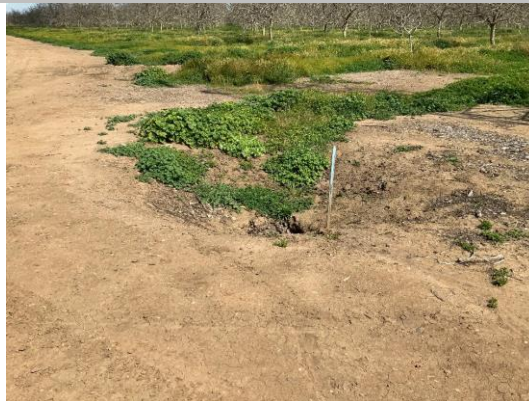
Photo 2 of 3 : UCIP_FA_2024_78702_94428.jpg

LS view: Toe from crown.

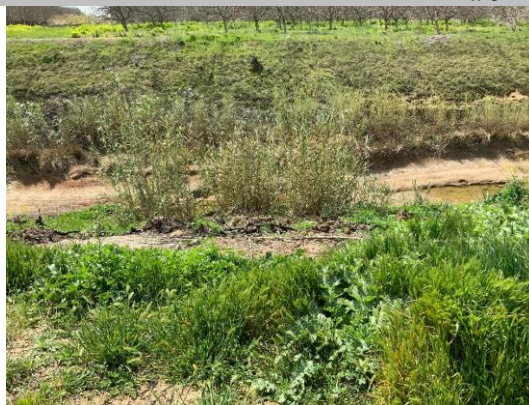
Photo 3 of 3 : UCIP_FA_2024_78702_94431.jpg

WS view: Toe from crown.

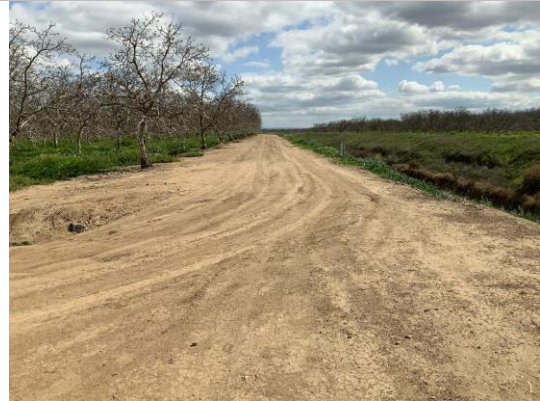
Photo 1 of 3 : UCIP_FA_2024_78703_94436.jpg

Comment Code						
Inspector Comment						
DS_ID:23236 FS_ID:78703 EP_NO: N/A Repair Type: Non-Urgent EVAL Issue: 11, Maintenance Compliance Issue Crossing Status: Found UCIP Comments: 03/25/2021 Pipe status is still Non-Urgent. Unit 15 - Mormon Slough (CLM 0 to 1.50 and 5.0 - 11.0) are considered a patrol road/high ground area with no defined levee prism, any issue found between CLM 0 - 1.50 and 5.0 - 11.0 of Unit 15 will be considered a maintenance issue, or an unauthorized encroachment, or an abandoned encroachment. LS pipe end filled with debris and dirt, recommend cleaning out. WS pipe end not seen. DWR DMP internal video inspection has not found pipe integrity issues. LOF of crossing is less or equal to 4.0. Recommend next video inspection in 5 years. Current condition of pipe crossing does not impede access to patrol road/high ground area. No permit was found authorizing this encroachment. CVFPB will need to review crossing to determine owner. The UCIP inspection was completed with LMA representative, H. Latu. (H. Dunn - GEI)04/10/2014 May need cleaning of the pipe. (P. Tariq - DWR UCIP) pipe not visible on waterside. FIELD_STRUCT_DESC: 18-inch corrugated metal storm drainage pipe (CMP) through the levee, 4.5 feet below the crown. Grouted inlet and outlet. [Additional Reference(s): DWR Levee Log, 1992, (HLM 10.22). USACE San Joaquin O&M Manual 611.1, Volume F, (HLM 10.22), 18-inch pipe listed]. FS Date: 3/25/2021

Levee crown looking upstream.

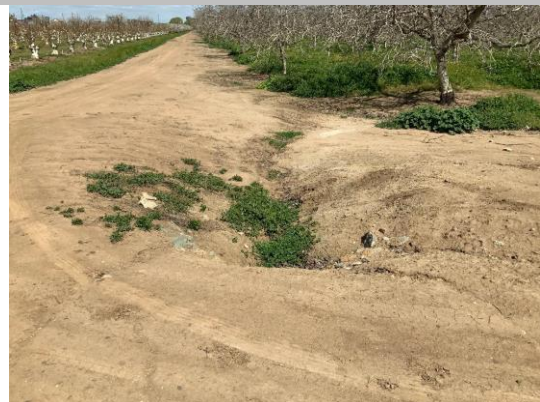
Photo 2 of 3 : UCIP_FA_2024_78703_94437.jpg

LS view: Toe from crown.

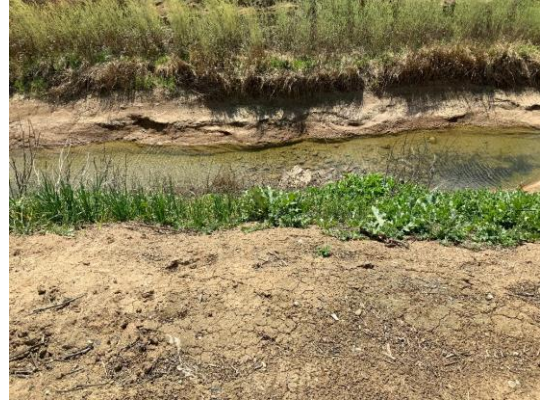
Photo 3 of 3 : UCIP_FA_2024_78703_94440.jpg

WS view: Toe from crown, no pipe visible.

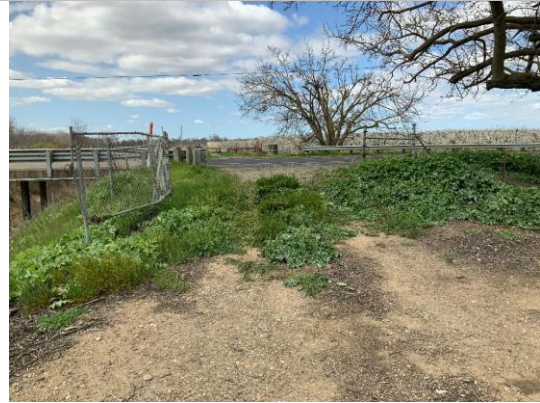
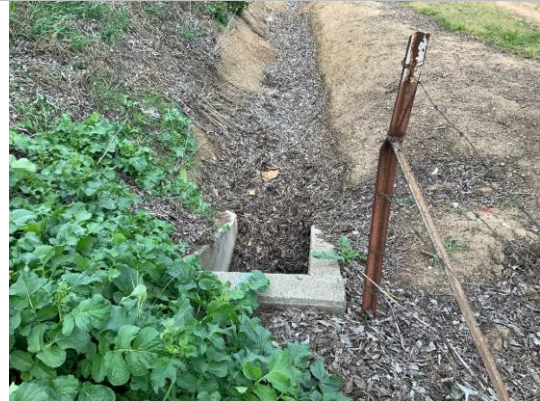
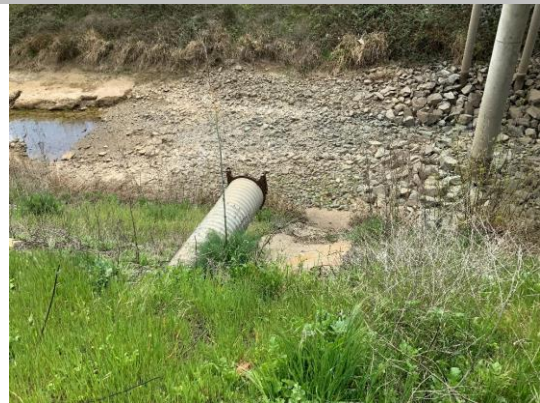
Photo 1 of 3 : UCIP_FA_2024_78704_94453.jpg

Comment Code					
Inspector Comment					
DS_ID:23237 FS_ID:78704 EP_NO: N/A Repair Type: Non-Urgent EVAL Issue: 11, Maintenance Compliance Issue Crossing Status: Found UCIP Comments: 03/25/2021 Record has been upgraded from No Action Needed to Non-Urgent. Unit 15 ? Mormon Slough (CLM 0 to 1.50 and 5.0 - 11.0) are considered a patrol road/high ground area with no defined levee prism, any issue found between CLM 0 - 1.50 and 5.0 ? 11.0 of Unit 15 will be considered a maintenance issue, or an unauthorized encroachment, or an abandoned encroachment. DWR DMP internal video inspection has found pipe integrity issues. LOF of crossing is between 4.1 and 5. Crossing will be monitored until funding becomes available for rehabilitation. Current condition of pipe crossing does not impede access to patrol road/high ground area. No permit was found authorizing this encroachment. CVFPB will need to review crossing to determine owner. The UCIP inspection was completed with LMA representative, H. Latu. (H. Dunn ? GEI)04/10/2014 May need cleaning of the inlet pipe. Vegetation debris on inlet box. (P. Tariq - DWR UCIP) FIELD_STRUCT_DESC: 18-inch corrugated metal storm drainage pipe (CMP) through the levee, 7.5 feet below the crown. Concrete U-shaped headwall on the landside (LS). Flap gate on the waterside (WS). [Additional Reference(s): DWR Levee Log, 1992, (HLM 10.47). USACE San Joaquin O&M Manual 611.1, Volume F, (HLM 10.47), 18-inch pipe listed]. FS Date: 3/25/2021

Levee crown looking downstream.

LS view: Toe from crown, headwall visible.

WS view: Toe from crown, pipe and flapgate visible.

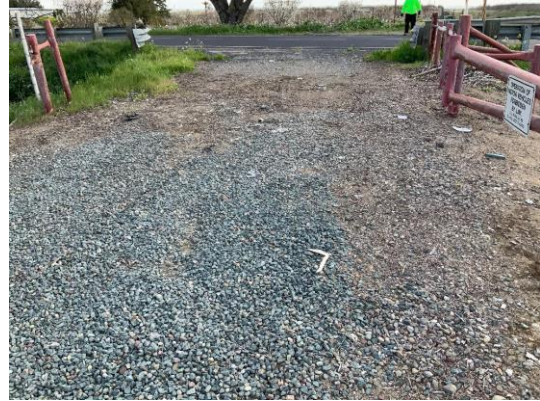
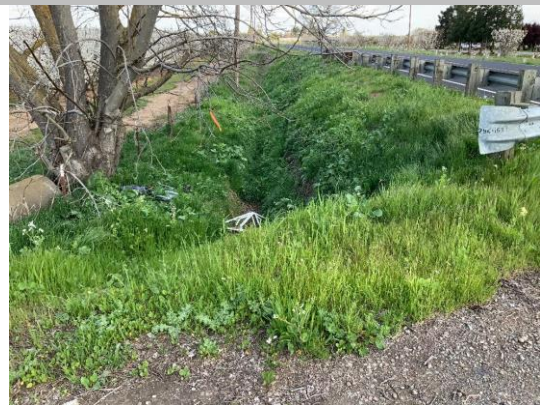
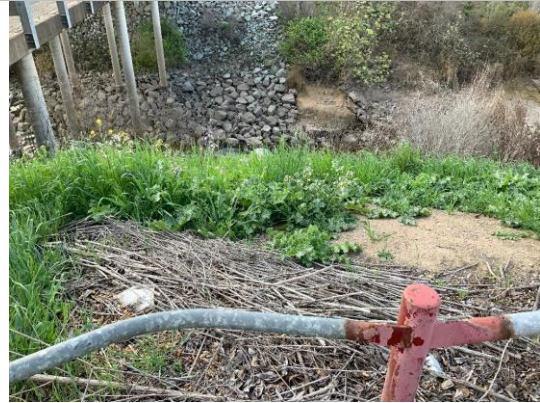
Photo 1 of 3 : UCIP_FA_2024_78705_94465.jpg

Comment Code						
Inspector Comment						
DS_ID:23238 FS_ID:78705 EP_NO: N/A Repair Type: Non-Urgent EVAL Issue: 11, Maintenance Compliance Issue Crossing Status: Found UCIP Comments: 03/25/2021 Pipe status is still Non-Urgent. Unit 15 - Mormon Slough (CLM 0 to 1.50 and 5.0 - 11.0) are considered a patrol road/high ground area with no defined levee prism, any issue found between CLM 0 - 1.50 and 5.0 - 11.0 of Unit 15 will be considered a maintenance issue, or an unauthorized encroachment, or an abandoned encroachment. Cannot see inlet or pipe on LS, likely covered in trash or vegetation, recommend clearing out. DWR DMP internal video inspection has not found pipe integrity issues. LOF of crossing is less or equal to 4.0. Recommend next video inspection in 5 years. Current condition of pipe crossing does not impede access to patrol road/high ground area. No permit was found authorizing this encroachment. CVFPB will need to review crossing to determine owner. The UCIP inspection was completed with LMA representative, H. Latu. (H. Dunn ? GEI)04/10/2014 Pipe buried on landside. May need cleaning of vegetation debris in inlet opening. (P. Tariq - DWR UCIP) FIELD_STRUCT_DESC: *HIGH GROUND* 18-inch corrugated metal storm drainage pipe (CMP) through the levee, 7.5 feet below the crown. Flap gate on the waterside (WS). [Additional Reference(s): DWR Levee Log, 1992, (HLM 10.49). USACE San Joaquin O&M Manual 611.1, Volume F, (HLM 10.49), 18-inch pipe listed]. FS Date: 3/25/2021

Levee crown looking upstream.

LS view: Toe from levee crown.

WS view: Toe from crown.

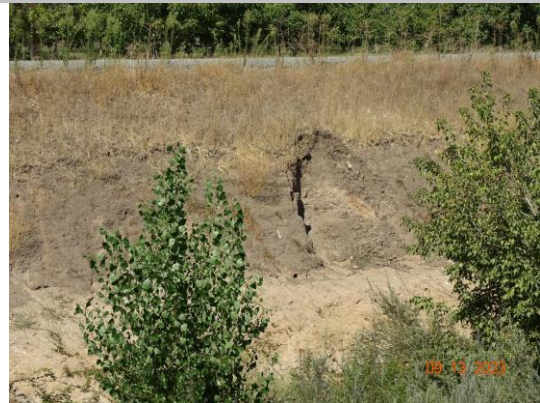
Photo 1 of 1 : FA_2024_NA0017_159_22_20240910_00010.jpg

LM Start	10.74	Rating **	A/W	Issue No.	22
LM End	10.74	Issue Type +	Ma	Location *	WS
Category	Earthen Levee			GPS Latitude/Longitude	
				Start	End
Item	Erosion / Bank Caving			37.963449°	37.963449°
				-121.157018°	-121.157018°
DWR ID	DWR_NA0017_15_f _ 2023_22

View of bank erosion from the opposite bank. Summer 2023

Comment Code
E1 : Note and monitor erosion site.
Inspector Comment
Issue has been transferred to Levee Mile Report and will continued to monitored. Site ID: NA0017U15RM12.12 *This area is patrol road only and therefore the site is not rated 08/02/2022: From 2020 to present, no significant changes were observed during the annual survey. 08/28/2019: The erosion is located at the lower slope of the channel bank and covered by dense vegetation.

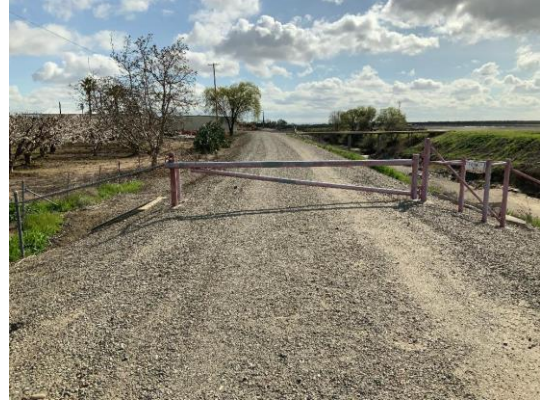
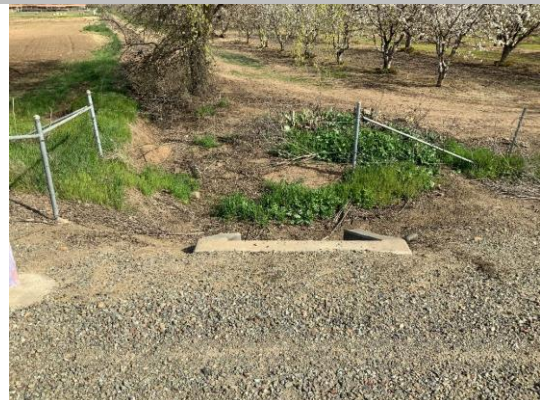
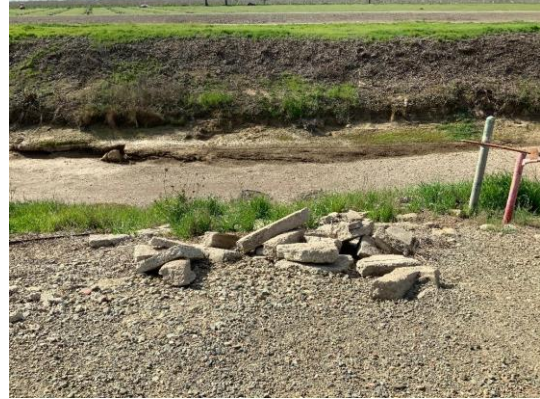
Photo 1 of 3 : UCIP_FA_2024_78710_94524.jpg

Comment Code						
Inspector Comment						
DS_ID:23243 FS_ID:78710 EP_NO: N/A Repair Type: Urgent EVAL Issue: 3a, Flood Risk Crossing Status: Found UCIP Comments: 03/25/2021 The record has been upgraded from Non-Urgent to Urgent. Pipe is heavily grouted around on WS, fairly hidden. No flapgate, open on both ends. Latest DMP internal video inspection has found moderate pipe defects. Crossing will be monitored until funding becomes available for rehabilitation. No permit was found authorizing this encroachment. CVFPB will need to review crossing to determine owner. The UCIP inspection was completed with LMA representative, H. Latu. (H. Dunn ? GEI)04/14/2014 Distorted outlet pipe on waterside. (P. Andy - DWR UCIP) FIELD_STRUCT_DESC: 18-inch corrugated metal storm drainage pipe (CMP) through the levee, 4.0 feet below the crown. Grouted outlet on the waterside (WS). [Additional Reference(s): DWR Levee Log, 1992, (HLM 11.64). USACE San Joaquin O&M Manual 611.1, Volume F, (HLM 11.64), 18-inch pipe listed]. FS Date: 3/25/2021

Levee crown looking upstream.

LS view: Toe from crown, headwall visible.

WS view: Toe from crown.

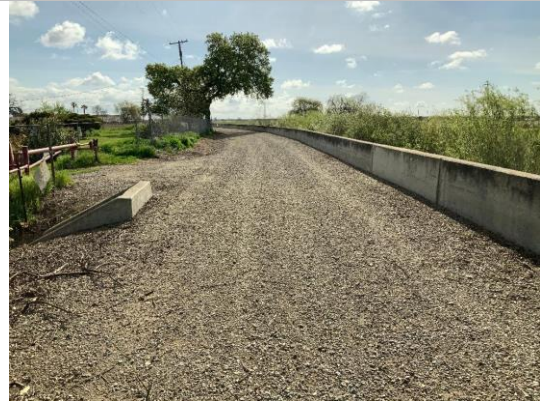
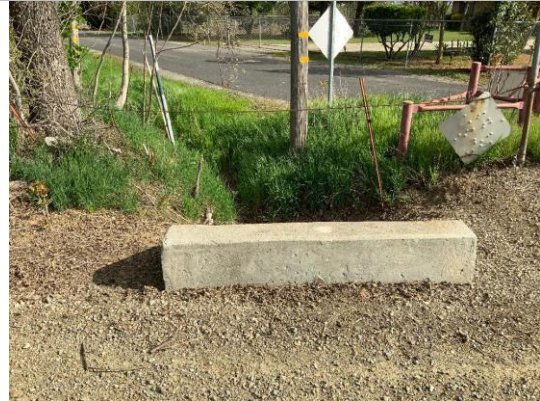
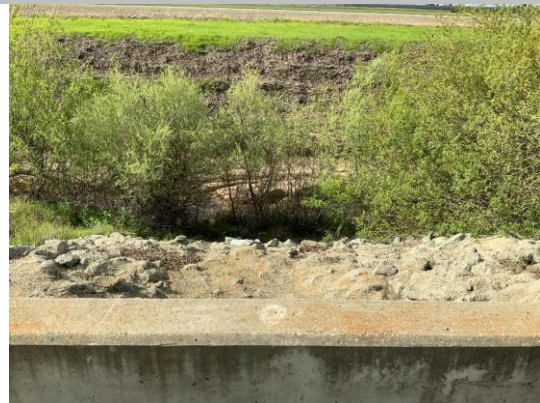
Photo 1 of 3 : UCIP_FA_2024_77709_94534.jpg

DS_ID:23244
 FS_ID:77709
 EP_NO: N/A
 Repair Type: Non-Urgent
 EVAL Issue:
 Crossing Status: Found
 UCIP Comments: 03/25/2021 The record has been upgraded from No Action Needed to Non-Urgent. DWR DMP internal video inspection has not found pipe integrity issues. LOF of crossing is less or equal to 4.0. Recommend next video inspection in 5 years. No permit was found authorizing this encroachment. CVFPB will need to review crossing to determine owner. The UCIP inspection was completed with LMA representative, H. Latu. (H. Dunn ? GEI)04/14/2014 New pipe and flapgate. (P. Andy - DWR UCIP)
 FIELD_STRUCT_DESC: 30-inch corrugated metal storm drainage pipe (CMP) through the levee, 4.5 feet below the crown. Flap gate on the waterside (WS). Headwall with open inlet pipe on the landside (LS). Grouted outlet. [Additional Reference(s): DWR Levee Log, 1992, (HLM 11.79), 18-inch pipe listed. USACE San Joaquin O&M Manual 611.1, Volume F, (HLM 11.79), 18-inch pipe listed].

Levee crown looking upstream.

LS view: Toe from crown, headwall visible.

WS view: Toe from crown, headwall visible.
