**Flood Control Project Maintenance
Levee Inspections****Maintenance Issue Types Only, Levee Inspection Report By Mile - Fall 2024****San Joaquin County Flood Control and Water Conservation District**

Waterway	Bank	Unit Miles	Inspection Start/End	Inspector
Unit No. 01 Littlejohn Creek	Left	2.59	10/21/2024 10/21/2024	Alberto De Leon

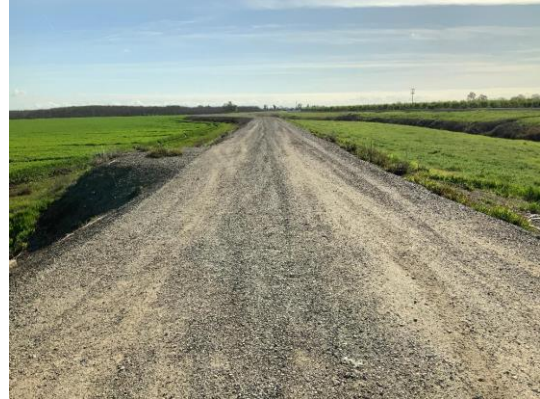
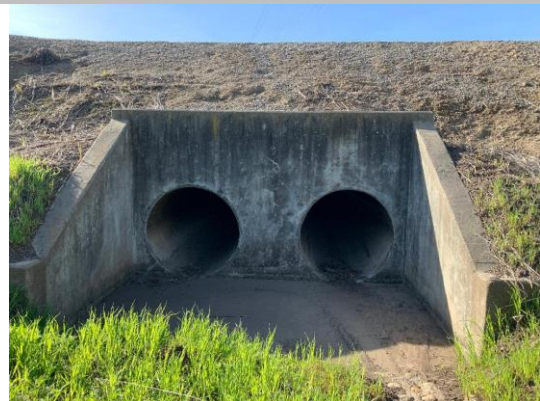
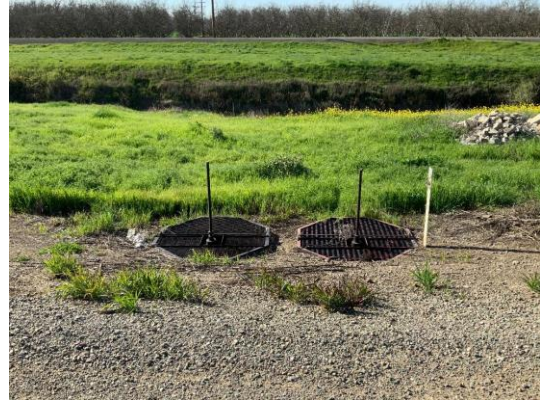
Photo 1 of 3 : UCIP_FA_2024_79157_94583.jpg

Comment Code						
Inspector Comment						
DS_ID:23247 FS_ID:79157 EP_NO: N/A Repair Type: Non-Urgent EVAL Issue: 5, Pipe Damage Crossing Status: Found UCIP Comments: 09/23/2024 DMP internal video inspection has found moderate pipe defects. Crossing will be monitored until funding becomes available for rehabilitation. (O. Yakimov - DWR UCIP) 03/25/2021 The record has been upgraded from No Action Needed to Non- Urgent. DWR DMP internal video inspection has not found pipe integrity issues. LOF of crossing is less or equal to 4.0, Recommend next video inspection in 5 years. No permit was found authorizing this encroachment. CVFPB will need to review crossing to determine owner. The UCIP inspection was completed with LMA representative, H. Latu. (H. Dunn - GEI)04/14/2014 May need mud and debris cleaning. (P. Andy - DWR UCIP) FIELD_STRUCT_DESC: 1 of 2: 48-inch drainage pipe of an unknown material through the levee, 11.5 feet below the crown. Slide gate in a corrugated metal pipe (CMP) riser unit on the waterside (WS) slope. Concrete U-shaped headwalls on each end. Flap gate on the WS end. Grouted rock outlet on the WS. [Additional Reference(s): DWR Levee Log, 1992, (HLM 12.65). USACE San Joaquin O&M Manual 611.1, Volume F, (HLM 12.65), 48-inch CMP listed]. FS Date: 3/25/2021

Levee crown looking upstream.

LS view: Headwall at toe.

WS view: Toe from crown.

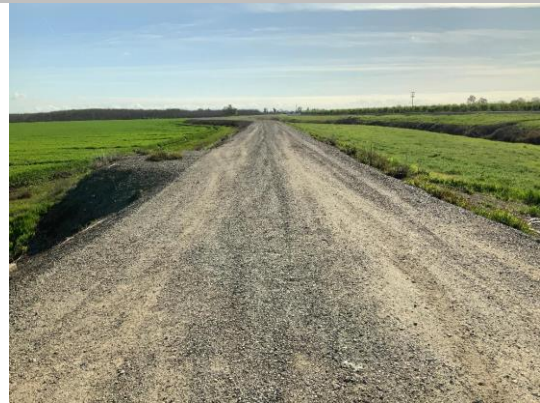
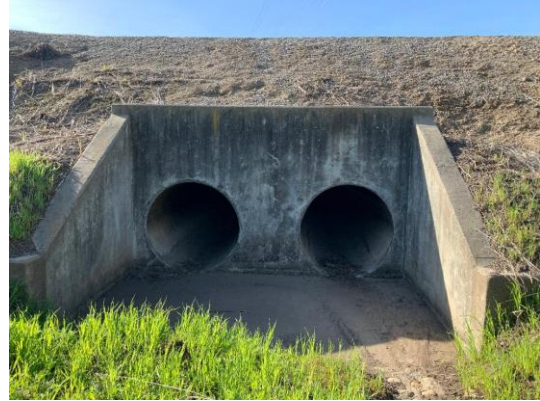
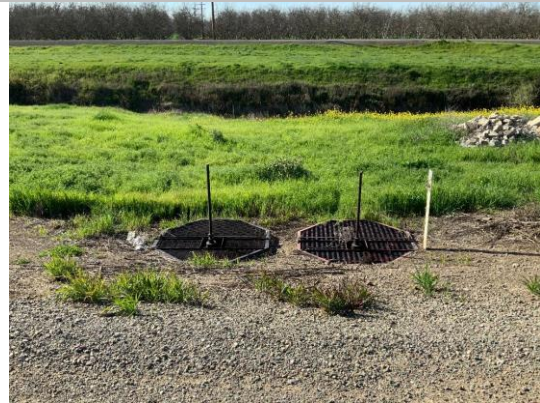
Photo 1 of 3 : UCIP_FA_2024_85073_94588.jpg

DS_ID:23454
FS_ID:85073
EP_NO: N/A
Repair Type: No Action Needed
EVAL Issue:
Crossing Status: Found
UCIP Comments: 10/21/2024 Record updated from Urgent to No Action Needed. LoF rating was changed due to the difference in CCTV operator opinion in severity of offset joint. (O. Yakimov - DWR UCIP) 03/25/2021 The record has been upgraded from No Action Needed to Urgent. Significant peeling of metal inside LS pipe. DWR DMP internal video inspection has found pipe integrity issues. LOF of crossing is between 5 and 6. Crossing will be monitored until funding becomes available to address the issues. No permit was found authorizing this encroachment. CVFPB will need to review crossing to determine owner. The UCIP inspection was completed with LMA representative, H. Latu. (H. Dunn ? GEI)04/14/2014 May need mud and debris cleaning. (P. Andy - DWR UCIP)
FIELD_STRUCT_DESC: 2 of 2: 48-inch drainage pipe of an unknown material through the levee, 11.5 feet below the crown. Slide gate in a corrugated metal pipe (CMP) riser unit on the waterside (WS) slope. Concrete U-shaped headwalls on each end. Flap gate on the WS end. Grouted rock outlet on the WS. [Additional Reference(s): DWR Levee Log, 1992, (HLM 12.65). USACE San Joaquin O&M Manual 611.1, Volume F, (HLM 12.65), 48-inch CMP listed].

Levee crown looking upstream.

LS view: Headwall at toe.

WS view: Toe from crown.

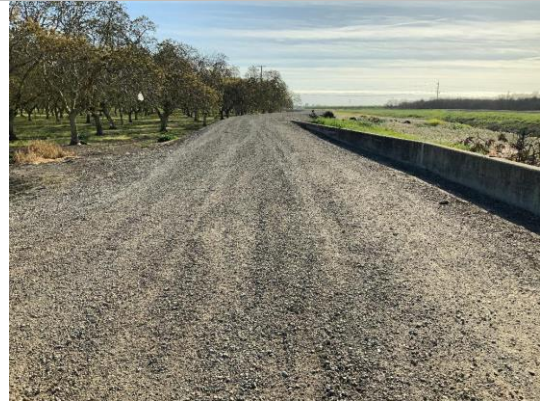
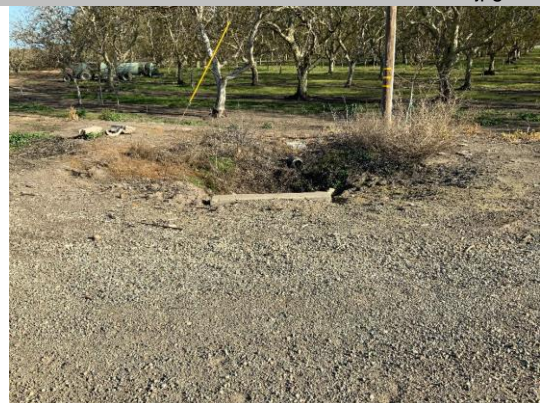
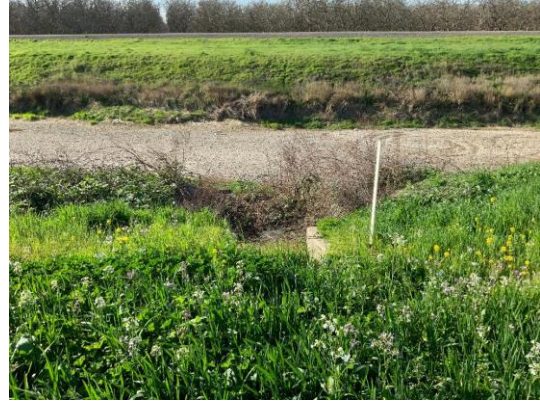
Photo 1 of 3 : UCIP_FA_2024_79160_94611.jpg

Comment Code						
Inspector Comment						
DS_ID:23249 FS_ID:79160 EP_NO: N/A Repair Type: Urgent EVAL Issue: 1, Pipe Integrity Crossing Status: Found UCIP Comments: 03/25/2021 The record has been upgraded from No Action Needed to Urgent. DWR DMP internal video inspection has found pipe integrity issues. LOF of crossing is between 5 and 6. Minor erosion along LS headwall edges. Unknown plastic pipe underground adjacent to LS headwall, does not go through the levee. Crossing will be monitored until funding becomes available to address the issues. No permit was found authorizing this encroachment. CVFPB will need to review crossing to determine owner. The UCIP inspection was completed with LMA representative, H. Latu. (H. Dunn ? GEI) 04/14/2014 May need cleaning of pipes. Flood wall on waterside shoulder. (P. Andy - DWR UCIP) FIELD_STRUCT_DESC: 30-inch corrugated metal storm drainage pipe (CMP) through the levee, 8.5 feet below the crown. Concrete U-shaped headwalls on each end. Flap gate on the waterside (WS) end. Grouted intake and outlet. [Additional Reference(s): DWR Levee Log, 1992, (HLM 12.83). USACE San Joaquin O&M Manual 611.1, Volume F, (HLM 12.83), 30-inch pipe listed]. FS Date: 3/25/2021

Levee crown looking upstream.

LS view: Headwall at toe from crown.

WS view: Headwall at toe from crown.

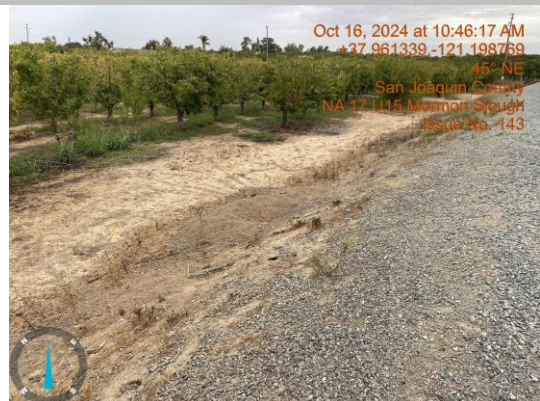
Photo 1 of 1 : FA_2024_NA0017_159_143_20241019_00226.jpg

View of large animal burrow along the landside easement. Fall 2024

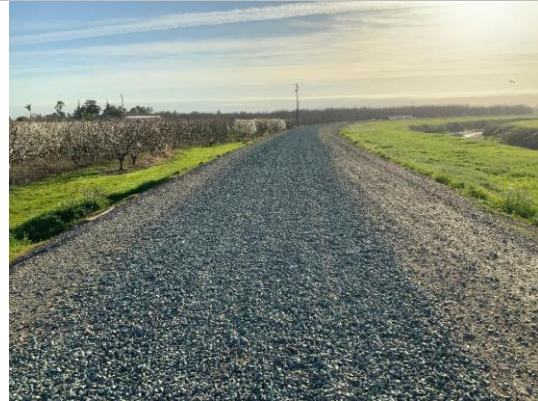
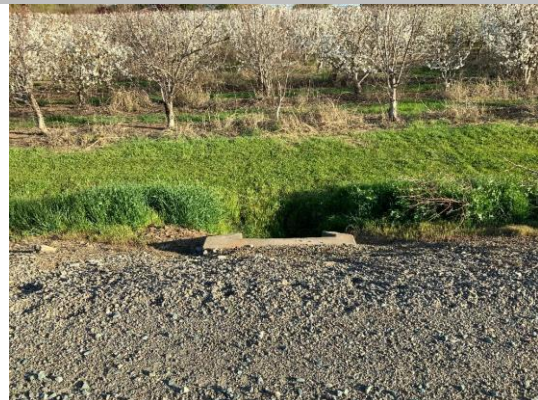
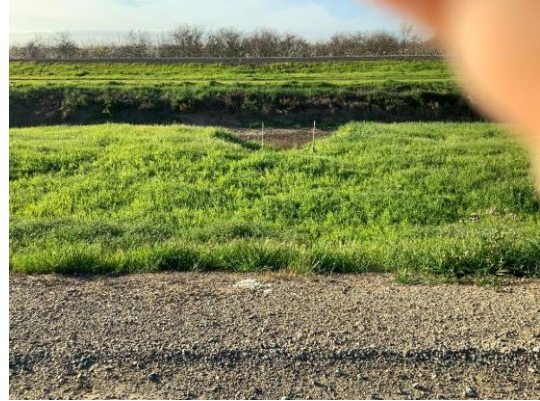
Photo 1 of 3 : UCIP_FA_2024_79161_94652.jpg

Comment Code						
Inspector Comment						
DS_ID:23252 FS_ID:79161 EP_NO: N/A Repair Type: Non-Urgent EVAL Issue: Crossing Status: Found UCIP Comments: 03/25/2021 Pipe status is still Non-Urgent. DWR DMP internal video inspection has not found pipe integrity issues. LOF of crossing is less or equal to 4.0. Recommend next video inspection in 5 years. No permit was found authorizing this encroachment. CVFPB will need to review crossing to determine owner. The UCIP inspection was completed with LMA representative, H. Latu. (H. Dunn ? GEI) 04/14/2014 Needs pipe cleaning. (P. Andy - DWr UCIP) FIELD_STRUCT_DESC: 30-inch corrugated metal storm drainage pipe (CMP) through the levee, 8.5 feet below the crown. Concrete U-shaped headwalls on each end. Flap gate on the waterside (WS) end. Grouted outlet on the WS. [Additional Reference(s): DWR Levee Log, 1992, (HLM 13.43). USACE San Joaquin O&M Manual 611.1, Volume F, (HLM 13.43), 30-inch pipe listed]. FS Date: 3/25/2021

Levee crown looking upstream.

LS view: Headwall at toe from crown.

WS view: Toe and slope from crown.

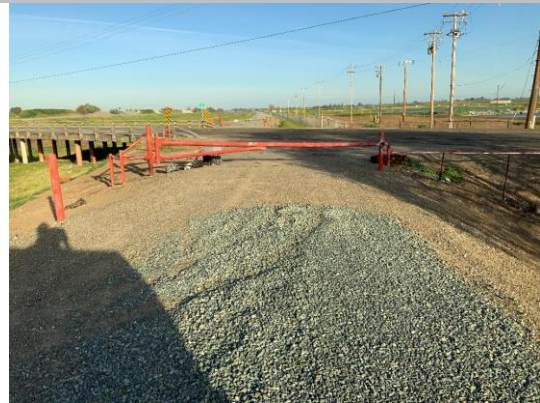
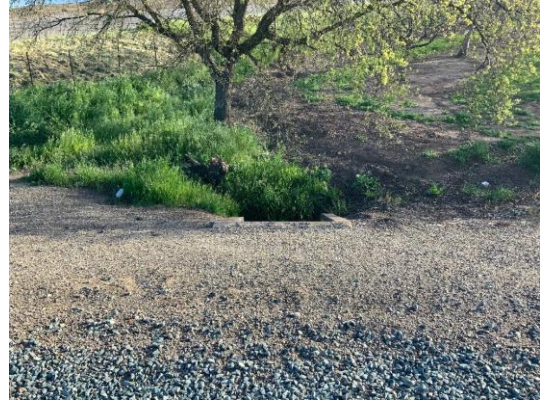
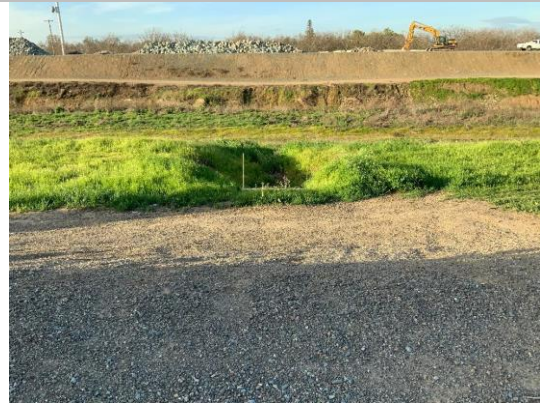
Photo 1 of 3 : UCIP_FA_2024_79162_95094.jpg

DS_ID:23254
FS_ID:79162
EP_NO: N/A
Repair Type: Non-Urgent
EVAL Issue:
Crossing Status: Found
UCIP Comments: 03/25/2021 Pipe status is still Non-Urgent. No permit was found authorizing this encroachment. CVFPB will need to review crossing to determine owner. The UCIP inspection was completed with LMA representative, H. Latu. (H. Dunn ? GEI)04/14/2014 Needs cleaning. (P. Andy - DWR UCIP)
FIELD_STRUCT_DESC: 36-inch corrugated metal storm drainage pipe (CMP) through the levee, 8.5 feet below the crown. Concrete U-shaped headwalls on each end. Flap gate on the waterside (WS) end. Grouted outlet on the WS. [Additional Reference(s): DWR Levee Log, 1992, (HLM 13.75). USACE San Joaquin O&M Manual 611.1, Volume F, (Station 0+79), 36-inch pipe listed].
FS Date: 3/25/2021

Levee crown looking upstream.

LS view: Headwall visible at toe from crown.

WS view: Headwall at toe from crown.

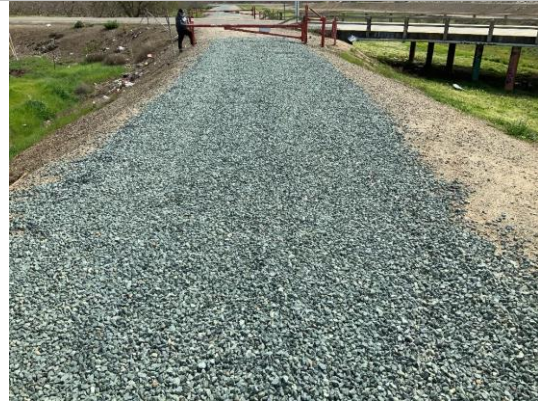
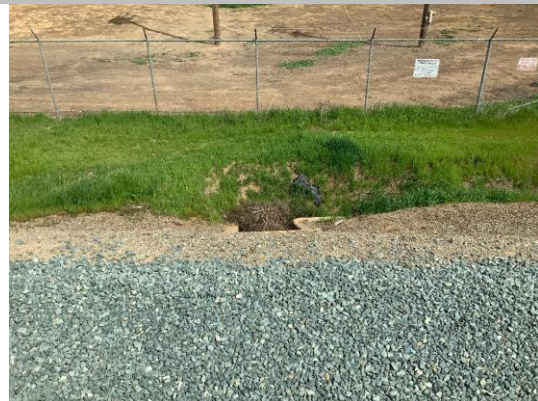
Photo 1 of 3 : UCIP_FA_2024_79420_95108.jpg

Comment Code						
Inspector Comment						
DS_ID:23257 FS_ID:79420 EP_NO: N/A Repair Type: Non-Urgent EVAL Issue: 5, Pipe Damage Crossing Status: Found UCIP Comments: 03/31/2023 Record updated from Urgent to Non-Urgent. LoF is equal to 5 due to pipe surface damage corrosion, integrity issues are not found. Crossing will be monitored until funding becomes available for rehabilitation. (O.Yakimov - DWR UCIP). 03/22/2021 The record has been upgraded from No Action Needed to Urgent. DWR DMP internal video inspection has found pipe integrity issues. LOF of crossing is between 5 and 6. Crossing will be monitored until funding becomes available to address the issues. No permit was found authorizing this encroachment. CVFPB will need to review crossing to determine owner. The UCIP inspection was completed with LMA representative, J. Jauregui. (H. Dunn ? GEI) 04/14/2014 May need cleaning. (P. Andy - DWR UCIP) FIELD_STRUCT_DESC: 30-inch corrugated metal storm drainage pipe (CMP) through the levee, 9.5 feet below the crown. Concrete U-shaped headwalls on each end. Flap gate on the waterside (WS) end. Grouted intake and outlet. [Additional Reference(s): DWR Levee Log, 1992, (HLM 13.79). USACE San Joaquin O&M Manual 611.1, Volume F, (HLM 13.79), 30-inch pipe listed]. FS Date: 3/22/2021

Levee crown looking upstream.

LS view: Headwall visible at toe from crown.

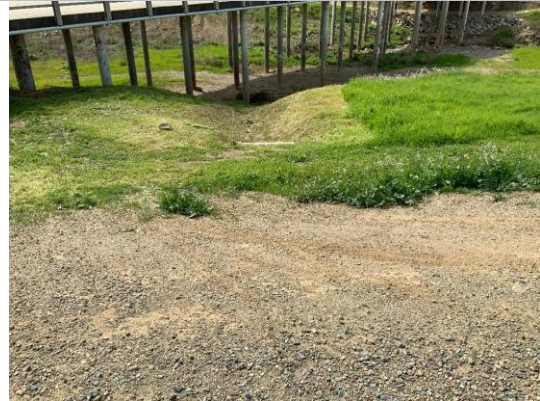
Photo 3 of 3 : UCIP_FA_2024_79420_95112.jpg

WS view: Headwall at toe from crown.

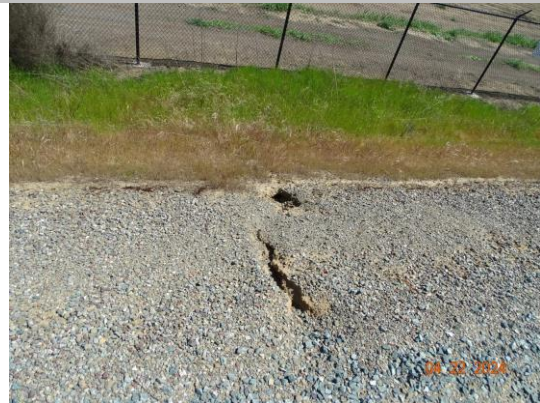
Photo 1 of 1 : FA_2024_NA0017_159_139_20240910_00026.jpg

LM Start	14.43	Rating **	M	Issue No.	139
LM End	14.43	Issue Type +	Ma	Location *	LS
Category	Earthen Levee			GPS Latitude/Longitude	
				Start	End
Item	Animal Control			37.969043°	37.969043°
				-121.219231°	-121.219231°
DWR ID	DWR_NA0017_15_s_2024_139				
Comment Code					
A3 : No rodents visible, but rodent burrows visible; need to backfill and compact or grout burrows.					
Inspector Comment

View of an animal burrow on the landside slope. Spring 2024

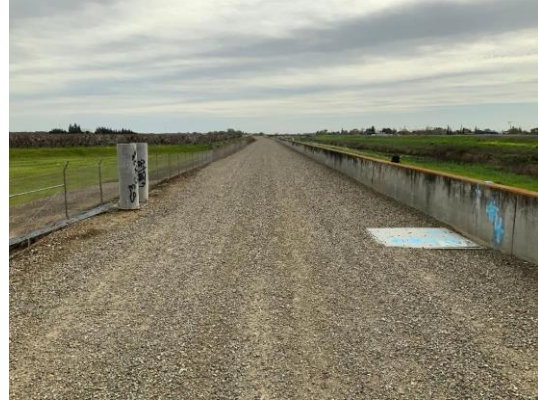
Photo 1 of 3 : UCIP_FA_2024_85080_95139.jpg

Comment Code						
Inspector Comment						
DS_ID:23456 FS_ID:85080 EP_NO: N/A Repair Type: No Action Needed EVAL Issue: Crossing Status: Found UCIP Comments: 10/21/2024 Record updated from Urgent to No Action Needed. Latest PACP inspection did not locate a hole in pipe noted in the previous inspection. DMP performed a man entry inspection and found no hole. (O. Yakimov - DWR UCIP) 03/22/2021 The record has been upgraded from No Action Needed to Urgent. DWR DMP internal video inspection has found pipe integrity issues. LOF of crossing is between 5 and 6. Crossing will be monitored until funding becomes available to address the issues. No permit was found authorizing this encroachment. CVFPB will need to review crossing to determine owner. The UCIP inspection was completed with LMA representative, J. Jauregui. (H. Dunn ? GEI)10/27/2017 This structure is inspected annually under the Structure and Channel Summer Inspection (part of the Levee Inspection Program) conducted by the DWR Flood Project Integrity and Inspection Branch (FPIIB). (DWR UCIP - O. Magana) Culvert inlet under the pump house. FIELD_STRUCT_DESC: [Mormon Slough Pumping Plant No. 3] 1 of 3: 30-inch by 30-inch reinforced concrete box drainage culvert (RCBC) through the levee, 18.0 feet below the crown. Slide gate in a riser unit on the waterside (WS) slope. Flap gate on the WS end. Concrete U-shaped headwall around all three pipes on the WS. Steel steps on the LS slope. [Additional Reference(s): DWR Levee Log, 1992, (HLM 15.42). USACE San Joaquin O&M Manual 611.1, Volume F, (HLM 15.42), 30-inch by 30-inch RCBC listed]. FS Date: 3/22/2021

Levee crown looking upstream.

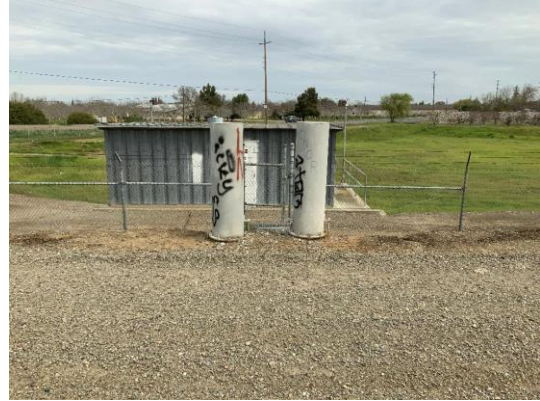
Photo 2 of 3 : UCIP_FA_2024_85080_95141.jpg

LS view: Toe from crown, pump house and risers.

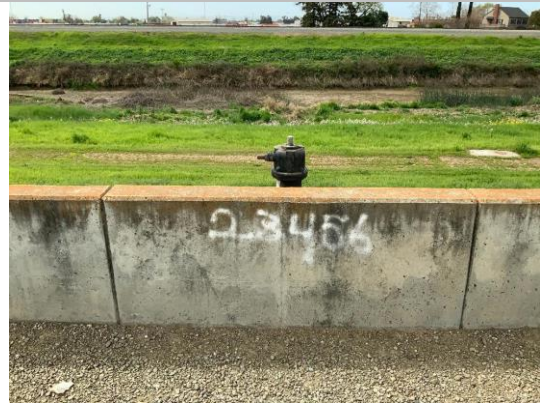
Photo 3 of 3 : UCIP_FA_2024_85080_95143.jpg

WS view: Toe from crown.

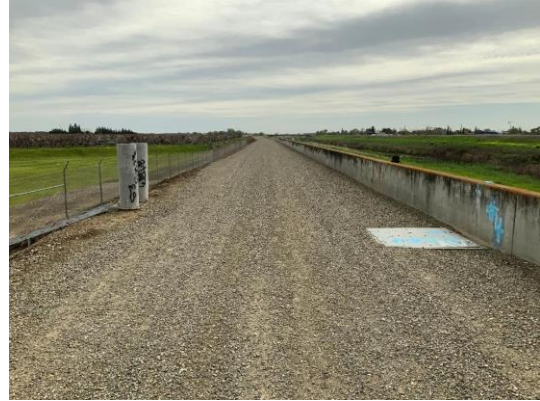
Photo 1 of 3 : UCIP_FA_2024_80885_95148.jpg

Comment Code					
Inspector Comment					
DS_ID:23261					
FS_ID:80885					
EP_NO: N/A					
Repair Type: No Action Needed					
EVAL Issue:					
Crossing Status: Found					
UCIP Comments: 03/22/2021 The record has been upgraded from No					
Action Needed to Non-Urgent. No permit was found authorizing this					
encroachment. CVFPB will need to review crossing to determine owner.					
The UCIP inspection was completed with LMA representative, J.					
Jauregui. (H. Dunn ? GEI)10/27/2017 This structure is inspected					
annually under the Structure and Channel Summer Inspection (part of					
the Levee Inspection Program) conducted by the DWR Flood Project					
Integrity and Inspection Branch (FPIIB). (DWR UCIP - O. Magana)					
Trash rack in inlet opening box.					
FIELD_STRUCT_DESC: [Mormon Slough Pumping Plant No. 3] 2 of 3:					
20-inch steel drainage pipe through the levee, 1.9 feet below the crown.					
Siphon breakers in 4-foot-high riser units on the landside (LS) shoulder.

Levee crown looking upstream.

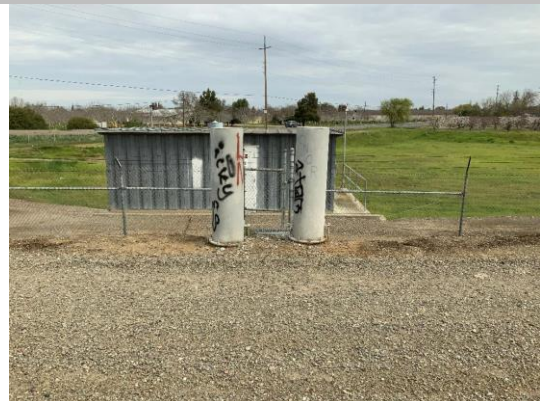
Photo 2 of 3 : UCIP_FA_2024_80885_95149.jpg

LS view: Toe from crown, risers and pump house.

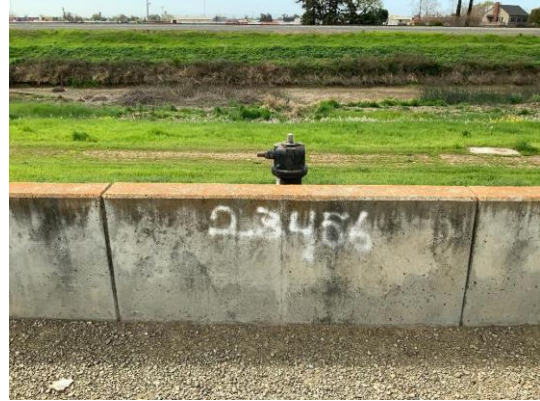
Photo 3 of 3 : UCIP_FA_2024_80885_95151.jpg

WS view: Toe from crown.

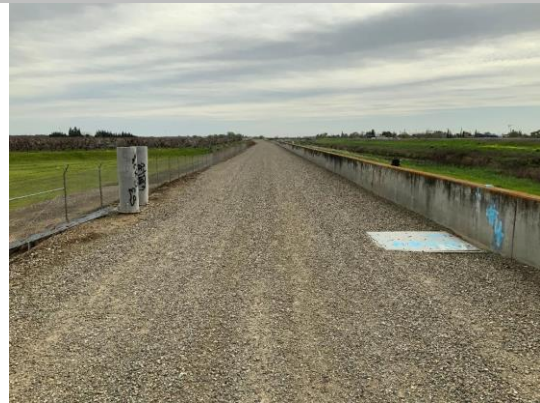
Photo 1 of 3 : UCIP_FA_2024_80886_95156.jpg

DS_ID:23455
FS_ID:80886
EP_NO: N/A
Repair Type: No Action Needed
EVAL Issue:
Crossing Status: Found
UCIP Comments: 03/22/2021 The record has been upgraded from No Action Needed to Non-Urgent. No permit was found authorizing this encroachment. CVFPB will need to review crossing to determine owner. The UCIP inspection was completed with LMA representative, J. Jauregui. (H. Dunn ? GEI)10/27/2017 This structure is inspected annually under the Structure and Channel Summer Inspection (part of the Levee Inspection Program) conducted by the DWR Flood Project Integrity and Inspection Branch (FPIIB). (DWR UCIP - O. Magana)
Steel trash rack in inlet opening.
FIELD_STRUCT_DESC: [Mormon Slough Pumping Plant No. 3] 3 of 3: 20-inch steel drainage pipe through the levee, 1.9 feet below the crown. Siphon breakers in 4-foot-high riser units on the landside (LS) shoulder. Flap gates on the waterside (WS) end. Concrete U-shaped headwall around all three pipes on the WS. Pump house on the LS. Steel steps on the LS slope. [Additional Reference(s): DWR Levee Log, 1992, (HLM 15.42). USACE San Joaquin O&M Manual 611.1, Volume F, (HLM 15.42), 20-inch pipe listed].

Levee crown looking upstream.

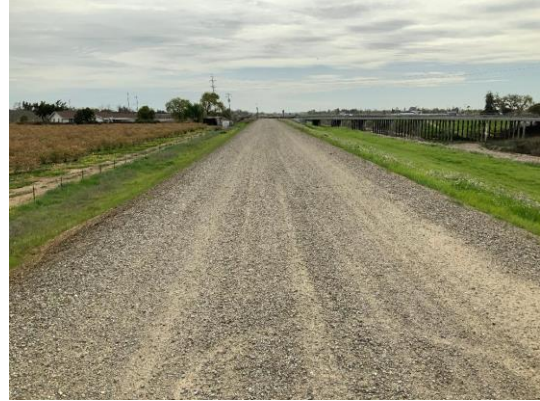
Photo 1 of 3 : UCIP_FA_2024_79421_95201.jpg

Comment Code					
Inspector Comment					
DS_ID:23188 FS_ID:79421 EP_NO: N/A Repair Type: Non-Urgent EVAL Issue: 5, Pipe Damage Crossing Status: Found UCIP Comments: 03/31/2023 Record updated from Urgent to Non-Urgent. LoF is equal to 5 due to pipe surface damage corrosion, integrity issues are not found. Crossing will be monitored until funding becomes available for rehabilitation. (O.Yakimov - DWR UCIP). 03/22/2021 The record has been upgraded from No Action Needed to Urgent. DWR DMP internal video inspection has found pipe integrity issues. LOF of crossing is between 5 and 6. Crossing will be monitored until funding becomes available to address the issues. No permit was found authorizing this encroachment. CVFPB will need to review crossing to determine owner. The UCIP inspection was completed with LMA representative, J. Jauregui. (H. Dunn ? GEI) 04/15/2014 May need cleaning. (P. Andy - DWR UCIP) FIELD_STRUCT_DESC: 30-inch corrugated metal storm drainage pipe (CMP) through the levee, 9.5 feet below the crown. Flap gate on the waterside (WS) end. Concrete U-shaped headwalls on each end. Grouted intake and outlet. [Additional Reference(s): DWR Levee Log, 1992, (HLM 15.58). USACE San Joaquin O&M Manual 611.1, Volume F, (HLM 15.58), 30-inch pipe listed]. FS Date: 3/22/2021

Levee crown looking upstream.

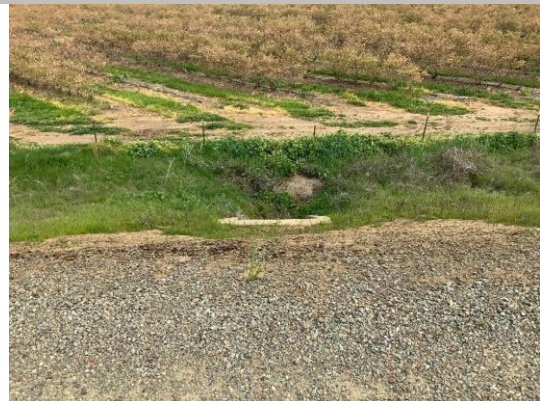
Photo 2 of 3 : UCIP_FA_2024_79421_95202.jpg

LS view: Headwall visible at toe from crown.

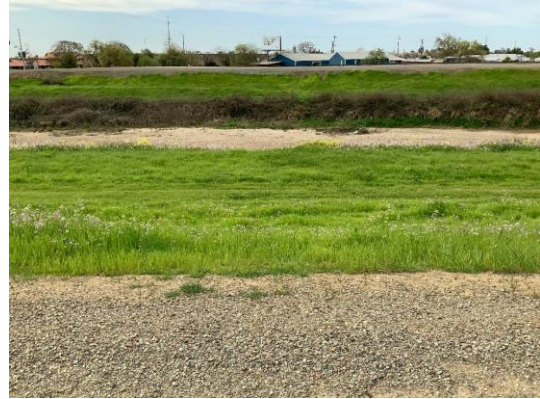
Photo 3 of 3 : UCIP_FA_2024_79421_95205.jpg

WS view: Toe from crown.

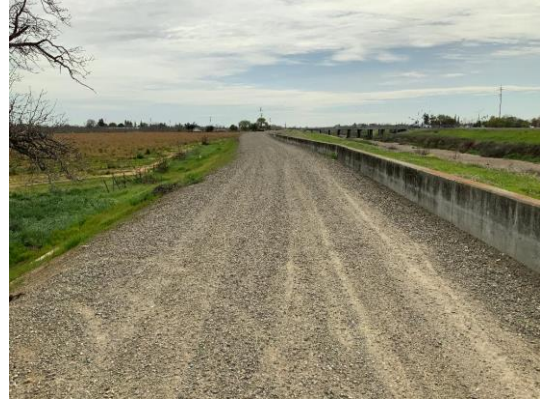
Photo 1 of 3 : UCIP_FA_2024_79422_95208.jpg

DS_ID:23189
FS_ID:79422
EP_NO: N/A
Repair Type: Non-Urgent
EVAL Issue: 5, Pipe Damage
Crossing Status: Found
UCIP Comments: 03/31/2023 Record updated from Urgent to Non-Urgent. LoF is equal to 5 due to pipe surface damage corrosion, integrity issues are not found. Crossing will be monitored until funding becomes available for rehabilitation. (O.Yakimov - DWR UCIP).
03/22/2021 Record updated from No Action Needed to Urgent. DMP internal video inspection has found pipe integrity issues. LOF of crossing is between 5 and 6. Crossing will be monitored until funding becomes available to address the issues. No permit was found authorizing this encroachment. CVFPB will need to review crossing to determine owner. The UCIP inspection was completed with LMA representative, J. Jauregui. (H. Dunn ? GEI)04/15/2014 May need cleaning. (P. Andy - DWR UCIP)
FIELD_STRUCT_DESC: 30-inch corrugated metal storm drainage pipe (CMP) through the levee, 9.5 feet below the crown. Flap gate on the waterside (WS) end. Concrete U-shaped headwalls on each end. Grouted intake and outlet. [Additional Reference(s): DWR Levee Log, 1992, (HLM 15.70). USACE San Joaquin O&M Manual 611.1, Volume F, (HLM 15.70), 30-inch pipe listed].

Levee crown looking upstream.

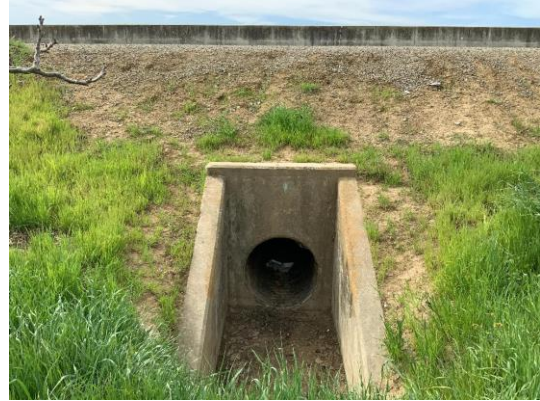
Photo 2 of 3 : UCIP_FA_2024_79422_95210.jpg

LS view: Headwall at toe.

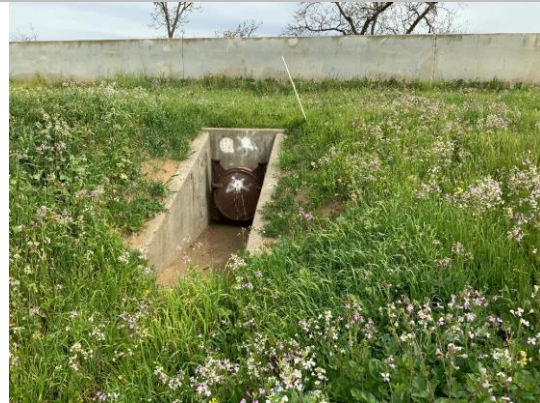
Photo 3 of 3 : UCIP_FA_2024_79422_95213.jpg

WS view: Headwall and flapgate at toe.

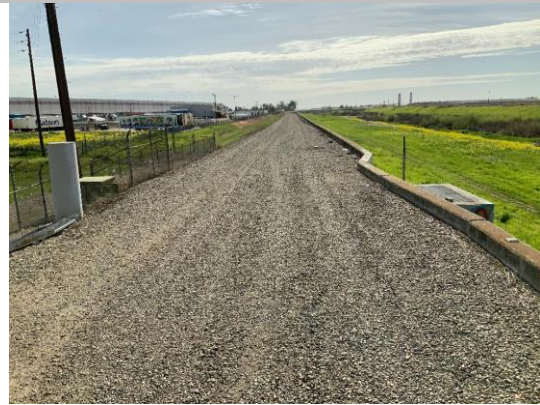
Photo 1 of 3 : UCIP_FA_2024_80887_95260.jpg

Comment Code						
Inspector Comment						
DS_ID:23457 FS_ID:80887 EP_NO: N/A Repair Type: No Action Needed EVAL Issue: Crossing Status: Found UCIP Comments: 03/22/2021 The record has been upgraded from No Action Needed to Non-Urgent. No permit was found authorizing this encroachment. CVFPB will need to review crossing to determine owner. The UCIP inspection was completed with LMA representative, J. Jauregui. (H. Dunn ? GEI)10/27/2017 This structure is inspected annually under the Structure and Channel Summer Inspection (part of the Levee Inspection Program) conducted by the DWR Flood Project Integrity and Inspection Branch (FPIIB). (DWR UCIP - O. Magana) Adjacent pipe is 48-inch by 48-inch RC box culvert through the levee 17.3 feet below the crownDue to dense vegetation and unsafe condition, headwall and flapgates not accessible. FIELD_STRUCT_DESC: [Mormon Slough Pumping Plant No. 2] 2 of 3: 30-inch steel drainage pipe through the levee, 4.5 feet below the crown. Siphon breaker in a 4-foot-high riser unit on the landside (LS) shoulder. Flap gate on a concrete U-shaped headwall on the waterside (WS). Pump house on the LS. Steel steps on the LS slope. [Additional Reference(s): DWR Levee Log, 1992, (HLM 16.64). USACE San Joaquin O&M Manual 611.1, Volume F, (HLM 16.64), 30-inch pipe listed]. FS Date: 3/22/2021

Levee crown looking upstream.

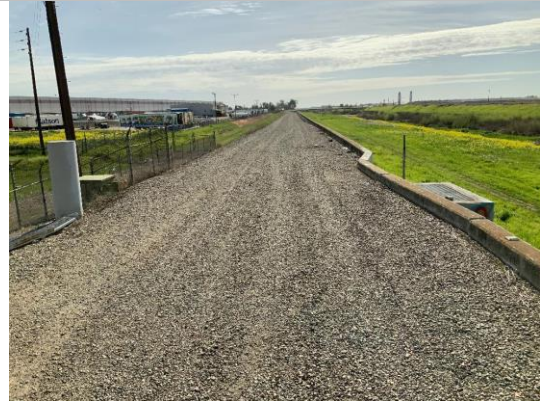
Photo 1 of 3 : UCIP_FA_2024_80888_95269.jpg

DS_ID:23458
FS_ID:80888
EP_NO: N/A
Repair Type: No Action Needed
EVAL Issue:
Crossing Status: Found
UCIP Comments: 03/22/2021 The record has been upgraded from No Action Needed to Non-Urgent. No permit was found authorizing this encroachment. CVFPB will need to review crossing to determine owner. The UCIP inspection was completed with LMA representative, J. Jauregui. (H. Dunn ? GEI)10/27/2017 This structure is inspected annually under the Structure and Channel Summer Inspection (part of the Levee Inspection Program) conducted by the DWR Flood Project Integrity and Inspection Branch (FPIIB). (DWR UCIP - O. Magana) Adjacent pipe is: 48-inch by 48-inch RC box culvert through the levee 17.3 feet below the crown Due to dense vegetation and unsafe condition, headwall and flapgates not accessible.
FIELD_STRUCT_DESC: [Mormon Slough Pumping Plant No. 2] 3 of 3: 30-inch steel drainage pipe through the levee, 4.5 feet below the crown. Siphon breaker in a 4-foot-high riser unit on the landside (LS) shoulder. Flap gate on a concrete U-shaped headwall on the waterside (WS). Pump house on the LS. Steel steps on the LS slope. [Additional Reference(s): DWR Levee Log, 1992, (HLM 16.64). USACE San Joaquin O&M Manual 611.1, Volume F, (HLM 16.64), 30-inch pipe listed].

Levee crown looking upstream.

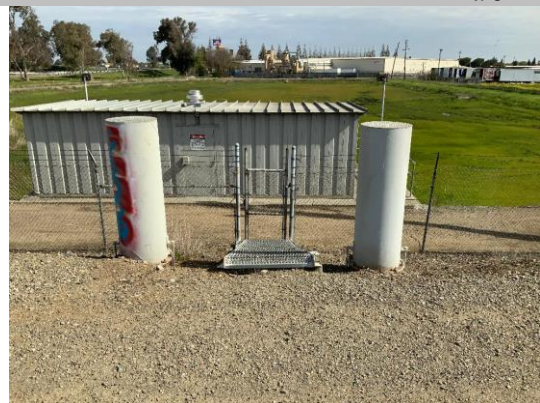
Photo 2 of 3 : UCIP_FA_2024_80888_95270.jpg

LS view: Toe from crown, pump station and risers.

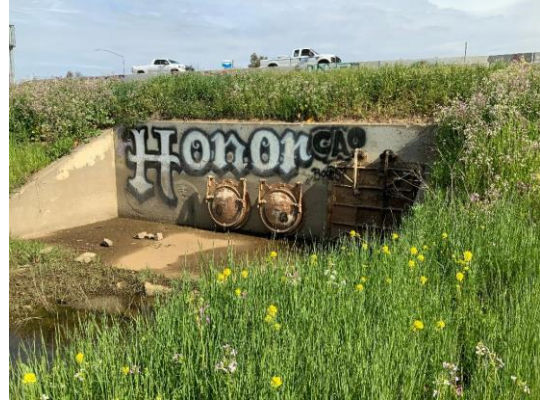
Photo 3 of 3 : UCIP_FA_2024_80888_95275.jpg

WS view: Headwall and flapgates at toe.

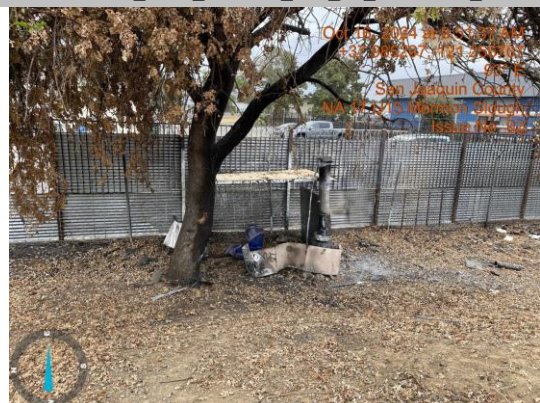
Photo 1 of 1 : FA_2024_NA0017_159_92_20241019_00224.jpg

LM Start	16.77	Rating **	M	Issue No.	92
LM End	16.77	Issue Type +	Ma	Location *	LS
Category	Earthen Levee			GPS Latitude/Longitude	
				Start	End
Item	Encroachments			37.985249°	37.985249°
				-121.256738°	-121.256738°
DWR ID	DWR_NA0017_15_f_2024_92				
Comment Code					
DE : Debris					
Inspector Comment

View of debris along the landside easement. Fall 2024

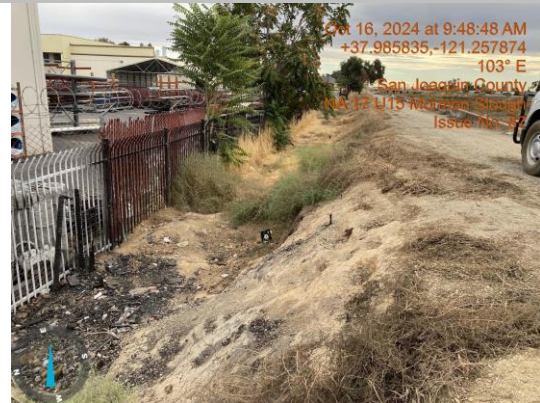
Photo 1 of 2 : FA_2024_NA0017_159_87_20241019_00223.jpg

LM Start	16.85	Rating **	U	Issue No.	87
LM End	16.85	Issue Type +	Ma	Location *	LS
Category	Earthen Levee			GPS Latitude/Longitude	
				Start	End
Item	Erosion / Bank Caving			37.985728°	37.985728°
				-121.257929°	-121.257929°
DWR ID	DWR_NA0017_15_s_2024_87				
Comment Code					
E2 : Schedule repair of erosion site prior to the next inspection.					
Inspector Comment					
Erosion caused by prior campers.

View of erosion along the landside slope. Fall 2024

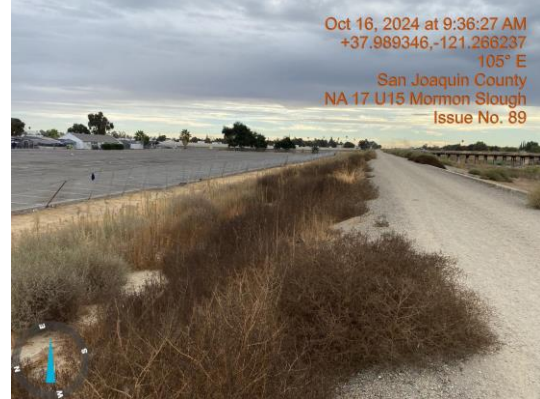
Photo 1 of 1 : FA_2024_NA0017_159_89_20241019_00222.jpg

View of wild growth and bushes along the landside slope and easement.
Fall 2024

LM Start	17.27	Rating **	U	Issue No.	89
LM End	17.37	Issue Type +	Ma	Location *	LS
Category	Earthen Levee			GPS Latitude/Longitude	
				Start	End
Item	Vegetation			37.988650°	37.989280°
				-121.264705°	-121.266264°
DWR ID	DWR_NA0017_15_f_2024_89				
Comment Code					
V2 : Remove the wild growth and woody vegetation other than native grasses from the levee slopes.					
Inspector Comment

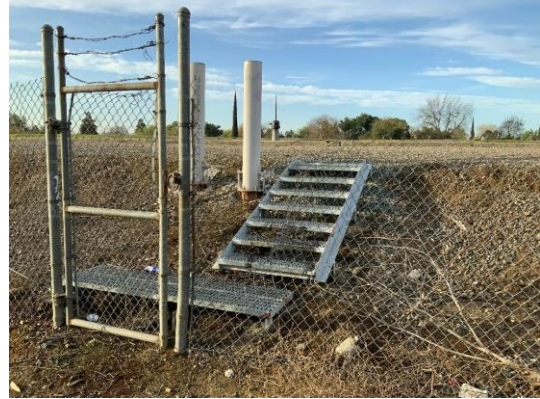
Photo 1 of 3 : UCIP_FA_2024_79171_95334.jpg

DS_ID:23265
FS_ID:79171
EP_NO: N/A
Repair Type: Non-Urgent
EVAL Issue:
Crossing Status: Found
UCIP Comments: 03/22/2021 The record has been upgraded from No Action Needed to Non-Urgent. DWR DMP internal video inspection has not found pipe integrity issues. LOF of crossing is less or equal to 4.0. Recommend next video inspection in 5 years. No permit was found authorizing this encroachment. CVFPB will need to review crossing to determine owner. The UCIP inspection was completed with LMA representative, J. Jauregui. (H. Dunn ? GEI)10/27/2017 This structure is inspected annually under the Structure and Channel Summer Inspection (part of the Levee Inspection Program) conducted by the DWR Flood Project Integrity and Inspection Branch (FPIIB). (DWR UCIP - O. Magana)
Adjacent pipes are: two 14-inch pipes through the levee 3.0 feet below the crownSteel trash rack on landside intake.
FIELD_STRUCT_DESC: [Mormon Slough Pumping Plant No. 1] 1 of 3: 30-inch by 30-inch reinforced concrete box drainage culvert (RCBC) through the levee, 17.6 feet below the crown. Slide gate in a riser unit on the waterside (WS) slope. Flap gate on the WS end. Concrete U-shaped headwall around all three pipes on the WS. Intake under the pump house on the landside (LS). Steel steps on the LS slope.

LS view: Slope from toe, stairs and standpipe.

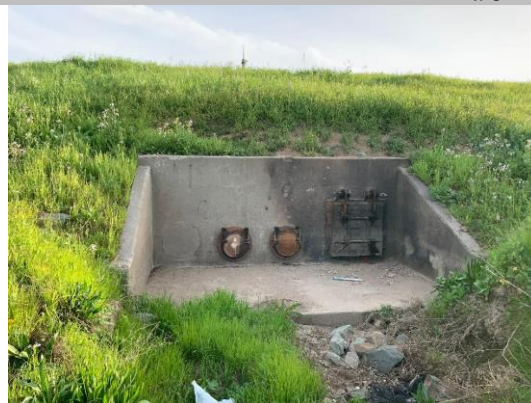
Photo 2 of 3 : UCIP_FA_2024_79171_95331.jpg

WS view: Headwall and flapgates at toe.

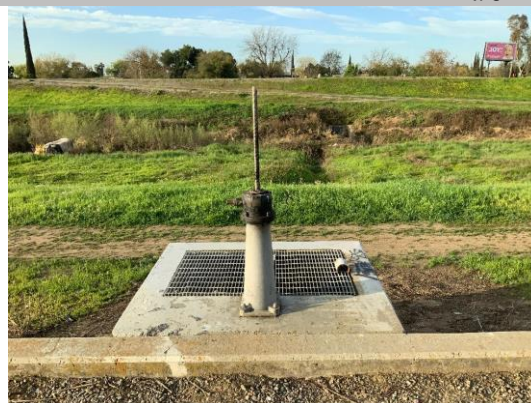
Photo 3 of 3 : UCIP_FA_2024_79171_95335.jpg

WS view: Toe from crown, slidegate in concrete box.

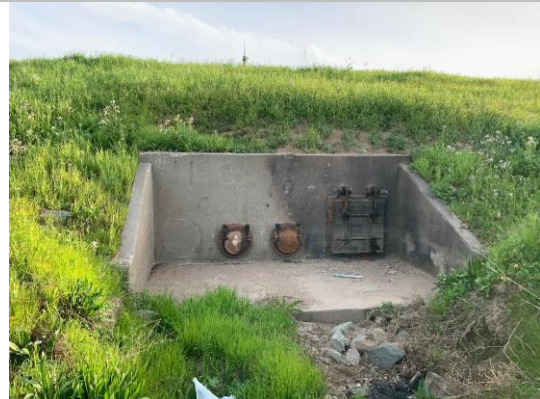
Photo 2 of 3 : UCIP_FA_2024_79172_95343.jpg

Comment Code					
Inspector Comment					
DS_ID:23460 FS_ID:79172 EP_NO: N/A Repair Type: Non-Urgent EVAL Issue: Crossing Status: Found UCIP Comments: 03/22/2021 The record has been upgraded from No Action Needed to Non-Urgent. No permit was found authorizing this encroachment. CVFPB will need to review crossing to determine owner. The UCIP inspection was completed with LMA representative, J. Jauregui. (H. Dunn ? GEI)10/27/2017 This structure is inspected annually under the Structure and Channel Summer Inspection (part of the Levee Inspection Program) conducted by the DWR Flood Project Integrity and Inspection Branch (FPIIB). (DWR UCIP - O. Magana) Adjacent pipe is: 30-inch by 30-inch RC box culvert through the levee 17.6 feet below the crownSteel trash rack on landside intake. FIELD_STRUCT_DESC: [Mormon Slough Pumping Plant No. 1] 2 of 3: 14-inch steel drainage pipe through the levee, 3.0 feet below the crown. Siphon breakers in 4-foot-high riser units on the landside (LS) shoulder. Flap gates on the waterside (WS) end. Concrete U-shaped headwall around all three pipes on the WS. Pump house on the LS. Steel steps on the LS slope. [Additional Reference(s): DWR Levee Log, 1992, (HLM 17.74). USACE San Joaquin O&M Manual 611.1, Volume F, (HLM 17.74), 14-inch pipe listed]. FS Date: 3/22/2021

WS view: Headwall and flapgate.

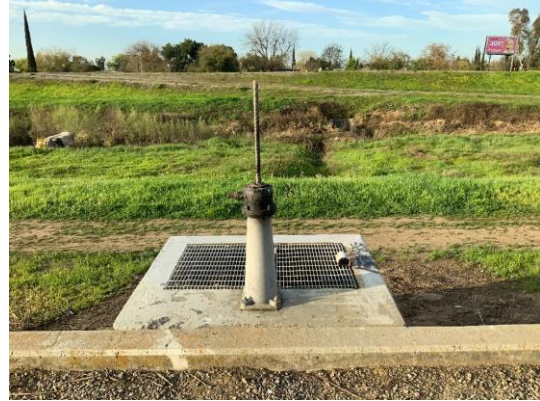
Photo 3 of 3 : UCIP_FA_2024_79172_95348.jpg

WS view: Toe from crown, slidegate in concrete box.

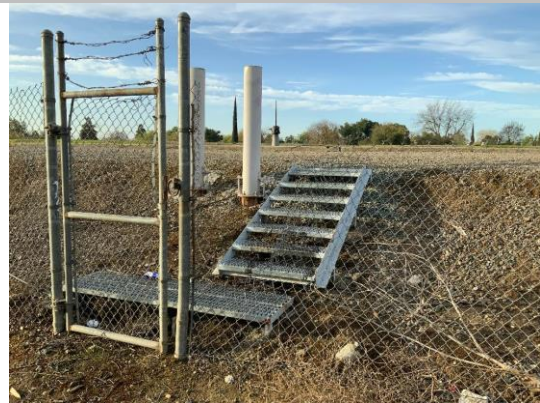
Photo 1 of 3 : UCIP_FA_2024_79173_95358.jpg

DS_ID:23461
 FS_ID:79173
 EP_NO: N/A
 Repair Type: Non-Urgent
 EVAL Issue:
 Crossing Status: Found
 UCIP Comments: 03/22/2021 The record has been upgraded from No Action Needed to Non-Urgent. No permit was found authorizing this encroachment. CVFPB will need to review crossing to determine owner. The UCIP inspection was completed with LMA representative, J. Jauregui. (H. Dunn ? GEI)10/27/2017 This structure is inspected annually under the Structure and Channel Summer Inspection (part of the Levee Inspection Program) conducted by the DWR Flood Project Integrity and Inspection Branch (FPIIB). (DWR UCIP - O. Magana)
 Adjacent pipe is: 30-inch by 30-inch RC box culvert through the levee 17.6 feet below the crown
 Steel trash rack on landside.
 FIELD_STRUCT_DESC: [Mormon Slough Pumping Plant No. 1] 3 of 3: 14-inch steel drainage pipe through the levee, 3.0 feet below the crown. Siphon breakers in 4-foot-high riser units on the landside (LS) shoulder. Flap gates on the waterside (WS) end. Concrete U-shaped headwall around all three pipes on the WS. Pump house on the LS. Wooden steps on the LS slope. [Additional Reference(s): DWR Levee Log, 1992, (HLM 17.74). USACE San Joaquin O&M Manual 611.1, Volume F, (HLM 17.74), 14-inch pipe listed].

LS view: Slope from toe.

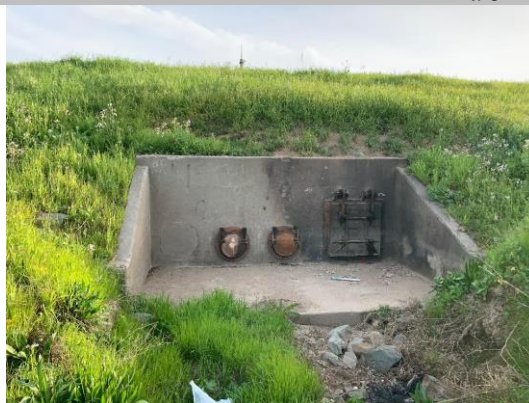
Photo 2 of 3 : UCIP_FA_2024_79173_95354.jpg

WS view: Headwall and flapgate at toe.

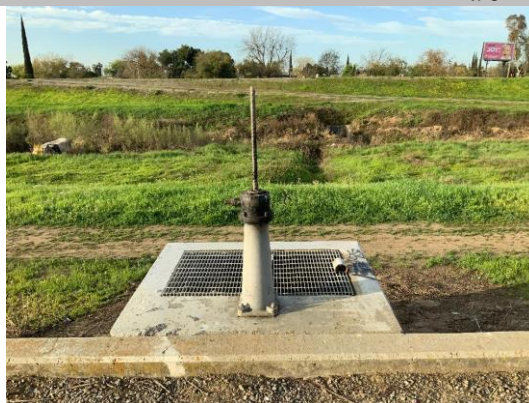
Photo 3 of 3 : UCIP_FA_2024_79173_95359.jpg

WS view: Toe from crown, slidegate in concrete box.

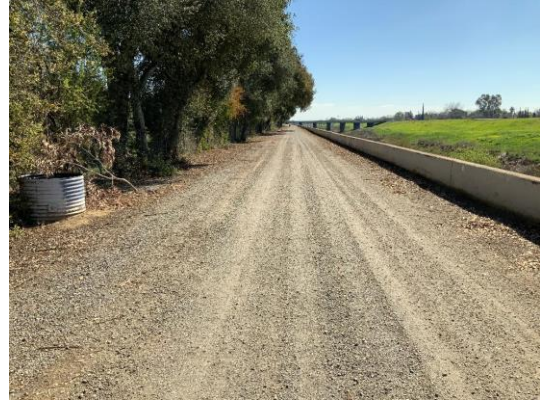
Photo 1 of 3 : UCIP_FA_2024_84810_96286.jpg

Comment Code					
Inspector Comment					
DS_ID:23267 FS_ID:84810 EP_NO: N/A Repair Type: Urgent EVAL Issue: 1, Pipe Integrity Crossing Status: Found UCIP Comments: 09/23/2024 Record updated from Non-Urgent to Urgent. DMP internal video inspection has found severe pipe defects. Crossing will be monitored until funding becomes available to address the issues. (O. Yakimov - DWR UCIP) 03/12/2021 Pipe status is still Non-Urgent. No cover on LS riser. Could not inspect LS pipe end due to fence for golf course. DMP internal video inspection has found moderate pipe defects. Crossing will be monitored until funding becomes available for rehabilitation. No permit was not found authorizing this encroachment. CVFPB will need to review crossing to determine owner. The UCIP inspection was completed with LMA representative, J. Jauregui. (H. Dunn ? GEI) 04/15/2014 CMP riser needs cleaning. (P. Taroq - DWR UCIP) FIELD_STRUCT_DESC: 30-inch corrugated metal storm drainage pipe (CMP) through the levee, 13.0 feet below the crown. Concrete U-shaped headwall on the waterside (WS) end. CMP riser unit at the landside (LS) toe. [Additional Reference(s): DWR Levee Log, 1992, (HLM 18.01). USACE San Joaquin O&M Manual 611.1, Volume F, (HLM 18.01), 30-inch pipe listed]. FS Date: 3/12/2021

Levee crown looking upstream.

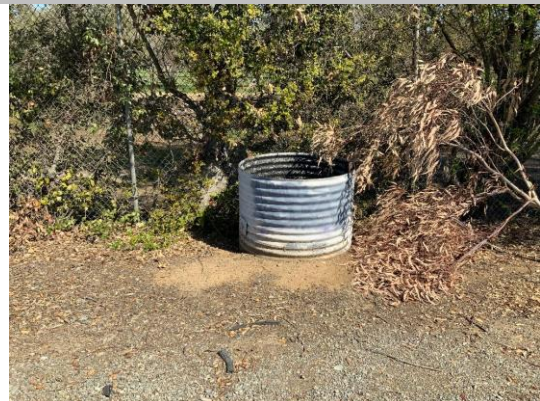
Photo 2 of 3 : UCIP_FA_2024_84810_96287.jpg

LS view: Toe from crown, fence behind CMP riser, cannot access.

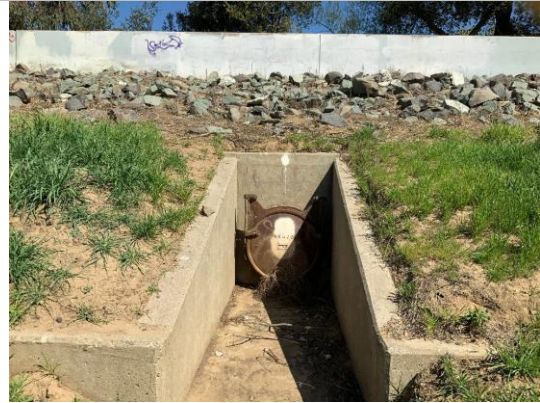
Photo 3 of 3 : UCIP_FA_2024_84810_96290.jpg

WS view: Headwall and flapgate at toe.

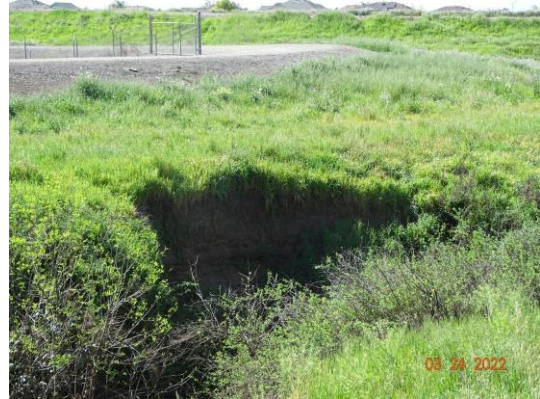
Photo 2 of 2 : SJR2024_NA0017U15RM4.62_2_.JPG

LM Start	18.16	Rating **	M	Issue No.	4
LM End	18.17	Issue Type +	Ma	Location *	WS
Category	Supplemental			GPS Latitude/Longitude	
				Start	End
Item	DWR Erosion Survey			37.994649°	37.994649°
				-121.278333°	-121.278333°
DWR ID	NA0017U15RM4.62				
Comment Code					
Inspector Comment					
Site ID: NA0017U15RM4.62 8/8/2024: From 2022 to present, no significant changes were observed during the annual survey. 03/24/2022: This site was discovered during the Spring 2022 Levee Inspections. There is a vertical scarp 10 ft tall and 15 ft wide. The erosion is on the left bank of the Calaveras River just upstream of the confluence with Mormon Slough (Stockton Diverting Canal) and 25 ft downstream of a concrete drainage box culvert (DSID 23462).

3/24/2022: Close-up view of the erosion pocket.

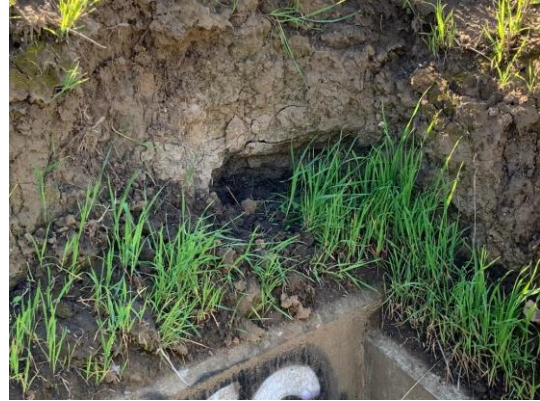
Photo 2 of 3 : UCIP_FA_2024_79176_96314.jpg

Comment Code						
Inspector Comment						
DS_ID:23269 FS_ID:79176 EP_NO: N/A Repair Type: Non-Urgent EVAL Issue: 4b, Safety Issue Crossing Status: Found UCIP Comments: 12/20/2022 Record updated from Urgent to Non-Urgent. Pipe has been CIPP lined. LOF of crossing is less or equal to 4. Recommend next video inspection in 5 years. Minor erosion above the WS headwall and a foot-wide hole under the riprap on one outer edge of the headwall still needs repair. (O.Yakimov - DWR UCIP) 03/12/2021 Record updated from Non-Urgent to Urgent. DMP internal video inspection has found pipe integrity issues. LOF of crossing is between 5 and 6. Crossing will be monitored until funding becomes available to address the issues. WS riser is missing the cover. Some minor erosion above the WS headwall and a foot wide hole under the riprap on one outer edge of the headwall, see pics. No permit was found authorizing this encroachment. CVFPB will need to review crossing to determine owner. The UCIP inspection was completed with LMA representative, J. Jauregui. (H. Dunn ? GEI)04/15/2014 Slide gate handle missing. Vegetation on both inlet and outlet box. (P. Tariq - DWR UCIP) FIELD_STRUCT_DESC: 36-inch CIPP-lined corrugated metal storm drainage pipe (CMP) through the levee, 15.0 feet below the crown. Concrete U-shaped headwalls on each side. Slide gate in a CMP riser unit on the waterside (WS) slope. Flap gate on the WS end. [Additional Reference(s): DWR Levee Log, 1992, (HLM 18.54). USACE San Joaquin O&M Manual 611.1, Volume F, (HLM 18.54), 36-inch pipe listed]. FS Date: 3/12/2021 11:46:30 AM

WS view: Minor erosion above headwall, 3 of 3 photos.

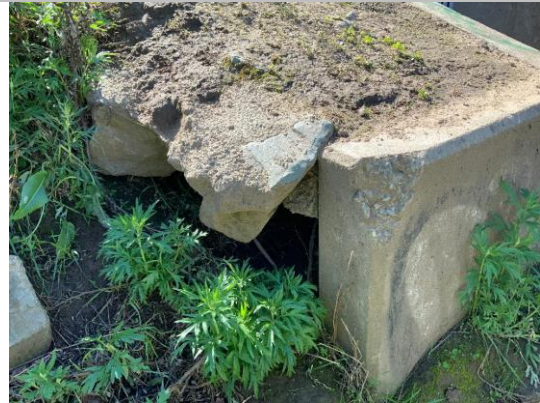
Photo 3 of 3 : UCIP_FA_2024_79176_96307.jpg

WS view: Hole underneath riprap and headwall edge.

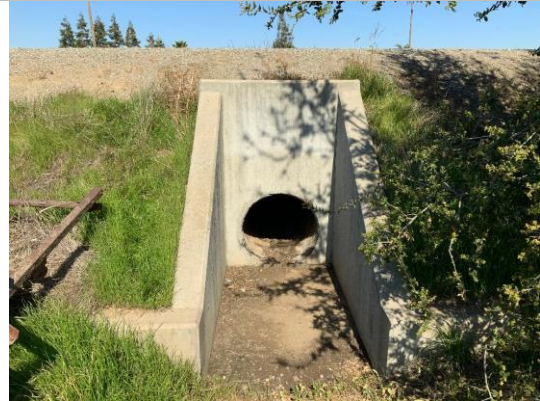
Photo 1 of 3 : UCIP_FA_2024_84801_96323.jpg

Comment Code					
Inspector Comment					
DS_ID:23270 FS_ID:84801 EP_NO: N/A Repair Type: Non-Urgent EVAL Issue: 5, Pipe Damage Crossing Status: Found UCIP Comments: 09/29/2024 Record updated from Urgent to Non-Urgent. DMP internal video inspection observed pipe deformation at landside inlet and included it in overall pipe rating. Crossing will be monitored until funding becomes available for rehabilitation. (O. Yakimov - DWR UCIP) 03/12/2021 The record has been upgraded from No Action Needed to Urgent. Inside of LS pipe is protruded down and there is metal peeling away around the pipe a few feet in. Recommend internal video inspection to verify pipe integrity. No permit was found authorizing this encroachment. CVFPB will need to review crossing to determine owner. The UCIP inspection was completed with LMA representative, J. Jauregui. (H. Dunn - GEI) FIELD_STRUCT_DESC: 30-inch steel storm drainage pipe through the levee, 7.0 feet below the crown. Concrete U-shaped headwalls on each end. Flap gate on the waterside (WS) end. Grouted outlet on the WS. [Additional Reference(s): DWR Levee Log, 1992, (HLM 18.68). USACE San Joaquin O&M Manual 611.1, Volume F, (HLM 18.68), 30-inch corrugated metal pipe (CMP) listed]. FS Date: 3/12/2021

LS view: Headwall at toe.

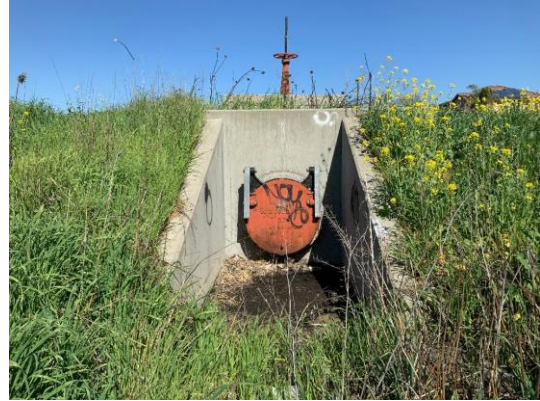
Photo 3 of 3 : UCIP_FA_2024_79178_96337.jpg

Comment Code					
Inspector Comment					
DS_ID:23464 FS_ID:79178 EP_NO: N/A Repair Type: Non-Urgent EVAL Issue: 11, Maintenance Compliance Issue Crossing Status: Found UCIP Comments: 03/12/2021 The record has been upgraded from No Action Needed to Non-Urgent. Vegetation debris and trash seen in LS pipe, recommend cleaning out. No permit was found authorizing this encroachment. CVFPB will need to review crossing to determine owner. The UCIP inspection was completed with LMA representative, J. Jauregui. (H. Dunn ? GEI)04/15/2014 Slide gate in a concrete box on waterside shoulder. (P. tariq - DWR UCIP) FIELD_STRUCT_DESC: 30-inch reinforced concrete (RC) storm drainage pipe through the levee, 6.0 feet below the crown. Slide gate in a concrete box on the waterside (WS) shoulder. [Additional Reference(s): USACE San Joaquin O&M Manual 611.1, Volume F, (Station 345+65), 30-inch pipe listed]. FS Date: 3/12/2021

WS view: Headwall, flapgate, and slidegate at toe.

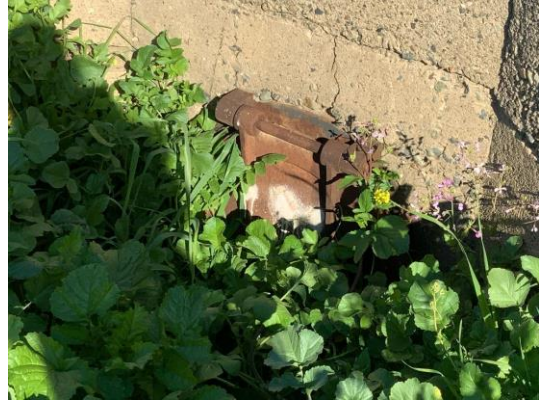
Photo 2 of 3 : UCIP_FA_2024_85078_96409.jpg

Comment Code						
Inspector Comment						
DS_ID:23274 FS_ID:85078 EP_NO: N/A Repair Type: Non-Urgent EVAL Issue: 5, Pipe Damage Crossing Status: Found UCIP Comments: 10/21/2024 Record updated from Urgent to Non-Urgent. LoF rating was changed due to the difference in CCTV operator opinion on surface aggregate missing versus surface missing wall. (O. Yakimov - DWR UCIP) 03/12/2021 Record has been upgraded from Non-Urgent to Urgent. DWR DMP internal video inspection has found pipe integrity issues. LOF of crossing is between 5 and 6. Crossing will be monitored until funding becomes available to address the issues. Cannot see LS manhole due to vegetation debris. WS flapgate overgrown with vegetation, recommend clearing. Based on previous inspection, a concrete block was found within the pipe so it is presumed abandoned, need confirmation from the owner. No permit was found authorizing this encroachment. CVFPB will need to review crossing to determine owner. The UCIP inspection was completed with LMA representative, J. Jauregui. (H. Dunn ? GE1)/16/2018 Internal video inspection revealed a concrete plug in the pipe, 49.2 feet from the outlet on the WS. Pipe improperly abandoned. Abandon properly or remove from levee. Crossing escalated to "Non-Urgent" due to the improper abandonment. Material type changed from steel to reinforced concrete. (A. McDonald - DWR UCIP) concrete headwall not found on the LS. Manhole found on the LS. FIELD_STRUCT_DESC: 24-inch reinforced concrete (RC) gravity stormwater drainage pipe through the levee, 12.0 feet below the crown. Flap gate and concrete headwall on the waterside (WS). Manhole on the landside (LS). Pipe partially plugged with concrete on the LS. [Additional Reference(s): DWR Levee Log, 1992, (HLM 20.14). USACE San Joaquin O&M Manual 611.1, Volume F, (HLM 20.14), 24-inch pipe listed]. FS Date: 3/12/2021

WS view: Close up of headwall and flapgate, overgrown with vegetation.

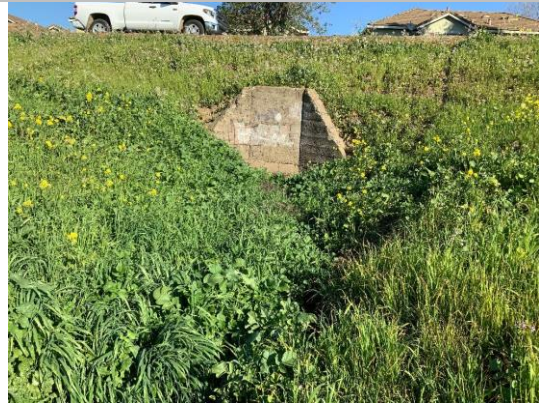
Photo 3 of 3 : UCIP_FA_2024_85078_96408.jpg

WS view: Headwall at toe, overgrown with vegetation.

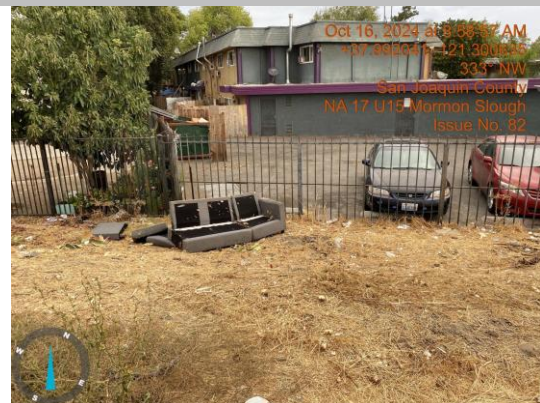
Photo 1 of 1 : FA_2024_NA0017_159_82_20241019_00221.jpg

LM Start	20.80	Rating **	M	Issue No.	82
LM End	20.80	Issue Type +	Ma	Location *	LS
Category	Earthen Levee			GPS Latitude/Longitude	
				Start	End
Item	Encroachments			37.991988°	37.991988°
				-121.300590°	-121.300590°
DWR ID	DWR_NA0017_15_f_2024_82				
Comment Code					
DE : Debris					
Inspector Comment

View of debris along the landside easement. Fall 2024
