**Flood Control Project Maintenance
Levee Inspections****Maintenance Issue Types Only, Levee Inspection Report By Mile - Fall 2024****San Joaquin County Flood Control and Water Conservation District**

Waterway	Bank	Unit Miles	Inspection Start/End	Inspector
Unit No. 01 Littlejohn Creek	Left	2.59	10/21/2024 10/21/2024	Alberto De Leon

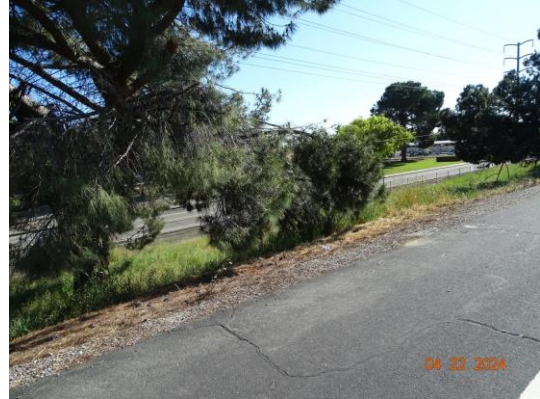
Photo 1 of 1 : FA_2024_NA0017_159_190_20240910_00034.jpg

LM Start	22.56	Rating **	U	Issue No.	190
LM End	22.56	Issue Type +	Ma	Location *	LS
Category	Earthen Levee			GPS Latitude/Longitude	
				Start	End
Item	Trim / Thin Trees			37.981900°	37.981900°
				-121.324967°	-121.324967°
DWR ID	DWR_NA0017_15_f_2019_190				
Comment Code					
T1 : Trim and thin trees to at least five feet above ground level to allow visibility of the ground and room to flood fight.					
Inspector Comment

View of untrimmed tree along the landside slope. Spring 2024

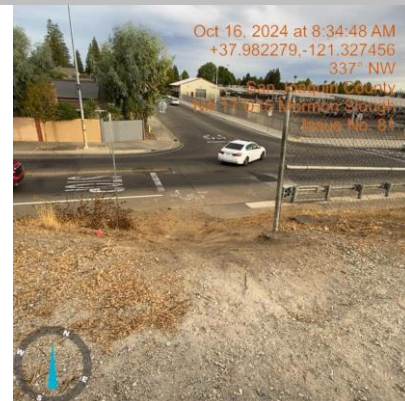
Photo 1 of 1 : FA_2024_NA0017_159_81_20241019_00220.jpg

LM Start	22.70	Rating **	M	Issue No.	81
LM End	22.70	Issue Type +	Ma	Location *	LS
Category	Earthen Levee			GPS Latitude/Longitude	
				Start	End
Item	Erosion / Foot Traffic			37.982234°	37.982234°
				-121.327489°	-121.327489°
DWR ID	DWR_NA0017_15_s_2024_81				
Comment Code					
E3 : Repair the levee slope damaged by foot traffic and prevent access where possible.					
Inspector Comment

View of erosion/pedestrian path along the landside slope. Fall 2024

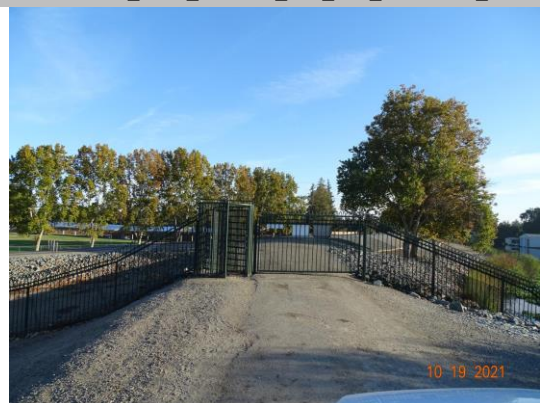
Photo 1 of 1 : FA_2024_NA0017_159_113_20240910_00021.jpg

LM Start	23.99	Rating **	A/W	Issue No.	113
LM End	23.99	Issue Type +	Ma	Location *	CR
Category	Earthen Levee			GPS Latitude/Longitude	
				Start	End
Item	Access Gates			37.974932°	37.974932°
				-121.347699°	-121.347699°
DWR ID	DWR_NA0017_15_s_2020_113				
Comment Code					
AG : Access Gates					
Inspector Comment					
The gate across the levee is for RD 2074.

View of metal gate and fence over levee road. Fall 2021

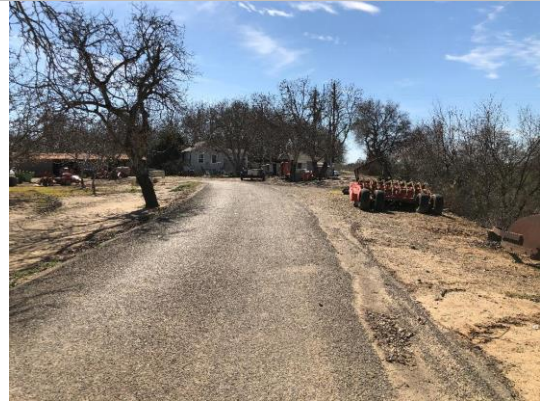
Photo 1 of 3 : UCIP_FA_2024_81202_93500.jpg

Comment Code						
Inspector Comment						
DS_ID:23315						
FS_ID:81202						
EP_NO: N/A						
Repair Type: Non-Urgent						
EVAL Issue:						
Crossing Status: Not Found						
UCIP Comments: 02/25/2021 Record updated from No Action Needed to Non-Urgent. Unit 16 ? Mormon Slough (CLM 0 to 11) is considered a patrol road/high ground area with no defined levee prism, any issue found between CLM 0 to 11 of Unit 16 will be considered a maintenance issue, or an unauthorized encroachment, or an abandoned encroachment. Current condition of pipe crossing does not impede access to patrol road/high ground area. Utility not found during inspection. Geophysical survey not suggestive of a pipe. The UCIP inspection was completed with LMA representative, J. Caruso. (N. Cholewinski - GEI)						
FIELD_STRUCT_DESC: 18-inch corrugated metal storm drainage pipe (CMP), 4.5 feet below the roadway. [Additional Reference(s): DWR Levee Log, 1992, (HLM 0.82). USACE San Joaquin O&M Manual 611.1, Volume F, (HLM 0.82), 18-inch pipe listed].

Crossing Overview

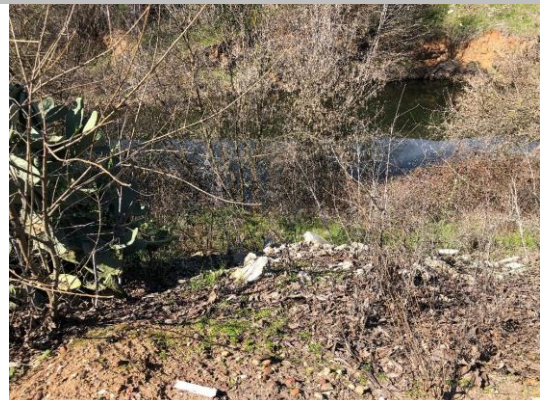
Photo 2 of 3 : UCIP_FA_2024_81202_93501.jpg

WS View: No utility visible.

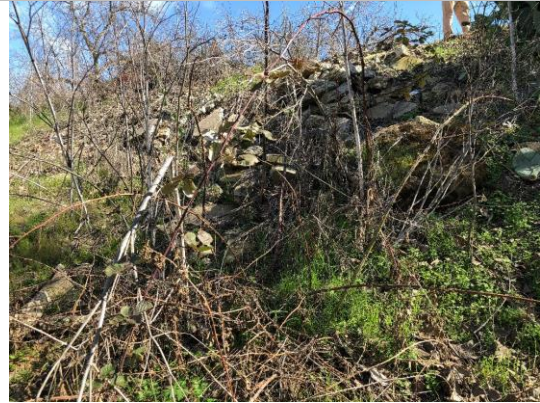
Photo 3 of 3 : UCIP_FA_2024_81202_93502.jpg

WS View: No utility visible.

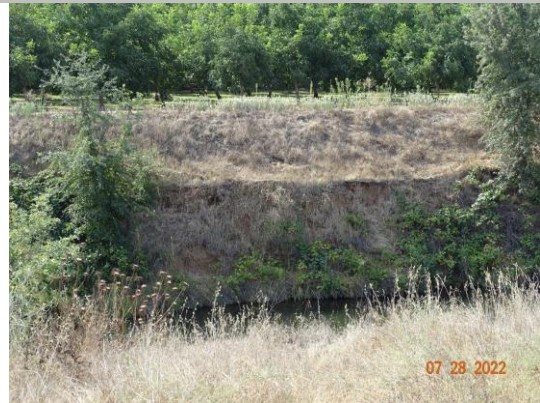
Photo 1 of 1 : FA_2024_NA0017_160_119_20240910_00037.jpg

LM Start	0.93	Rating **	A/W	Issue No.	119
LM End	0.96	Issue Type +	Ma	Location *	WS
Category	Earthen Levee			GPS Latitude/Longitude	
				Start	End
Item	Erosion / Bank Caving			38.042836°	38.042512°
				-121.025613°	-121.025905°
DWR ID	DWR_NA0017_16_f_2023_119

*This area is patrol road only and therefore the site is not rated 07/28/2022: From 2013 to present, no significant changes were observed during the annual survey. The erosion length was updated to 180 ft based on more accurate field measurements.

08/22/2012: The erosion was surveyed and documented for monitoring purpose. There is no levee structure on the site, only high ground protecting the land behind. There is a drainage pipe at the site, which might have caused the problem at one pocket erosion.

View of bank erosion from opposite bank. Summer 2022

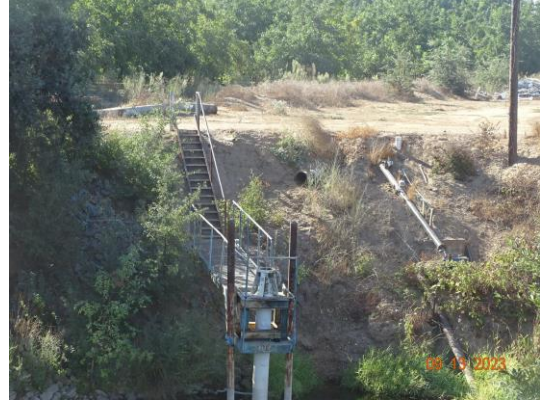
Photo 1 of 1 : FA_2024_NA0017_160_120_20240910_00038.jpg

Comment Code					
E1 : Note and monitor erosion site.					
Inspector Comment					
Issue has been transferred to Levee Mile Report and will continued to monitored. Site ID: NA0017U16RM22.58					
*This area is patrol road only and therefore the site is not rated					
07/28/2022: From 2021 to present, no significant changes were observed during the annual survey.					
07/23/2020: The site has less vegetation and more bare soil on the upper slope since the previous inspection. Some sloughing was also observed.					
08/28/2019: From 2013 to 2019, no significant changes were observed during the annual survey.					
08/22/2012: The erosion is at the outside corner of a river bend, and next to a tree at the levee toe. Irrigation structure presents at the site.					
There is no levee structure on site.

View of bank erosion from opposite bank. Summer 2023

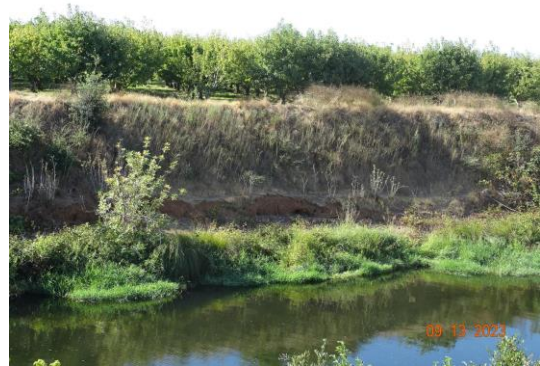
Photo 1 of 1 : FA_2024_NA0017_160_126_20240910_00043.jpg

Comment Code					
E1 : Note and monitor erosion site.					
Inspector Comment					
Issue has been transferred to Levee Mile Report and will continued to monitored. Site ID: NA0017U16RM22.58					
*This area is patrol road only and therefore the site is not rated					
07/28/2022: From 2021 to present, no significant changes were observed during the annual survey.					
07/23/2020: The site has less vegetation and more bare soil on the upper slope since the previous inspection. Some sloughing was also observed.					
08/28/2019: From 2013 to 2019, no significant changes were observed during the annual survey.					
08/22/2012: The erosion is at the outside corner of a river bend, and next to a tree at the levee toe. Irrigation structure presents at the site. There is no levee structure on site. Site ID: NA0017U16RM22.16					
*This area is patrol road only and therefore the site is not rated					
07/28/2022: The length was increased to 100 ft. Otherwise, no significant changes were observed since the previous inspection.

06/23/2021: The site was discovered during the field survey. The erosion is just downstream of a weir. There is some caving and sloughing visible on the slope and a large, 1.5-ft long and 0.8-ft wide rodent hole at the toe.

View of bank erosion from opposite bank. Summer 2023

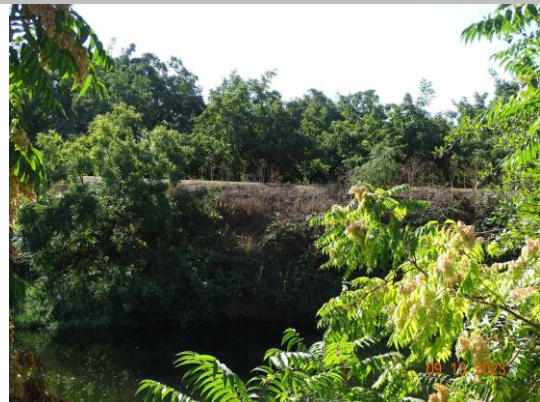
Photo 1 of 1 : FA_2024_NA0017_160_127_20240910_00044.jpg

LM Start	1.67	Rating **	A/W	Issue No.	127
LM End	1.68	Issue Type +	Ma	Location *	WS
Category	Earthen Levee			GPS Latitude/Longitude	
				Start	End
Item	Erosion / Bank Caving			38.038691°	38.038587°
				-121.037411°	-121.037514°
DWR ID	DWR_NA0017_16_f_2023_127				
Comment Code					
E1 : Note and monitor erosion site.					
Inspector Comment					
Issue has been transferred to Levee Mile Report and will continued to monitored. Site ID: NA0017U16RM22.15					
*This area is patrol road only and therefore the site is not rated					
07/28/2022: From 2013 to present, no significant changes were					
observed during the annual survey. This site was combined with a site					
immediately downstream (NA0017U016RM22.01) and the erosion					
length increased to 50 ft.					
08/22/2012: The berm is estimated at 10 ft. Dense vegetation on site.					
There is no levee structure on site.

View of bank erosion from the opposite bank. Summer 2023

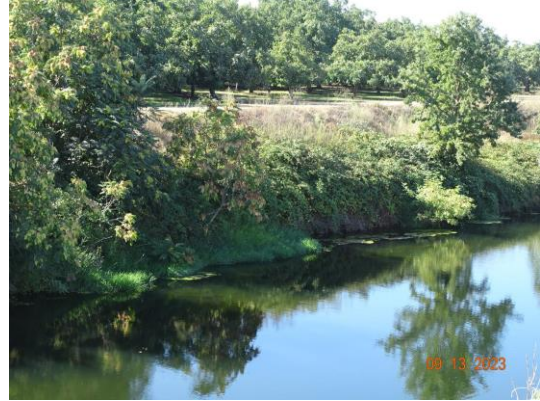
Photo 1 of 1 : FA_2024_NA0017_160_129_20240910_00045.jpg

LM Start	1.72	Rating **	A/W	Issue No.	129
LM End	1.78	Issue Type +	Ma	Location *	WS
Category	Earthen Levee			GPS Latitude/Longitude	
				Start	End
Item	Erosion / Bank Caving			38.038360°	38.037812°
				-121.038088°	-121.039016°
DWR ID	DWR_NA0017_16_f_2023_129				
Comment Code					
E1 : Note and monitor erosion site.					
Inspector Comment					
Issue has been transferred to Levee Mile Report and will continued to monitored. Site ID: NA0017U16RM21.95					
*This area is patrol road only and therefore the site is not rated 07/28/2022: From 2013 to present, no significant changes were observed during the annual survey. The scarp is nearly vertical at the toe. This site was combined with a site immediately downstream (NA0017U16RM21.94) and the erosion length increased to 320 ft. 08/22/2012: The erosion is covered by dense vegetation. There is no levee structure on site.

View of bank erosion from the opposite bank. Summer 2023

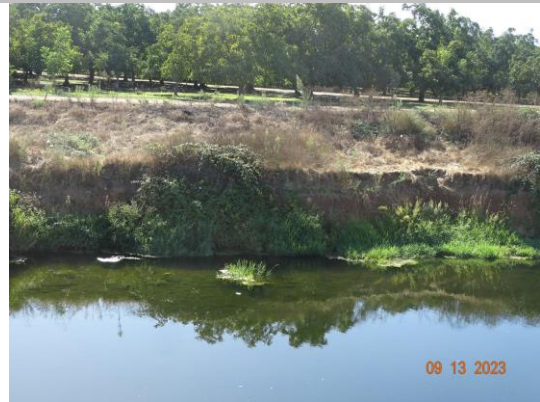
Photo 1 of 1 : FA_2024_NA0017_160_130_20240910_00046.jpg

LM Start	1.87	Rating **	A/W	Issue No.	130
LM End	1.92	Issue Type +	Ma	Location *	WS
Category	Earthen Levee			GPS Latitude/Longitude	
				Start	End
Item	Erosion / Bank Caving			38.036775°	38.036129°
				-121.039941°	-121.040464°
DWR ID	DWR_NA0017_16_f_2023_130

Comment Code					
E1 : Note and monitor erosion site.					
Inspector Comment					
Issue has been transferred to Levee Mile Report and will continued to monitored. Site ID: NA0017U16RM21.05					
*This area is patrol road only and therefore the site is not rated					
07/28/2022: From 2013 to present, no significant changes were observed during the annual survey. The erosion length was updated to 290 ft in 2021 based on more accurate field measurements and the site was combined with a site immediately downstream					
(NA0017U16RM21.03). The erosion is just up and downstream of an irrigation pipe crossing (see DSIDs 23321/24938).					
08/22/2012: Berm width is estimated as 5 ft. There is no levee structure on site.

View of bank erosion from the opposite bank. Summer 2023

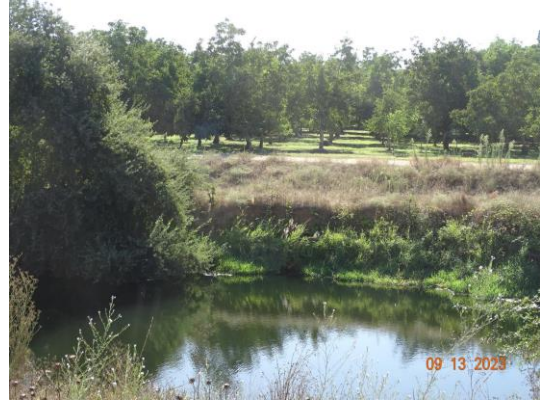
Photo 1 of 1 : FA_2024_NA0017_160_131_20240910_00047.jpg

LM Start	2.26	Rating **	A/W	Issue No.	131
LM End	2.27	Issue Type +	Ma	Location *	WS
Category	Earthen Levee			GPS Latitude/Longitude	
				Start	End
Item	Erosion / Bank Caving			38.032553°	38.032481°
				-121.044654°	-121.044755°
DWR ID	DWR_NA0017_16_f_2023_131				
Comment Code					
E1 : Note and monitor erosion site.					
Inspector Comment					
Issue has been transferred to Levee Mile Report and will continued to monitored. Site ID: NA0017U16RM20.71					
*This area is patrol road only and therefore the site is not rated					
07/28/2022: From 2013 to present, no significant changes were observed during the annual survey. The erosion length was updated to 75 ft based on more accurate field measurements.					
08/22/2012: Site is covered with dense vegetation. There is no levee structure on site.

View of bank erosion from the opposite bank. Summer 2023

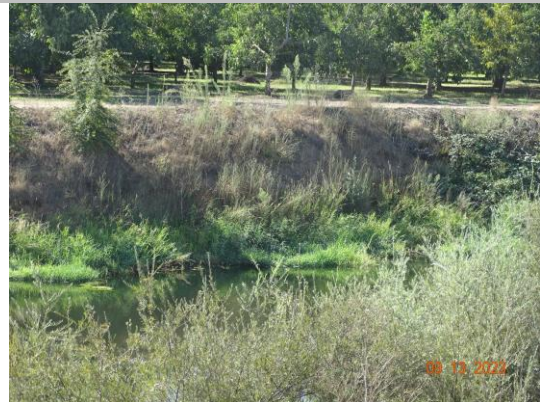
Photo 1 of 1 : FA_2024_NA0017_160_132_20240910_00048.jpg

LM Start	2.29	Rating **	A/W	Issue No.	132
LM End	2.31	Issue Type +	Ma	Location *	WS
Category	Earthen Levee			GPS Latitude/Longitude	
				Start	End
Item	Erosion / Bank Caving			38.032309°	38.032087°
				-121.045041°	-121.045332°
DWR ID	DWR_NA0017_16_f_2023_132				
Comment Code					
E1 : Note and monitor erosion site.					
Inspector Comment					
Issue has been transferred to Levee Mile Report and will continued to monitored. Site ID: NA0017U16RM20.62					
*This area is patrol road only and therefore the site is not rated					
07/28/2022: From 2013 to present, no significant changes were observed during the annual survey. The erosion length was updated to 120 ft based on more accurate field measurements.					
08/22/2012: The erosion was first reported in the 2012 spring levee inspection report. There is no levee structure on site.

View of bank erosion from opposite bank. Summer 2023

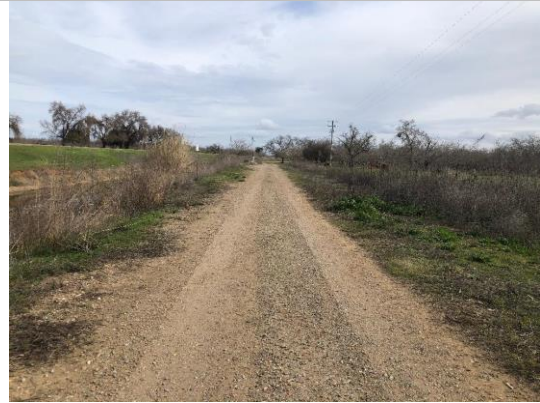
Photo 1 of 3 : UCIP_FA_2024_79191_95459.jpg

Comment Code					
Inspector Comment					
DS_ID:23323 FS_ID:79191 EP_NO: N/A Repair Type: Non-Urgent EVAL Issue: Crossing Status: Found UCIP Comments: 03/09/2021 Record remains Non-Urgent. Unit 16 ? Mormon Slough (CLM 0 to 11) is considered a patrol road/high ground area with no defined levee prism, any issue found between CLM 0 to 11 of Unit 16 will be considered a maintenance issue, or an unauthorized encroachment, or an abandoned encroachment. Current condition of pipe crossing does not impede access to patrol road/high ground area. Access limited to pipe inlet due to fencing. Pipe inlet appears bent and partly filled with sediment. Briar bush and vegetation overgrowth limiting visibility of WS slope. No permit has been identified authorizing utility. CVFPB will need to review crossing to determine owner. The UCIP inspection was completed with LMA representative, H. Latu. (N. Cholewinski - GE04/24/2014 Heavy vegetation obscuring outlet. remove vegetation and verify flapgate installed. (W. Wylie - DWR UCIP) FIELD_STRUCT_DESC: 18-inch corrugated metal storm drainage pipe (CMP) through the levee, 3.0 feet below the roadway. Grouted outlet on the waterside (WS). [Additional Reference(s): DWR Levee Log, 1992, (HLM 2.52). USACE San Joaquin O&M Manual 611.1, Volume F, (HLM 2.52), 18-inch pipe listed]. FS Date: 3/9/2021

Crossing Overview

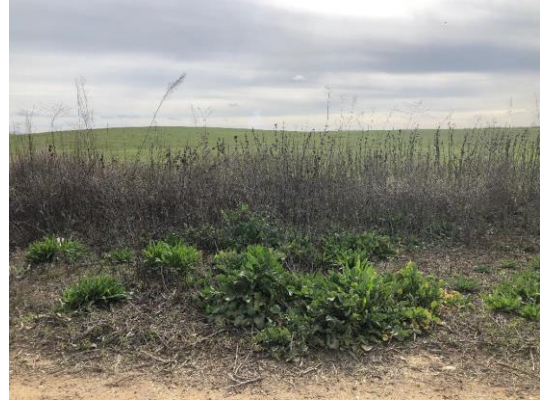
Photo 2 of 3 : UCIP_FA_2024_79191_95460.jpg

LS View

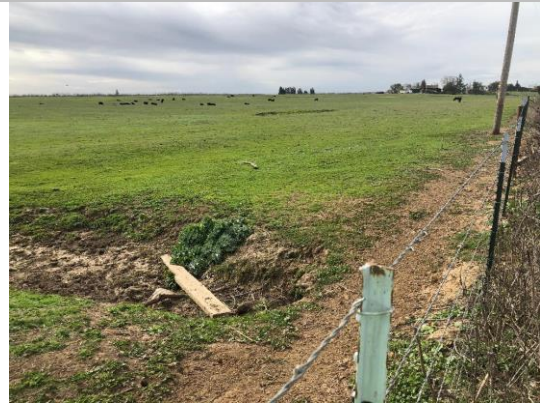
Photo 3 of 3 : UCIP_FA_2024_79191_95461.jpg

LS View: Pipe inlet visible at LS.

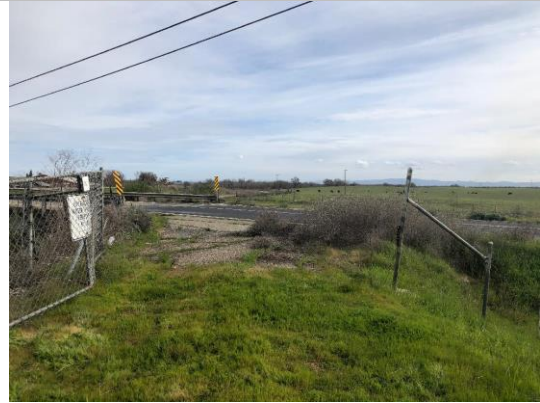
Photo 1 of 3 : UCIP_FA_2024_81203_95452.jpg

Comment Code						
Inspector Comment						
DS_ID:23446 FS_ID:81203 EP_NO: N/A Repair Type: Non-Urgent EVAL Issue: 11, Maintenance Compliance Issue Crossing Status: Found UCIP Comments: 03/09/2021 Record remains Non-Urgent. Unit 16 ? Mormon Slough (CLM 0 to 11) is considered a patrol road/high ground area with no defined levee prism, any issue found between CLM 0 to 11 of Unit 16 will be considered a maintenance issue, or an unauthorized encroachment, or an abandoned encroachment. DWR DMP internal video inspection has not found pipe integrity issues. LOF of crossing is less or equal to 4.0. Recommend next video inspection in 5 years. Current condition of pipe crossing does not impede access to patrol road/high ground area. Briar bush overgrowth limiting access and visibility at WS slope. No flapgate at WS. No permit has been identified authorizing utility. CVFPB will need to review crossing to determine owner. The UCIP inspection was completed with LMA representative, H. Latu. (N. Cholewinski - GE09/18/2018 Lots of sediment in the inlet: needs to be cleared out. No integrity issues, yet there's dense vegetation and potential flooding risk during high water. Crossing downgraded to "Non-Urgent." (A. McDonald - DWR UCIP0/31/2016 Same as last inspection. Pipe is open on both ends, no flap gate. (O. Magana - DWR UCIP0/24/2014 Pipe in non-project levee area. Pipe open on both ends, no flapgate. (W. Wylie - DWR UCIP) FIELD_STRUCT_DESC: *HIGH GROUND* 36-inch corrugated metal storm drainage pipe (CMP) through the levee, 10.0 feet below the crown. Pipe open on both ends. [Additional Reference(s): USACE San Joaquin O&M Manual Unit 611, Part No. 1 ? Mormon Slough Project, Unit 16 Mormon Slough, (HLM 2.82), 36-inch pipe listed]. FS Date: 3/9/2021

Crossing Overview

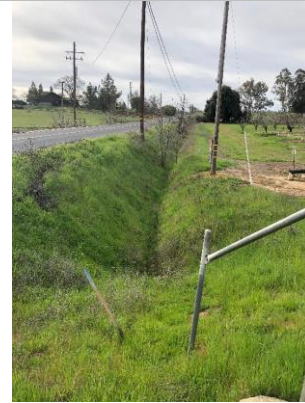
Photo 2 of 3 : UCIP_FA_2024_81203_95453.jpg

LS View: Pipe in drainage ditch at LS.

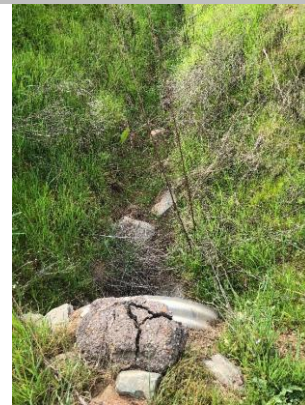
Photo 3 of 3 : UCIP_FA_2024_81203_95454.jpg

LS View: Pipe in drainage ditch at LS.

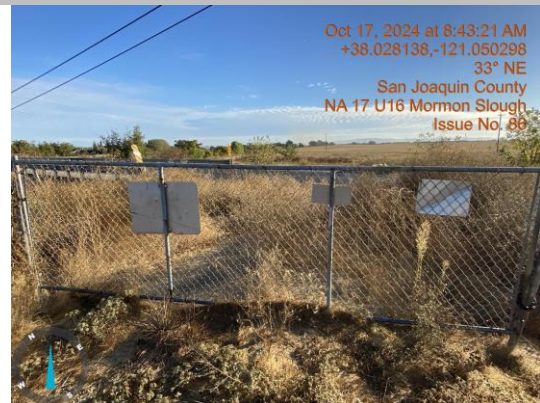
Photo 1 of 1 : FA_2024_NA0017_160_86_20241019_00262.jpg

LM Start	2.70	Rating **	U	Issue No.	86
LM End	2.70	Issue Type +	Ma	Location *	CR
Category	Earthen Levee			GPS Latitude/Longitude	
				Start	End
Item	Vegetation			38.028159°	38.028159°
				-121.050268°	-121.050268°
DWR ID	DWR_NA0017_16_s_2024_86				
Comment Code					
V2 : Remove the wild growth and woody vegetation other than native grasses from the levee slopes.					
Inspector Comment

View of heavy vegetation near access gate. Fall 2024

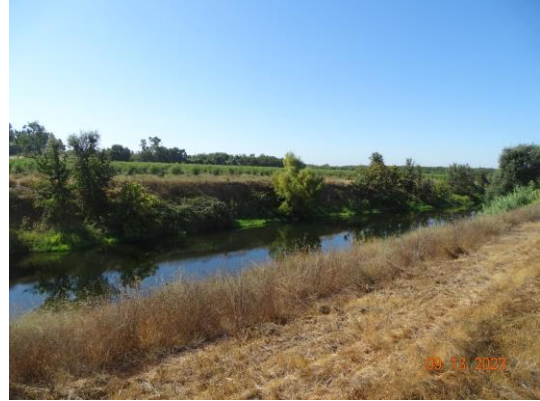
Photo 1 of 1 : FA_2024_NA0017_160_133_20240910_00049.jpg

Comment Code					
E1 : Note and monitor erosion site.					
Inspector Comment					
Issue has been transferred to Levee Mile Report and will continued to monitored. Site ID: NA0017U16RM19.95 *This area is patrol road only and therefore the site is not rated 07/28/2022: From 2013 to present, no significant changes were observed during the annual survey. The erosion length was updated to 110 ft based on more accurate field measurements. Additionally, the coordinates, LM, and RM were updated and the Site ID changed from NA0017U16RM20 to NA0017U16RM19.95. 08/22/2012: Site comprised of series of pocket and scarp erosions. Some of erosions are covered by grass or shrubs. There is no levee structure on site.

View of bank erosion from the opposite bank. Summer 2023

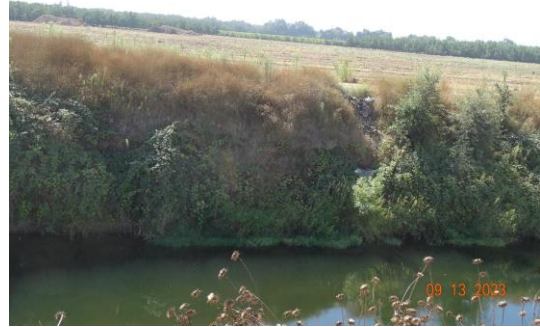
Photo 1 of 1 : FA_2024_NA0017_160_134_20240910_00050.jpg

LM Start	3.61	Rating **	A/W	Issue No.	134
LM End	3.62	Issue Type +	Ma	Location *	WS
Category	Earthen Levee			GPS Latitude/Longitude	
				Start	End
Item	Erosion / Bank Caving			38.019626°	38.019523°
				-121.062832°	-121.062950°
DWR ID	DWR_NA0017_16_f_2023_134				
Comment Code					
E1 : Note and monitor erosion site.					
Inspector Comment					
Issue has been transferred to Levee Mile Report and will continued to monitored. Site ID: NA0017U16RM19.29					
*This area is patrol road only and therefore the site is not rated					
07/28/2022: From 2015 to present, no significant changes were observed during the annual survey. The erosion length was updated to 60 ft based on more accurate field measurements. The vegetation growth has increased.					
08/20/2014: A pocket erosion was found near the water's edge.

View of bank erosion from the opposite bank. Summer 2023

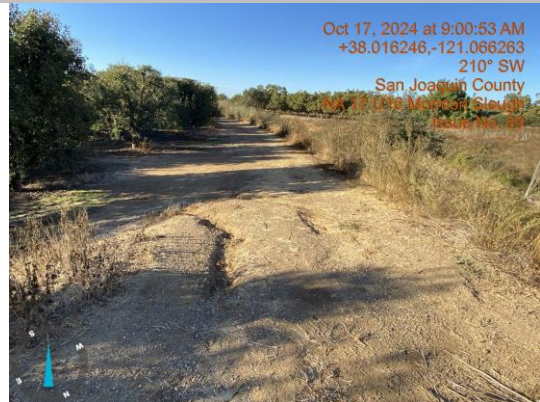
Photo 1 of 1 : FA_2024_NA0017_160_89_20241019_00263.jpg

LM Start	3.91	Rating **	M	Issue No.	89
LM End	4.11	Issue Type +	Ma	Location *	CR
Category	Earthen Levee			GPS Latitude/Longitude	
				Start	End
Item	Crown Surface / Depressions / Rutting			38.016204°	38.013550°
				-121.066301°	-121.067707°
DWR ID	DWR_NA0017_16_s_2024_89				
Comment Code					
C3 : Add appropriate gravel or road base. Grade and compact.					
Inspector Comment

View of ruts and depressions on surface road. Fall 2024

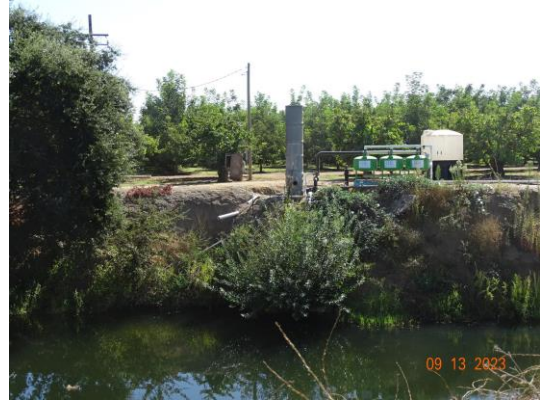
Photo 1 of 1 : FA_2024_NA0017_160_135_20240910_00051.jpg

Comment Code					
E1 : Note and monitor erosion site.					
Inspector Comment					
Issue has been transferred to Levee Mile Report and will continued to monitored. Site ID: NA0017U16RM18.69					
*This area is patrol road only and therefore the site is not rated					
07/28/2022: From 2018 to present, no significant changes were observed during the annual survey. The erosion length was updated to 50 ft based on more accurate field measurements. The site is located just upstream of an irrigation pipe crossing (DSIDs 23328/24945).					
08/30/2017: New erosion observed at the site, under the irrigation pipe.					
08/16/2016: From 2013 to present, no significant changes were observed during the annual survey.					
08/22/2012: An irrigation pipe is present at the site, but probably did not cause the erosion. There is no levee structure on site.

View of bank erosion from the opposite bank. Summer 2023

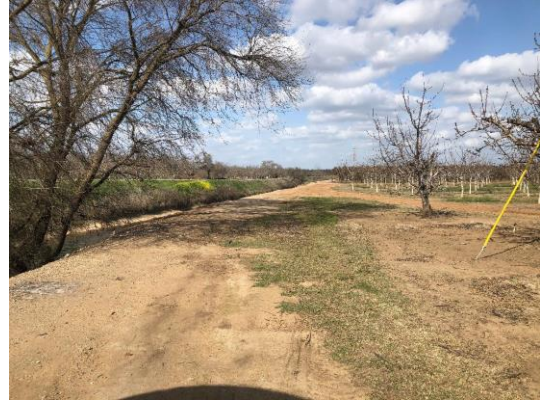
Photo 1 of 3 : UCIP_FA_2024_81206_95383.jpg

Comment Code					
Inspector Comment					
DS_ID:23447 FS_ID:81206 EP_NO: N/A Repair Type: Non-Urgent EVAL Issue: Crossing Status: Indicator Found UCIP Comments: 03/08/2021 Record updated from No Action Needed to Non-Urgent. Unit 16 ? Mormon Slough (CLM 0 to 11) is considered a patrol road/high ground area with no defined levee prism, any issue found between CLM 0 to 11 of Unit 16 will be considered a maintenance issue, or an unauthorized encroachment, or an abandoned encroachment. Geophysical study indicates possible presence of pipe through levee. Owner needs to coordinate with the CVFPB to remove or abandon crossing according to Title 23 requirements. Current condition of pipe crossing does not impede access to patrol road/high ground area. Utility not found during inspection. Grout apron observed on WS slope, approximately 50 feet upstream of geophysics location. No permit was found authorizing this encroachment. CVFPB will need to review crossing to determine owner. The UCIP inspection was completed with LMA representative, H. Latu. (N. Cholewinski - GEI) FIELD_STRUCT_DESC: 18-inch corrugated metal storm drainage pipe (CMP) through the levee, 3.0 feet below the roadway. Drain inlet ungated. [Additional Reference(s): USACE San Joaquin O&M Manual 611.1, Volume F, (HLM 4.33), 18-inch pipe listed]. FS Date: 3/8/2021

Crossing Overview

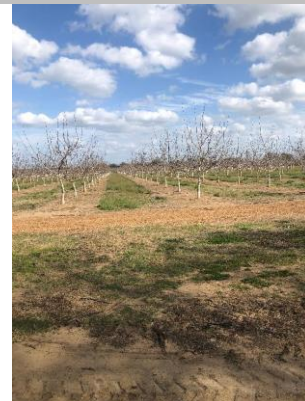
Photo 2 of 3 : UCIP_FA_2024_81206_95384.jpg

LS View

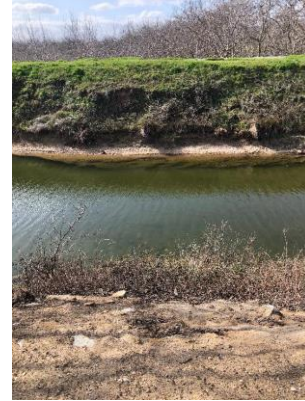
Photo 3 of 3 : UCIP_FA_2024_81206_95385.jpg

WS View: Grout apron at WS slope.

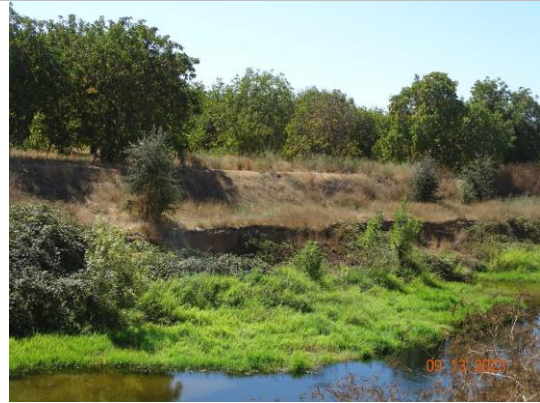
Photo 1 of 1 : FA_2024_NA0017_160_136_20240910_00052.jpg

LM Start	5.33	Rating **	A/W	Issue No.	136
LM End	5.37	Issue Type +	Ma	Location *	WS
Category	Earthen Levee			GPS Latitude/Longitude	
				Start	End
Item	Erosion / Bank Caving			37.997992°	37.997423°
				-121.077478°	-121.077952°
DWR ID	DWR_NA0017_16_f_2023_136				
Comment Code					
E1 : Note and monitor erosion site.					
Inspector Comment					
Issue has been transferred to Levee Mile Report and will continued to monitored. Site ID: NA0017U16RM17.81					
*This area is patrol road only and therefore the site is not rated					
07/28/2022: From 2013 to present, no significant changes were					
observed during the annual survey. The erosion length was updated to					
210 ft based on more accurate field measurements.					
08/22/2012: The site is located at the opposite river bank of E. Tobacco					
Road. There is no levee structure on site.

View of bank erosion from the opposite bank. Summer 2023

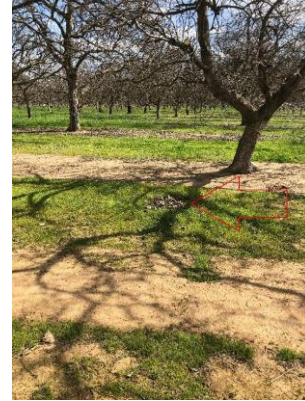
Photo 2 of 3 : UCIP_FA_2024_78013_95183.jpg

LS View: Small depression visible at LS.

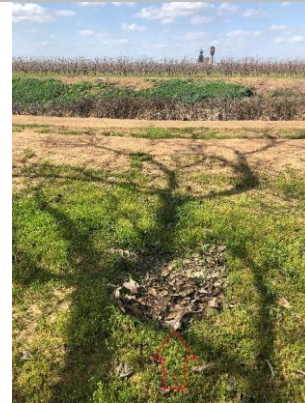
Photo 3 of 3 : UCIP_FA_2024_78013_95184.jpg

LS View: Small depression visible at LS.

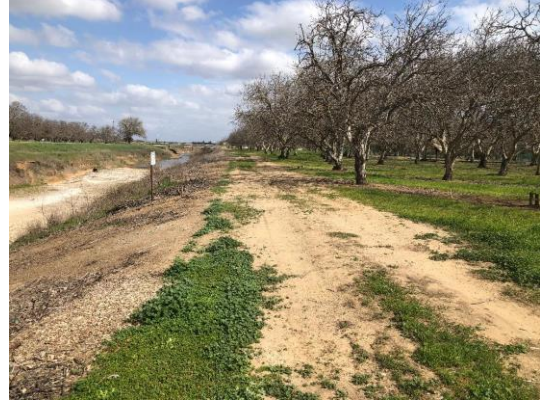
Photo 1 of 3 : UCIP_FA_2024_81210_95045.jpg

Comment Code					
Inspector Comment					
DS_ID:23448 FS_ID:81210 EP_NO: N/A Repair Type: Non-Urgent EVAL Issue: Crossing Status: Indicator Found UCIP Comments: 03/08/2021 Record updated from No Action Needed to Non-Urgent. Unit 16 ? Mormon Slough (CLM 0 to 11) is considered a patrol road/high ground area with no defined levee prism, any issue found between CLM 0 to 11 of Unit 16 will be considered a maintenance issue, or an unauthorized encroachment, or an abandoned encroachment. Current condition of pipe crossing does not impede access to patrol road/high ground area. Utility not found during inspection. No permit has been identified authorizing utility. CVFPB will need to review crossing to determine owner. The UCIP inspection was completed with LMA representative, H. Latu. (N. Cholewinski - GEI) FIELD_STRUCT_DESC: 18-inch corrugated metal storm drainage pipe (CMP) through the levee, 3.0 feet below the roadway. Drain inlet ungated. [Additional Reference(s): USACE San Joaquin O&M Manual 611.1, Volume F, (HLM 6.70), 18-inch pipe listed]. FS Date: 3/8/2021

Crossing Overview

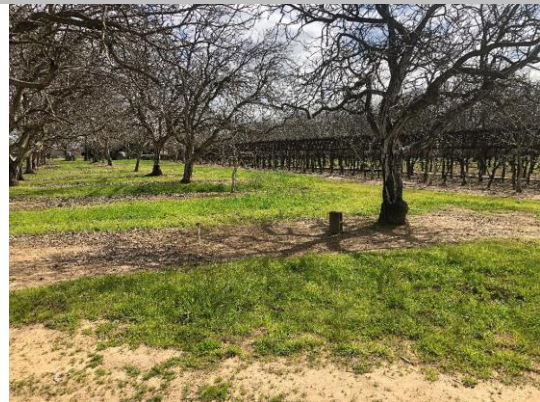
Photo 2 of 3 : UCIP_FA_2024_81210_95046.jpg

LS View

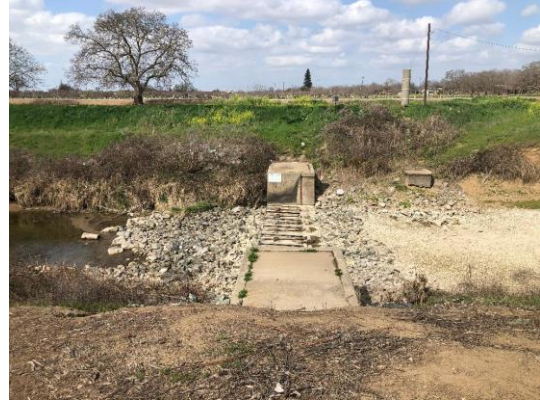
Photo 3 of 3 : UCIP_FA_2024_81210_95047.jpg

WS View

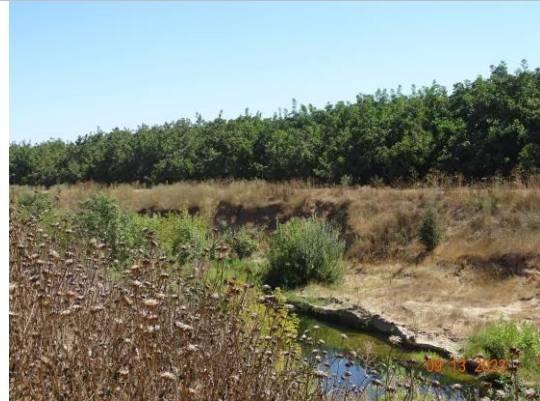
Photo 1 of 1 : FA_2024_NA0017_160_138_20240910_00054.jpg

07/28/2022: From 2014 to present, no significant changes were observed during the annual survey. Noticed several locations with signs of burrowing activity near the downstream end of the erosion site. The erosion length was updated to 600 ft based on more accurate field measurements.

08/22/2012: Discontinuous scarp or pocket erosions occurred along a long stretch of the river, with an erosion height greater than 25 ft. at certain points. There is no levee structure on site.

View of bank erosion from the opposite bank. Summer 2023

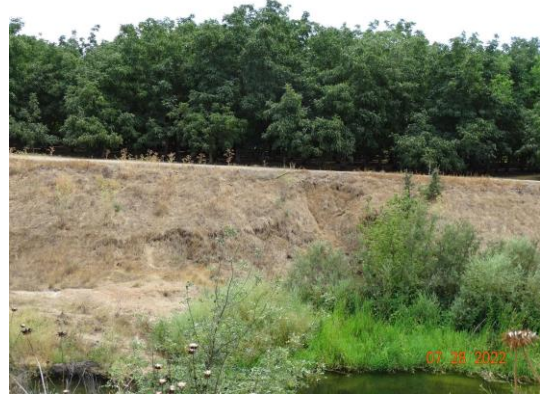
Photo 1 of 1 : FA_2024_NA0017_160_140_20240910_00055.jpg

LM Start	6.70	Rating **	A/W	Issue No.	140
LM End	6.71	Issue Type +	Ma	Location *	WS
Category	Earthen Levee			GPS Latitude/Longitude	
				Start	End
Item	Erosion / Bank Caving			37.982343°	37.982251°
				-121.092543°	-121.092750°
DWR ID	DWR_NA0017_16_f_2023_140				
Comment Code					
E1 : Note and monitor erosion site.					
Inspector Comment					
Issue has been transferred to Levee Mile Report and will continued to monitored. Site ID: NA0017U16RM16.15					
*This area is patrol road only and therefore the site is not rated					
07/28/2022: From 2020 to present, no changes were observed during the annual survey.					
08/29/2019: There is no levee at the site. The erosion is likely caused by surface runoff.

View of bank erosion from the opposite bank. Summer 2022

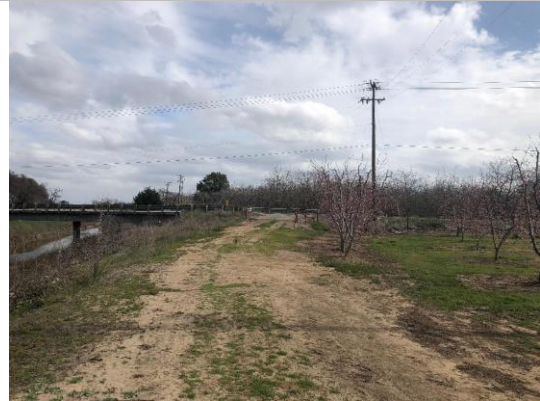
Photo 1 of 3 : UCIP_FA_2024_78026_95024.jpg

Comment Code						
Inspector Comment						
DS_ID:23450 FS_ID:78026 EP_NO: N/A Repair Type: Non-Urgent EVAL Issue: Crossing Status: Indicator Found UCIP Comments: 03/08/2021 Record updated from No Action Needed to Non-Urgent. Unit 16 ? Mormon Slough (CLM 0 to 11) is considered a patrol road/high ground area with no defined levee prism, any issue found between CLM 0 to 11 of Unit 16 will be considered a maintenance issue, or an unauthorized encroachment, or an abandoned encroachment. Geophysical study indicates possible presence of pipe through levee. Owner needs to coordinate with the CVFPB to remove or abandon crossing according to Title 23 requirements. Utility not found during visual inspection. Current condition of pipe crossing does not impede access to patrol road/high ground area. No permit was found authorizing this encroachment. CVFPB will need to review crossing to determine owner. Angular cobbles and briar bush overgrowth on WS slope. The UCIP inspection was completed with LMA representative, H. Latu. (N. Cholewinski - GEI) FIELD_STRUCT_DESC: 18-inch corrugated metal storm drainage pipe (CMP) through the levee, 3.0 feet below the roadway. Drain inlet ungated. [Additional Reference(s): USACE San Joaquin O&M Manual 611.1, Volume F, (HLM 7.10), 18-inch pipe listed]. FS Date: 3/8/2021

Crossing Overview

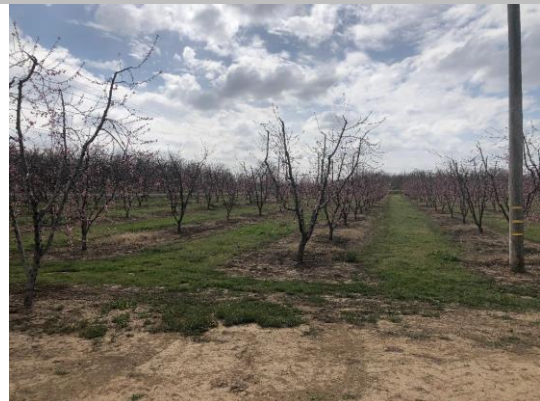
Photo 2 of 3 : UCIP_FA_2024_78026_95025.jpg

LS View

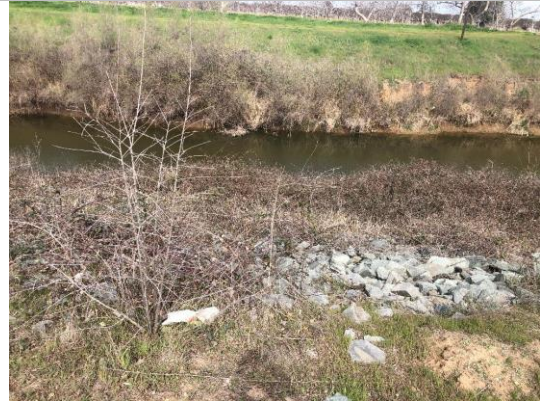
Photo 3 of 3 : UCIP_FA_2024_78026_95026.jpg

WS View: Angular cobbles on WS slope.

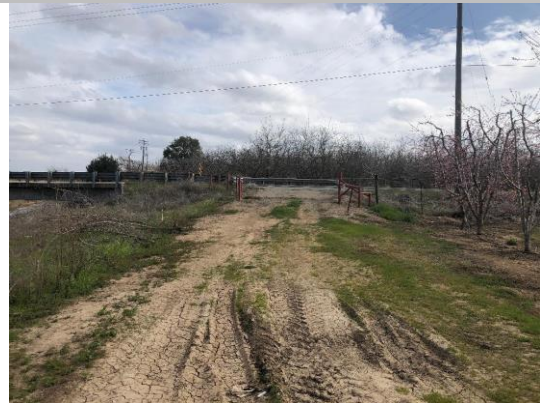
Photo 1 of 3 : UCIP_FA_2024_78027_95028.jpg

DS_ID:23449
FS_ID:78027
EP_NO: N/A
Repair Type: Non-Urgent
EVAL Issue:
Crossing Status: Indicator Found
UCIP Comments: 03/08/2021 Record updated from No Action Needed to Non-Urgent. Unit 16 ? Mormon Slough (CLM 0 to 11) is considered a patrol road/high ground area with no defined levee prism, any issue found between CLM 0 to 11 of Unit 16 will be considered a maintenance issue, or an unauthorized encroachment, or an abandoned encroachment. Utility not found during visual inspection. Geophysical study indicates possible presence of pipe through levee. Owner needs to coordinate with the CVFPB to remove or abandon crossing according to Title 23 requirements. Current condition of pipe crossing does not impede access to patrol road/high ground area. No permit was found authorizing this encroachment. CVFPB will need to review crossing to determine owner. Angular cobbles and briar bush overgrowth on WS slope. The UCIP inspection was completed with LMA representative, H. Latu. (N. Cholewinski - GEI)

FIELD_STRUCT_DESC: 18-inch corrugated metal storm drainage pipe (CMP) through the levee, 3.0 feet below the roadway. Drain inlet ungated. [Additional Reference(s): USACE San Joaquin O&M Manual 611.1, Volume F, (HLM 7.08), 18-inch pipe listed].
FS Date: 3/8/2021

Crossing Overview

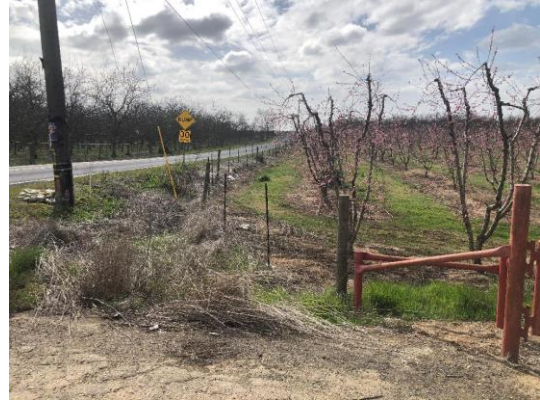
Photo 2 of 3 : UCIP_FA_2024_78027_95029.jpg

LS View

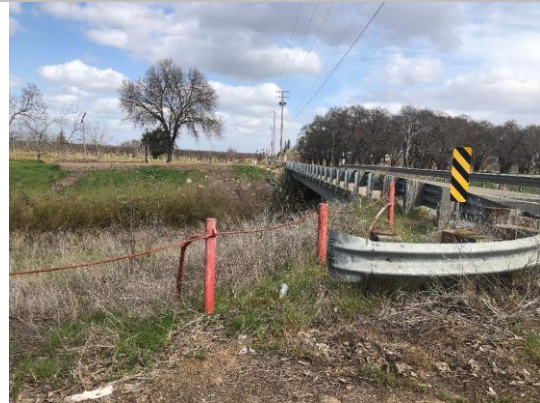
Photo 3 of 3 : UCIP_FA_2024_78027_95030.jpg

WS View: Angular cobbles and briar bush overgrowth on WS slope.

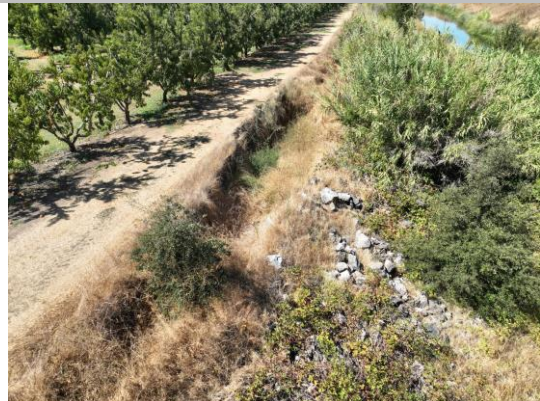
Photo 1 of 2 : SJR2024_NA0017U16RM15.87_7.JPG

Site ID: NA0017U16RM15.87
8/8/2024: From 2023 to present, no changes in erosion observed during annual survey.
9/13/2023: The site was discovered by the LMA and visited during the annual field survey. There is a 8-ft vertical scarp for approximately 100 ft along the patrol road hinge.

8/8/2024: Aerial view of erosion.

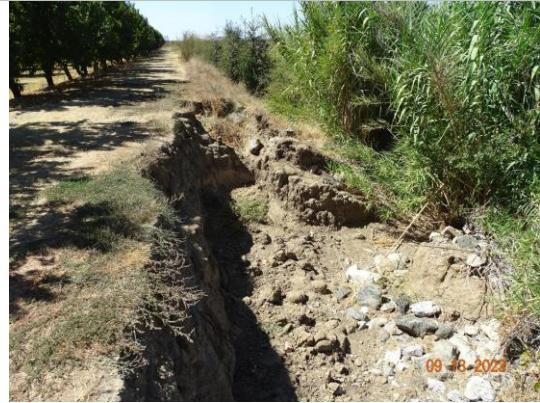
Photo 2 of 2 : SJR2024_NA0017U16RM15.87_12.JPG

9/13/2023: View of erosion looking downstream.

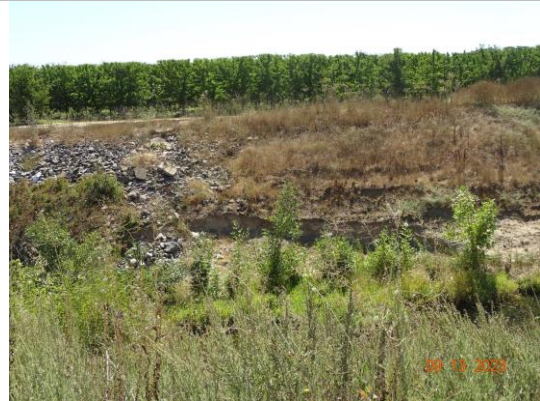
Photo 1 of 1 : FA_2024_NA0017_160_144_20240910_00058.jpg

Issue has been transferred to Levee Mile Report and will continued to monitored. Site ID: NA0017U16RM15.57
 *This area is patrol road only and therefore the site is not rated
 07/28/2022: From 2014 to present, no significant changes were observed during the annual survey. The erosion length was updated to 80 ft based on more accurate field measurements. The site ID changed from NA0017U16RM10.82 to NA0017U16RM15.57 in 2014 to reflect the correct river mile.
 09/12/2013: The site is located at immediately downstream of a levee segment protected by broken concrete. There is no levee structure on site.

View of bank erosion from the opposite bank. Summer 2023

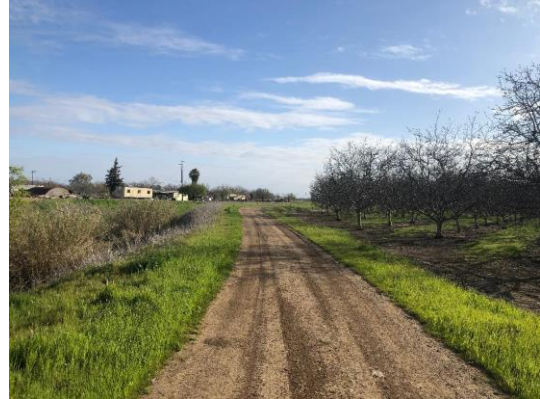
Photo 1 of 3 : UCIP_FA_2024_79194_94940.jpg

Comment Code						
Inspector Comment						
DS_ID:23341 FS_ID:79194 EP_NO: N/A Repair Type: Non-Urgent EVAL Issue: Crossing Status: Indicator Found UCIP Comments: 03/08/2021 Record remains Non-Urgent. Unit 16 ? Mormon Slough (CLM 0 to 11) is considered a patrol road/high ground area with no defined levee prism, any issue found between CLM 0 to 11 of Unit 16 will be considered a maintenance issue, or an unauthorized encroachment, or an abandoned encroachment. Geophysical study indicates possible presence of pipe through levee. Owner needs to coordinate with the CVFPB to remove or abandon crossing according to Title 23 requirements. Utility not found during inspection. Current condition of pipe crossing does not impede access to patrol road/high ground area. No permit was found authorizing this encroachment. CVFPB will need to review crossing to determine owner. No inlet observed on LS, but low point visible at LS toe. Briar bush overgrowth at WS toe. The UCIP inspection was completed with LMA representative, H. Latu. (N. Cholewinski - GEOM/30/2014 Pipe inlet filled with soil and should be cleared. (W. Wylie - DWR UCIP) FIELD_STRUCT_DESC: 18-inch corrugated metal storm drainage pipe (CMP) through the levee, 6.0 feet below the crown. Grouted inlet and outlet. [Additional Reference(s): DWR Levee Log, 1992, (HLM 8.83). USACE San Joaquin O&M Manual 611.1, Volume F, (HLM 8.83), 18-inch pipe listed]. FS Date: 3/8/2021

Crossing Overview

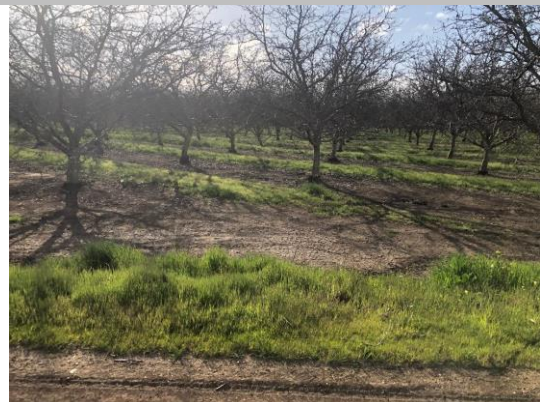
Photo 2 of 3 : UCIP_FA_2024_79194_94941.jpg

LS View: Depression at LS toe.

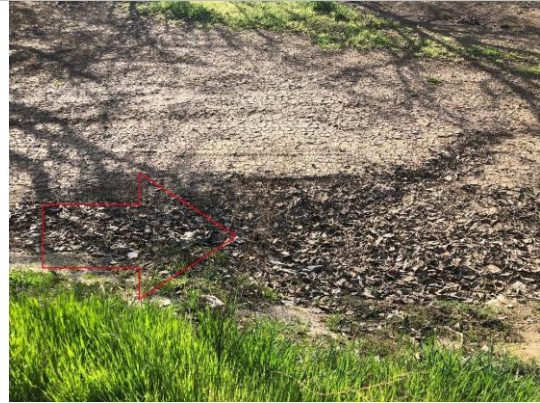
Photo 3 of 3 : UCIP_FA_2024_79194_94942.jpg

LS View: Depression at LS toe.

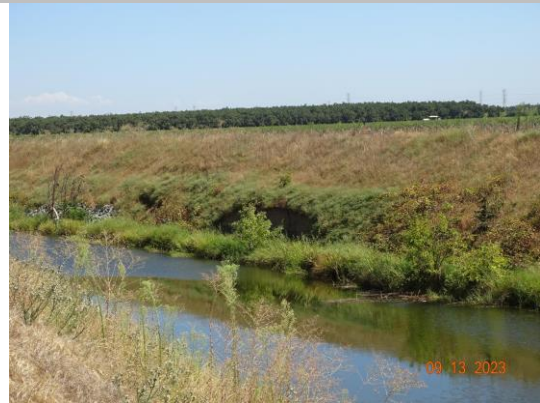
Photo 1 of 1 : FA_2024_NA0017_160_147_20240910_00061.jpg

Issue has been transferred to Levee Mile Report and will continued to monitored. Site ID: NA0017U16RM13.85
 *This area is patrol road only and therefore the site is not rated
 08/02/2022: From 2014 to present, no significant changes were observed during the annual survey. The site was combined with NA0017U16RM13.83 and NA0017U16RM13.86 and the length increased to 160 ft.
 09/12/2013: The erosion might have been caused by river flow combined with runoff. Dense vegetation is presents at the site. There is no levee structure on site.

View of bank erosion from the opposite bank. Summer 2023

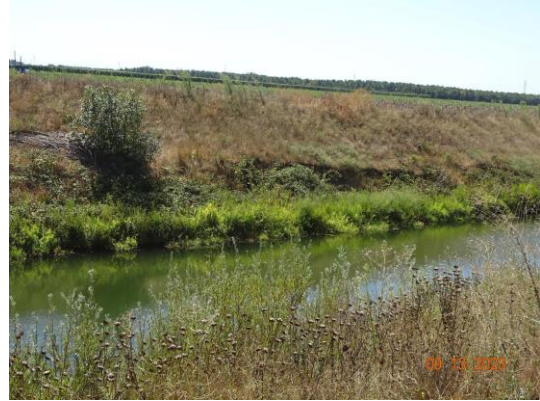
Photo 1 of 1 : FA_2024_NA0017_160_148_20240910_00062.jpg

LM Start	9.11	Rating **	A/W	Issue No.	148
LM End	9.13	Issue Type +	Ma	Location *	WS
Category	Earthen Levee			GPS Latitude/Longitude	
				Start	End
Item	Erosion / Bank Caving			37.966857°	37.966926°
				-121.129388°	-121.129763°
DWR ID	DWR_NA0017_16_f_2023_148				
Comment Code					
E1 : Note and monitor erosion site.					
Inspector Comment					
Issue has been transferred to Levee Mile Report and will continued to monitored. Site ID: NA0017U16RM13.72					
*This area is patrol road only and therefore the site is not rated					
08/02/2022: From 2013 to present, no significant changes were observed during the annual survey. The erosion length was updated to 110 ft based on more accurate field measurements.					
08/22/2012: The erosion is covered with dense vegetation. There is no levee structure on site.

View of bank erosion from the opposite bank. Summer 2023

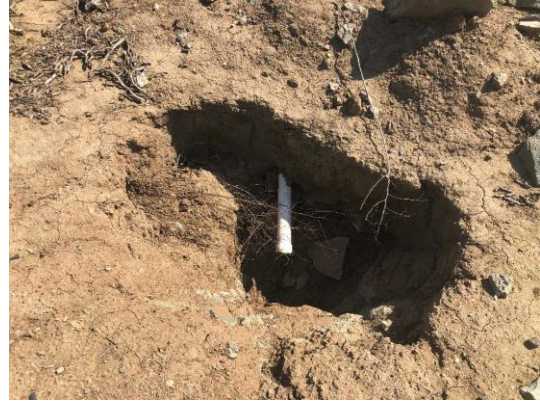
Photo 2 of 3 : UCIP_FA_2024_79196_94890.jpg

LS View: PVC pipe discharging at LS pipe opening.

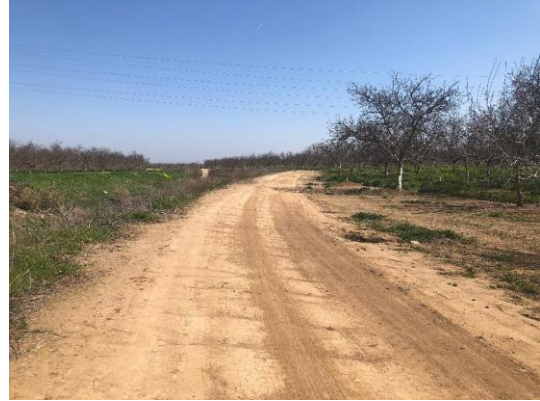
Photo 1 of 3 : UCIP_FA_2024_79949_94882.jpg

Comment Code						
Inspector Comment						
DS_ID:23345 FS_ID:79949 EP_NO: N/A Repair Type: No Action Needed EVAL Issue: Crossing Status: Found UCIP Comments: 05/09/2023 Record updated from Non-Urgent to No Action Needed. CIPP liner was installed on June 15, 2022. DMP internal video inspection has found none or minor pipe defects. Recommend next video inspection in 5 years. (O.Yakimov - DWR UCIP) 03/04/2021 Record remains Non-Urgent. Unit 16 ? Mormon Slough (CLM 0 to 11) is considered a patrol road/high ground area with no defined levee prism, any issue found between CLM 0 to 11 of Unit 16 will be considered a maintenance issue, or an unauthorized encroachment, or an abandoned encroachment. DMP internal video inspection has found pipe integrity issues. LOF of crossing is between 5 and 6. Crossing will be monitored until funding becomes available to address the issues. CM pipe is bent and deformed with visible gaps at the LS pipe opening. Pipe appears rusty and weathered on WS. Current condition of pipe crossing does not impede access to patrol road/high ground area. No permit was found authorizing this encroachment. CVFPB will need to review crossing to determine owner. The UCIP inspection was completed with LMA representative, H. Latu. (N. Cholewinski - GE04/30/2014 Inlet on LS burried in soil. (W. Wylie - DWR UCIP) FIELD_STRUCT_DESC: *HIGH GROUND* 18-inch CIPP-lined corrugated metal storm drainage pipe (CMP) through the levee, 3.5 feet below the crown. Grouted inlet and outlet. [Additional Reference(s): DWR Levee Log, 1992, (HLM 10.07). USACE San Joaquin O&M Manual 611.1, Volume F, (HLM 10.07), 18-inch pipe listed]. FS Date: 3/4/2021

Crossing Overview

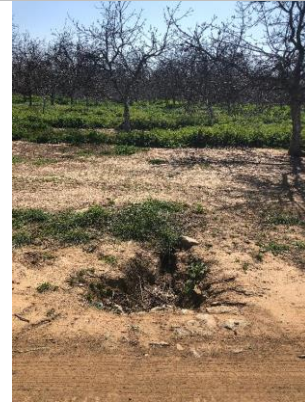
Photo 2 of 3 : UCIP_FA_2024_79949_94883.jpg

LS View: Pipe damaged at LS.

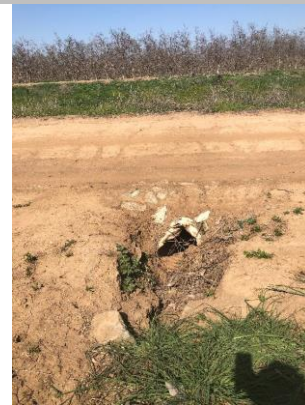
Photo 3 of 3 : UCIP_FA_2024_79949_94884.jpg

LS View: Pipe damaged at LS.

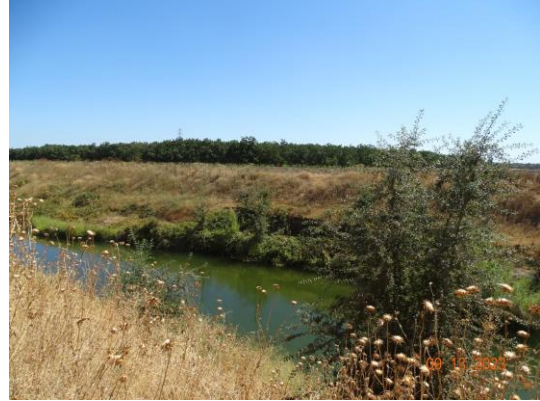
Photo 1 of 1 : FA_2024_NA0017_160_150_20240910_00064.jpg

LM Start	9.86	Rating **	A/W	Issue No.	150
LM End	9.88	Issue Type +	Ma	Location *	WS
Category	Earthen Levee			GPS Latitude/Longitude	
				Start	End
Item	Erosion / Bank Caving			37.964699°	37.964709°
				-121.142398°	-121.142726°
DWR ID	DWR_NA0017_16_f_2023_150				
Comment Code					
E1 : Note and monitor erosion site.					
Inspector Comment					
Issue has been transferred to Levee Mile Report and will continued to monitored. Site ID: NA0017U16RM12.95					
*This area is patrol road only and therefore the site is not rated					
08/02/2022: From 2013 to present, no significant changes were observed during the annual survey. The erosion length was updated to 80 ft based on more accurate field measurements.					
08/22/2012: Dense vegetation on site. There is no levee structure on site.

View of bank erosion from the opposite bank. Summer 2023

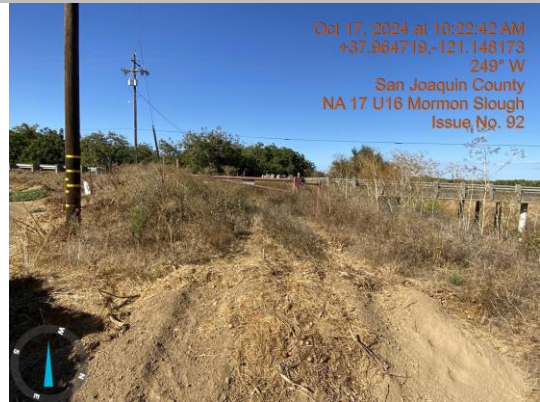
Photo 1 of 1 : FA_2024_NA0017_160_92_20241019_00265.jpg

LM Start	10.19	Rating **	M	Issue No.	92
LM End	10.19	Issue Type +	Ma	Location *	CR
Category	Earthen Levee			GPS Latitude/Longitude	
				Start	End
Item	Vegetation			37.964642°	37.964642°
				-121.148290°	-121.148290°
DWR ID	DWR_NA0017_16_f_2024_92				
Comment Code					
V2 : Remove the wild growth and woody vegetation other than native grasses from the levee slopes.					
Inspector Comment

View of vegetation blocking the access gate. Fall 2024

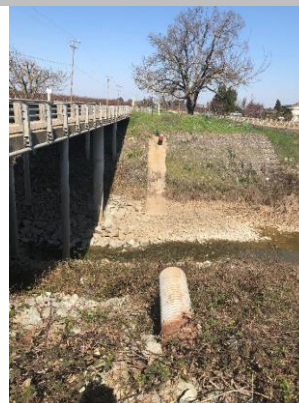
Photo 3 of 3 : UCIP_FA_2024_79950_94865.jpg

WS View: Pipe and flapgate at WS slope. Briar bush overgrowth present.

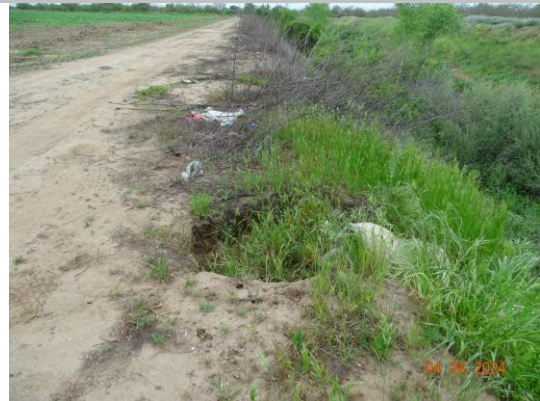
Photo 1 of 1 : FA_2024_NA0017_160_288_20240910_00073.jpg

LM Start	10.57	Rating **	M	Issue No.	288
LM End	10.57	Issue Type +	Ma	Location *	WS
Category	Earthen Levee			GPS Latitude/Longitude	
				Start	End
Item	Erosion / Bank Caving			37.963542°	37.963542°
				-121.155111°	-121.155111°
DWR ID	DWR_NA0017_16_f_2019_288				
Comment Code					
E2 : Schedule repair of erosion site prior to the next inspection.					
Inspector Comment					
Erosion may cut into patrol access road.

View of erosion on the waterside shoulder. Spring 2024

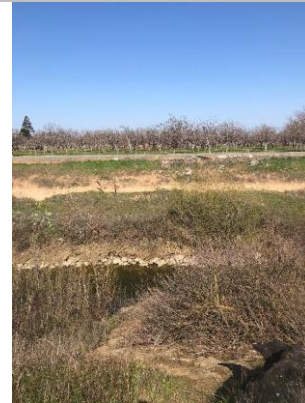
Photo 3 of 3 : UCIP_FA_2024_81216_94832.jpg

WS View: Grout apron at WS slope.

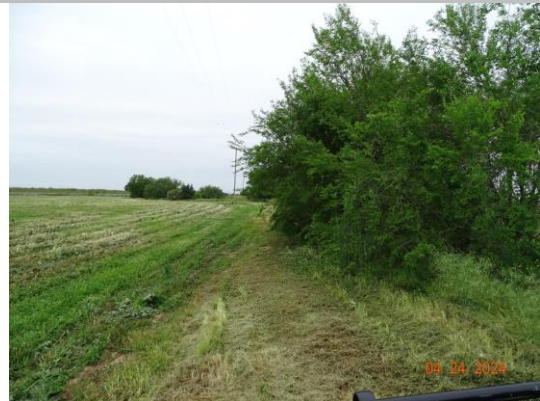
Photo 1 of 1 : FA_2024_NA0017_160_3_20240910_00003.jpg

LM Start	10.90	Rating **	U	Issue No.	3
LM End	10.90	Issue Type +	Ma	Location *	CR
Category	Earthen Levee			GPS Latitude/Longitude	
				Start	End
Item	Trim / Thin Trees			37.961464°	37.961464°
				-121.160376°	-121.160376°
DWR ID	DWR_NA0017_16_s_2022_3				
Comment Code					
T4 : Trim trees over roadway to at least 12 feet above ground level.					
Inspector Comment

View of untrimmed trees along the waterside of the crown. Spring 2024
