**Flood Control Project Maintenance
Levee Inspections****Maintenance Issue Types Only, Levee Inspection Report By Mile - Fall 2024****San Joaquin County Flood Control and Water Conservation District**

Waterway	Bank	Unit Miles	Inspection Start/End	Inspector
Unit No. 01 Littlejohn Creek	Left	2.59	10/21/2024 10/21/2024	Alberto De Leon

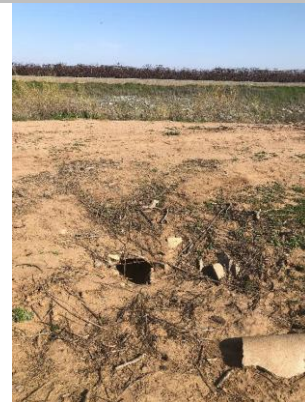
Photo 2 of 3 : UCIP_FA_2024_79199_94806.jpg

Comment Code						
Inspector Comment						
DS_ID:23354 FS_ID:79199 EP_NO: N/A Repair Type: Non-Urgent EVAL Issue: 5, Pipe Damage Crossing Status: Found UCIP Comments: 03/04/2021 Record was updated from No Action Needed to Non-Urgent. DWR DMP has found integrity issues, LOF between 4 and 5. Crossing will be monitored until funding becomes available for rehabilitation. No permit was found authorizing this encroachment. CVFPB will need to review crossing to determine owner. Soil accumulation and concrete debris near LS pipe opening. No visual of pipe at WS grout apron. The UCIP inspection was completed with LMA representative, H. Latu. (N. Cholewinski - GEI) FIELD_STRUCT_DESC: 18-inch corrugated metal storm drainage pipe (CMP) through the levee, 3.5 feet below the crown. Grouted outlet on the waterside (WS). [Additional Reference(s): DWR Levee Log, 1992, (HLM 11.41). USACE San Joaquin O&M Manual 611.1, Volume F, (HLM 11.41), 18-inch pipe listed]. FS Date: 3/4/2021

LS View: Soil accumulation and concrete debris at pipe opening.

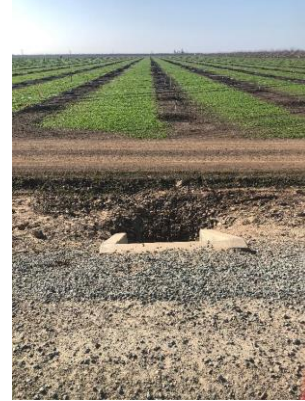
Photo 2 of 3 : UCIP_FA_2024_79200_94796.jpg

LS View: Headwall at LS toe.

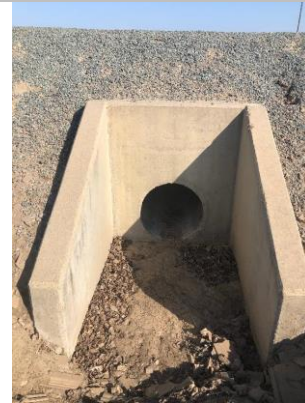
Photo 3 of 3 : UCIP_FA_2024_79200_94797.jpg

LS View: Headwall at LS toe.

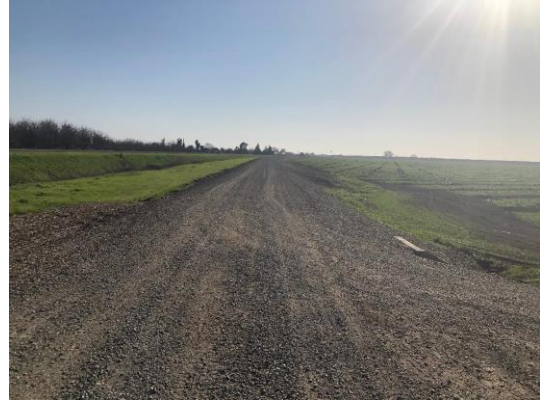
Photo 1 of 3 : UCIP_FA_2024_79201_94767.jpg

Comment Code					
Inspector Comment					
DS_ID:23385 FS_ID:79201 EP_NO: N/A Repair Type: Non-Urgent EVAL Issue: 5, Pipe Damage Crossing Status: Found UCIP Comments: 09/23/2024 DMP internal video inspection has found moderate pipe defects. Crossing will be monitored until funding becomes available for rehabilitation. (O. Yakimov - DWR UCIP) 03/04/2021 Record was updated from No Action Needed to Non-Urgent. No permit was found authorizing this encroachment. CVFPB will need to review crossing to determine owner. Observed a 4.5-inch PVC pipe discharging at headwall on LS. Flapgate on WS has single bullet hole. The UCIP inspection was completed with LMA representative, H. Latu. (N. Cholewinski - GEI) FIELD_STRUCT_DESC: 30-inch corrugated metal storm drainage pipe (CMP) through the levee, 5.5 feet below the crown. Concrete U-shaped headwalls on each end. Flap gate on the waterside (WS) end. Grouted inlet and outlet. [Additional Reference(s): DWR Levee Log, 1992, (HLM 12.24). USACE San Joaquin O&M Manual 611.1, Volume F, (HLM 12.24), 30-inch pipe listed]. FS Date: 3/4/2021

Crown Overview

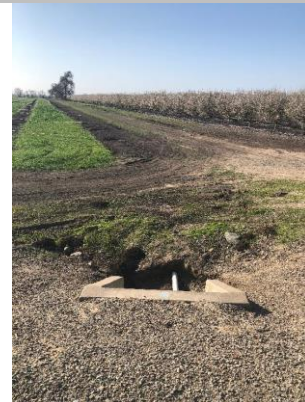
Photo 2 of 3 : UCIP_FA_2024_79201_94768.jpg

LS View: Headwall at LS toe.

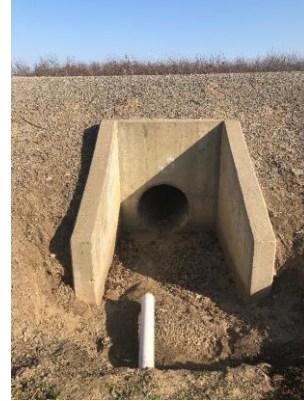
Photo 3 of 3 : UCIP_FA_2024_79201_94769.jpg

LS View: Headwall at LS toe. PVC pipe discharging at headwall.

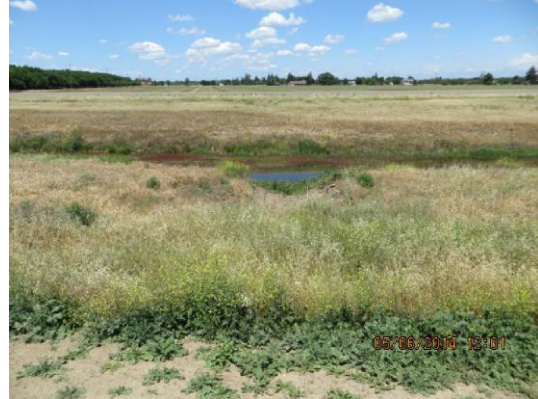
Photo 1 of 3 : UCIP_FA_2024_79202_65589.jpg

Comment Code					
Inspector Comment					
DS_ID:23388 FS_ID:79202 EP_NO: N/A Repair Type: Non-Urgent EVAL Issue: 5, Pipe Damage Crossing Status: Found UCIP Comments: 09/23/2024 DMP internal video inspection has found moderate pipe defects. Crossing will be monitored until funding becomes available for rehabilitation. (O. Yakimov - DWR UCIP) 03/03/2021 Record was updated from No Action Needed to Non-Urgent. DMP internal video inspection has not found pipe integrity issues. LOF of crossing is less or equal to 4.0. Recommend next video inspection in 5 years. No permit was found authorizing this encroachment. CVFPB will need to review crossing to determine owner. Burrow holes observed above headwall on LS slope. Pipe is rusty and CM of pipe seems to be slightly seperating at LS toe. The UCIP inspection was completed with LMA representative, H. Latu. (N. Cholewinski - GEI) FIELD_STRUCT_DESC: 30-inch corrugated metal storm drainage pipe (CMP) through the levee, 9.0 feet below the crown. Concrete U-shaped headwalls on each end. Flap gate on the waterside (WS) end. Grouted inlet and outlet. [Additional Reference(s): DWR Levee Log, 1992, (HLM 12.58). USACE San Joaquin O&M Manual 611.1, Volume F, (HLM 12.58), 30-inch pipe listed]. FS Date: 3/3/2021

Grouted spillway on WS berm.

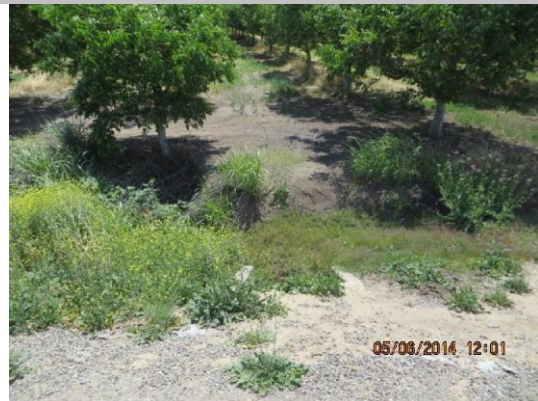
Photo 2 of 3 : UCIP_FA_2024_79202_65588.jpg

Concrete headwall on LS toe.

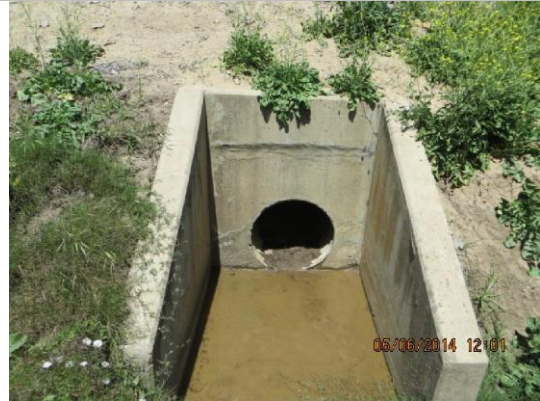
Photo 3 of 3 : UCIP_FA_2024_79202_65587.jpg

Concrete headwall on LS toe.

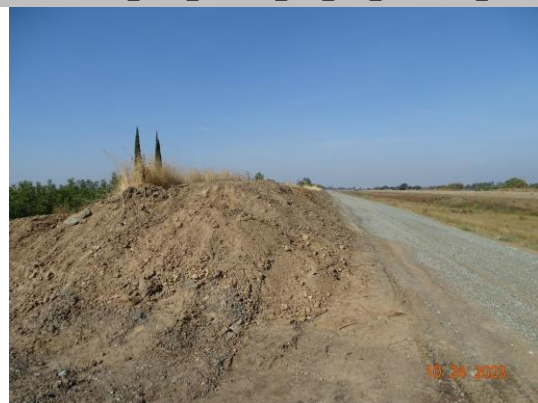
Photo 1 of 1 : FA_2024_NA0017_160_277_20240910_00071.jpg

LM Start	13.96	Rating **	U	Issue No.	277
LM End	14.01	Issue Type +	Ma	Location *	CR
Category	Earthen Levee			GPS Latitude/Longitude	
				Start	End
Item	Encroachments			37.964838°	37.965214°
				-121.212834°	-121.213627°
DWR ID	DWR_NA0017_16_s_2019_277				
Comment Code					
MA : Material					
Inspector Comment					
Fill material is stored on the landside crown.

View of fill material stored landside shoulder. Fall 2023

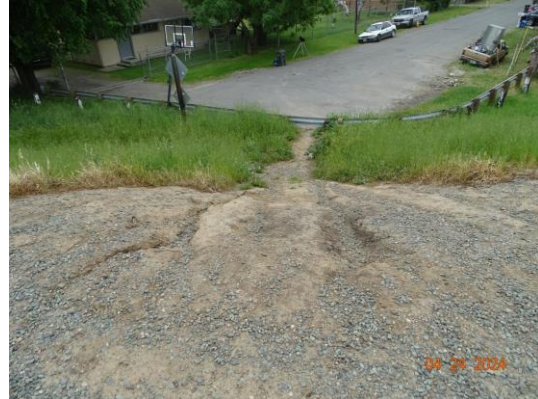
Photo 1 of 1 : FA_2024_NA0017_160_142_20240910_00056.jpg

View of erosion rill on the landside slope. Spring 2024

LM Start	14.46	Rating **	M	Issue No.	142
LM End	14.46	Issue Type +	Ma	Location *	LS
Category	Earthen Levee			GPS Latitude/Longitude	
				Start	End
Item	Erosion / Rills			37.968688°	37.968688°
				-121.220539°	-121.220539°
DWR ID	DWR_NA0017_16_s_2024_142				
Comment Code					
E5 : Schedule repair of rills prior to the next inspection.					
Inspector Comment

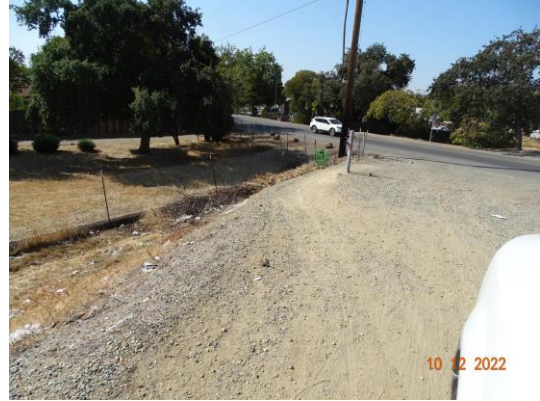
Photo 1 of 1 : FA_2024_NA0017_160_270_20240910_00070.jpg

View of pedestrian pathway along the landside slope. Fall 2022

LM Start	16.84	Rating **	A/W	Issue No.	270
LM End	16.84	Issue Type +	Ma	Location *	LS
Category	Earthen Levee			GPS Latitude/Longitude	
				Start	End
Item	Erosion / Foot Traffic			37.985132°	37.985132°
				-121.258825°	-121.258825°
DWR ID	DWR_NA0017_16_s_2021_270				
Comment Code					
E3 : Repair the levee slope damaged by foot traffic and prevent access where possible.					
Inspector Comment

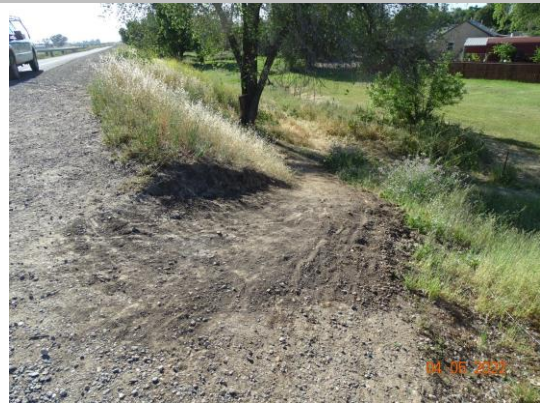
Photo 1 of 1 : FA_2024_NA0017_160_289_20240910_00074.jpg

View of foot path along the landside slope. Spring 2022

LM Start	17.07	Rating **	M	Issue No.	289
LM End	17.07	Issue Type +	Ma	Location *	LS
Category	Earthen Levee			GPS Latitude/Longitude	
				Start	End
Item	Erosion / Foot Traffic			37.986713°	37.986713°
				-121.262346°	-121.262346°
DWR ID	DWR_NA0017_16_s_2022_289				
Comment Code					
E3 : Repair the levee slope damaged by foot traffic and prevent access where possible.					
Inspector Comment

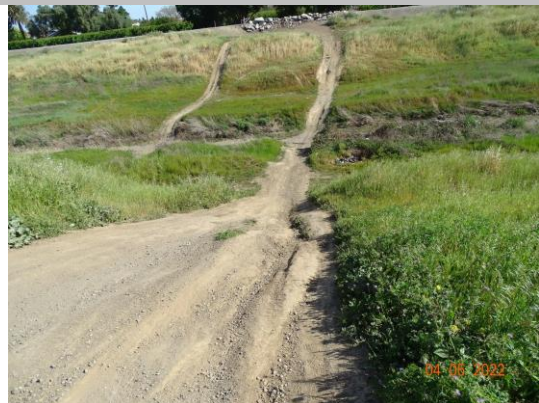
Photo 1 of 1 : FA_2024_NA0017_160_306_20240910_00079.jpg

LM Start	17.89	Rating **	M	Issue No.	306
LM End	17.89	Issue Type +	Ma	Location *	LS
Category	Earthen Levee			GPS Latitude/Longitude	
				Start	End
Item	Erosion / Vehicle Traffic			37.992320°	37.992320°
				-121.275567°	-121.275567°
DWR ID	DWR_NA0017_16_s_2022_306				
Comment Code					
E6 : Repair the levee slope damaged by vehicle traffic and prevent access where possible.					
Inspector Comment					
The erosion is caused by off-road motorcycle activity.

View of erosion within the waterside slope caused by motorcycle traffic.
Spring 2022

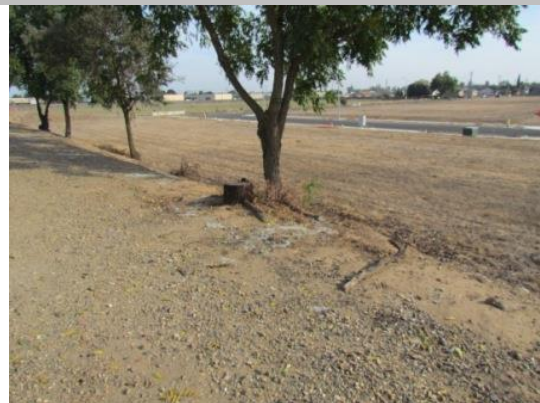
Photo 1 of 1 : FA_2024_NA0017_160_65_20240910_00015.jpg

LM Start	18.94	Rating **	N	Issue No.	65
LM End	18.94	Issue Type +	Ma	Location *	LS
Category	Earthen Levee			GPS Latitude/Longitude	
				Start	End
Item	Trim / Thin Trees			37.991937°	37.991937°
				-121.293932°	-121.293932°
DWR ID	DWR_NA0017_16_s_2012_65				
Comment Code					
T5 : Tree stumps.					
Inspector Comment

A tree stump was found on the landside of the levee looking upstream.

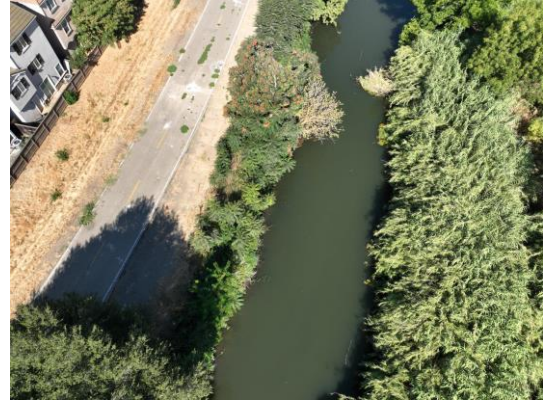
Photo 1 of 3 : SJR2024_NA0017U16RM2.01_3.jpg

8/1/2024: Aerial view of erosion.

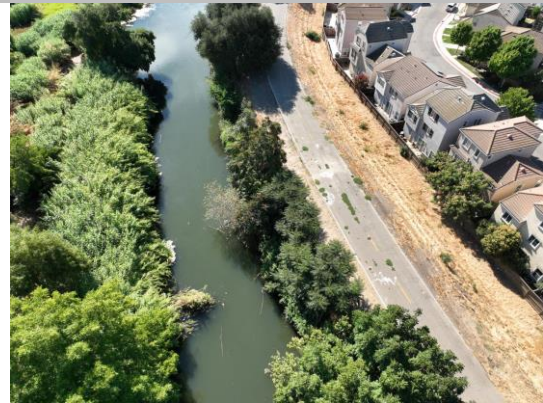
Photo 2 of 3 : SJR2024_NA0017U16RM2.01_5.jpg

8/1/2024: Aerial view of erosion.

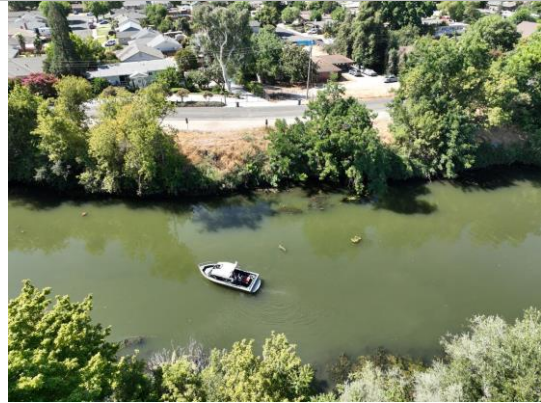
Photo 1 of 2 : SJR2024_NA0017U16RM1.24_4.jpg

LM Start	21.61	Rating **	M	Issue No.	91
LM End	21.62	Issue Type +	Ma	Location *	WS
Category	Supplemental			GPS Latitude/Longitude	
				Start	End
Item	DWR Erosion Survey			37.979935°	37.979935°
				-121.334118°	-121.334118°
DWR ID	NA0017U16RM1.24				
Comment Code					
Inspector Comment					
Site ID: NA0017U16RM1.24 8/01/2024: The site was discovered by the LMA and visited during the annual levee inspection. There is a 20-ft vertical scarp for approximately 100 ft beginning 10-12 feet from the edge of pavement along the levee crown.

8/1/2024: Aerial view of erosion.

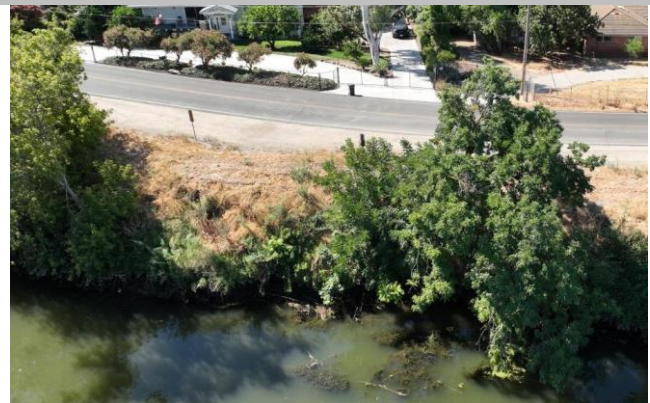
Photo 2 of 2 : SJR2024_NA0017U16RM1.24_7.jpg

8/1/2024: Zoomed in view of erosion.

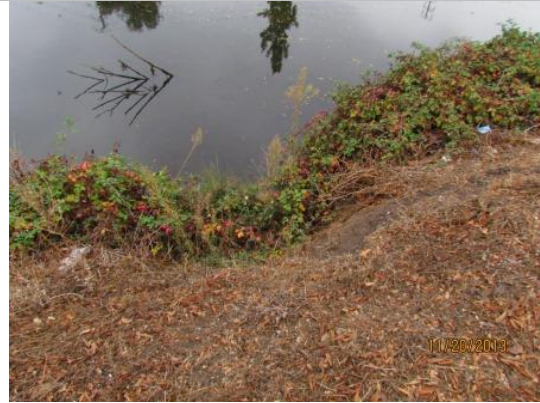
Photo 1 of 1 : FA_2024_NA0017_160_62_20240910_00014.jpg

Erosion was found on the waterside slope of the levee looking upstream.

LM Start	21.94	Rating **	A/W	Issue No.	62
LM End	21.94	Issue Type +	Ma	Location *	WS
Category	Earthen Levee			GPS Latitude/Longitude	
				Start	End
Item	Erosion / Bank Caving			37.979251°	37.979251°
				-121.340012°	-121.340012°
DWR ID	DWR_NA0017_16_f_2020_62				
Comment Code					
E1 : Note and monitor erosion site.					
Inspector Comment

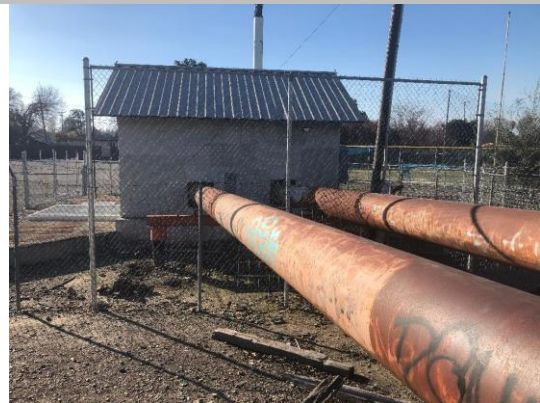
Photo 2 of 3 : UCIP_FA_2024_78197_93578.jpg

LS View: Pipe and pumphouse at LS toe.

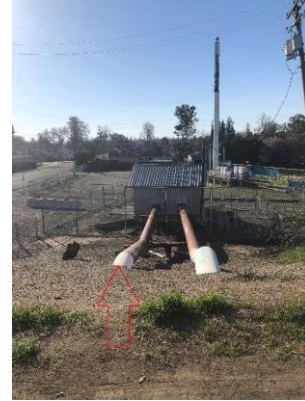
Photo 3 of 3 : UCIP_FA_2024_78197_93579.jpg

LS View: Pipe and pumphouse at LS slope and toe.

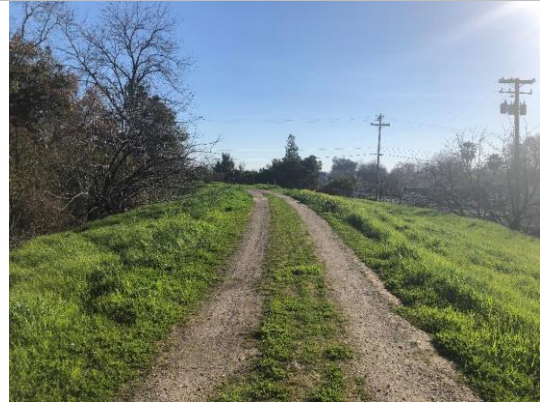
Photo 1 of 3 : UCIP_FA_2024_78198_93572.jpg

DS_ID:23503
 FS_ID:78198
 EP_NO: N/A
 Repair Type: Non-Urgent
 EVAL Issue:
 Crossing Status: Found
 UCIP Comments: 03/01/2021 Record was updated from No Action Needed to Non-Urgent. No permit was found authorizing this encroachment. CVFPB will need to review crossing to determine owner. No issues observed during inspection. The UCIP inspection was completed with LMA representative, H. Latu. (N. Cholewinski - GEI)
 FIELD_STRUCT_DESC: 2 of 2: 20-inch steel storm drainage pipe through the levee, 4.3 feet below the crown. Siphon breaker on the waterside (WS) slope. Pump house near the landside (LS) toe. (Reclamation District No. 1618 [RD1618]). [Additional Reference(s): DWR Levee Log, 1992, (HLM 23.36). USACE San Joaquin O&M Manual 611.1, Volume F, (HLM 23.36), 20-inch pipe listed].
 FS Date: 3/1/2021

Crown Overview

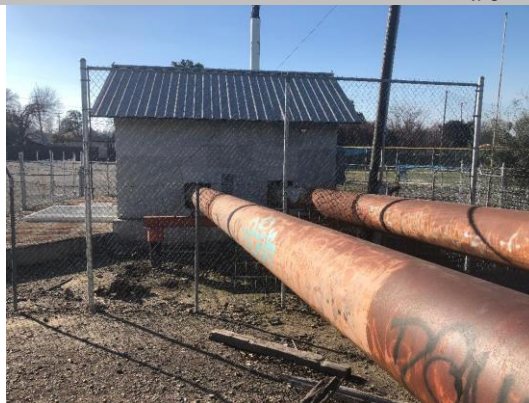
Photo 2 of 3 : UCIP_FA_2024_78198_93574.jpg

LS View: Pipe and pumphouse at LS toe.

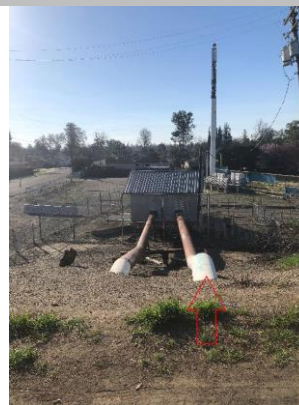
Photo 3 of 3 : UCIP_FA_2024_78198_93575.jpg

LS View: Pipe and pumphouse at LS slope and toe.

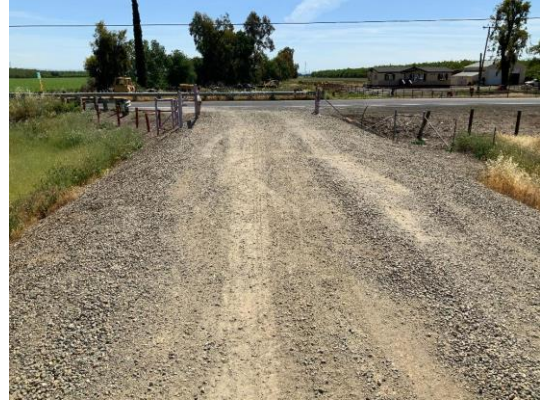
Photo 1 of 2 : UCIP_FA_2024_78217_98503.jpg

Comment Code					
Inspector Comment					
DS_ID:18542 FS_ID:78217 EP_NO: N/A Repair Type: Non-Urgent EVAL Issue: Crossing Status: Not Found UCIP Comments: 04/29/2021 The record has been upgraded from No Action Needed to Non-Urgent. Pipe not found by visual inspection. Geophysical results did not confirm presence of pipe through levee. Record will remain in UCIP's inspection records until future Levee Improvement Project can confirm no crossing was found through the levee. No permit was found authorizing this encroachment. CVFPB will need to review crossing to determine owner. The UCIP inspection was completed with LMA representative, J. Nelson. (H. Dunn ? GEI) FIELD_STRUCT_DESC: 30-inch corrugated metal storm drainage pipe (CMP) through the levee, 6.0 feet below the crown. Concrete U-shaped headwalls on each end. Flap gate on the waterside (WS) end. Grouted inlet and outlet. [Additional Reference(s): DWR Levee Log, 1992, (HLM 0.00), 36-inch pipe listed. USACE San Joaquin O&M Manual 611.1, Volume F, (HLM 0.00), 30-inch pipe listed]. FS Date: 4/29/2021

Levee crown looking upstream.

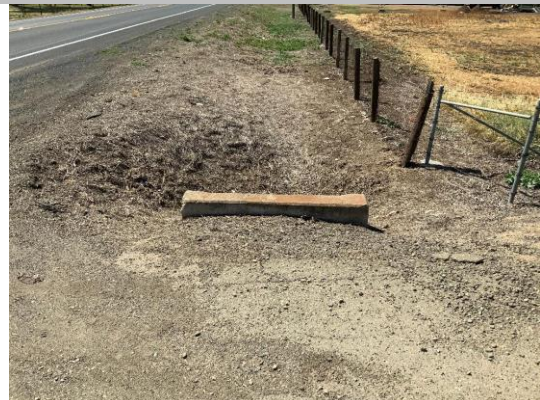
Photo 2 of 2 : UCIP_FA_2024_78217_98504.jpg

LS view: Toe from crown, pipe not visible.

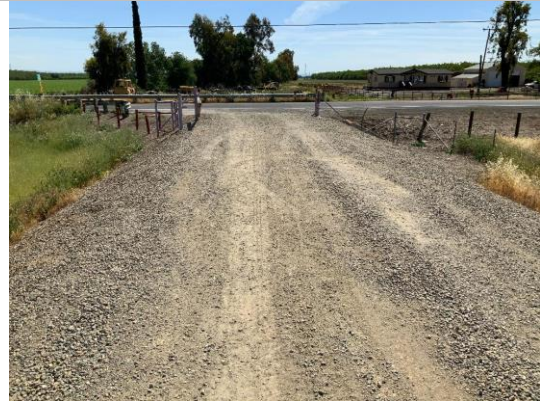
Photo 1 of 3 : UCIP_FA_2024_79205_99067.jpg

Comment Code					
Inspector Comment					
DS_ID:23952 FS_ID:79205 EP_NO: N/A Repair Type: Non-Urgent EVAL Issue: Crossing Status: Found UCIP Comments: 04/29/2021 The record has been upgraded from No Action Needed to Non-Urgent. No permit was found authorizing this encroachment. CVFPB will need to review crossing to determine owner. The UCIP inspection was completed with LMA representative, J. Nelson. (H. Dunn ? GEI)04/04/2014 Looks well maintained crossing. (P. Mahesh - DWR UCIP) FIELD_STRUCT_DESC: 30-inch corrugated metal storm drainage pipe (CMP) through the levee, 6.0 feet below the crown. Concrete U-shaped headwalls on each end. Flap gate on the waterside (WS) end. Grouted inlet and outlet. [Additional Reference(s): USACE San Joaquin O&M Manual 611.1, Volume F, (Station 173+30), 30-inch pipe listed]. FS Date: 4/29/2021

Levee crown looking upstream.

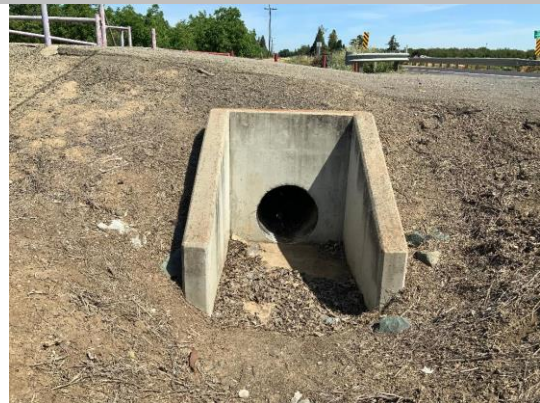
Photo 2 of 3 : UCIP_FA_2024_79205_98740.jpg

LS view: Slope and headwall at toe.

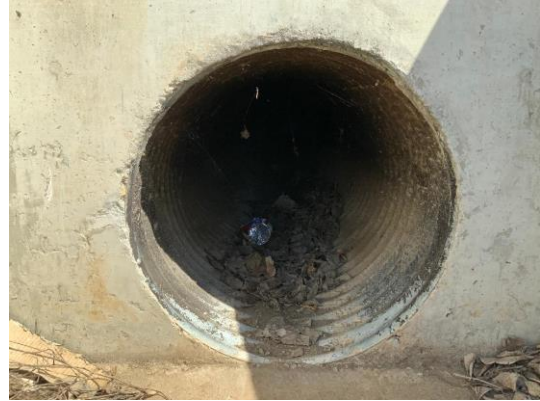
Photo 3 of 3 : UCIP_FA_2024_79205_98741.jpg

LS view: Close up of pipe inlet.

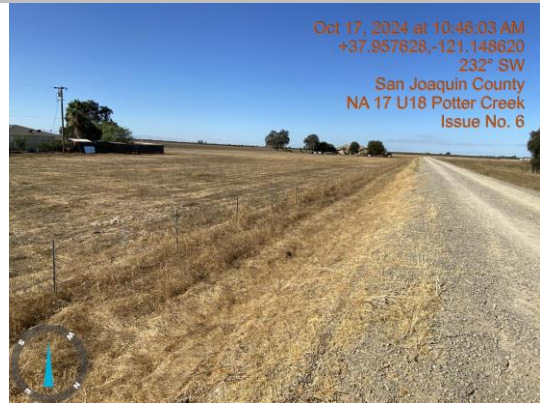
Photo 1 of 1 : FA_2024_NA0017_162_6_20241019_00016.jpg

Typical view of well maintained vegetation along the landside slope and easement. Fall 2024

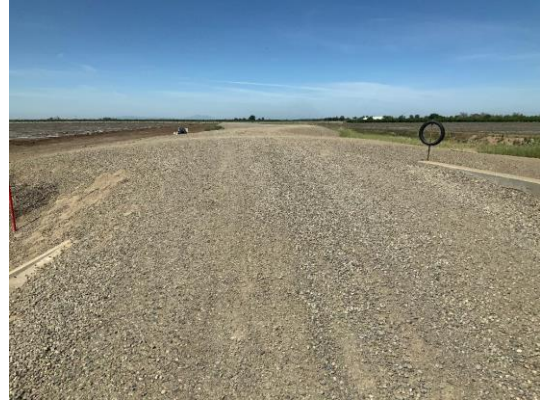
Photo 1 of 3 : UCIP_FA_2024_78219_98748.jpg

Comment Code					
Inspector Comment					
DS_ID:18541 FS_ID:78219 EP_NO: N/A Repair Type: Urgent EVAL Issue: 3a, Flood Risk Crossing Status: Found UCIP Comments: 04/29/2021 The record has been upgraded from No Action Needed to Urgent. There is a new plastic irrigation pipe going through this metal pipe that prevents the flapgate from closing. Pipe needs to be removed before flood season so flapgate can close. No permit was found authorizing this encroachment. CVFPB will need to review crossing to determine owner. The UCIP inspection was completed with LMA representative, J. Nelson. (H. Dunn ? GEI)					
04/04/2014 Long flood wall along the levee. (P. Mahesh - DWR UCIP) FIELD_STRUCT_DESC: 30-inch corrugated metal storm drainage pipe (CMP) through the levee, 6.0 feet below the crown. Concrete U-shaped headwalls on each end. Flap gate on the waterside (WS) end. Grouted inlet and outlet. [Additional Reference(s): DWR Levee Log, 1992, (HLM 0.28), 36-inch pipe listed. USACE San Joaquin O&M Manual 611.1, Volume F, (HLM 0.28), 30-inch pipe listed]. FS Date: 4/29/2021

Levee crown looking downstream.

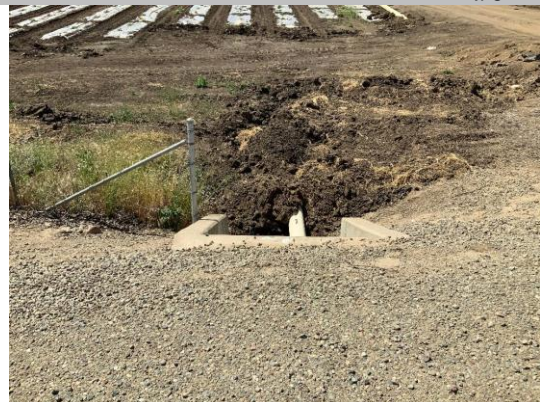
Photo 2 of 3 : UCIP_FA_2024_78219_98750.jpg

LS view: Headwall visible at toe from crown.

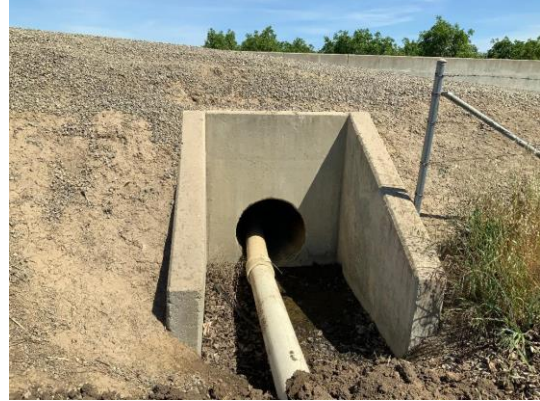
Photo 3 of 3 : UCIP_FA_2024_78219_98751.jpg

LS view: Slope and headwall at toe. Irrigation pipe going through inlet.

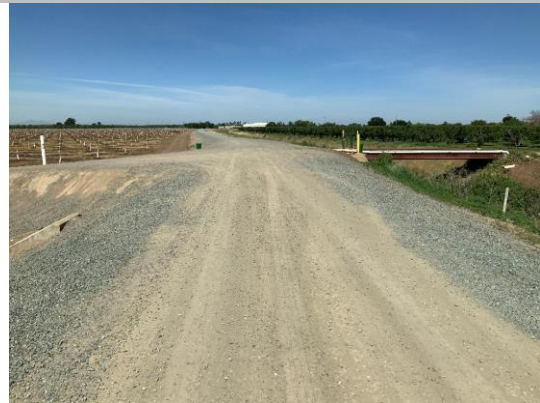
Photo 1 of 3 : UCIP_FA_2024_78222_98760.jpg

DS_ID:23954
 FS_ID:78222
 EP_NO: N/A
 Repair Type: Non-Urgent
 EVAL Issue:
 Crossing Status: Not Found
 UCIP Comments: 04/29/2021 The record has been upgraded from No Action Needed to Non-Urgent. Pipe not found by visual inspection. Geophysical results did not confirm presence of pipe through levee. Record will remain in UCIP's inspection records until future Levee Improvement Project can confirm no crossing was found through the levee. No permit was found authorizing this encroachment. CVFPB will need to review crossing to determine owner. The UCIP inspection was completed with LMA representative, J. Nelson. (H. Dunn ? GEI)
 FIELD_STRUCT_DESC: 30-inch corrugated metal storm drainage pipe (CMP) through the levee, 6.0 feet below the crown. Concrete U-shaped headwalls on each end. Flap gate on the waterside (WS) end. Grouted inlet and outlet. [Additional Reference(s): USACE San Joaquin O&M Manual 611.1, Volume F, (Station 145+26), 30-inch pipe listed].

Levee crown looking downstream.

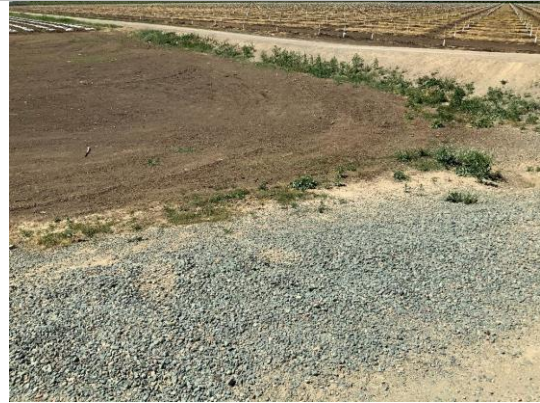
Photo 2 of 3 : UCIP_FA_2024_78222_98761.jpg

LS view: Toe from crown, no pipe visible.

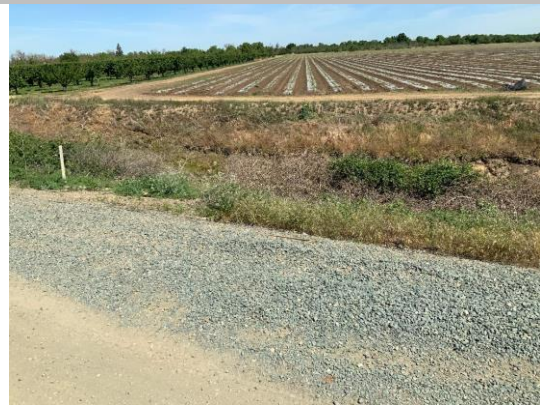
Photo 3 of 3 : UCIP_FA_2024_78222_98762.jpg

WS view: Toe from crown, no pipe visible.

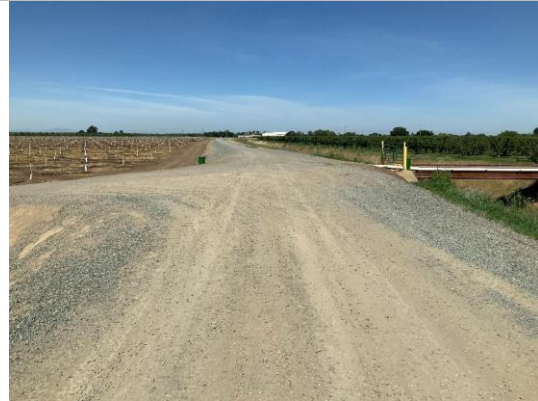
Photo 1 of 3 : UCIP_FA_2024_85072_98763.jpg

Comment Code						
Inspector Comment						
DS_ID:18539 FS_ID:85072 EP_NO: N/A Repair Type: Non-Urgent EVAL Issue: 5, Pipe Damage Crossing Status: Found UCIP Comments: 10/21/2024 Record updated from Urgent to Non-Urgent. LoF rating was changed due to the difference in CCTV operator opinion in severity of offset joint. (O. Yakimov - DWR UCIP) 04/29/2021 Record has been upgraded from No Action Needed to Urgent. DWR DMP internal video inspection has found pipe integrity issues. LOF of crossing is between 5 and 6. Crossing will be monitored until funding becomes available to address the issues. No permit was found authorizing this encroachment. CVFPB will need to review crossing to determine owner. The UCIP inspection was completed with LMA representative, J. Nelson. (H. Dunn ? GE04/04/2014 May need cleaning the pipe. (P. Mahesh - DWR UCIP) FIELD_STRUCT_DESC: 30-inch corrugated metal storm drainage pipe (CMP) through the levee, 6.0 feet below the crown. Concrete U-shaped headwalls on each end. Flap gate on the waterside (WS) end. Grouted inlet and outlet. [Additional Reference(s): DWR Levee Log, 1992, (HLM 0.54), 36-inch pipe listed. USACE San Joaquin O&M Manual 611.1, Volume F, (HLM 0.54), 30-inch pipe listed]. FS Date: 4/29/2021

Levee crown looking downstream.

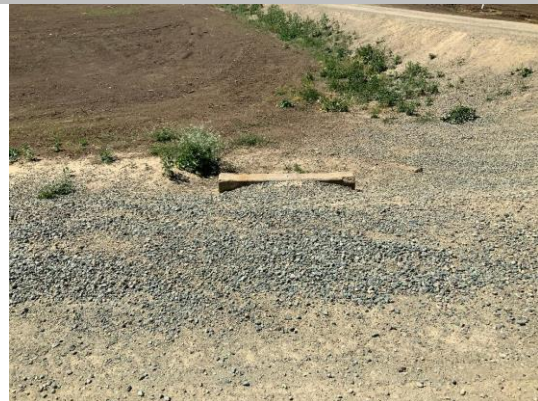
Photo 2 of 3 : UCIP_FA_2024_85072_98764.jpg

LS view: Headwall visible at toe from crown.

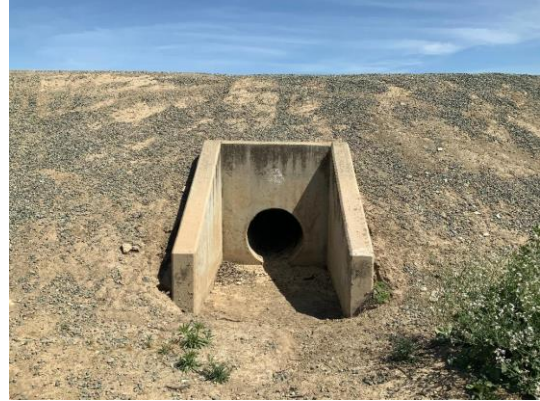
Photo 3 of 3 : UCIP_FA_2024_85072_98765.jpg

LS view: Slope and headwall at toe.
