**Flood Control Project Maintenance
Levee Inspections**

Maintenance Issue Types Only, Levee Inspection Report By Mile - Fall 2021

Reclamation District No. 0556 Upper Andrus

Waterway	Bank	Unit Miles	Inspection Start/End	Inspector
Unit No. 01 Georgiana Slough	Right	5.48	09/01/2021 09/01/2021	David Julian

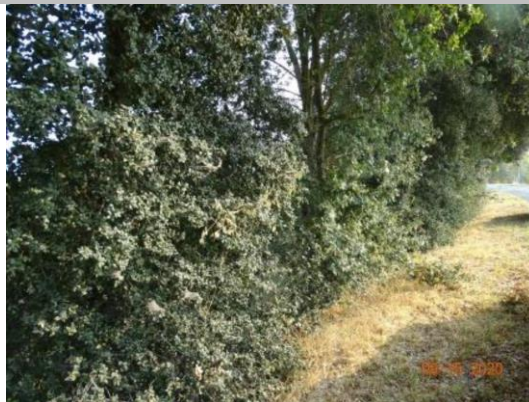
Photo 1 of 1 : FA_2021_RD0556_18_46_20210830_00026.jpg

LM Start	1.55	Rating **	U	Issue No.	46
LM End	1.64	Issue Type +	Ma	Location *	LS
Category	Earthen Levee			GPS Latitude/Longitude	
				Start	End
Item	Trim / Thin Trees			38.225268 °	38.224587 °
				-121.534733 °	-121.536129 °
DWR ID	DWR_RD0556_01_s_2018_46				
Comment Code					
T1 : Trim trees to at least five feet above ground level.					
Inspector Comment

View looking upstream at thick trees on the landside slope (Fall 2020).

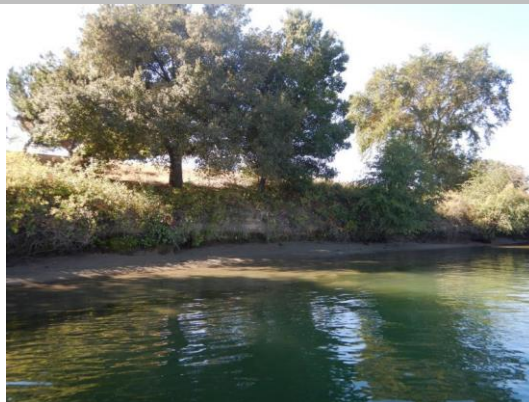
Photo 2 of 2 : FA_2021_RD0556_19_18_20211218_60.jpg

USACE 2018 Erosion Photo #2

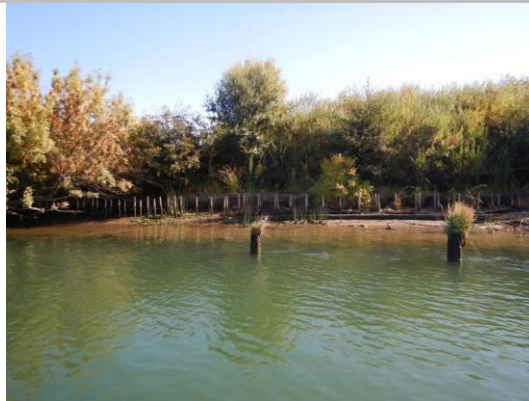
Photo 1 of 2 : FA_2021_RD0556_19_17_20211218_10.jpg

USACE 2018 Erosion Photo #1

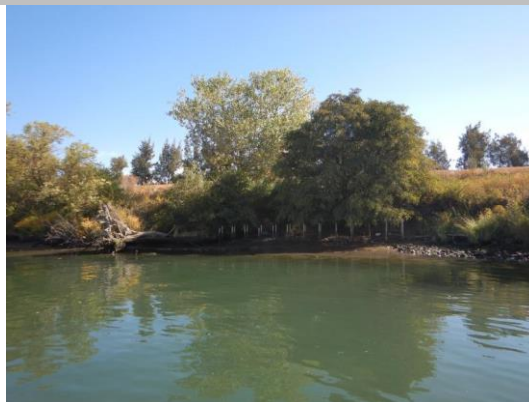
Photo 2 of 2 : FA_2021_RD0556_19_16_20211218_9.jpg

USACE 2018 Erosion Photo #2

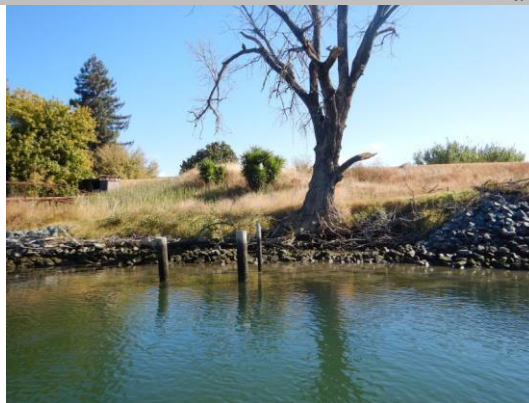
Photo 1 of 2 : FA_2021_RD0556_19_15_20211218_6.jpg

USACE 2018 Erosion Photo #1

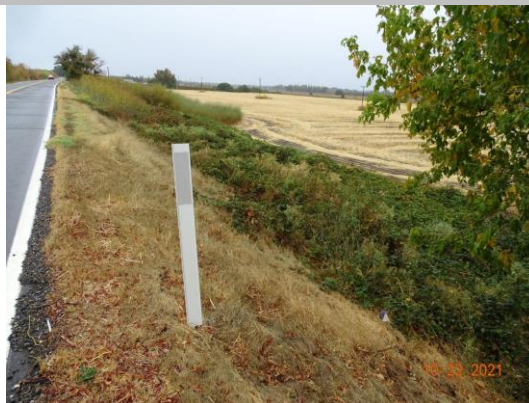
Photo 1 of 1 : FA_2021_RD0556_19_105_20211022_00104.jpg

LM Start	4.13	Rating **	U	Issue No.	105
LM End	4.32	Issue Type +	Ma	Location *	LS
Category	Earthen Levee			GPS Latitude/Longitude	
				Start	End
Item	Vegetation			38.210922 °	38.208171 °
				-121.556735 °	-121.556800 °
DWR ID	DWR_RD0556_02_f_2021_105				
Comment Code					
V2 : Remove the wild growth other than native grasses from the levee slopes.					
Inspector Comment

View looking upstream at thick vegetation on the landside slope (Fall 2021).

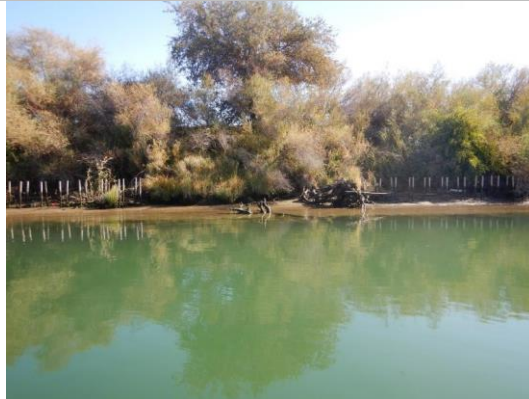
Photo 2 of 2 : FA_2021_RD0556_19_14_20211218_5.jpg

USACE 2018 Erosion Photo #2

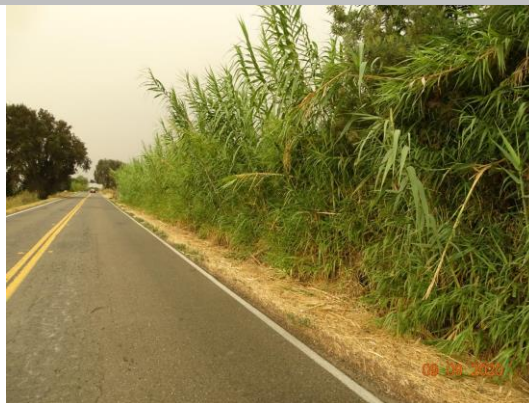
Photo 1 of 1 : FA_2021_RD0556_19_3_20210830_00003.jpg

LM Start	4.68	Rating **	U	Issue No.	3
LM End	4.72	Issue Type +	Ma	Location *	WS
Category	Earthen Levee			GPS Latitude/Longitude	
				Start	End
Item	Vegetation			38.202942 °	38.202431 °
				-121.556870 °	-121.556960 °
DWR ID	DWR_RD0556_02_f_2020_3				
Comment Code					
V7 : Trees / Woody Vegetation					
Inspector Comment					
Cut arundo back 20' from waterside slope.

View of looking downstream at arundo on the waterside slope (Fall 2020).

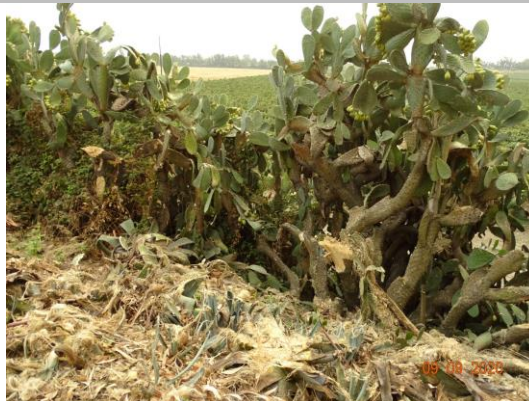
Photo 1 of 1 : FA_2021_RD0556_19_37_20210830_00021.jpg

LM Start	5.08	Rating **	U	Issue No.	37
LM End	5.16	Issue Type +	Ma	Location *	LS
Category	Earthen Levee			GPS Latitude/Longitude	
				Start	End
Item	Vegetation			38.197407 °	38.196388 °
				-121.558950 °	-121.559558 °
DWR ID	DWR_RD0556_02_f_2017_37				
Comment Code					
V7 : Trees / Woody Vegetation					
Inspector Comment					
Remove large cactus partway down the landside slope.

View looking upstream at cactus partway down the landside slope (Fall 2020).
