**Flood Control Project Maintenance  
Levee Inspections**

## Maintenance Issue Types Only, Levee Inspection Report By Mile - Spring 2024

### Reclamation District No. 0784 Plumas Lake

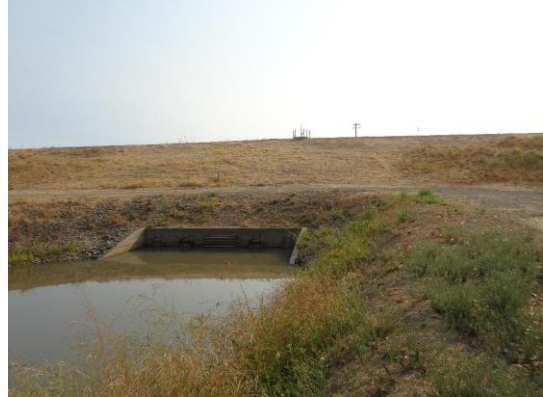
Photo 1 of 3 : UCIP\_SP\_2024\_69858\_101115.jpg

Water-Side: Outlet structure with five openings beyond waterside toe.

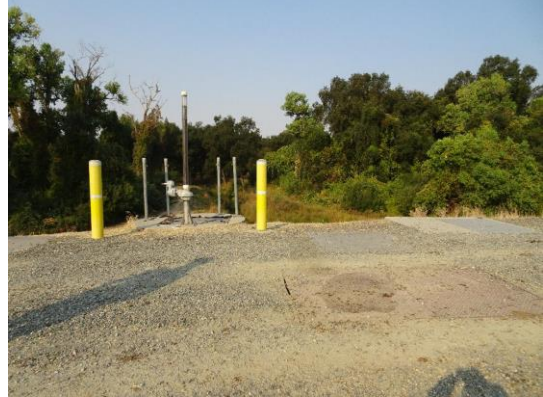
Photo 2 of 3 : UCIP\_SP\_2024\_69859\_101133.jpg

Water-Side: Vaults and screw gate at waterside shoulder.

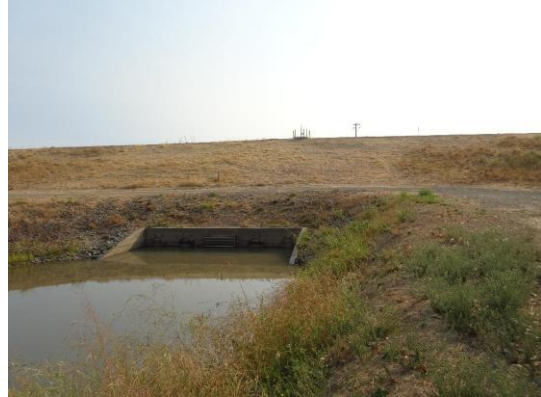
Photo 1 of 3 : UCIP\_SP\_2024\_69854\_101142.jpg

Water-Side: Outlet structure with five openings beyond waterside toe.

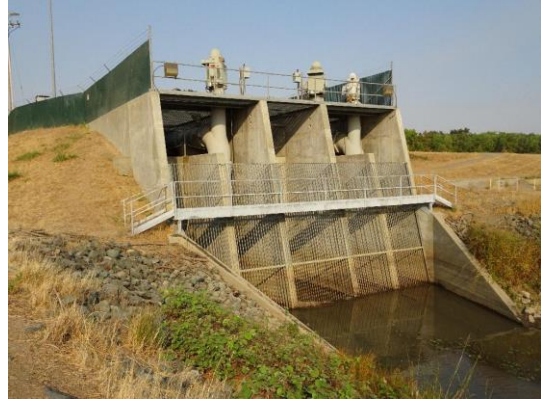
Photo 3 of 3 : UCIP\_SP\_2024\_69854\_101145.jpg

Land-Side: Inlet structure with pumps beyond landside toe.

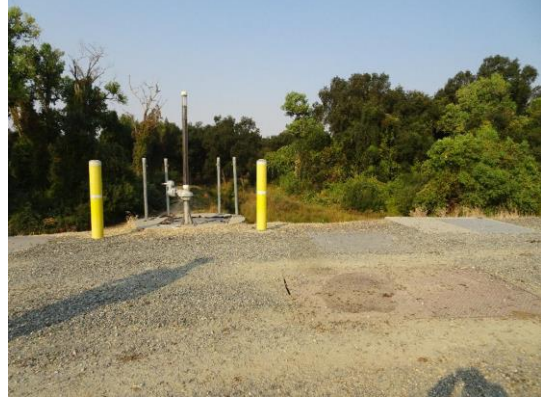
Photo 2 of 3 : UCIP\_SP\_2024\_69855\_101156.jpg

Water-Side: Vaults and screw gate at waterside shoulder.

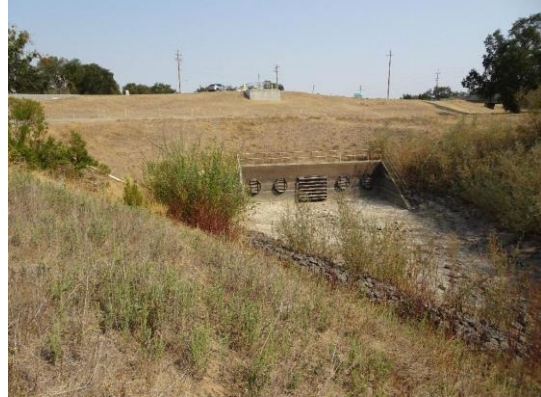
Photo 1 of 3 : UCIP\_SP\_2024\_69899\_101216.jpg

Water-Side: Outlet structure with five openings beyond waterside toe.

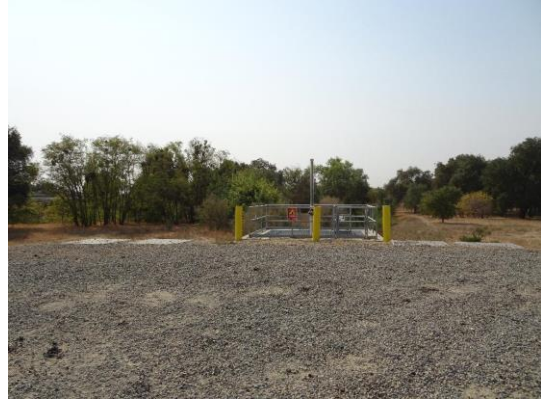
Photo 2 of 3 : UCIP\_SP\_2024\_69895\_101240.jpg

Water-Side: Five vaults and a screw gate at waterside shoulder.

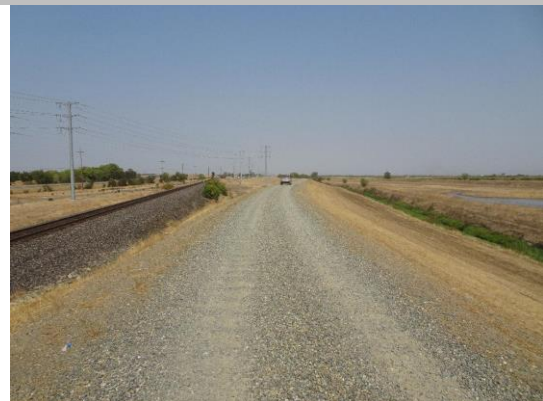
Photo 1 of 3 : UCIP\_SP\_2024\_70203\_100693.jpg

Overview of Levee: looking upstream from the crown.

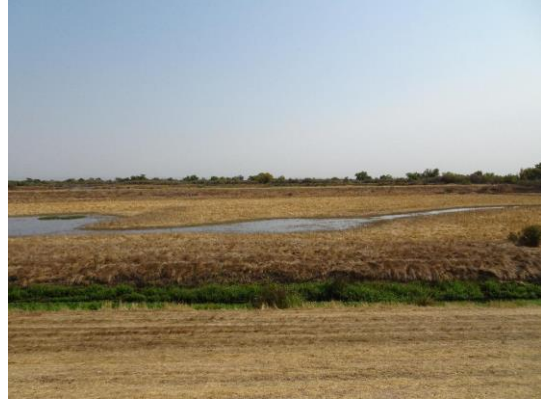
Photo 2 of 3 : UCIP\_SP\_2024\_70203\_100694.jpg

View of waterside from crown, no indicator of pipe.

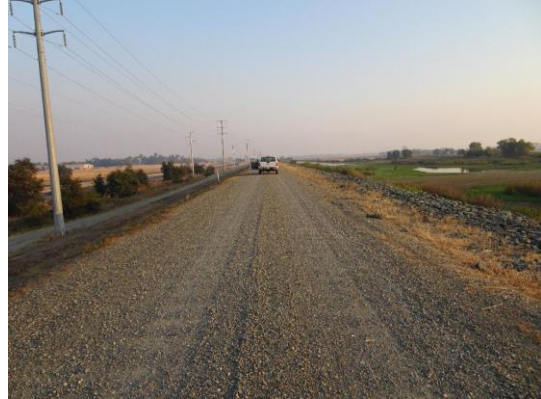
Photo 1 of 3 : UCIP\_SP\_2024\_70205\_100723.jpg

Overview of Levee: looking upstream from crown.

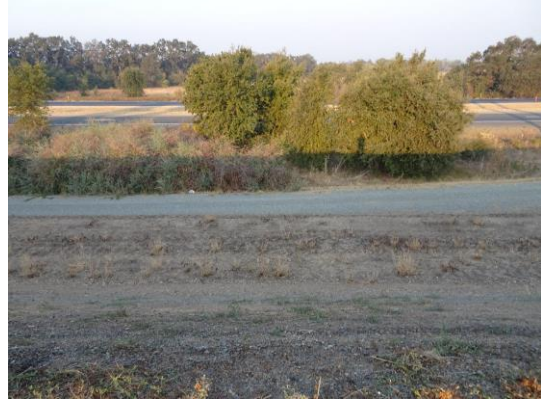
Photo 3 of 3 : UCIP\_SP\_2024\_70205\_100726.jpg

Landside view from crown.

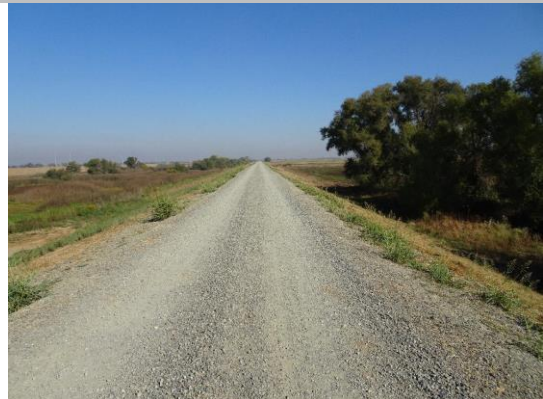
Photo 1 of 3 : UCIP\_SP\_2024\_70299\_100890.jpg

Overview of Levee: Looking upstream from crown.

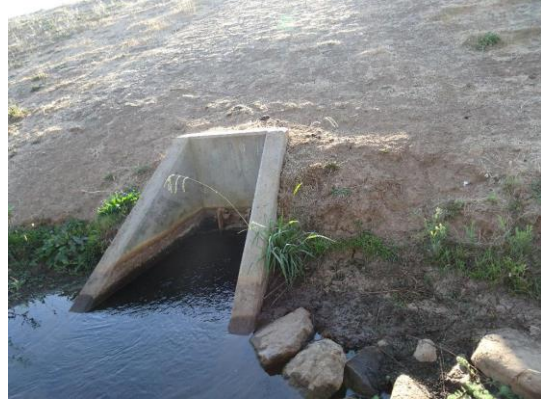
Photo 2 of 3 : UCIP\_SP\_2024\_82831\_100936.jpg

Water-Side: Outlet structure with flap gate at waterside toe.

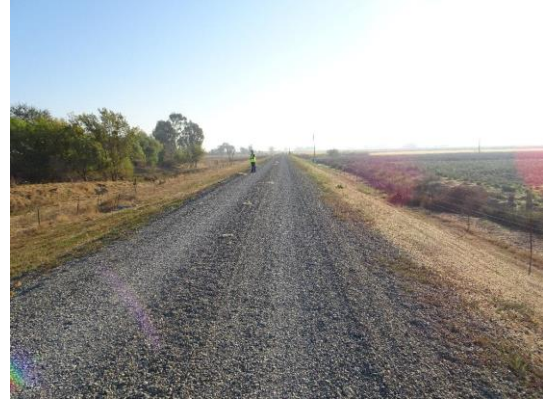
Photo 1 of 3 : UCIP\_SP\_2024\_70308\_100946.jpg

Overview of Levee: Looking upstream from crown.

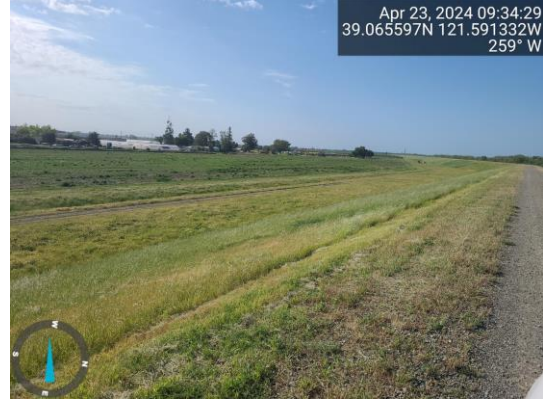
Photo 1 of 1 : SP\_2024\_RD0784\_530\_1\_20240423\_00001.jpg

LM Start	0.00	Rating **	M	Issue No.	1
LM End	5.67	Issue Type +	Ma	Location *	LS
Category	Earthen Levee			GPS Latitude/Longitude	
				Start	End
Item	Vegetation			39.090278°	39.010617°
				-121.584750°	-121.579733°
DWR ID	DWR_RD0784_09_s_2024_1				
Comment Code					
V1 : Control annual grass and weeds on the levee slopes and easements.					
Inspector Comment					
Annual vegetation on the landside slope needs to be maintained, Spring 2024.

View of vegetation on the landside slope, Spring 2024.
