**Flood Control Project Maintenance  
Levee Inspections**

**Fall 2019 Levee Maintenance Deficiency Summary Report**

**Sacramento River Basin**

| <b>RD1600</b> | Overall LMA Rating | Total LMA Miles | | | | | | |
|---|---|---|---|---|---|---|---|---|
| <b>Reclamation District No. 1600 Mull</b> | <b>U</b> | <b>14.69</b> | | | | | | |

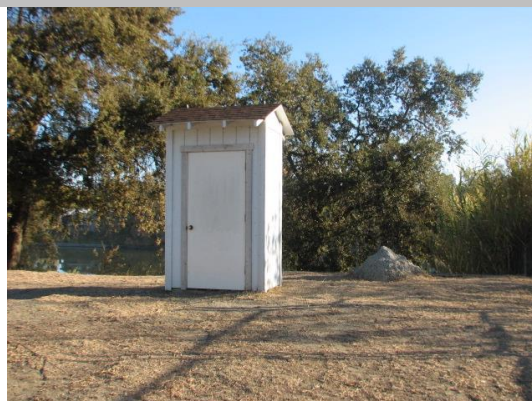
Photo 1 of 2 : FA\_2019\_RD1600\_191\_129\_20190829\_00027.jpg

The small building is a pump house for the well. It services the house with water. Fall 2013

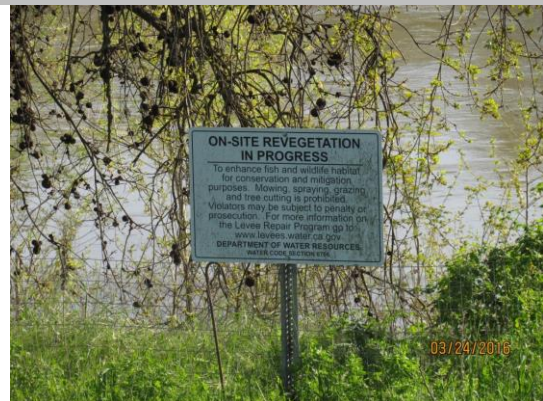
Photo 1 of 2 : FA\_2019\_RD1600\_191\_49\_20190829\_00020.jpg

Sign stating revegetation site. Spring 2016.

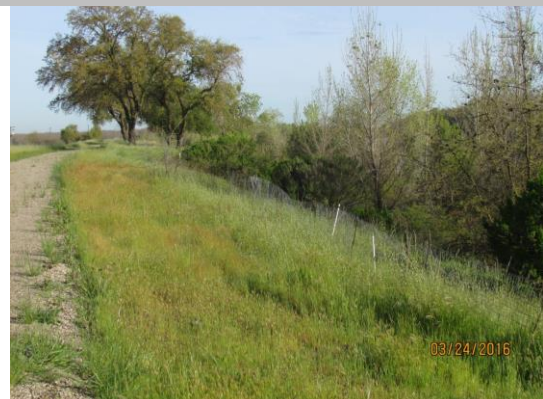
Photo 2 of 2 : FA\_2019\_RD1600\_191\_49\_20190829\_00021.jpg

View of the revegetation site and fence on the waterward side of the levee looking upstream. Spring 2016.

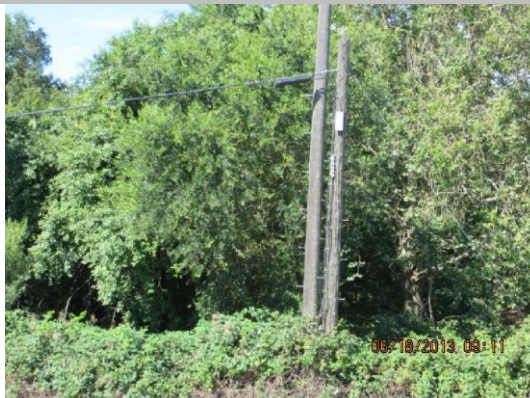
Photo 1 of 1 : UCIP\_FA\_2019\_15087\_24812.jpg

Line visible on JP off LS toe. Likely this is the source of crossing.

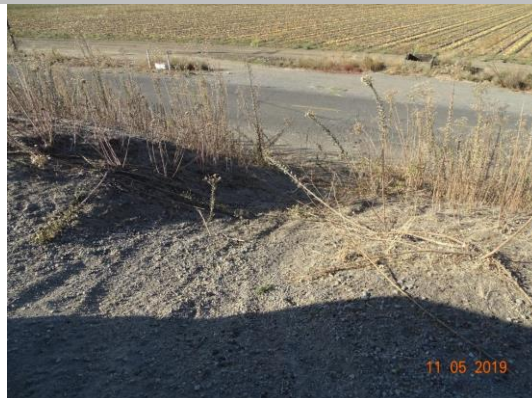
Photo 1 of 2 : FA\_2019\_RD1600\_191\_133\_20191112\_00055.jpg

View of settlement and footpath on landside slope. Fall 2019.

| S2 : Repair the levee slope damaged by foot traffic and prevent access where possible. | | | | | |

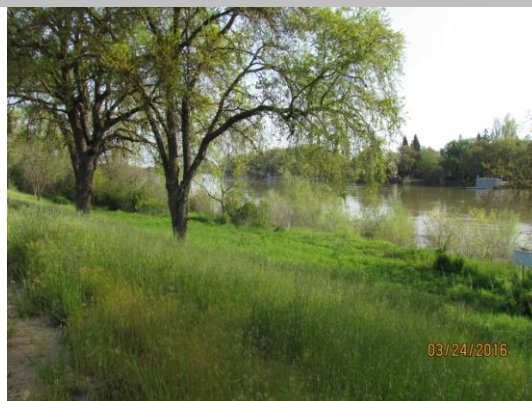
Photo 1 of 2 : FA\_2019\_RD1600\_191\_22\_20190829\_00011.jpg

View of the revegetation site at the berm edge on the waterward side of the levee looking upstream. Spring 2016.

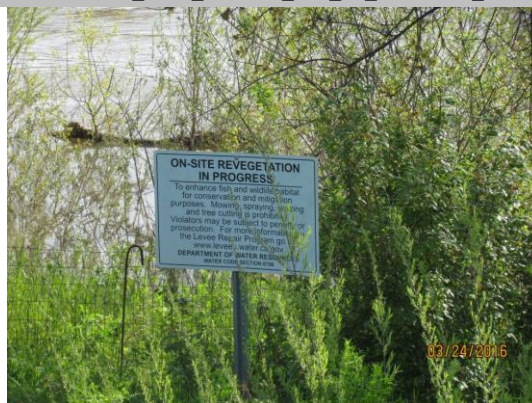
Photo 2 of 2 : FA\_2019\_RD1600\_191\_22\_20190829\_00012.jpg

Sign stating revegetation site. Spring 2016.

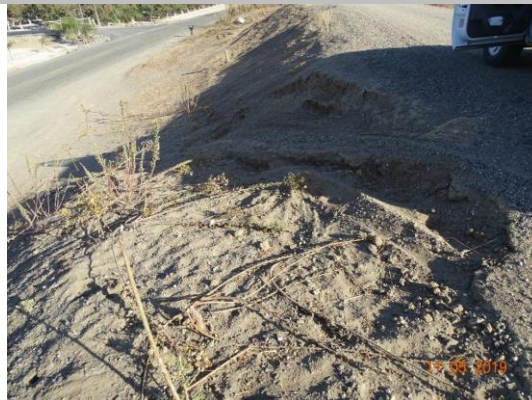
Photo 1 of 2 : FA\_2019\_RD1600\_191\_4\_20191112\_00057.jpg

| Erosion where tire ruts previously were formed. | | | | | |

View of erosion on the landside slope. Fall 2019.

| E2 : Schedule repair of erosion site prior to the next inspection. | | | | | |

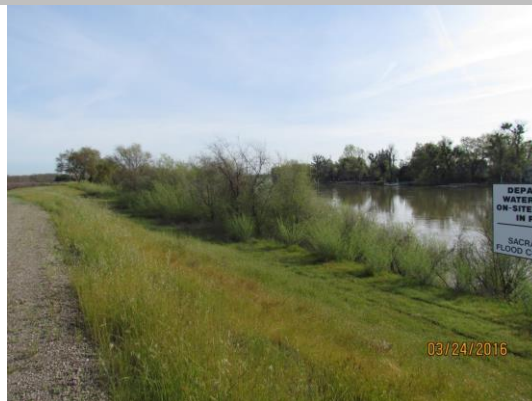
Photo 1 of 2 : FA\_2019\_RD1600\_191\_5\_20190829\_00002.jpg

View of the revegetation site on the berm of the waterward side of the levee looking upstream. Spring 2016.

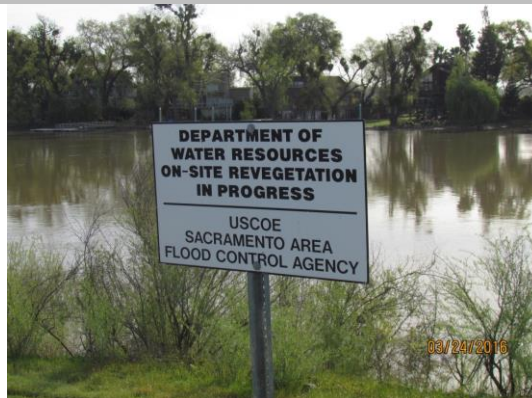
Photo 2 of 2 : FA\_2019\_RD1600\_191\_5\_20190829\_00003.jpg

DWR revegetation site. Spring 2016.

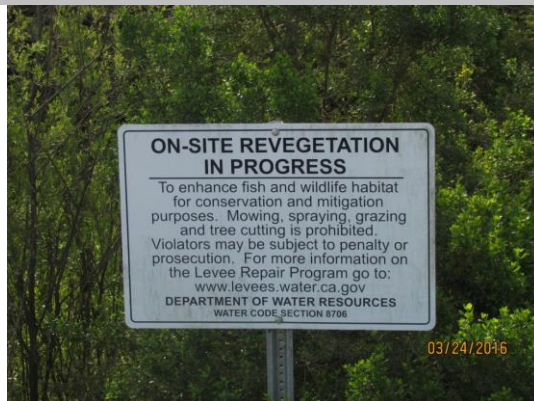
Photo 1 of 2 : FA\_2019\_RD1600\_191\_35\_20190829\_00014.jpg

Sign for revegetation site. Spring 2016.

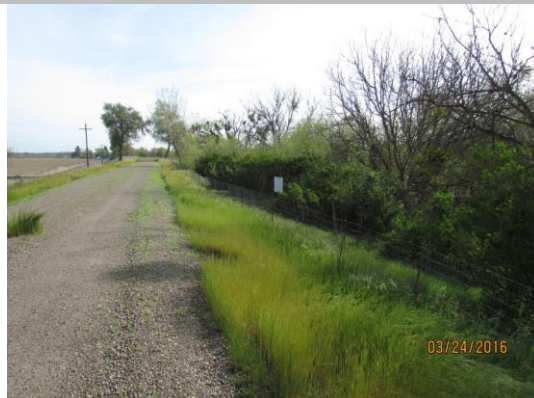
Photo 2 of 2 : FA\_2019\_RD1600\_191\_35\_20190829\_00015.jpg

View of the revegetation site on the waterward side of the levee looking upstream. Spring 2016.

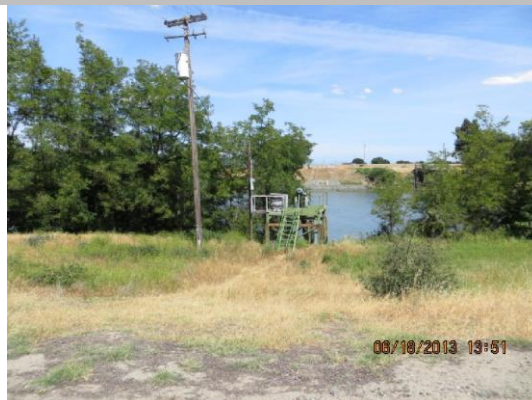
Photo 2 of 3 : UCIP\_FA\_2019\_15125\_24845.jpg

Slant pump on metal pier on WS berm.

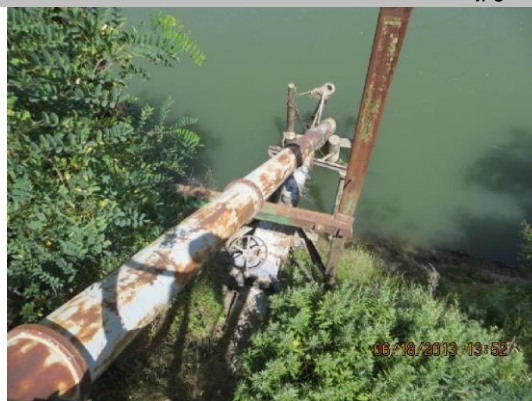
Photo 3 of 3 : UCIP\_FA\_2019\_15125\_24844.jpg

16-inch pipe ties into 24-inch pipe under pump platform at slide gate.

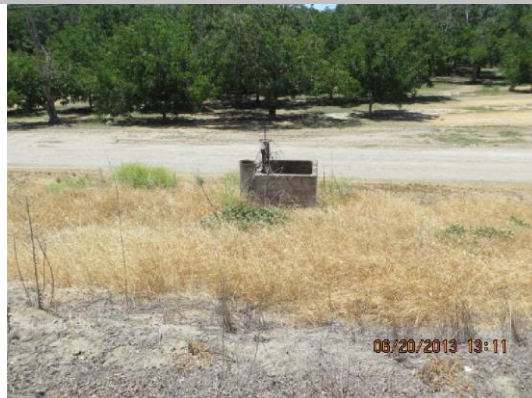
Photo 1 of 3 : UCIP\_FA\_2019\_53410\_25011.jpg

6'X6' concrete distribution box on LS toe.

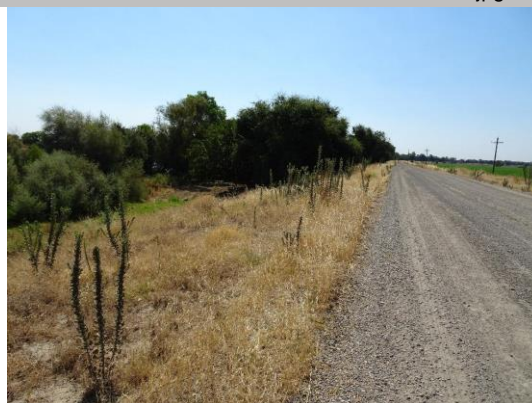
Photo 1 of 3 : UCIP\_FA\_2019\_50169\_75607.jpg

view along the levee crown looking downstream. WS slope of the levee is visible.

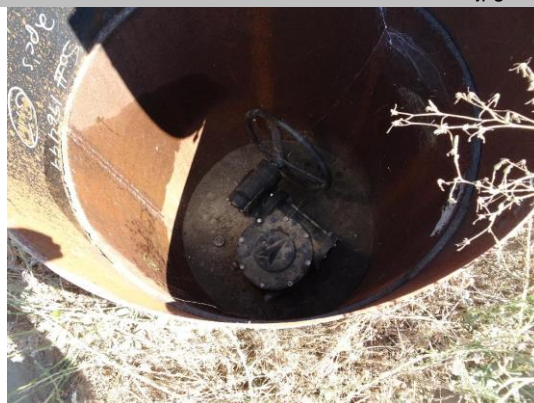
Photo 2 of 3 : UCIP\_FA\_2019\_50169\_75608.jpg

view of positive closure device in metal riser on WS shoulder of levee.

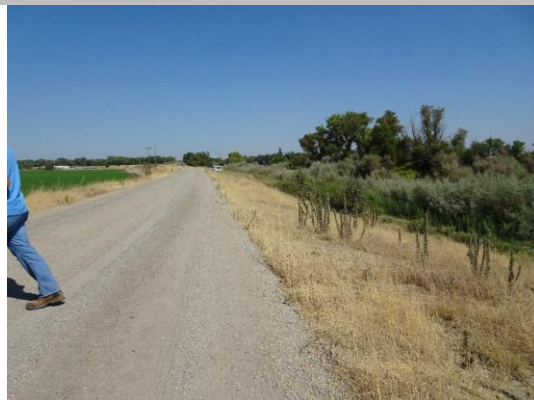
Photo 3 of 3 : UCIP\_FA\_2019\_50169\_75609.jpg

view of levee crown looking upstream from pipe location.

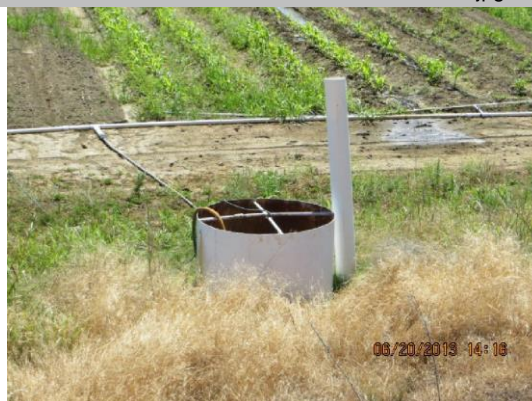
Photo 1 of 1 : UCIP\_FA\_2019\_16310\_27485.jpg

| DS_ID:21480<br>FS_ID:16310<br>EP_NO: 7339<br>Repair Type: Non-Urgent<br>Crossing Status: Indicator Found<br>UCIP Comments: Need to determine disposition of pipe. If abandoned, it should be done so properly.<br>FIELD_STRUCT_DESC: 24-inch steel irrigation pipe through the levee, 3.8 feet below the crown. Steel plate welded on the waterside (WS) end. Pipe not visible on either slope. Pylons in river at the WS toe, and a 4-foot-diameter steel standpipe on the landside (LS) toe. Seepage area at the landside (LS) toe. (Permit No. 7339, 1971 - Layton Knaggs).<br>[Additional Reference(s): DWR Levee Log, 1988].<br>FS Date: 6/20/2013 | | | | | |

4-foot diameter steel standpipe at LS toe, may be indicator of pipe location.

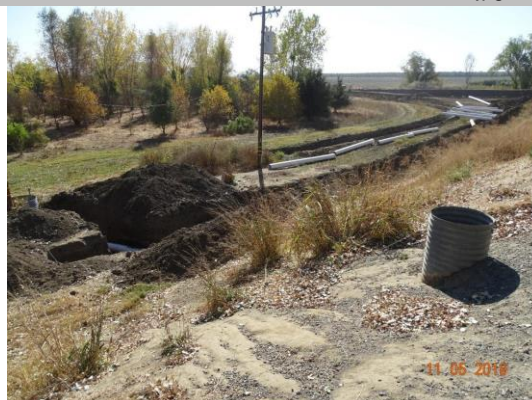
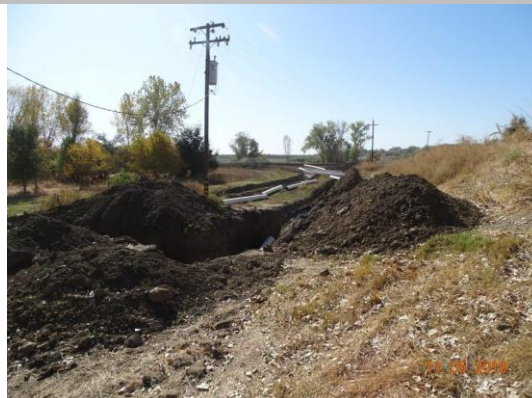
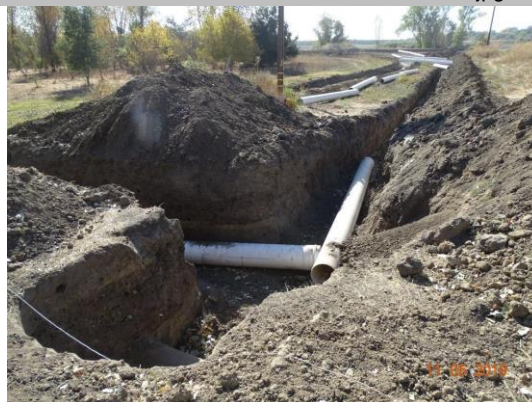
| DS_ID:21481<br>FS_ID:55622<br>EP_NO: 1960<br>Repair Type: Urgent<br>Crossing Status: Found<br>UCIP Comments: 11/12/2019 A levee inspector reported to the Board excavating within 10-foot landside easement. (O.Yakimov - DWR UCIP)<br>FIELD_STRUCT_DESC: 16-inch steel irrigation pipe through the levee, 3.6 feet below the crown. Slant pump on the waterside (WS) slope with a butterfly valve. Metal cutoff wall. 5-foot-diameter corrugated metal pipe (CMP) standpipe on the landside (LS) toe. Vent in 24-inch corrugated metal pipe (CMP) riser on the LS shoulder. 3.5-inch polyvinyl chloride (PVC) electrical conduit at the same location. (Permit No. 1960, 1954 - LDS Church). [Additional Reference(s): DWR Levee Log, 1988].<br>FS Date: 11/12/2019 3:21:53 PM | | | | | |

Excavation near LS levee toe

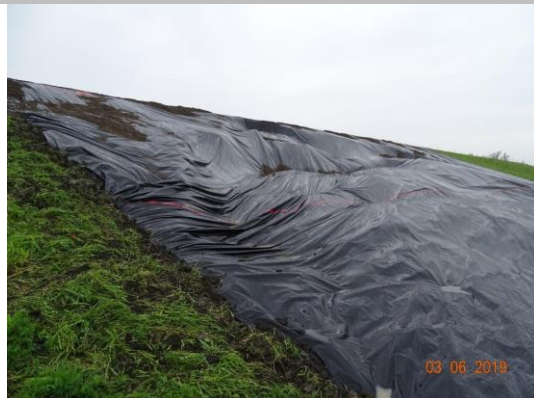
Photo 3 of 3 : FA\_2019\_RD1600\_192\_8\_20190829\_00004.jpg

Additional view of sloughing. Spring 2019.

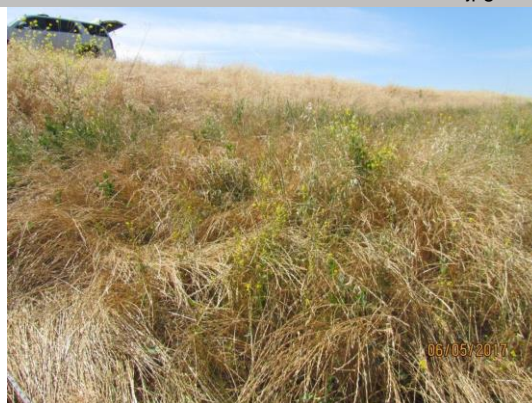
Photo 1 of 3 : LEVAL\_FA\_2019\_202\_1210.jpg

| Notes: Long stretches of wavewash on the waterside slope. | | | | | |

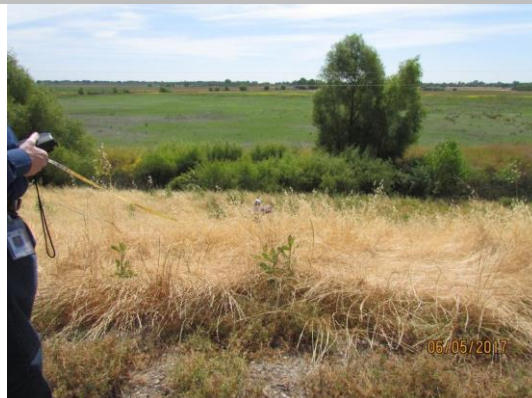
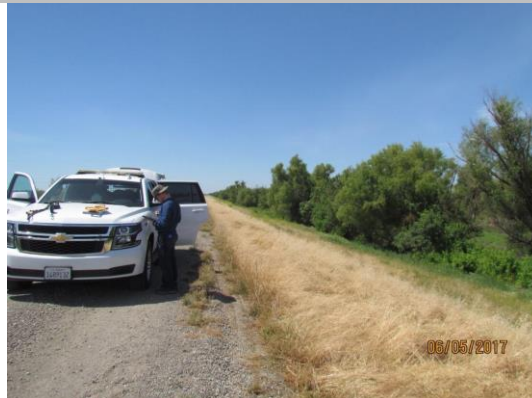
| Notes: Long streches of wavewash on the waterside slope. | | | | | | |
