**Flood Control Project Maintenance
Levee Inspections**

Fall 2012 Levee Maintenance Deficiency Summary Report

Reclamation District No. 1602 Del Puerto

Waterway			Bank	Unit Miles
Unit No. 01 San Joaquin River			Left	6.29
	Spring (March - May)	Summer (June - August)	(September - November) Fall	Winter (December - February)
Unit Maintenance Rating (Fall Only)			U	
Date of Inspection	05/16/2012 - 05/16/2012		11/27/2012 - 11/27/2012	
DWR Inspector	Pavel Kazi		Pavel Kazi	
Accompanied By	Tony Martinez RD1602		Tony Martinez RD1602

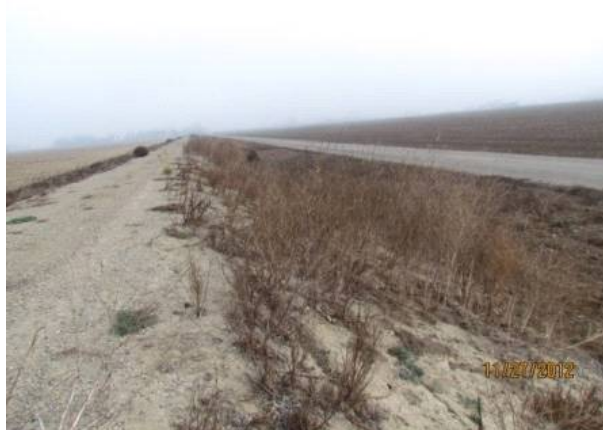
pkazi_f_20121128_160.jpg

Vegetation was found on the landside slope of the levee looking upstream.

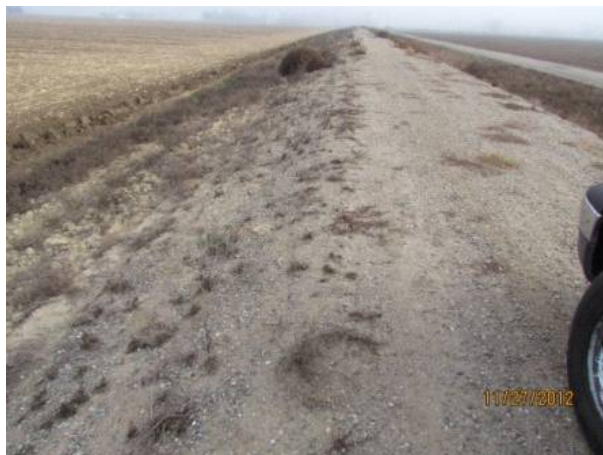
pkazi_f_20121128_161.jpg

Animal hole was repaired by the LMA on the waterside slope of the levee looking upstream.

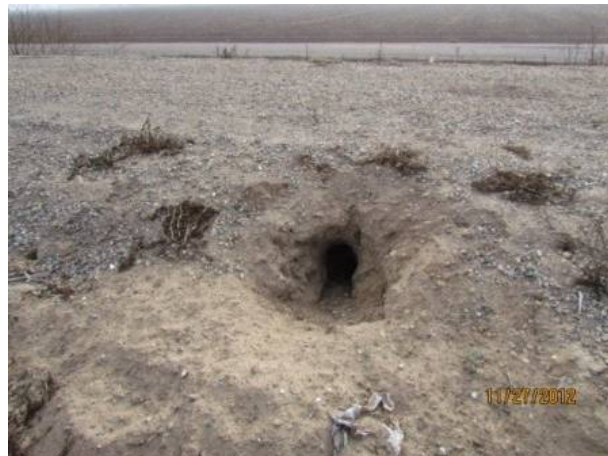
pkazi_f_20121128_162.jpg

Updated picture of the rodent hole on the waterside shoulder of the levee looking from toe of the levee. The picture was taken during the fall 2012 inspection.

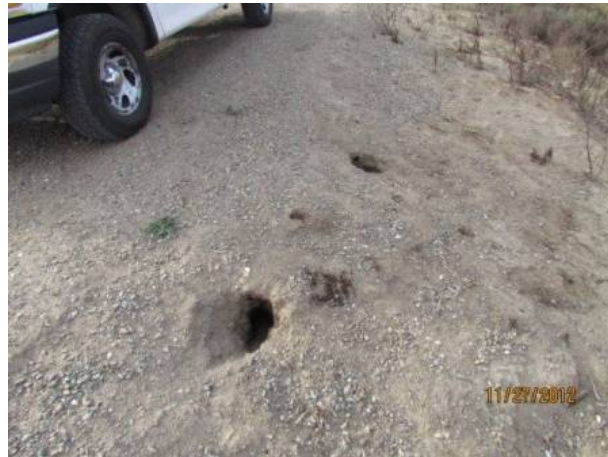
pkazi_f_20121128_163.jpg

Updated picture of the rodent holes on the waterside shoulder of the levee looking downstream taken during the fall 2012 inspection.

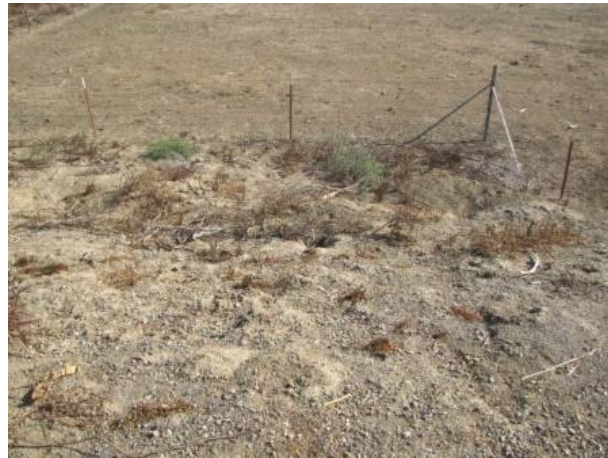
pkazi_f_20120913_825.jpg

View of rodent holes on the waterward slope looking waterward.

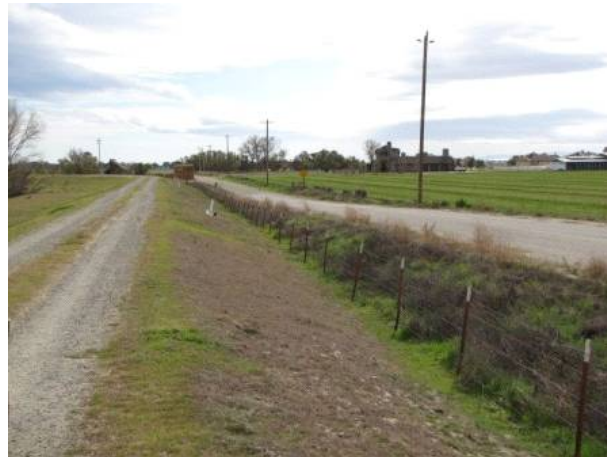
pkazi_f_20120913_883.jpg

View of barbed wire fence at landward toe looking upstream.

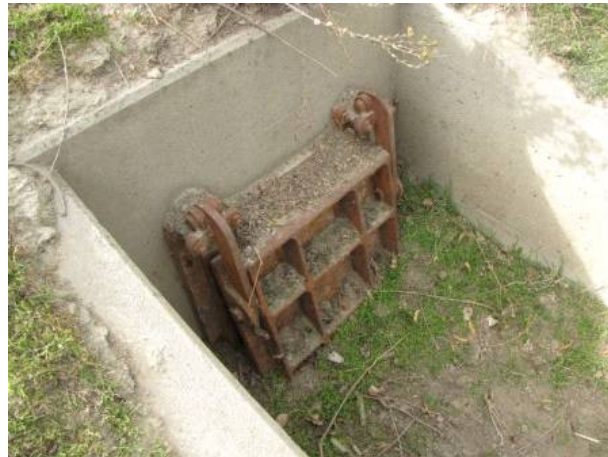
pkazi_f_20120913_885.jpg

View of a flap gate with sediment preventing it from closing.

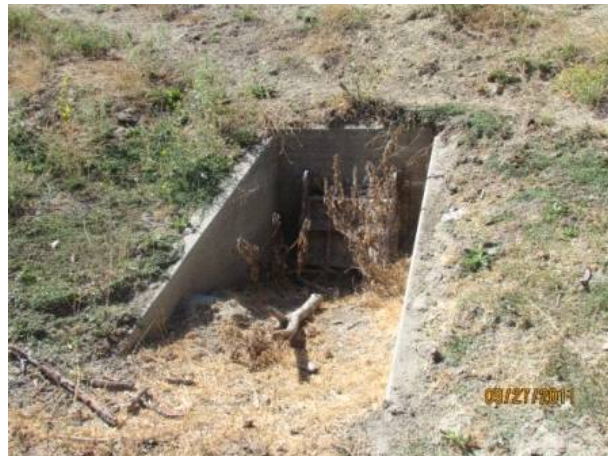
pkazi_f_20120913_886.jpg

Debris and sediments were obstructing the flap gate. The picture was taken from toe of waterside of the levee looking towards the crown. This picture was taken during the fall 2011 inspection.

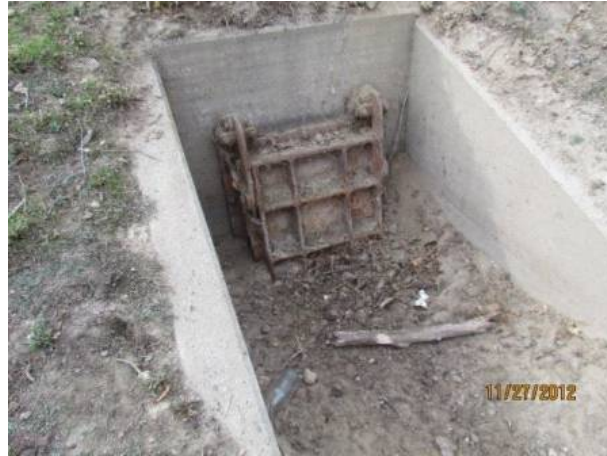
pkazi_f_20121129_169.jpg

Debris and sediments were obstructing the flap gate from closing completely. The picture was taken from toe of waterside of the levee during the fall 2012 inspection.

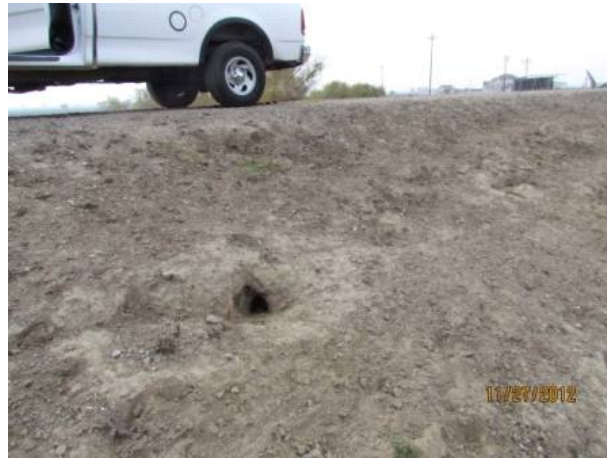
pkazi_f_20121129_170.jpg

Updated picture of the rodent hole on the waterside slope of the levee looking downstream.

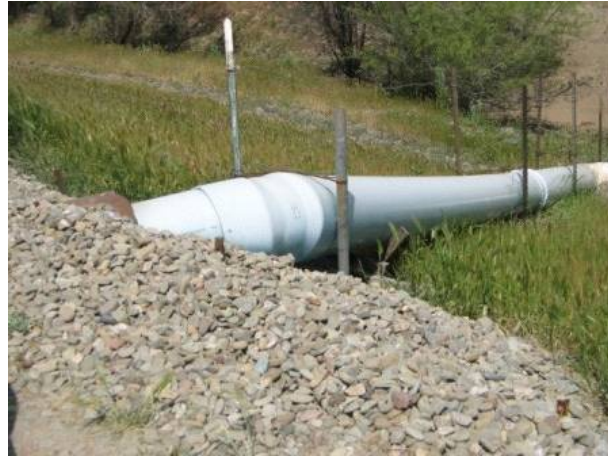
pkazi_f_20120913_830.jpg

PVC sleeve through steel pipe on waterward slope at LM 1.02.

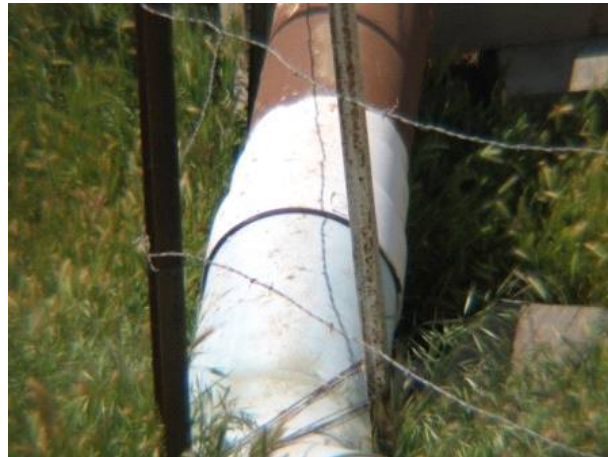
pkazi_f_20120913_831.jpg

PVC pipe connected to steel pipe on landward toe at LM 1.02.

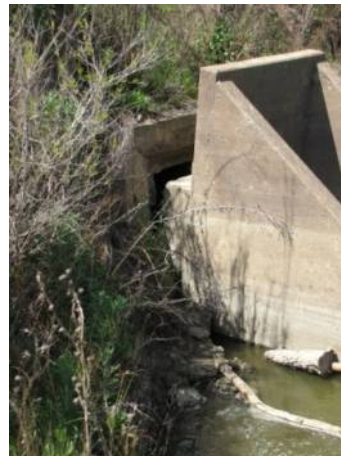
pkazi_f_20120913_873.jpg

Separation of outfall structure from the outlet pipe at LM 1.04.

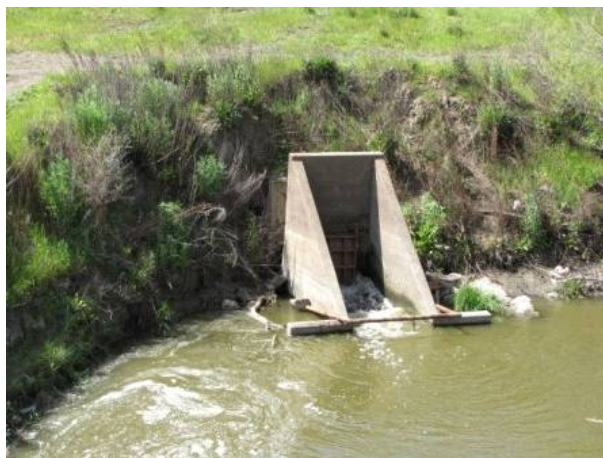
pkazi_f_20120913_874.jpg

Additional view of outfall structure at LM 1.04.

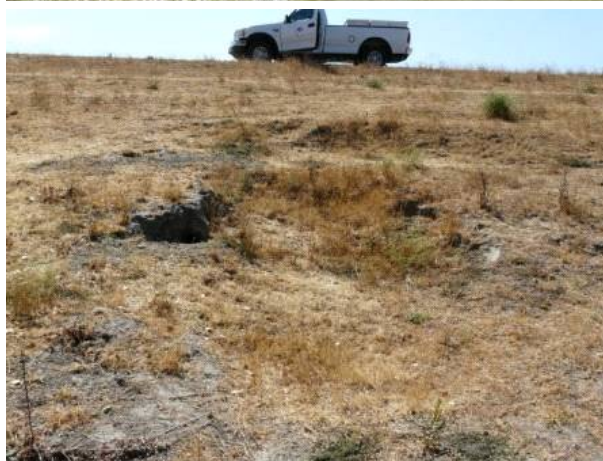
pkazi_f_20120913_858.JPG

Small amount of slumping at water toe.

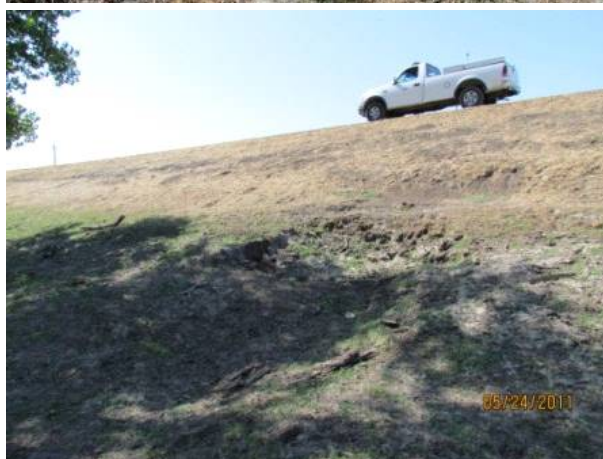
pkazi_f_20120913_859.jpg

Depression at the waterside slope of the levee during Spring 2011 inspection.

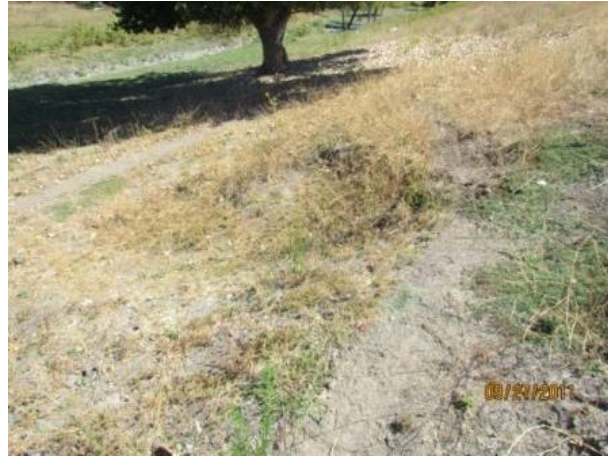
pkazi_f_20120913_860.jpg

Updated picture of the depression at the waterside toe of the levee. The picture was taken from the crown of the levee looking upstream.

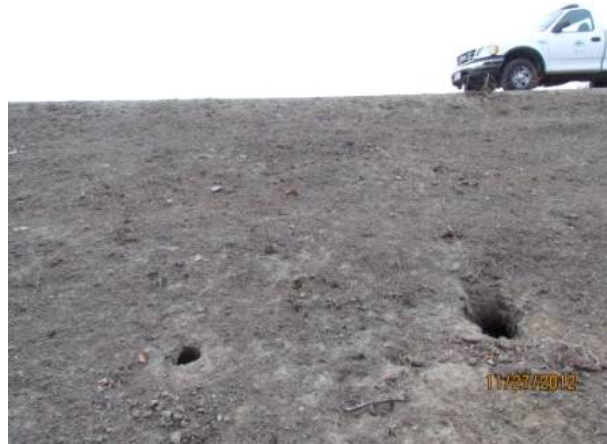
pkazi_f_20121129_173.jpg

Rodent holes were found on the waterside toe of the levee. The picture was taken from toe of the levee looking towards the crown.

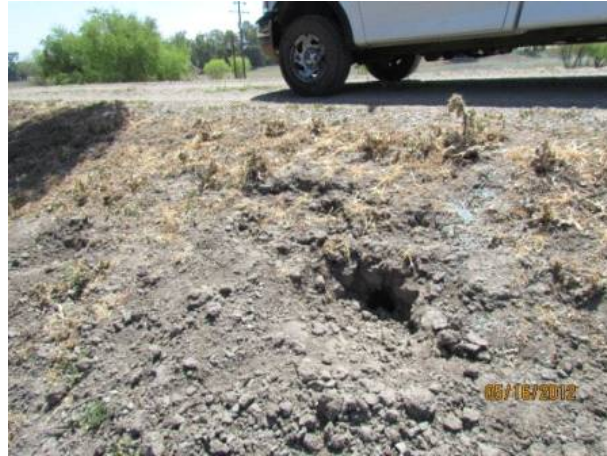
pkazi_f_20120913_889.jpg

Rodent hole on the waterside shoulder of the levee looking upstream.

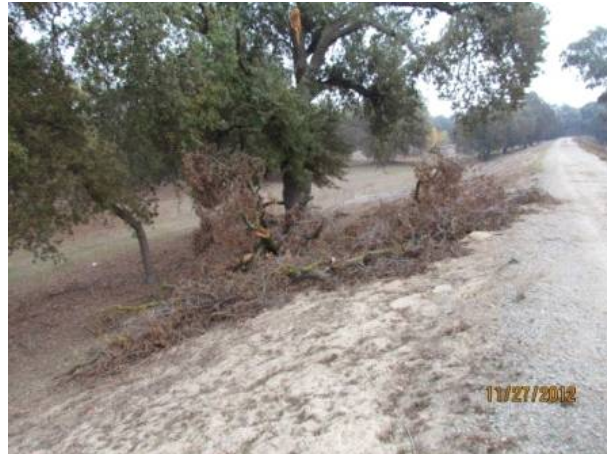
pkazi_f_20121129_176.jpg

Prunings were found on the waterside slope of the levee looking upstream.

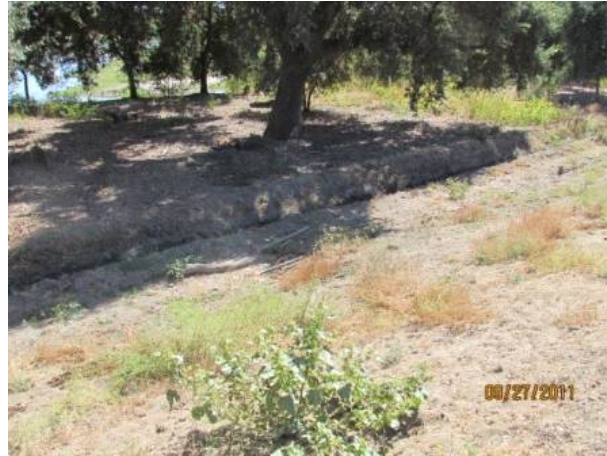
pkazi_f_20120913_869.jpg

A ditch was located on the waterside toe of the levee. The picture was taken from the crown looking upstream.

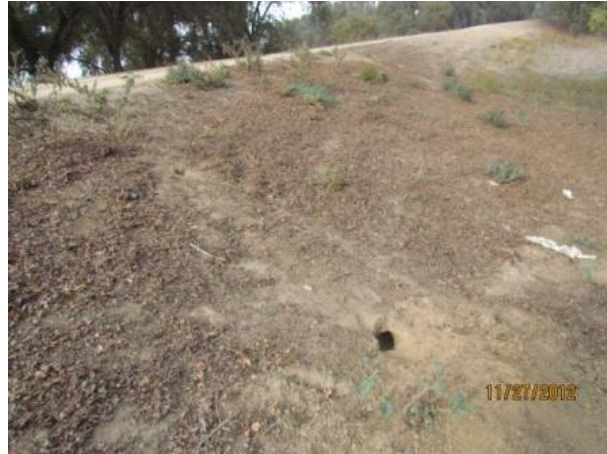
pkazi_f_20121129_185.jpg

A rodent hole was found on the waterside toe of the levee looking downstream.

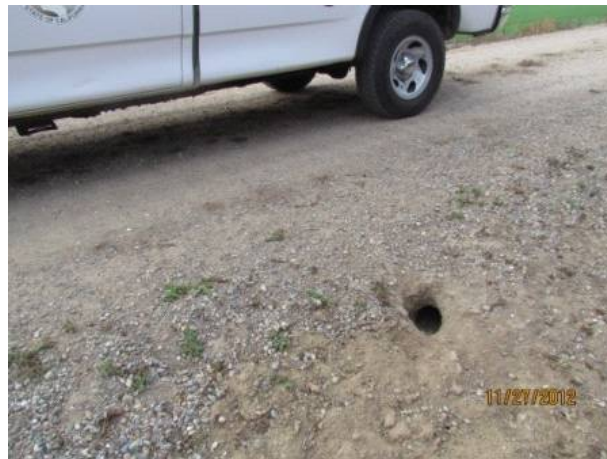
pkazi_f_20121129_186.jpg

A rodent hole was found on the waterside shoulder of the levee looking downstream.

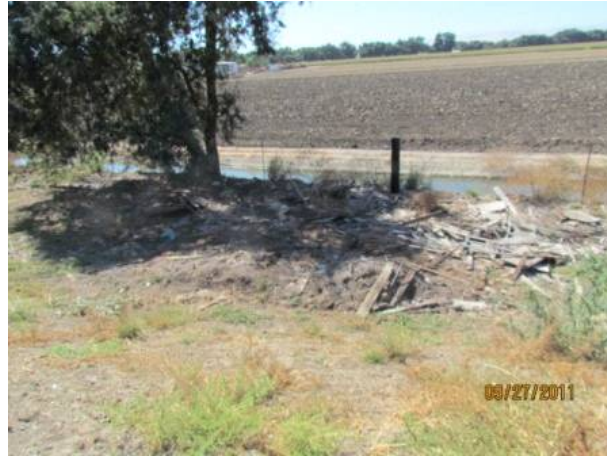
pkazi_f_20120913_836.jpg

Debris was located on the landside of the levee. The picture was taken from the crown looking upstream.

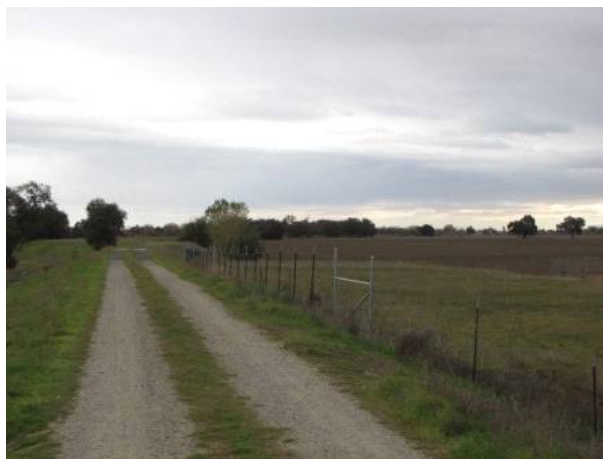
pkazi_f_20120913_879.jpg

View of a barbed wire fence on the landward slope looking upstream.

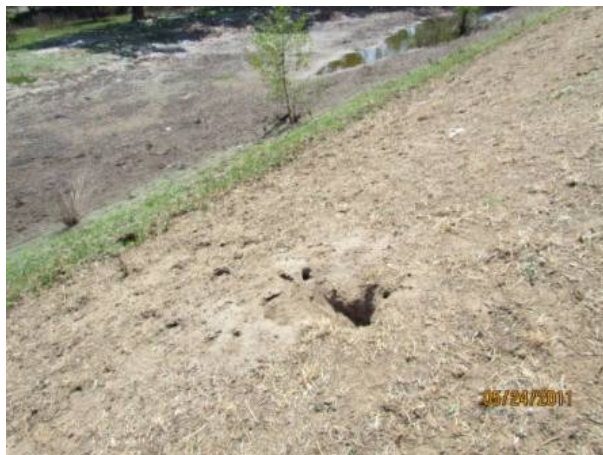
pkazi_f_20120913_837.jpg

Rodent hole at the waterside slope of the levee. The picture was taken from the crown looking upstream.

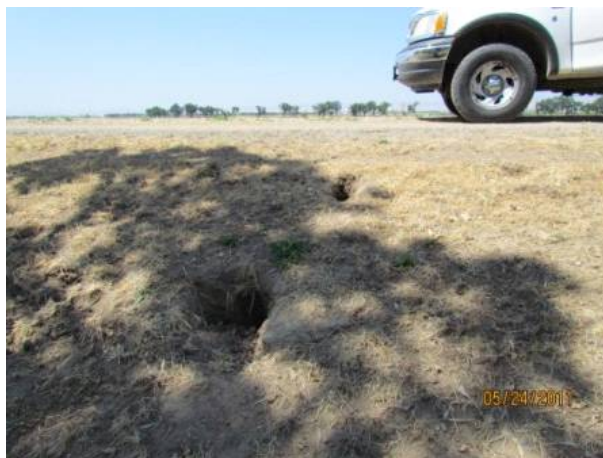
pkazi_f_20120913_839.jpg

Rodent hole was found on the waterside of the levee. The picture was taken from the crown looking upstream.

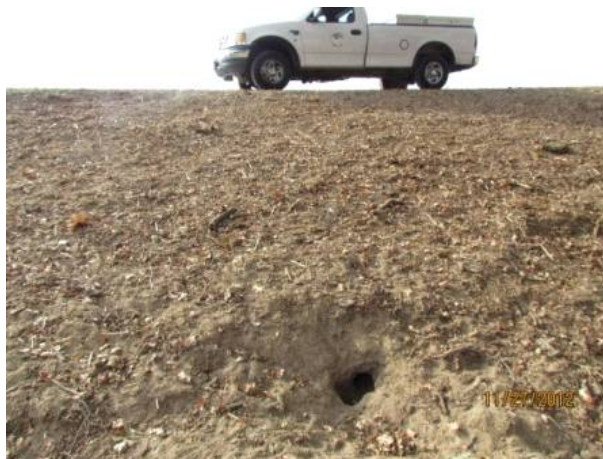
pkazi_f_20121129_189.jpg

A rodent hole was found on the waterside toe of the levee looking downstream.

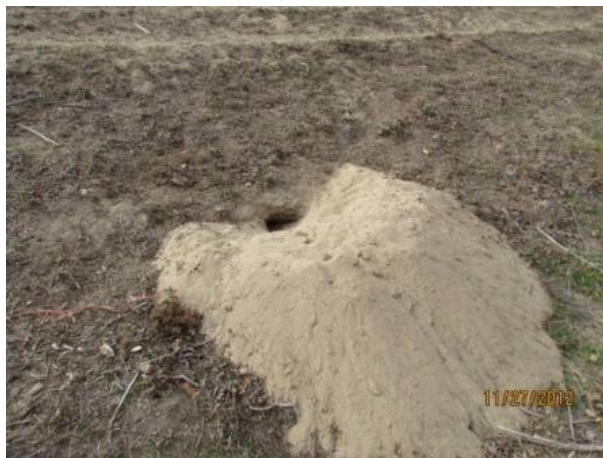
pkazi_f_20121129_190.jpg

A rodent hole was found on the waterside toe of the levee looking downstream.

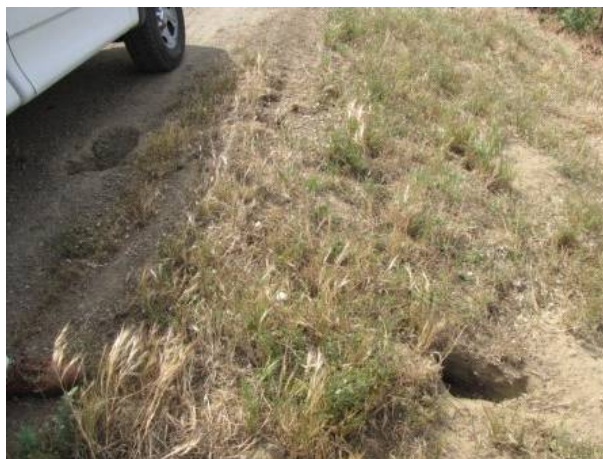
pkazi_f_20120913_834.jpg

View of rodent holes on the landward slope looking upstream.

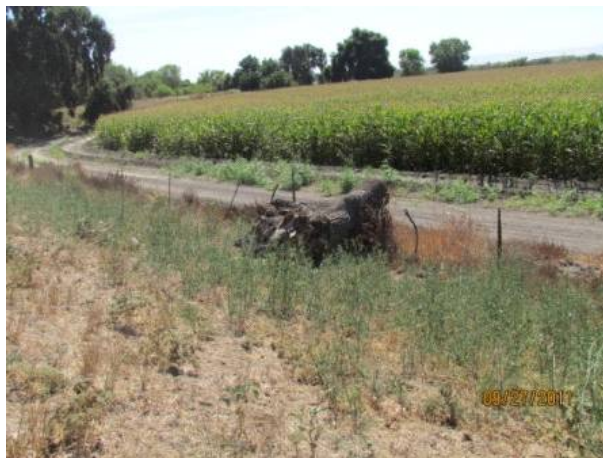
pkazi_f_20120913_882.jpg

A broken tree trunk was found on the toe of the landside of the levee. The picture was taken from the crown looking upstream.

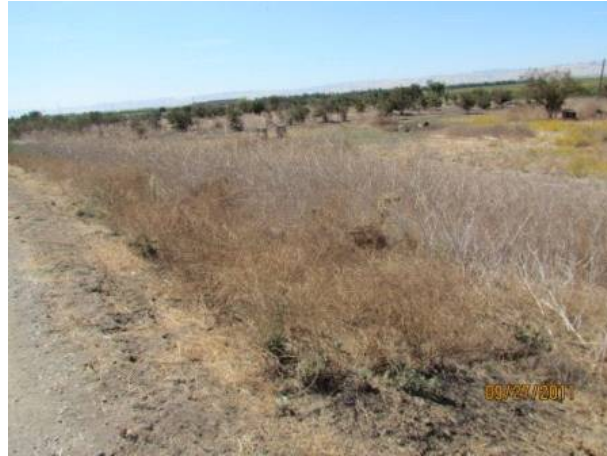
pkazi_f_20120913_884.jpg

Wild growth was found on the landside of the levee looking upstream.

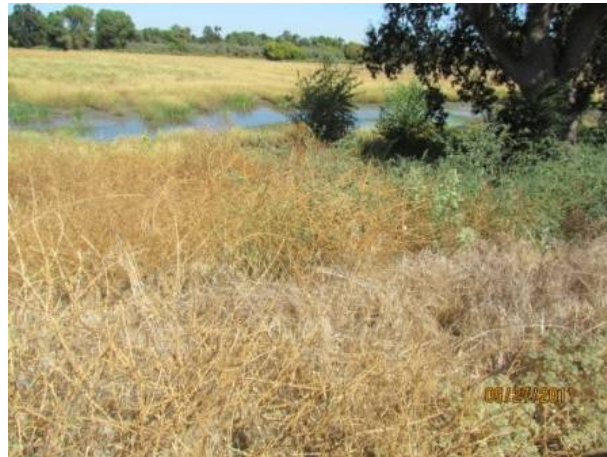
pkazi_f_20120913_887.jpg

Wild growth was found on the waterside of the levee looking upstream.

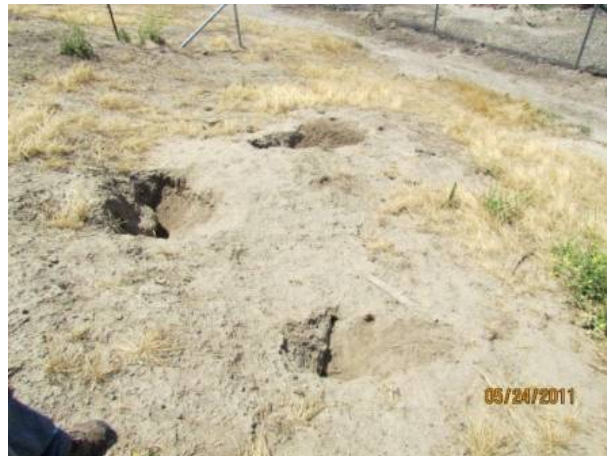
pkazi_f_20120913_845.jpg

Rodent holes possibly made worse by a dog digging in it. It is located on the landside of the levee. The picture was taken from the crown looking upstream.

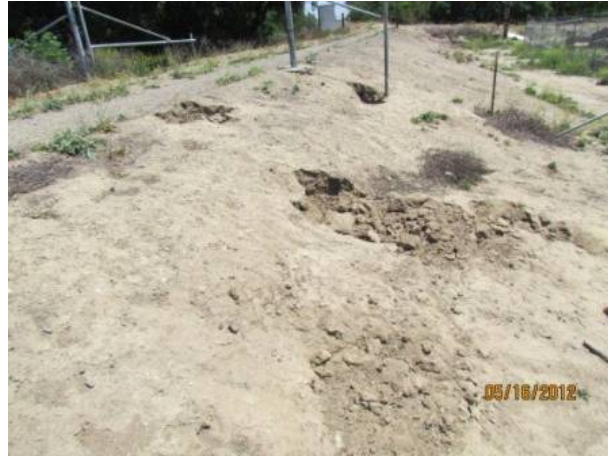
pkazi_f_20120913_846.jpg

Rodent holes found possible were damaged further by dogs on the landside of the levee looking upstream. This picture was taken during spring 2012 inspection.

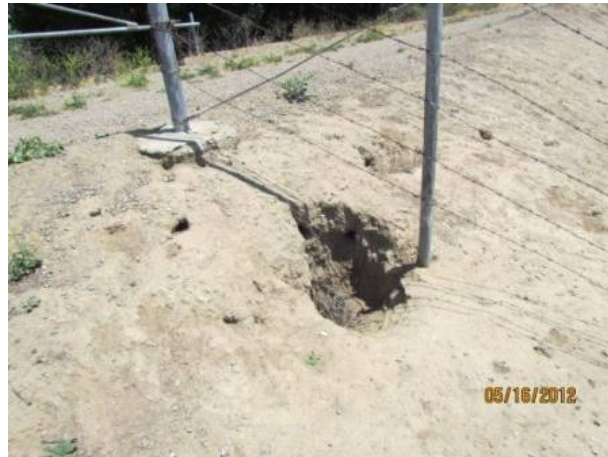
pkazi_f_20120913_847.jpg

Levee Mile Report Line	98
Start Levee Mile	5.25
End Levee Mile	5.25
Location	Land Side
Category	Earthen Levee
Item	Animal Control

Rodent hole damage possible due to other factor was found on the landside of the levee looking upstream. This picture was taken during spring 2012 inspection.

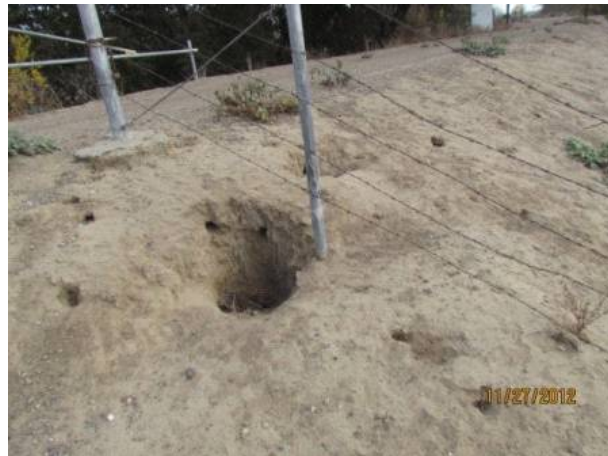
pkazi_f_20121129_191.jpg

Levee Mile Report Line	98
Start Levee Mile	5.25
End Levee Mile	5.25
Location	Land Side
Category	Earthen Levee
Item	Animal Control

Updated picture of the holes primarily made by rodents and then possibly worsened by dogs on the landside slope of the levee looking upstream.

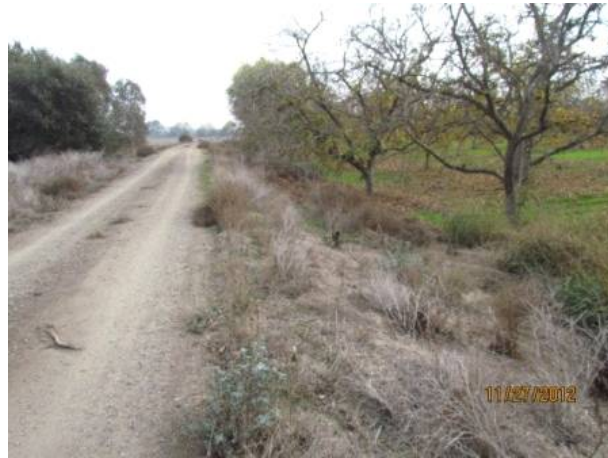
pkazi_f_20121129_192.jpg

Vegetation was found on the landside slope of the levee looking upstream.

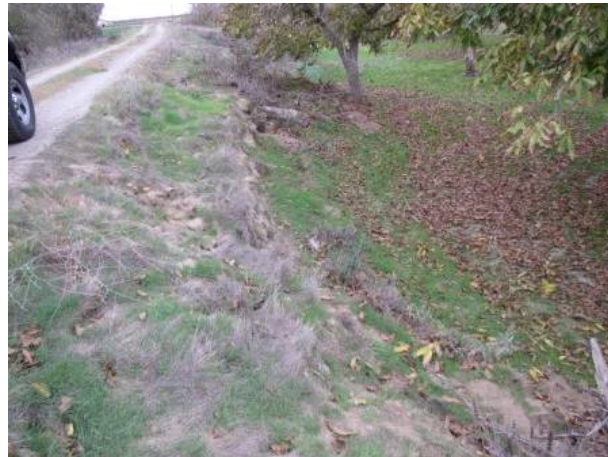
pkazi_f_20120913_896.jpg

Levee Mile Report Line	101
Start Levee Mile	5.34
End Levee Mile	5.34
Location	Land Side
Category	Earthen Levee
Item	Slope Stability

View of significant damage and erosion to the landward slope looking upstream.

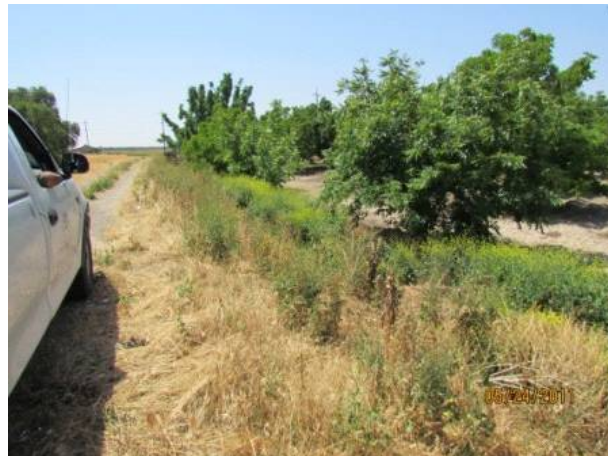
pkazi_f_20120913_877.jpg

Levee Mile Report Line	103
Start Levee Mile	5.36
End Levee Mile	5.36
Location	Land Side
Category	Earthen Levee
Item	Vegetation

Vegetation was obstructing the view of the landside of the levee. The picture was taken from the crown looking upstream.

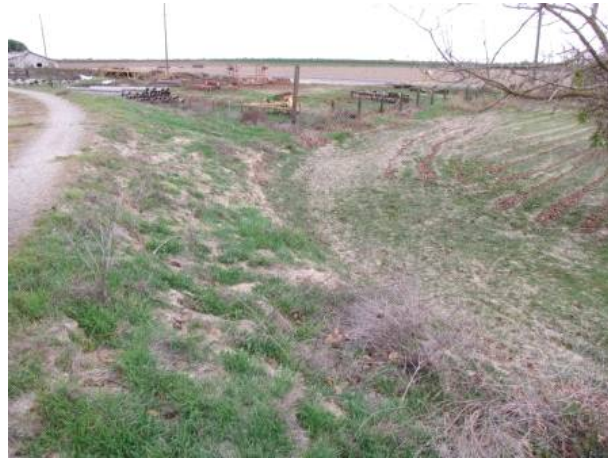
pkazi_f_20120913_897.jpg

View of tilling into the landward slope of the levee looking upstream. This slope has also been significantly damaged by rodent activity.

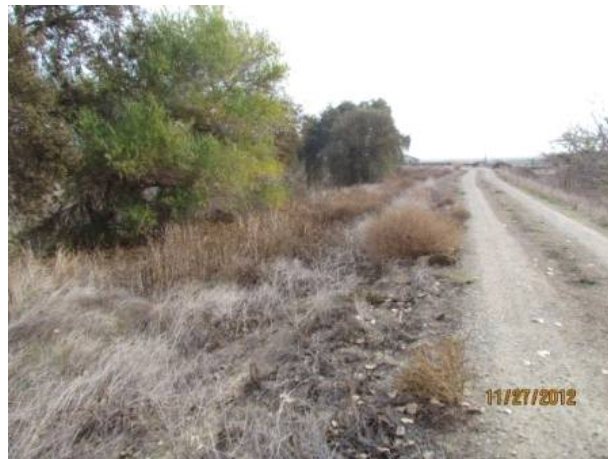
pkazi_f_20121129_193.jpg

Levee Mile Report Line	106
Start Levee Mile	5.40
End Levee Mile	5.54
Location	Water Side
Category	Earthen Levee
Item	Vegetation

Overgrown vegetation was found on the waterside slope of the levee looking upstream.

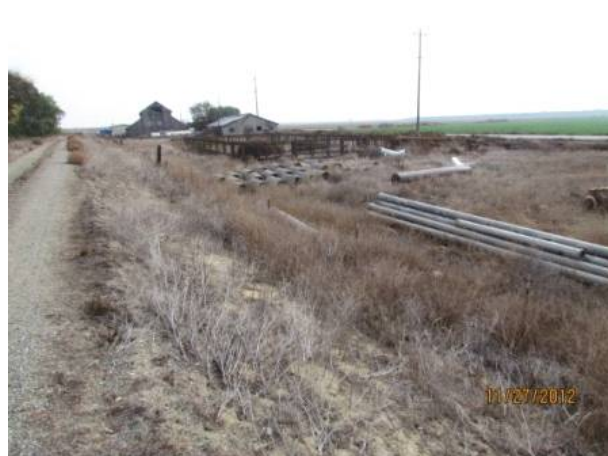
pkazi_f_20121129_194.jpg

Levee Mile Report Line	107
Start Levee Mile	5.42
End Levee Mile	5.49
Location	Land Side
Category	Earthen Levee
Item	Encroachments

A fence was found on the landside toe of the levee looking upstream.
