**Flood Control Project Maintenance  
Levee Inspections**  
**LMA District Cover Sheet**  
**Spring 2020 Levee Inspection Results**

**Reclamation District No. 2062 Stewart**

| Waterway | | | Bank | Unit Miles |
|--|---|---|---|---|
| Unit No. 01 San Joaquin River | | | Left | 2.64 |

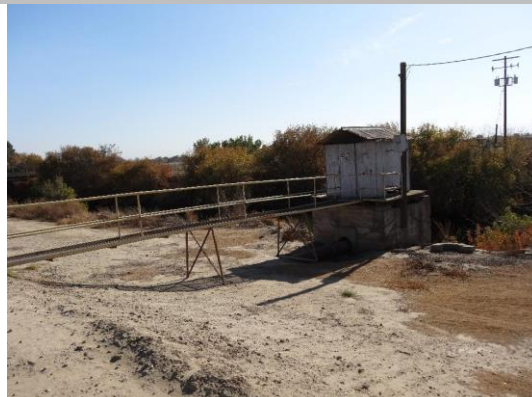
Photo 1 of 3 : UCIP\_SP\_2020\_51468\_39195.jpg

WS view: pipe, walkway, and pumphouse on levee berm. Service pole on waterside.

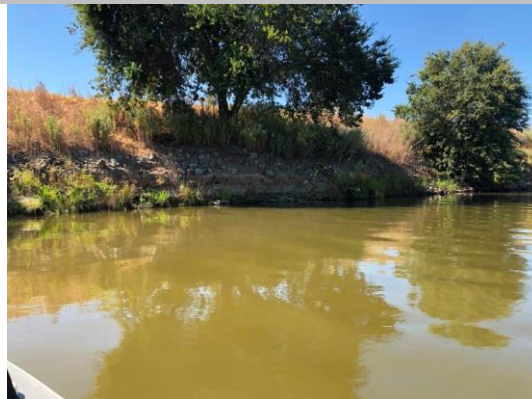
Photo 1 of 3 : SP\_2020\_RD2062\_311\_2\_20200228\_00004.jpg

Front view of the site.

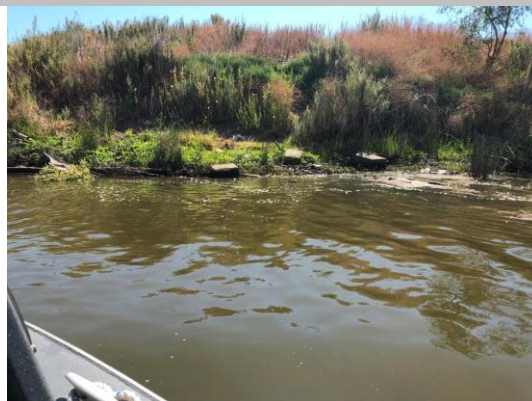
Photo 1 of 3 : SP\_2020\_RD2062\_311\_7\_20200228\_00016.jpg

11/05/2008: Site is located inside of a bend; scarp looks to be into the levee prism; piles of concrete chunks placed on the slope, with some of them already starting to slide.

Close-up view of the site.

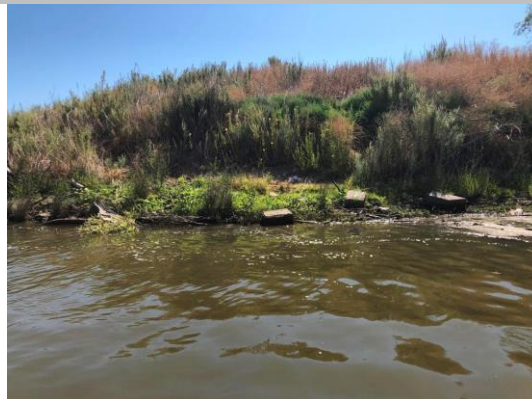
Photo 2 of 3 : SP\_2020\_RD2062\_311\_7\_20200228\_00017.jpg

Front view of the site.

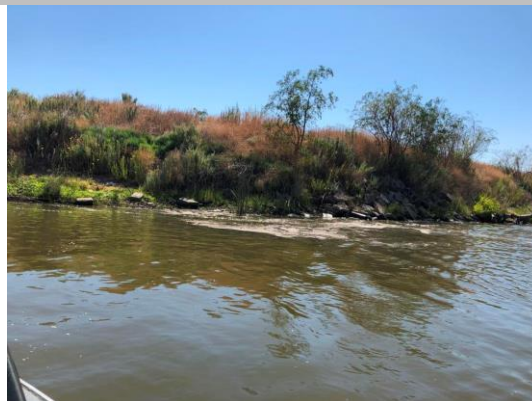
Photo 3 of 3 : SP\_2020\_RD2062\_311\_7\_20200228\_00018.jpg

Front view of the site.

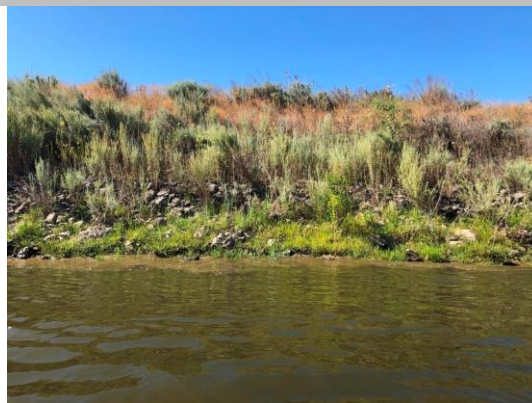
Photo 1 of 3 : SP\_2020\_RD2062\_311\_8\_20200228\_00019.jpg

| Site ID: RD2062U03RM31.12<br>08/14/2019: No significant change observed.<br>09/13/2017: No significant change observed.<br>07/25/2016: No significant change observed.<br>06/25/2015: No significant change observed.<br>07/02/2014: No significant change observed.<br>08/13/2013: No significant change observed.<br>08/07/2012: The site has been visited by boat survey. No significant change observed<br>08/23/2011: No significant change observed on site.<br>09/07/2010: No significant change observed on site. Much of the seasonal grass along the slope was cleared. Site consists of an existing scalloped erosion approximately 30 feet long by 5 feet wide at its widest opening. The lateral crack is extended outwards along the middle slope. There is a 1 to 2 feet of differential settlement that could further develop into a shallow slide.<br>08/06/2010: Recommended as local maintenance issue, per CLRO.<br>03/09/2010: As discussed with Michael Moncrief of MBK Engineer, site will be 'addressed' this year.<br>09/28/2009: No major change observed; section of rip rap has slipped, creating a terraced effect; dense vegetation growth; recommended as a local maintenance issue, per CLRO CES Evaluation 2008 Report; Site # is the same as RM31.12,LM1.25; previously rated "U".<br>09/14/2006: 1-2' into prism. | | | | | | |

Front view of the site.

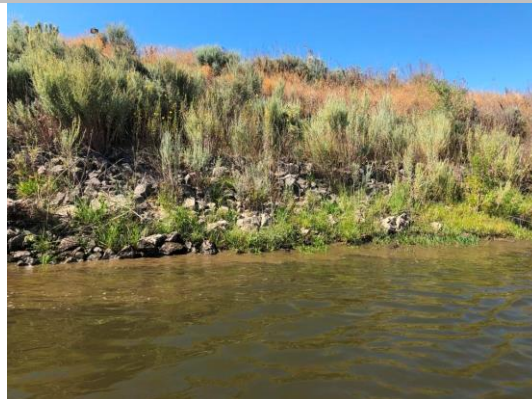
Photo 3 of 3 : SP\_2020\_RD2062\_311\_8\_20200228\_00021.jpg

Close-up view of the site.

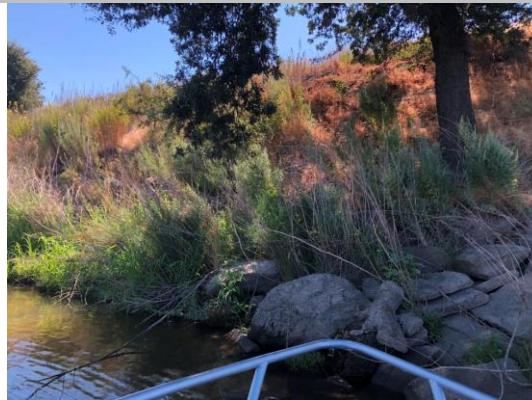
Photo 2 of 3 : SP\_2020\_RD2062\_311\_9\_20200228\_00023.jpg

Close-up view of the site.
