**Flood Control Project Maintenance  
Levee Inspections**  
**LMA District Cover Sheet**  
**Spring 2011 Levee Inspection Results**

**Reclamation District No. 2089 Stark**

**Levee Inspection Report By Mile - Spring 2011**

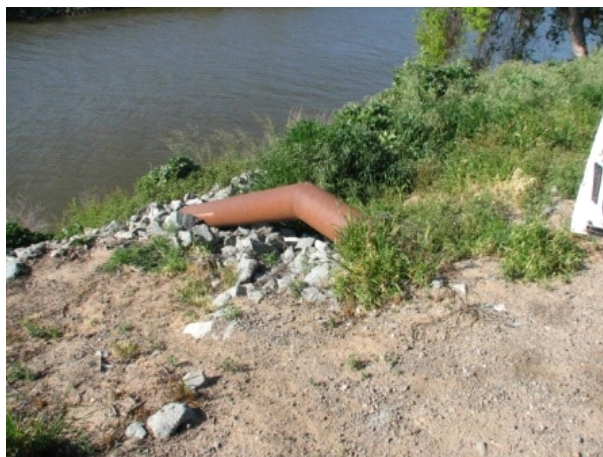
jeto\_s\_20110301\_215.jpg

Waterside of drainage discharge to Old River.

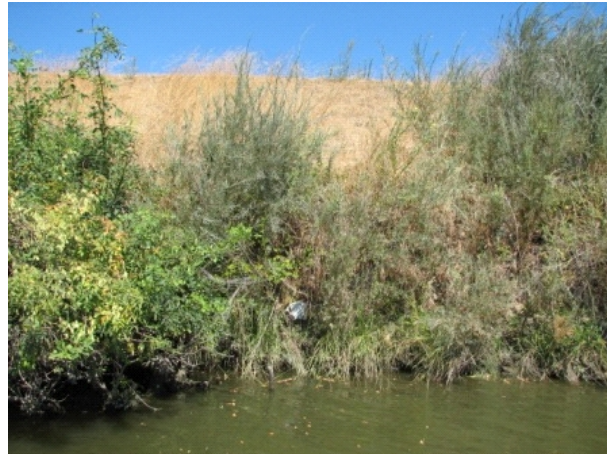
| jeto_s_20110301_211.jpg | |

| Front view of site. | |

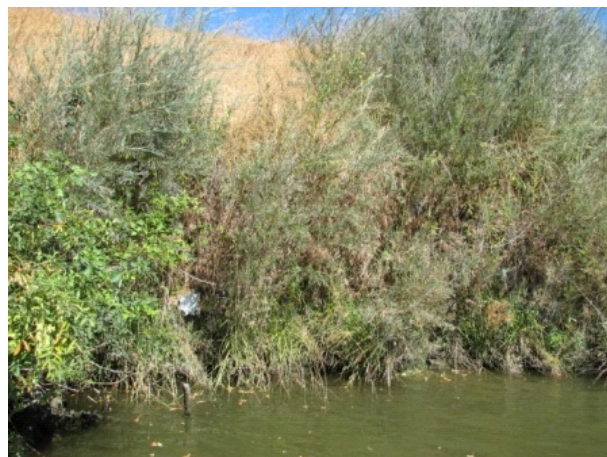
| jeto_s_20110301_212.jpg | |

| Upstream view of site. | |

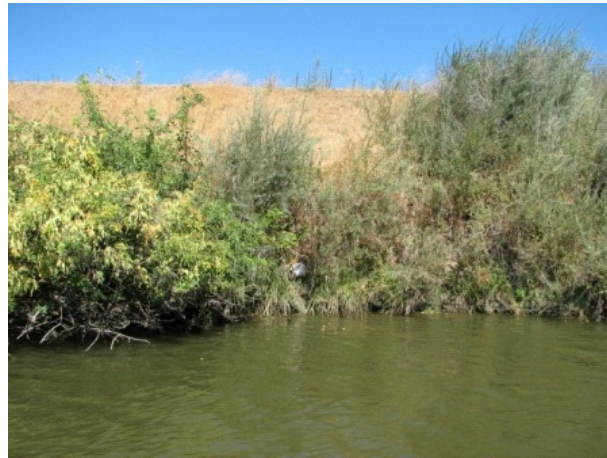
jeto\_s\_20110301\_213.jpg

Front view of site.

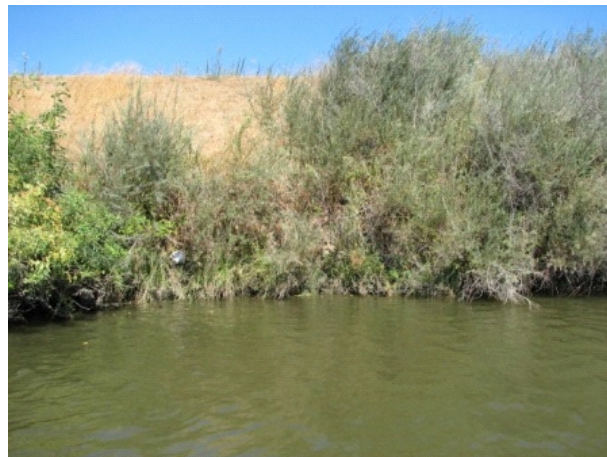
jeto\_s\_20110301\_214.jpg

Front view of site.

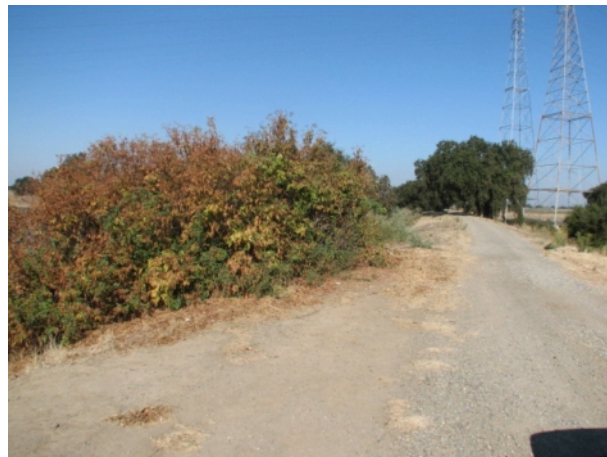
| jeto_s_20110301_239.jpg | |

| Fall 2009 photo of unacceptable vegetation on levee slope. | |

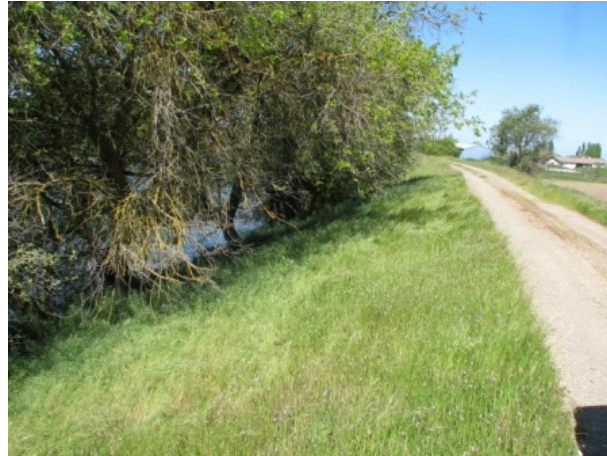
| jeto_s_20110301_240.jpg | |

| Trees within 20' of crown on waterside slope should be trimmed to allow access and visibility. | |

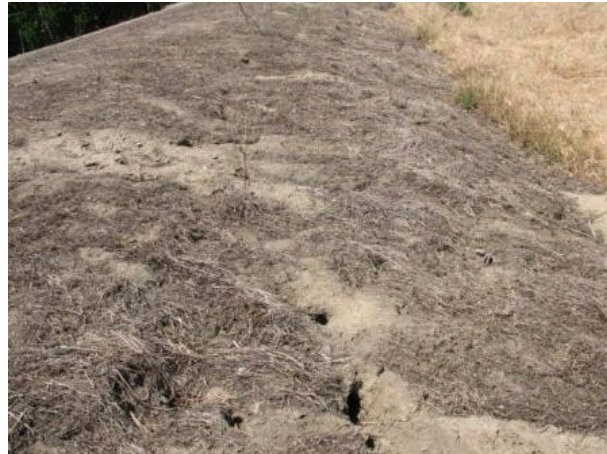
| jeto_s_20110525_514.jpg | |

| 05/24/2011 Active burrows, ground squirrel sighted in area. | |

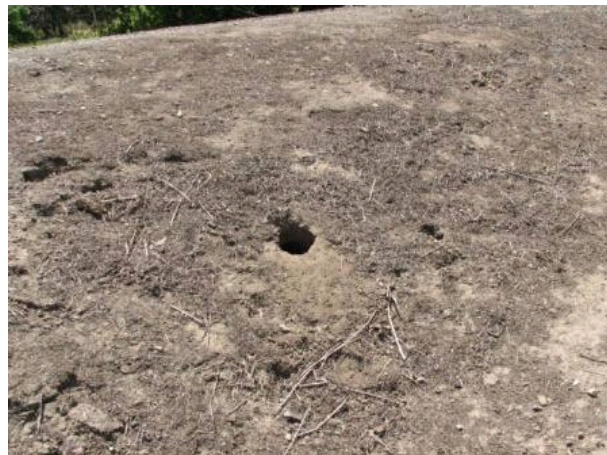
| jeto_s_20110525_515.jpg | |

| Waterway | | | | | | | Bank | Unit Miles | Inspection Start/End | Inspector |
|---|---|---|---|---|---|---|--|---|---|---|
| 10 | 0.38 | 0.38 | Earthen Levee | Animal Control | LS | M | No rodents visible, but rodent burrows visible; need to backfill and compact or grout burrows.<br>Inspector Comments: Active burrow needs to be repaired. | 37.810125 °<br>-121.412317 ° | 37.810125 °<br>-121.412317 ° | 26<br>Y |

| 05/24/2011 Active rodent burrow. | |

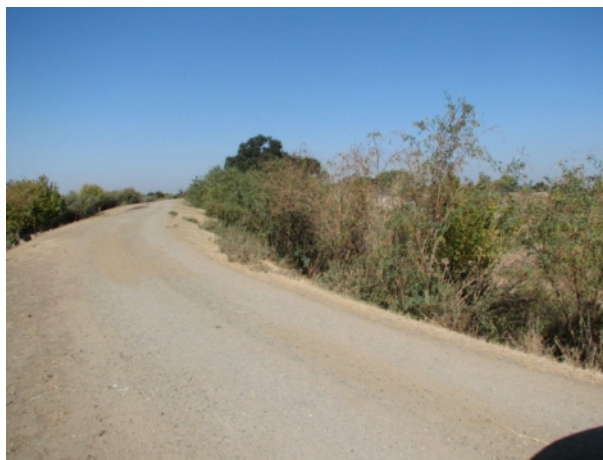
jeto\_s\_20110301\_241.jpg

Fall 2009 photo: brush on landside toe limits visibility and accessibility.

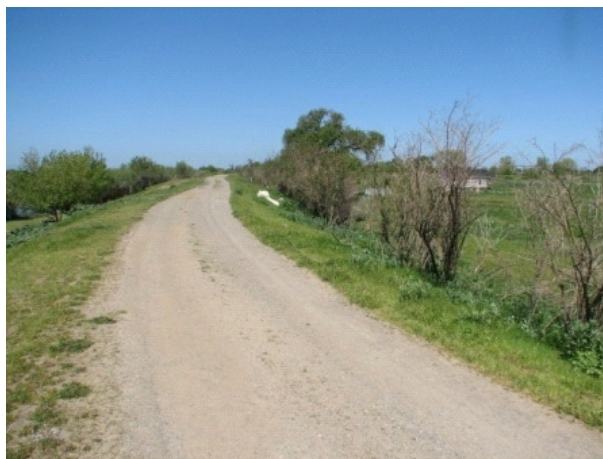
jeto\_s\_20110301\_242.jpg

Brush on landside slope limits access.

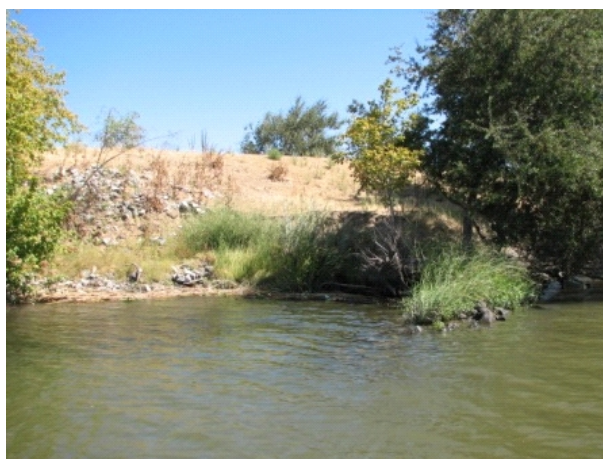
jeto\_s\_20110301\_235.jpg

| Waterway | | | | | | | Bank | Unit Miles | Inspection Start/End | Inspector |
|---|---|---|---|---|---|---|--|---|---|---|
| 12 | 0.42 | 0.43 | Supplemental | DWR Erosion Survey | WS | U | Inspector Comments: 09/07/2010: Site consists of a jutting rip rap that has created an eddy, scouring the levee slope. Most sections of the toe and lower slope are lined with rip rap. However, the rip rap is sloughing on the mid slope and at the toe, exposing the underlaying soils and tree roots. The remaining revetment is no longer adequately protecting the slope. There are 3 Sycamore trees at the toe with exposed tree roots.<br>08/05/2010: Recommended for repair, per CLRO.<br>[2010 SiteID: RD2089U02RM28.35] | 37.809960 °<br>-121.413200 ° | 37.809960 °<br>-121.413200 ° | 1<br>Y |

Upstream view of site where jutting rip rap is located.

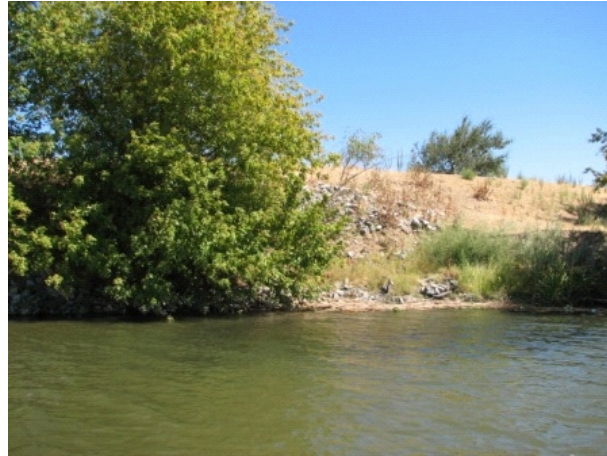
jeto\_s\_20110301\_236.jpg

Upstream view of site where rip rap has sloughed.

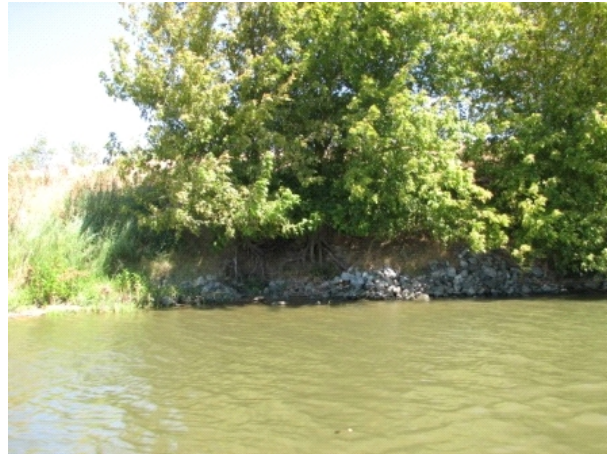
jeto\_s\_20110301\_237.jpg

Front view of Sycamore trees with roots exposed. Note existing toe revetment.

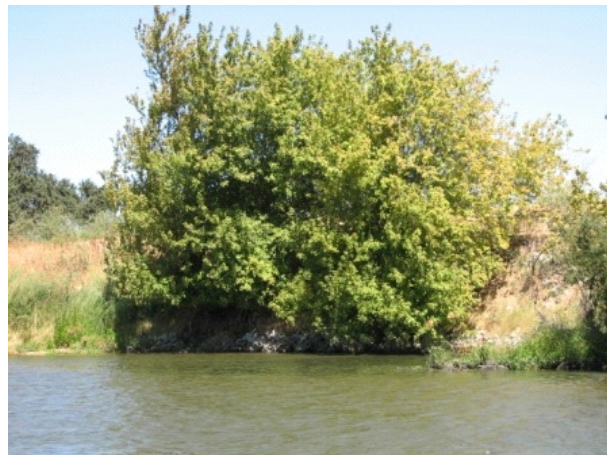
jeto\_s\_20110301\_238.jpg

Downstream view of site. Note existing toe and lower slope revetment. Much of the revetment has sloughed.

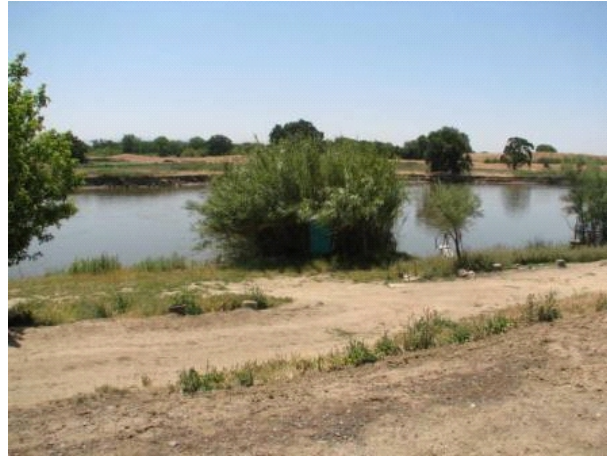
jeto\_s\_20110525\_516.jpg

05/24/2011 Portable toilet is in the shadows in the center of the photo at the water's edge.

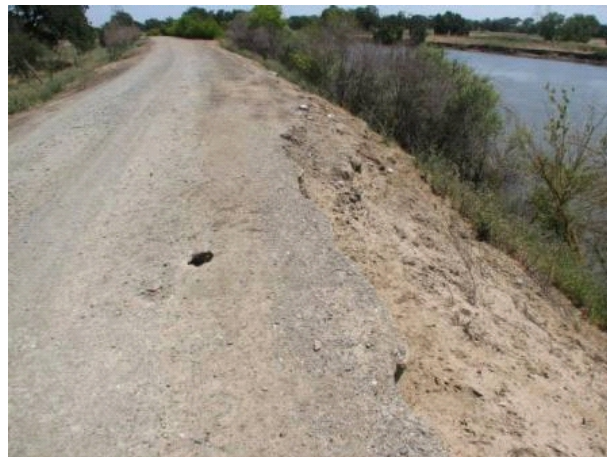
jeto\_s\_20110525\_517.jpg

| LMIR No. | Levee Mile | | Category | Item | Location | Rating | Action/Comment | GPS Latitude/Longitude | | Issue No.<br>Photo |
|---|---|---|---|---|---|---|---|---|---|---|
| 14 | 0.54 | 0.56 | Earthen Levee | Animal Control | WS | U | No rodents visible, but rodent burrows visible; need to backfill and compact or grout burrows.<br>Inspector Comments: No rodents present, but significant tracks and burrows, need to be corrected. May be the cause of the drop off on the waterside of the levee crown. See photos. | 37.811212 °<br>-121.414769 ° | 37.811480 °<br>-121.415141 ° | 35<br>Y |

05/24/2011 Burrow shown on levee crown,

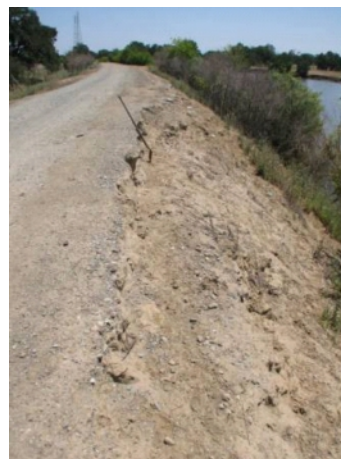
jeto\_s\_20110525\_518.jpg

05/24/2011 Photo shows dropoff from levee crown roundpoint shovel shown for perspective, shovel is located adjacent to burrow shown in previous photo.

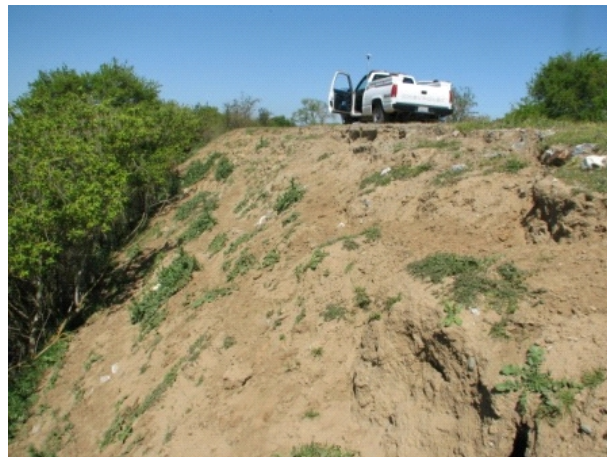
jeto\_s\_20110301\_244.jpg

Animal tracks on landside slope have created a slope stability issue.

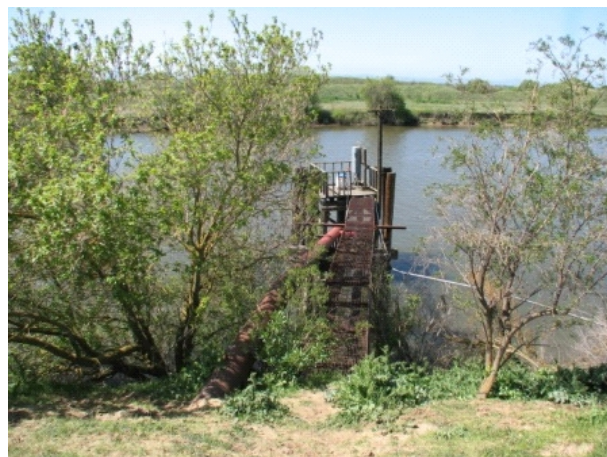
jeto\_s\_20110301\_245.jpg

Irrigation intake pump and pipe at waterside slope.

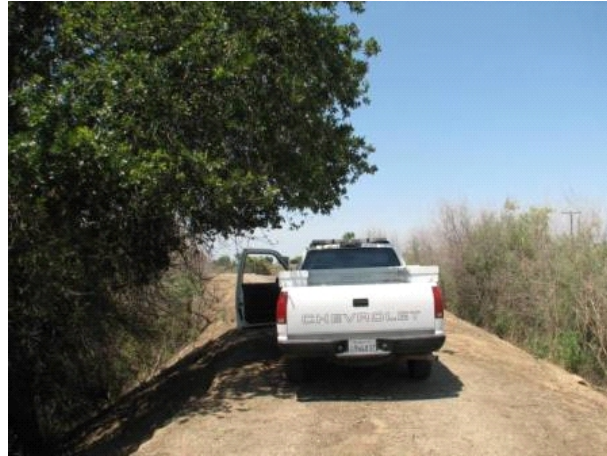
jeto\_s\_20110525\_521.jpg

05/24/2011 Trees need to be trimmed up 12' over road.

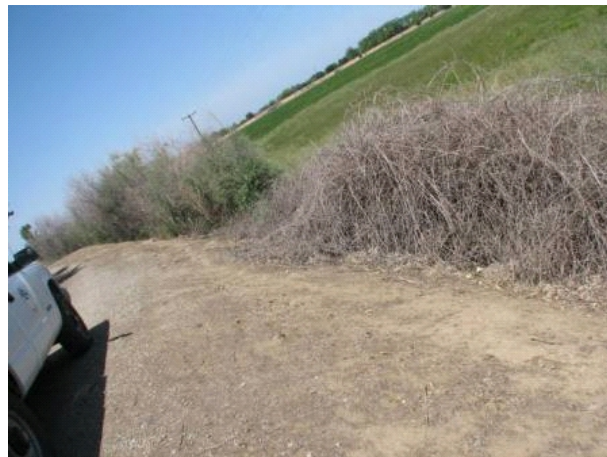
jeto\_s\_20110525\_520.jpg

05/24/2011 Extremely thick dead brush prevents access and visibility.

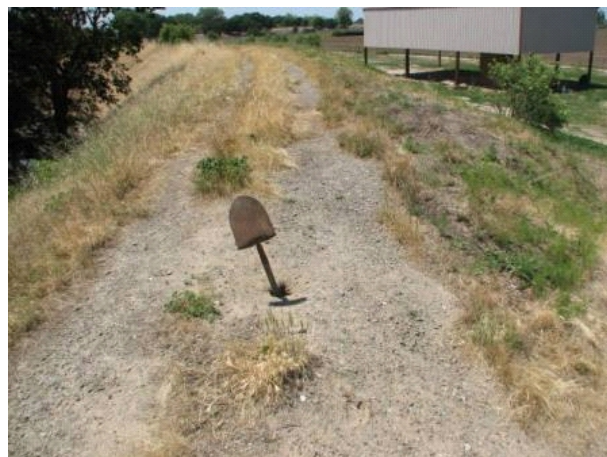
jeto\_s\_20110525\_522.jpg

05/24/2011 Deep vertical burrow in levee crown.

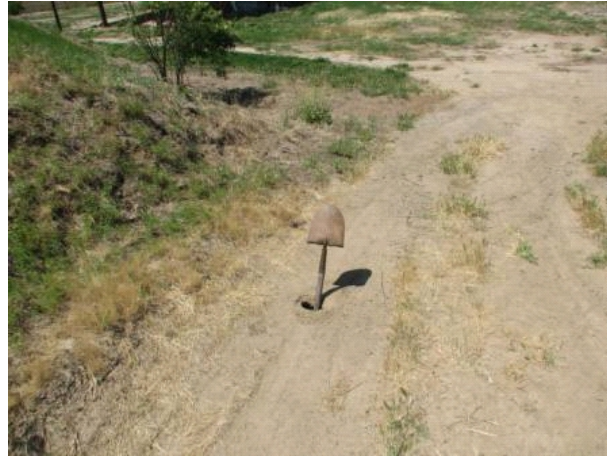
| jeto_s_20110525_523.jpg | |

| 05/24/2011 Deep vertical burrow in ramp on land side of levee. | |

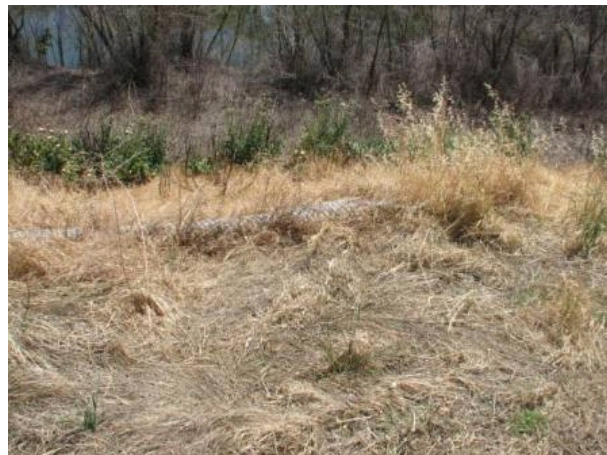
| jeto_s_20110525_525.jpg | |

| 05/24/2011 Old CMP left on waterside levee slope, needs to be removed. | |

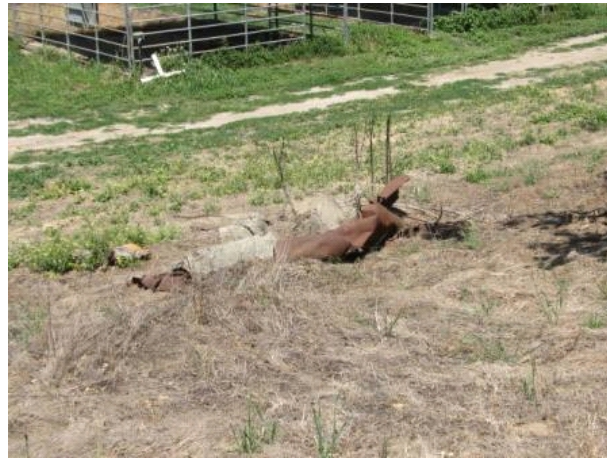
| jeto_s_20110525_526.jpg | |

| 05/24/2011 Concrete and metal debris at landside toe needs to be removed. | |

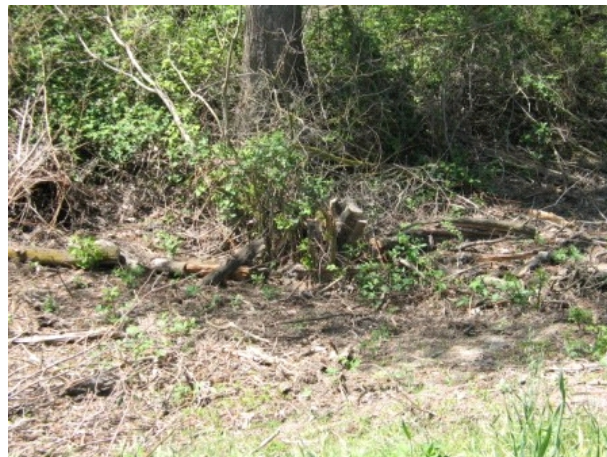
| jeto_s_20110301_250.jpg | |

| Tree stump >2" left after vegetation and tree removal. | |

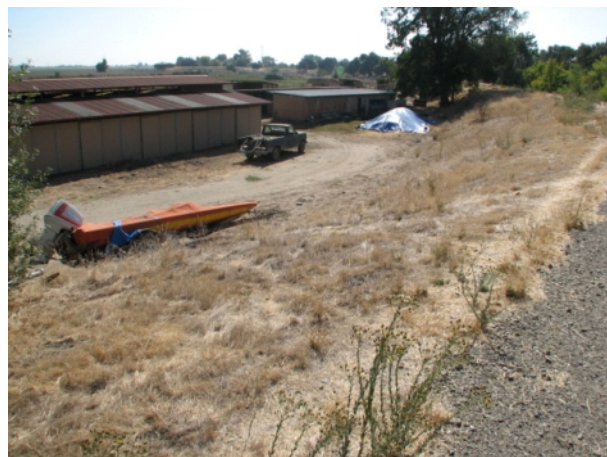
| jeto_s_20110301_248.jpg | |

| Fall 2009 photo: boat and equipment stored within 10-ft of levee slope are an encroachment. | |

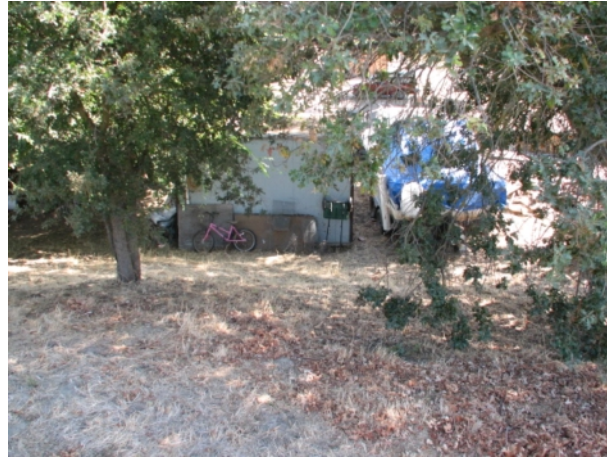
jeto\_s\_20110301\_249.jpg

Fall 2009 photo: Buildings and patio decks are built within 10-ft of the levee slope.

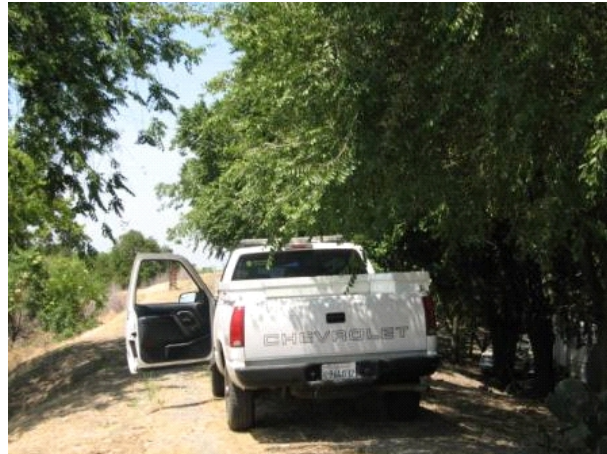
jeto\_s\_20110525\_527.jpg

05/24/2011 Low hanging trees need to be trimmed up 12' over road.
