Flood Control Project Maintenance Levee Inspections

Fall 2020 Levee Maintenance Deficiency Summary Report

Sacramento River Basin

Reclamation District No. 2098 Cache and Haas Slough

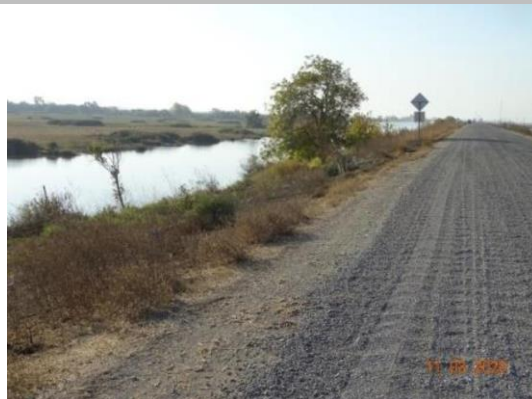
Photo 1 of 1 : FA_2020_RD2098_244_11_20201103_00033.jpg

LM Start	0.07	Rating **	M	Issue No.	11
LM End	0.75	Issue Type +	Ma	Location *	WS
Category	Earthen Levee			GPS Latitude/Longitude	
				Start	End
Item	Vegetation			38.328010 °	38.318138 °
				-121.694038 °	-121.694020 °
DWR ID	DWR_RD2098_01_f _ 2020_11				
Comment Code					
V1 : Control annual grass and weeds on the levee slopes and easements.					
Inspector Comment

View looking downstream at vegetation on the waterside slope (Fall 2020).

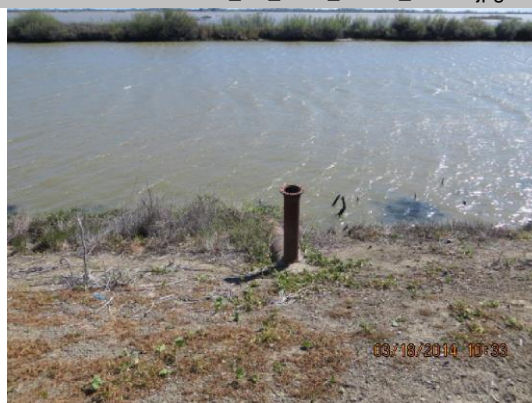
Photo 2 of 3 : UCIP_FA_2020_32227_58691.jpg

Siphon breaker in steel riser on WS slope.

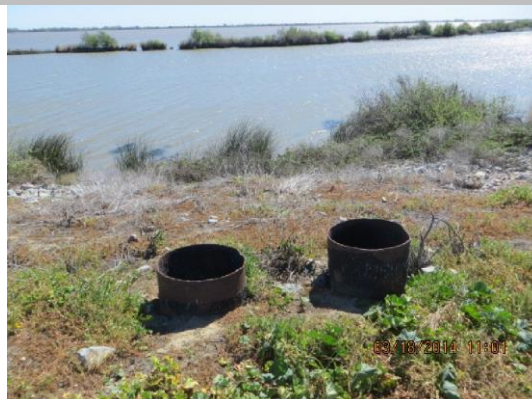
Photo 3 of 3 : UCIP_FA_2020_41717_58707.jpg

Siphon breaker in 24-inch steel riser on WS shoulder.

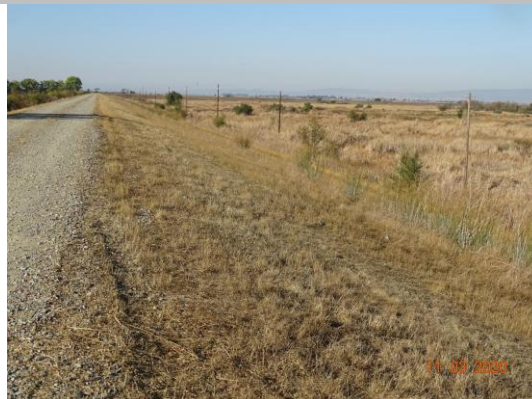
Photo 1 of 1 : FA_2020_RD2098_245_1_20201103_00003.jpg

View of well maintained vegetation on the landside slope (Fall 2020).

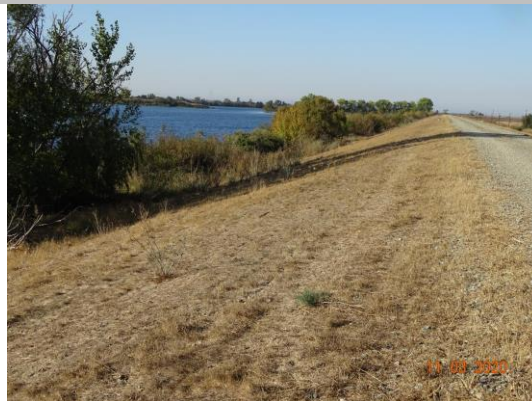
Photo 1 of 1 : FA_2020_RD2098_245_3_20201103_00002.jpg

View of well maintained vegetation on the waterside slope (Fall 2020).

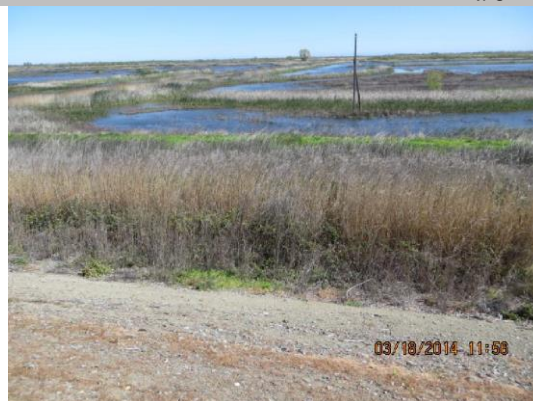
Photo 1 of 3 : UCIP_FA_2020_32287_58755.jpg

LS - no pipe visible.

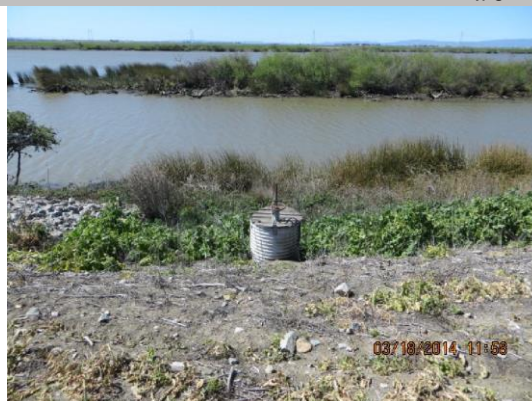
Photo 2 of 3 : UCIP_FA_2020_32287_58754.jpg

Slide gate in 36-inch standpipe on WS slope.

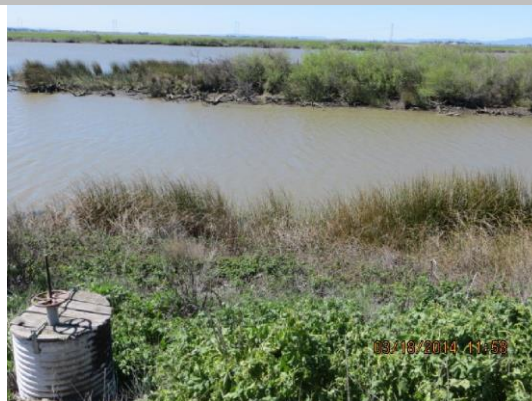
Photo 3 of 3 : UCIP_FA_2020_32287_58753.jpg

Slide gate in 36-inch standpipe on WS slope.

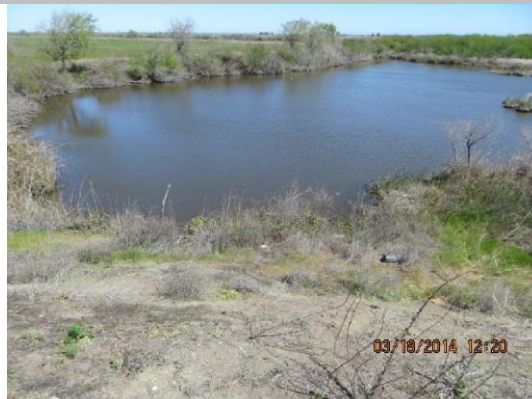
Photo 2 of 3 : UCIP_FA_2020_33784_61161.jpg

Inlet not visible on LS toe.

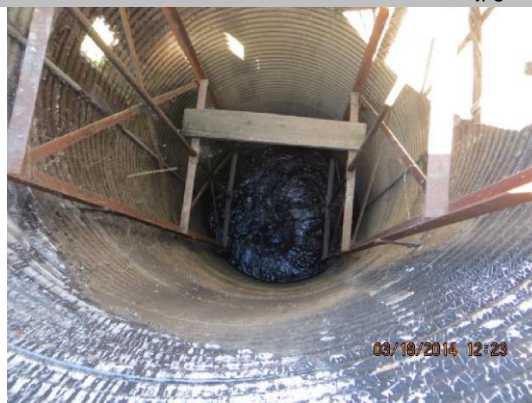
Photo 3 of 3 : UCIP_FA_2020_33784_61160.jpg

View inside CMP riser on WS shoulder.

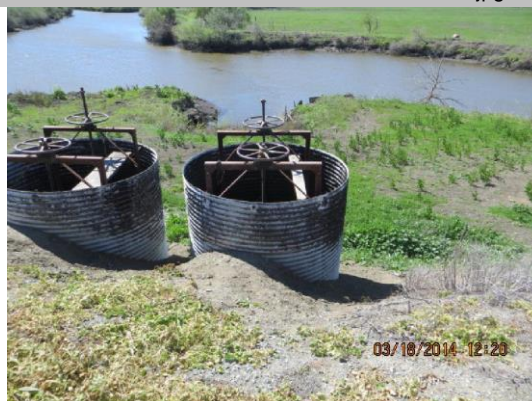
Photo 2 of 3 : UCIP_FA_2020_32285_58748.jpg

7-foot diameter CMP riser with two slide gates inside.

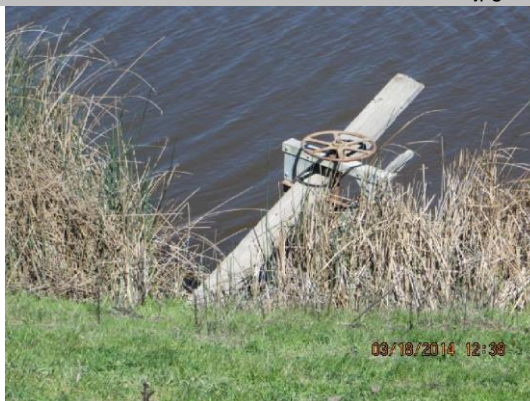
Photo 1 of 3 : UCIP_FA_2020_32290_58764.jpg

Slide gate at LS toe.

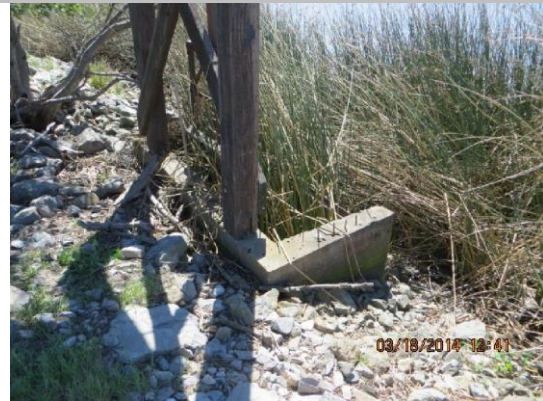
Photo 3 of 3 : UCIP_FA_2020_32290_58762.jpg

Concrete U-shaped headwall on WS toe.

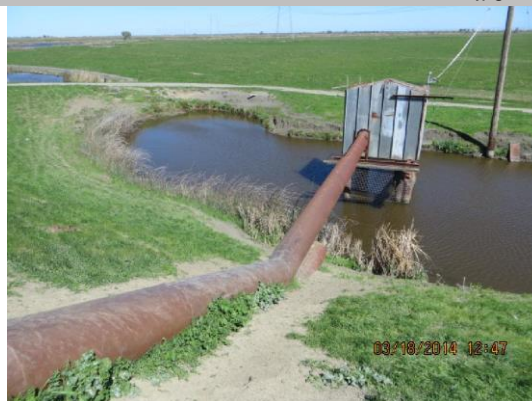
Photo 1 of 3 : UCIP_FA_2020_32303_58782.jpg

Pipe visible under new pipe on LS slope.

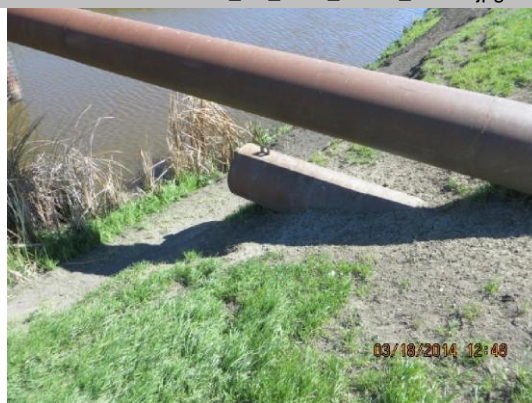
Photo 2 of 3 : UCIP_FA_2020_32303_58781.jpg

Pipe visible under new pipe on LS slope.

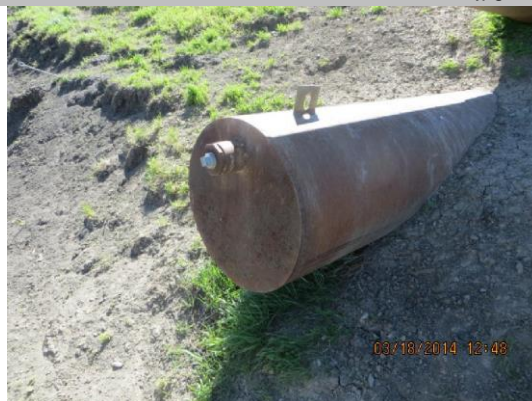
Photo 3 of 3 : UCIP_FA_2020_32303_58780.jpg

Welded steel cap over LS end of pipe.

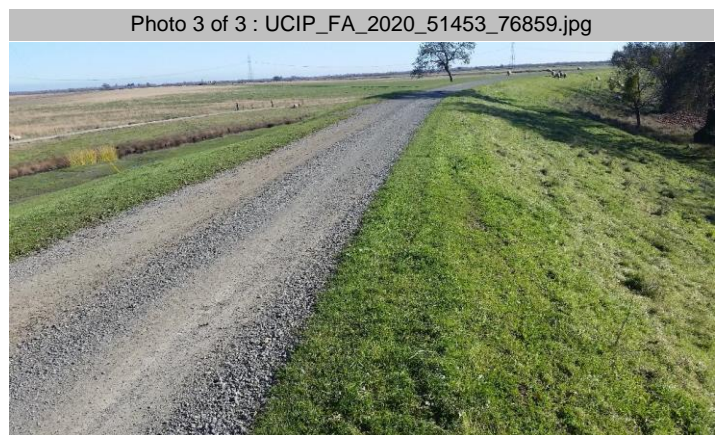
View of levee crown at pipe crossing.

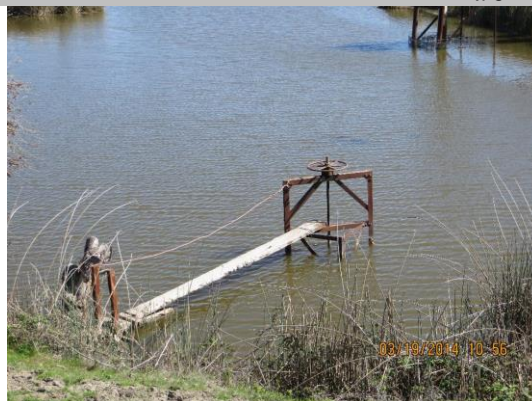
Photo 1 of 2 : UCIP_FA_2020_32384_58883.jpg

Slide gate at LS toe.

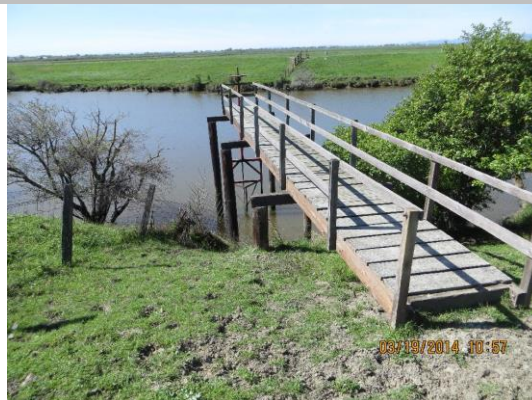
Photo 2 of 2 : UCIP_FA_2020_32384_58882.jpg

LM Start	8.35	Rating **	A/W	Issue No.	15	
LM End	8.35	Issue Type +	Ma	Location *		
Category	Supplemental			GPS Latitude/Longitude		
				Start		End
Item	DWR UCIP LMA Responsibility			38.306916 °	38.306916 °	
				-121.731984 °	-121.731984 °	
DWR ID	20962					
Comment Code						
Inspector Comment						
DS_ID:20962 FS_ID:32384 EP_NO: 10174 Repair Type: No Action Needed EVAL Issue: Crossing Status: Found UCIP Comments: FIELD_STRUCT_DESC: 60-inch corrugated metal drainage pipe through the levee, 25.5 feet below the crown. Walkway to the slide gates at both ends of the pipe. (Permit No. 1607, 1951 - R. F. Moore and Lorraine W. Zanetti. This pipe was retained under Automatic Board Order (ABO) issued as Permit No. 10174, 1974 - Glen A. Bowlsbey). [Additional Reference(s): DWR Levee Log, 2003. USACE Sacramento O&M Manual 109, April 1962, (HLM 8.40)]. FS Date: 3/19/2014

Walkway with slide gate on WS toe.

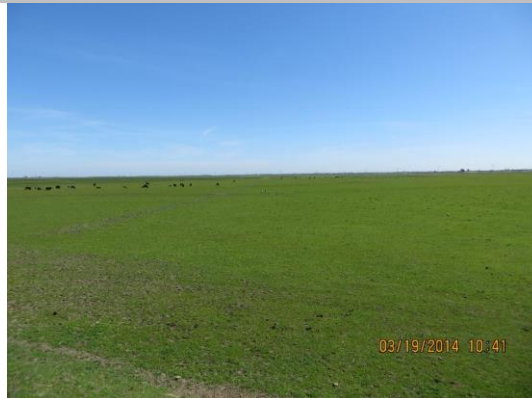
Photo 1 of 2 : UCIP_FA_2020_32383_58881.jpg

LM Start	9.49	Rating **	M	Issue No.	13	
LM End	9.49	Issue Type +	En	Location *		
Category	Supplemental			GPS Latitude/Longitude		
				Start		End
Item	DWR UCIP Field Study			38.321032 °		38.321032 °
				-121.740154 °		-121.740154 °
DWR ID	20983					
Comment Code						
Inspector Comment						
DS_ID:20983 FS_ID:32383 EP_NO: N/A Repair Type: Non-Urgent EVAL Issue: Crossing Status: Indicator Found UCIP Comments: 03/19/2014 need to verify status of gaslines in region with PG&E (888) 743-7431 Email: PipelineRequests@pge.com. (W. Wylie - DWR UCIP) FIELD_STRUCT_DESC: 4-inch gas line of an unknown material through the levee, 2 feet below the crown. Shutoff valve located 370 feet east of the levee crown. [Additional Reference(s): DWR Levee Log, 2003]. FS Date: 3/19/2014

Shutoff valve visible 370-feet off LS toe.

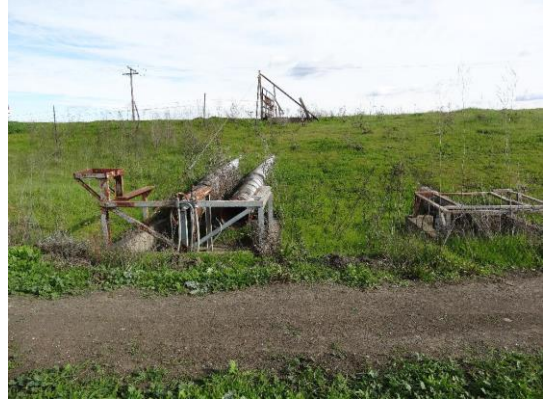
Photo 3 of 3 : UCIP_FA_2020_53381_76868.jpg

View of WS--pipe crossing is located on the right.

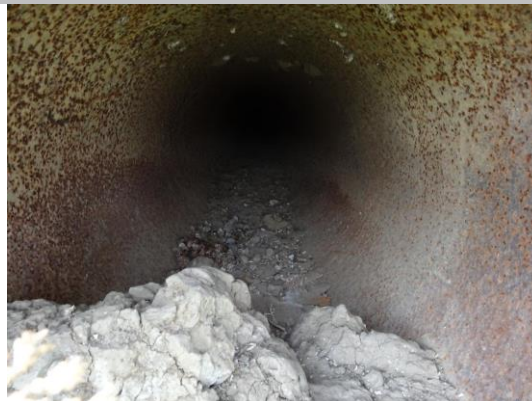
Photo 3 of 3 : UCIP_FA_2020_53383_76885.jpg

Comment Code						
Inspector Comment						
DS_ID:21013 FS_ID:53383 EP_NO: 5426-A Repair Type: Urgent EVAL Issue: Crossing Status: Found UCIP Comments: 10/2/2018 Same as last inspection; remaining as Urgent and recommend internal pipe inspection (D. Sanoski - DWR UCIP).12/06/2016 Crossing is opened on both WS and LS. Concrete box located on the LS has been removed. According to Mr. Mike Hardesty, this crossing is not abandoned the crossing is out of service for now. Recommend internal integrity inspection and coordinating with CVFPB to comply with Title 23. (O. Magana - DWR UCIP)03/19/2014 Pipe appears abandoned and if so should be done so properly. Foundation for concrete distribution box on LS toe at canal has failed. Box has fallen into canal and LS slope has erosion at same location. Pipe open on both ends. (W. Wylie - DWR UCIP) FIELD_STRUCT_DESC: 2 of 2: 18-inch coated steel drainage pipe through the levee, 3 feet below the crown. Vertical pumps missing from steel pad over a 7-foot by 4-foot concrete sump located on the waterside (WS) toe. Concrete cattle guard structure, 7 feet long, 15 feet wide, and 4 feet deep, located on the crown around the pipes. Discharge structure is located on the landside (LS) slope. (Permit No. 5426, 1966, and 5426-A, 1967 - Reclamation District No. 2068. Permit recordation indicates one 14-inch pipe and one 18-inch pipe to be installed). [Additional Reference(s): DWR Levee Log, 2003]. FS Date: 10/2/2018 4:54:00 PM

Inside view of pipe from LS.
