Flood Control Project Maintenance Levee Inspections

Fall 2021 Levee Maintenance Deficiency Summary Report

Sacramento River Basin

Reclamation District No. 2098 Cache and Haas Slough

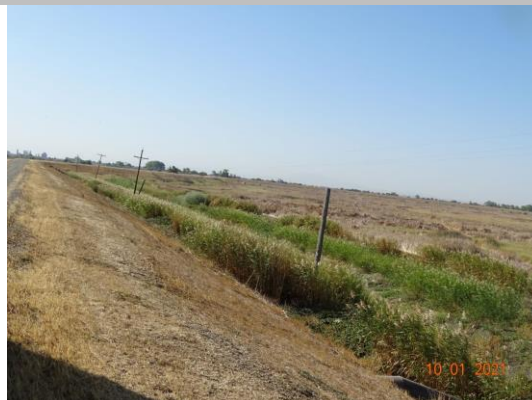
Photo 1 of 1 : FA_2021_RD2098_244_11_20211014_00035.jpg

LM Start	3.00	Rating **	M	Issue No.	11
LM End	3.45	Issue Type +	Ma	Location *	LS
Category	Earthen Levee			GPS Latitude/Longitude	
				Start	End
Item	Vegetation			38.285613 °	38.279482 °
				-121.693638 °	-121.695643 °
DWR ID	DWR_RD2098_01_f_2021_11				
Comment Code					
V2 : Remove the wild growth other than native grasses from the levee slopes.					
Inspector Comment

View looking downstream at vegetation on the landside toe (Fall 2021).

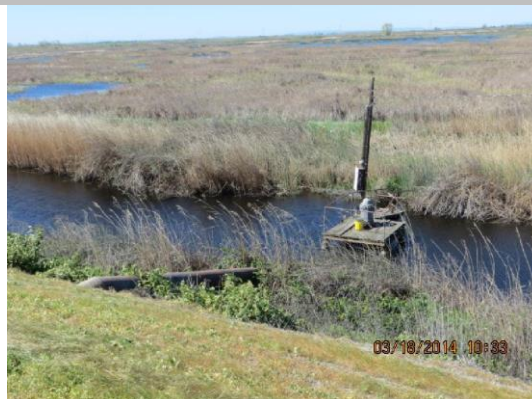
Photo 1 of 3 : UCIP_FA_2021_32227_58692.jpg

Comment Code						
Inspector Comment						
DS_ID:20969 FS_ID:32227 EP_NO: 13222 Repair Type: Non-Urgent EVAL Issue: Crossing Status: Found UCIP Comments: 03/18/2014 Pipe rusted through at outlet on WS slope, may indicate further degradation of pipe within levee. Good candidate for video inspection. (W. Wylie - DWR UCIP) FIELD_STRUCT_DESC: 20-inch steel drainage pipe through the levee, 7.5 feet below the crown. Siphon breaker on the waterside (WS) shoulder. Pump on pile structure in drainage ditch on the landside (LS). (This pipe was retained under Automatic Board Order (ABO) issued as Permit No. 10168, 1974 - Moresco Brothers. Pipe removed and replaced with a 19-inch steel pipe under the crown and along the LS slope under Permit No. 13222, 1981 - Prudential Insurance Company of America). [Additional Reference(s): DWR Levee Log, 2003. USACE Sacramento O&M Manual 109, April 1962, (HLM 2.98)]. FS Date: 3/18/2014

Pump on pile structure in drainage channel on LS toe.

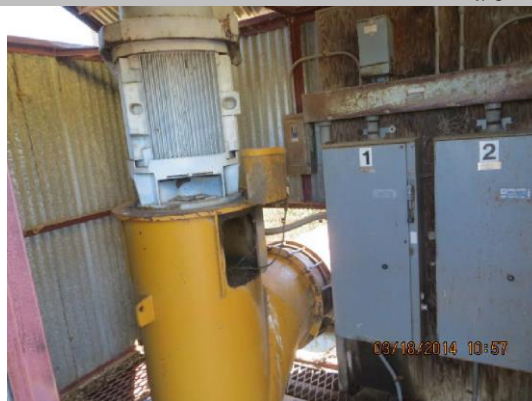
Photo 1 of 3 : UCIP_FA_2021_41717_58704.jpg

DS_ID:20971
 FS_ID:41717
 EP_NO: 15169
 Repair Type: Non-Urgent
 EVAL Issue:
 Crossing Status: Found
 UCIP Comments: 12/22/2016 Met with Mike Hadesty, LMA Superintendent, and Brian Bush, LMA General Manager, to go over the list of pipes in RD2098. Per LMA, pipe is a drainage pipe. New property owner is John Anderson. (O. Magana - DWR UCIP)
 03/18/2014 Debris and soil buildup in riser may prevent proper function of siphon breaker. (W. Wylie - DWR UCIP)
 FIELD_STRUCT_DESC: 1 of 2: 24-inch coated steel drainage pipe through the levee, 5.6 feet below the crown. Cutoff wall around the pipe at the center of the levee. Siphon breaker at the waterside (WS) shoulder. Flap gate on the WS end. Pump in pump house on piling structure on the landside (LS). (Permit No. 15169, 1989 - Maxim Development). [Additional Reference(s): DWR Levee Log, 2003].
 FS Date: 3/18/2014

Pump in pumphouse on LS toe.

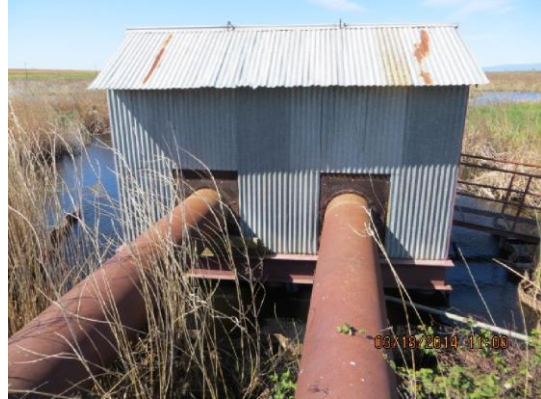
Photo 2 of 3 : UCIP_FA_2021_41717_58703.jpg

Pump in pumphouse on LS toe.

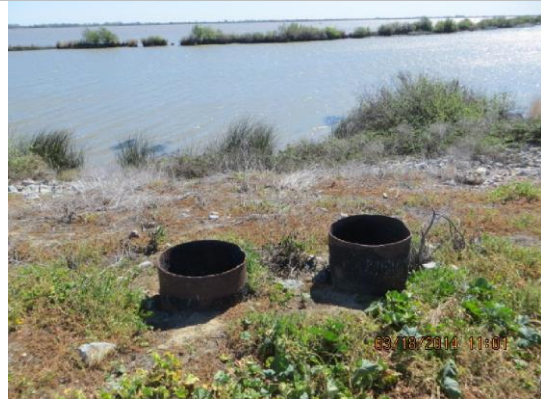
Photo 3 of 3 : UCIP_FA_2021_41717_58707.jpg

Siphon breaker in 24-inch steel riser on WS shoulder.

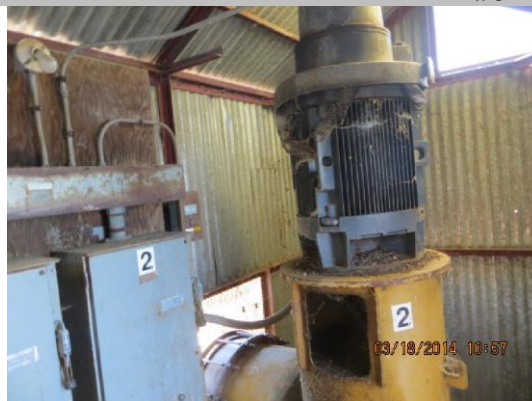
Photo 1 of 3 : UCIP_FA_2021_32245_58710.jpg

DS_ID:20959
FS_ID:32245
EP_NO: 15169
Repair Type: Non-Urgent
EVAL Issue:
Crossing Status: Found
UCIP Comments: 12/22/2016 Met with Mike Hadesty, LMA Superintendent, and Brian Bush, LMA General Manager, to go over the list of pipes in RD2098. Per LMA, pipe is a drainage pipe. New property owner is John Anderson. (O. Magana - DWR UCIP)
03/18/2014 Soil and debris buildup in steel riser on WS shoulder may prevent proper function of siphon breaker. (W. Wylie - DWR UCIP)
FIELD_STRUCT_DESC: 2 of 2: 24-inch coated steel drainage pipe through the levee, 5.6 feet below the crown. Cutoff wall around the pipe at the center of the levee. Siphon breaker on the waterside (WS) shoulder. Flap gate on the WS end. Pump in pump house on piling structure on the landside (LS). (Permit No. 15169, 1989 - Maxim Development). [Additional Reference(s): DWR Levee Log, 2003].
FS Date: 3/18/2014

Pump in pumphouse on LS toe.

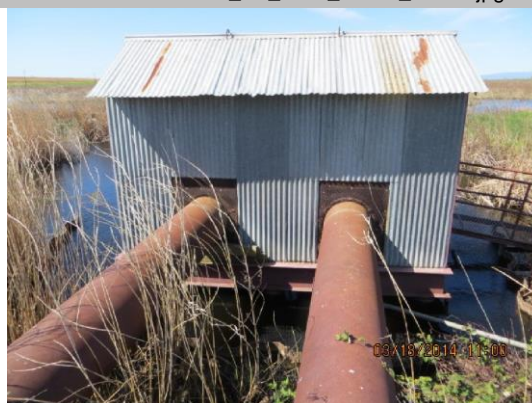
Photo 2 of 3 : UCIP_FA_2021_32245_58709.jpg

Pump in pumphouse on LS toe.

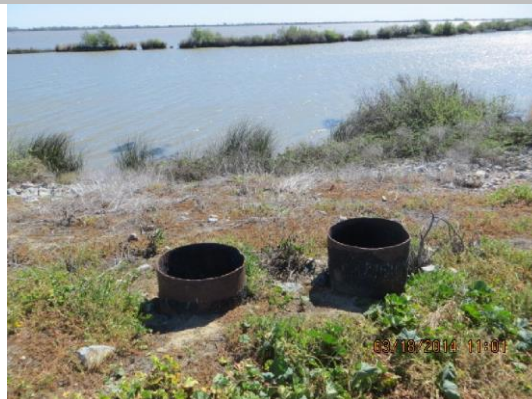
Photo 3 of 3 : UCIP_FA_2021_32245_58708.jpg

Siphon breaker in steel riser on WS shoulder.

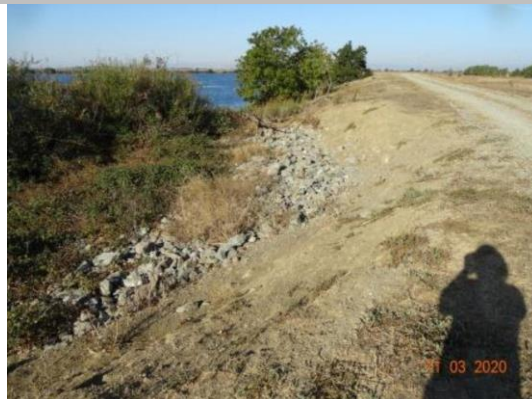
Photo 1 of 1 : FA_2021_RD2098_246_11_20210830_00002.jpg

This waterside slump site is not new, and is somewhat protected by riprap and thick brushy vegetation, but it has the potential to erode to crown during high water with a strong south wind. It currently has a two-foot vertical scarp at the levee shoulder.

View looking upstream at erosion into waterside slope (Fall 2020).

E2 : Schedule repair of erosion site prior to the next inspection.

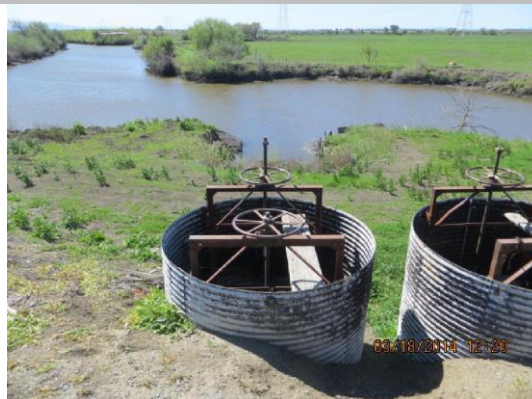
Photo 1 of 3 : UCIP_FA_2021_33784_61162.jpg

DS_ID:20976
FS_ID:33784
EP_NO: 10172
Repair Type: Non-Urgent
EVAL Issue:
Crossing Status: Found
UCIP Comments: 03/18/2014 Headwalls on WS toe failing at outlet. It is unclear if these were permanent installations or something that was installed as a temporary fix. (W. Wylie - DWR UCIP)
FIELD_STRUCT_DESC: 1 of 2: 48-inch corrugated metal drainage pipe through the levee, 29 feet below the crown. Two slide gates in a 7-foot-diameter corrugated metal pipe (CMP) riser on the waterside (WS) slope. (two 48-inch [HLM 6.75] authorized under Automatic Board Order (ABO) issued as Permit No. 10172, 1974 - Moresco Brothers).
[Additional Reference(s): DWR Levee Log, 2003. USACE Sacramento O&M Manual 109, April 1962, (HLM 6.75)].
FS Date: 3/18/2014

Two slide gates in 7-foot diameter CMP riser on waterward slope.

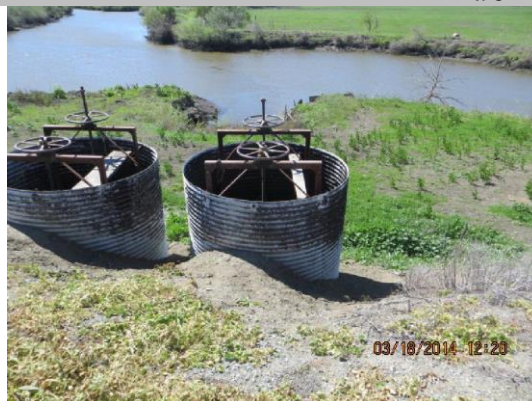
Photo 2 of 3 : UCIP_FA_2021_32285_58748.jpg

7-foot diameter CMP riser with two slide gates inside.

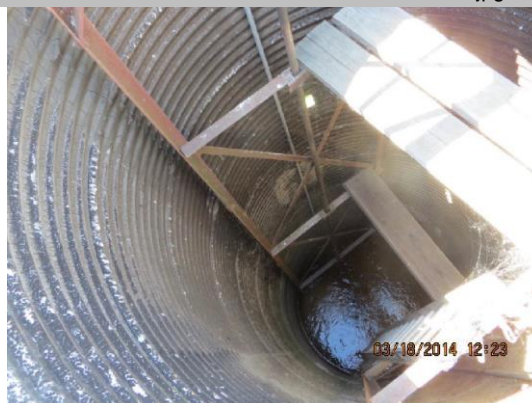
Photo 3 of 3 : UCIP_FA_2021_32285_58747.jpg

7-foot diameter CMP riser with two slide gates inside.

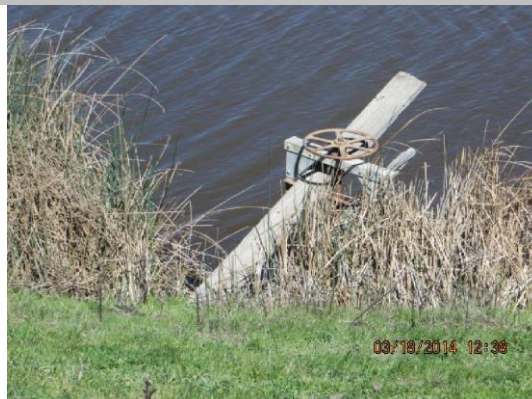
Photo 1 of 3 : UCIP_FA_2021_32290_58764.jpg

Comment Code					
Inspector Comment					
DS_ID:20977 FS_ID:32290 EP_NO: 10171 Repair Type: Non-Urgent EVAL Issue: Crossing Status: Found UCIP Comments: 12/22/2016 Met with Mike Hadesty, LMA Superintendent, and Brian Bush, LMA General Manager, to go over the list of pipes in RD2098. Per LMA, pipe is a drainage pipe.(O. Magana - DWR UCIP) 03/18/2014 Pipe appears to be abandoned and if so it should be done so properly. Walkway to gate valve actuator on WS slope is in disrepair and does not appear to be safe for use. (W. Wylie - DWR UCIP) FIELD_STRUCT_DESC: 36-inch corrugated metal drainage pipe through the levee, 23 feet below the crown. Walkway to slide gate on the waterside (WS) end. Slide gate at the landside (LS) toe. (This pipe was retained under Automatic Board Order (ABO) issued as Permit No. 10171, 1974 - Glenn A. Bowlsbey). [Additional Reference(s): DWR Levee Log, 2003. USACE Sacramento O&M Manual 109, April 1962, (HLM 7.23)]. FS Date: 3/18/2014

Slide gate at LS toe.

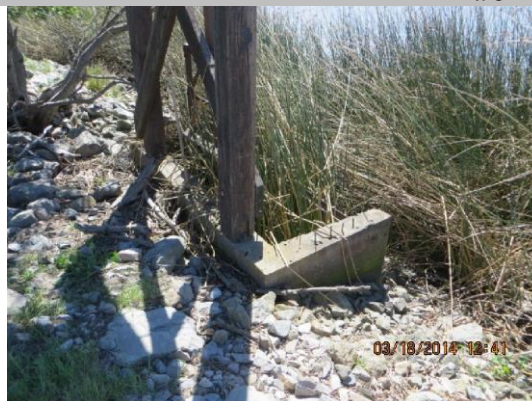
Photo 3 of 3 : UCIP_FA_2021_32290_58762.jpg

Concrete U-shaped headwall on WS toe.

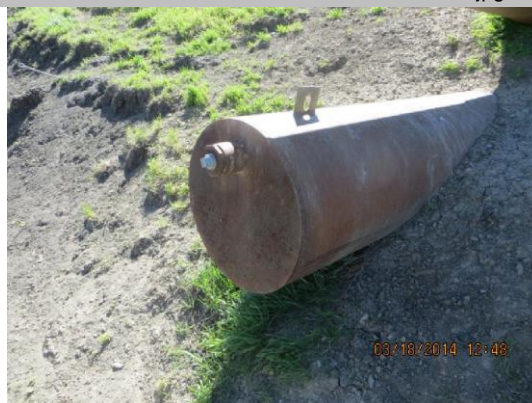
Photo 3 of 3 : UCIP_FA_2021_32303_58780.jpg

Welded steel cap over LS end of pipe.

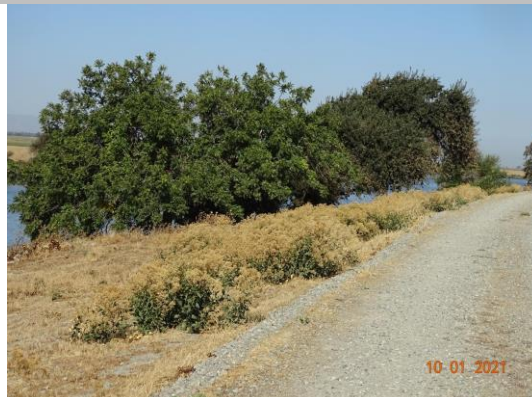
Photo 1 of 1 : FA_2021_RD2098_247_6_20211014_00008.jpg

LM Start	7.19	Rating **	M	Issue No.	6
LM End	7.81	Issue Type +	Ma	Location *	WS
Category	Earthen Levee			GPS Latitude/Longitude	
				Start	End
Item	Vegetation			38.293173 °	38.300916 °
				-121.724241 °	-121.728175 °
DWR ID	DWR_RD2098_03_f _ 2021_6				
Comment Code					
V1 : Control annual grass and weeds on the levee slopes and easements.					
Inspector Comment

View looking upstream at vegetation on the waterside hinge (Fall 2021).

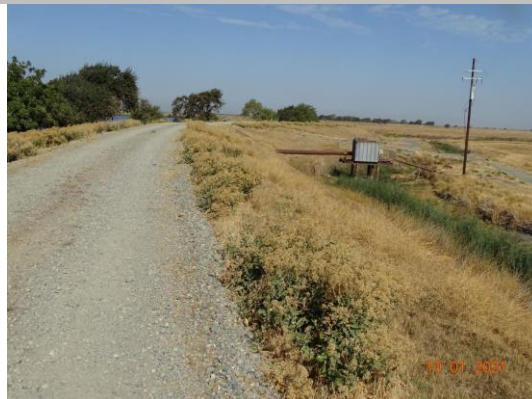
Photo 1 of 1 : FA_2021_RD2098_247_5_20211014_00009.jpg

LM Start	7.19	Rating **	M	Issue No.	5
LM End	7.82	Issue Type +	Ma	Location *	LS
Category	Earthen Levee			GPS Latitude/Longitude	
				Start	End
Item	Vegetation			38.293173 °	38.300981 °
				-121.724241 °	-121.728163 °
DWR ID	DWR_RD2098_03_f _ 2021_5				
Comment Code					
V1 : Control annual grass and weeds on the levee slopes and easements.					
Inspector Comment

View looking upstream at vegetation on the landside hinge (Fall 2021).

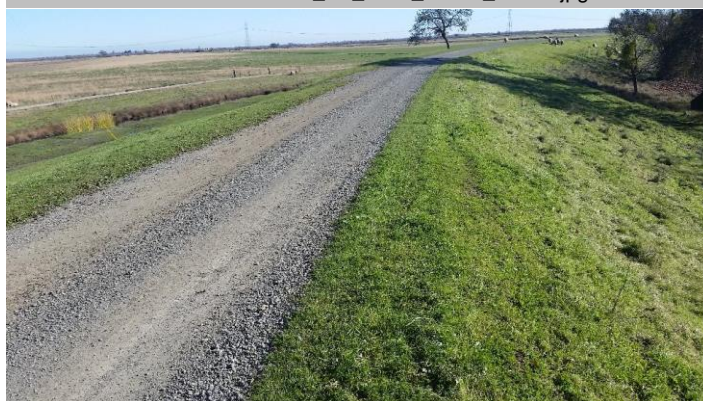
Photo 3 of 3 : UCIP_FA_2021_51453_76859.jpg

View of levee crown at pipe crossing.

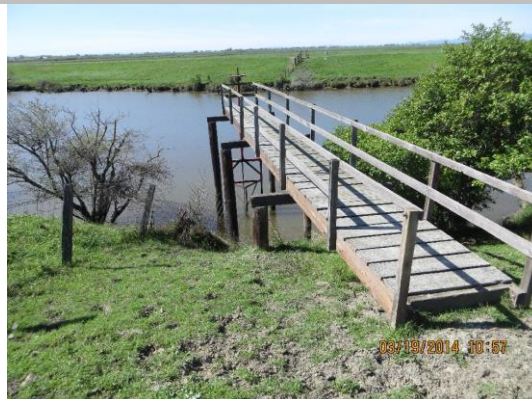
Photo 2 of 2 : UCIP_FA_2021_32384_58882.jpg

Walkway with slide gate on WS toe.

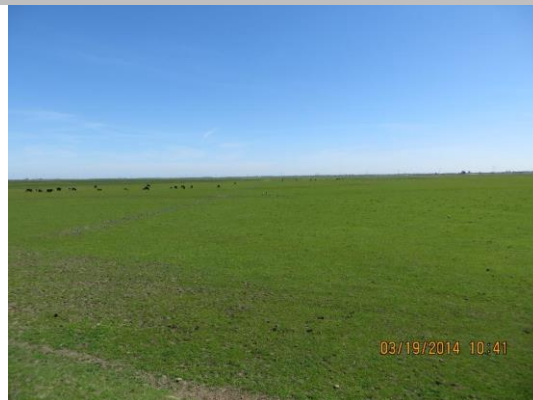
Photo 1 of 2 : UCIP_FA_2021_32383_58881.jpg

LM Start	9.49	Rating **	M	Issue No.	14	
LM End	9.49	Issue Type +	En	Location *		
Category	Supplemental			GPS Latitude/Longitude		
				Start	End	
Item	DWR UCIP Field Study			38.321032 °	38.321032 °	
				-121.740154 °	-121.740154 °	
DWR ID	20983					
Comment Code						
Inspector Comment						
DS_ID:20983						
FS_ID:32383						
EP_NO: N/A						
Repair Type: Non-Urgent						
EVAL Issue:						
Crossing Status: Indicator Found						
UCIP Comments: 03/19/2014 need to verify status of gaslines in region with PG&E (888) 743-7431 Email: PipelineRequests@pge.com. (W. Wylie - DWR UCIP)						
FIELD_STRUCT_DESC: 4-inch gas line of an unknown material through the levee, 2 feet below the crown. Shutoff valve located 370 feet east of the levee crown. [Additional Reference(s): DWR Levee Log, 2003].						
FS Date: 3/19/2014

Shutoff valve visible 370-feet off LS toe.

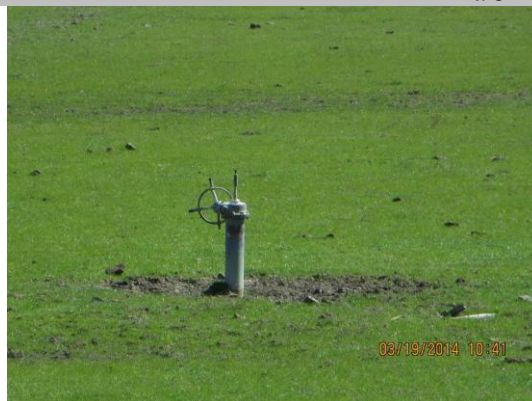
Photo 2 of 2 : UCIP_FA_2021_32383_58880.jpg

Shutoff valve visible 370-feet off LS toe.

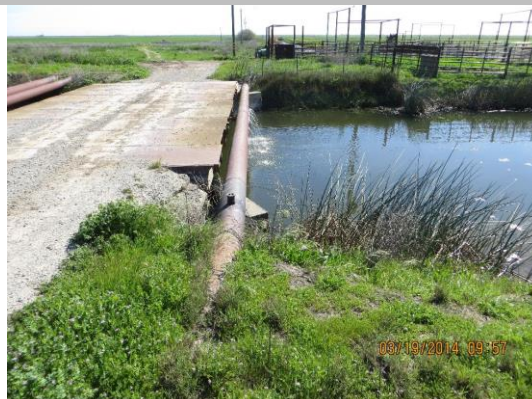
Photo 1 of 3 : UCIP_FA_2021_32403_58905.jpg

Pipe and siphon breaker visible on LS at canal crossing.

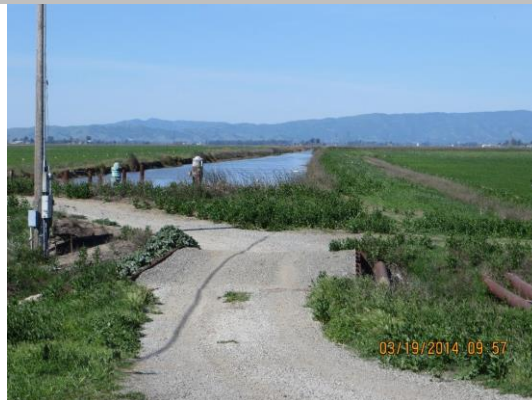
Photo 2 of 3 : UCIP_FA_2021_32403_58904.jpg

Pump on pier in irrigation canal off WS toe.

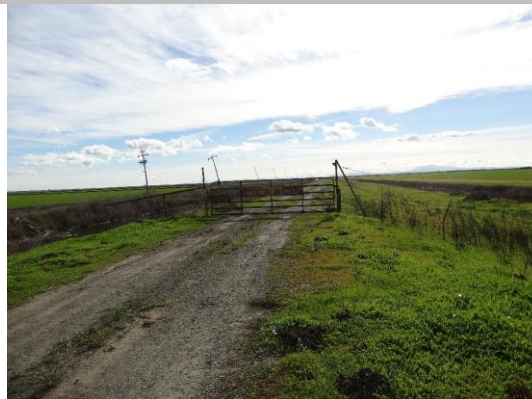
Photo 1 of 3 : UCIP_FA_2021_53381_76867.jpg

Overview of levee crown at multiple pipe crossings.

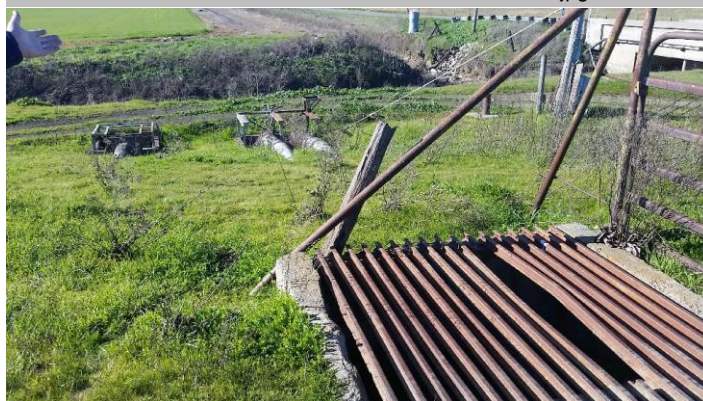
Photo 2 of 3 : UCIP_FA_2021_53381_76872.jpg

View of WS photo taken from levee crown.

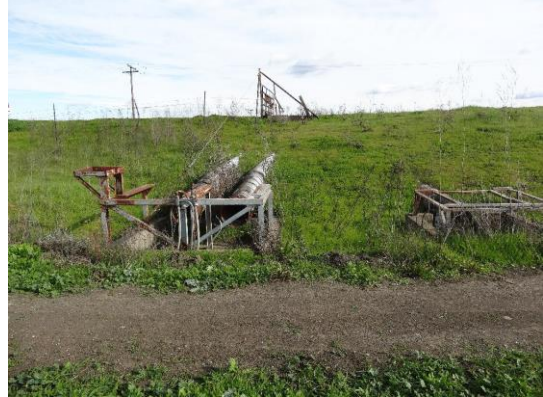
Photo 3 of 3 : UCIP_FA_2021_53381_76868.jpg

View of WS--pipe crossing is located on the right.

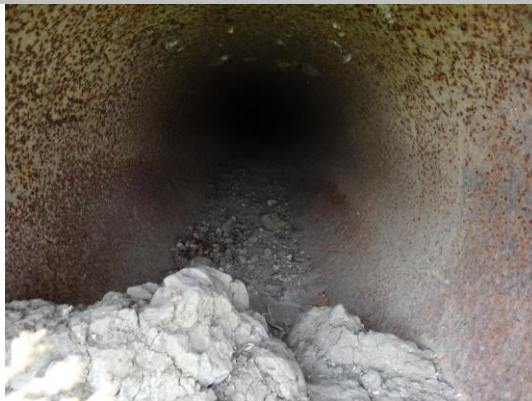
Photo 3 of 3 : UCIP_FA_2021_53383_76885.jpg

Comment Code						
Inspector Comment						
DS_ID:21013 FS_ID:53383 EP_NO: 5426-A Repair Type: Urgent EVAL Issue: Crossing Status: Found UCIP Comments: 10/2/2018 Same as last inspection; remaining as Urgent and recommend internal pipe inspection (D. Sanoski - DWR UCIP).12/06/2016 Crossing is opened on both WS and LS. Concrete box located on the LS has been removed. According to Mr. Mike Hardesty, this crossing is not abandoned the crossing is out of service for now. Recommend internal integrity inspection and coordinating with CVFPB to comply with Title 23. (O. Magana - DWR UCIP)03/19/2014 Pipe appears abandoned and if so should be done so properly. Foundation for concrete distribution box on LS toe at canal has failed. Box has fallen into canal and LS slope has erosion at same location. Pipe open on both ends. (W. Wylie - DWR UCIP) FIELD_STRUCT_DESC: 2 of 2: 18-inch coated steel drainage pipe through the levee, 3 feet below the crown. Vertical pumps missing from steel pad over a 7-foot by 4-foot concrete sump located on the waterside (WS) toe. Concrete cattle guard structure, 7 feet long, 15 feet wide, and 4 feet deep, located on the crown around the pipes. Discharge structure is located on the landside (LS) slope. (Permit No. 5426, 1966, and 5426-A, 1967 - Reclamation District No. 2068. Permit recordation indicates one 14-inch pipe and one 18-inch pipe to be installed). [Additional Reference(s): DWR Levee Log, 2003]. FS Date: 10/2/2018 4:54:00 PM

LM Start	12.05	Rating **	U	Issue No.	19 (cont)
LM End	12.05	Issue Type +	En	Location *

Inside view of pipe from LS.

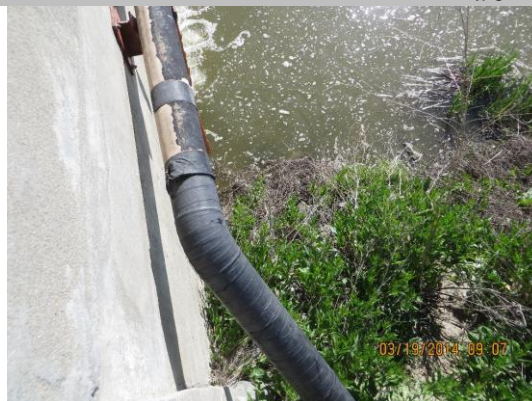
Photo 1 of 3 : UCIP_FA_2021_32566_59110.jpg

LM Start	12.07	Rating **	M	Issue No.	20
LM End	12.07	Issue Type +	En	Location *	
Category	Supplemental			GPS Latitude/Longitude	
				Start	End
Item	DWR UCIP Field Study			38.358110 °	38.358110 °
				-121.740381 °	-121.740381 °
DWR ID	24845				
Comment Code					
Inspector Comment					
DS_ID:24845 FS_ID:32566 EP_NO: N/A Repair Type: Non-Urgent EVAL Issue: Crossing Status: Found UCIP Comments: 03/19/2014 Need to verify status with gas company and install signs. No permit identified for crossing, though it may be connected to a permitted line installed in RD 2068 under Permit No. 13490. (W. Wylie - DWR UCIP) FIELD_STRUCT_DESC: 6-inch coated steel gas line through the levee, 3 feet below the crown. Signs on the east side of the levee. Pipe visible on the downstream side of the roadway bridge. FS Date: 3/19/2014

Pipe visible on South side of Bridge at Swan Road.

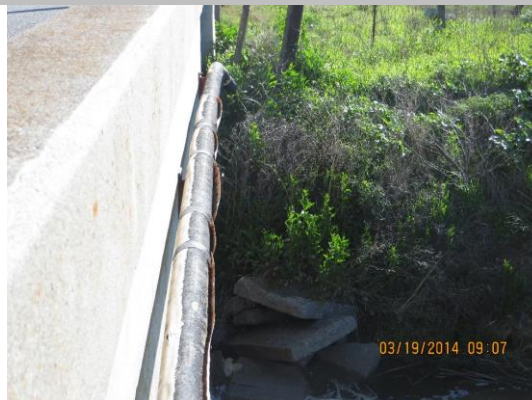
Photo 2 of 3 : UCIP_FA_2021_32566_59109.jpg

Pipe visible on South side of Bridge at Swan Road.

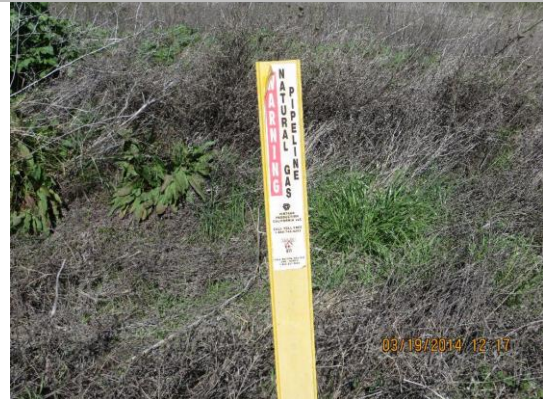
Photo 3 of 3 : UCIP_FA_2021_32566_59108.jpg

Sign off LS toe on East side of canal.
