**Flood Control Project Maintenance
Levee Inspections
Unit Cover Sheet**

Reclamation District No. 2098 Cache and Haas Slough

Levee Inspection Report By Mile - Spring 2021

Waterway	Bank	Unit Miles	Inspection Start/End	Inspector
Unit No. 01 Yolo Bypass	Right	3.60	03/19/2021 03/19/2021	David Julian

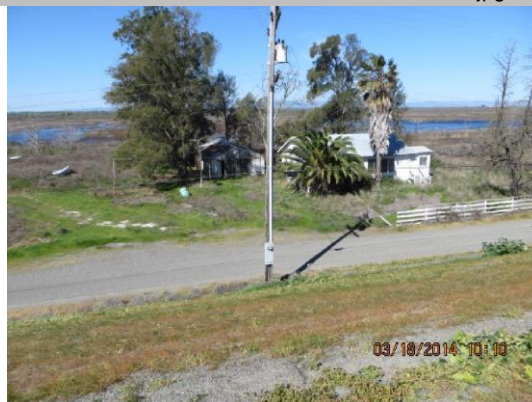
Photo 2 of 3 : UCIP_SP_2021_32225_58686.jpg

Power pole and meter next to spigot on LS toe.

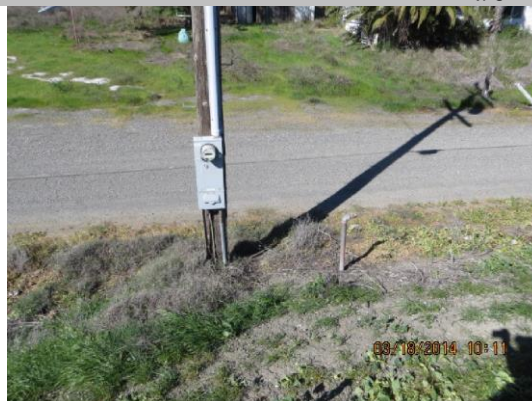
Photo 3 of 3 : UCIP_SP_2021_32225_58685.jpg

Power pole and meter next to spigot on LS toe.

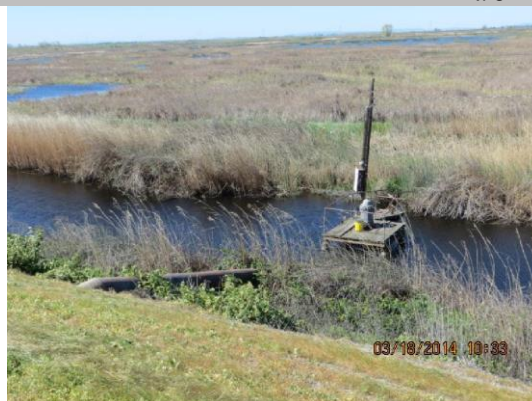
Photo 1 of 3 : UCIP_SP_2021_32227_58692.jpg

Comment Code						
Inspector Comment						
FS_ID:32227 DS_ID:20969 EP_NO: 13222 Repair Type: Non-Urgent Crossing Status: Found UCIP Comments: 03/18/2014 Pipe rusted through at outlet on WS slope, may indicate further degradation of pipe within levee. Good candidate for video inspection. (W. Wylie - DWR UCIP) FIELD_STRUCT_DESC: 20-inch steel drainage pipe through the levee, 7.5 feet below the crown. Siphon breaker on the waterside (WS) shoulder. Pump on pile structure in drainage ditch on the landside (LS). (This pipe was retained under Automatic Board Order (ABO) issued as Permit No. 10168, 1974 - Moresco Brothers. Pipe removed and replaced with a 19-inch steel pipe under the crown and along the LS slope under Permit No. 13222, 1981 - Prudential Insurance Company of America). [Additional Reference(s): DWR Levee Log, 2003. USACE Sacramento O&M Manual 109, April 1962, (HLM 2.98)]. FS Date: 3/18/2014

Pump on pile structure in drainage channel on LS toe.

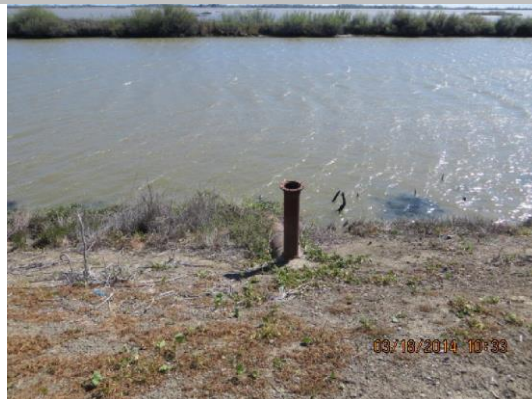
Photo 2 of 3 : UCIP_SP_2021_32227_58691.jpg

Siphon breaker in steel riser on WS slope.

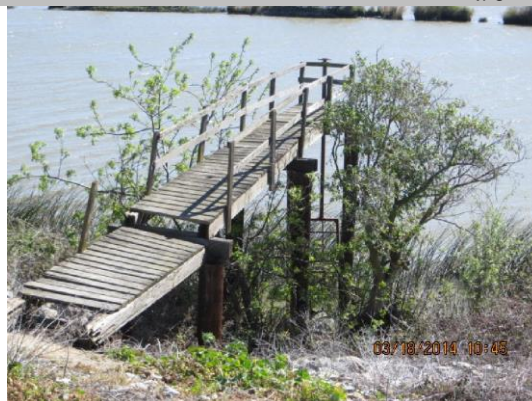
Photo 1 of 3 : UCIP_SP_2021_32243_58702.jpg

Comment Code						
Inspector Comment						
FS_ID:32243 DS_ID:20970 EP_NO: 10168 Repair Type: Non-Urgent Crossing Status: Found UCIP Comments: 03/18/2014 Walkway to slidegate on WS toe is in poor structural condition and may not be safe for accessing the slide gate actuator. Pipe appears abandoned and if so should be done so properly. Outlet on LS toe may be buried. (W. Wylie - DWR UCIP) FIELD_STRUCT_DESC: 24-inch steel irrigation pipe through the levee, 22.3 feet below the crown. Slide gate on the waterside (WS) end. Walkway from the WS shoulder to the slide gate control. Flap gate on the landside (LS) end. (This pipe was retained under Automatic Board Order (ABO) issued as Permit No. 10168, 1974 - Moresco Brothers). [Additional Reference(s): DWR Levee Log, 2003]. FS Date: 3/18/2014

Walkway to slide gate actuator on WS toe.

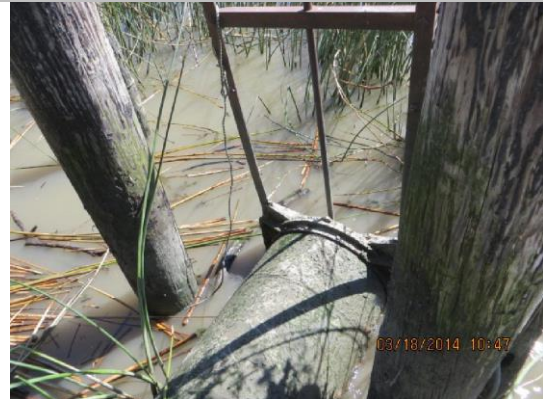
Photo 3 of 3 : UCIP_SP_2021_32243_58700.jpg

Slidegate on WS toe at pipe.

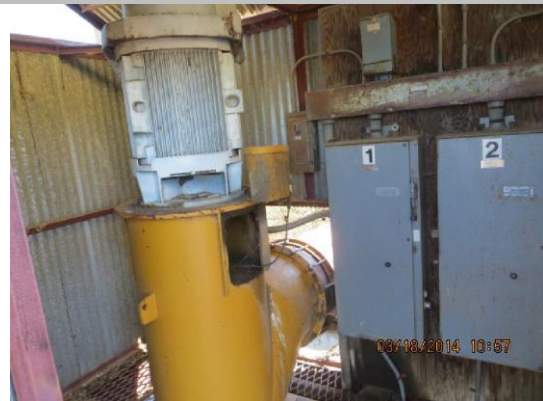
Photo 1 of 3 : UCIP_SP_2021_41717_58704.jpg

Pump in pumphouse on LS toe.

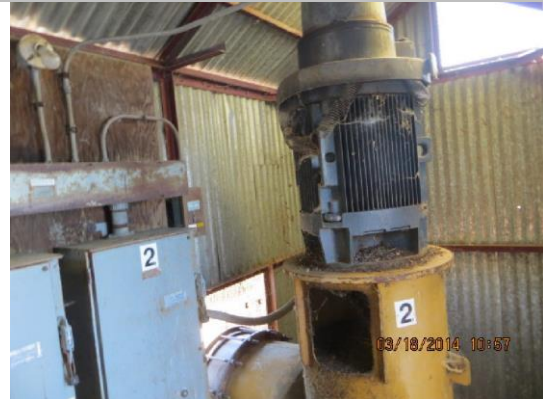
Photo 1 of 3 : UCIP_SP_2021_32245_58710.jpg

Pump in pumphouse on LS toe.

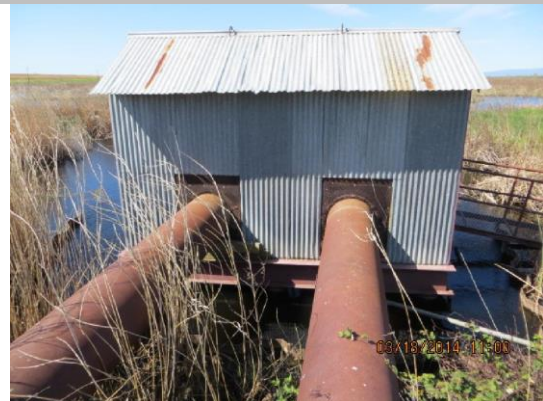
Photo 2 of 3 : UCIP_SP_2021_32245_58709.jpg

Pump in pumphouse on LS toe.

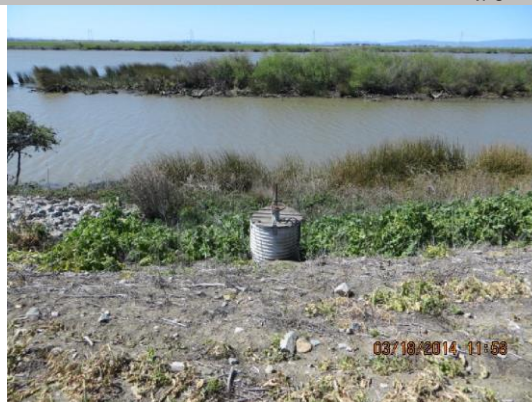
Photo 2 of 3 : UCIP_SP_2021_32287_58754.jpg

Slide gate in 36-inch standpipe on WS slope.

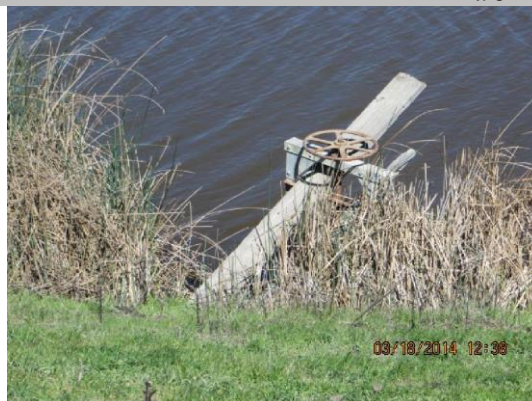
Photo 1 of 3 : UCIP_SP_2021_32290_58764.jpg

Slide gate at LS toe.

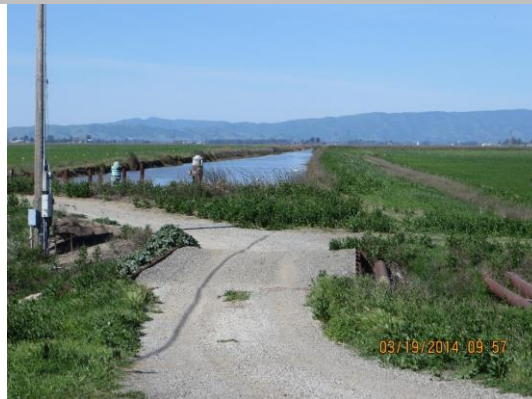
Photo 2 of 3 : UCIP_SP_2021_32403_58904.jpg

Pump on pier in irrigation canal off WS toe.

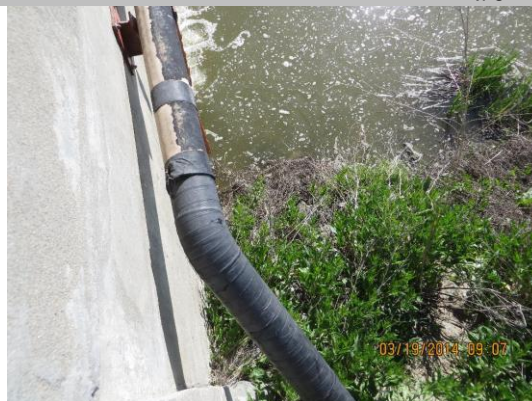
Photo 1 of 3 : UCIP_SP_2021_32566_59110.jpg

FS_ID:32566
 DS_ID:24845
 EP_NO: N/A
 Repair Type: Non-Urgent
 Crossing Status: Found
 UCIP Comments: 03/19/2014 Need to verify status with gas company and install signs. No permit identified for crossing, though it may be connected to a permitted line installed in RD 2068 under Permit No. 13490. (W. Wylie - DWR UCIP)
 FIELD_STRUCT_DESC: 6-inch coated steel gas line through the levee, 3 feet below the crown. Signs on the east side of the levee. Pipe visible on the downstream side of the roadway bridge.
 FS Date: 3/19/2014

Pipe visible on South side of Bridge at Swan Road.

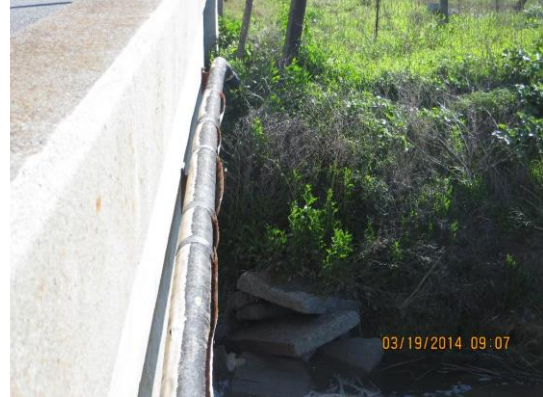
Photo 2 of 3 : UCIP_SP_2021_32566_59109.jpg

Pipe visible on South side of Bridge at Swan Road.

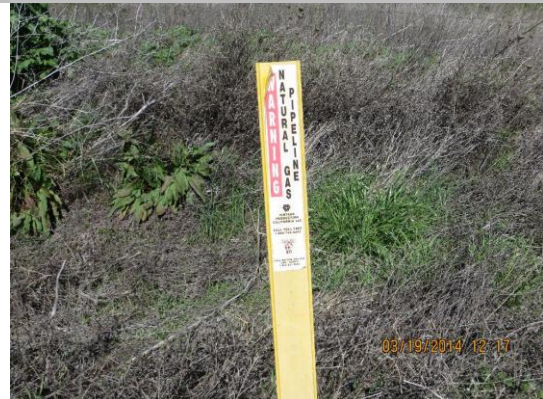
Photo 3 of 3 : UCIP_SP_2021_32566_59108.jpg

Sign off LS toe on East side of canal.
