Flood Control Project Maintenance
Levee Inspections
LMA District Cover Sheet

Reclamation District No. 2098 Cache and Haas Slough

**Flood Control Project Maintenance
Levee Inspections
Unit Cover Sheet**

Waterway	Bank	Unit Miles
Unit No. 01 Yolo Bypass	Right	3.60

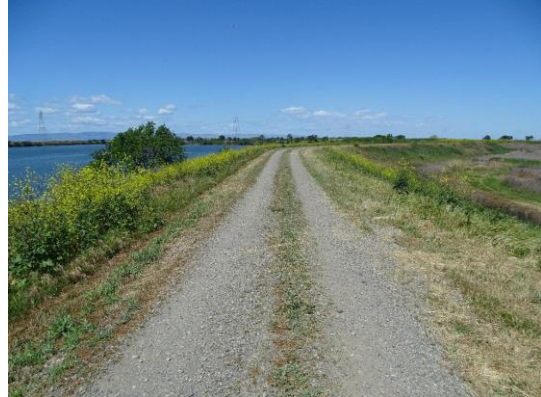
Photo 1 of 3 : UCIP_SP_2024_74580_111390.jpg

View of levee crown.

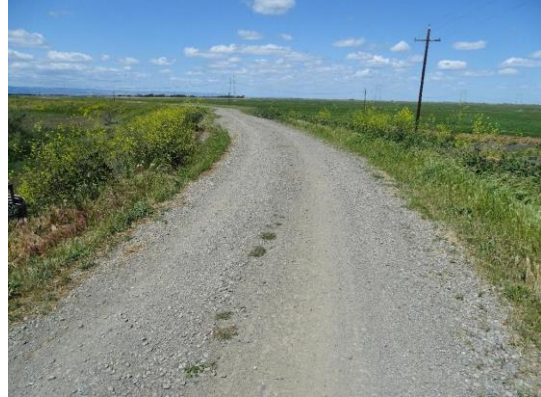
Photo 1 of 3 : UCIP_SP_2024_74585_111408.jpg

View of levee crown.

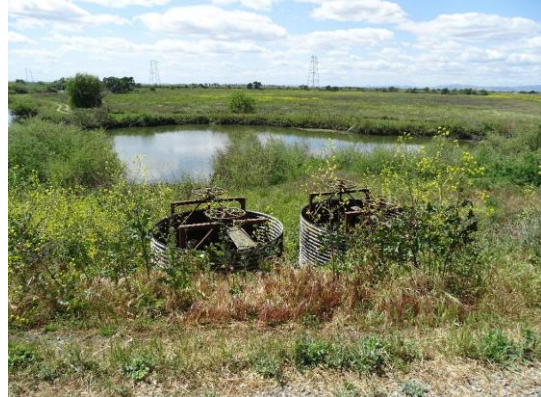
Photo 3 of 3 : UCIP_SP_2024_74585_111409.jpg

View of WS shoulder with CMP riser on slope.

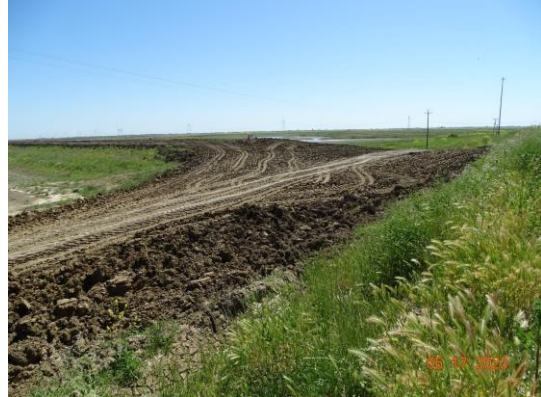
Photo 1 of 1 : SP_2024_RD2098_247_6_20240301_00003.jpg

LM Start	7.18	Rating **	A/W	Issue No.	6
LM End	8.31	Issue Type +	En	Location *	CR
Category	Earthen Levee			GPS Latitude/Longitude	
				Start	End
Item	Encroachments			38.293107°	38.306511°
				-121.724136°	-121.731462°
DWR ID	DWR_RD2098_03_s_2023_6				
Comment Code					
LC : Authorized Levee Construction					
Inspector Comment					
This section of Unit 3 is part of the Lookout Slough Tidal Habitat Restoration and Flood Improvement Project (in progress). The project area is bounded by a newly constructed levee along Duck Slough, which connects to Unit 3 at LM 8.31.

View of the newly constructed setback levee along Duck Slough connecting to Unit 3 at LM 8.31, looking east-southeast (Spring 2023).

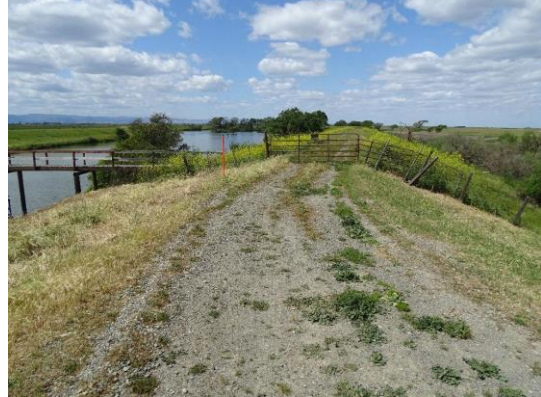
Photo 1 of 3 : UCIP_SP_2024_74611_111487.jpg

View of levee crown.
