**Flood Control Project Maintenance
Levee Inspections**

Fall 2024 Levee Maintenance Deficiency Summary Report

Sacramento River Basin

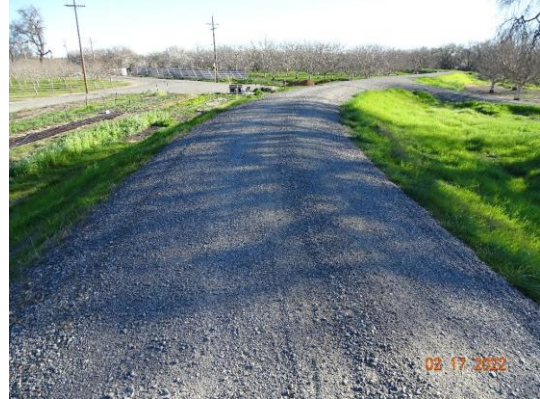
Photo 1 of 3 : UCIP_FA_2024_72495_108477.jpg

Comment Code						
Inspector Comment						
DS_ID:16271 FS_ID:72495 EP_NO: 10192 Repair Type: Non-Urgent EVAL Issue: Crossing Status: Indicator Found UCIP Comments: 02/17/2022 Record updated from No Action Needed to Non-Urgent. Concrete pipes are visible inside concrete riser on waterside. Unable to confirm that pipe is crossing new levee setback. Geophysical results did not confirm presence of pipe through levee. Record will remain in UCIP's inspection records until future Levee Improvement Project can confirm no crossing was found through the levee. No permit has been identified authorizing pipe. Crossing appears abandoned. Concrete debris, abandoned CMP riser at riverbank. Pipe was crossing old levee at angle. (O.Yakimov - DWR UCIP) 11/16/2018 There is a concrete standpipe and no other pipes connected to this standpipe. The standpipe is located between setback levee and the old levee. No other structure or pipe found. (Ted Skidgel - Sac Yard) FIELD_STRUCT_DESC: 24-inch corrugated metal drainage pipe through the levee, 6 feet below the crown. Slide gate in a concrete riser on the waterside (WS) shoulder. Plate welded on the waterside end. Well, pump, and discharge box on the landside (LS). (24-inch steel pipe [HLM 1.17] authorized under Automatic Board Order (ABO) issued as Permit No. 10192, 1974 - Harry H. and Jane Dewey). [Additional Reference(s): DWR Levee Log, 1993 (HLM 1.17), listed as abandoned 24-inch pipe. USACE Sacramento O&M Manual 126, November 1961, (HLM 1.17)]. USACE As-Built Drawing No. 50-04-3227, January 1960, Sheet 3, STA 215+50]. FS Date: 2/17/2022 9:28:04 AM

Top of Levee: View of levee crown looking downstream

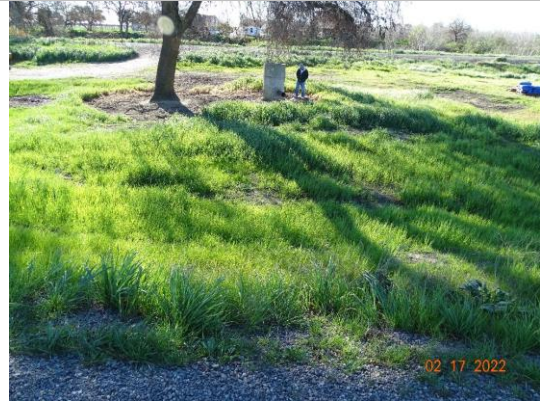
Photo 2 of 3 : UCIP_FA_2024_72495_108479.jpg

Water-Side: View of levee slope looking from crown

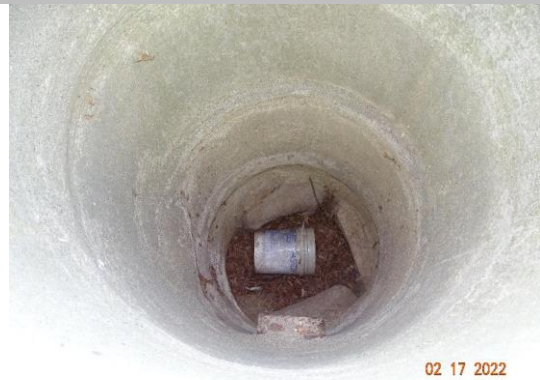
Photo 3 of 3 : UCIP_FA_2024_72495_108480.jpg

Water-Side: Concrete pipes inside concrete standpipe

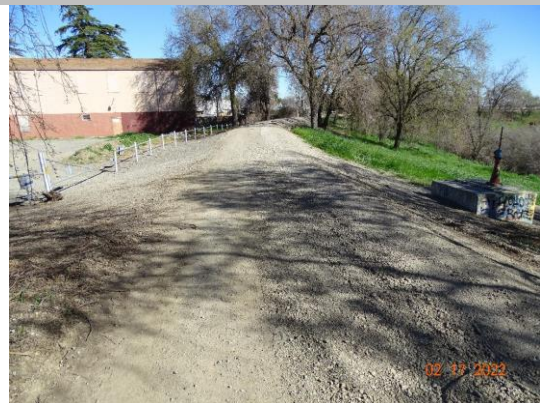
Photo 1 of 3 : UCIP_FA_2024_72523_108546.jpg

Comment Code					
Inspector Comment					
DS_ID:16269 FS_ID:72523 EP_NO: 13077A Repair Type: Non-Urgent EVAL Issue: 5, Pipe Damage Crossing Status: Found UCIP Comments: 09/23/2024 DMP internal video inspection has found moderate pipe defects. Crossing will be monitored until funding becomes available for rehabilitation. (O. Yakimov - DWR UCIP) 02/17/2022 Record remains No Action Needed. No issues observed during inspection. (O.Yakimov - DWR UCIP) 11/16/18 SMY Ted Skidgel W/S brush needs cleared FIELD_STRUCT_DESC: 30-inch square cast-in-place reinforced concrete drainage conduit through the levee, 19 feet below the crown. Screw gate on the waterside (WS) slope. Gate riser structure approximately 4 feet off the WS levee shoulder. Flap gate on the 30-inch pipe end at the discharge structure. Grated drain in the street parallel to the levee. (Construction of a storm drainage system authorized under Permit No. 13077, 1981 - Yolo County). (Revision of initial permit to use 30-inch cast-in-place square conduit authorized under Permit No. 13077-A, 1981 - Yolo County DPW). [Additional Reference(s): DWR Levee Log, 1993 (HLM 2.06), listed as a pipe through levee]. FS Date: 2/17/2022 3:17:46 PM

Top of Levee: View of levee crown looking downstream

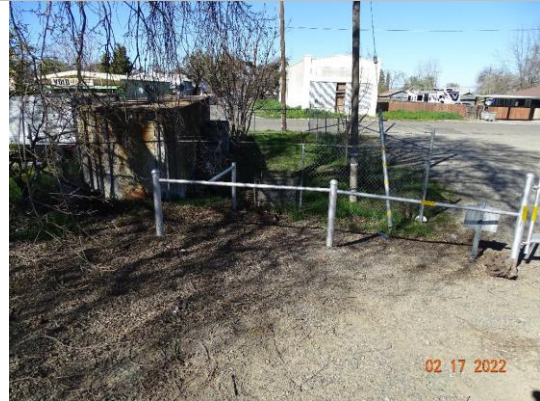
Photo 2 of 3 : UCIP_FA_2024_72523_108543.jpg

Land-Side: View of levee slope looking from crown

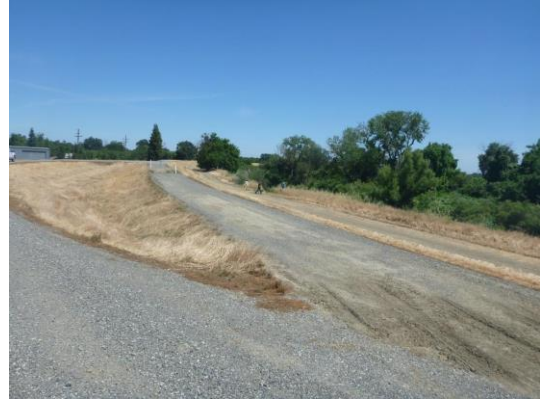
Photo 1 of 2 : LEVAL_FA_2024_249_954.jpg

View of toe road where erosion is located.

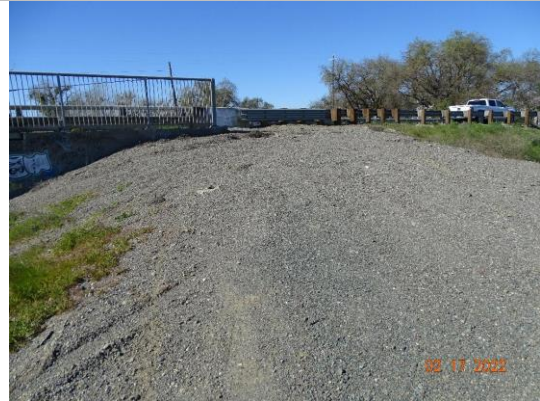
Photo 1 of 3 : UCIP_FA_2024_72612_108754.jpg

DS_ID:16265
FS_ID:72612
EP_NO: 7232
Repair Type: Non-Urgent
EVAL Issue: 11, Maintenance Compliance Issue
Crossing Status: Indicator Found
UCIP Comments: 02/17/2022 Record remains Non-Urgent. Broken communication line sign found at landside toe needs repair. (O.Yakimov - DWR UCIP)
06/16/2016 May need marker on WS (Ted Skidgel - Sac Yard)
FIELD_STRUCT_DESC: Telephone conduit of an unknown size or material through the levee, 2.5 feet below the crown. Communications marker located on the east side of Highway 113 on the landside (LS) toe. (Telephone conduit authorized under Permits No. 7232, 7232-A, issued in 1970 and 1971 correspondingly - Pacific Telephone and Telegraph Company [PT&T]). [Additional Reference(s): DWR Levee Log, 1993 (HLM 4.97)].
FS Date: 2/17/2022 9:12:09 AM

Top of Levee: View of levee crown looking upstream. State Hwy 113 on the background

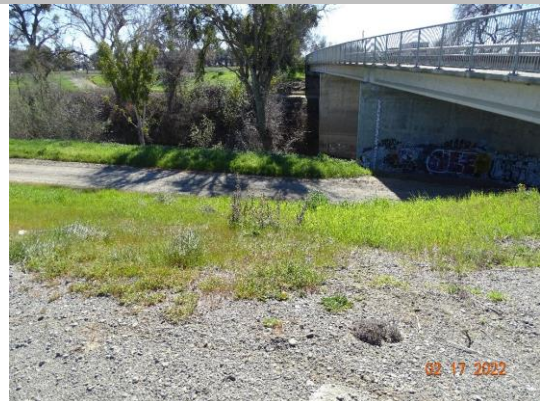
Photo 2 of 3 : UCIP_FA_2024_72612_108755.jpg

Water-Side: View of levee slope looking from crown

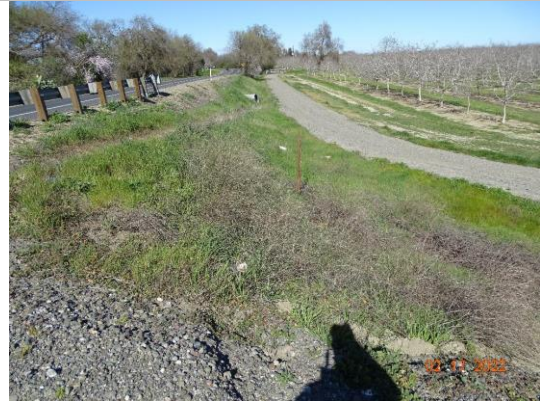
Photo 3 of 3 : UCIP_FA_2024_72612_108756.jpg

Land-Side: View of levee slope looking from crown

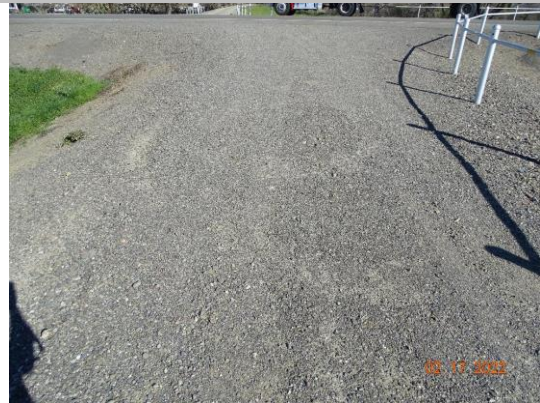
Photo 1 of 3 : UCIP_FA_2024_72622_108798.jpg

Comment Code					
Inspector Comment					
DS_ID:25072 FS_ID:72622 EP_NO: 7668 Repair Type: Non-Urgent EVAL Issue: 11, Maintenance Compliance Issue Crossing Status: Indicator Found UCIP Comments: 02/17/2022 Record is Non-Urgent. Manholes covered with debris. Markers are not installed on any side of levee. (O.Yakimov - DWR UCIP) FIELD_STRUCT_DESC: 4-inch telephone conduit of an unknown material through both levees and under Cache Creek, 6 feet below the crown. Conduit runs 10 feet west along County Road 102. Manhole just off the landside toe next to CO RD 102. (Telephone conduit authorized under Permit No. 7668, 1971 - Pacific Telephone and Telegraph Company [PT&T]). [Additional Reference(s): DWR Levee Log, 1993 (HLM 7.21)]. FS Date: 2/17/2022 11:22:31 AM

Top of Levee: View of levee crown looking downstream

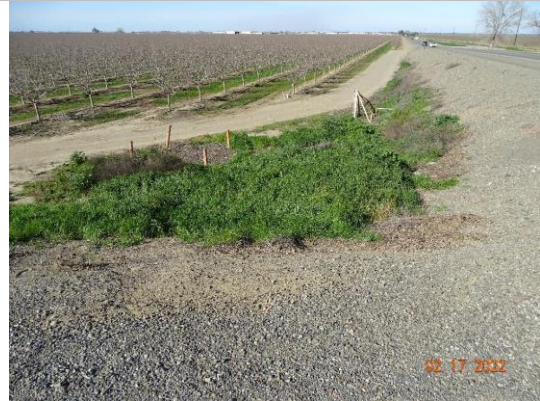
Photo 2 of 3 : UCIP_FA_2024_72622_108795.jpg

Land-Side: View of levee slope looking from crown

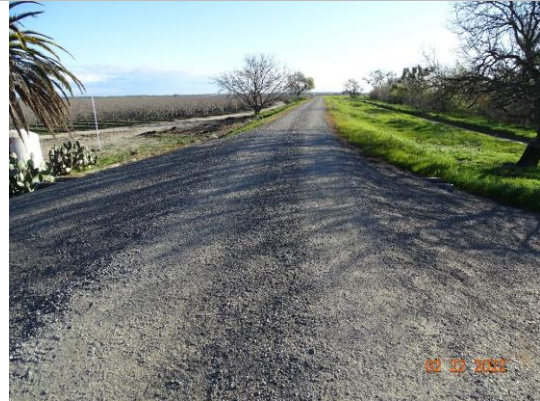
Photo 1 of 3 : UCIP_FA_2024_72738_109096.jpg

DS_ID:16765
FS_ID:72738
EP_NO: 16810
Repair Type: Non-Urgent
EVAL Issue: 11, Maintenance Compliance Issue
Crossing Status: Found
UCIP Comments: 02/22/2022 Record updated from No Action Needed to Non-Urgent. Pipe is open on landside. Recommend owner to install a cap on landside pipe end. (O.Yakimov - DWR UCIP)
11/16/18 Two pipes W/S 1 capped, L/S both open. (Ted Skidgel - Sac Yard)
FIELD_STRUCT_DESC: 1 of 2: 14-inch coated steel irrigation pipe through the levee approximately 2-3 feet below the crown. Pipe connects to a seasonal 14-inch polyvinyl chloride (PVC) pipe and a 100-horsepower mobile pumping plant on the waterside slope. (One 14-inch steel pipe authorized under Permit No. 16810, 1998 - W. Ashley Payne, permit inspection notes indicate that two 14-inch pipes were installed). (Retention of two 14-inch pipes authorized under Permit No. 16810-R, 2002 - Ashley Payne).
FS Date: 2/22/2022 3:41:16 PM

Top of Levee: View of levee crown looking downstream

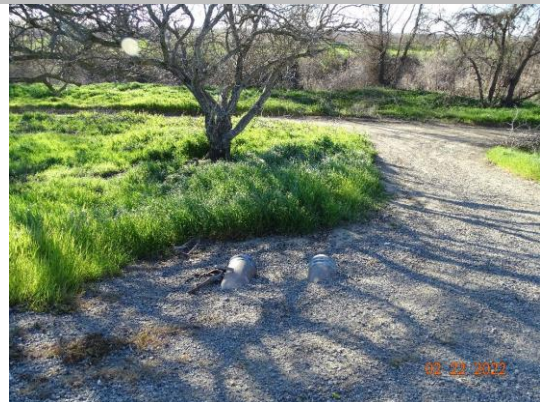
Photo 2 of 3 : UCIP_FA_2024_72738_109097.jpg

Water-Side: View of levee slope looking from crown

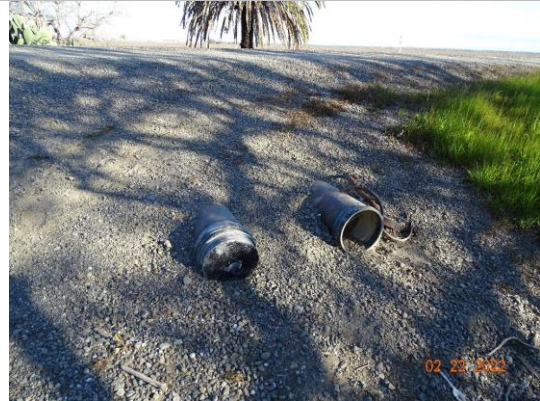
Photo 3 of 3 : UCIP_FA_2024_72738_109094.jpg

Water-Side: pipes on levee slope. Cap is installed on pipe end

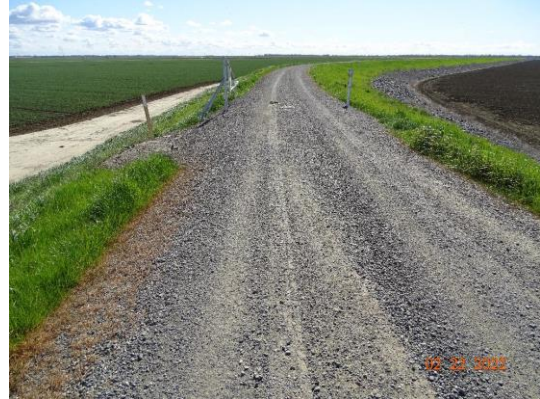
Photo 1 of 3 : UCIP_FA_2024_72789_109241.jpg

Comment Code						
Inspector Comment						
DS_ID:17113 FS_ID:72789 EP_NO: N/A Repair Type: Non-Urgent EVAL Issue: 11, Maintenance Compliance Issue Crossing Status: Found UCIP Comments: 02/22/2022 Record updated from No Action Needed to Non-Urgent. No permit has been found authorizing this pipe through the levee. Damaged siphon breaker on landside shoulder needs maintenance. (O.Yakimov - DWR UCIP) 11/16/2018 Waterside buried landside closed. (Ted Skidgel - Sac Yard) FIELD_STRUCT_DESC: 18-inch, 0.25-inch-thick soil-proofed steel irrigation pipe, 3 feet below the crown. Installed during Cache Creek Settling Basin enlargement in 1991. (24-inch steel irrigation pipes at 5 locations authorized under Permit No. 12705, 1979 - Layton Knaggs. Permit was administratively closed). [Additional Reference(s): DWR Levee Log, 1993 (HLM 9.37), listed as 24-inch pipe0. USACE As-Built Drawing No. CC5-04-0070, 6 May 1991, Sheet 15, STA UNK]. FS Date: 2/22/2022 10:59:45 AM

Top of Levee: View of levee crown looking downstream

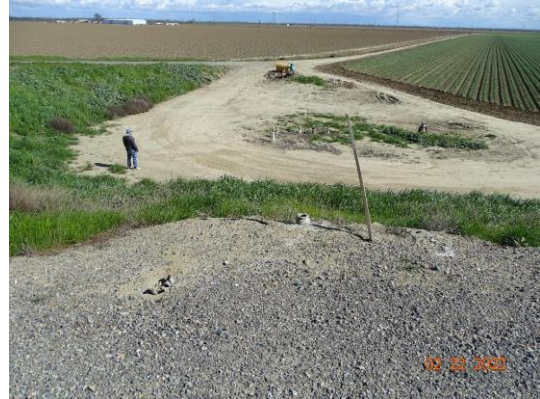
Photo 3 of 3 : UCIP_FA_2024_72789_109243.jpg

Land-Side: View of levee slope looking from crown. Water well in the field

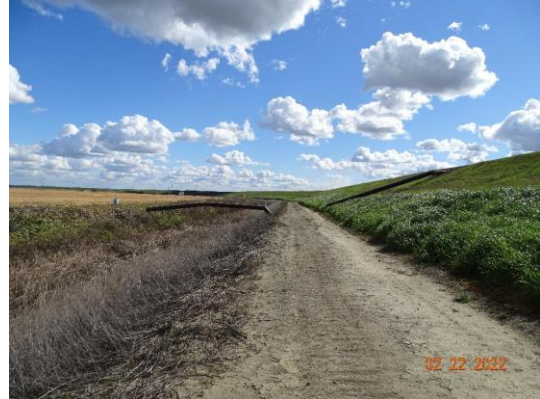
Photo 2 of 3 : UCIP_FA_2024_72795_109256.jpg

Land-Side: Pipe profile on landside

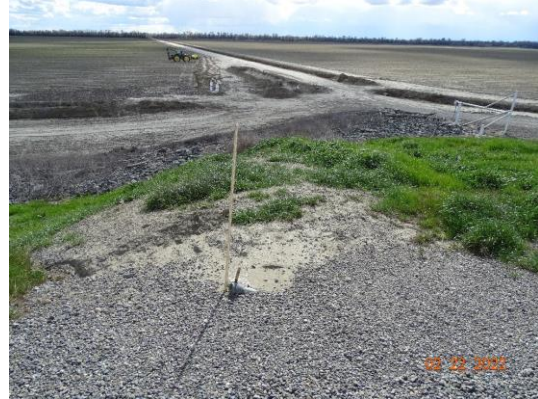
Photo 1 of 3 : UCIP_FA_2024_72797_109260.jpg

Water-Side: View of levee slope looking from crown

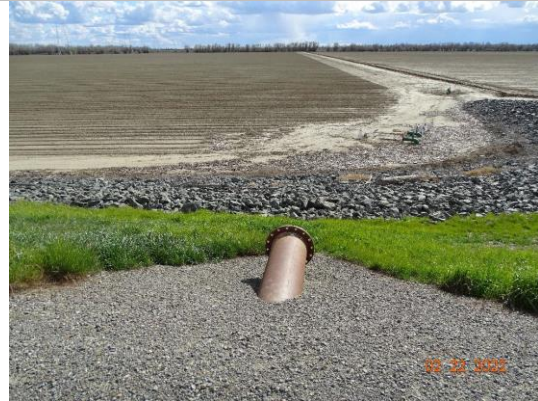
Photo 1 of 3 : UCIP_FA_2024_72802_109280.jpg

Water-Side: View of levee slope looking from crown. Pipe end is open

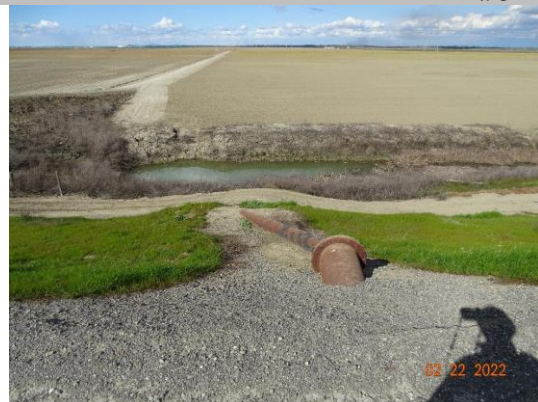
Photo 2 of 3 : UCIP_FA_2024_72802_109281.jpg

Land-Side: View of levee slope looking from crown

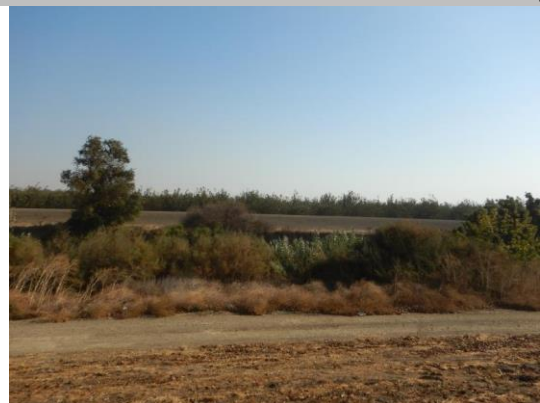
Photo 1 of 2 : FA_2024_ST0001_260_2_20240909_00002.jpg

LM Start	0.90	Rating **	A/W	Issue No.	2
LM End	0.92	Issue Type +	Ma	Location *	WS
Category	Supplemental			GPS Latitude/Longitude	
				Start	End
Item	2018 USACE Erosion Survey			38.732678 °	38.732903 °
				-121.795347 °	-121.795017 °
DWR ID	DWR_ST0001_02_f_2022_2				
Comment Code					
Inspector Comment					
2018 Site ID: CHC 0.9 R					
Status: Eroding New					
2018 Field Notes: Vertical eroding bank slope.					
Site History:

USACE 2018 Erosion Photo #1

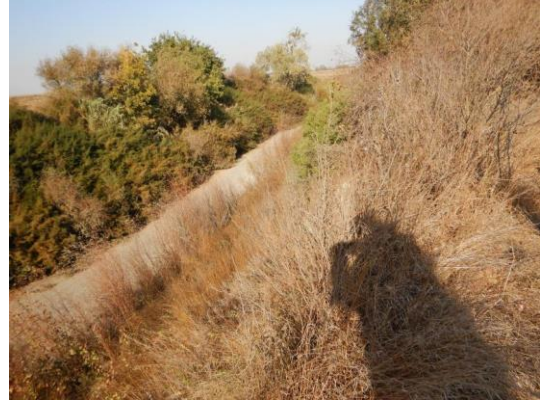
Photo 2 of 2 : FA_2024_ST0001_260_2_20240909_00003.jpg

USACE 2018 Erosion Photo #2

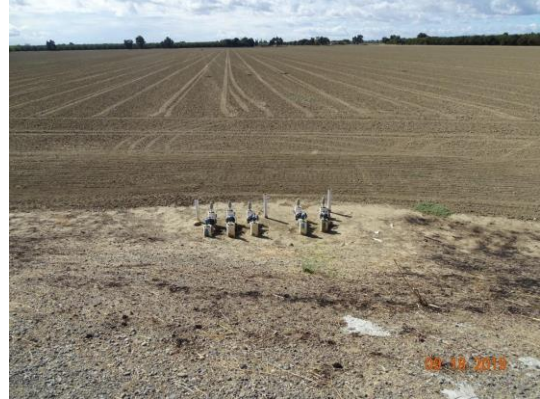
Photo 1 of 1 : FA_2024_ST0001_260_24_20240909_00014.jpg

LM Start	1.97	Rating **	M	Issue No.	24
LM End	1.97	Issue Type +	En	Location *	LS
Category	Earthen Levee			GPS Latitude/Longitude	
				Start	End
Item	Encroachments			38.727653 °	38.727653 °
				-121.782412 °	-121.782412 °
DWR ID	DWR_ST0001_02_f_2019_24				
Comment Code					
EQ : Equipment					
Inspector Comment					
There are small pumps with 10 air valves, and 3 bollards located at the landside toe. The pipes do not appear to cross levee. Need to find permit.

View of the pumps, air valves, and bollards at the landside toe. Fall 2019.

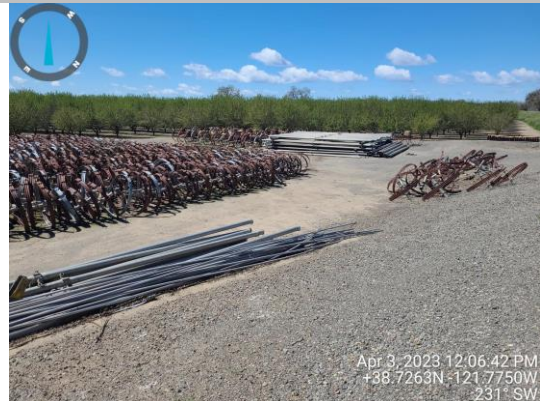
Photo 1 of 1 : FA_2024_ST0001_260_38_20240909_00019.jpg

LM Start	2.36	Rating **	M	Issue No.	38
LM End	2.38	Issue Type +	En	Location *	LS
Category	Earthen Levee			GPS Latitude/Longitude	
				Start	End
Item	Encroachments			38.726376 °	38.726299 °
				-121.775610 °	-121.775301 °
DWR ID	DWR_ST0001_02_f_2022_38				
Comment Code					
EQ : Equipment					
Inspector Comment					
There is farm equipment on the landside toe.

View of pipes and equipment on the landside toe. Spring 2023.

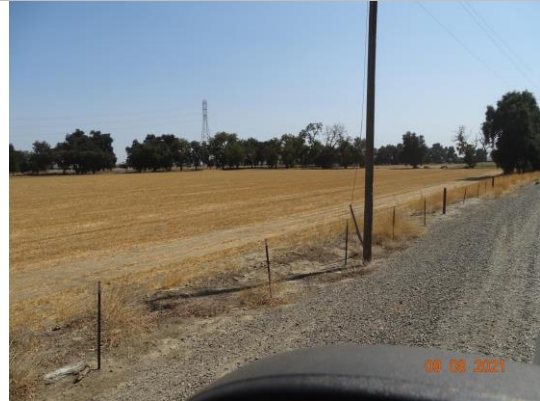
Photo 1 of 1 : FA_2024_ST0001_260_15_20240909_00011.jpg

LM Start	3.30	Rating **	M	Issue No.	15
LM End	3.52	Issue Type +	En	Location *	LS
Category	Earthen Levee			GPS Latitude/Longitude	
				Start	End
Item	Encroachments			38.719546°	38.722053°
				-121.761213°	-121.759600°
DWR ID	DWR_ST0001_02_f_2016_15				
Comment Code					
FE : Fence					
Inspector Comment					
There is a wire fence at the landside toe.

View of fence at landside toe. Fall 2021.

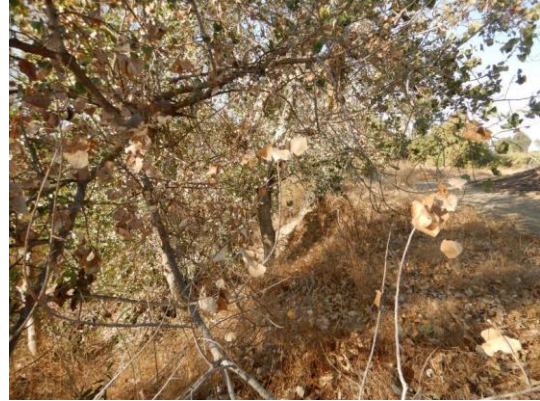
Photo 1 of 2 : FA_2024_ST0001_260_11_20240909_00008.jpg

USACE 2018 Erosion Photo #1

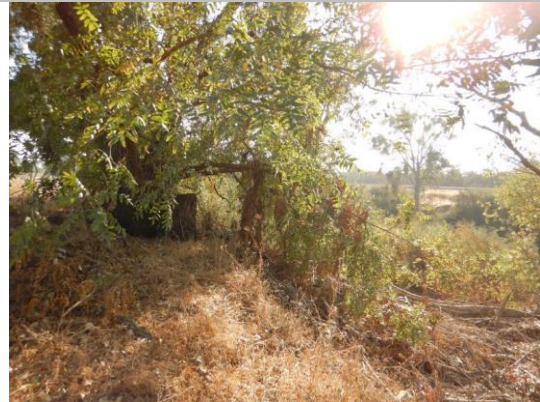
Photo 2 of 2 : FA_2024_ST0001_260_11_20240909_00009.jpg

2018 Site ID: CHC 3.5 R
Status: Eroding
2018 Field Notes: No observed change.
Site History: 2010 - Large slump on the upper berm, a tree has recently slid down the slope. 2011 - Large slump and new erosion. 2012 - Slightly steeper slopes and cracks observed. 2017 - Significant amount of debris along bank.

USACE 2018 Erosion Photo #2

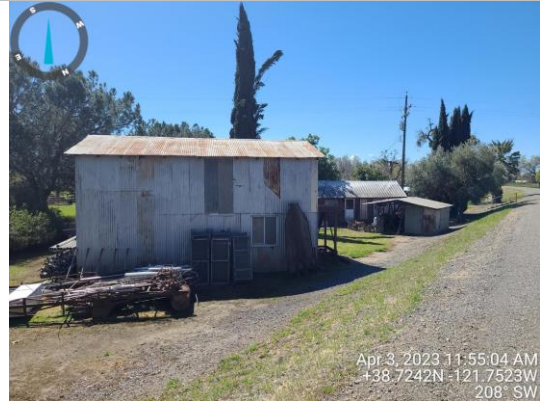
Photo 1 of 1 : FA_2024_ST0001_260_8_20240909_00006.jpg

LM Start	4.06	Rating **	M	Issue No.	8
LM End	4.06	Issue Type +	En	Location *	LS
Category	Earthen Levee			GPS Latitude/Longitude	
				Start	End
Item	Encroachments			38.723992 °	38.723992 °
				-121.752511 °	-121.752511 °
DWR ID	DWR_ST0001_02_f_2023_8				
Comment Code					
BU : Building					
Inspector Comment					
A building is within the easement of the levee.

View of building within the landside easement. Spring 2023.

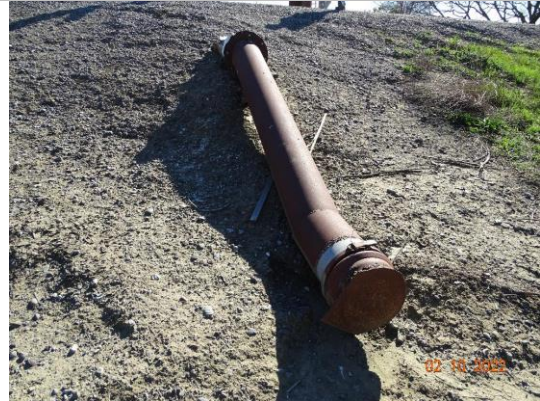
Photo 1 of 3 : UCIP_FA_2024_72295_107644.jpg

DS_ID:16767
FS_ID:72295
EP_NO: 17174
Repair Type: Non-Urgent
EVAL Issue: 11, Maintenance Compliance Issue
Crossing Status: Found
UCIP Comments: 02/10/2022 Record updated from No Action Needed to Non-Urgent. Crossing appears abandoned. Waterside pipe end is capped, landside end is open. Recommend closing landside end. (O.Yakimov - DWR UCIP)
08/05/2020: same observation as previous inspection 11/17/2017: water side closed, landside open
FIELD_STRUCT_DESC: 14-inch coated steel irrigation pipe through the levee, 2 feet below the crown. Seasonal removable pipe and pump facility on the waterside (WS) slope. (14-inch irrigation pipe, removable pipe, and pump facility authorized under Permit No. 17174, 2000 - Howald Farms).
FS Date: 2/10/2022 11:40:24 AM

Water-Side: View of levee slope looking from toe. Capped pipe on the slope

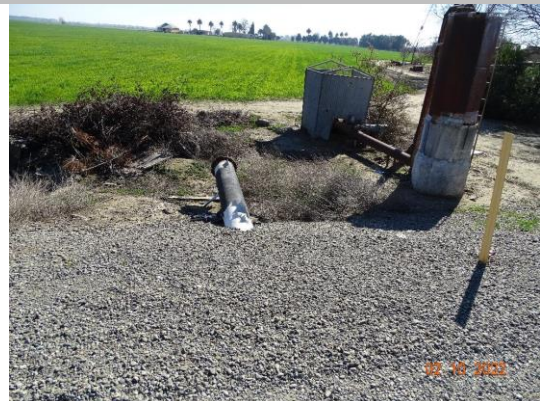
Photo 2 of 3 : UCIP_FA_2024_72295_107647.jpg

Land-Side: View of levee slope looking from crown

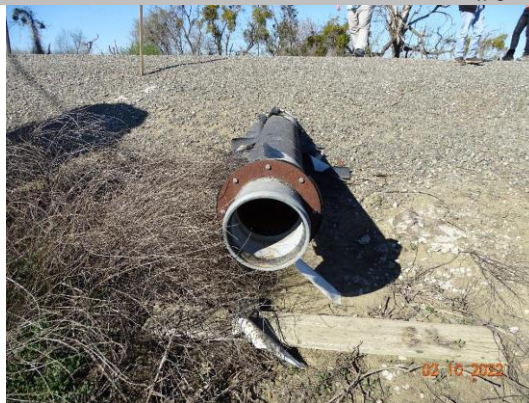
Photo 3 of 3 : UCIP_FA_2024_72295_107648.jpg

LM Start	4.51	Rating **	M	Issue No.	39 (cont)	
LM End	4.51	Issue Type +	En	Location *		
Category	Supplemental			GPS Latitude/Longitude		
				Start		End
Item	DWR UCIP Field Study			38.727145°	38.727145°	
				-121.745603°	-121.745603°	
DWR ID	16767

Land-Side: Pipe end open on landside

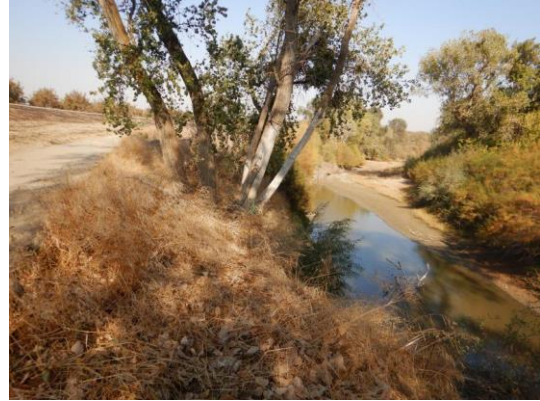
Photo 1 of 2 : FA_2024_ST0001_260_27_20240909_00015.jpg

2018 Site ID: CHC 5.4 L
Status: Eroding
2018 Field Notes: No observed change.
Site History: 2009 - Erosion into the levee slope. 2010 - Minor new erosion. 2011 - New erosion and a freshly fallen tree. 2012 - New animal holes and slightly steeper slopes. 2013 - New tree pop out and 2 feet of erosion along the top bank. 2017 - Site continues to erode due to the high 2017 storm event.

LM Start	5.33	Rating **	A/W	Issue No.	27 (cont)
LM End	5.37	Issue Type +	Ma	Location *	WS

USACE 2018 Erosion Photo #1

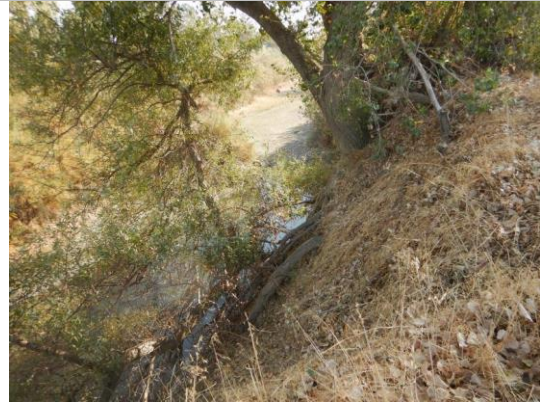
Photo 2 of 2 : FA_2024_ST0001_260_27_20240909_00016.jpg

USACE 2018 Erosion Photo #2
