**Flood Control Project Maintenance
Levee Inspections**

Maintenance Issue Types Only, Levee Inspection Report By Mile - Spring 2017

Sacramento Maintenance Yard Putah Creek

Waterway	Bank	Unit Miles	Inspection Start/End	Inspector
Unit No. 01 Putah Creek or North Levee	Left	8.79	04/19/2017 04/18/2017	Herman Phillips

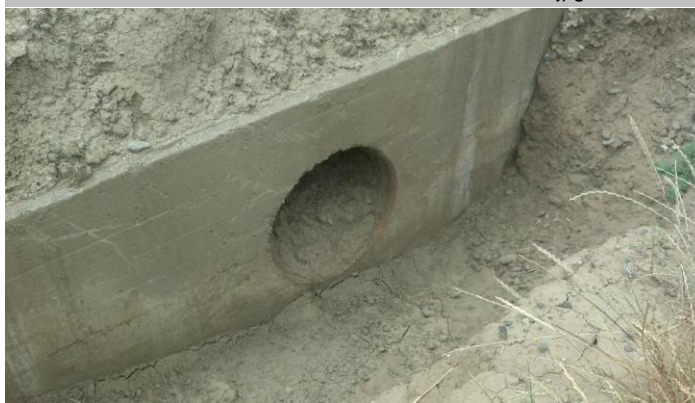
Photo 1 of 3 : UCIP_SP_2017_33328_60329.jpg

LM Start	8.28	Rating **	A/W	Issue No.	61
LM End	8.28	Issue Type +	Ma	Location *	WS
Category	Supplemental			GPS Latitude/Longitude	
				Start	End
Item	DWR UCIP LMA Responsibility			38.521246 °	38.521246 °
				-121.776434 °	-121.776434 °
DWR ID					
Comment Code					
Inspector Comment					
FS_ID:33328 DS_ID:520 EP_NO: 10247 Repair Type: No Action Needed Crossing Status: Found UCIP Comments: Cleaned inlet and outlets. Owner of pipe may need to clean pipe FIELD_STRUCT_DESC: 4-inch drainpipe through the levee 8.0 feet below the crown. Slide gate on waterward end. (ABO No. 10247 U.C.D.) FS Date: 4/10/2014 2:23:46 PM

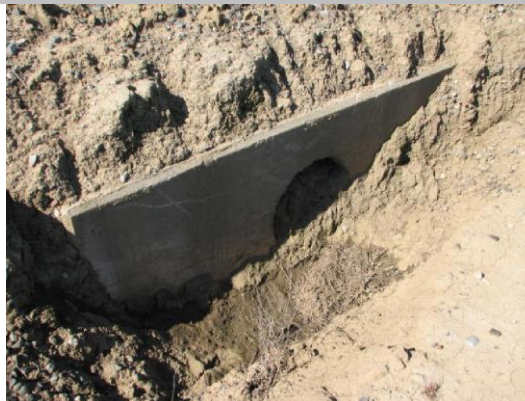
Photo 2 of 3 : UCIP_SP_2017_33328_60327.jpg

LS headwall showing pipe plugged with soil

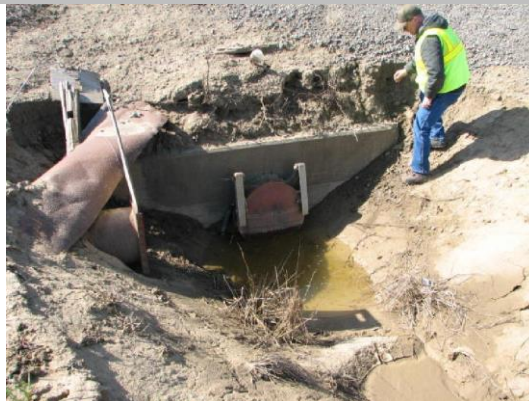
Photo 2 of 3 : UCIP_SP_2017_33375_60429.jpg

WS headwall and flapgate.

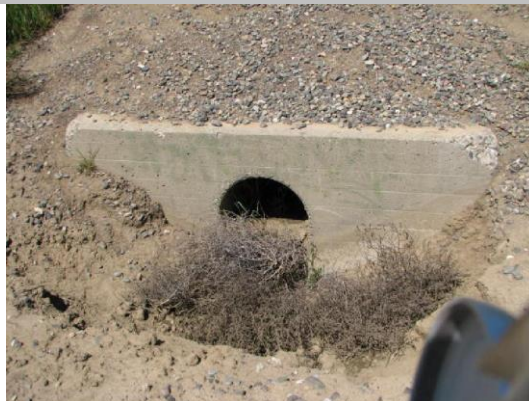
Photo 1 of 2 : UCIP_SP_2017_33353_60380.jpg

LS headwall and pipe showing sediment buildup.

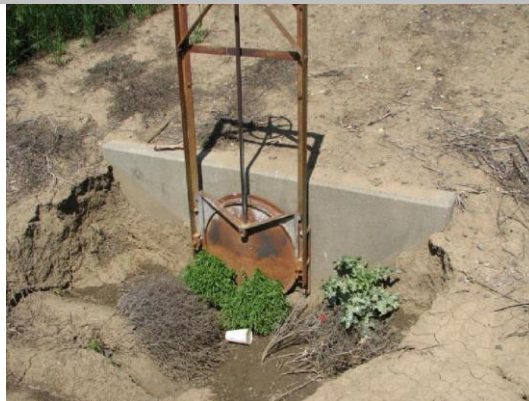
Photo 1 of 2 : UCIP_SP_2017_42959_60374.jpg

LS slide gate
