**Flood Control Project Maintenance
Levee Inspections**

Maintenance Issue Types Only, Levee Inspection Report By Mile - Spring 2020

Sacramento Maintenance Yard Putah Creek

Waterway	Bank	Unit Miles	Inspection Start/End	Inspector
Unit No. 01 Putah Creek or North Levee	Left	8.79	04/23/2020 04/23/2020	David Julian

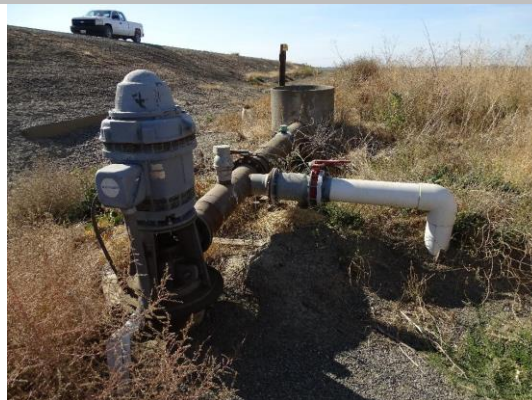
Photo 3 of 3 : UCIP_SP_2020_55584_82058.jpg

Water well connected to standpipe at LS toe. Top of headwall is visible

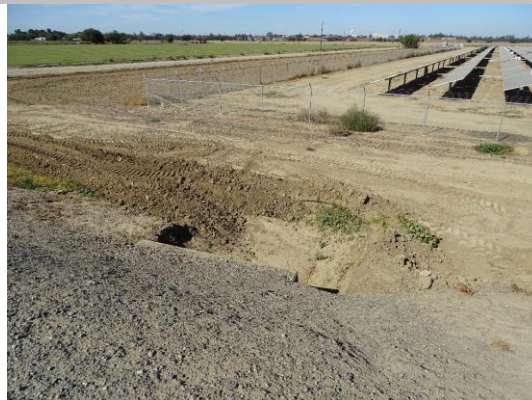
Photo 1 of 3 : UCIP_SP_2020_55647_82273.jpg

Comment Code						
Inspector Comment						
DS_ID:505 FS_ID:55647 EP_NO: 10253 Repair Type: Non-Urgent Crossing Status: Found UCIP Comments: 10/22/2019 Record updated from No Action Needed to Non-Urgent. Levee toe erosion on both sides of headwall on WS. Need to have CVFPB review ABO and determine current owner. (O.Yakimov - DWR UCIP) FIELD_STRUCT_DESC: 24-inch CIPP-lined corrugated metal drainage pipe through the levee, 10.4 feet below the crown. Slide gate on the waterside (WS), and concrete headwalls on both the WS and the landside (LS). (24-inch pipe [HLM 6.57] authorized under Automatic Board Order (ABO) issued as Permit No. 10253, 1974 - Lester J. Hamel). [Additional Reference(s): DWR Levee Log, 2005 (HLM 6.57. USACE Sacramento O&M Manual, Unit 119, December 1952, Revised 29 Dec 2016, (Station 145+50 PCT), listed as 24-inch pipe. USACE As-Built Drawing No. 50-04-2396, Revision 4, pdf page 24, Sheet 8, December 1947]. FS Date: 10/22/2019 11:07:35 AM

View of LS looking from levee crown

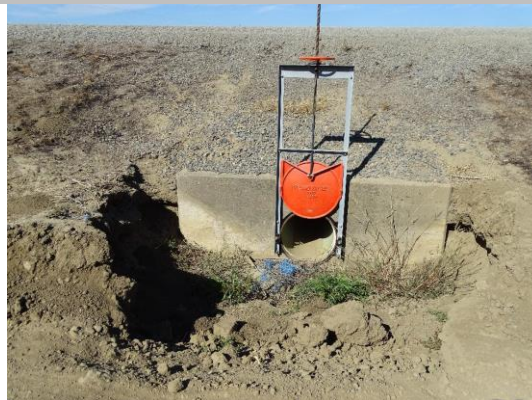
Photo 3 of 3 : UCIP_SP_2020_55647_82275.jpg

WS levee slope, headwall, and slide gate

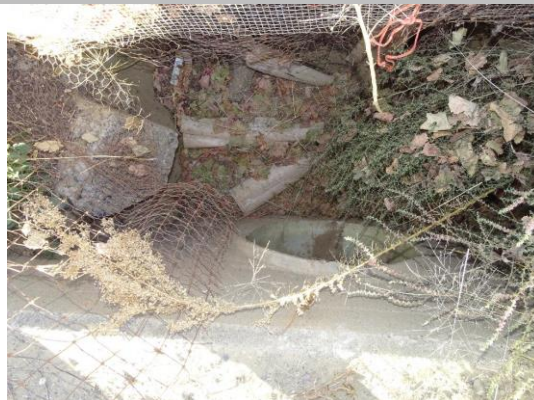
Photo 2 of 3 : UCIP_SP_2020_55675_82383.jpg

LS: headwall and pipe end near a fence

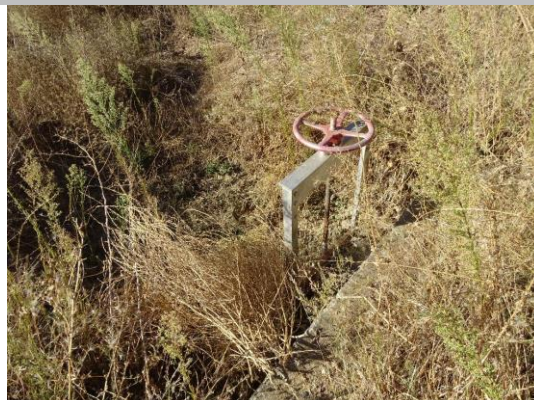
Photo 3 of 3 : UCIP_SP_2020_55675_82385.jpg

WS: headwall and slide gate

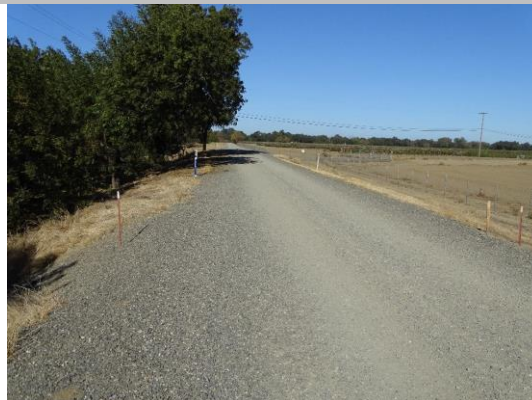
Photo 1 of 3 : UCIP_SP_2020_55679_82393.jpg

View of levee crown at the crossing

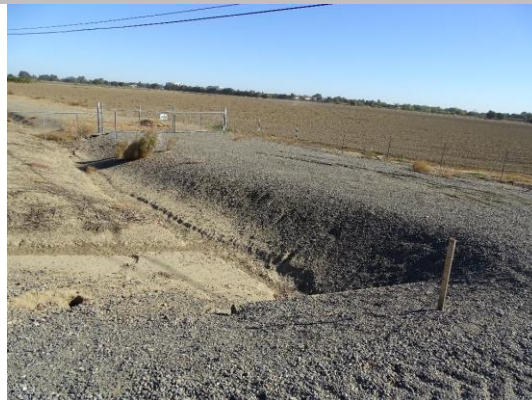
Photo 2 of 3 : UCIP_SP_2020_55680_82399.jpg

View of LS looking from levee crown

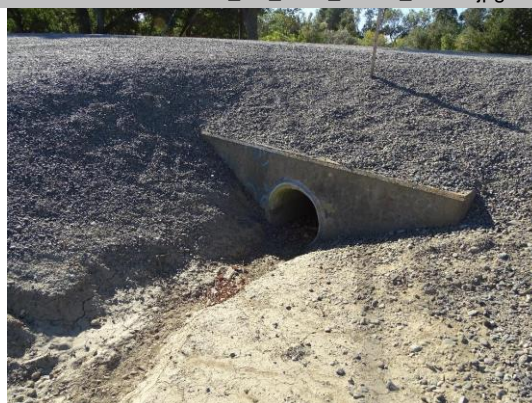
Photo 3 of 3 : UCIP_SP_2020_55680_82400.jpg

LS levee slope, headwall, and pipe end

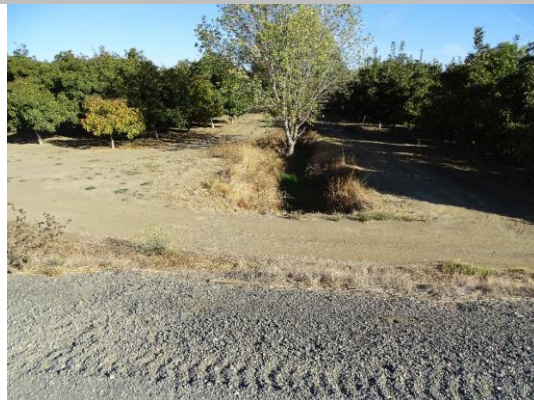
Photo 1 of 3 : UCIP_SP_2020_55424_81638.jpg

View of WS looking from levee crown

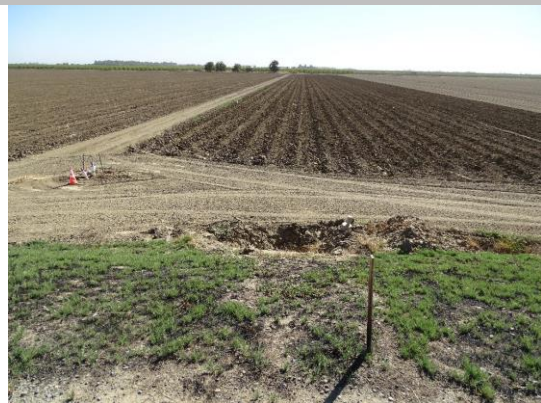
Photo 1 of 3 : UCIP_SP_2020_55411_81619.jpg

Comment Code						
Inspector Comment						
DS_ID:16625 FS_ID:55411 EP_NO: 10277 Repair Type: Urgent Crossing Status: Found UCIP Comments: 10/21/2019 Record updated from No Action Needed to Urgent. A PVC pipe runs through a drainage pipe from LS to WS levee toe. Slide gate cannot be closed properly to prevent flooding on LS. Remove PVC pipe. Need to have CVFPB review ABO and determine current owner. (O.Yakimov - DWR UCIP) FIELD_STRUCT_DESC: 24-inch CIPP-lined corrugated metal drainage pipe through the levee, 9 feet below the crown. Slide gate on the waterside (WS) slope. Concrete headwalls on both ends. (24-inch pipe [HLM 2.71] authorized under Automatic Board Order (ABO) issued as Permit No. 10277, 1974 - Naomi Schoeningh). [Additional Reference(s): DWR Levee Log, 2005 (HLM 2.71). USACE Sacramento O&M Manual, Unit 119, December 1952, Revised 29 Dec 2016, (Station 30+15 PCT), listed as 24-inch pipe. USACE As-Built Drawing No. 50-04-2396, Revision 4, pdf page 23, Sheet 7, December 1947]. FS Date: 10/21/2019 11:18:53 AM

View of LS from levee crown

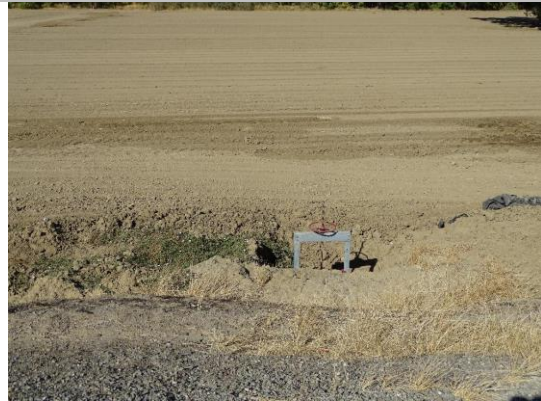
Photo 2 of 3 : UCIP_SP_2020_55411_81620.jpg

View of WS from levee crown

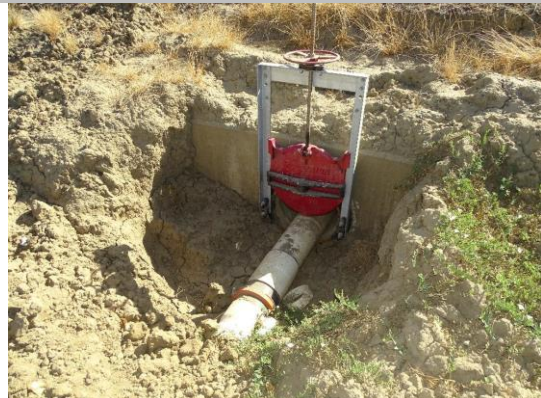
Photo 3 of 3 : UCIP_SP_2020_55411_81621.jpg

Headwall and slidegate at WS toe with a PVC pipe running through

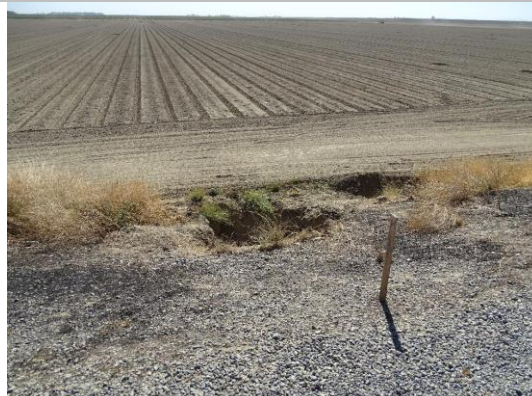
Photo 1 of 3 : UCIP_SP_2020_55412_81623.jpg

View of LS from levee crown

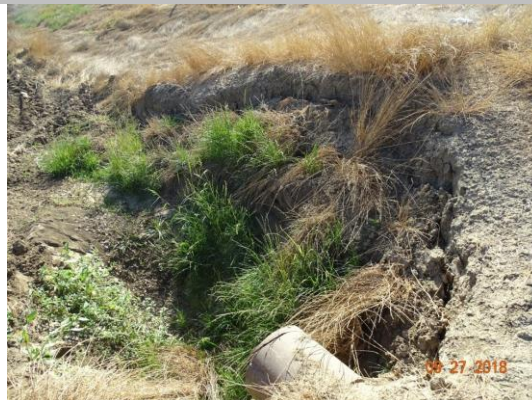
Photo 2 of 2 : SP_2020_ST0007_283_33_20200304_00013.jpg

View of erosion on the levee slope appears to be due to water from the pipe and trench (September 2018).

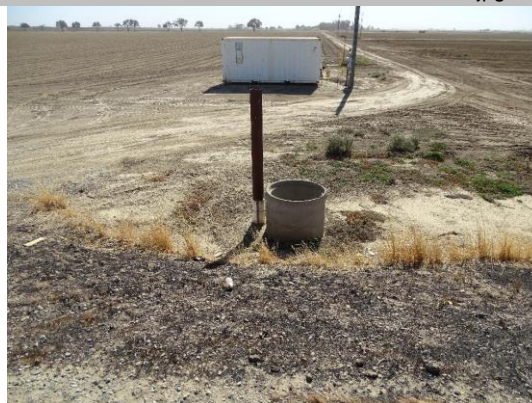
Photo 1 of 3 : UCIP_SP_2020_55436_81697.jpg

DS_ID:16644
 FS_ID:55436
 EP_NO: 10271
 Repair Type: Non-Urgent
 Crossing Status: Found
 UCIP Comments: 10/21/2019 Record updated from No Action Needed to Non-Urgent. Need to have CVFPB review ABO and determine current owner. (O.Yakimov - DWR UCIP)
 FIELD_STRUCT_DESC: 24-inch corrugated metal drainage pipe through the levee, 9.5 feet below the crown. Flap gate on the waterside (WS). 36-inch standpipe on the landside (LS). (24-inch pipe [HLM 4.77] authorized under Automatic Board Order (ABO) issued as Permit No. 10271, 1974 - Ray H. Hamel). [Additional Reference(s): DWR Levee Log, 2005 (HLM 4.77). USACE Sacramento O&M Manual, Unit 119, December 1952, Revised 29 Dec 2016, (Station 136+40 PCT), listed as 24-inch pipe. USACE As-Built Drawing No. 50-04-2396, Revision 4, pdf page 24, Sheet 8, December 1947].
 FS Date: 10/21/2019 9:46:01 AM

View of LS looking from levee crown. 36-inch standpipe near levee toe

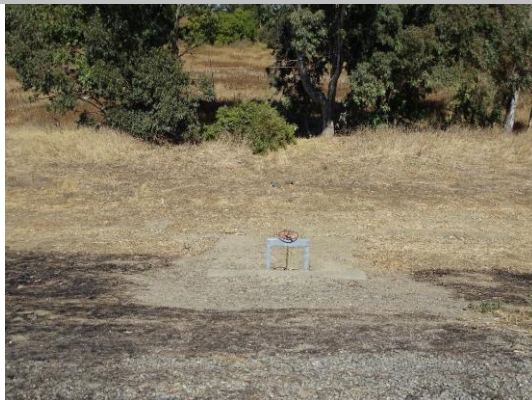
Photo 2 of 3 : UCIP_SP_2020_55439_81708.jpg

View of WS looking from levee crown

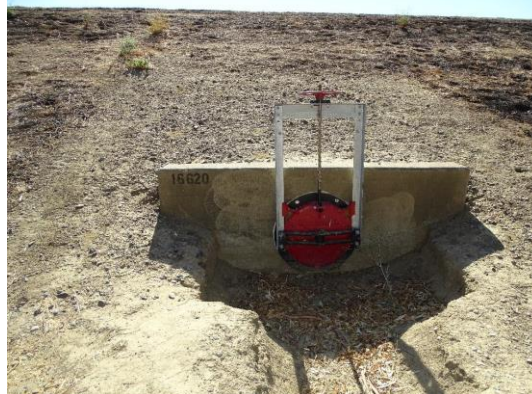
Photo 3 of 3 : UCIP_SP_2020_55439_81709.jpg

WS levee slope, headwall and slide gate

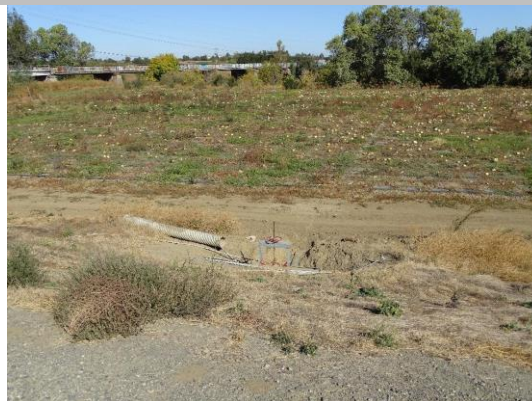
Photo 1 of 3 : UCIP_SP_2020_55419_81628.jpg

View of WS from levee crown

Comment Code					
Inspector Comment					
DS_ID:16636 FS_ID:55419 EP_NO: 10279 Repair Type: Urgent Crossing Status: Found UCIP Comments: 10/21/2019 Rating updated from No Action Needed to Urgent. A 6-inch hose connected to a water well on LS runs through a drainage pipe from LS to WS. Slide gate cannot be closed properly to prevent flooding on LS. Remove hose. (O.Yakimov - DWR UCIP)05/22/2013 Pipe was cleaned by the owner and 6 in pipe is still being used. (C. Lund - DWR Sacramento Yard) 04/05/2012 Pipe needs to be cleared of sedimentation. (W. Wylie - DWR UCIP) FIELD_STRUCT_DESC: 24-inch CIPP-lined corrugated metal drainage pipe through the levee, 14 feet below the crown. Slide gate on the waterside (WS) end. Concrete headwall on landside (LS) end. (name change for existing 24-inch drainpipe and slide gate on WS [HLM 5.89] issued under Permit No. 10279-1, 2012 - Elizabeth Dankworth and Michelle Christison; 24-inch pipe [HLM 5.89] authorized under Automatic Board Order (ABO) issued as Permit No. 10279, 1974 - Carmelita Watkins). [Additional Reference(s): DWR Levee Log, 2005 (HLM 5.89). USACE Sacramento O&M Manual, Unit 119, December 1952, Revised 29 Dec 2016, (Station 193+00 PCT), listed as 24-inch pipe. USACE As-Built Drawing No. 50-04-2396, Revision 4, pdf page 25, Sheet 9, December 1947]. FS Date: 10/21/2019 1:39:07 PM

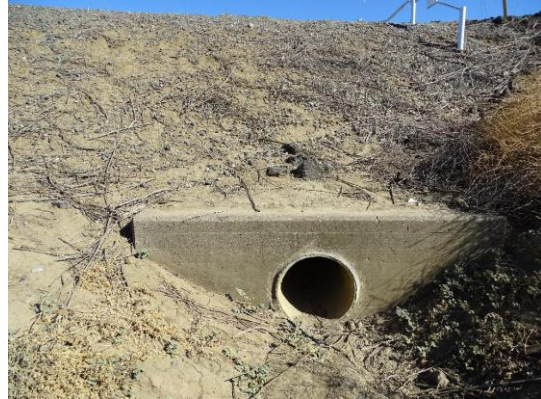
Photo 3 of 3 : UCIP_SP_2020_55446_81720.jpg

LS levee slope, headwall and pipe

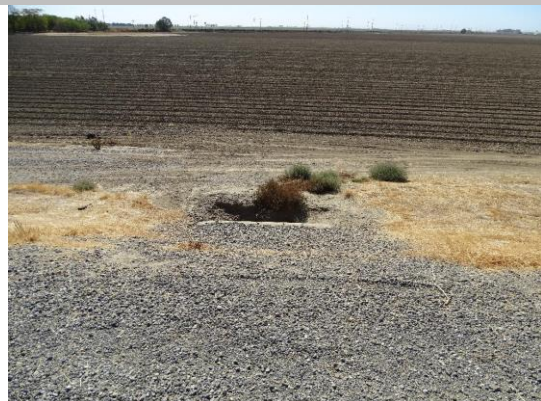
Photo 1 of 3 : UCIP_SP_2020_55448_81724.jpg

DS_ID:16641
 FS_ID:55448
 EP_NO: 10265
 Repair Type: Non-Urgent
 Crossing Status: Found
 UCIP Comments: 10/21/2019 Record updated from No Action Needed to Non-Urgent. Need to have CVFPB review ABO and determine current owner. (O.Yakimov - DWR UCIP)04/05/2012 Pipe has some sedimentation buildup internally. (W. Wylie - DWR UCIP)
 FIELD_STRUCT_DESC: 24-inch CIPP-lined corrugated metal drainage pipe through the levee, 11 feet below the crown. Slide gate on the waterside (WS) end. Concrete headwall on the landside (LS) end. (24-inch pipe [HLM 6.19] authorized under Automatic Board Order (ABO) issued as Permit No. 10265, 1974 - State of California, Division of Highways. Also included in Automatic Board Order (ABO) issued as Permit No. 11296, 1974 - Capitol National Bank of Sacramento and Crocker Citizens National Bank). [Additional Reference(s): DWR Levee Log, 2005 (HLM 6.19). USACE Sacramento O&M Manual, Unit 119, December 1952, Revised 29 Dec 2016, (Station 208+00 PCT), listed as 24-inch pipe. USACE As-Built Drawing No. 50-04-2396, Revision 4, pdf page 25, Sheet 9, December 1947].

View of LS looking from levee crown

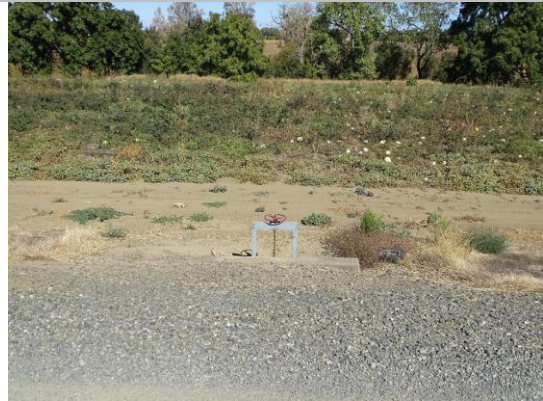
Photo 2 of 3 : UCIP_SP_2020_55448_81725.jpg

View of WS looking from levee crown

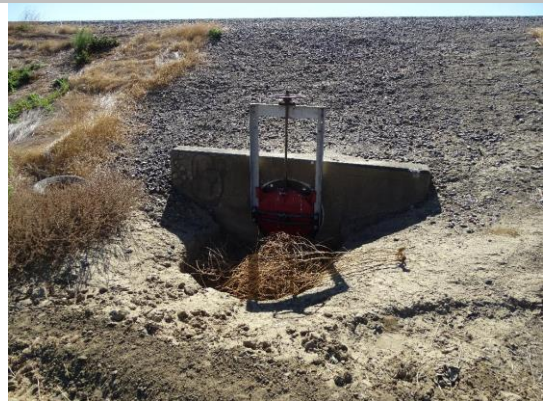
Photo 3 of 3 : UCIP_SP_2020_55448_81726.jpg

WS levee slope, headwall, and slide gate

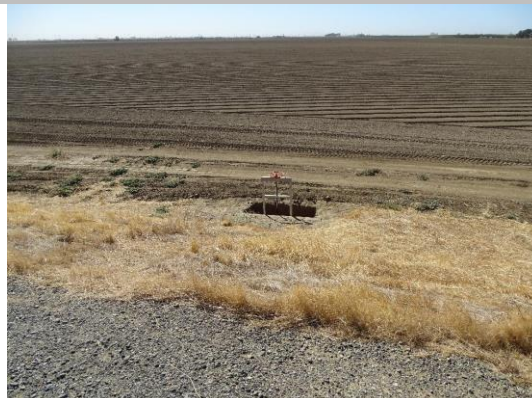
Photo 1 of 3 : UCIP_SP_2020_55450_81729.jpg

DS_ID:16642
FS_ID:55450
EP_NO: 10265
Repair Type: Non-Urgent
Crossing Status: Found
UCIP Comments: 10/21/2019 Record remains Non-Urgent. Need to have CVFPB review ABO and determine current owner. (O. Yakimov - DWR UCIP)07/12/2019 After reviewing the USACE O&M manual as-built there is no reference to this 30-inch pipe. Will need to coordinate with previous UCIP inspector to determine if additional information is available to tie pipe to USACE O&M manual. (O. Magana - DWR UCIP) 04/10/2019 There is no more debris around pipe. And is now sprayed and maintained. (J. McCabe - DWR Sacramento yard) 04/01/2019 Debris buildup at WS outlet.
FIELD_STRUCT_DESC: 30-inch CIPP-lined drainage pipe of an unknown material through the levee, 17 feet below the crown. Headwall and slide gate on the landside (LS) end. Flap gate on the waterside (WS) end, 120 feet to the north of the crossing. (36-inch pipe [HLM 6.50] authorized under Automatic Board Order (ABO) issued as Permit No. 10265, 1974 - State of California, Division of Highways. Also included in Automatic Board Order (ABO) issued as Permit No. 11296, 1974 - Capitol National Bank of Sacramento and Crocker Citizens National Bank). [Additional Reference(s): DWR Levee Log, 2005, (HLM 6.50), 36-inch pipe listed. USACE Sacramento O&M Manual 119, December 1952].

View of LS looking from levee crown

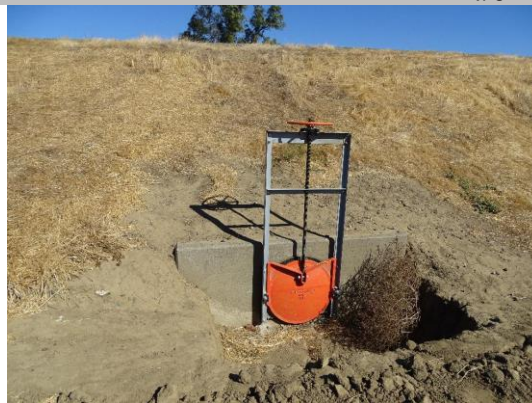
Photo 2 of 3 : UCIP_SP_2020_55450_81730.jpg

LS slope, headwall, and slide gate

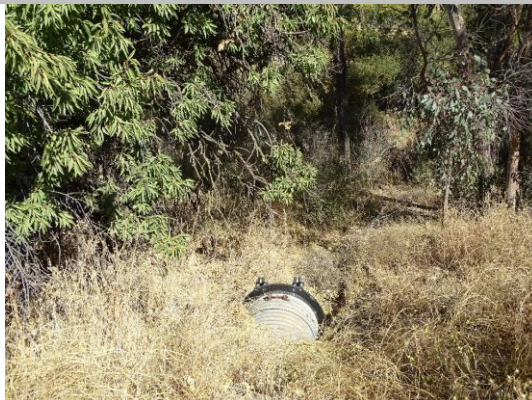
Photo 3 of 3 : UCIP_SP_2020_55450_81731.jpg

Pipe end on WS

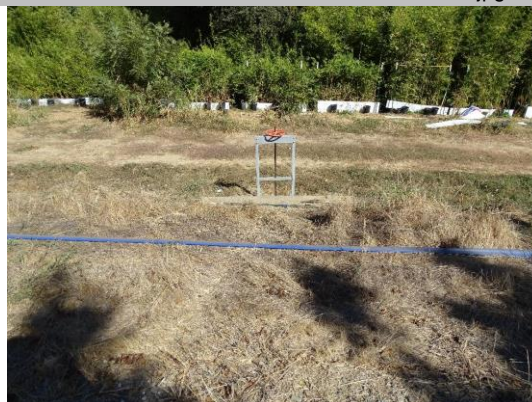
Photo 2 of 3 : UCIP_SP_2020_55452_81740.jpg

View of WS looking from levee crown

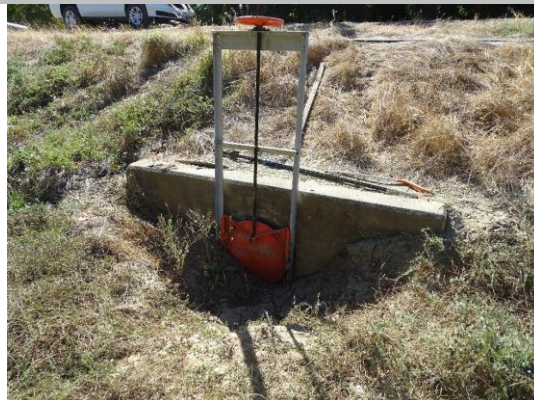
Photo 3 of 3 : UCIP_SP_2020_55452_81741.jpg

WS levee slope, headwall, and slide gate
