**Flood Control Project Maintenance
Levee Inspections**

Maintenance Issue Types Only, Levee Inspection Report By Mile - Spring 2021

Sacramento Maintenance Yard Putah Creek

| Waterway | Bank | Unit Miles | Inspection Start/End | Inspector |
|--|---|---|---|---|
| Unit No. 01 Putah Creek or North Levee | Left | 8.79 | 03/18/2021 03/18/2021 | David Julian |

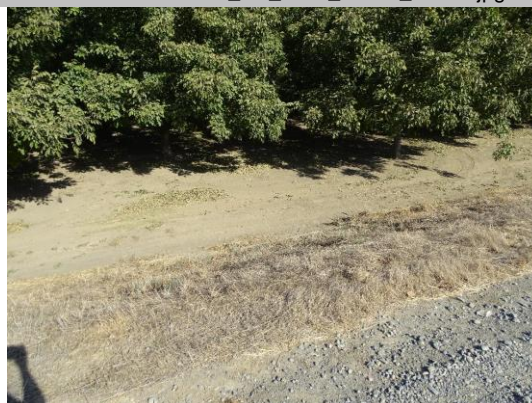
Photo 2 of 3 : UCIP_SP_2021_55597_82103.jpg

View of LS looking from levee crown

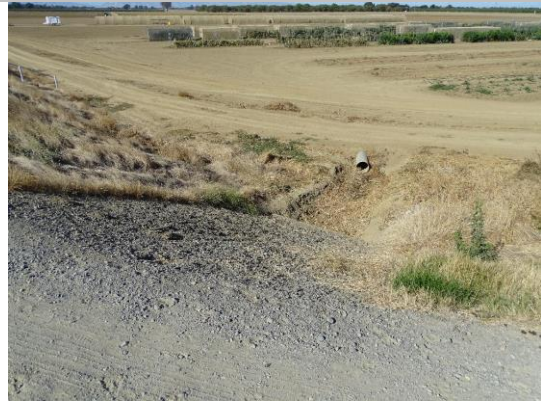
Photo 3 of 3 : UCIP_SP_2021_55455_81755.jpg

FS_ID:55455
DS_ID:496
EP_NO: 10251
Repair Type: Non-Urgent
Crossing Status: Found
UCIP Comments: 10/22/2019 Record updated from No Action Needed to Non-Urgent. Need to have CVFPB review ABO and determine current owner. Installed a new precast concrete box on the waterside. Pipe will be lined in November 2019 according to FMO staff. (O.Yakimov - DWR UCIP)4/10/2019 Major erosion through out pipe. Erosion on WS allows water to enter pipe and flood LS field. Erosion on farmers waterman valve. Field water drains into pipe and floods LS field. (J.McCabe - DWR Sacramento Yard)
FIELD_STRUCT_DESC: 24-inch corrugated metal drainage pipe through levee, 15 feet below the crown. Two metal cutoff walls were installed through the levee. A T-post and T-handle are located on the landside (LS) toe. The outfall structure and flap gate are located on the west side of bridge, waterside (WS). (24-inch pipe [HLM 3.87] authorized under Automatic Board Order (ABO) issued as Permit No. 10251, 1974 - F.M.C. Corp.) [Additional Reference(s): DWR Levee Log, 1981 and 2005 (HLM 3.87). USACE Sacramento O&M Manual, Unit 119, December 1952, Revised 29 Dec 2016, (Station 1+50 PCT), listed as 24-inch pipe. USACE As-Built Drawing No. 50-04-2396, Revision 4, pdf page 23, Sheet 7, December 1947]

View of LS looking from levee crown

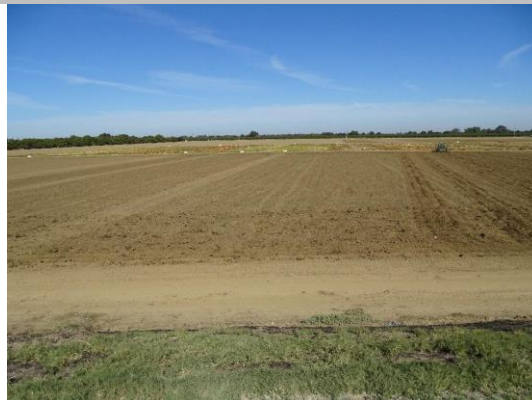
Photo 2 of 3 : UCIP_SP_2021_55456_81761.jpg

FS_ID:55456
DS_ID:497
EP_NO: 10251
Repair Type: Non-Urgent
Crossing Status: Found
UCIP Comments: 10/22/2019 Record updated from No Action Needed to Non-Urgent. Geophysical study indicates possible presence of pipe through levee. Need to have CVFPB review ABO and determine current owner. Pipe inlet and headwall are not visible on LS. Slide gate in CMP riser is in closed position, crossing looks abandoned. Construction according to permit 10251-1 hasn't started yet. Field structure description is updated to match original pipe construction. (O.Yakimov - DWR UCIP)
FIELD_STRUCT_DESC: 24-inch drainage pipe of unknown material through levee, 16 feet below the crown. 36-inch galvanized corrugated metal pipe (CMP) riser located on the waterside (WS) slope. (24-inch pipe [HLM 4.13] authorized under Automatic Board Order (ABO) issued as Permit No. 10251, 1974 - F.M.C. Corp.; assumed original 24-inch pipe was installed in 12/12/1952 per O&M manual) [Additional Reference(s): DWR Levee Log, 1981 and 2005 (HLM 4.13). USACE Sacramento O&M Manual, Unit 119, December 1952, Revised 29 Dec 2016, (Station 17+00 PCT), listed as 24-inch pipe. USACE As-Built Drawing No. 50-04-2396, Revision 4, pdf page 23, Sheet 7, December 1947]

View of LS looking from levee crown

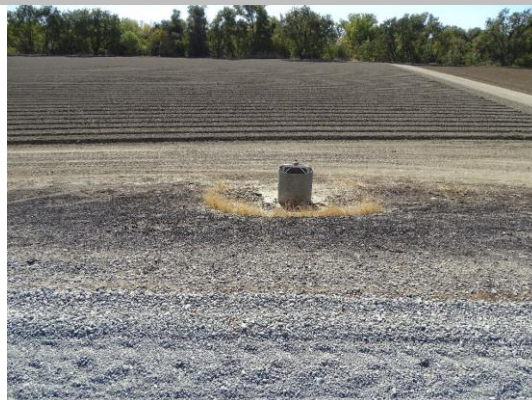
Photo 3 of 3 : UCIP_SP_2021_55456_81762.jpg

View of WS looking from levee crown

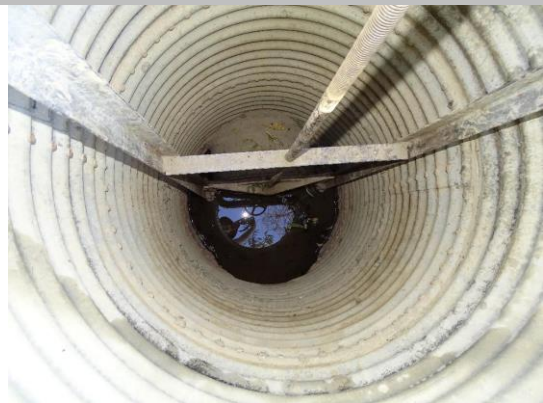
Photo 3 of 3 : UCIP_SP_2021_55460_81781.jpg

| FS_ID:55460 DS_ID:501 EP_NO: 10256 Repair Type: Non-Urgent Crossing Status: Found UCIP Comments: 10/22/2019 Record updated from No Action Needed to Non-Urgent. Need to have CVFPB review ABO and determine current owner. Crossing has been modified to supply water from LS to WS. Should not be considered a storm drainage pipe. (O.Yakimov - DWR UCIP) FIELD_STRUCT_DESC: 24-inch corrugated metal drainage pipe through the levee, 12.5 feet below the crown. Slide gate on the waterside (WS) end in 36-inch standpipe. Concrete standpipe at LS toe with fill-in pipe. (24-inch pipe [HLM 5.40] authorized under Automatic Board Order (ABO) issued as Permit No. 10256, 1974 - Albert H. Lederer). [Additional Reference(s): DWR Levee Log, 2005 (HLM 5.40). USACE Sacramento O&M Manual, Unit 119, December 1952, Revised 29 Dec 2016, (Station 84+40 PCT), listed as 24-inch pipe. USACE As-Built Drawing No. 50-04-2396, Revision 4, pdf page 24, Sheet 8, December 1947]. FS Date: 10/22/2019 3:28:15 PM | | | | | |

View inside of CMP standpipe on WS

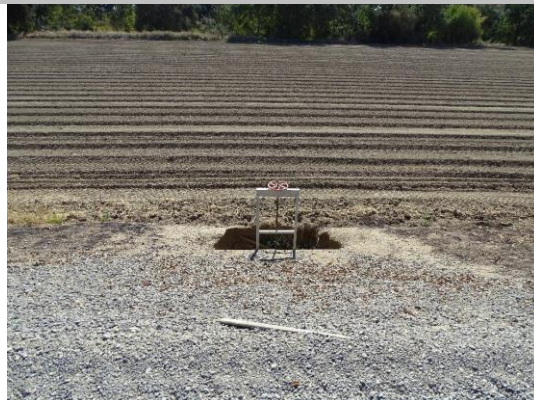
Photo 2 of 3 : UCIP_SP_2021_59863_82262.jpg

FS_ID:59863
 DS_ID:503
 EP_NO: 10252
 Repair Type: Non-Urgent
 Crossing Status: Found
 UCIP Comments: 10/22/2019 Record updated from No Action Needed to Non-Urgent. Need to have CVFPB review ABO and determine current owner. (O.Yakimov - DWR UCIP) 05/06/2013 Owner of pipe needs to clean out obstruction in pipe. (C. Lund - DWR Sacramento Yard)
 04/04/2012 Partially obstructed with sedimentation throughout crossing. (W. Wylie - DWR UCIP)
 FIELD_STRUCT_DESC: 24-inch CIPP-lined corrugated metal drainage pipe through the levee, 12 feet below the crown. Slide gate on the waterside (WS) end. Concrete headwall on the landside (LS) end. (24-inch pipe [HLM 5.86] authorized under Automatic Board Order (ABO) issued as Permit No. 10252, 1974 - John F. Hamel). [Additional Reference(s): DWR Levee Log, 2005 (HLM 5.86). USACE Sacramento O&M Manual, Unit 119, December 1952, Revised 29 Dec 2016, (Station 108+00 PCT), listed as 24-inch pipe. USACE As-Built Drawing No. 50-04-2396, Revision 4, pdf page 24, Sheet 8, December 1947].

View of WS looking from levee crown

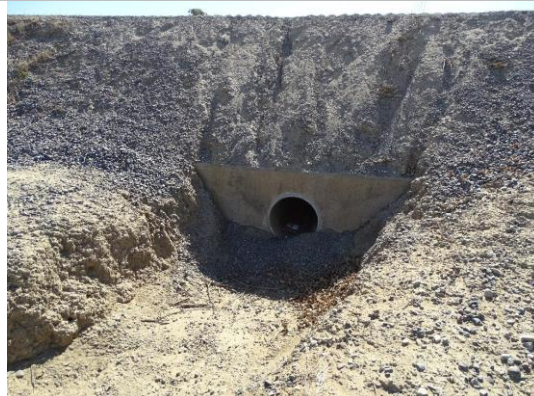
Photo 3 of 3 : UCIP_SP_2021_59863_82263.jpg

LS levee slope, headwall, and pipe end

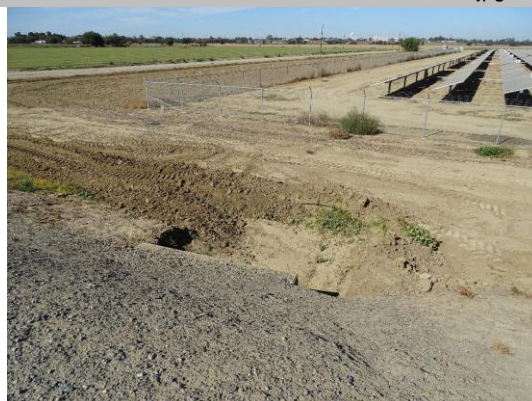
Photo 1 of 3 : UCIP_SP_2021_55647_82273.jpg

| FS_ID:55647 DS_ID:505 EP_NO: 10253 Repair Type: Non-Urgent Crossing Status: Found UCIP Comments: 10/22/2019 Record updated from No Action Needed to Non-Urgent. Levee toe erosion on both sides of headwall on WS. Need to have CVFPB review ABO and determine current owner. (O.Yakimov - DWR UCIP) FIELD_STRUCT_DESC: 24-inch CIPP-lined corrugated metal drainage pipe through the levee, 10.4 feet below the crown. Slide gate on the waterside (WS), and concrete headwalls on both the WS and the landside (LS). (24-inch pipe [HLM 6.57] authorized under Automatic Board Order (ABO) issued as Permit No. 10253, 1974 - Lester J. Hamel). [Additional Reference(s): DWR Levee Log, 2005 (HLM 6.57. USACE Sacramento O&M Manual, Unit 119, December 1952, Revised 29 Dec 2016, (Station 145+50 PCT), listed as 24-inch pipe. USACE As-Built Drawing No. 50-04-2396, Revision 4, pdf page 24, Sheet 8, December 1947]. FS Date: 10/22/2019 11:07:35 AM | | | | | | |

View of LS looking from levee crown

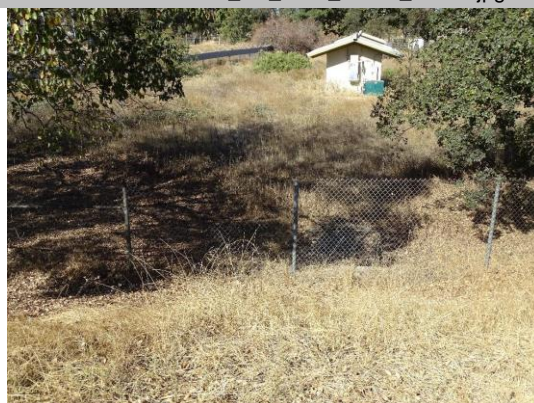
Photo 3 of 3 : UCIP_SP_2021_55664_82345.jpg

View of LS looking from levee crown

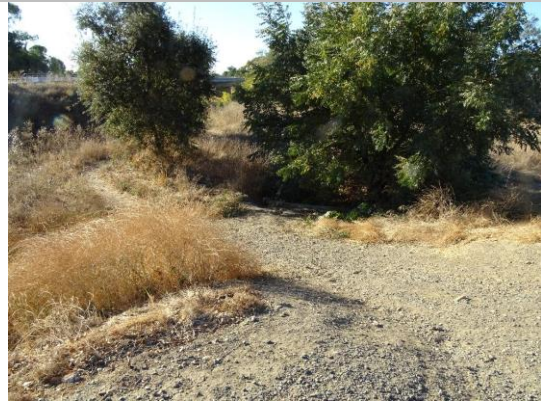
Photo 1 of 3 : UCIP_SP_2021_59869_82357.jpg

| FS_ID:59869 DS_ID:512 EP_NO: 10247 Repair Type: Non-Urgent Crossing Status: Found UCIP Comments: 10/21/2019 Record updated from No Action Needed to Non-Urgent. Need to have CVFPB review ABO and determine current owner. (O.Yakimov - DWR UCIP) 05/07/2013 Debris removed from outlet. (C. Lund - DWR Sacramento Yard) 04/04/2012 Some debris blocking outlet. (W. Wylie - DWR UCIP) FIELD_STRUCT_DESC: 24-inch CIPP-lined drainage pipe of an unknown material through the levee, 12 feet below the crown. Flap gate on the waterside (WS) end. Concrete headwall on the landside (LS) end. (24-inch [HLM 7.36] authorized under Automatic Board Order (ABO) issued as Permit No. 10247, 1974 - University of California, Office of the Regents). [Additional Reference(s): DWR Levee Log, 2005 (HLM 7.36). USACE Sacramento O&M Manual, Unit 119, December 1952, Revised 29 Dec 2016, (Station 183+97 PCT), listed as 24-inch pipe. USACE As-Built Drawing No. 50-04-2396, Revision 4, pdf page 25, Sheet 9, December 1947]. FS Date: 10/21/2019 2:33:00 PM | | | | | | |

View of WS looking from levee crown

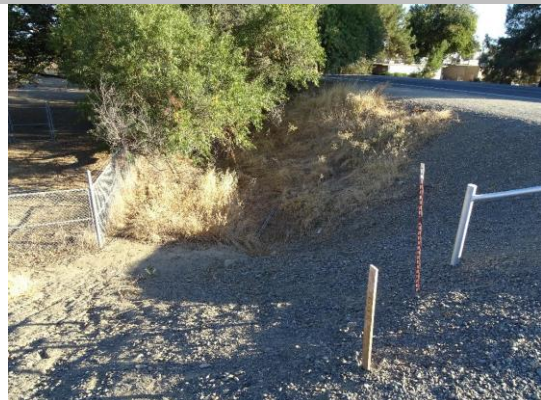
Photo 2 of 3 : UCIP_SP_2021_59869_82355.jpg

View of LS looking from levee crown

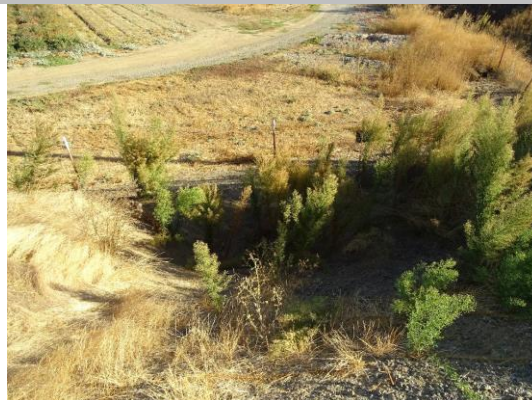
Photo 2 of 3 : UCIP_SP_2021_59874_82373.jpg

View of LS looking from levee crown

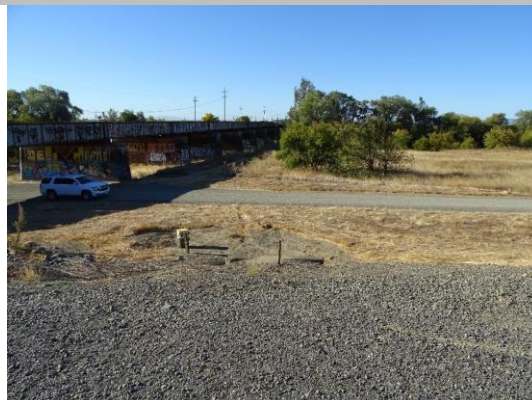
Photo 3 of 3 : UCIP_SP_2021_59874_82374.jpg

View of WS looking from levee crown

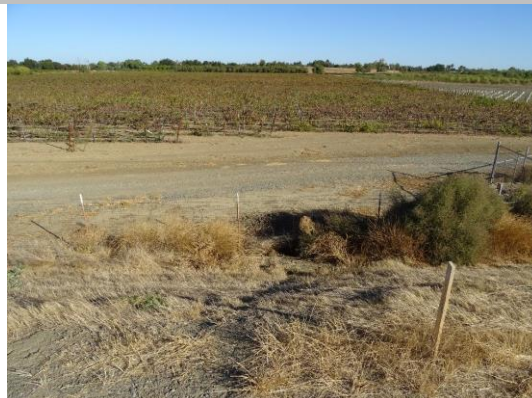
Photo 1 of 3 : UCIP_SP_2021_59875_82382.jpg

| FS_ID:59875 DS_ID:518 EP_NO: 10247 Repair Type: Non-Urgent Crossing Status: Found UCIP Comments: 10/21/2019 Difficult access to pipe inlet on LS due to a fence. (O.Yakimov - DWR UCIP)05/07/2013 Fence blocking inlet. Owner of fence needs to move fence away from inlet. (C. Lund - DWR Sacramento Yard) 04/05/2012 Clear debris from pipe. (W. Wylie - DWR UCIP) FIELD_STRUCT_DESC: 24-inch CIPP-lined corrugated metal drainage pipe through the levee, 12 feet below the crown. Slide gate on the waterside (WS) slope, and headwalls on both sides. (24-inch pipe [HLM 7.75] authorized under Automatic Board Order (ABO) issued as Permit No. 10247, 1974 - University of California, Office of the Regents). [Additional Reference(s): DWR Levee Log, 2005 (HLM 7.75). USACE Sacramento O&M Manual, Unit 119, December 1952, Revised 29 Dec 2016, (Station 204+00 PCT), listed as 24-inch pipe. USACE As-Built Drawing No. 50-04-2396, Revision 4, pdf page 25, Sheet 9, December 1947]. FS Date: 10/21/2019 8:27:00 AM | | | | | | |

View of LS looking from levee crown

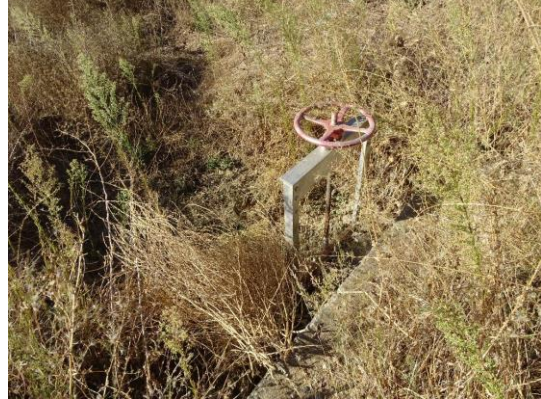
Photo 3 of 3 : UCIP_SP_2021_59875_82385.jpg

WS: headwall and slide gate

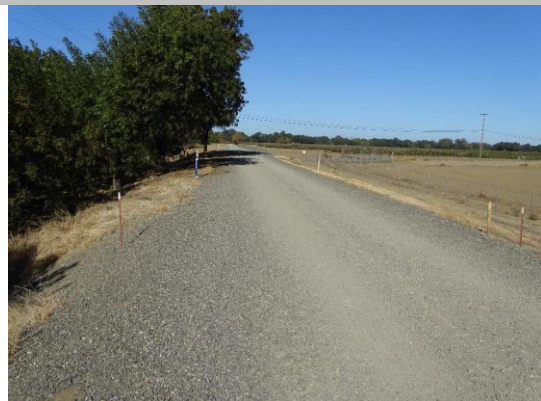
Photo 1 of 3 : UCIP_SP_2021_59879_82393.jpg

FS_ID:59879
DS_ID:520
EP_NO: 10247
Repair Type: Non-Urgent
Crossing Status: Found
UCIP Comments: 10/21/2019 Record updated from No Action Needed to Non-Urgent. Need to have CVFPB review ABO and determine current owner. (O.Yakimov - DWR UCIP) 05/07/2012 Cleaned inlet and outlets. Owner of pipe may need to clean pipe. (C. Lund - DWR Sacramento Yard)
04/05/2012 Pipe is plugged with soil on LS. (W. Wylie - DWR UCIP)
FIELD_STRUCT_DESC: 24-inch CIPP-lined corrugated metal drainage pipe through the levee, 8 feet below the crown. Slide gate on the waterside (WS) end. (24-inch pipe [HLM 8.45] authorized under Automatic Board Order (ABO) issued as Permit No. 10247, 1974 - University of California, Office of the Regents). [Additional Reference(s): DWR Levee Log, 2005 (HLM 8.45). USACE Sacramento O&M Manual, Unit 119, December 1952, Revised 29 Dec 2016, (Station 241+50 PCT), listed as 24-inch pipe. USACE As-Built Drawing No. 50-04-2396, Revision 2, pdf page 26, Sheet 10, December 1947].

View of levee crown at the crossing

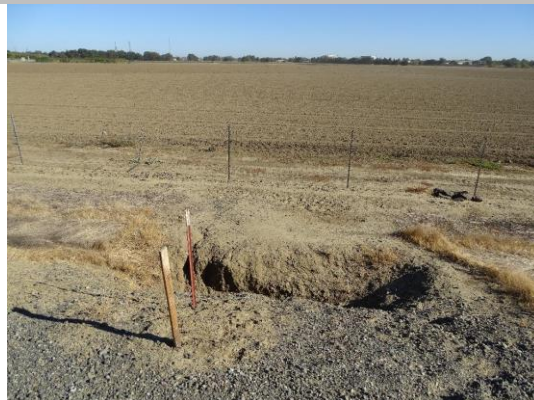
Photo 2 of 3 : UCIP_SP_2021_59879_82394.jpg

View of LS looking from levee crown

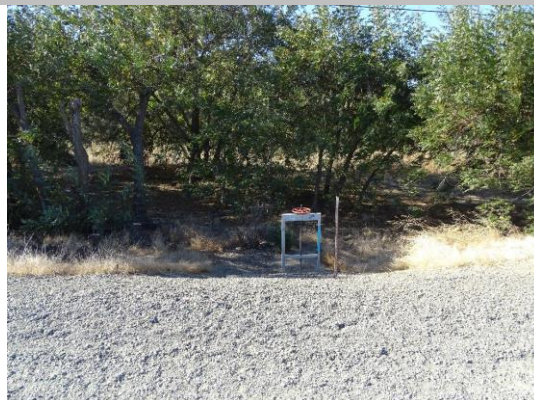
Photo 3 of 3 : UCIP_SP_2021_59879_82395.jpg

View of WS looking from levee crown

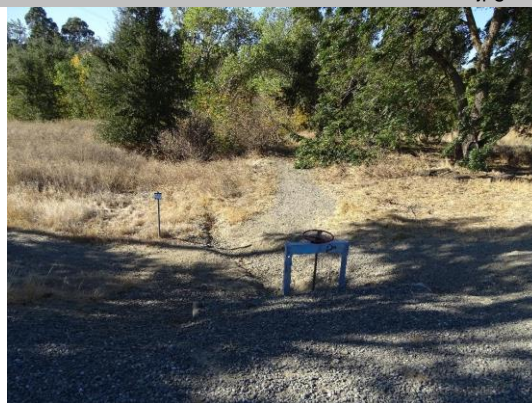
Photo 1 of 3 : UCIP_SP_2021_59880_82398.jpg

FS_ID:59880
DS_ID:521
EP_NO: 10247
Repair Type: Non-Urgent
Crossing Status: Found
UCIP Comments: 10/21/2019 Record updated from No Action Needed to Non-Urgent. Need to have CVFPB review ABO and determine current owner. (O.Yakimov - DWR UCIP) 05/07/2013 Removed material at slidegate and inlet. (C. Lund - DWR Sacramento Yard) 04/05/2012 Pipe is partially blocked by sedimentation and slide gate will not open. (W. Wylie - DWR UCIP)
FIELD_STRUCT_DESC: 24-inch CIPP-lined corrugated metal drainage pipe through the levee, 7 feet below the crown. Slide gate on the waterside (WS) end. Headwalls on both ends. (24-inch pipe [HLM 8.50] authorized under Automatic Board Order (ABO) issued as Permit No. 10247, 1974 - University of California, Office of the Regents. Also mentioned in Permit No. 5896, 1967 - The Regents of the University of California, Office of Architects and Engineers, University of California, Davis Campus). [Additional Reference(s): DWR Levee Log, 2005 (HLM 8.50). USACE Sacramento O&M Manual, Unit 119, December 1952, Revised 29 Dec 2016, (Station 244+20 PCT), listed as 24-inch pipe. USACE As-Built Drawing No. 50-04-2396, Revision 2, pdf page 26, Sheet 10, December 1947].

View of WS looking from levee crown

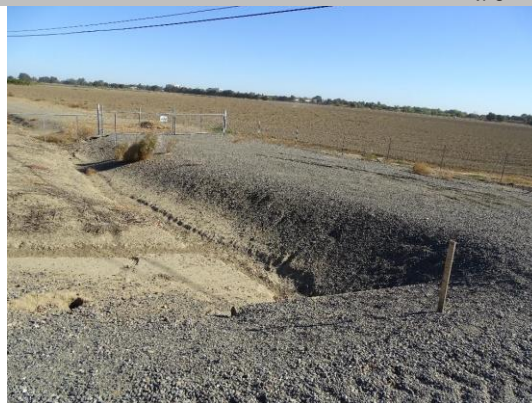
Photo 2 of 3 : UCIP_SP_2021_59880_82399.jpg

View of LS looking from levee crown

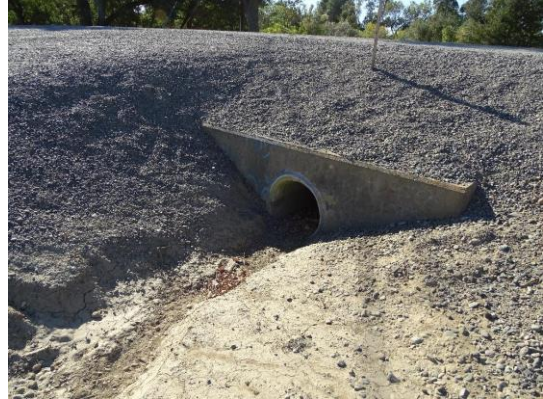
Photo 3 of 3 : UCIP_SP_2021_59880_82400.jpg

LS levee slope, headwall, and pipe end

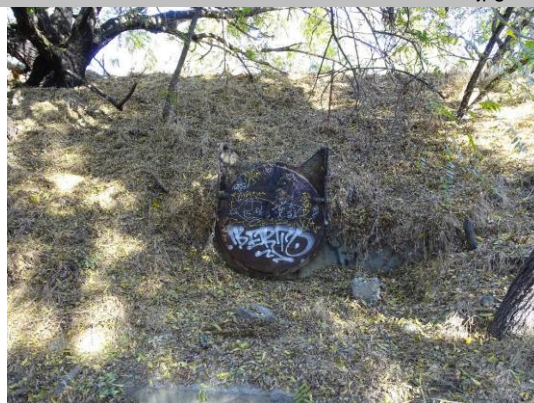
Photo 1 of 3 : UCIP_SP_2021_59884_82410.jpg

| FS_ID:59884 DS_ID:523 EP_NO: 10247 Repair Type: Non-Urgent Crossing Status: Found UCIP Comments: 10/21/2019 Record remains Non-Urgent. Pipe inlet is closed with steel plate bolted to headwall in drainage canal on LS. (O.Yakimov - DWR UCIP) FIELD_STRUCT_DESC: 48-inch corrugated metal drainage pipe through the levee, 15.0 feet below the crown. Steel plate installed over inlet off the landside (LS) toe. Pipe not grouted. Flap gate on waterside (WS) end. Headwalls on both ends. (48-inch pipe [HLM 8.88] authorized under Automatic Board Order (ABO) issued as Permit No. 10247, 1974 - University of California, Office of the Regents). [Additional Reference(s): DWR Levee Log, 2005 (HLM 8.88). USACE Sacramento O&M Manual, Unit 119, December 1952, Revised 29 Dec 2016, (Station 262+30 PCT), 48-inch pipe referenced. USACE As-Built Drawing No. 50-04-2396, Revision 2, pdf page 26, Sheet 10, 24-inch pipe referenced on levee alignment, December 1947]. FS Date: 10/21/2019 1:46:00 PM | | | | | | |

WS levee slope, headwall, and flap gate

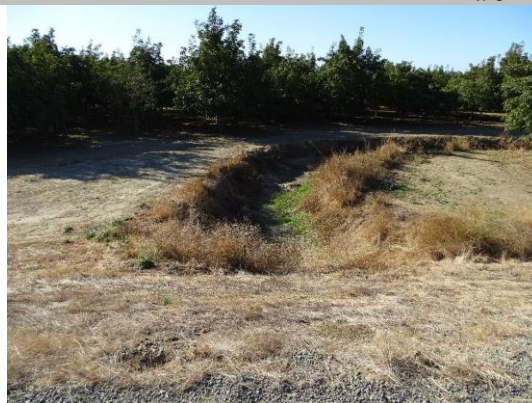
Photo 2 of 3 : UCIP_SP_2021_55424_81639.jpg

View of LS looking from levee crown

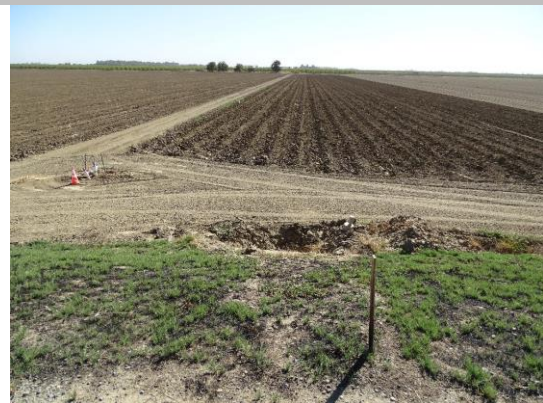
Photo 1 of 3 : UCIP_SP_2021_55411_81619.jpg

| FS_ID:55411 DS_ID:16625 EP_NO: 10277 Repair Type: Urgent Crossing Status: Found UCIP Comments: 10/21/2019 Record updated from No Action Needed to Urgent. A PVC pipe runs through a drainage pipe from LS to WS levee toe. Slide gate cannot be closed properly to prevent flooding on LS. Remove PVC pipe. Need to have CVFPB review ABO and determine current owner. (O.Yakimov - DWR UCIP) FIELD_STRUCT_DESC: 24-inch CIPP-lined corrugated metal drainage pipe through the levee, 9 feet below the crown. Slide gate on the waterside (WS) slope. Concrete headwalls on both ends. (24-inch pipe [HLM 2.71] authorized under Automatic Board Order (ABO) issued as Permit No. 10277, 1974 - Naomi Schoeningh). [Additional Reference(s): DWR Levee Log, 2005 (HLM 2.71). USACE Sacramento O&M Manual, Unit 119, December 1952, Revised 29 Dec 2016, (Station 30+15 PCT), listed as 24-inch pipe. USACE As-Built Drawing No. 50-04-2396, Revision 4, pdf page 23, Sheet 7, December 1947]. FS Date: 10/21/2019 11:18:53 AM | | | | | | |

View of LS from levee crown

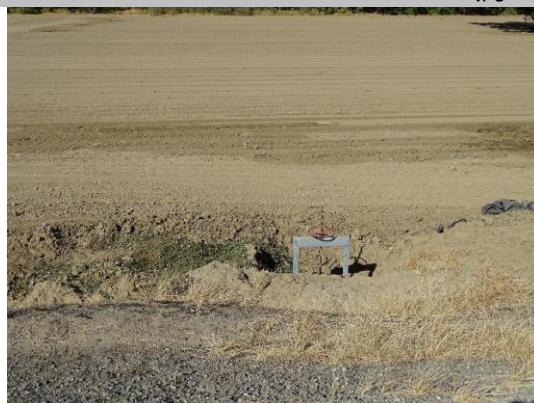
Photo 2 of 3 : UCIP_SP_2021_55411_81620.jpg

View of WS from levee crown

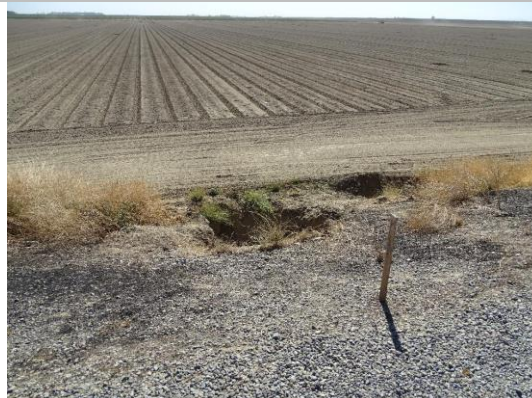
Photo 1 of 3 : UCIP_SP_2021_55412_81623.jpg

View of LS from levee crown

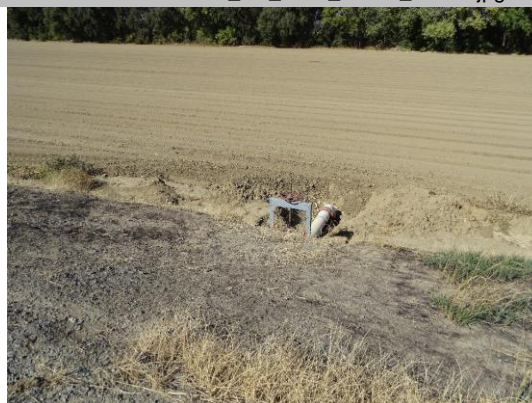
Photo 2 of 3 : UCIP_SP_2021_55412_81624.jpg

View of WS from levee crown

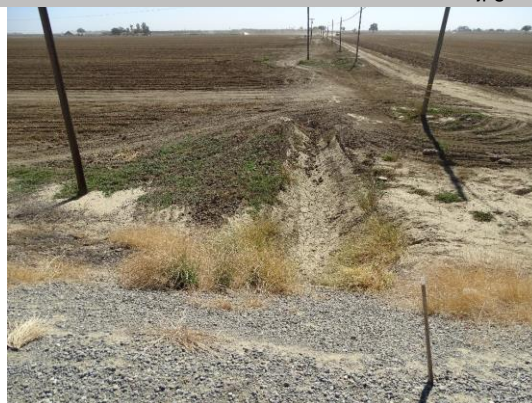
Photo 1 of 3 : UCIP_SP_2021_55434_81690.jpg

FS_ID:55434
 DS_ID:16629
 EP_NO: 10269
 Repair Type: Non-Urgent
 Crossing Status: Found
 UCIP Comments: 10/21/2019 Pipe is partially silted, cleanup pipe.
 Record updated from No Action Needed to Non-Urgent. Need to have CVFPB review ABO and determine current owner. (O.Yakimov - DWR UCIP)
 FIELD_STRUCT_DESC: 24-inch CIPP-lined corrugated metal drainage pipe through the levee, 12.5 feet below the crown. Slide gate on the waterside (WS) end. Concrete headwalls on both ends. (24-inch pipe [HLM 4.26] authorized under Automatic Board Order (ABO) issued as Permit No. 10269, 1974 - Joseph Fahn). [Additional Reference(s): DWR Levee Log, 2005 (HLM 4.26). USACE Sacramento O&M Manual, Unit 119, December 1952, Revised 29 Dec 2016, (Station 109+75 PCT), listed as 24-inch pipe. USACE As-Built Drawing No. 50-04-2396, Revision 4, pdf page 24, Sheet 8, December 1947].
 FS Date: 10/21/2019 9:16:52 AM

View of LS looking from levee crown

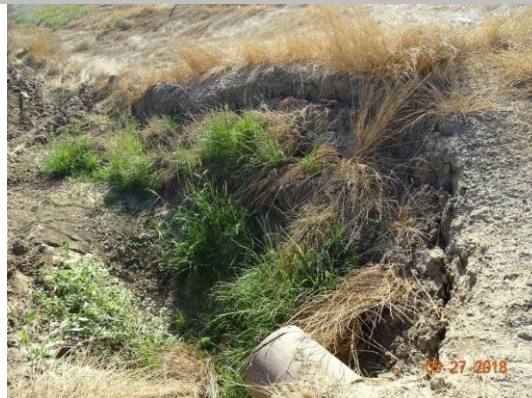
Photo 2 of 2 : SP_2021_ST0007_283_33_20210301_00009.jpg

View of erosion on the levee slope appears to be due to water from the pipe and trench (September 2018).

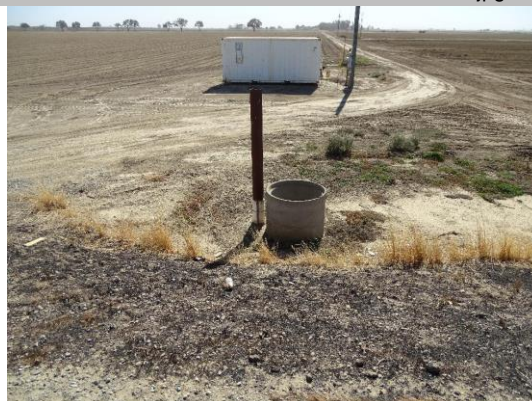
Photo 1 of 3 : UCIP_SP_2021_55436_81697.jpg

FS_ID:55436
 DS_ID:16644
 EP_NO: 10271
 Repair Type: Non-Urgent
 Crossing Status: Found
 UCIP Comments: 10/21/2019 Record updated from No Action Needed to Non-Urgent. Need to have CVFPB review ABO and determine current owner. (O.Yakimov - DWR UCIP)
 FIELD_STRUCT_DESC: 24-inch corrugated metal drainage pipe through the levee, 9.5 feet below the crown. Flap gate on the waterside (WS). 36-inch standpipe on the landside (LS). (24-inch pipe [HLM 4.77] authorized under Automatic Board Order (ABO) issued as Permit No. 10271, 1974 - Ray H. Hamel). [Additional Reference(s): DWR Levee Log, 2005 (HLM 4.77). USACE Sacramento O&M Manual, Unit 119, December 1952, Revised 29 Dec 2016, (Station 136+40 PCT), listed as 24-inch pipe. USACE As-Built Drawing No. 50-04-2396, Revision 4, pdf page 24, Sheet 8, December 1947].
 FS Date: 10/21/2019 9:46:01 AM

View of LS looking from levee crown. 36-inch standpipe near levee toe

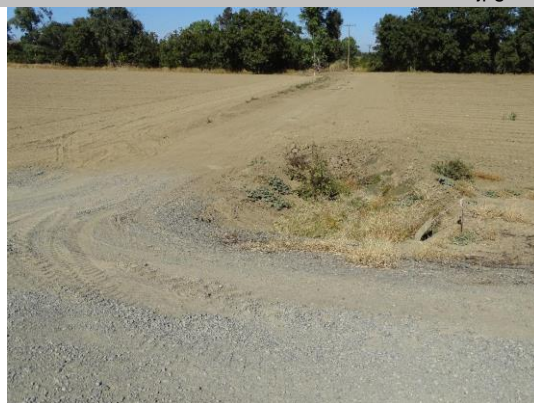
Photo 2 of 3 : UCIP_SP_2021_55436_81698.jpg

View of WS looking from levee crown

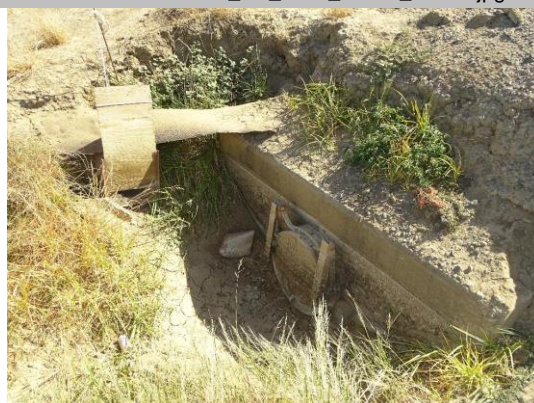
Photo 3 of 3 : UCIP_SP_2021_55436_81699.jpg

Headwall and flap gate at WS levee toe

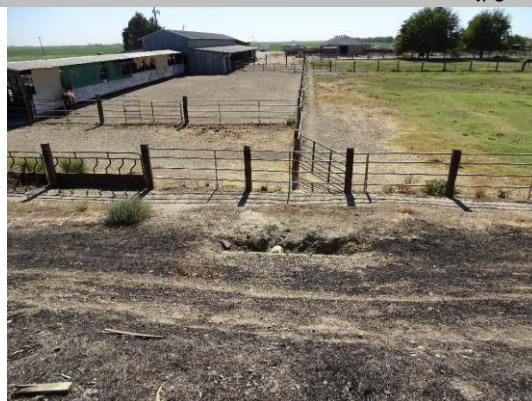
Photo 1 of 3 : UCIP_SP_2021_59897_81707.jpg

View of LS looking from levee crown

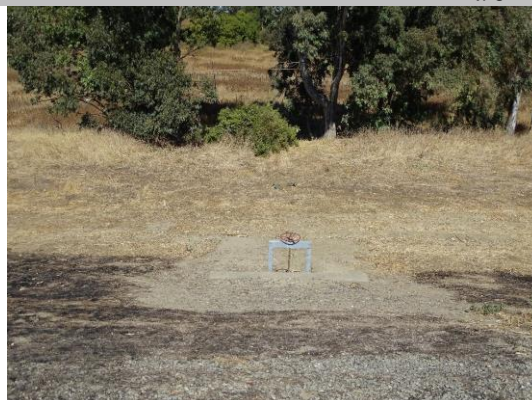
Photo 2 of 3 : UCIP_SP_2021_59897_81708.jpg

View of WS looking from levee crown

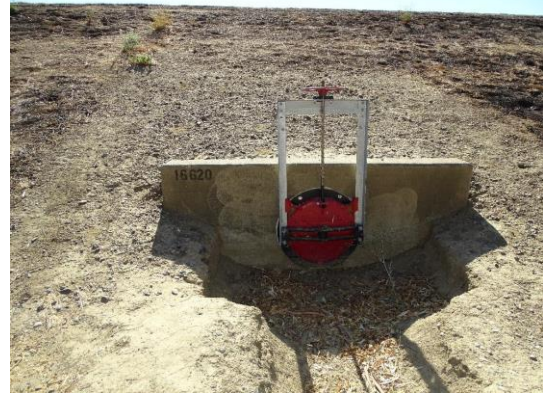
Photo 3 of 3 : UCIP_SP_2021_59897_81709.jpg

WS levee slope, headwall and slide gate

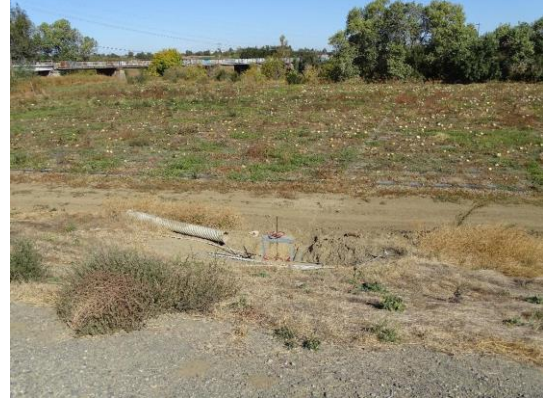
Photo 1 of 3 : UCIP_SP_2021_59900_81628.jpg

View of WS from levee crown

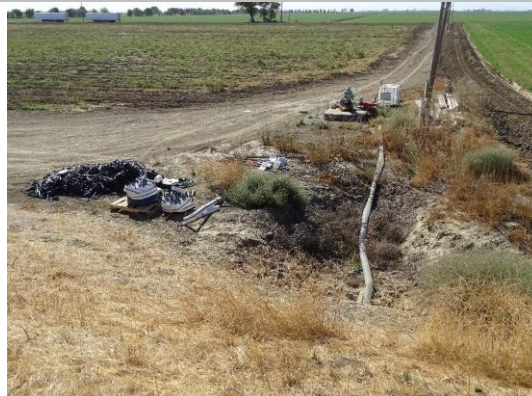
Photo 2 of 3 : UCIP_SP_2021_59900_81629.jpg

View of LS from levee crown

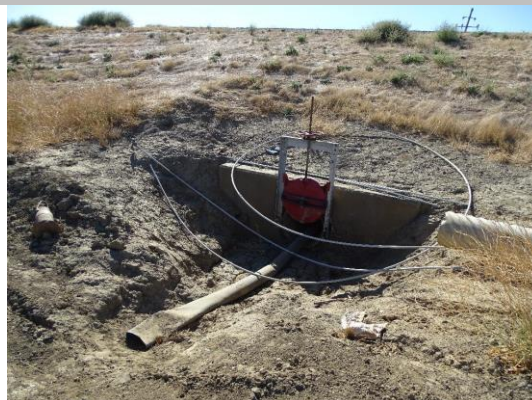
Photo 3 of 3 : UCIP_SP_2021_59900_81630.jpg

WS slope with headwall and slide gate

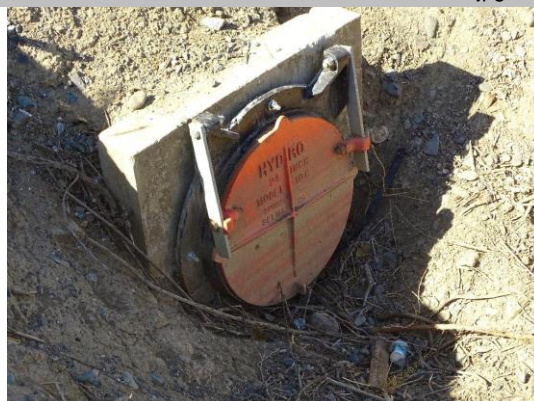
Photo 1 of 3 : UCIP_SP_2021_59903_81718.jpg

Headwall and flap gate

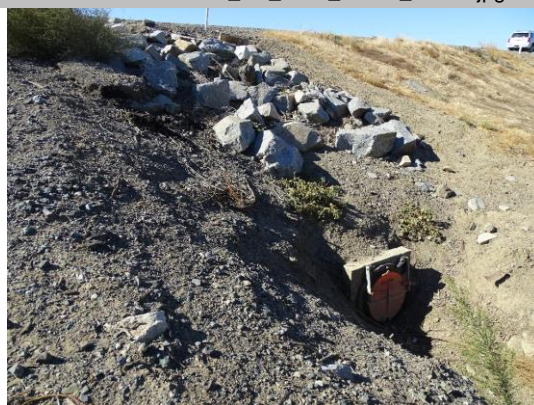
Photo 2 of 3 : UCIP_SP_2021_59903_81719.jpg

View of WS slope and flap gate at levee toe

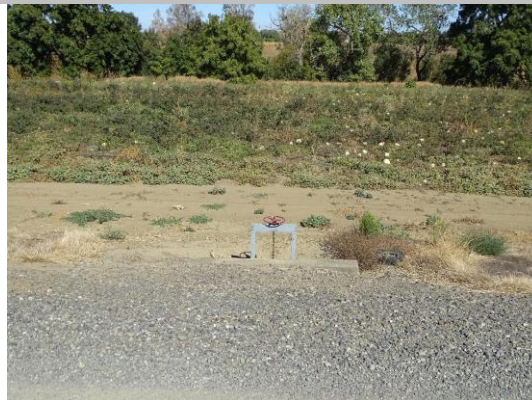
Photo 2 of 3 : UCIP_SP_2021_59905_81725.jpg

View of WS looking from levee crown

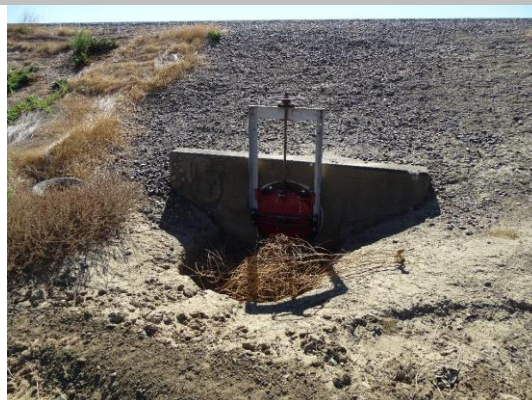
Photo 3 of 3 : UCIP_SP_2021_59905_81726.jpg

WS levee slope, headwall, and slide gate

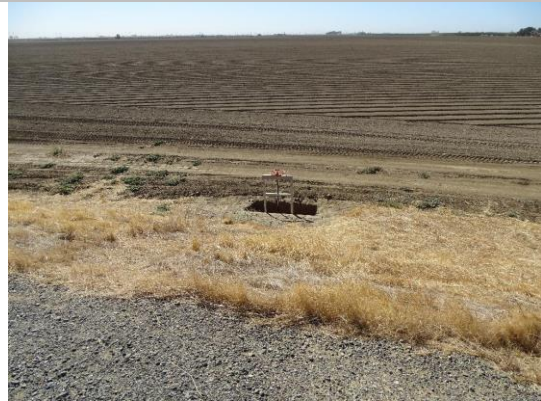
Photo 1 of 3 : UCIP_SP_2021_59906_81729.jpg

FS_ID:59906
DS_ID:16642
EP_NO: 10265
Repair Type: Non-Urgent
Crossing Status: Found
UCIP Comments: 10/21/2019 Record remains Non-Urgent. Need to have CVFPB review ABO and determine current owner. (O. Yakimov - DWR UCIP)07/12/2019 After reviewing the USACE O&M manual as-built there is no reference to this 30-inch pipe. Will need to coordinate with previous UCIP inspector to determine if additional information is available to tie pipe to USACE O&M manual. (O. Magana - DWR UCIP) 04/10/2019 There is no more debris around pipe. And is now sprayed and maintained. (J. McCabe - DWR Sacramento Yard) 04/01/2019 Debris buildup at WS outlet. (J. McCabe - DWR Sacramento Yard)
FIELD_STRUCT_DESC: 30-inch CIPP-lined drainage pipe of an unknown material through the levee, 17 feet below the crown. Headwall and slide gate on the landside (LS) end. Flap gate on the waterside (WS) end, 120 feet to the north of the crossing. (36-inch pipe [HLM 6.50] authorized under Automatic Board Order (ABO) issued as Permit No. 10265, 1974 - State of California, Division of Highways. Also included in Automatic Board Order (ABO) issued as Permit No. 11296, 1974 - Capitol National Bank of Sacramento and Crocker Citizens National Bank). [Additional Reference(s): DWR Levee Log, 2005, (HLM 6.50), 36-inch pipe listed. USACE Sacramento O&M Manual 119, December 1952].

View of LS looking from levee crown

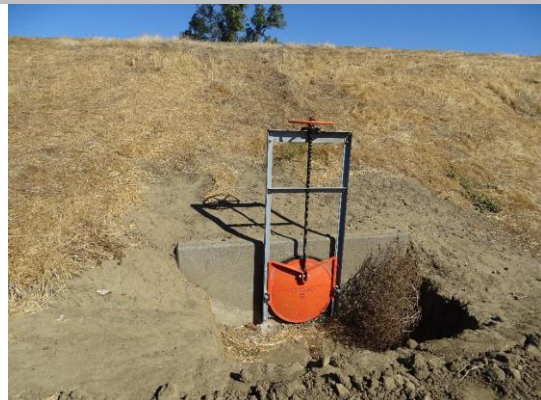
Photo 2 of 3 : UCIP_SP_2021_59906_81730.jpg

LS slope, headwall, and slide gate

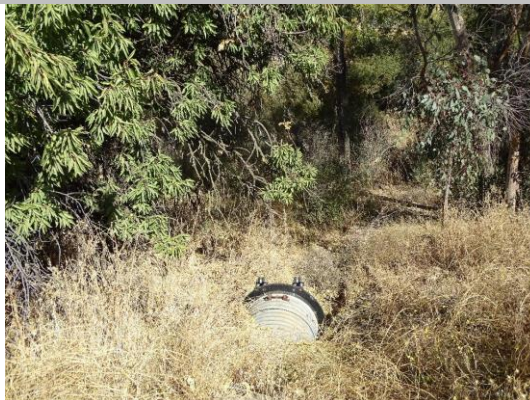
Photo 3 of 3 : UCIP_SP_2021_59906_81731.jpg

Pipe end on WS

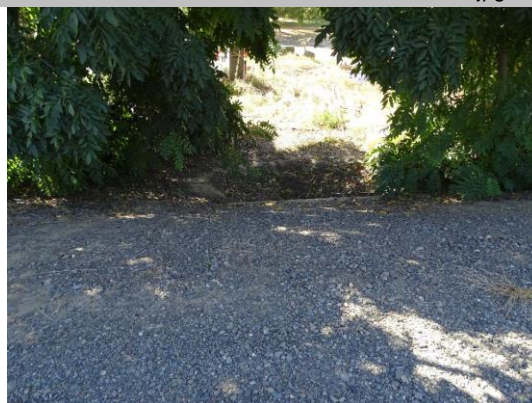
Photo 1 of 3 : UCIP_SP_2021_59908_81739.jpg

| FS_ID:59908 DS_ID:16633 EP_NO: 10276 Repair Type: Non-Urgent Crossing Status: Found UCIP Comments: 10/21/2019 Record remains Non-Urgent. Minor sediment buildup at slide gate. Need to have CVFPB review ABO and determine current owner. (O.Yakimov - DWR UCIP)05/22/2013 Will contact owner of pipe and ask to clean for inspection. (C. Lund - DWR Sacramento Yard) 04/05/2012 Pipe heavily clogged with soil. (W. Wylie - DWR UCIP) FIELD_STRUCT_DESC: 24-inch CIPP-lined drainage pipe of an unknown material through the levee, 6 feet below the crown. Slide gate on the waterside (WS) end, and headwalls on both ends. (24-inch pipe [HLM 6.83] authorized under Automatic Board Order (ABO) issued as Permit No. 10276, 1974 - Patricia Schlages). [Additional Reference(s): DWR Levee Log, 2005 (HLM 6.83). USACE Sacramento O&M Manual, Unit 119, December 1952, Revised 29 Dec 2016, (Station 237+50 PCT), listed as 24-inch pipe. USACE As-Built Drawing No. 50-04-2396, Revision 2, pdf page 26, Sheet 10, December 1947]. FS Date: 10/21/2019 2:32:00 PM | | | | | | |

View of LS looking from levee crown

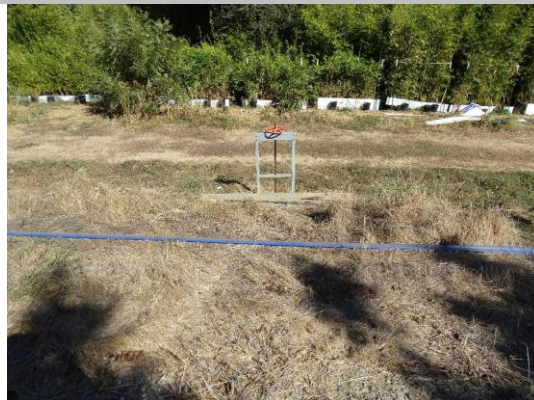
Photo 2 of 3 : UCIP_SP_2021_59908_81740.jpg

View of WS looking from levee crown

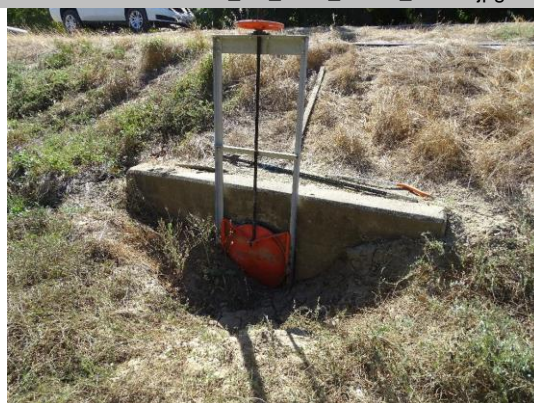
Photo 3 of 3 : UCIP_SP_2021_59908_81741.jpg

WS levee slope, headwall, and slide gate
