**Flood Control Project Maintenance
Levee Inspections**

Maintenance Issue Types Only, Levee Inspection Report By Mile - Spring 2022

Sacramento Maintenance Yard Putah Creek

Waterway	Bank	Unit Miles	Inspection Start/End	Inspector
Unit No. 01 Putah Creek or North Levee	Left	8.79	03/16/2022 03/16/2022	David Julian

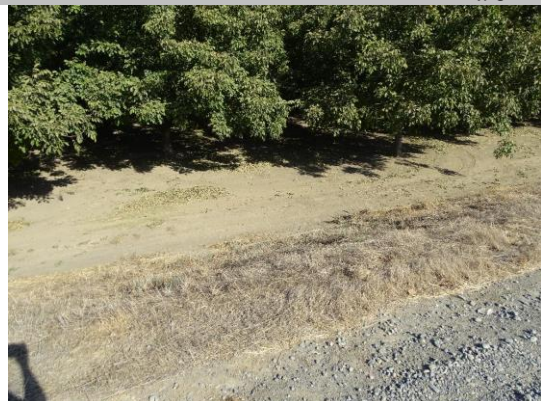
Photo 2 of 3 : UCIP_SP_2022_55597_82103.jpg

View of LS looking from levee crown

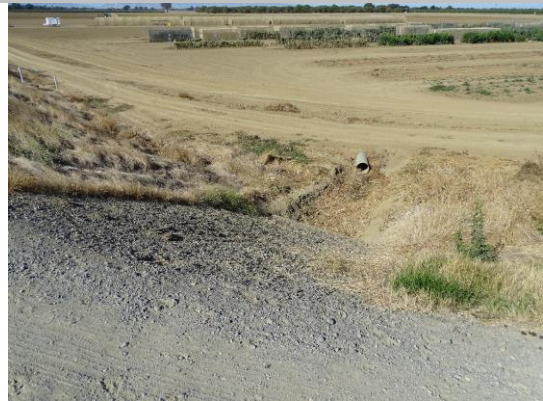
Photo 3 of 3 : UCIP_SP_2022_55455_81755.jpg

FS_ID:55455
DS_ID:496
EP_NO: 10251
Repair Type: Non-Urgent
Crossing Status: Found
UCIP Comments: 10/22/2019 Record updated from No Action Needed to Non-Urgent. Need to have CVFPB review ABO and determine current owner. Installed a new precast concrete box on the waterside. Pipe will be lined in November 2019 according to FMO staff. (O.Yakimov - DWR UCIP)4/10/2019 Major erosion through out pipe. Erosion on WS allows water to enter pipe and flood LS field. Erosion on farmers waterman valve. Field water drains into pipe and floods LS field. (J.McCabe - DWR Sacramento Yard)
FIELD_STRUCT_DESC: 24-inch corrugated metal drainage pipe through levee, 15 feet below the crown. Two metal cutoff walls were installed through the levee. A T-post and T-handle are located on the landside (LS) toe. The outfall structure and flap gate are located on the west side of bridge, waterside (WS). (24-inch pipe [HLM 3.87] authorized under Automatic Board Order (ABO) issued as Permit No. 10251, 1974 - F.M.C. Corp.) [Additional Reference(s): DWR Levee Log, 1981 and 2005 (HLM 3.87). USACE Sacramento O&M Manual, Unit 119, December 1952, Revised 29 Dec 2016, (Station 1+50 PCT), listed as 24-inch pipe. USACE As-Built Drawing No. 50-04-2396, Revision 4, pdf page 23, Sheet 7, December 1947]

View of LS looking from levee crown

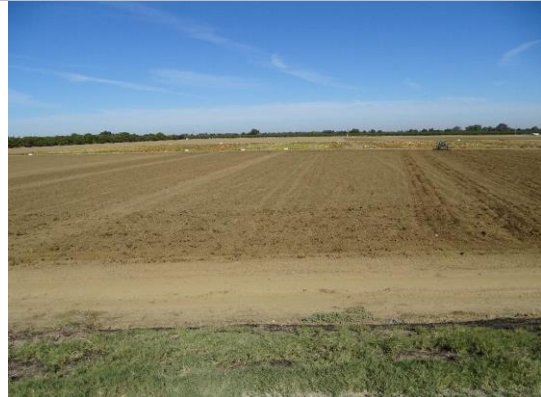
Photo 2 of 3 : UCIP_SP_2022_55456_81761.jpg

Comment Code					
Inspector Comment					
FS_ID:55456 DS_ID:497 EP_NO: 10251 Repair Type: Non-Urgent Crossing Status: Found UCIP Comments: 10/22/2019 Record updated from No Action Needed to Non-Urgent. Geophysical study indicates possible presence of pipe through levee. Need to have CVFPB review ABO and determine current owner. Pipe inlet and headwall are not visible on LS. Slide gate in CMP riser is in closed position, crossing looks abandoned. Construction according to permit 10251-1 hasn't started yet. Field structure description is updated to match original pipe construction. (O.Yakimov - DWR UCIP) FIELD_STRUCT_DESC: 24-inch drainage pipe of unknown material through levee, 16 feet below the crown. 36-inch galvanized corrugated metal pipe (CMP) riser located on the waterside (WS) slope. (24-inch pipe [HLM 4.13] authorized under Automatic Board Order (ABO) issued as Permit No. 10251, 1974 - F.M.C. Corp.; assumed original 24-inch pipe was installed in 12/12/1952 per O&M manual) [Additional Reference(s): DWR Levee Log, 1981 and 2005 (HLM 4.13). USACE Sacramento O&M Manual, Unit 119, December 1952, Revised 29 Dec 2016, (Station 17+00 PCT), listed as 24-inch pipe. USACE As-Built Drawing No. 50-04-2396, Revision 4, pdf page 23, Sheet 7, December 1947] FS Date: 10/22/2019 11:37:56 AM

View of LS looking from levee crown

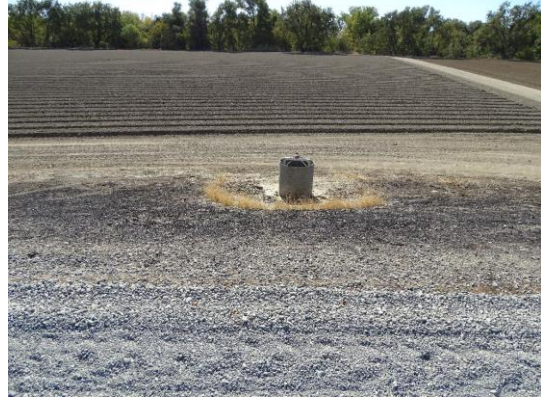
Photo 3 of 3 : UCIP_SP_2022_55456_81762.jpg

View of WS looking from levee crown

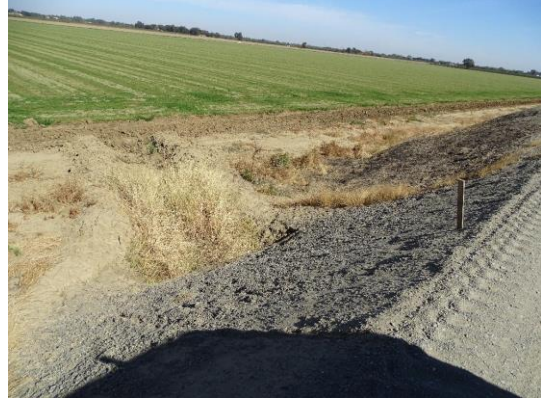
Photo 1 of 3 : UCIP_SP_2022_59861_81775.jpg

FS_ID:59861
DS_ID:500
EP_NO: 10256
Repair Type: Non-Urgent
Crossing Status: Found
UCIP Comments: 10/22/2019 Record updated from No Action Needed to Non-Urgent. Need to have CVFPB review ABO and determine current owner. (O.Yakimov - DWR UCIP)05/06/2013 Debris removed. See picture (C. Lund - DWR Sacramento Yard)
04/04/2012 Some debris in pipe invert LS (W. Wylie - DWR UCIP)
FIELD_STRUCT_DESC: 24-inch CIPP-lined corrugated metal drainage pipe through the levee, 15 feet below the crown. Slide gate on the waterside (WS) end. Concrete headwall on the landside (LS) end. (24-inch pipe [HLM 5.39] authorized under Automatic Board Order (ABO) issued as Permit No. 10256, 1974 - Albert H. Lederer). [Additional Reference(s): DWR Levee Log, 2005 (HLM 5.39). USACE Sacramento O&M Manual, Unit 119, December 1952, Revised 29 Dec 2016, (Station 83+70 PCT), listed as 24-inch pipe. USACE As-Built Drawing No. 50-04-2396, Revision 4, pdf page 24, Sheet 8, December 1947].

View of LS looking from levee crown

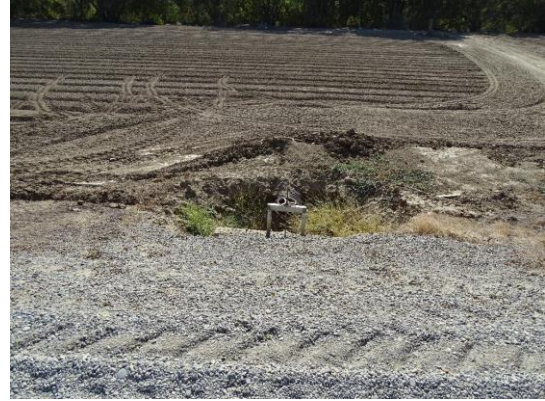
Photo 2 of 3 : UCIP_SP_2022_59861_81776.jpg

View of WS looking from levee crown

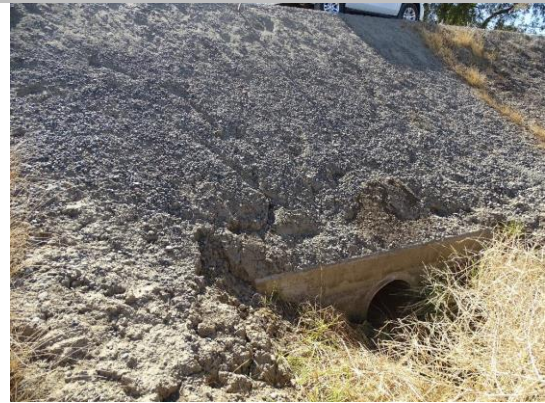
Photo 3 of 3 : UCIP_SP_2022_59861_81777.jpg

LS levee slope, headwall, and pipe end

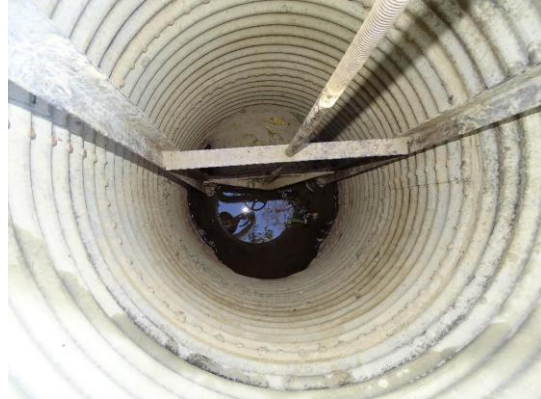
Photo 3 of 3 : UCIP_SP_2022_55460_81781.jpg

Comment Code						
Inspector Comment						
FS_ID:55460 DS_ID:501 EP_NO: 10256 Repair Type: Non-Urgent Crossing Status: Found UCIP Comments: 10/22/2019 Record updated from No Action Needed to Non-Urgent. Need to have CVFPB review ABO and determine current owner. Crossing has been modified to supply water from LS to WS. Should not be considered a storm drainage pipe. (O.Yakimov - DWR UCIP) FIELD_STRUCT_DESC: 24-inch corrugated metal drainage pipe through the levee, 12.5 feet below the crown. Slide gate on the waterside (WS) end in 36-inch standpipe. Concrete standpipe at LS toe with fill-in pipe. (24-inch pipe [HLM 5.40] authorized under Automatic Board Order (ABO) issued as Permit No. 10256, 1974 - Albert H. Lederer). [Additional Reference(s): DWR Levee Log, 2005 (HLM 5.40). USACE Sacramento O&M Manual, Unit 119, December 1952, Revised 29 Dec 2016, (Station 84+40 PCT), listed as 24-inch pipe. USACE As-Built Drawing No. 50-04-2396, Revision 4, pdf page 24, Sheet 8, December 1947]. FS Date: 10/22/2019 3:28:15 PM

View inside of CMP standpipe on WS

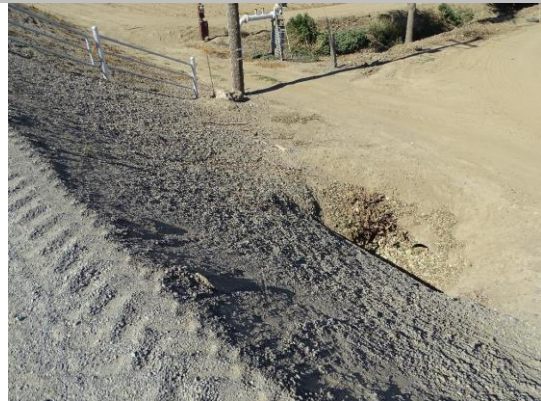
Photo 1 of 3 : UCIP_SP_2022_55461_81782.jpg

FS_ID:55461
DS_ID:502
EP_NO: 10255
Repair Type: Non-Urgent
Crossing Status: Found
UCIP Comments: 10/22/2019 Record updated from No Action Needed to Non-Urgent. Need to have CVFPB review ABO and determine current owner. (O.Yakimov - DWR UCIP)
FIELD_STRUCT_DESC: 24-inch CIPP-lined corrugated metal drainage pipe through the levee, 11 feet below the crown. Slide gate on the waterside (WS) end. Concrete headwall on the landside (LS) end. (24-inch pipe [HLM 5.67] authorized under Automatic Board Order (ABO) issued as Permit No. 10255, 1974 - Owen W. and Ray W. Hamel).
[Additional Reference(s): DWR Levee Log, 2005 (HLM 5.67). USACE Sacramento O&M Manual, Unit 119, December 1952, Revised 29 Dec 2016, (Station 97+00 PCT), listed as 24-inch pipe. USACE As-Built Drawing No. 50-04-2396, Revision 4, pdf page 24, Sheet 8, December 1947].
FS Date: 10/22/2019 4:03:27 PM

View of LS looking from levee crown

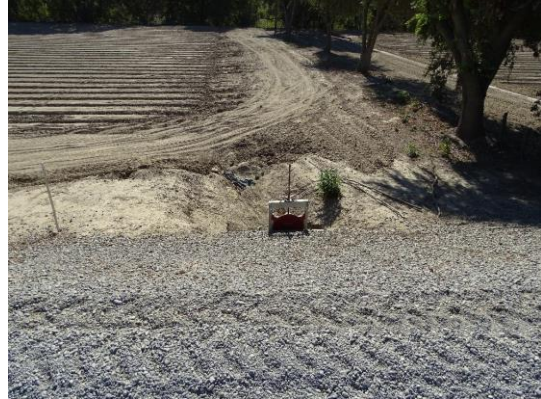
Photo 2 of 3 : UCIP_SP_2022_55461_81783.jpg

View of WS looking from levee crown

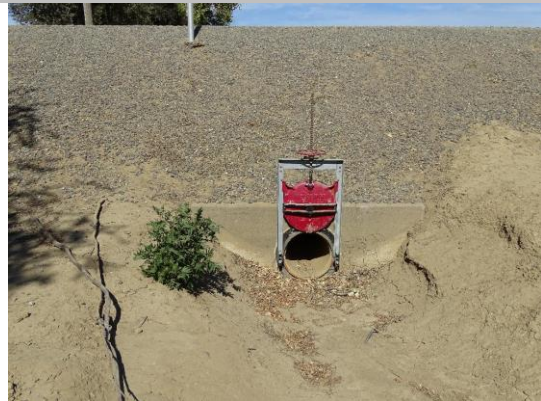
Photo 3 of 3 : UCIP_SP_2022_55461_81784.jpg

WS levee slope, headwall, and slide gate

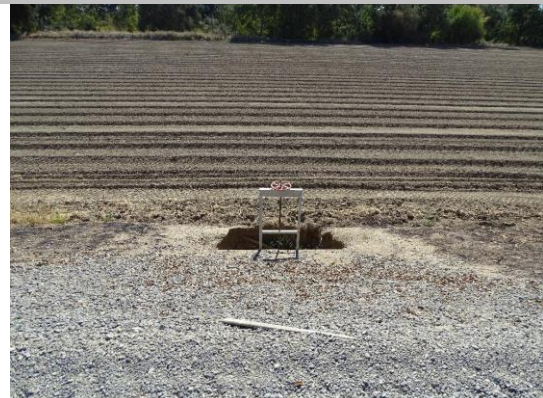
Photo 2 of 3 : UCIP_SP_2022_59863_82262.jpg

Comment Code						
Inspector Comment						
FS_ID:59863 DS_ID:503 EP_NO: 10252 Repair Type: Non-Urgent Crossing Status: Found UCIP Comments: 10/22/2019 Record updated from No Action Needed to Non-Urgent. Need to have CVFPB review ABO and determine current owner. (O.Yakimov - DWR UCIP) 05/06/2013 Owner of pipe needs to clean out obstruction in pipe. (C. Lund - DWR Sacramento Yard) 04/04/2012 Partially obstructed with sedimentation throughout crossing. (W. Wylie - DWR UCIP) FIELD_STRUCT_DESC: 24-inch CIPP-lined corrugated metal drainage pipe through the levee, 12 feet below the crown. Slide gate on the waterside (WS) end. Concrete headwall on the landside (LS) end. (24-inch pipe [HLM 5.86] authorized under Automatic Board Order (ABO) issued as Permit No. 10252, 1974 - John F. Hamel). [Additional Reference(s): DWR Levee Log, 2005 (HLM 5.86). USACE Sacramento O&M Manual, Unit 119, December 1952, Revised 29 Dec 2016, (Station 108+00 PCT), listed as 24-inch pipe. USACE As-Built Drawing No. 50-04-2396, Revision 4, pdf page 24, Sheet 8, December 1947]. FS Date: 10/22/2019 10:55:00 AM

View of WS looking from levee crown

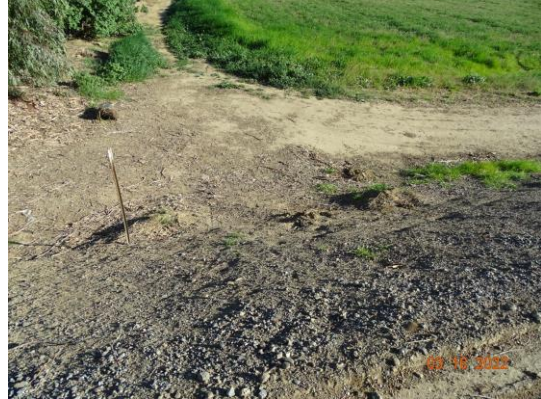
Photo 1 of 1 : SP_2022_ST0007_282_69_20220316_00121.jpg

LM Start	6.63	Rating **	M	Issue No.	69
LM End	6.63	Issue Type +	Ma	Location *	LS
Category	Earthen Levee			GPS Latitude/Longitude	
				Start	End
Item	Animal Control			38.517697 °	38.517697 °
				-121.747210 °	-121.747210 °
DWR ID	DWR_ST0007_01_s_2022_69				
Comment Code					
A1 : Exterminate rodents and backfill and compact or grout burrows.					
Inspector Comment

View of animal burrows in the landside slope (Spring 2022).

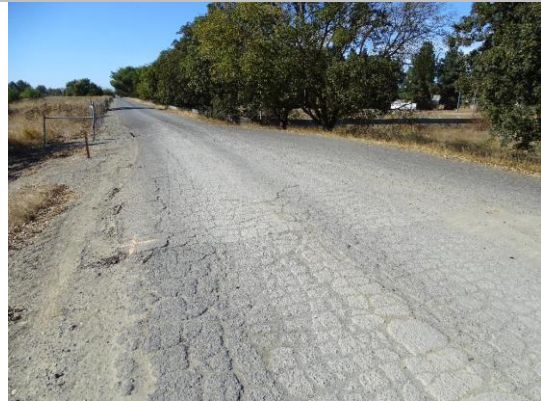
Photo 1 of 3 : UCIP_SP_2022_55664_82343.jpg

Comment Code						
Inspector Comment						
FS_ID:55664 DS_ID:508 EP_NO: 10247 Repair Type: Non-Urgent Crossing Status: Found UCIP Comments: 10/22/2019 Record updated from No Action Needed to Non-Urgent. Need to have CVFPB review ABO and determine current owner. (O.Yakimov - DWR UCIP) FIELD_STRUCT_DESC: 24-inch CIPP-lined corrugated metal drainage pipe through the levee, 11.0 feet below the crown. Flap gate on the waterside (WS) end. Concrete headwall on the landside (LS) end. Concrete Apron on the WS. (24-inch pipe [HLM 7.09] authorized under Automatic Board Order (ABO) issued as Permit No. 10247, 1974 - University of California, Office of the Regents). [Additional Reference(s): DWR Levee Log, 2005 (HLM 7.09). USACE Sacramento O&M Manual, Unit 119, December 1952, Revised 29 Dec 2016, (Station 172+00 PCT), listed as 24-inch pipe. USACE As-Built Drawing No. 50-04-2396, Revision 4, pdf page 25, Sheet 9, December 1947]. FS Date: 10/22/2019 1:55:30 PM

View of levee crown at the crossing

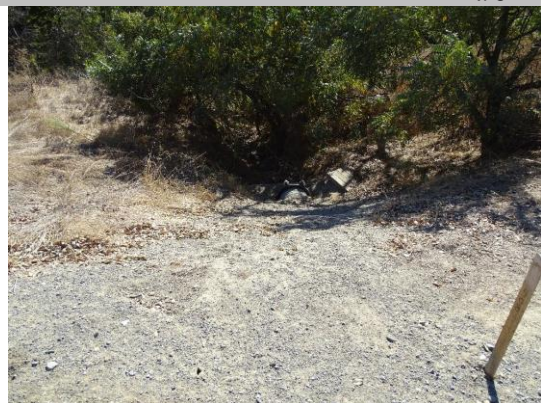
Photo 2 of 3 : UCIP_SP_2022_55664_82344.jpg

View of WS looking from levee crown

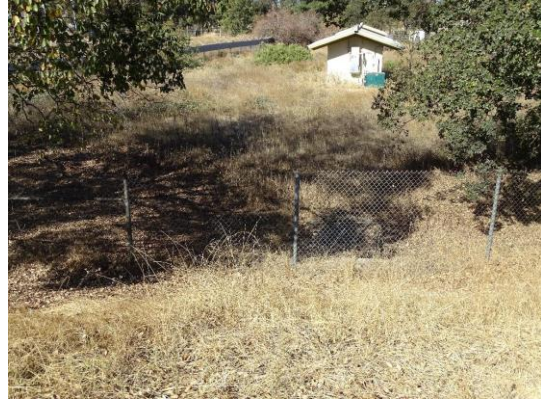
Photo 3 of 3 : UCIP_SP_2022_55664_82345.jpg

View of LS looking from levee crown

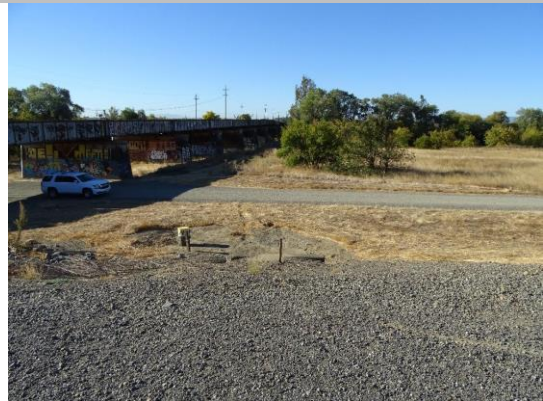
Photo 3 of 3 : UCIP_SP_2022_59874_82374.jpg

FS_ID:59874
 DS_ID:516
 EP_NO: 10260
 Repair Type: Non-Urgent
 Crossing Status: Found
 UCIP Comments: 10/21/2019 Record remains Non-Urgent. Need to have CVFPB review ABO and determine current owner. (O.Yakimov - DWR UCIP) 05/07/2013 Owner of pipe may have to clean sediment. (C. Lund - DWR Sacramento Yard)
 04/05/2012 Pipe is partially obstructed with sedimentation. (W. Wylie - DWR UCIP)
 FIELD_STRUCT_DESC: 24-inch corrugated metal drainage pipe through the levee, 12 feet below the crown. Flap gate on the waterside (WS) end. (24-inch pipe [HLM 7.52] authorized under Automatic Board Order (ABO) issued as Permit No. 10260, 1974 - Southern Pacific Transportation Company). [Additional Reference(s): DWR Levee Log, 2005 (HLM 7.52). USACE Sacramento O&M Manual, Unit 119, December 1952, Revised 29 Dec 2016, (Station 193+20 PCT), listed as 24-inch pipe. USACE As-Built Drawing No. 50-04-2396, Revision 4, pdf page 25, Sheet 9, December 1947].

View of WS looking from levee crown

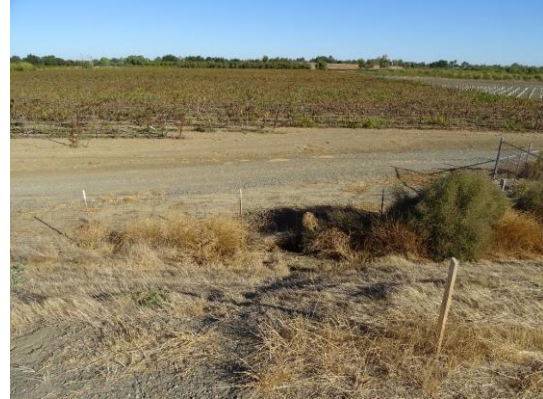
Photo 1 of 3 : UCIP_SP_2022_59875_82382.jpg

Comment Code						
Inspector Comment						
FS_ID:59875 DS_ID:518 EP_NO: 10247 Repair Type: Non-Urgent Crossing Status: Found UCIP Comments: 10/21/2019 Difficult access to pipe inlet on LS due to a fence. (O.Yakimov - DWR UCIP)05/07/2013 Fence blocking inlet. Owner of fence needs to move fence away from inlet. (C. Lund - DWR Sacramento Yard) 04/05/2012 Clear debris from pipe. (W. Wylie - DWR UCIP) FIELD_STRUCT_DESC: 24-inch CIPP-lined corrugated metal drainage pipe through the levee, 12 feet below the crown. Slide gate on the waterside (WS) slope, and headwalls on both sides. (24-inch pipe [HLM 7.75] authorized under Automatic Board Order (ABO) issued as Permit No. 10247, 1974 - University of California, Office of the Regents). [Additional Reference(s): DWR Levee Log, 2005 (HLM 7.75). USACE Sacramento O&M Manual, Unit 119, December 1952, Revised 29 Dec 2016, (Station 204+00 PCT), listed as 24-inch pipe. USACE As-Built Drawing No. 50-04-2396, Revision 4, pdf page 25, Sheet 9, December 1947]. FS Date: 10/21/2019 8:27:00 AM

View of LS looking from levee crown

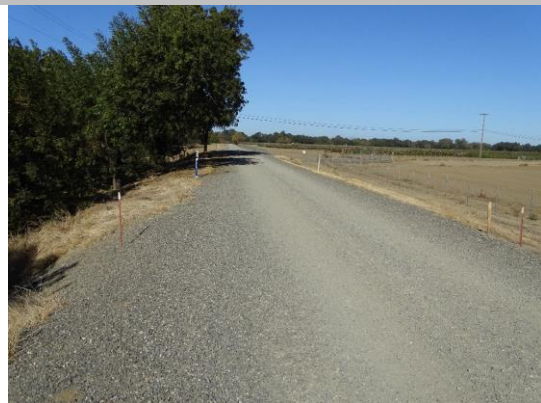
Photo 1 of 3 : UCIP_SP_2022_59879_82393.jpg

FS_ID:59879
DS_ID:520
EP_NO: 10247
Repair Type: Non-Urgent
Crossing Status: Found
UCIP Comments: 10/21/2019 Record updated from No Action Needed to Non-Urgent. Need to have CVFPB review ABO and determine current owner. (O.Yakimov - DWR UCIP) 05/07/2012 Cleaned inlet and outlets. Owner of pipe may need to clean pipe. (C. Lund - DWR Sacramento Yard)
04/05/2012 Pipe is plugged with soil on LS. (W. Wylie - DWR UCIP)
FIELD_STRUCT_DESC: 24-inch CIPP-lined corrugated metal drainage pipe through the levee, 8 feet below the crown. Slide gate on the waterside (WS) end. (24-inch pipe [HLM 8.45] authorized under Automatic Board Order (ABO) issued as Permit No. 10247, 1974 - University of California, Office of the Regents). [Additional Reference(s): DWR Levee Log, 2005 (HLM 8.45). USACE Sacramento O&M Manual, Unit 119, December 1952, Revised 29 Dec 2016, (Station 241+50 PCT), listed as 24-inch pipe. USACE As-Built Drawing No. 50-04-2396, Revision 2, pdf page 26, Sheet 10, December 1947].

View of levee crown at the crossing

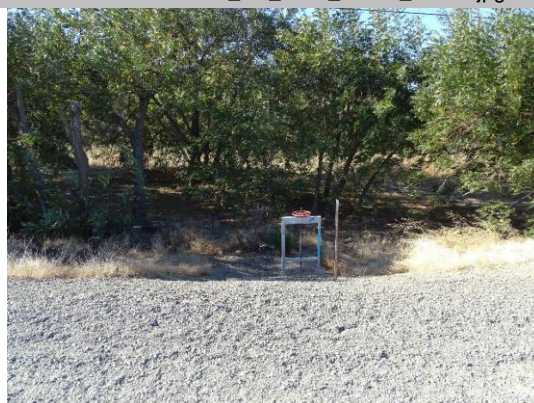
Photo 3 of 3 : UCIP_SP_2022_59879_82395.jpg

View of WS looking from levee crown

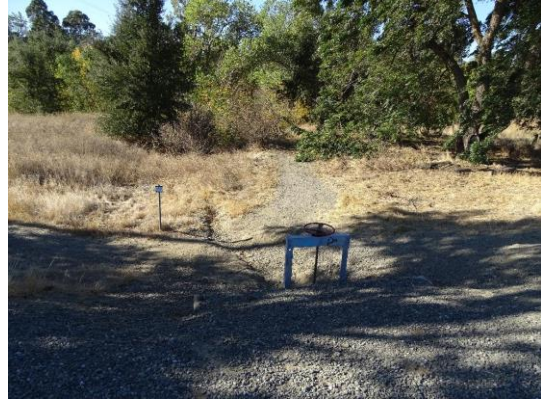
Photo 1 of 3 : UCIP_SP_2022_59880_82398.jpg

Comment Code					
Inspector Comment					
FS_ID:59880 DS_ID:521 EP_NO: 10247 Repair Type: Non-Urgent Crossing Status: Found UCIP Comments: 10/21/2019 Record updated from No Action Needed to Non-Urgent. Need to have CVFPB review ABO and determine current owner. (O.Yakimov - DWR UCIP) 05/07/2013 Removed material at slidegate and inlet. (C. Lund - DWR Sacramento Yard) 04/05/2012 Pipe is partially blocked by sedimentation and slide gate will not open. (W. Wylie - DWR UCIP) FIELD_STRUCT_DESC: 24-inch CIPP-lined corrugated metal drainage pipe through the levee, 7 feet below the crown. Slide gate on the waterside (WS) end. Headwalls on both ends. (24-inch pipe [HLM 8.50] authorized under Automatic Board Order (ABO) issued as Permit No. 10247, 1974 - University of California, Office of the Regents. Also mentioned in Permit No. 5896, 1967 - The Regents of the University of California, Office of Architects and Engineers, University of California, Davis Campus). [Additional Reference(s): DWR Levee Log, 2005 (HLM 8.50). USACE Sacramento O&M Manual, Unit 119, December 1952, Revised 29 Dec 2016, (Station 244+20 PCT), listed as 24-inch pipe. USACE As-Built Drawing No. 50-04-2396, Revision 2, pdf page 26, Sheet 10, December 1947]. FS Date: 10/21/2019 11:46:00 AM

View of WS looking from levee crown

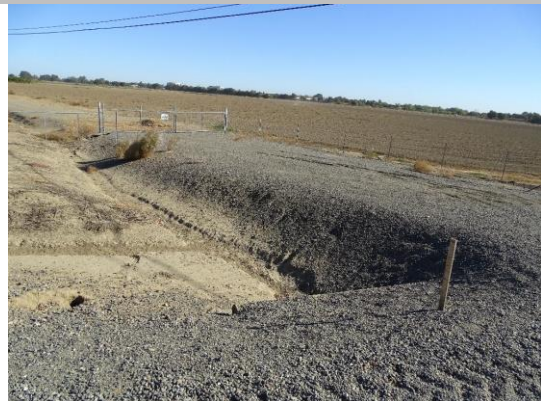
Photo 2 of 3 : UCIP_SP_2022_59880_82399.jpg

View of LS looking from levee crown

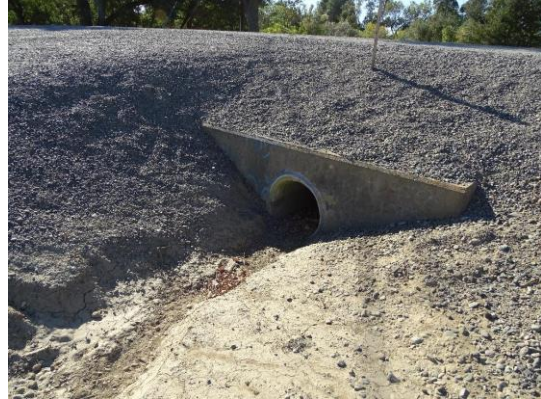
Photo 3 of 3 : UCIP_SP_2022_59880_82400.jpg

LS levee slope, headwall, and pipe end

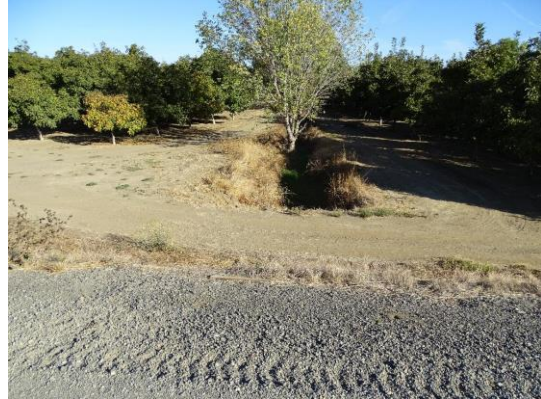
Photo 1 of 3 : UCIP_SP_2022_55424_81638.jpg

Comment Code						
Inspector Comment						
FS_ID:55424 DS_ID:16621 EP_NO: 10270 Repair Type: Non-Urgent Crossing Status: Found UCIP Comments: 10/22/2019 Crossing visually is in good condition. 12-inch diameter through hole has developed due to soil instability on WS berm visible on the top of pipe outlet embankment. Need to have CVFPB review ABO and determine current owner. (O.Yakimov - DWR UCIP) FIELD_STRUCT_DESC: 36-inch corrugated metal drainage pipe through the levee, 14 feet below the crown. Flap gate on the waterside (WS) end. Concrete headwall on the landside (LS) end. (36-inch pipe [HLM 0.85] authorized under Automatic Board Order (ABO) issued as Permit No. 10270, 1974 - Hamel). [Additional Reference(s): DWR Levee Log, 2005 (HLM 0.85). USACE Sacramento O&M Manual, Unit 119, December 1952, Revised 29 Dec 2016, (Station T 1+45), listed as 36-inch pipe. USACE As-Built Drawing No. 50-04-2396, Revision 1, pdf page 21, Sheet 5, December 1947]. FS Date: 10/22/2019 9:59:31 AM

View of WS looking from levee crown

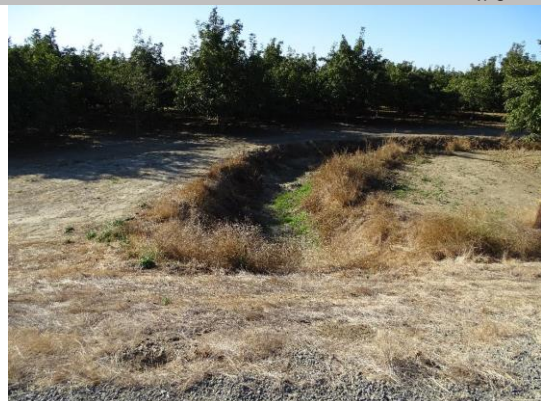
Photo 2 of 3 : UCIP_SP_2022_55424_81639.jpg

View of LS looking from levee crown

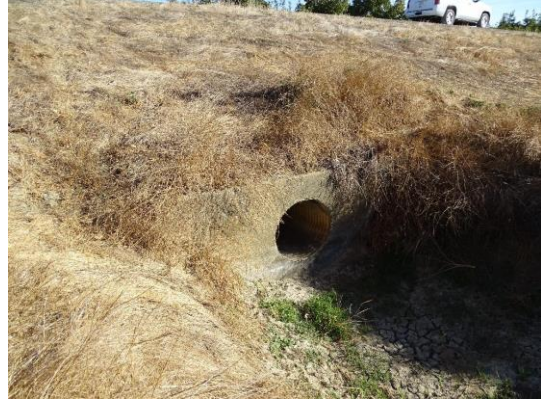
Photo 3 of 3 : UCIP_SP_2022_55424_81640.jpg

Headwall and pipe at LS toe

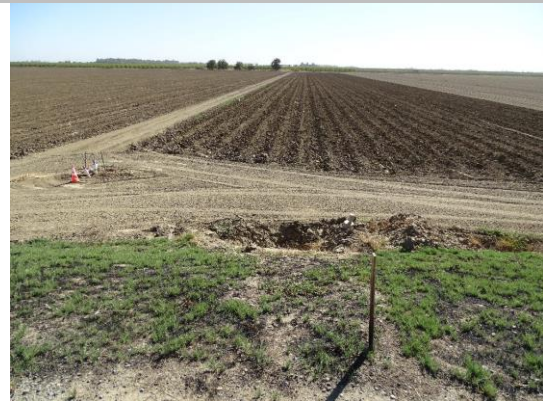
Photo 1 of 3 : UCIP_SP_2022_55411_81619.jpg

Comment Code						
Inspector Comment						
FS_ID:55411 DS_ID:16625 EP_NO: 10277 Repair Type: Urgent Crossing Status: Found UCIP Comments: 10/21/2019 Record updated from No Action Needed to Urgent. A PVC pipe runs through a drainage pipe from LS to WS levee toe. Slide gate cannot be closed properly to prevent flooding on LS. Remove PVC pipe. Need to have CVFPB review ABO and determine current owner. (O.Yakimov - DWR UCIP) FIELD_STRUCT_DESC: 24-inch CIPP-lined corrugated metal drainage pipe through the levee, 9 feet below the crown. Slide gate on the waterside (WS) slope. Concrete headwalls on both ends. (24-inch pipe [HLM 2.71] authorized under Automatic Board Order (ABO) issued as Permit No. 10277, 1974 - Naomi Schoeningh). [Additional Reference(s): DWR Levee Log, 2005 (HLM 2.71). USACE Sacramento O&M Manual, Unit 119, December 1952, Revised 29 Dec 2016, (Station 30+15 PCT), listed as 24-inch pipe. USACE As-Built Drawing No. 50-04-2396, Revision 4, pdf page 23, Sheet 7, December 1947]. FS Date: 10/21/2019 11:18:53 AM

View of LS from levee crown

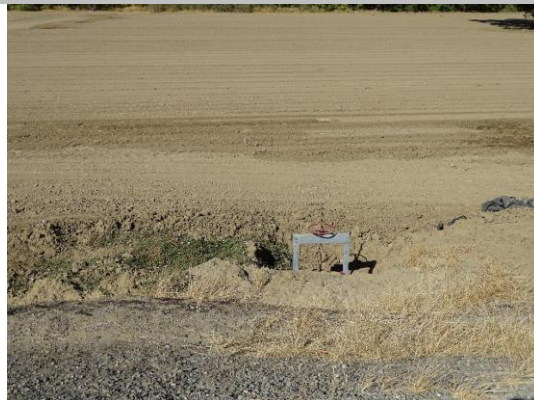
Photo 2 of 3 : UCIP_SP_2022_55411_81620.jpg

View of WS from levee crown

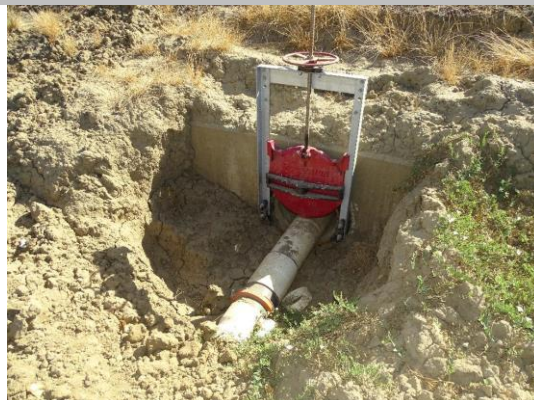
Photo 3 of 3 : UCIP_SP_2022_55411_81621.jpg

Headwall and slidegate at WS toe with a PVC pipe running through

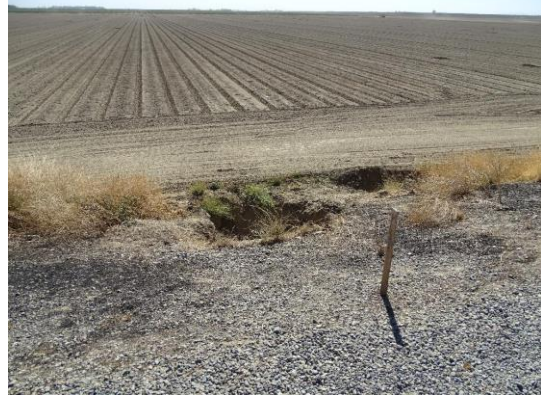
Photo 1 of 3 : UCIP_SP_2022_55412_81623.jpg

Comment Code						
Inspector Comment						
FS_ID:55412 DS_ID:16626 EP_NO: 10277 Repair Type: Urgent Crossing Status: Found UCIP Comments: 10/21/2019 Record updated from No Action Needed to Urgent. A PVC pipe runs through a drainage pipe from LS to WS levee toe. Slide gate cannot be closed properly to prevent flooding on LS. Remove PVC pipe. Need to have CVFPB review ABO and determine current owner. (O.Yakimov - DWR UCIP) FIELD_STRUCT_DESC: 24-inch CIPP-lined corrugated metal drainage pipe through the levee, 9 feet below the crown. Slide gate on the waterside (WS) slope, and headwalls on both sides. (24-inch pipe [HLM 3.11] authorized under Automatic Board Order (ABO) issued as Permit No. 10277, 1974 - Naomi Schoeningh). [Additional Reference(s): DWR Levee Log, 2005 (HLM 3.11). USACE Sacramento O&M Manual, Unit 119, December 1952, Revised 29 Dec 2016, (Station 50+72 PCT), listed as 24-inch pipe. USACE As-Built Drawing No. 50-04-2396, Revision 4, pdf page 23, Sheet 7, December 1947]. FS Date: 10/21/2019 1:30:39 PM

View of LS from levee crown

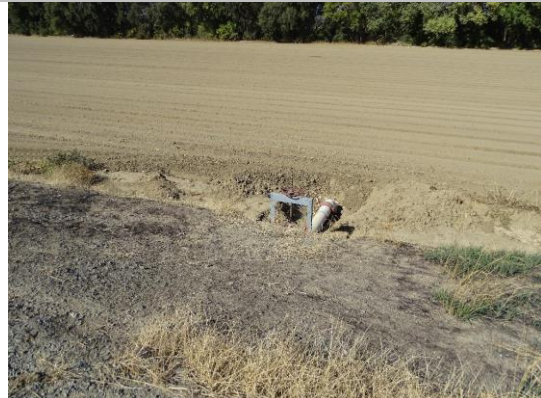
Photo 2 of 3 : UCIP_SP_2022_55412_81624.jpg

View of WS from levee crown

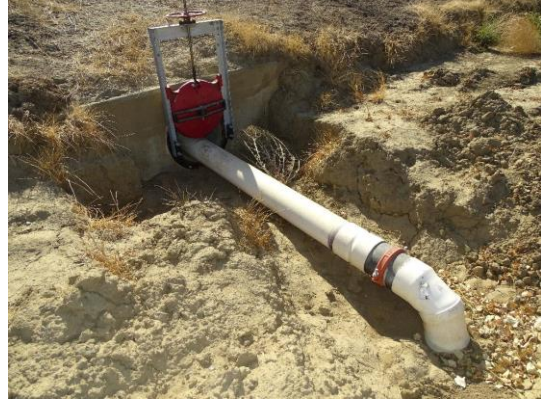
Photo 3 of 3 : UCIP_SP_2022_55412_81625.jpg

Headwall and slidegate at WS toe with a PVC pipe running through

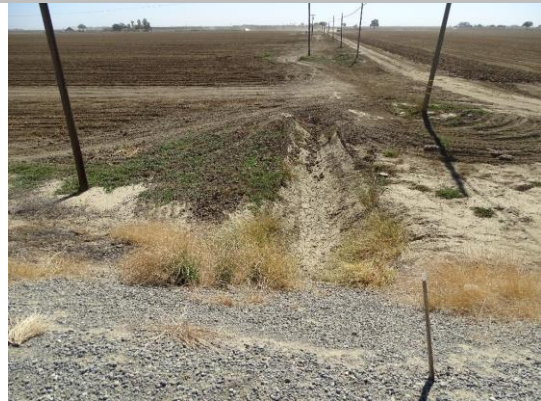
Photo 1 of 3 : UCIP_SP_2022_55434_81690.jpg

FS_ID:55434
 DS_ID:16629
 EP_NO: 10269
 Repair Type: Non-Urgent
 Crossing Status: Found
 UCIP Comments: 10/21/2019 Pipe is partially silted, cleanup pipe.
 Record updated from No Action Needed to Non-Urgent. Need to have CVFPB review ABO and determine current owner. (O.Yakimov - DWR UCIP)
 FIELD_STRUCT_DESC: 24-inch CIPP-lined corrugated metal drainage pipe through the levee, 12.5 feet below the crown. Slide gate on the waterside (WS) end. Concrete headwalls on both ends. (24-inch pipe [HLM 4.26] authorized under Automatic Board Order (ABO) issued as Permit No. 10269, 1974 - Joseph Fahn). [Additional Reference(s): DWR Levee Log, 2005 (HLM 4.26). USACE Sacramento O&M Manual, Unit 119, December 1952, Revised 29 Dec 2016, (Station 109+75 PCT), listed as 24-inch pipe. USACE As-Built Drawing No. 50-04-2396, Revision 4, pdf page 24, Sheet 8, December 1947].
 FS Date: 10/21/2019 9:16:52 AM

View of LS looking from levee crown

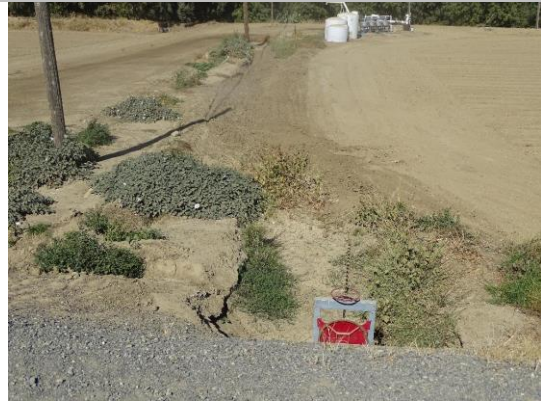
Photo 2 of 3 : UCIP_SP_2022_55434_81691.jpg

View of WS looking from levee crown

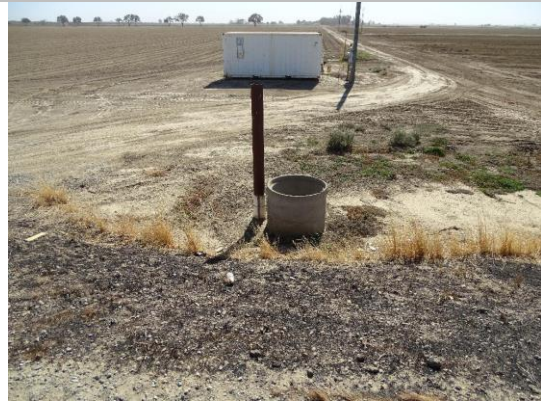
Photo 1 of 3 : UCIP_SP_2022_55436_81697.jpg

Comment Code						
Inspector Comment						
FS_ID:55436 DS_ID:16644 EP_NO: 10271 Repair Type: Urgent Crossing Status: Found UCIP Comments: 10/21/2019 Record updated from No Action Needed to Non-Urgent. Need to have CVFPB review ABO and determine current owner. (O.Yakimov - DWR UCIP) FIELD_STRUCT_DESC: 24-inch corrugated metal drainage pipe through the levee, 9.5 feet below the crown. Flap gate on the waterside (WS). 36-inch standpipe on the landside (LS). (24-inch pipe [HLM 4.77] authorized under Automatic Board Order (ABO) issued as Permit No. 10271, 1974 - Ray H. Hamel). [Additional Reference(s): DWR Levee Log, 2005 (HLM 4.77). USACE Sacramento O&M Manual, Unit 119, December 1952, Revised 29 Dec 2016, (Station 136+40 PCT), listed as 24-inch pipe. USACE As-Built Drawing No. 50-04-2396, Revision 4, pdf page 24, Sheet 8, December 1947]. FS Date: 10/21/2019 9:46:01 AM

View of LS looking from levee crown. 36-inch standpipe near levee toe

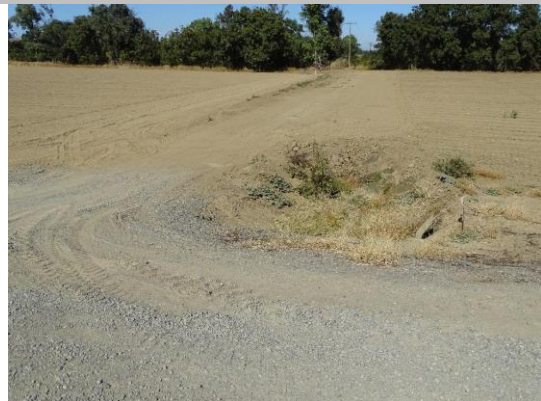
Photo 2 of 3 : UCIP_SP_2022_55436_81698.jpg

View of WS looking from levee crown

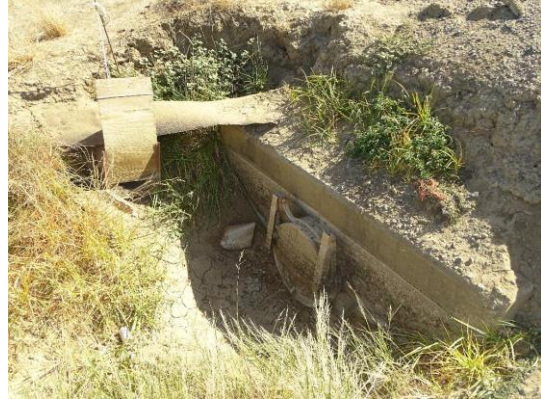
Photo 3 of 3 : UCIP_SP_2022_55436_81699.jpg

Headwall and flap gate at WS levee toe

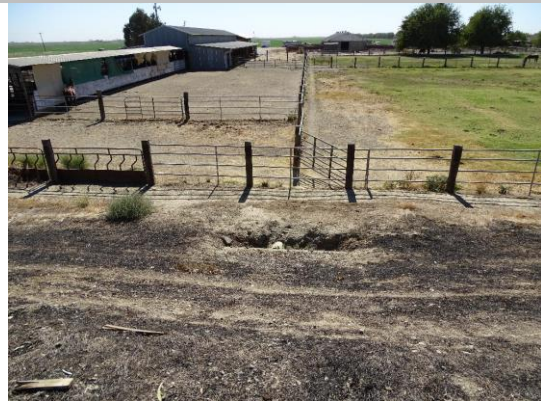
Photo 1 of 3 : UCIP_SP_2022_59897_81707.jpg

FS_ID:59897
DS_ID:16620
EP_NO: 10267
Repair Type: Non-Urgent
Crossing Status: Found
UCIP Comments: 10/21/2019 Record updated from No Action Needed to Non-Urgent. Need to have CVFPB review ABO and determine current owner. (O.Yakimov - DWR UCIP)05/22/2013 Gate has been oiled and debris removed from outlet on land side. (C. Lund - DWR Sacramento Yard) 04/06/2012 Pipe is partially filled with sediment and slide gate is in need of maintenance as it will not move. (W. Wylie - DWR UCIP)
FIELD_STRUCT_DESC: 24-inch CIPP-lined corrugated metal drainage pipe through the levee, 13 feet below the crown. Slide gate on the waterside (WS) slope. Concrete headwalls on both ends. (24-inch pipe [HLM 5.56] authorized under Automatic Board Order (ABO) issued as Permit No. 10267, 1974 - Davis Laboratories, Inc.). [Additional Reference(s): DWR Levee Log, 2005 (HLM 5.56). USACE Sacramento O&M Manual, Unit 119, December 1952, Revised 29 Dec 2016, (Station 177+60 PCT), listed as 24-inch pipe. USACE As-Built Drawing No. 50-04-2396, Revision 4, pdf page 25, Sheet 9, December 1947].

View of LS looking from levee crown

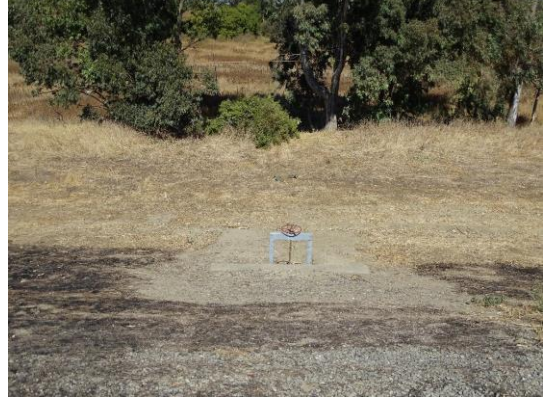
Photo 2 of 3 : UCIP_SP_2022_59897_81708.jpg

View of WS looking from levee crown

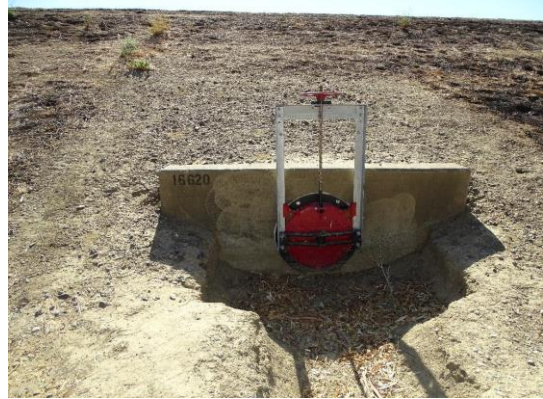
Photo 3 of 3 : UCIP_SP_2022_59897_81709.jpg

WS levee slope, headwall and slide gate

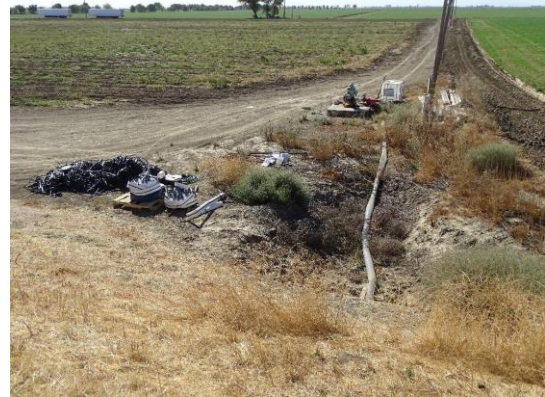
Photo 2 of 3 : UCIP_SP_2022_59900_81629.jpg

Comment Code					
Inspector Comment					
FS_ID:59900 DS_ID:16636 EP_NO: 10279 Repair Type: Urgent Crossing Status: Found UCIP Comments: 01/25/2022 Enforcement Case No. 2020-15562 issued earlier for unpermitted lay-flat irrigation hose has been closed. (O.Yakimov - DWR UCIP) 10/21/2019 Rating updated from No Action Needed to Urgent. A 6-inch hose connected to a water well on LS runs through a drainage pipe from LS to WS. Slide gate cannot be closed properly to prevent flooding on LS. Remove hose. (O.Yakimov - DWR UCIP)05/22/2013 Pipe was cleaned by the owner and 6 in pipe is still being used. (C. Lund - DWR Sacramento Yard) 04/05/2012 Pipe needs to be cleared of sedimentation. (W. Wylie - DWR UCIP) FIELD_STRUCT_DESC: 24-inch CIPP-lined corrugated metal drainage pipe through the levee, 14 feet below the crown. Slide gate on the waterside (WS) end. Concrete headwall on landside (LS) end. (name change for existing 24-inch drainpipe and slide gate on WS [HLM 5.89] issued under Permit No. 10279-1, 2012 - Elizabeth Dankworth and Michelle Christison; 24-inch pipe [HLM 5.89] authorized under Automatic Board Order (ABO) issued as Permit No. 10279, 1974 - Carmelita Watkins). [Additional Reference(s): DWR Levee Log, 2005 (HLM 5.89). USACE Sacramento O&M Manual, Unit 119, December 1952, Revised 29 Dec 2016, (Station 193+00 PCT), listed as 24-inch pipe. USACE As-Built Drawing No. 50-04-2396, Revision 4, pdf page 25, Sheet 9, December 1947]. FS Date: 10/21/2019 1:39:00 PM

View of LS from levee crown

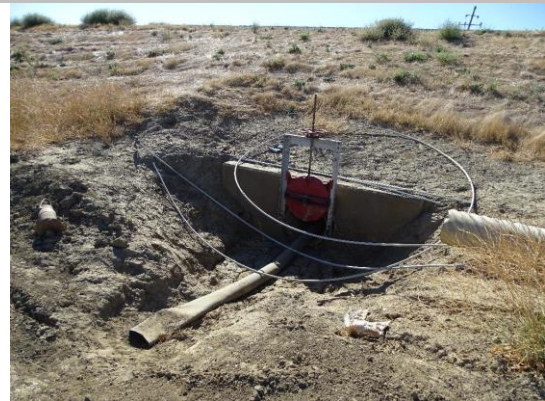
Photo 3 of 3 : UCIP_SP_2022_59900_81630.jpg

WS slope with headwall and slide gate

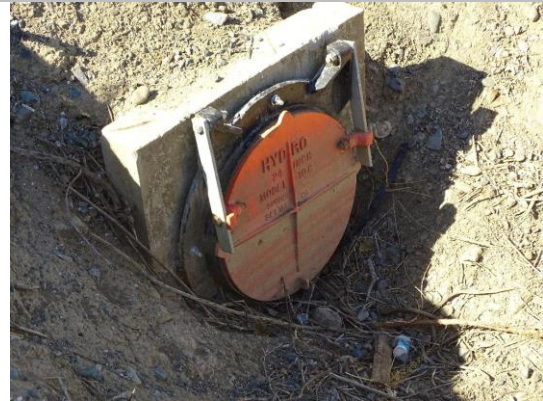
Photo 1 of 3 : UCIP_SP_2022_59903_81718.jpg

Comment Code						
Inspector Comment						
FS_ID:59903 DS_ID:16639 EP_NO: 10278 Repair Type: Non-Urgent Crossing Status: Found UCIP Comments: 10/21/2019 Record updated from No Action Needed to Non-Urgent. Need to have CVFPB review ABO and determine current owner. (O.Yakimov - DWR UCIP)07/12/2019 After reviewing the USACE O&M manual as-builts there is no reference to this 24-inch pipe. Will need to coordinate with previous UCIP inspector to determine if additional information is available to tie pipe to USACE O&M manual. (O. Magana - DWR UCIP) 05/22/2013 All material was removed. (C. Lund - DWR Sacramento Yard) 04/05/2012 Flap gate blocked by minor amounts of sedimentation. (W. Wylie - DWR UCIP) FIELD_STRUCT_DESC: 24-inch CIPP-lined corrugated metal drainage pipe through the levee, 15 feet below the crown. Flap gate on waterside (WS) end. Headwall on the landside (LS). (24-inch pipe [HLM 5.99] authorized under Automatic Board Order (ABO) issued as Permit No. 10278, 1974 - Southern Pacific Transportation Company). [Additional Reference(s): DWR Levee Log, 2005, (HLM 5.99). USACE Sacramento O&M Manual 119, December 1952]. FS Date: 10/21/2019 1:46:00 PM

Headwall and flap gate

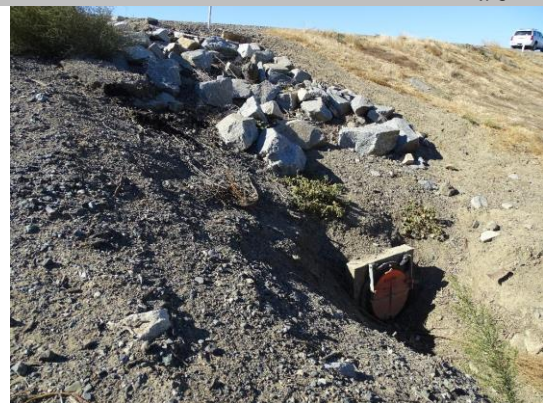
Photo 2 of 3 : UCIP_SP_2022_59903_81719.jpg

View of WS slope and flap gate at levee toe

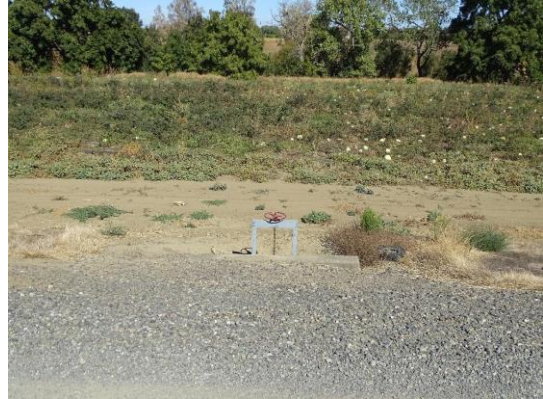
Photo 2 of 3 : UCIP_SP_2022_59905_81725.jpg

FS_ID:59905
DS_ID:16641
EP_NO: 10265
Repair Type: Non-Urgent
Crossing Status: Found
UCIP Comments: 10/21/2019 Record updated from No Action Needed to Non-Urgent. Need to have CVFPB review ABO and determine current owner. (O.Yakimov - DWR UCIP)04/05/2012 Pipe has some sedimentation buildup internally. (W. Wylie - DWR UCIP)
FIELD_STRUCT_DESC: 24-inch CIPP-lined corrugated metal drainage pipe through the levee, 11 feet below the crown. Slide gate on the waterside (WS) end. Concrete headwall on the landside (LS) end. (24-inch pipe [HLM 6.19] authorized under Automatic Board Order (ABO) issued as Permit No. 10265, 1974 - State of California, Division of Highways. Also included in Automatic Board Order (ABO) issued as Permit No. 11296, 1974 - Capitol National Bank of Sacramento and Crocker Citizens National Bank). [Additional Reference(s): DWR Levee Log, 2005 (HLM 6.19). USACE Sacramento O&M Manual, Unit 119, December 1952, Revised 29 Dec 2016, (Station 208+00 PCT), listed as 24-inch pipe. USACE As-Built Drawing No. 50-04-2396, Revision 4, pdf page 25, Sheet 9, December 1947].

View of WS looking from levee crown

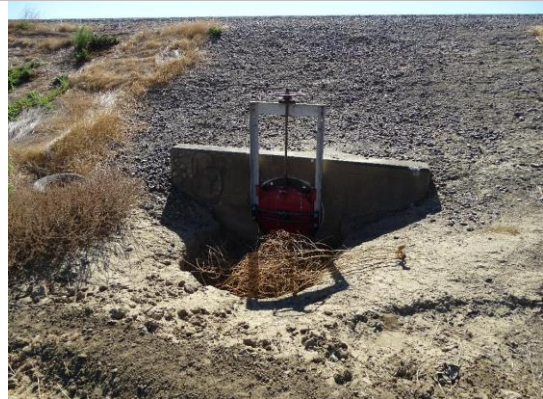
Photo 3 of 3 : UCIP_SP_2022_59905_81726.jpg

WS levee slope, headwall, and slide gate

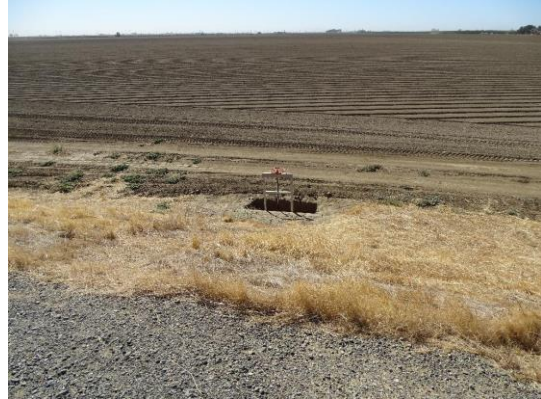
Photo 1 of 3 : UCIP_SP_2022_59906_81729.jpg

Comment Code						
Inspector Comment						
FS_ID:59906 DS_ID:16642 EP_NO: 10265 Repair Type: Non-Urgent Crossing Status: Found UCIP Comments: 10/21/2019 Record remains Non-Urgent. Need to have CVFPB review ABO and determine current owner. (O.Yakimov - DWR UCIP)07/12/2019 After reviewing the USACE O&M manual as-built there is no reference to this 30-inch pipe. Will need to coordinate with previous UCIP inspector to determine if additional information is available to tie pipe to USACE O&M manual. (O. Magana - DWR UCIP) 04/10/2019 There is no more debris around pipe. And is now sprayed and maintained. (J. Mccabe - DWR Sacramento Yard) 04/01/2019 Debris buildup at WS outlet. (J. Mccabe - DWR Sacramento Yard) FIELD_STRUCT_DESC: 30-inch CIPP-lined drainage pipe of an unknown material through the levee, 17 feet below the crown. Headwall and slide gate on the landside (LS) end. Flap gate on the waterside (WS) end, 120 feet to the north of the crossing. (36-inch pipe [HLM 6.50] authorized under Automatic Board Order (ABO) issued as Permit No. 10265, 1974 - State of California, Division of Highways. Also included in Automatic Board Order (ABO) issued as Permit No. 11296, 1974 - Capitol National Bank of Sacramento and Crocker Citizens National Bank). [Additional Reference(s): DWR Levee Log, 2005, (HLM 6.50), 36-inch pipe listed. USACE Sacramento O&M Manual 119, December 1952]. FS Date: 10/21/2019 2:11:00 PM

View of LS looking from levee crown

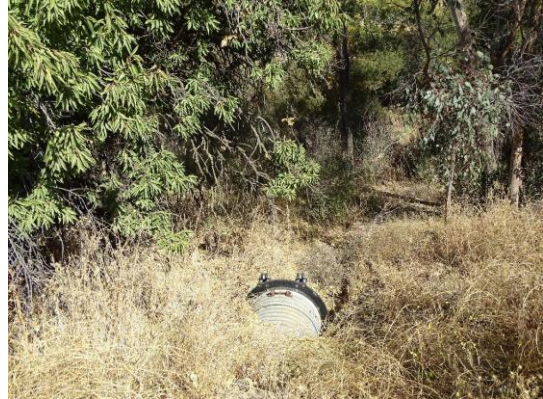
Photo 3 of 3 : UCIP_SP_2022_59906_81731.jpg

Pipe end on WS

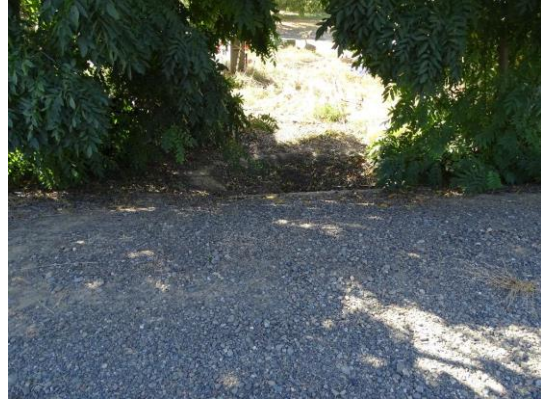
Photo 1 of 3 : UCIP_SP_2022_59908_81739.jpg

Comment Code						
Inspector Comment						
FS_ID:59908 DS_ID:16633 EP_NO: 10276 Repair Type: Non-Urgent Crossing Status: Found UCIP Comments: 10/21/2019 Record remains Non-Urgent. Minor sediment buildup at slide gate. Need to have CVFPB review ABO and determine current owner. (O.Yakimov - DWR UCIP)05/22/2013 Will contact owner of pipe and ask to clean for inspection. (C. Lund - DWR Sacramento Yard) 04/05/2012 Pipe heavily clogged with soil. (W. Wylie - DWR UCIP) FIELD_STRUCT_DESC: 24-inch CIPP-lined drainage pipe of an unknown material through the levee, 6 feet below the crown. Slide gate on the waterside (WS) end, and headwalls on both ends. (24-inch pipe [HLM 6.83] authorized under Automatic Board Order (ABO) issued as Permit No. 10276, 1974 - Patricia Schlages). [Additional Reference(s): DWR Levee Log, 2005 (HLM 6.83). USACE Sacramento O&M Manual, Unit 119, December 1952, Revised 29 Dec 2016, (Station 237+50 PCT), listed as 24-inch pipe. USACE As-Built Drawing No. 50-04-2396, Revision 2, pdf page 26, Sheet 10, December 1947]. FS Date: 10/21/2019 2:32:00 PM

View of LS looking from levee crown

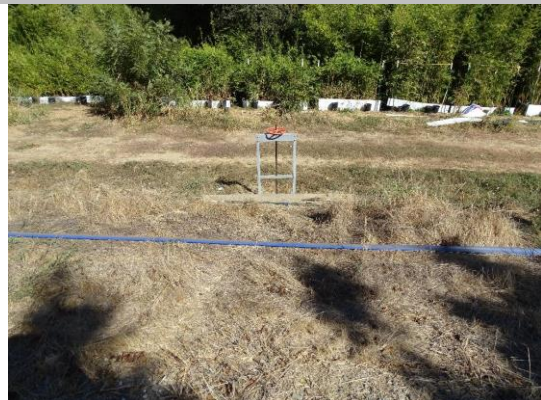
Photo 2 of 3 : UCIP_SP_2022_59908_81740.jpg

View of WS looking from levee crown
