**Flood Control Project Maintenance
Levee Inspections**

Maintenance Issue Types Only, Levee Inspection Report By Mile - Spring 2023

Sacramento Maintenance Yard Putah Creek

Waterway	Bank	Unit Miles	Inspection Start/End	Inspector
Unit No. 01 Putah Creek or North Levee	Left	8.79	05/15/2023 05/15/2023	Nate Hicks

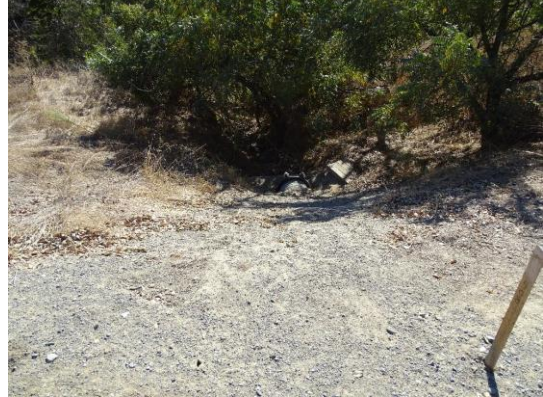
Photo 2 of 3 : UCIP_SP_2023_55664_82344.jpg

View of WS looking from levee crown

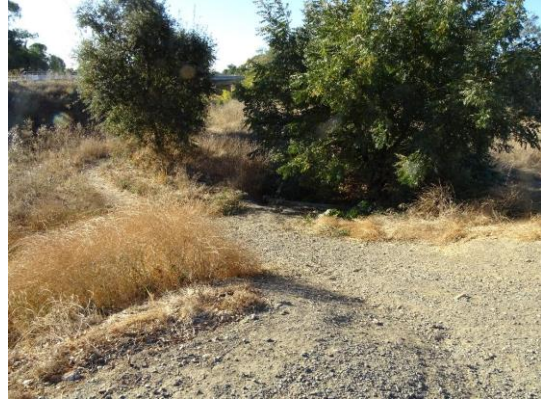
Photo 1 of 3 : UCIP_SP_2023_59869_82357.jpg

View of WS looking from levee crown

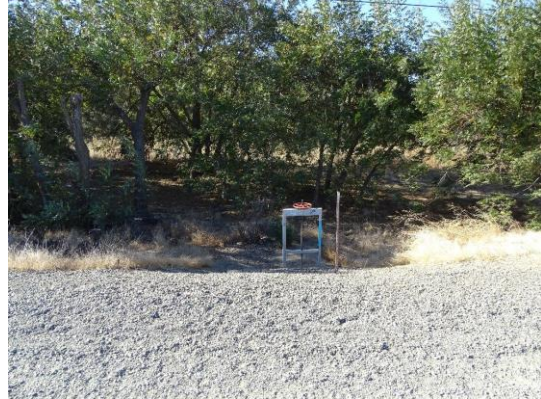
Photo 3 of 3 : UCIP_SP_2023_59879_82395.jpg

View of WS looking from levee crown

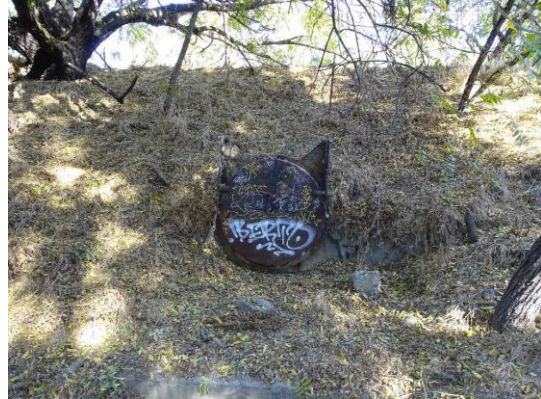
Photo 1 of 3 : UCIP_SP_2023_59884_82410.jpg

WS levee slope, headwall, and flap gate

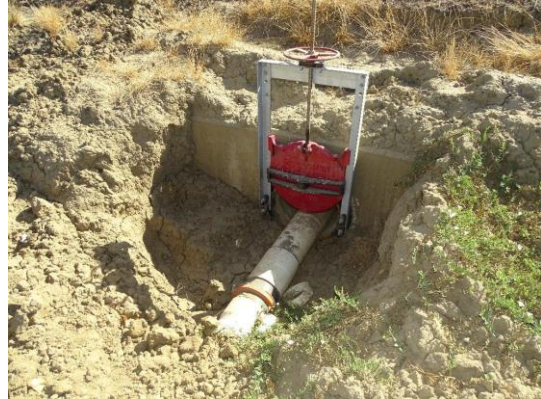
Photo 3 of 3 : UCIP_SP_2023_79825_81621.jpg

Headwall and slidegate at WS toe with a PVC pipe running through

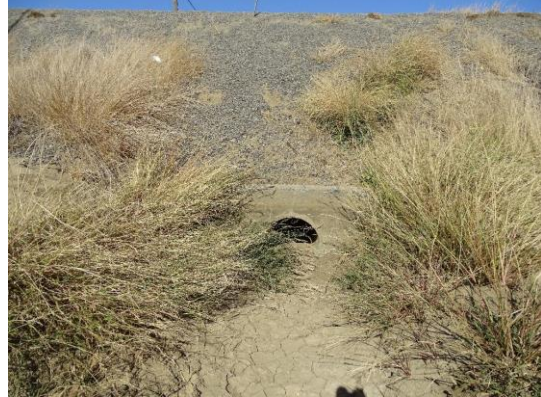
Photo 3 of 3 : UCIP_SP_2023_55434_81688.jpg

LS slope, headwall and pipe at levee toe

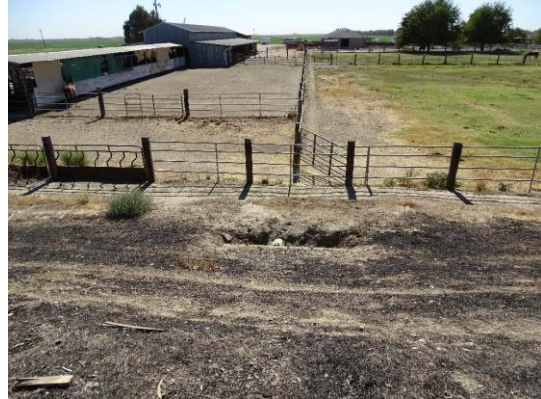
Photo 1 of 3 : UCIP_SP_2023_59897_81707.jpg

View of LS looking from levee crown

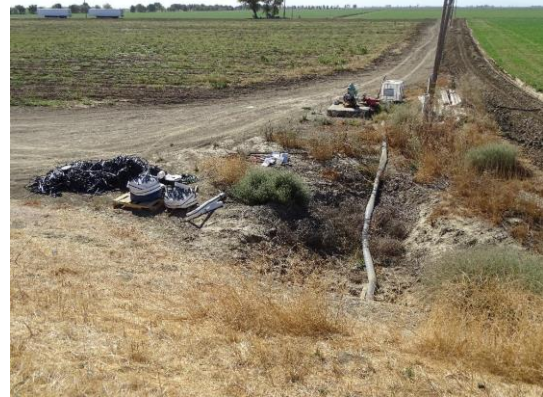
Photo 2 of 3 : UCIP_SP_2023_77888_81629.jpg

View of LS from levee crown

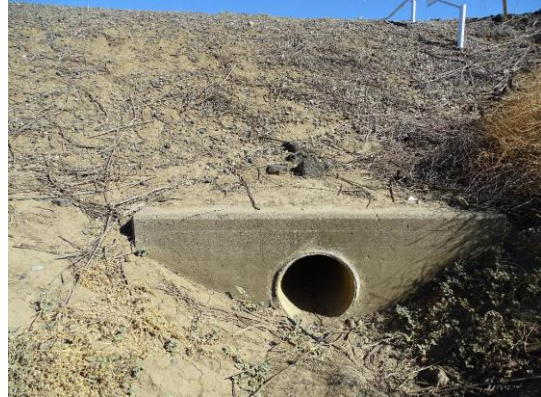
Photo 3 of 3 : UCIP_SP_2023_59903_81720.jpg

LS levee slope, headwall and pipe
