**Flood Control Project Maintenance
Levee Inspections**
LMA District Cover Sheet
Spring 2020 Levee Inspection Results

Spring 2020 Levee Inspection Results

Sutter Maintenance Yard Wadsworth Canal

Waterway			Bank	Unit Miles
Unit No. 01 Wadsworth Canal			Left	4.63
	Spring (March - May)	Summer (June - August)	(September - November) Fall	Winter (December - February)
Unit Maintenance Rating (Fall Only)				
Date of Inspection	3/19/2020 - 3/19/2020			
DWR Inspector	Makar Sokol			
Accompanied By

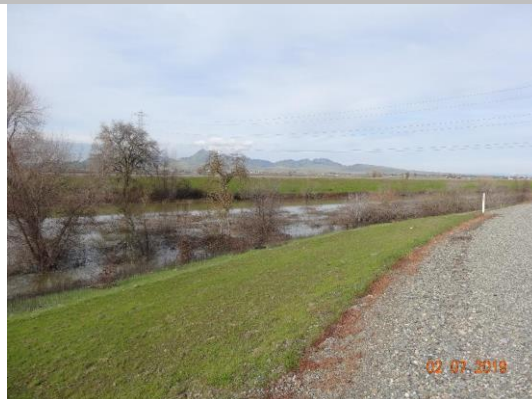
Photo 1 of 3 : UCIP_SP_2020_55976_78653.jpg

WS view: Clean slope with no evidence of line present.

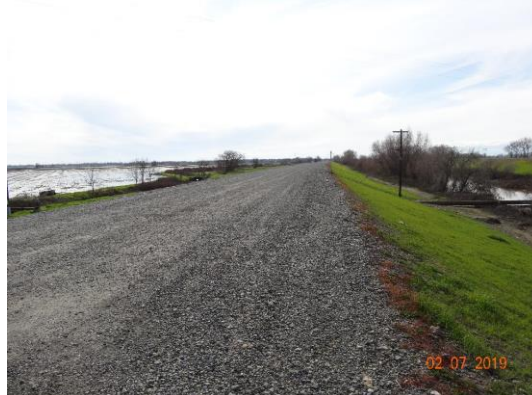
Photo 2 of 3 : UCIP_SP_2020_55977_78656.jpg

Overview of levee crown at pipe crossing.

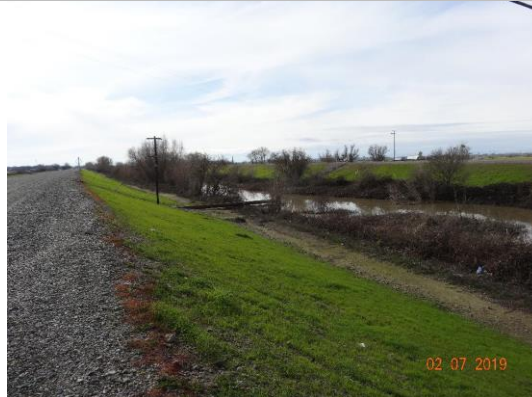
Photo 3 of 3 : UCIP_SP_2020_55977_78657.jpg

WS view: overview of WS looking downstream.

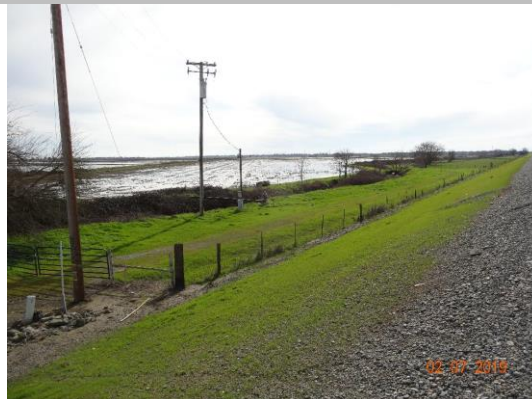
Photo 1 of 3 : UCIP_SP_2020_55978_78664.jpg

LS view: gas marker visible by gate located on LS toe near first power pole.

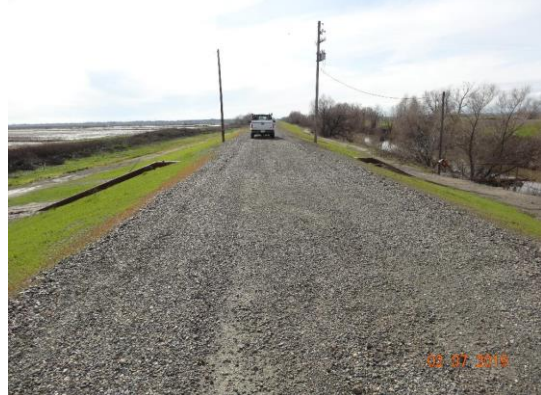
Photo 2 of 3 : UCIP_SP_2020_55500_78676.jpg

DS_ID:17063
FS_ID:55500
EP_NO: N/A
Repair Type: Urgent
Crossing Status: Found
UCIP Comments: 02/07/2019 Pipe has been upgraded from Non-Urgent to Urgent due to the pipe failure (sink hole) observed on the LS. Need to determine pipe integrity through the levee. Pipe and appurtenances have been abandoned. Power meter has been removed from the WS. Scour hole has developed on the WS berm edge located about 15 feet from WS toe. Owner will need to coordinate with CVFPB to properly remove pipe per Title 23. (O. Magana - DWR UCIP)04/10/2017 Abandoned. 10/12/2016 Abandoned crossing.(DWR Sutter Yard - afreitag)04/19/2016 Abandoned crossing. No noticeable issues to report.05/12/2015 Abandoned crossing. Cap was made and installed on WS open end of pipe.11/18/2014 Same as last inspection.05/13/2014 Cap was made and bolted on to WS open end of pipe.10/29/2013 Same as last inspection.05/16/2013 Same as last inspection. Steve Beckley is looking into finding pipe owner to properly abandon pipe.10/09/2012 Pipe abandoned. Pipe open and not plugged. Pipe should be removed or abandoned properly. Extensive animal burrowing occurring along pipe alignment. (W. Wylie - DWR UCIP)

Overview of crossing looking downstream towards crossing.

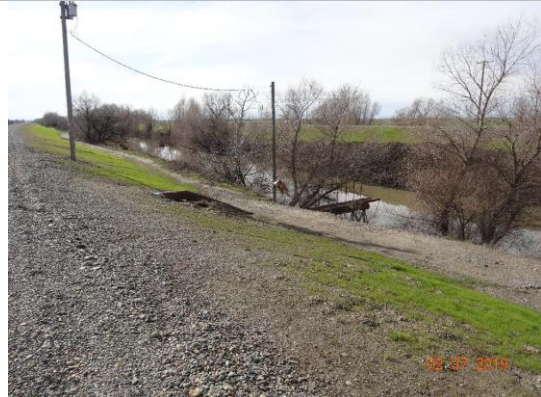
Photo 3 of 3 : UCIP_SP_2020_55500_78677.jpg

WS view: overview of WS.

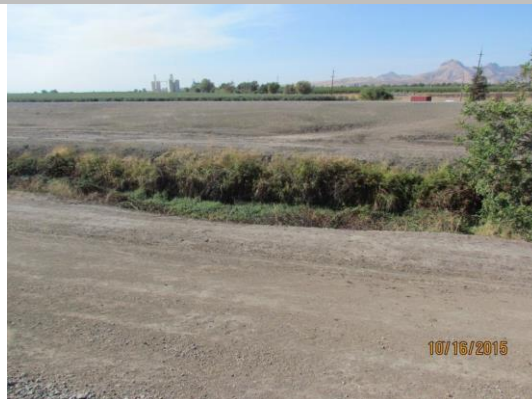
Photo 3 of 4 : SP_2020_ST0010_42_6_20200226_00006.jpg

View of the erosion along the waterside toe.

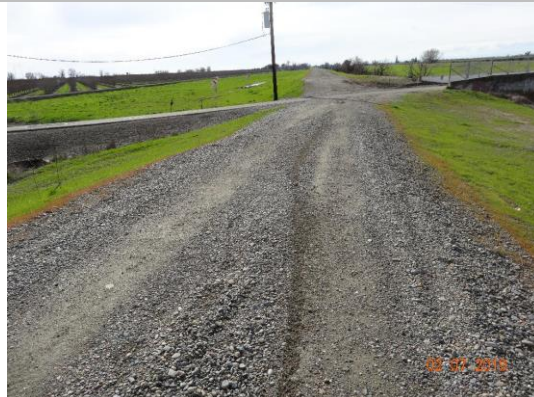
Photo 2 of 3 : UCIP_SP_2020_55502_78687.jpg

DS_ID:17065
FS_ID:55502
EP_NO: 7209
Repair Type: Non-Urgent
Crossing Status: Found
UCIP Comments: 02/07/2019 Record remains Non-Urgent due to of few maintenance issues observed during inspection. Pipe is being used as a shooting target. Multiple holes are visible on the exposed WS section of the pipe. The inlet pipe section located on the LS has been damaged (pipe wall section pulled). This pipe qualifies as an LMA responsible crossing as it was originally listed in the USACE O&M manual as a drainage pipe. The CVFPB issued a permit in 1970 for the replacement of the original USACE drainage pipe. (O. Magana - DWR UCIP)04/10/2017 WS pipe end is in good condition. LS pipe end is still deformed and vegetated. (DWR Sutter Yard - AFreitag)10/12/2016 LS inlet is still deformed and being overgrown by vegetation.(DWR Sutter Yard - afreitag)04/19/2016 Crossing appears to be in good condition.05/12/2015 LS inlet still deformed a little but does not affect the crossing function.11/18/2014 Same as last inspection.05/13/2014 Same as last inspection.10/29/2013 Same as last inspection.05/16/2013 Pipe intake on LS appears to be bent and damaged but that does not appear to be affecting water flow or channel bank.

Overview of levee crown looking downstream at crossing.

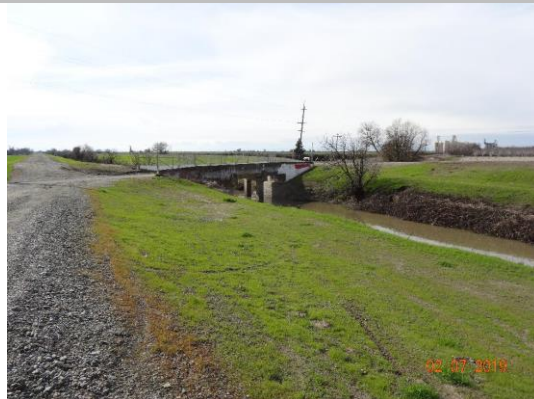
Photo 3 of 3 : UCIP_SP_2020_55502_78686.jpg

WS view: overview of WS.

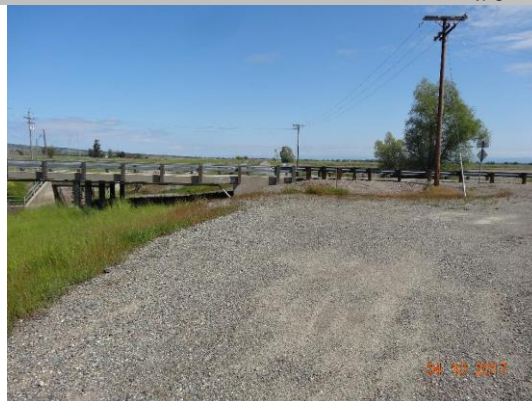
Photo 2 of 3 : UCIP_SP_2020_55503_76953.jpg

Levee overview looking upstream.

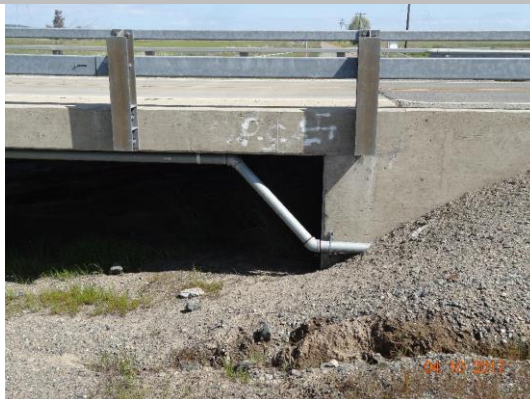
Photo 3 of 3 : UCIP_SP_2020_55503_76954.jpg

Conduit exiting WS slope and attaching to the downstream side of South Butte Rd bridge.

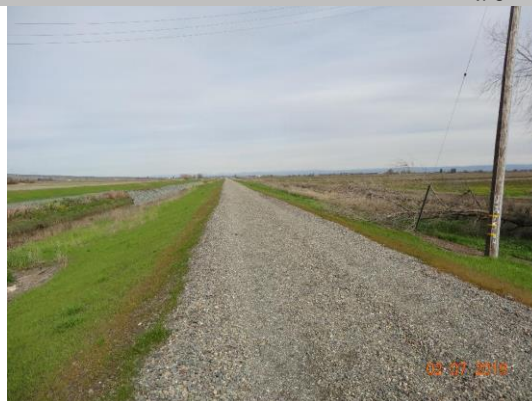
Photo 2 of 3 : UCIP_SP_2020_55504_78701.jpg

Overview of levee crown looking upstream towards crossing.

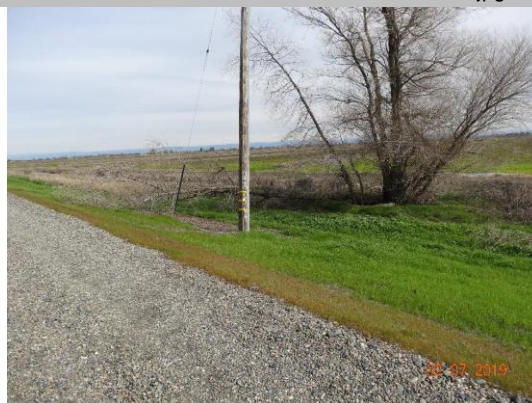
Photo 3 of 3 : UCIP_SP_2020_55504_78702.jpg

LS view: power pole located on LS.

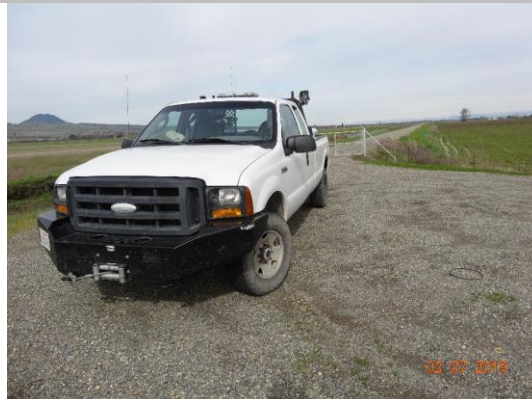
Photo 2 of 3 : UCIP_SP_2020_55506_78708.jpg

Overview of levee crown where crossing should be.

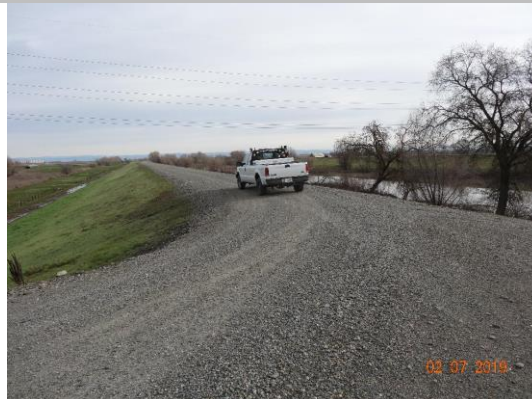
Photo 2 of 3 : UCIP_SP_2020_55507_78712.jpg

Overview of levee crown where crossing should be.

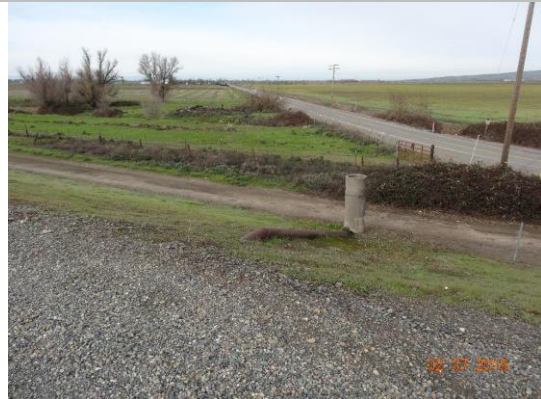
Photo 1 of 3 : UCIP_SP_2020_55508_78718.jpg

Comment Code					
Inspector Comment					
DS_ID:17069 FS_ID:55508 EP_NO: N/A Repair Type: Non-Urgent Crossing Status: Found UCIP Comments: 02/07/2019 Record remains Non-Urgent, pipe and appurtenances have been abandoned through this section of the levee. Utility pole base has rotted out and fallen down on the WS berm slope. Abandoned pump is still present on the WS berm edge. Large rodent holes are visible on the WS near the rip rap section where pipe daylights on the WS. Need to contact owner to properly remove or abandon line according to Title 23 requirements. Owner will need to coordinate with the CVFPB to properly address abandoned pipe. (O. Magana - DWR UCIP)04/10/2017 Abandoned crossing with heavy rodent activity around it. Needs to be removed. (DWR Sutter Yard-AFreitag)10/12/2016 Abandoned crossing.(DWR Sutter Yard - afreitag)04/19/2016 Abandoned crossing. Rodent activity still present on WS slope.05/12/2015 Abandoned crossing. Signs of rodent activity on both sides of levee.11/18/2014 Same as last inspection.05/13/2014 Same as last inspection.10/29/2013 Same as last inspection.05/16/2013 Same as last inspection.10/09/2012 Pipe appears improperly abandoned. No motor present, electrical equipment is stripped. Heavy rodent activity along pipe WS and LS. Pipe needs to be removed or properly abandoned. (W. Wylie - DWR UCIP) FIELD_STRUCT_DESC: *ABANDONED* 10-inch steel irrigation pipe through the levee, 4.8 feet below the crown. Pump mounted on concrete pad near canal bank located on the waterside (WS). Service pole located on the berm. 36-inch concrete standpipe located on the landside (LS) toe. (10-inch pipe authorized under Permit No. 945, 1944 - Becker). [Additional Reference(s): DWR Levee Log, 2005. USACE Sacramento O&M Manual 135, May 1953, (Station 61+10), Dwg. No. 50-04-1949, page 1 of 3]. FS Date: 2/7/2019 11:11:00 AM

LS view: overview of LS.

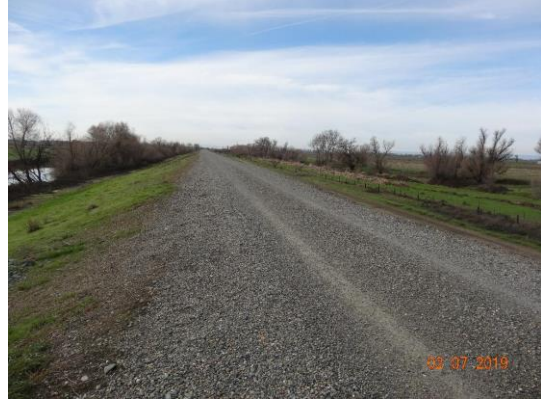
Photo 2 of 3 : UCIP_SP_2020_55508_78717.jpg

Overview of levee crown at pipe crossing.

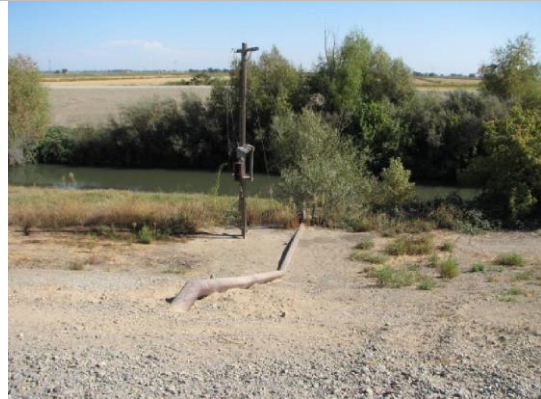
Photo 3 of 3 : UCIP_SP_2020_55508_64727.jpg

Pipe and pump facilities on WS slope.

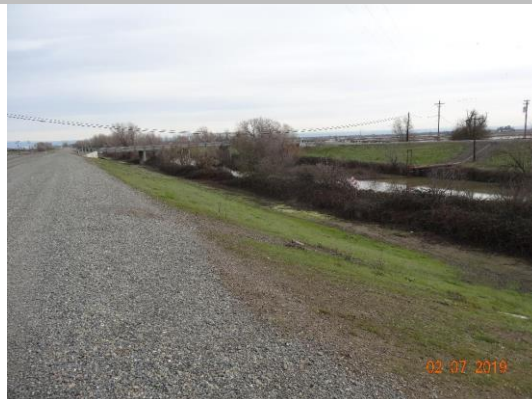
Photo 1 of 3 : UCIP_SP_2020_55509_78722.jpg

Comment Code						
Inspector Comment						
DS_ID:17084 FS_ID:55509 EP_NO: 17478 Repair Type: Non-Urgent Crossing Status: Indicator Found UCIP Comments: 02/07/2019 Line has been changed from No Action Need to Non-Urgent evaluation. No maintenance records were made available for this line. Need to contact owner to obtain maintenance records to determine current status of line (need to confirm integrity of line through levee). (O. Magana - DWR UCIP)04/10/2017 Crossing appears to be in good condition. New markers are present on the LS shoulder and WS toe. (DWR Sutter Yard- A Freitag)10/12/2016 Crossing appears to be in good condition.(DWR Sutter Yard - a Freitag)04/19/2016 Crossing appears to be in good condition.05/12/2015 Crossing appears in good condition. No noticeable issues to report.11/18/2014 Same as last inspection.05/13/2014 Same as last inspection.10/29/2013 Same as last inspection.05/16/2013 Same as last inspection. FIELD_STRUCT_DESC: 8-inch steel gas line bored across and under Wadsworth Canal and its levees at an angle, approximately 30 and 60 feet below channel and levees. Line was reinstalled because the County replaced the bridge over Wadsworth Canal. Gas line markers present on Franklin Roadside. No pipe attached to the upstream side of Franklin Road bridge as shown in the permit records. (8-inch gas line authorized and existing 12-inch line removed under Permit No. 17478 and 17478-R, 2002 - Pacific Gas & Electric Company [PG&E]). [Additional Reference(s): DWR Levee Log, 2005]. FS Date: 2/7/2019 11:12:00 AM

WS view: overview of WS.

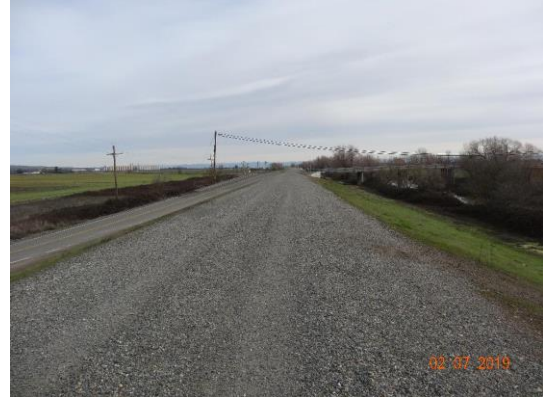
Photo 2 of 3 : UCIP_SP_2020_55509_78723.jpg

Overview of levee crown where line crosses.

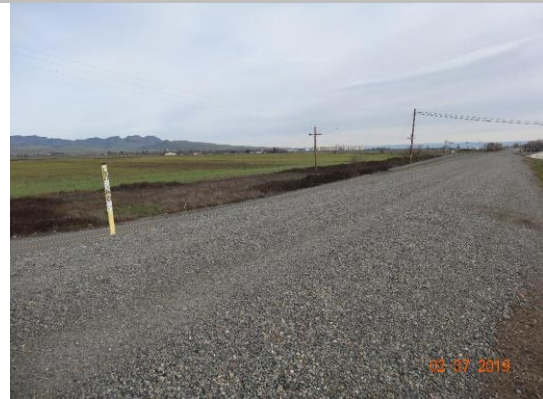
Photo 3 of 3 : UCIP_SP_2020_55509_78724.jpg

LS view: paddle marker visible on LS shoulder.

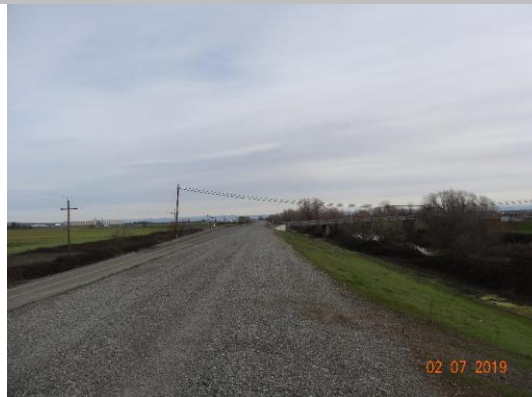
Photo 2 of 3 : UCIP_SP_2020_55510_78727.jpg

Overview of levee crown looking towards where crossing should be.

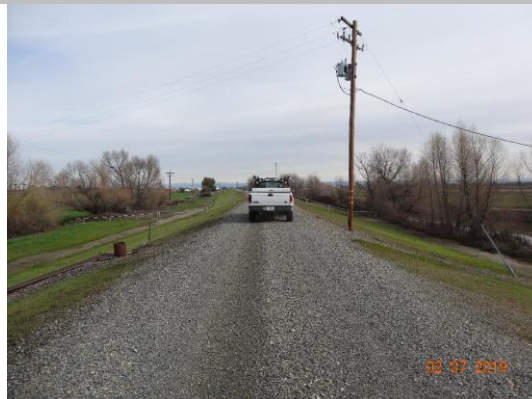
Photo 2 of 3 : UCIP_SP_2020_55513_78742.jpg

Overview of levee crown at pipe crossing.

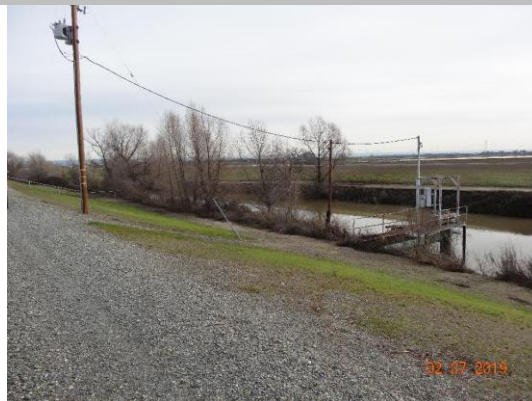
Photo 3 of 3 : UCIP_SP_2020_55513_78744.jpg

WS view: overview of WS looking upstream towards pipe.

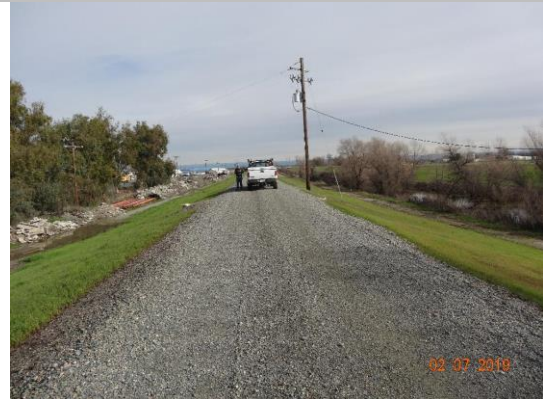
Photo 2 of 3 : UCIP_SP_2020_55515_78757.jpg

Overview of levee crown.

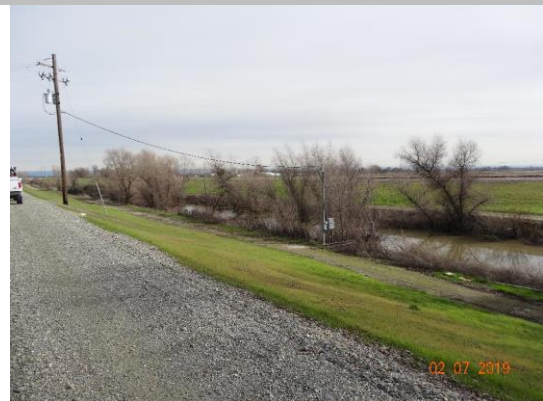
Photo 3 of 3 : UCIP_SP_2020_55515_78758.jpg

WS view: overview of WS.

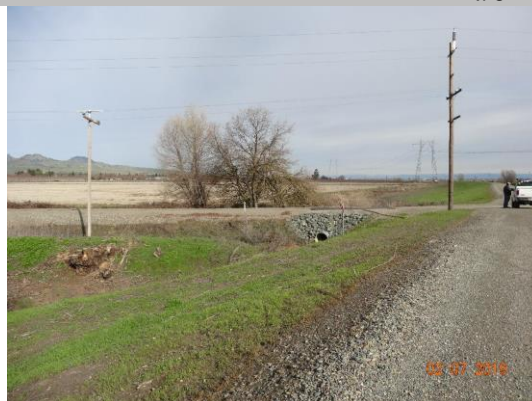
Photo 1 of 3 : UCIP_SP_2020_55516_78767.jpg

LS view: overview of LS.

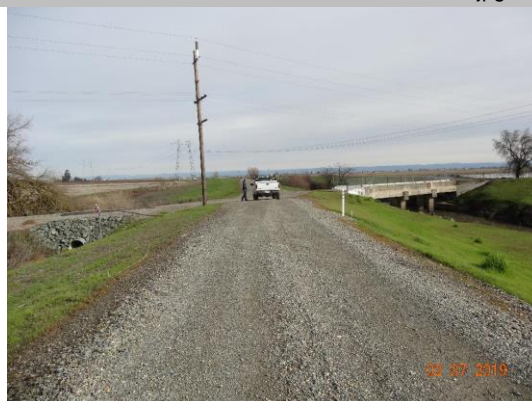
Photo 2 of 3 : UCIP_SP_2020_55516_78765.jpg

Overview of levee crown looking upstream towards crossing.

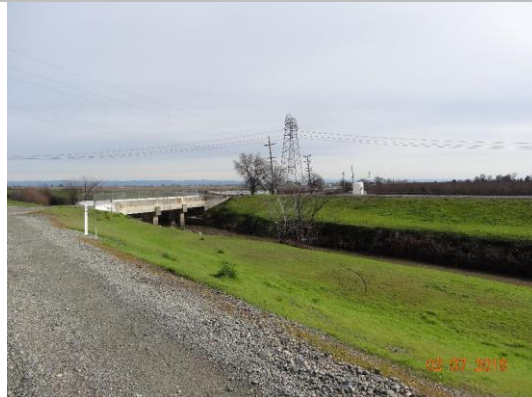
Photo 3 of 3 : UCIP_SP_2020_55516_78766.jpg

WS view: overview of WS.

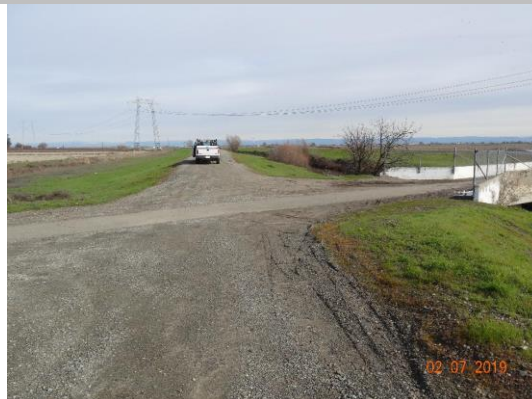
Photo 1 of 3 : UCIP_SP_2020_55981_78776.jpg

DS_ID:17077
FS_ID:55981
EP_NO: 7209
Repair Type: Non-Urgent
Crossing Status: Found
UCIP Comments: 02/07/2019 Record remains Non-Urgent due to the tree obstructing access to the WS pipe outlet. Maintenance will need to be performed to clear some of the vegetation preventing access to the flap gate. This pipe qualifies as an LMA responsible crossing as it was originally listed in the USACE O&M manual as a drainage pipe. The CVFPB issued a permit in 1970 for the replacement of the original USACE drainage pipe. (O. Magana - DWR UCIP)04/10/2017 Tree still present and a problem at the WS pipe outlet. LS inlet is still vegetated. (DWR Sutter Yard- AFreitag)10/12/2016 Tree at the WS pipe end is still an issue and needs to be cut away. LS inlet is also being overgrown with vegetation.(DWR Sutter Yard - afreitag)04/19/2016 Tree at WS pipe end needs to be trimmed back and/or removed. 05/12/2015 Tree growing near WS pipe end is getting too big and will affect the crossing. It needs to be cut back or removed.11/18/2014 Same as last inspection.05/13/2014 Same as last inspection.10/29/2013 Same as last inspection.05/16/2013 Same as last inspection.

Overview of levee crown looking upstream towards crossing.

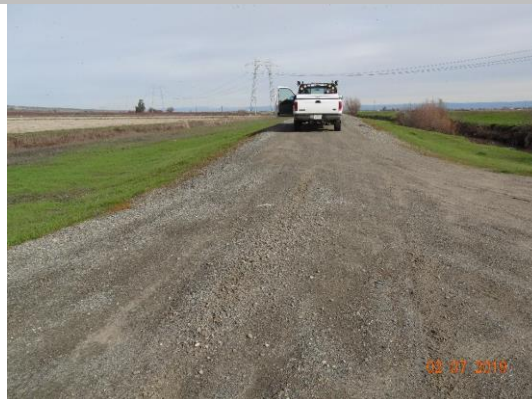
Photo 2 of 3 : UCIP_SP_2020_55981_78777.jpg

Overview of levee crown.

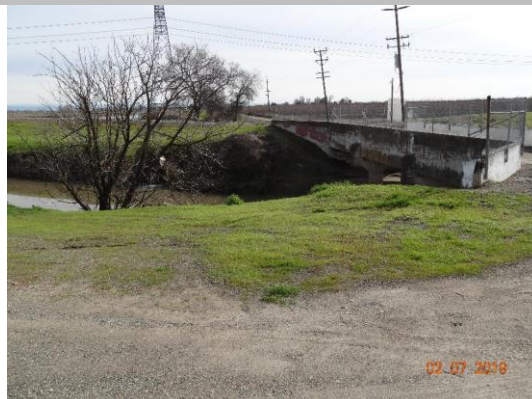
Photo 3 of 3 : UCIP_SP_2020_55981_78771.jpg

WS view: overview of WS.

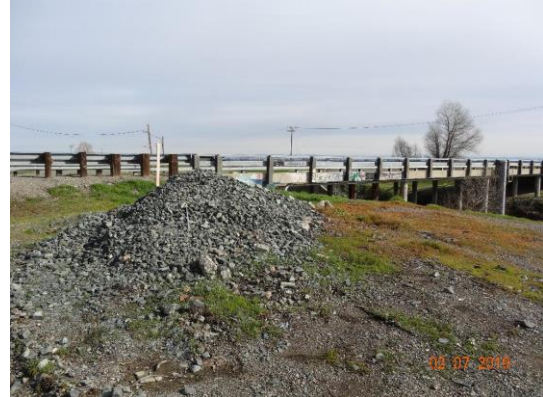
Photo 1 of 3 : UCIP_SP_2020_55518_78779.jpg

Comment Code						
Inspector Comment						
DS_ID:23098 FS_ID:55518 EP_NO: N/A Repair Type: Non-Urgent Crossing Status: Found UCIP Comments: 02/07/2019 Record remains Non-Urgent due to no permit found authorizing conduit through the levee. Carsonite marker lists CVIN as owner. Contact phone number listed on marker to be used before digging is 855-442-6010. Need to contact owner to obtain permit authorizing conduit through levee. (O. Magana - DWR UCIP)04/10/2017 Crossing appears to be in good condition. (DWR Sutter Yard- AFreitag)10/12/2016 Crossing appears to be in good condition.(DWR Sutter Yard - afreitag)05/27/2016 Need photos of markers and levee overview. (O. Magana)04/19/2016 Crossing appears to be in good condition. No permit on file.05/12/2015 No issues recorded during inspection but does not have a permit on file for it.11/18/2014 Same as last inspection.05/13/2014 Same as last inspection.10/29/2013 Same as last inspection.05/16/2013 No known permit for work. FIELD_STRUCT_DESC: 4-inch steel communication conduit through the levee, 2 feet below the crown. Fiber optics line attached to bottom of downstream side of South Butte Road bridge. Position marked with orange markers on both the waterside (WS) and landside (LS). No permit has been identified since crossing was field discovered in 2012. FS Date: 2/7/2019 11:19:00 AM

WS view: overview of WS.

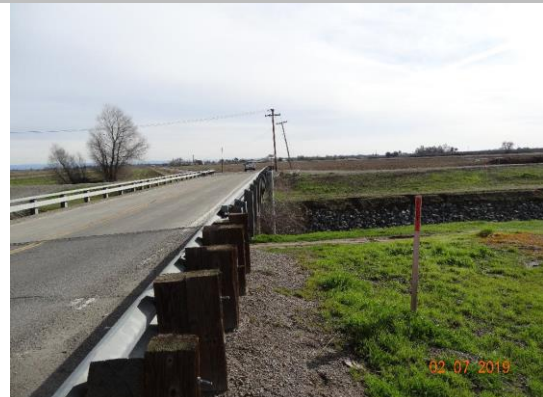
Photo 2 of 3 : UCIP_SP_2020_55518_78783.jpg

WS view: overview of bridge.

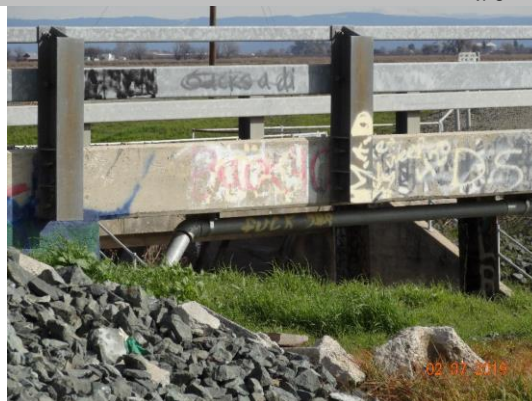
Photo 3 of 3 : UCIP_SP_2020_55518_78780.jpg

WS view: conduit attached to bridge.

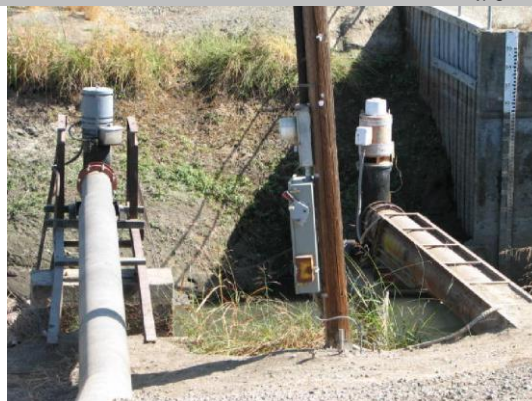
Photo 1 of 3 : UCIP_SP_2020_55519_64761.jpg

DS_ID:17078
FS_ID:55519
EP_NO: 10473
Repair Type: Urgent
Crossing Status: Found
UCIP Comments: 02/07/2019 Record remains Urgent due to two sink holes present on the LS slope. The CVFPB - Enforcement Section is pursuing corrective actions for this pipe under CVFPB Enforcement Id (Enf ID) 14602. (O. Magana - DWR UCIP)10/04/2018 Two sink holes visible on the LS slope. Crossing has been upgraded from Non-Urgent to Urgent because there are signs that the pipe has failed through the LS slope. Recommend video inspection to confirm pipe failure through the levee. Need to coordinate with CVFPB to have them contact the owner of the crossing. Unable to determine the extent of damage (size of sink holes) due to dense vegetation. Notified J. Peterson with CVFPB - Enforcement Section about the updated inspection for this pipe (sink holes now present). The CVFPB - Enforcement Section is pursuing corrective actions for this pipe under CVFPB Enforcement Id (Enf ID) 14602. (O. Magana - DWR UCIP)04/10/2017 WS appears to be in good condition. No repairs appear to have been made to the LS yet. Pipe measures to be 16". (DWR Sutter Yard-AFreitag)10/12/2016 WS appears to be in good condition. LS is still very rusted where it extends over the LS ditch.(DWR Sutter Yard - aFreitag)04/19/2016 No changes have been made to this crossing. LS pipe outlet is still very rusted. 05/12/2015 Pipe is very rusty at Outlet in LS channel. No noticeable issues with WS.11/18/2014 Same as last inspection.05/13/2014 Same as last inspection.10/29/2013 Same as last inspection.05/16/2013 Same as last inspection.10/09/2012 Pipe shows signs of heavy rust at outlet in channel. Good candidate for video inspection. (W. Wylie - DWR UCIP)

Pump on steel pier at WS toe.

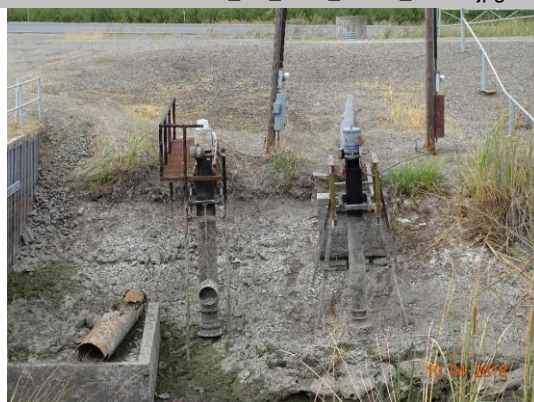
Photo 3 of 3 : UCIP_SP_2020_55519_78288.jpg

Overview photo of crossings from opposite bank. Pipe to left is associated with dsid 17078 and pipe to right is dsid 17081.

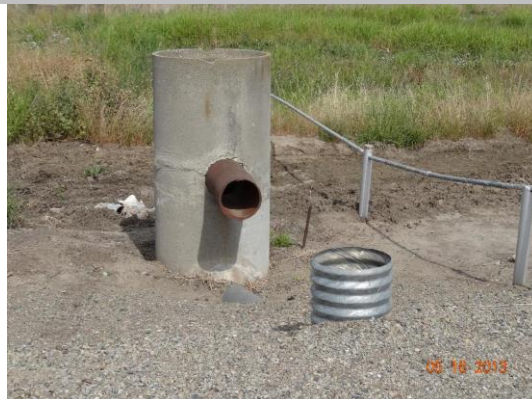
Photo 2 of 3 : UCIP_SP_2020_55520_64763.jpg

DS_ID:17081
FS_ID:55520
EP_NO: 5622
Repair Type: Urgent
Crossing Status: Found
UCIP Comments: 02/07/2019 Record remains Urgent due to the unknown conditions through the levee and from the standpipe to LS exposed pipe section. The CVFPB - Enforcement Section is pursuing corrective actions for this pipe under CVFPB Enforcement Id (Enf ID) 14602. (O. Magana - DWR UCIP)10/04/2018 Pipe measured in the field: Pipe size is 14 inches instead of 15 inches, as previously referenced. Unable to locate the hole rusted through the 12-inch pipe previously referenced in 2013 due to dense vegetation. Crossing remains Urgent due to the unknown conditions through the levee and from the standpipe to LS exposed pipe section. Recommend video inspection through the crossing to determine pipe integrity. Notified J. Peterson with CVFPB - Enforcement Section about the updated inspection for this pipe. The CVFPB - Enforcement Section is pursuing corrective actions for this pipe under CVFPB Enforcement Id (Enf ID) 14602. (O. Magana - DWR UCIP)04/10/2017 WS appears to be in good condition. No repairs appear to have been made yet to the LS. Pipe measures to be 15" (DWR Sutter Yard- AFreitag)10/12/2016 WS seems to be in good condition. No repairs have been made yet where the pipe appears to be leaking under the LS toe road.(DWR Sutter Yard - afreitag)04/19/2016 No repairs seem to have been made yet. Pipe still appears to be leaking under the LS toe road. (DWR Sutter Yard - afreitag)05/12/2015 Pipe appears to have not yet been repaired. Still looks to be leaking under the LS toe road. (DWR Sutter Yard - afreitag)11/18/2014 Same as last inspection. (DWR Sutter Yard - afreitag)05/13/2014 Same as last inspection. (DWR Sutter Yard - afreitag)10/29/2013 Same as last inspection. (DWR Sutter Yard - afreitag)05/16/2013 Signs of leaks near concrete stand pipe on LS toe-road. Area about 20ft. long is muddy and there has not been any rain for a few weeks. (DWR Sutter Yard - afreitag)

36in. concrete standpipe and 12in. cm riser on LS.

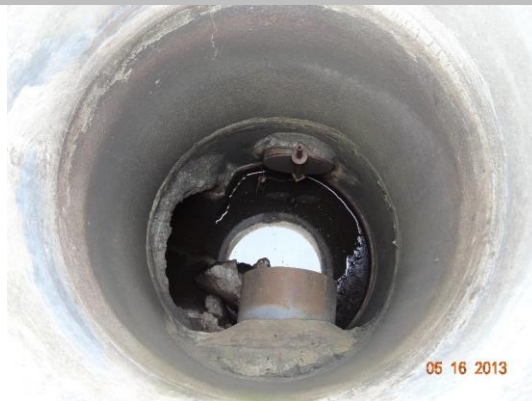
Photo 3 of 3 : UCIP_SP_2020_55520_64762.jpg

Inside of 36in. concrete riser

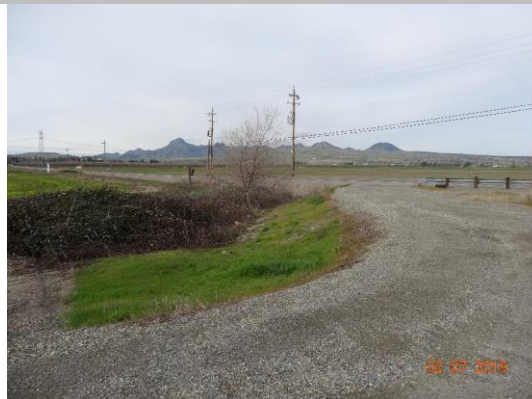
Photo 1 of 3 : UCIP_SP_2020_55522_78795.jpg

DS_ID:17079
FS_ID:55522
EP_NO: N/A
Repair Type: Non-Urgent
Crossing Status: Found
UCIP Comments: 02/07/2019 Record has been updated from No Action Needed to Non-Urgent due to the gaps in the permit records. Unable to confirm whether the permit issued in 1946 is the permit authorizing the 14-inch pipe. Need to contact owner to confirm permit authorizing pipe crossing. UCIP's records indicate the pipe was authorized under Permit No. 1095 which means the pipe is about 74 years old. (O. Magana - DWR UCIP)04/10/2017 Crossing appears to be in good condition. Pipe measures to be 14". (DWR Sutter Yard-AFreitag)10/12/2016 Crossing appears to be in good condition.(DWR Sutter Yard - afreitag)04/19/2016 Crossing appears to be in good condition.05/12/2015 Crossing appears in good condition. No noticeable issues to report.11/18/2014 Same as last inspection.05/13/2014 Same as last inspection.10/29/2013 Same as last inspection.05/16/2013 Same as last inspection.

LS view: overview of LS.

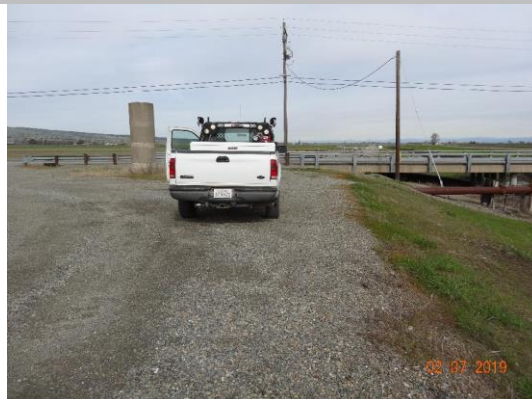
Photo 2 of 3 : UCIP_SP_2020_55522_78794.jpg

Overview of levee crown looking towards crossing.

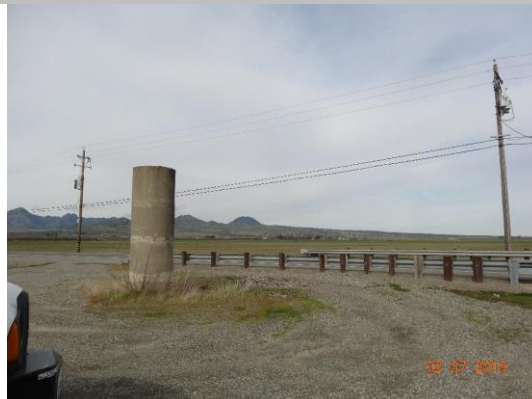
Photo 2 of 3 : UCIP_SP_2020_55523_78805.jpg

Comment Code						
Inspector Comment						
DS_ID:17070 FS_ID:55523 EP_NO: 4680 Repair Type: Non-Urgent Crossing Status: Indicator Found UCIP Comments: 02/07/2019 Record has been updated from No Action Needed to Non-Urgent due to modifications made to authorized encroachment. Unable to determine the status of the buried conduit and the permit authorizing the aerial lines at this location. (O. Magana - DWR UCIP)04/10/2017 Aerial lines. (DWR Sutter Yard-AFreitag)10/12/2016 Crossing appears to be in good condition.(DWR Sutter Yard - afreitag)04/19/2016 Crossing appears to be in good condition.05/12/2015 Crossing now appears to be an aerial line. No issues to report.11/18/2014 Same as last inspection.05/13/2014 Same as last inspection.10/29/2013 Same as last inspection.05/16/2013 Same as last inspection.10/09/2012 Appears lines no longer cross levee at downstream side of bridge as there is no conduit. (W. Wylie - DWR UCIP) FIELD_STRUCT_DESC: 4-inch steel communication conduit (telephone cable inside) through the levee, 2.3 feet below the crown. Conduit line goes through Wadsworth Canal and its levees. Annular space between pipe and conduit grouted. Line is attached to the south side of the Butte House Road bridge (no longer attached in 2012). (4-inch conduit authorized under Permit No. 4680, 1964-Pacific Telephone and Telegraph Company [PT&T]). [Additional Reference(s): DWR Levee Log, 2005]. FS Date: 2/7/2019 12:12:00 PM

WS view: aerial power lines present but no markers of communication line, photo 1 of 2.
