**Flood Control Project Maintenance
Levee Inspections
Unit Cover Sheet**

Sutter Maintenance Yard Wadsworth Canal

Levee Inspection Report By Mile - Spring 2021

Waterway	Bank	Unit Miles	Inspection Start/End	Inspector
Unit No. 01 Wadsworth Canal	Left	4.63	03/30/2021 03/30/2021	Makar Sokol

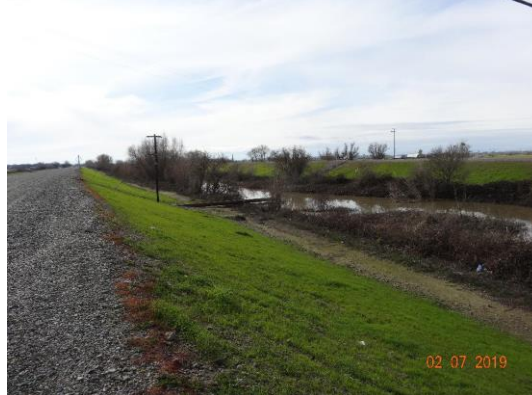
Photo 3 of 3 : UCIP_SP_2021_60106_78657.jpg

WS view: overview of WS looking downstream.

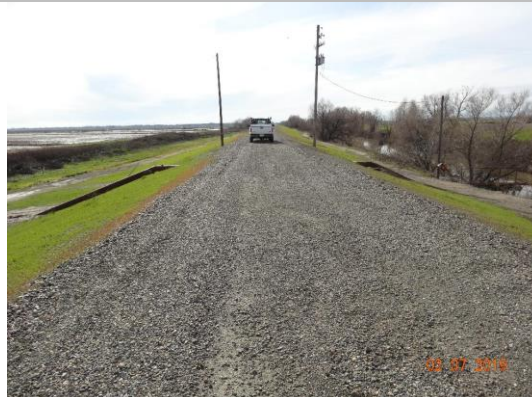
Photo 2 of 3 : UCIP_SP_2021_60148_78676.jpg

Overview of crossing looking downstream towards crossing.

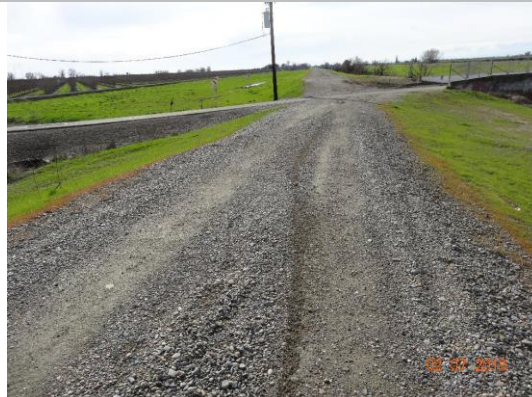
Photo 2 of 3 : UCIP_SP_2021_60113_78687.jpg

Overview of levee crown looking downstream at crossing.

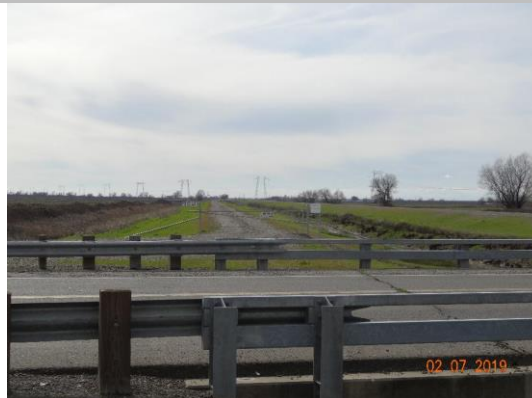
Photo 1 of 3 : UCIP_SP_2021_60115_78705.jpg

FIELD_STRUCT_DESC: 4-inch steel communication conduit (telephone cable inside) through the levee, 2.3 feet below the crown. Conduit line goes through Wadsworth Canal and its levees. Annular space between pipe and conduit grouted. Line is attached to south side of the Butte House Road bridge (no longer attached in 2012). (4-inch conduit authorized under Permit No. 4680, 1964 - Pacific Telephone and Telegraph Company [PT&T]). [Additional Reference(s): DWR Levee Log, 2005 (HLM 4.37, listed as 4-inch steel conduit)].
FS Date: 2/7/2019 2:54:00 PM

No markers visible on levee crown for conduit, photo 1 of 2.

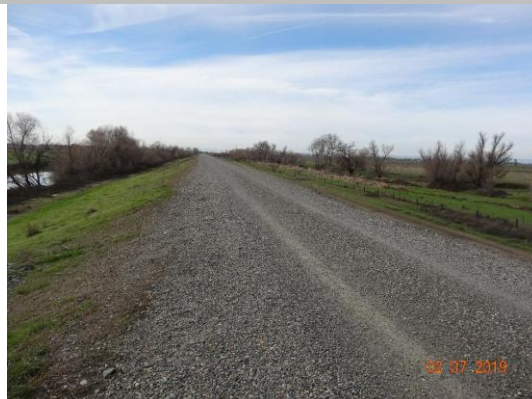
Photo 2 of 3 : UCIP_SP_2021_60118_78717.jpg

Overview of levee crown at pipe crossing.

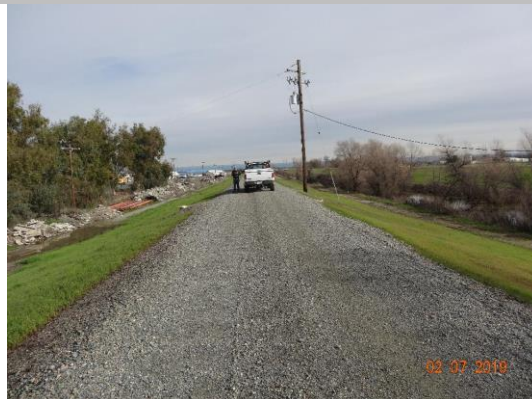
Photo 2 of 3 : UCIP_SP_2021_60126_78757.jpg

Overview of levee crown.

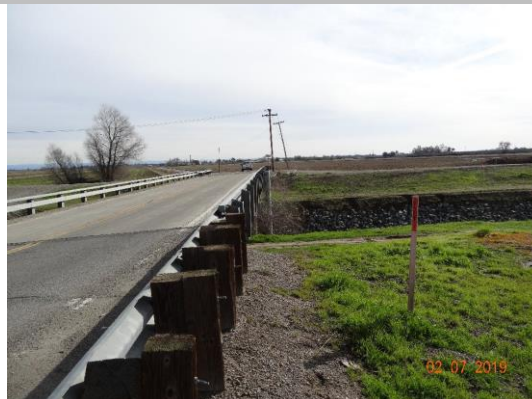
Photo 2 of 3 : UCIP_SP_2021_58005_78783.jpg

WS view: overview of bridge.
