**Flood Control Project Maintenance
Levee Inspections
LMA District Cover Sheet**

Sutter Maintenance Yard Wadsworth Canal

**Flood Control Project Maintenance
Levee Inspections
Unit Cover Sheet**

Waterway			Bank	Unit Miles
Unit No. 01 Wadsworth Canal			Left	4.63
	Spring (March - May)	Summer (June - August)	(September - November) Fall	Winter (December - February)
Unit Maintenance Rating (Fall Only)				
Date of Inspection	3/9/2022 - 3/9/2022			
DWR Inspector	Makar Sokol			
Accompanied By	Cory Hutton DWR Sutter Yard

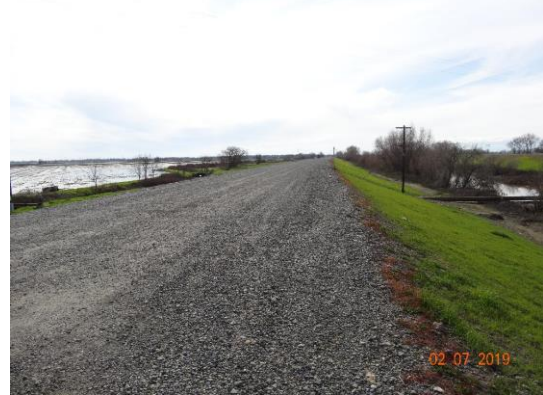
Photo 2 of 3 : UCIP_SP_2022_60106_78656.jpg

Overview of levee crown at pipe crossing.

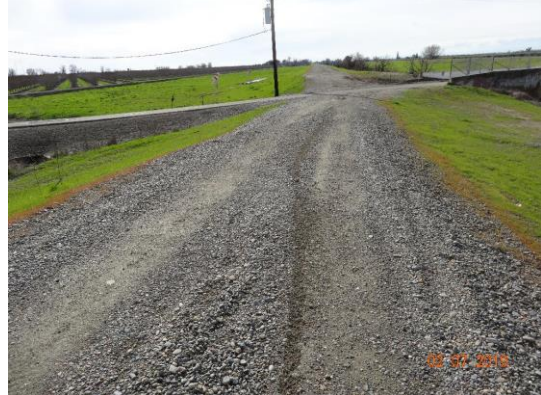
Photo 2 of 3 : UCIP_SP_2022_60113_78687.jpg

Overview of levee crown looking downstream at crossing.

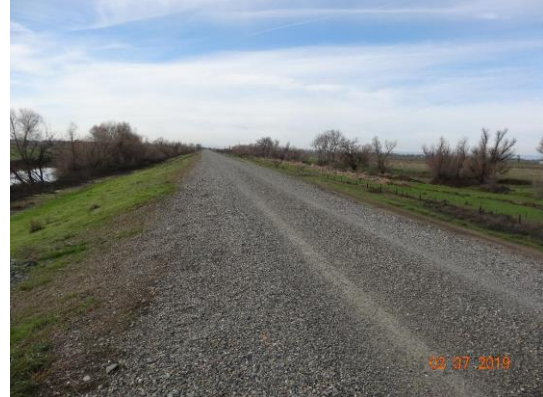
Photo 2 of 3 : UCIP_SP_2022_60118_78717.jpg

Overview of levee crown at pipe crossing.

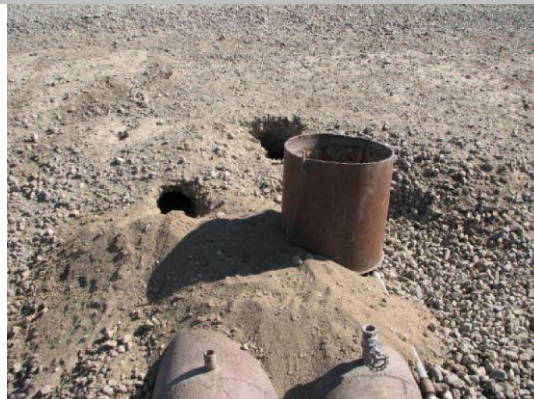
Photo 2 of 3 : UCIP_SP_2022_60125_64735.jpg

Pipe on LS showing rodent activity.

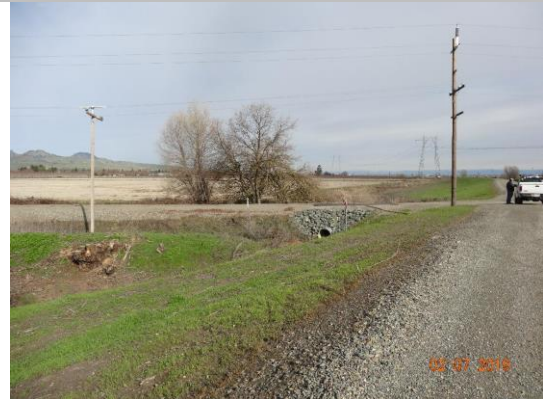
Photo 1 of 3 : UCIP_SP_2022_60127_78767.jpg

DWR Sutter Yard)10/29/2013 Same as last inspection. (A. Freitag -						
DWR Sutter Yard)05/16/2013 Same as last inspection. (A. Freitag -						
DWR Sutter Yard)						
FIELD_STRUCT_DESC: 6-inch asphalt coated steel gas line through						
the levee, 1.1 feet below the crown. Gas line crosses Wadsworth Canal						
and its levees. Gas line markers located on the landside (LS) toe and						
across channel. (6-inch gas line authorized under Permit No. 764,						
1939 - Pacific Gas and Electric Company [PG&E]. 6-inch Pipe						
reconstructed under Permit No. 9191, 1974 - PG&E). [Additional						
Reference(s): DWR Levee Log, 2005 (HLM 3.02, listed as 7-inch gas						
line). USACE Sacramento O&M Manual, Unit 135, May 1953, (Station						
157+35), listed as 6-inch steel pipe, USACE As-built Drawing No. 50-						
04-1949, Drawing No. 2, Sheet 3, March 1952, page 2 of 3].						
FS Date: 2/7/2019 11:17:00 AM

LS view: overview of LS.

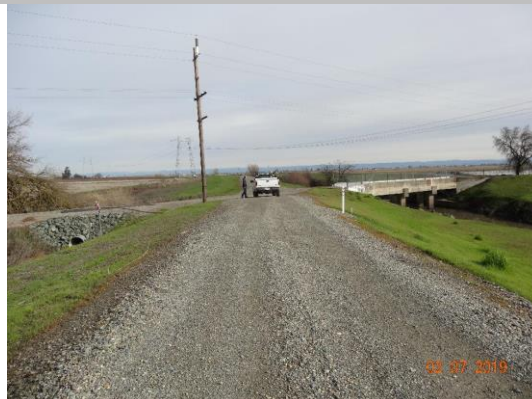
Photo 2 of 3 : UCIP_SP_2022_60127_78765.jpg

Overview of levee crown looking upstream towards crossing.

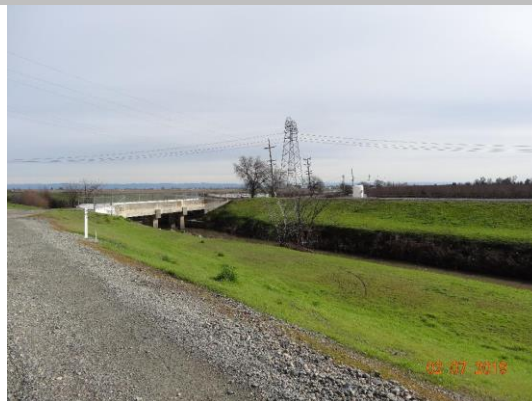
Photo 3 of 3 : UCIP_SP_2022_60127_78766.jpg

WS view: overview of WS.

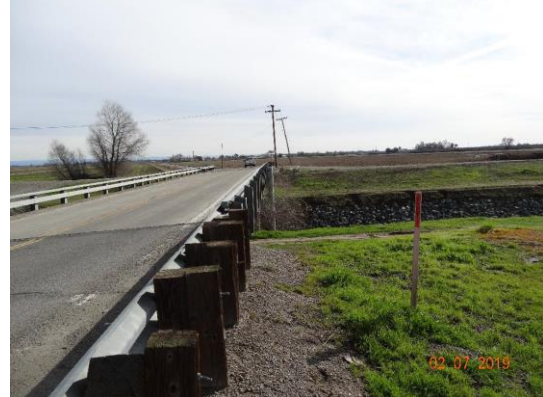
Photo 2 of 3 : UCIP_SP_2022_58005_78783.jpg

WS view: overview of bridge.

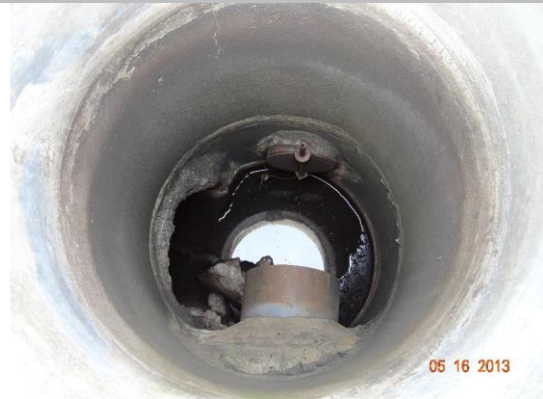
Photo 3 of 3 : UCIP_SP_2022_60133_64762.jpg

Inside of 36in. concrete riser

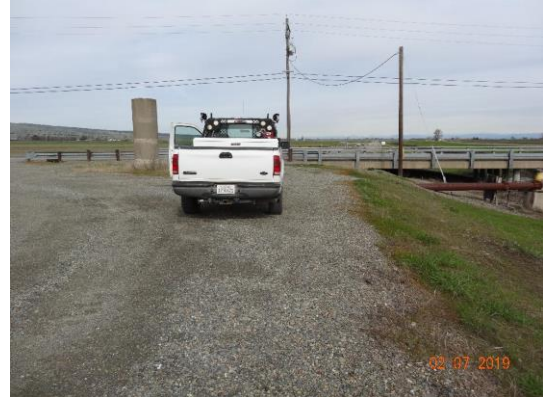
Photo 2 of 3 : UCIP_SP_2022_60135_78794.jpg

Overview of levee crown looking towards crossing.

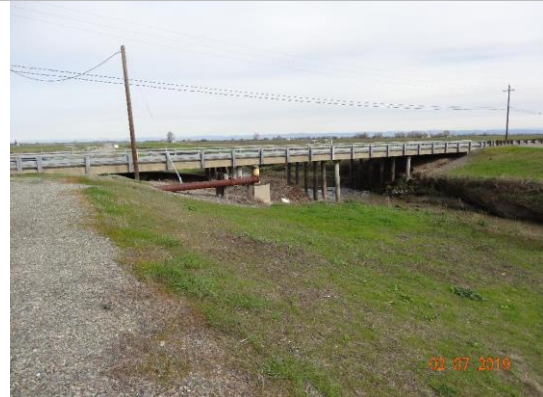
Photo 3 of 3 : UCIP_SP_2022_60135_78796.jpg

WS view: overview of WS.
