LMA: **NA0010 U23 Lower San Joaquin Levee District**

Waterway: **RB San Joaquin River**

Site ID: **NA0010U23RM224.27**

Status: **Repaired Site**

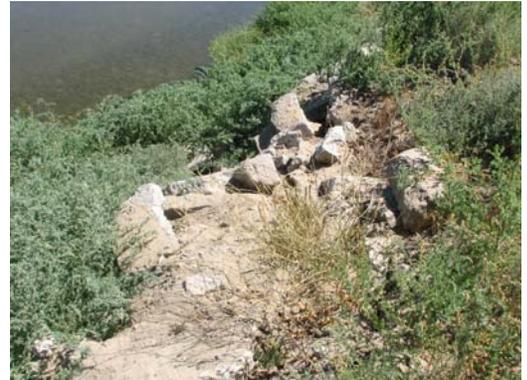
07/24/2012: Site has been repaired with riprap rocks and broken concrete blocks, but loose material and cracking are visible at the top of the repaired site. The site needs close monitoring for performance evaluation.

Looking downstream standing at the middle of the erosion site. Note the cracking and loosen material

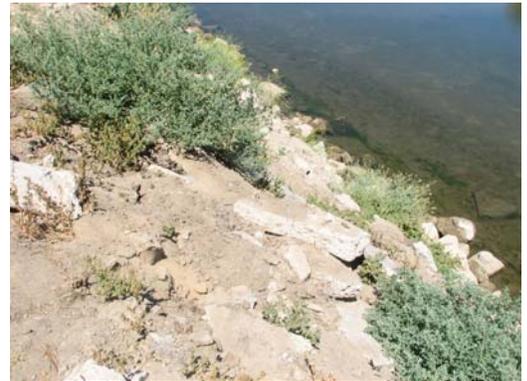
Close look at the repaired site.

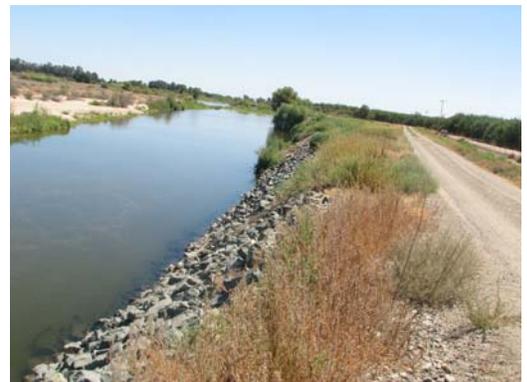
Looking downstream.

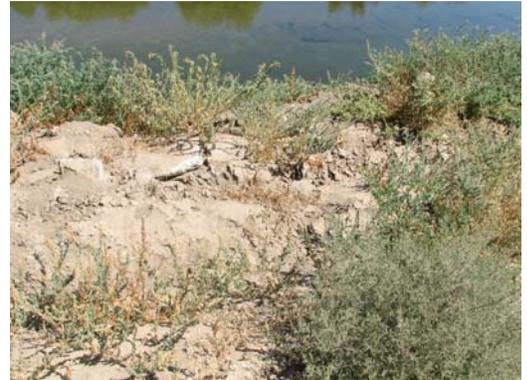
07/24/2012: The site has been repaired with clay material, riprap rocks, and broken concrete blocks, but the loose material and large crackings at the repaired site are visible. Need monitoring for the performance during the coming high flow events.

A close view at the repaired site at the corner of the river bend. Note the losen material and cracking

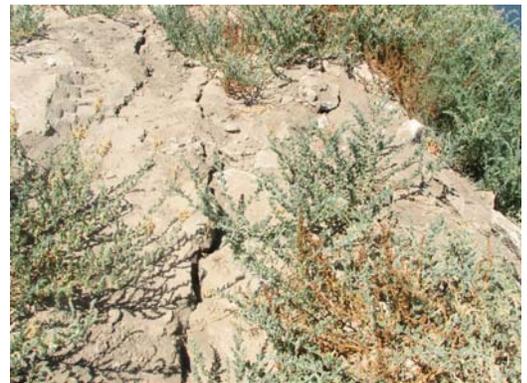
Looking downat the cracking at the repaired site

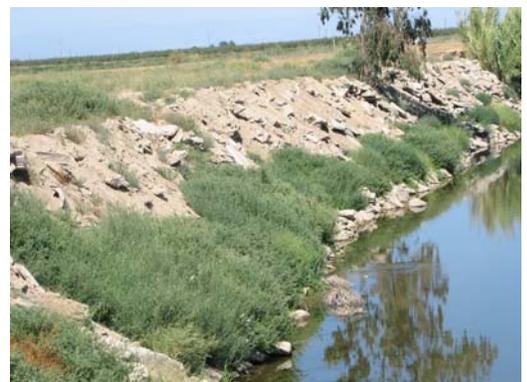
Looking upstream

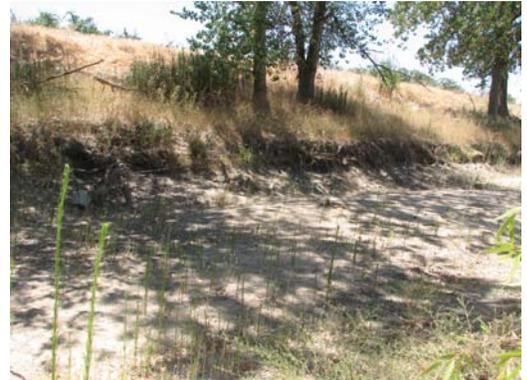
View from the riverbed

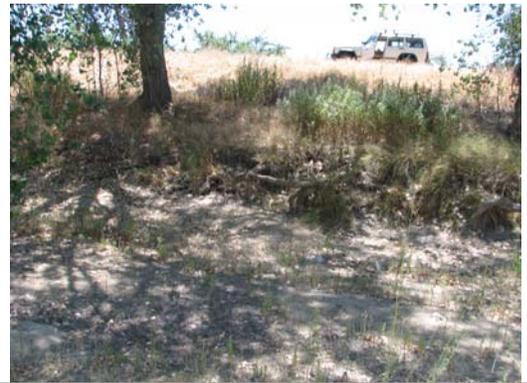
Tree roots exposed

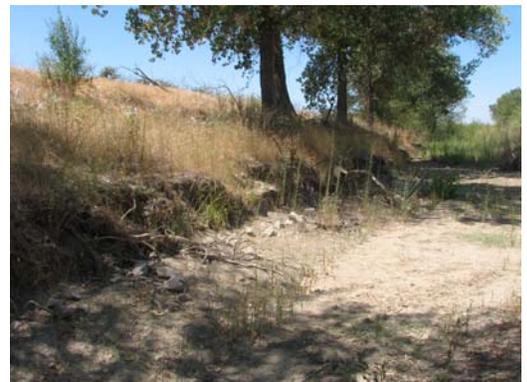
Looking upstream standing on the riverbed

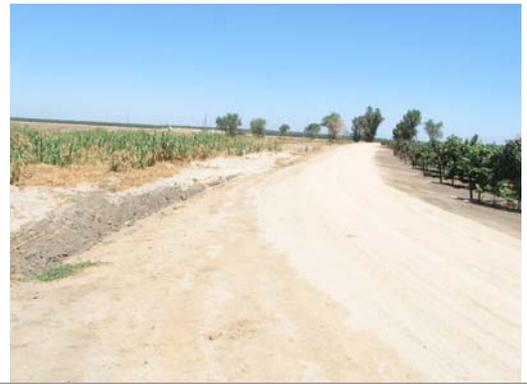
Close look at the site

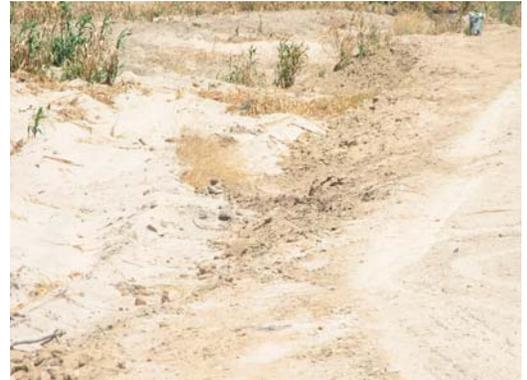
New dirt added to the levee

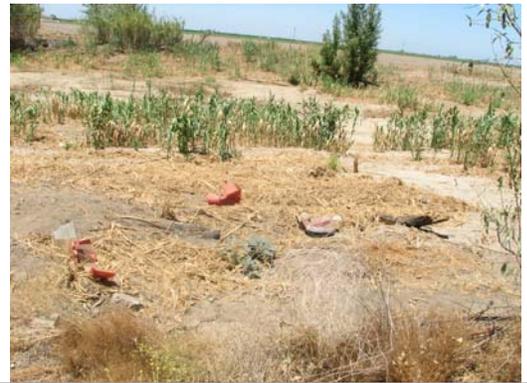
Notice the trash on the site

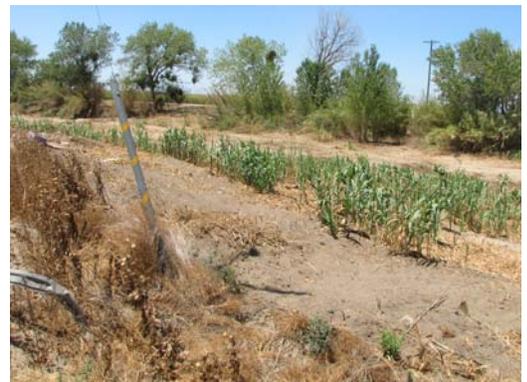
Vegetation on the levee

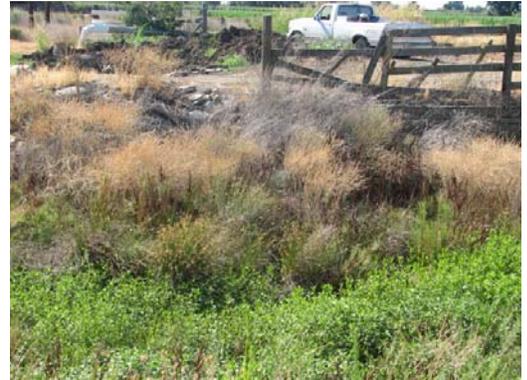
Site covered with dense vegetation.

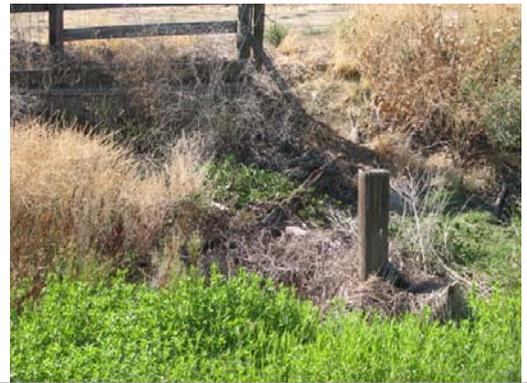
Wooden posts and fence on site

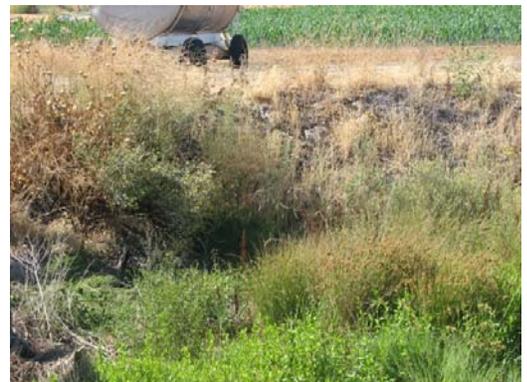
Dense vegetation

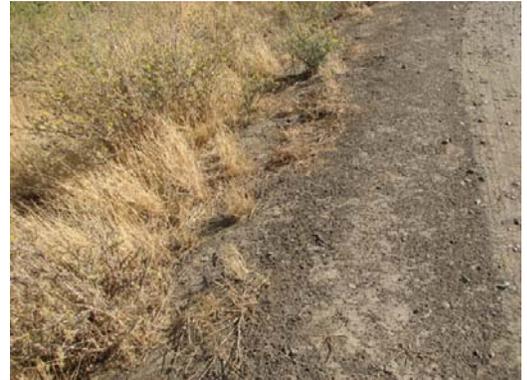
No significant change visible from the levee top

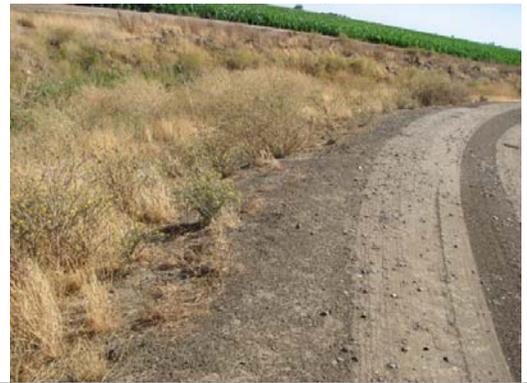
The site is covered with dense thistles.

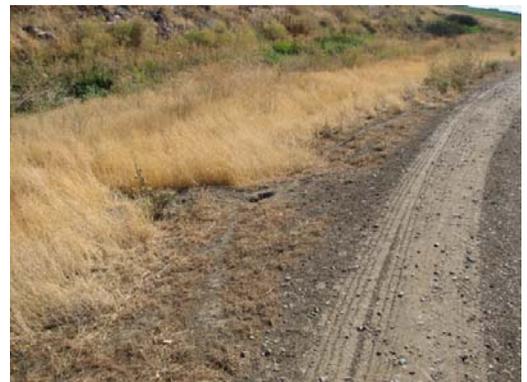
Minor cracking observed last year at the levee shoulder not visible because of the dried grass

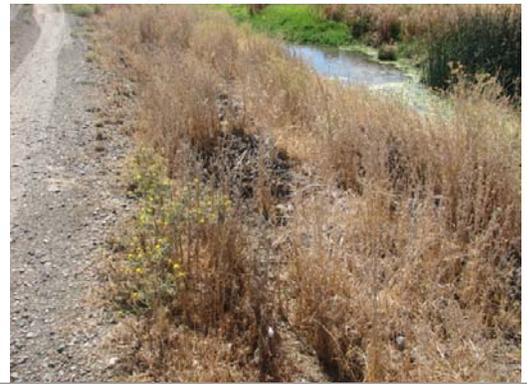
The site is covered with dense star thistles. No significant changes visible

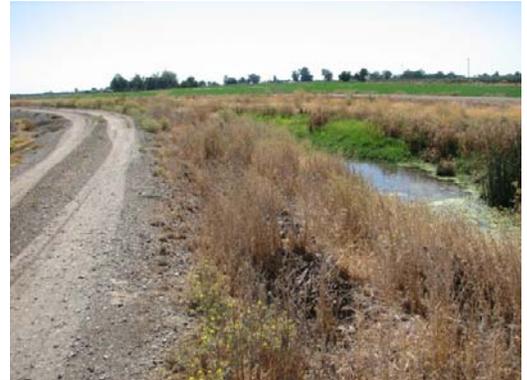
The site is covered with dense star thistles

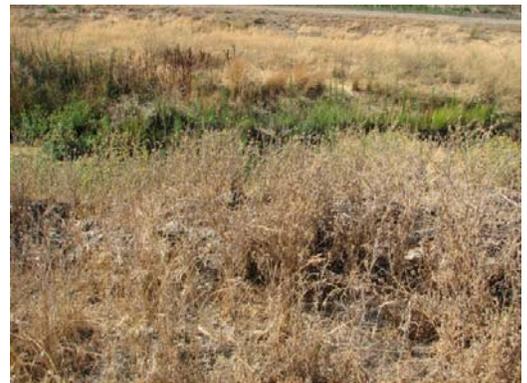
The site is covered with dense star thistles

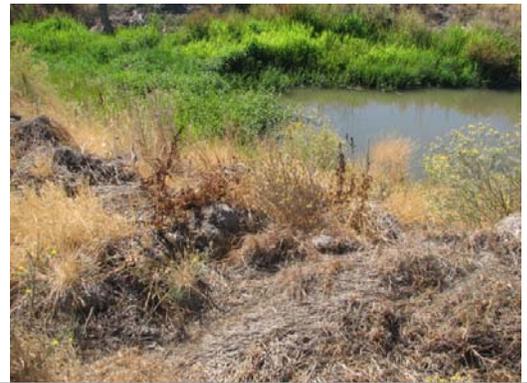
The site is covered with thick vegetation

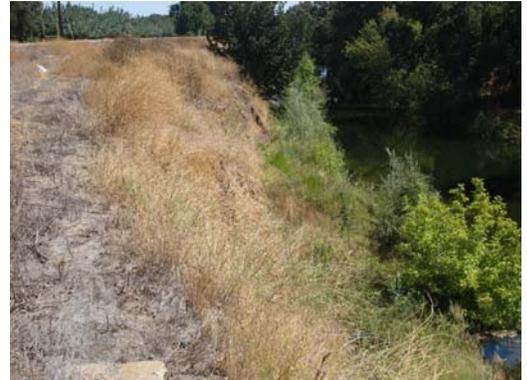
Close view of the erosion. Note the dense vegetation and tree on site.

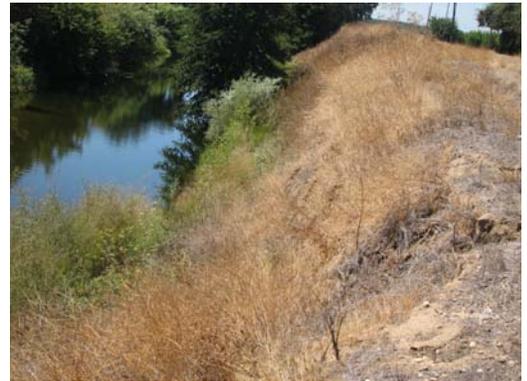
Close view of erosion site. Note the sloughing soil at the shoulder.

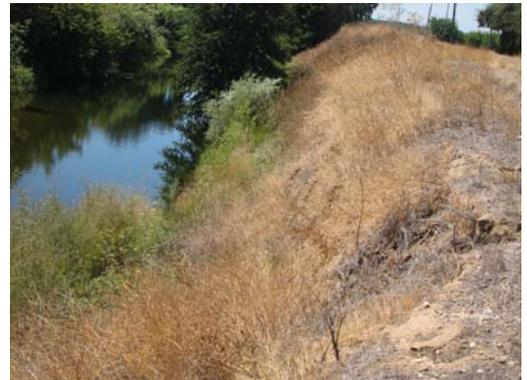
Closer look at the site. Sliding soil at upper slope.

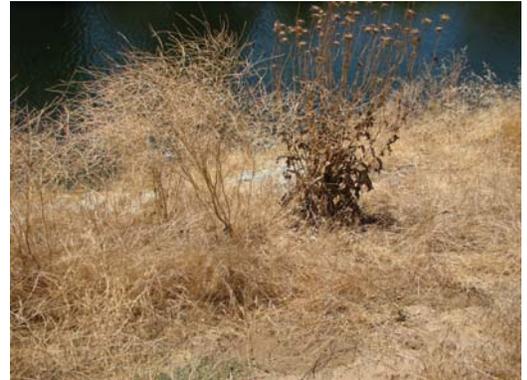
Close look of the repaired site

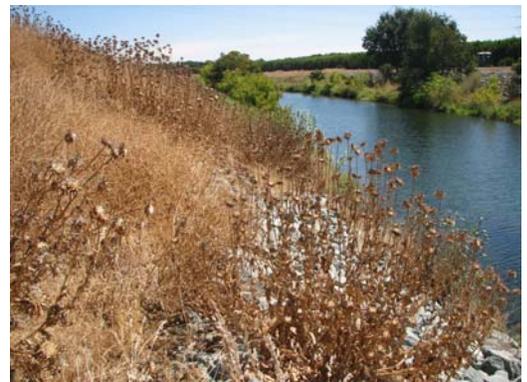
Close view of the repaired site.

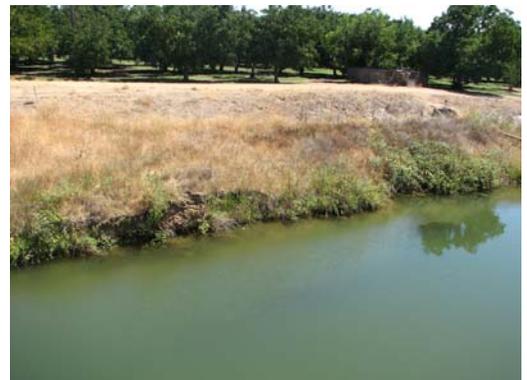
08/22/2012: Site is visited and no new erosion activity found at the repaired site, but new pocket erosion has developed at the toe downstream of the bridge.
 09/02/2011: The site has been repaired by the district. The site was previously rated "M".
 11/02/2010: No significant changes observed on site. Bridge scour has created a pocket erosion, exposing a portion of the underlying concrete padding.
 8/11/2009: Site is adjacent to abutment on Milton Road Bridge; pocket erosion has developed and will continue to expose the bridge foundation; this erosion appears to be critical as it may affect the bridge foundation.

The new developed erosion immediately downstream of the bridge. Viewed from the right bank.

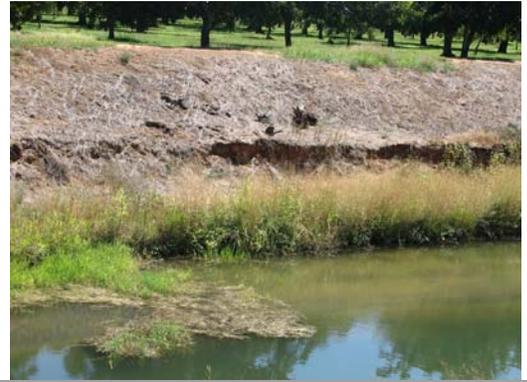
Closer view of the site

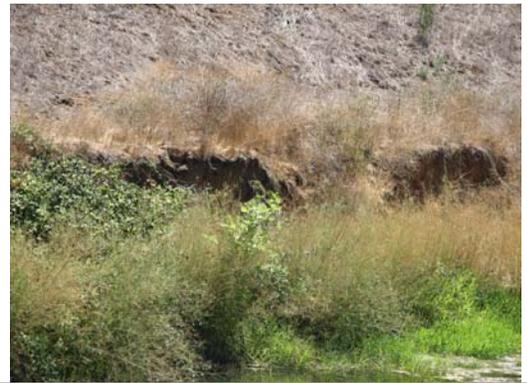
Closer view of erosion

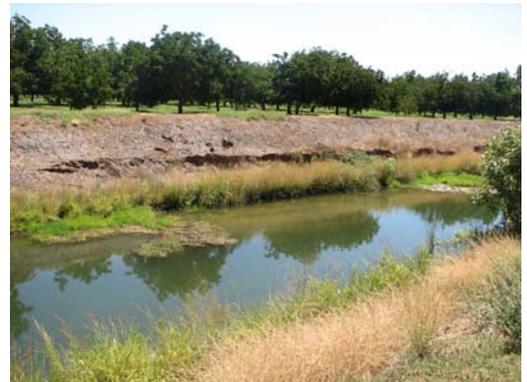
Front view of erosion

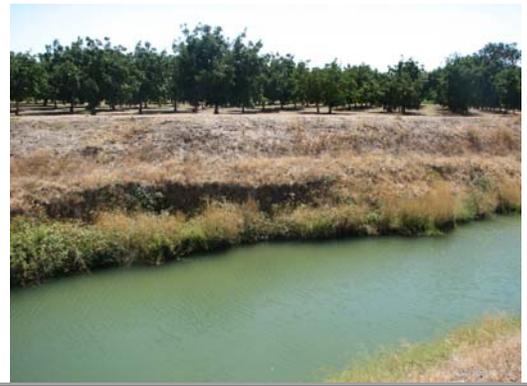
08/22/2012: Dense vegetation on site

Front view of erosion

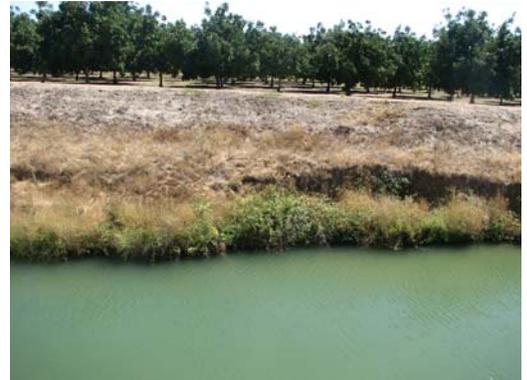
Front view of erosion

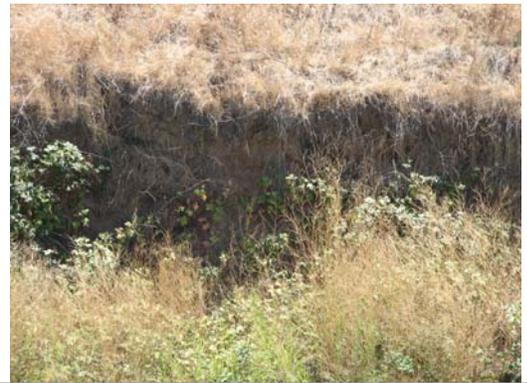
Closer view of erosion

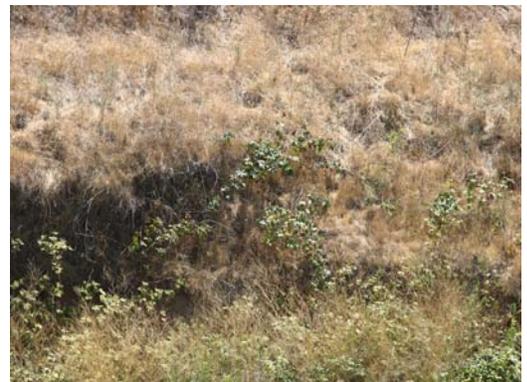
Close look at the erosion

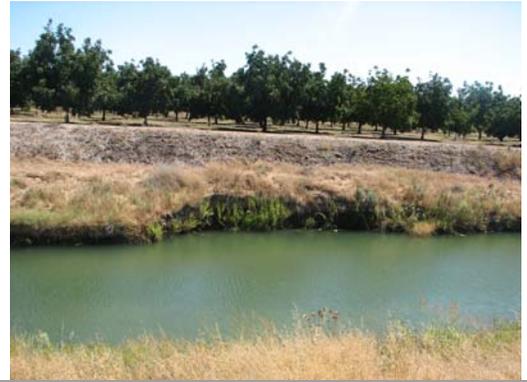
front view of erosion

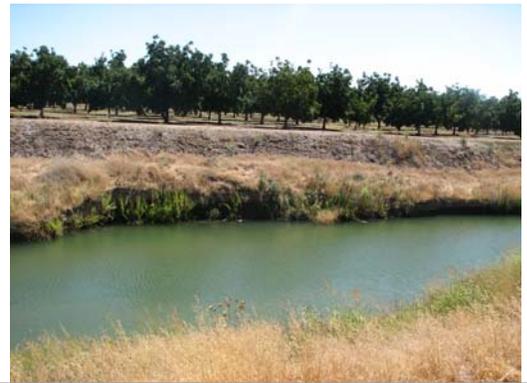
Front view of erosion

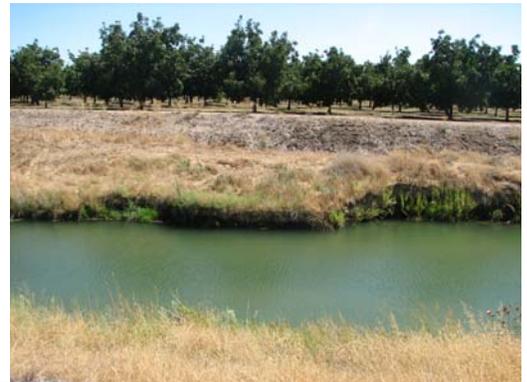
Front of view of erosion

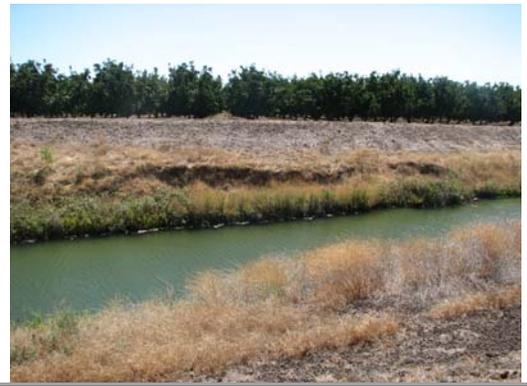
08/22/2012: Erosion is covered with dense vegetation.

Looking downstream at the erosion

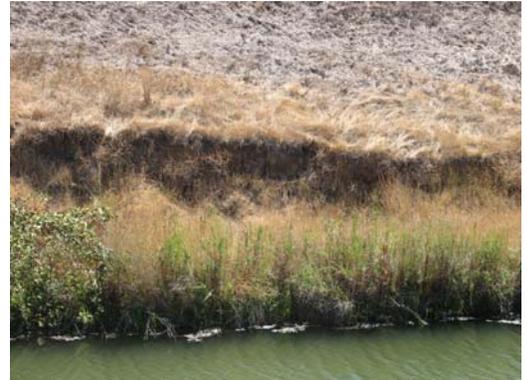
Close view of erosion

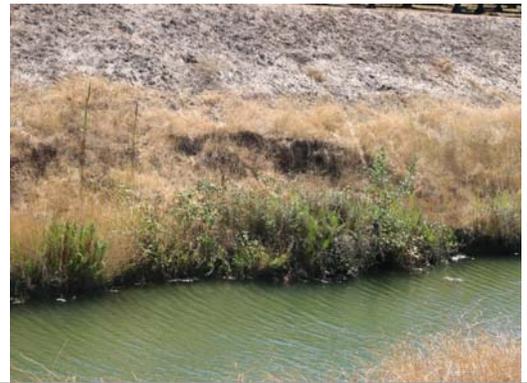
Another close view of erosion

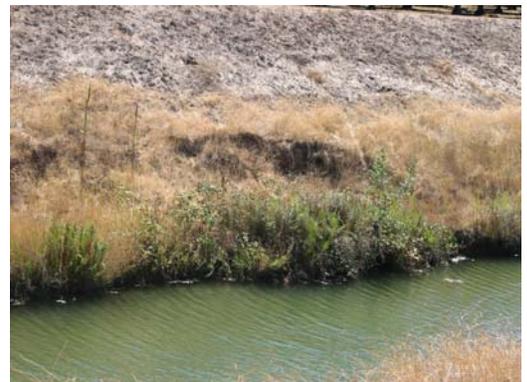
Front view of erosion

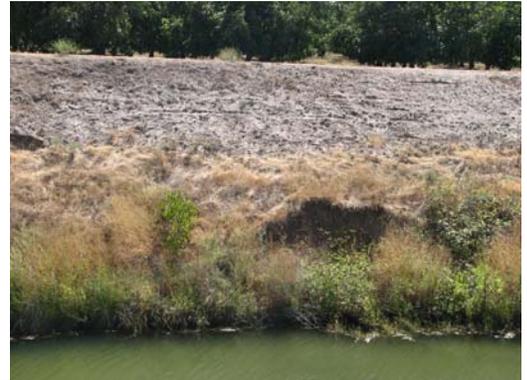
Front view of erosion

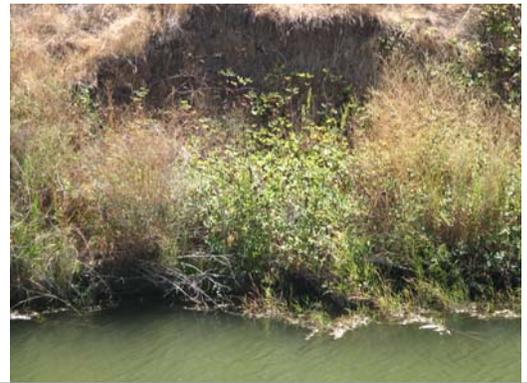
Closer view of erosion

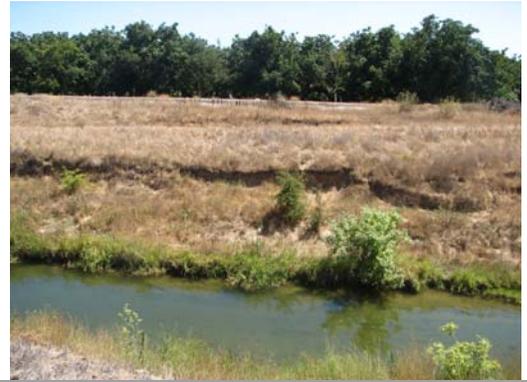
Front view of erosion

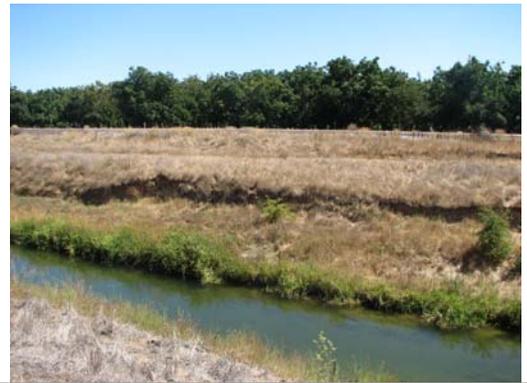
Front view of erosion

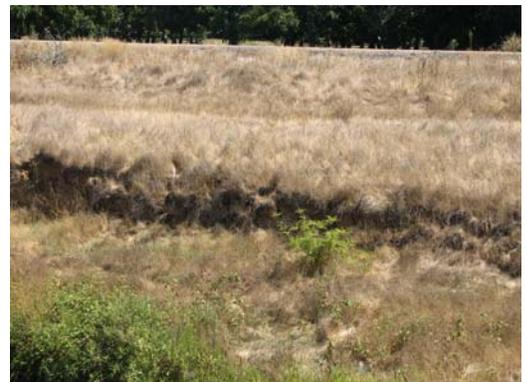
Closer view of erosion

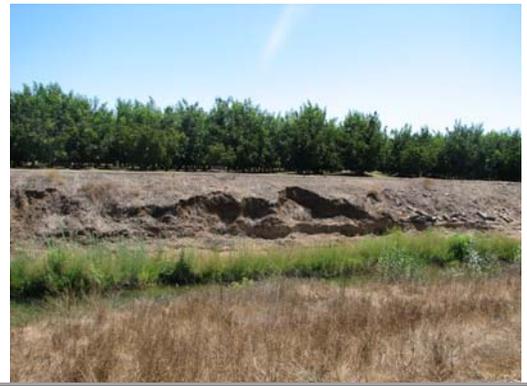
08/22/2012: Discontinuous scarp or pocket erosions occurred along a long stretch of the river, with a highest height larger than 25 ft at certain points.

Looking at the most downstream erosion at the site.

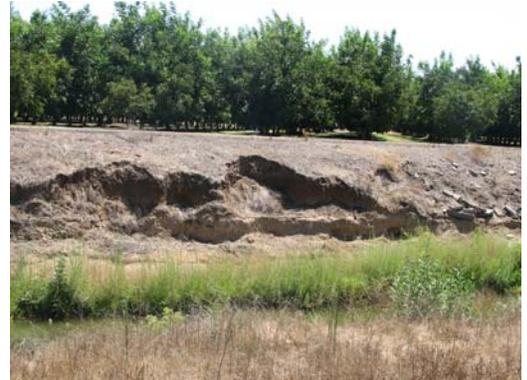
Closer view of the erosion

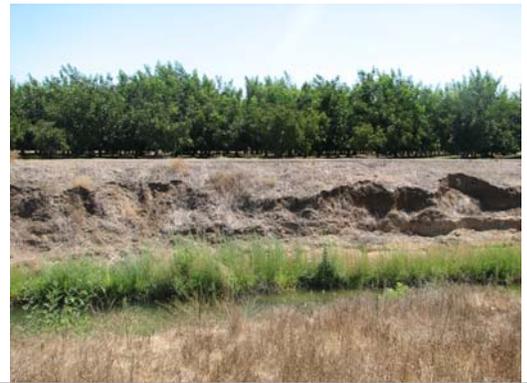
Front view of the erosion

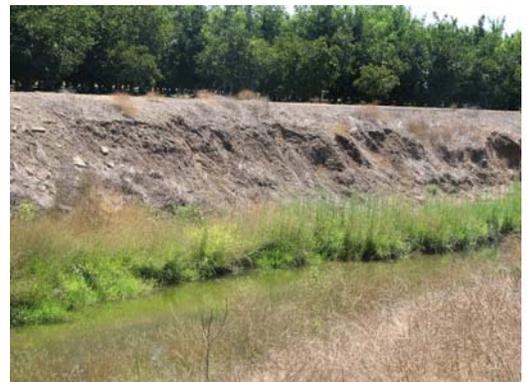
Front view of erosion

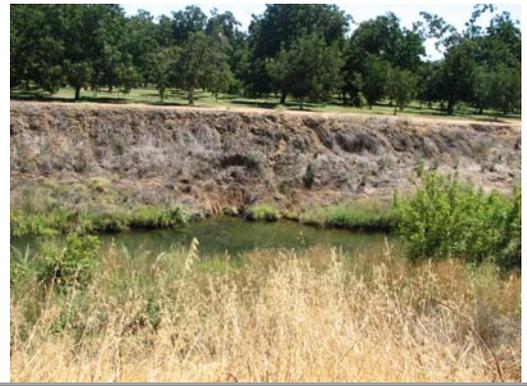
08/22/2012: A pocket erosion at the levee toe and on lower slope. The levee surface at the upper slope also shows signs of erosion due to poor maintenance.

Front view of erosion

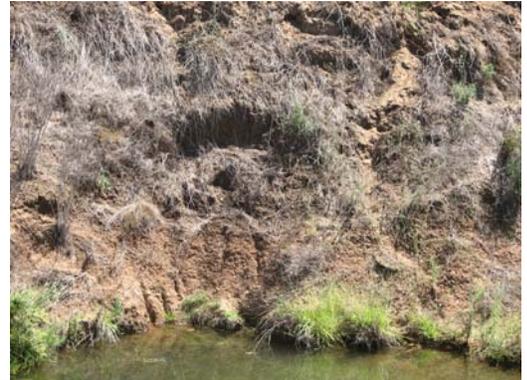
Close look at the erosion

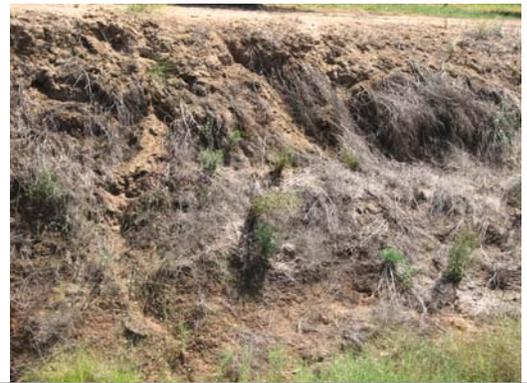
A close look at the upper levee slope above the pocket erosion

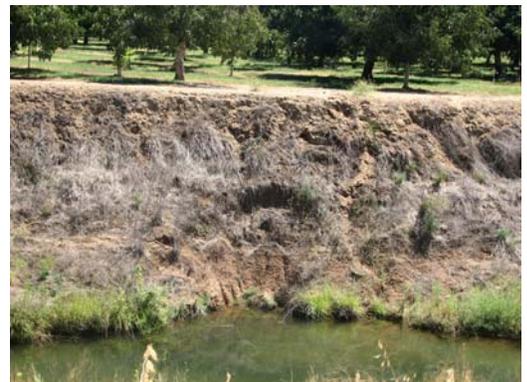
Front view of erosion

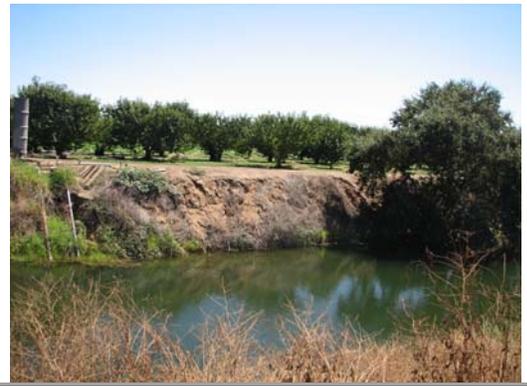
08/22/2012: A irrigation pipe presents at the site, but not likely has caused the erosion.

Front view of erosion. Note the irrigation pipe and the tree

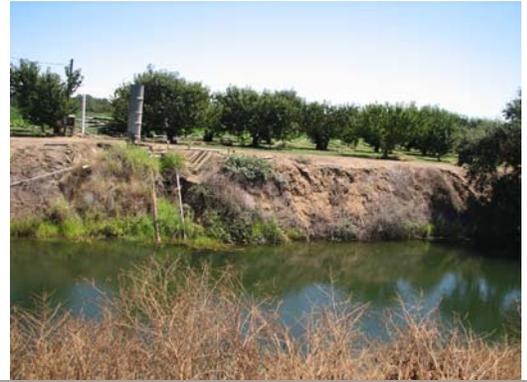
Front view of erosion.

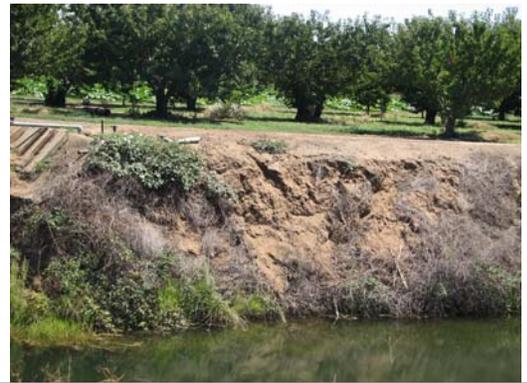
Closer look at erosion

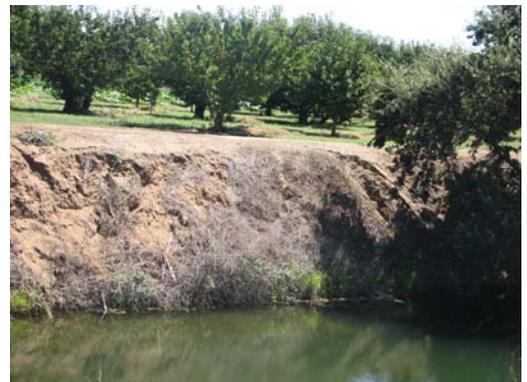
Closer look at erosion

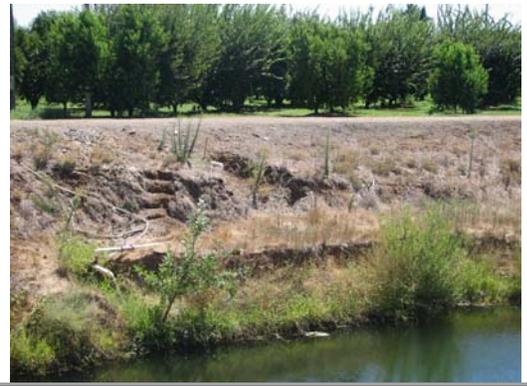
08/22/2012: River-induced erosion occurred on the berm, while the runoff-induced erosion on the levee slope. Site is covered with vegetation

Close look at the erosion. Note the erosion at the levee slope as well as berm.

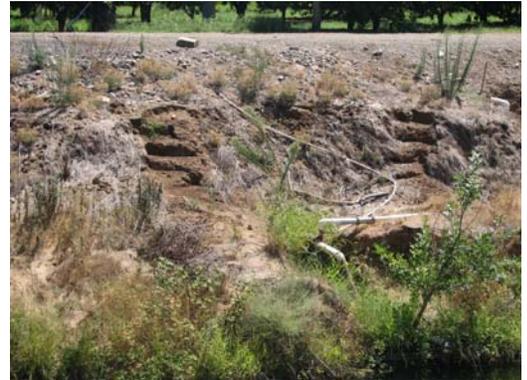
A closer look at the erosion

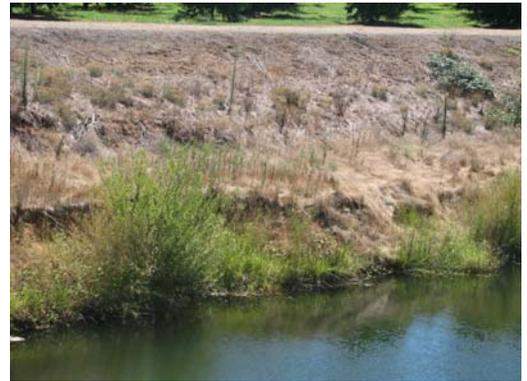
Front view of erosion at berm

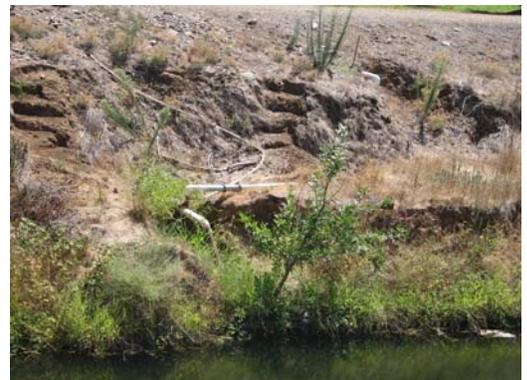
Another closer look at the erosion

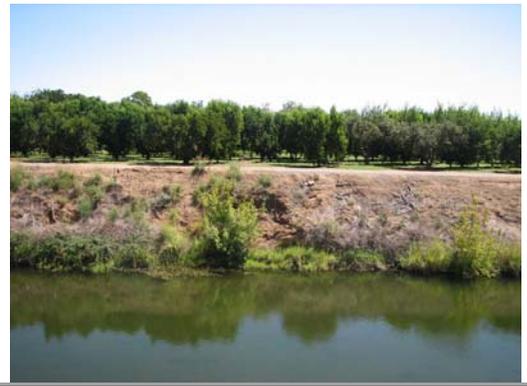
08/22/2012: Erosion is covered with grass and shrubs.

Front view of erosion

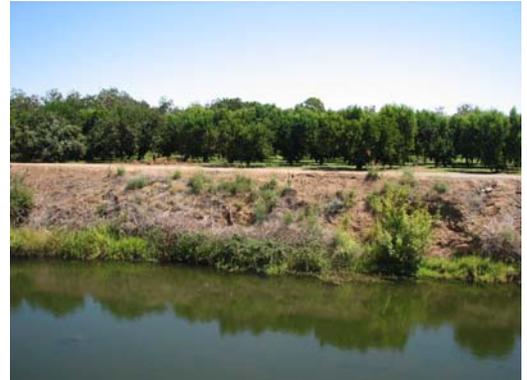
Front view of erosion

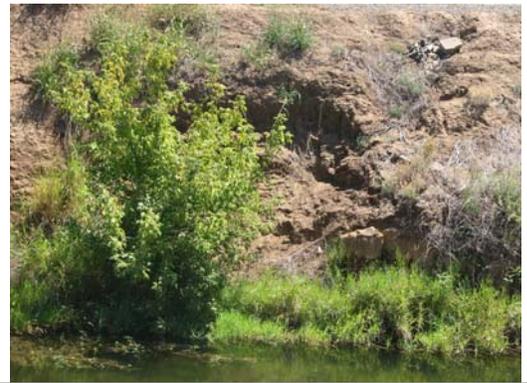
A closer look at the erosion

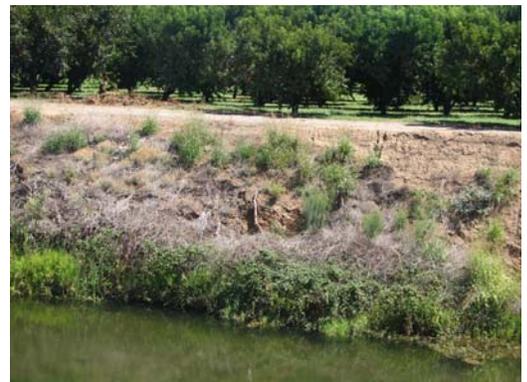
Front view of erosion

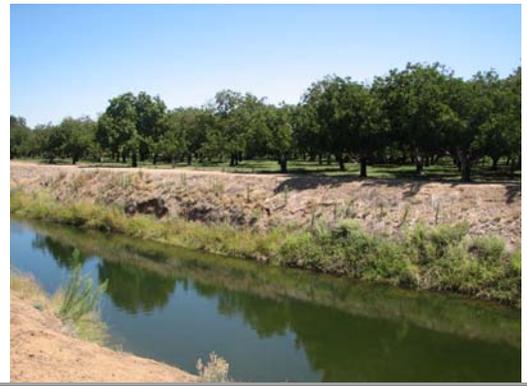
08/22/2012: Tow large-size pocket erosions. Site is covered with dense vegetation.

Looking upstream

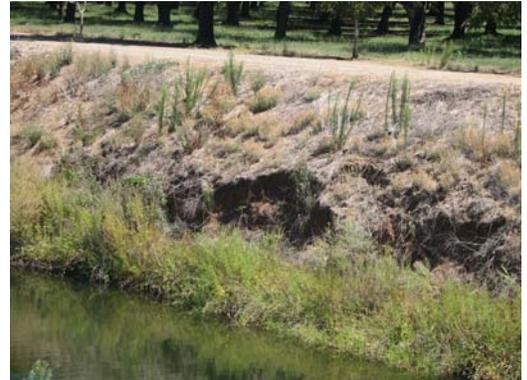
Front view of erosion

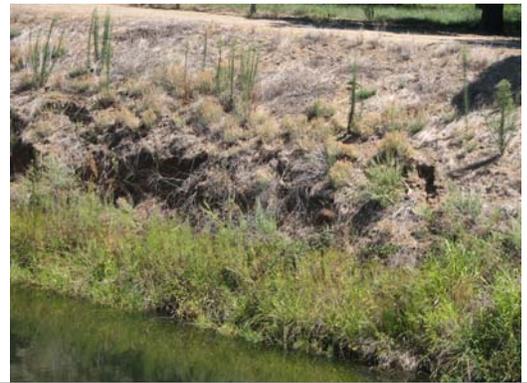
front view of erosion

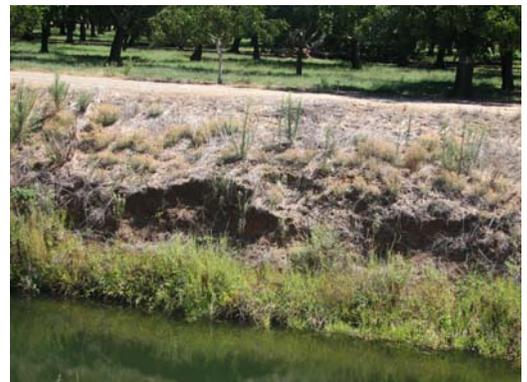
A closer look at the erosion

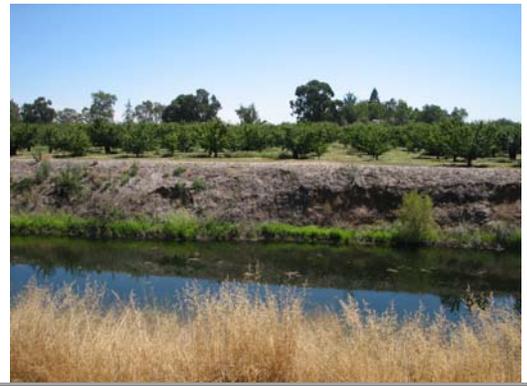
08/22/2012: Site Comprised of series of pocket and scarp erosions. Some of erosions are covered by grass or shrubs.

Front view of the erosion.

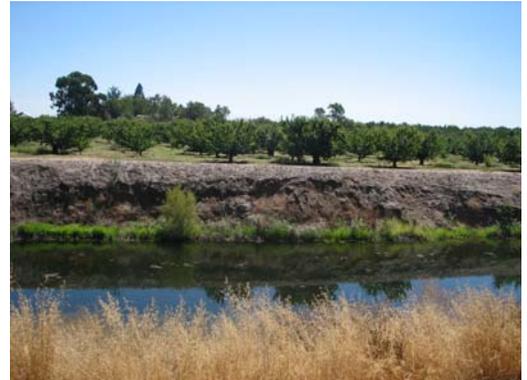
Front view of erosion

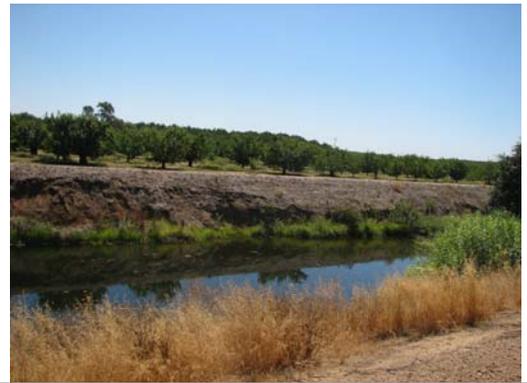
Looking downstream

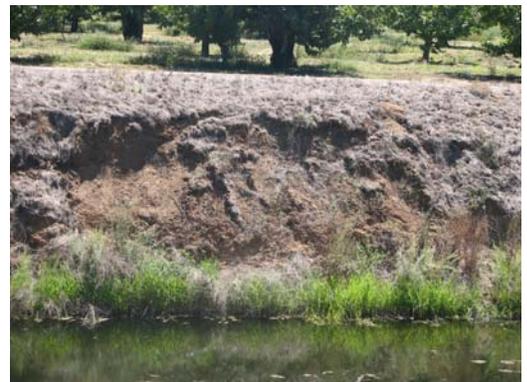
Close view of the scarp erosion

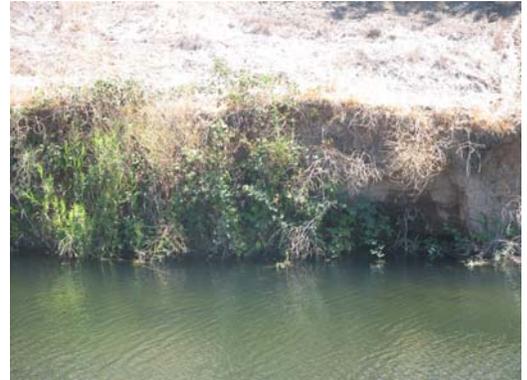
Close view of erosion. Note the vegetation at the site

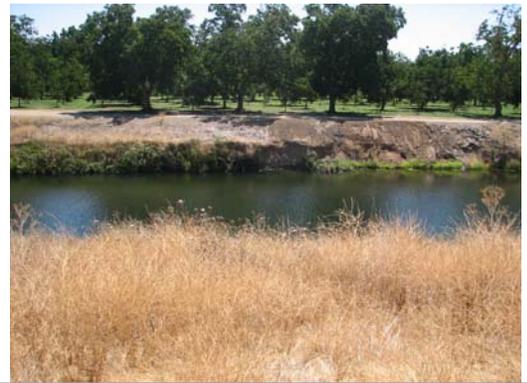
Front view of erosion

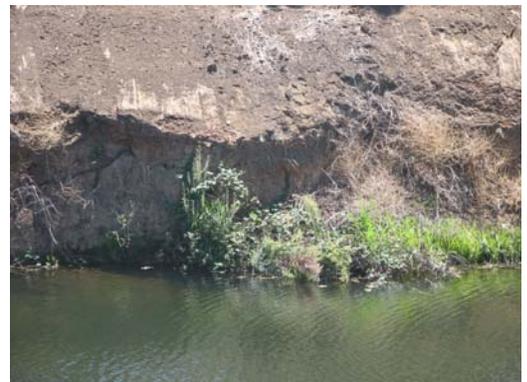
Close look at the site.

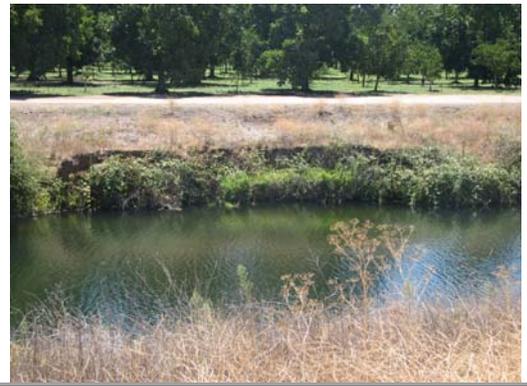
08/22/2012: Site is covered with dense vegetation.

Front view of the erosion.

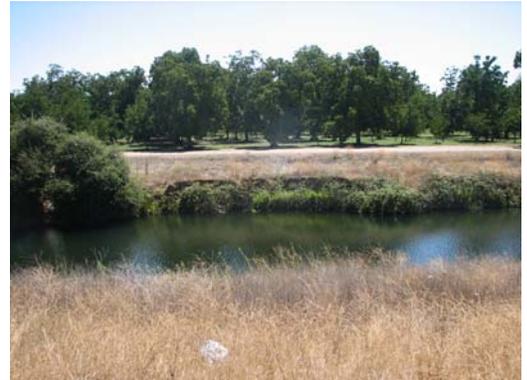
Front view of the erosion. Site is covered with vegetation and trees.

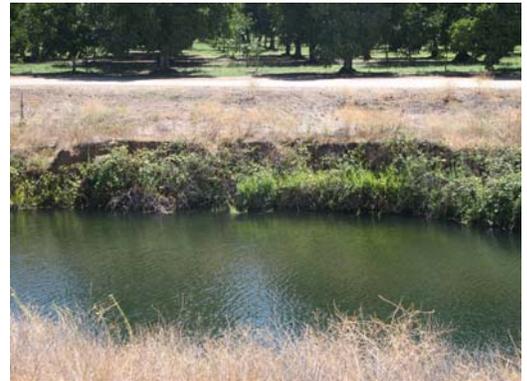
Closer view of the erosion

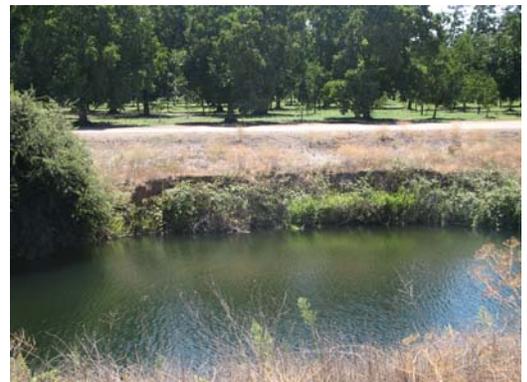
front of the erosion

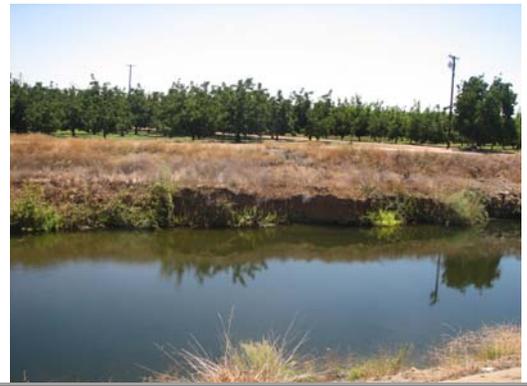
08/22/2012: Berm width is estimated as 5 ft.

Looking downstream at the erosion site

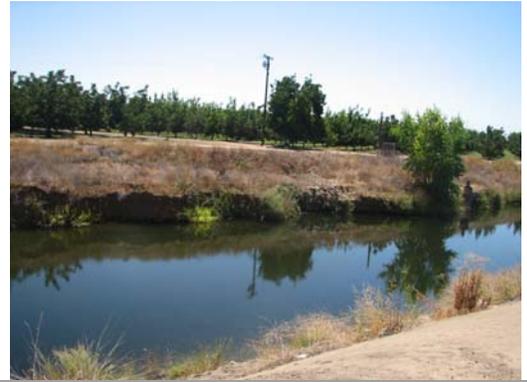
Looking downstream at the erosion

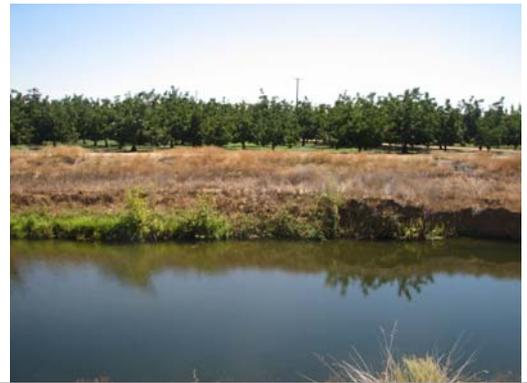
Front view of the erosion

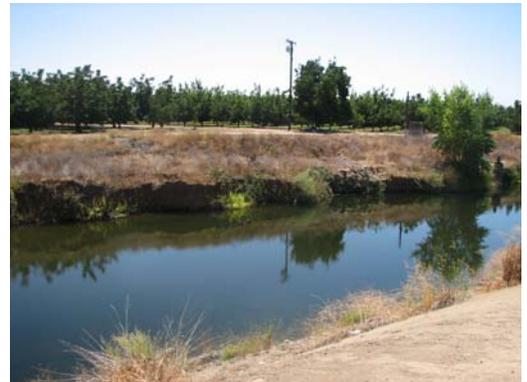
Front view of the erosion

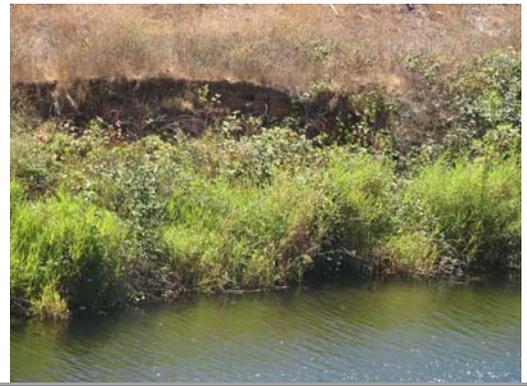
08/22/2012: Site is covered by dense vegetation. Berm width is estimated as 5 ft.

Close view of the erosion

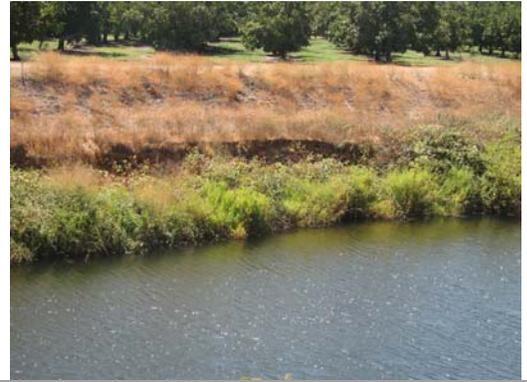
Looking downstream at the erosion

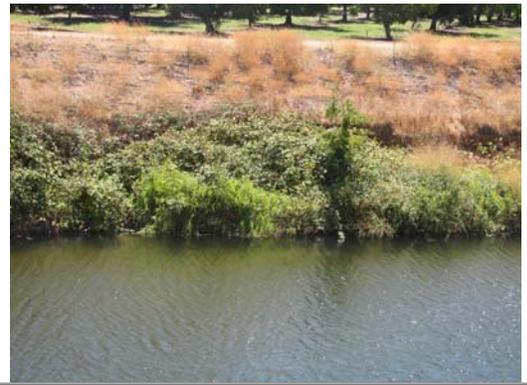
Front view of the erosion

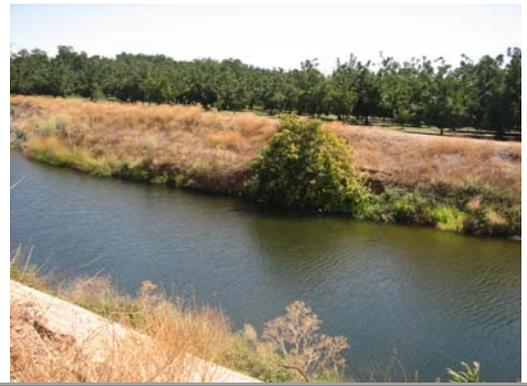
08/22/2012: Erosion is covered by dense vegetation.

Front view of erosion site

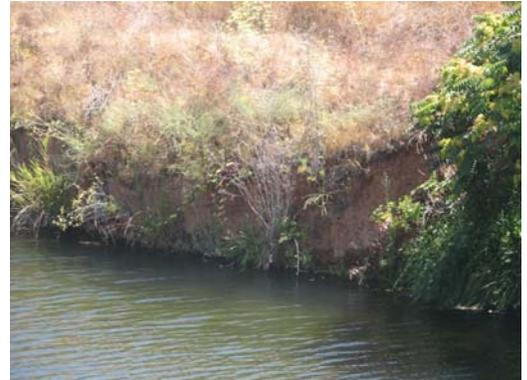
Close view of erosion

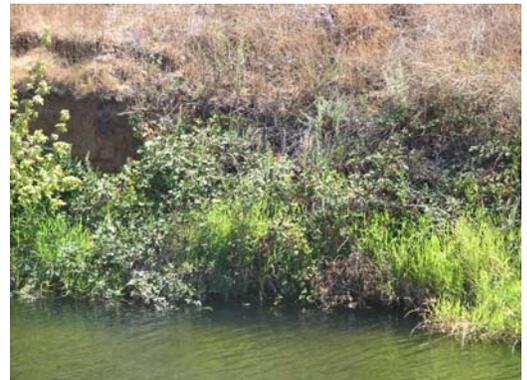
close view of erosion. Note the dense vegetation at the site

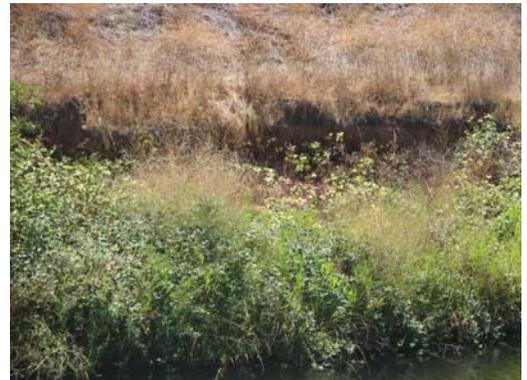
Front view of erosion

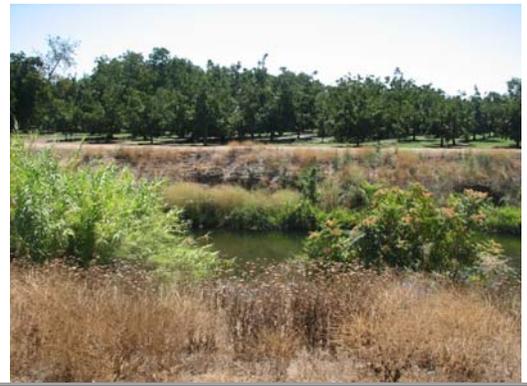
08/22/2012: Site is covered with dense vegetation. A scarp erosion is adjacent to a pocket erosion at the downstream.

Front view of erosion site. A pocket erosion is at the downstream

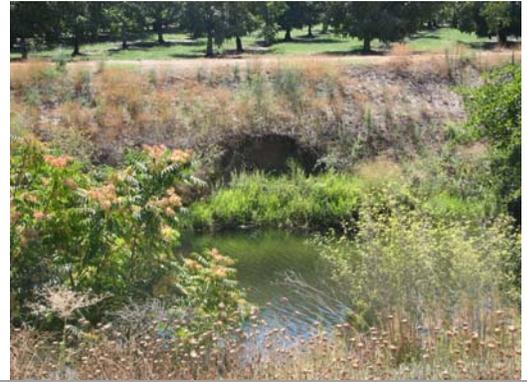
Front view of the pocket erosion

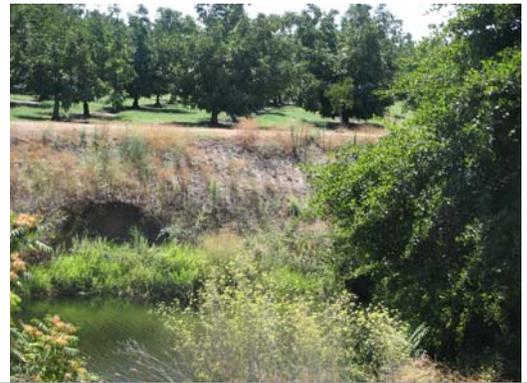
Front of pocket erosion

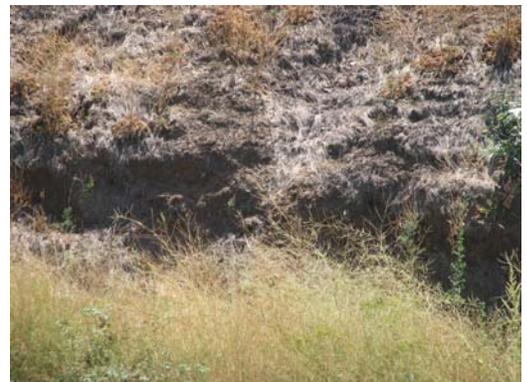
Close view of the scarp erosion

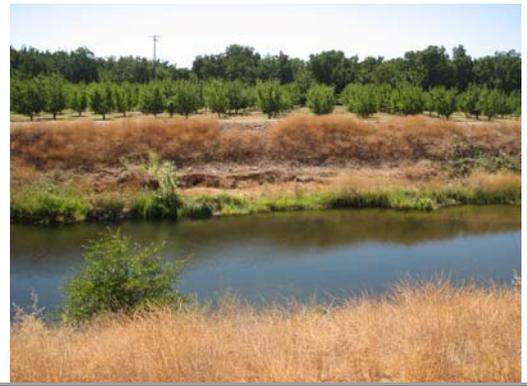
08/22/2012: The berm is estimated at 10 ft. Dense vegetation on site

Front view of erosion.

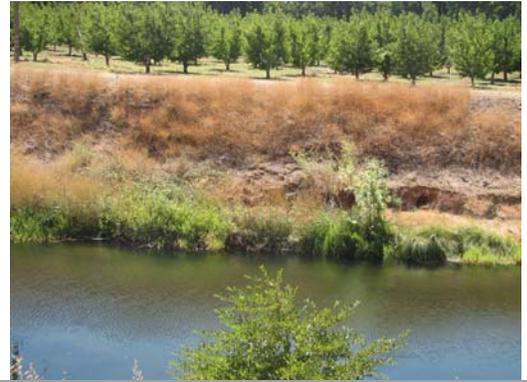
Close look at the erosion

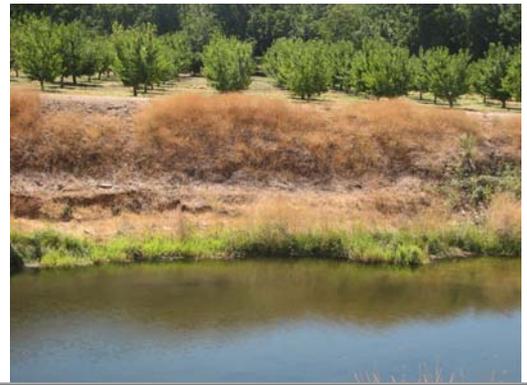
Front view of erosion

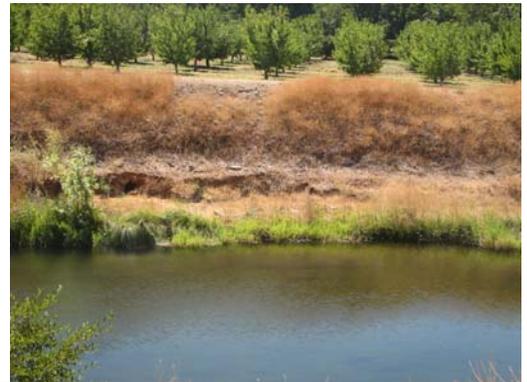
Front view of erosion

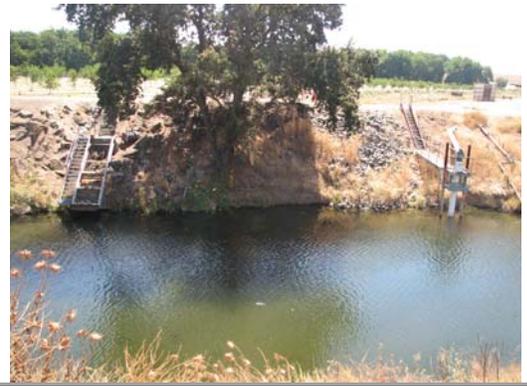
08/22/2012: Erosion is at the outside corner of a river bend, and next to a tree at the levee toe. Irrigation structure presents at the site.

Front view of erosion. Erosion is next to a tree at the levee toe.

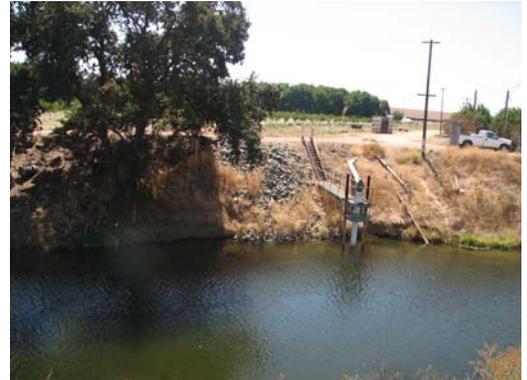
Front view of eroision. Note the irrigation pipe at the erosion site

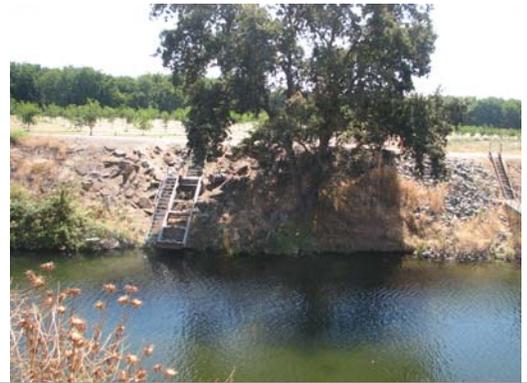
Front view of erosion and broken concrete protection at levee slope

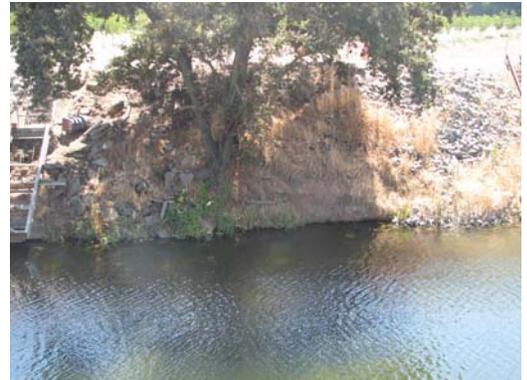
Closer view of erosion
