LMA: **NA0010 U23 Lower San Joaquin Levee District**

Waterway: **RB San Joaquin River**

Site ID: **NA0010U23RM224.27**

Status: **Repaired Site**

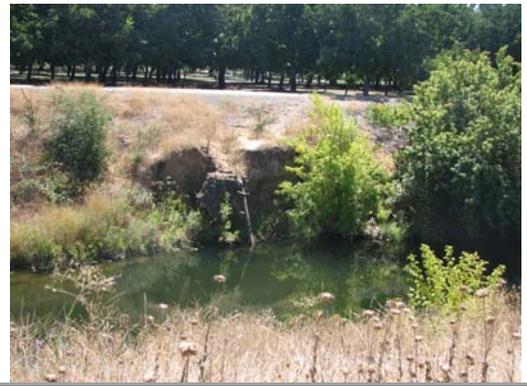
08/22/2012: The erosion was surveyed and documented for monitoring purpose. There is no levee structure on the site, only high ground protecting the land behind.. There is a drainage pipe at the site, which might have caused the problem at one pocket erosion.

Front view of erosion. Note the drainage pipe at the site.

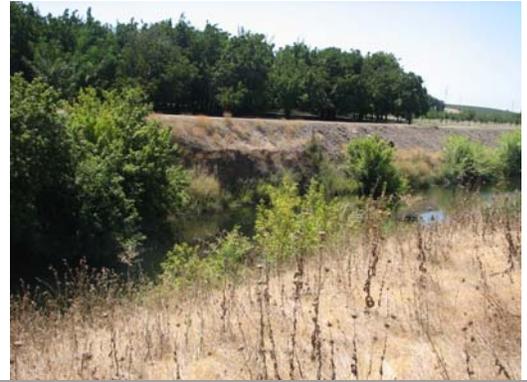
Looking downstream

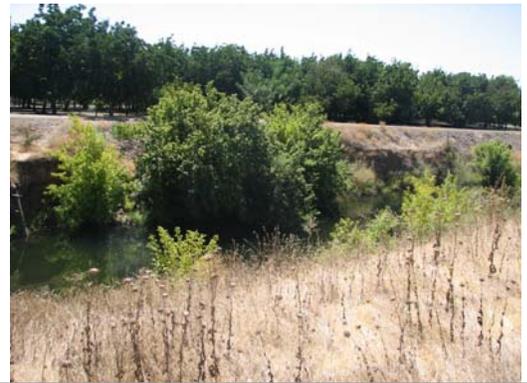
Looking downstream

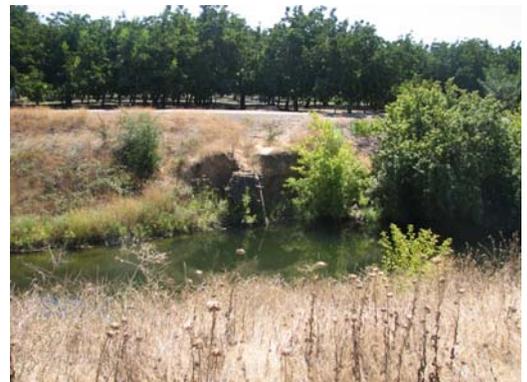
Front view of the site

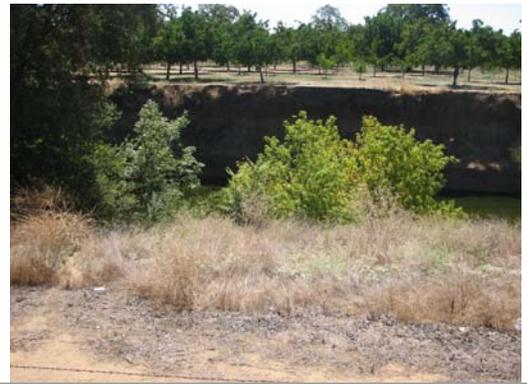
08/22/2012: The erosion was surveyed and documented for monitoring purpose. There is no levee structure on the site, only high ground protecting the land behind.

Front view of erosion. Looking from the right side of the river.

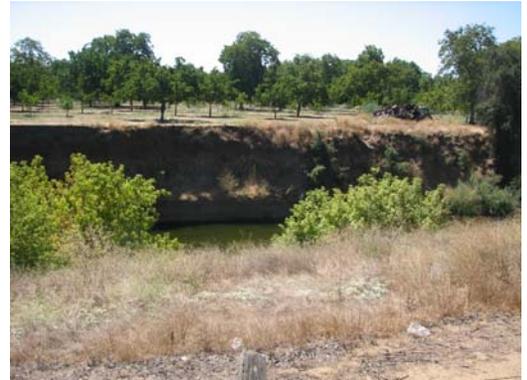
Looking downstream standing on the right side river bank.

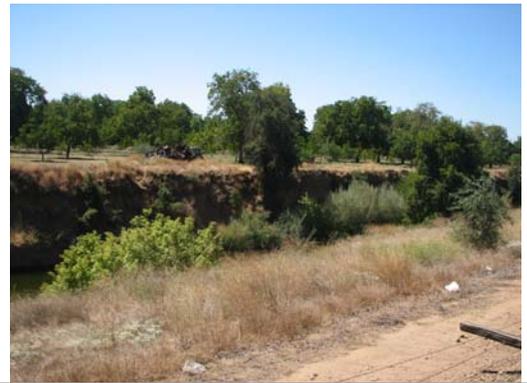
Looking downstream from right side of the river

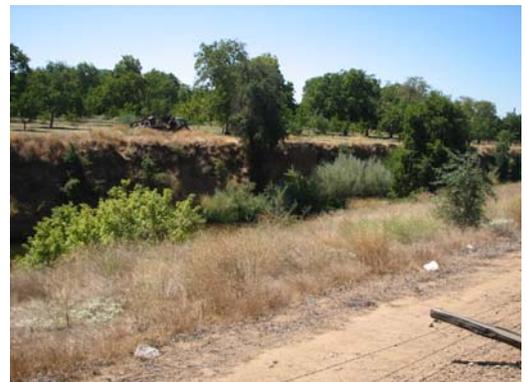
close view of the erosion

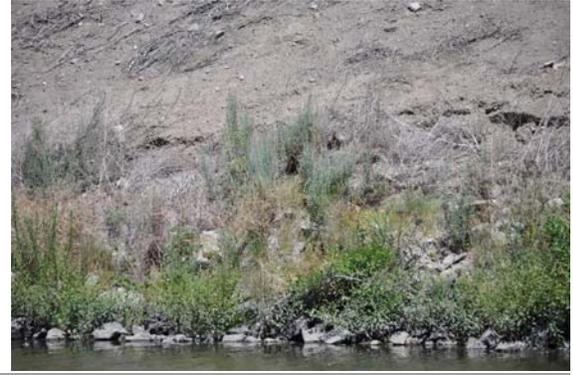
Close view of erosion

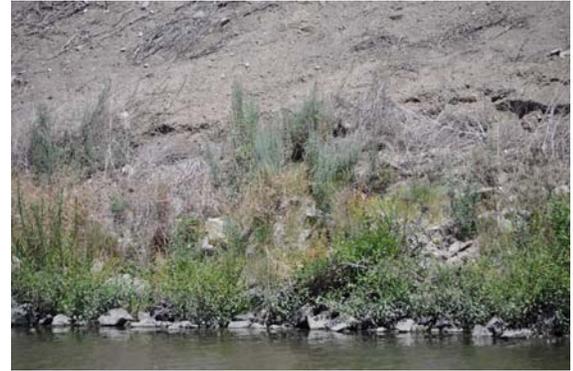
Close view of erosion

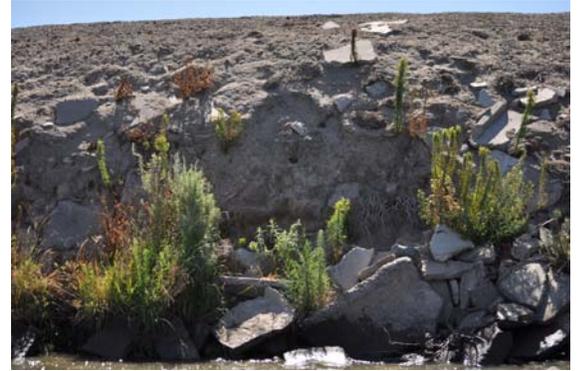
Close view of erosion. Animal holes are visible

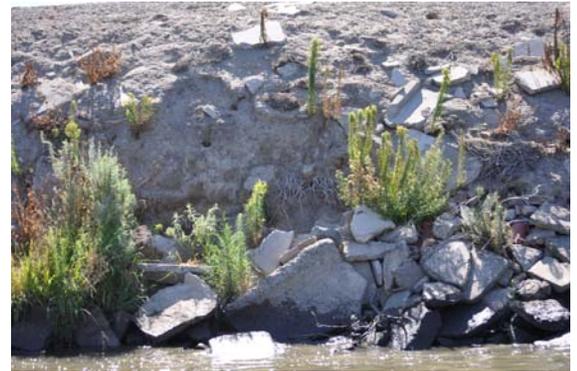
Close view of erosion

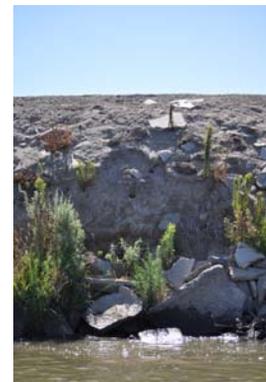
Close view of erosion

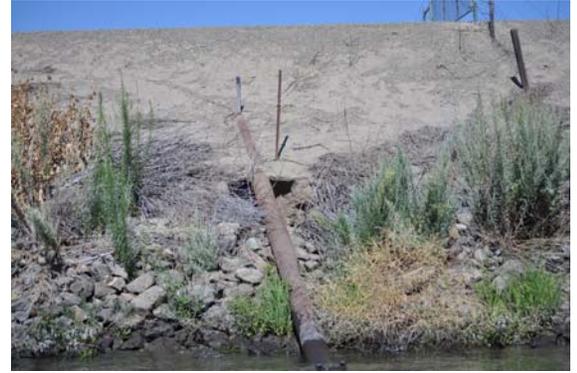
08/07/2012: Erosion is underneath an irrigation pipe. The likely cause of the erosion is the pipe leakage.

Front view of the site

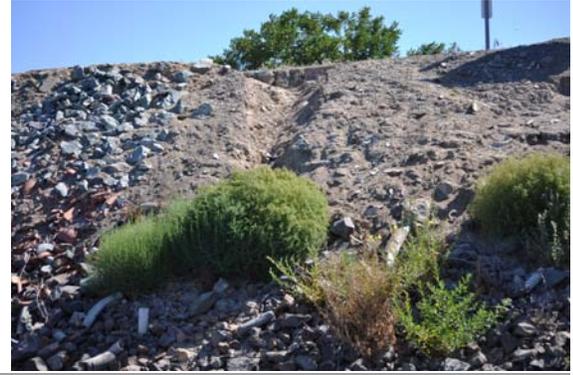
08/07/2012: The erosion is immediately upstream of riprap protection section. The possible cause of the erosion is the rainfall runoff washout.

Close view of the site

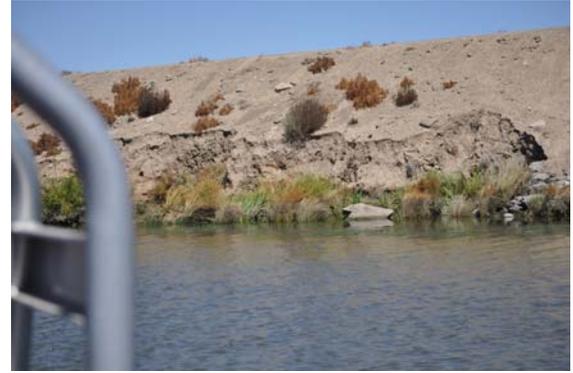
08/07/2012: The site has been visited by boat survey. The erosion has developed in size, and more pocket erosions found.
 8/23/2011: Pockets erosions observed by last survey seem have progressed during the last food season. Continuous monitoring of this site suggested
 9/07/2010: No significant change observed on site. There is emergent vegetation at the water line. Several pocket erosions lined along the lower slope that stretches from RM 40.86 to RM 41.14.
 9/30/2009: No major change observed; the site was combined with other existing sites are RM's 40.93, 40.98, and 41.14 as one site; several pocket erosion just above non-uniform toe rip rap; previously rated "U"; bare spots along the upper slope.
 2008: Possibly caused by wave wash erosion; several pocket erosion along the lower slope; site is inside of a bend.
 2006: Visited site 09/12/06.

Front view of the site

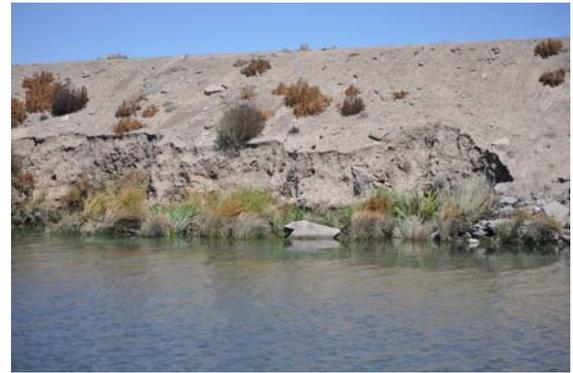
Front view of the site

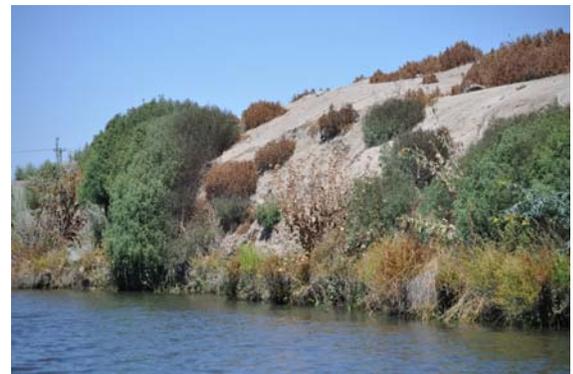
Downstream view of the site

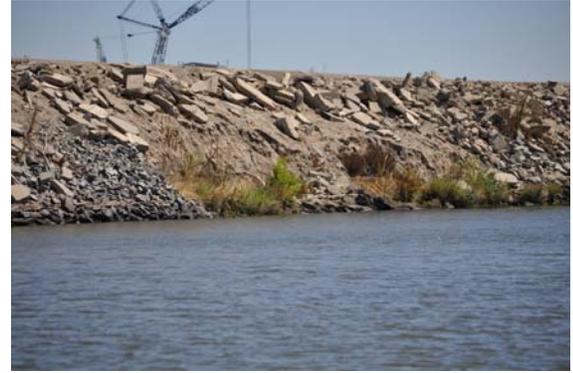
8/7/2012: The erosion is next to a repaired site and approximately 400 feet downstream of a river bend. There are broken concretes at the upper levee slope, but not visible at the levee toe or lower slope. Likely the protection concrete blocks have been washed away

A closer look at the site. Note the protected bank downstream and upstream of the erosion

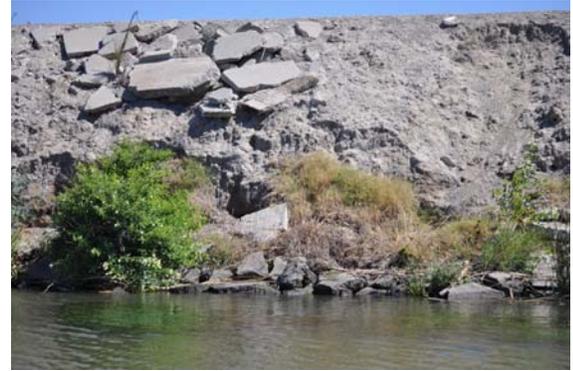
08/07/2012: The site was first discovered by levee inspector in the spring inspection. Levee slope was protected with broken concrete blocks, but those blocks have been washed away during high flows.

Close view of erosion

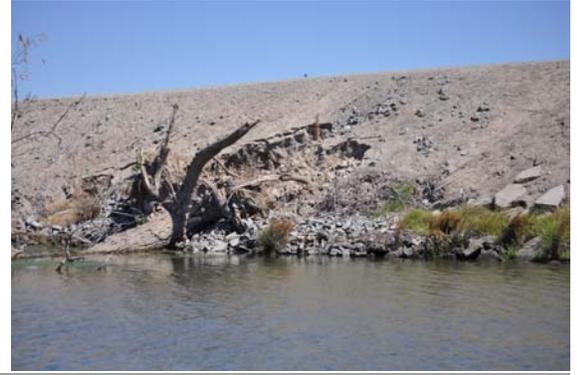
08/07/2012: The rootball of a fallen tree removed material from the levee. Immediately action needed to remove the fallen tree trunk and repair the damage.

close view of the site

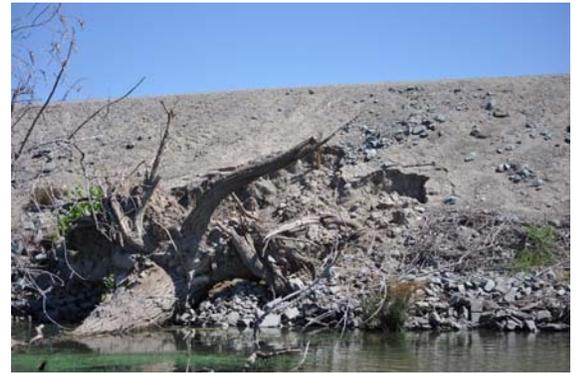
Closer view of the site

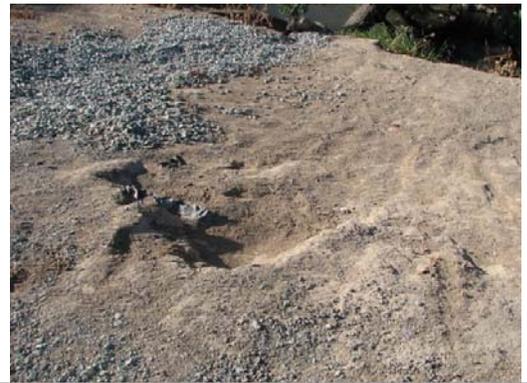
Close look at the repaired site.

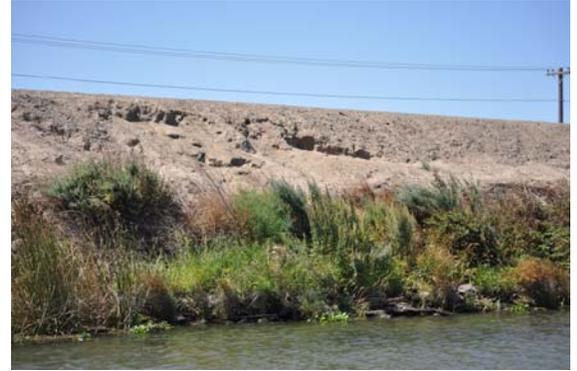
8/7/2012: Erosion is at the upper levee slope, and likely caused by slope slip. The lower levee slope is covered with dense vegetation.

Front view of the site

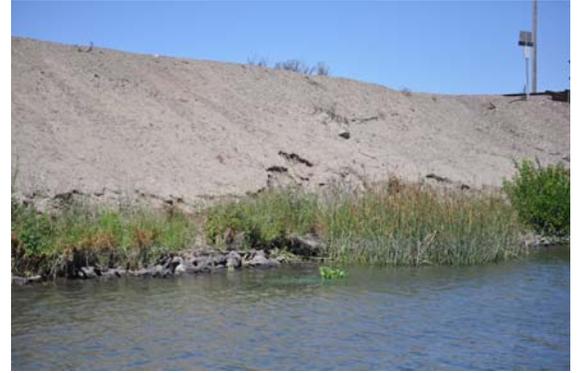
08/07/2012: The site has been visited by boat survey. No significant change observed
 08/23/2011: The site is located immediately upstream of a Railroad bridge. Dense vegetation at the water line interferes the view of erosion.

Front view of the erosion site. Vegetation visible

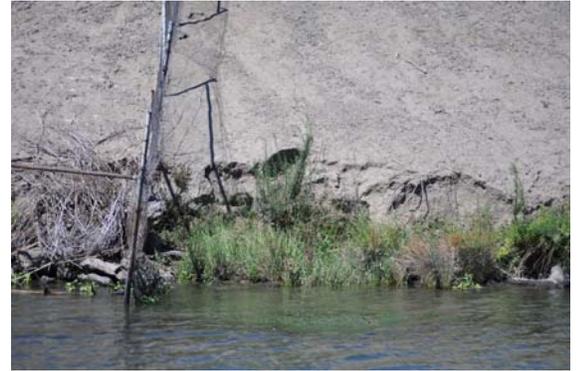
Front view of erosion

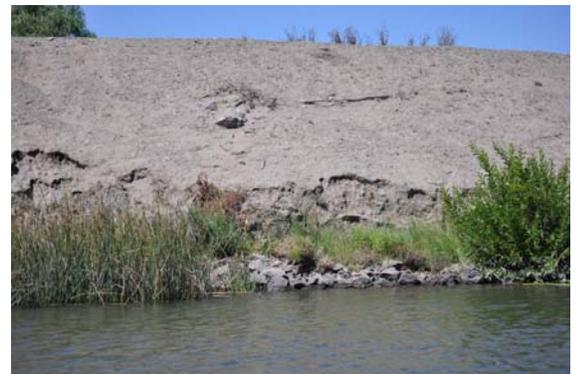
Front view of erosion

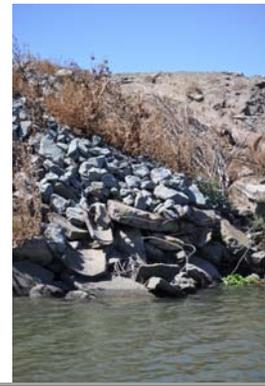
Comments:
 08/07/2012: The site has been visited by boat survey. No significant change observed
 08/23/2011: The erosion site is immediately donstream of the riprap protection.

Front view of the erosion. Note the riprap protection near the site

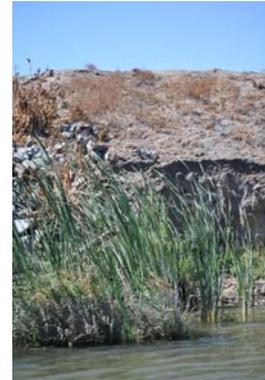
A close view of the erosion

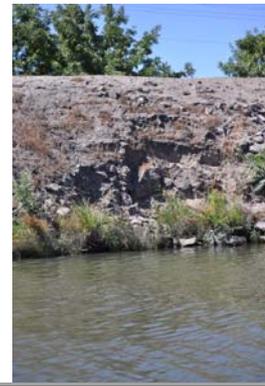
08/07/2012: The erosion was discovered during the boat survey.

Front view of erosion

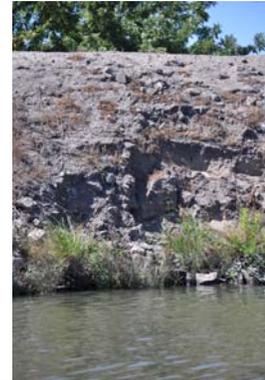
Front view of erosion

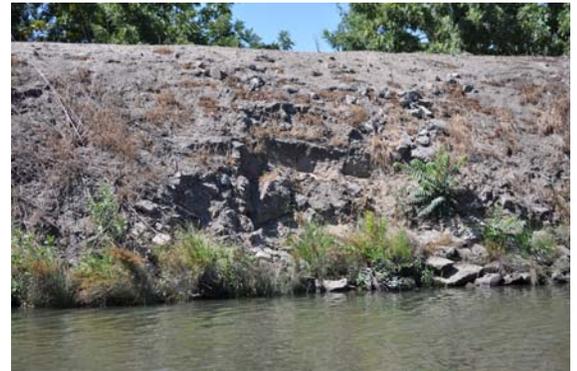
Front view of erosion

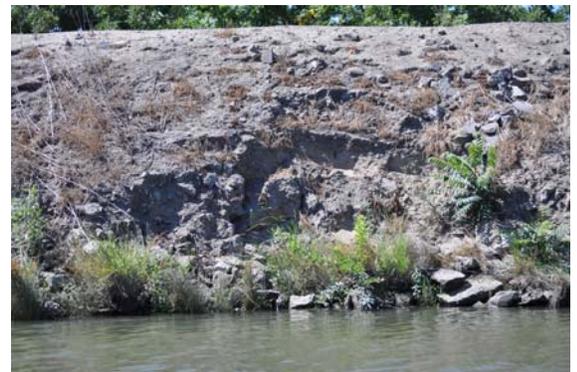
Front view of erosion

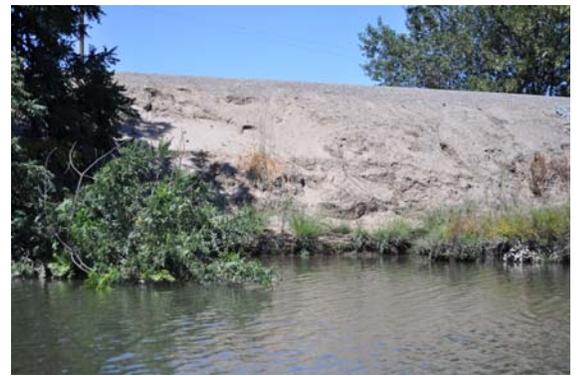
Direct view of the site.

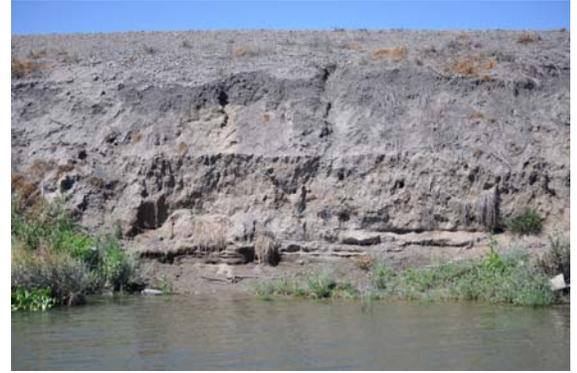
Front view of the erosion

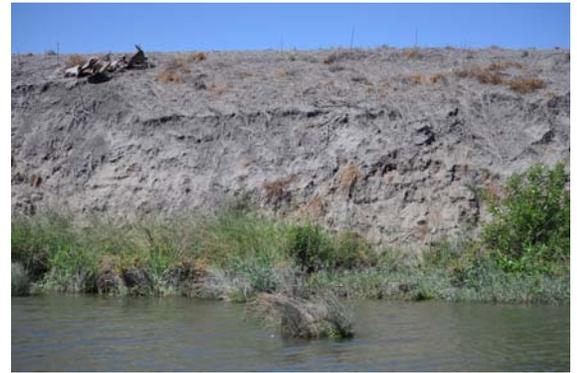
Front view of the erosion

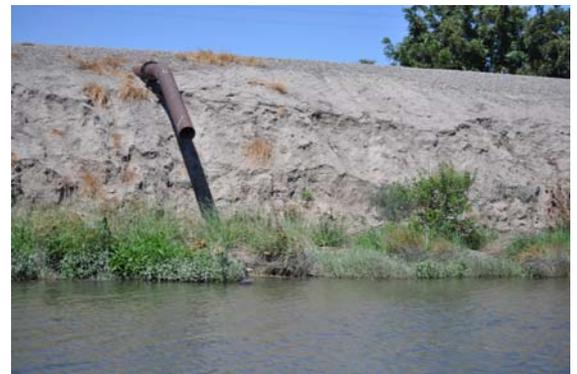
Front view of the erosion. Note the drainage pipe on the site. .

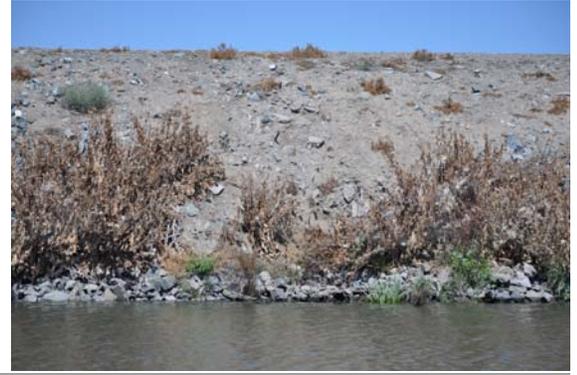
Close view of the erosion

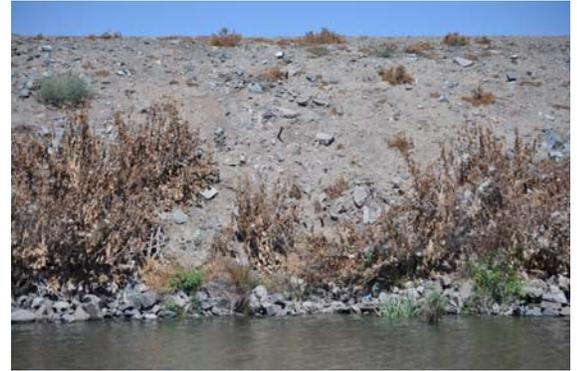
Close view of the erosion

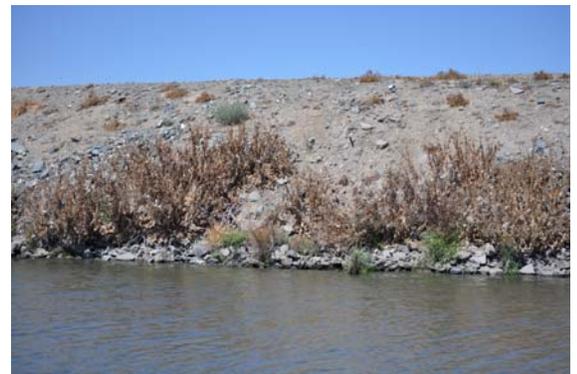
Downstream view of the erosion

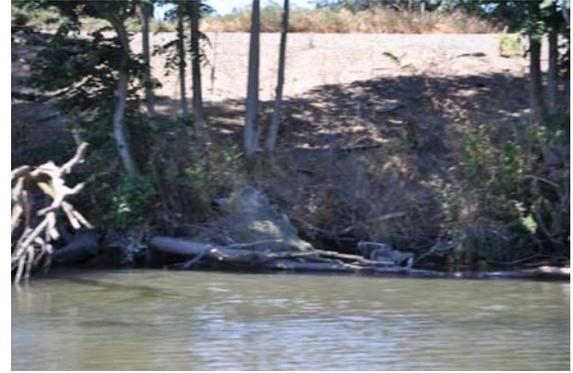
08/07/2012: : The site has been visited by boat survey. No significant change observed
 08/23/2011: No significant changes observed on site. Trees concerned still in place.
 09/07/2010: No significant changes observed on site. The concern here is the undermining of the levee toe where most of trees are. There are erosion pockets lined along the lower slope and at the base of the trees, exposing tree roots. There is minimal slope protection.
 09/29/2009: The lower slope is lined with minor erosion pockets; some tree roots are exposed; there is visible undermining of the levee toe; site is immediately upstream of the Highway 4 Bridge; the bridge is possibly causing a scour to occur, eroding the bank.

Large trees along the levee toe. There is minimal slope protection. The erosion near tree visible.

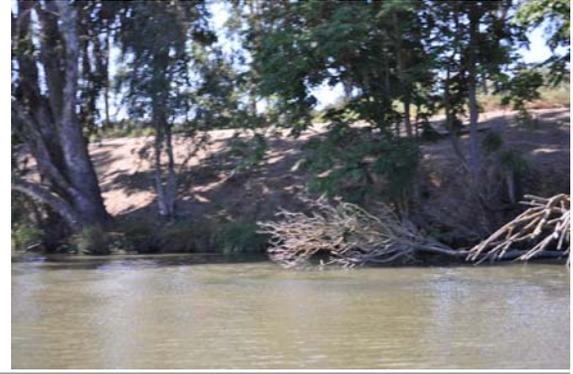
Front view of erosion

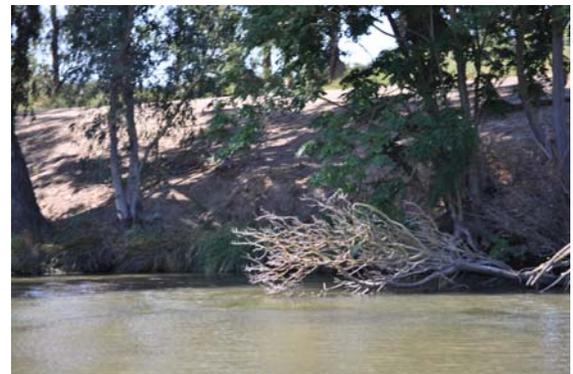
Fallen tree near the site

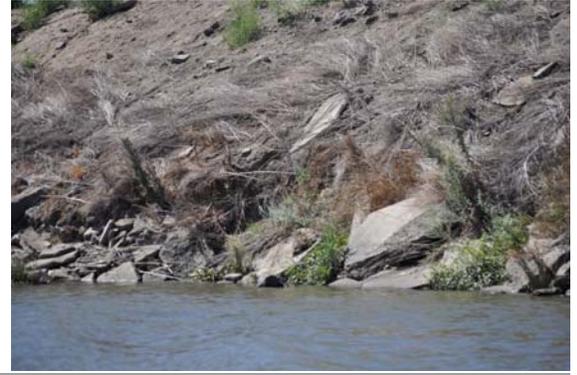
Close view of the pocket erosion

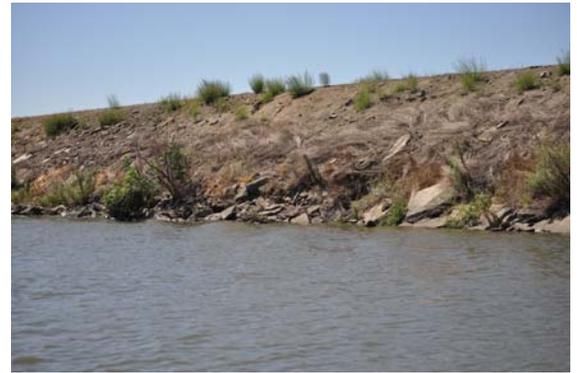
Downstream view of erosion.

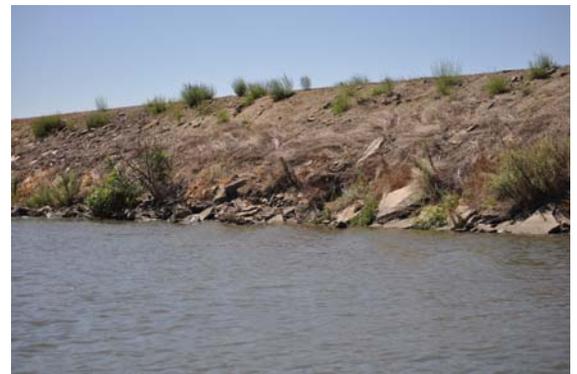
front view of erosion

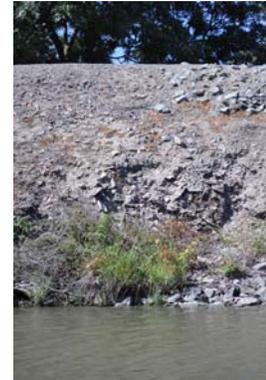
Front view of the site

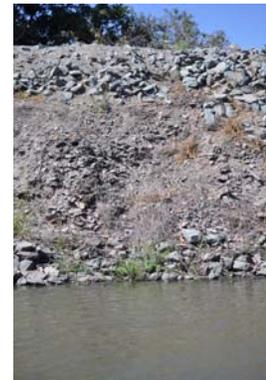
Front view fo the site. Note the soil type

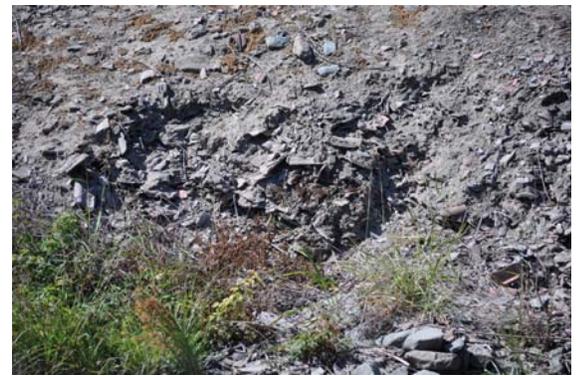
closer view of the erosion

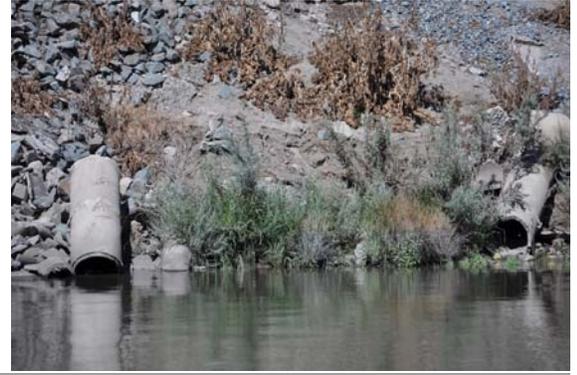
Close view of erosion

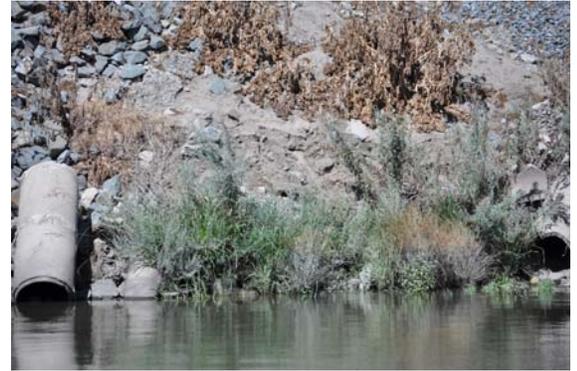
closer view of erosion

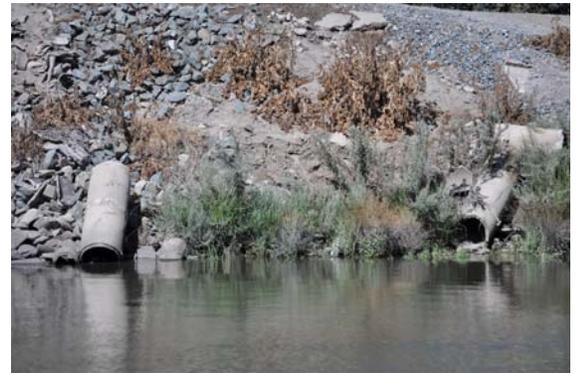
Front view of erosion

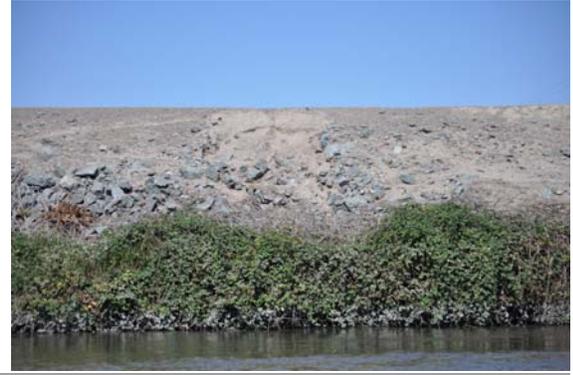
Close view of erosion

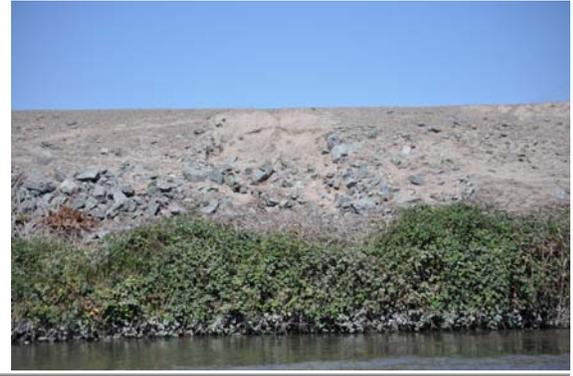
Close view of erosion

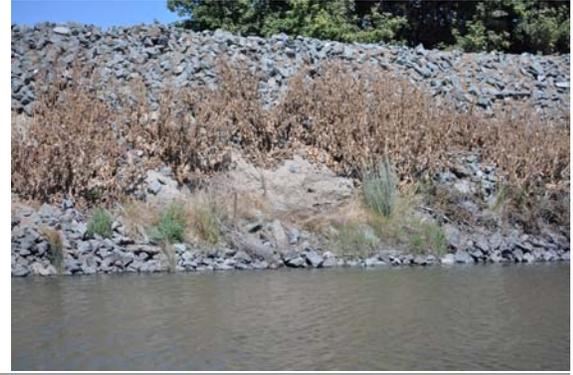
Comments:
 08/07/2012: The site has been repaired. Protecting riprap revetment has been placed at the levee shoulder and slope, but minor erosions are visible at the levee toe.
 08/23/2011: Sloughing rip rap is visible on the site

A closer view of the erosion

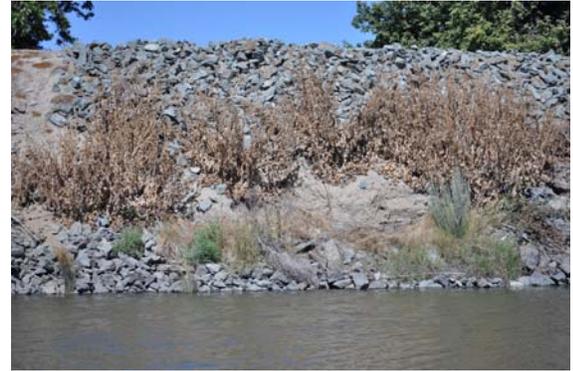
Closer view of the erosion

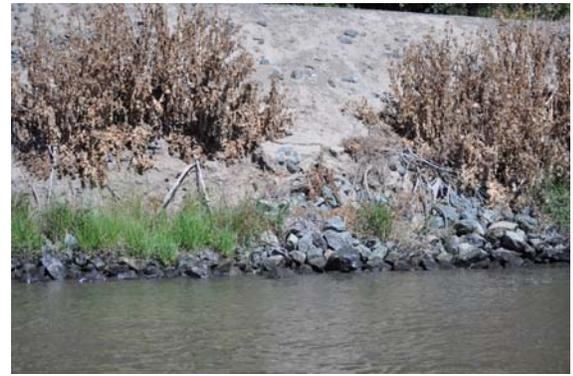
Front view of erosion

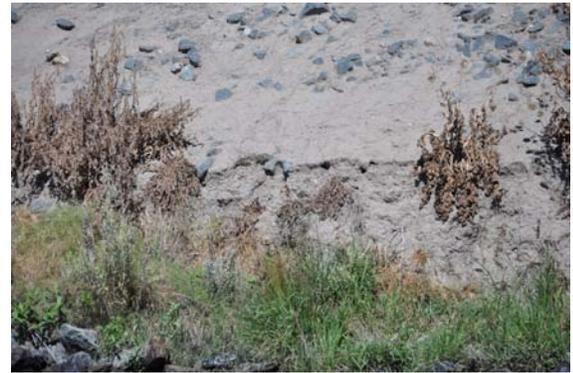
Front view of erosion

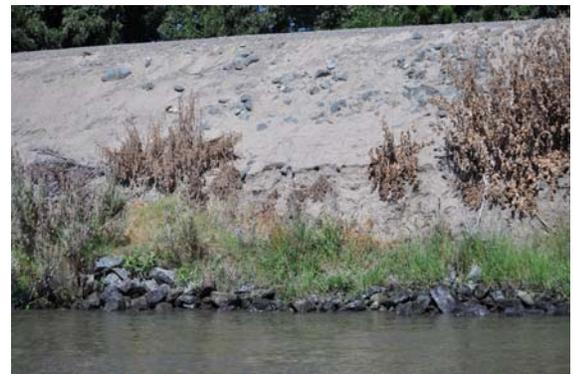
Front view of erosion

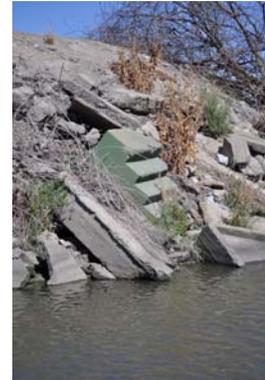
08/07/2012: Erosion is located at the inside of a river bend. Site is covered with broken concrete blocks and other debris.

Front view of the site.

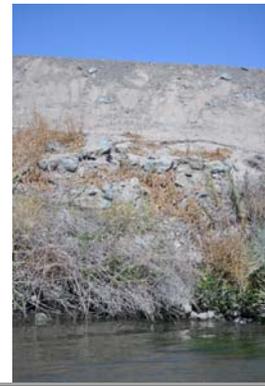
08/07/2012: The site has been visited by boat survey. No significant change observed
 08/23/2011: Cracking erosion along the levee bank. Erosion appears to be caused by river flows.

Front view of the erosion site

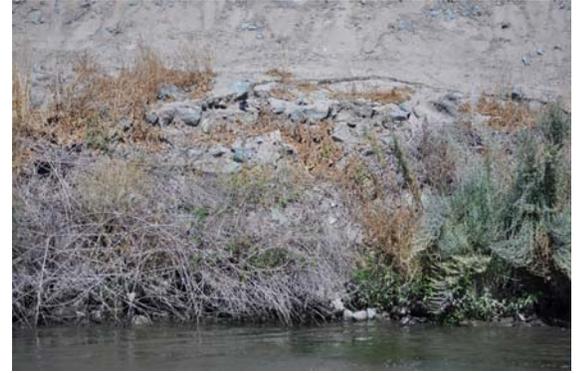
Front view of the erosion.

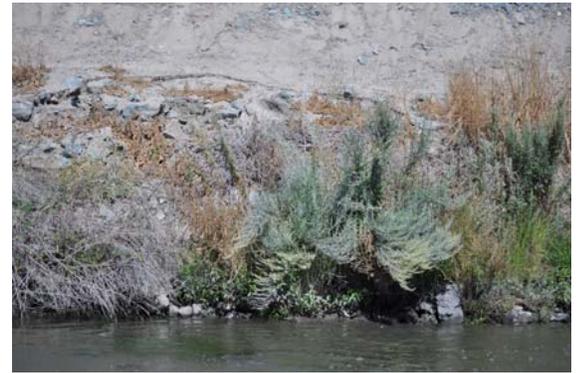
Front view of the site.

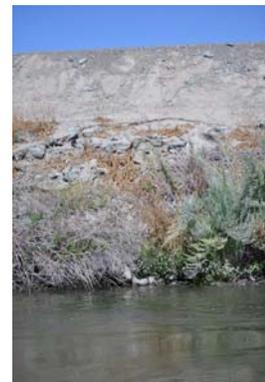
Close view of the site. Note the vegetation at the site

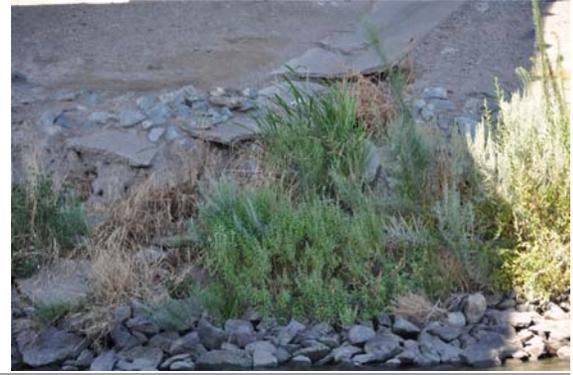
08/07/2012: : The site has been visited by boat survey. No significant change observed
 08/23/2011: No significant changes observed on site.
 09/07/2010: No significant changes observed on site. Erosion site is located beneath Howard Road Bridge. Majority of the existing rip rap has slipped, dragging away levee materials and exposing the underlying soft soil.
 08/06/2010: Recommend for annual assessment and monitoring during flood events, per CLRO.
 09/30/2009: No major changes observed since the last visit; upper portion of existing revetment has slipped, exposing the degrading bank; note that site # is the same as RM46.30, LM5.69 found in the CLRO CES Evaluation 2008 Report; site was previously rated "M".
 11/04/2008: Previously repaired using rock revetment; upper portion of th revetment is sliding, causing deformation on the levee slope; site is upstream of Howards Road Bridge.

Sloughing rip rap adjacent to Howard Bridge.

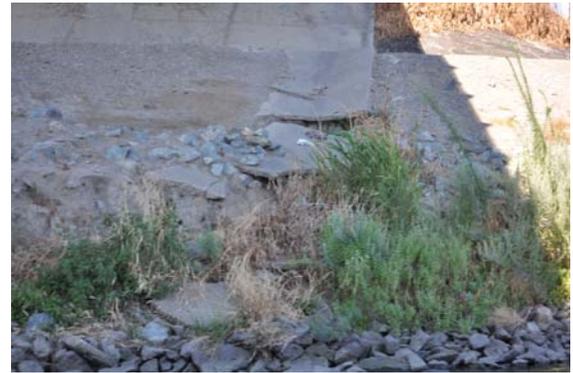
Front view of sloughing rip rap.

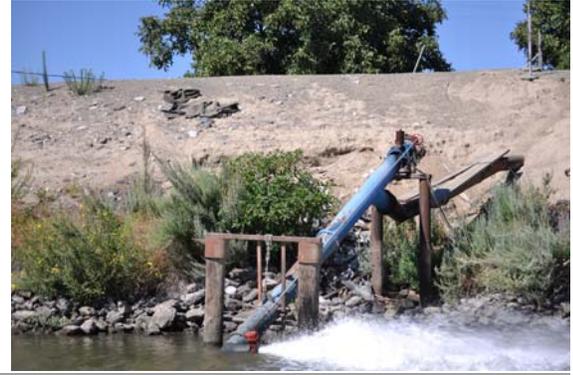
08/07/2012: The erosion is near a water-intake structure. Pipe leakage likely caused the erosion.

Closer look of the erosion and the pipe

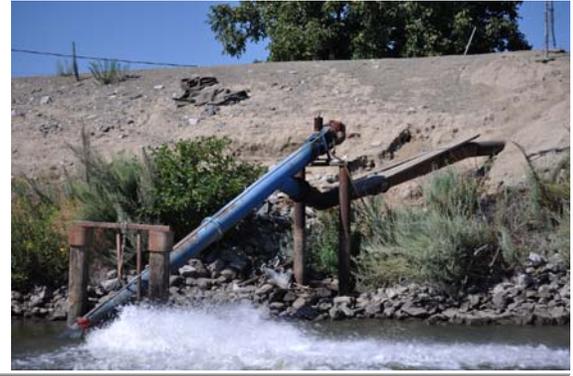
Closer look of the erosion and the pipe

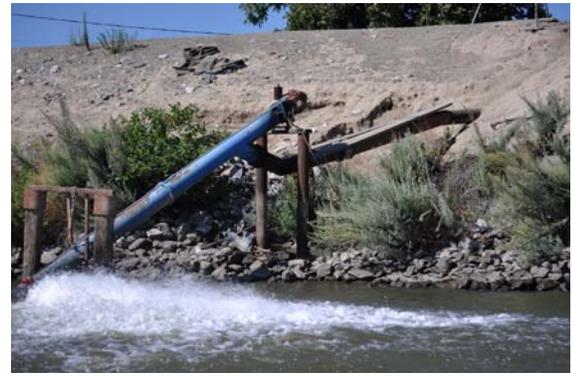
Closer look of the erosion and the pipe

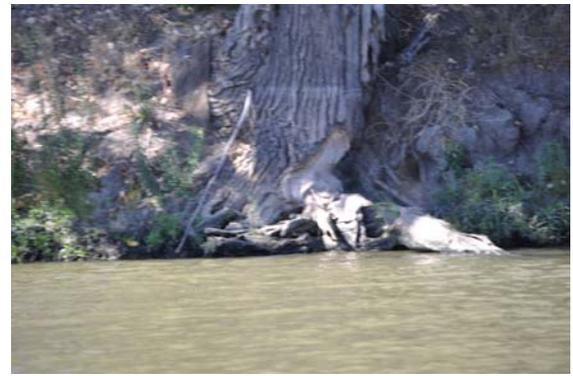
08/07/2012: :The site has been visited by boat survey. The site has been repaired with riprap protection. Rotten tree roots and minor erosion visible immediately upstream of the site
 08/23/2011: No significant changes observed on site.
 09/07/2010: No significant changes observed on site. There are minor pockets of erosion lining the lower slope and undermining of the toe. There are annual grasses and emergent vegetation at the lower slope. Burrow holes were observed along the slope and persist throughout the 200-foot long site.
 08/05/2010: Recommended for annual assessment and monitoring during flood events, per CLRO.
 09/30/2009: No major change observed since last visit; despite dense vegetation, the bank continues to erode and slough; the levee toe is being undermined; note the tree on site; the site was previously rated "U".
 10/21/2008: Undermining of the levee toe; rodent holes in several location; trees with roots partially exposed; sloughing on slope.

View of the tree root

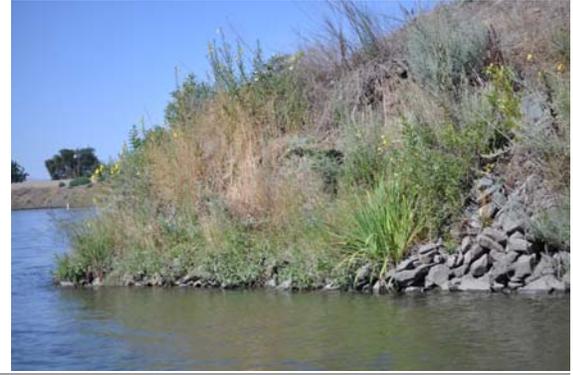
Front view of erosion

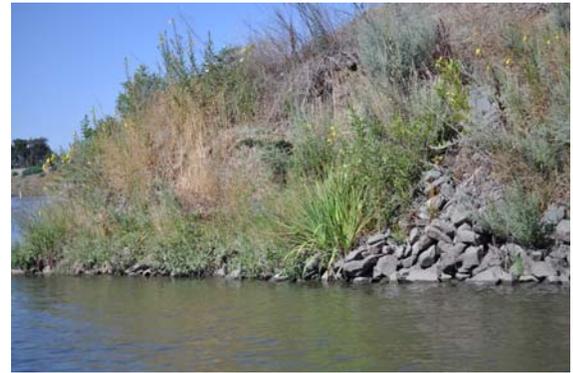
Front view of erosion

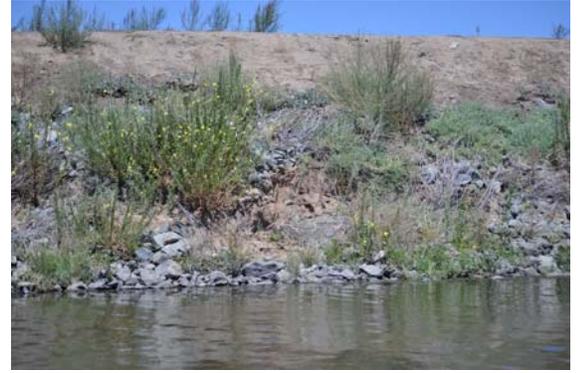
Front view of pocket erosion

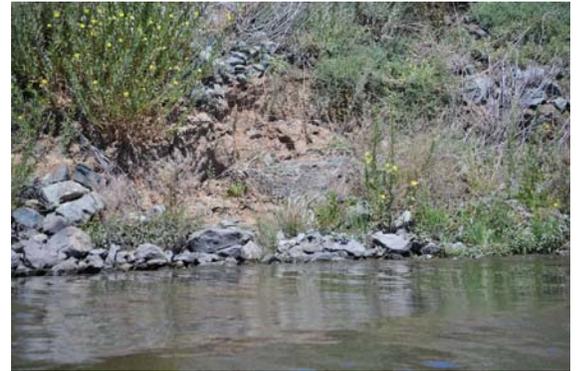
close look at the erosion

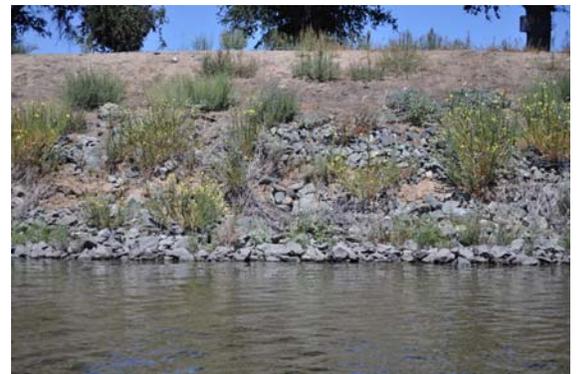
Front view of pocket erosions

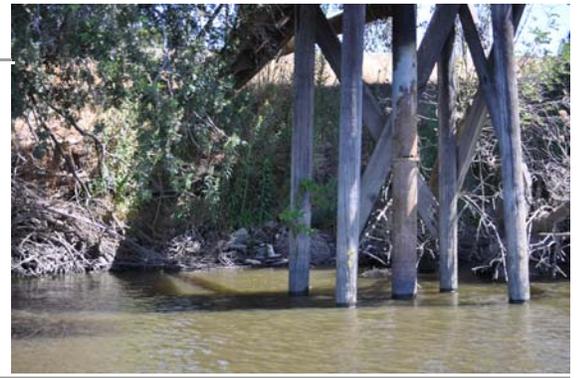
08/07/2012: The site was first reported in 2012 spring levee inspection report. The data were estimated as the site is underneath a irrigation pump station and inaccessible by boat or land survey. It's possible the pump station played a role in the erosion.

Front view of the erosion site. View is partially blocked by the pump structure and vegetation

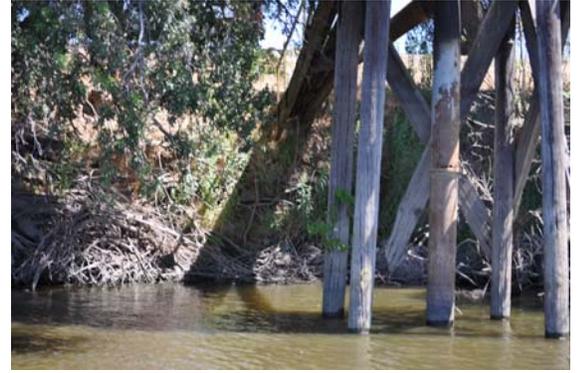
Front view of the site

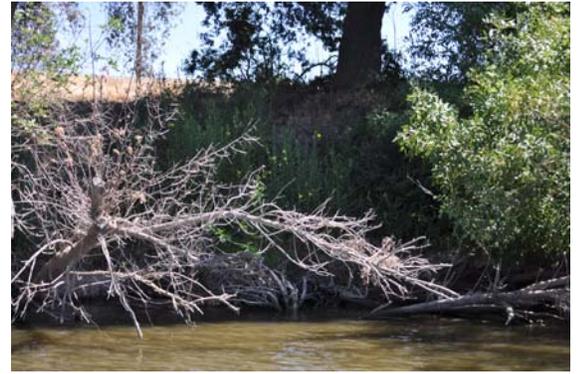
Close view of a fallen tree near the site

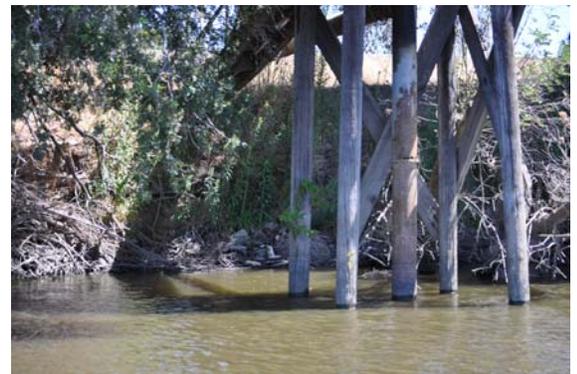
Front view of site

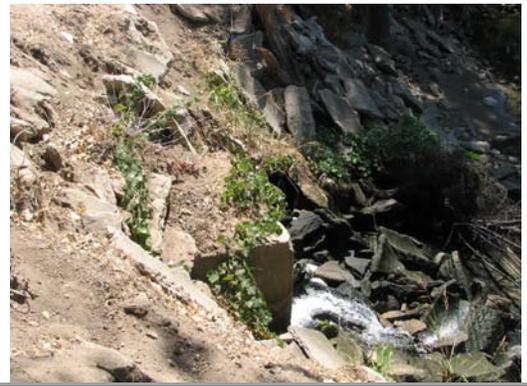
07/18/2012: No significant changes observed.
 08/18/2011: No significant changes observed on site. Debris that blocks the irrigation outlet visible.
 10/19/2010: No significant changes observed on site. Sloughing of the bank is occurring adjacent to an irrigation outlet structure. There is moderate to heavy vegetation along the bank that is well established. Broken chunks and slabs of concrete are used as rip rap and line the outside of the irrigation outlet structure. However, much of the rip rap along the slope is sloughing and could possibly lead to future slope instability.
 08/05/2010: Recommended as a local maintenance issue, per CLRO.
 08/20/2009: No major change observed since last visit; 1 inch fissure cracks developing on the slope; rip rap is showing signs of sloughing; recommend as local maintenance issue; site was previously rated "U".
 2008: No change from previous year; irrigation outlet located on site; rip rap placed on river bank.

Direct view of the site.

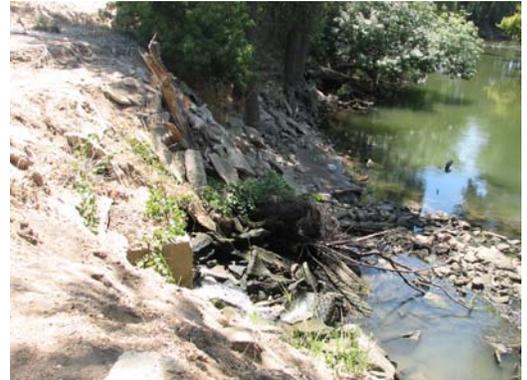
Looking downstream of the site. The irrigation outlet operating. Debris at the outlet visible

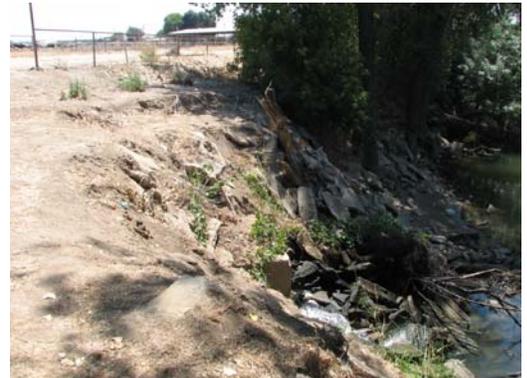
View of the current condition of the levee slope just above the irrigation outlet.

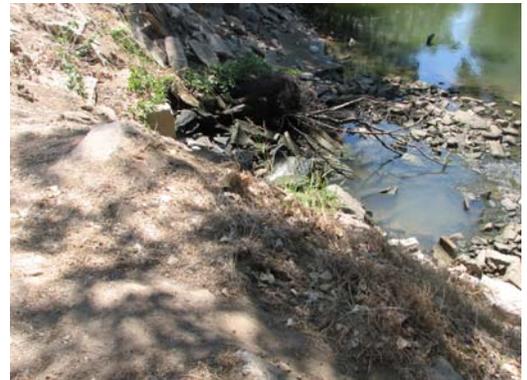
Downstream view of the site.

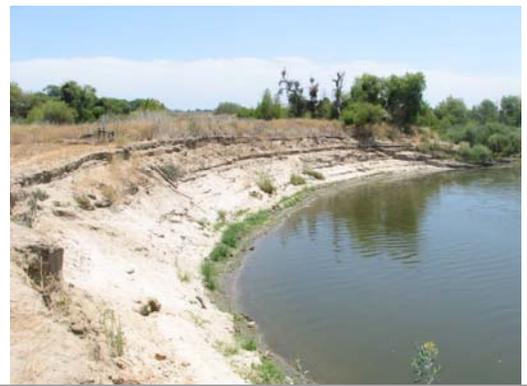
07/18/2012: No significant change observed on the site.
 08/18/2011: No significant changes observed on the site. Dead trees and animal activities visible. The closest point of the erosion site to the levee toe is about 100 ft.
 10/19/2010: There is active scouring occurring on the bank due to the nature of the flow and the lack of armor protection. There is also a fallen log immediately downstream of where the erosion has occurred and is protruding outward, possibly creating an eddy and scouring the bank. With the remaining 100-foot wide berm, the levee prism is not yet affected. However, the bank will continue to degrade, and eventually intrude into the levee prism if no protection is put in place. Erosion site is recommended for annual assessment and monitoring during flood events.

From the berm looking downstream.

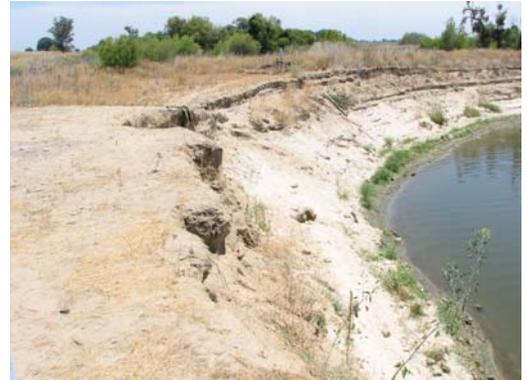
Close look at the erosion

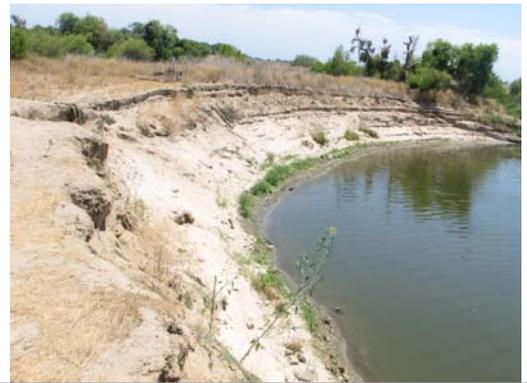
Close look at the erosion

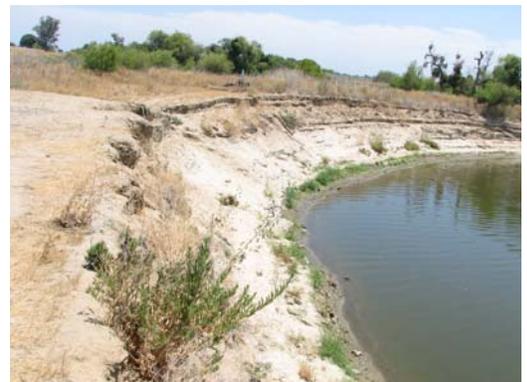
Close look at the erosion

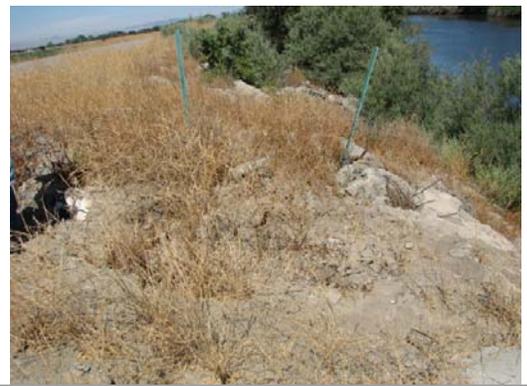
07/31/2012: Site was visited on 07/26/2012. No significant change observed. A new vertical pipe was installed and concrete blocks left on the site. Dense vegetation around the site. No signs of new leaks or spill from the siphon breaker.

07/23/2009: A possible leak or spill from a siphon breaker is eroding the slope and developing into a headward erosion; a portion of the buried pipe is exposed; the lower slope seems to be lined with chunks of concrete debris or other rock material.

Close look at the site. Note the concrete blocks and vegetation.

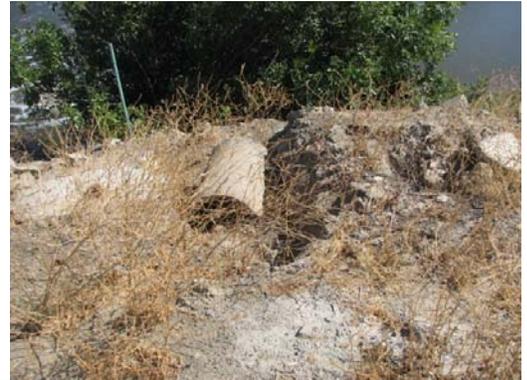
Direct view of siphon breaker.

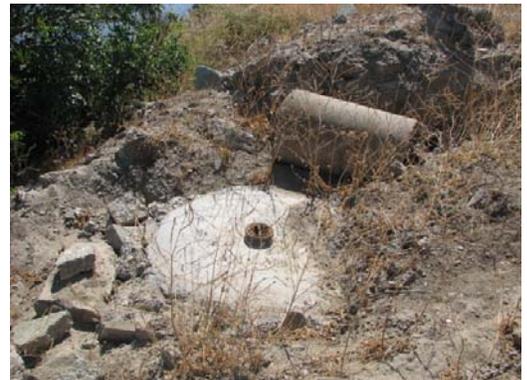
Direct view of siphon breaker. Recently placed vertical pipe

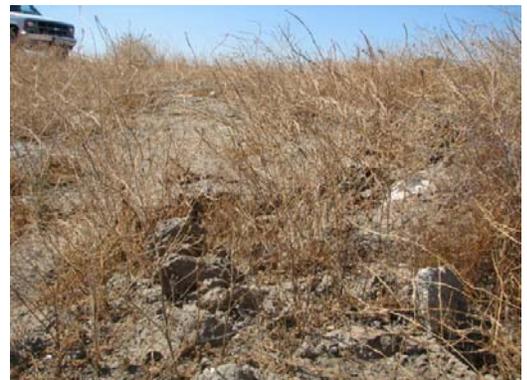
A close look at the site. Note the concrete debris.

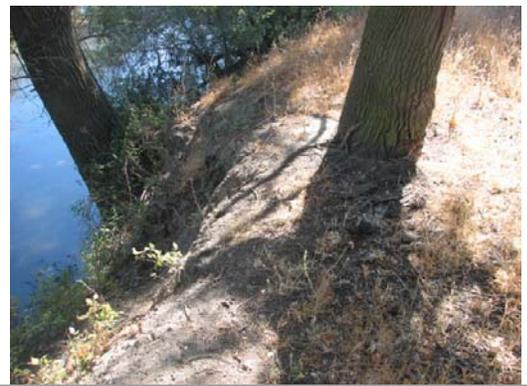
07/26/2012: The site has been visited, and no significant change has been observed.
 09/02/2011: This site was not visited due to the time limit.
 09/22/2010: No significant changes observed. Minor pocket erosions are lined at the lower bank. Two large Oak and Willow trees are on midslope and bench. The remaining bench was re-measured and found to be approximately 10 feet. There was no indication of active erosion on site during the site visit.
 08/05/2010: Recommended for annual assessment and monitoring of site during flood events, per CLRO.
 07/23/2009: No major change observed since last visit; site is a 200-ft. long near-vertical berm erosion; recommend annual assessment and monitoring of erosion site, per CLRO CES Evaluation 2008 Report; Site # is the same site previously reported as RM4.0,LM4.51; previously rated "U".
 09/10/2008: Two large trees (2-3' DBH) with partial roots exposed.
 2007: Visited site 03/13/2007.

Direct view at a pocket erosion site. Vegetation has developed and covered the erosion.

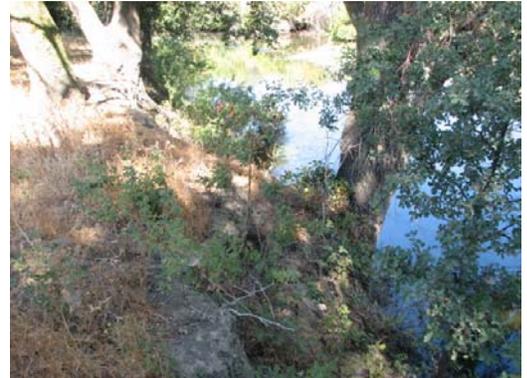
Direct view at the erosion near a tree

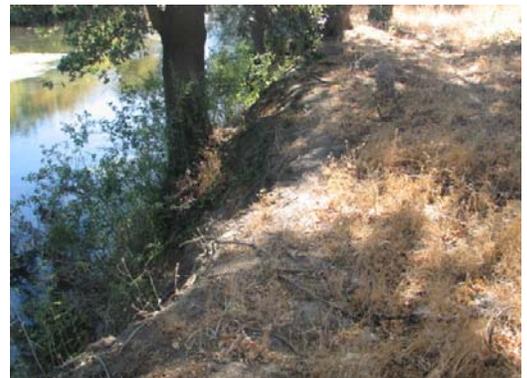
Direct view at the erosion near a tree

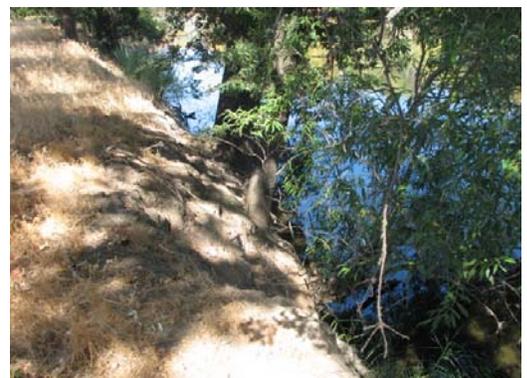
Direct view at the erosion near a tree

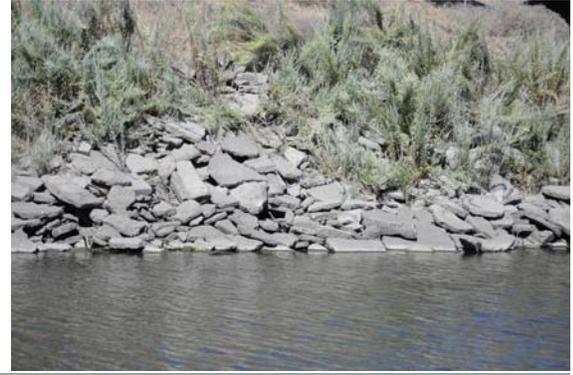
Front view of the rip rap

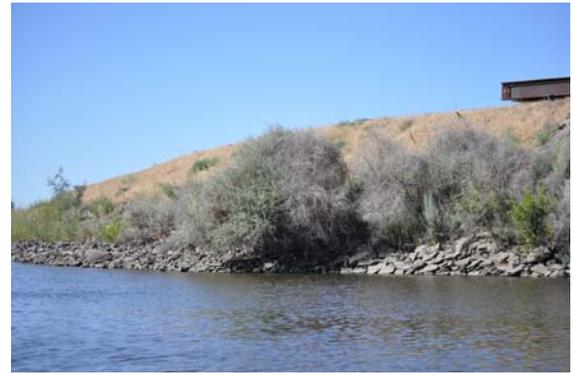
Downstream view of the erosion site and riprap revetment
