LMA: **NA0010 U23 Lower San Joaquin Levee District**

Waterway: **RB San Joaquin River**

Site ID: **NA0010U23RM224.27**

Status: **Repaired Site**

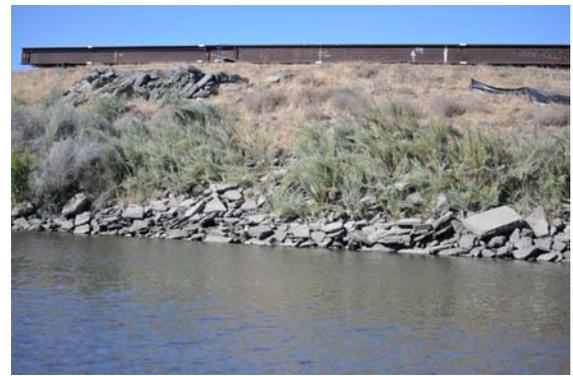
Front view of the site

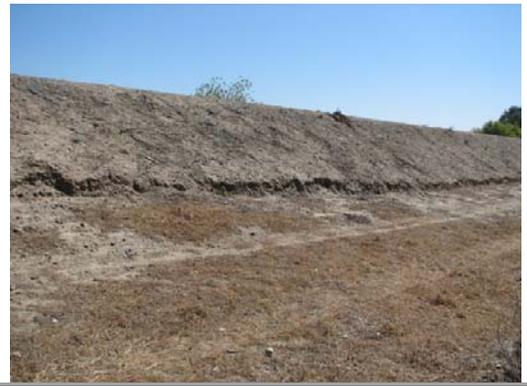
07/31/2012: Site was visited on 07/26/2012. No significant change observed.
 09/02/2011: No significant changes observed on site from the previous visit.
 09/22/2010: No significant changes observed on site. The foot-high near-vertical scarp still exists on levee toe. There is little to no vegetation on the slope.
 03/09/2010: As discussed with Michael Moncrief of MBK, site will be addressed this year.
 07/27/2009: 1 to 2 feet of near-vertical scarp on levee toe; damage was most likely caused by farming equipment during clearing or tilling operation; this is a maintenance-related issue.

Upstream view of site. Note the vertical scarp at the toe.

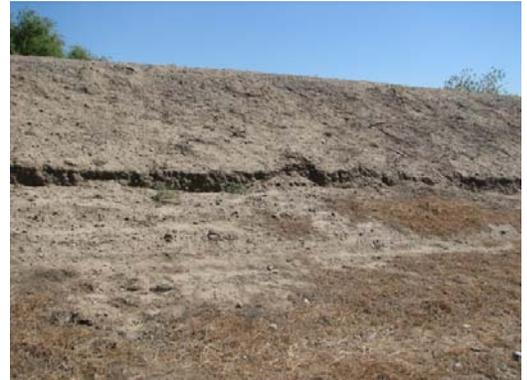
Direct view of site.

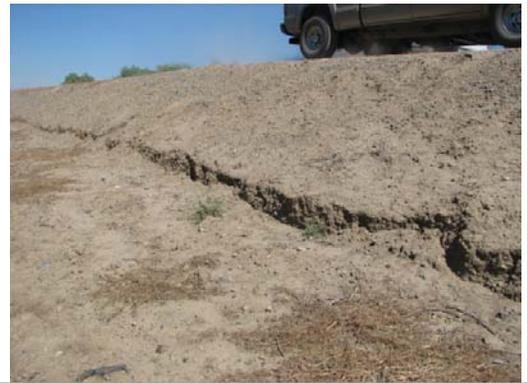
Downstream view of site.

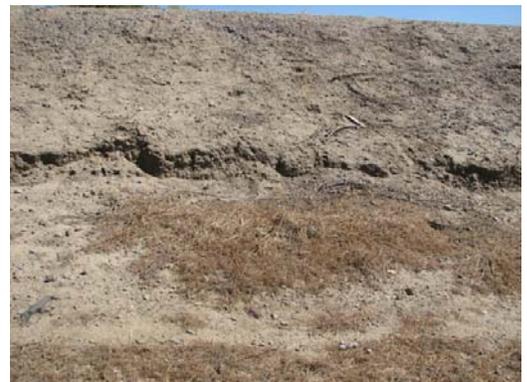
A close view of site.

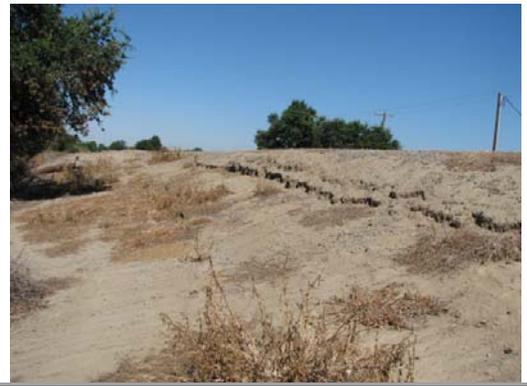
07/26/2012: Site was visited on 07/26/2012. No significant changes observed.
 09/02/2011: : No significant changes observed on site from last visit.
 09/22/2010: No significant changes observed on site. The fencing located on the berm was removed. Levee slope and berm area 10 feet from the levee toe are bare of any vegetation. The 1- to 2 feet of near-vertical scarp on the levee toe is unchanged.
 03/09/2010: As discussed with Michael Moncrief of MBK Engineer, the district will address the site this year.
 7/27/2009: 1 to 2 feet of near-vertical scarp on the levee toe; damage was most likely caused by agricultural equipment during clearing or tilling operation; this is a maintenance-related issue.

Downstream view of scarp caused by a maintenance equipment.

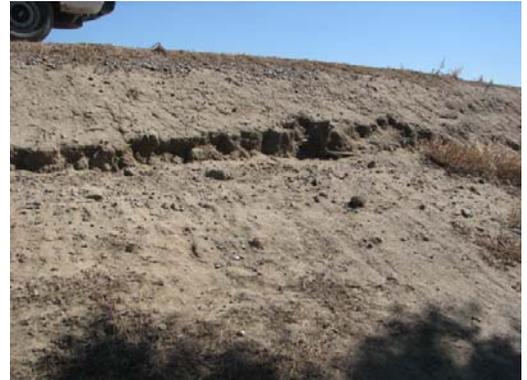
Close view of scarp.

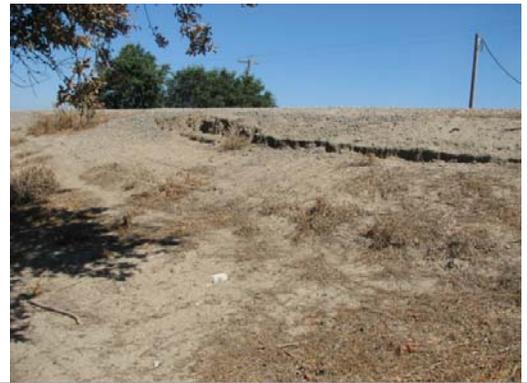
downstream view of site.

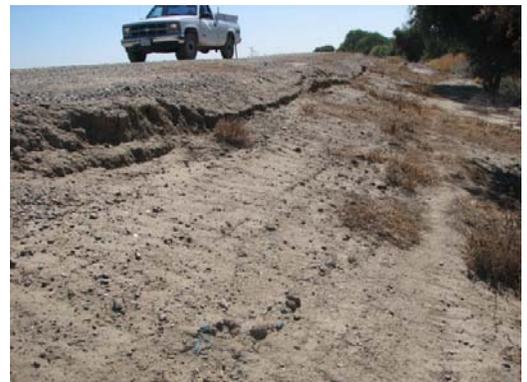
Upstream view of site.

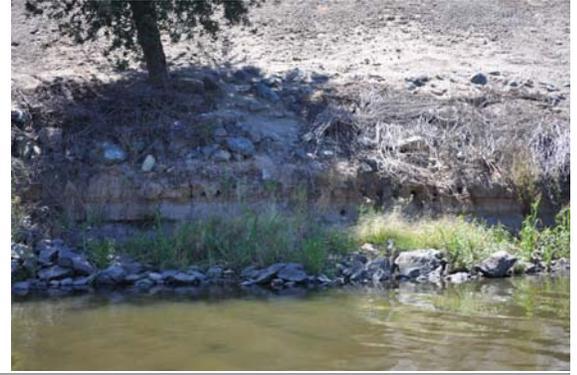
Front view of the erosion

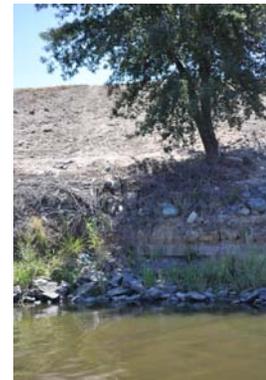
Upstream view of the erosion

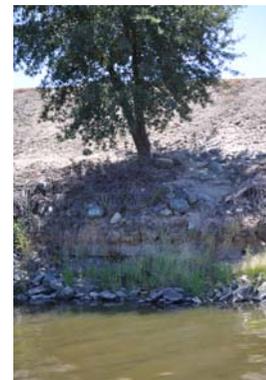
Front view of the erosion. Note the dense vegetation.

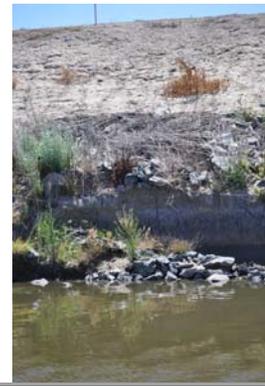
08/07/2012: The site has been visited by boat survey. No significant change observed
 08/23/2011: Hard to view the erosion because of the dense vegetation and trees on site.
 The site is under the bush, close to the tree.

close view of the site

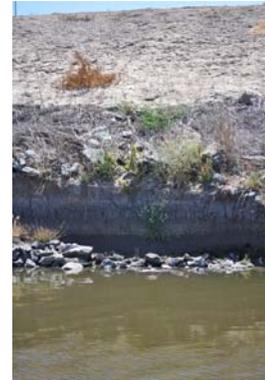
Close view of the site

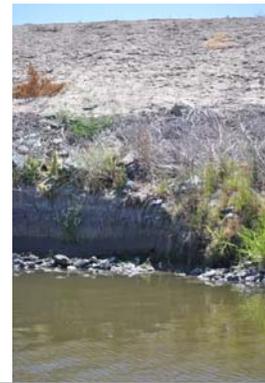
Front view of the site. Note the vegetation

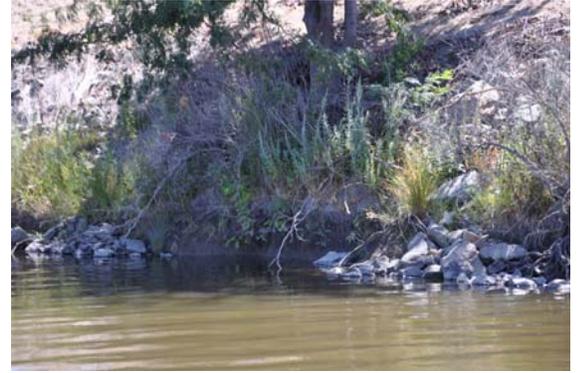
Front view of the erosion

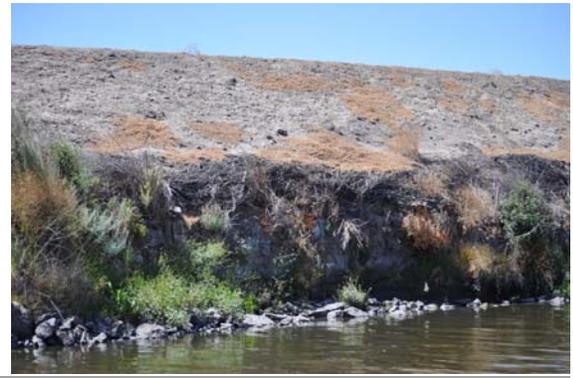
Another view of the same 5-ft scarp.

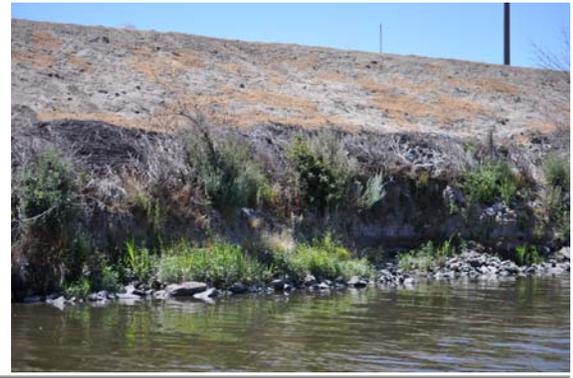
08/07/2012: The site has been visited by boat survey. No significant change observed
 08/23/2011: No significant changes observed on site. Dense vegetation visible along the water line.
 09/07/2010: No significant changes observed on site. Much of the upper slope was recently cleared of vegetation by spraying. 4- to 6-foot vertical scarp and pocket erosions are lined along a span of 475 feet. In some sections, the vertical scarp encroaches into the levee prism. There is a lack of berm along this reach, exposing the levee slope to high flow velocities during normal and flood events.
 08/06/2010: Recommended as local maintenance issue, per CLRO.
 03/09/2010: As discussed with Michael Moncrief of MBK Engineers, the site will be 'addressed' later this year.
 09/29/2009: No major change observed since last visit; pocket erosion and a vertical scarp forming; this site was combined with Site RM30.13 and 30.02 with a combined total erosion length of 475 feet; recommended as annual assessment and monitoring of site, per CLRO CES Evaluation 2008 Report; previously rated "M".

Front view of the site with dense vegetation.

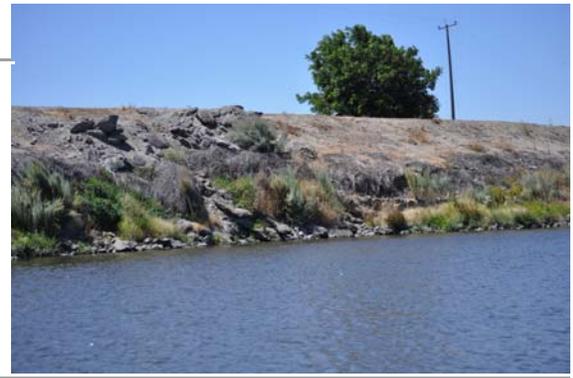
08/07/2012: The site has been visited by boat survey. No significant change observed
 08/23/2011: The site is right at the downstream of a river bend.

Upstream view of the erosion.

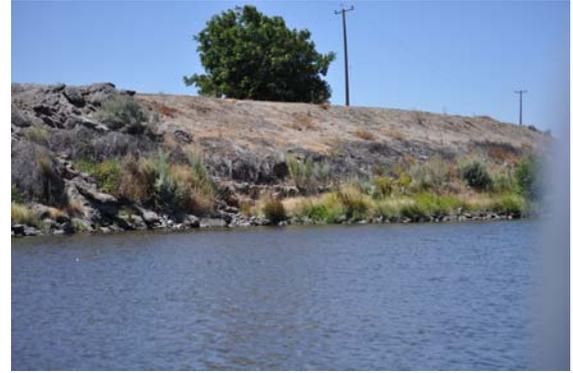
Close view of the site

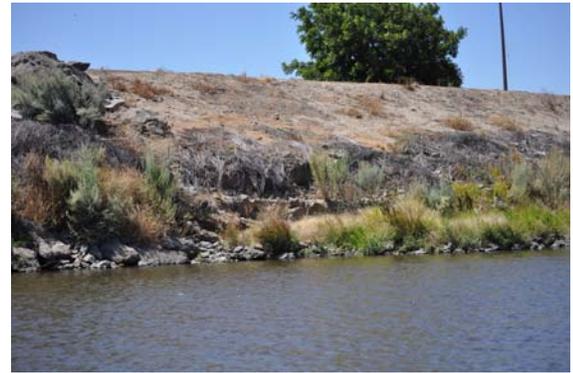
Front view of the erosion.

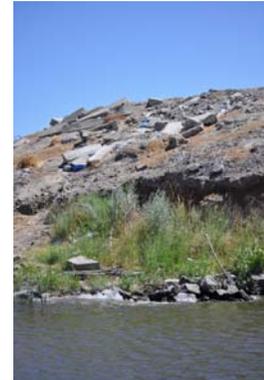
08/07/2012: The site has been visited by boat survey. No significant change observed
 08/23/2011: No significant changes observed on site.
 09/07/2010: No significant changes observed on site. Much of the placed rip rap revetment has slid. It is no longer adequately protecting the slope.
 08/06/2010: Recommended as local maintenance issue, per CLRO Report.
 03/09/2010: As discussed with Michael Moncrief of MBK, site will be 'addressed' this year.
 09/29/2009: No major change observed since last visit; a section of the rip rap has slipped, exposing a levee section that has eroded; recommended as local maintenance issue, per CLRO CES Evaluation 2008 Report; Site # is the same as RM30.43, LMO.63; previously rated "U".
 11/05/2008: Site is located inside of a bend; scarp looks to be into the levee prism; piles of concrete chunks placed on the slope, with some of them already starting to slide.

Front view of the site. Previously placed rip rap slipped, exposing the underlying soils and creating a pocket.

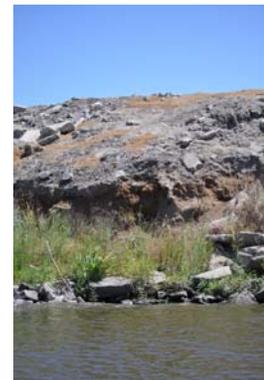
Front view of the site. Rip rap no longer adequately protecting levee slope.

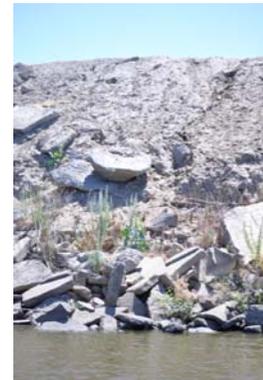
08/07/2012: The site has been visited by boat survey. No significant change observed
 08/23/2011: No significant changes observed on site.
 09/07/2010: No significant changes observed on site. There is a small- to medium sized Oak tree on the mid-slope just above rip rap. Some of the rip rap has collapsed, creating a pocket erosion just above the existing toe rip rap and upstream of the Oak tree.
 08/06/2010: Recommended as local maintenance issue, per CLRO.
 03/09/2010: As discussed with Michael Moncrief of MBK Engineer, site will be 'addressed' in 2010.
 09/29/2009: No major change since last visit; sliding of the rip rap at the base of the lone tree; there is noticeable man-made trail and foot traffic extending from the crown to the toe; much of the broken concrete used as temporary rip rap has slid, exposing portion of the bare levee slope; recommended as local maintenance issue, per CLRO CES Evaluation 2008 Report; Site # is the same as RM31.3,LM1.45; previously rated "M".

A closer look of the site near the oak tree

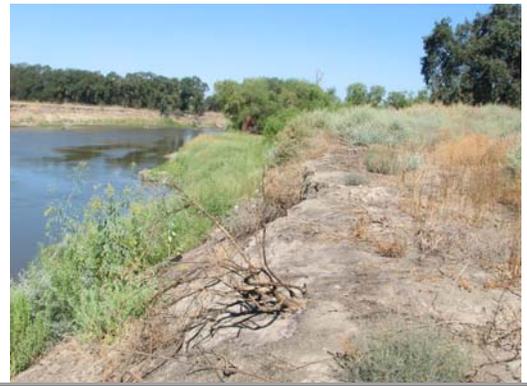
10/14/2011. This site was reported on Jan. 18, 2011. The first 100' of erosion appears to be a previous cut with fresh activity. At station 2+00 the district president indicated that 60 - 80' of material eroded. The remainder berm width is at least 32 ft from the levee toe. As the levee is not at risk at this time, the site is not rated, but needs to be closely monitored for possible erosion failure during the upcoming flooding season.

Looking downstream at the erosion

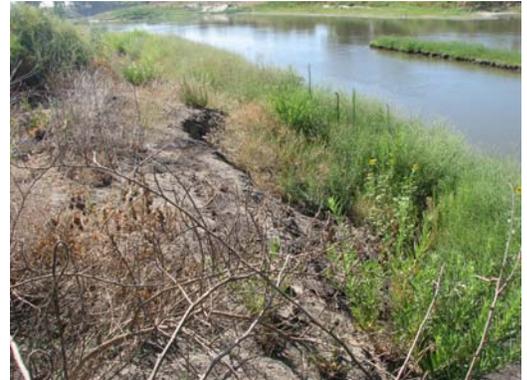
Direct view of the erosion

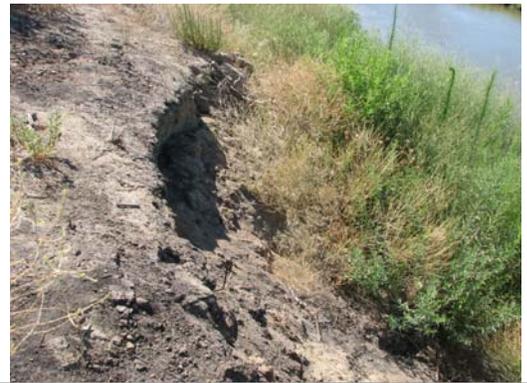
Closer view of the erosion

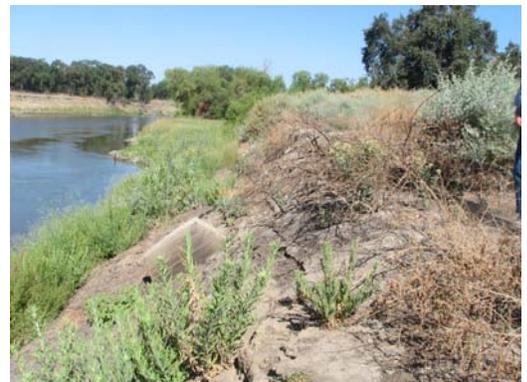
Looking downstream at the erosion

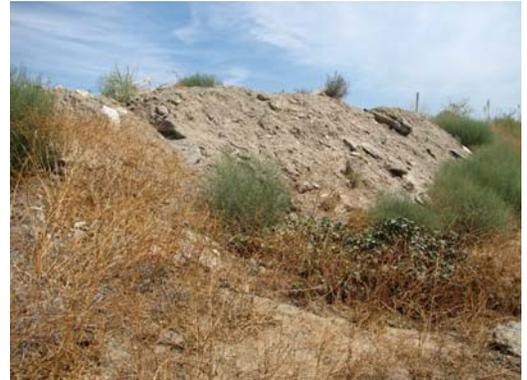
09/13/2012: No significant changes observed on site.
 08/18/2011: No significant changes observed on site. Some new material added to the water side levee slope, but the added material is loose and seems not helping the levee protection.
 10/05/2010: No significant changes observed on site. Levee slope has minimal vegetation and lacks rip rap protection. Sandy material found on the lower and middle slope is an undesirable material to have on a levee.
 08/05/2010: Recommended for annual assessment and monitoring during flood events, per CLRO.
 08/20/2009: No major change since last visit; site is located in an oxbow; slope surface consists of very sandy material; there is a tree on site leaning and with exposed tree roots; site is recommended as a local maintenance issue, per CLRO CES Evaluation 2008 Report; Eddy Cordoza from the district is aware of the site and is looking for recommendation; site is previously rated "U".

Looking up to the levee crown at the added material.

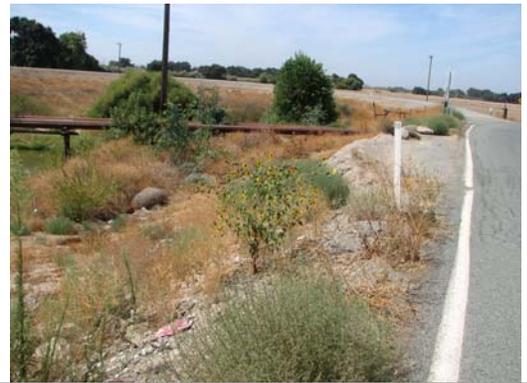
Looking upstream of the erosion site

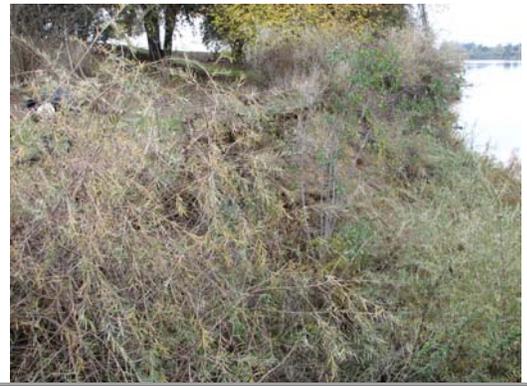
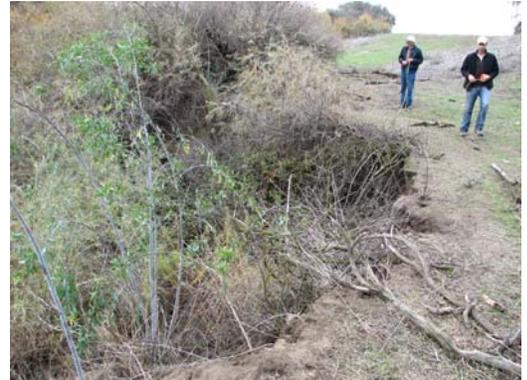
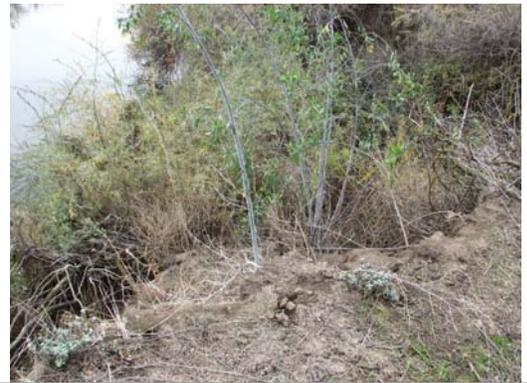
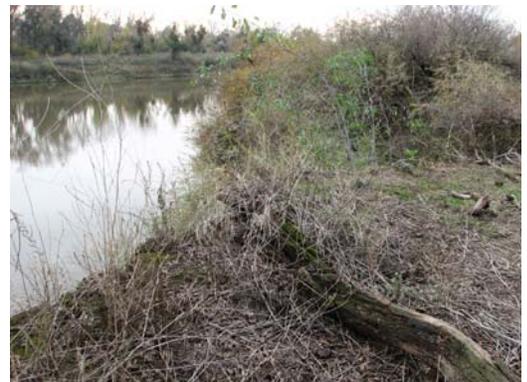
12/04/2012: The erosion has progressed remarkably toward levee, extended to the up- and downstream of the original pocket erosion. Trees and dense bush present at the site. Animal burrow holes are visible, and possibly can cause seepage.
 09/22/2010: No significant changes observed. There is little visibility due to seasonal grass on the berm and slope.
 08/18/2009: Site is located on berm; pocket erosion has developed; the site is covered in dense vegetation; there are several relief wells on the landside of the levee; site is Not Rated because berm width is greater than 30 feet; site should be monitored to keep track of erosion progress.

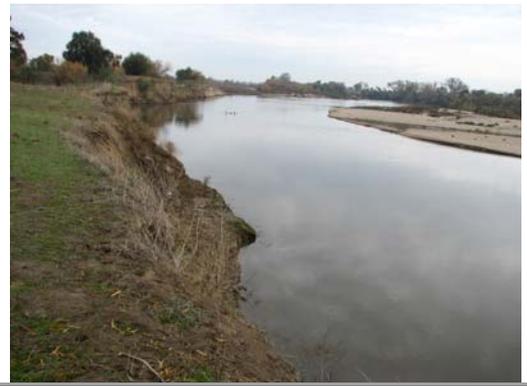
12/04/2012: This site has been documented before, and a cost estimate to repair has been prepared dated 05/09/2010. The fresh cut shows the erosion is developing. The berm width is at least 42 feet. Sticks were placed at three locations along the river bank, with 3 sticks 5 feet apart at each location.

Looking downstream. At the downstream end the erosion occurring at a spur levee.

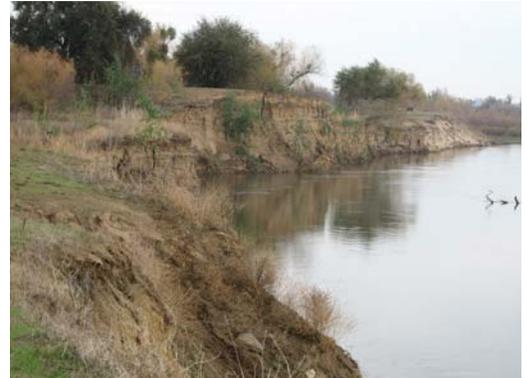
Looking downstream at the erosion at the spur levee

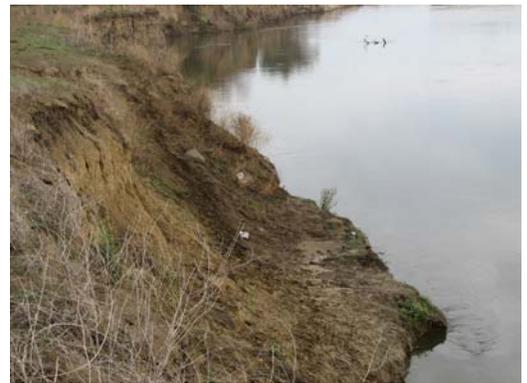
Direct view of the erosion

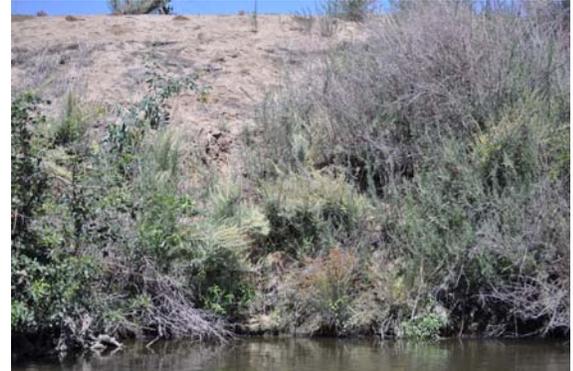
08/07/2012: The site has been visited by boat survey. No significant change observed
 08/23/2011: The 5-foot vertical scarp shows no significant change from the last year inspection. No new erosion activities observed. Dense white willow trees on site.
 09/07/2010: It was difficult to view the erosion due to the thick Willow thickets and other vegetation at the water line. At the time of the inspection, there were no signs of repair on site. As noted during the last survey, there is a 5-foot vertical scarp along the lower slope that may be subjected to high flow velocities.
 08/05/2010: Recommended for repair, per CLRO; "Erosion of this site may be subjective to rapid rates of erosion."
 09/28/2009: No major change observed; 5-foot vertical scarp is immediately downstream of where berm has tapered; site is recommended as local maintenance issue, per CLRO CES Evaluation 2008 Report; Site # is the same as RM29.6,LM0.60; previously rated "U".

Front view of the site. Note the very dense white willow thickets on site.

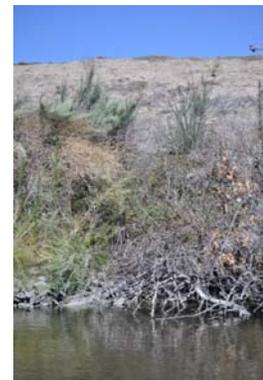
Front view of the site. Note the erosion invisible because of the dense vegetation

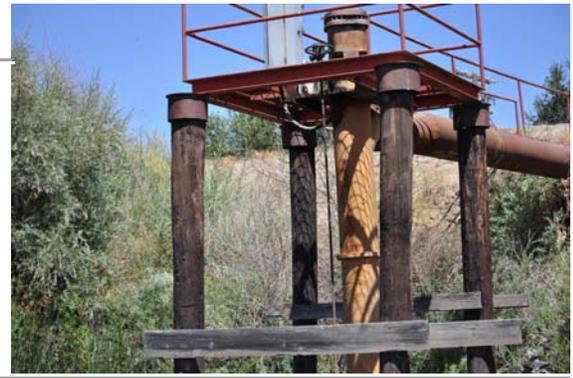
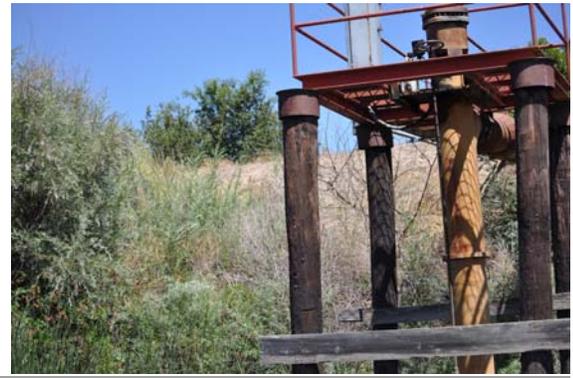
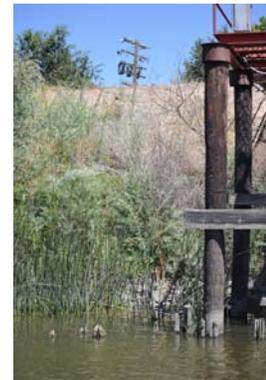
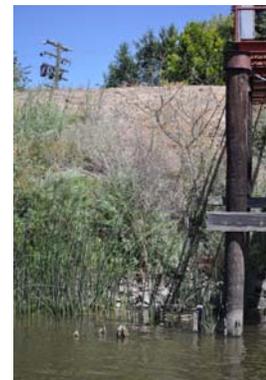
08/07/2012: The site has been visited by boat survey. No significant change observed
 08/23/2011: The site shows loose material around the pipe crossing. The operation of the pipe might have caused certain impact on the levee.

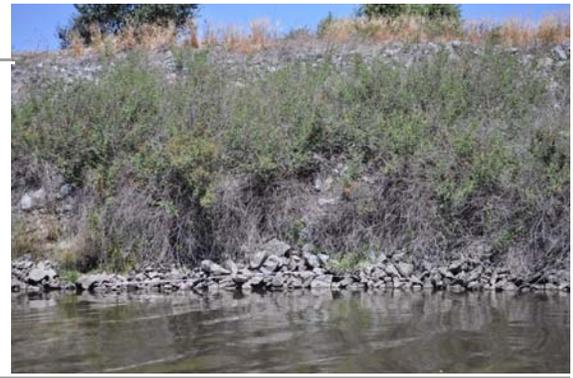
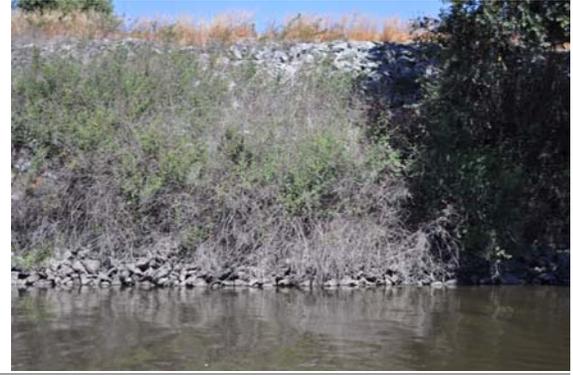
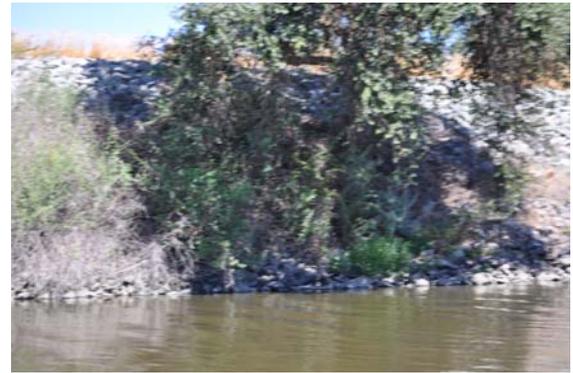
08/07/2012: The site has been visited by boat survey. No significant change observed
 08/23/2011: No significant changes observed on site.
 09/07/2010: Site appears to have been repaired by placing shot rock along the entire slope as revetment. Seasonal grasses growing over the placed revetment. Emergent vegetation at the lower slope that could possibly be covering the vertical scarp that was previously observed. It is recommended that another inspection be conducted to verify status of site. It was previously rated "U".
 08/06/2010: Recommended as local maintenance issue, per CLRO.
 09/28/2009: Rock revetment placed on the upper slope; however, vertical scarp still exists; site is recommended for annual assessment and monitoring of erosion site, per CLRO CES Evaluation 2008 Report; Site # is the same as RM29.95, LM0.22; previously rated "M".
 11/05/2008: Pocket erosion with vertical scarp; loss of rip rap; mild vegetation growth since previous survey.

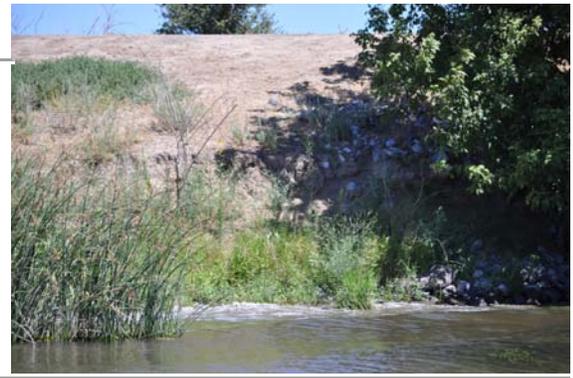
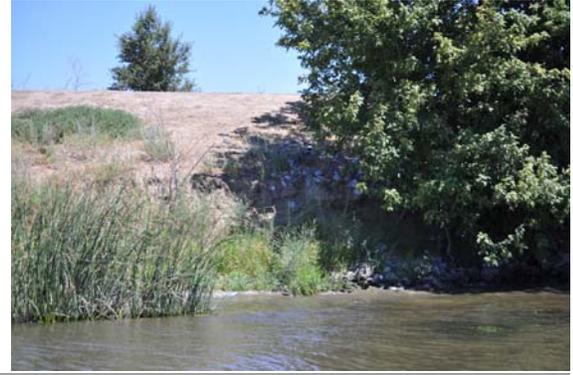
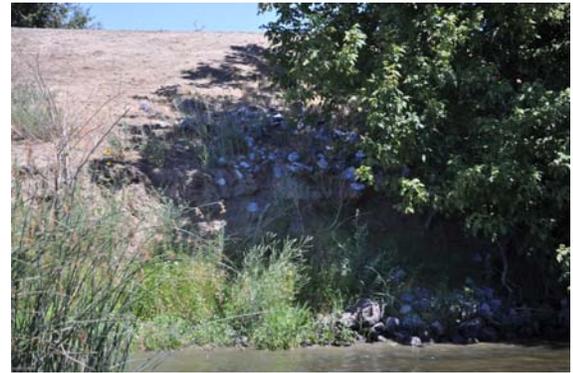
08/07/2012: The site has been visited by boat survey. No significant change observed
 08/23/2011: No significant changes observed on site.
 09/07/2010: Site consists of a jutting rip rap that has created an eddy, scouring the levee slope. Most sections of the toe and lower slope are lined with rip rap. However, the rip rap is sloughing on the mid slope and at the toe, exposing the underlying soils and tree roots. The remaining revetment is no longer adequately protecting the slope. There are 3 Sycamore trees at the toe with exposed tree roots.
 08/05/2010: Recommended for repair, per CLRO.
 09/28/2009: Pocket erosion on lower slope just above the toe rip rap; protruding rip rap upstream is creating an eddy, scouring the levee slope; Site # is the same as RM28.40,LM0.30; previously rated "U"; pictures will be made available during the next survey.
 11/05/2008: Cut into levee profile; riprap slide; rodent holes; pictures do not match GPS and current condition.

Close view of the site

Close look of the site

A closer look of the site

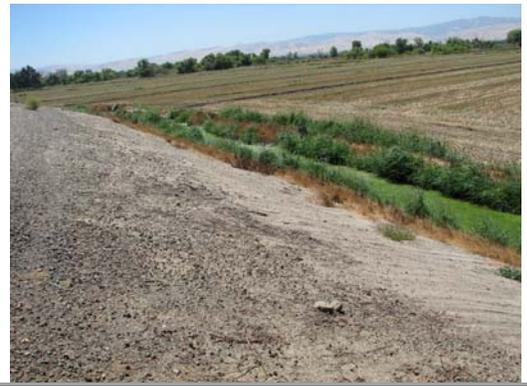
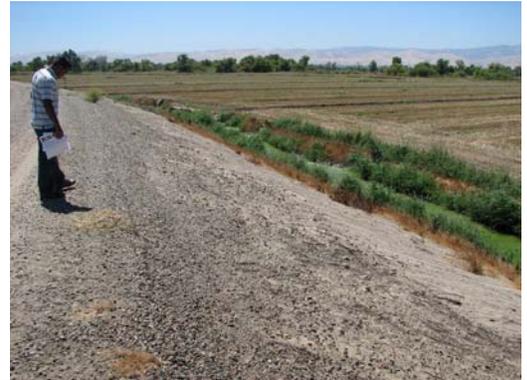
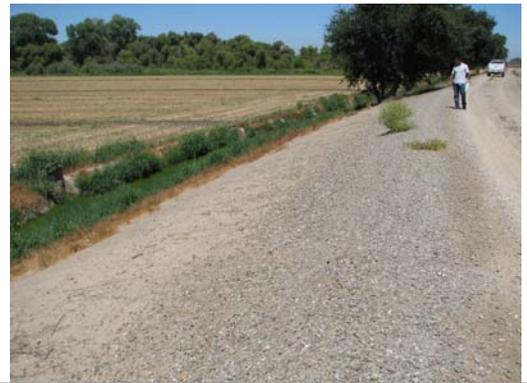
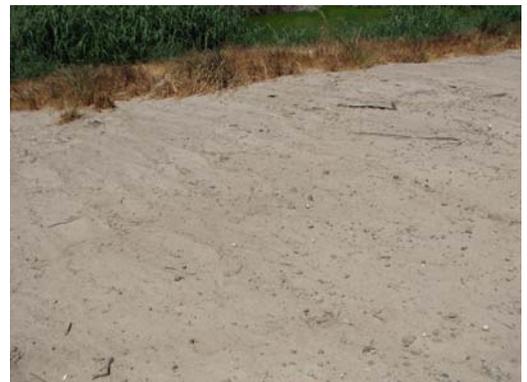
09/26/2012: Site was not surveyed this year due to time constraints. There have been no reports from the levee inspectors or district that this site has new erosion.
 08/18/2011: This site was repaired. No new erosion visible.
 11/30/2010: Site was not surveyed this year due to time constraints. There have been no reports from the district that this site was corrected.
 08/05/2010: Recommended for annual assessment and monitoring during flood events, per CLRO.
 08/25/2009: No major change since last visit; sloughing of the lower slope that's created a terraced effect; damage could be caused by wave action during an extended flooding; site is recommended as local maintenance issue, per CLRO CES Evaluation 2008 Report; previously rated "M".
 08/09/2007: Not as serious - use lower rating.

Upstream view of the site looking from the levee crown.

Upstream view of the site

Downstream view of the site.

Close-in view of the repaired site.

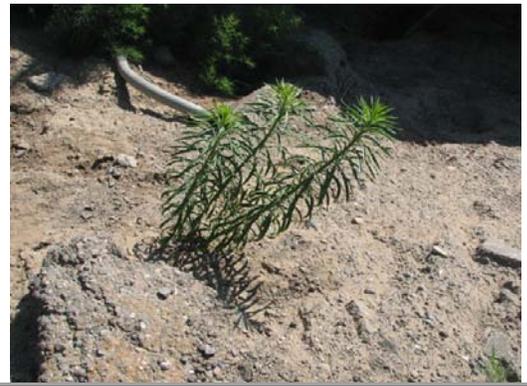
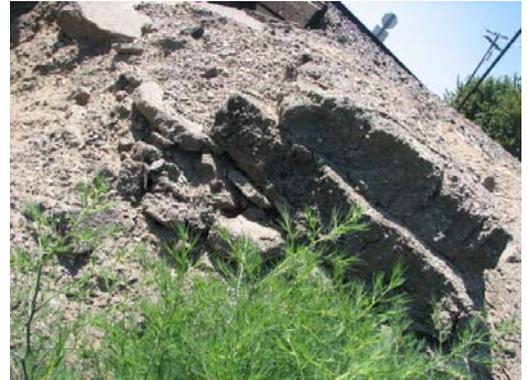
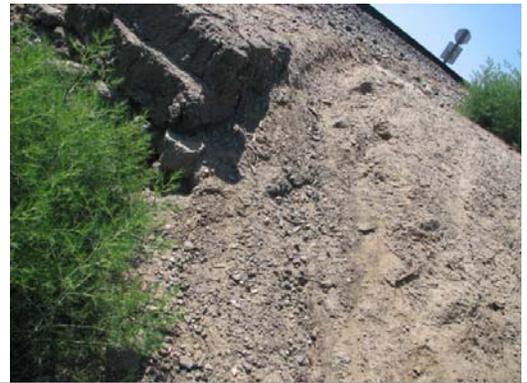
07/18/2012: No significant changes observed on site.
 09/02/2011: No significant changes observed on site.
 09/22/2010: No significant changes observed on site. There is now considerable vegetation at the water line and along the lower berm slope. However, the erosion on the lower berm slope is still present and has not been corrected.
 08/06/2010: Recommended for local maintenance issue, per CLRO.
 07/29/2009: No major change since last visit; noticeable vegetation growth; erosion is on berm, but if left untreated, it will eventually erode into levee prism; site is recommended for annual assessment and monitoring of site, per CLRO CES 2008 Report; Site # is the same as RM6.80,LM0.73; previously rated "U".
 07/22/2008: Downstream of WPRR near siphon pipe & pump; sandy levee; visited by Jeff Van Gilder and LRO in 2008 for repair assessment; scouring downstream of RxR crossing, possibly caused by eddy effects.

Direct view of the erosion at the downstream of RR bridge.

looking up at the erosion from the lower levee slope

Closer view of the erosion

Upstream side of RR bridge

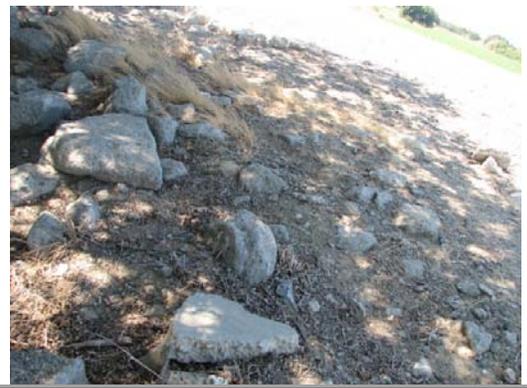
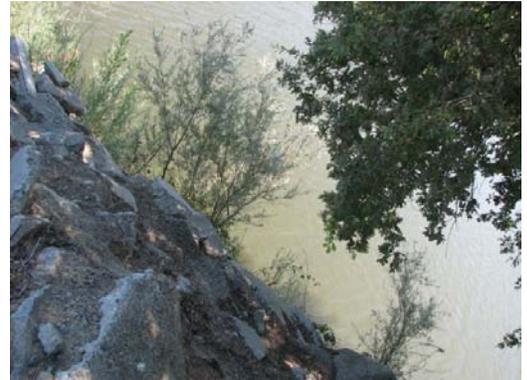
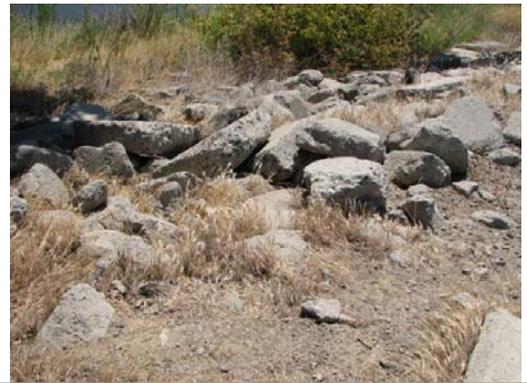
07/18/2012: No significant changes observed.
 09/02/2011: No significant changes observed.
 09/22/2010: No significant changes observed. Sloughing of the existing rip rap possibly due to a combination of steep slope and undesirable flood conditions.
 08/06/2010: Recommended as local maintenance issue, per CLRO.
 07/29/2009: No major change observed since last visit; near-vertical slope that has rip rap sloughing; site is recommended as a local maintenance issue, per CLRO CES Evaluation 2008 Report; Site # is the same as RM6.90, LMO.86; previously rated "U".
 07/22/2008: Previous erosion site that is partially protected with concrete rubble; erosion scarp is adjacent to the sloughing rip rap.
 03/13/2007: Site visited on 03/13/2007.

Direct view of the site

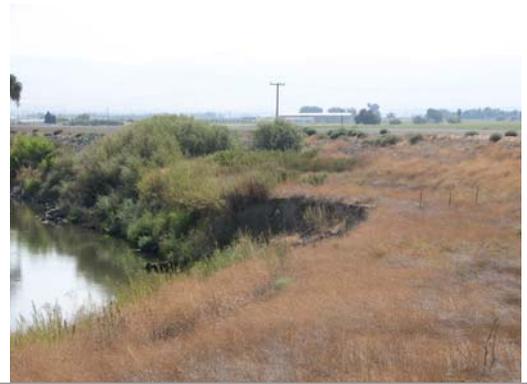
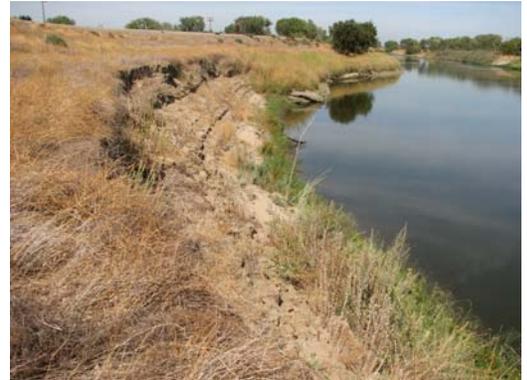
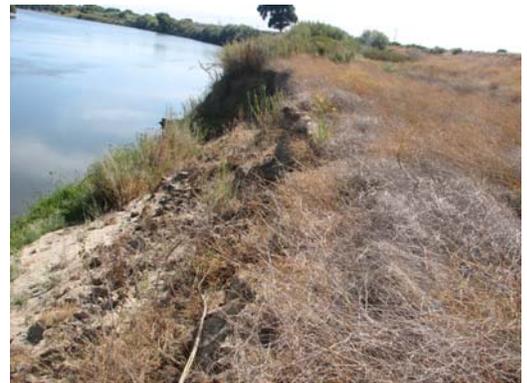
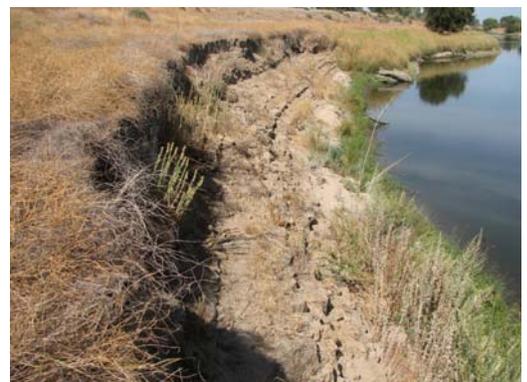
09/13/2012: The site has been visited by land survey. The vegetation on the site shows the erosion has not developed significantly from the last survey. The site was not visited by boat survey due to the limitation of navigatable waterway.
 08/23/2011: No significant changes observed on the site.
 9/22/2010: No significant changes observed on site. There is moderate vegetation growth on the berm. Despite the erosion occurring on the berm, corrective action should be taken before the issue becomes severe.
 9/29/2009: Site is immediately downstream of a section of existing rip rap; there is a 20-foot berm remaining; berm will continue to erode unless erosion is mitigated; Site# is the same as RM62.6, LM1.87; recommended for annual assessment, per CES Evaluation 2008 Report
 2006: Visited 10/20/06

Looking upstream of the site. Note dense vegetation on the berm.

Looking downstream of the site.

Close view of the site.

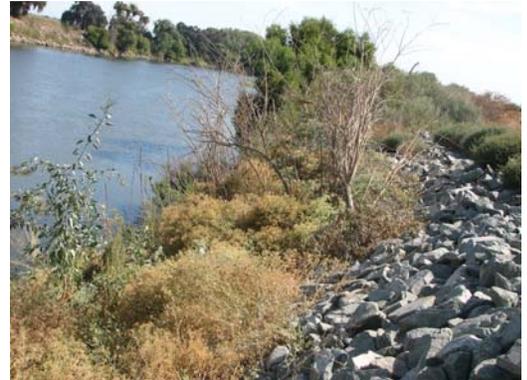
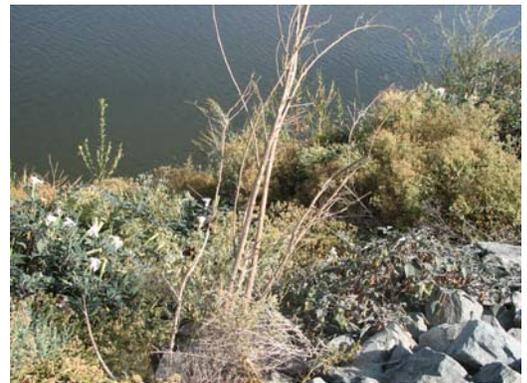
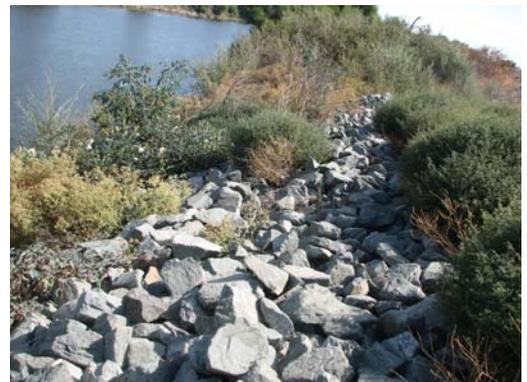
09/23/2010: At the time of the inspection, the erosion site was difficult to view from the levee. Erosion is located on the bank toe, below the existing rip rap. There were no signs of repair on site, nor has the site been reported to be repaired by the district. Images taken from last year indicate that existing rip rap at the bank toe has sloughed exposing the underlying soils. Weakening of the toe could lead to future bank instability.

09/29/2009: No major change observed since last visit; sloughing of the rip rap above toe; erosion begins immediately downstream of existing rip rap revetment; roughly 15-foot berm remains; however, it will continue to erode and eventually intrude into the levee profile if left untreated.

Front view of the erosion.

Direct view of the erosion.

A closer look at the site

08/05/2010: Recommended for annual assessment and monitoring during flood events, per CLRO.

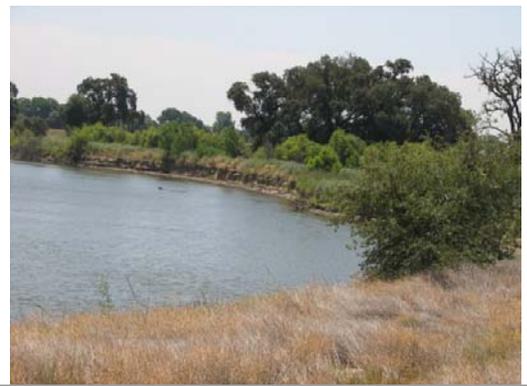
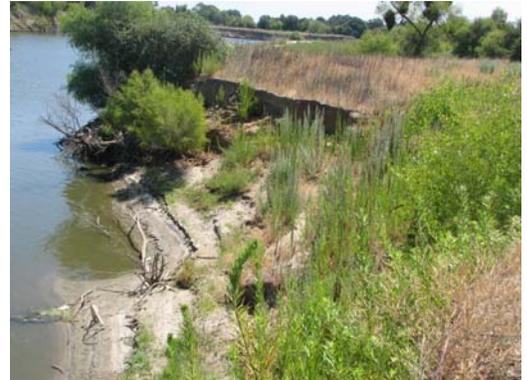
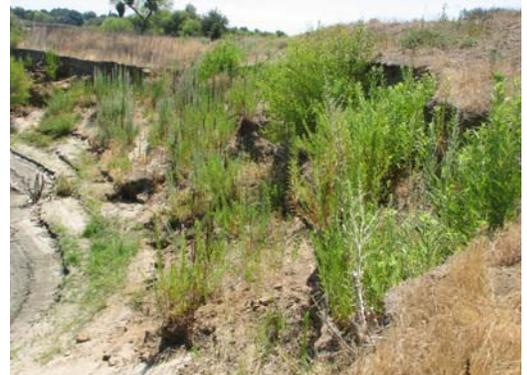
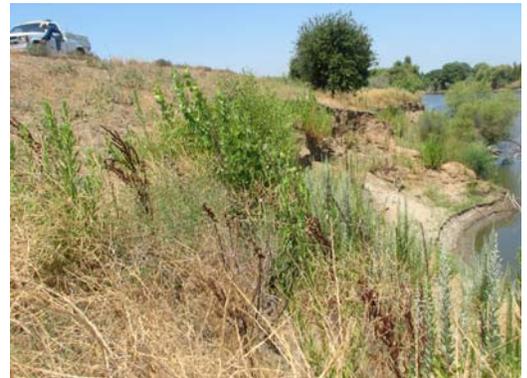
07/18/2012: Erosion has further developed toward levee crown. Vegetation has been removed.
 08/18/2011: Erosion progressed significantly during the past flood season. The levee toe along the erosion site was washed away, and the erosion has cut the levee structure up to the point about 1/3 of the levee slope. The scarp height is approximately 17 feet. Very dense vegetation on the site. Trees visible.
 10/19/2010: No significant changes observed on site. Remaining levee berm topsoil is of silty sand mixture. Erosion is near the downstream transition. An eddy has formed, and has scoured away a 100-foot section of the bank, possibly encroaching into the levee prism. Vegetation on site includes willows, oak, and cotton wood located from the bench to the toe. On the landside are rows of corn crop.
 08/05/2010: Recommended for Repair, per CLRO.
 2009: Site recommended as annual assessment and monitoring if critical erosion site, per CLRO CES Evaluation 2008 Report; an eddy has formed, eroding bank and intruding into the levee prism; Site # is the same as RM76.3,LM1.89; previously rated "U".

Looking downstream from levee top. The tree at the water edge is the visible starting point of the erosion.

A close look at the erosion.

Looking downstream at the scour site. It seems the erosion has further developed upward to the levee top since the last survey

Looking downstream at the scour site. The fresh scoring is visible.

08/30/2007: Recommended for short list of immediate repair sites; silty sand levee material.
