**State of California
The Resources Agency
DEPARTMENT OF WATER RESOURCES**

**2005
PROJECT CHANNEL REPORT**

**INSPECTION OF
FLOOD CONTROL PROJECT CHANNELS ON THE
SACRAMENTO AND SAN JOAQUIN RIVERS AND
THEIR TRIBUTARIES AND THE TRUCKEE RIVER**

**Prepared By The
Flood Operations Branch
Flood Project Inspection Section**

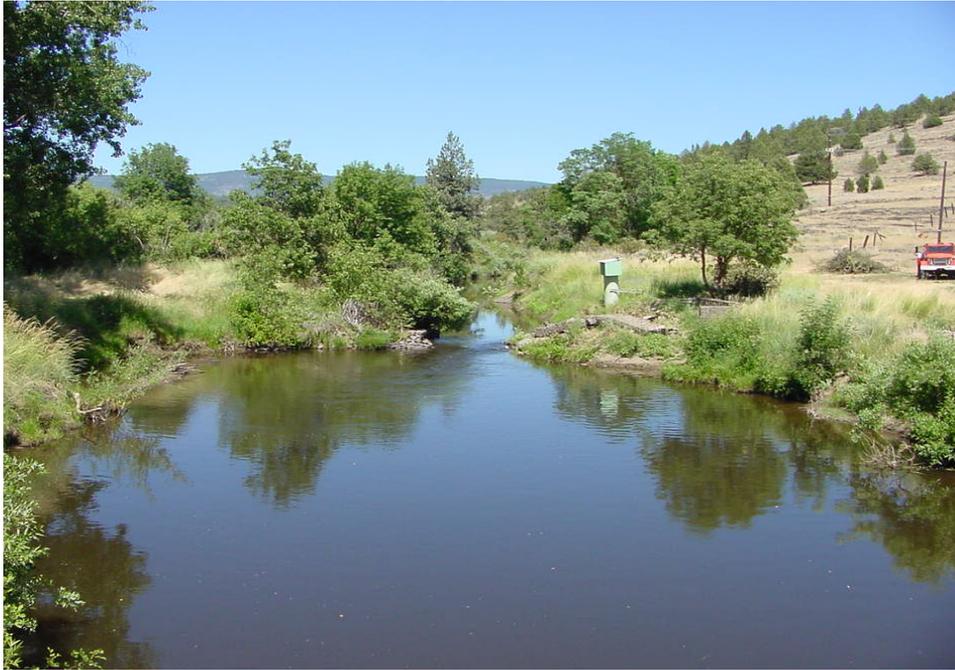
Upstream from Main Street (Highway 299) towards the gauging station

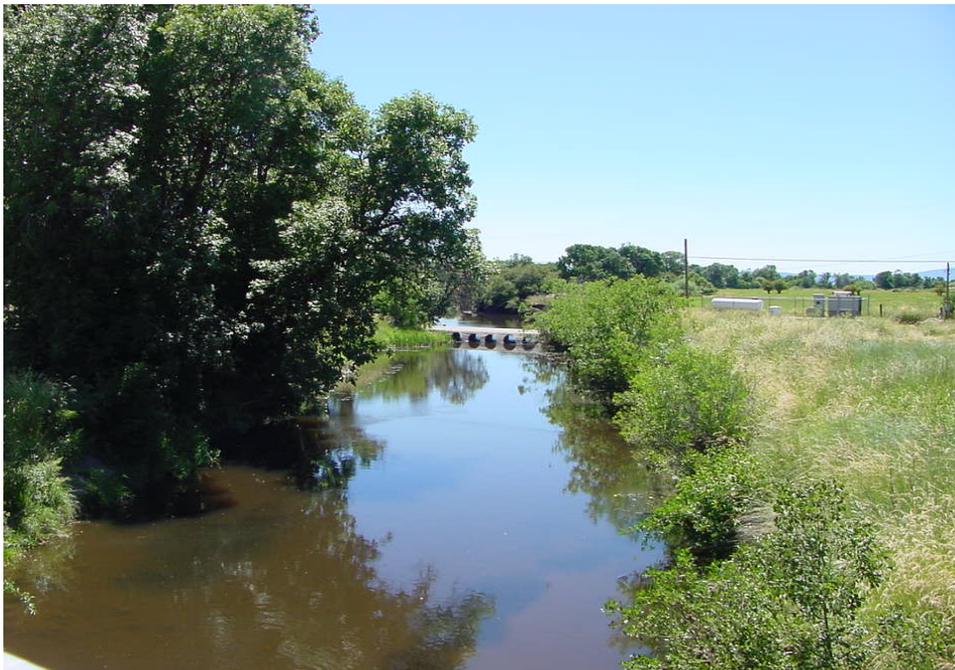
Downstream from Main Street (Hwy. 299) at the Ash St. low water crossing

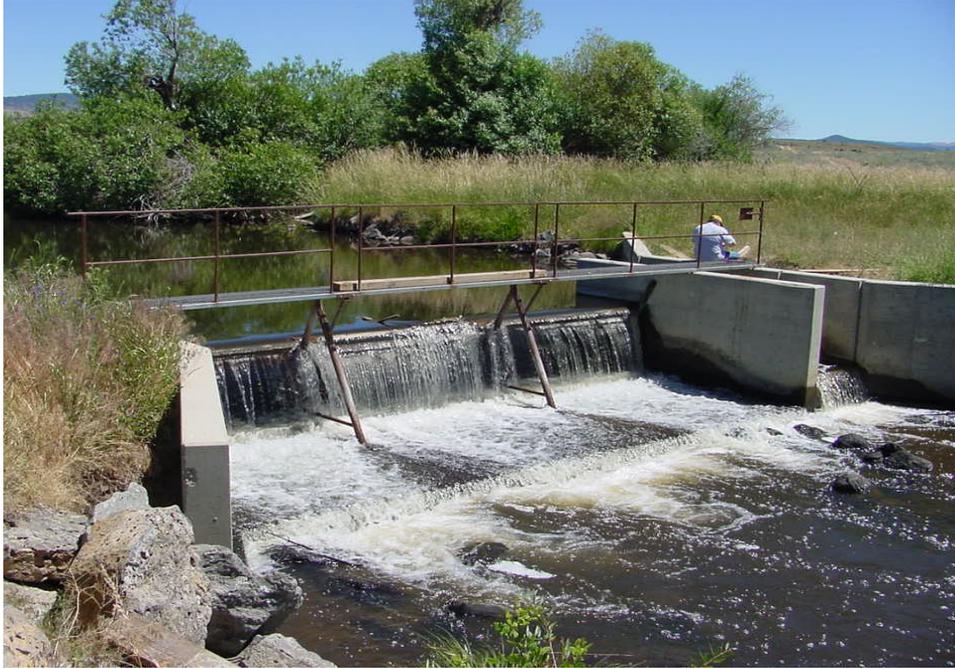
Upstream from the downstream limit

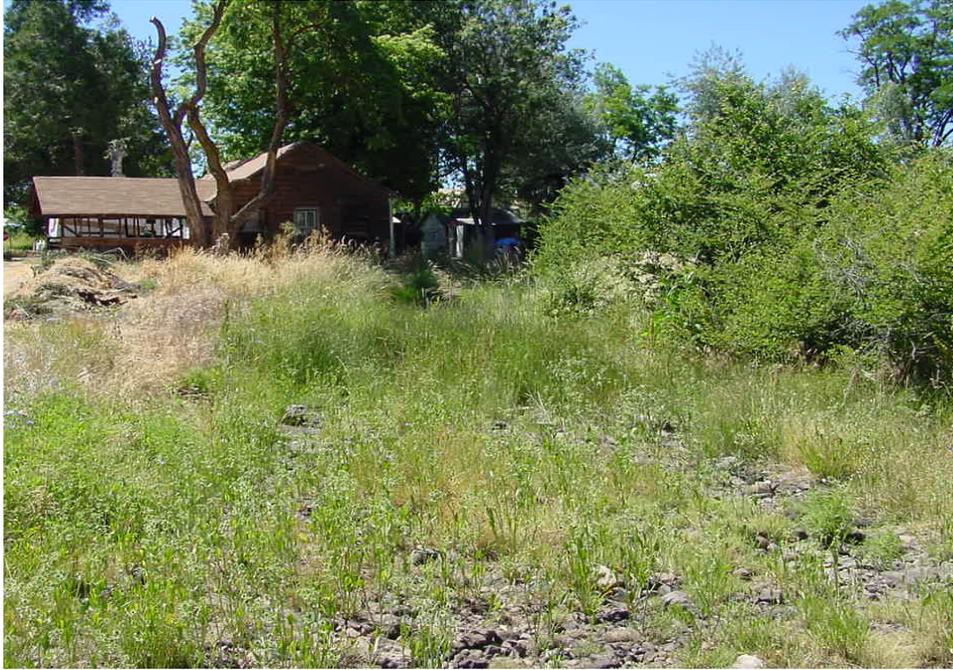
Downstream where Dry Creek meets Ash Creek

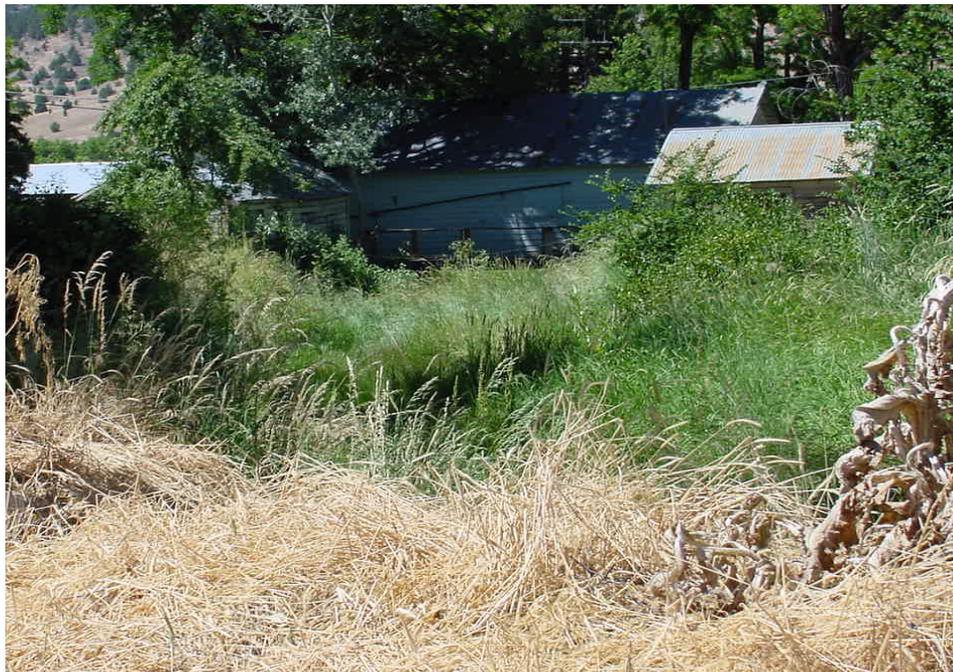
Downstream at Cedar Street

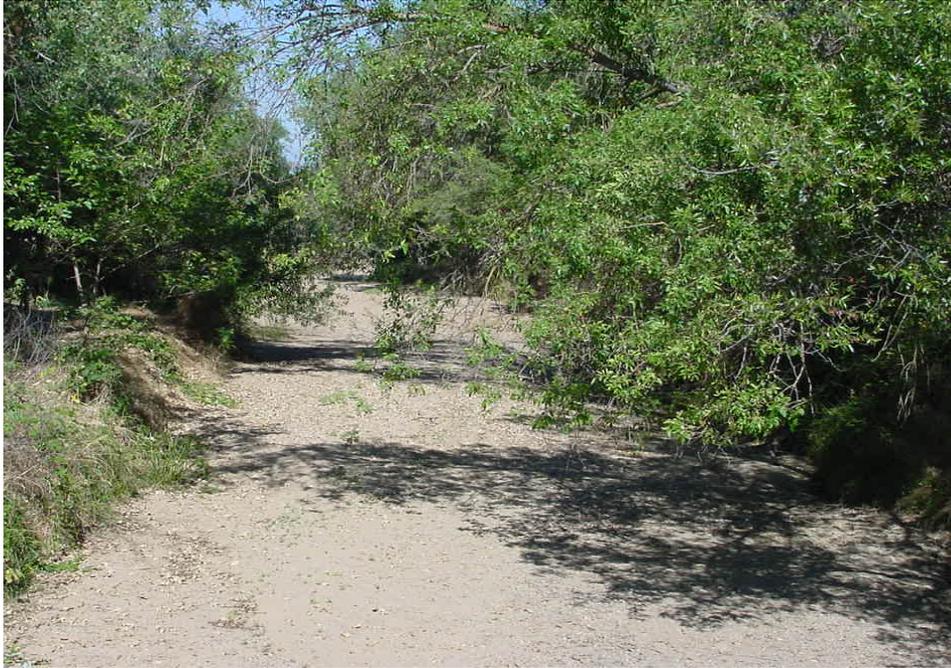
Upstream from extension of Truckee Avenue

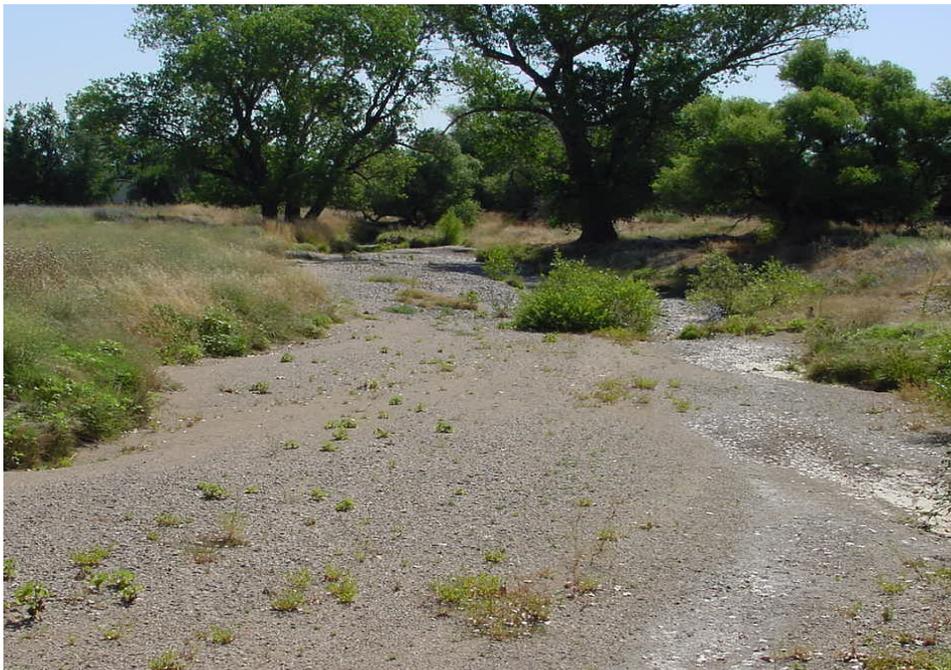
Downstream from extension of Truckee Avenue

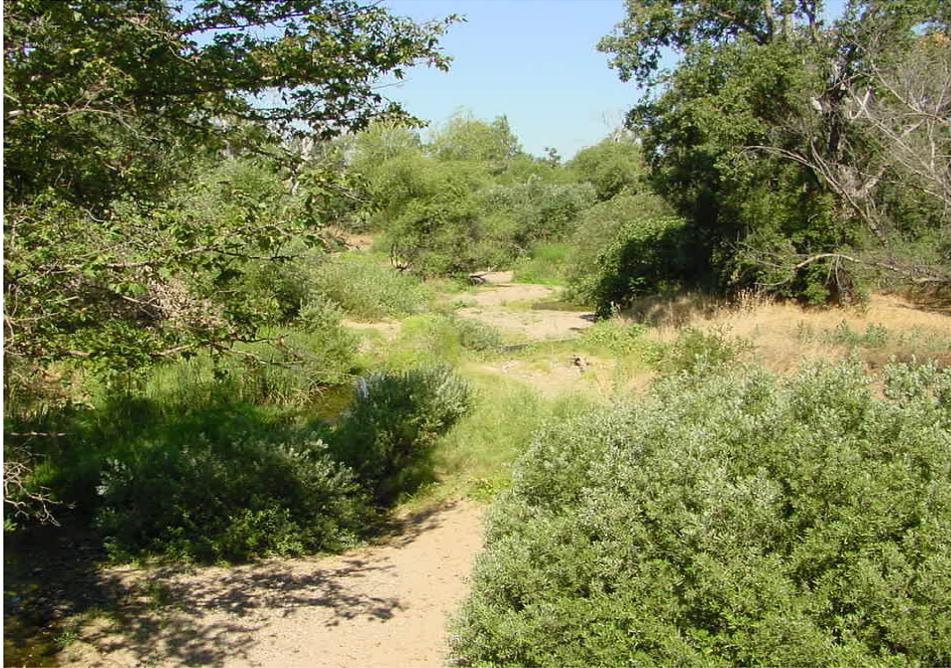
Upstream from Highway 99 W bridge

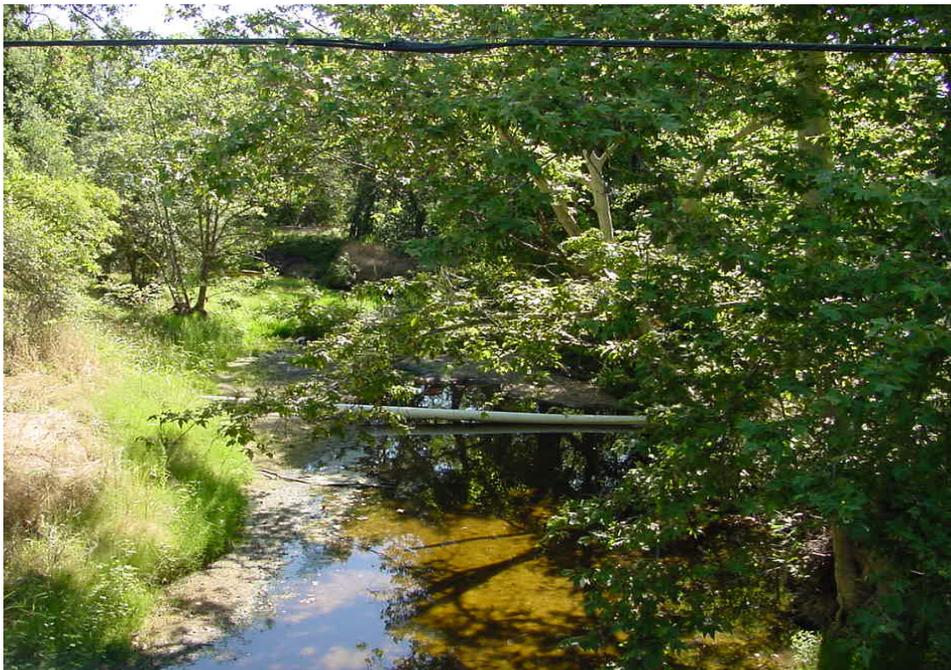
Downstream from Highway 99 W bridge

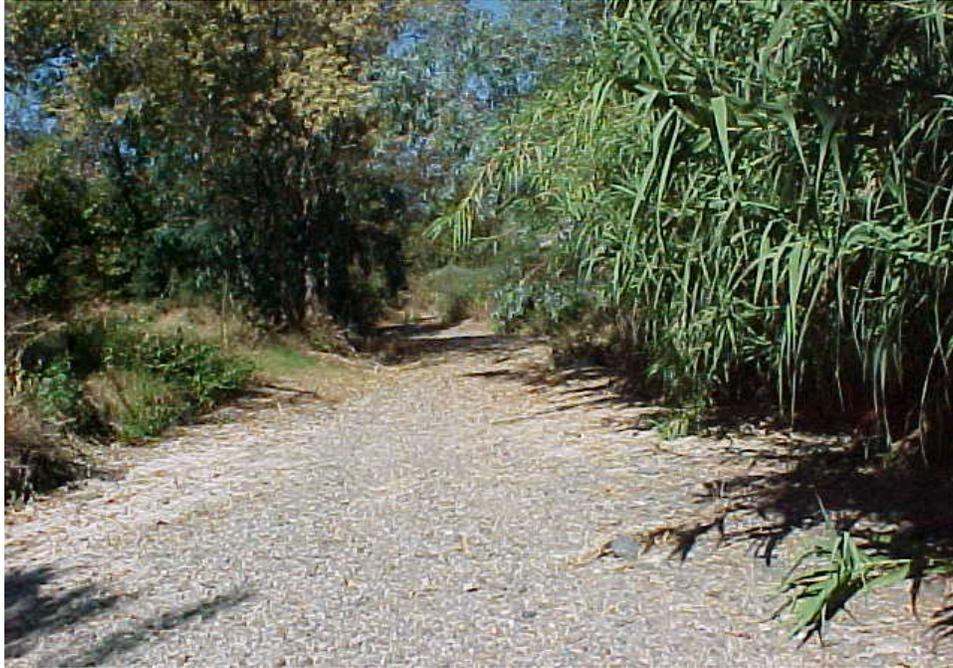
Downstream view approximately 2500 feet downstream of the Hwy 99 Bridge

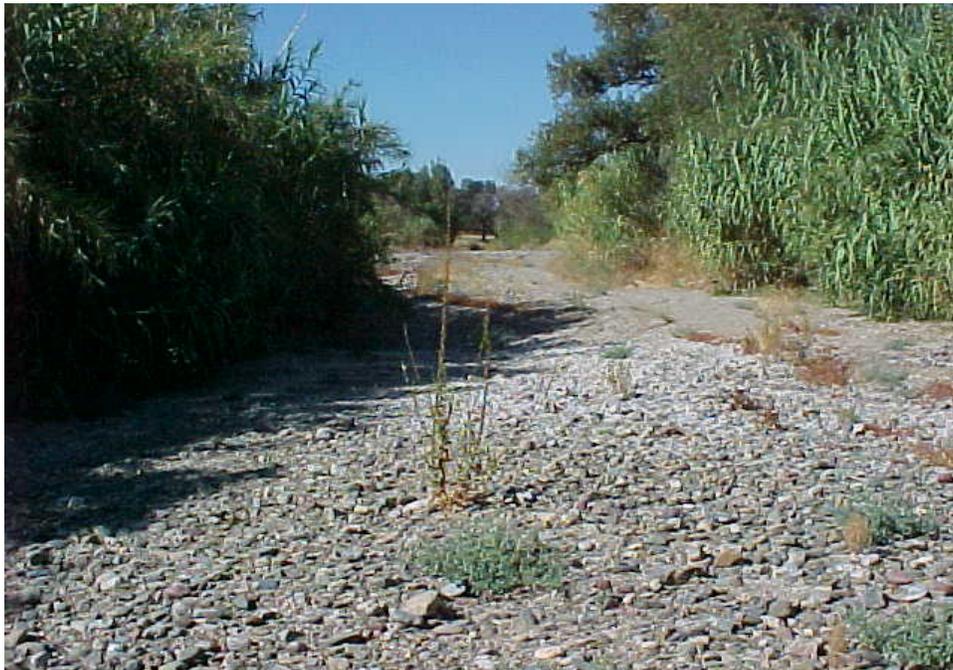
Upstream from the downstream limit

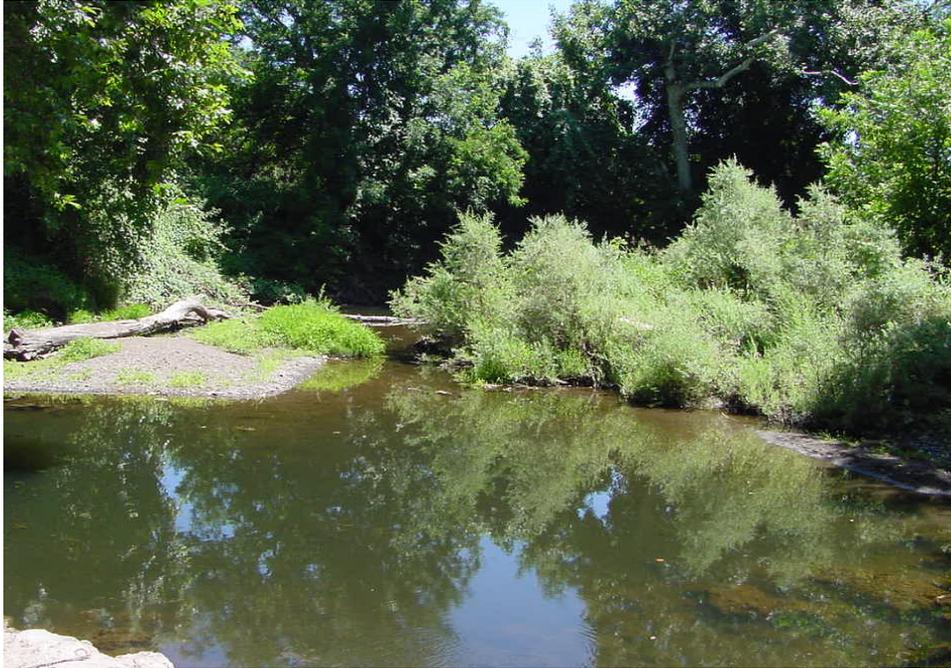
Downstream of low water crossing logs and dense vegetation is encroaching in the channel

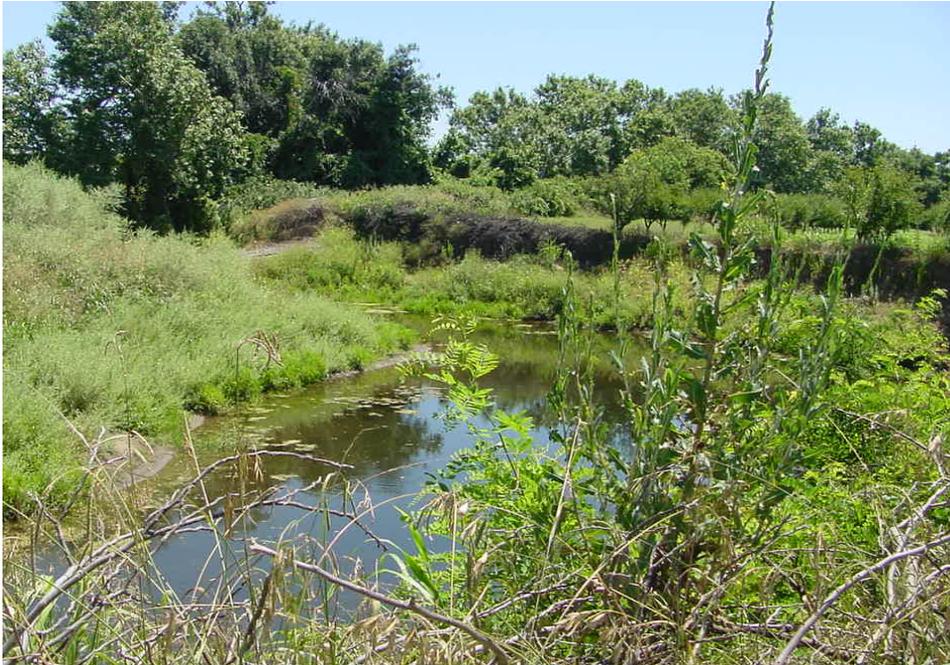
Down stream approximately 200 feet of erosion along the right bank

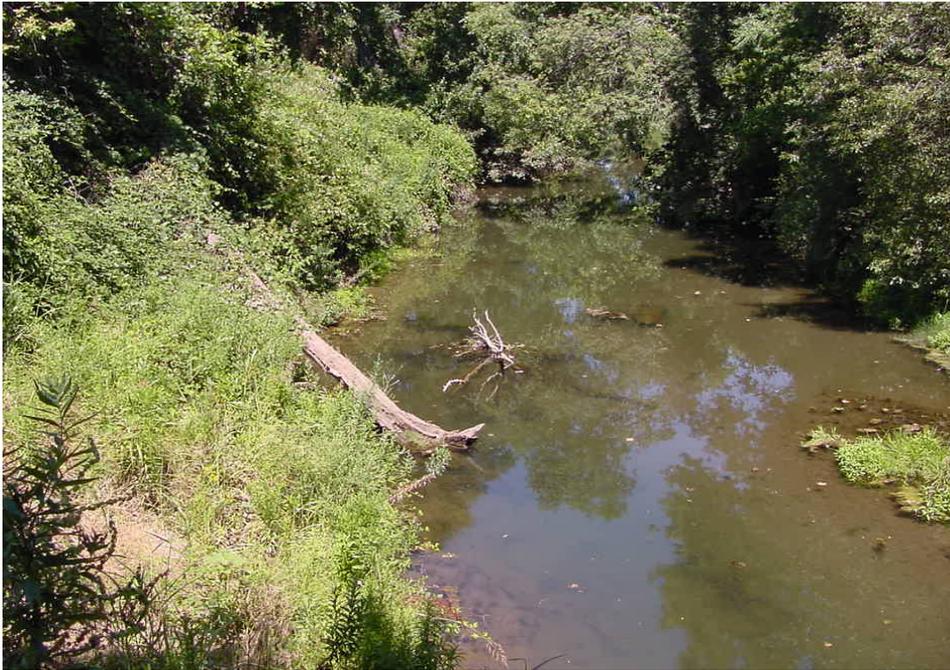
Logs and dense vegetation needs to be removed from channel

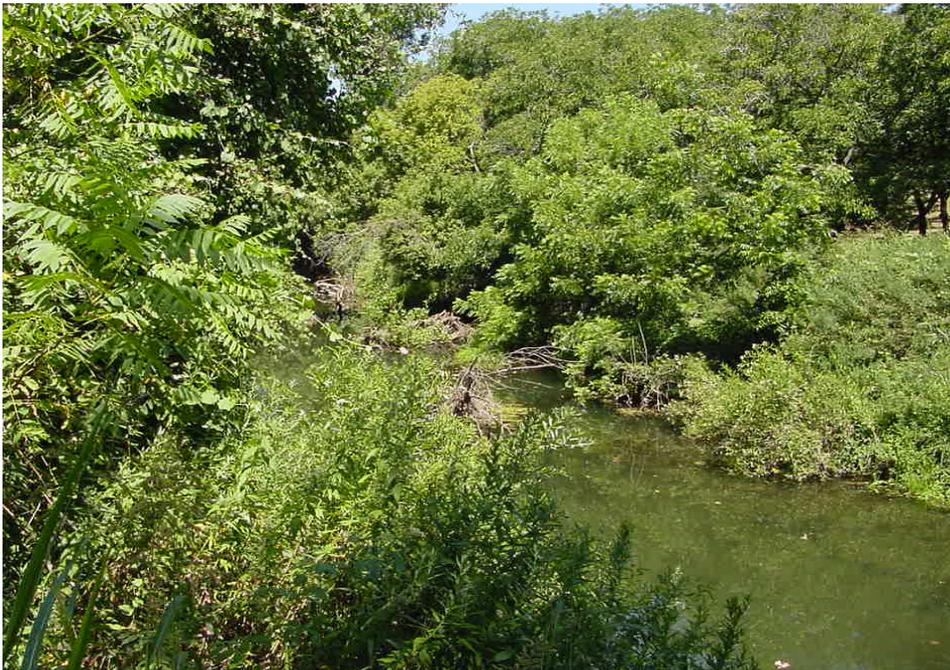
**Upstream, approximately 2800 feet from the downstream limit
dense vegetation on both banks**

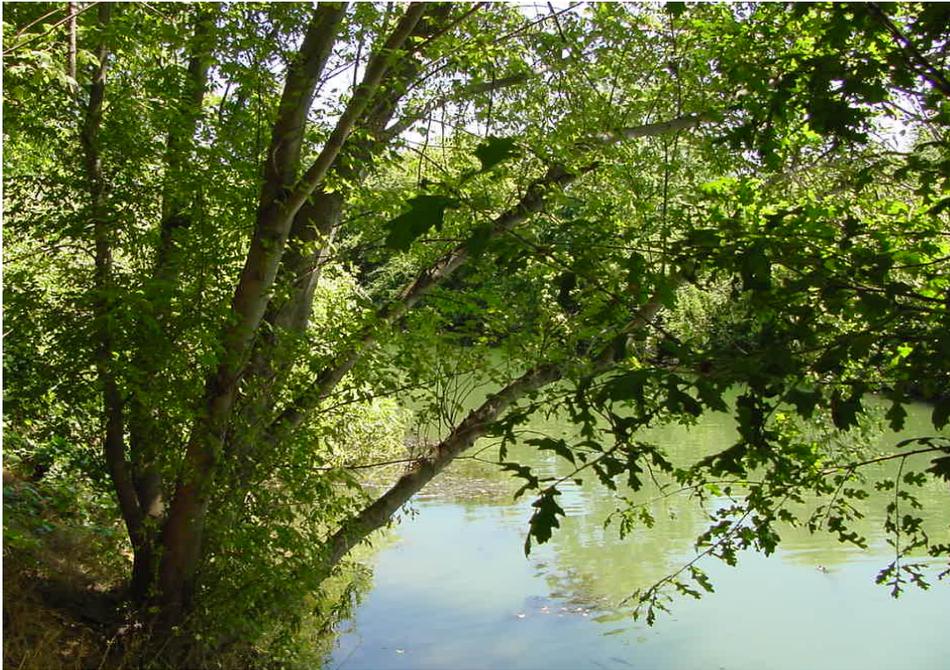
**Upstream, approximately 700 feet upstream of the downstream limit
dense vegetation along both banks**

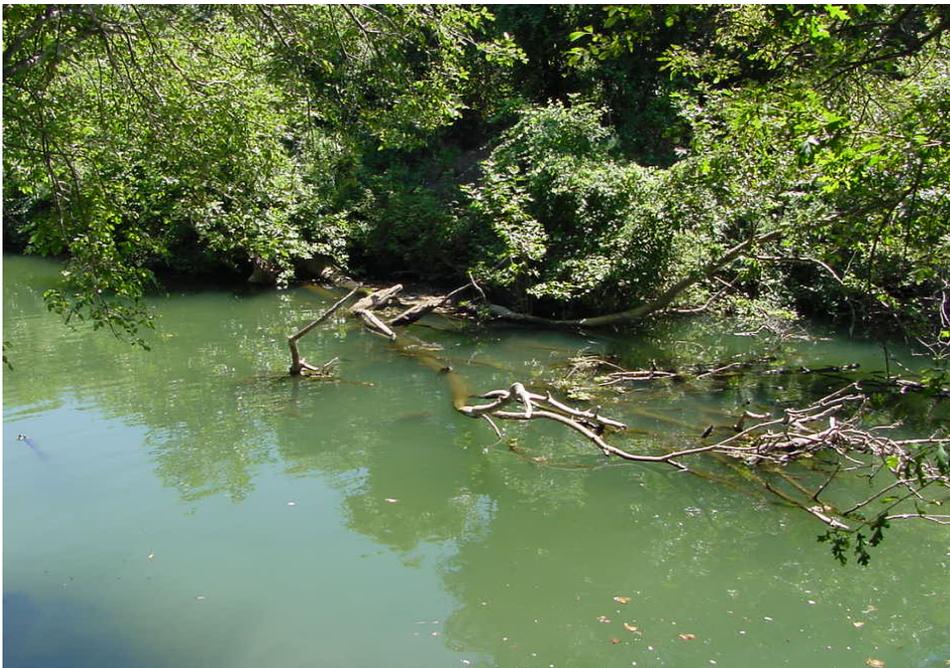
**Downstream, approximately 700 feet upstream from the confluence with the
Sacramento River**

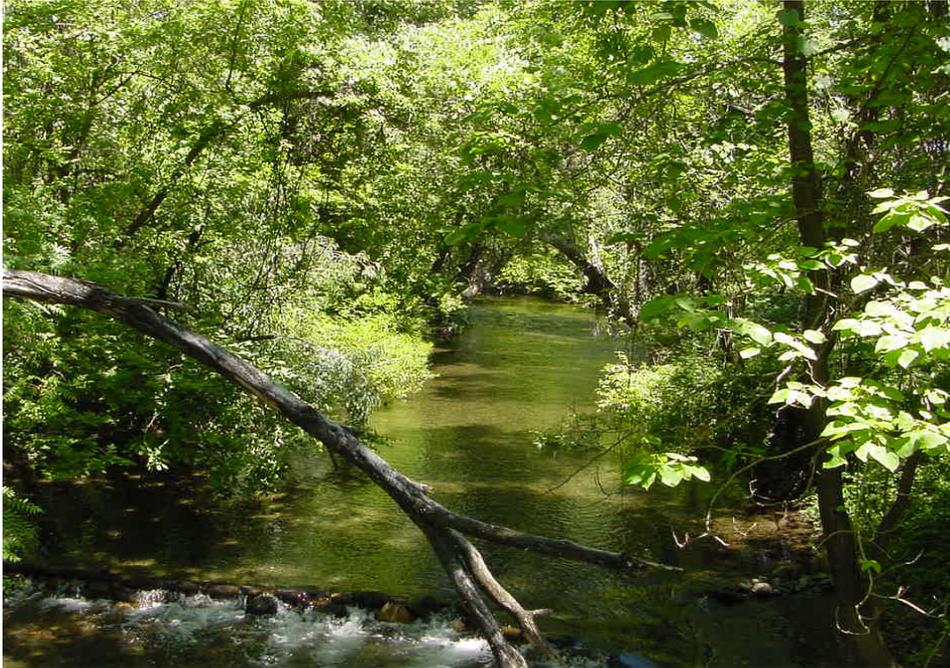
Downstream from the Big Chico Creek Control Structure

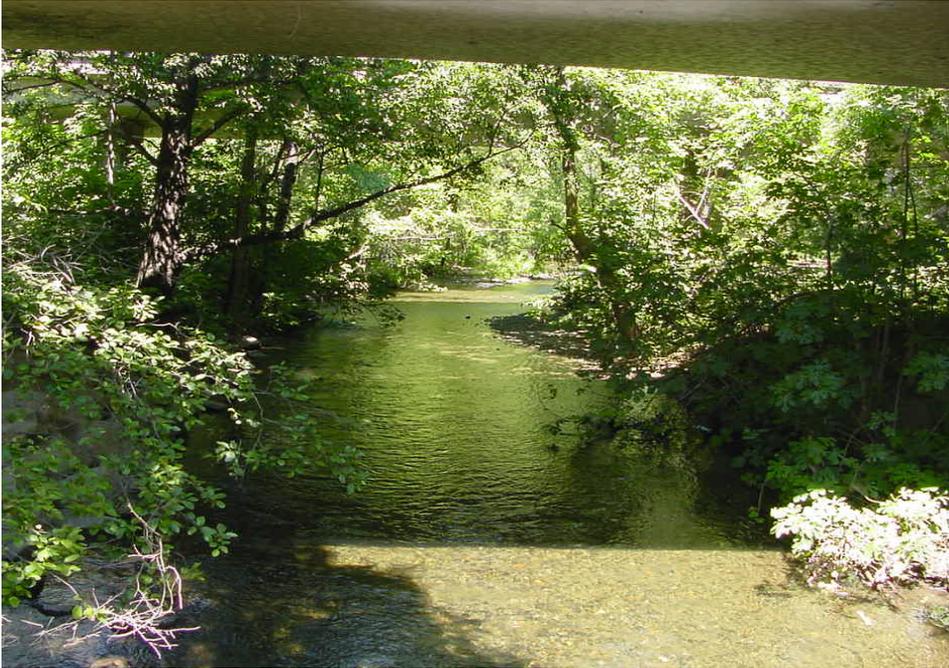
Upstream from Highway 99 heavy growth along both banks

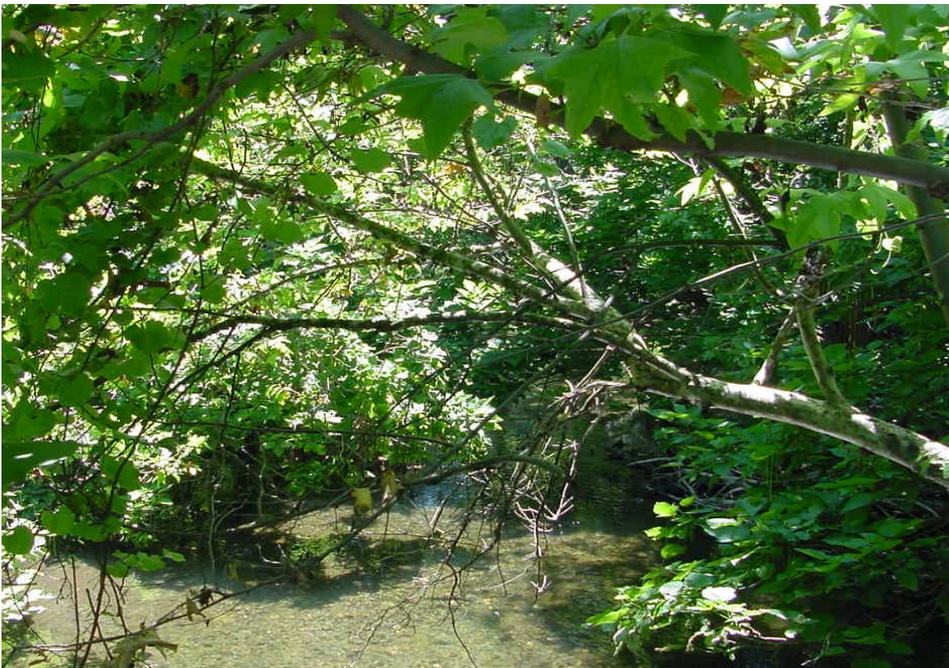
Downstream from Highway 99 dense vegetation in channel

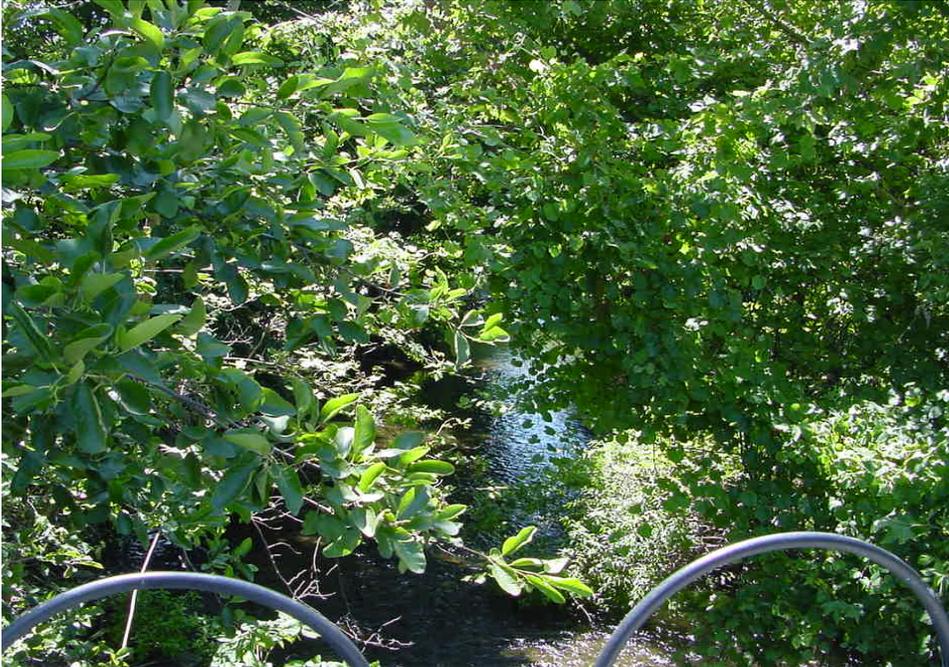
Upstream from the Esplanade heavy growth on both banks

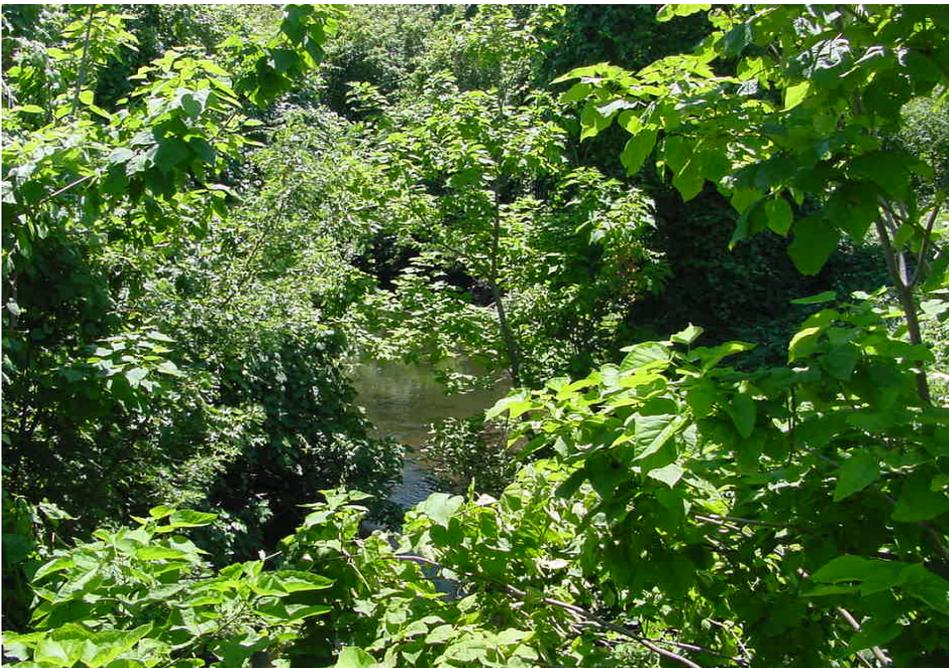
Downstream from Highway 32 heavy growth on both banks

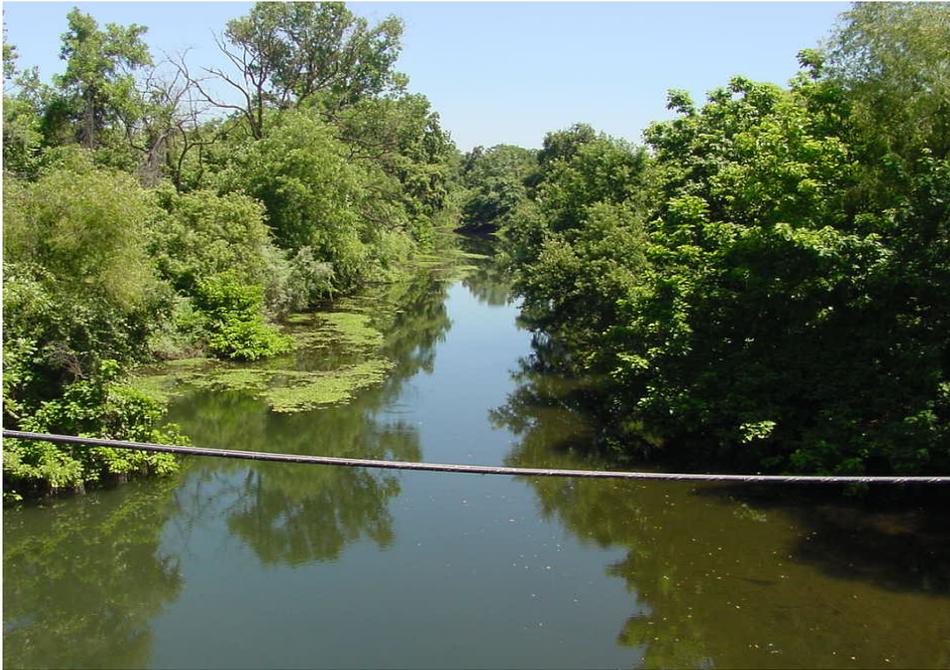
**Upstream approximately 500 feet upstream
of the confluence with the Sacramento River**

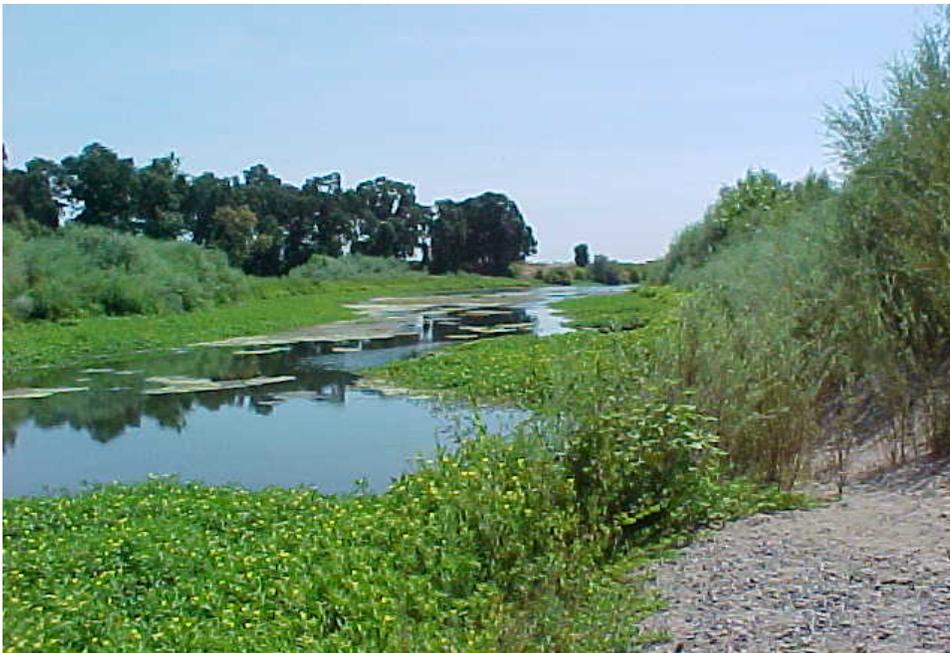
Downstream towards the confluence with the Sacramento River

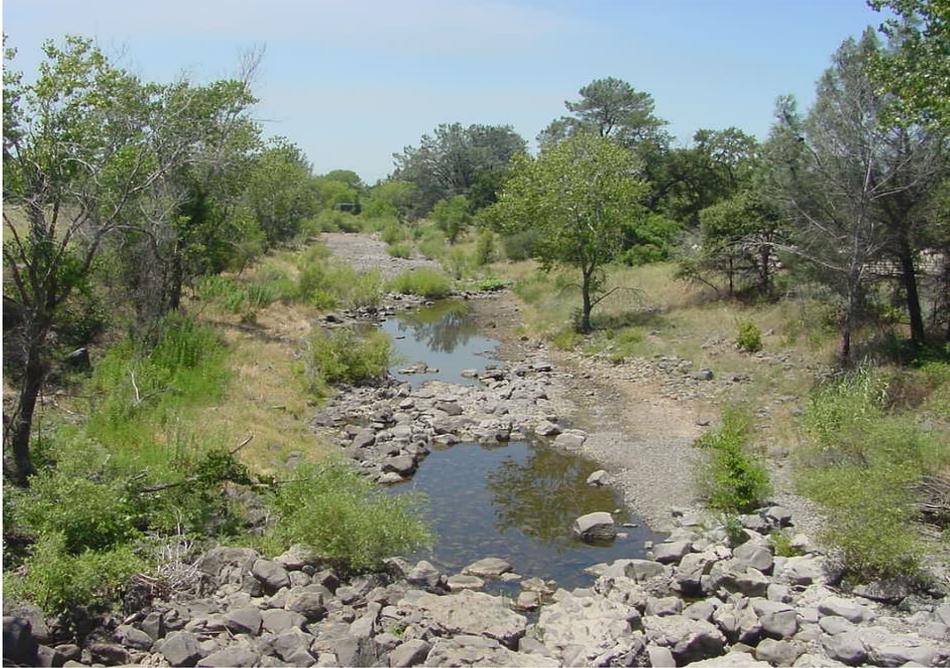
Downstream from the Lindo Channel Diversion Structure

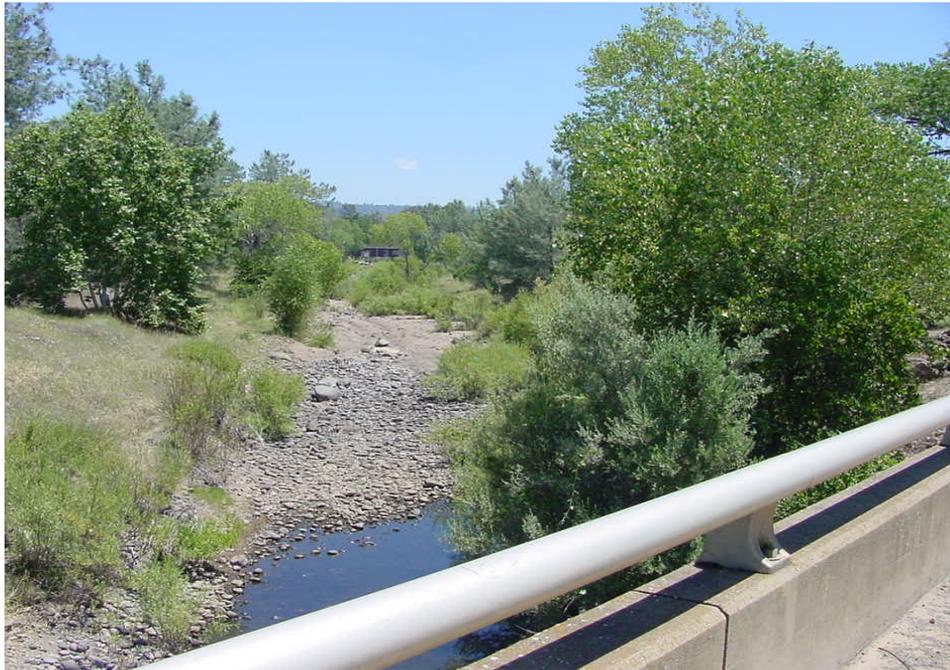
Downstream from Manzanita Avenue

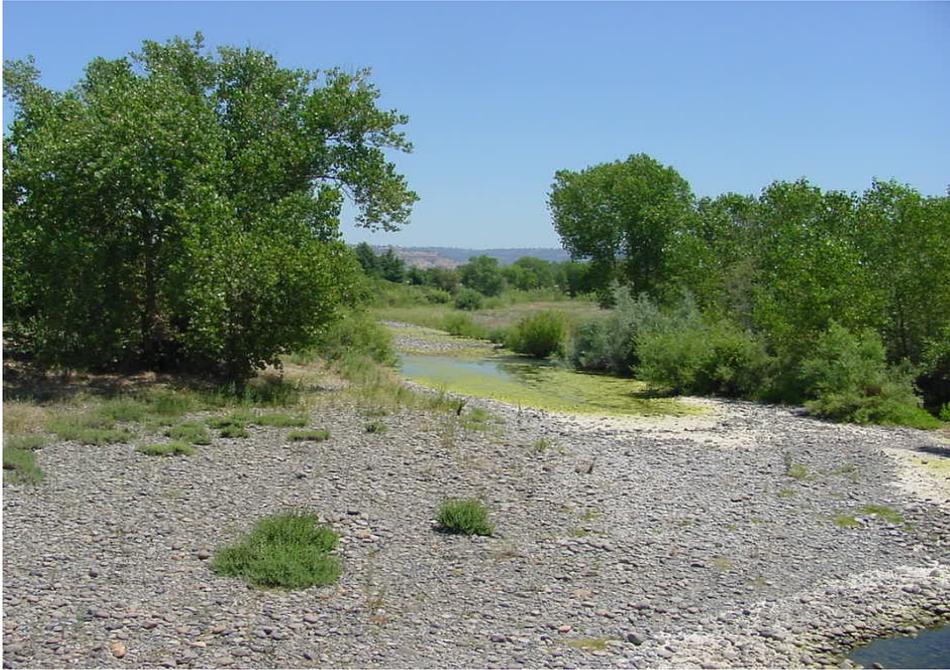
Upstream from the bike path bridge at the extension of Madrone Avenue

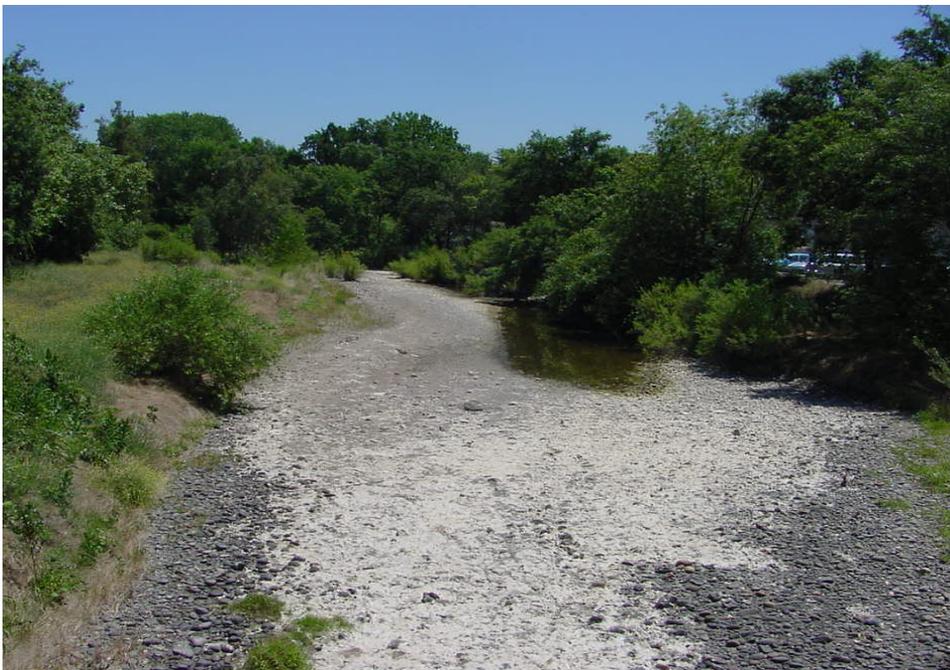
Upstream from Mariposa

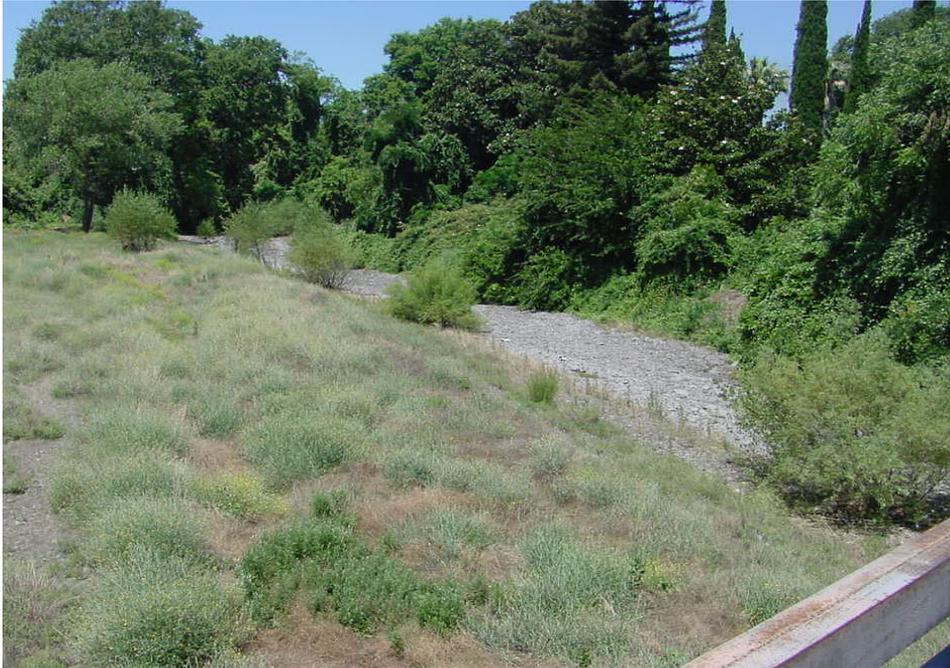
Downstream from the Esplanade

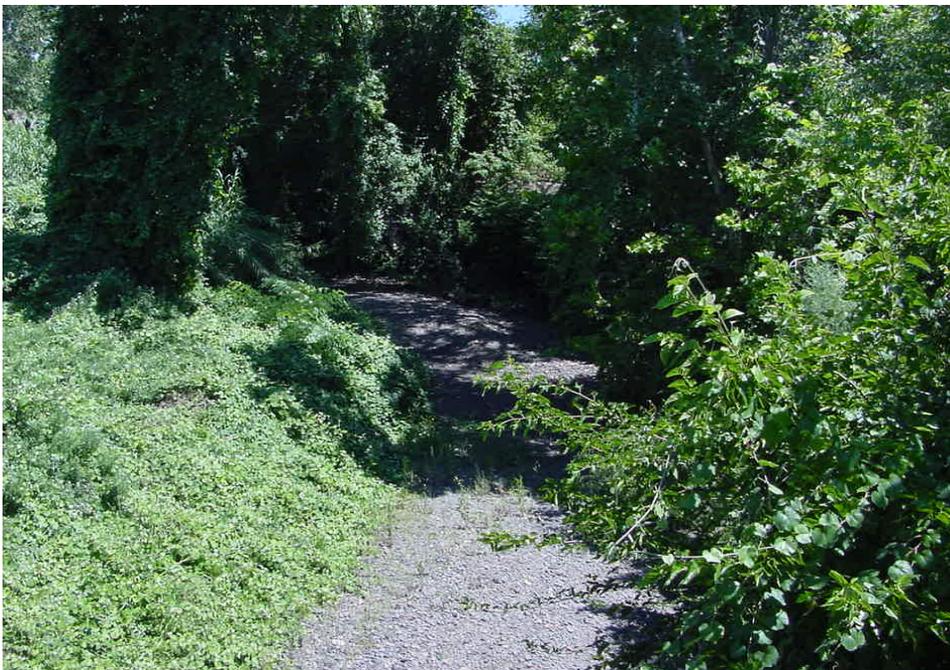
Upstream from Highway 32

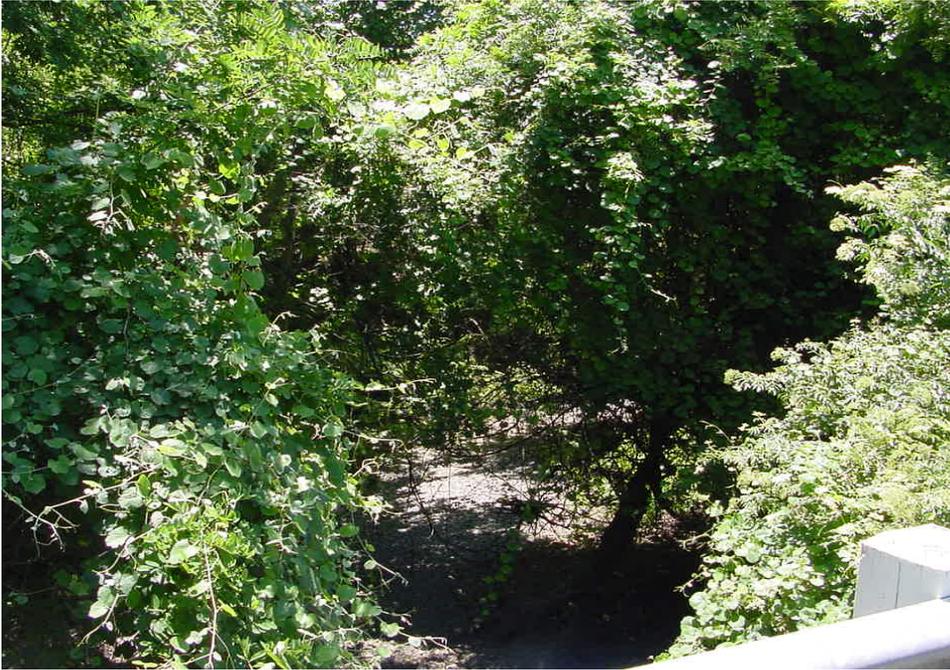
Downstream from Oak Ave

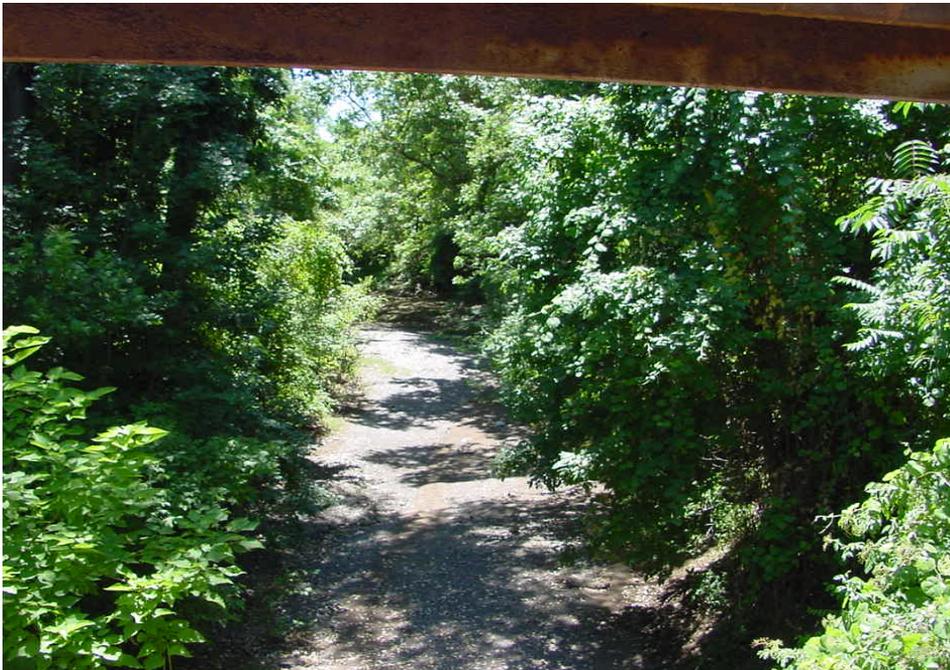
Downstream from Grape Way

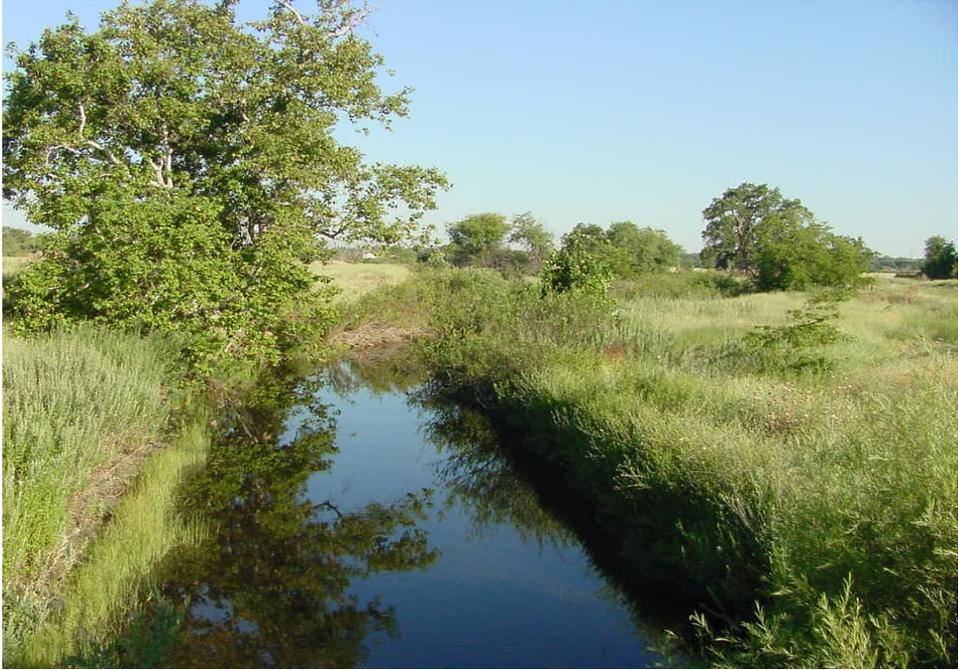
Downstream from Bruce Road

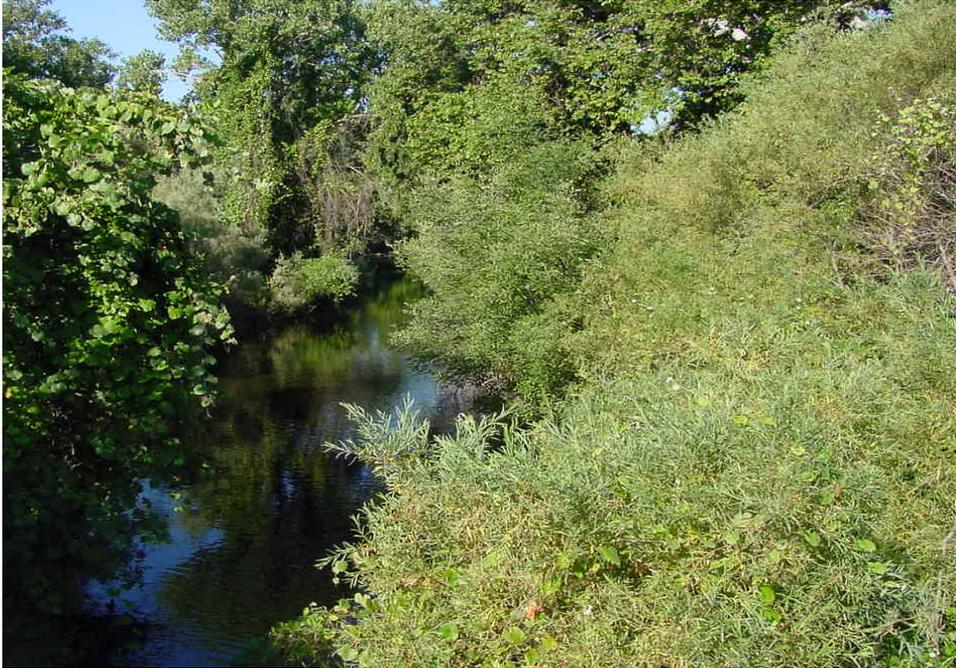
Downstream from Forest Avenue

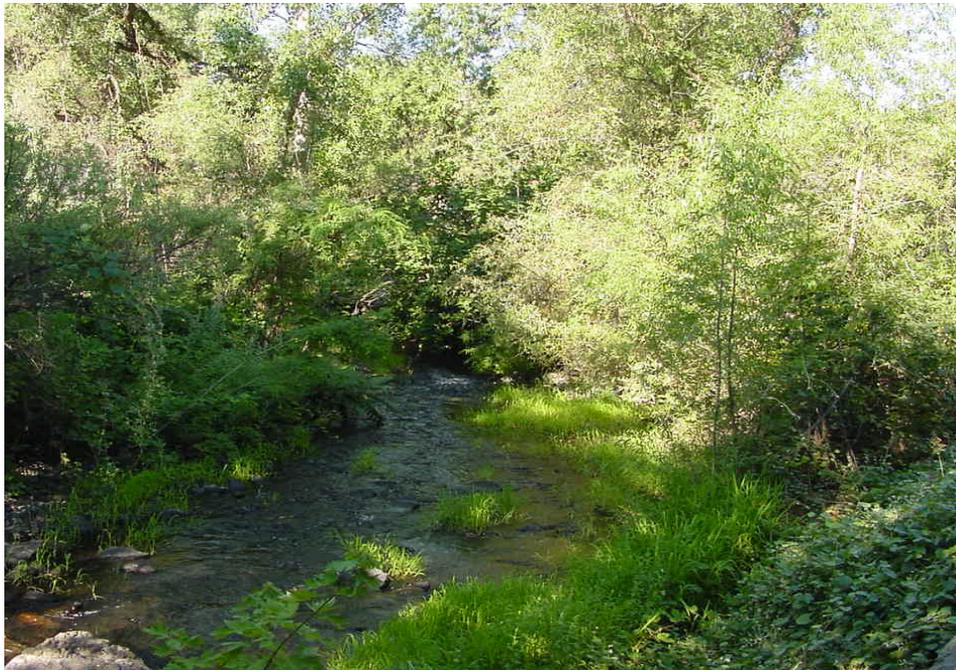
Downstream of Highway 99
