**State of California
The Resources Agency
DEPARTMENT OF WATER RESOURCES**

**2005
PROJECT CHANNEL REPORT**

**INSPECTION OF
FLOOD CONTROL PROJECT CHANNELS ON THE
SACRAMENTO AND SAN JOAQUIN RIVERS AND
THEIR TRIBUTARIES AND THE TRUCKEE RIVER**

**Prepared By The
Flood Operations Branch
Flood Project Inspection Section**

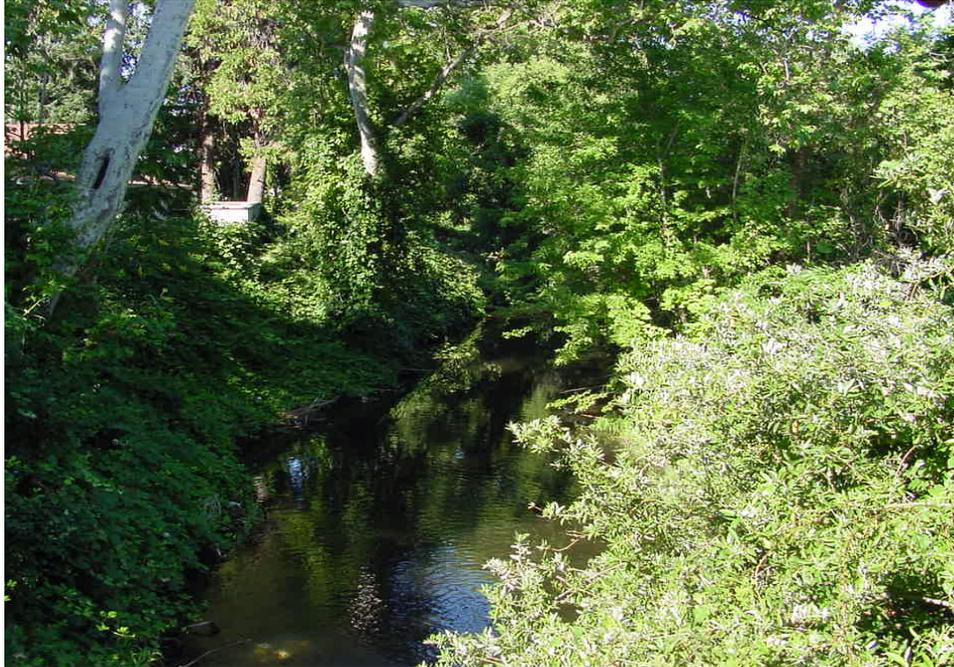
Downstream from Olive Street

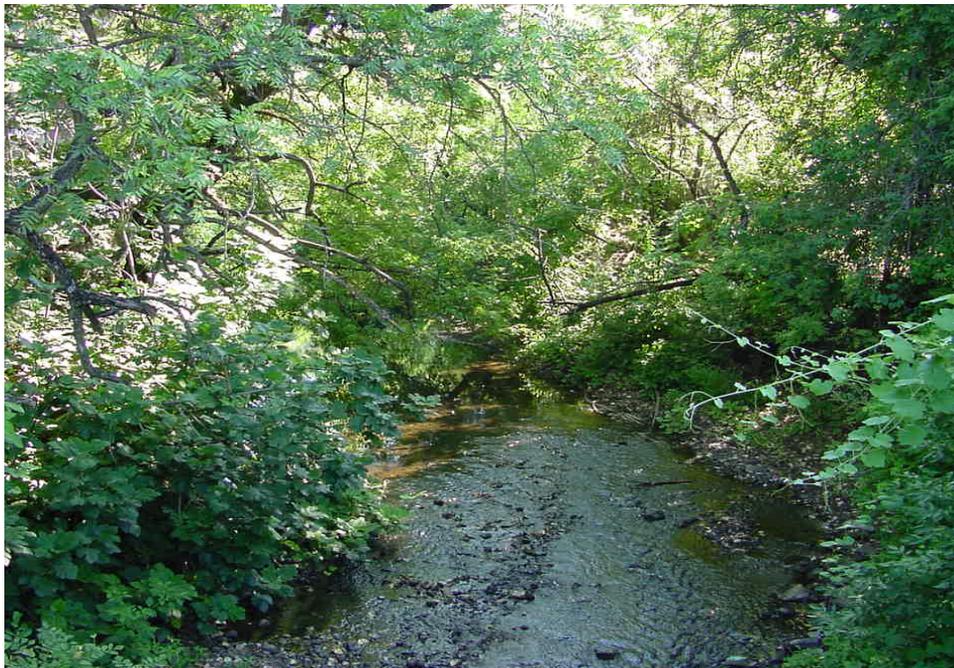
Upstream from Chestnet Street. Heavy overhead growth in channel

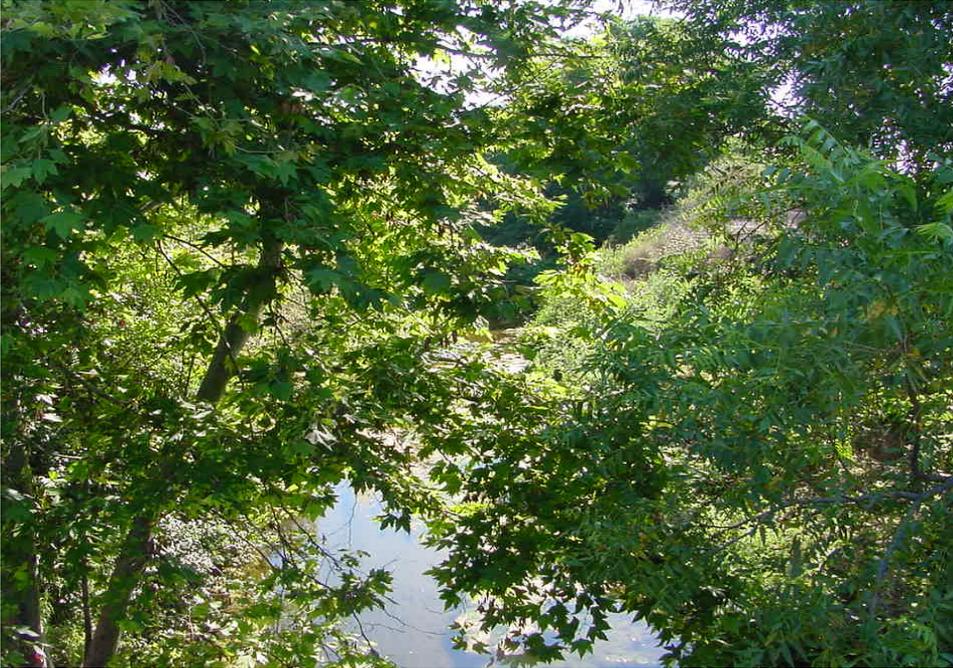
Upstream from Crouch Avenue

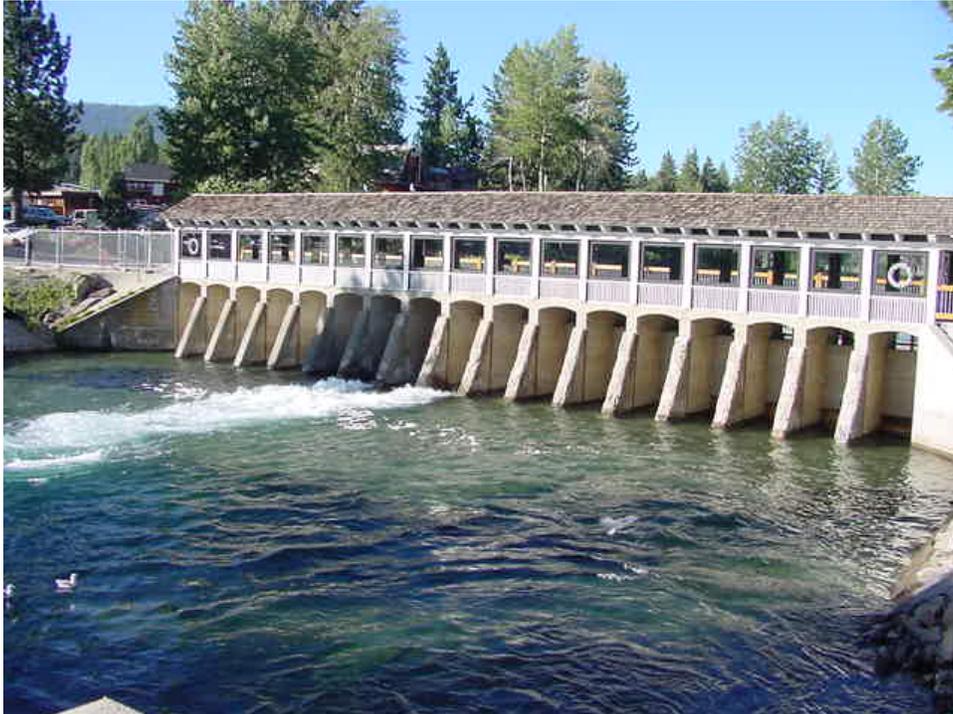
The outlet structure upstream from Highway 89

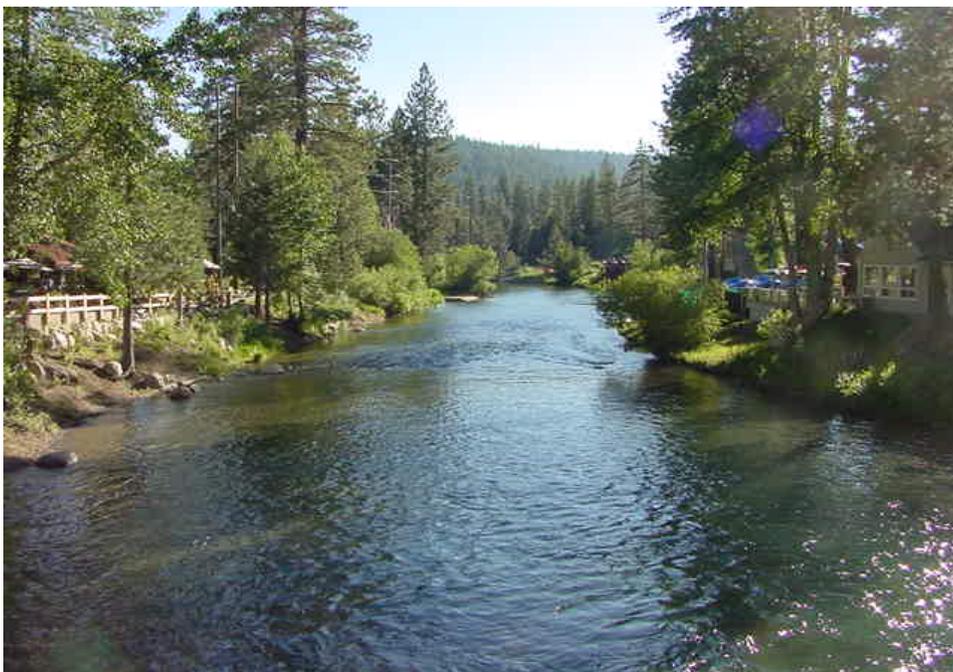
Downstream from Highway 89 bridge

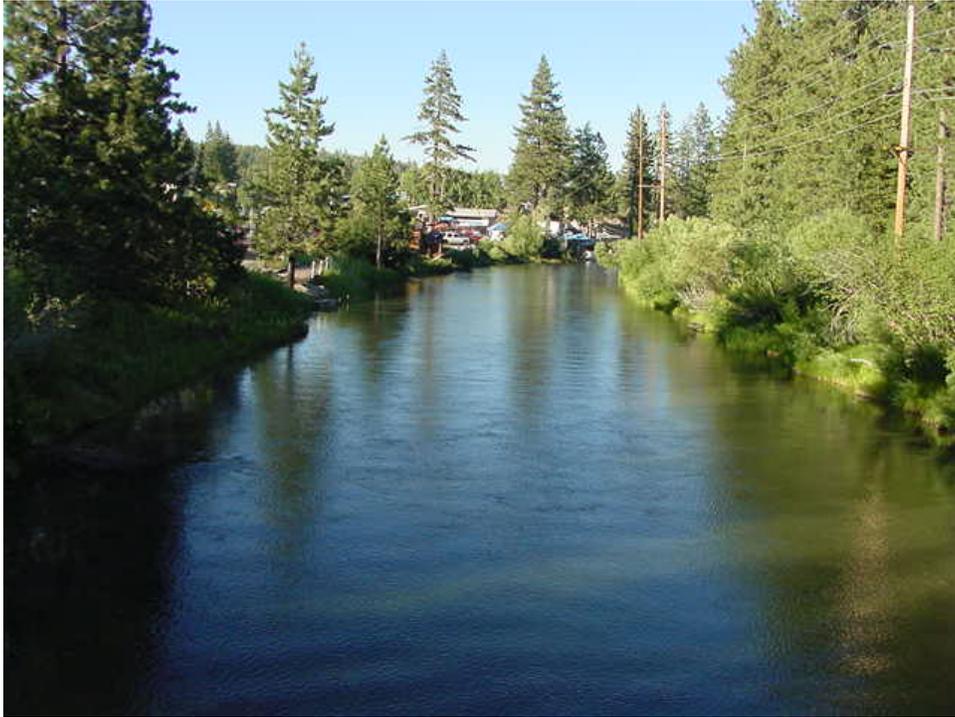
**Upstream from the bike bridge, 1,100 feet
down stream of the Lake Tahoe Outlet Structure**

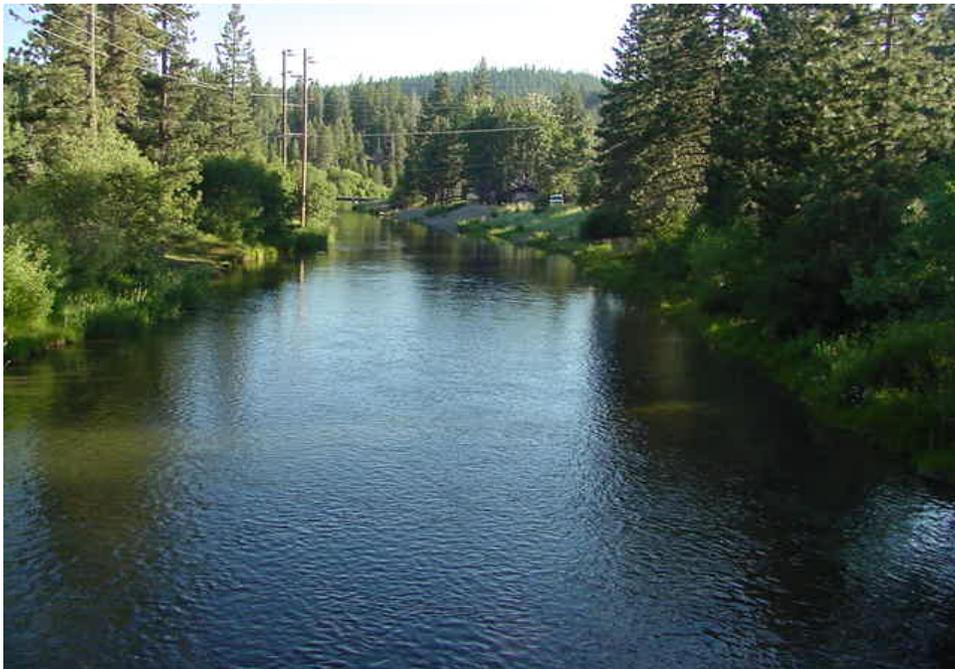
Downstream from the bike bridge

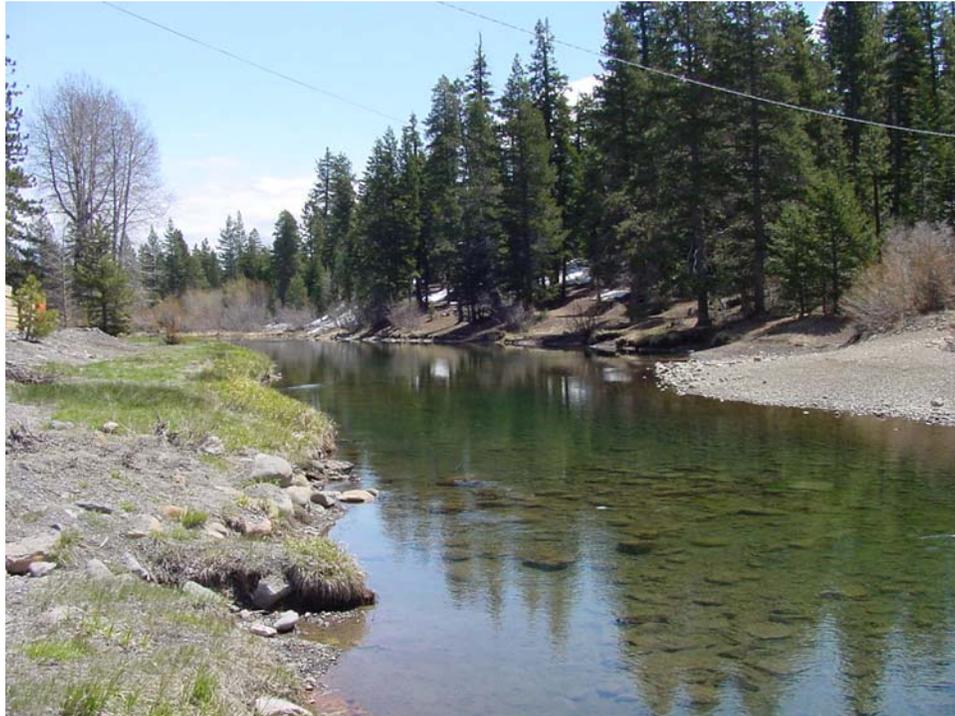
Upstream from the Tahoe City Lumber Yard

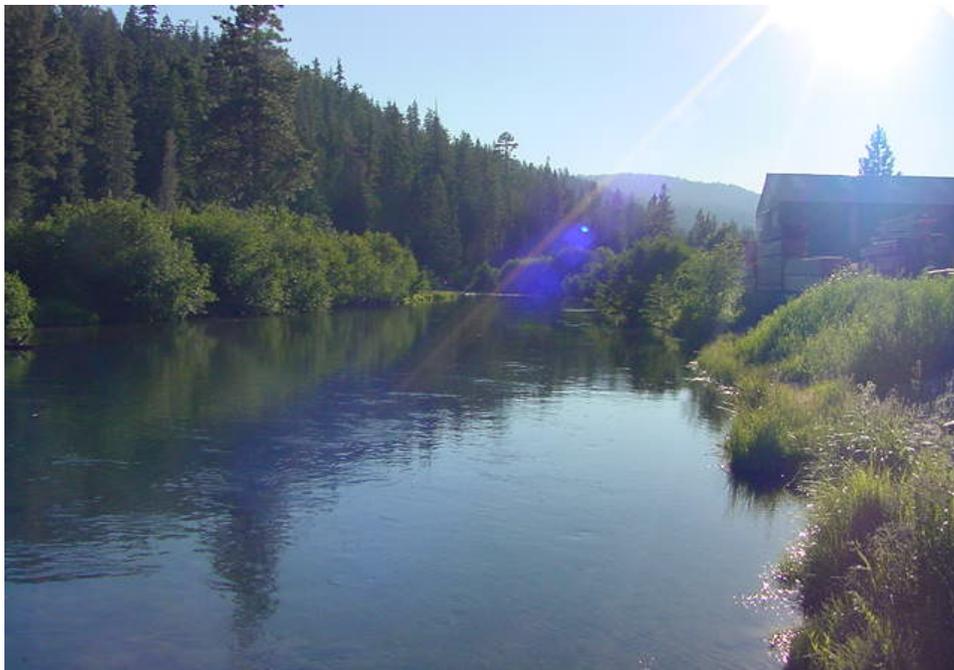
**Downstream from the Tahoe City Lumber Yard
nearing the downstream limit of the project**

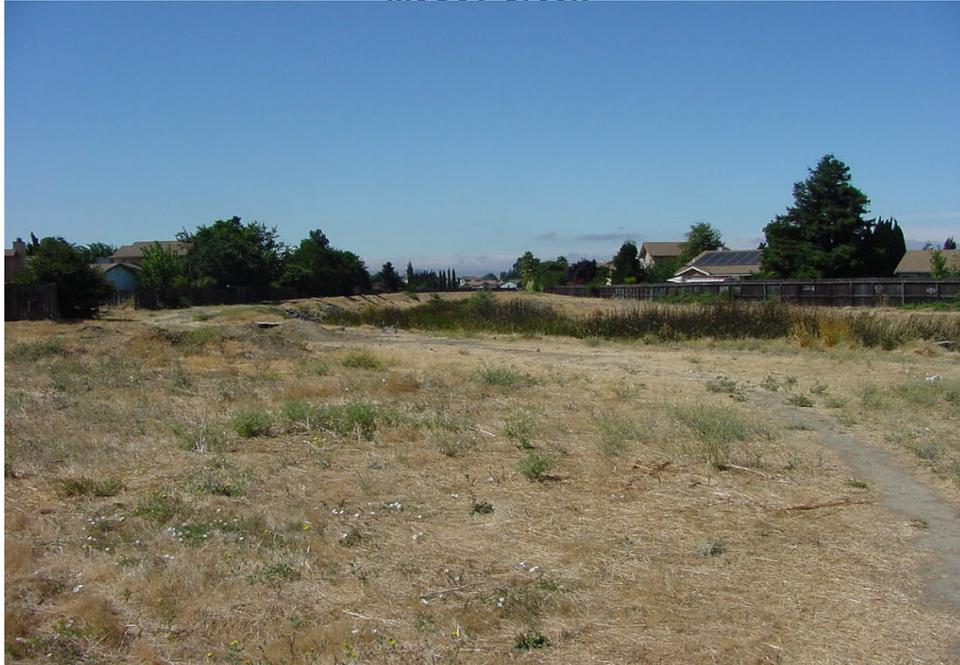
Downstream from Bella Vista Drive

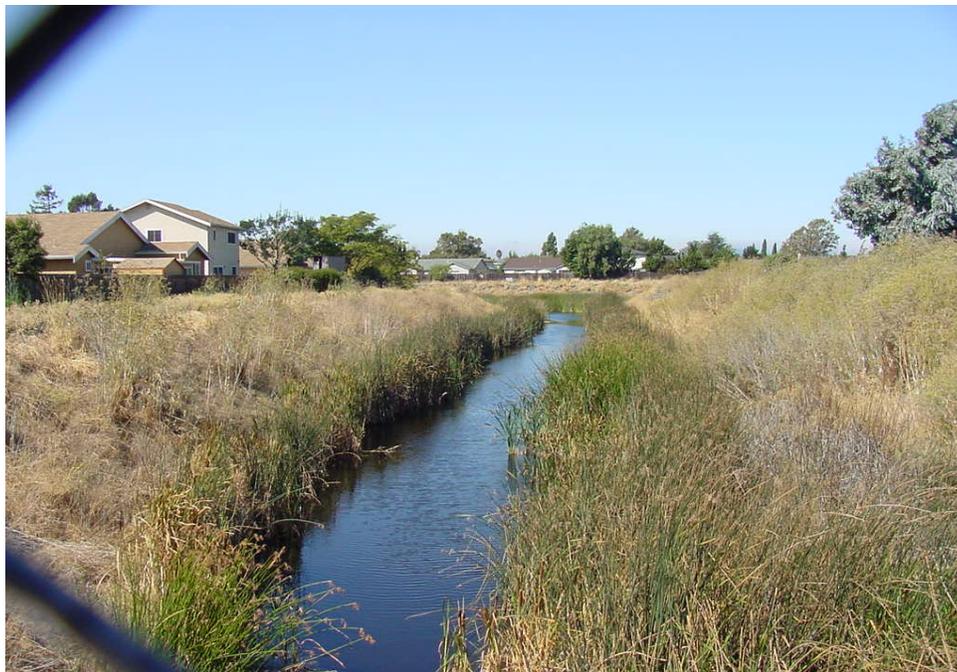
Downstream from Emperor Drive

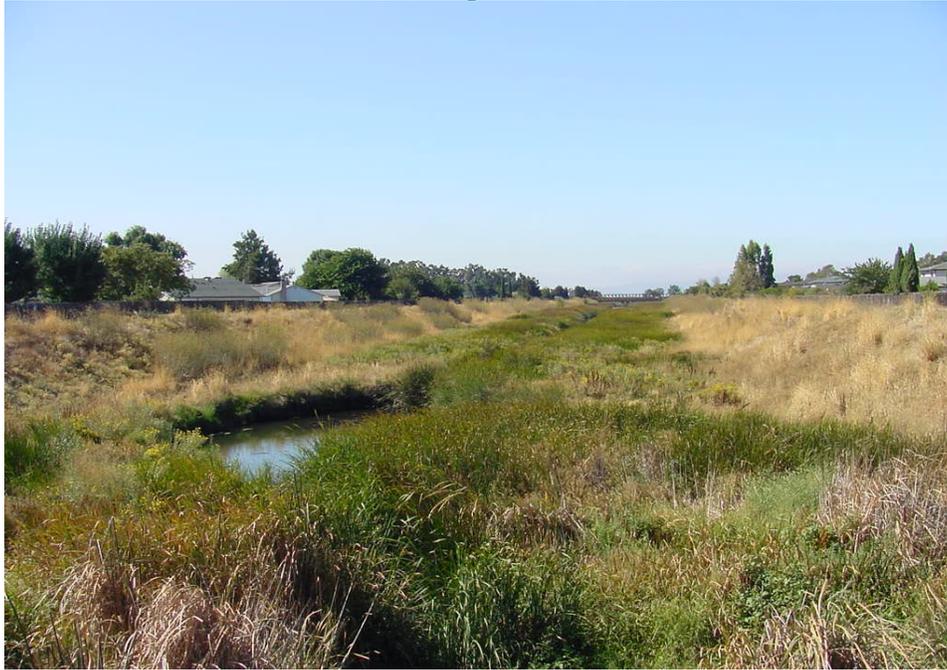
Upstream from Pintail Avenue

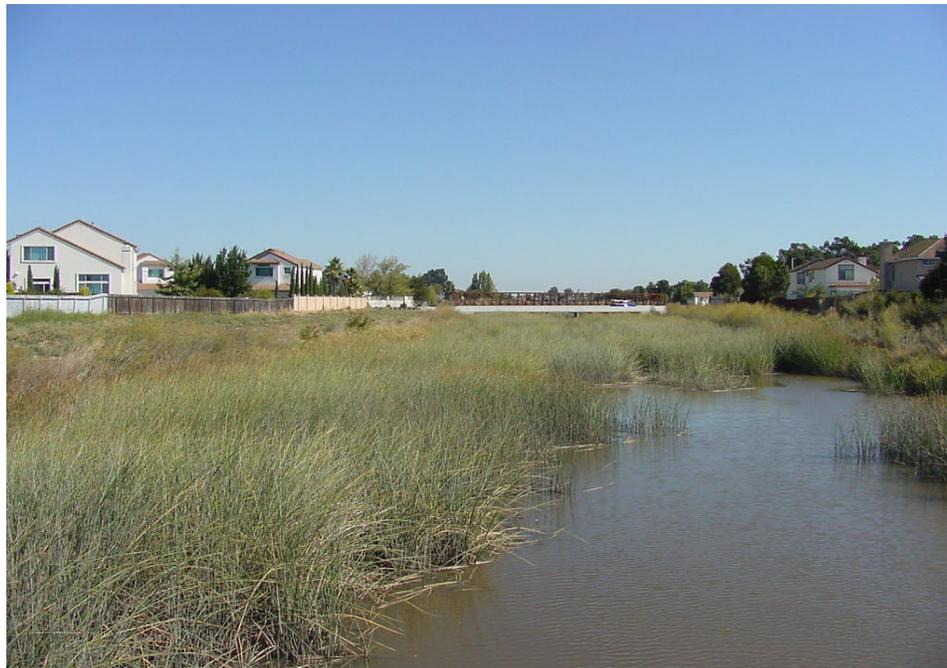
Upstream from Anderson Drive

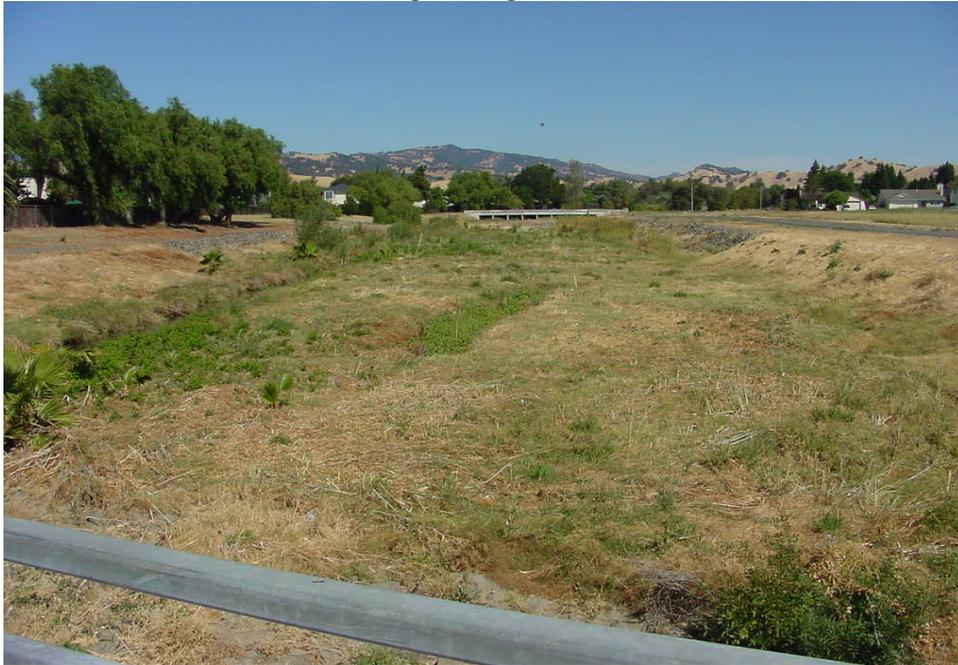
Upstream from Cement Hill Road towards Gulf Drive

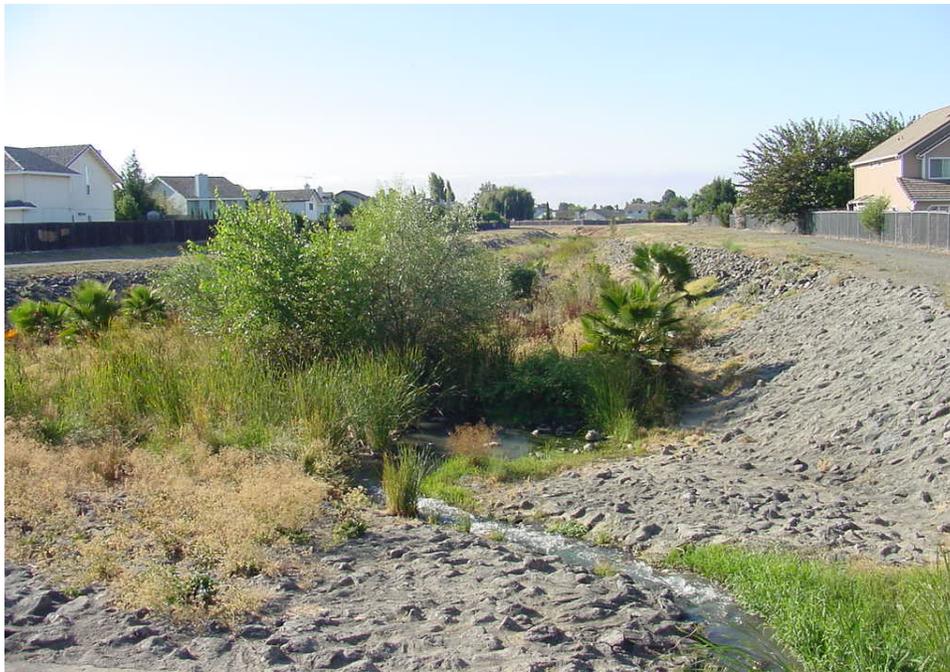
Downstream from Cement Hill Road

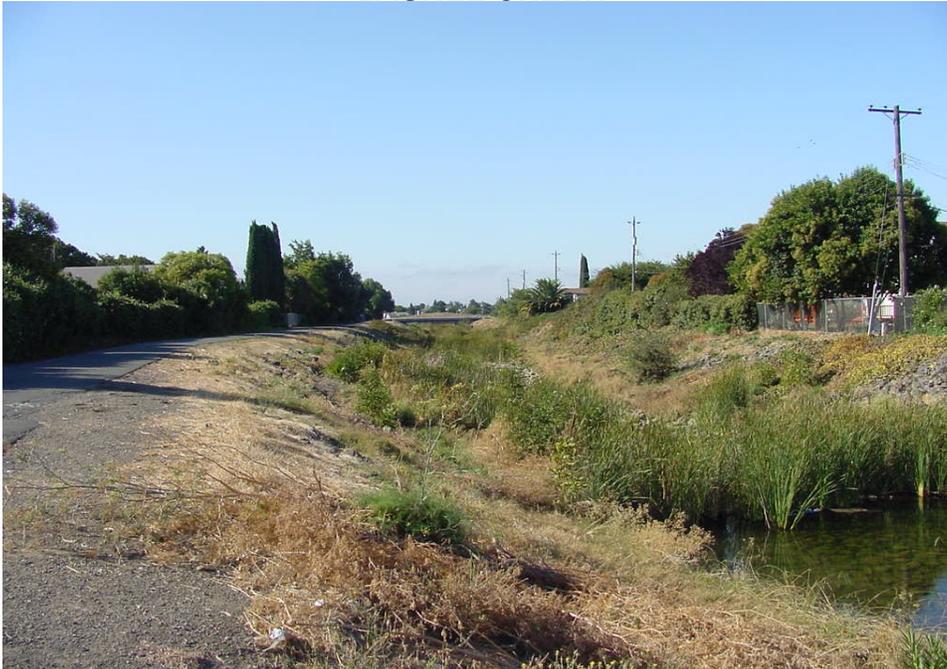
Downstream from Meadowlark Drive

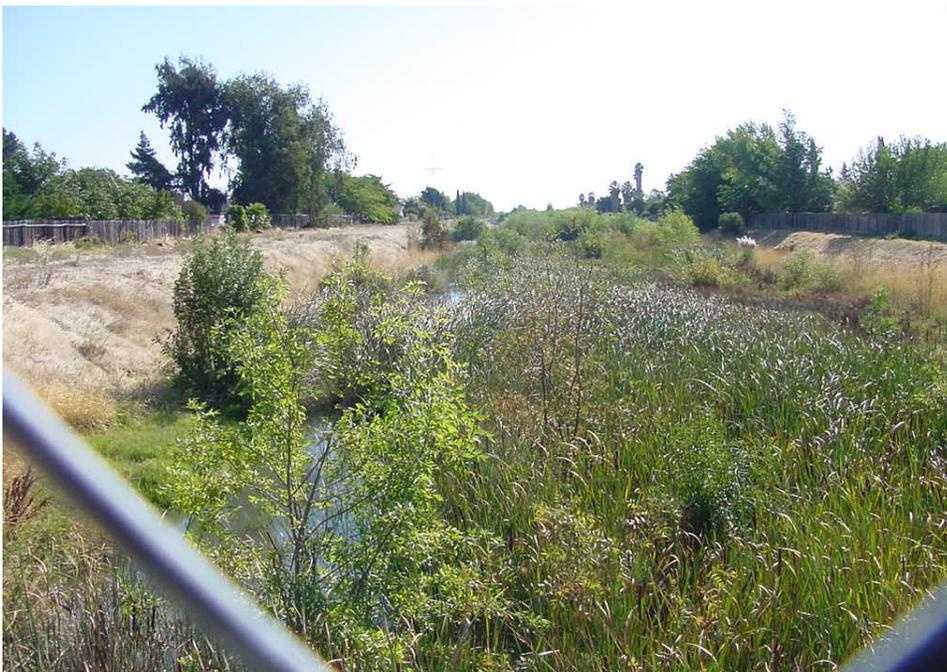
Downstream from Blossom Road

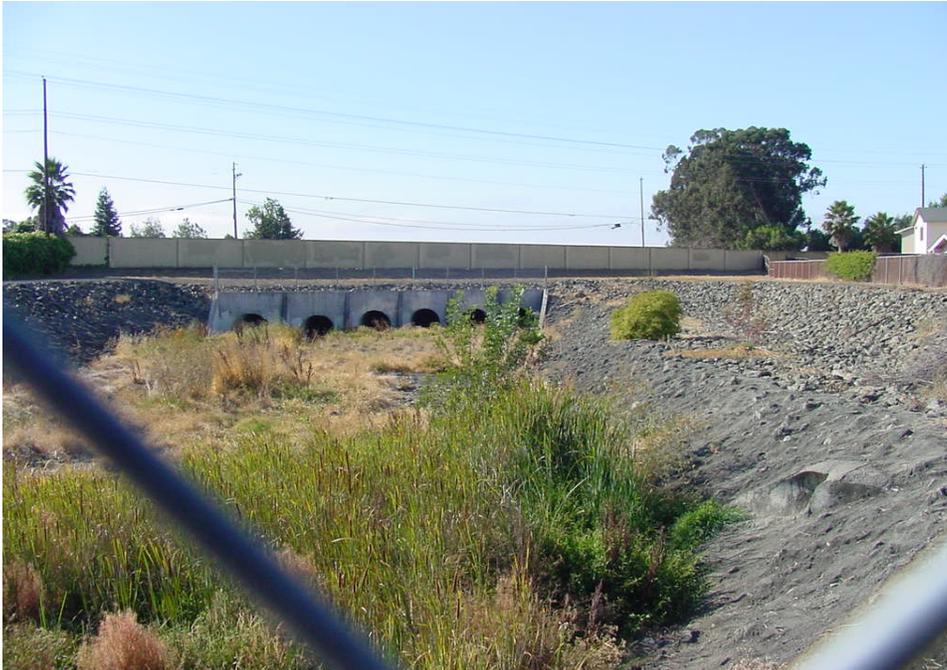
**Downstream from Matthew Road towards
Railroad culvert under crossing**

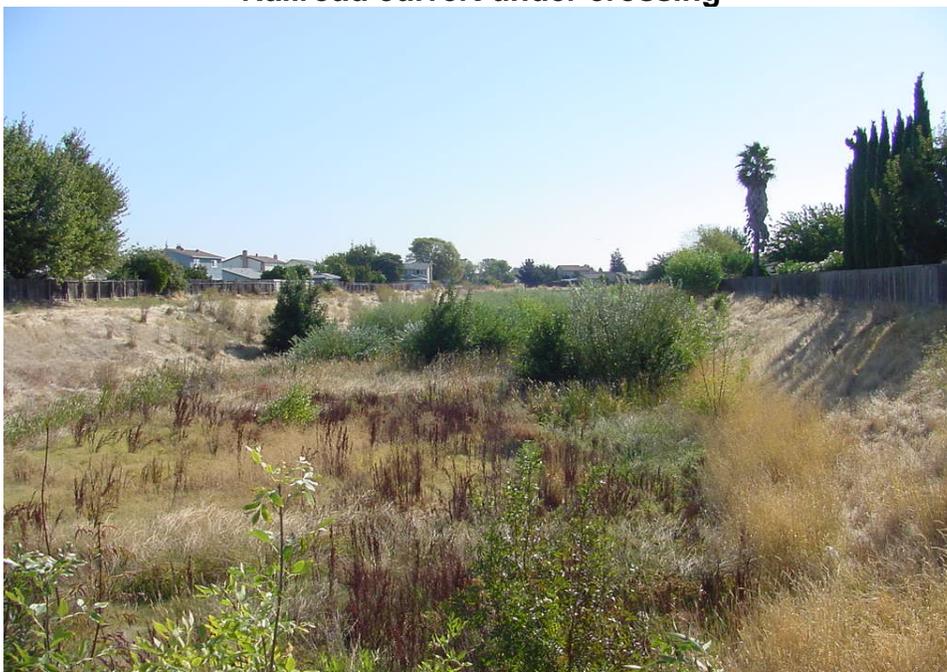
Downstream from Worley Road towards the confluence with McCoy Creek

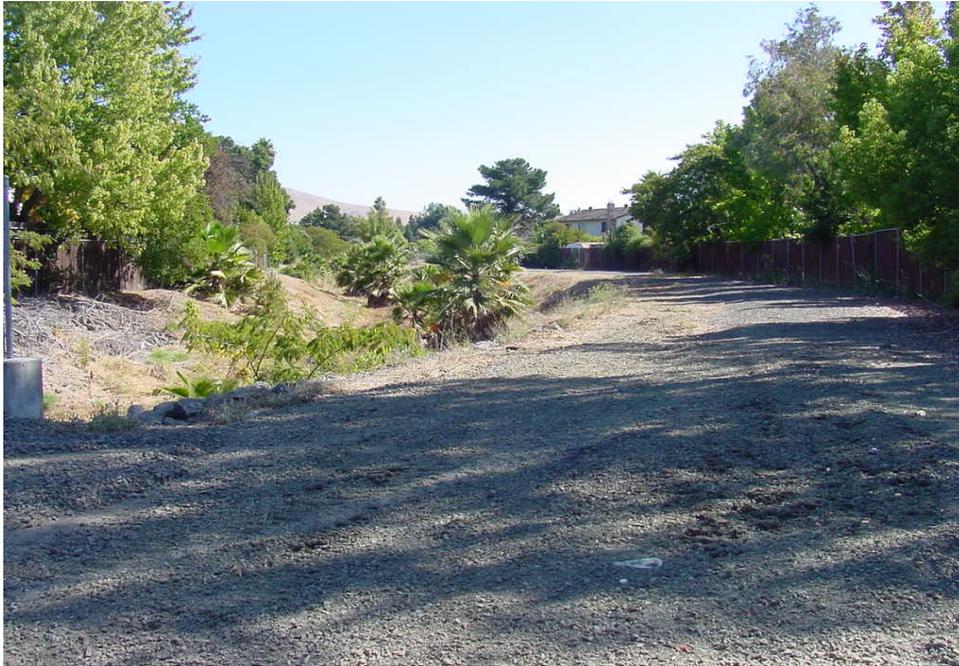
Downstream from North Texas Street

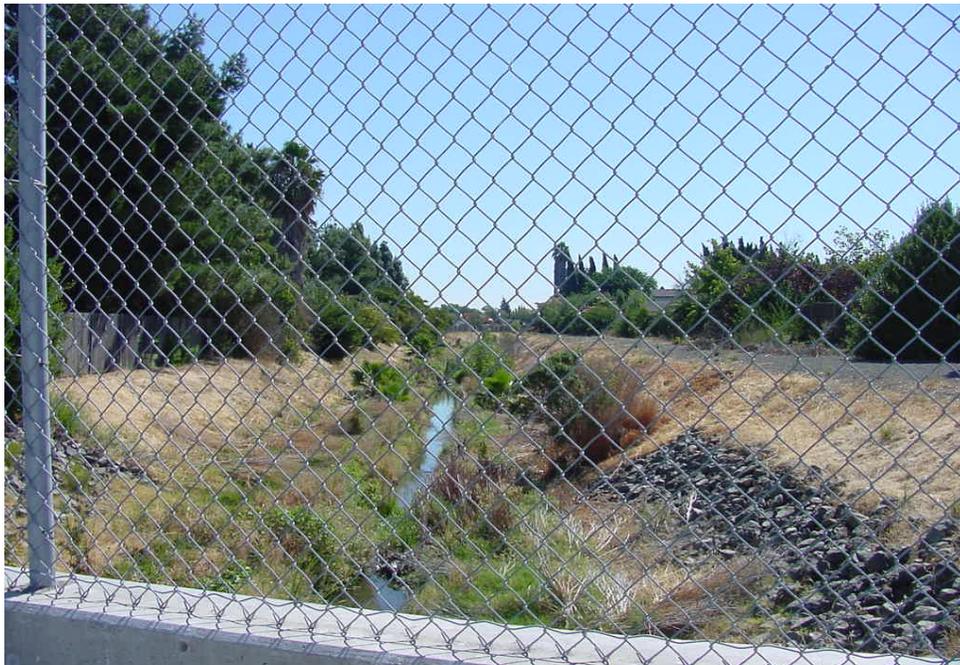
Downstream from Camrose Avenue

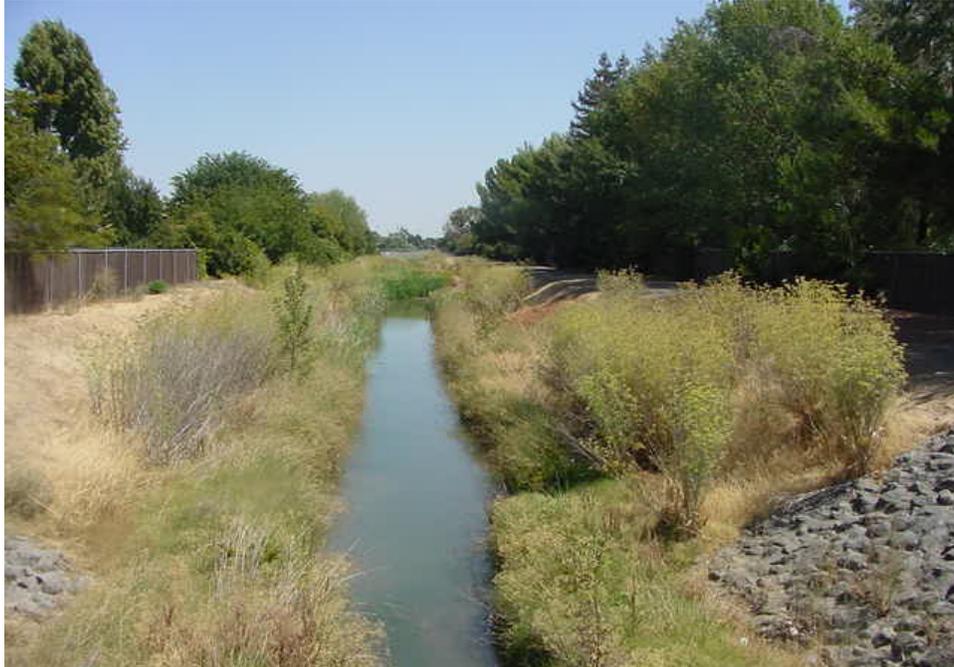
Downstream from Dover Ave

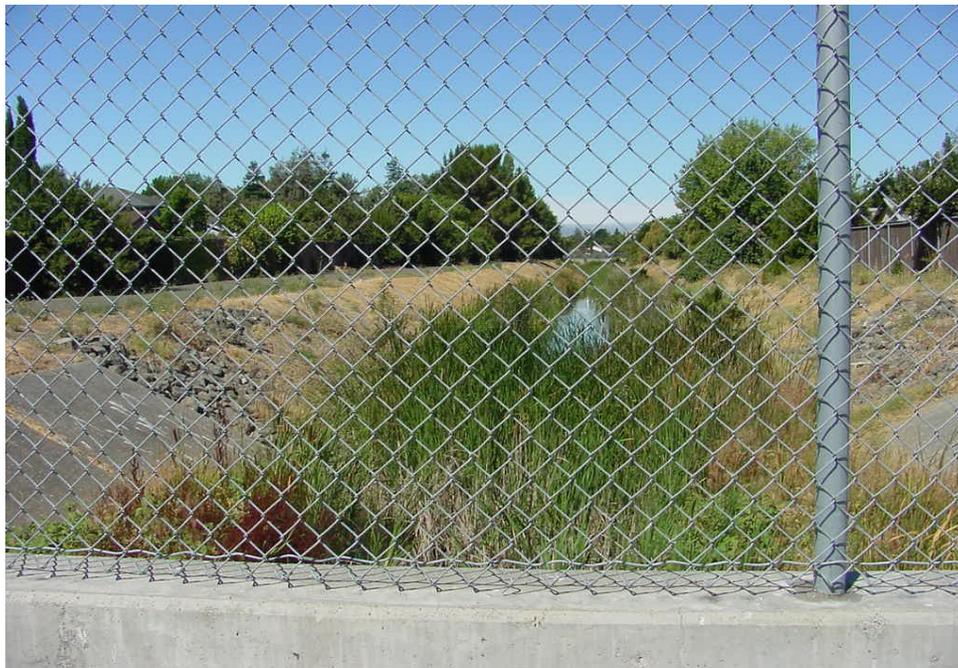
Upstream from the downstream limits at Gulf Drive

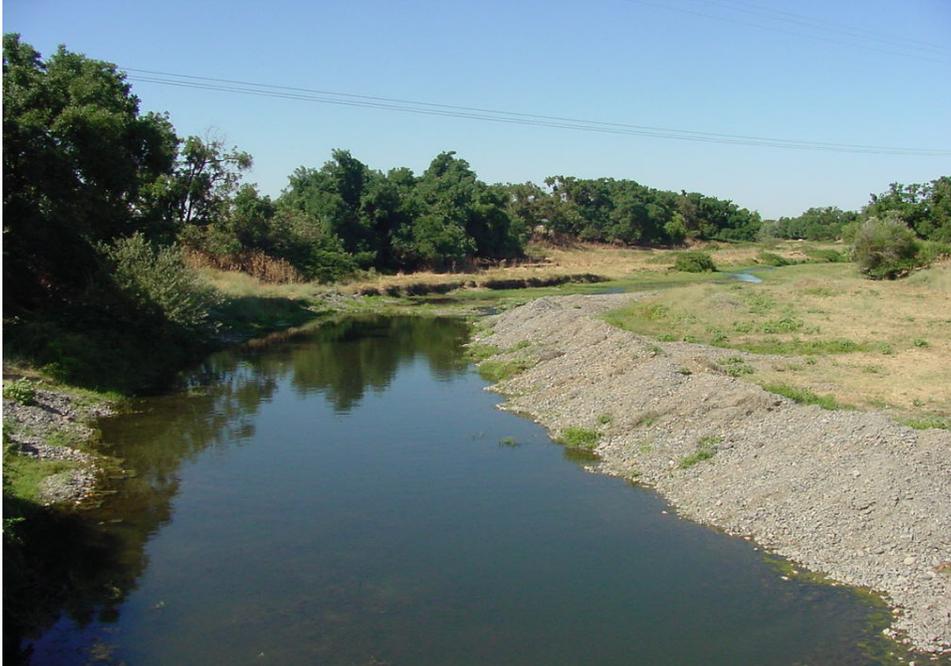
Downstream from 0.5 mile upstream of the Bonner Road bridge

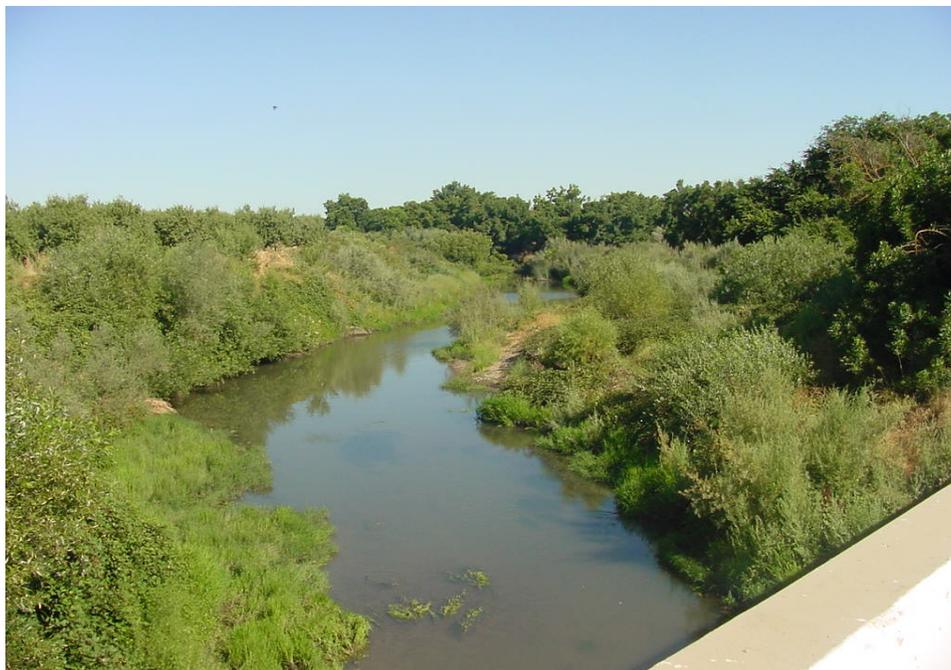
Downstream from Arboleda Drive

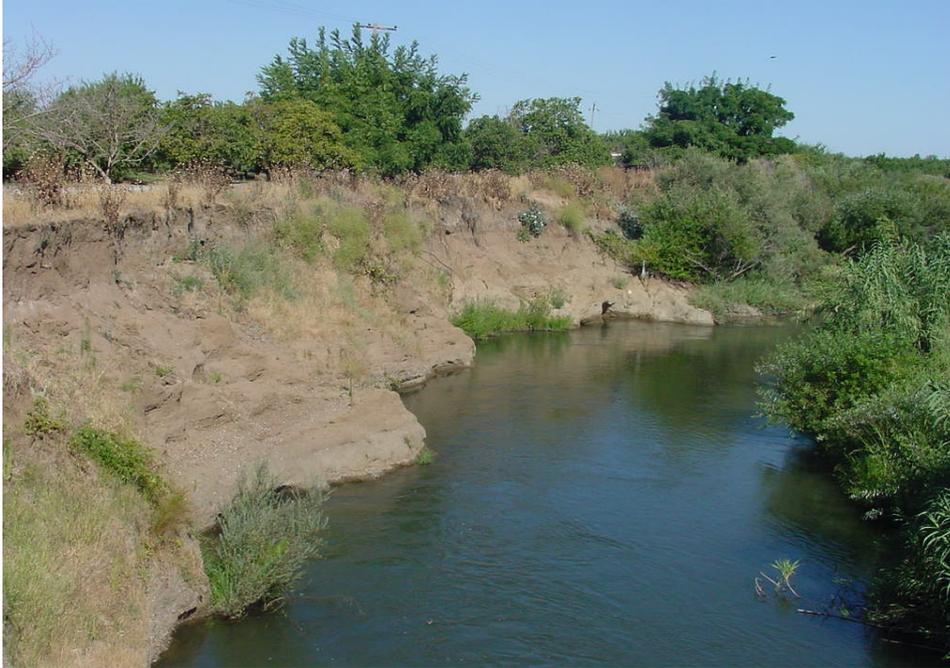
Downstream from Kibby Road

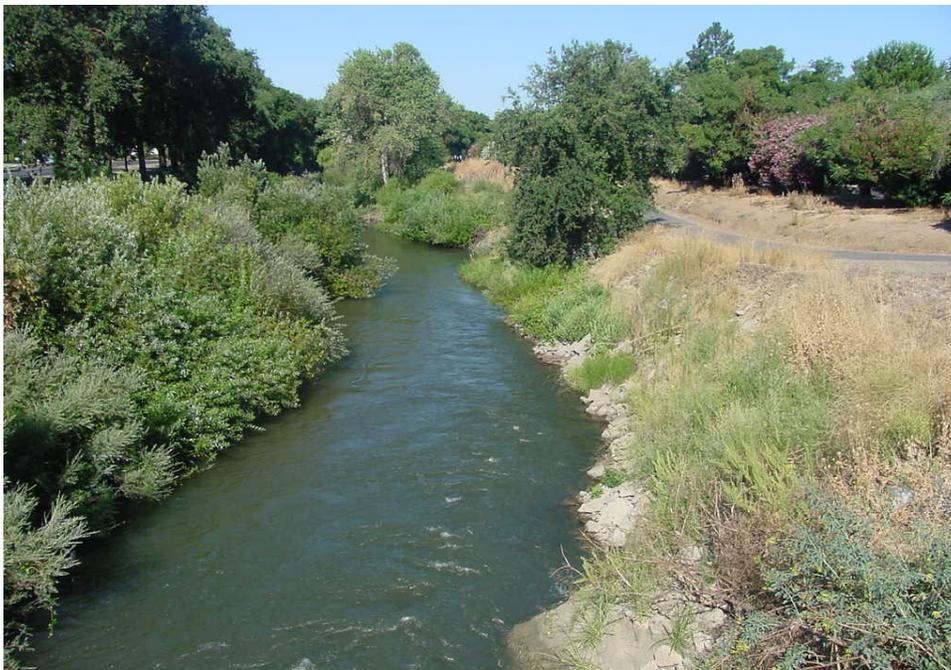
Downstream from McKee Road

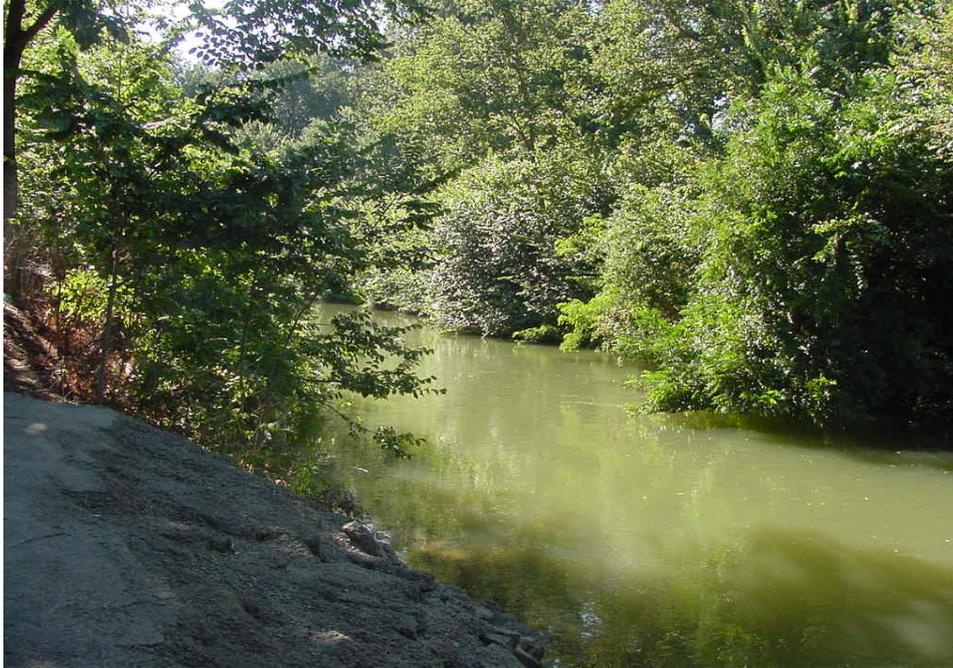
Downstream from "M" Street

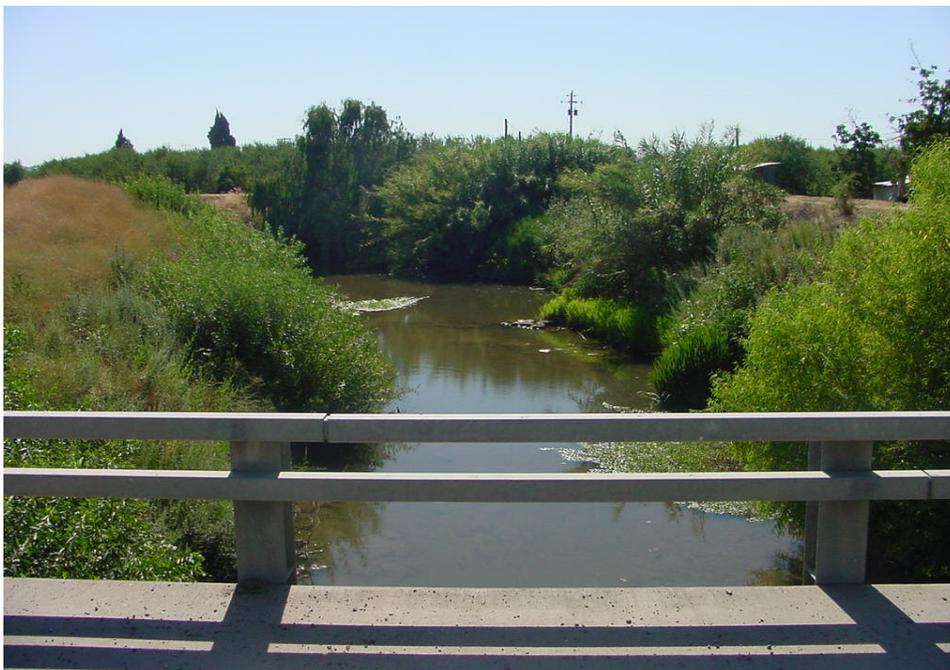
Downstream from Buhach Road

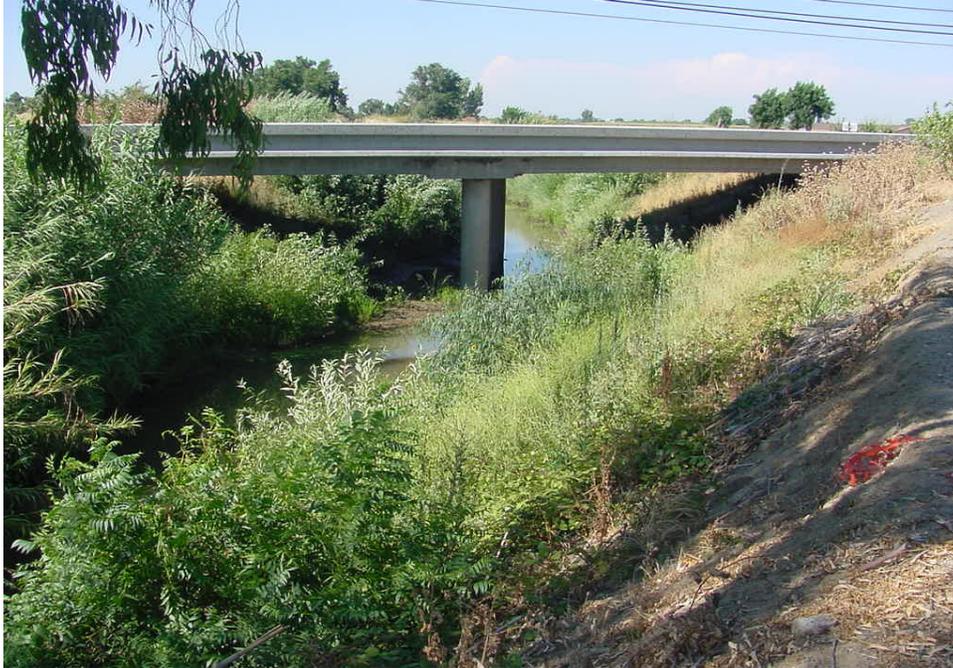
Upstream toward Highway 140

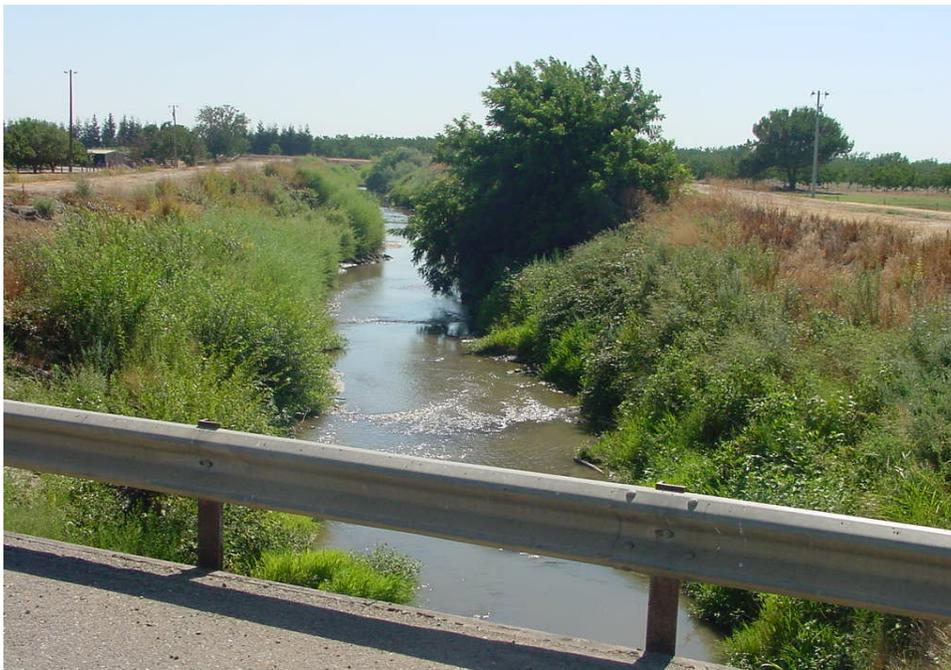
Downstream from Franklin Road

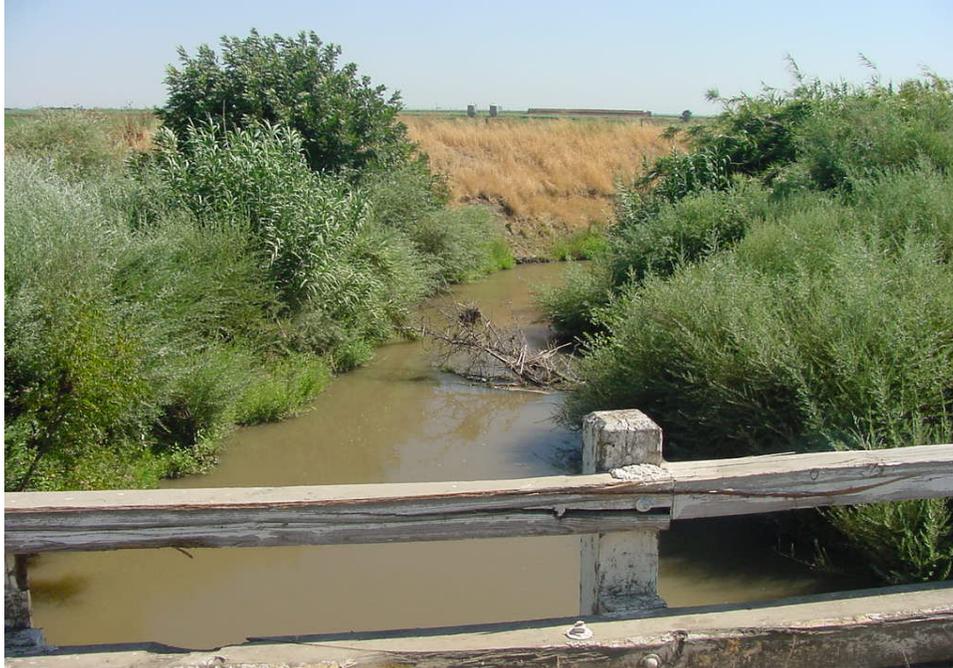
Downstream from Dickerson Ferry Road

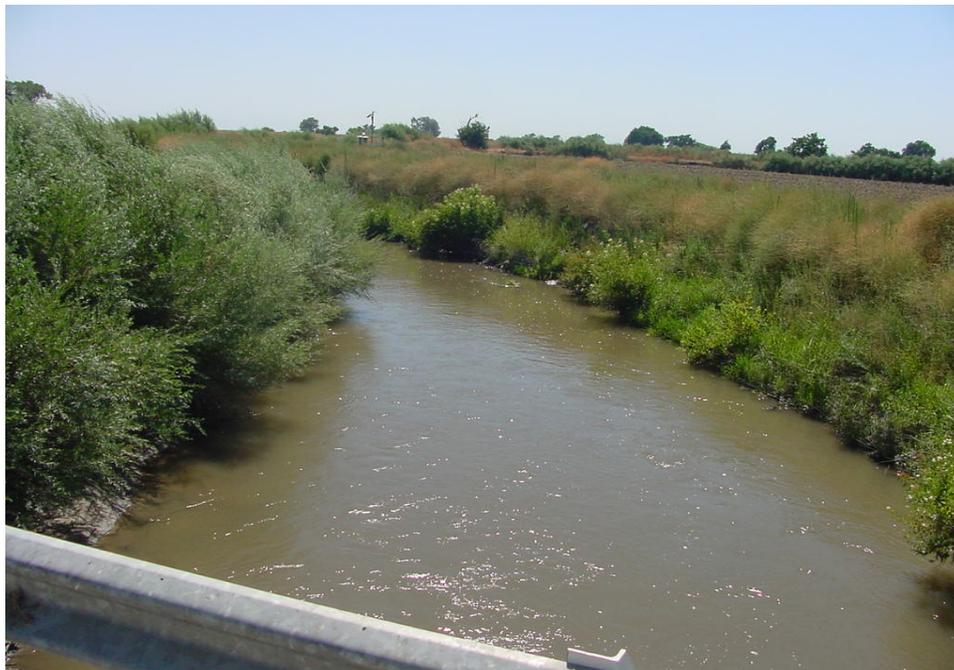
Upstream from Bert Crane Road

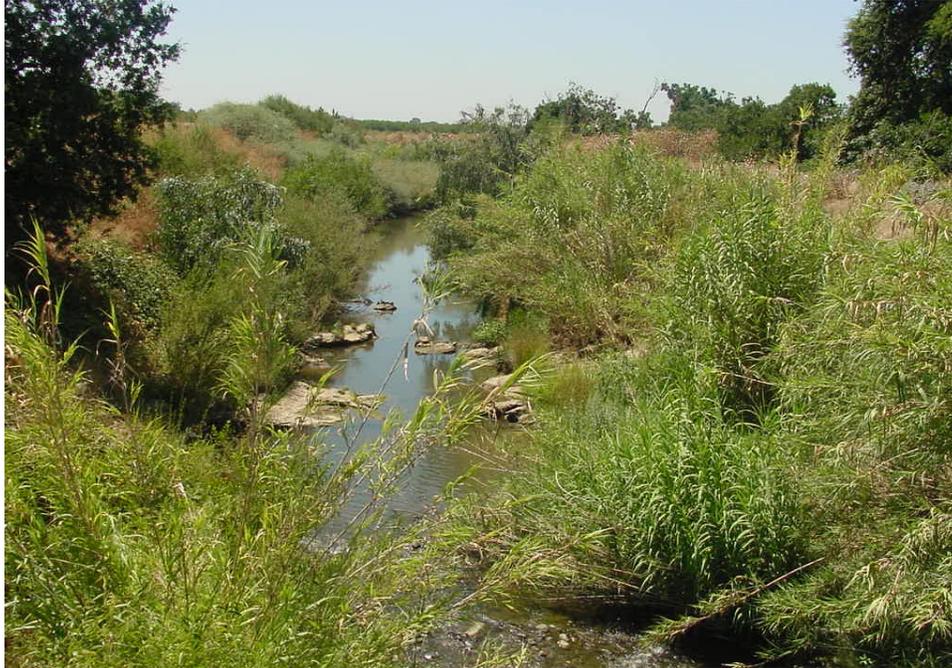
Downstream from the Crocker Dam

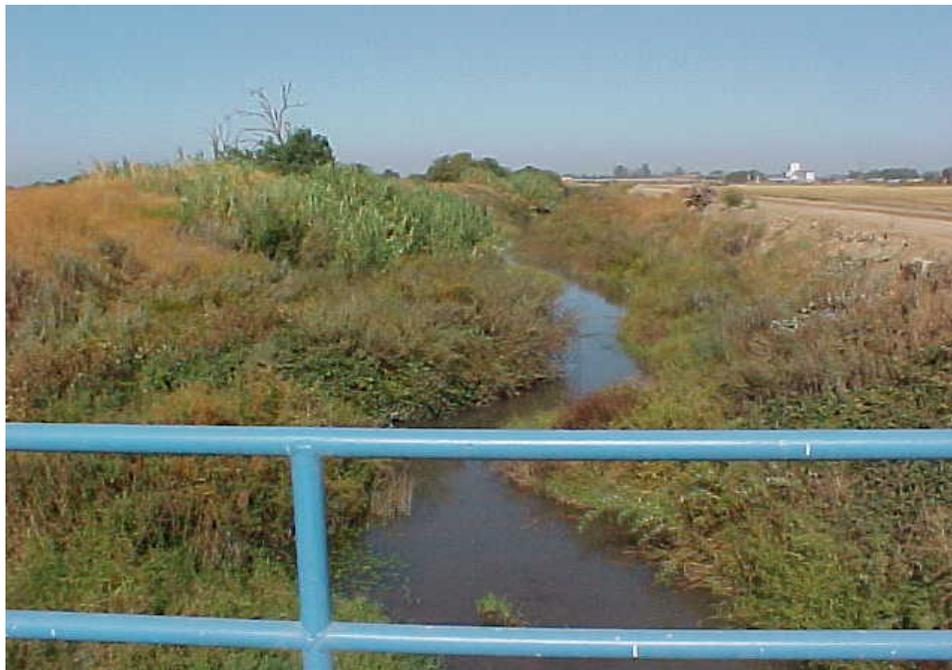
Downstream from Franklin Road
