**State of California
The Resources Agency
DEPARTMENT OF WATER RESOURCES**

**2005
PROJECT CHANNEL REPORT**

**INSPECTION OF
FLOOD CONTROL PROJECT CHANNELS ON THE
SACRAMENTO AND SAN JOAQUIN RIVERS AND
THEIR TRIBUTARIES AND THE TRUCKEE RIVER**

**Prepared By The
Flood Operations Branch
Flood Project Inspection Section**

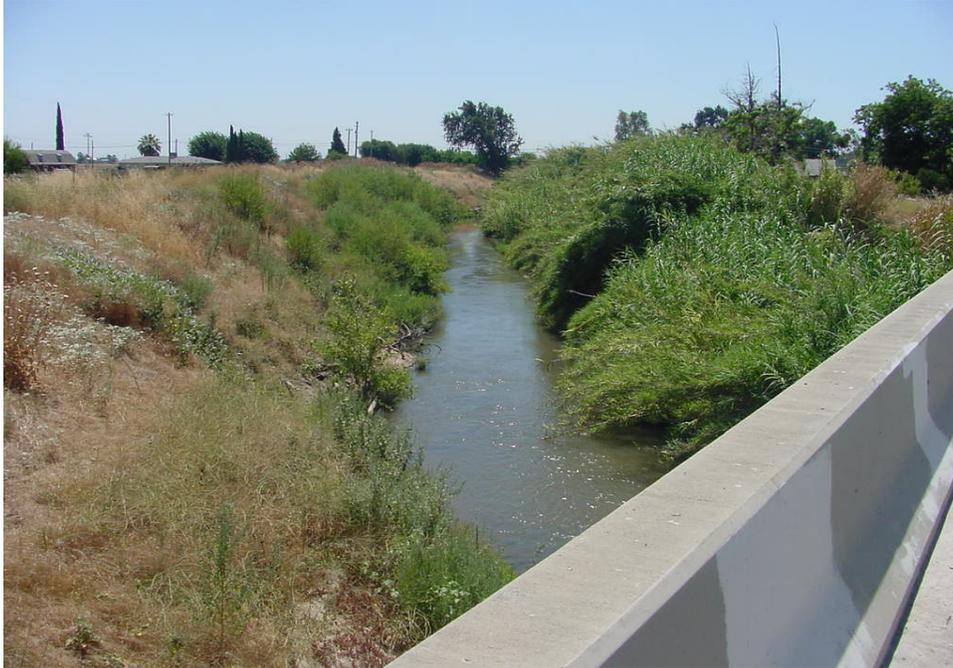
Downstream from Highway 140

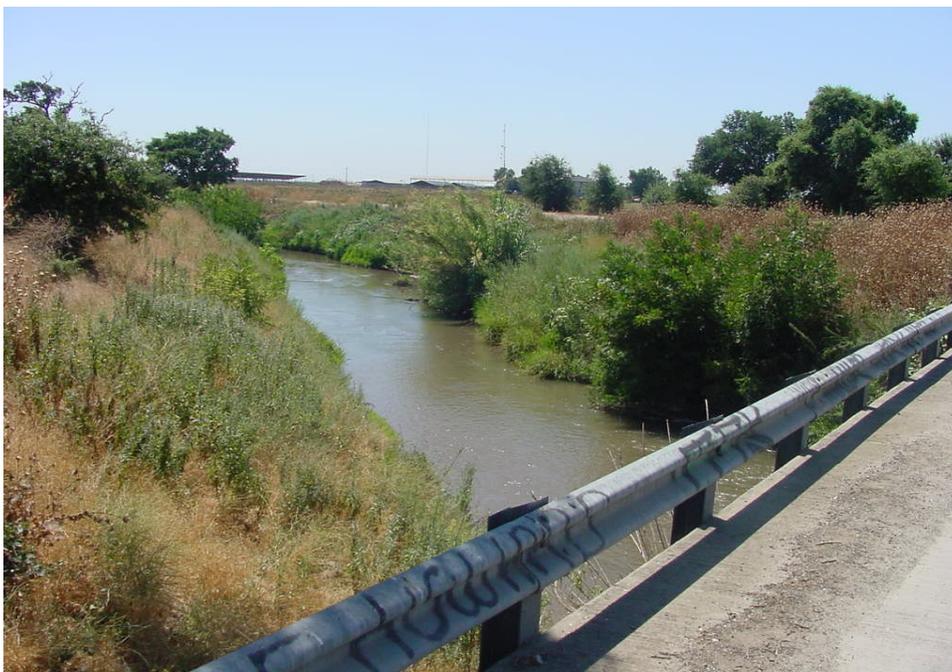
Downstream from Oak Avenue

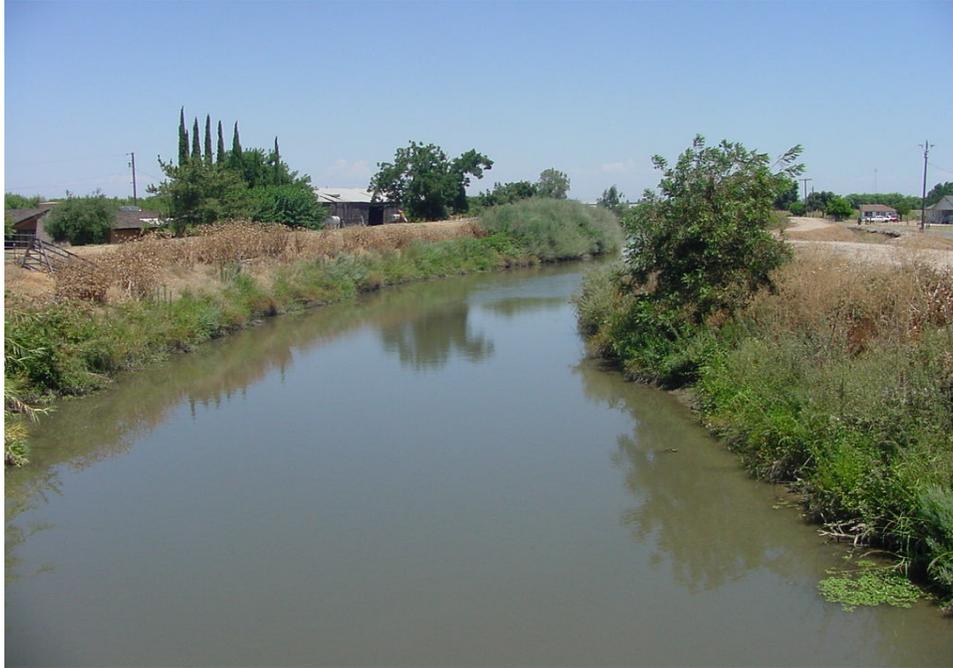
Upstream from Quinley Road

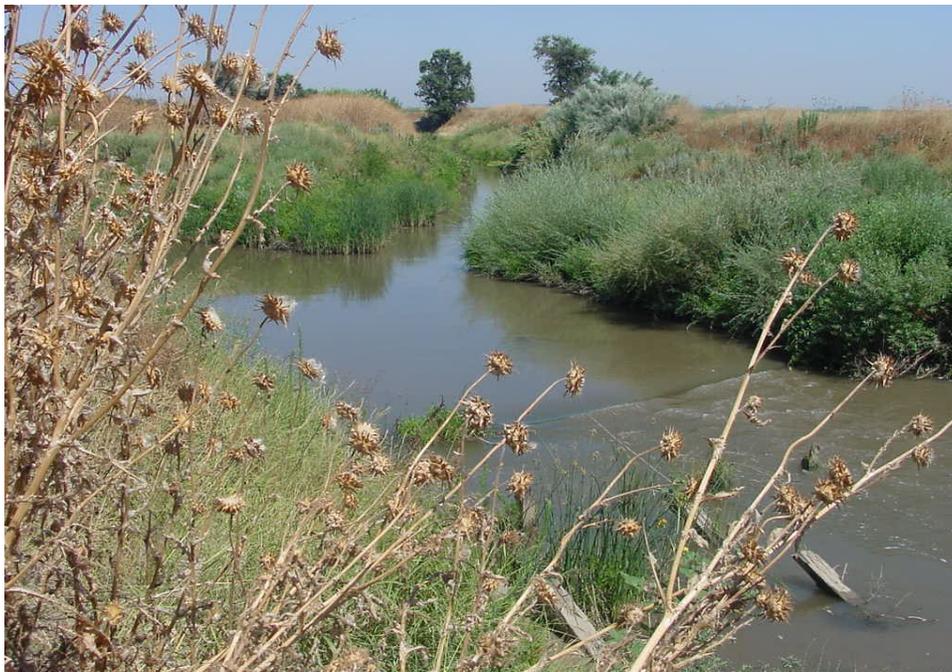
At the confluence of Black Rascal & Bear Creek

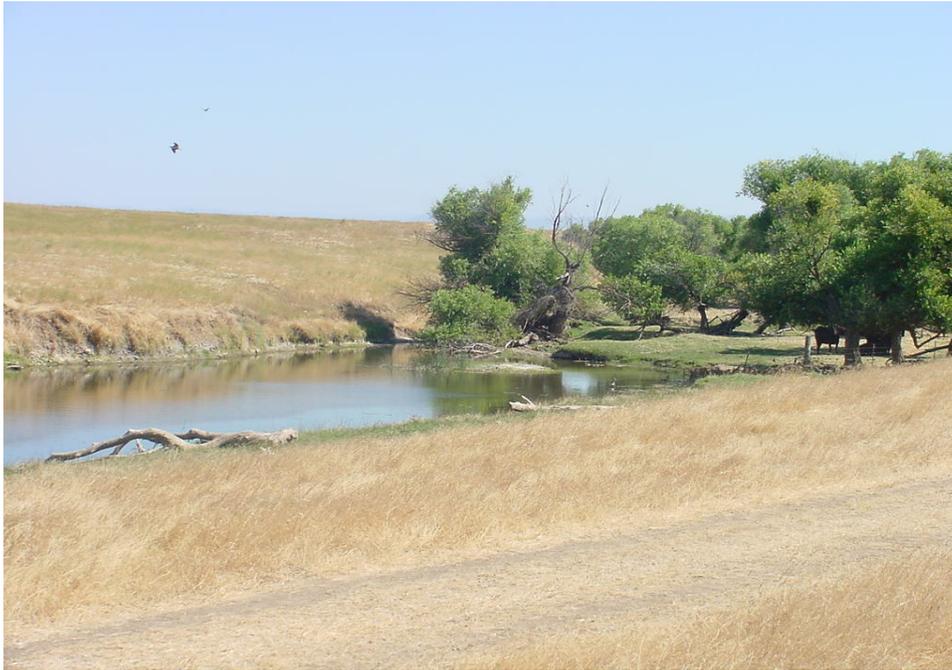
Upstream from Bonner Road on Flying "S" Ranch

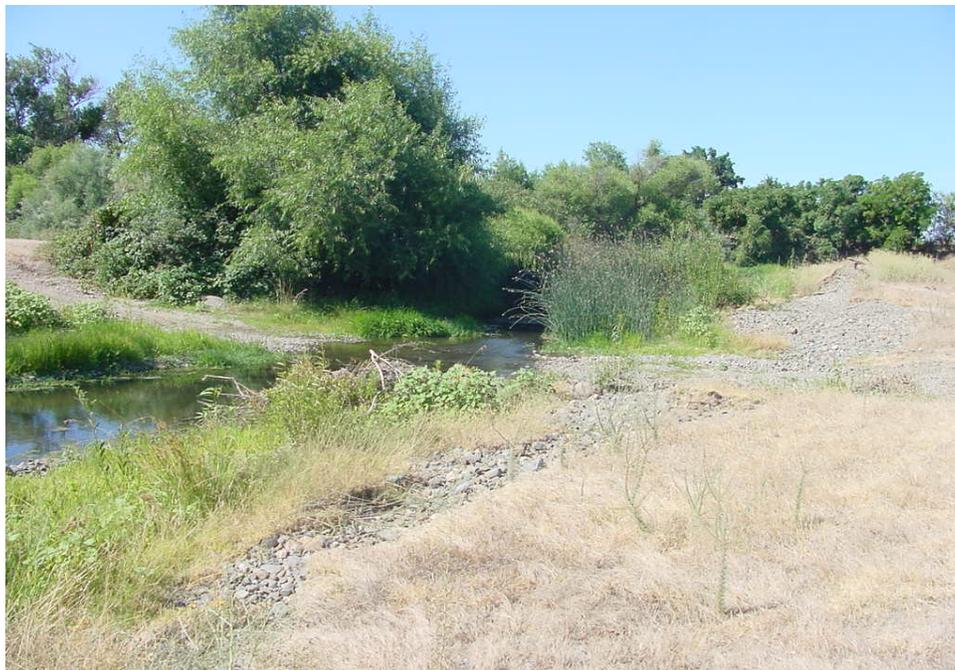
Low water crossing along Burns Creek

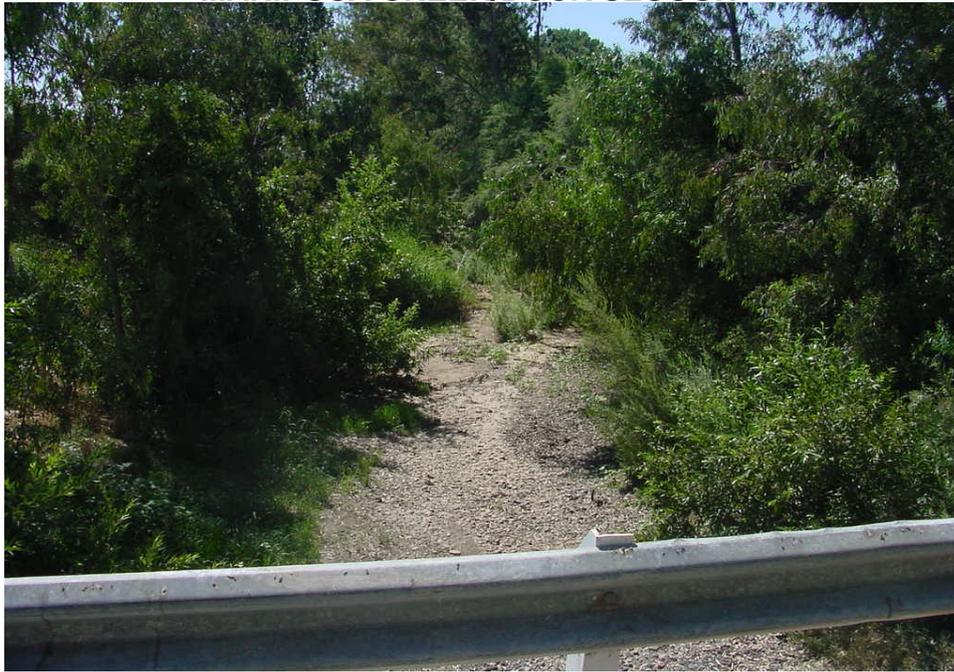
Upstream from Fresno Road

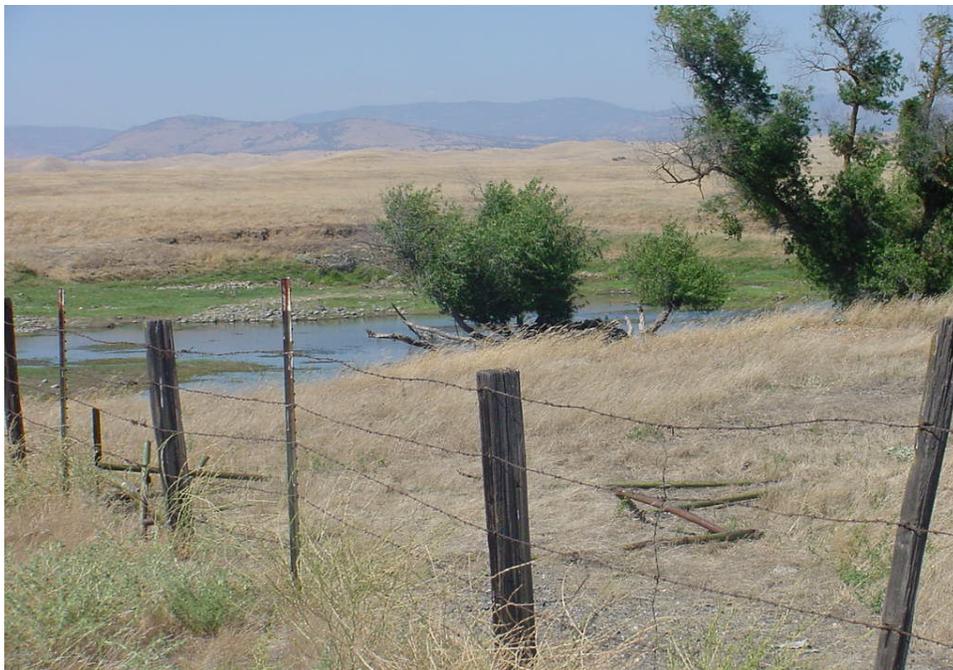
Upstream of White Rock Road

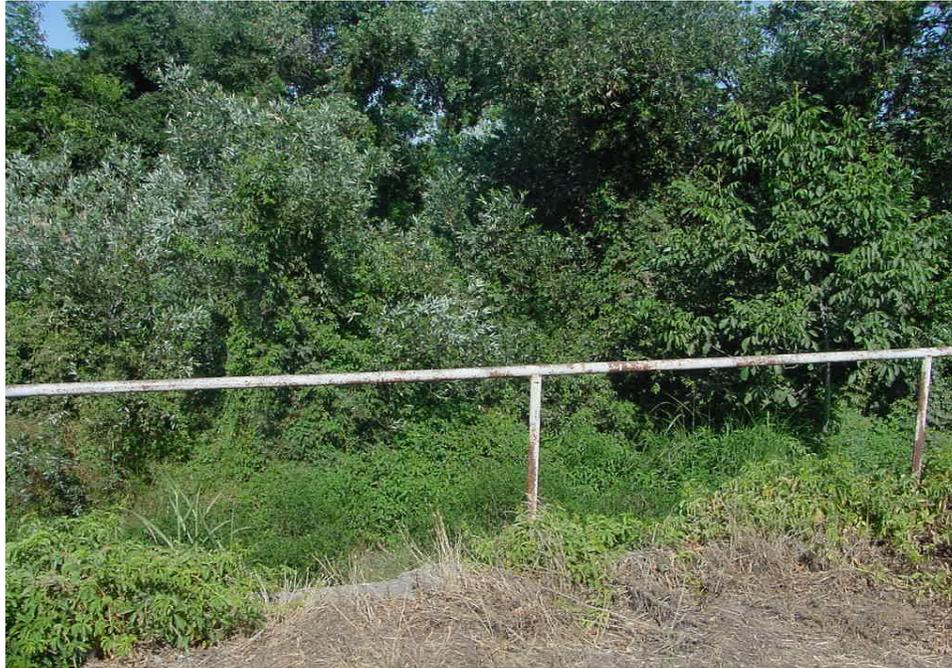
Downstream from Road 9 & Bliss Road (Trees should be removed 100 feet for bridge).
