**State of California  
The Resources Agency  
DEPARTMENT OF WATER RESOURCES**

**2007  
PROJECT CHANNEL REPORT**

**INSPECTION OF  
FLOOD CONTROL PROJECT CHANNELS ON THE  
SACRAMENTO AND SAN JOAQUIN RIVERS AND  
THEIR TRIBUTARIES AND THE TRUCKEE RIVER**

**Prepared By The  
Flood Operations Branch  
Flood Project Inspection Section**

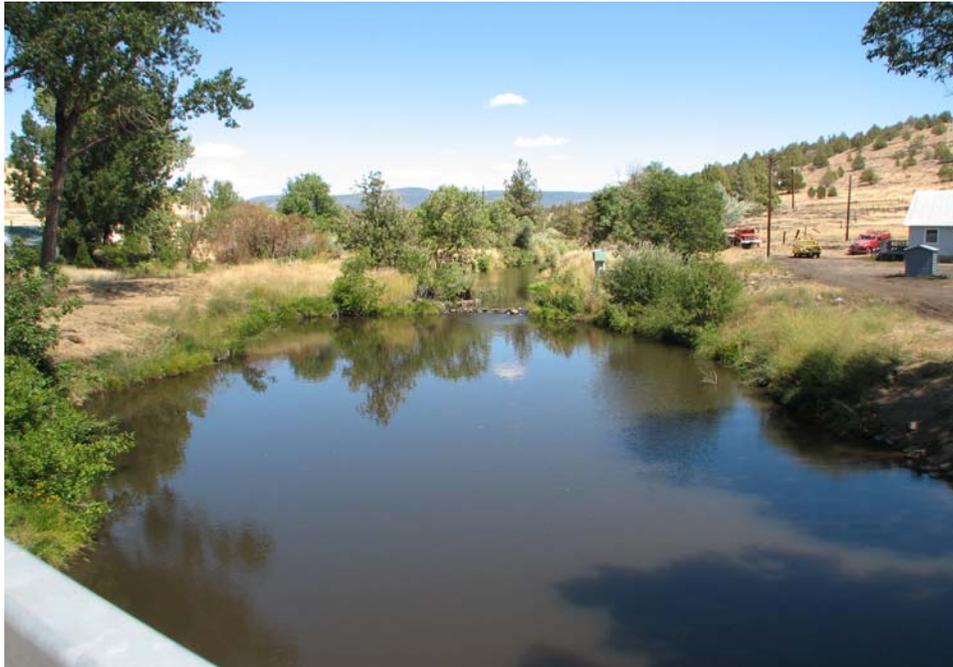
**Upstream from Main Street (Highway 299) towards the gauging station**

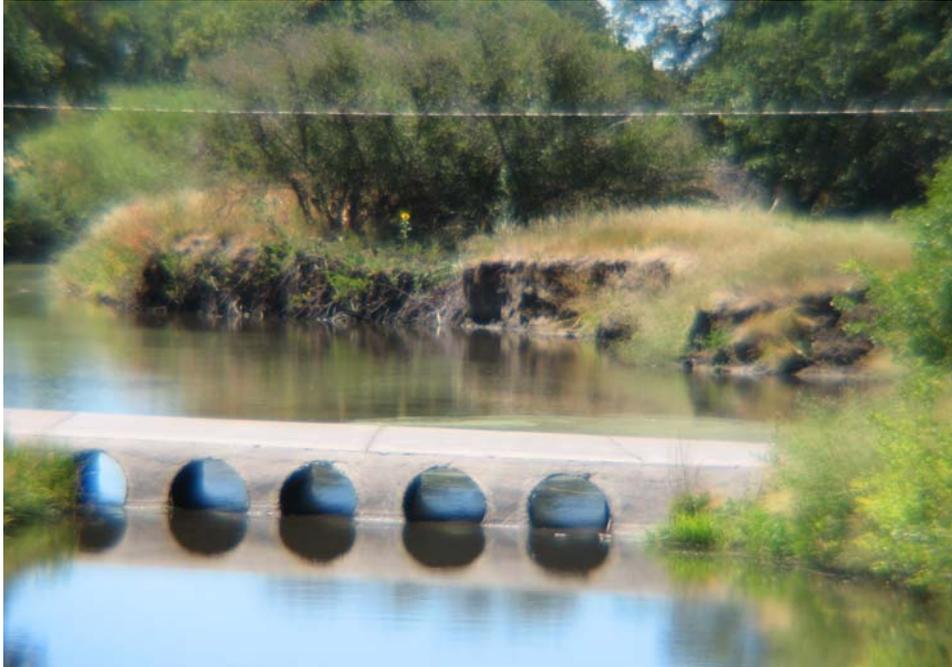
**Downstream from Ash Street, moderate tree growth and bank erosion**

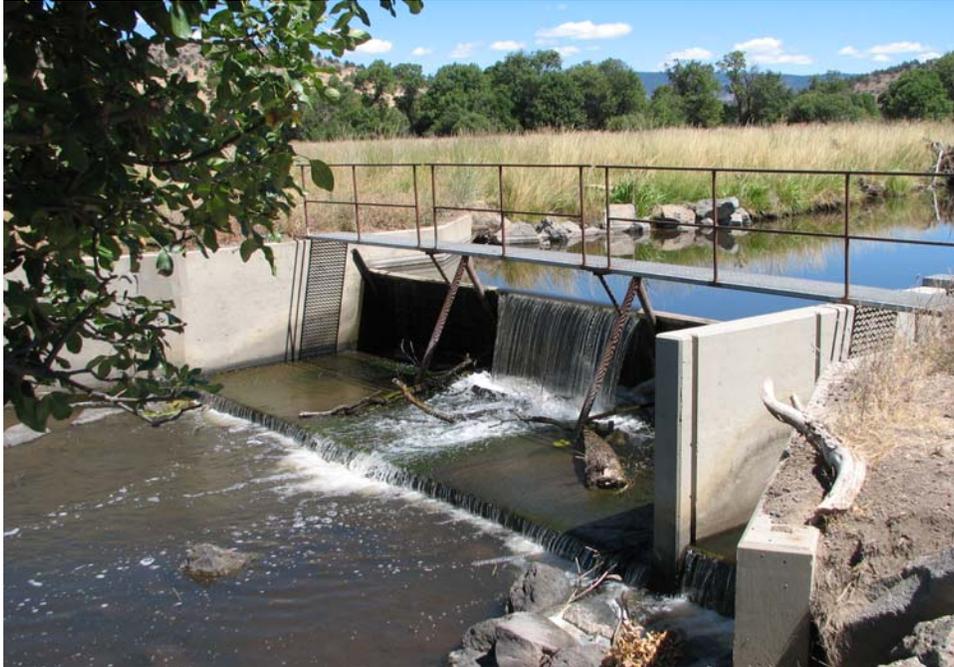
**Upstream from the downstream limit**

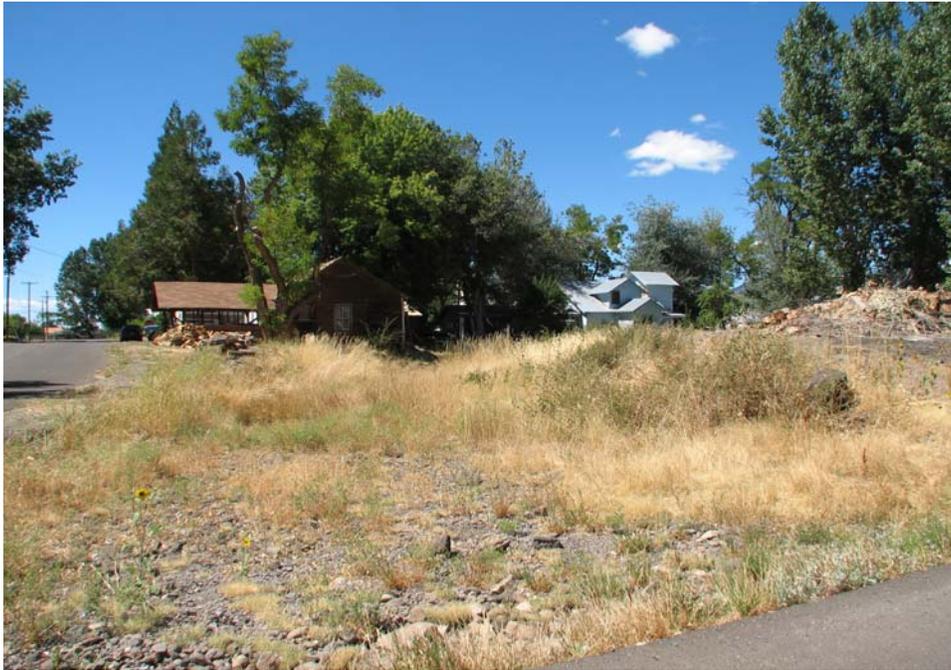
**Downstream at Cedar Street moderate growth in channel**

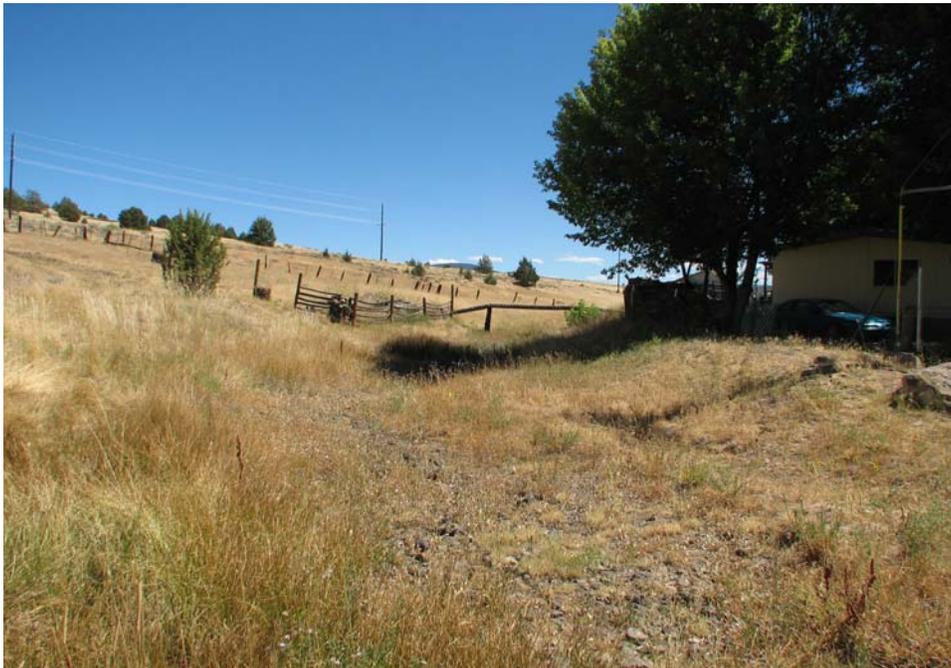
**Upstream at Cedar Street growth in channel**

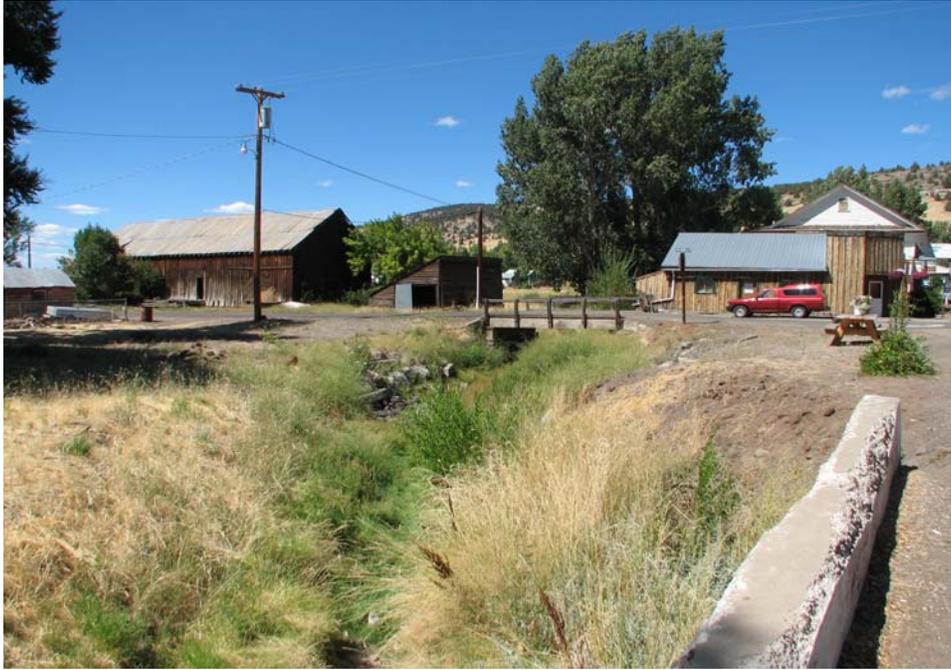
**Downstream from Main Street (Highway 299), moderate growth in channel**

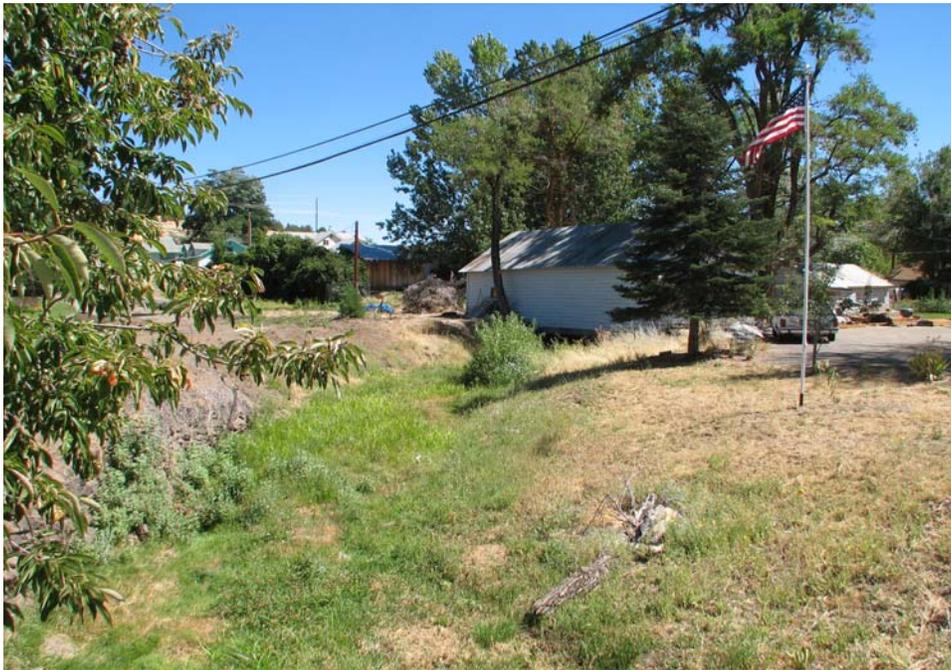
**Upstream from Main street (highway 299), moderate growth in channel**

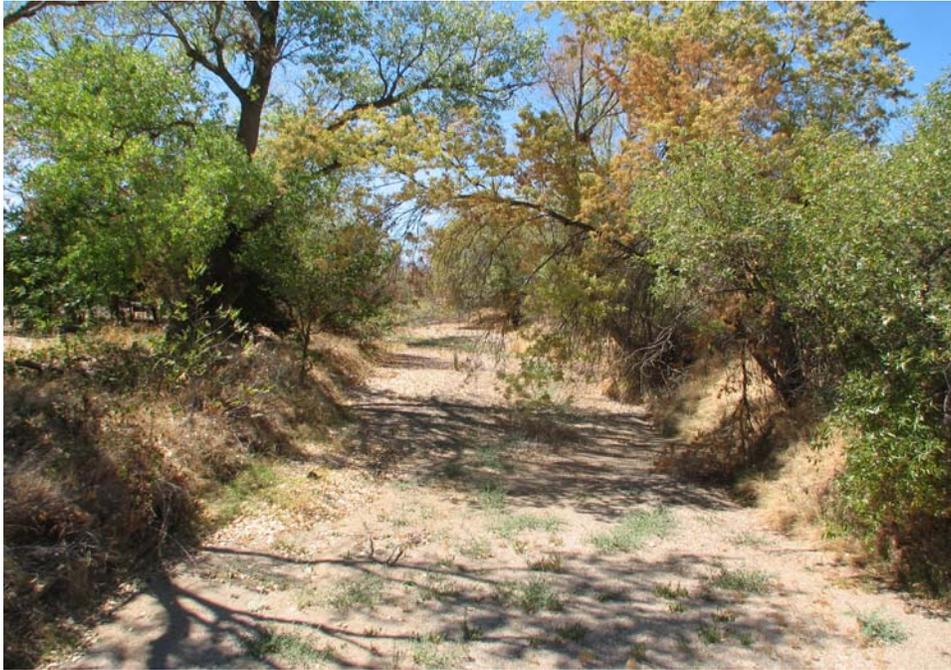
**Upstream from extension of Truckee Avenue**

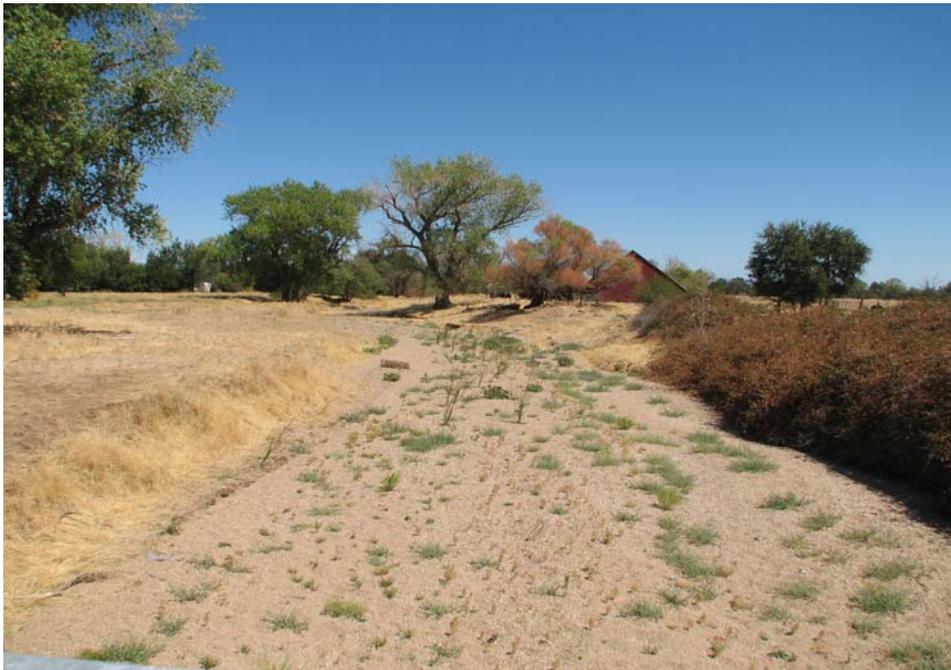
**Downstream from extension of Truckee Avenue**

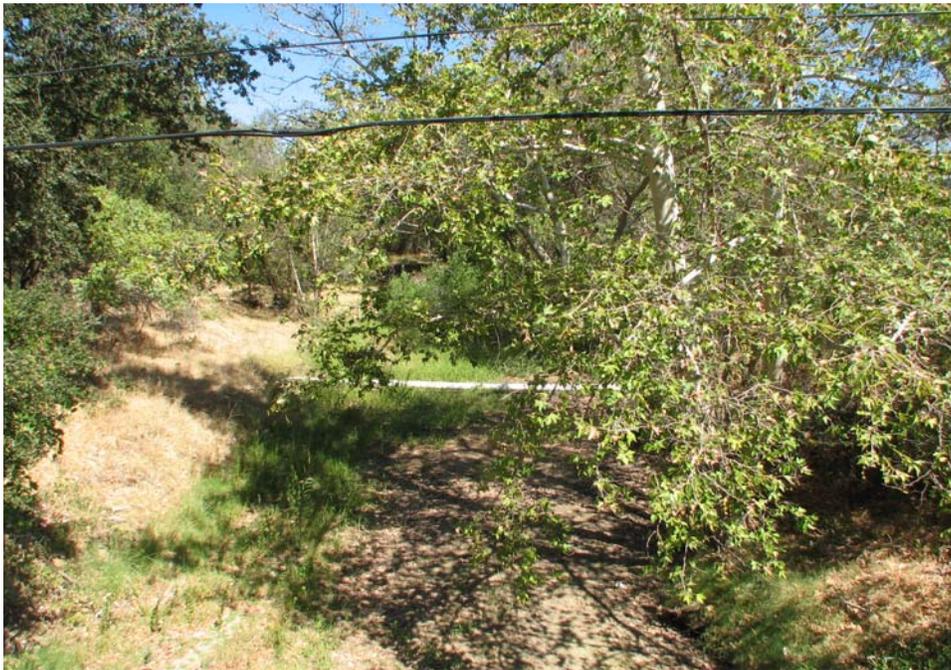
**Downstream from Highway 99 W bridge**

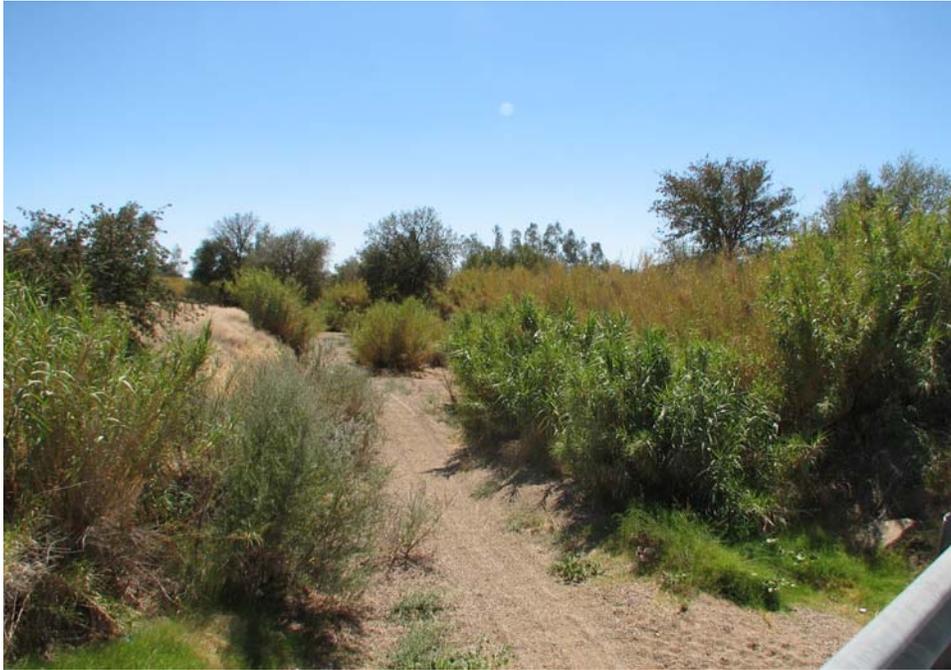
**Upstream from Hamilton Road**

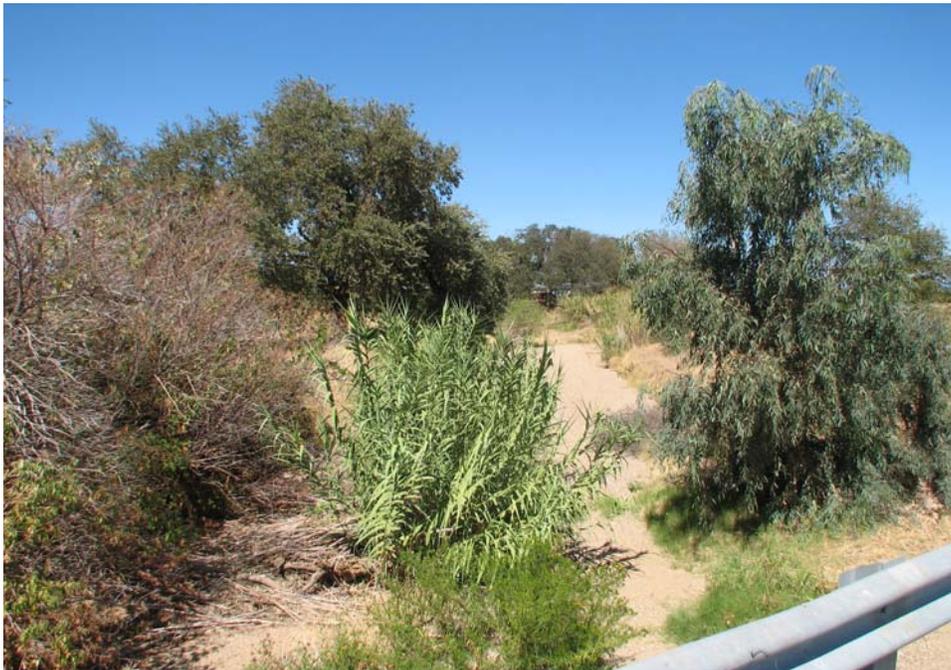
**Downstream from Hamilton Road**

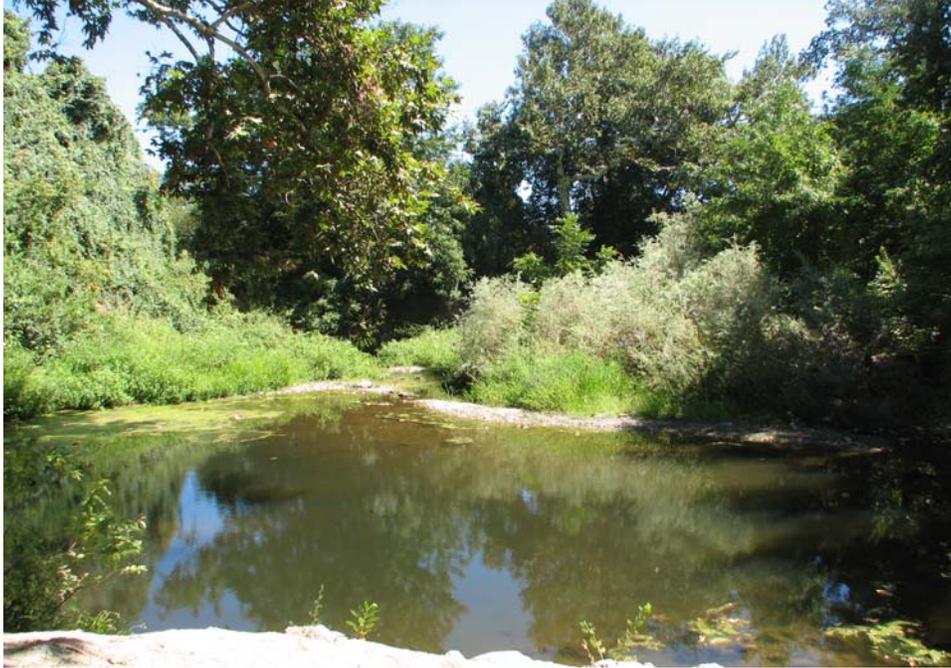
**Downstream of low water crossing logs and dense vegetation is encroaching in the channel**

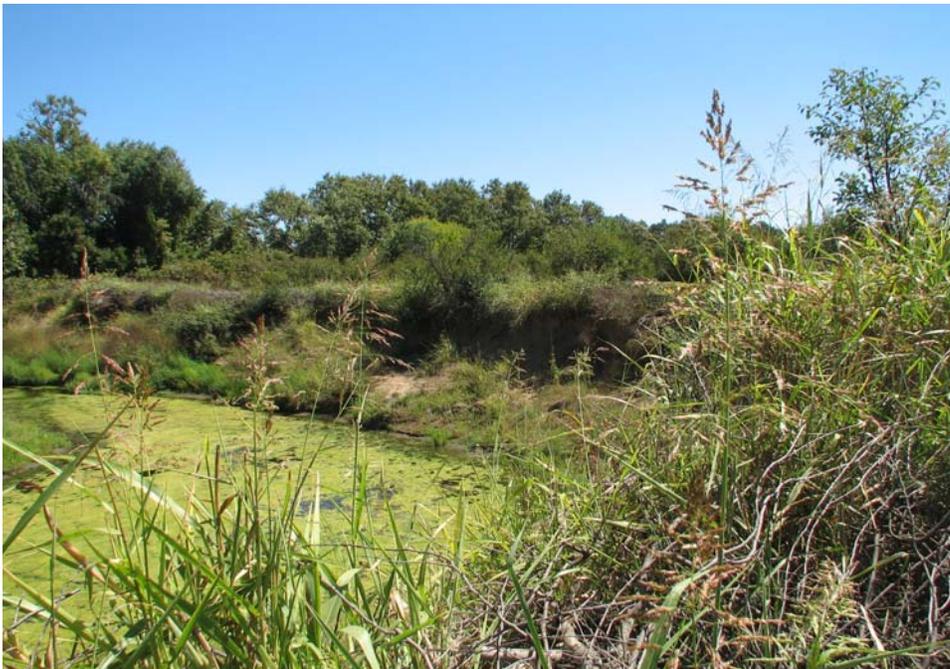
**Down stream approximately 200 feet of erosion along the right bank**

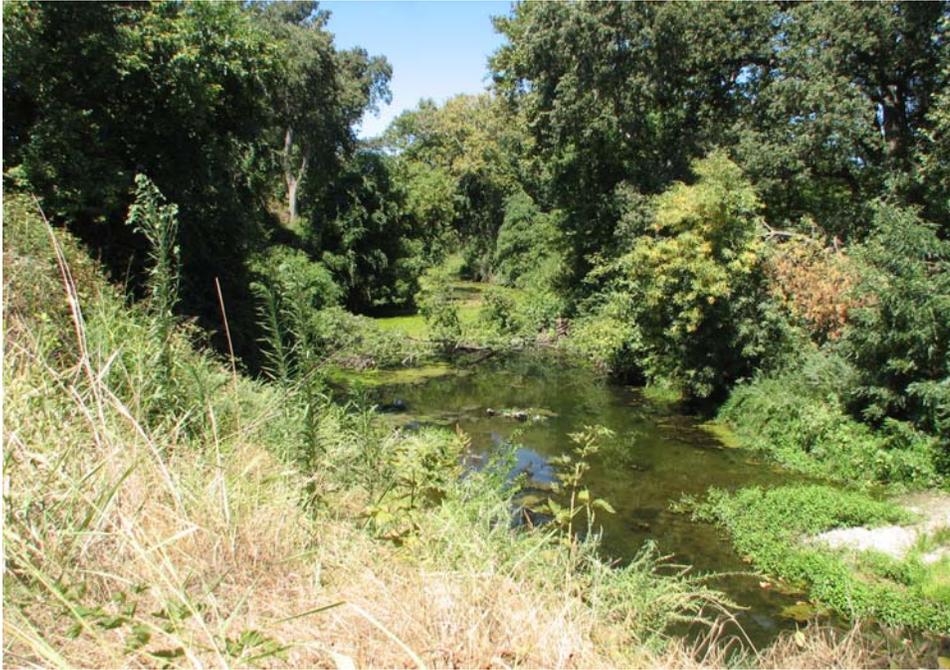
**Logs and dense vegetation needs to be removed from channel**

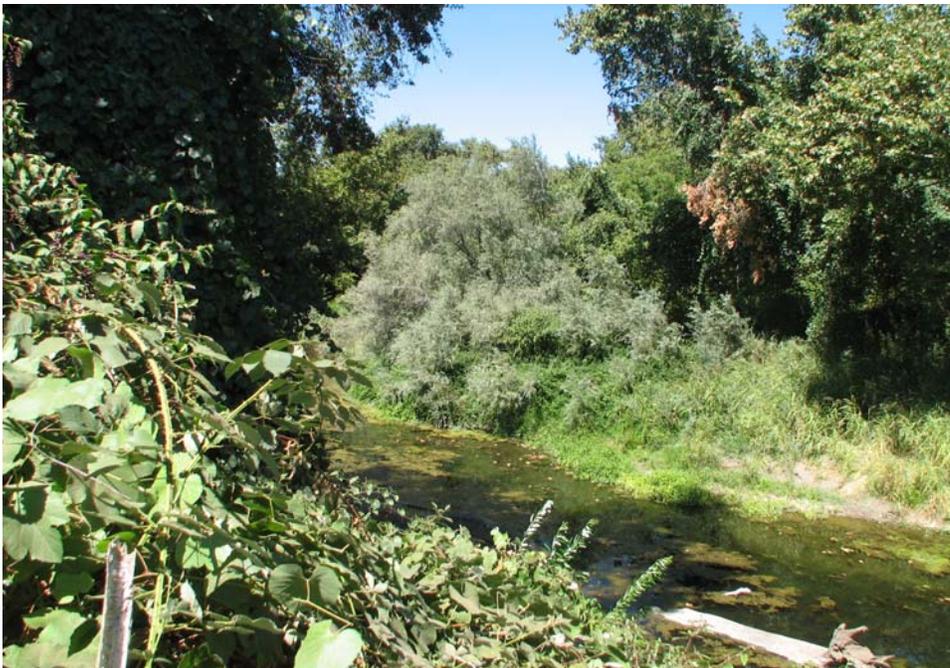
**Upstream, approximately 2800 feet from the downstream limit  
Dense vegetation on both banks**

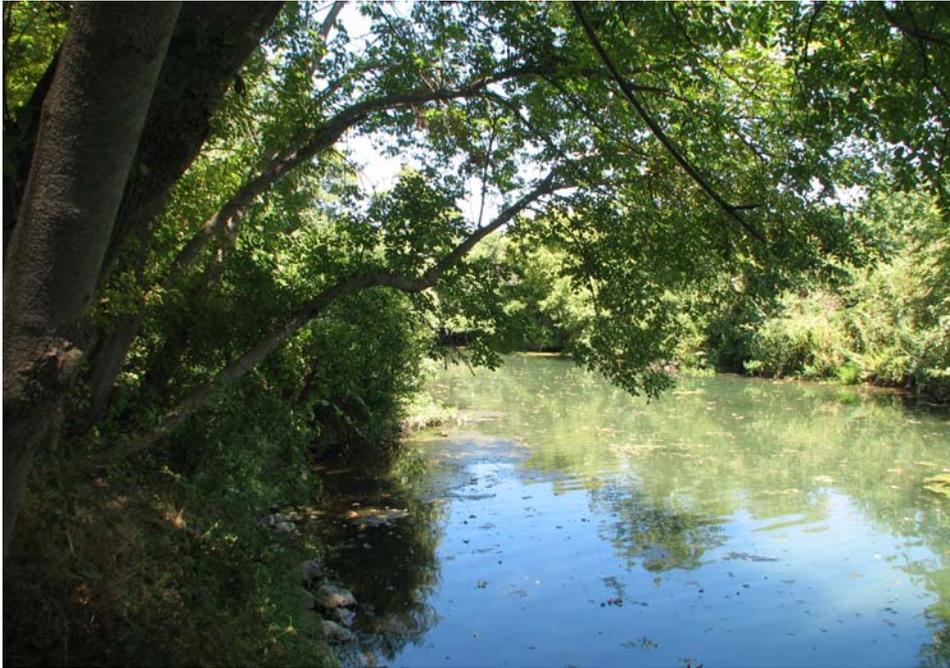
**Upstream, approximately 700 feet upstream of the downstream limit  
Dense vegetation along both banks**

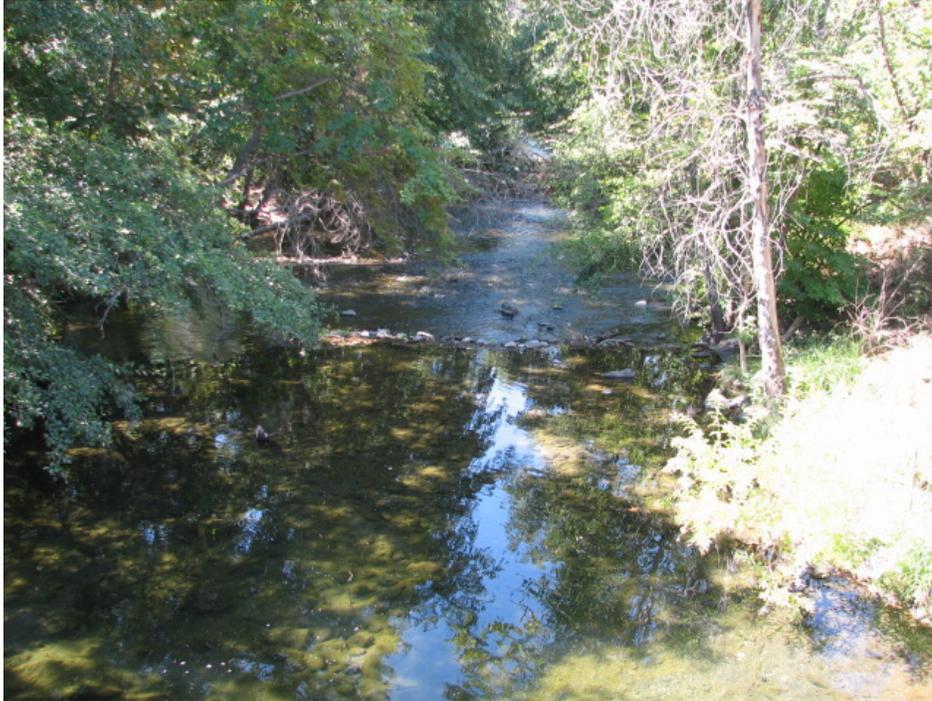
**Downstream from the Big Chico Creek Control Structure**

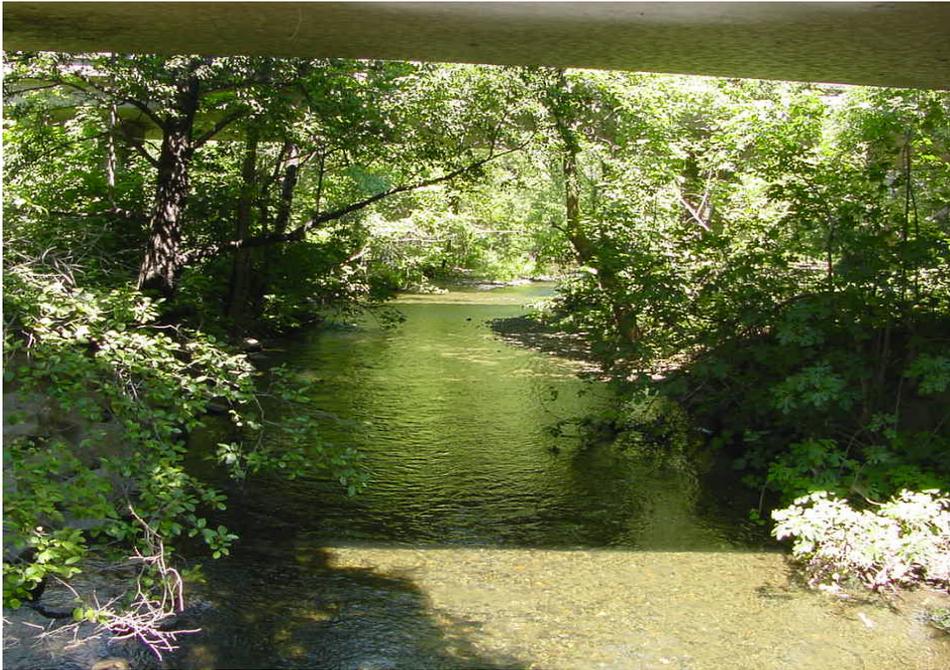
**Upstream from Highway 99 heavy growth along both banks**

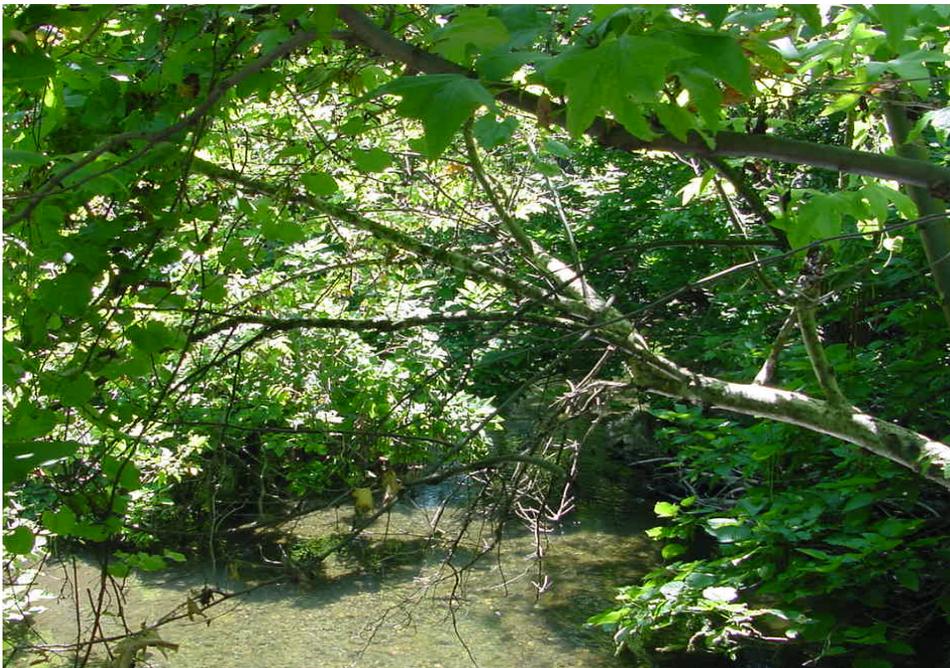
**Downstream from Highway 99 dense vegetation in channel**

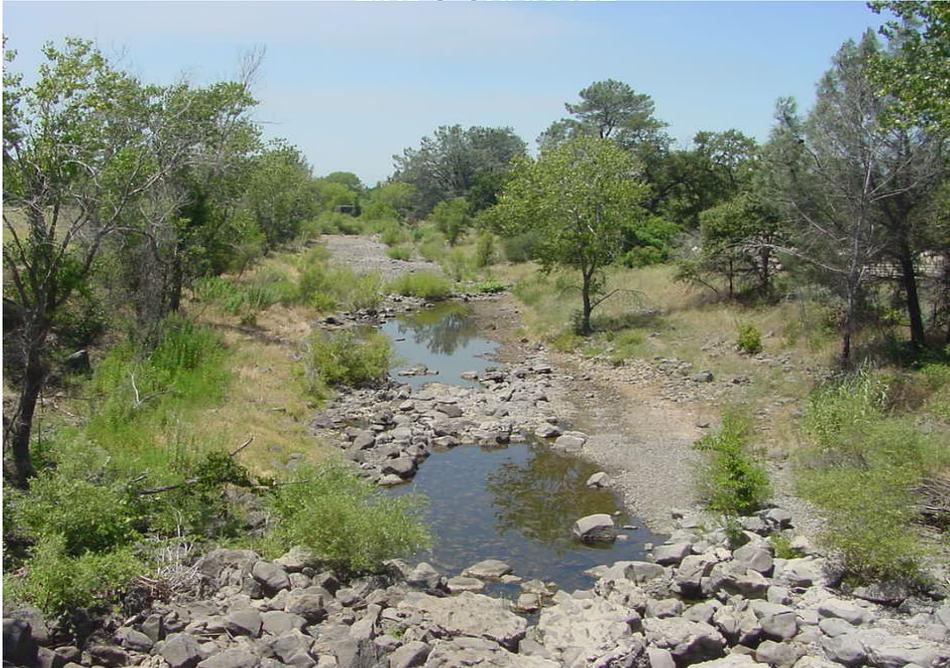
**Downstream from the Lindo Channel Diversion Structure**

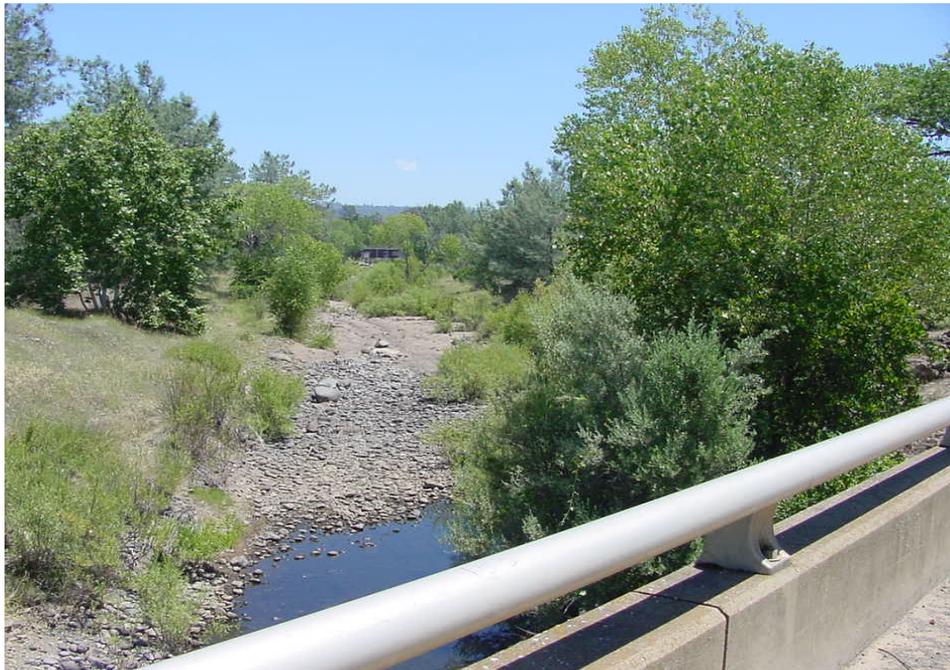
**Downstream from Manzanita Avenue**

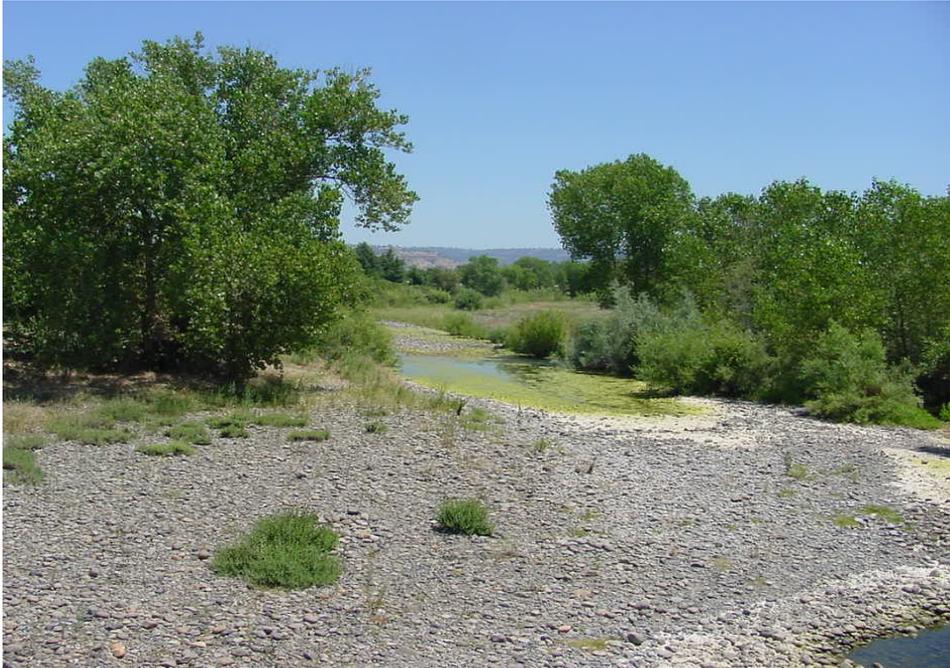
**Upstream from the bike path bridge at the extension of Madrone Avenue**

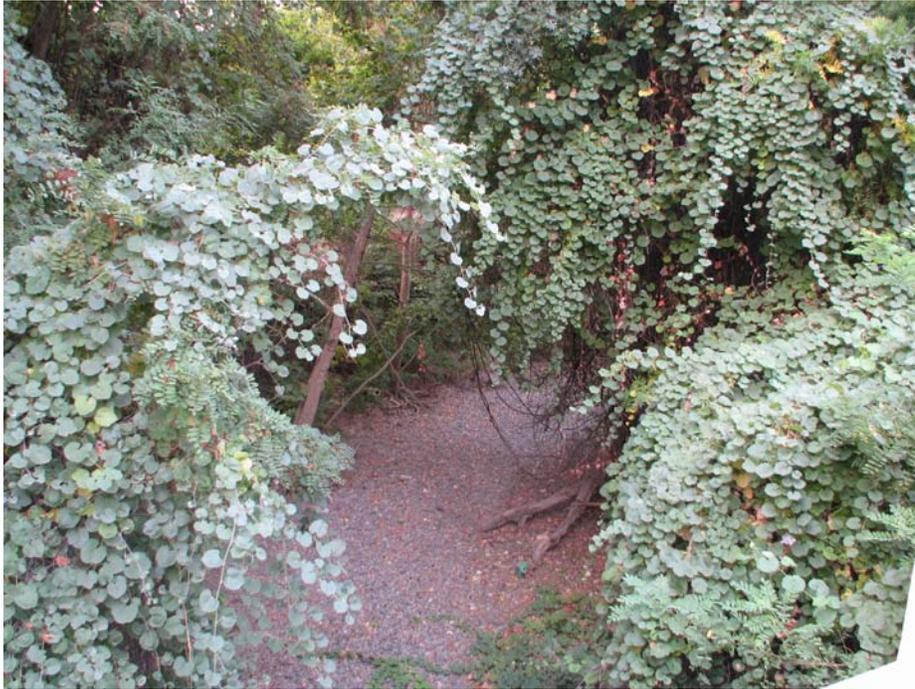
**Downstream from Oak Ave**

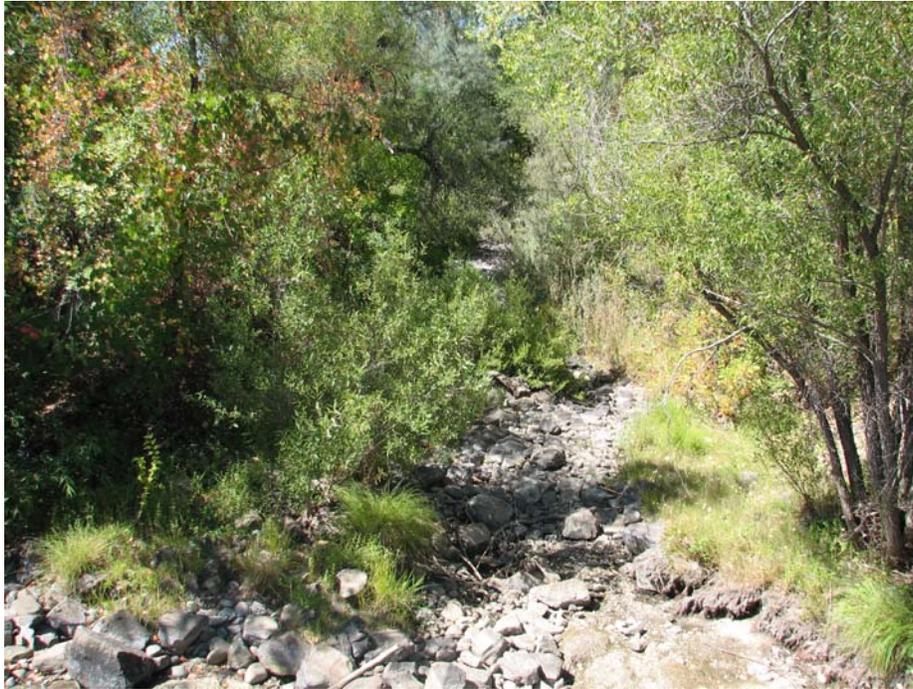
**Downstream from the control structure on Little Chico Creek  
moderate growth in the channel**

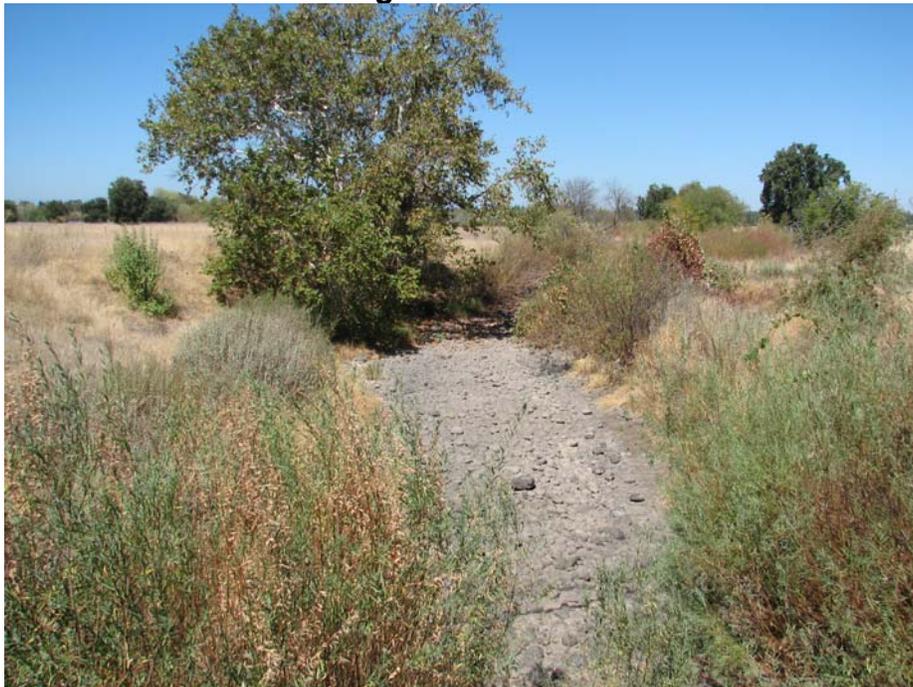
**Downstream from Bruce Road**

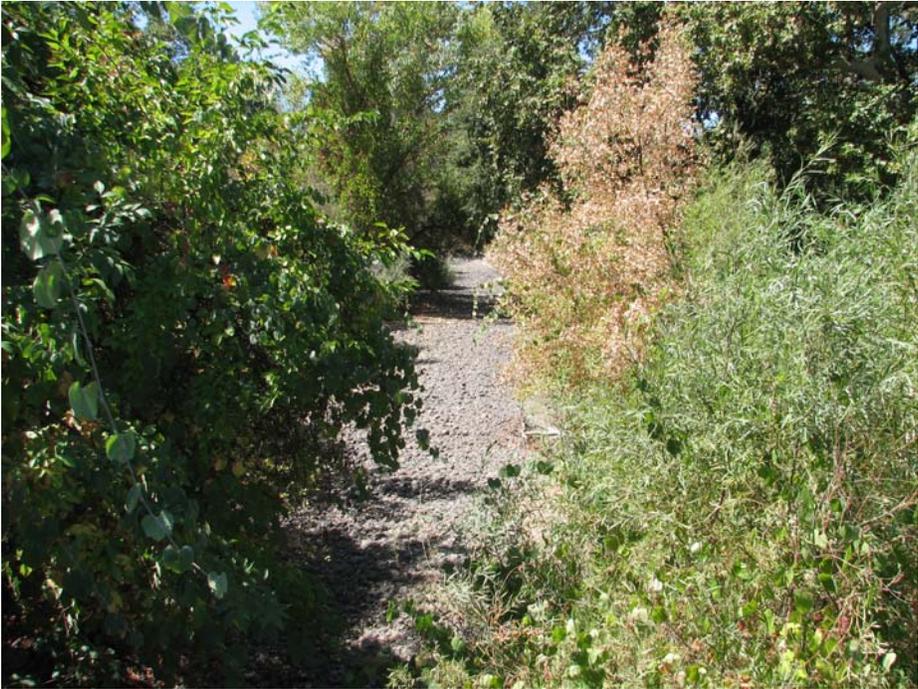
**Upstream from Forest Avenue**

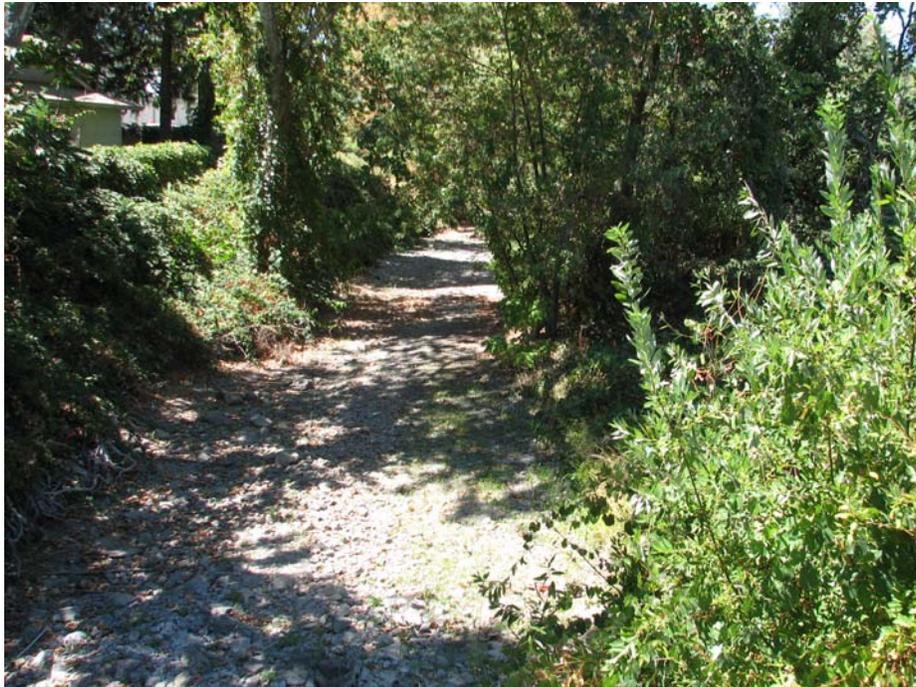
**Downstream from Olive Street**

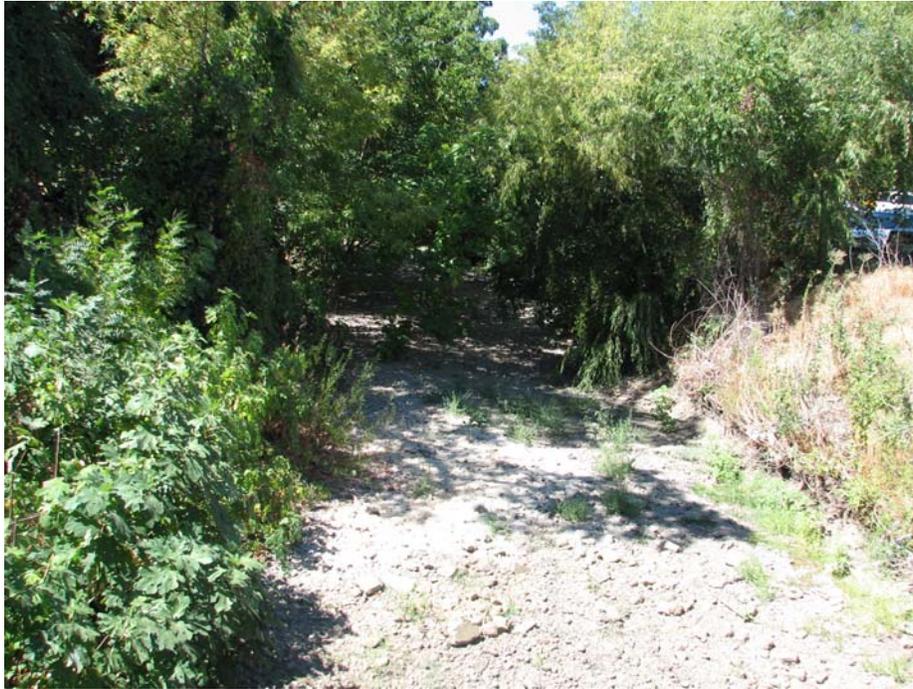
**Downstream from Broadway St. Growth on both banks.**

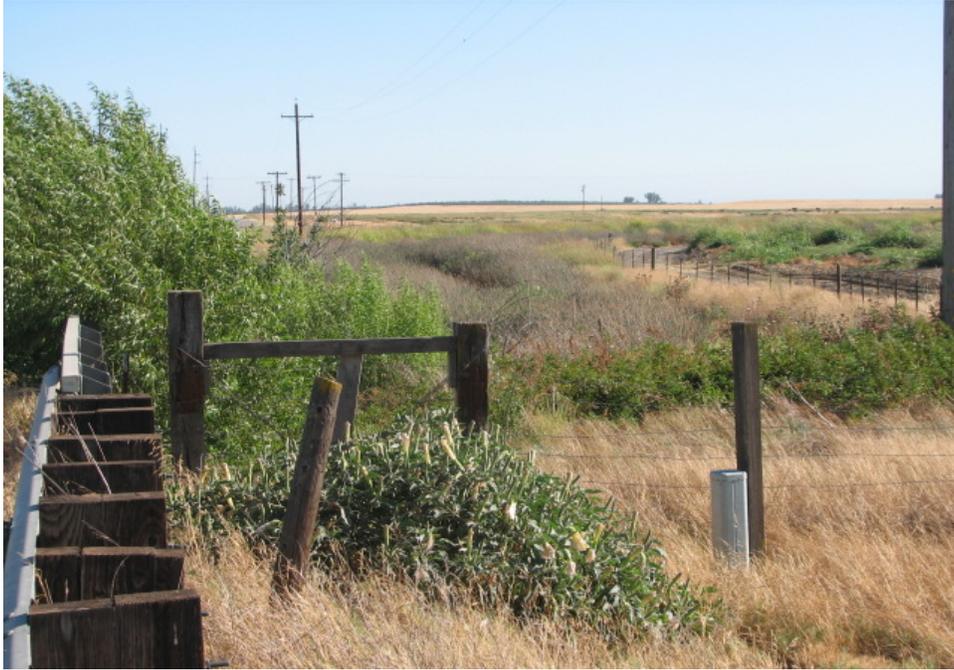
**Downstream from Cunningham Road**

**In August 2007, an inspection was made of Owens Creek channel. The project channel begins at Cunningham Road and extends downstream for 2.0 miles to Owens Creek Diversion channel. The entire channel was inspected. Heavy dense tule growth was found in the channel. Tules should be sprayed to control growth.**

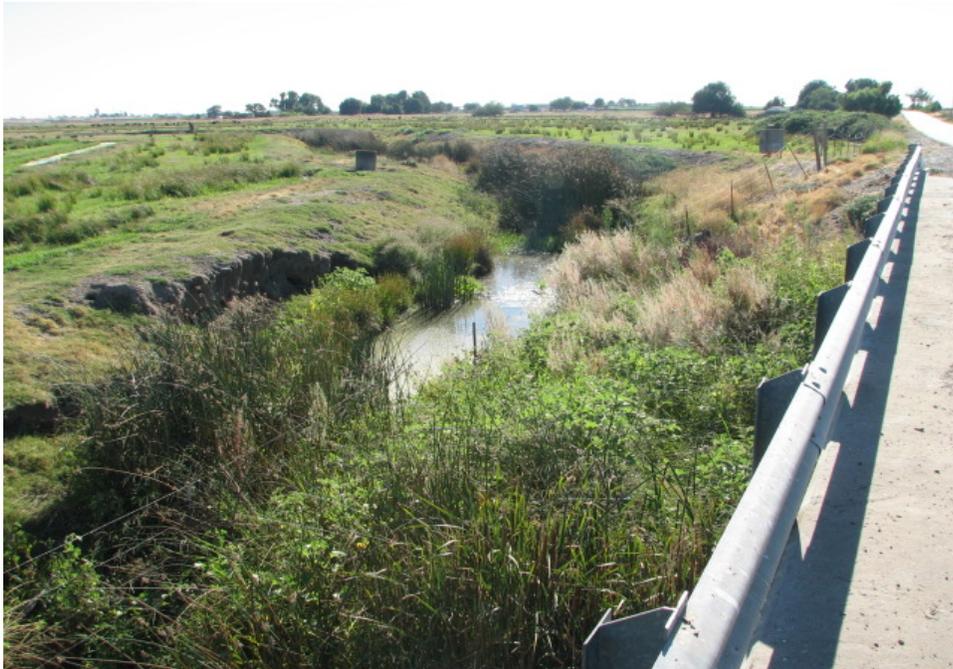
**Downstream from Childs Avenue, note the erosion left bank**

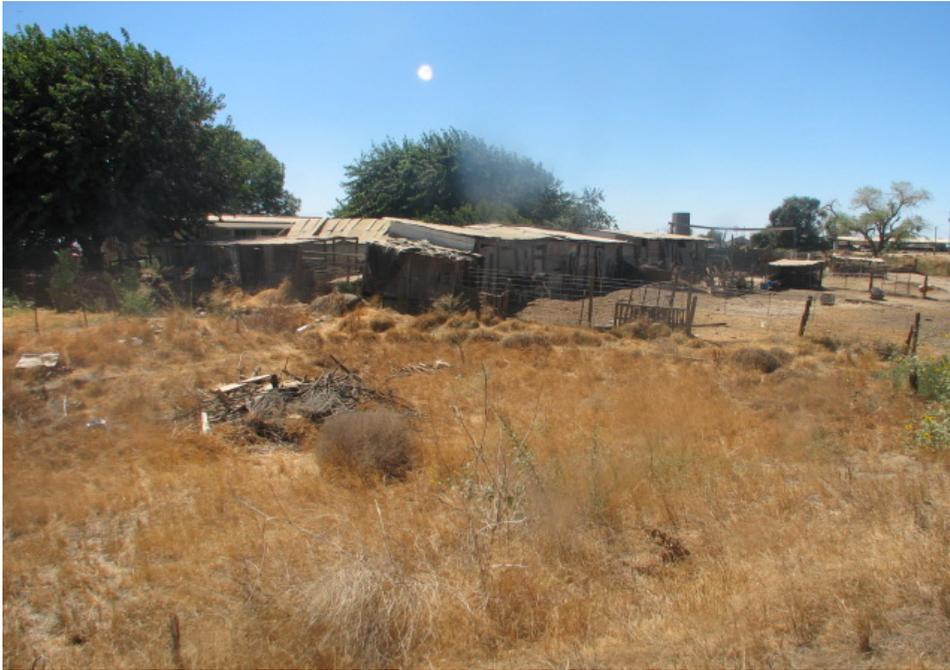
**Animal stall upstream of Road 10 (GPS 37.12053 -120.36039)**
