State of California
The California Natural Resources Agency
Department of Water Resources
Division of Flood Management

2011
INSPECTION REPORT
OF THE
CENTRAL VALLEY STATE-FEDERAL
FLOOD PROTECTION SYSTEM

PUBLISHED IN DECEMBER 2011

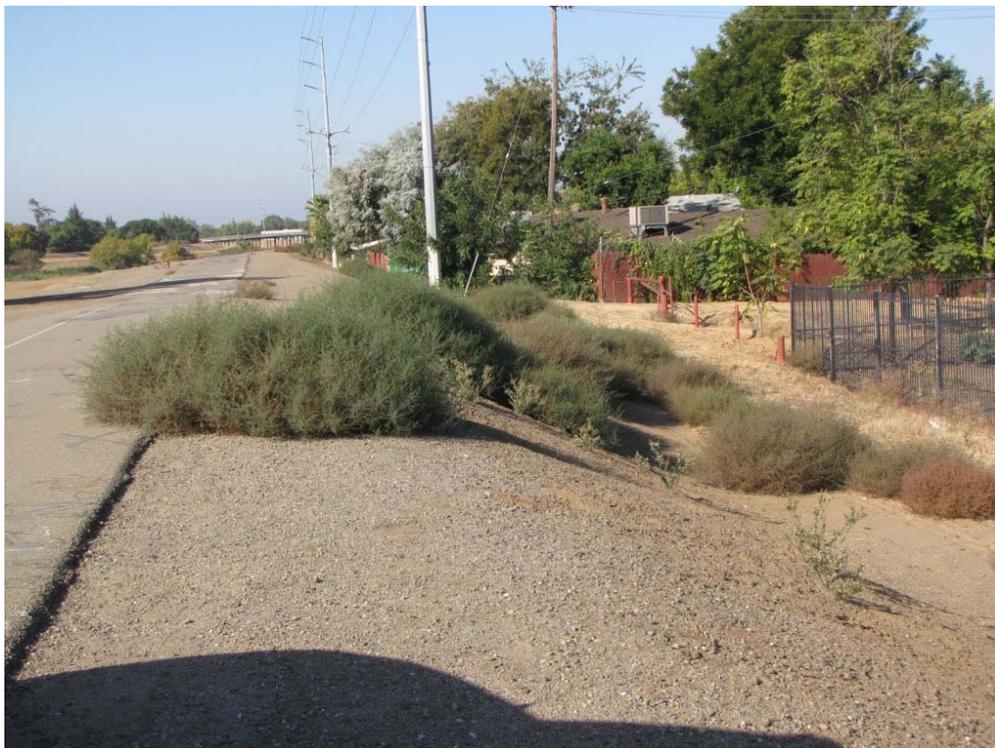
Minimally Acceptable Maintenance: Grass or brush partially obstruct visibility and access

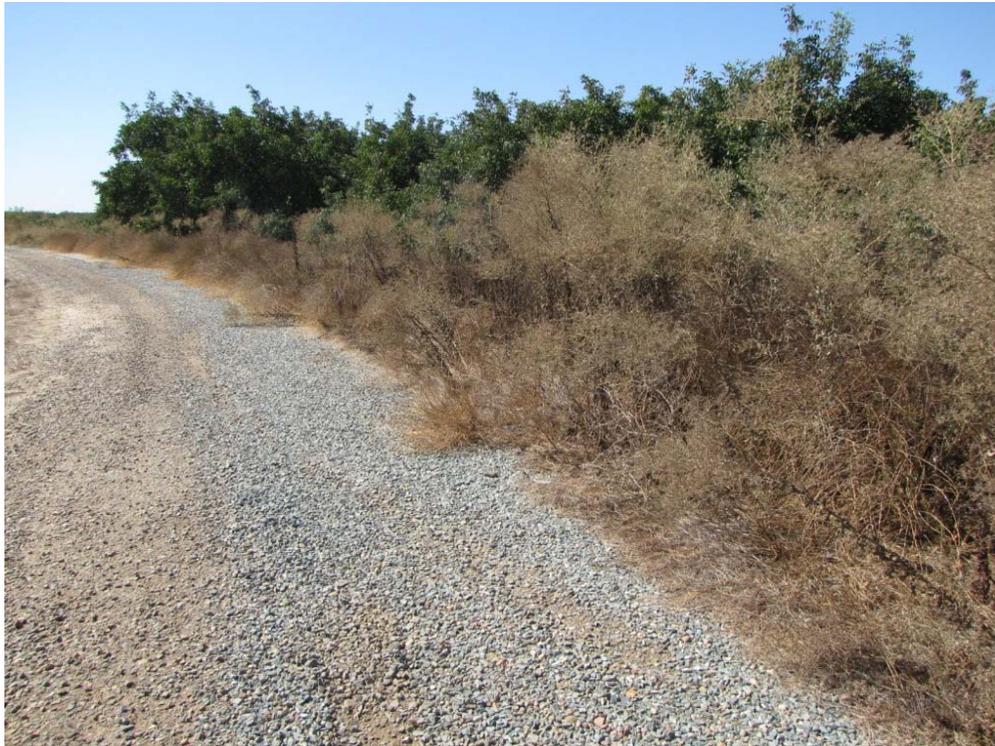
Unacceptable Maintenance: Grass or brush completely obstruct visibility and access

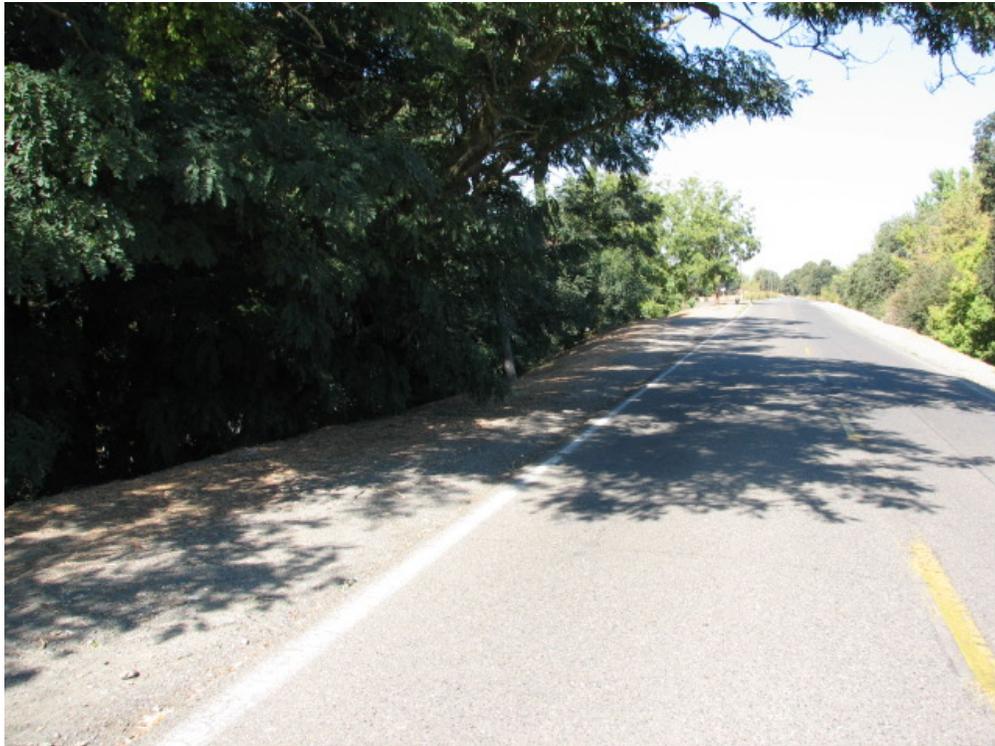
Minimally Acceptable Tree Maintenance: Moderate density of tree limbs partially obstruct visibility and access

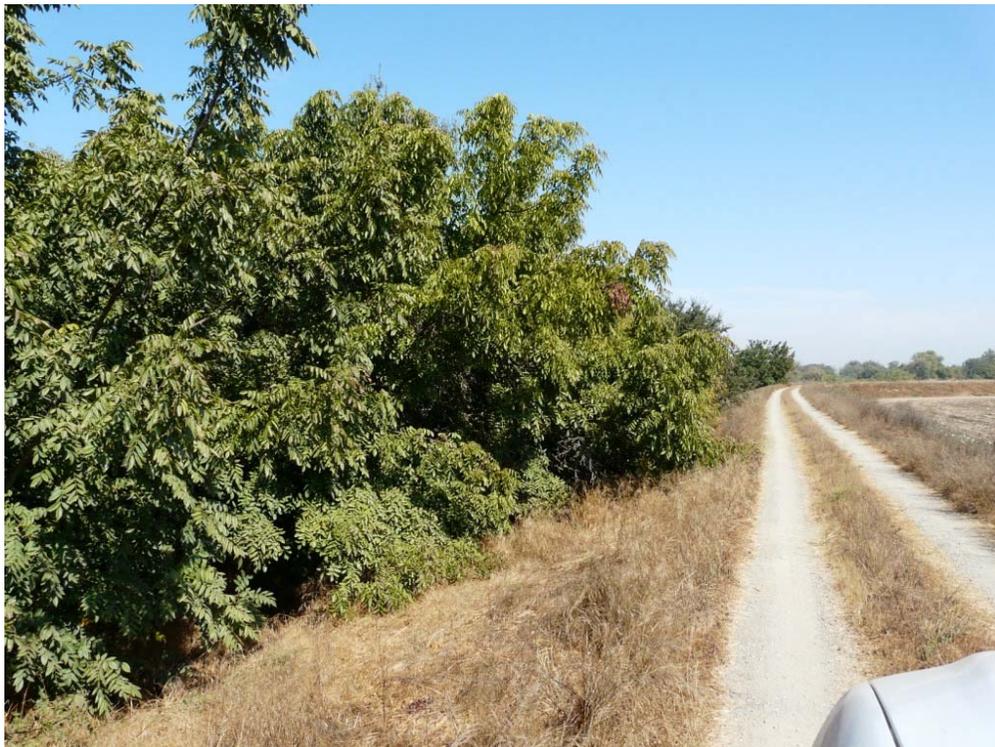
Unacceptable Tree Maintenance: Significant density of tree limbs completely obstruct visibility and access

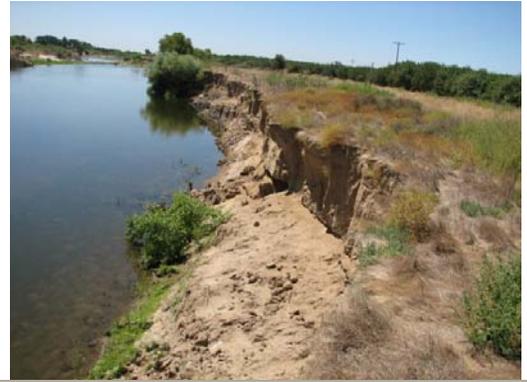
Looking downstream standing at the middle of the erosion site.

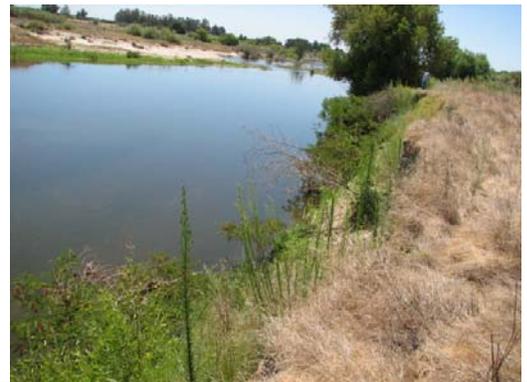
Close look at the site. Dense vegetation is visible.

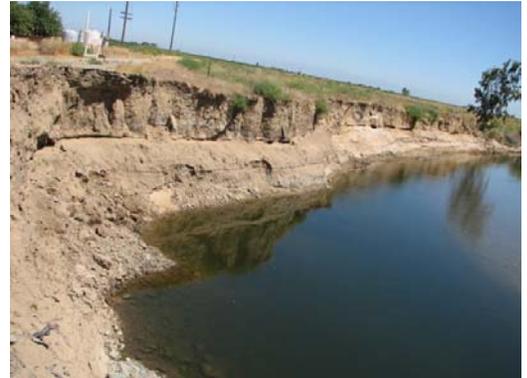
Standing next to the erosion point cutting into the levee.

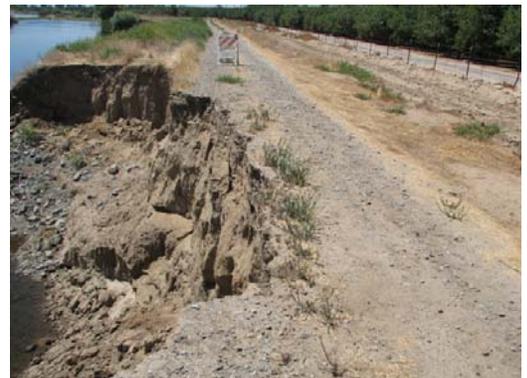
Looking downstream. The image shows the point where the erosion is cutting into the levee.

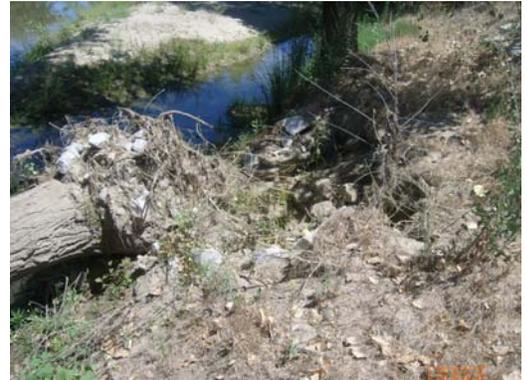
The fallen tree about 20 feet from the site.

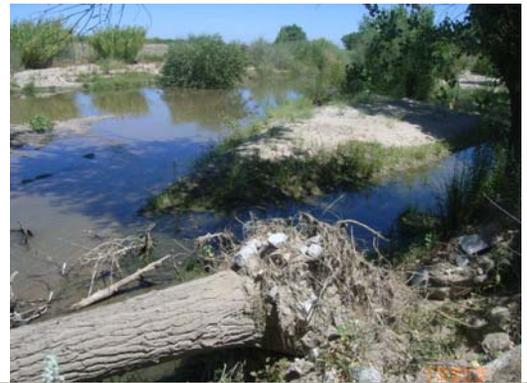
The fallen tree and exposed root

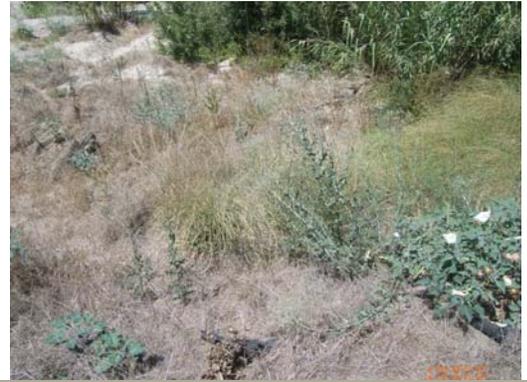
The erosion is covered with dense grass and bushes.

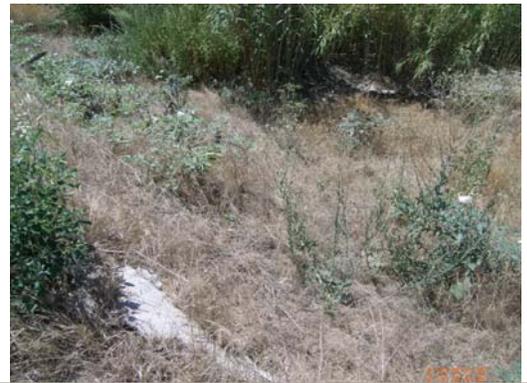
The erosion is covered with dense grass and bushes.

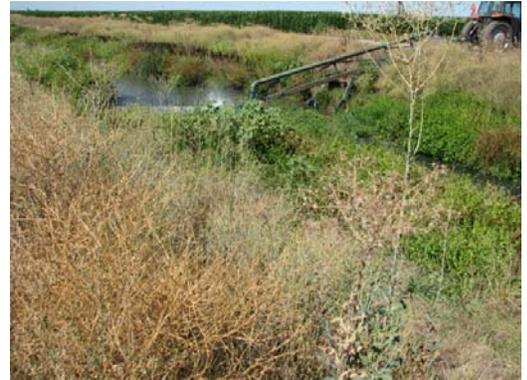
Site covered with dense vegetation.

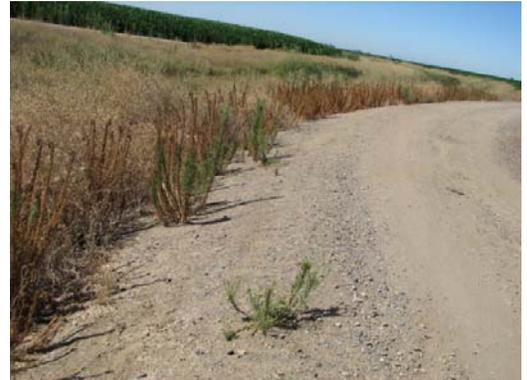
No significant change visible from the levee top

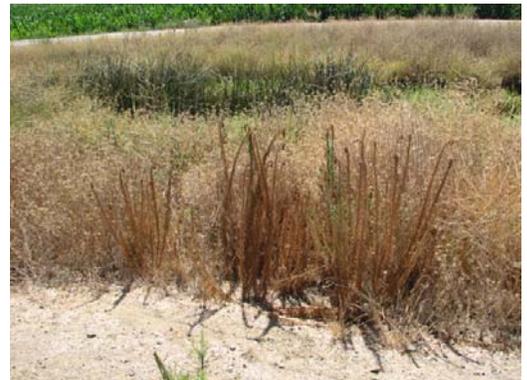
The site is covered with dense thistles.

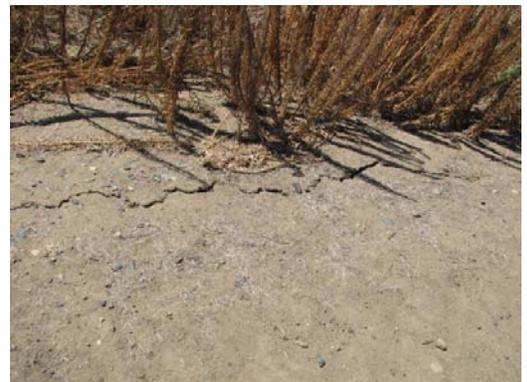
Minor cracking visible at the levee shoulder

08/16/2011: No significant change was visible. Minor cracking on the waterside levee slope was spotted. 100 percent vegetation coverage with star thistles.
 11/30/2010: Site was not inspected this year due to time constraints. There have been no reports from the district that the site has been corrected.
 2009: Site recommended as local maintenance issue, per CLRO CES Evaluation 2008 Report; previously rated "U".
 9/10/2007: GPS extended from opposite bank using Google Earth; signs of vehicular damage on levee.

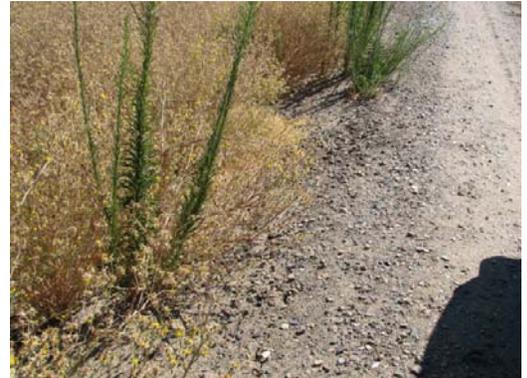
The site is covered with dense star thistles

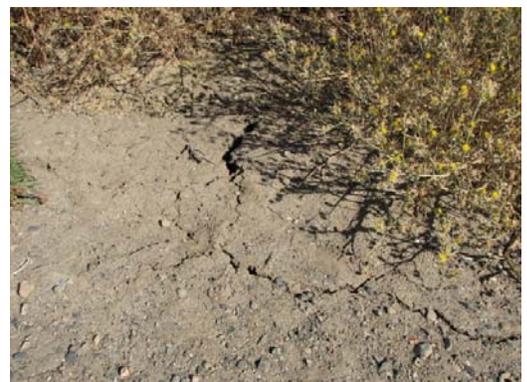
Minor cracking visible on the site

08/16/2011: No visible significant changes. 100 percent vegetation coverage with star thistles. Minor cracking visible on the waterside slope.
 11/30/2010: Site was not inspected this year due to time constraints. There have been no reports from the district that the site has been corrected.
 2009: Site is recommended as local maintenance issue, per CLRO CES Evaluation 2008 Report; terracing damage from livestock traversing; there is a wooden platform installed on site; landside is on high ground; site was previously rated "M".
 9/10/2007: GPS extended from opposite bank using Google Earth; GPS on file is correct.

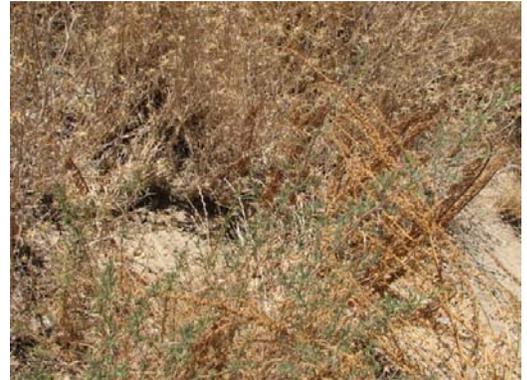
The site is covered with thick vegetation

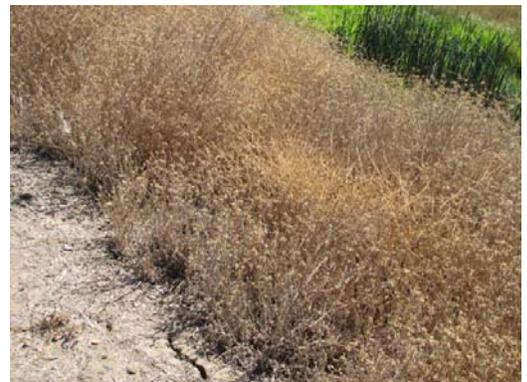
Minor cracking on waterside levee shoulder

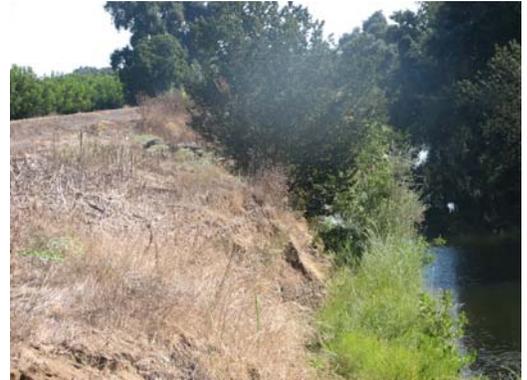
09/02/2011: No significant changes observed on site.
 11/02/2010: No significant changes observed on site. The mile-long erosion continues to degrade the bank. There are a few trees along the mile-long stretch on the lower bank slope that are affected by the scarp. WS Levee Slope was changed to 2:1. As a result, normalized score increased from 62 to 65.
 08/05/2010: Recommended for waterside repair, per CLRO; "water velocity is a major factor for accelerating bank slope erosion."
 8/12/2009: Near-vertical bank erosion; degrading channel is incising the banks; recommend annual assessment and monitoring of critical erosion site, per CLRO CES Evaluation 2008 Report; district is monitoring site for changes in condition; site was previously rated "U".
 2007: Visited site 02/06/2007; possible critical site.

Close view of the erosion. Note the dense vegetation and tree on site.

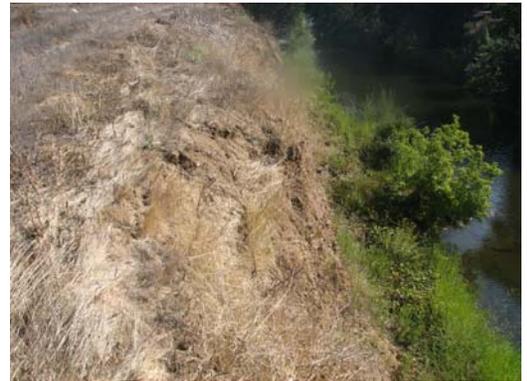
Close view of erosion site. Note the exposed soil at the top might be caused by animal activities.

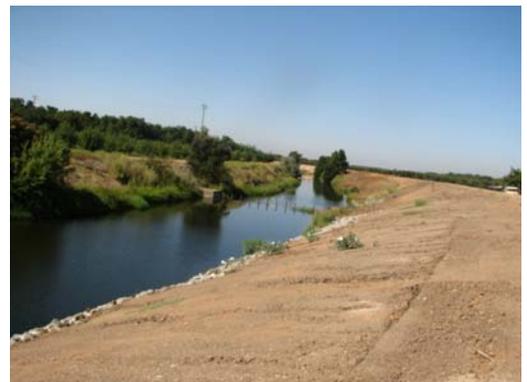
Looking downstream to the drop structure.

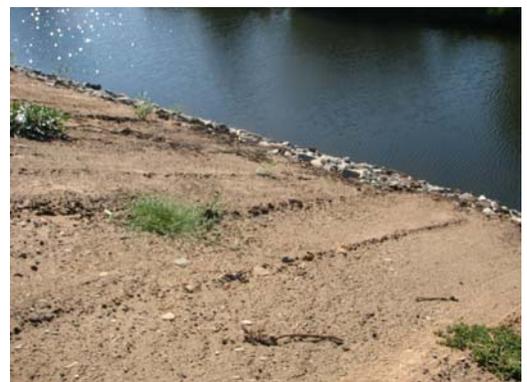
09/02/2011: Site was repaired in 2011 summer by the district. Needs to monitor during the next flood season for performance. The site was previously rated "U".
 11/02/2010: No significant changes observed on site. Bank erosion extends approximately 100 feet downstream and 250 feet upstream of the drop structure.
 8/12/2009: No major change observed; erosion is upstream and downstream of drop structure; bank erosion is associated with high velocities; it is recommended for annual assessment and monitoring of critical erosion site per CLRO CES Evaluation 2008 Report; it was previously rated "U".
 2007: Visited site 02/06/2007.

Close view of the repaired site. Note the riprap at the toe

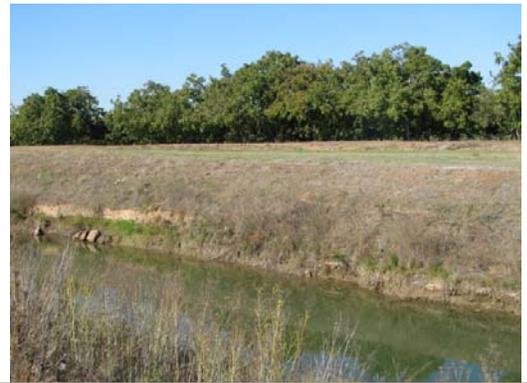
Looking downstream at the bank scarp. Minor erosion is not affecting the levee due to a wide berm.

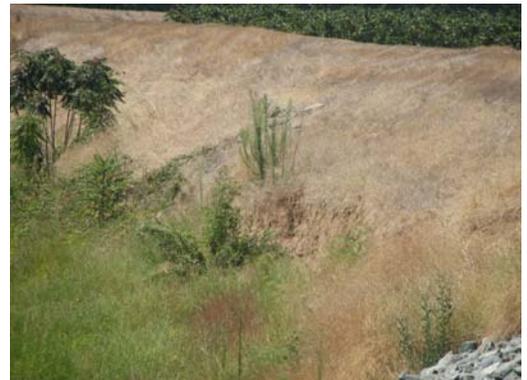
09/02/2011: A pocket erosion was found downstream of the repaired site. The pocket erosion is at the lower slope of the levee, with a size of approximately 5ft long and 3 ft in height.
 11/02/2010: The site has been repaired by the district. It was previously rated "M."
 8/12/2009: Erosion is incising into the levee; a pipe outlet is located on the levee toe; there are traces of concrete lining originally placed over the WS slope; landside is on high ground; inspect for pipe condition.

Downstream view of repaired site. Note the pocket erosion downstream of the riparian protection.

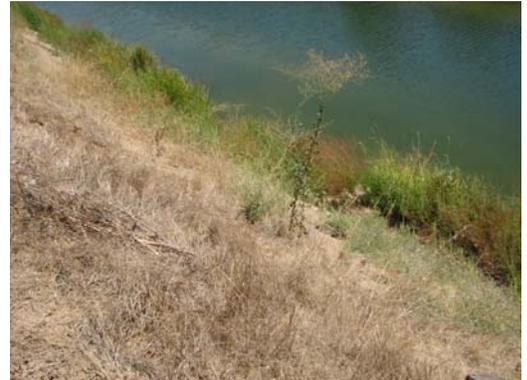
Looking at the upstream of the repaired site. Note the pocket erosion at the toe.

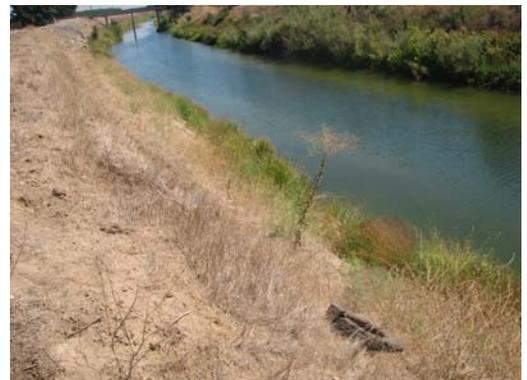
Looking upstream of the repaired site. The burning wood pile still on site.

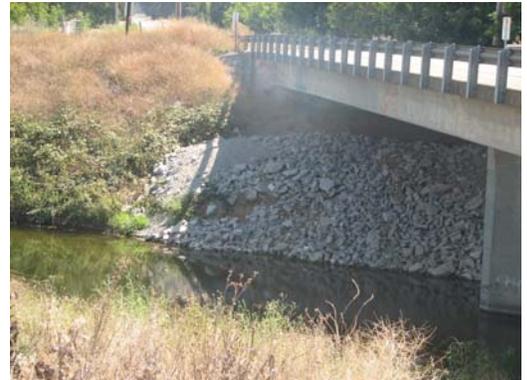
Close view of the fixed site from upstream of the Milton Bridge.

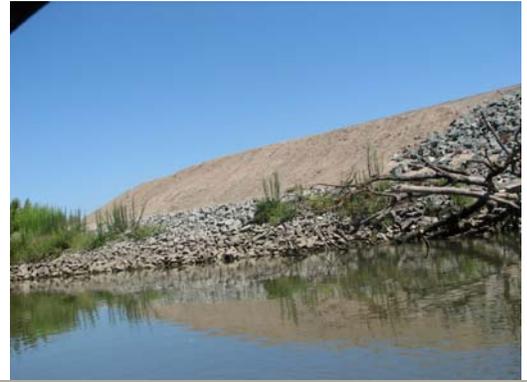
Vegetation and dead trees visible on the site.

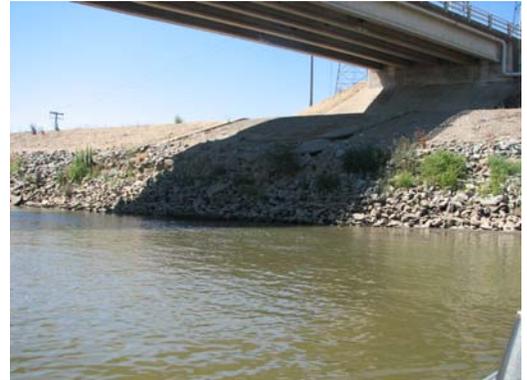
Shot rock was used to fill an existing pocket erosion just above the water line.

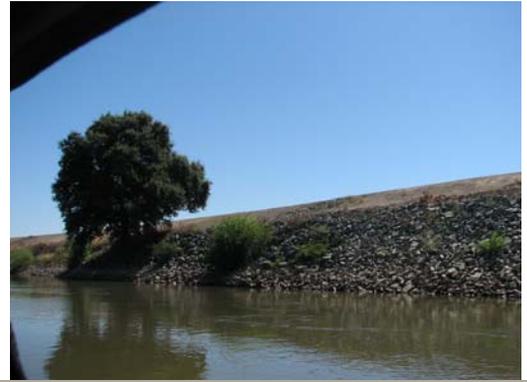
Tree and vegetation visible on the site

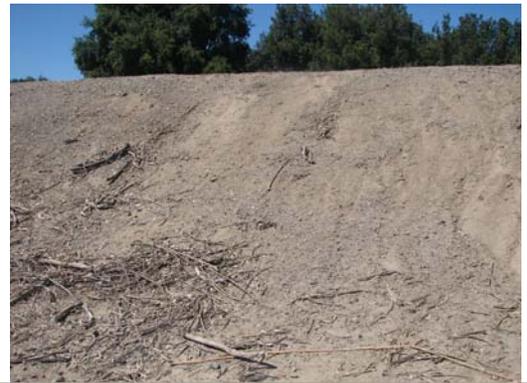
Looking from the levee toe at the site.

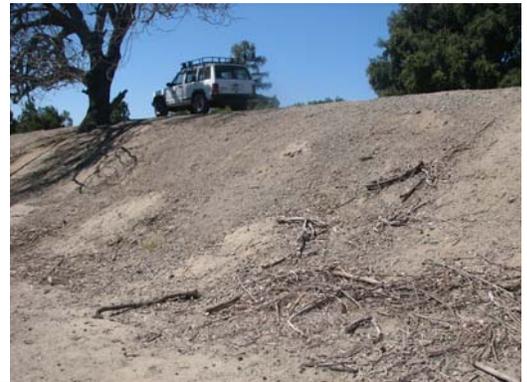
Looking downstream from levee toe

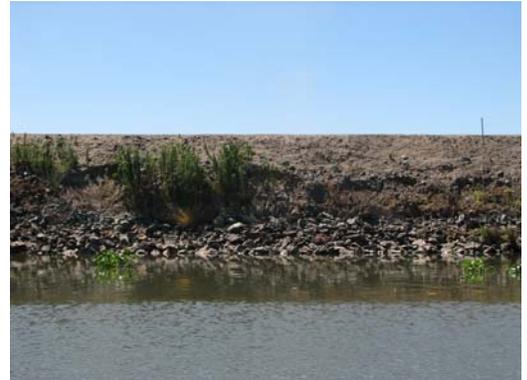
Direct view of the site.

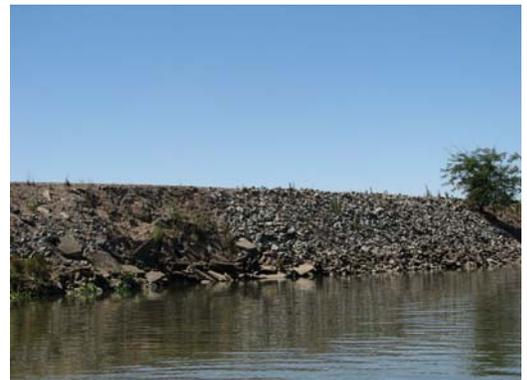
Upstream view. Sloughing mid-slope possibly caused by sliding of the revetment.

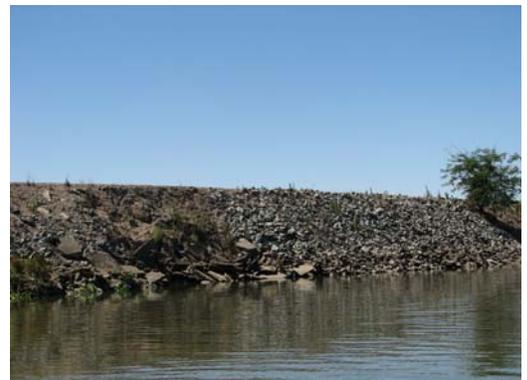
Direct view of the site showing emergent vegetation growing at the midslope.

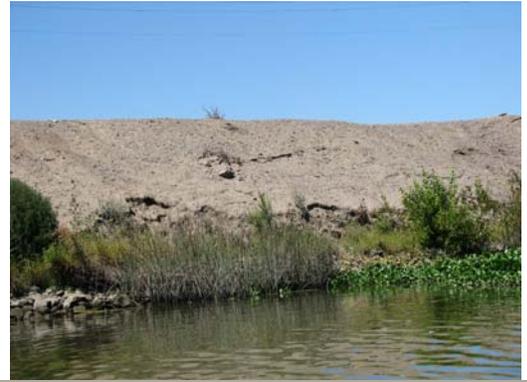
Front view of the erosion site. Vegetation visible

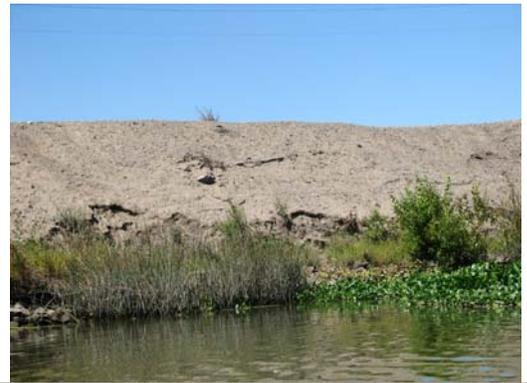
Front view of erosion

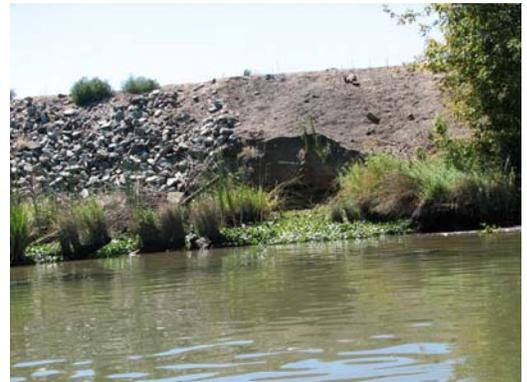
A close view of the erosion

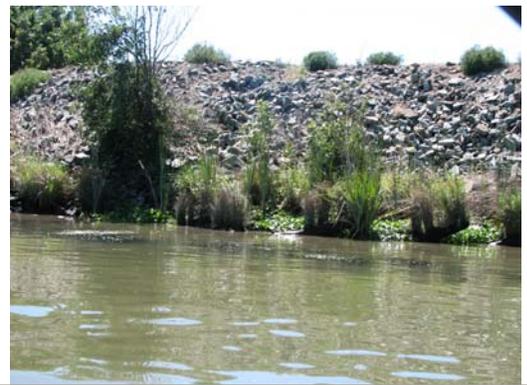
Front view of the upstream riprap protection.

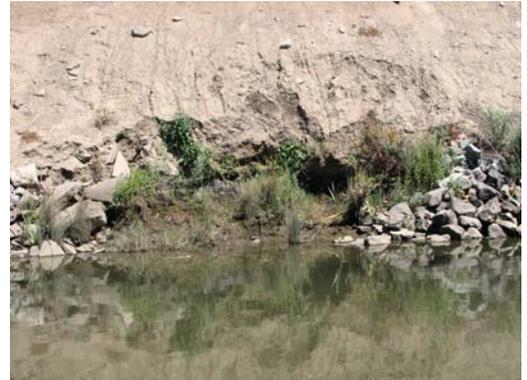
Close view of the erosion. The protection has been washed away.

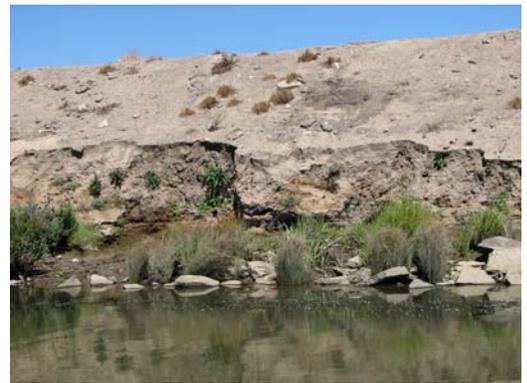
Front view of the erosion

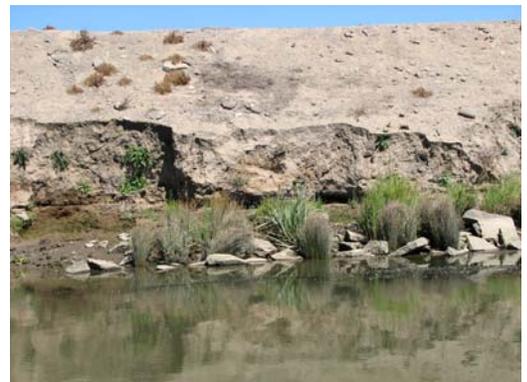
Front view of the erosion

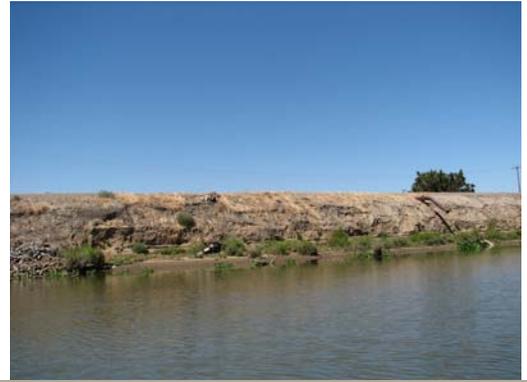
Upstream view of the site.

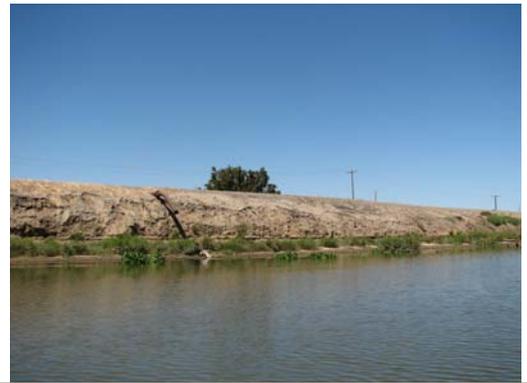
Direct view of the site.

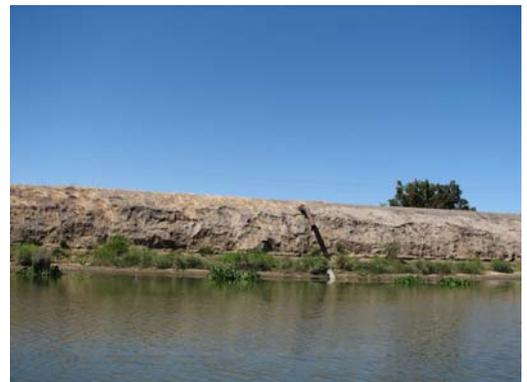
Direct view of the site.

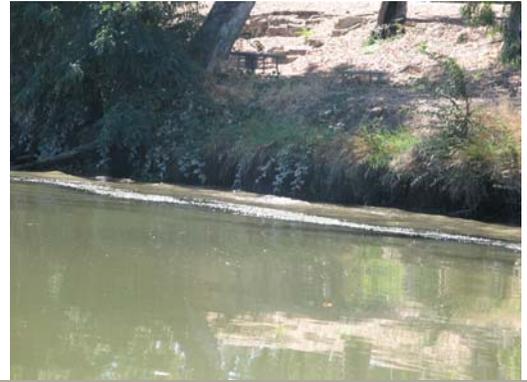
Large trees along the levee toe. There is minimal slope protection. The erosion near tree visible.

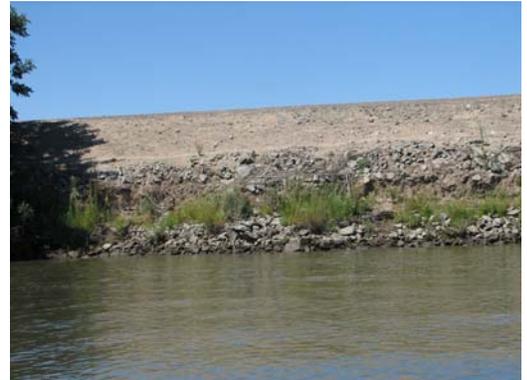
A closer view of the erosion

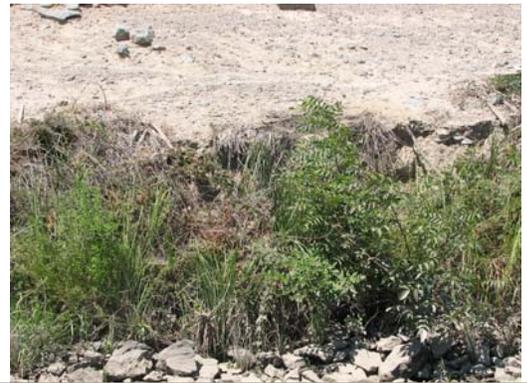
Closer view of the erosion

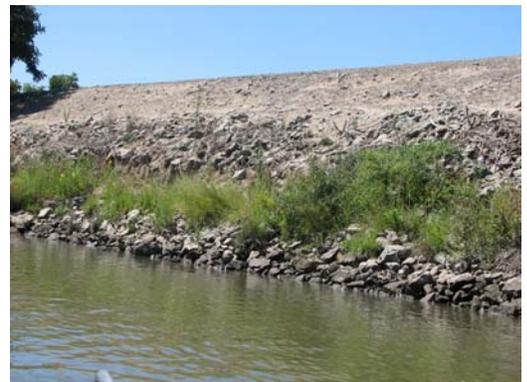
Front view of the erosion

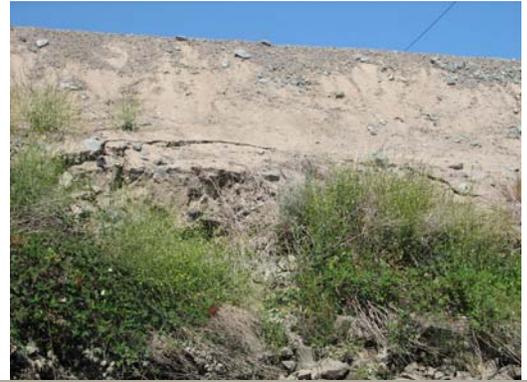
08/23/2011: Cracking erosion along the levee bank. Erosion appears to be caused by river flows.

Front view of the erosion. Note the notches caused by the cracking

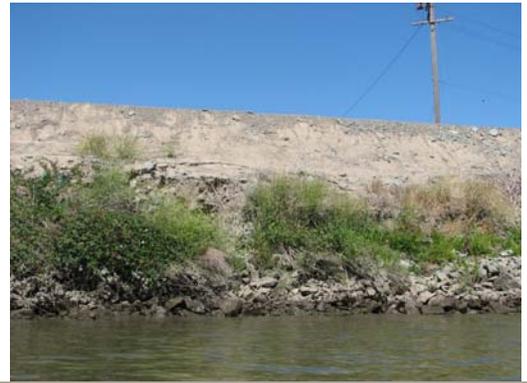
Front view of the site.

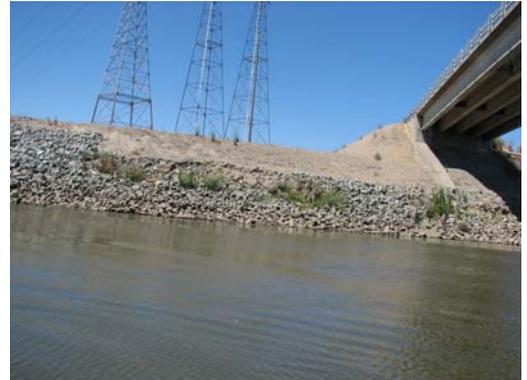
08/23/2011: No significant changes observed on site.
 09/07/2010: No significant changes observed on site. Erosion site is located beneath Howard Road Bridge. Majority of the existing rip rap has slipped, dragging away levee materials and exposing the underlying soft soil.
 08/06/2010: Recommend for annual assessment and monitoring during flood events, per CLRO.
 09/30/2009: No major changes observed since the last visit; upper portion of existing revetment has slipped, exposing the degrading bank; note that site # is the same as RM46.30, LM5.69 found in the CLRO CES Evaluation 2008 Report; site was previously rated "M".
 11/04/2008: Previously repaired using rock revetment; upper portion of th revetment is sliding, causing deformation on the levee slope; site is upstream of Howards Road Bridge.

Sloughing rip rap adjacent to Howard Bridge.

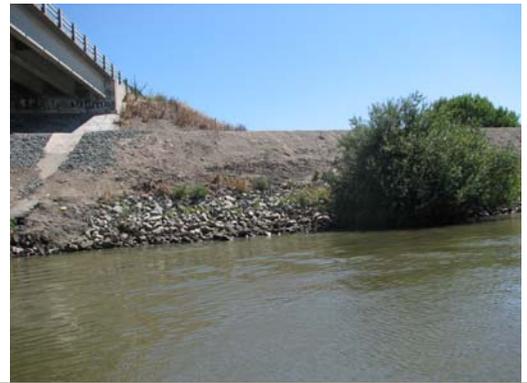
Upstream view of sloughing rip rap.

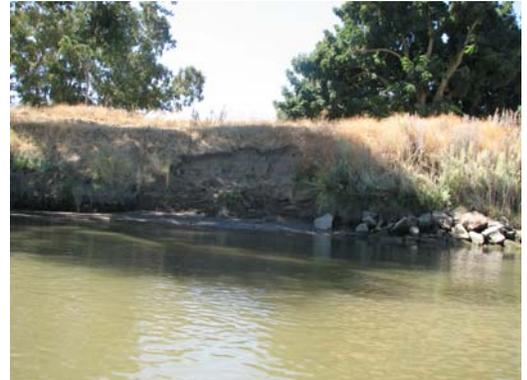
08/23/2011: No significant changes observed on site.
09/07/2010: No significant changes observed on site. There are minor pockets of erosion lining the lower slope and undermining of the toe. There are annual grasses and emergent vegetation at the lower slope. Burrow holes were observed along the slope and persist throughout the 200-foot long site.
08/05/2010: Recommended for annual assessment and monitoring during flood events, per CLRO.
09/30/2009: No major change observed since last visit; despite dense vegetation, the bank continues to erode and slough; the levee toe is being undermined; note the tree on site; the site was previously rated "U".
10/21/2008: Undermining of the levee toe; rodent holes in several location; trees with roots partially exposed; sloughing on slope.

Upstream view of the site where undermining of the slope has occurred.

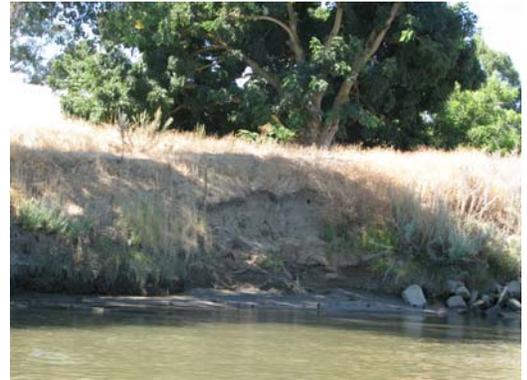
Front view of the site.

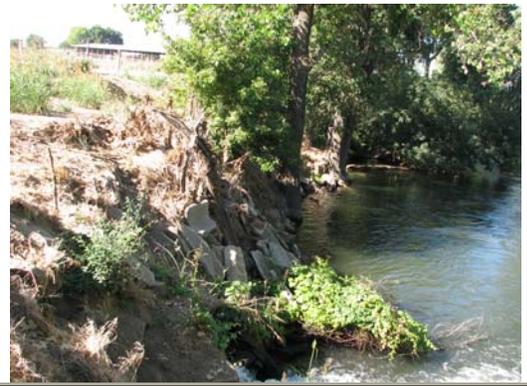
08/18/2011: No significant changes observed on site. Debris that blocks the irrigation outlet visible.

Looking downstream of the site.

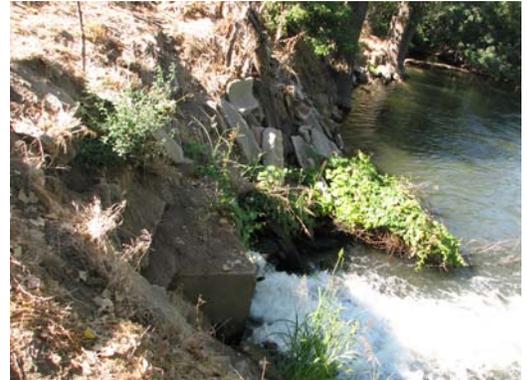
Looking downstream of the site. The irrigation outlet operating. Debris at the outlet visible

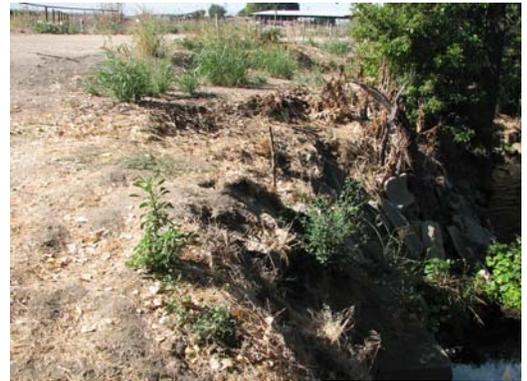
10/19/2010: No significant changes observed on site. Sloughing of the bank is occurring adjacent to an irrigation outlet structure. There is moderate to heavy vegetation along the bank that is well established. Broken chunks and slabs of concrete are used as rip rap and line the outside of the irrigation outlet structure. However, much of the rip rap along the slope is sloughing and could possibly lead to future slope instability.

View of the current condition of the levee slope just above the irrigation outlet.

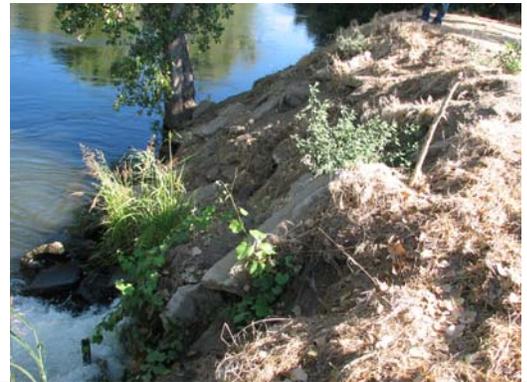
Downstream view of the site.

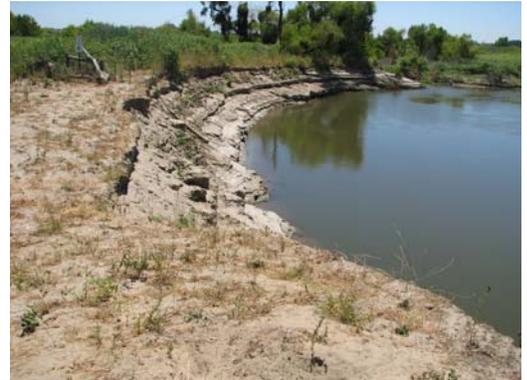
08/18/2011: No significant changes observed on the site. Dead trees and animal activities visible. The closest point of the erosion site to the levee toe is about 100 ft.
 10/19/2010: There is active scouring occurring on the bank due to the nature of the flow and the lack of armor protection. There is also a fallen log immediately downstream of where the erosion has occurred and is protruding outward, possibly creating an eddy and scouring the bank. With the remaining 100-foot wide berm, the levee prism is not yet affected. However, the bank will continue to degrade, and eventually intrude into the levee prism if no protection is put in place. Erosion site is recommended for annual assessment and monitoring during flood events.

Upstream view of adjacent bank affected by erosion. The loose sand visible on the site.

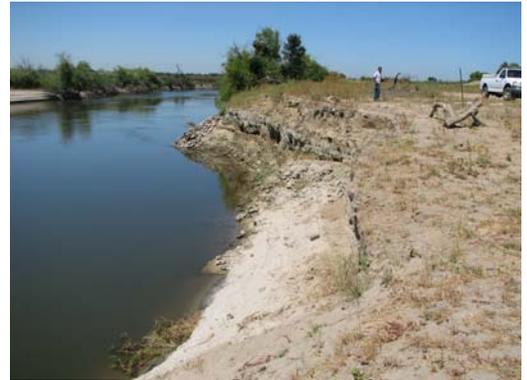
Looking downstream. The starting point of the protection visible.

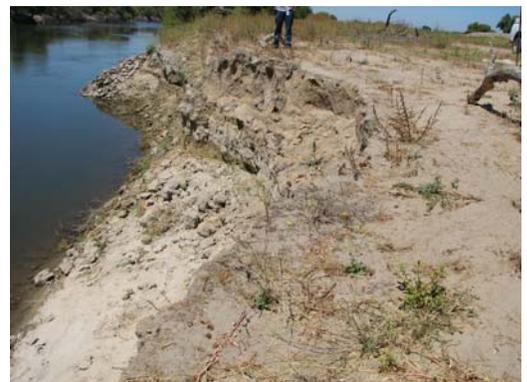
A close look of the erosion. The loose sandy material visible.

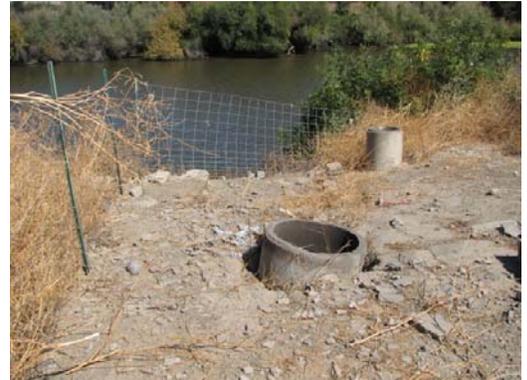
Direct view of siphon breaker.

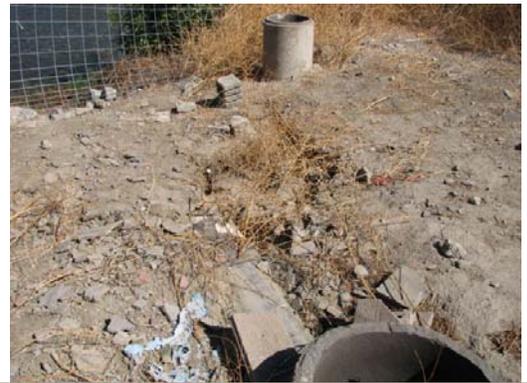
Direct view of siphon breaker.

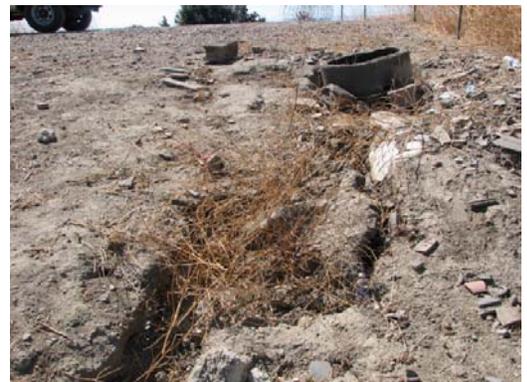
Notches created by water leaking/overflowing from the siphon breaker.

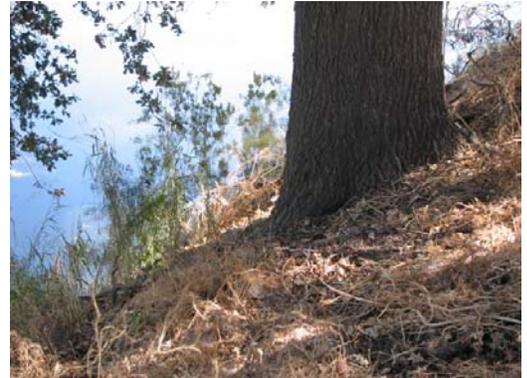
Upstream view of the base of 1 of 2 large Oake trees on site. No signs of scouring on the base.

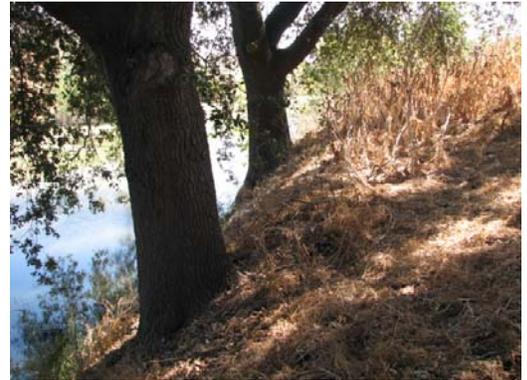
Upstream view of both Oak trees located on the bench.

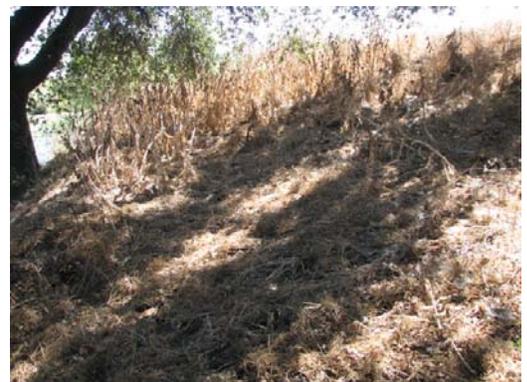
Upstream view of the waterside slope. Vegetation on the slope was recently sprayed.

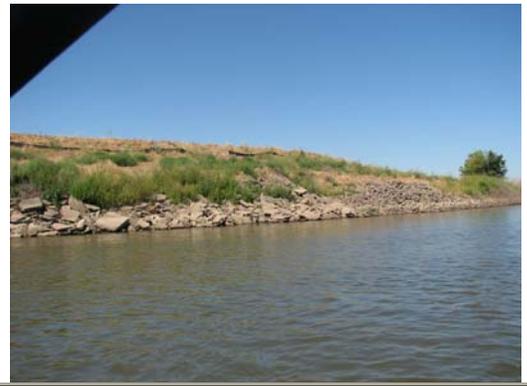
Length (ft): **15**
 Scarp Height (ft): **4**
 Location of Erosion: **Lower 1/2 Slope**
 WS Berm Width (ft): **0**
 WS Vegetation: **2/3 of ground covered**
 WS Burrow Hole Activity: **No signs of activity**
 WS Levee Slope (H:V): **2.5:1**
 WS Soil Type: **Silt (ML)**
 Site Relative to Bend: **Inside of Bend**
 Radius of Curvature(Rc/W): **2.10**

Front view of the erosion

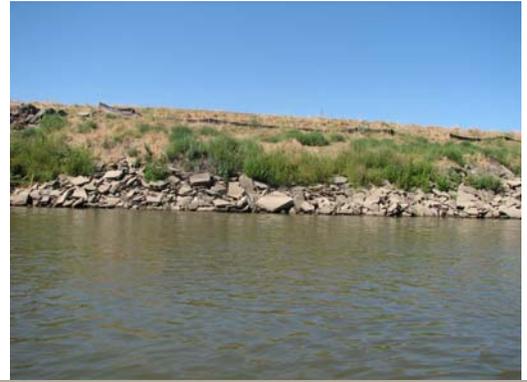
Front view of the rip rap

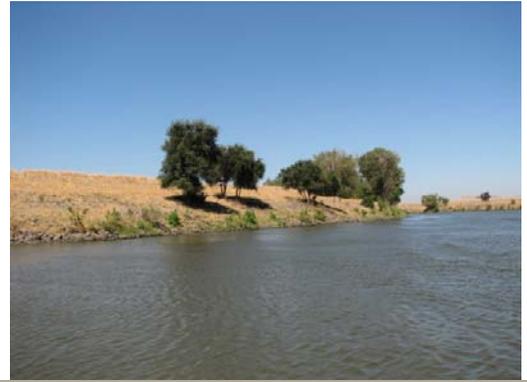
Downstream view of site.

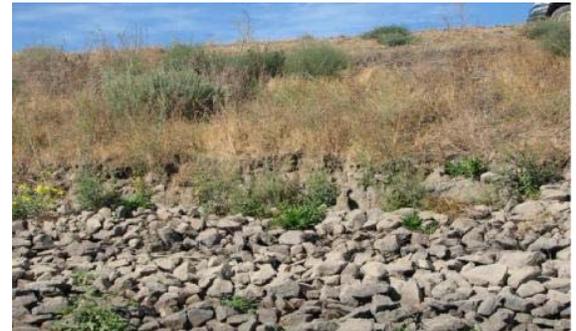
Photograph taken in 2006. Close up view of scarp just above the lower slope revetment.

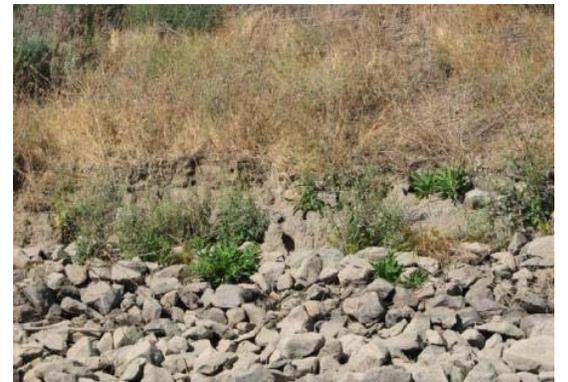
Photograph taken in 2006. Front view of scarp above the lower slope revetment.

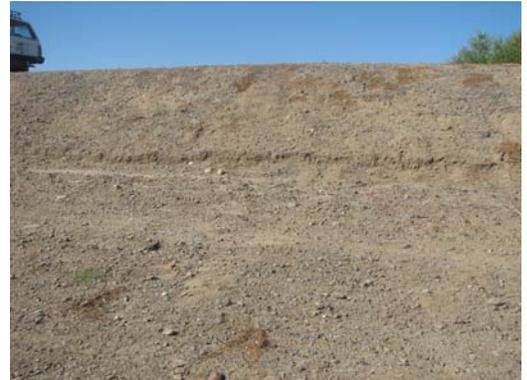
Direct view of site.

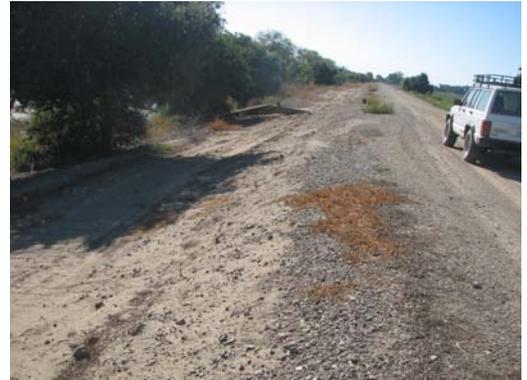
Upstream view of scarp.

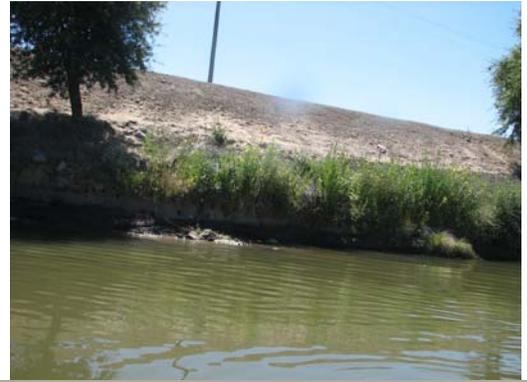
Front view of the erosion

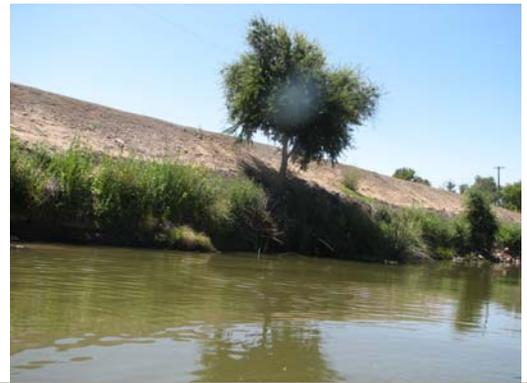
Upstream view of the erosion near the end of the site

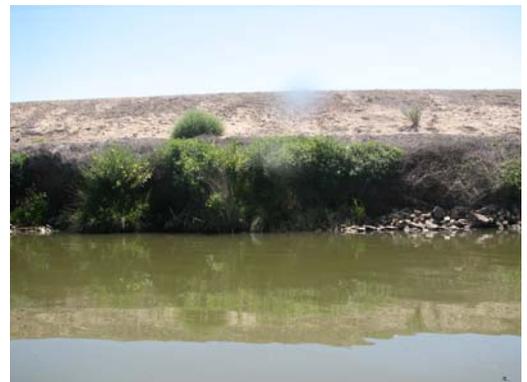
Front view of the erosion. Note the dense vegetation.

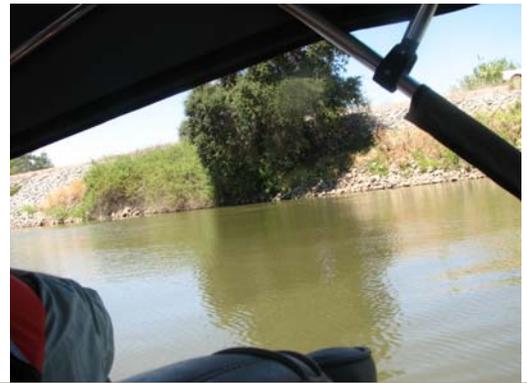
08/23/2011: Hard to view the erosion because of the dense vegetation and trees on site. The site is under the bush, close to the tree.

Front view of the site. Note the vegetation and trees on site

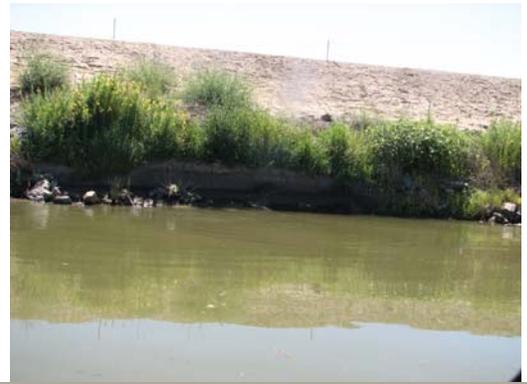
Front view of the erosion

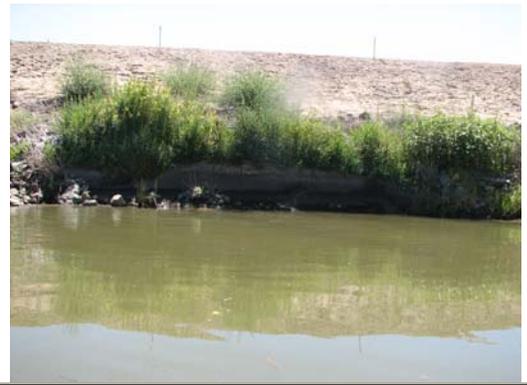
Front view of the erosion

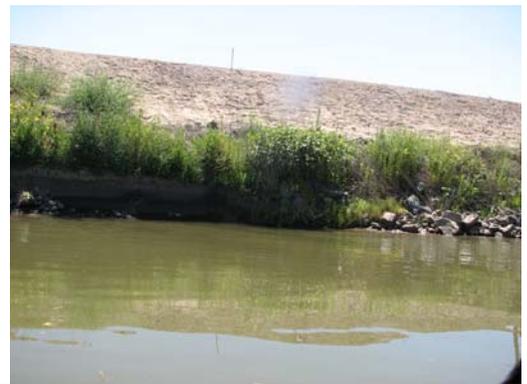
Front view of the site. Note the protection downstream of the erosion

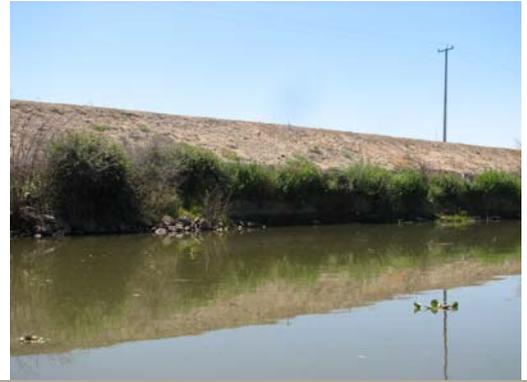
Another view of the same 5-ft scarp.

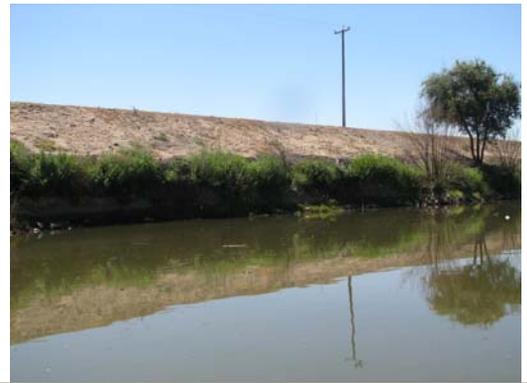
Front view of the site with dense vegetation.

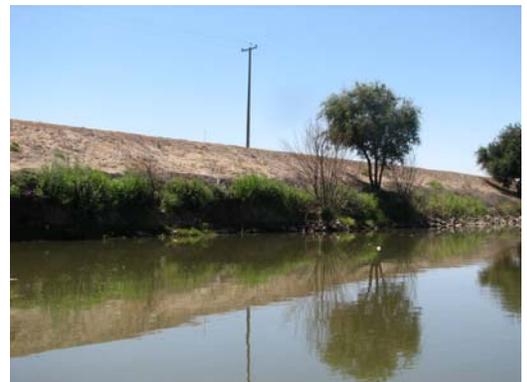
Front view of the site with dense vegetation

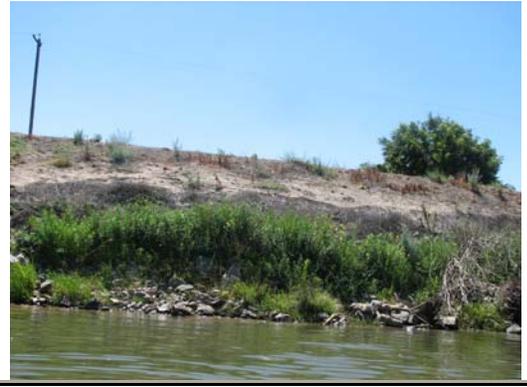
downstream view of the site
