State of California
The California Natural Resources Agency
Department of Water Resources
Division of Flood Management

2011
INSPECTION REPORT
OF THE
CENTRAL VALLEY STATE-FEDERAL
FLOOD PROTECTION SYSTEM

PUBLISHED IN DECEMBER 2011

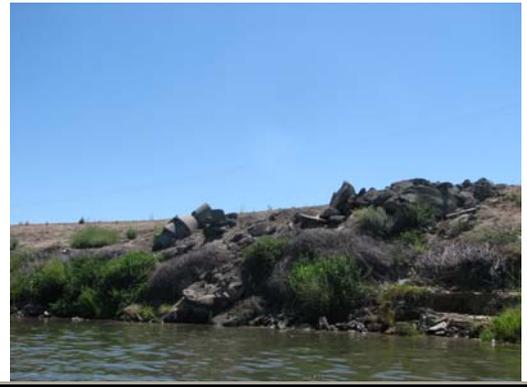
Front view of the erosion. Note the protection at the upstream of the site.

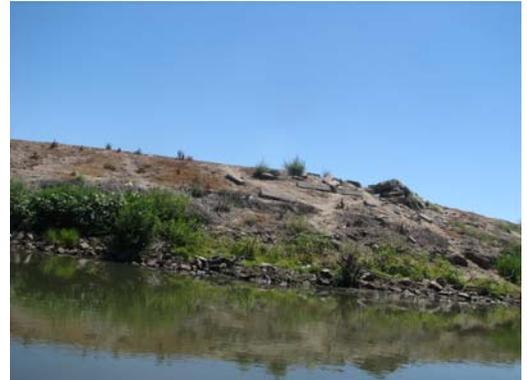
08/23/2011: No significant changes observed on site.
 09/07/2010: No significant changes observed on site. Much of the placed rip rap revetment has slid. It is no longer adequately protecting the slope.
 08/06/2010: Recommended as local maintenance issue, per CLRO Report.
 03/09/2010: As discussed with Michael Moncrief of MBK, site will be 'addressed' this year.
 09/29/2009: No major change observed since last visit; a section of the rip rap has slipped, exposing a levee section that has eroded; recommended as local maintenance issue, per CLRO CES Evaluation 2008 Report; Site # is the same as RM30.43, LM0.63; previously rated "U".
 11/05/2008: Site is located inside of a bend; scarp looks to be into the levee prism; piles of concrete chunks placed on the slope, with some of them already starting to slide.

Front view of the site. Previously placed rip rap slipped, exposing the underlying soils and creating a pocket.

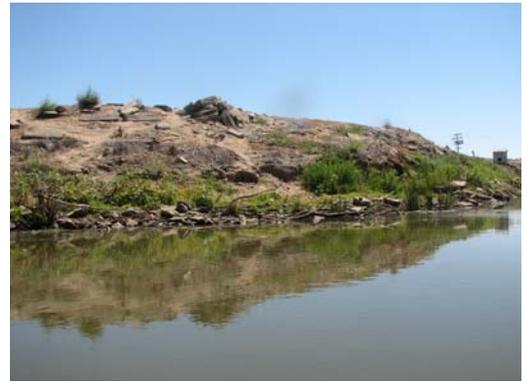
Front view of the site. Rip rap no longer adequately protecting levee slope.

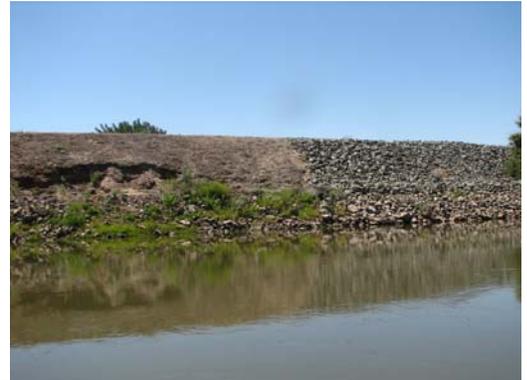
Upstream view of the site

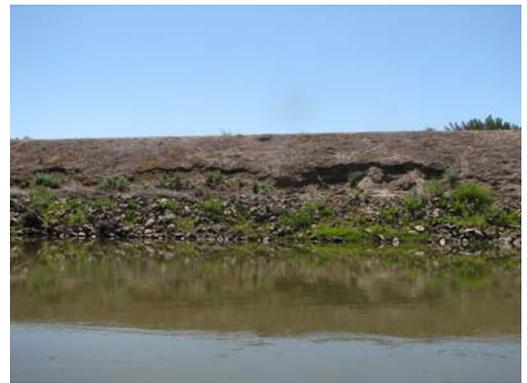
Front view of the site. Note the lateral crack along the middle slope

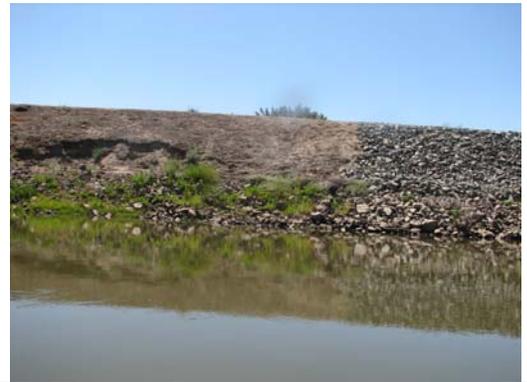
Front view of the site just above existing rip rap.

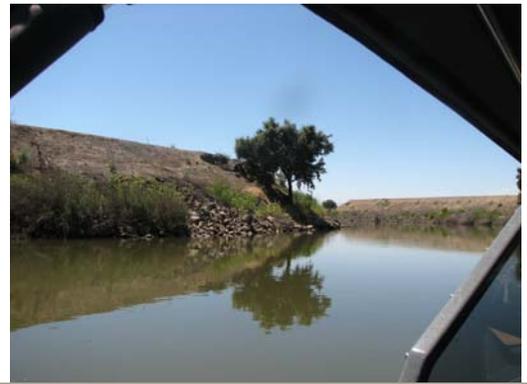
08/23/2011: No significant changes observed on site.
 09/07/2010: No significant changes observed on site. There is a small- to medium sized Oak tree on the mid-slope just above rip rap. Some of the rip rap has collapsed, creating a pocket erosion just above the existing toe rip rap and upstream of the Oak tree.
 08/06/2010: Recommended as local maintenance issue, per CLRO.
 03/09/2010: As discussed with Michael Moncrief of MBK Engineer, site will be 'adressed' in 2010.
 09/29/2009: No major change since last visit; sliding of the rip rap at the base of the lone tree; there is noticeable man-made trail and foot traffic extending from the crown to the toe; much of the broken concrete used as temporary rip rap has slid, exposing portion of the bare levee slope; recommended as local maintenance issue, per CLRO CES Evaluation 2008 Report; Site # is the same as RM31.3,LM1.45; previously rated "M".

11/05/2008: Portion of rip rap collapsing.
 09/14/2006: Portion of rip rap along the slope has collapsed; exposed levee section is starting to erode, exposing roots from the nearby tree.

Upstream view of the site where a small to medium sized Oak tree is located.

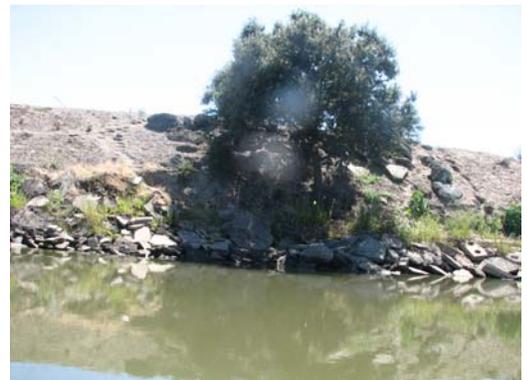
Front view of the site. Note existing broken concrete on the upper slope as well as on the lower slope and at the toe.

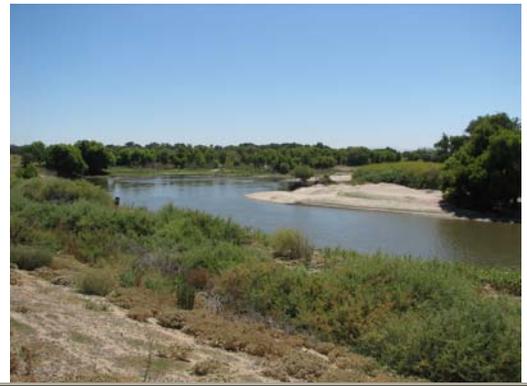
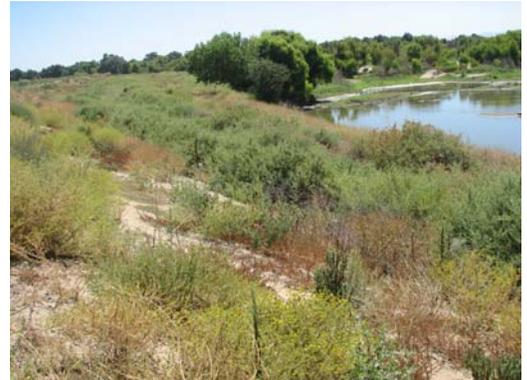
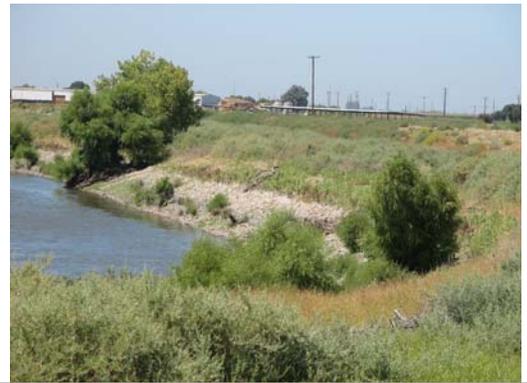
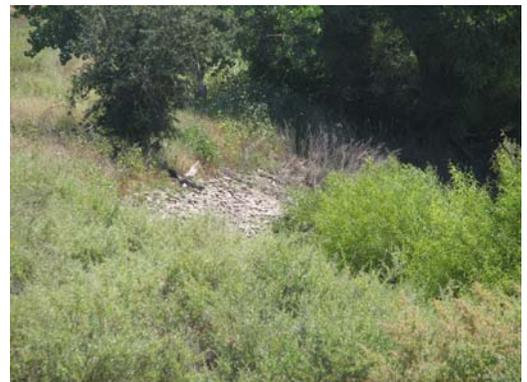
08/18/2011: No sign of new erosion activities observed on site.
 10/20/2010: Site has been repaired by the district. Site was previously rated "M".
 08/06/2010: Recommended as local maintenance issue, per CLRO.
 2009: Note this site has not been reported to be repaired.
 08/07/2007: sinkhole that is approximately 7'x7'x2'; rated "M".

Looking upstream of the site.

Looking upstream of the site . Vegetation developing

Looking downstream of the repaired site.

A close look of the repaired site

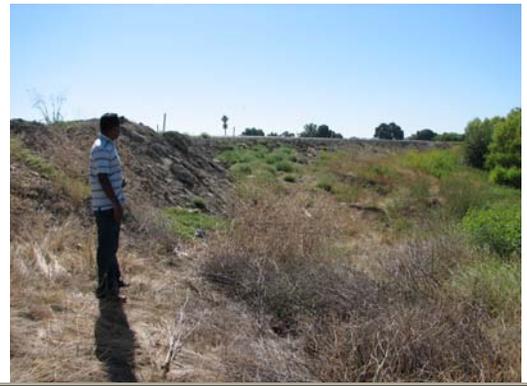
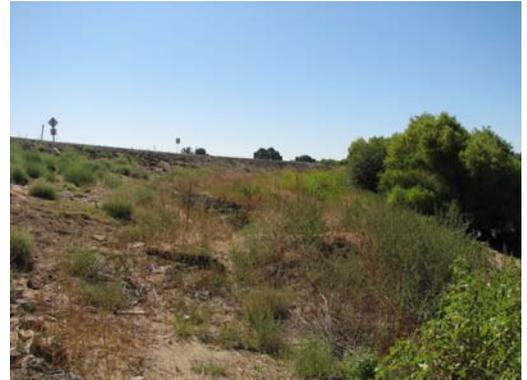
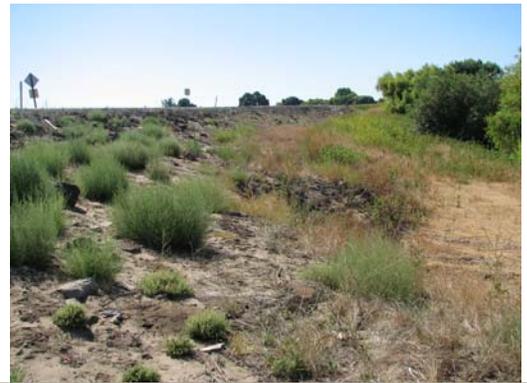
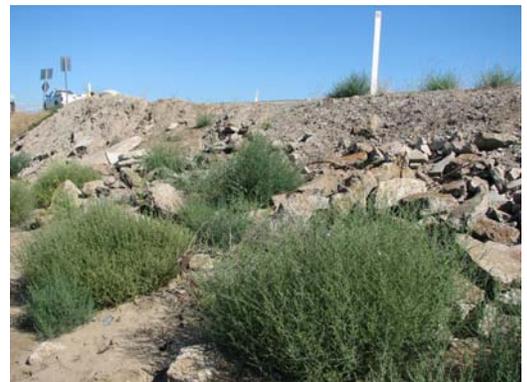
08/18/2011: No significant changes observed on site. Some new material added to the water side levee slope, but the added material is loose and seems not helping the levee protection.

10/05/2010: No significant changes observed on site. Levee slope has minimal vegetation and lacks rip rap protection. Sandy material found on the lower and middle slope is an undesirable material to have on a levee.

08/20/2009: No major change since last visit; site is located in an oxbow; slope surface consists of very sandy material; there is a tree on site leaning and with exposed tree roots; site is recommended as a local maintenance issue, per CLRO CES Evaluation 2008 Report; Eddy Cordoza from the district is aware of the site and is looking for recommendation; site is previously rated "U".

Looking upstream of the site towards the levee crown.

Looking up to the levee crown at the added material.

Looking upstream of the erosion site

Looking downstream from the added material to the levee

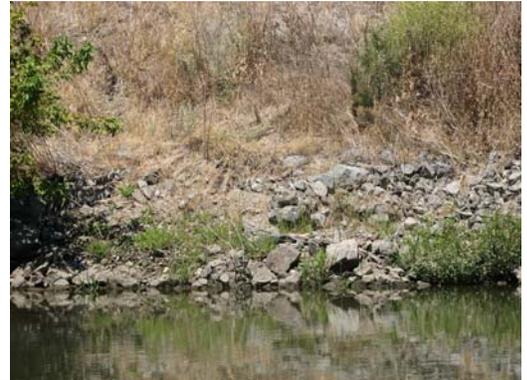
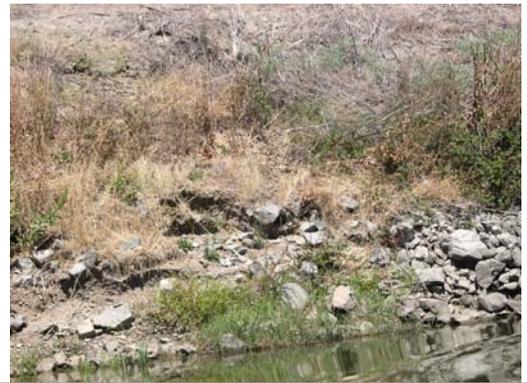
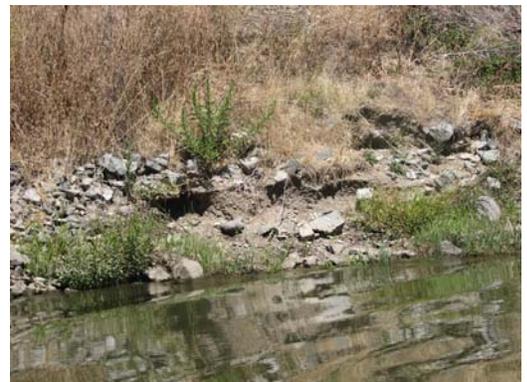
08/23/2011: Minor erosion activities are observed at the toe of the rip rap. Dense vegetation can block view for potential erosion.

09/07/2010: Site has been repaired. It appears that additional shot rock was placed on top of the exposed area, adding protection at the levee toe. Site was previously rated "M".

Close view of the minor erosion activities.

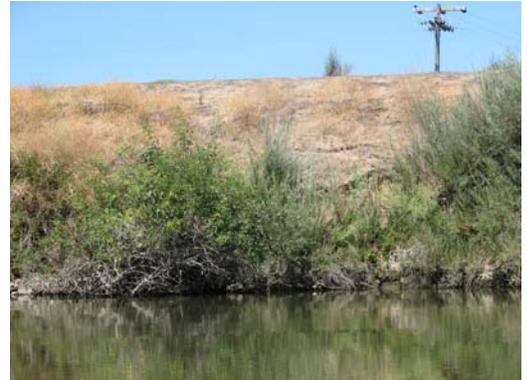
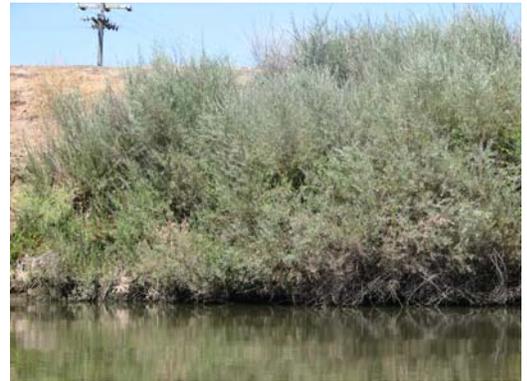
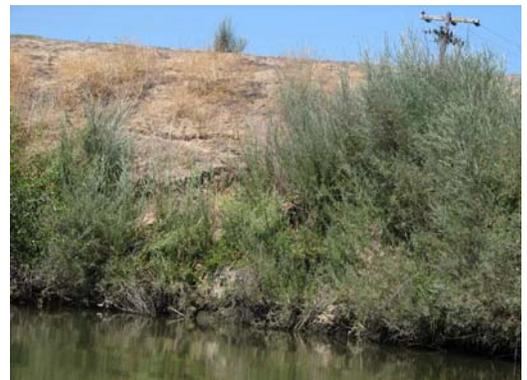
08/23/2011: The 5-foot vertical scarp shows no significant change from the last year inspection. No new erosion activities observed. Dense white willow trees on site.
 09/07/2010: It was difficult to view the erosion due to the thick Willow thickets and other vegetation at the water line. At the time of the inspection, there were no signs of repair on site. As noted during the last survey, there is a 5-foot vertical scarp along the lower slope that may be subjected to high flow velocities.
 08/05/2010: Recommended for repair, per CLRO; "Erosion of this site may be subjective to rapid rates of erosion."
 09/28/2009: No major change observed; 5-foot vertical scarp is immediately downstream of where berm has tapered; site is recommended as local maintenance issue, per CLRO CES Evaluation 2008 Report; Site # is the same as RM29.6,LM0.60; previously rated "U".
 11/05/2008: No change observed; rodent holes on lower slope; wide levee crown.

Downstream view of the site. Note the very dense white willow thickets on site.

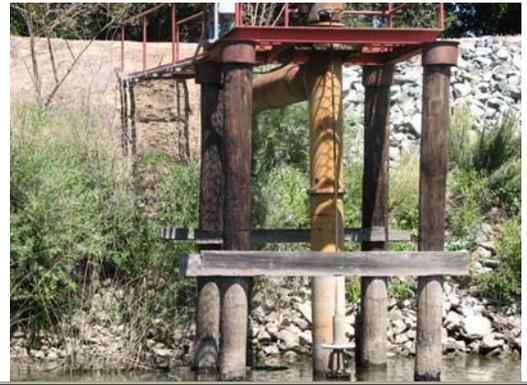
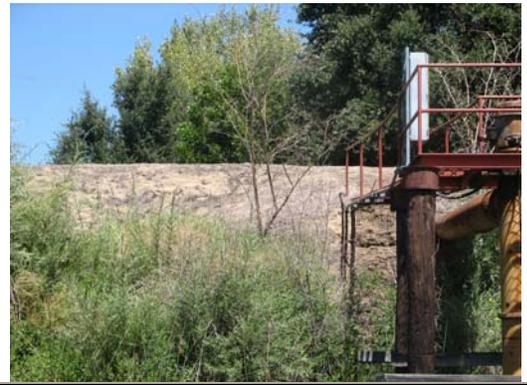
08/23/2011: The site shows loose material around the pipe crossing. The operation of the pipe might have caused certain impact on the levee.

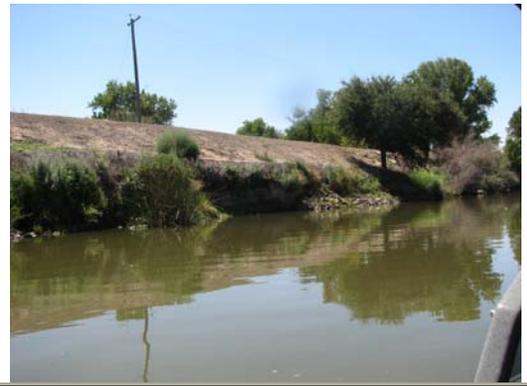
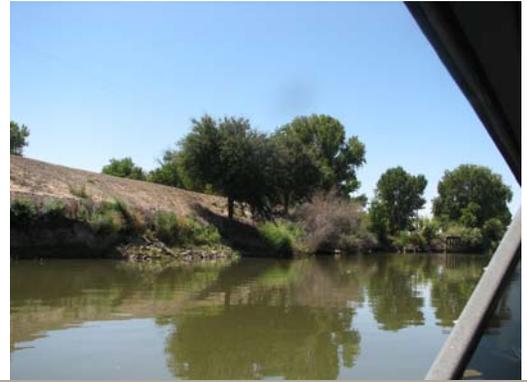
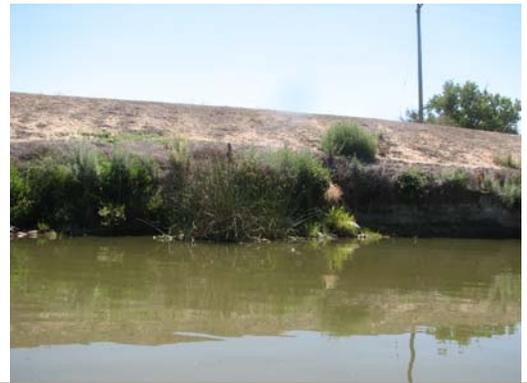
09/07/2010: Site appears to have been repaired by placing shot rock as rip rap protection. Note patches of seasonal grass on revetment. It is recommended that an inspection in the near future be conducted to verify the condition of the revetment. Site was previously rated "M".

Upstream view of the scarp at the levee toe

upstream view of the scarp.

Front view of the repaired site.

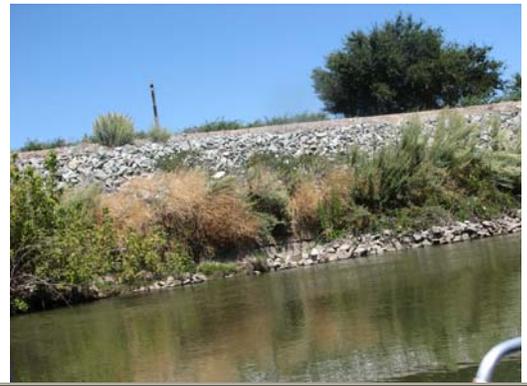
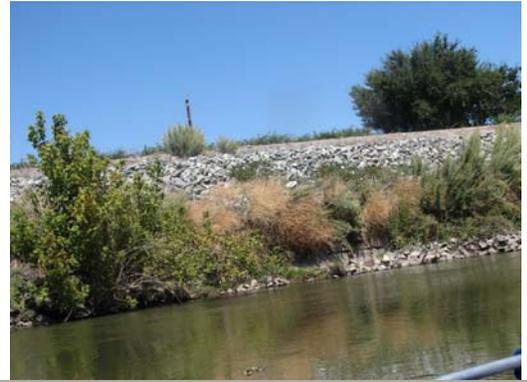
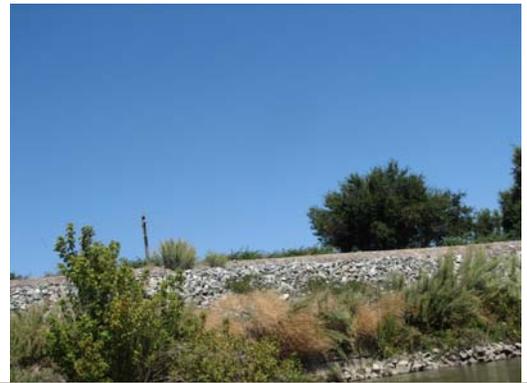
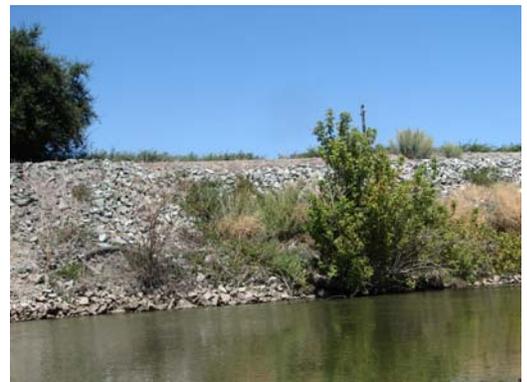
08/23/2011: No significant changes observed on site.
 09/07/2010: Site appears to have been repaired by placing shot rock along the entire slope as revetment. Seasonal grasses growing over the placed revetment. Emergent vegetation at the lower slope that could possibly be covering the vertical scarp that was previously observed. It is recommended that another inspection be conducted to verify status of site. It was previously rated "U".
 08/06/2010: Recommended as local maintenance issue, per CLRO.
 09/28/2009: Rock revetment placed on the upper slope; however, vertical scarp still exists; site is recommended for annual assessment and monitoring of erosion site, per CLRO CES Evaluation 2008 Report; Site # is the same as RM29.95, LM0.22; previously rated "M".
 11/05/2008: Pocket erosion with vertical scarp; loss of rip rap; mild vegetation growth since previous survey.
 10/20/2006: Site visited on 10/20/2006.

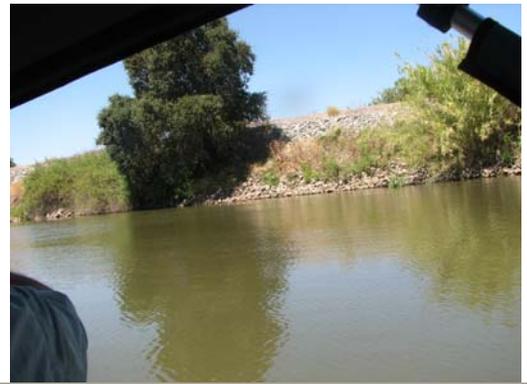
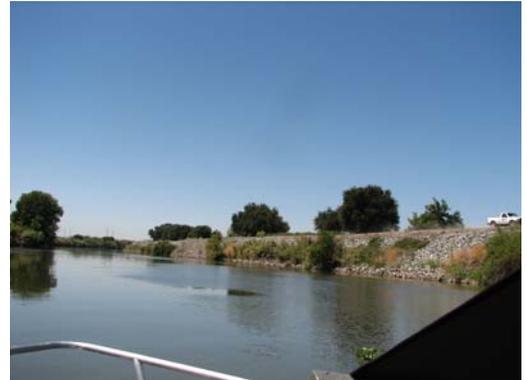
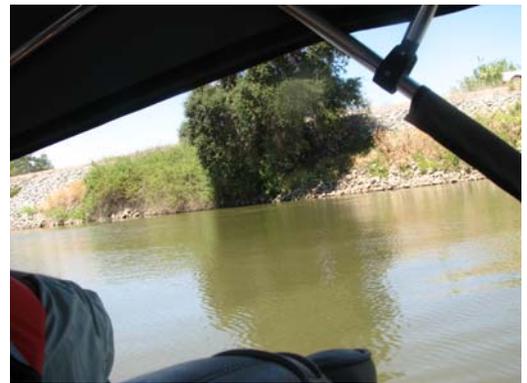
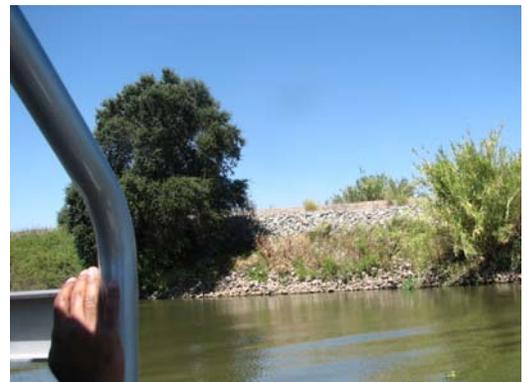
08/23/2011: No new erosion activities observed on site. Dense vegetation and trees are visible.
 09/07/2010: Site appears to have been repaired by placing shot rock along the slope for revetment. There is an abundance of seasonal grass all along the upper and middle slopes. It is recommended that a second inspection be conducted to confirm status of site.
 09/28/2009: Localized sloughing near the toe; rock protection has been added on the lower slope and toe; site is recommended for annual assessment and monitoring, per CLRO CES Evaluation 2008 Report; previously rated "M".
 11/05/2008: Minor toe erosion.
 10/20/2006: Site visited 10/20/2006.

Downstream view of the site. Thick vegetation found on the middle and upper slopes.

Downstream view of the site. Note existing toe revetment.

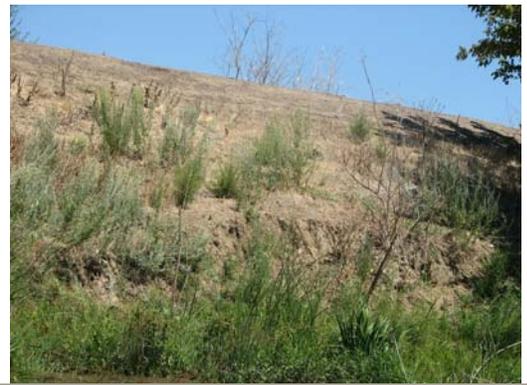
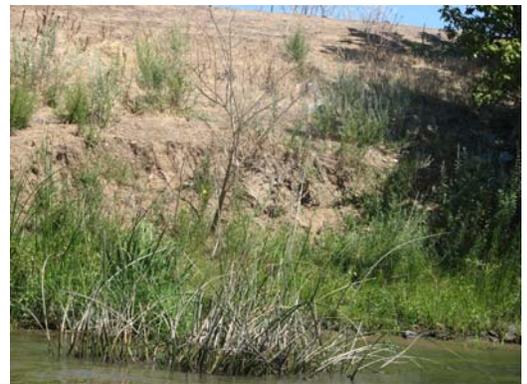
08/23/2011: No significant changes observed on site.
 09/07/2010: Site consists of a jutting rip rap that has created an eddy, scouring the levee slope. Most sections of the toe and lower slope are lined with rip rap. However, the rip rap is sloughing on the mid slope and at the toe, exposing the underlying soils and tree roots. The remaining revetment is no longer adequately protecting the slope. There are 3 Sycamore trees at the toe with exposed tree roots.
 08/05/2010: Recommended for repair, per CLRO.
 09/28/2009: Pocket erosion on lower slope just above the toe rip rap; protruding rip rap upstream is creating an eddy, scouring the levee slope; Site # is the same as RM28.40,LM0.30; previously rated "U"; pictures will be made available during the next survey.
 11/05/2008: Cut into levee profile; riprap slide; rodent holes; pictures do not match GPS and current condition.

A closer look of the site with minor erosions.

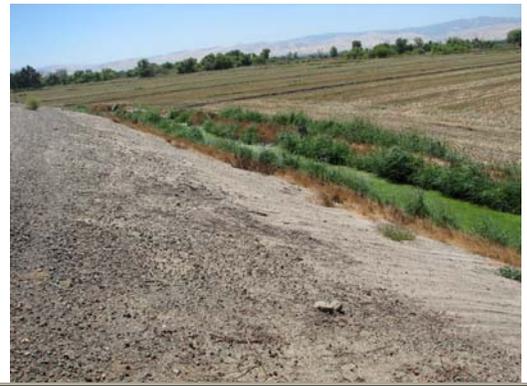
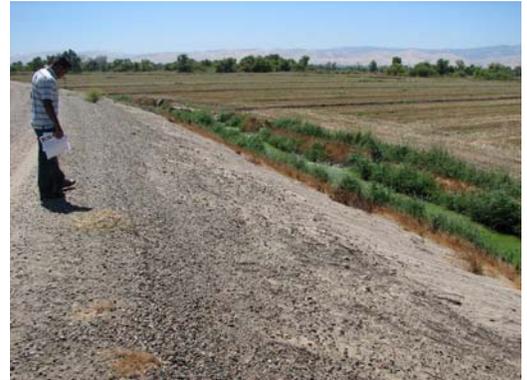
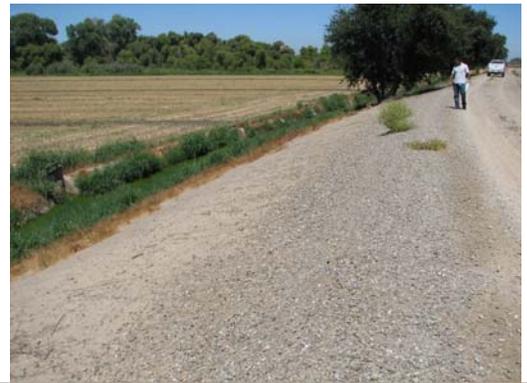
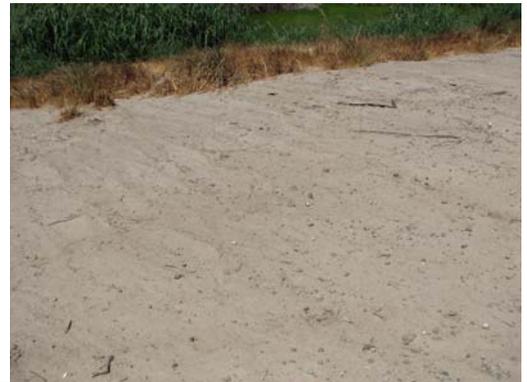
08/18/2011: This site was repaired. No new erosion visible.
 11/30/2010: Site was not surveyed this year due to time constraints. There have been no reports from the district that this site was corrected.
 08/05/2010: Recommended for annual assessment and monitoring during flood events, per CLRO.
 08/25/2009: No major change since last visit; sloughing of the lower slope that's created a terraced effect; damage could be caused by wave action during an extended flooding; site is recommended as local maintenance issue, per CLRO CES Evaluation 2008 Report; previously rated "M".
 08/09/2007: Not as serious - use lower rating.

Close-in view of the repaired site.

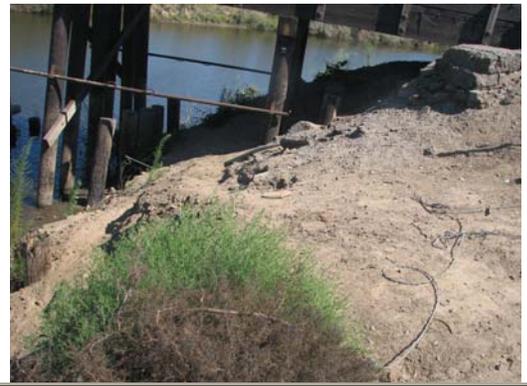
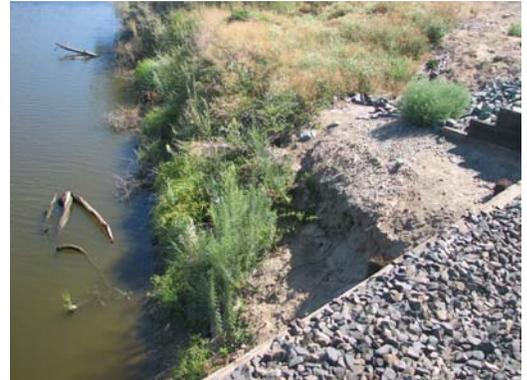
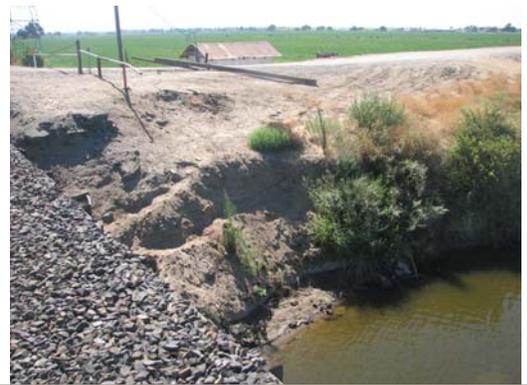
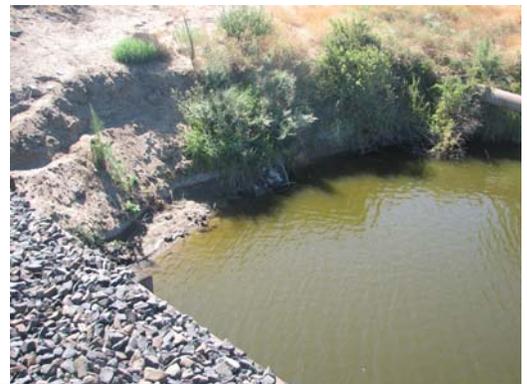
09/02/2011: No significant changes observed on site.
 09/22/2010: No significant changes observed on site. There is now considerable vegetation at the water line and along the lower berm slope. However, the erosion on the lower berm slope is still present and has not been corrected.
 08/06/2010: Recommended for local maintenance issue, per CLRO.
 07/29/2009: No major change since last visit; noticeable vegetation growth; erosion is on berm, but if left untreated, it will eventually erode into levee prism; site is recommended for annual assessment and monitoring of site, per CLRO CES 2008 Report; Site # is the same sa RM6.80, LM0.73; previously rated "U".
 07/22/2008: Downstream of WPRR near siphon pipe & pump; sandy levee; visited by Jeff Van Gilder and LRO in 2008 for repair assessment; scouring downstream of RxR crossing, possibly caused by eddy effects.
 03/13/2007: Site visited on 03/13/2007.

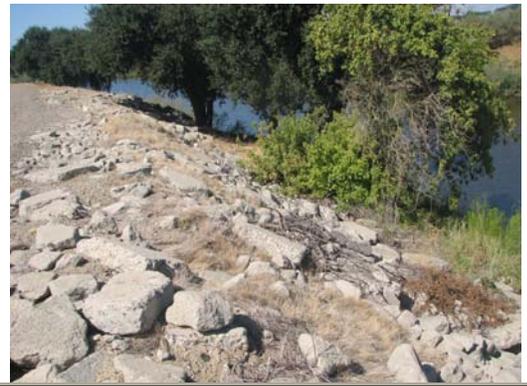
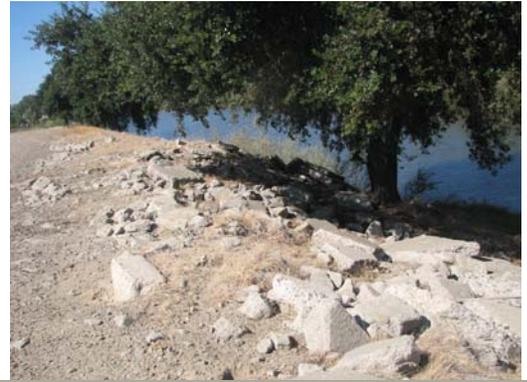
09/02/2011: No significant changes observed.
 09/22/2010: No significant changes observed. Sloughing of the existing rip rap possibly due to a combination of steep slope and undesirable flood conditions.
 08/06/2010: Recommended as local maintenance issue, per CLRO.
 07/29/2009: No major change observed since last visit; near-vertical slope that has rip rap sloughing; site is recommended as a local maintenance issue, per CLRO CES Evaluation 2008 Report; Site # is the same as RM6.90,LM0.86; previously rated "U".
 07/22/2008: Previous erosion site that is partially protected with concrete rubble; erosion scarp is adjacent to the sloughing rip rap.
 03/13/2007: Site visited on 03/13/2007.

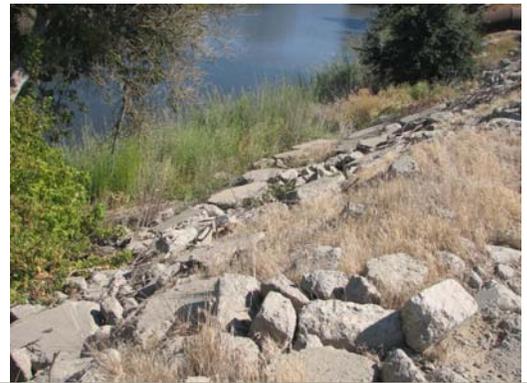
Upstream view of the site.

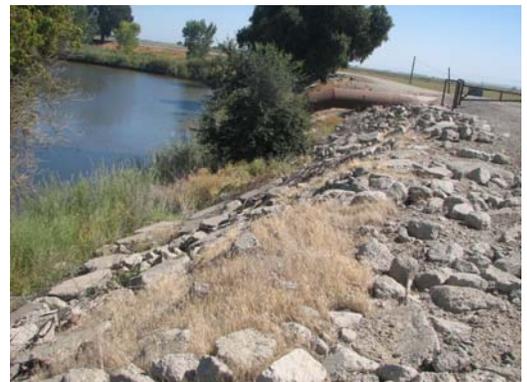
Upstream view of the site from upper slope.

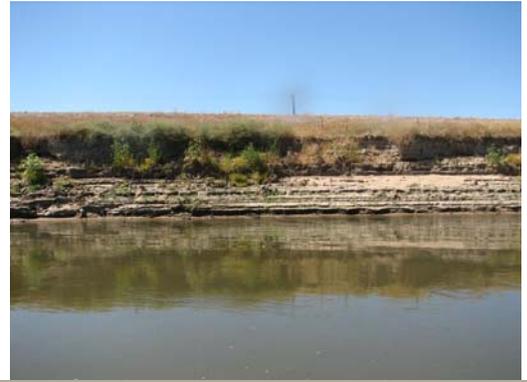
08/23/2011: No significant changes observed on the site.
 9/22/2010: No significant changes observed on site. There is moderate vegetation growth on the berm. Despite the erosion occurring on the berm, corrective action should be taken before the issue becomes severe.
 9/29/2009: Site is immediately downstream of a section of existing rip rap; there is a 20-foot berm remaining; berm will continue to erode unless erosion is mitigated; Site# is the same as RM62.6, LM1.87; recommended for annual assessment, per CES Evaluation 2008 Report
 2006: Visited 10/20/06

Front view of the site.

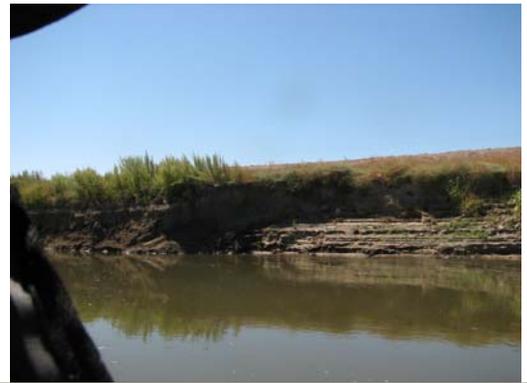
Upstream view of the site.

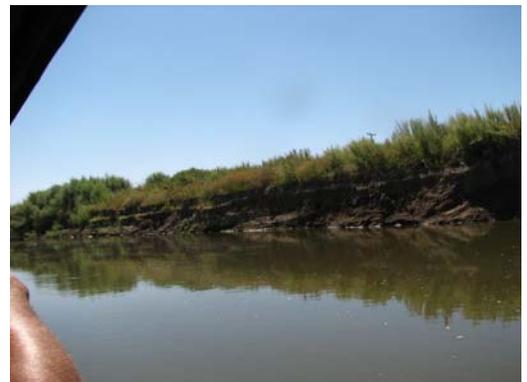
Front view of the site.

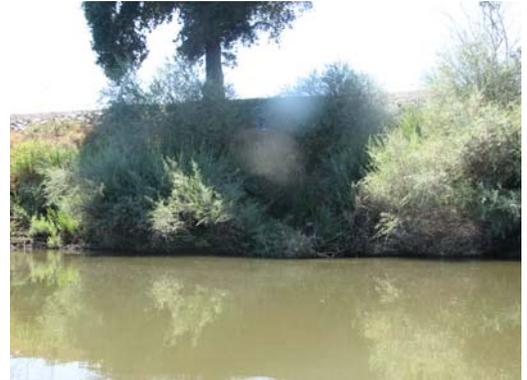
08/23/2011: Dense vegetation makes it difficult to view the possible erosion. No new development was observed on site.
 09/23/2010: At the time of the inspection, the erosion site was difficult to view from the levee. Erosion is located on the bank toe, below the existing rip rap. There were no signs of repair on site, nor has the site been reported to be repaired by the district. Images taken from last year indicate that existing rip rap at the bank toe has sloughed exposing the underlying soils. Weakening of the toe could lead to future bank instability.
 08/05/2010: Recommended for annual assessment and monitoring during flood events, per CLRO.
 09/29/2009: No major change observed since last visit; sloughing of the rip rap above toe; erosion begins immediately downstream of existing rip rap revetment; roughly 15-foot berm remains; however, it will continue to erode and eventually intrude into the levee profile if left untreated.

Front view of the erosion.

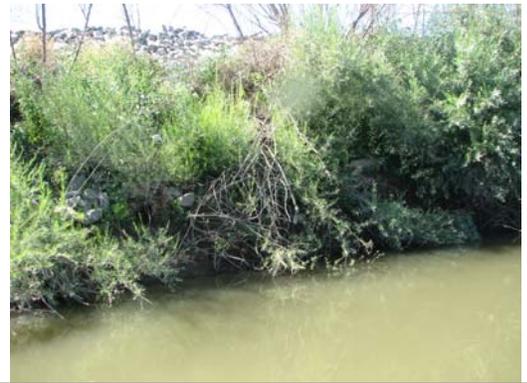
Direct view of the erosion.

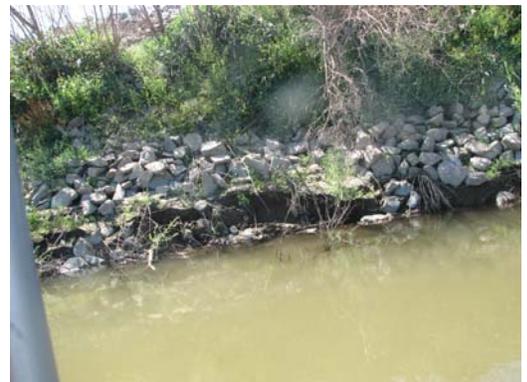
A closer look at the site

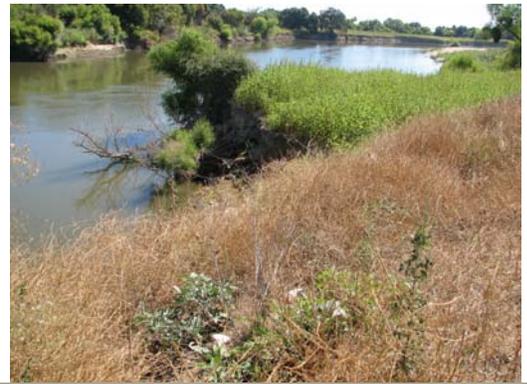
10/19/2010: No significant changes observed on site. Remaining levee berm topsoil is of silty sand mixture. Erosion is near the downstream transition. An eddy has formed, and has scoured away a 100-foot section of the bank, possibly encroaching into the levee prism. Vegetation on site includes willows, oak, and cotton wood located from the bench to the toe. On the landside are rows of corn crop.

Looking upstream from levee top. The tree at the water edge is the visible starting point of the erosion.

08/05/2010: Recommended for Repair, per CLRO.

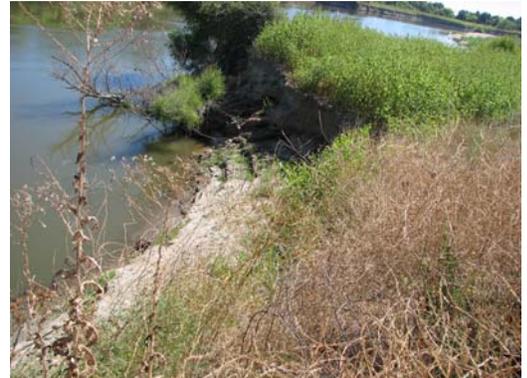
A close look at the erosion. The viewing point is about half of the levee slope.

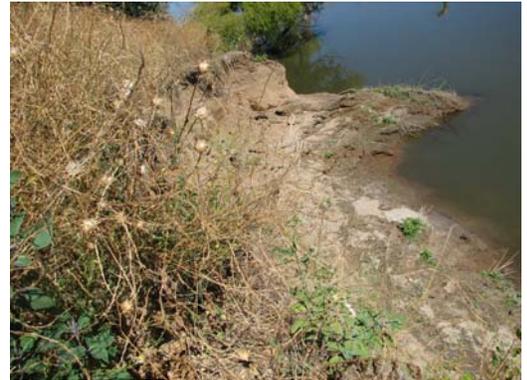
Looking downstream at the scour site. The erosion has developed to about 1/3 of the levee slope. The levee toe has been washed away.

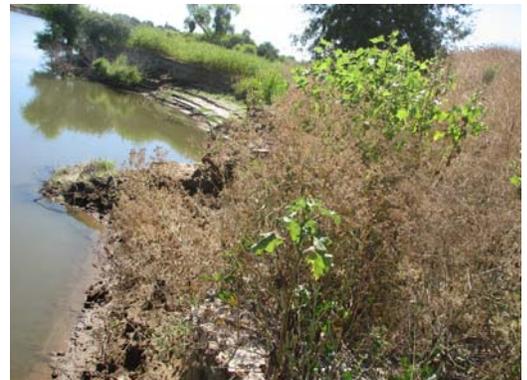
Looking upstream at the scour site. The dense vegetation visible.
