**State of California
The Resources Agency
DEPARTMENT OF WATER RESOURCES
Division of Flood Management**

**2001
OFFICE REPORT**

**INSPECTION OF FLOOD CONTROL STRUCTURES
ON THE SACRAMENTO AND SAN JOAQUIN RIVERS
AND THEIR TRIBUTARIES**

**Prepared by
FLOOD PROJECT INSPECTION SECTION**

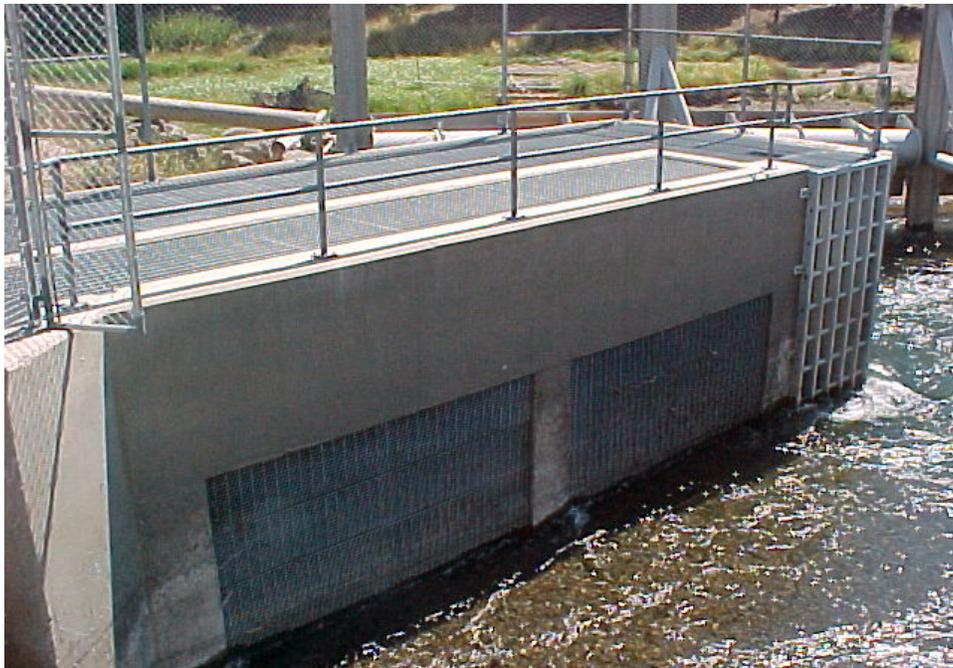
1. **Condition of concrete diversion structure.**
 - a. **Good.**
2. **Condition of the gauging house and equipment.**
 - a. **Fair. There are still numerous bullet holes in the door.**
3. **Condition of the steel trash racks.**
 - a. **Good.**
4. **Condition of debris deflection structure.**
 - a. **Good. The damaged sections reported in the 1998 Structure Report have been repaired.**
5. **Condition of the revetments.**
 - a. **Good.**
6. **Accumulation of trash and debris around structure or in the channel.**
 - a. **Minimal amount of debris around the deflection structure.**
7. **Vegetation around the structure or in the channel.**
 - a. **None.**
8. **Condition of the conduits.**
 - a. **The center conduit was inspected this year and found to be in good condition. However the separations at the joints between the monoliths have increased.**

Looking at the steel trash racks.

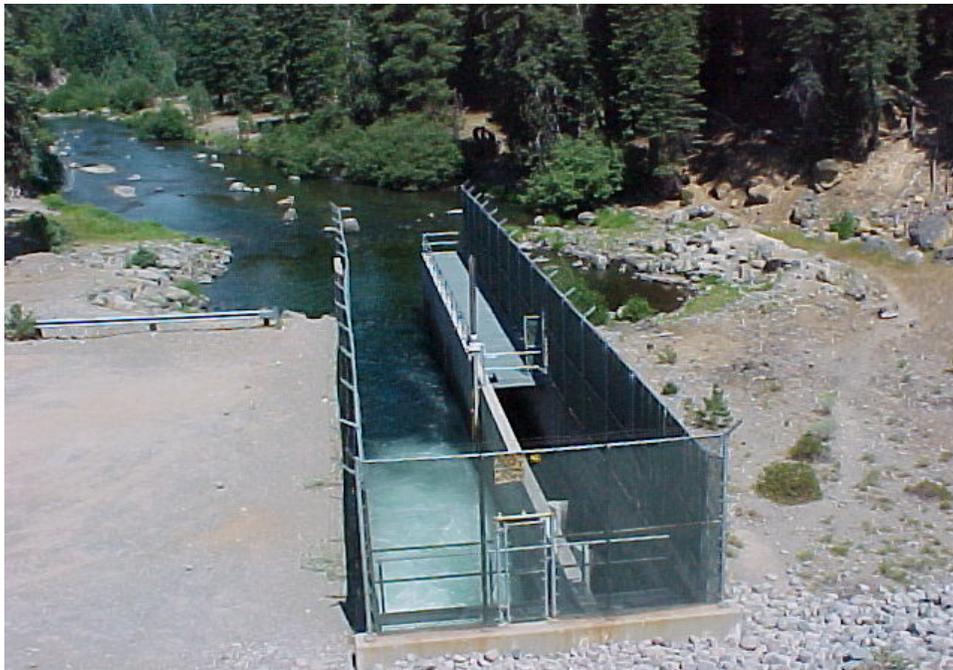
- 9. Condition of the discharge structure.**
- a. The structure is in good condition, however the lock was missing from the gate located on the east side of the structure.**

Looking downstream at the outlet works.

Note open gate.

- a. Good maintenance.**
- b. Replace the lock on the discharge structure gate for security and public safety.**

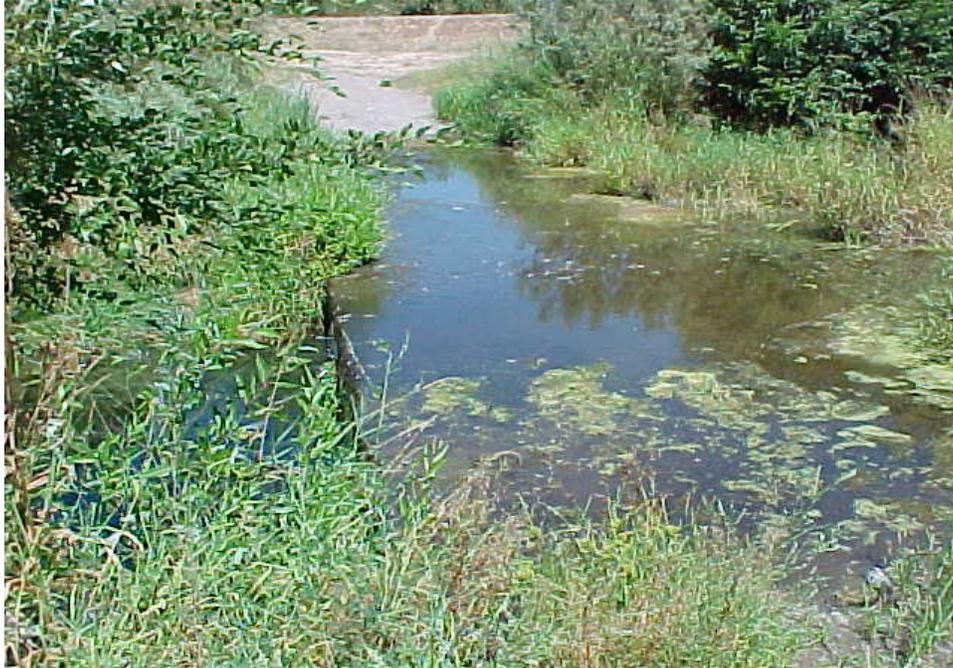
1. **Condition of concrete weir structure.**
 - a. **Good, but ineffective due to accumulation of gravel upstream of the structure.**
2. **Condition of the diversion structure and wingwalls.**

**Looking at water flowing over the concrete weir.
Weir is ineffective due to gravel build-up upstream.**

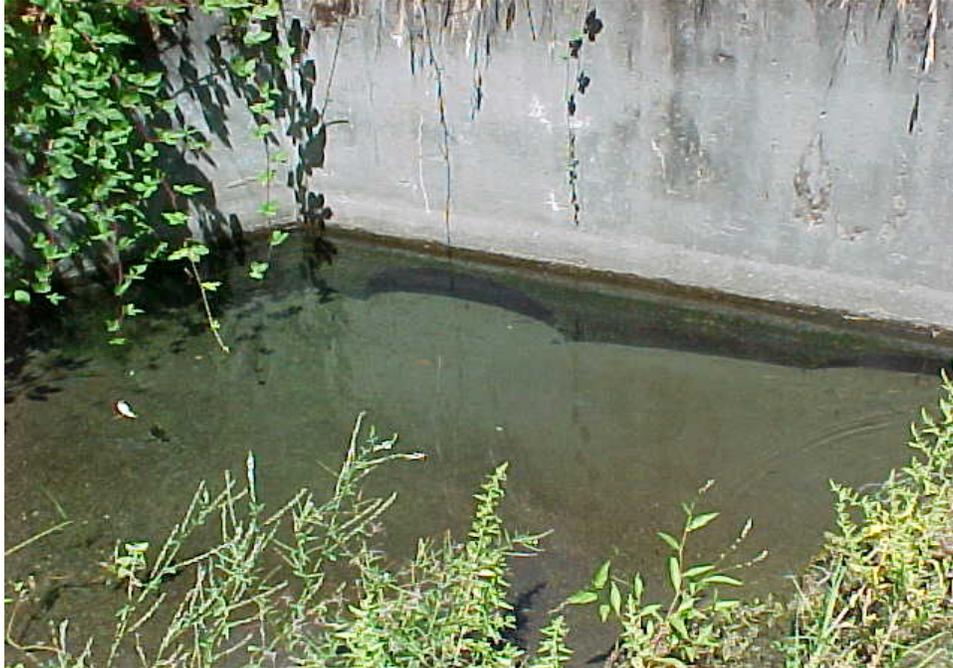
- a. **Good, but pipes are three quarters full of sand.**
3. **Condition of the bulkhead.**
 - a. **Good.**
4. **Condition of the control gates and mechanism.**

**Looking at two of the six, 36 inch discharge
pipes at the outlet side of diversion structure.
These pipes are nearly full of sediment.**

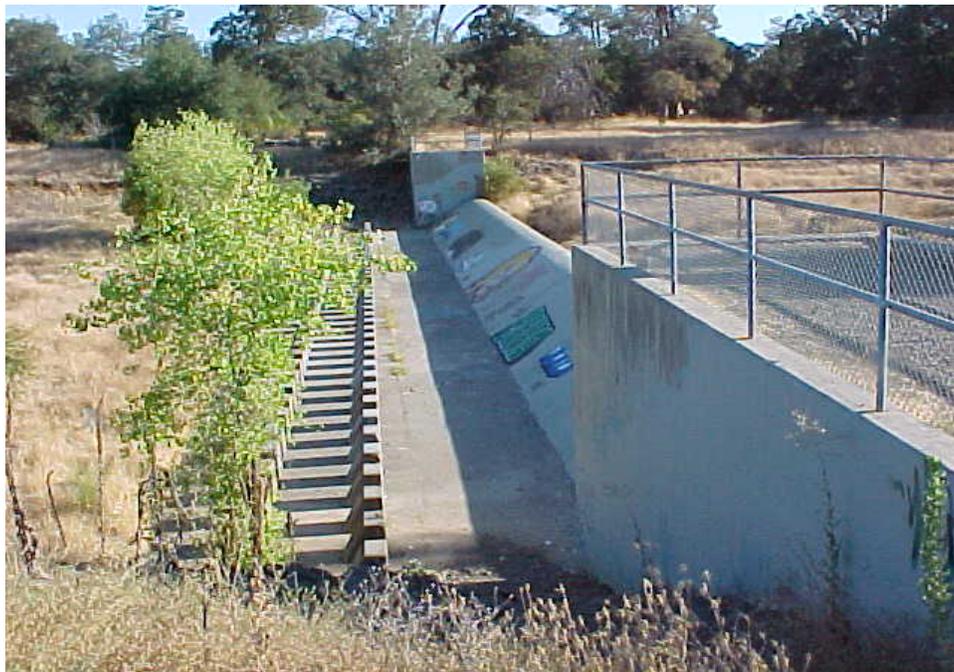
- 1. Condition of concrete weir structure and stilling basin, and velocity dissipaters.**
 - a. There are minor joint separations on the north and south ends of the weir where it contacts the abutments.**
 - b. There is minor damage to several velocity dissipaters and severe damage to one.**
- 2. Condition of concrete abutments and wingwalls.**
 - a. Good.**
- 3. Condition of revetment.**
 - a. Good.**
- 4. Accumulation of trash and debris around the structure or in the channel.**
 - a. None.**
- 5. Vegetation around structure or in the channel.**
 - a. Minimal.**
- 6. Condition of gauging house and equipment.**
 - a. Fair.**
- 7. Comments:**
 - a. Repair the severely damaged velocity dissipater.**
 - b. Remove vegetation from channel.**
 - c.**
 - d. Good maintenance.**

Looking at the velocity dissipaters on the downstream side of structure from the left bank.

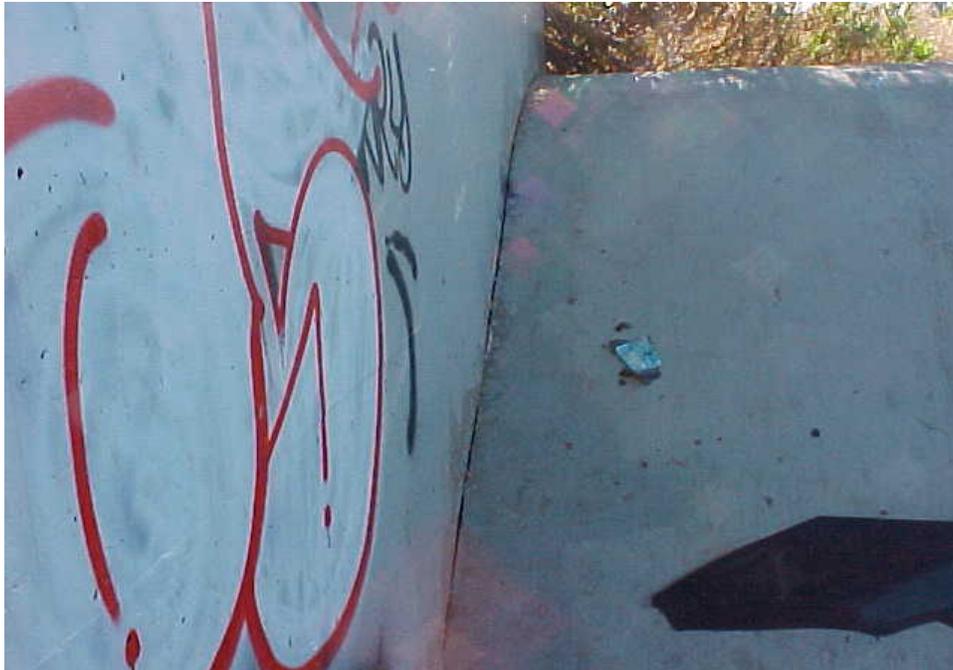
Typical view of minimal joint separation at both ends of weir.

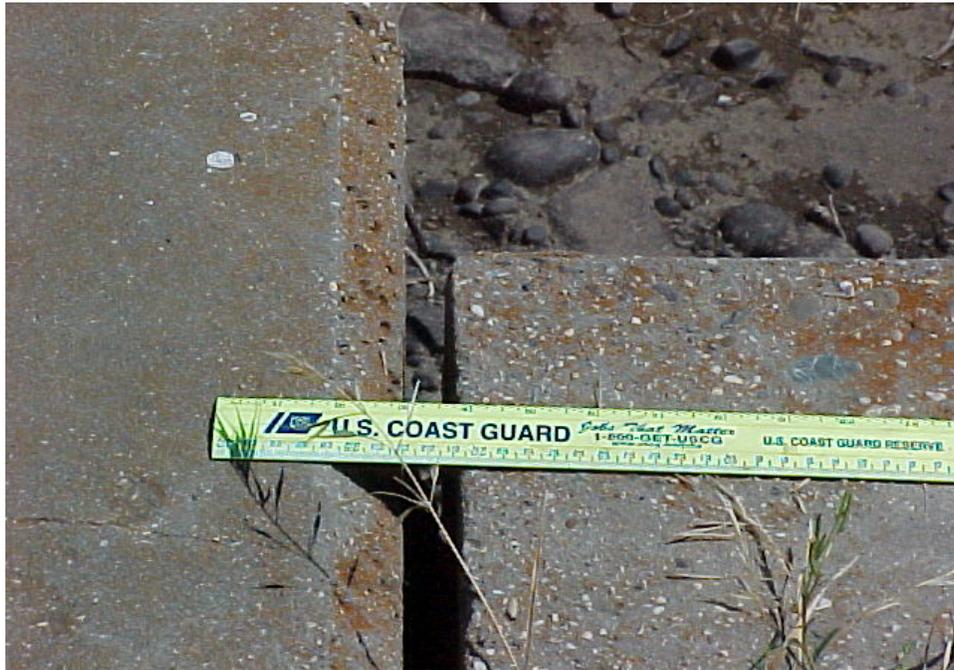
1. **Condition of concrete control structure.**
 - a. **Good.**
2. **Condition of bulkheads and wingwalls of the control structure.**
 - a. **The upstream wingwall on the right abutment is 5/8-inch out of alignment at the top. The downstream wingwall on the right abutment is 3/4-inch out of alignment at the top.**

**5/8ths inch separation between the control structure
and the abutment on the upstream side.**

- 9. Accumulation of trash and debris around the structures or in the channel.**
 - a. Minimal.**
- 10. Vegetation around the control structure, the weir, or in the channel.**
 - a. Minimal.**
- 11. Comments:**
 - a. Monitor joint separation between the control structure and the abutment and repair as needed.**
 - b. Remove driftwood and cobbles from dissipaters.**
 - c. This office will contact Sutter Maintenance Yard regarding the log boom.**
 - c. Good maintenance.**

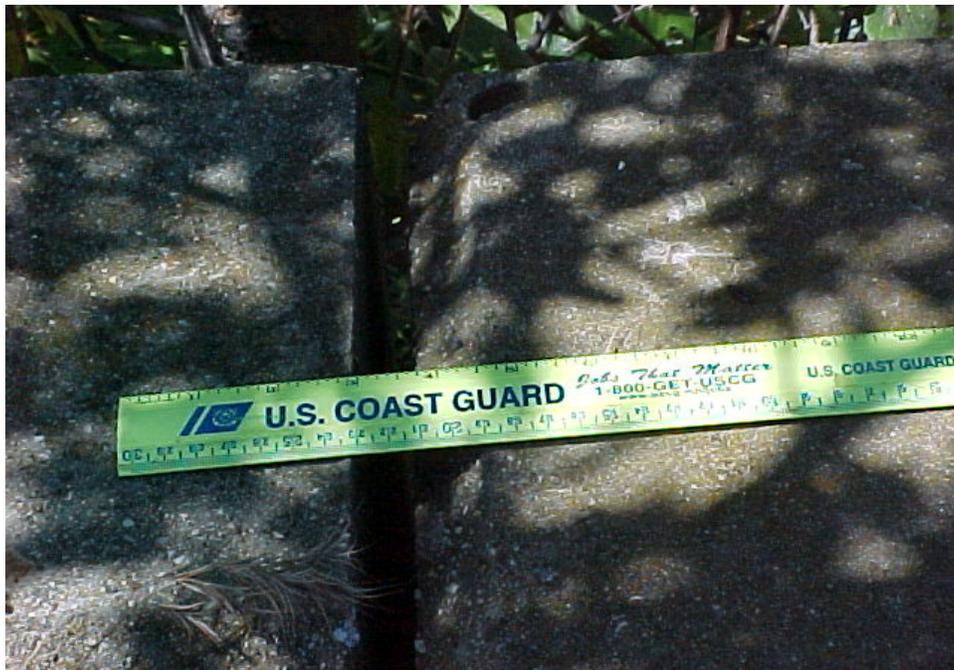
3/4 inch separation between the control structure

and the abutment on the downstream side.

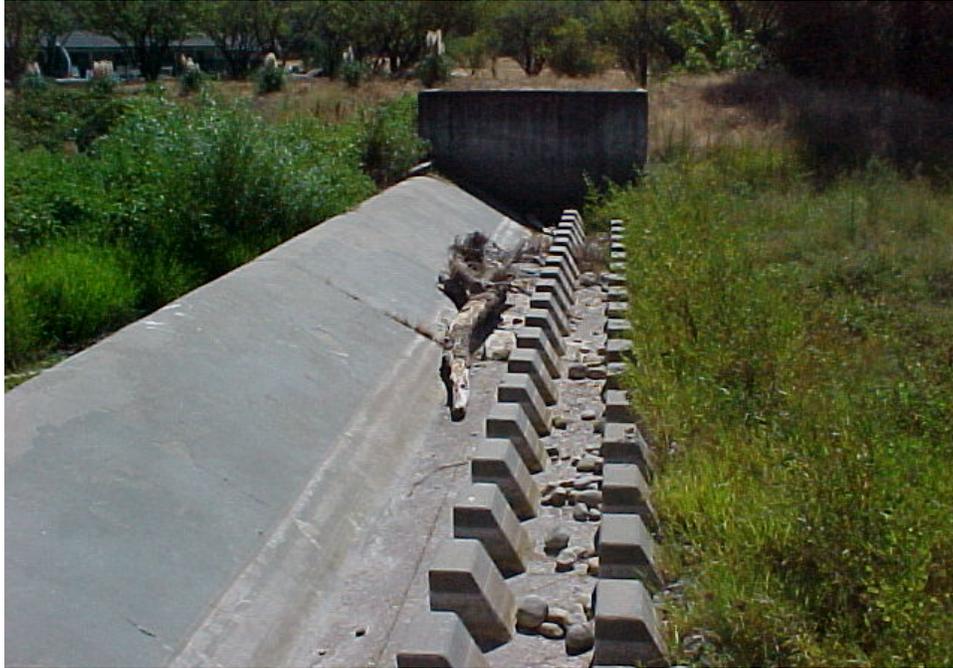
Looking south at the weir, minimal debris in the stilling basin.

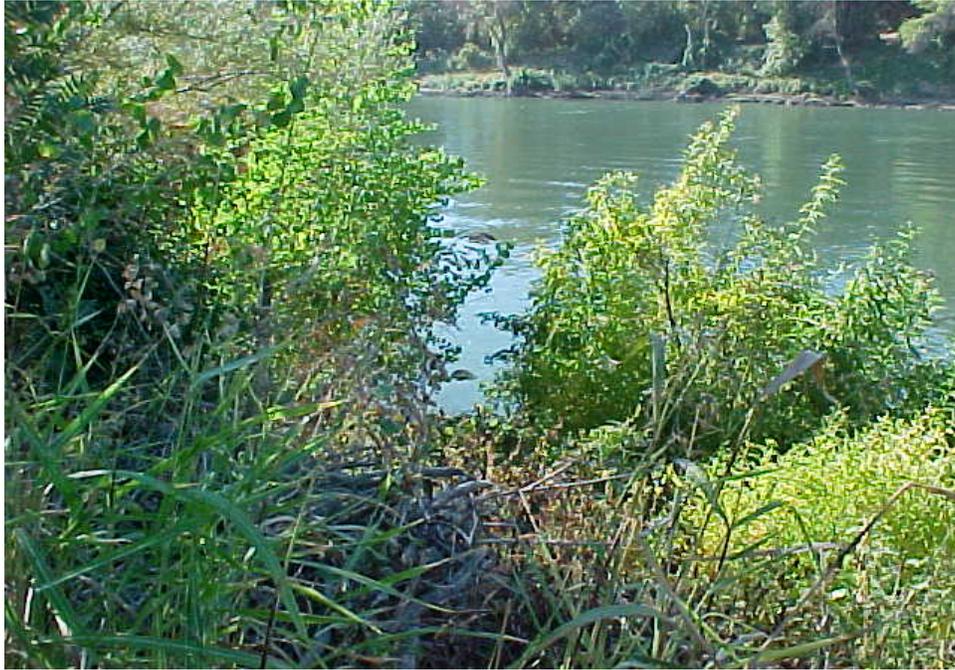
1. **Condition of the corrugated metal pipe (CMP) drainage structure.**
 - a. **Good.**
2. **Condition of the control gate, mechanisms, and flap gates.**
 - a. **Could not properly inspect due to excessive vegetation.**
3. **Condition of the revetment.**
 - a. **Good.**
4. **Accumulation of trash and debris around the inlet, in the pipe or in the channel.**
 - a. **Could not properly inspect due to excessive vegetation.**
5. **Vegetation around the structure or in the channel.**
 - a. **Heavy vegetation around structure. Growth is so dense that intake and discharge ends of structure cannot be seen.**
6. **Comments:**
 - a. **Remove vegetation from inlet and discharge ends of structure. If growth is not removed, the drainage structure could become non functional.**
 - b. **No maintenance.**

Looking at the dense growth covering the outlet.

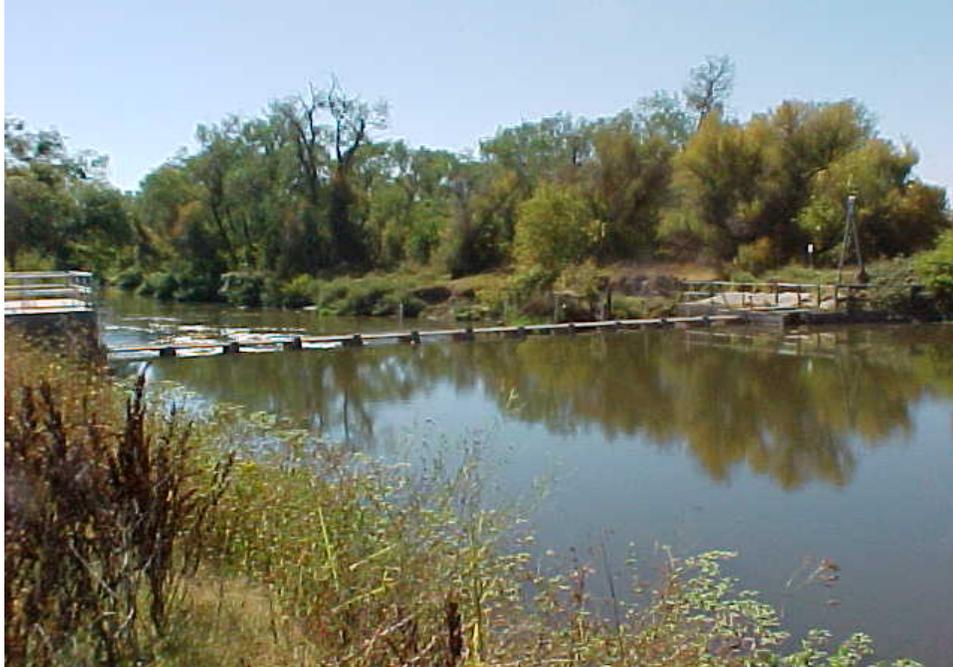
Looking at the upstream side of the structure.

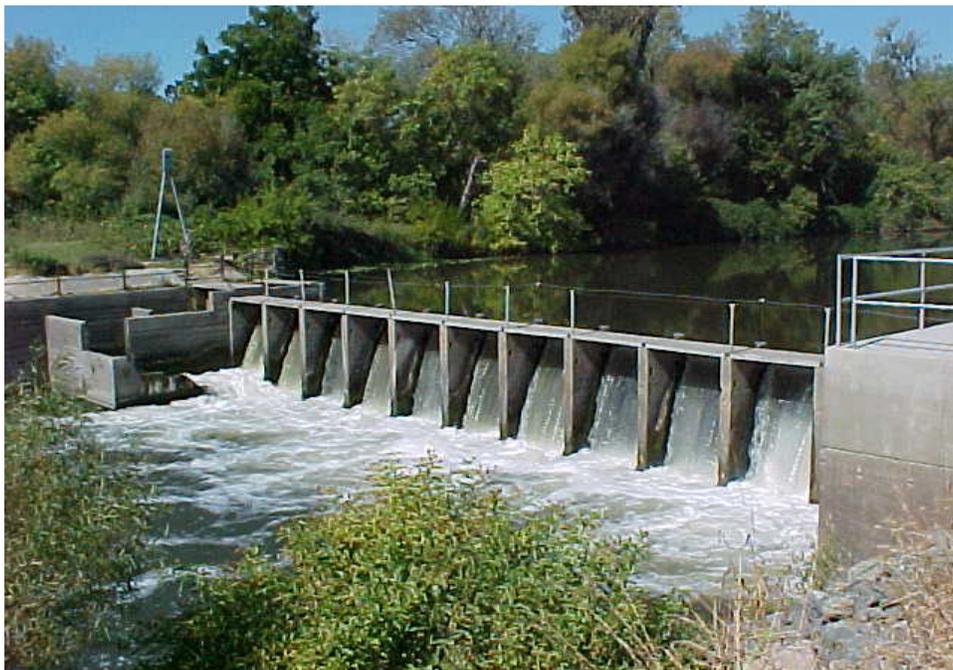
Looking at the downstream side of the structure.

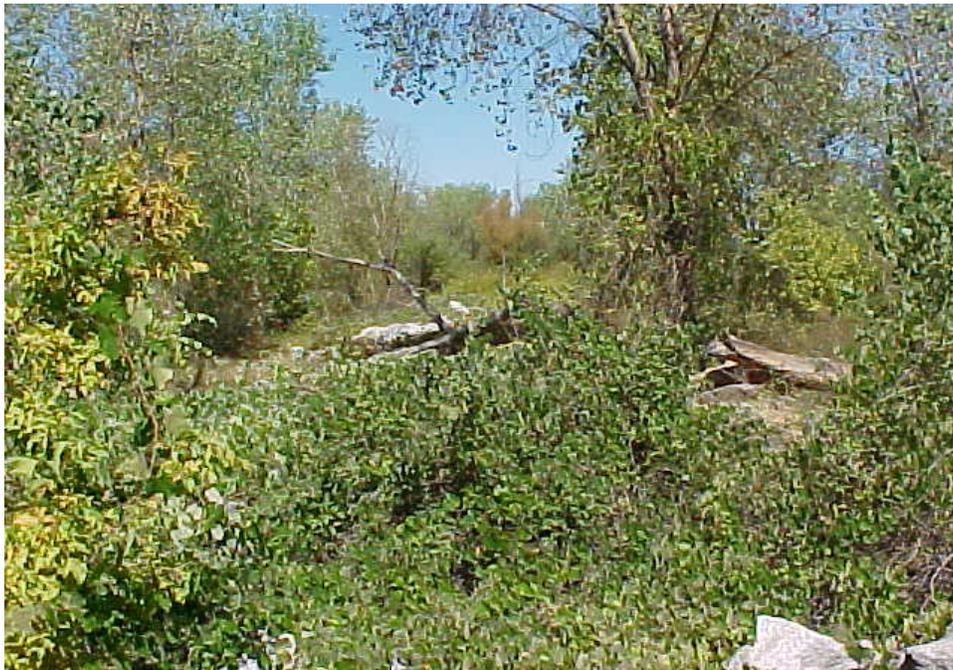
- 1. Condition of quarry rock weir section.**
 - a. Good.**
- 2. Condition of revetments.**
 - a. Good.**
- 3. Accumulation of trash and debris around structure or in the channel.**
 - a. Areas of debris exist along the weir and in the channel.**
- 4. Vegetation around structure or in the channel.**
 - a. Vegetation is very heavy, with trees, brush and berries on the weir section and in the rock revetments.**
- 5. Comments:**
 - a. No clearing done since 1985. The vegetation is extremely dense and could impair the functioning of the weir.**
 - b. Poor maintenance.**

**Looking north from the approximate midway
point of the weir at the dense vegetation and debris.**

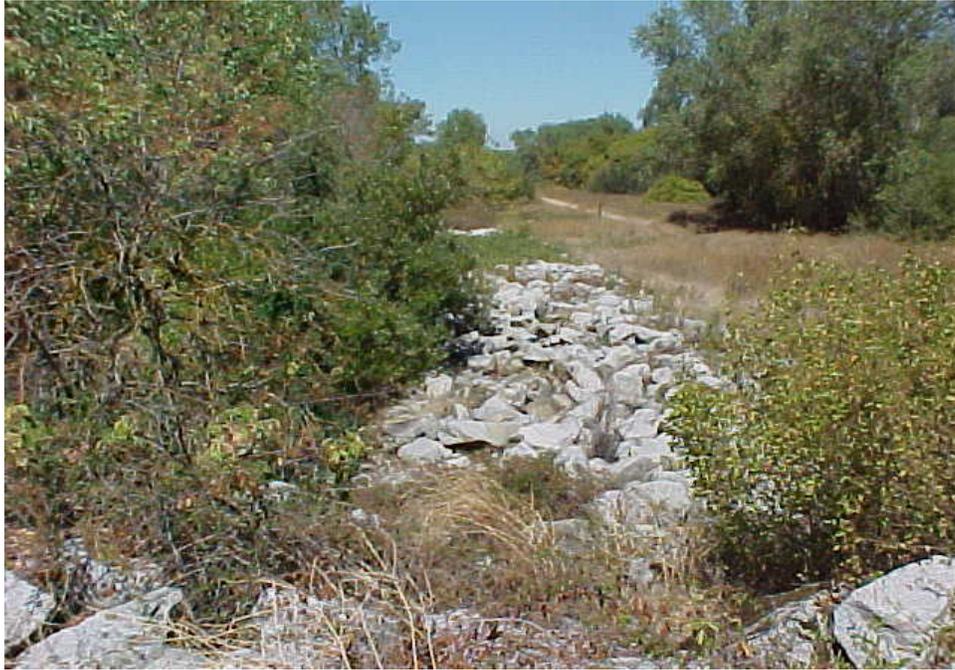
Looking north from the southwest end of the rock weir.

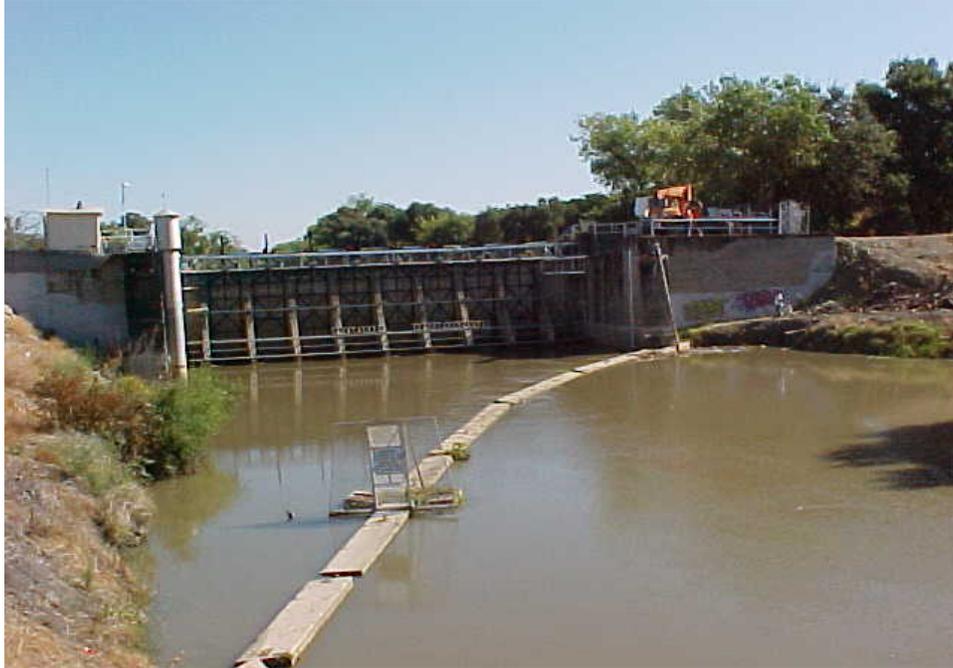
Looking at the upstream side of structure from the right bank.

- 10. Comments:**
 - a. Structure is inspected daily.**
 - b. The seepage through the structure should be monitored during high water stages.**
 - c. Sacramento Maintenance Facility performs a yearly pre-season inspection of the structure and its components by October 15.**
 - d. Remove the debris on the right bank upstream of the structure.**
 - e. Good maintenance.**

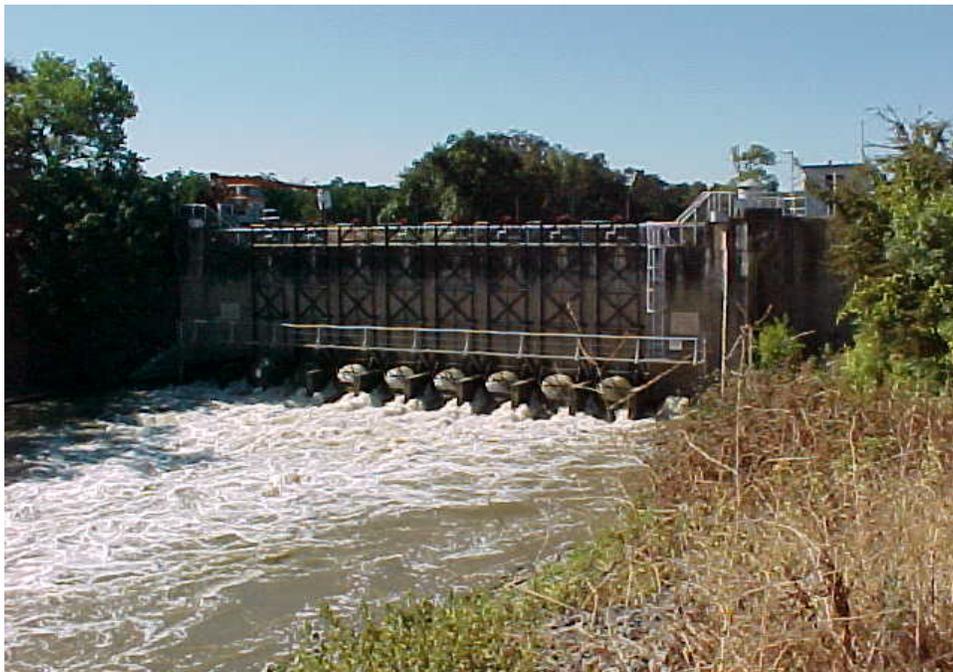
1. **Condition of outfall structure.**
 - a. **Good.**
2. **Condition of bulkheads.**
 - a. **Fair. The large vertical crack and displacement on the downstream side, left bank, does not appear to have enlarged. The crack is not accessible for measurement, but the overall width is estimated to be 1 inch.**

Looking at the downstream side of the structure from the right bank.

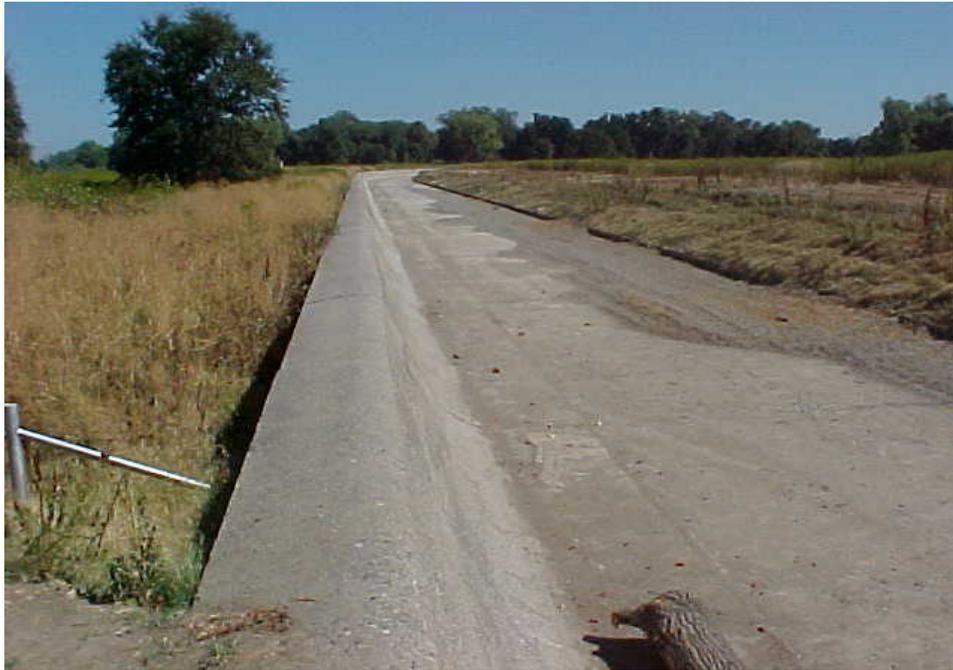
- 1. Condition of concrete weir and stilling basin.**
 - a. Some cracks and spalling exist on the weir and in the stilling basin.**
- 2. Condition of concrete abutment.**
 - a. Good.**
 - b. The crack on the downstream side of the right (west) abutment, and the two cracks on the right abutment at Rattlesnake Island, have not enlarged.**
- 3. Condition of revetment.**
 - a. Good.**
- 4. Accumulation of trash and debris around the structure or in the channel.**
 - a. Minimal.**
- 5. Vegetation around the structure or in the channel.**
 - a. Minimal.**
 - b. Minimal.**
- 6. Condition of gauging house and equipment.**
 - a. Good.**
- 7. Comments:**
 - a. Monitor the cracks and spalling and repair as needed.**
 - b. Remove debris from the stilling basin prior to flood season.**
 - c. Good maintenance.**

View of weir and stilling basin from the north abutment.

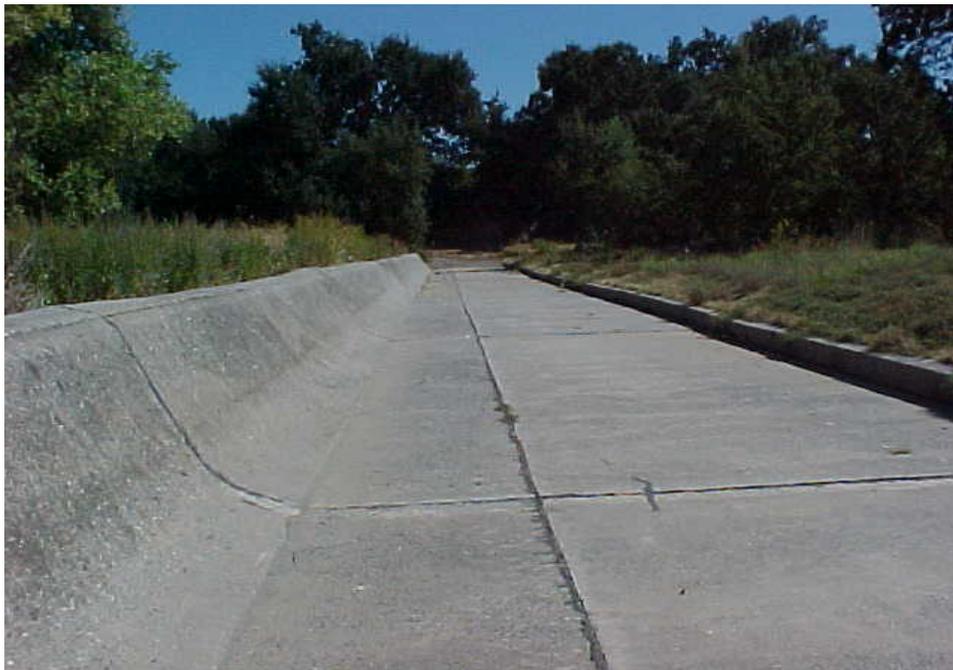
Looking towards Rattlesnake Island.

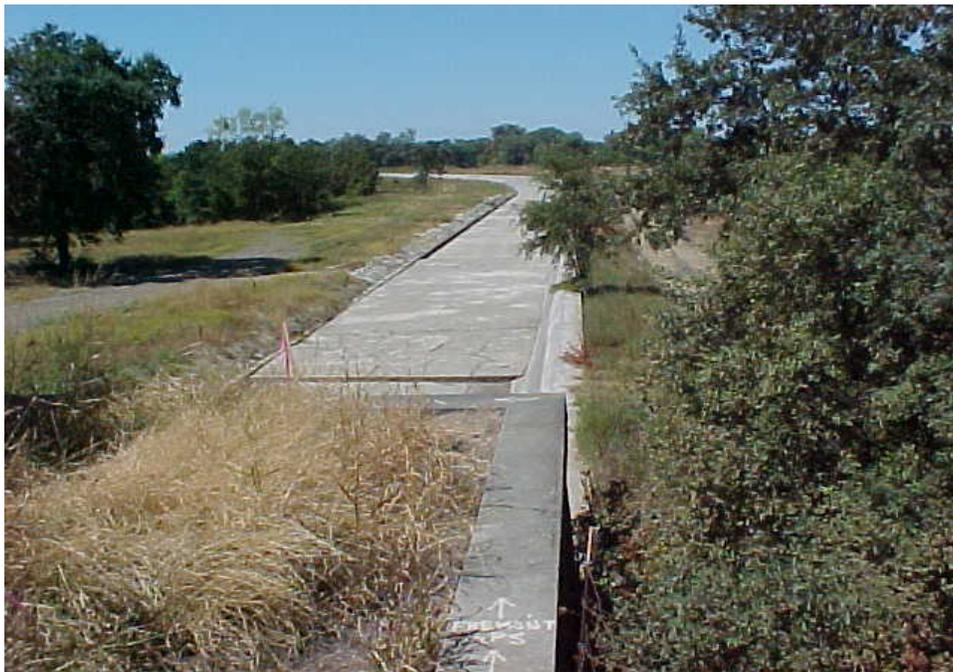
Looking northwest from the southern abutment.

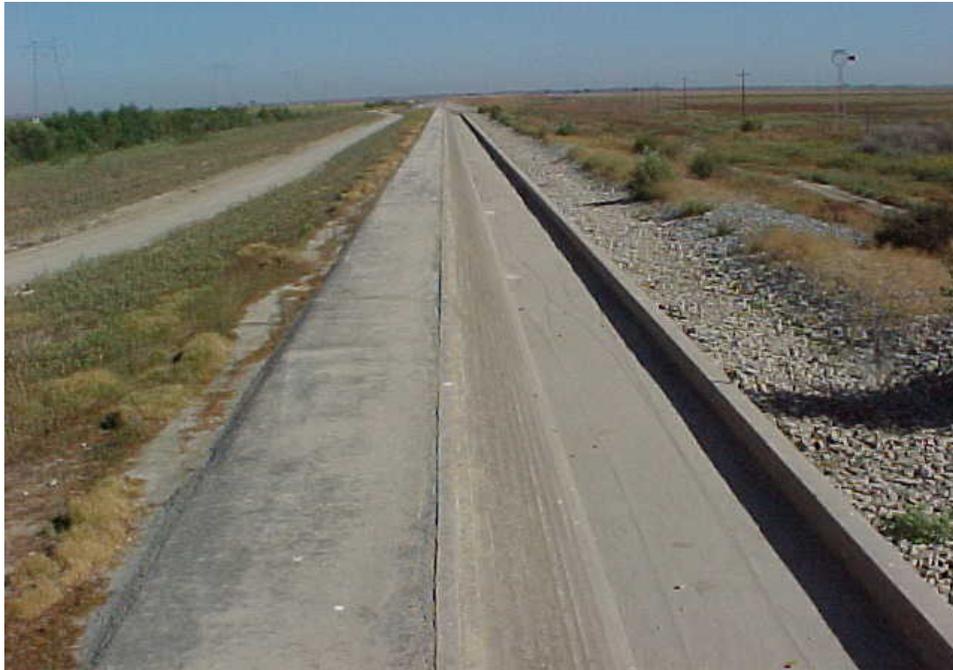
Looking north east at the weir and settling basin.

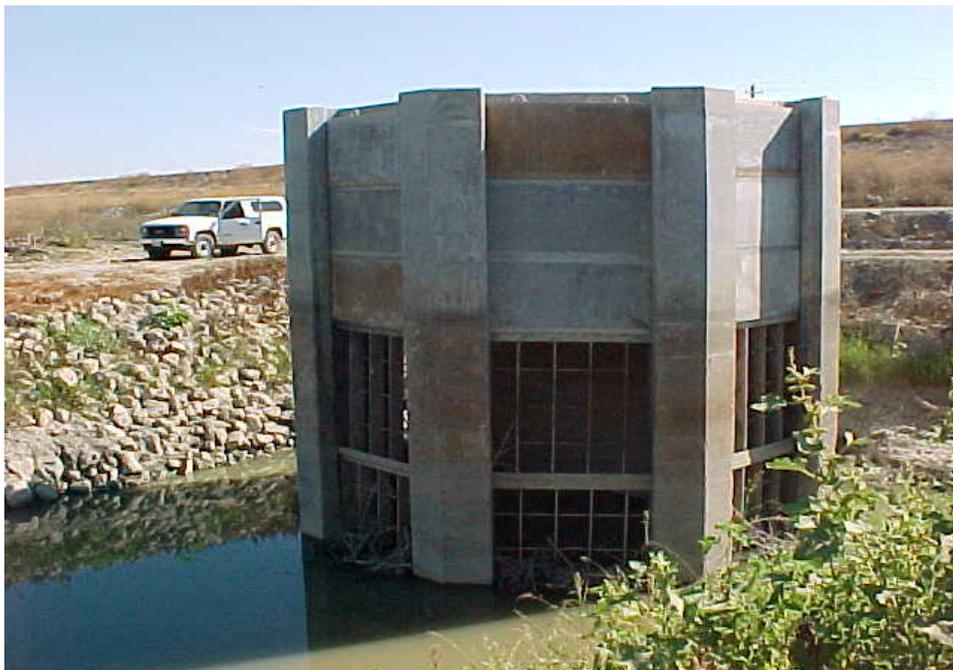
View of the drainage structure.

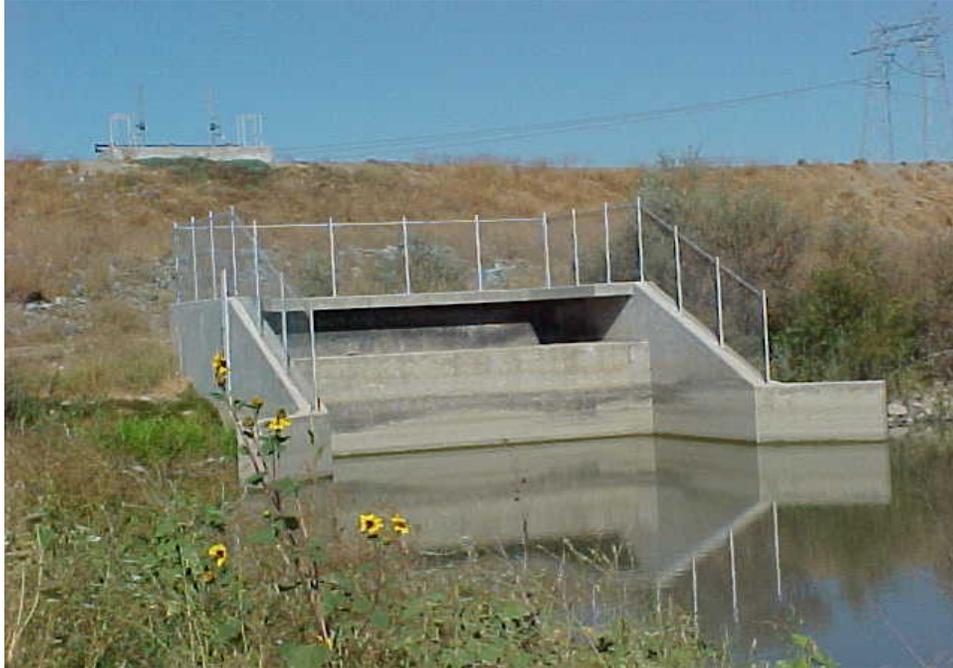
View of the outlet for the drainage structure.

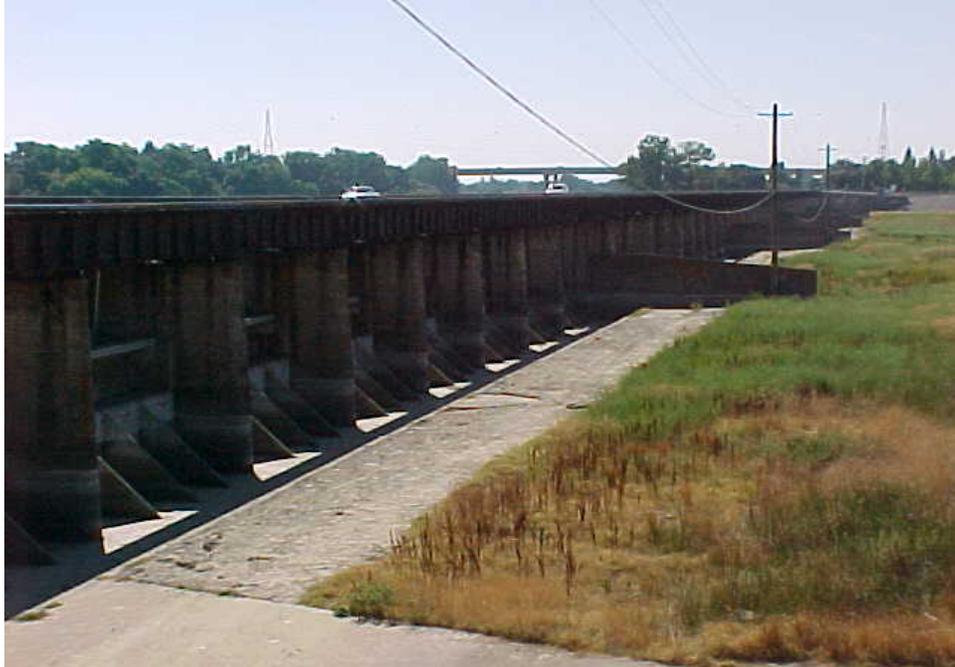
Looking at the outlet side of weir from the north end.

- a. A final pre-season operational inspection is scheduled for the week of October 15 by the Sacramento Maintenance Facility.**
- b. Remove the growth, trash, and debris from around the structure.**
- c. Good maintenance.**

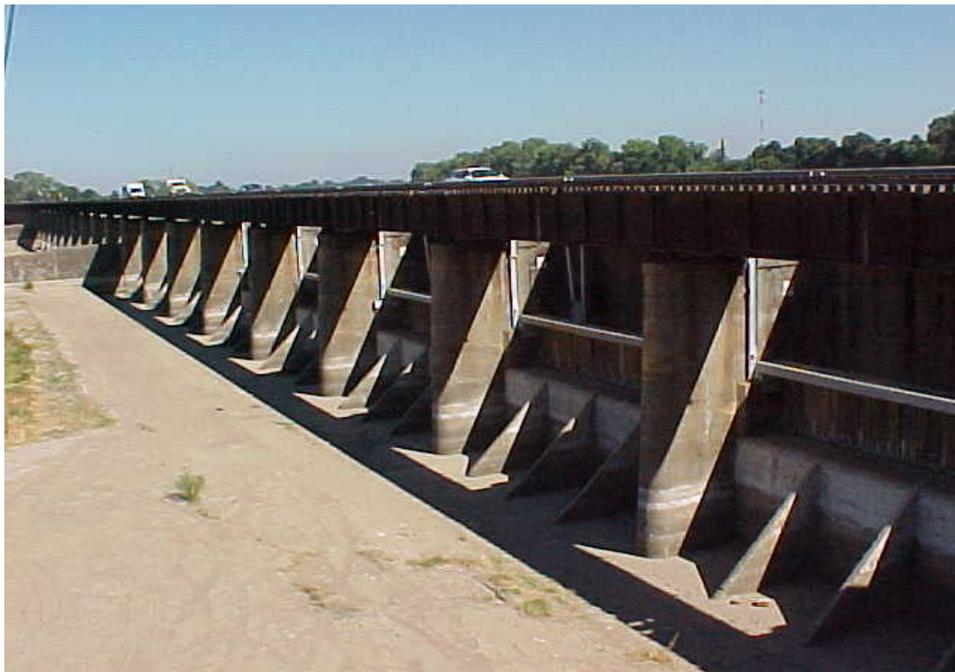
Looking at the outlet side of weir from the south end.

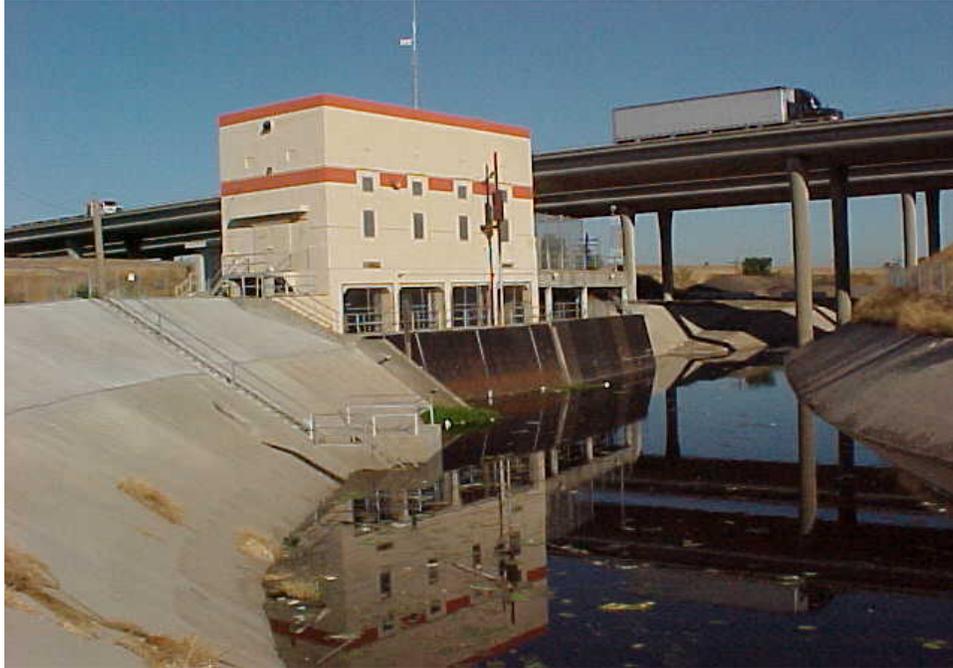
Looking at pumping plant, sump, and trashracks at inlet side on the landward side from the left bank levee of the Natomas East Main Drain.

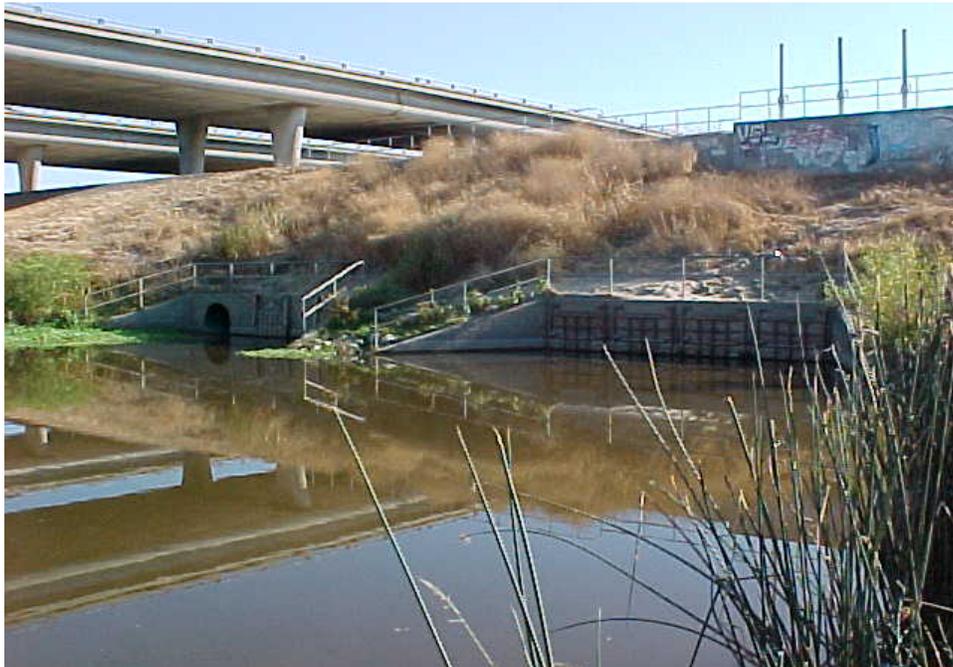
Looking at the discharge end of structure on the waterward side from the left bank levee of the Natomas East Side Drain.

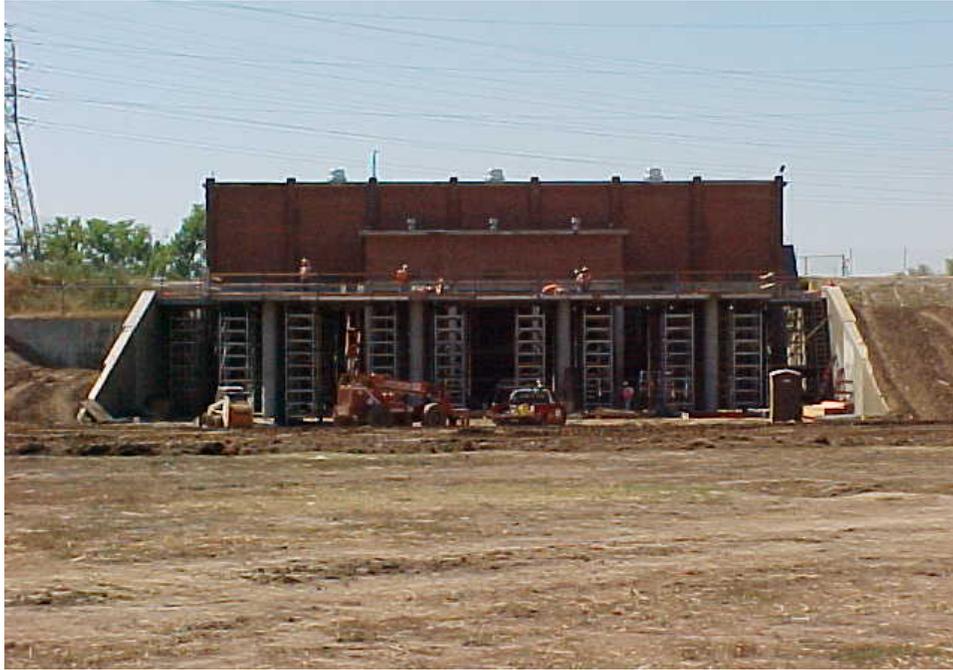
Looking at pumping plant, sump and trashracks at inlet on the landward side of the right bank levee of the American River.

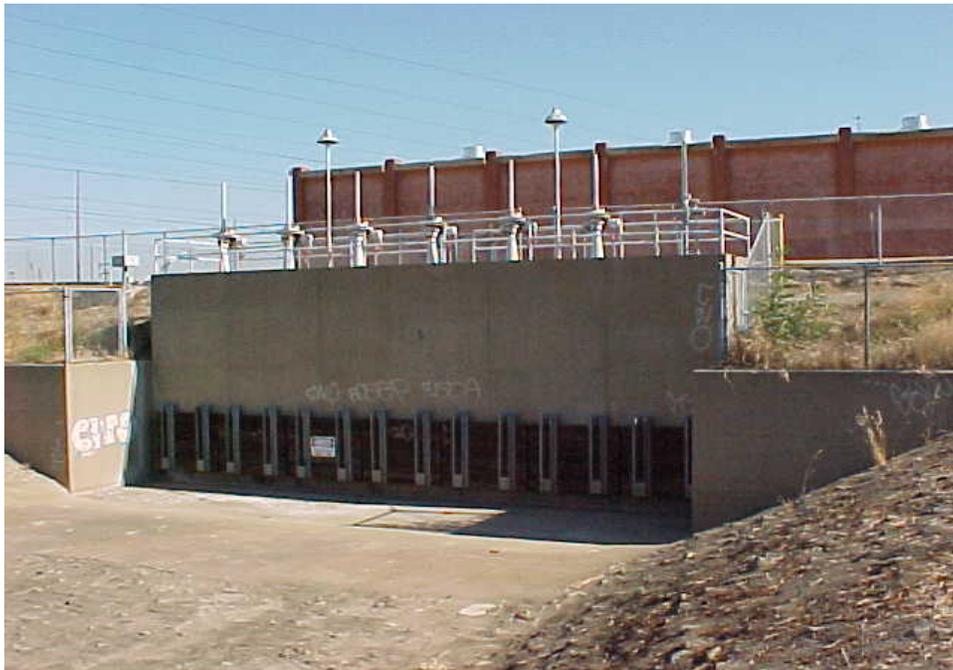
Looking at gate controls and gates at the discharge side of the pumping plant.

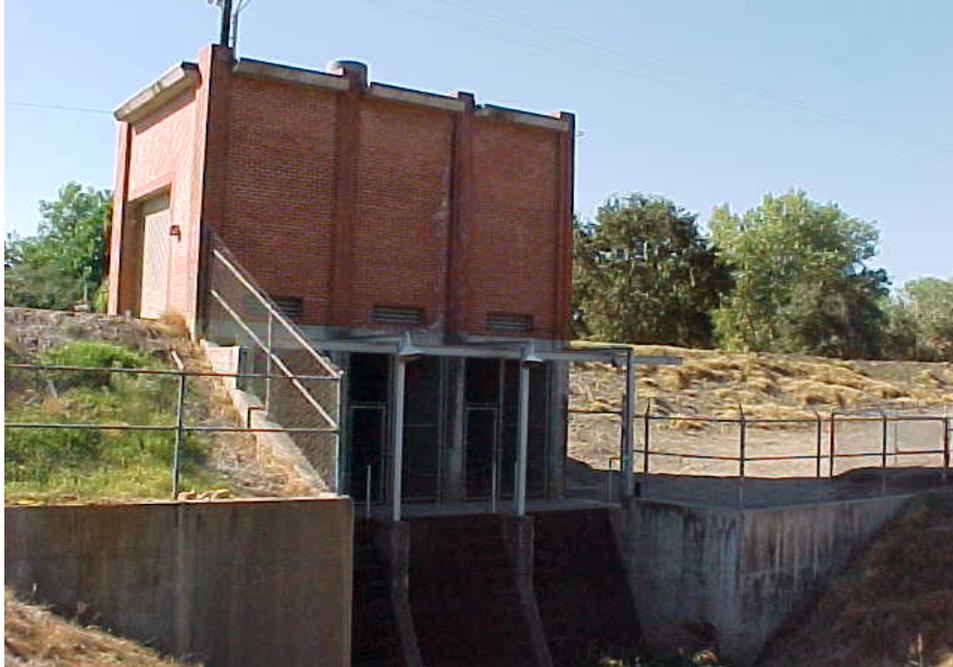
Looking at the trashracks on the intake side of the pumping plant.

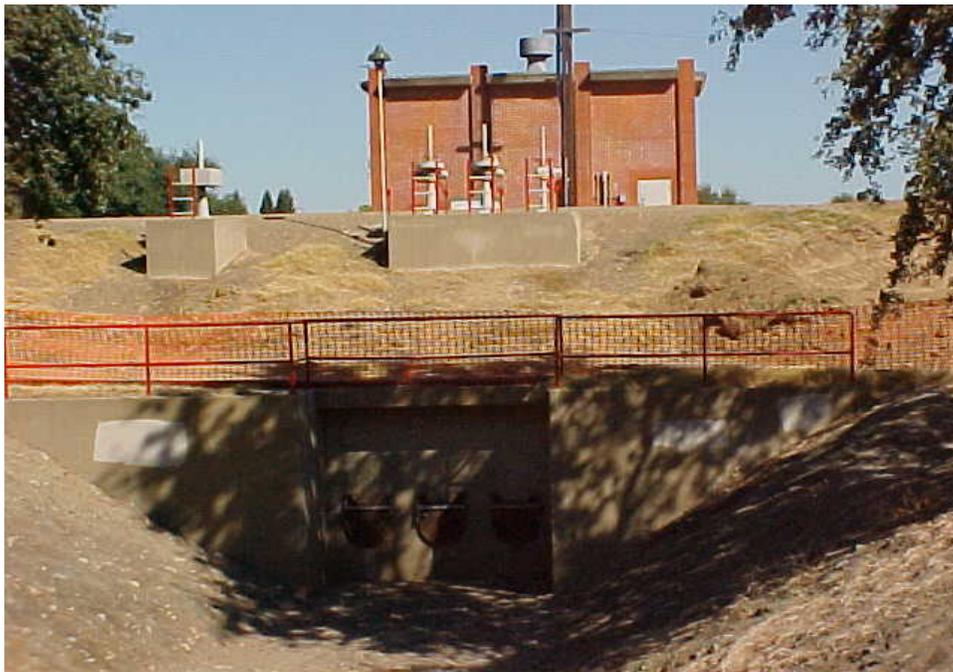
Looking at the gate controls and flap gates on the discharge side of the pumping plant.

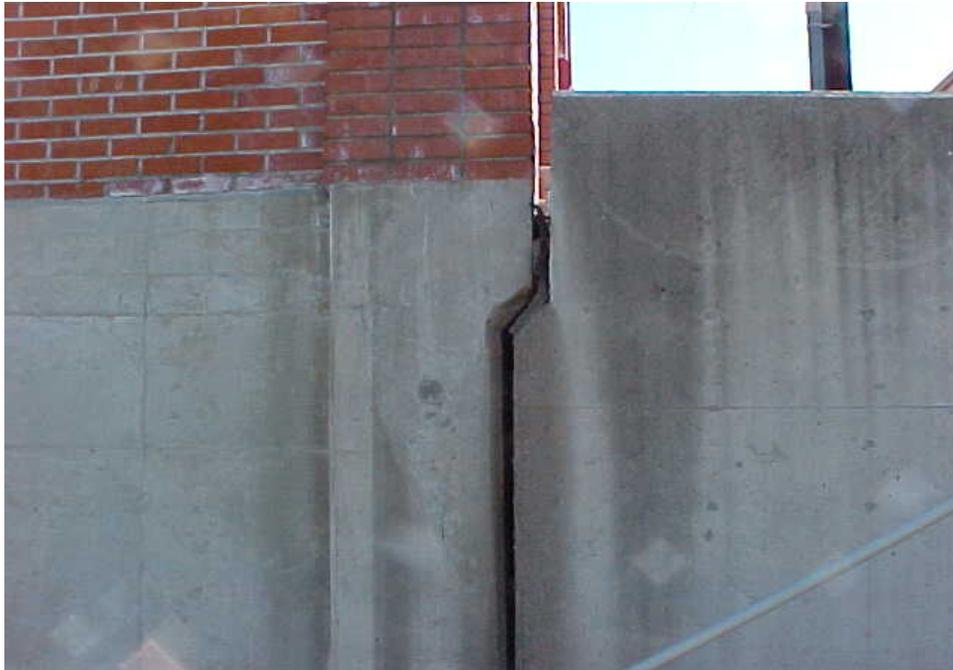
- 1. Condition of the main pump structure.**
 - a. Good.**
- 2. Condition of abutments and wingwalls.**
 - a. There is a 3 5/8-inch deflection in the retaining wall next to the stairway on the west side of structure.**
- 3. Condition of pumps and motors.**
 - a. Good.**
- 4. Condition of control gates, mechanisms, and flap gates.**
 - a. Good.**
- 5. Condition of electrical equipment.**
 - a. Good.**
- 6. Condition of trashracks.**
 - a. Good.**
- 7. Accumulation of trash and debris in the upper and lower sumps.**
 - a. None.**
- 8. Vegetation in the upper and lower sumps.**
 - a. Minor growth.**

Looking at the 3 5/8-inch deflection in the west retaining wall.

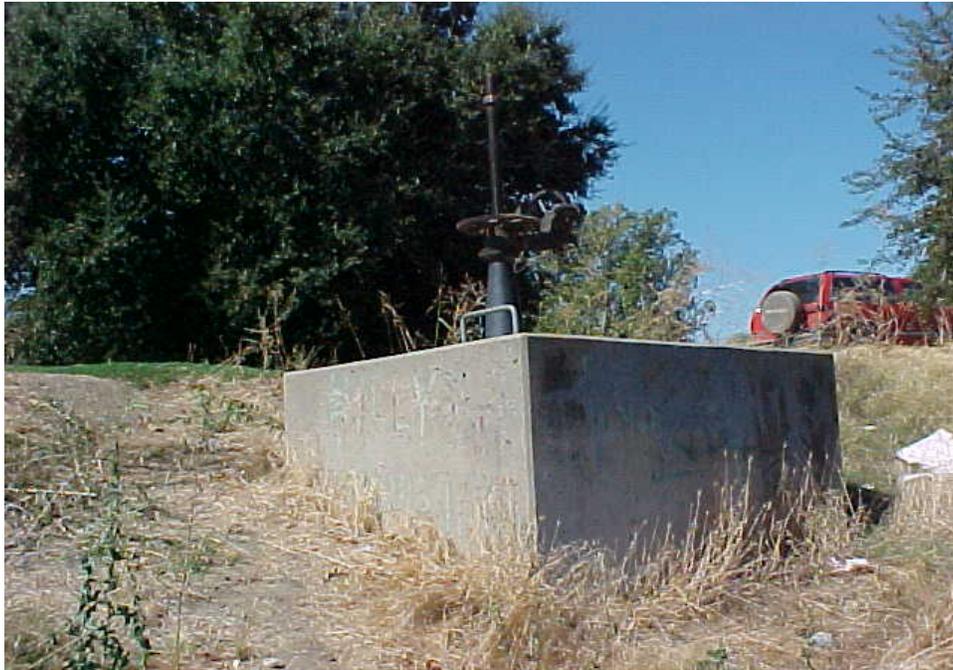
View of the gate control mechanism box.
