**State of California
The Resources Agency
DEPARTMENT OF WATER RESOURCES
Division of Flood Management**

**2001
OFFICE REPORT**

**INSPECTION OF FLOOD CONTROL STRUCTURES
ON THE SACRAMENTO AND SAN JOAQUIN RIVERS
AND THEIR TRIBUTARIES**

**Prepared by
FLOOD PROJECT INSPECTION SECTION**

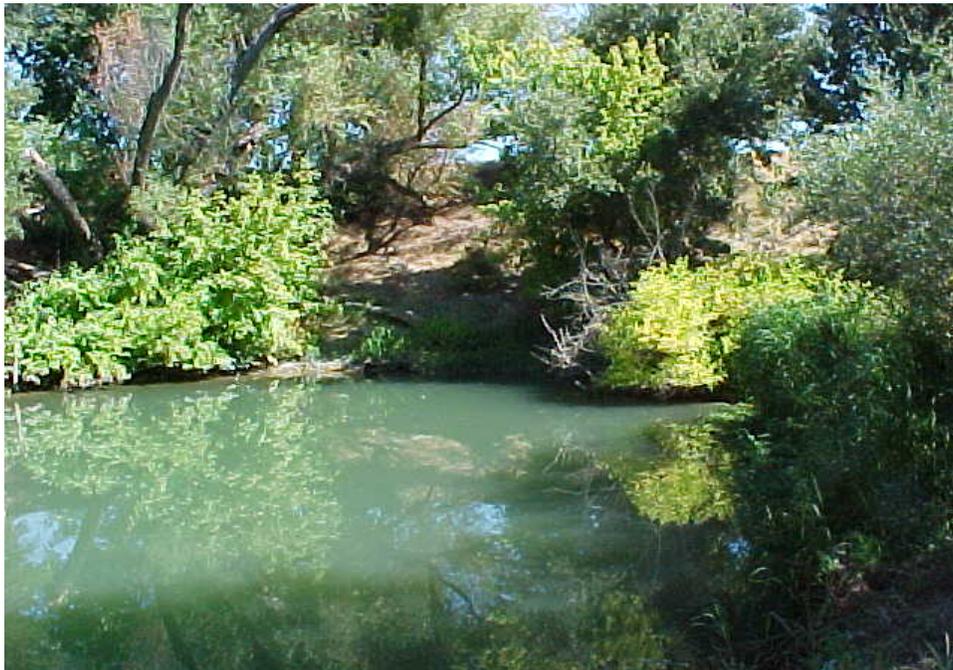
- 1. Condition of inlet structure.**
 - a. Good.**
- 2. Condition of control gate mechanism.**
 - a. Good.**
- 3. Accumulation of trash and debris around the structure or in the channel.**
 - a. None.**
- 4. Vegetation around the structure.**
 - a. Minor growth around outlet.**
- 5. Comments:**
 - a. Monitor and remove growth around outlet as needed.**
 - b. Good maintenance.**

**View of the discharge side of inlet structure into Elk Slough.
The structure is under water.**

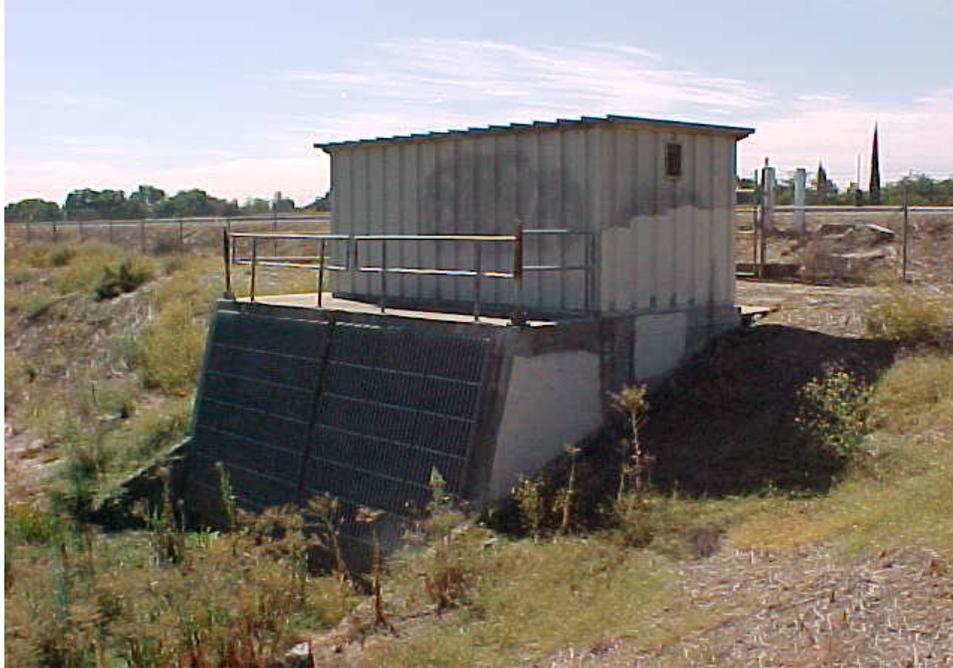
Looking at the trashracks on the intake side of the pumping plant.

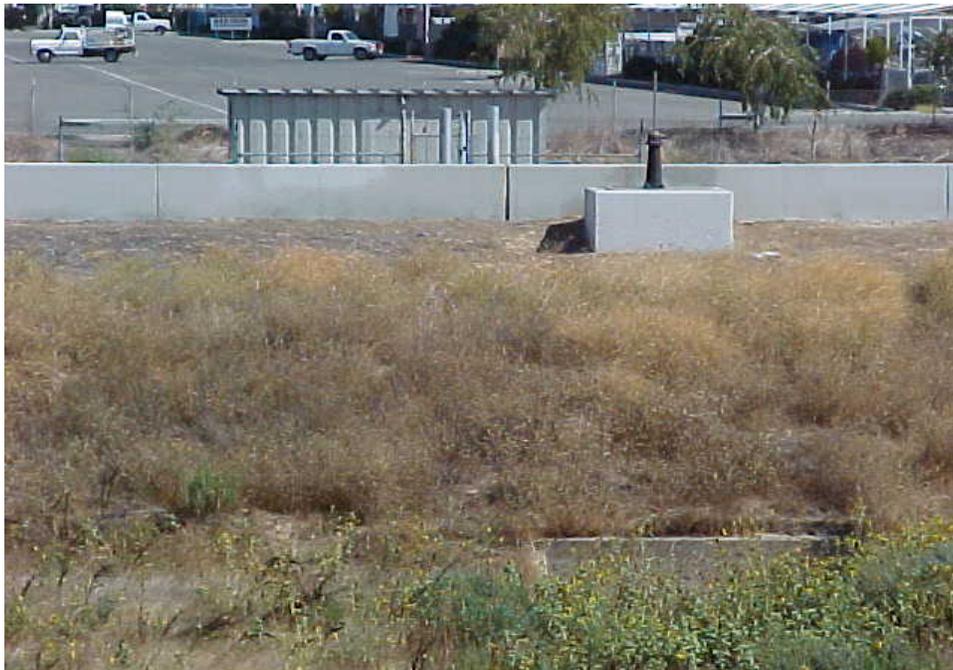
**Looking at the flood wall, screw gate and
the outlet side of the pumping plant.**

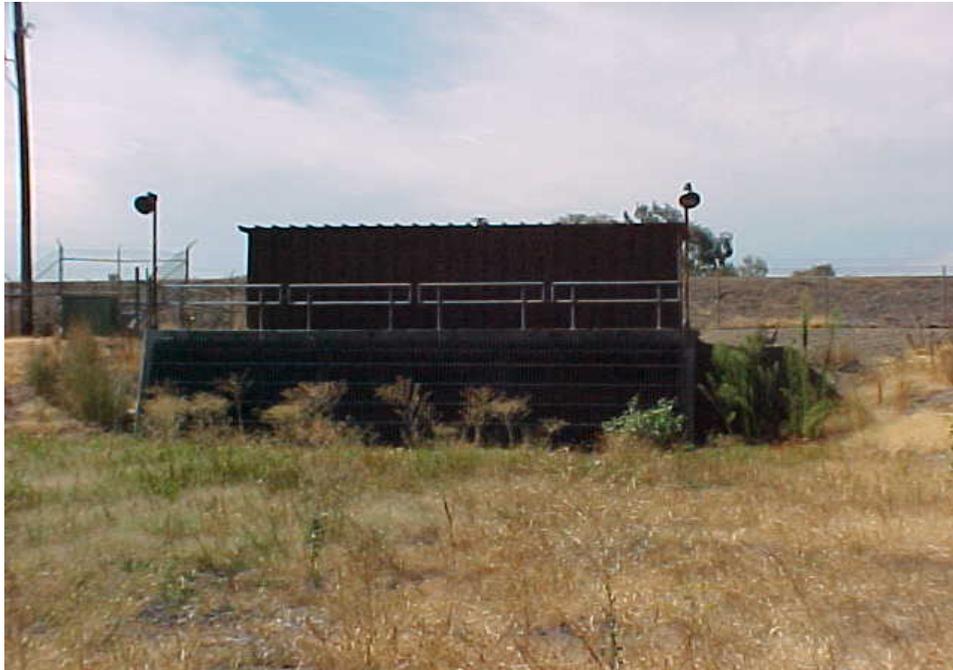
Looking at the inlet side of the pumping plant.

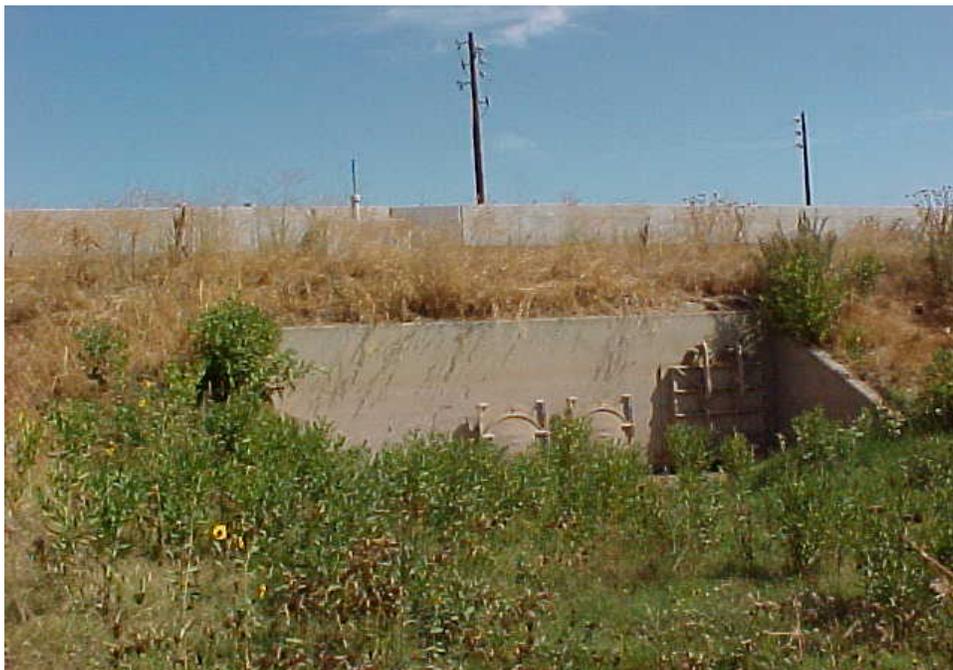
Looking at the outlet side of the pumping plant.

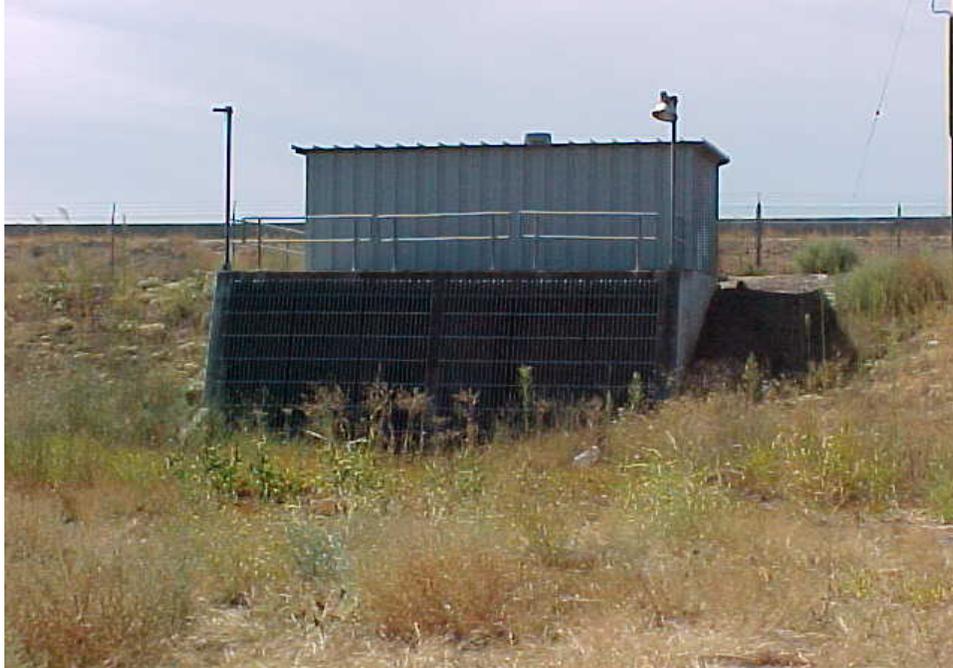
Looking at the inlet side of the pumping plant.

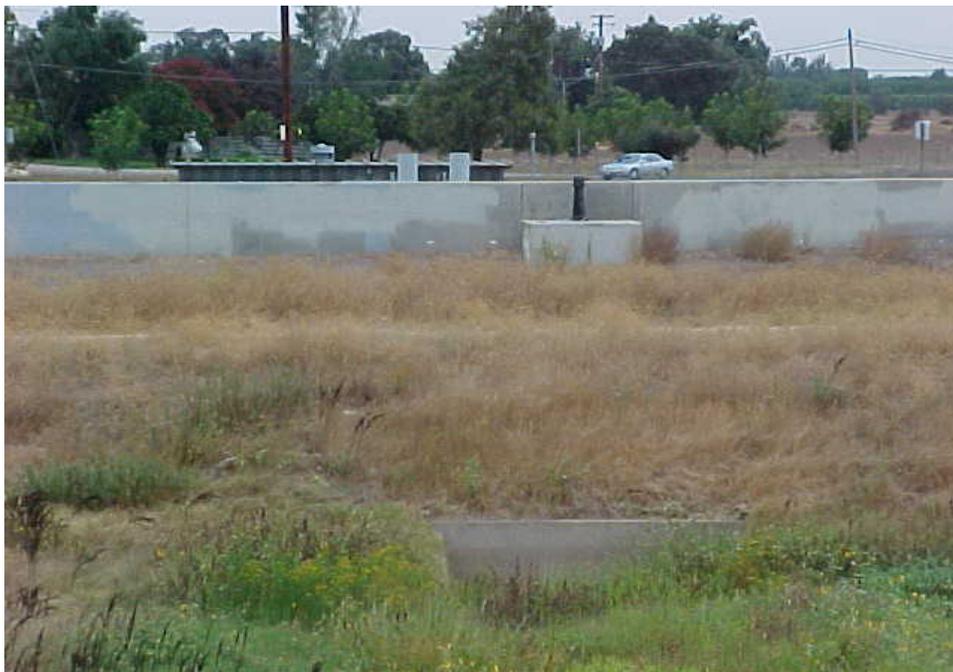
Looking at the flood wall, screw gate and outlet side of the pumping plant.

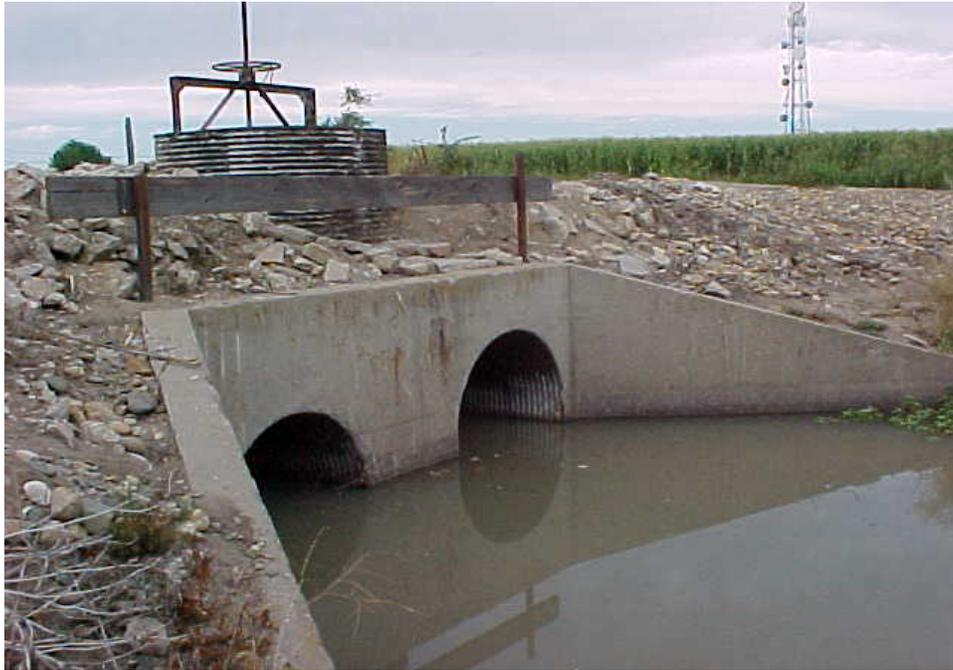
Looking at the inlet side of control structure.

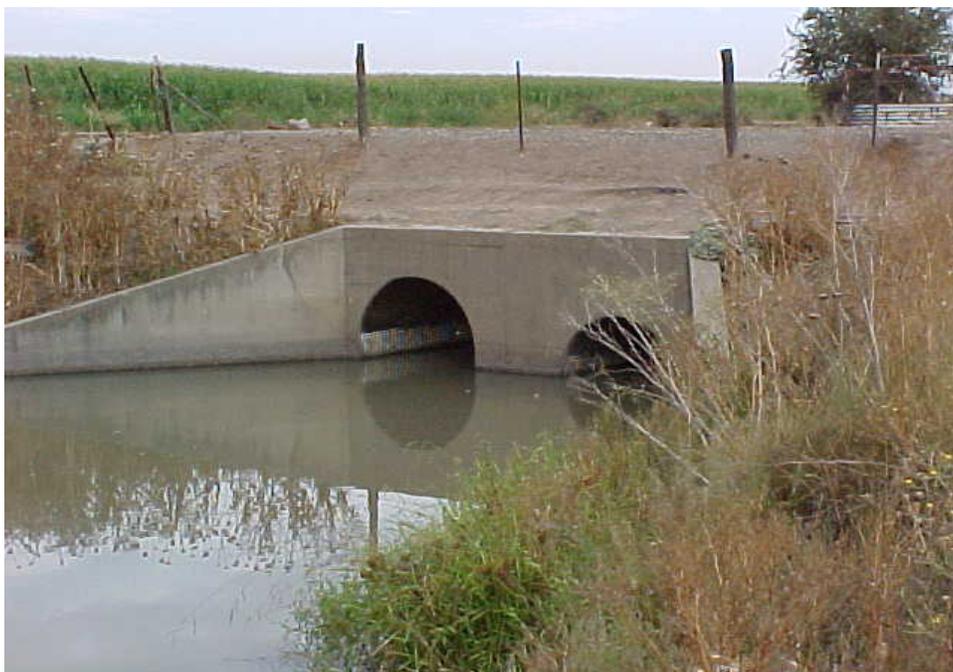
Looking at the outlet side of the structure.

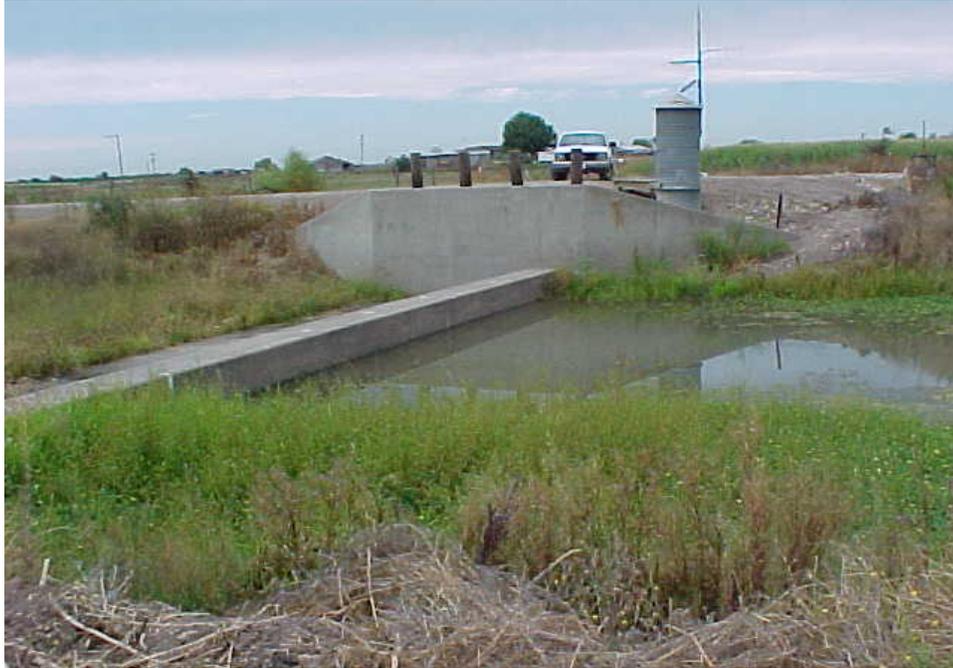
Looking at the upstream side of diversion weir.

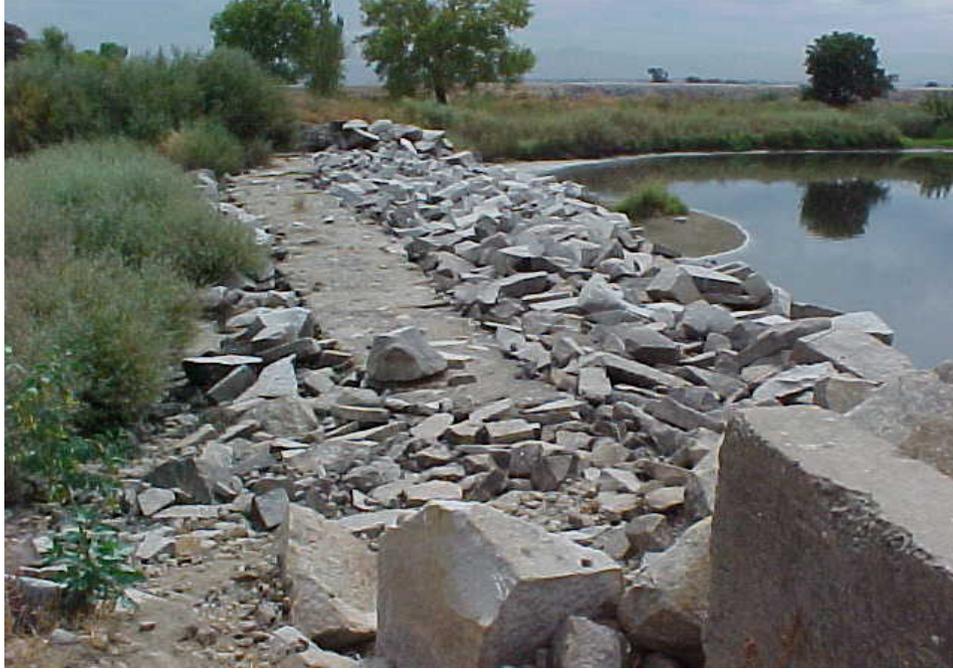
- 1. Condition of the concrete rubble dam section.**
 - a. Good.**
- 2. Accumulation of trash and debris around the structure or in the channel.**
 - a. None.**
- 3. Vegetation around the structure and in the channel.**
 - a. There are small willow trees on the upstream side of the structure.**
- 4. Comments:**
 - a. Willow trees should be removed.**

Looking at the upstream side of dam.

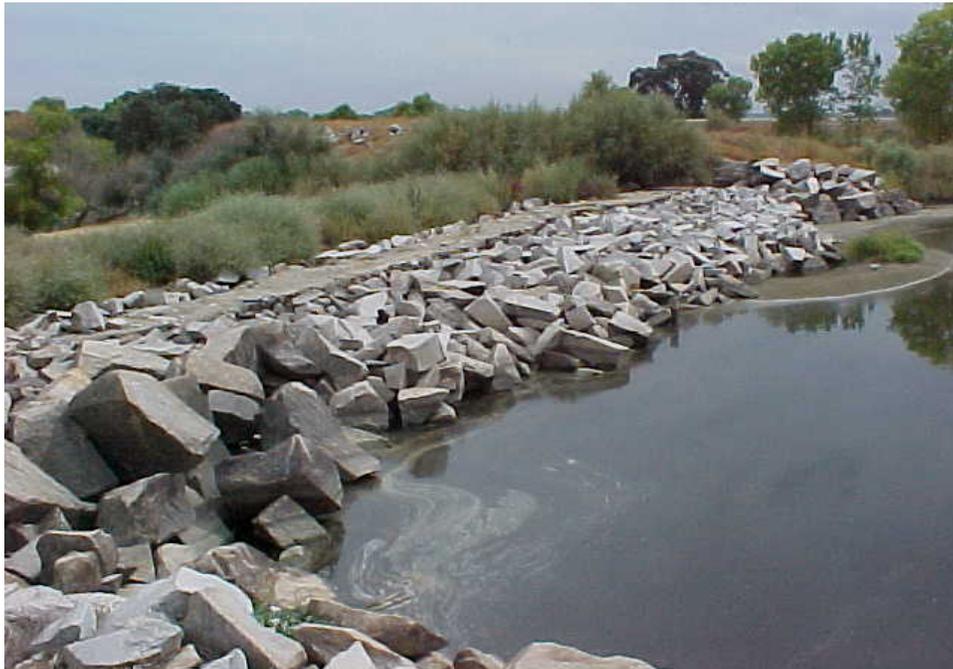
Looking at the downstream side of dam.

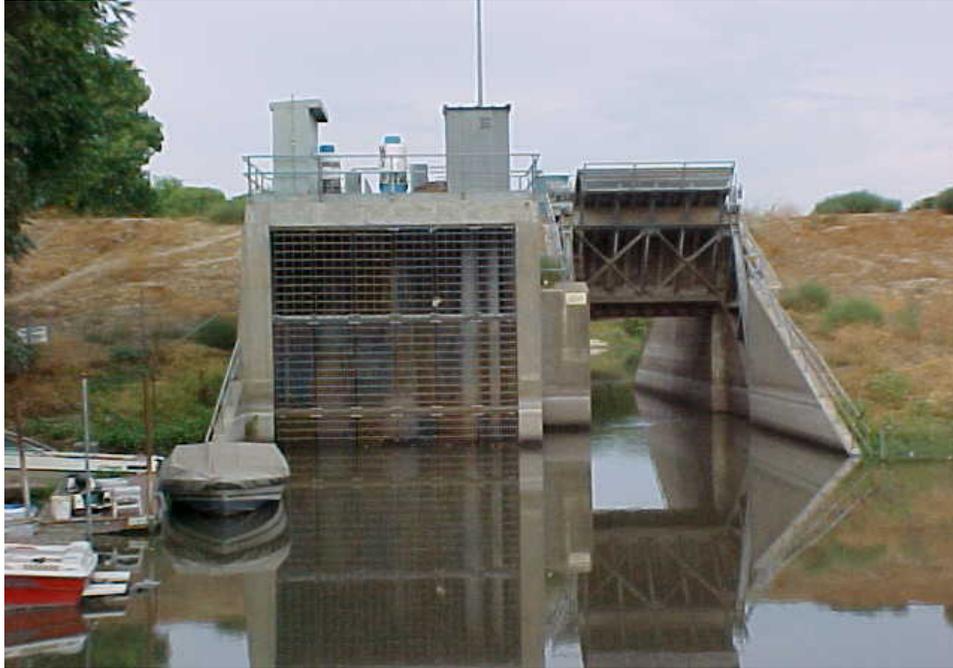
Looking at the downstream side of the structure.

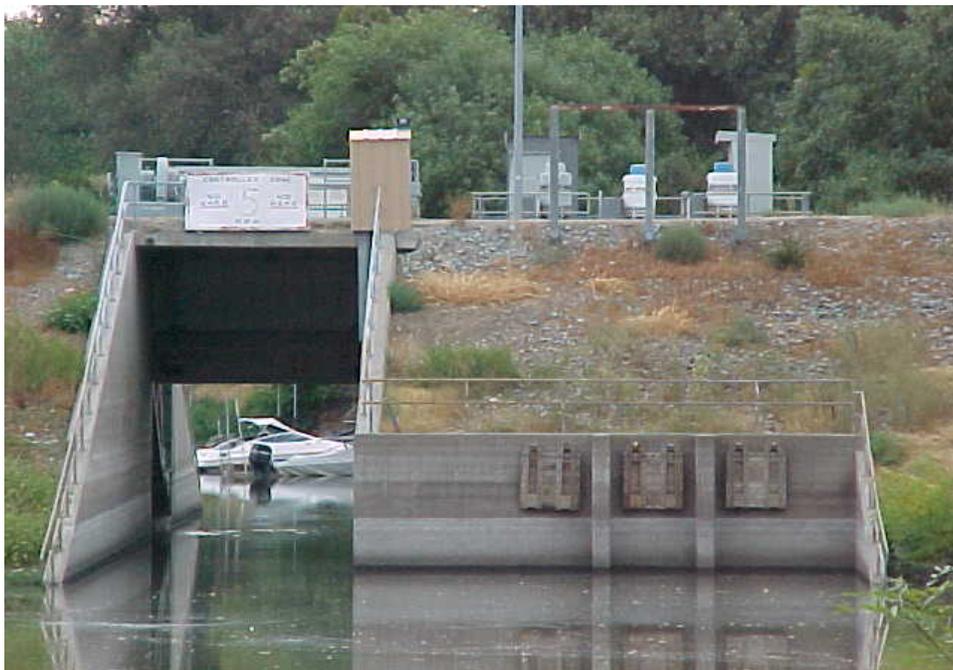
Looking at the upstream side of the structure.

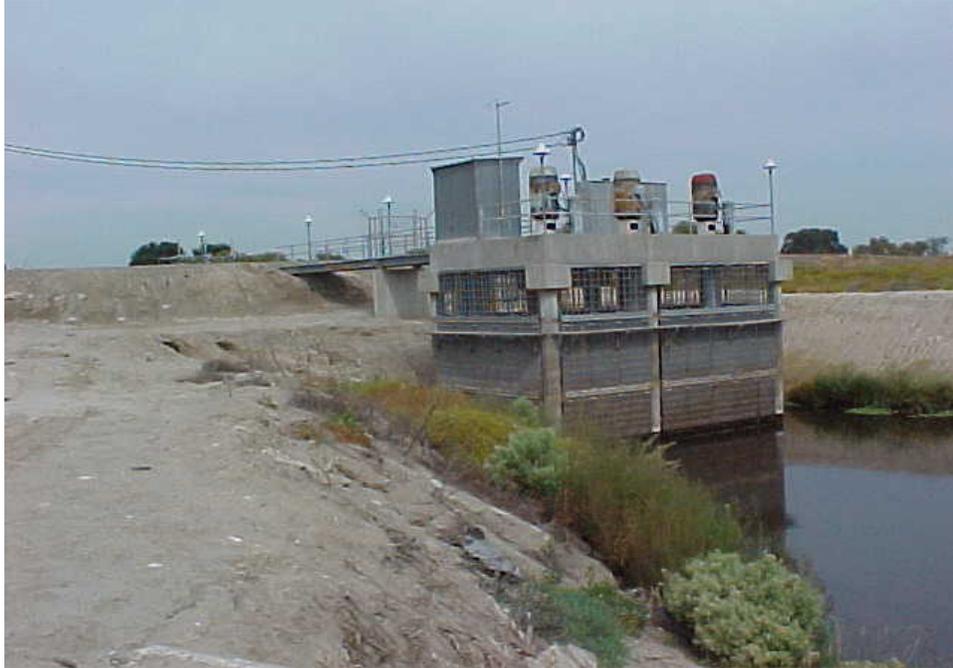
Looking at the intake of the pumping plant.

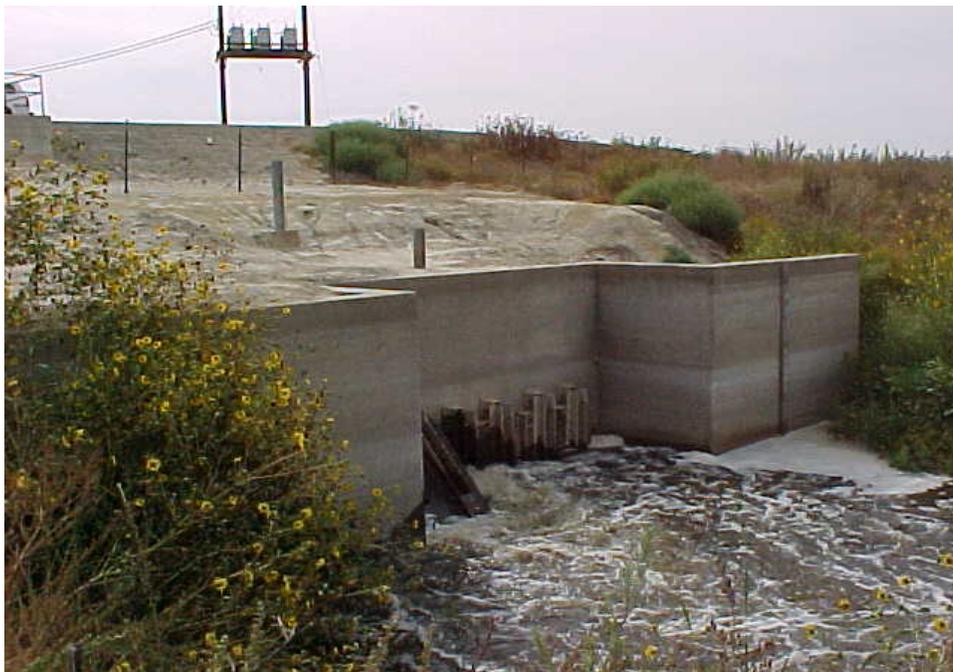
Looking at the discharge side of the structure from the north side.

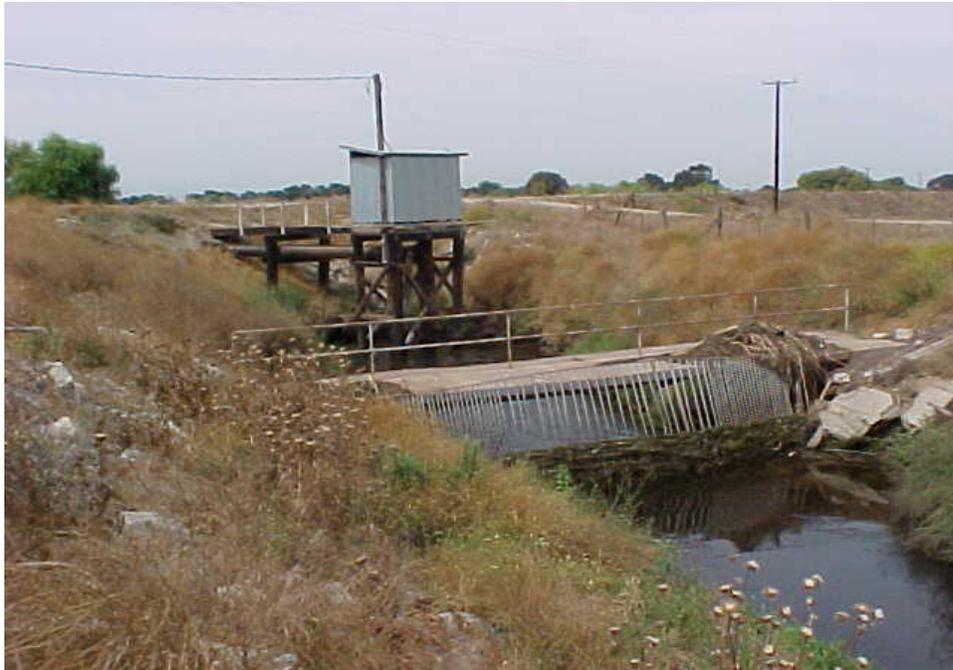
4. **Condition of control gate, mechanism and flap gate.**
 - a. **Good.**
5. **Condition of the trashracks.**
 - a. **Fair.**
6. **Accumulation of trash and debris around the structure or in the channel.**

Looking at the trash racks and the structure.

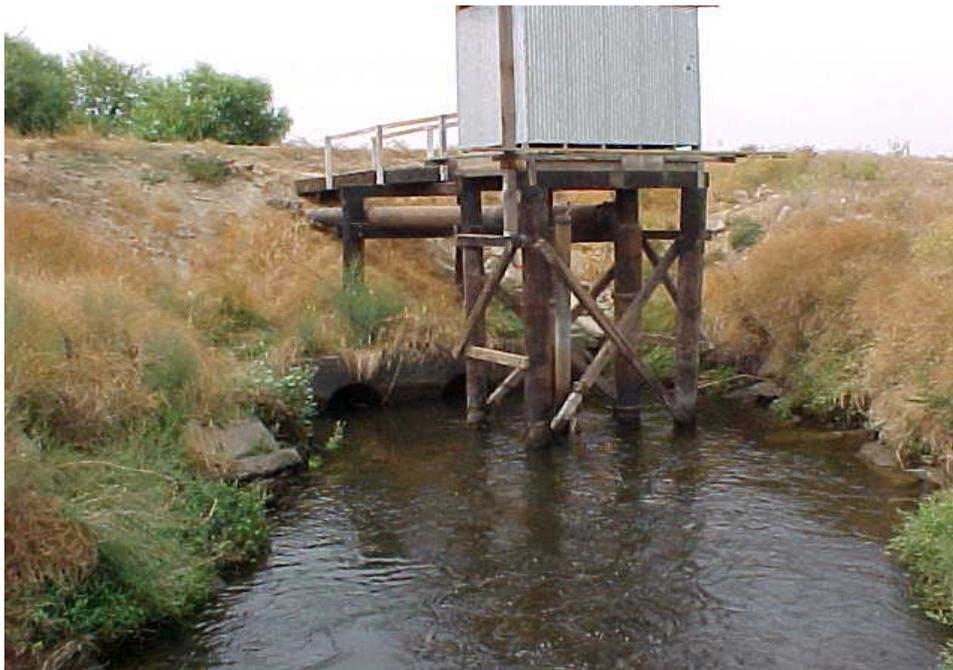
Looking at the intake side of the structure.

- b. **Remove trees at discharge end of structure.**
 - c. **Fair maintenance.**

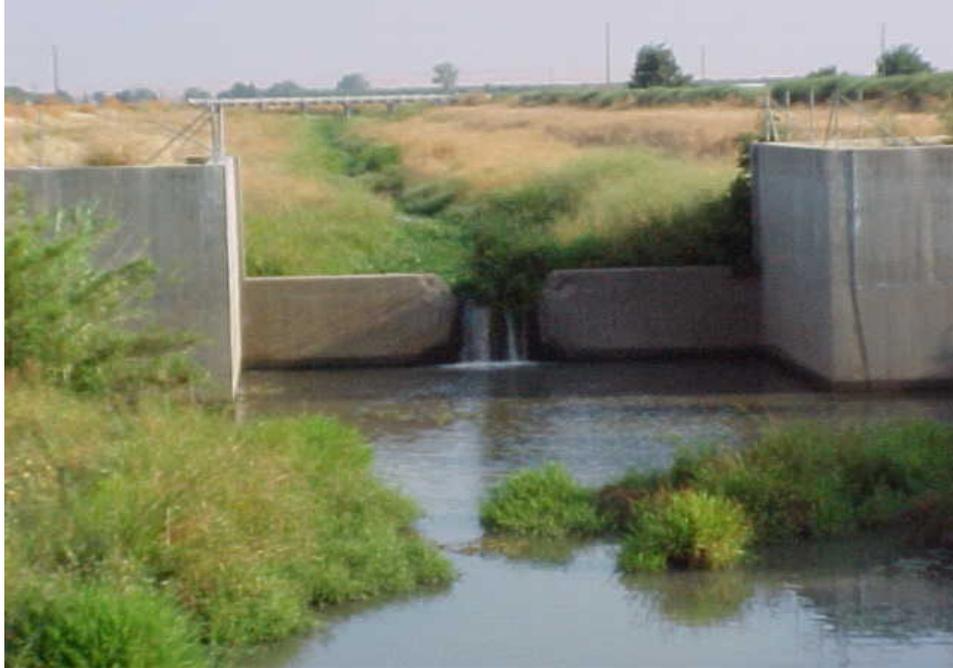
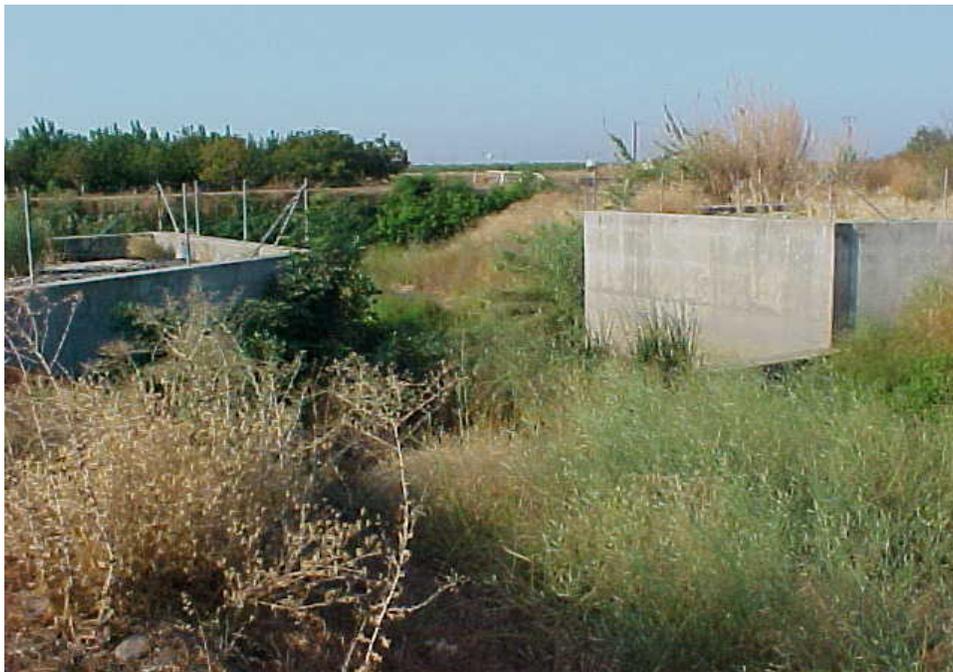
**INSPECTION OF BLACK RASCAL CREEK DROP STRUCTURE
(Maintained by Merced Irrigation District for Merced County)
August 2001**

1. **Condition of concrete drop structure.**
 - a. **Good.**
2. **Condition of concrete abutments.**
 - a. **Good.**
 - b. **Separation of the left bank wall is stable.**
3. **Condition of revetment.**
 - a. **Good.**
4. **Accumulation of trash and debris around the structure or in the channel.**
 - a. **None.**
5. **Vegetation around the structure or in the channel.**
 - a. **Minimal**
6. **Comments:**
 - a. **Good maintenance.**

Looking upstream at the structure.

Looking at the upstream side structure.

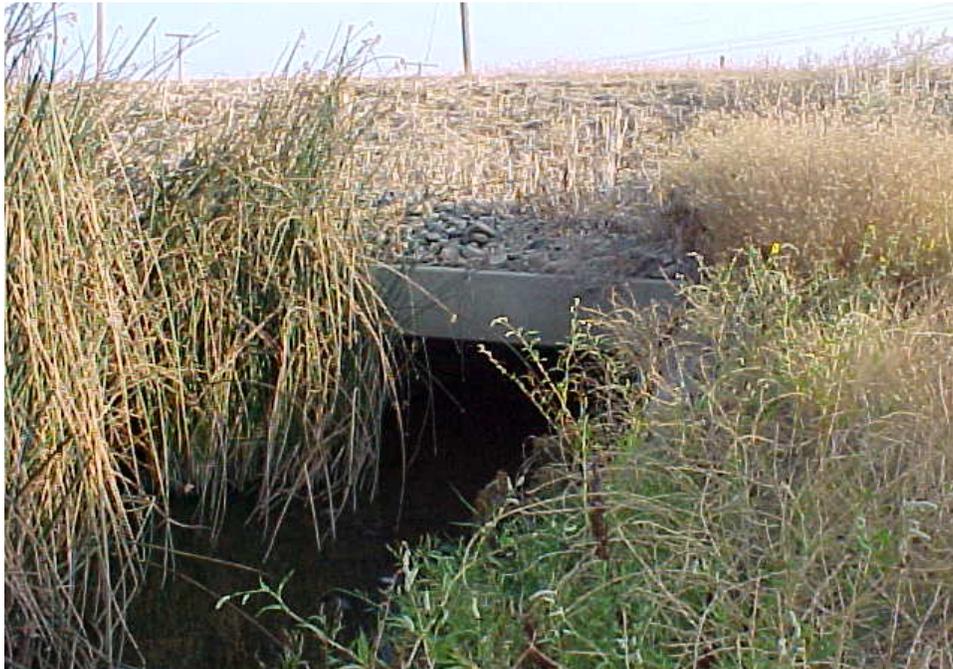
1. **Condition of concrete siphon structure.**
 - a. **Good.**
2. **Condition of concrete abutments and wingwalls.**
 - a. **Good.**
 - b. **Separation of the left bank wall is stable.**
3. **Condition of revetment.**
 - a. **Good.**
4. **Accumulation of trash and debris around the structure or in the channel.**
 - a. **None.**
5. **Vegetation around the structure or in the channel.**
 - a. **There is dense tule and weed growth in the channel immediately upstream and downstream of the structure.**
6. **Comments:**
 - a. **Remove weeds and tule growth.**
 - b. **Fair maintenance.**

Looking at the downstream side of the structure.

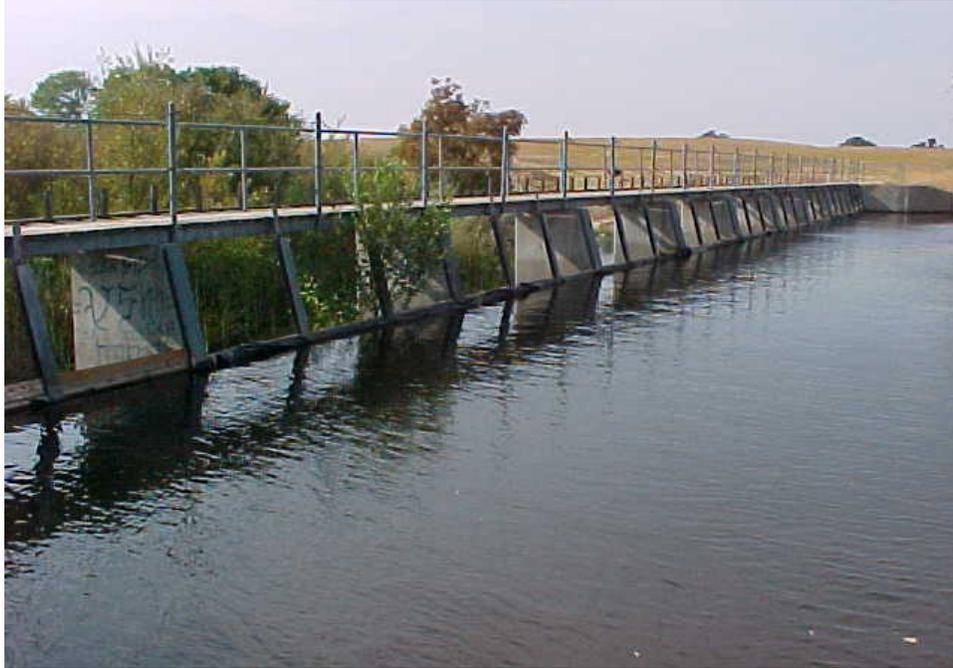
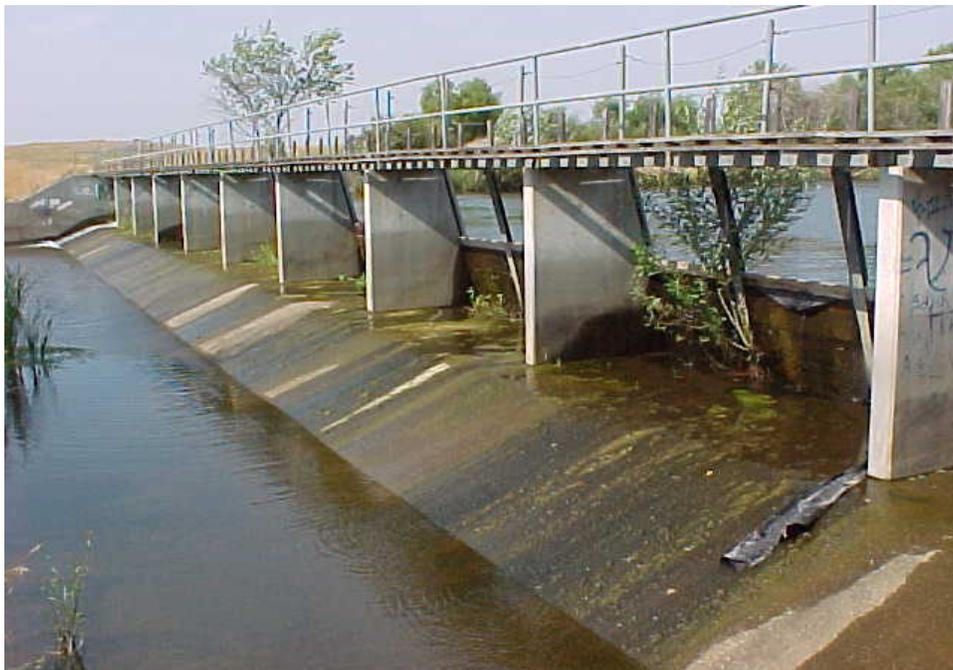
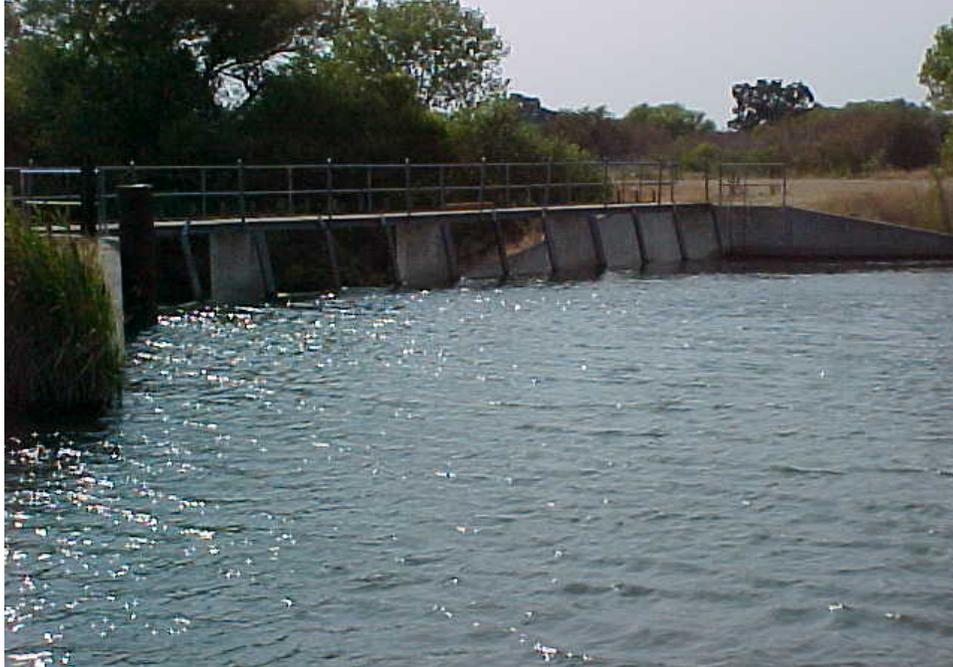
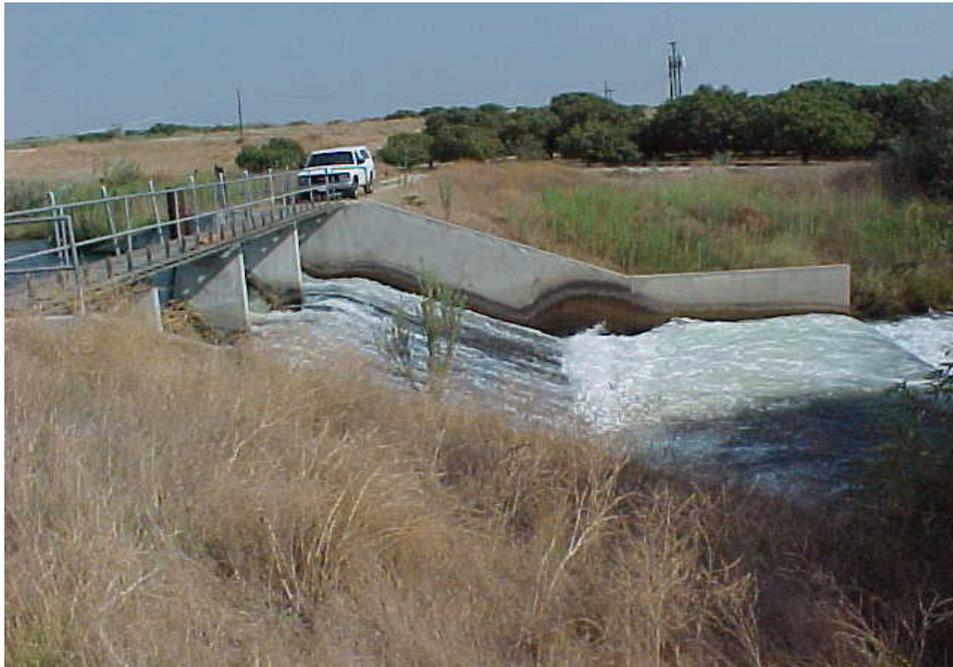
**INSPECTION OF ASH AND BERENDA SLOUGH
CONTROL STRUCTURES
(Maintained by Madera County F.C. & W.C.A.)
August 2001**

1. **Condition of concrete control structures.**
 - a. **Good.**
2. **Condition of concrete abutments and wingwalls.**
 - a. **Good.**
3. **Condition of stop logs and supports.**
 - a. **Good.**
4. **Condition of revetments.**
 - a. **Good.**
5. **Accumulation of trash and debris around the structures or in the channels.**
 - a. **None.**
6. **Vegetation around the control structures or in the channels.**
 - a. **Trees in the channel downstream of the Ash Slough Structure and near the right wingwall of the Berenda Slough Structure.**
7. **Comments:**
 - a. **Remove the trees from the channels and around the structures.**
 - b. **Good maintenance.**

Looking at the upstream side of Ash Slough Structure.

Looking at the downstream side of the Ash Slough Structure.

Looking at the upstream side of the Berenda Slough Structure.

Looking at the downstream side of the Berenda Slough Structure.

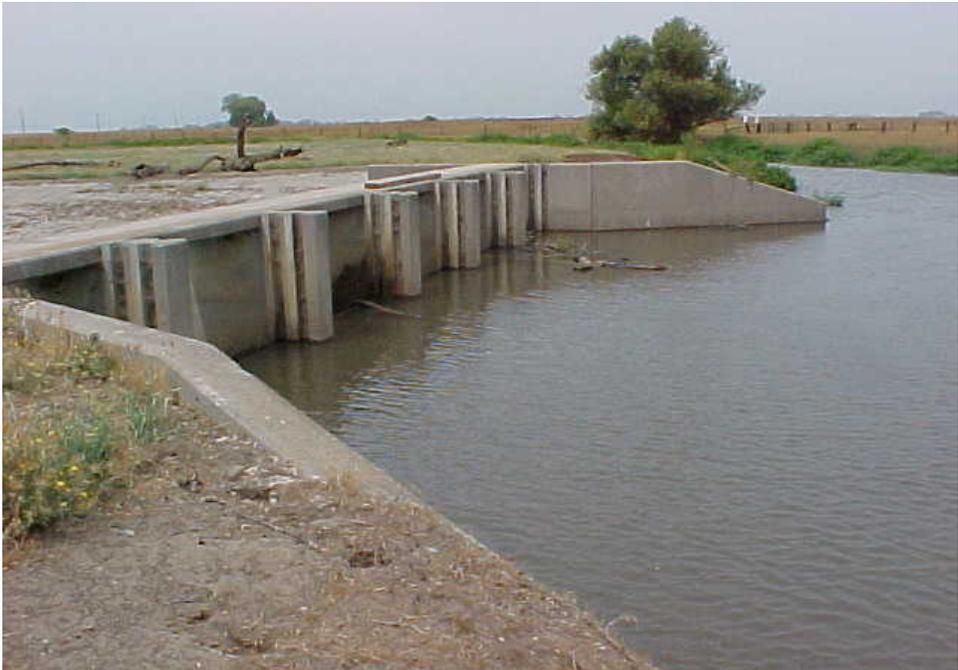
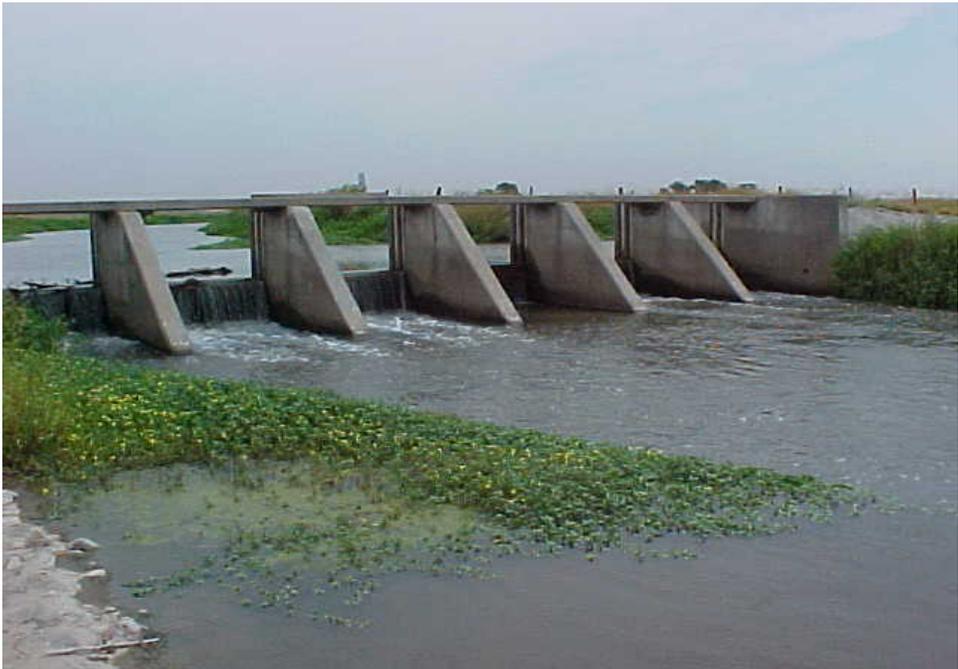
**INSPECTION OF BEAR CREEK DIVERSION STRUCTURE
(Maintained by Lower San Joaquin Levee District)
August 2001**

1. **Condition of concrete weir structure and stilling basin.**
 - a. **Good.**
2. **Condition of concrete abutments and wingwalls.**
 - a. **Good.**
3. **Condition of revetment.**
 - a. **Damage to left bank upstream of structure.**
4. **Accumulation of trash and debris around the structure or in the channel.**
 - a. **None.**
5. **Vegetation around the structure or in the channel.**
 - a. **None.**
6. **Comments:**
 - a. **Repair left bank before next flood season.**
 - b. **Good maintenance.**

Looking at the upstream side of the structure.

Looking at the downstream side of the structure.

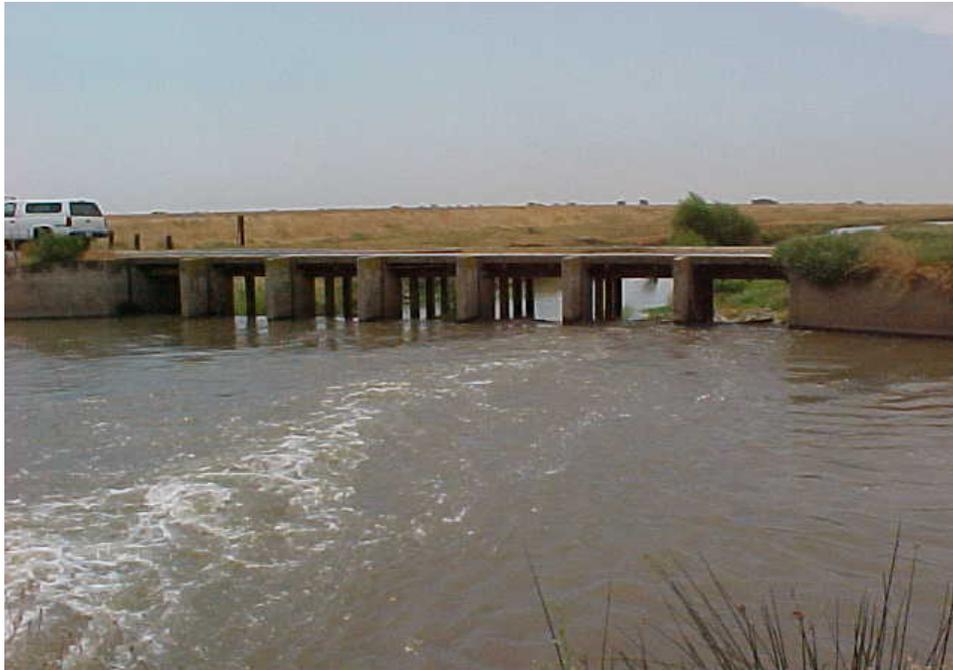
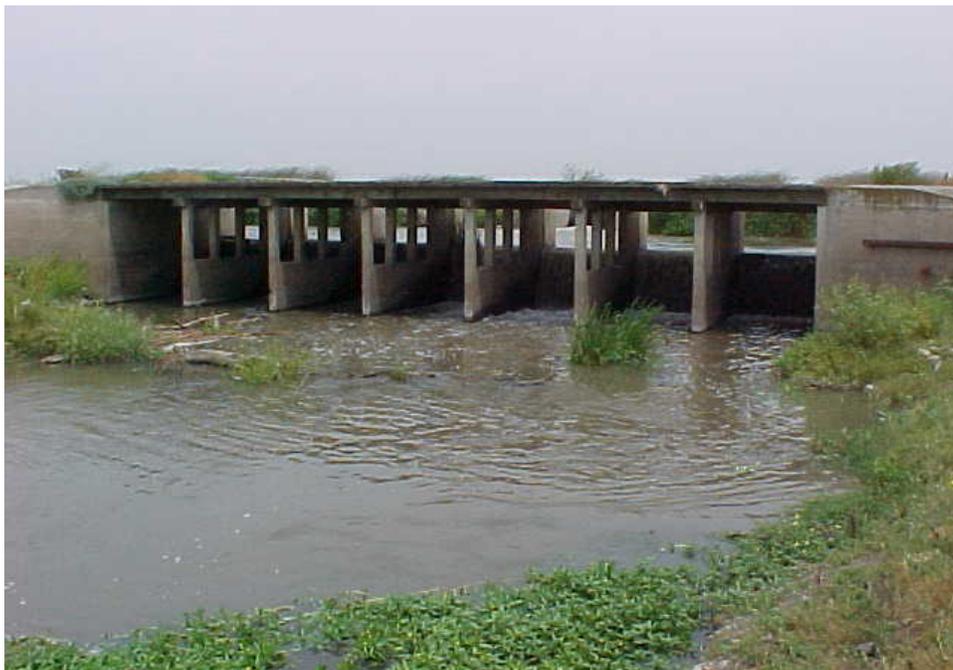
**INSPECTION OF OWENS CREEK CONTROL STRUCTURE
(Maintained by the Lower San Joaquin Levee District)
August 2001**

1. **Condition of concrete control structure.**
 - a. **Good**
2. **Condition of abutments and wingwalls.**
 - a. **Good.**
3. **Condition of stop logs and supports.**
 - a. **Good.**
4. **Accumulation of trash and debris around the structure or in the channel.**
 - a. **None.**
5. **Vegetation around the structure or in the channel.**
 - a. **None.**
6. **Comments:**
 - a. **This structure was in existence prior to the construction of the project and is a part of the Lower San Joaquin Levee District but is operated by Eastside Canal Company. The structure is showing some wear from aging but is still in good condition.**
 - b. **Good maintenance.**

Looking at the upstream side of the structure from the left bank.

Looking at the downstream side of the structure from the right bank.

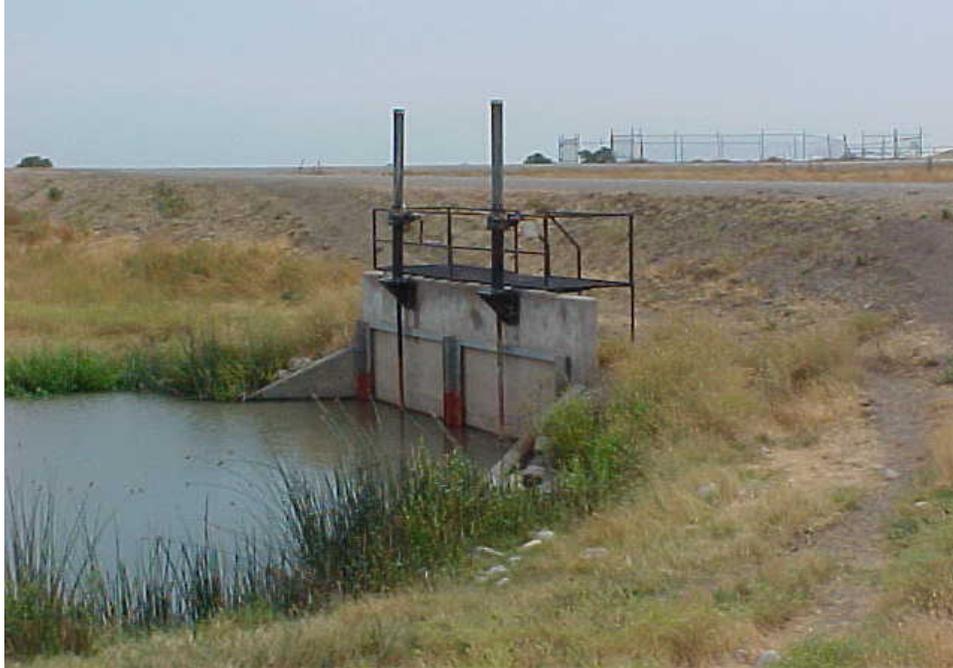
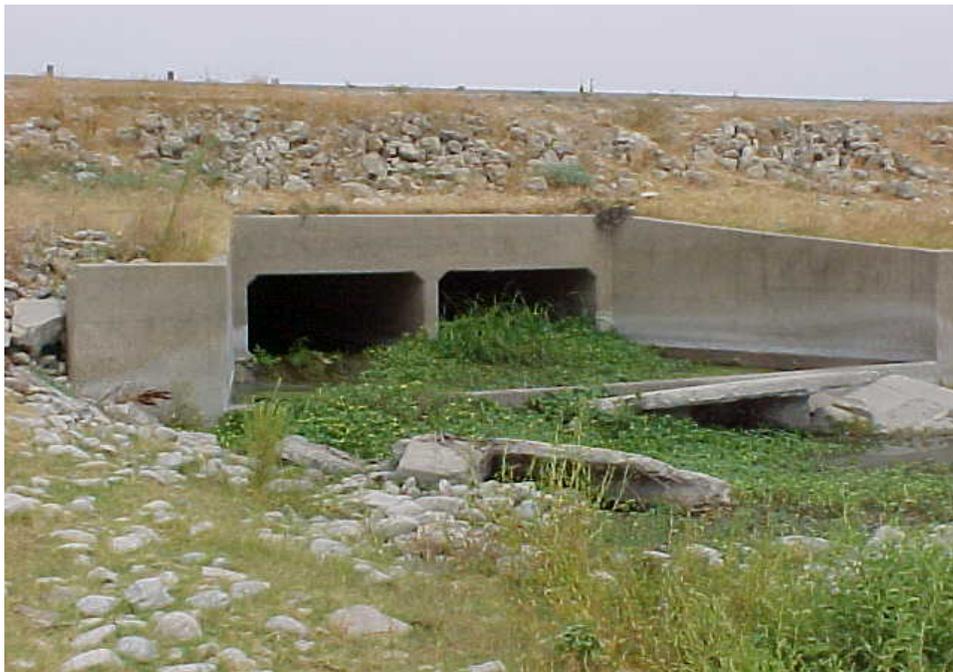
**INSPECTION OF OWENS CREEK OVERFLOW STRUCTURE (UNLISTED)
(Maintained by Lower San Joaquin Levee District)
August 2001**

- 1. Condition of the concrete overflow structure.**
 - a. Fair, the concrete apron on the discharge side is damaged.**
- 2. Condition of the abutments and wingwalls.**
 - a. Good.**
- 3. Condition of the control gates and mechanism.**
 - a. Good.**
- 4. Condition of the revetment.**
 - a. Poor on downstream edge of structure.**
- 5. Accumulation of trash and debris around the structure or in the channel.**
 - a. None.**
- 6. Vegetation around the structure or in the channel.**
 - a. None.**
- 7. Comments:**
 - a. Fair maintenance.**
 - b. Repair the concrete apron on the discharge side of the structure.**
 - c. Replace moved revetment at downstream edge of structure.**

View of the two 72 inch slide gates at the intake side of the structure.

**View of the discharge side of the structure
where it empties into the Eastside Bypass.**
