**State of California
The Resources Agency
DEPARTMENT OF WATER RESOURCES
Division of Flood Management**

**2001
OFFICE REPORT**

**INSPECTION OF FLOOD CONTROL STRUCTURES
ON THE SACRAMENTO AND SAN JOAQUIN RIVERS
AND THEIR TRIBUTARIES**

**Prepared by
FLOOD PROJECT INSPECTION SECTION**

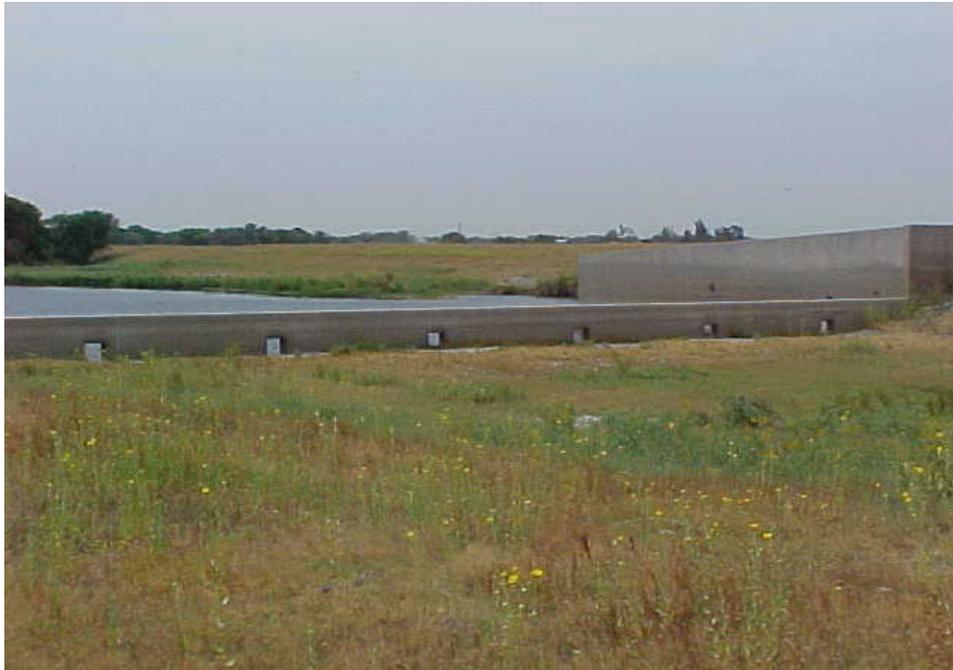
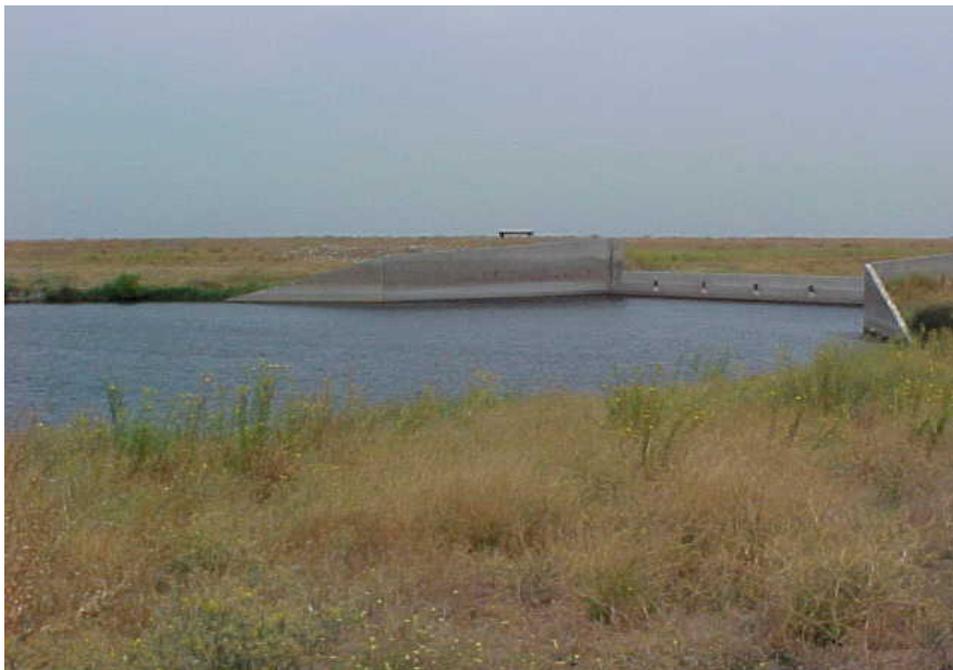
**INSPECTION OF MARIPOSA BYPASS DROP STRUCTURE
(Maintained by Lower San Joaquin Levee District)
August 2001**

- 1. Condition of concrete drop structure, stilling basin, and velocity dissipators.**
 - a. Good.**
- 2. Condition of concrete abutments and wingwalls.**
 - a. Left wingwall has 3/4-inch separation at the joint but otherwise it is in excellent condition.**
- 3. Condition of revetment.**
 - a. Good.**
- 4. Accumulation of trash and debris around the structure or in the channel.**
 - a. None.**
- 5. Vegetation around the structure or in the channel.**
 - a. None.**
- 6. Comments:**
 - a. Good maintenance.**

Looking at the upstream side of the structure.

Looking at the downstream side of the structure.

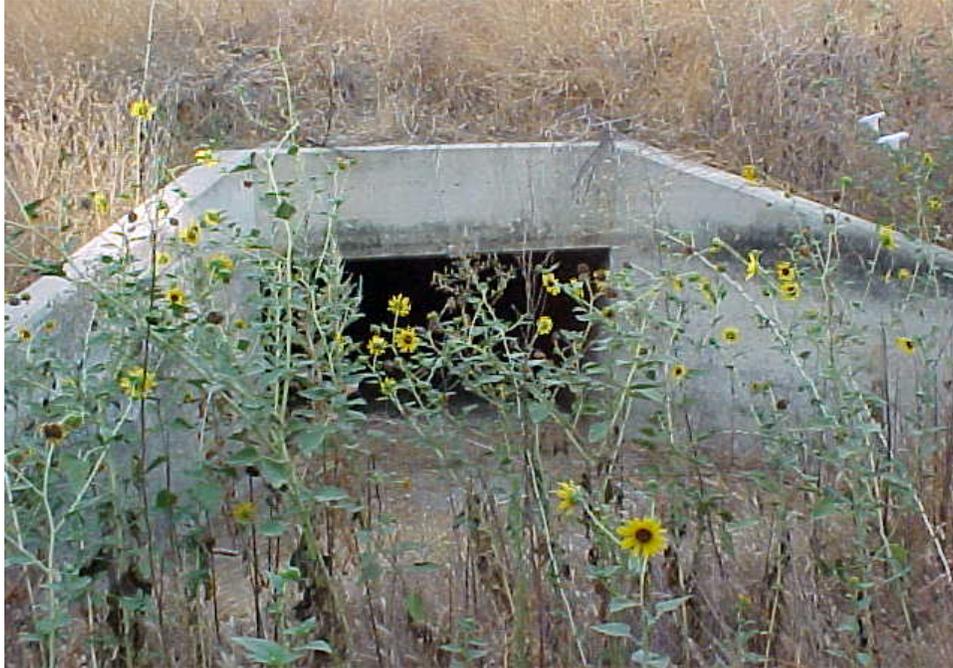
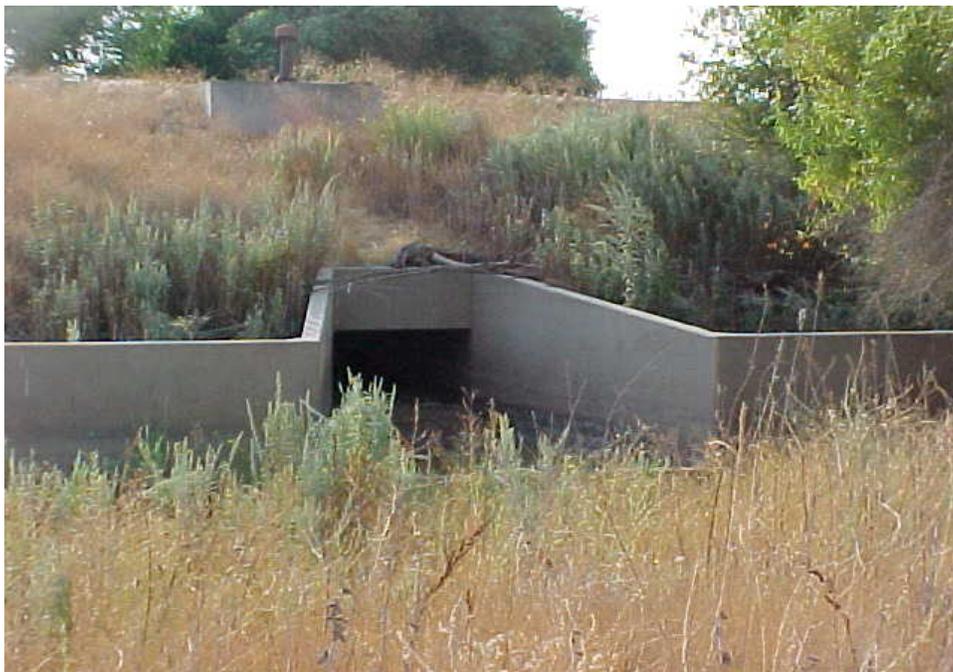
**INSPECTION OF FRESNO RIVER DRAINAGE STRUCTURE
(Maintained by Lower San Joaquin Levee District)
August 2001**

- 1. Condition of concrete drainage structure.**
 - a. Good.**
- 2. Condition of abutments and wingwalls.**
 - a. Good.**
- 3. Condition of control gate, mechanism, and flap gate.**
 - a. The control mechanism is bent.**
- 4. Condition of revetment.**
 - a. Good.**
- 5. Accumulation of trash and debris around the structure or in the channel.**
 - a. Good.**
- 6. Vegetation around the structure or in the channel.**
 - a. None.**
- 7. Comments:**
 - a. The control mechanism for the gate needs to be straightened but otherwise this structure is in good condition.**

Looking at the intake (upstream) side of the structure.

Looking at the discharge (downstream) side of the structure.

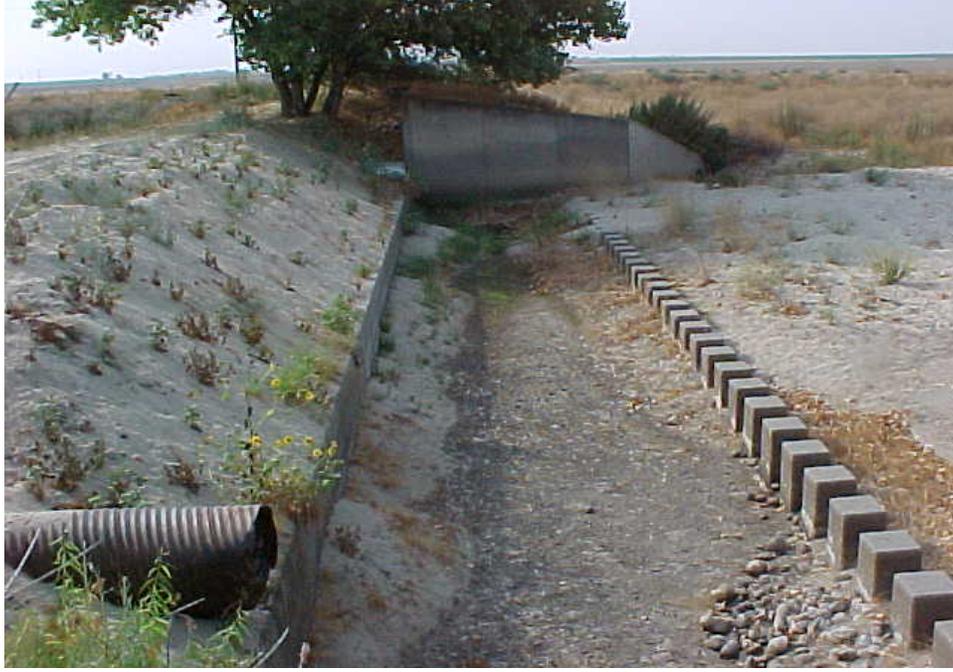
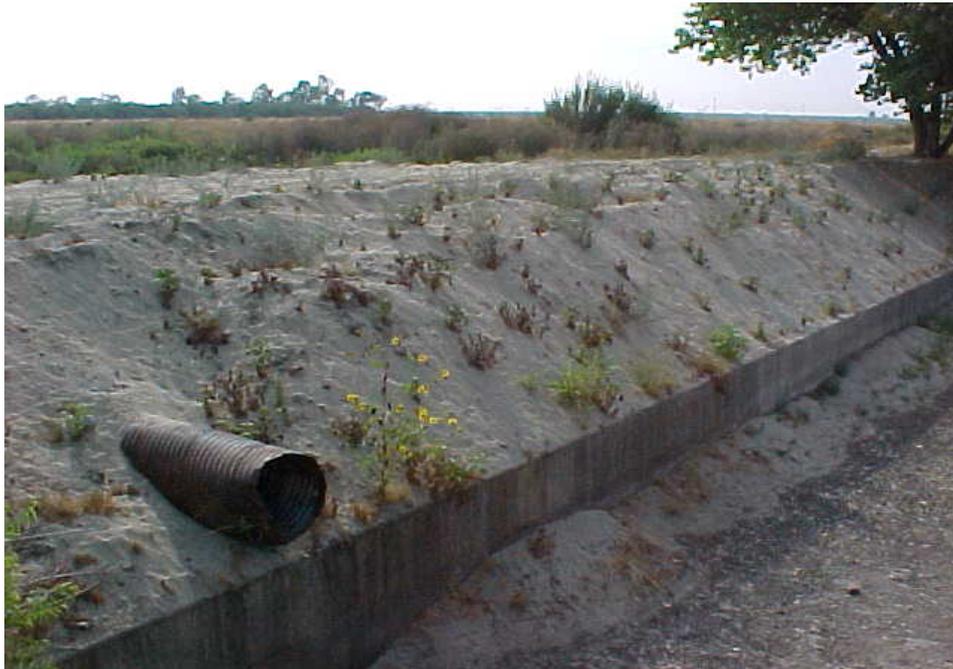
**INSPECTION OF ASH SLOUGH DROP STRUCTURE NO. 4
(Maintained by Lower San Joaquin Levee District)
August 2001**

- 1. Condition of concrete drop structure, stilling basin, and velocity dissipaters.**
 - a. What can be seen is in good condition, but a seasonal sand dam is in place backing up water for irrigation purposes on the upstream side.**
- 2. Condition of concrete abutment wingwalls.**
 - a. Good.**
- 3. Condition of revetment.**
 - a. Good.**
- 4. Accumulation of trash and debris around the structure or in the channel.**
 - a. None.**
- 5. Vegetation around the structure or in the channel.**
 - a. Bamboo growing along right wingwall.**
- 6. Comments:**
 - a. The seasonal sand dam on the upstream side is for irrigation purposes and can be easily breached or washed out in the event of high water.**
 - b. Remove bamboo.**

Looking at the downstream side of the drop structure.

Looking at the seasonal sand irrigation dam with two culverts installed.

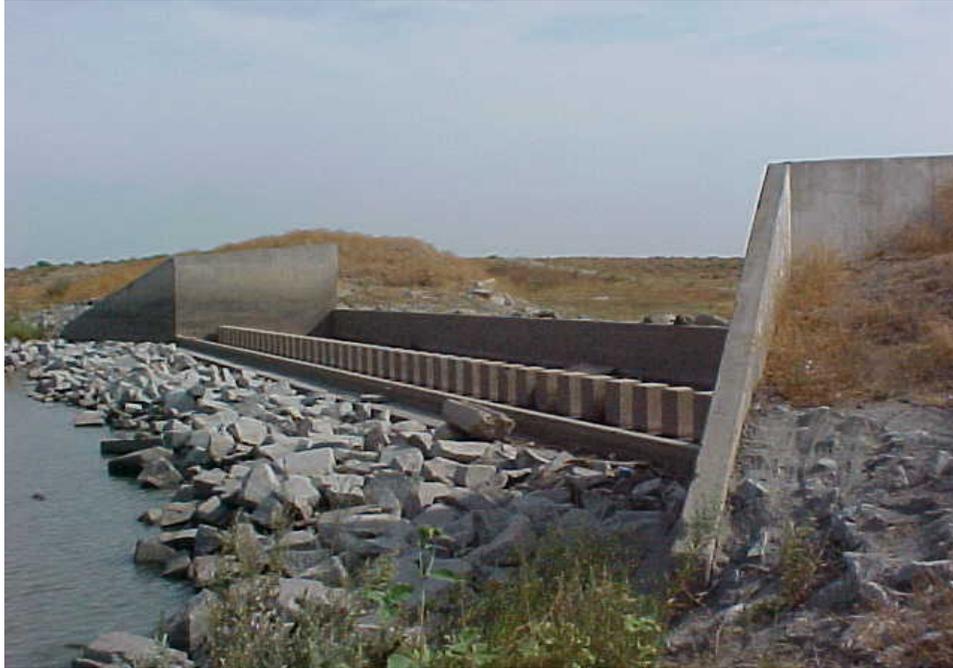
**INSPECTION OF EASTSIDE DROP STRUCTURE NO. 2
(Maintained by Lower San Joaquin Levee District)
August 2001**

1. **Condition of concrete structure, stilling basin, and velocity dissipators.**
 - a. **Good.**
 - b. **It was noted last year that concrete spalling exists on the floor of the stilling basin. This was first noted in 1969.**
2. **Condition of concrete abutments and wingwalls.**
 - a. **Good.**
3. **Condition of revetment.**
 - a. **Good.**
4. **Accumulation of trash and debris around the structure or in the channel.**
 - a. **None.**
5. **Vegetation and debris around the structure or in the channel.**
 - a. **None.**
6. **Comments:**
 - a. **Good maintenance.**

Looking at the downstream side of the structure.

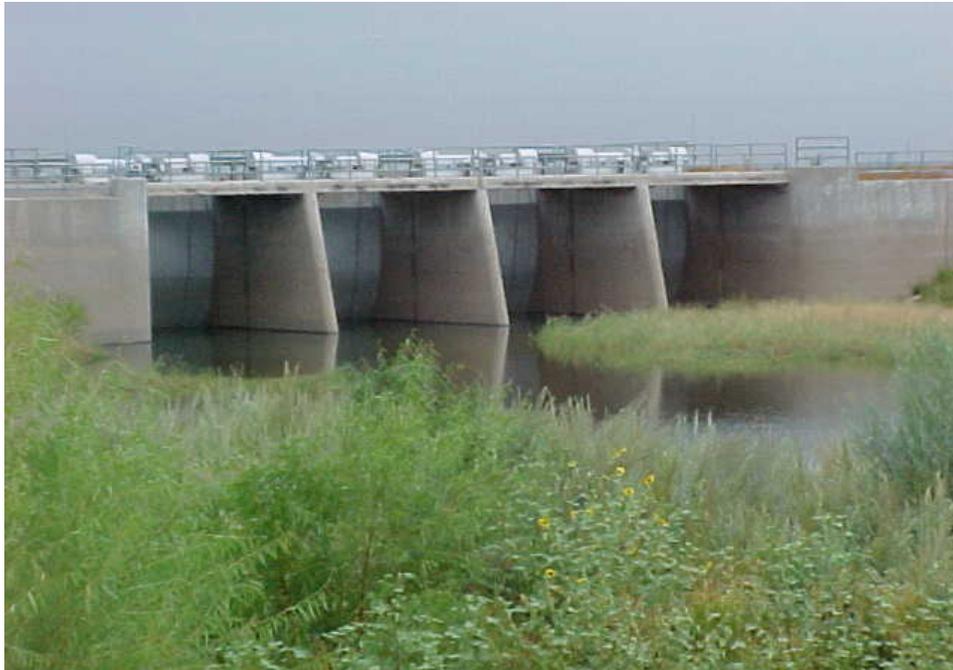
**INSPECTION OF SAN JOAQUIN RIVER AND
CHOWCHILLA CANAL BYPASS CONTROL STRUCTURES
(Maintained by Lower San Joaquin Levee District)
August 2001**

1. **Condition of the San Joaquin River Control Structure.**
 - a. **Good.**
2. **Condition of the Chowchilla Canal Bypass Structure.**
 - a. **Good.**
3. **Condition of the abutments and wingwalls.**
 - a. **Good.**
4. **Condition of the radial gates and mechanisms.**
 - a. **Good.**
5. **Condition of the gate hoist equipment.**
 - a. **Good.**
6. **Condition of the engine generator set.**
 - a. **Good.**
7. **Condition of the floatwells and equipment.**
 - a. **Good.**
8. **Accumulation of trash and debris around the structures or in the channel.**
 - a. **None.**
9. **Vegetation around the structures or in the channel.**
 - a. **None.**

Looking at the upstream side of the Chowchilla Canal Bypass structure.

- a. All equipment is tested and serviced by the U.S. Bureau of Reclamation prior to flood season.**
- b. Remove debris against San Joaquin River Control Structure trashrack.**
- c. Good maintenance.**

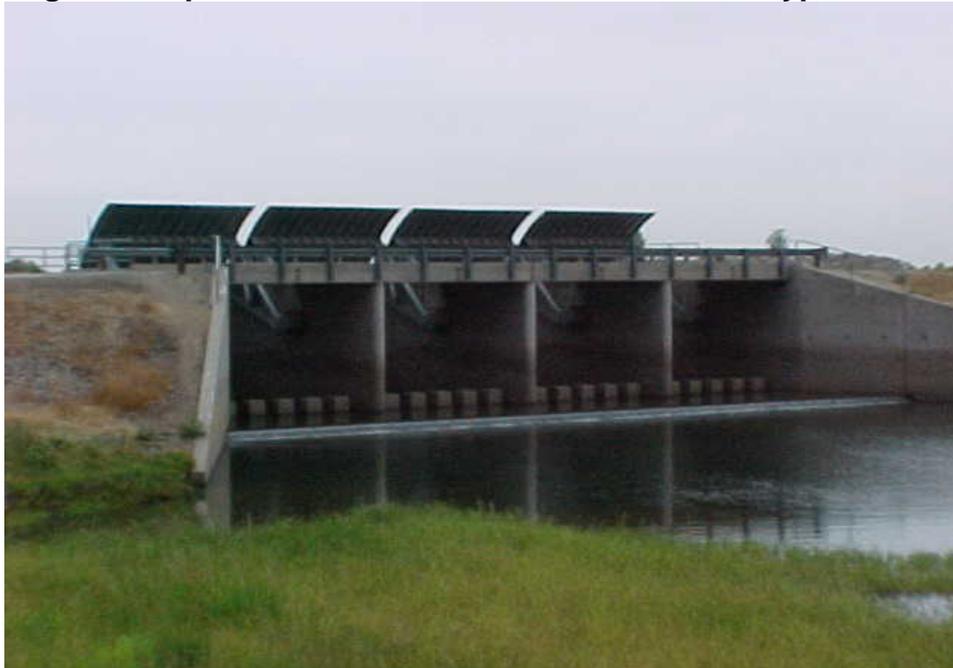
Looking downstream at the Chowchilla Canal Bypass.

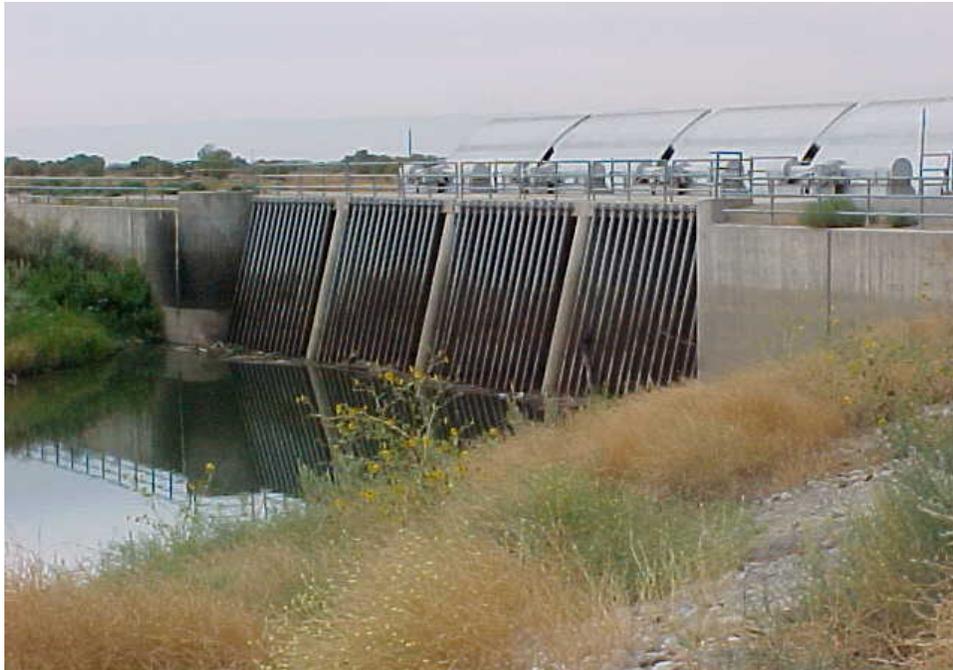
Looking at downstream side of the San Joaquin River Control Structure.

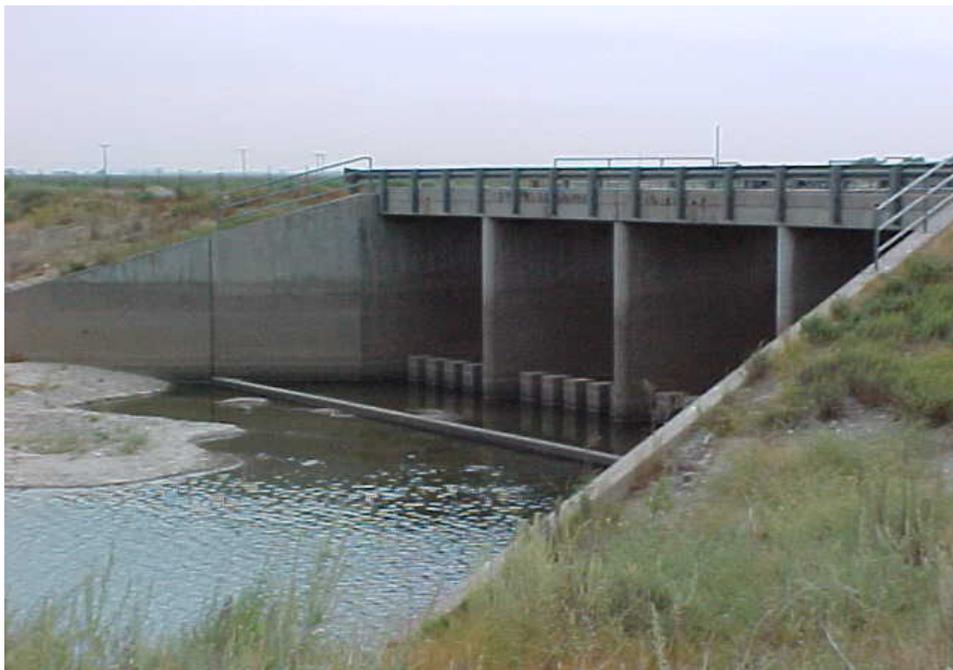
Looking at the upstream side of the San Joaquin River Control Structure.
